**ARCHAEOLOGICAL ASSESSMENT OF THE DESIGNATED WRECK
OF THE *NORTHUMBERLAND* ON THE GOODWIN SANDS**

**PROJECT REPORT
2018**

Ref: 7700

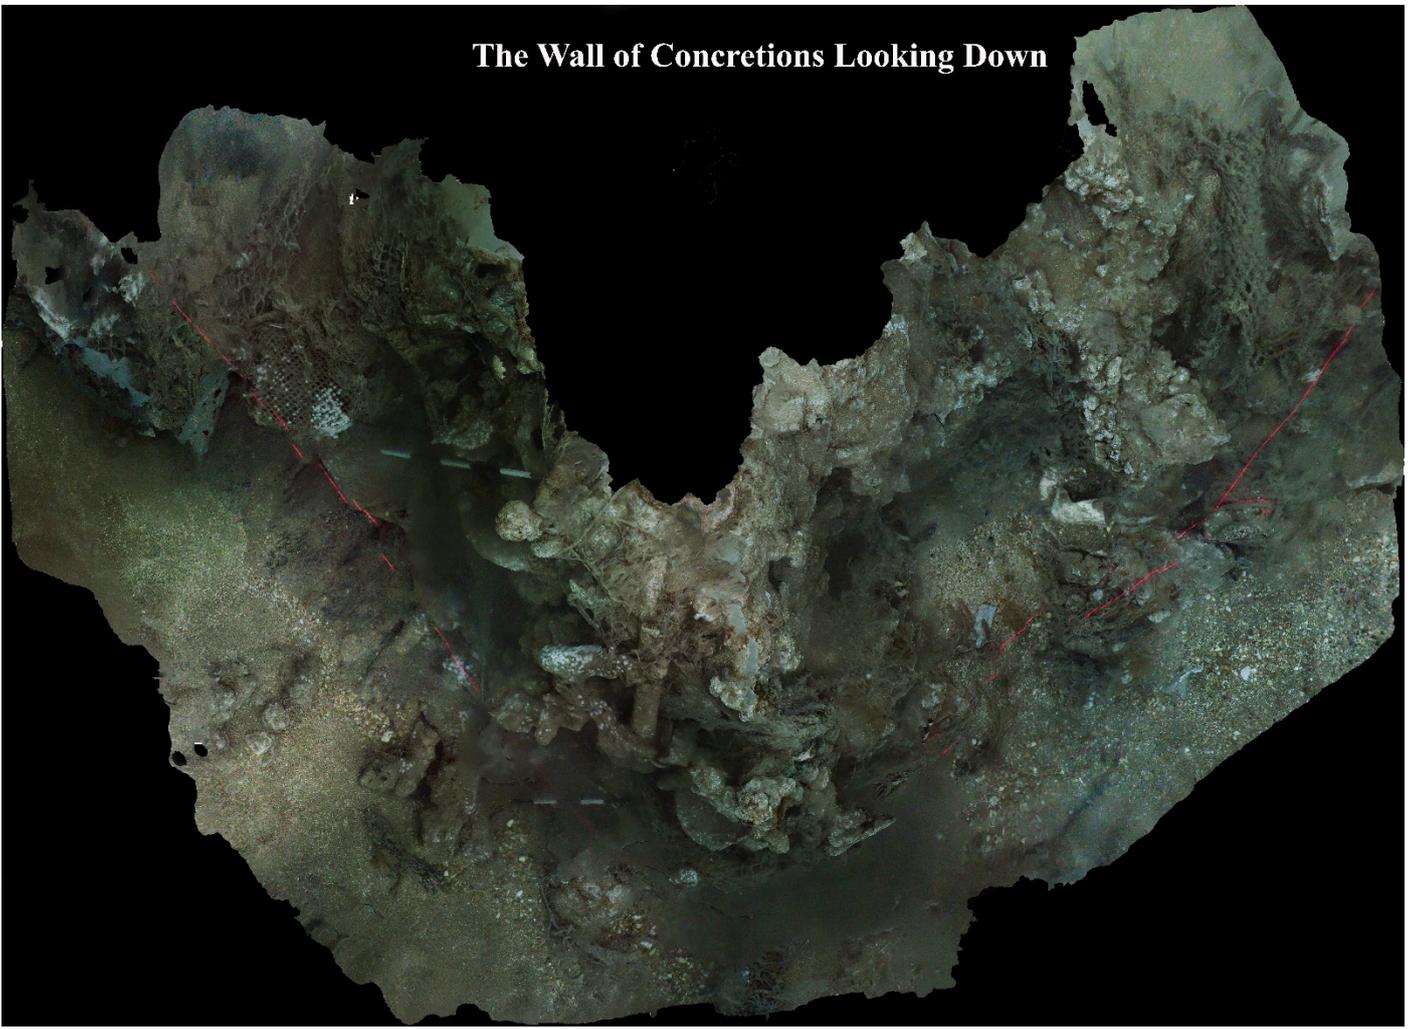
Figure 3: An orthophotomosaic of the plan view of the wall of concretion at the SE of the site. The scales in the image are 1m with 20cm increments.

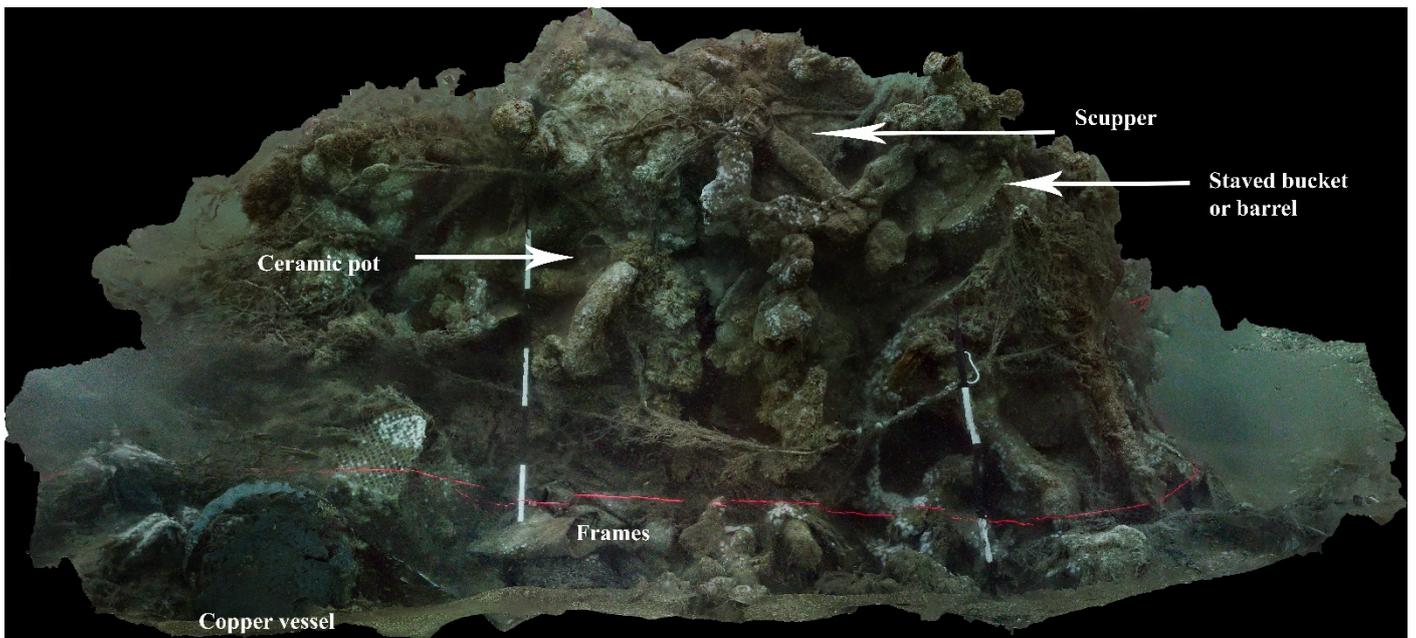
- 4.2.8. Above the timbers the concretion rises vertically by 2m. The face of the feature is heavily entangled with fishing gear, including a lobster pot, trawl and gill nets (Figure 4). On this section of the concretion it is possible to identify several objects. Near the top is a lead scupper 700mm long. It has a flange at one end on the outward side of the concretion. The external diameter of the scupper is 90mm (Figures 4 and 6). To the right of the scupper is a concreted barrel or a staved bucket. It is partially obscured by trawl netting. The diameter of the base is 330mm (Figures 4, 7 and 8). Below and to the left of the scupper is a small vessel, possibly ceramic (Figure 4). It has an external diameter of 150mm. These objects are surrounded by a mess of ferrous objects including shot, possible bar shot, iron rings and a mass of unidentifiable concretions of all shapes and sizes.

Figure 4: An orthophotomosaic of the west face of the concretion wall with annotations. The scales in the image are 1 metre with 20cm increments.

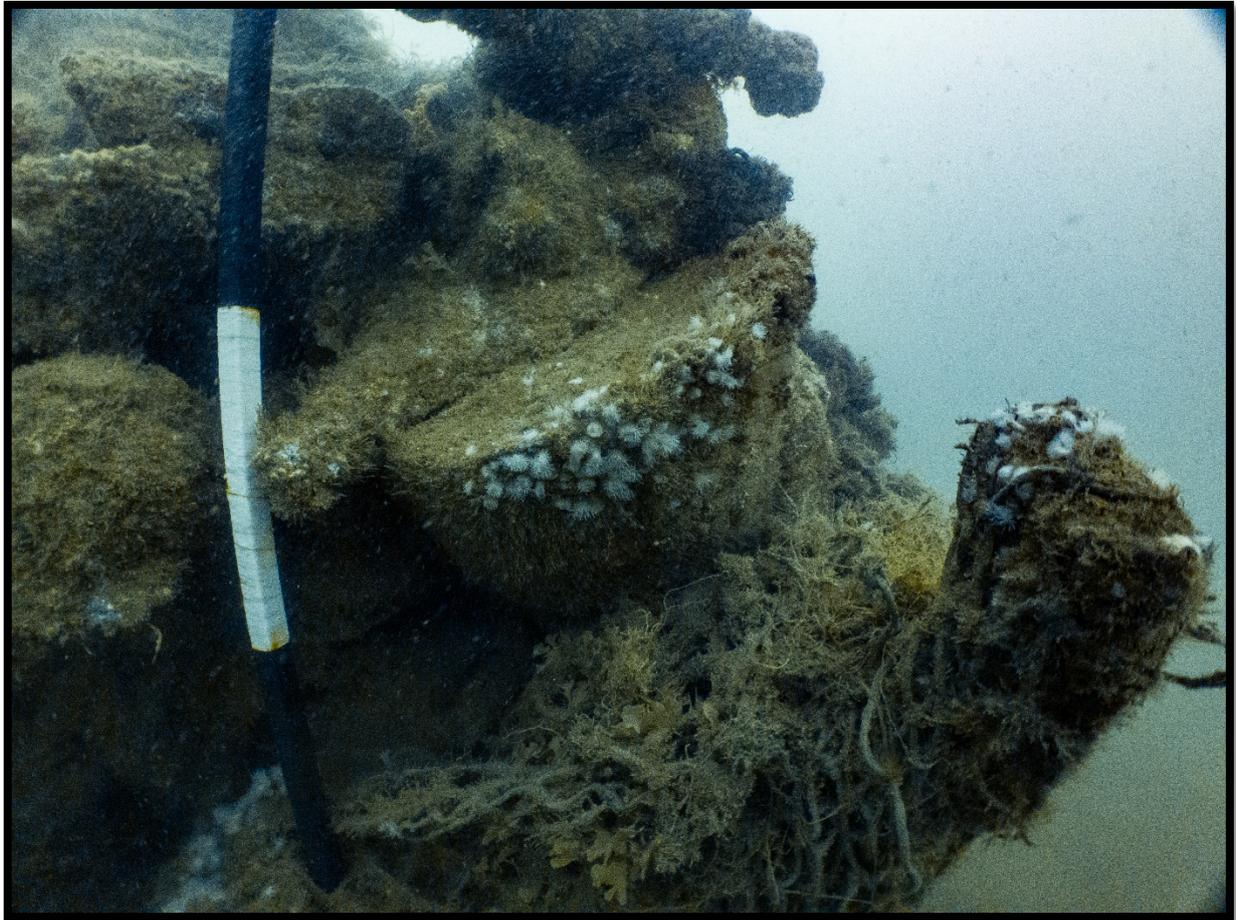
Figure 7: At the centre of the image a concreted staved bucket or barrel.

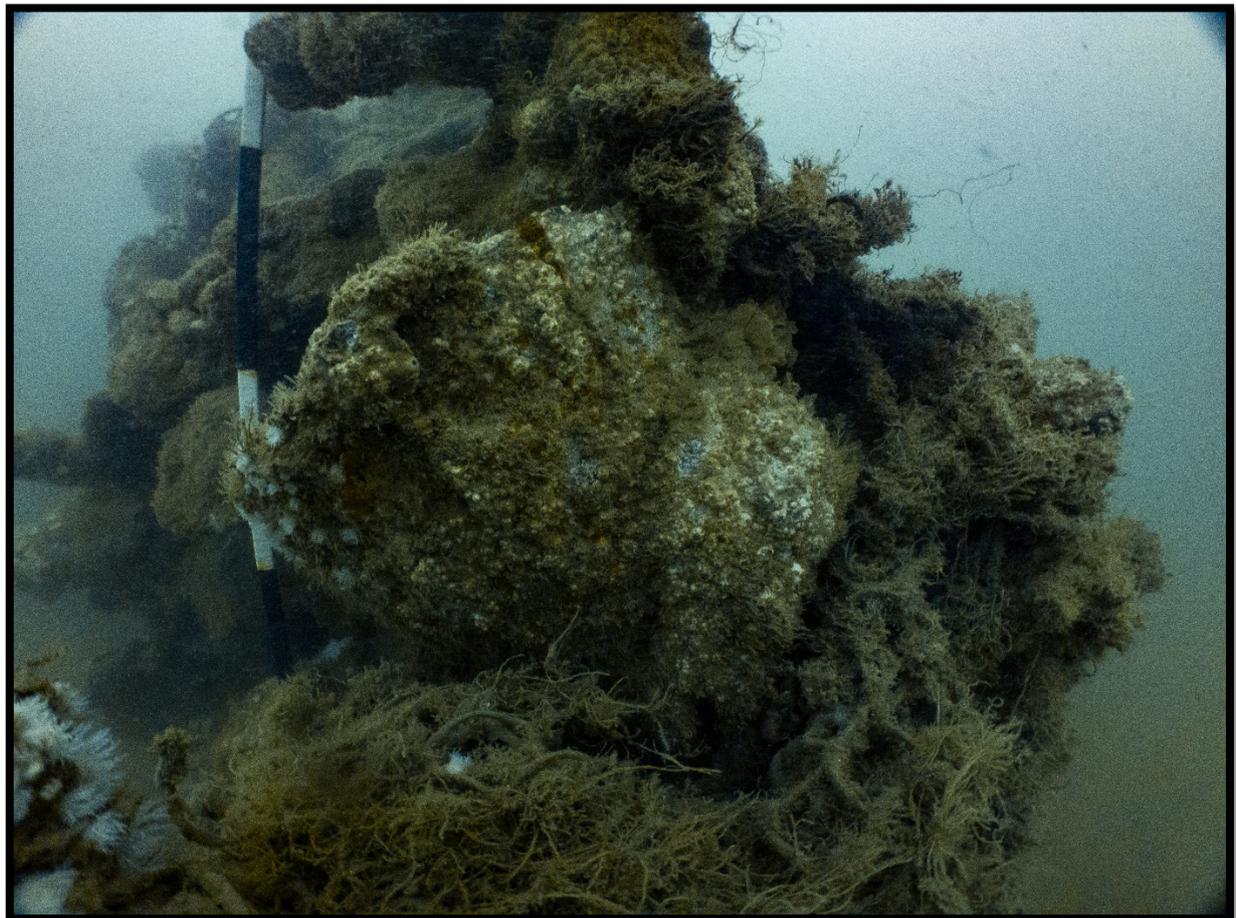
Figure 8: A side view of the concreted stave bucket or barrel.

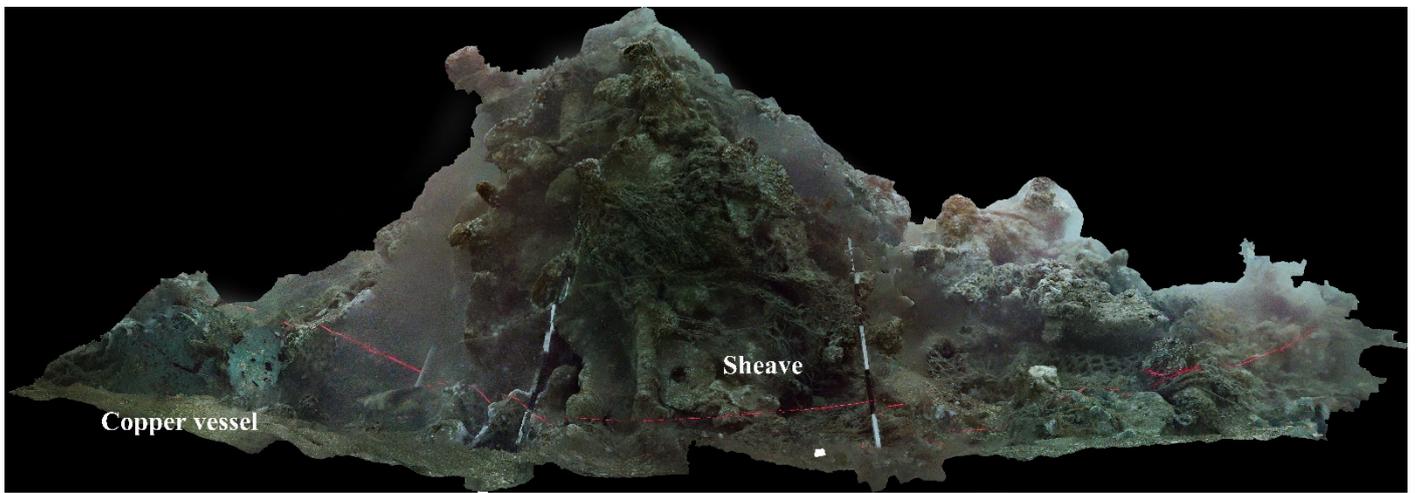
- 4.2.9. Moving round the concretion wall to the south face looking north, a large pulley sheave can be seen. It has a diameter of 300mm (just under 12 inches) and the hole for the pin has a diameter of 60mm (Figure 9). Above the sheave the face of the concretion is obscured by trawl netting. Just under two metres to the east, at seabed level, is at least one other pulley sheave. It is partially buried but looks equally as large as the previous. Once again there is a lot of trawl net covering this area of the concretion.

Figure 9: An orthophotomosaic of the south face of the wall of concretion. The scales are 1 metre with 20cm increments.

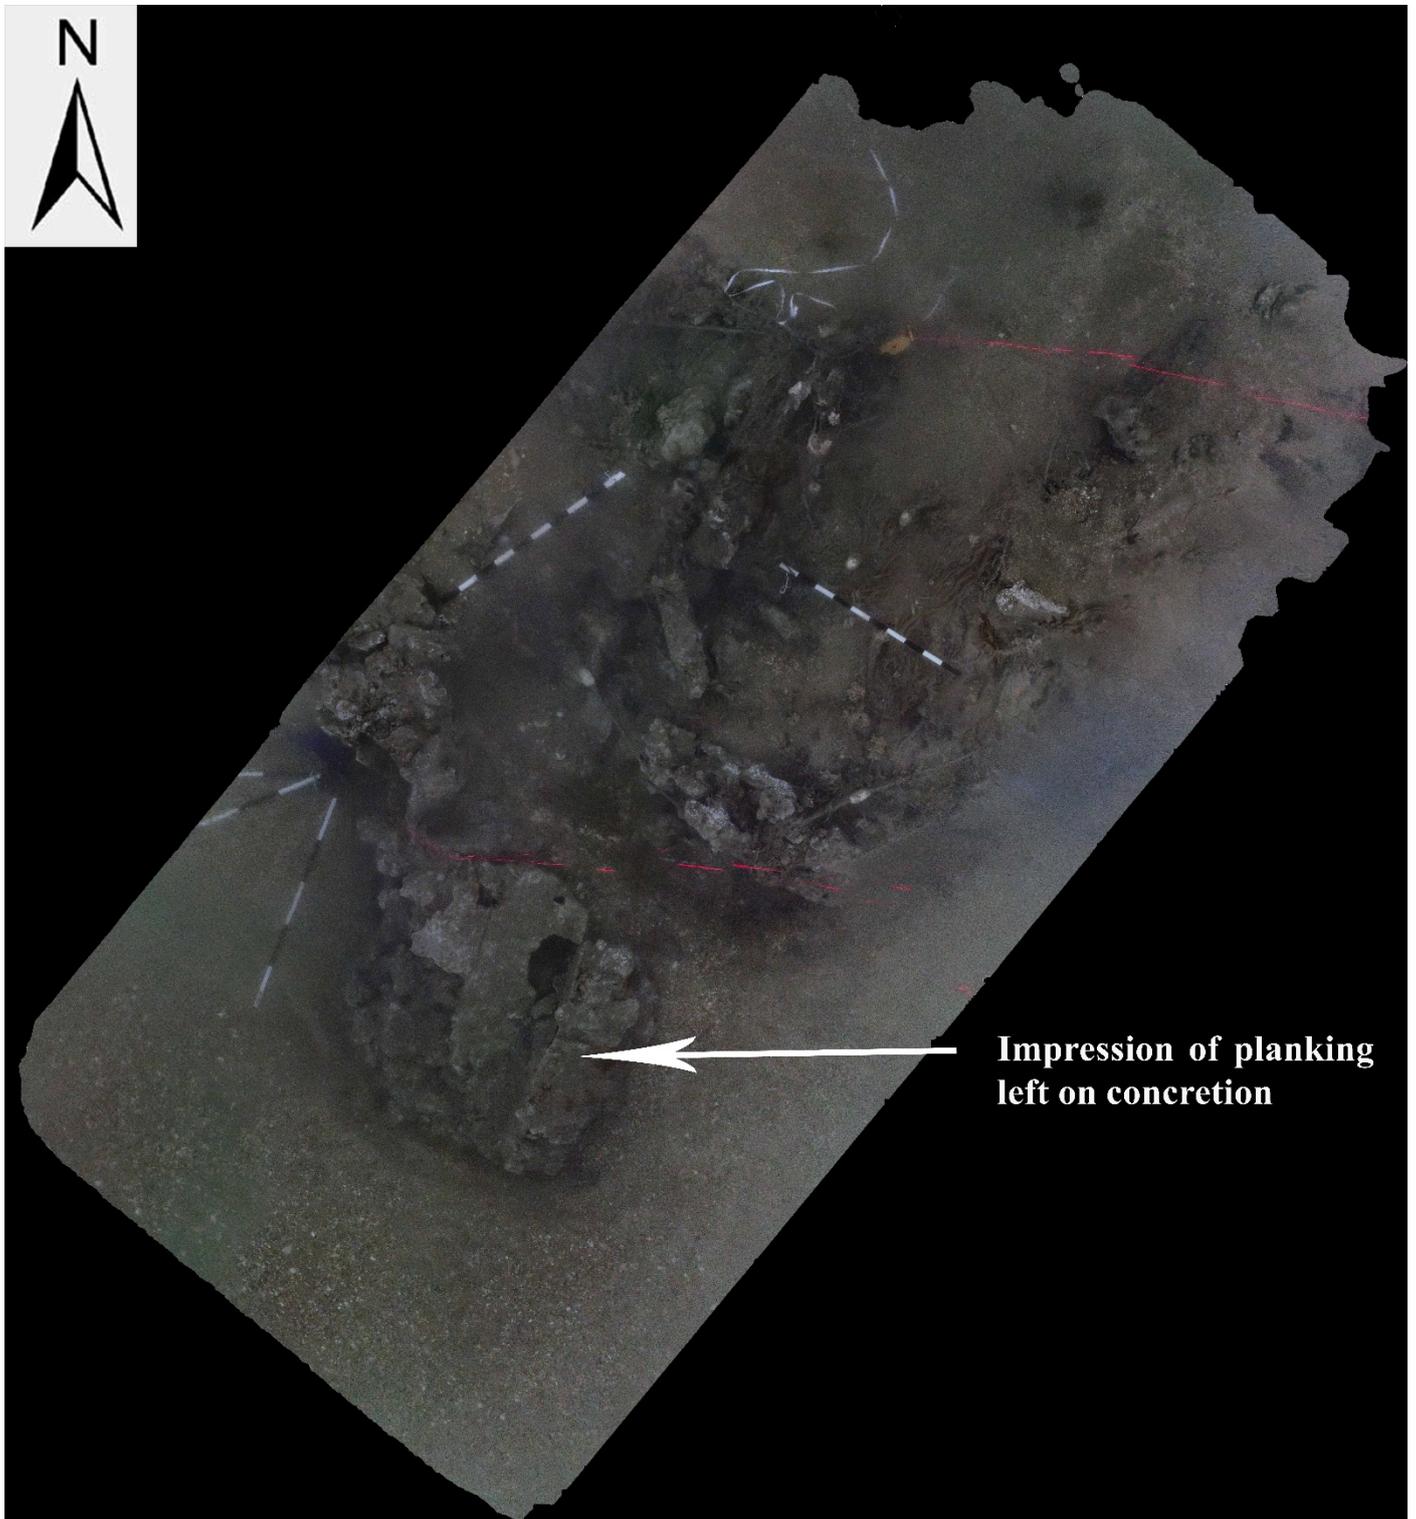
- 4.2.12. Moving towards the centre of the wreck mound is another area of concretions. This was partly recorded photogrammetrically. There was nothing visibly obvious to help with its identification. Although, on the western side, impressions of planking were visible in the surface of the concretion. From the impression left behind the planking was 450mm wide and 150mm thick (Figure 12).

Figure 12: An orthophotomosaic of an area of concretions near the centre of the wreck mound. The scales in the image are 1 metre with 10 and 20cm increments.

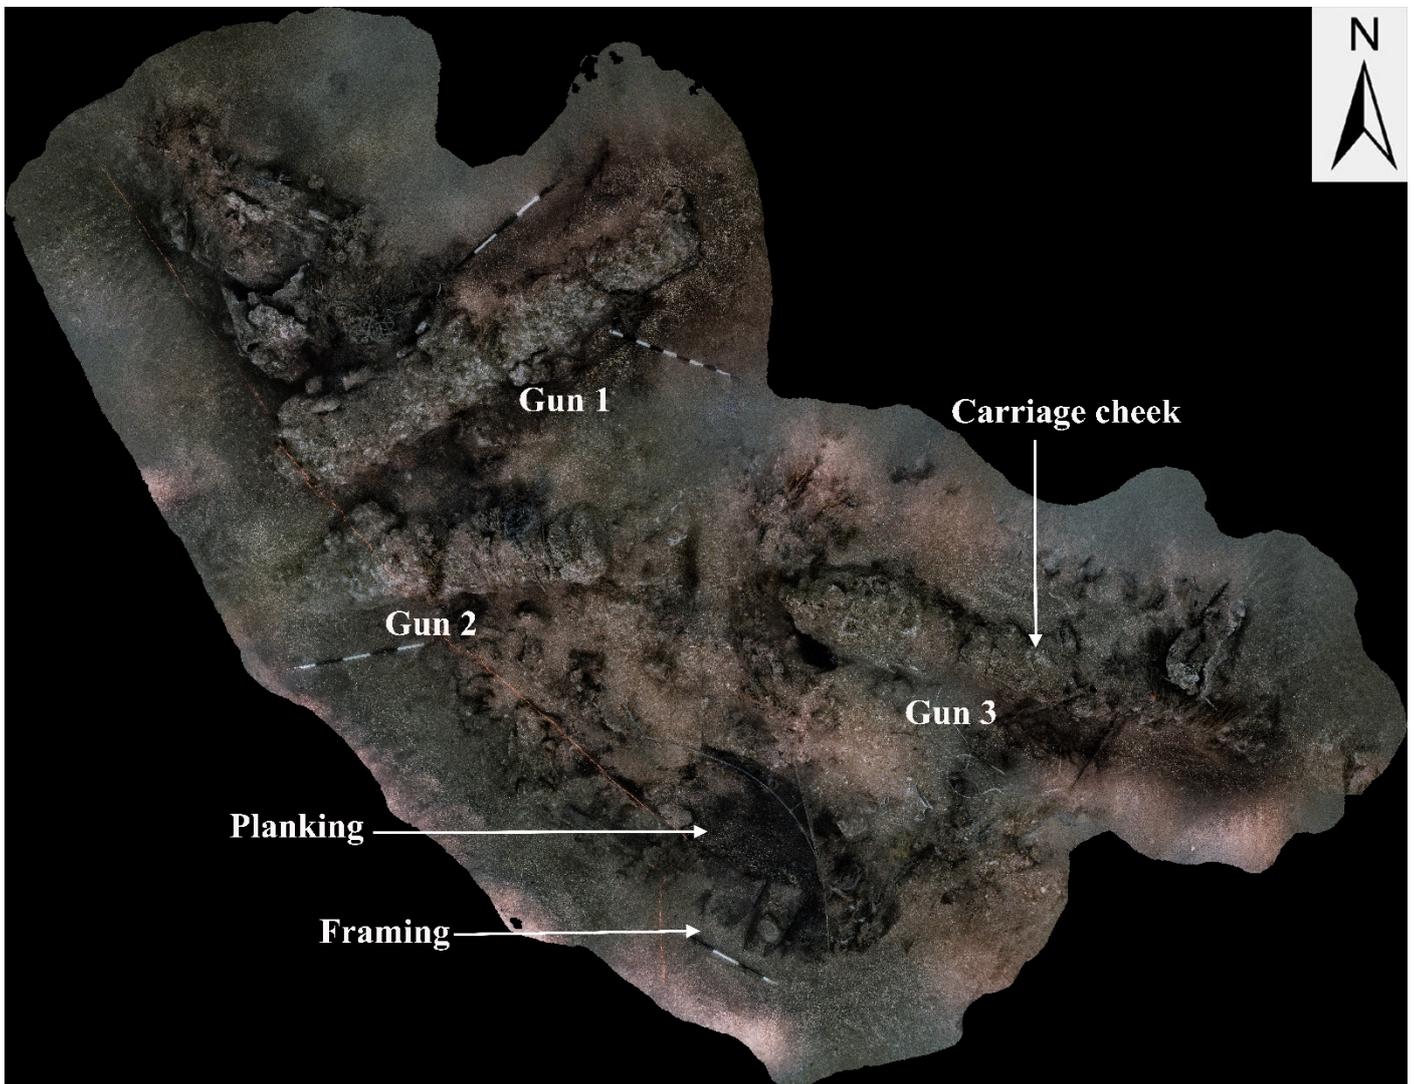
- 4.2.13. Moving 15m to the northwest from the previous area of concretions is an area consisting of three iron guns and a section of structure. This area was recorded photogrammetrically (Figure 13 and 15). The guns are all heavily concreted, so their measurements will be used only as a guide to help identification of their possible type. The guns have been labelled 1 to 3 for this assessment but attempts will be made to match them to guns recorded on previous site plans (Figure 14).

- 4.2.16. Gun 3 is orientated ESE/WNW with the muzzle end pointing ESE. The breech end is 1.3m from the muzzle of Gun 2 (Figure 13). The gun is heavily concreted with other concreted objects stuck to it. This is especially the case around the breech end, which makes identifying the exact location of the base ring almost impossible. It is, therefore, only possible to record the overall length. The length of the gun from the end of the muzzle to the end of the button is 3.6m (11ft 8 inches). The longest guns carried by the *Northumberland* were the culverins, and they were 11 feet long from muzzle to base ring. The Culverins are likely to have been the ship's stern chasers.

Figure 13: An orthophotomosaic of the group of three guns. The scales in the image are 1 metre with 10 and 20cm increments.

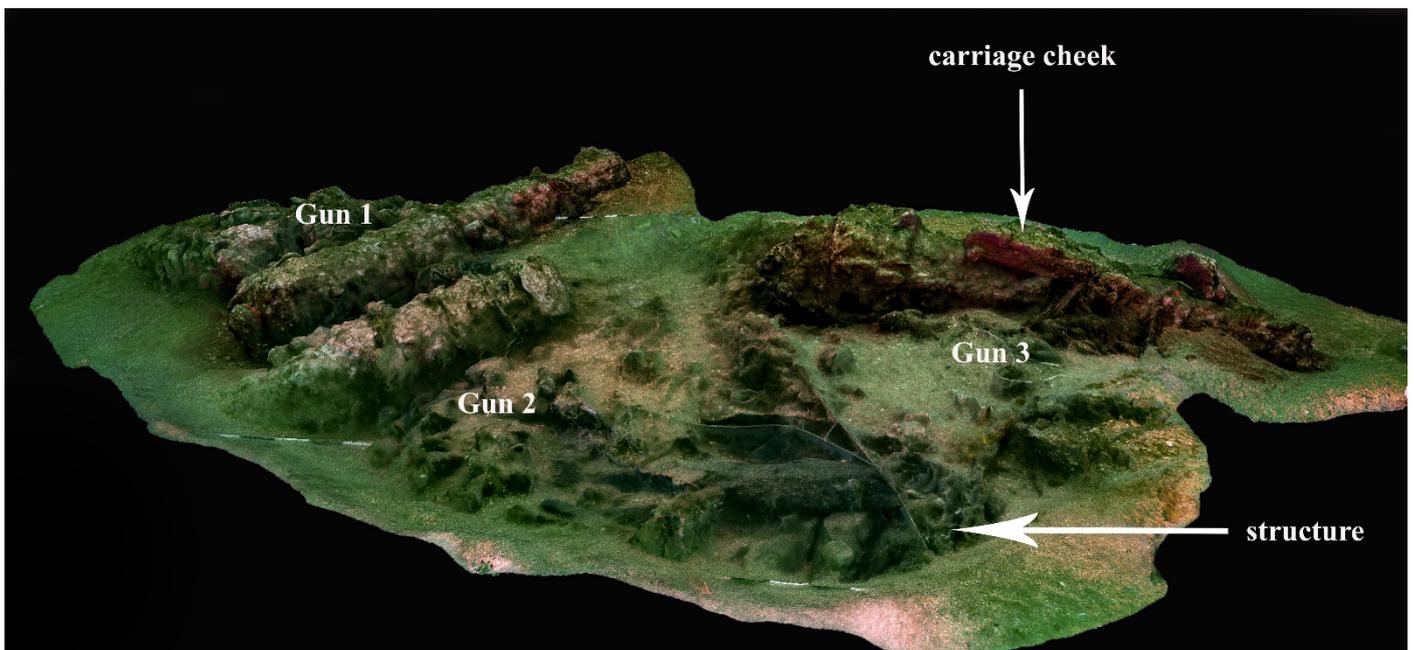
Figure 14: An image taken from the photogrammetry model of the guns. The scales in the image are 1m with 10 and 20cm increments.

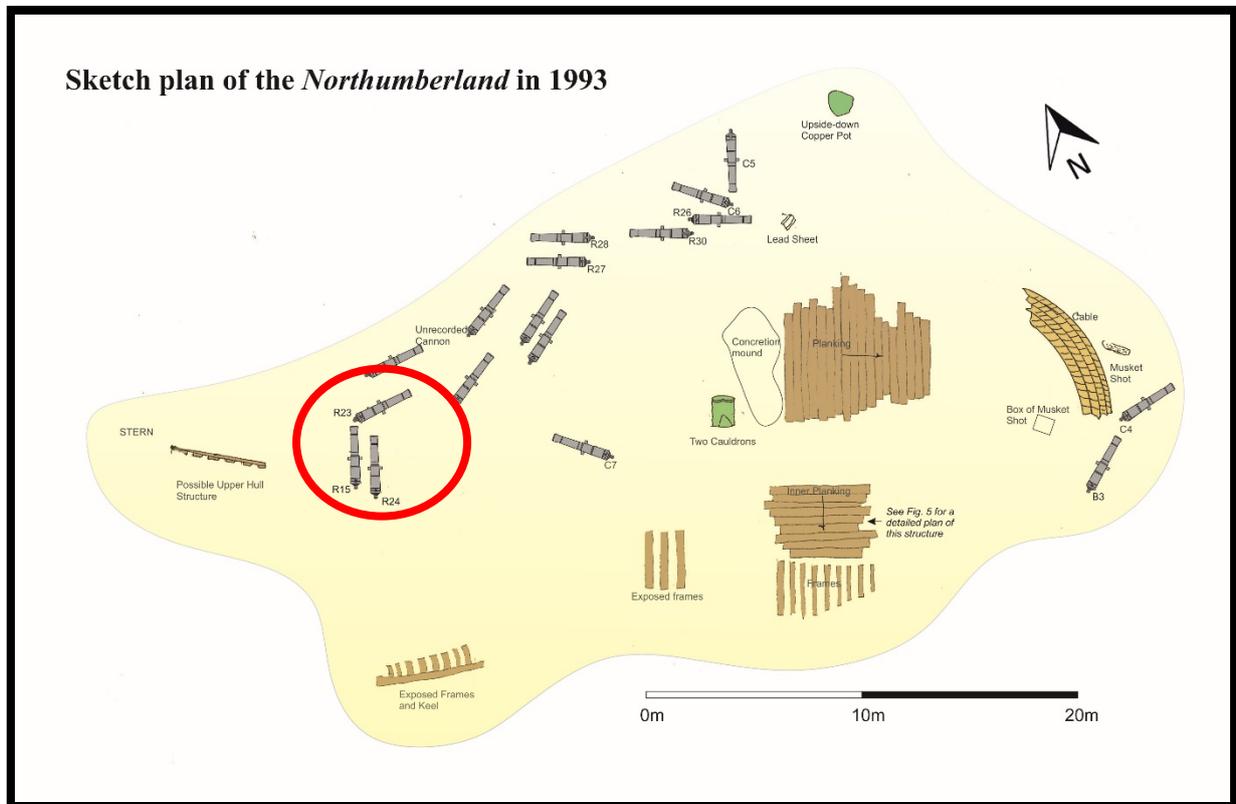
Figure 15: The 1993 sketch plan of the site. The red circle shows the group of guns under the current investigation

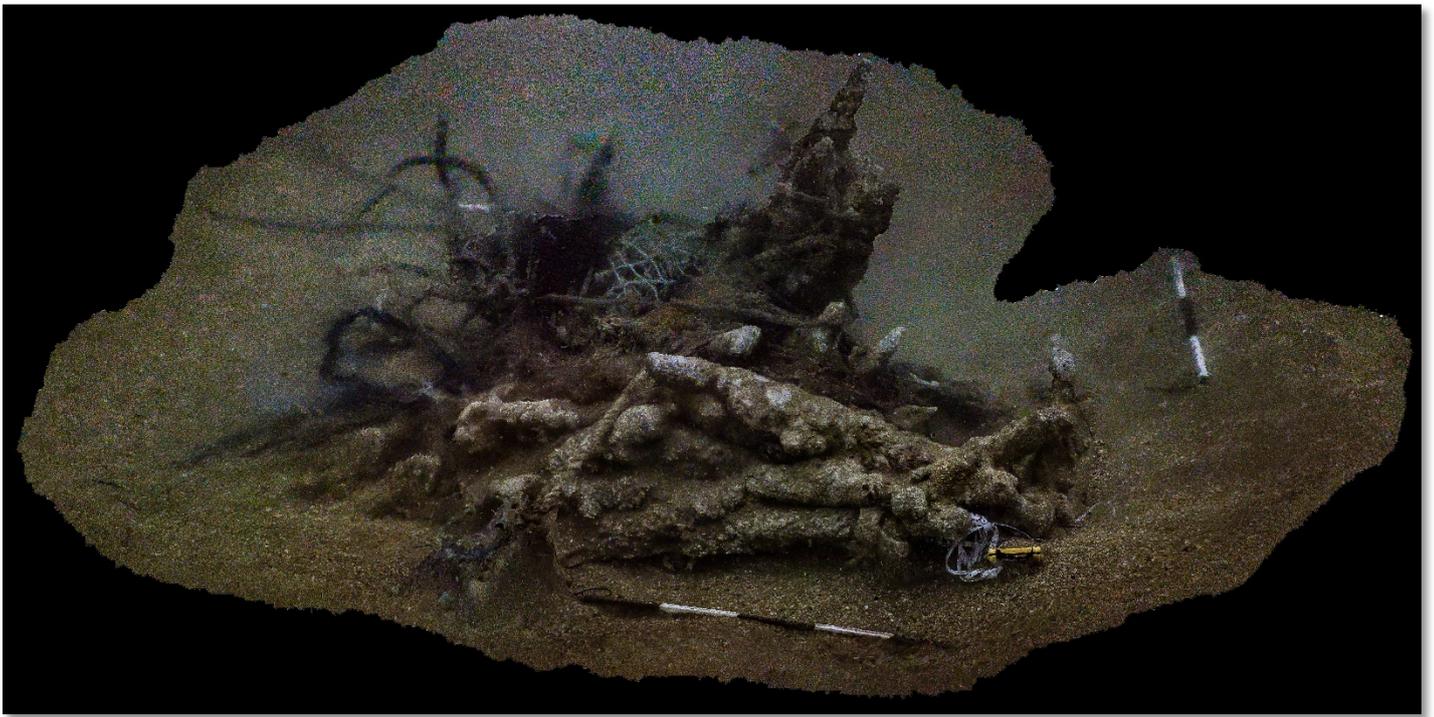
Figure 19: An orthophotomosaic from the side view. It shows how the swords are distributed in horizontally and vertically. The scales are 1 metre with 20cm increments.

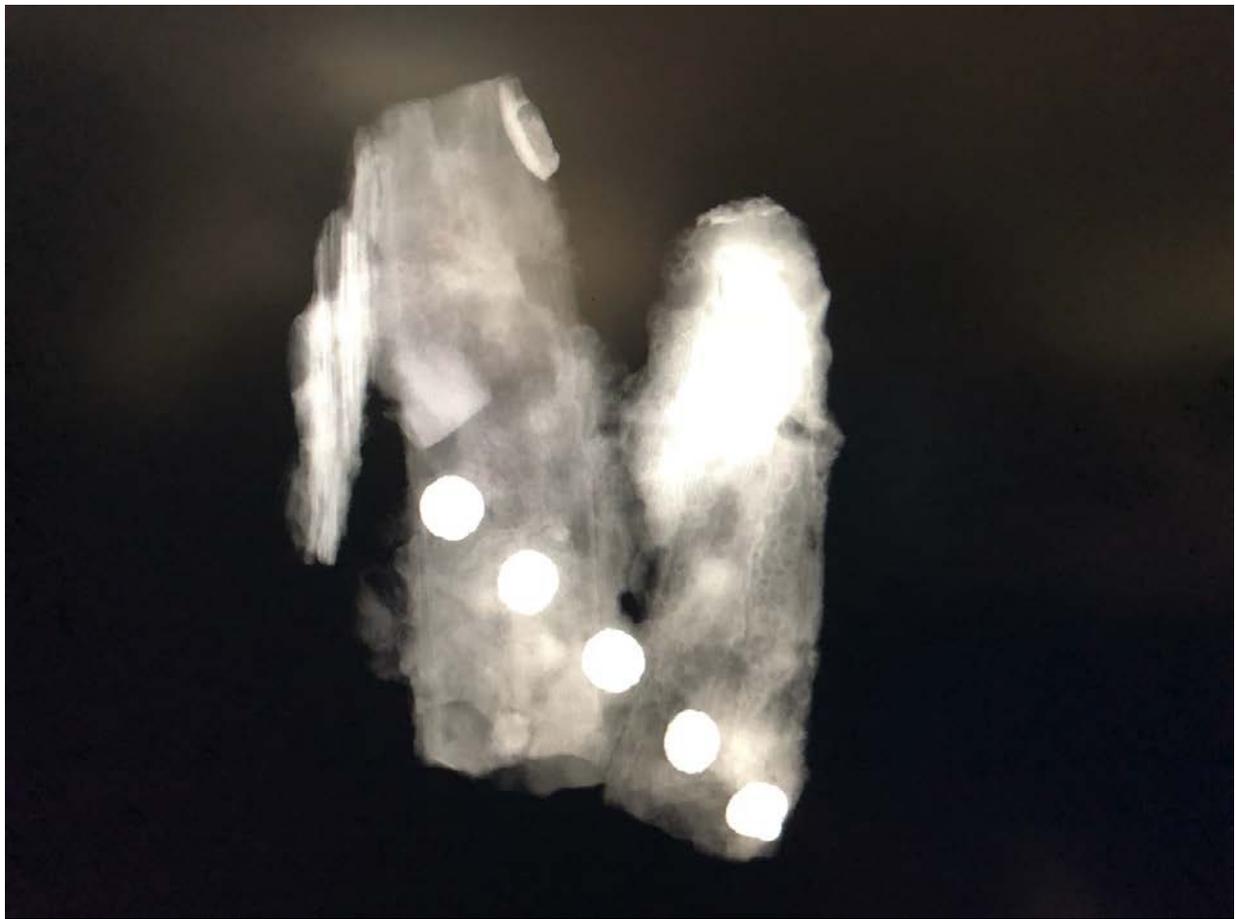
Figure 23: An X-ray identifying the ends of blades plus five metallic buttons in a row.

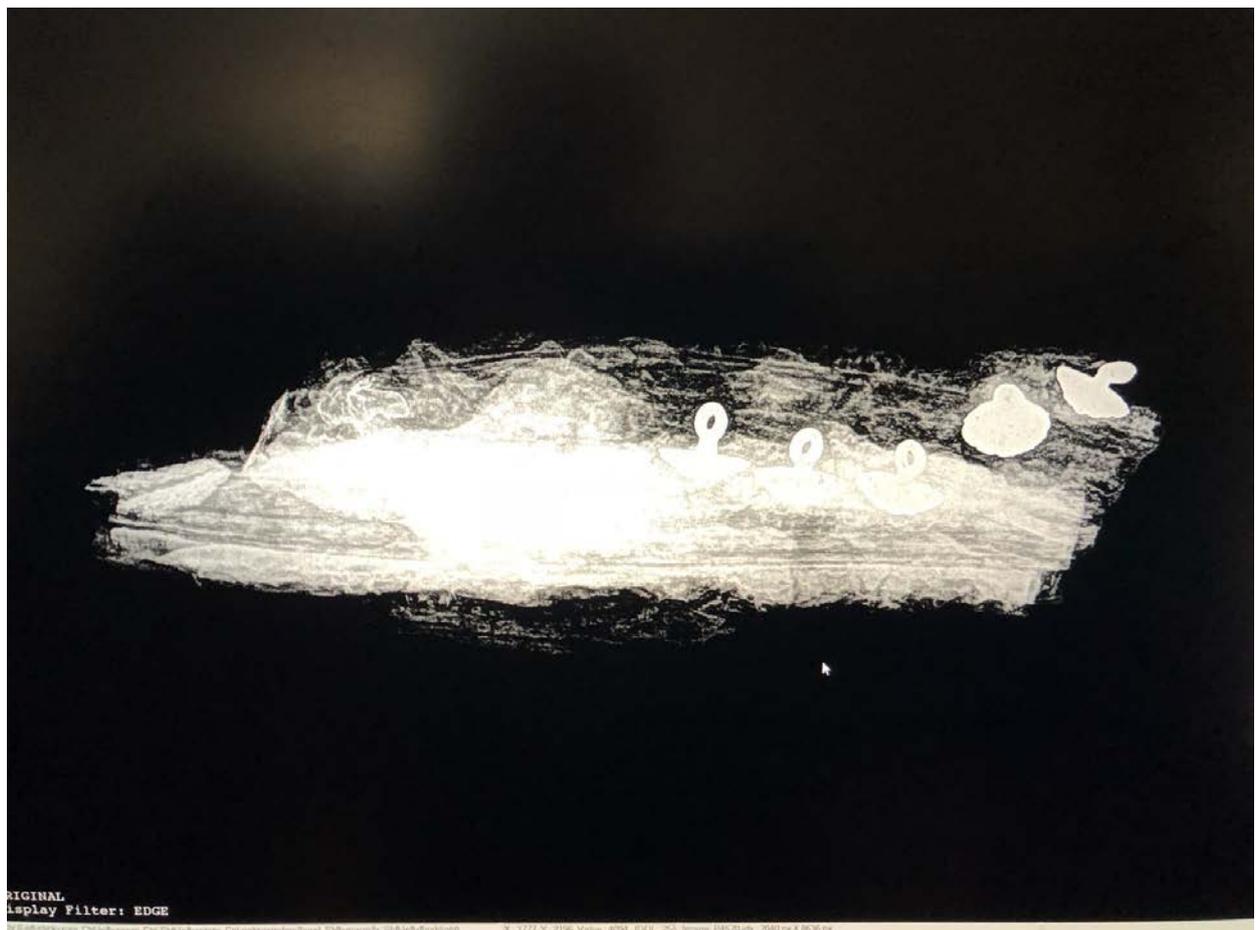
Figure 24: An X-ray image from the side show the row of five buttons.
