Specifications required by Stephen Green, Director of Bradwell Roman Villa Excavation (MK105,1976) regarding further investigation of the ironsbound lead(?) casket.

AM No	X-Ray No	Photo No	Description and Report	Ref No
765655			Working Report of the Lifting of the Iron- Bound <del>Lead (?)</del> Casket at Bradwell Roman Villa, Bucks.	
A.			Stage 1: Examination.  THAN NO 1 VIEWS  (1) — (3)  Fig:1  Shetohplan of Object on site.	
			A B	
			Fig:2 Section through AB to show position of Object.	
*			Fig.3 Sketch of Object.

THE "BRADEMLL VILLA" CHEST, SKCAVATION, CONSERVATION AND RECONSTRUCTION

Brief report for the purpose of exhibiting the casket at the May ballot of the Society of Antiquaries of London.

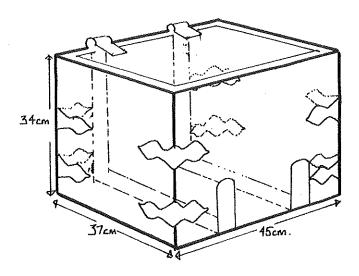
Specifications - Approximate dimentions of iron-bound chest from Bradwell Villa

Separate 1id 37 x 45 x 2.6cm
(Thickness of original wood - approximately 2.6cm)

- 1. Fittings.
- a) Attachement of iron corner clamps which have in many cases attached nails bent over at their ends, and fragments of iron replaced wood.
- b) Nails to be slotted in position through 'end grain' section.
- c) Attachment of iron straps base of box must be supported.

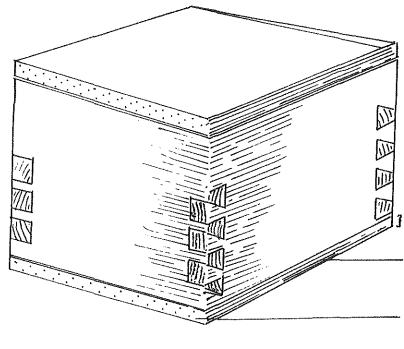
section of base strap 10.

). Board thickness 2.6cm.

Board thickness 2.0cm.

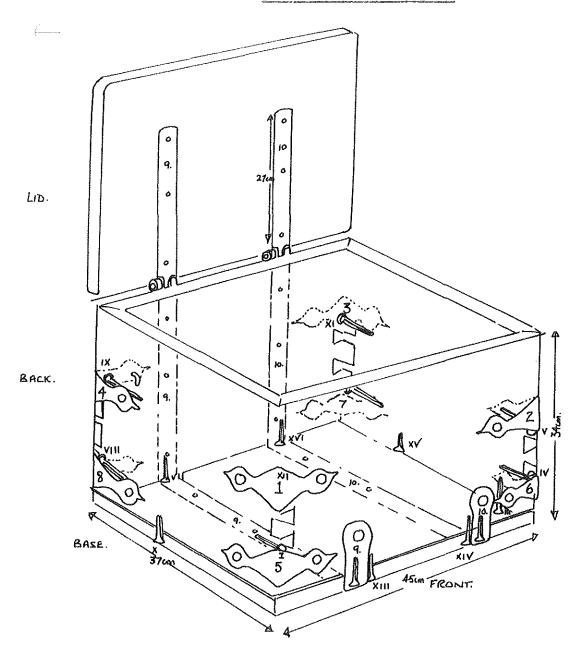
Lid

2.6cm approximate thickness (nails a and C) hammered flat at ends) horizontal wood grain across top straps 9 and 10 and md nails ... end grain at sides and horizontal grain to front/back.
