Bunksland, East Anstey, Devon: Historic Building Assessment and Survey

Research Report Series 013-2022

HISTORIC BUILDING ASSESSMENT AND SURVEY

NGR: SS 85016 26274

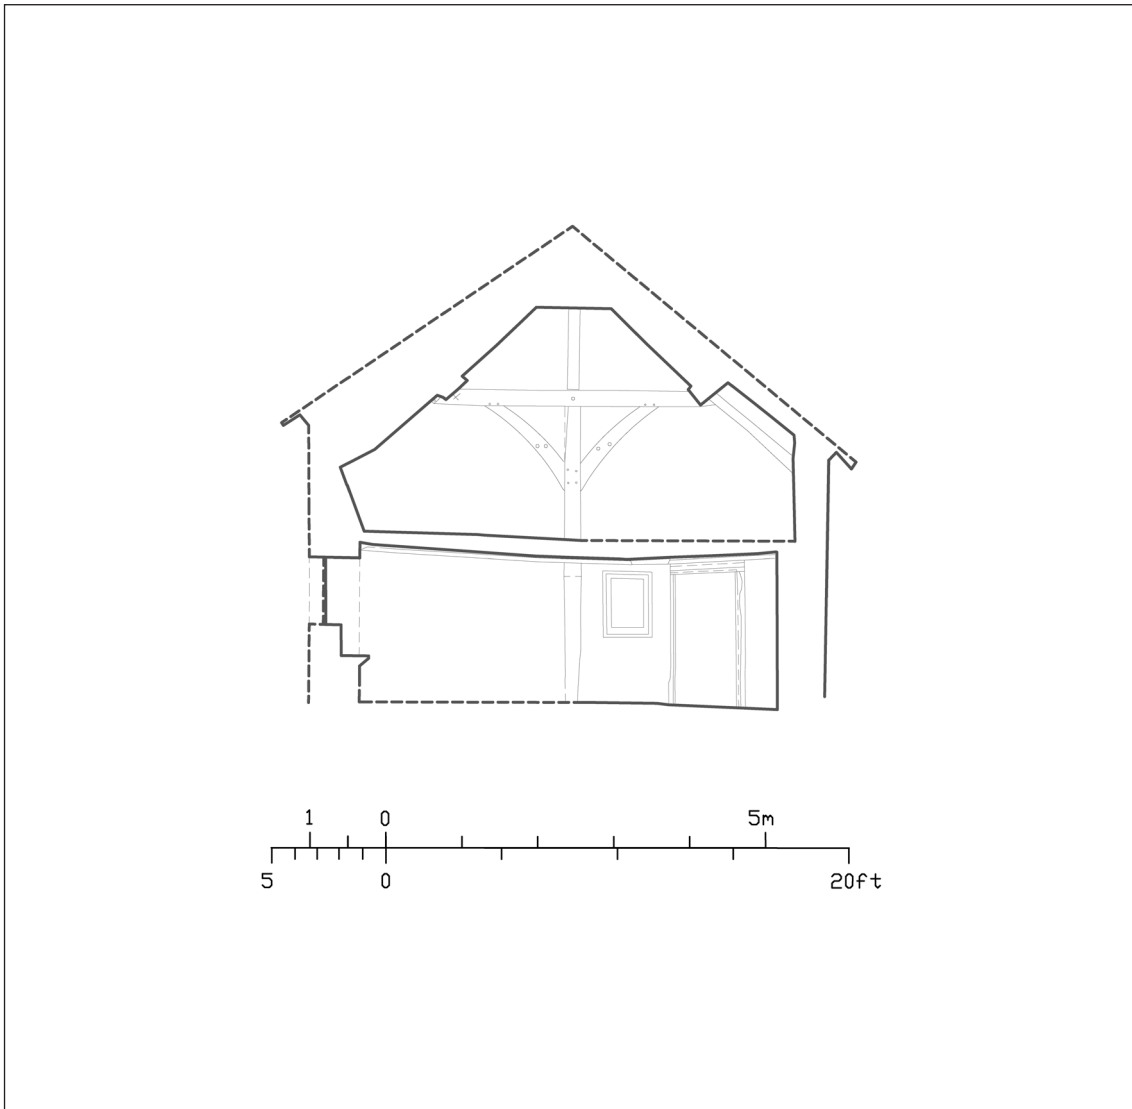
Figure 13 Cross section through the building showing the form of the original partition and truss at A-A1, looking west [© Historic England]

The truss and associated timber framed partition at A-A1 form the original partition between the high-end room and the hall to the east. The western side of this partition and truss cannot be examined in detail at present, but from the east it is clear that it is formed of a timber frame of an unusual form in Devon, although some comparable examples are known (Figure 13; *see Conclusion*). It comprises a central post rising the full height of the building to support the ridge piece, although the very top of the post and the ridge piece are not currently visible. This gives the appearance of a king-post arrangement to the truss. A large empty recess on the post, just below the later first-floor level, indicates that there was originally a

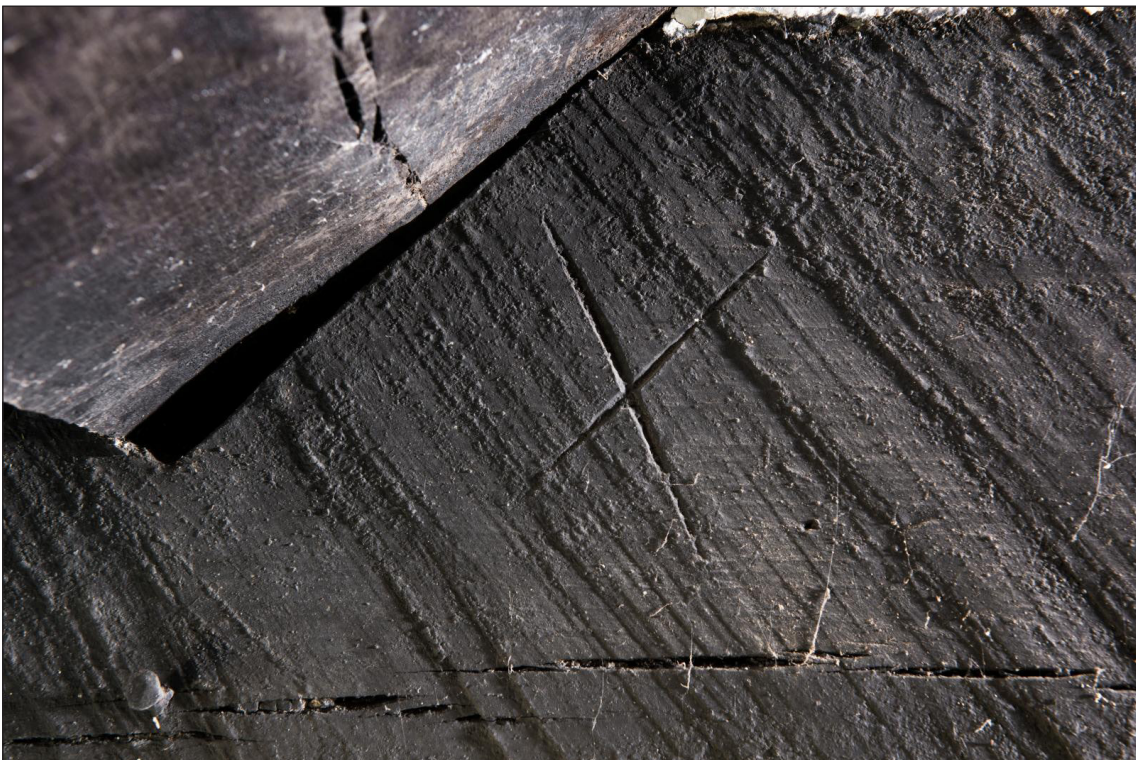
Figure 17 Scratch carpenter's mark on the eastern side of the southern principal rafter of truss A-A1, looking west [DP220566]

into the upper end of the house. A close examination of the top of the collar would confirm whether this was the case. Alternatively the form of the original partition at this end may have allowed some smoke through despite being closed. A carpenter's mark was observed on the eastern side of the collar, in the form of a scratched cross (Figure 17). This was the only truss which could be closely examined, so it is not clear if this formed part of a sequence or whether the trusses were identified with non-sequential marks.

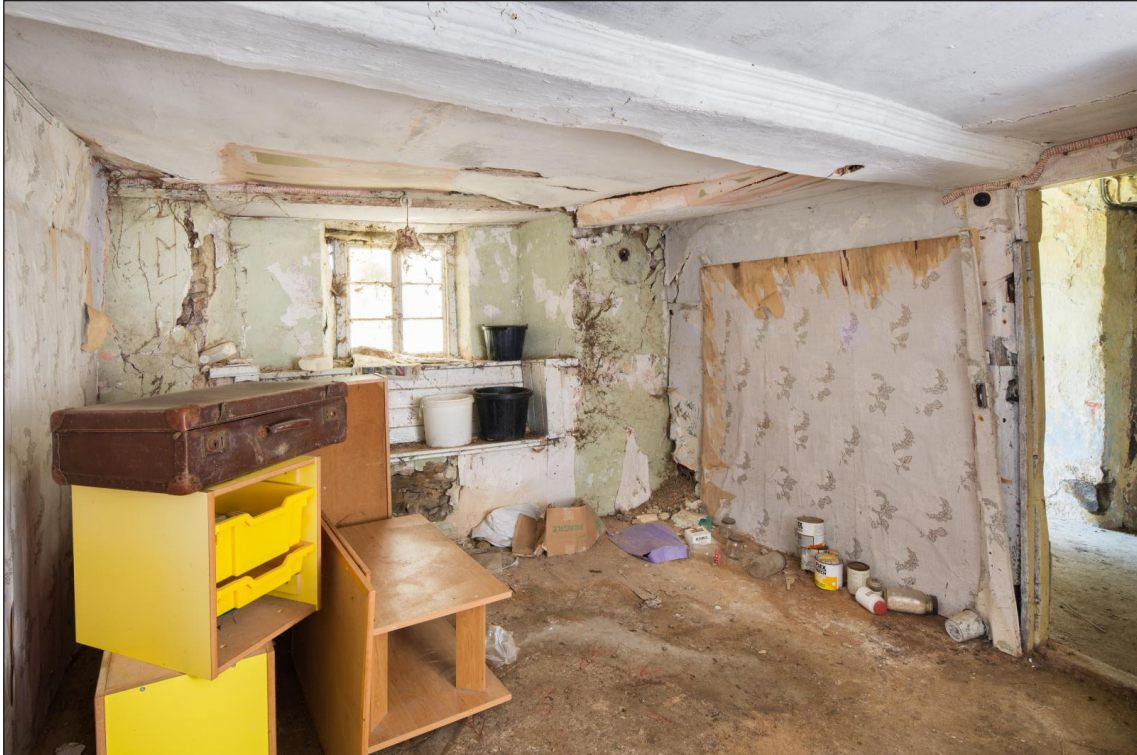
Figure 21 Ground-floor eastern room, looking south west, showing the profile of the post surviving in the partition between the room and the cross passage, adjacent to the current doorway [DP220542]

Originally there may have been some form of partition at a lower level under truss C-C1, such as a timber screen, which would have left little trace in the surviving structure. One possible feature that may relate to this, however, is a post surviving in the east wall of the cross passage (Figure 21). This is largely papered over, but its outline can be discerned. It may form part of the later full-height partition inserted under the truss (*see* Phase Three below), but it is considerably larger than the timber studs typically used for the later partition. It remains possible therefore that it is part of an original low-level screen arrangement at this end. Any work which uncovered elements of the post would probably resolve this question.

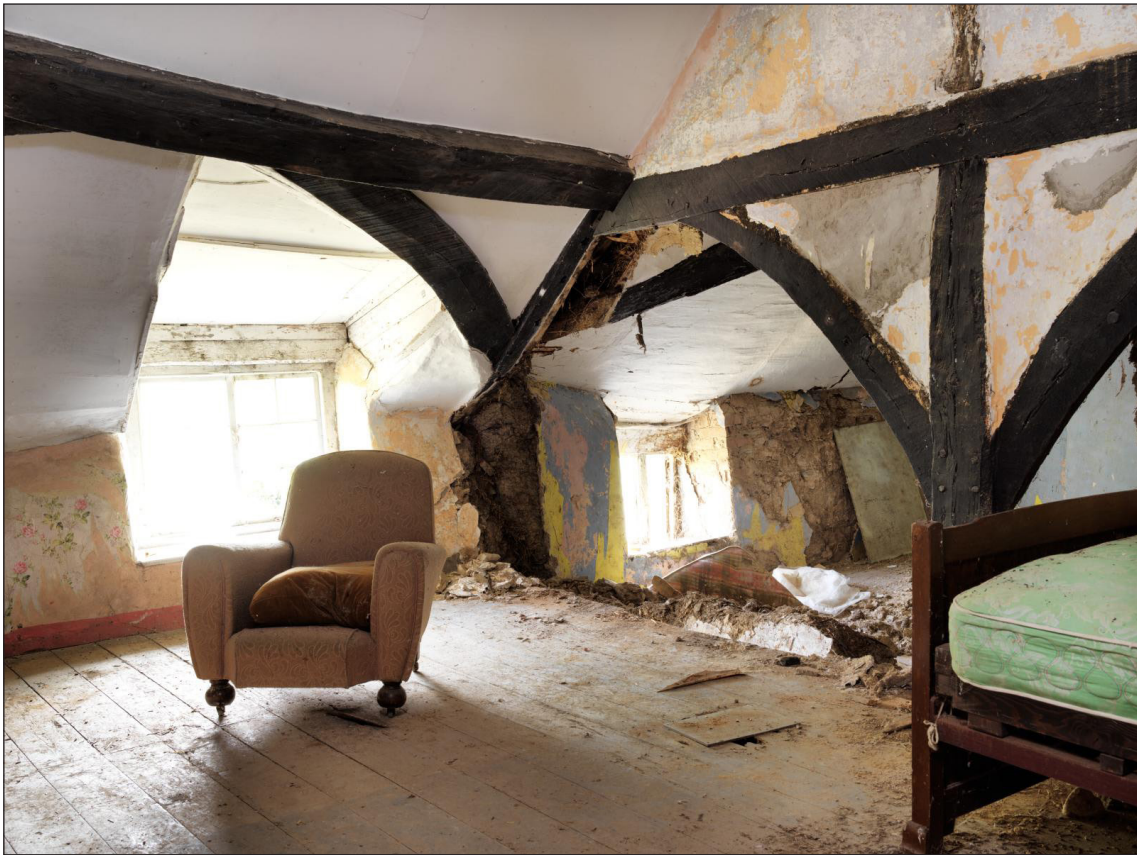
Figure 22 Upper part of hall, looking south west towards truss A-A1, showing purlin and wind brace arrangement to either side of the truss [DP220757]

Spanning the trusses are purlins of relatively large scantling (Figure 22). These extend from the west wall to truss A-A1, with further sets in the next two bays (A-A1 to B-B1 and B-B1 to C-C1). Extending further east from truss C-C1 one possible original purlin survives in the southern part of the roof (Figure 23). This could not be closely examined, and is now sitting at an angle within the eastern first-floor room. A detailed examination of this may confirm whether it is original and could provide more detail of its form. The purlins are seated on the back of trusses B-B1 and C-C1, but clasped between the collar and the principal rafters of truss A-A1.

Below the purlins run a series of curved wind-braces (*see Figure 22*). Originally, these appear to have formed a pair in each bay of the roof structure, rising from the trusses to the purlin towards the centre of the bay. Only the two pairs on the southern side in the central two bays survive, with a single further brace on the southern side of the western bay. Where they survive the wind-braces are lapped onto the back of the purlins and all three of the trusses. There is no evidence of a further tier of wind braces above the purlins, although there has been some alteration in this area, and no investigation of the upper part of the roof structure was possible.

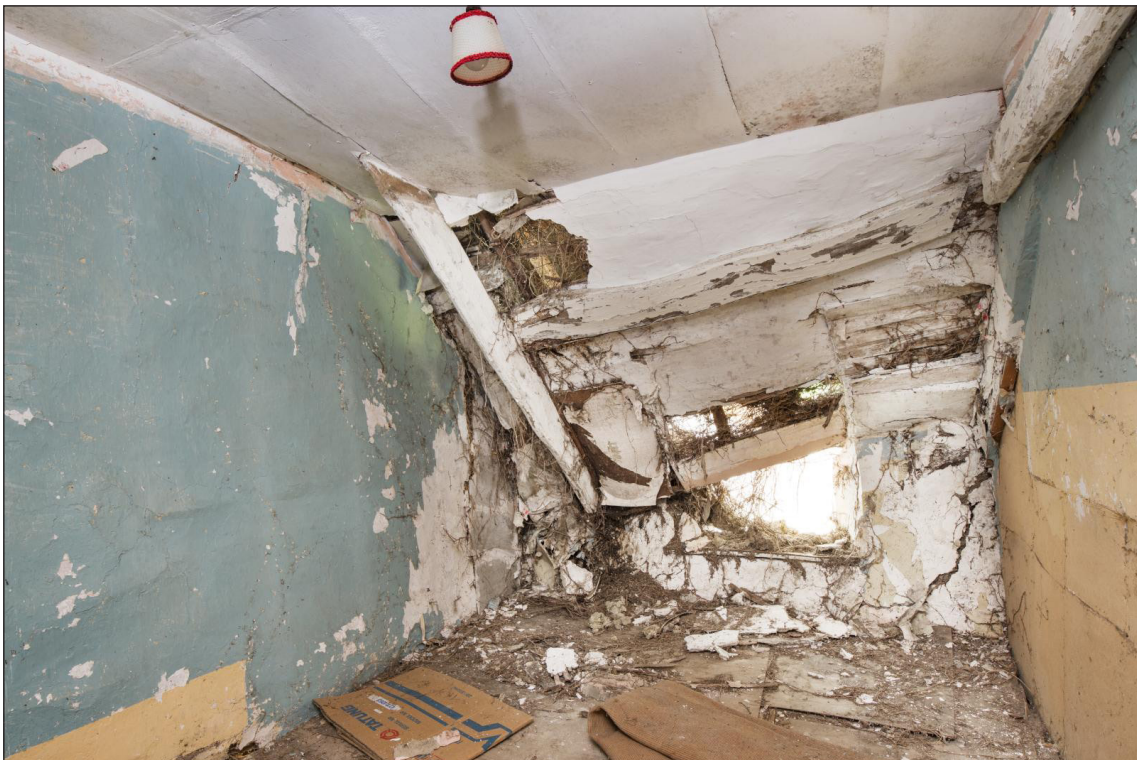
Figure 23 First-floor eastern room, looking south east, showing southern purlin which may be part of the original roof structure, with other later timbers [DP220551]

analysis of what appears to be a surviving purlin visible in the collapse in the south side of the first-floor east room (*see below*).

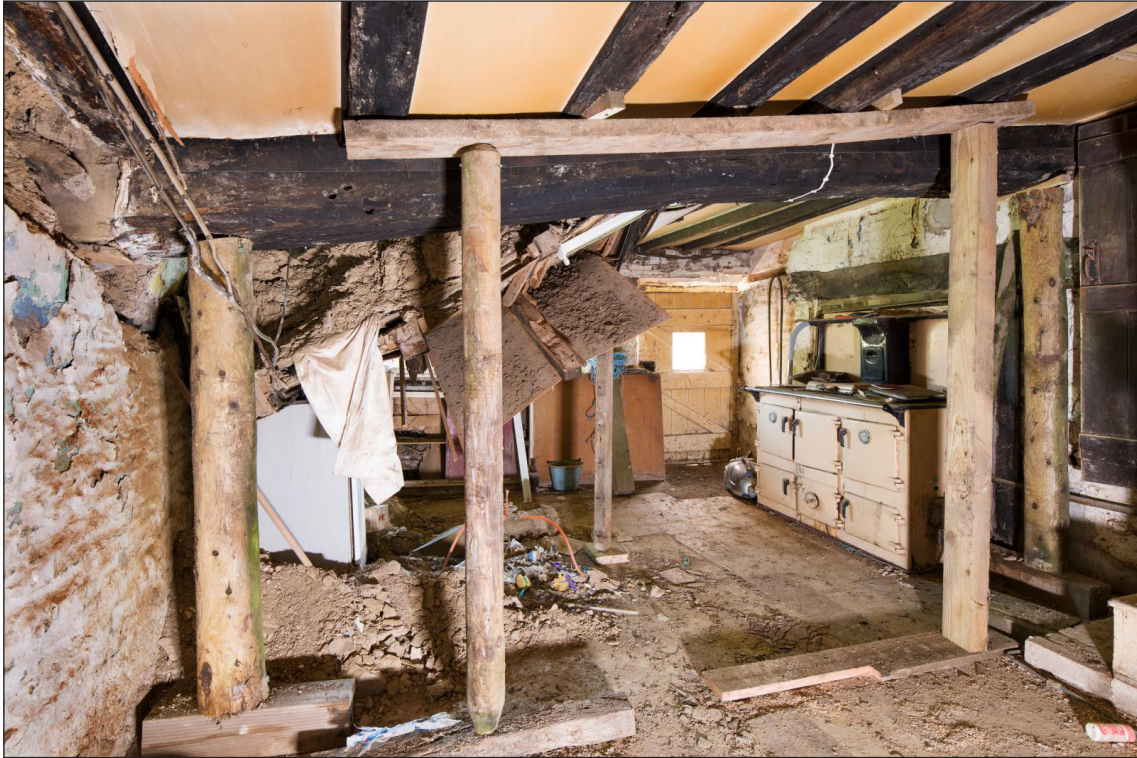
A relatively early alteration appears to have been the insertion of a ceiling over the high-end room, to create an upper chamber (Figure 24). This would have extended the accommodation for the owner of Bunksland and his family, and reflects the growing importance of privacy at this time. This area of the building is currently difficult to access due to the collapse of the floor; however, a number of features can be observed. The inserted floor was supported by a large central spine beam, with two half beams to the north and south, chased into the external walls (Figure 25). The two half beams are chamfered on their inner edges and the central spine beam is chamfered on both sides, with run out stops at its eastern end (Figure 26). There are no stops currently visible at the western end. The beams all have seatings for close-set joists, around 0.14m wide, with only a gap of about 0.15m between them. Some of these seatings have been reused for the current joist arrangement but this does not appear to use any original joists, as even where the original seatings have been reused the joists are generally smaller than the timbers they were originally designed for.

Figure 25 Ground-floor west room, showing the floor inserted as part of Phase Two, looking south [DP220539]

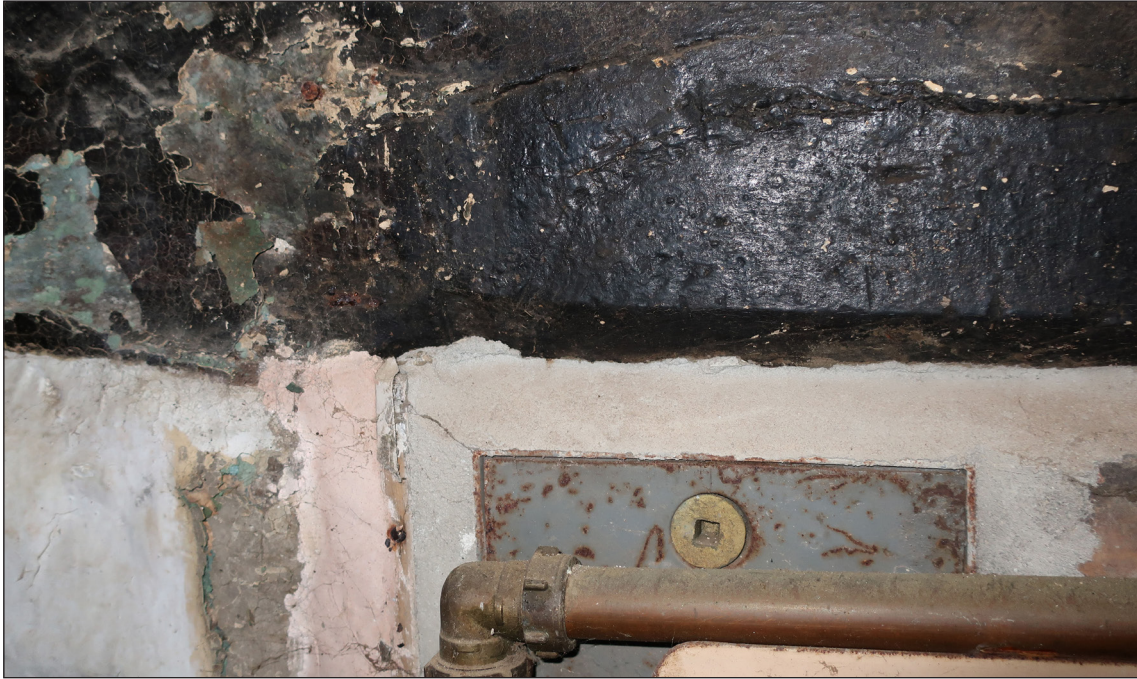
Figure 28 Detail of the chamfer and associated chamfer stop on the bressumer of the fireplace in the ground-floor west room [© Historic England Rebecca Lane]

Another feature which may possibly belong to the same phase is the fireplace in the western gable wall of the house. This projects into the former high-end room (now kitchen), and the rear of the chimney stack projects westwards from the original end wall of the building, in the area that now forms part of the (later) stable or hay barn (see Figure 7). Within the house the stack is now plastered and the fireplace itself is blocked by a modern panel. The timber bressumer of the fireplace is still partly visible, however. It is chamfered along its lower side, with a stepped and run-out stop visible at the southern end (Figure 28).

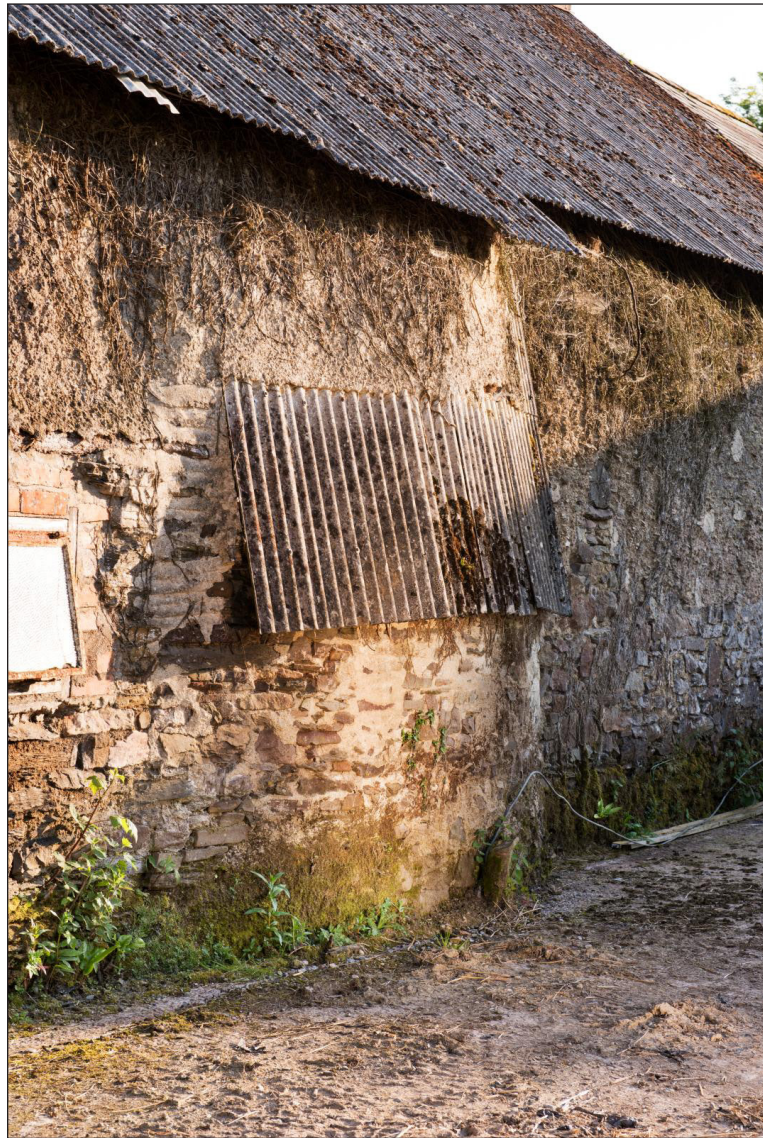
Figure 54 North elevation of the farmhouse, looking south west, showing the curving external wall of the bread oven [DP220577]

At some stage, probably in the 18th century and possibly at the same time as the reorganisation of the low end of the building, the hall area fireplace was also modified by the insertion of a bread oven into its northern side. This necessitated significant reconstruction of the north wall of the house in the area to the north of the fireplace. This was rebuilt in stone and curves outwards from the main wall line, rising to a height of around 2m (Figure 54). Internally the insertion of the bread oven narrowed the hall fireplace from its original extent, and may have necessitated some reorganisation of the arrangement of brackets supporting the 17th century cross beam (*see* Figure 30). The oven is lined with brick and its opening into the side of the fireplace also has a crude segmental-arched brick head (Figure 55). This is the first known use of the material within the building. The character of the brickwork suggests an 18th-century date rather than anything earlier, and it is quite different from the bright red brick used in the late 19th-century alterations to the farmstead. A precise date for this alteration is very difficult to establish, however, and it may have taken place over a broad date range from the 18th into the early 19th century.

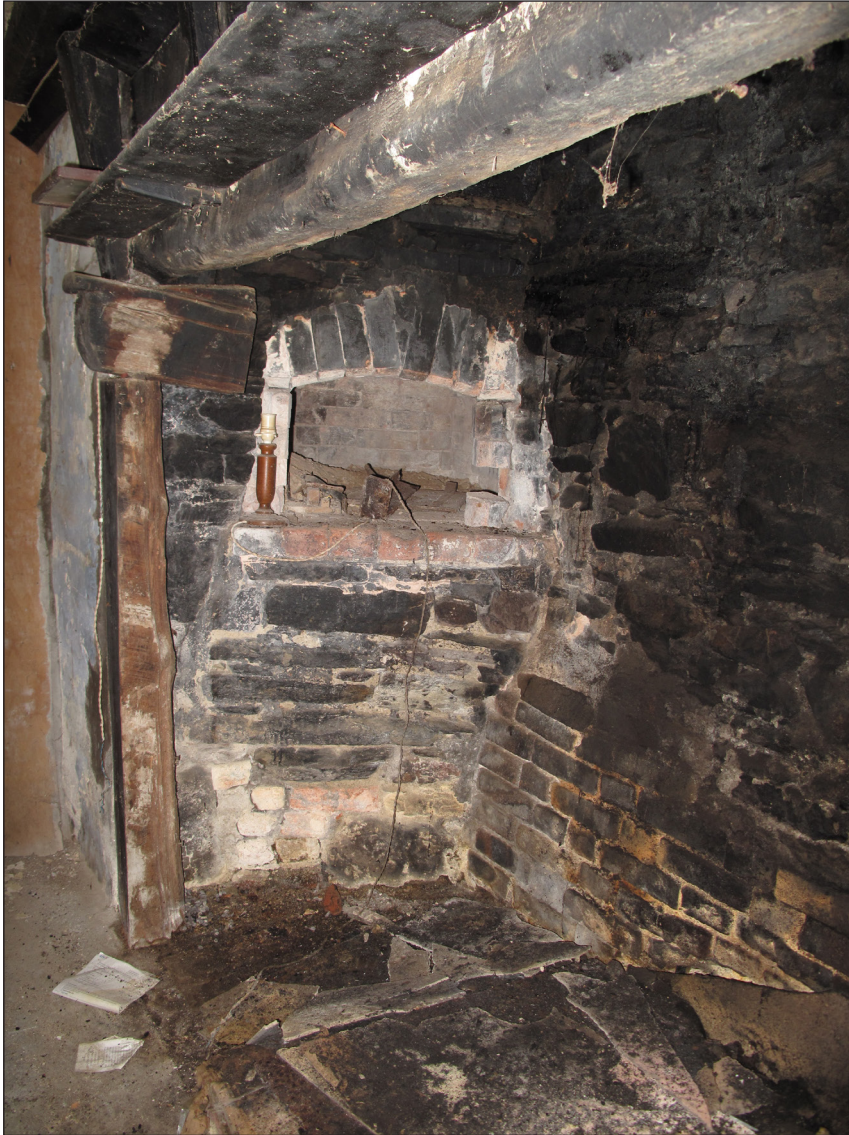
Figure 55 North jamb of the fireplace in the hall, looking north east, showing detail of the opening to the bread oven [© Historic England Rebecca Lane]

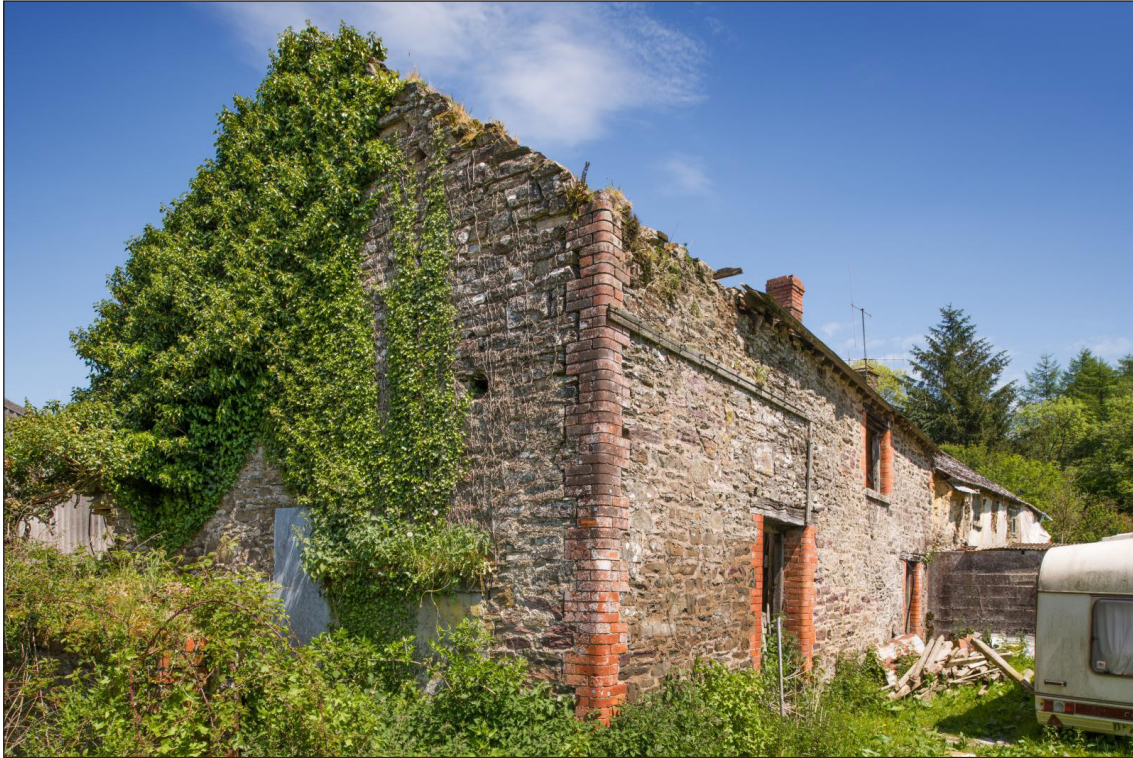
The farmstead, including the farmhouse, appears to have undergone some further modifications in the 19th century, although within the house itself these are relatively modest. The most significant alteration was at the western end of the farmhouse range, where a hay barn or stable was constructed (Figure 56). This is attached to and of the same width as the earlier farmhouse. It was, at least partially, of two storeys, with a ground-floor area accessed via two doorways in the south elevation. Above this was a hay loft with a taking-in door, also on the south elevation. The range is largely built of stone, but with brick dressings which make a distinct contrast with the other buildings on the site. Around the inner side of the openings bull-nosed bricks have been used. Internally the surviving section of the hay loft is built of roughly hewn timber, with some machine-cut pieces interspersed. The surviving elements of the roof are of machine-cut timber, although much of this has collapsed. The surviving central truss has a king post arrangement with raking struts, a standard type seen in late 19th-century farm buildings.

Figure 56 Hay barn or stable, looking north east [DP220512]

Projecting from the west end of the north elevation of this range was an apparently contemporary outshut. This appears to have been open to the south, with a lower wall to the west and possibly an opening in its northern face. It is unclear what function this served.

The hay barn or stable range appears on the 1st edition OS map of 1890, so must have been built at some point prior to that date (*see* Figure 4). Its stylistic similarities with the later dairy (built sometime between 1890 and 1905; *see* Phase Seven below) perhaps suggests that it is likely to have been in the years immediately prior to 1890 rather than a date significantly earlier.

As part of the building of the hay barn, the west wall of the farmhouse appears to have been partially reconstructed, although it is possible that some elements of the earlier gable wall were retained. As noted under Phase One above, there is some evidence of a timber post surviving in this gable wall (*see* Figure 12). It is unclear whether this represents a residual element of an earlier gable end or is part of this reconstruction phase. Closer examination of this element once access to this part of the building is possible may resolve this.

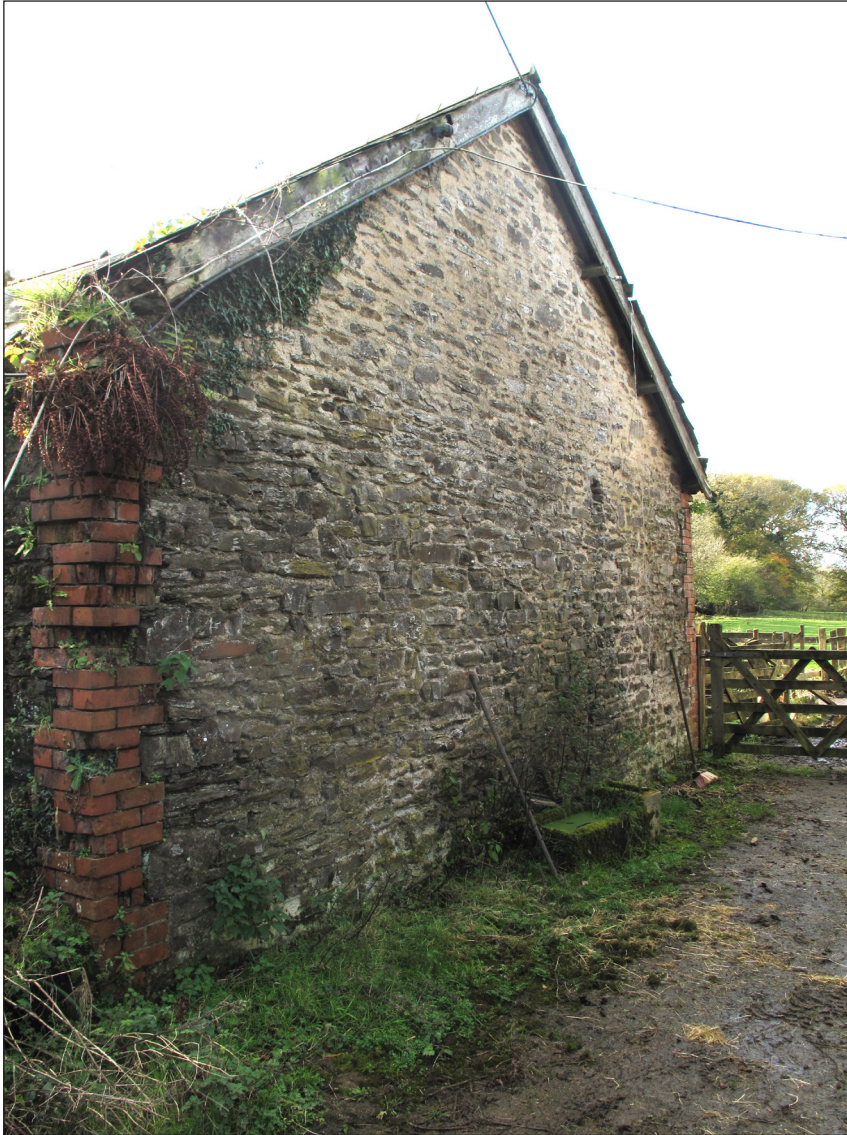
Minor modifications were undertaken to the house and farmstead in the 20th century. The most significant construction in the main farmstead range was the addition of the dairy building to the north of the earlier stable block or hay barn (Figure 59). This is a tall single-storey block with a pitched slate roof. Much of the detailing around the original doorways is of the same bright red brick as the earlier stable block or hay barn. However, this time all the brick is of a standard rectangular form, rather than including the bull-nosed brick used for the openings in the slightly earlier range. The dairy building does not appear on the 1890 OS mapping, but does appear on the 1905 revision, indicating it was built at around the turn of the 20th century (compare Figures 4 and 5). The interior of the dairy is not currently accessible.

Figure 59 The north wall of the dairy, looking south west [© Historic England Rebecca Lane]

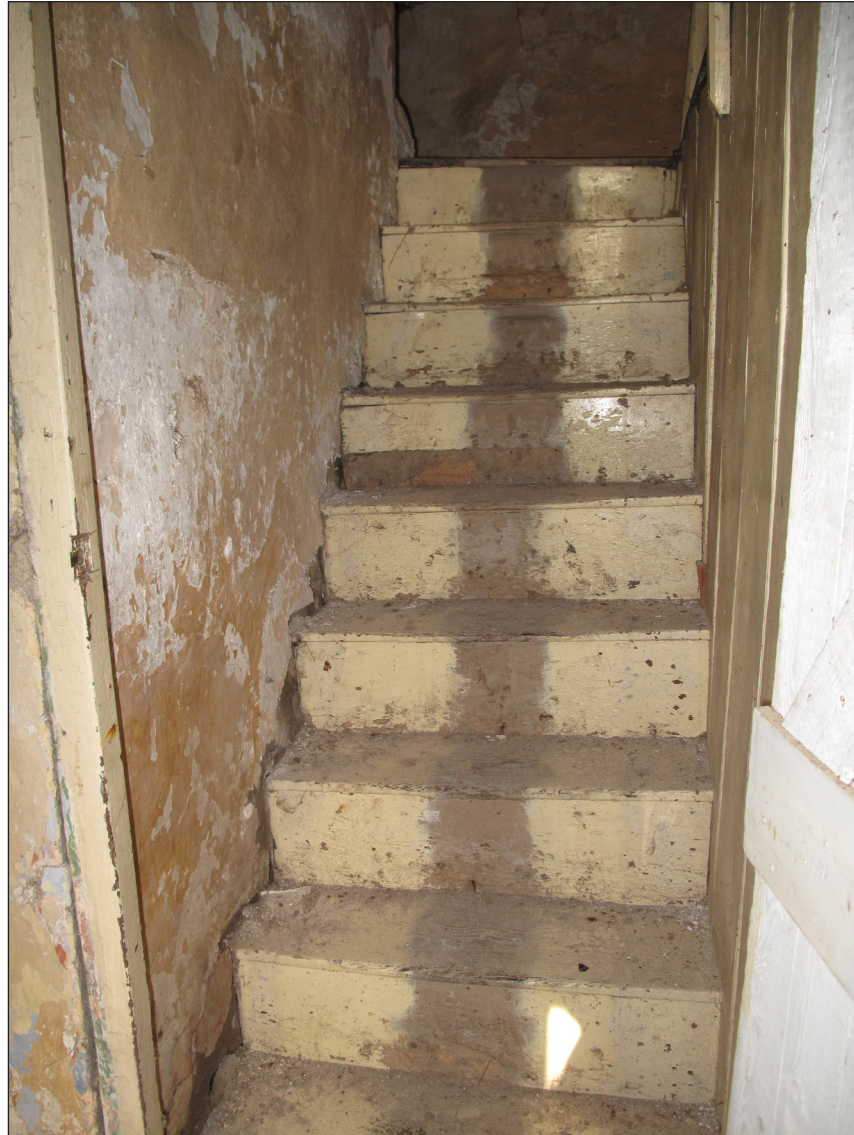
Figure 60 The current stair, probably in the location of an earlier stair arrangement, looking north [© Historic England Rebecca Lane]
