ARCHAEOLOGICAL ASSESSMENT AND NET REMOVAL FROM THE DESIGNATED
WRECK OF THE *NORTHUMBERLAND* ON THE GOODWIN SANDS

PROJECT REPORT
2022

February 2022

Ref: 7913

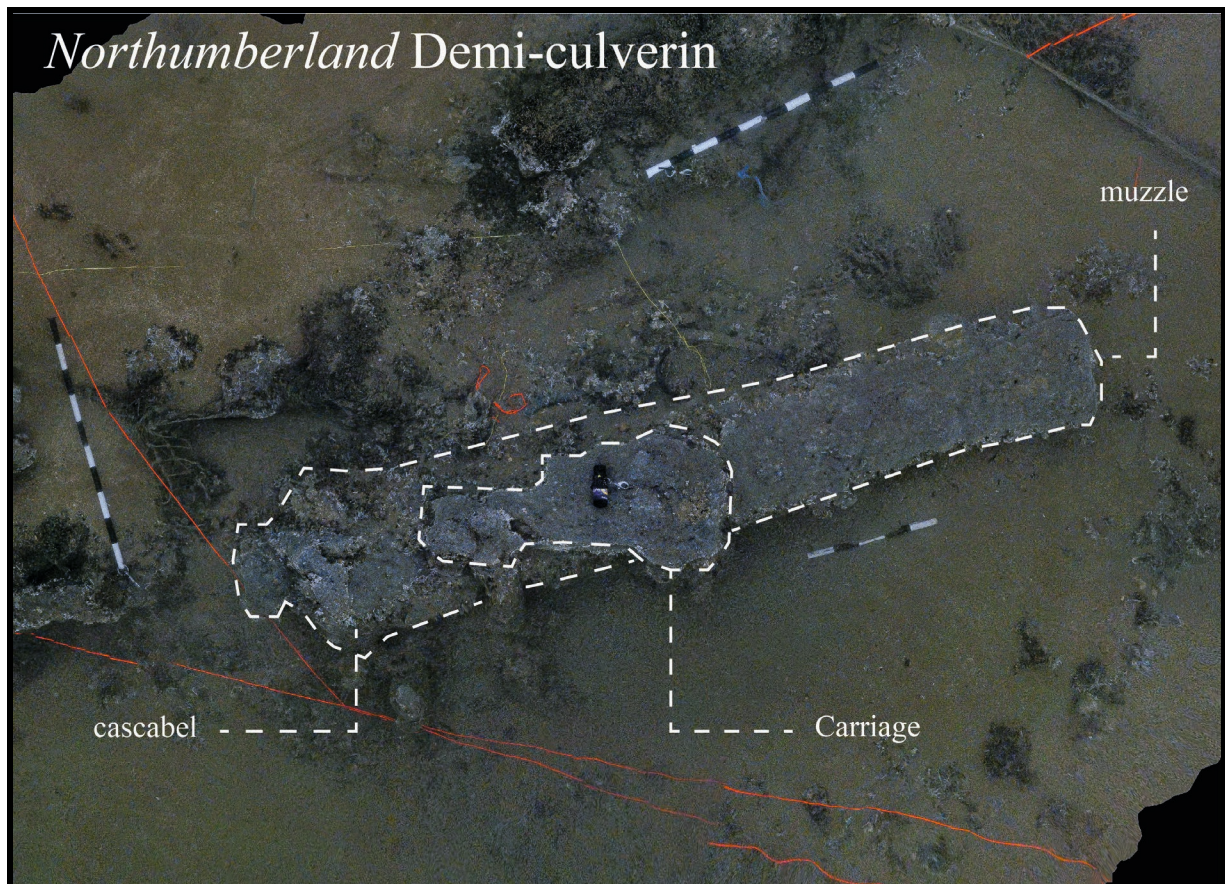
New gun with carriage recently emerged from the sands.

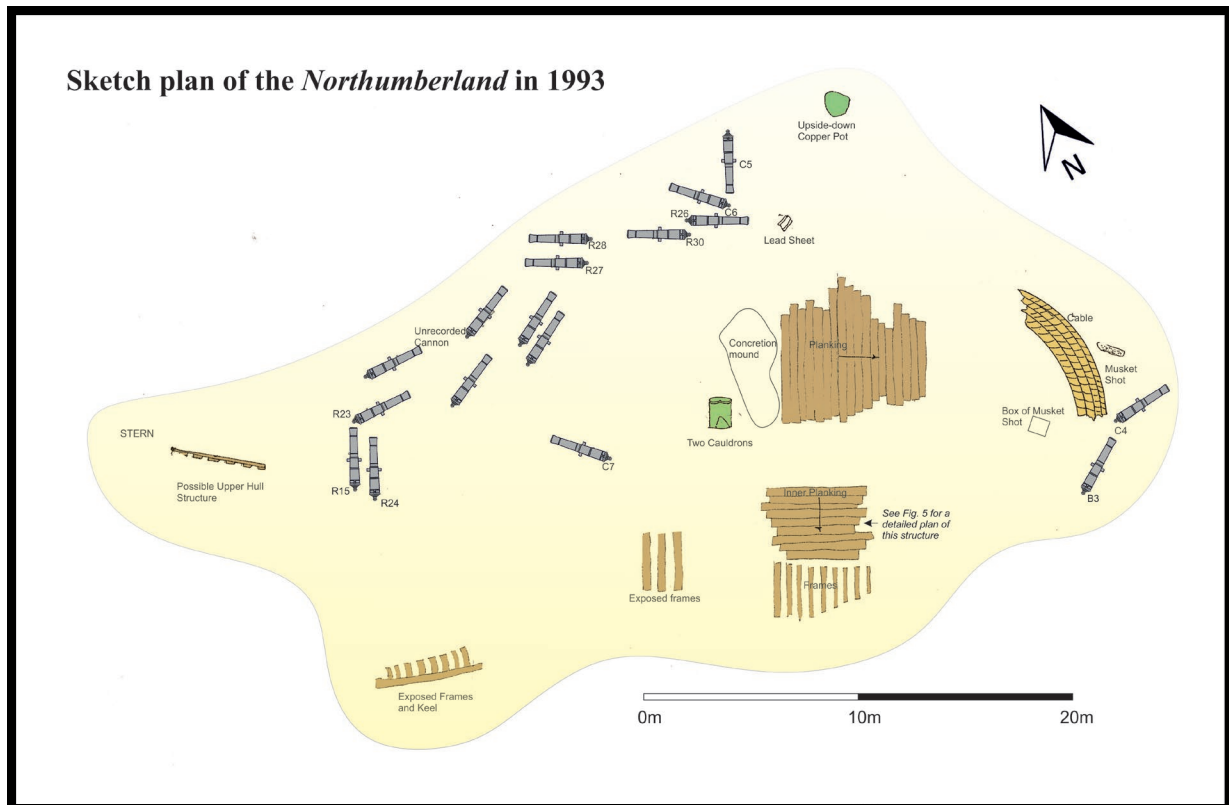
- 4.2.4. This end of the site was unrecognizable with the 2020 bathymetry with a much greater area of exposure extending southeast from the large concretion mound. Diver observations recorded an area of exposed wreck material 8m long by 8m wide. All of the exposed features were covered in a thick layer of juvenile mussels.
- 4.2.5. The mussels camouflaged much of the archaeology making identification difficult. Removal of small areas of mussels was necessary to identify the archaeology. This revealed that a significant proportion of the area consisted of coils of cordage still in a remarkable condition (Figure 3 and label 1 in Figure 2). The location of the cordage coincided with the previous licensee's site plan, which shows a mixture of different sizes of rope in neat coils southeast of the large concretion (Figure 4).

Figure 4: The 1993 site plan showing area of cordage forward of concretion mound.

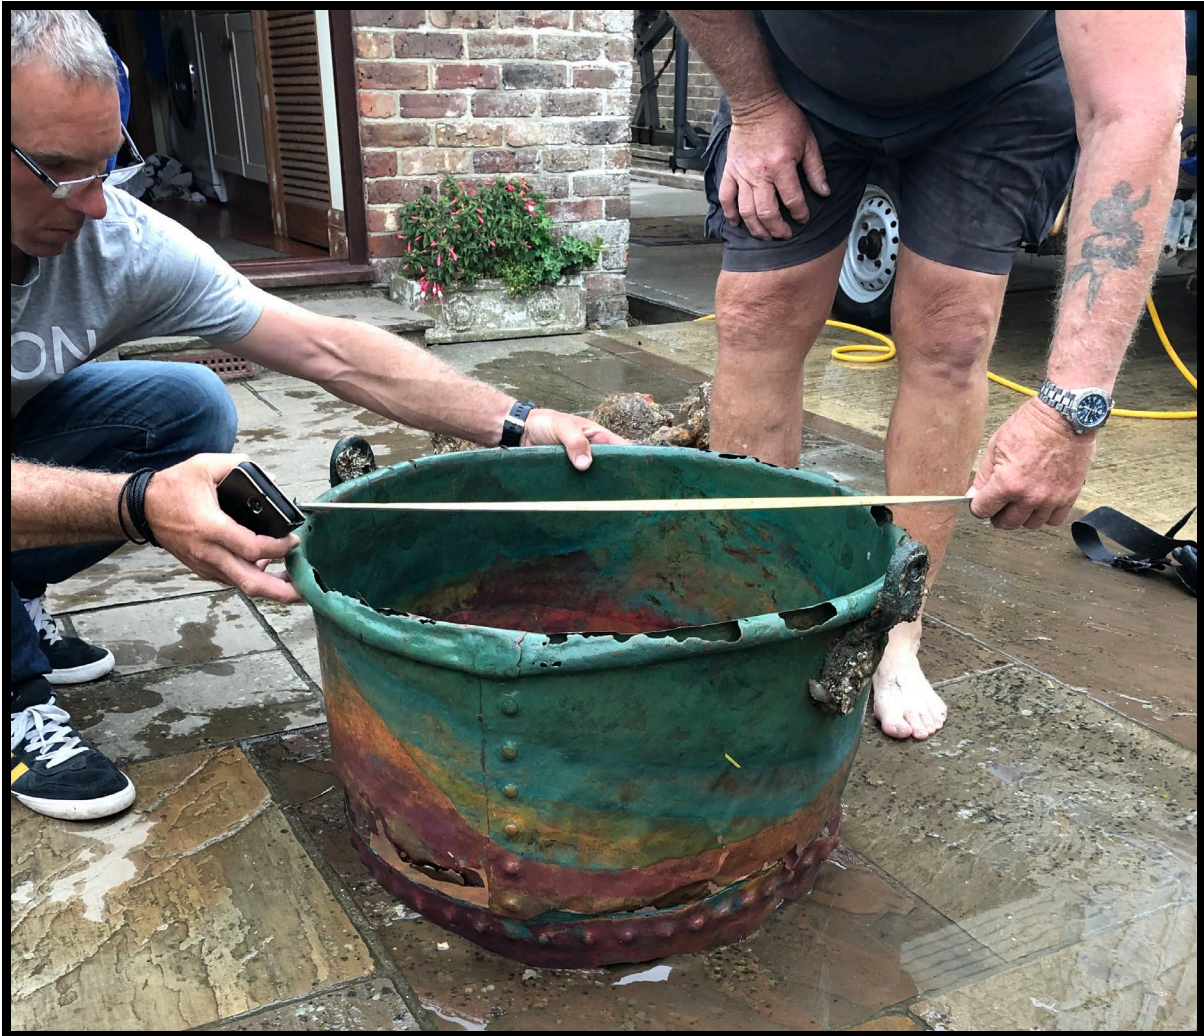
4.2.10. On the eastern side of the large concretion and near the bottom of the slope was a complete copper cauldron (Label 5 Figure 2). It was on its side with the base on the outside of the wreck mound. It was slightly squashed around the sides and open end. The sides of the cauldron were riveted to a separate base piece and its approximate diameter across the base was 700mm (Figure 9). Its location is consistent with the copper pot shown on the 1993 sketch plan (Figure 4). It is very similar to examples recovered from the wreck of the *Hazardous*, lost in 1706 off the coast of Bracklesham (Figure 10).

Figure 10: A similar type of copper cauldron recovered from the wreck of the *Hazardous*, lost 1706.

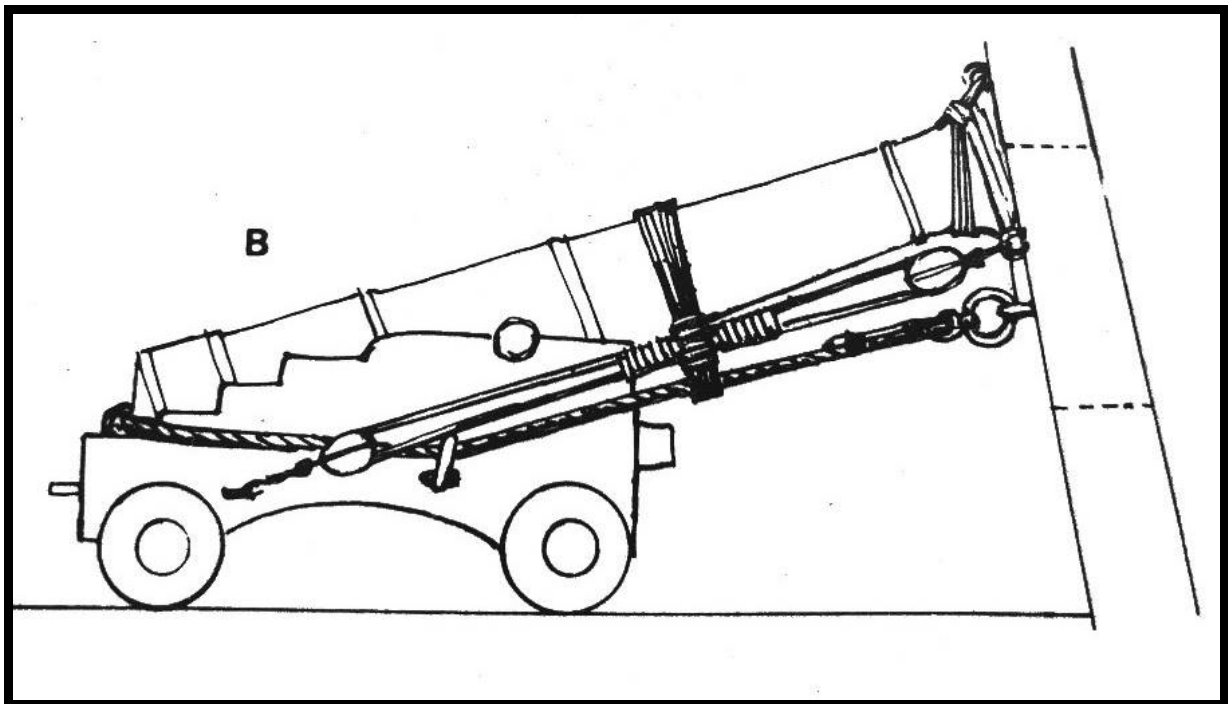
4.2.14. Also clear is the position of the gun within the carriage. The muzzle is elevated, demonstrating that it was run in with the muzzle lashed above the inside of the port (Figures 12 and 13). This was a standard procedure when housing the guns in

preparation for rough seas, so gunports could be closed to keep the vessel as watertight as possible (Harland 1984,210).

Figure 13: Illustration showing gun housed with muzzle secured above the inside of the port (From Harland 1984,210).
