Barracuda Aircraft wreck site, Solent, Hampshire

Examination, analysis and conservation of artefacts recovered from
a Second World War aircraft wreck

2024

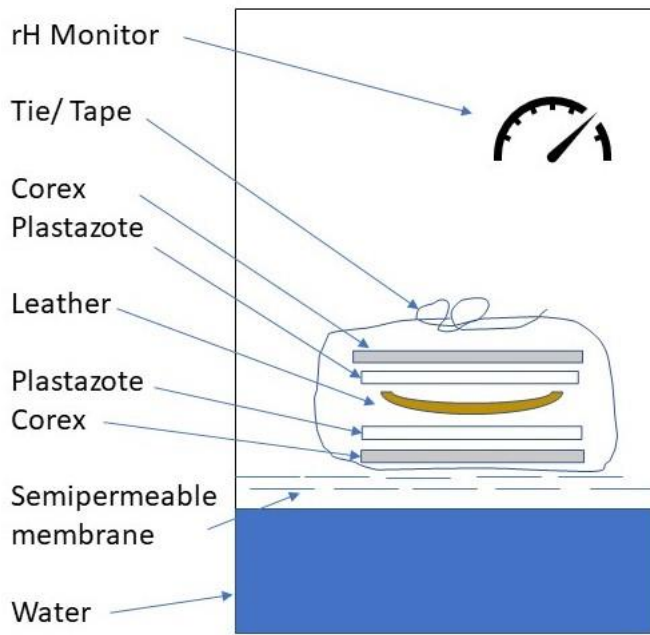
During freeze drying, leather will shrink a bit and some pieces may experience distortion. One such example was shoe insole 5353. This was gently re-shaped by placing it inside a closed system (box with tight-fitting lid) over a semipermeable membrane covering a box filled with water (Figure 3). Over the course of a couple of days the humidity inside the box rose and water molecules entered the leather fibre structure, making it supple. At this point it was sandwiched between layers of polyethylene foam (Plastazote®) and fluted polypropylene sheets (Corex®) and gently straightened out again (Figure 4). The sandwich boards were secured with ties and tapes and the leather placed back into the box, with the lid slightly open. As the water slowly evaporated, the humidity reduced to ambient, and the leather remained in the more sympathetic shape appropriate for an insole.

Figure 3: Schematic representation of set-up for reshaping insole 5353 (graphic by Angela Middleton).

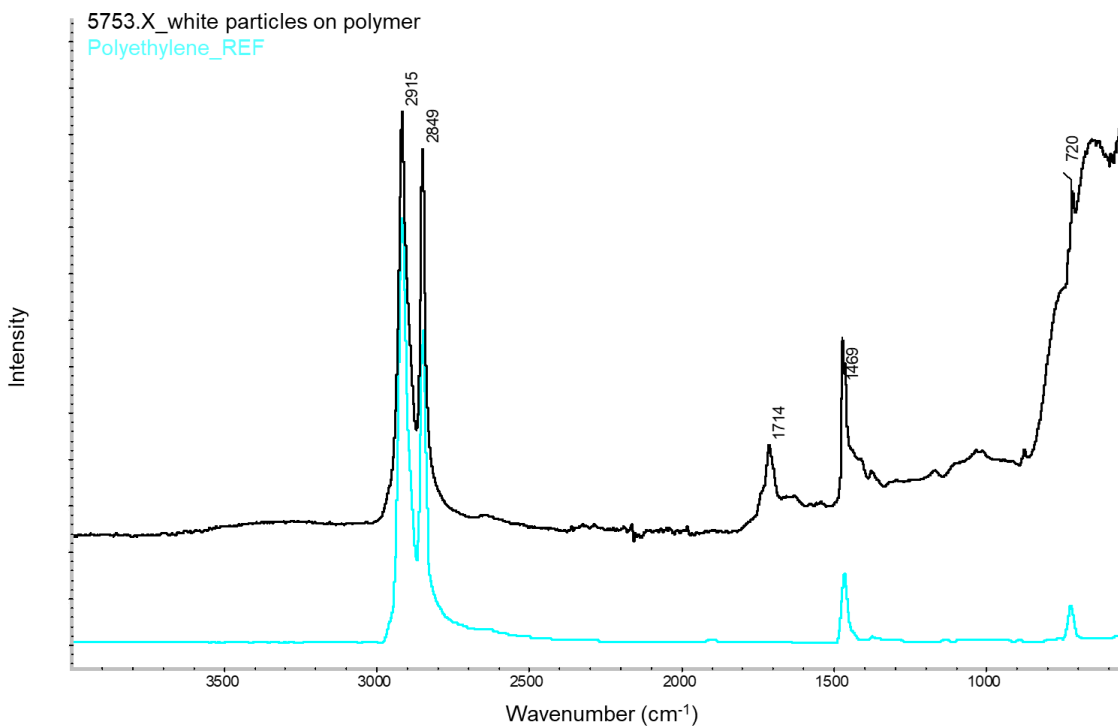
FTIR analysis of a sample from 5753.X shows the object is made of poly(methylmetacrylate) (Figure 6) and the presence of chlorine suggests it is a haloacrylate. Haloacrylates are substituted with a halogen atom, usually chlorine. They have been synthesised since 1938 and they are harder, stronger and with higher softening temperature compared to normal acrylics. These polymers were probably used because of their flame-retardant properties. In 1939, Imperial Chemical Industries in UK produced this polymer and during the war, the synthesis was optimised by different companies in the USA (National Institute of Industrial Research 2005). In the sample some white particles were also observed and identified as polyethylene (Figure 7).

Figure 7: FTIR spectrum of the sample of polymer 5753.X identifying polyethylene as the white particles on the material.

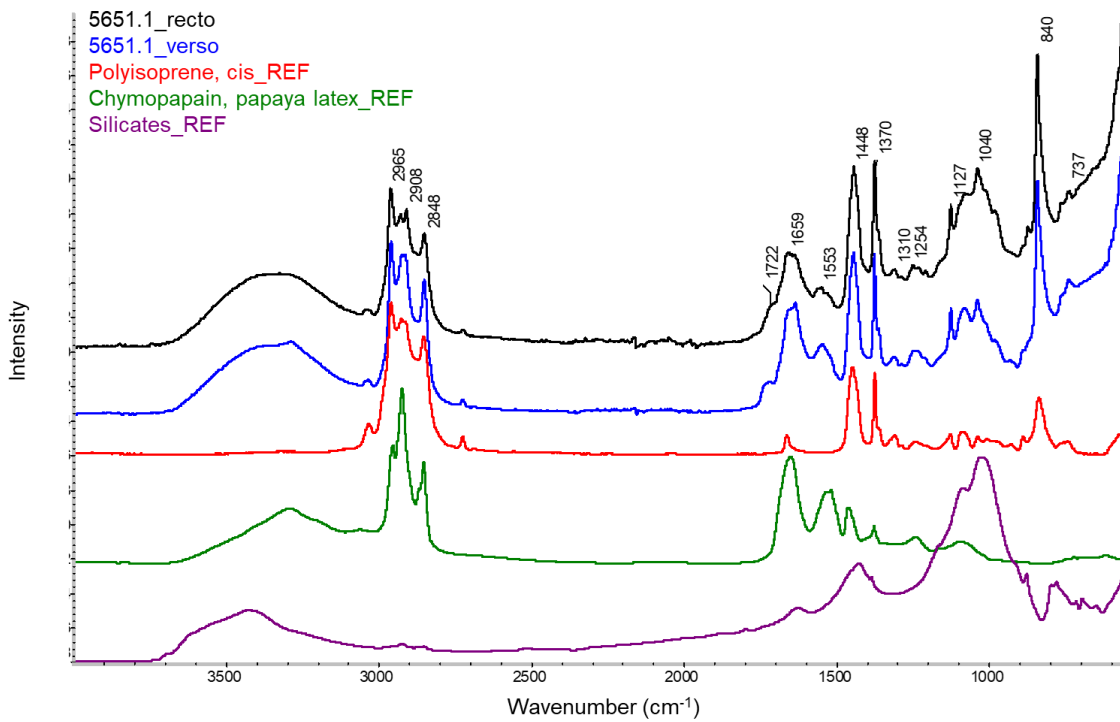
FTIR analysis found that adhesive samples from 5651.1 and 5651.3 are made of latex, a natural rubber based on polyisoprene (Figures 10 and 11); reference spectra of papaya latex and polyisoprene are added for comparison. Inorganic additives (silicates) were added to the polymer as fillers.

Figure 10: FTIR spectra for both sides of the adhesive sample collected from 5651.1 with reference spectra.

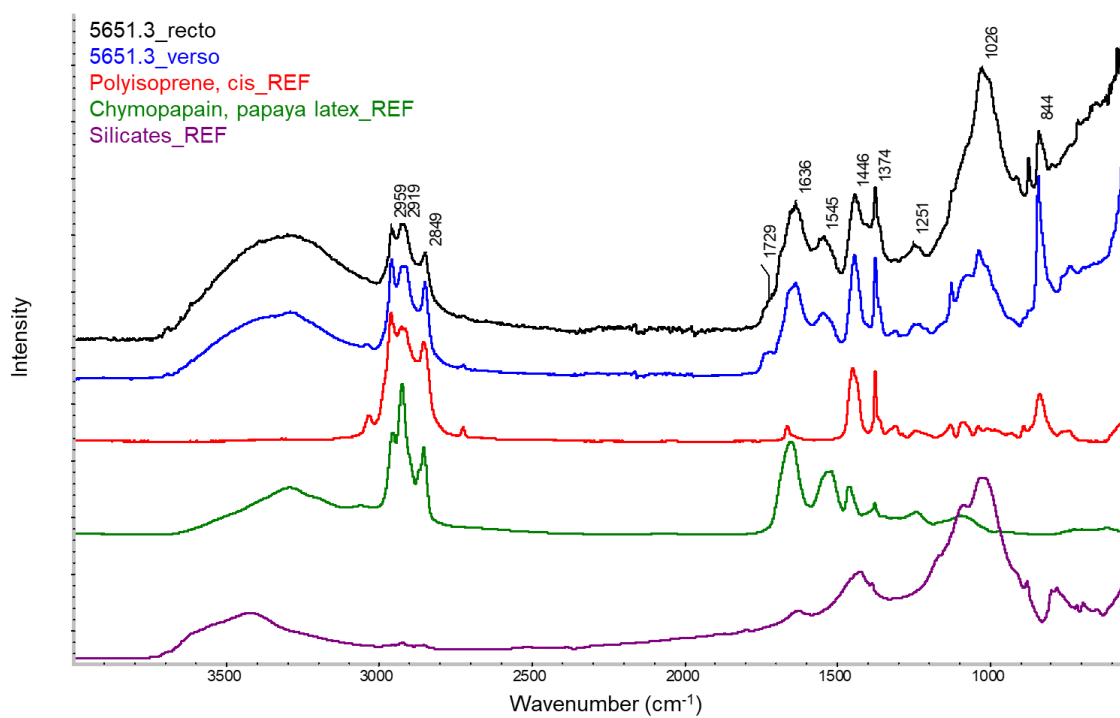
Figure 11: FTIR spectra for both sides of the adhesive sample collected from 5651.3 with reference spectra.

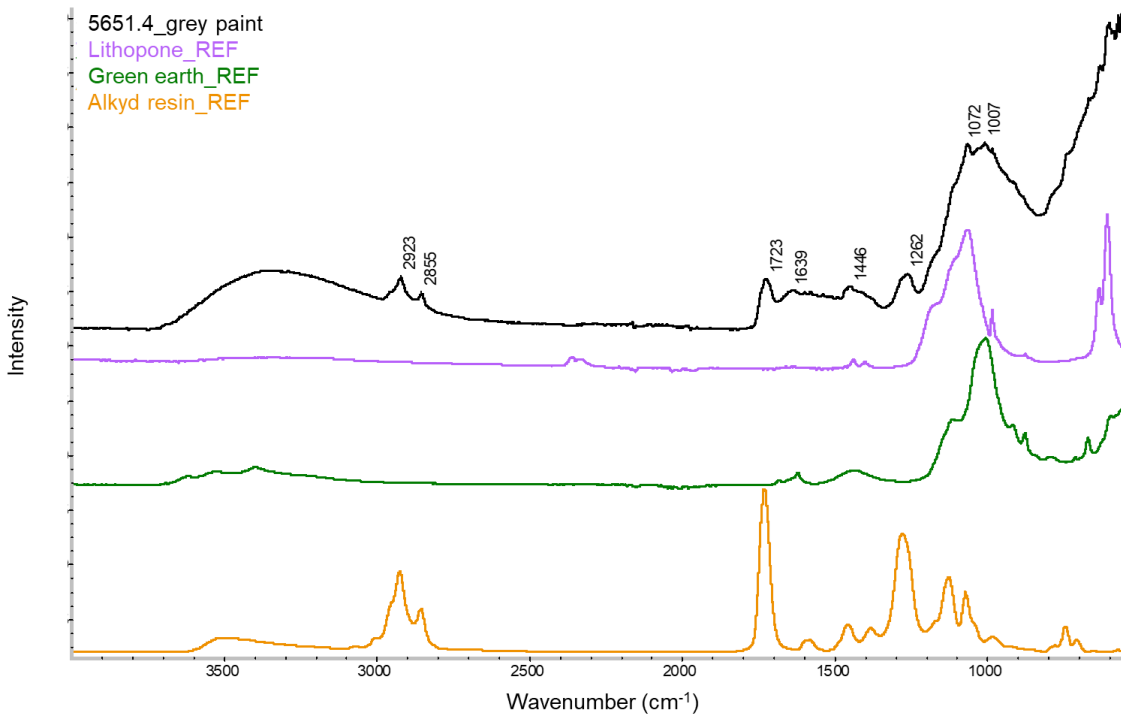
Two layers were visible in the sample from 5651.4, a white lower layer and a grey upper layer. The FTIR spectrum of the paint sample from 5651.4 (Figure 16) confirms the presence of titanium and zinc white pigments in the lower white layer of paint. The upper grey paint layer is an alkyd paint with a silicate-based pigment (such as green earth) and lithopone, which is a mixture of barium sulphate and zinc sulphide (Figure 17). No binder was found in either of these layers.

Figure 17: FTIR spectrum of the upper grey paint layer sample from 5651.4 with reference spectra.

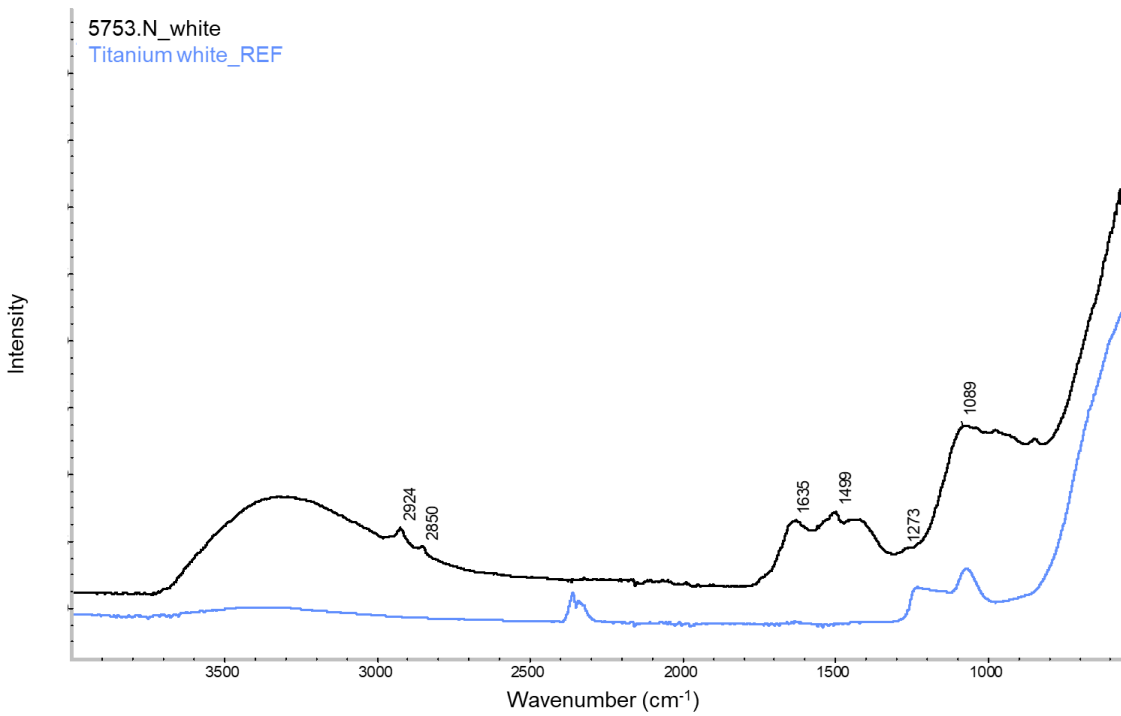
On 5753.N, the white lower paint layer and grey upper paint layer are both visible. A sample of the grey paint is again an alkyd paint with pigments based on silicates (such as green earth) and lithopone (Figure 19). This is confirmed by XRF data showing the presence of barium (Ba), zinc (Zn), silicon (Si) and sulphur (S) (Table 5). Titanium (Ti) was detected in the white paint, proving that titanium white was present in that layer as before (Figure 20 and Table 5).

Figure 20: FTIR spectrum of the white paint layer sample from 5753.N with a reference spectrum of titanium oxide.

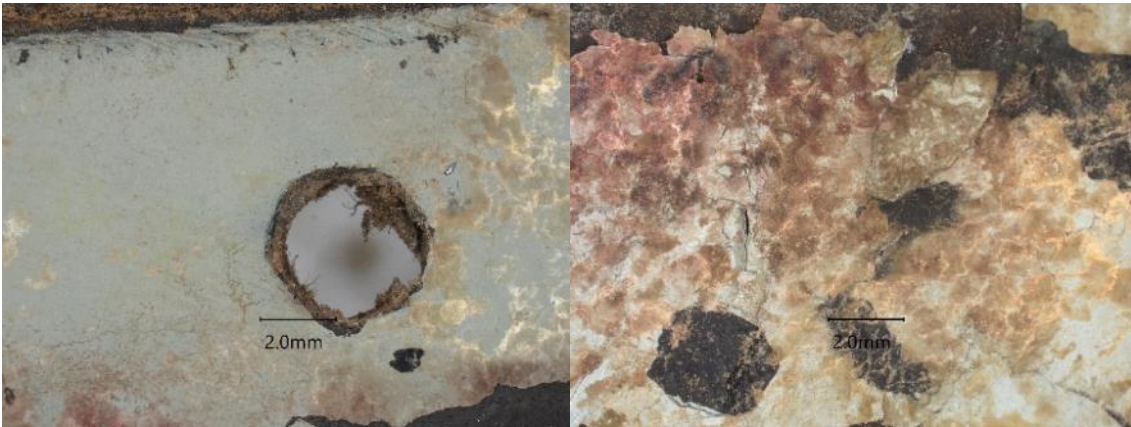
Figure 21: Optical images at different magnifications of the leather gaiter from control column of Blackburn Barracuda, showing grey paint, with small patches of black pigment, over a black fibrous substrate.

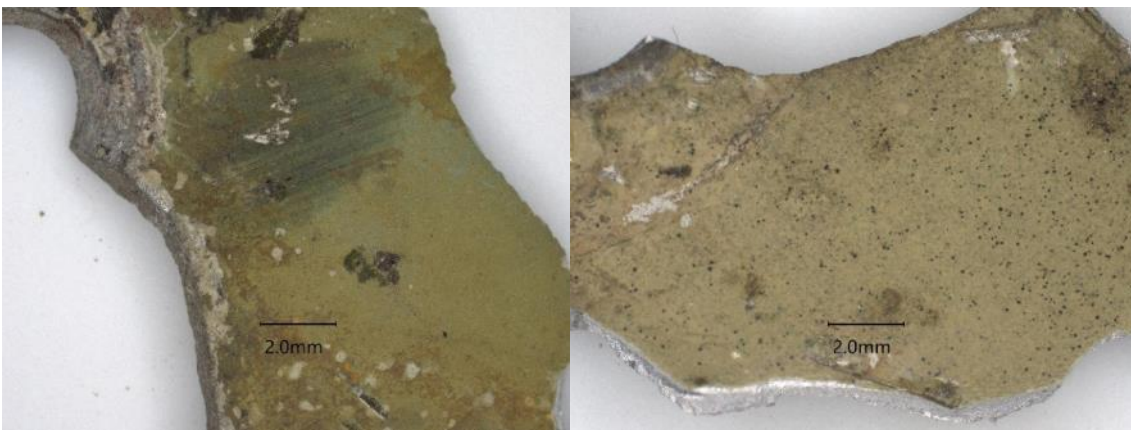
Figure 22: Optical images of the metal from the cockpit structure from the portside torpedo control of Boulton Paul DP872 with beige paint on both sides and some surviving green topcoat paint on one side (left image).

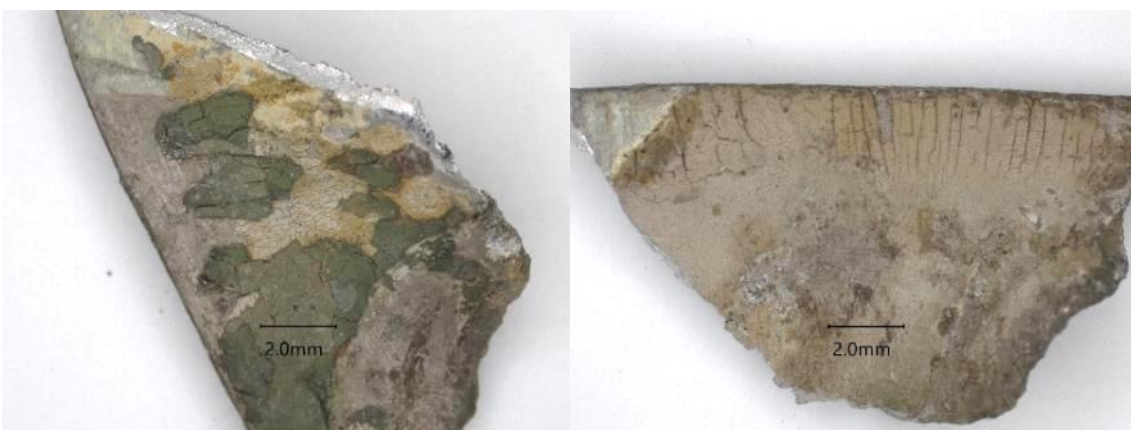
Figure 23: Optical images of the metal from the combing in front of the portside windshield from Boulton Paul DP872 showing both beige paint and green topcoat on one side, but only the beige layer surviving on the other.

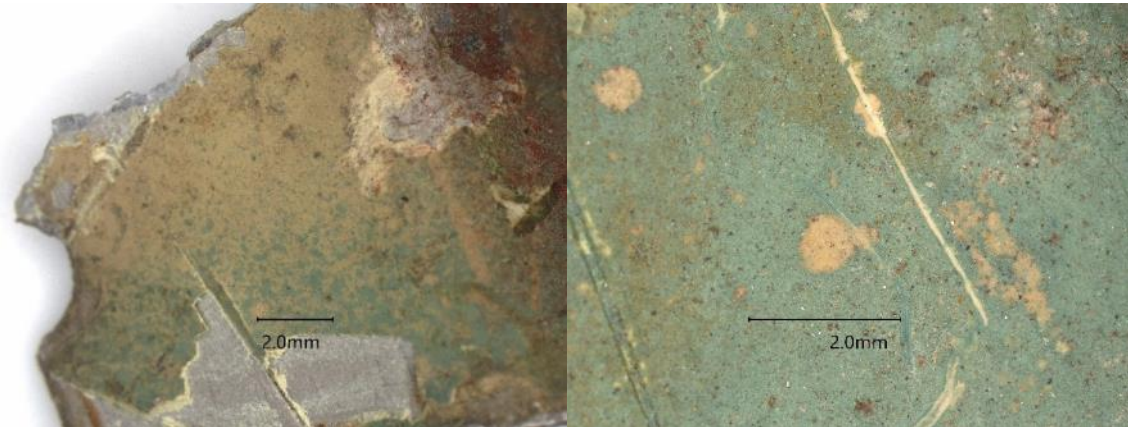
Figure 24: Optical images of the metal from the cockpit of Boulton Paul Barracuda DP872, both sides with surviving beige paint and green topcoat.

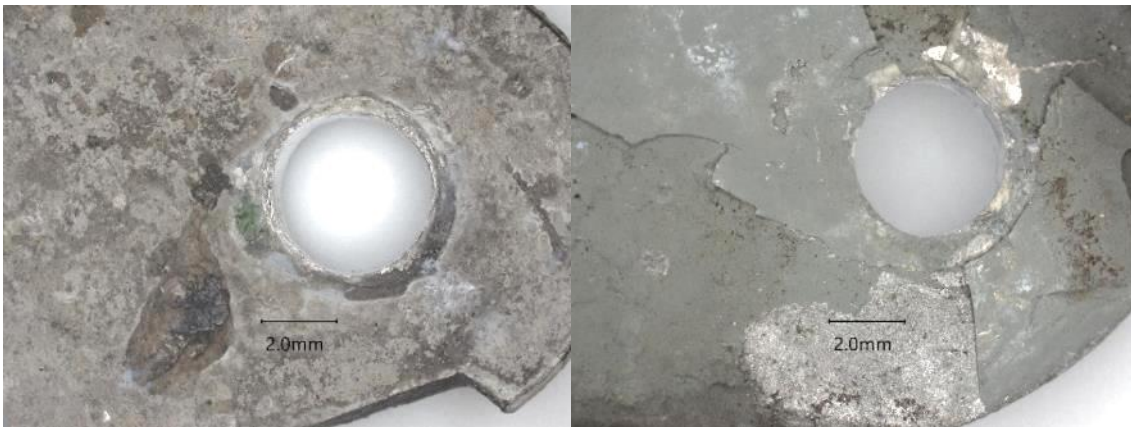
Figure 25: Optical images of the metal from the cockpit of Fairey built Barracuda PM870 showing the grey/green paint, metallic substrate and small area of green pigmented topcoat paint on one surface (left).

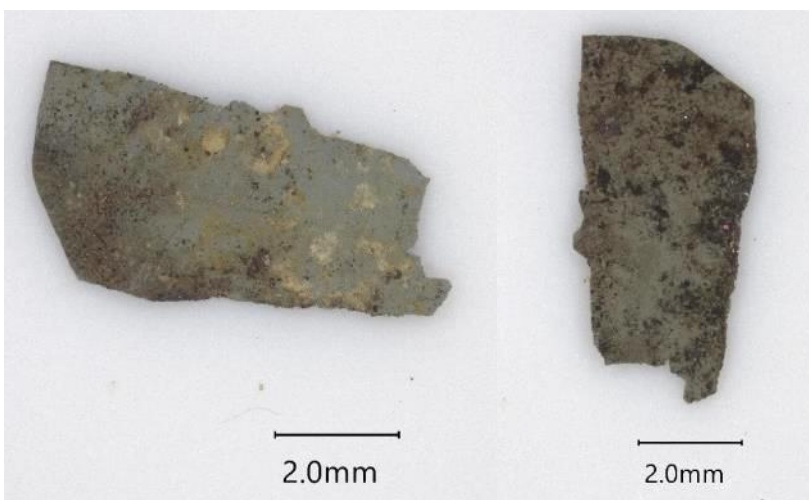
Figure 26: Optical images of the paint sample from the cockpit floor structure of Fairey Barracuda LS931 showing grey/green paint.

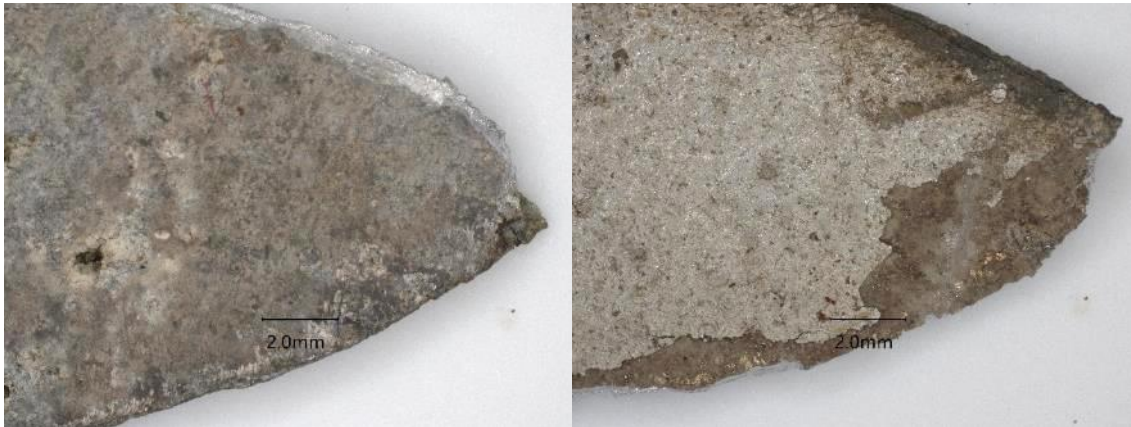
Figure 27: Optical images of a piece of painted metal from the cockpit floor structure of Fairey Barracuda LS931, with grey paint on both sides and an additional silver layer on one side (right).

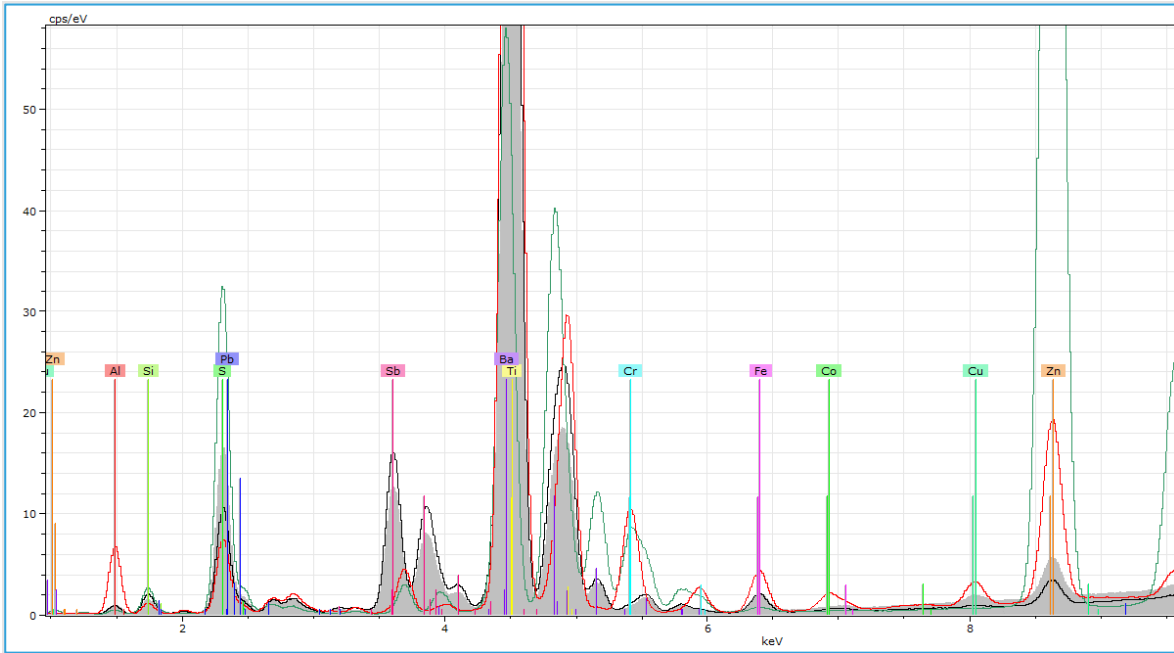
Figure 30: XRF spectra for the paints from Fairey (black line), Blackburn (red line) and Boulton Paul (DP872) (green line) aircraft with the Solent wreck (solid grey spectrum), sample WF-1.
