The Value of Maintenance?

Project Report

Compiled By: James Phillips BA(Hons), BArch, RIBA CA

Date of Report: 29/03/2019

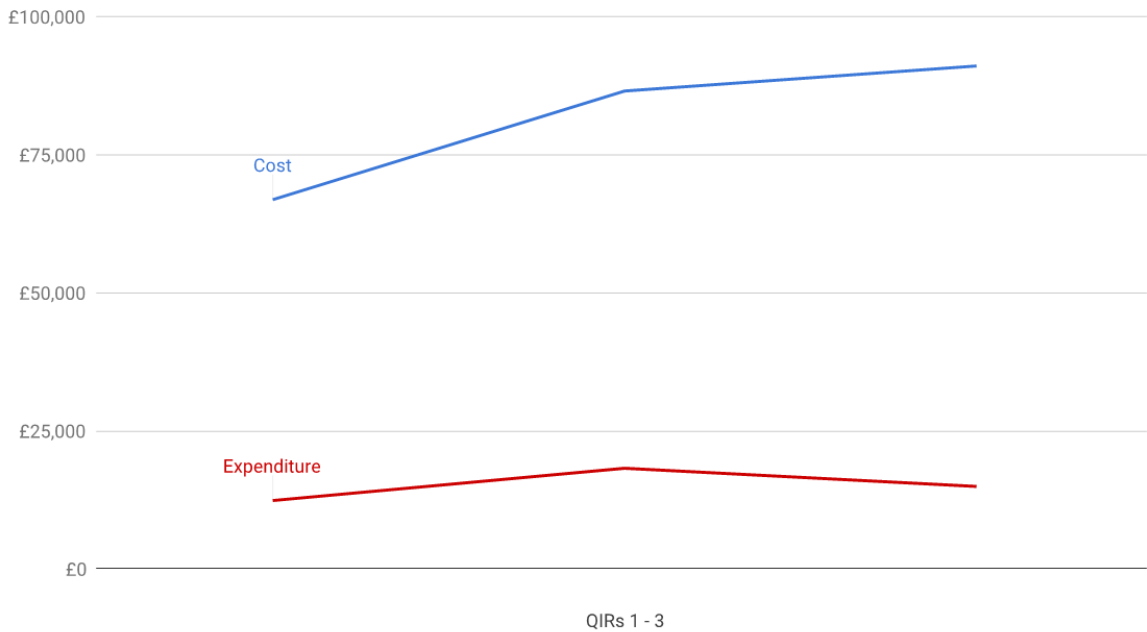
Figure 03- Average Cost and Expenditure by QI for Roofs – 12 churches with minimal maintenance/repair

The following graphs (Figures 03 & 04) illustrate the average cost and expenditure associated with roofs for a sample of churches that have had minimal maintenance, compared with a sample of churches that had regular maintenance and repair. It is clear in both graphs that as expenditure reduces, cost increases and vice versa. The cost of repair was greater for the Churches carrying out minimal maintenance and increased across the study period. The expenditure the regularly maintained churches were much closer to the cost liability than those churches with minimal maintenance.

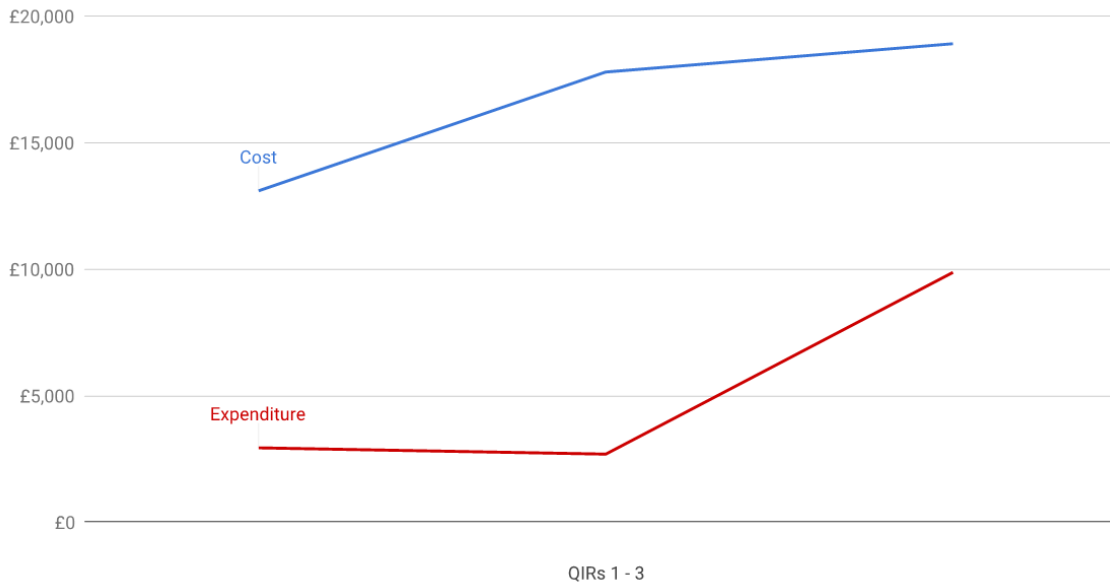
Figure 05- Average Cost and Expenditure by QI for Rainwater Goods and Drainage – 12 churches with minimal maintenance/repair

4.4.13. The following graphs (Figures 05 & 06) illustrate the average cost and expenditure associated with rainwater goods and drainage for a sample of churches that have had minimal maintenance, compared with a sample of churches that have had regular maintenance and repair. The graphs show that the regularly maintained churches' expenditure was closely aligned with the cost liability, whereas, in contrast, there was a much lower expenditure on the

minimal maintenance churches compared to cost liability. However, it can be seen that as the expenditure increases, the rate of deterioration notably slows.

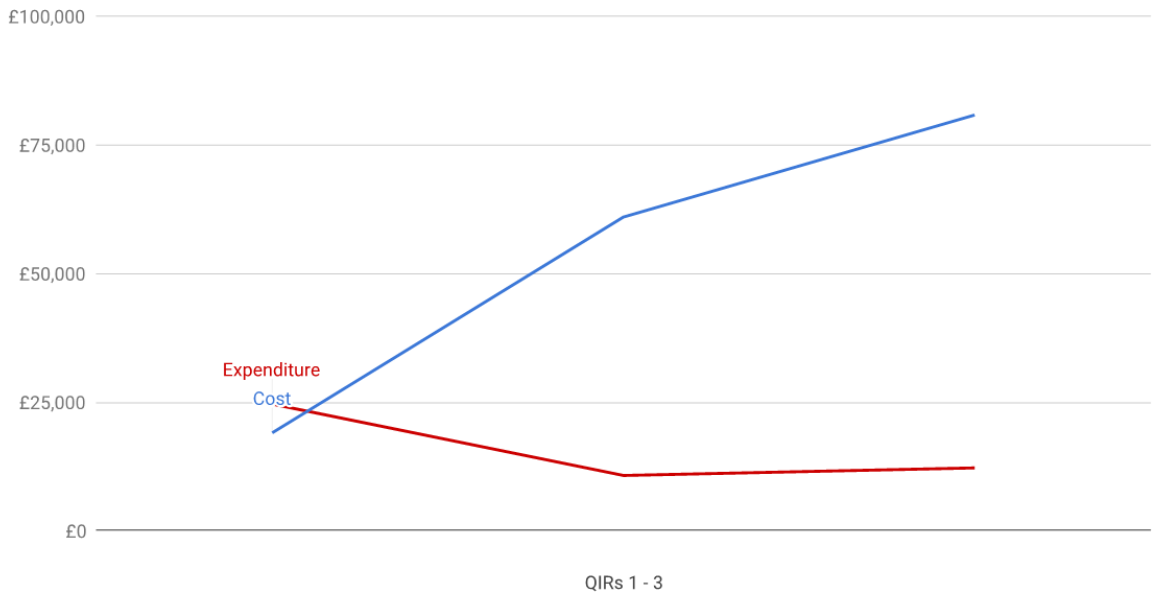
Figure 07- Average Cost and Expenditure by QI for Interior – 12 churches with minimal maintenance/repair

- 4.6.10. The following graphs (Figure 07 & 08) illustrate the average cost and expenditure associated with the interior for a sample of churches that have had minimal maintenance, compared with a sample of Churches that had undertaken regular maintenance and repair. The common pattern of increasing cost liability for churches that carried out minimal maintenance was again apparent. The graphs also appear to validate the observation that churches where roofs and rainwater goods were in good condition had fewer interior defects when compared to those with minimal repair. For those churches with minimal maintenance, there is a common trend between the graph below and the corresponding graphs for roofs and rainwater goods.

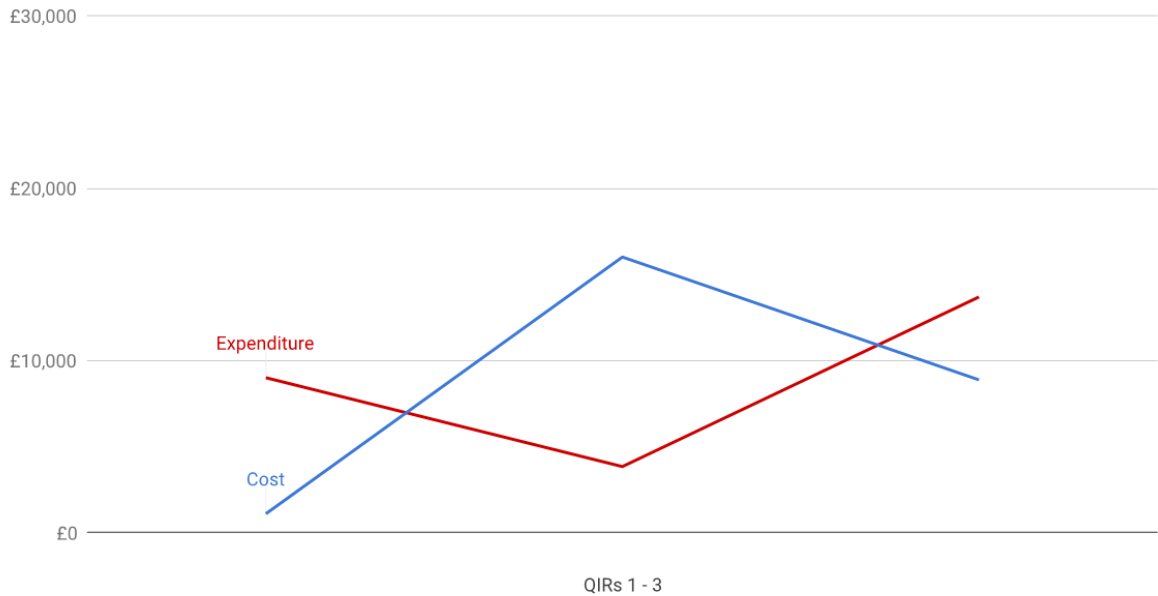
Figure 12 - Average Cost and Expenditure by QI for Services – 9 churches with regular maintenance/repair

- 4.8.7. The following graphs (Figure 11 & 12) illustrate the average cost and expenditure associated with services for a sample of churches that have had minimal maintenance, compared with a sample of churches that had regular maintenance and repair. The two graphs below are broadly similar, reflective of ‘services’ being an area of building fabric that is generally disconnected from the impact of defects elsewhere. Service repairs tend to be quite isolated items (e.g. an old boiler being replaced), so there is a much clearer relationship between expenditure and cost, without the impact of deterioration noted in the other elemental categories.

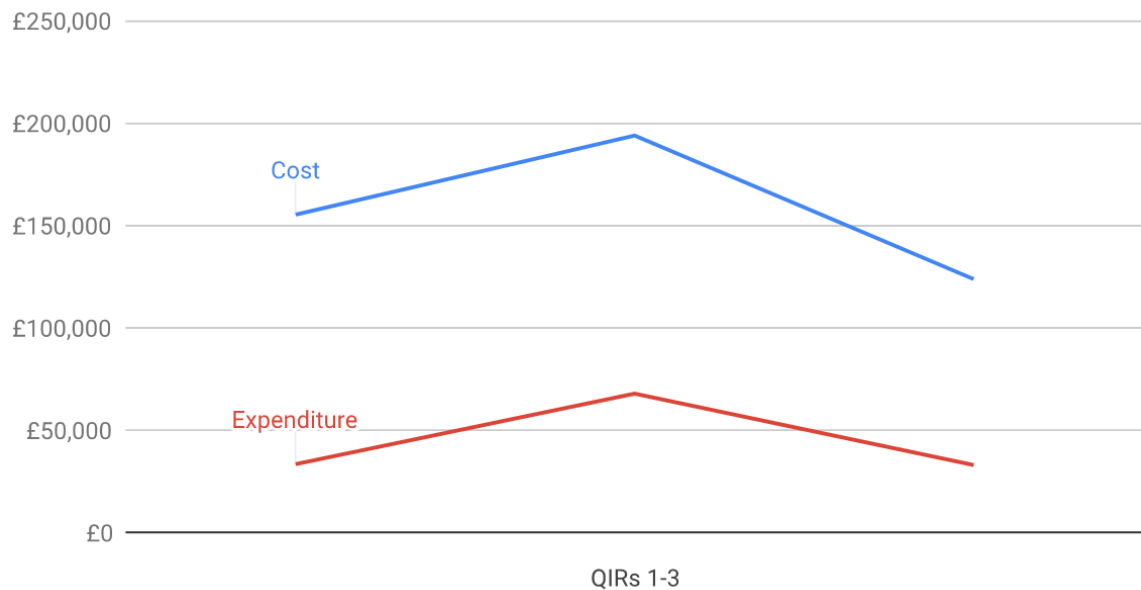
Figure 15 - Average Cost and Expenditure by QI for Medieval churches

5.2.3. The graphs on the following pages (Figures 15 to 18) show the cost against expenditure for Medieval and Victorian/Pre WW1 churches, first as a total figure, and then separated by element. This is taken from the sample of each age category, so includes a mixture of churches in good and in poor condition.

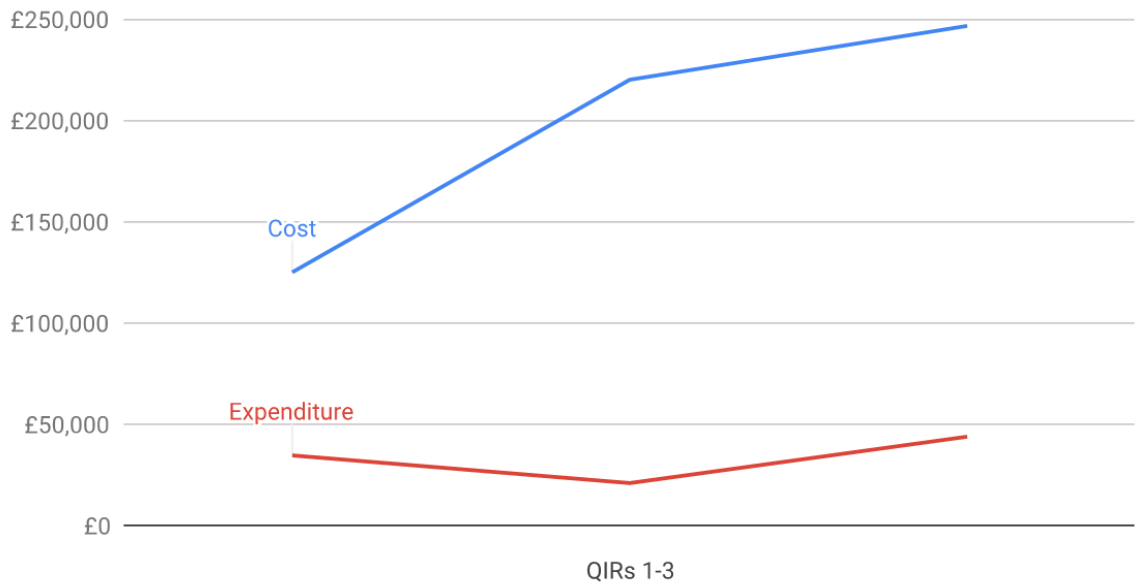
Figure 16 - Average Cost and Expenditure by QI for Victorian/Pre WW1 churches

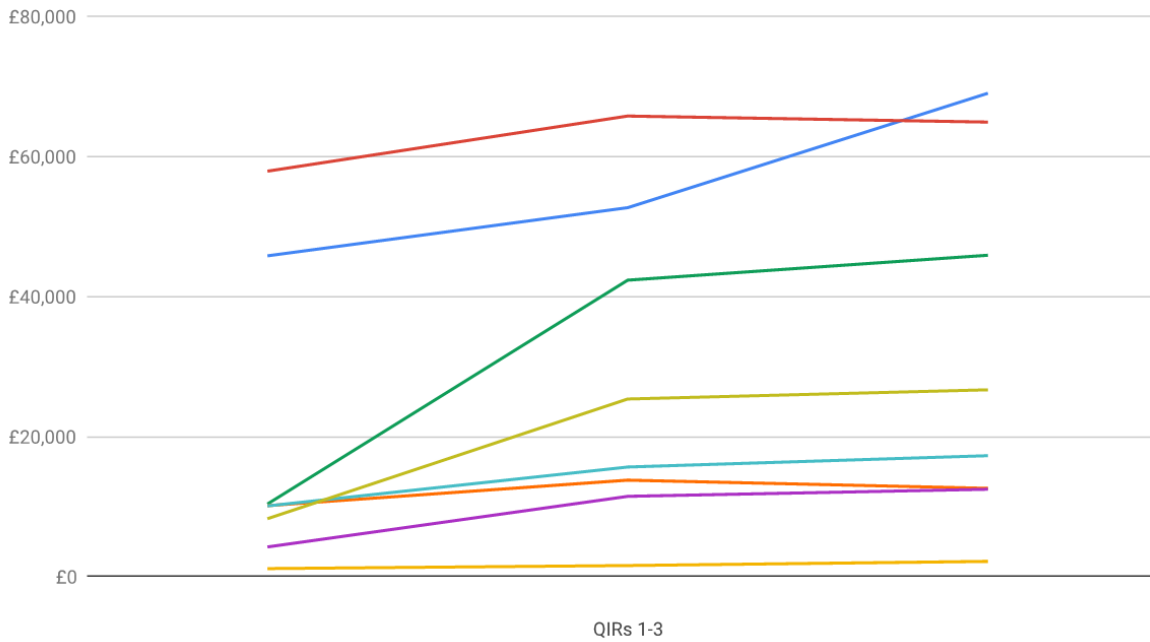
Figure 18 - Average Cost by QI and Element for Victorian/Pre WW1 churches

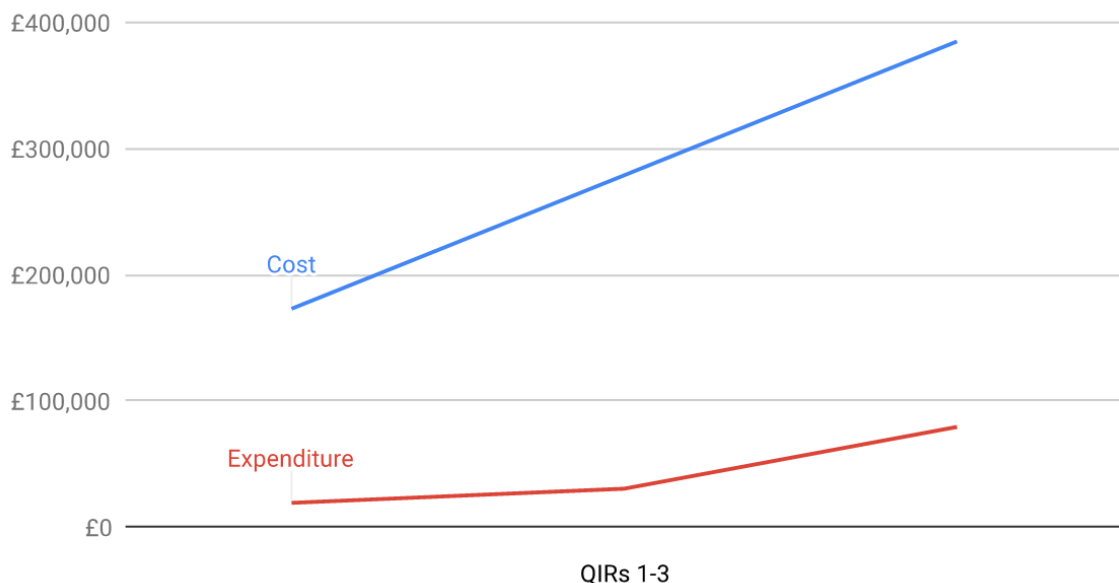
Figure 19 - Average Cost and Expenditure by QI for churches on HAR for over 3 years

The graphs on the following pages (Figures 19 to 22) demonstrate the overall estimated cost and expenditure from one QIR to the next for each HAR category, taken as an average of the churches in that category.

- 5.3.3. In all but the first category (Churches on HAR for over 3 years) the range of cost and expenditure, as an average of the churches in each category, is in broadly the same region (£100,000 to £250,000). In all cases the average cost of repairs is 4 to 5 times greater than the expenditure on repairs in the same period. No Church in the study has, or has spent, the necessary funds required to completely resolve the defects noted at any one time. It is therefore imperative that funds are spent wisely to ensure that expenditure has the greatest possible beneficial impact.

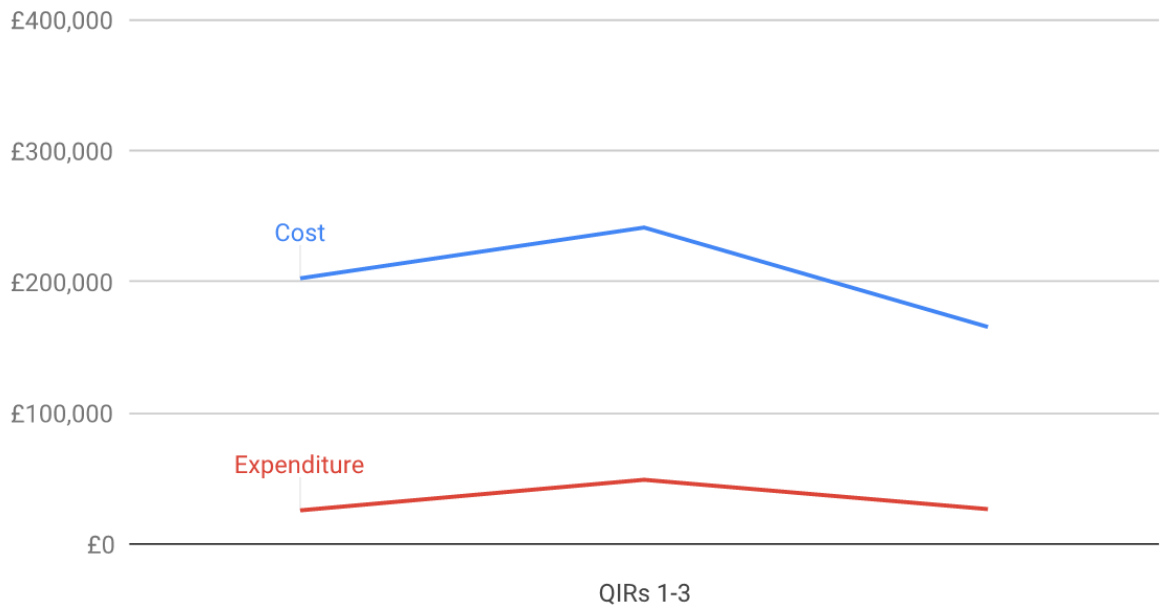
Figure 20 - Average Cost and Expenditure by QI for churches added to HAR in 2018

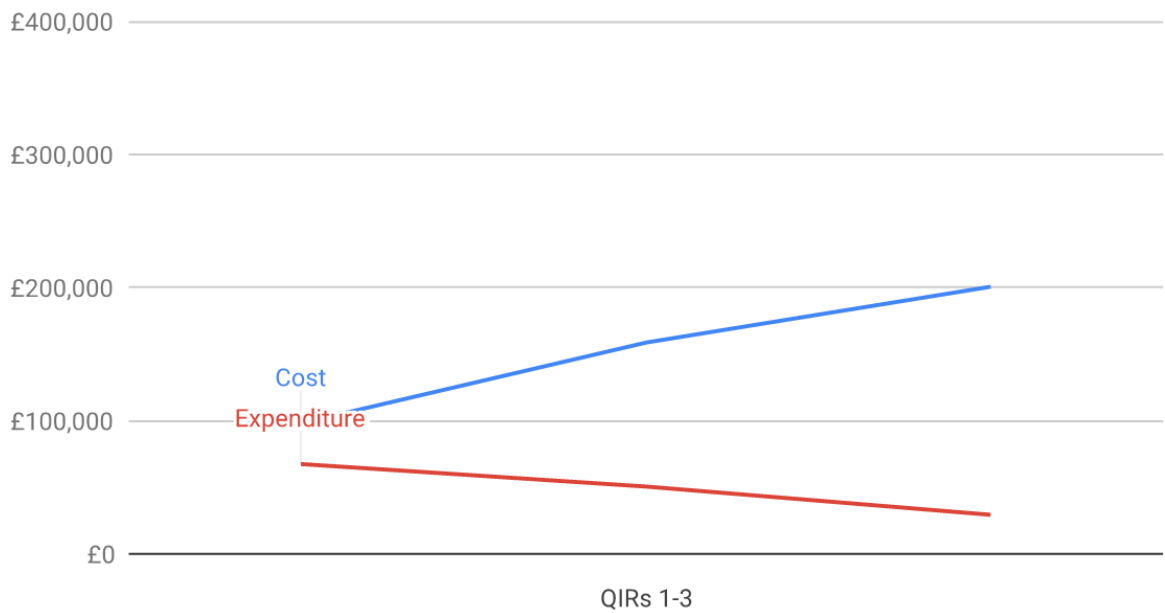
Figure 21 - Average Cost and Expenditure by QI for churches assessed in 2012 but not HAR

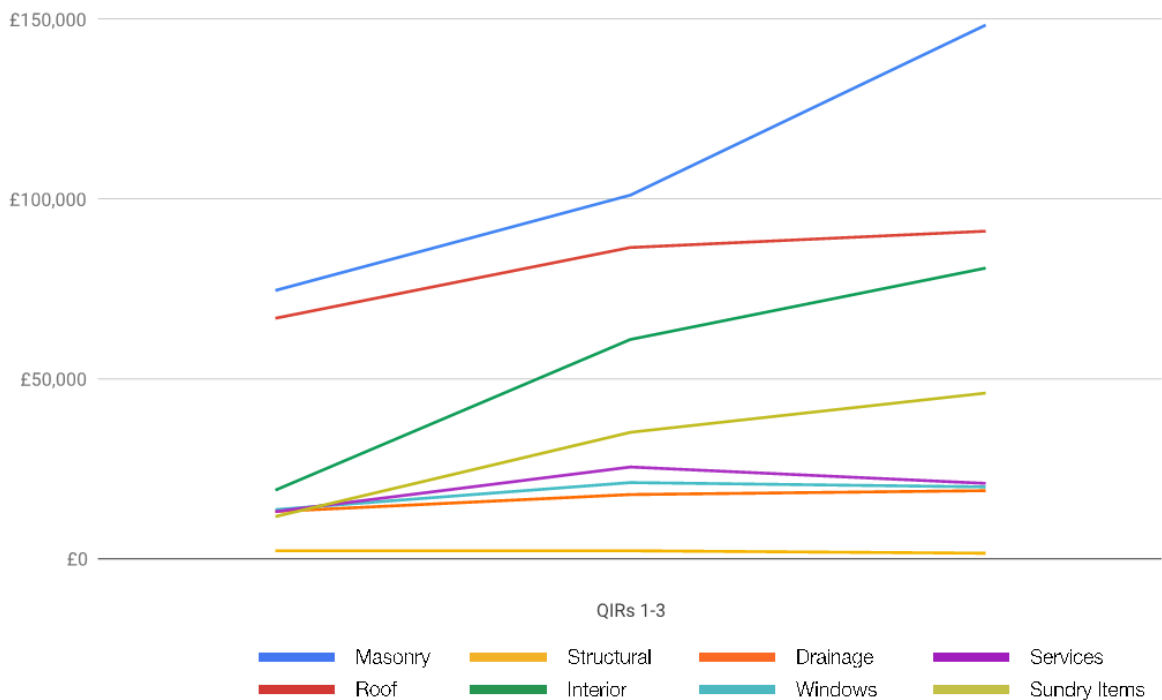
Figure 24 – Average Cost by QI and Element – 12 churches with minimal maintenance/repair

6.1.1. This research project set out to assess whether regular maintenance and a pro-active response to maintenance requirements can reduce the long-term cost liability of a church. It also sought to identify how ignoring these ‘stitch in time’ repairs and neglecting regular maintenance can affect a church, and how quickly the fabric could deteriorate as a result. The starkest demonstration of the findings is the comparison of the elemental cost of repairs of a well-maintained church, compared to one with minimal maintenance.

- 6.1.2. Across all elements, the cost liabilities for the churches that were poorly maintained and repaired were significantly higher than those that received regular attention. Although those churches also experienced sudden costs due to wear and tear failures, by carrying out regular repair and maintenance, the expenditure across each quinquennium was much more consistent, making it easier to predict and budget for.

- 6.1.3. Of particular note is the trajectory of ‘masonry’ and ‘interior’; the two key elements that are susceptible to consequential defects as a result of defects in roofs and rainwater goods. Figure 24 demonstrates a significant increase in estimated cost from one QIR to the next, which is attributed to the increasing impact of unresolved roof and rainwater goods defects. It is interesting to observe that whilst the cost of roof repairs increases as more of the roof fails and needs replacement, the cost line for rainwater goods remains relatively constant (although still higher than for the well-maintained churches). This is because, in isolation, once rainwater goods reach a point of failure where they require complete overhaul, the cost will not increase to the kind of levels for roof repair. It is the consequential damage in other elements where the cost increase arises, not the basic cost of repairing the rainwater goods themselves.

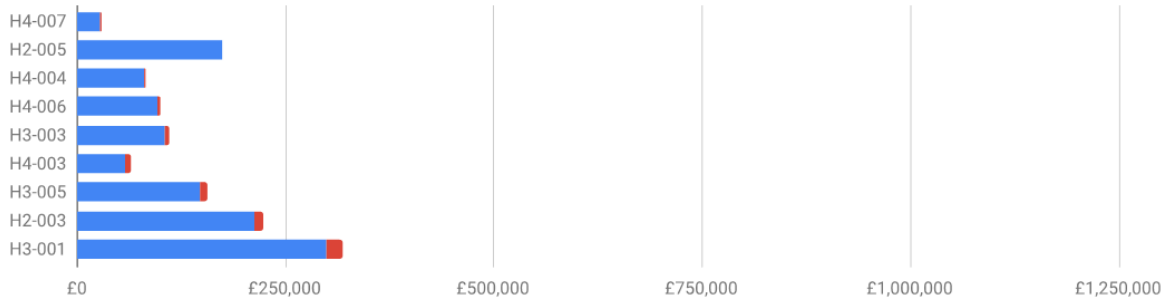
Figure 29 – Cumulative Cost of Delayed Repair – 9 churches with regular maintenance/repair

■ Initial cost of repair ■ Increase in cost as a result of a lack of timely repair

6.2.3. Figures 28 and 29 compare the initial cost of defects with the final cost, where change in cost was purely associated in worsening condition as a result of the lack of timely maintenance and repair. This increase in cost is shown in red on these graphs. At a basic level, this increase was all avoidable cost, though obviously available resources and funding do limit what is possible. This is why even the well maintained churches have sums of cumulative cost. However, it is clear that, when reviewing the percentage of the initial cost, churches where minimal maintenance and repair was carried out experienced much greater increase in cost liability as a result of not carrying out work in a timely fashion.

6.2.4. These graphs only demonstrate part of the cost associated with delaying repair. The costs shown on the graphs are the totals of cumulative costs of delay for individual items in isolation. For example, this may be that the initial cost was for a small amount of slipped slates, which by the end had increased as the number of slipped slates increased due to lack of repair. What it doesn't account for, however, is the consequential damage as a result of this, e.g. a plaster ceiling collapsing as a result of water ingress through these slipped slates. This is difficult to quantify on a cause and effect basis, as many issues have numerous causes. However, it was clear from the text of the QIRs that this consequential damage does occur and so the overall cost impact of delaying repair can be considerably greater than demonstrated on the previous graphs and can indeed be many times the cost of the original repair. The impact is best demonstrated by the overall increase in cost of the total cost liability of a church over the study period.
