THE COACH HOUSE, STABLES
AND OFFICES IN
DANSON PARK, BEXLEY

*An Assessment of the Surviving Fabric
and its Setting*

Richard Lea and Chris Miele

Historical Analysis & Research Team
Reports and Papers (First Series, 6)
1996

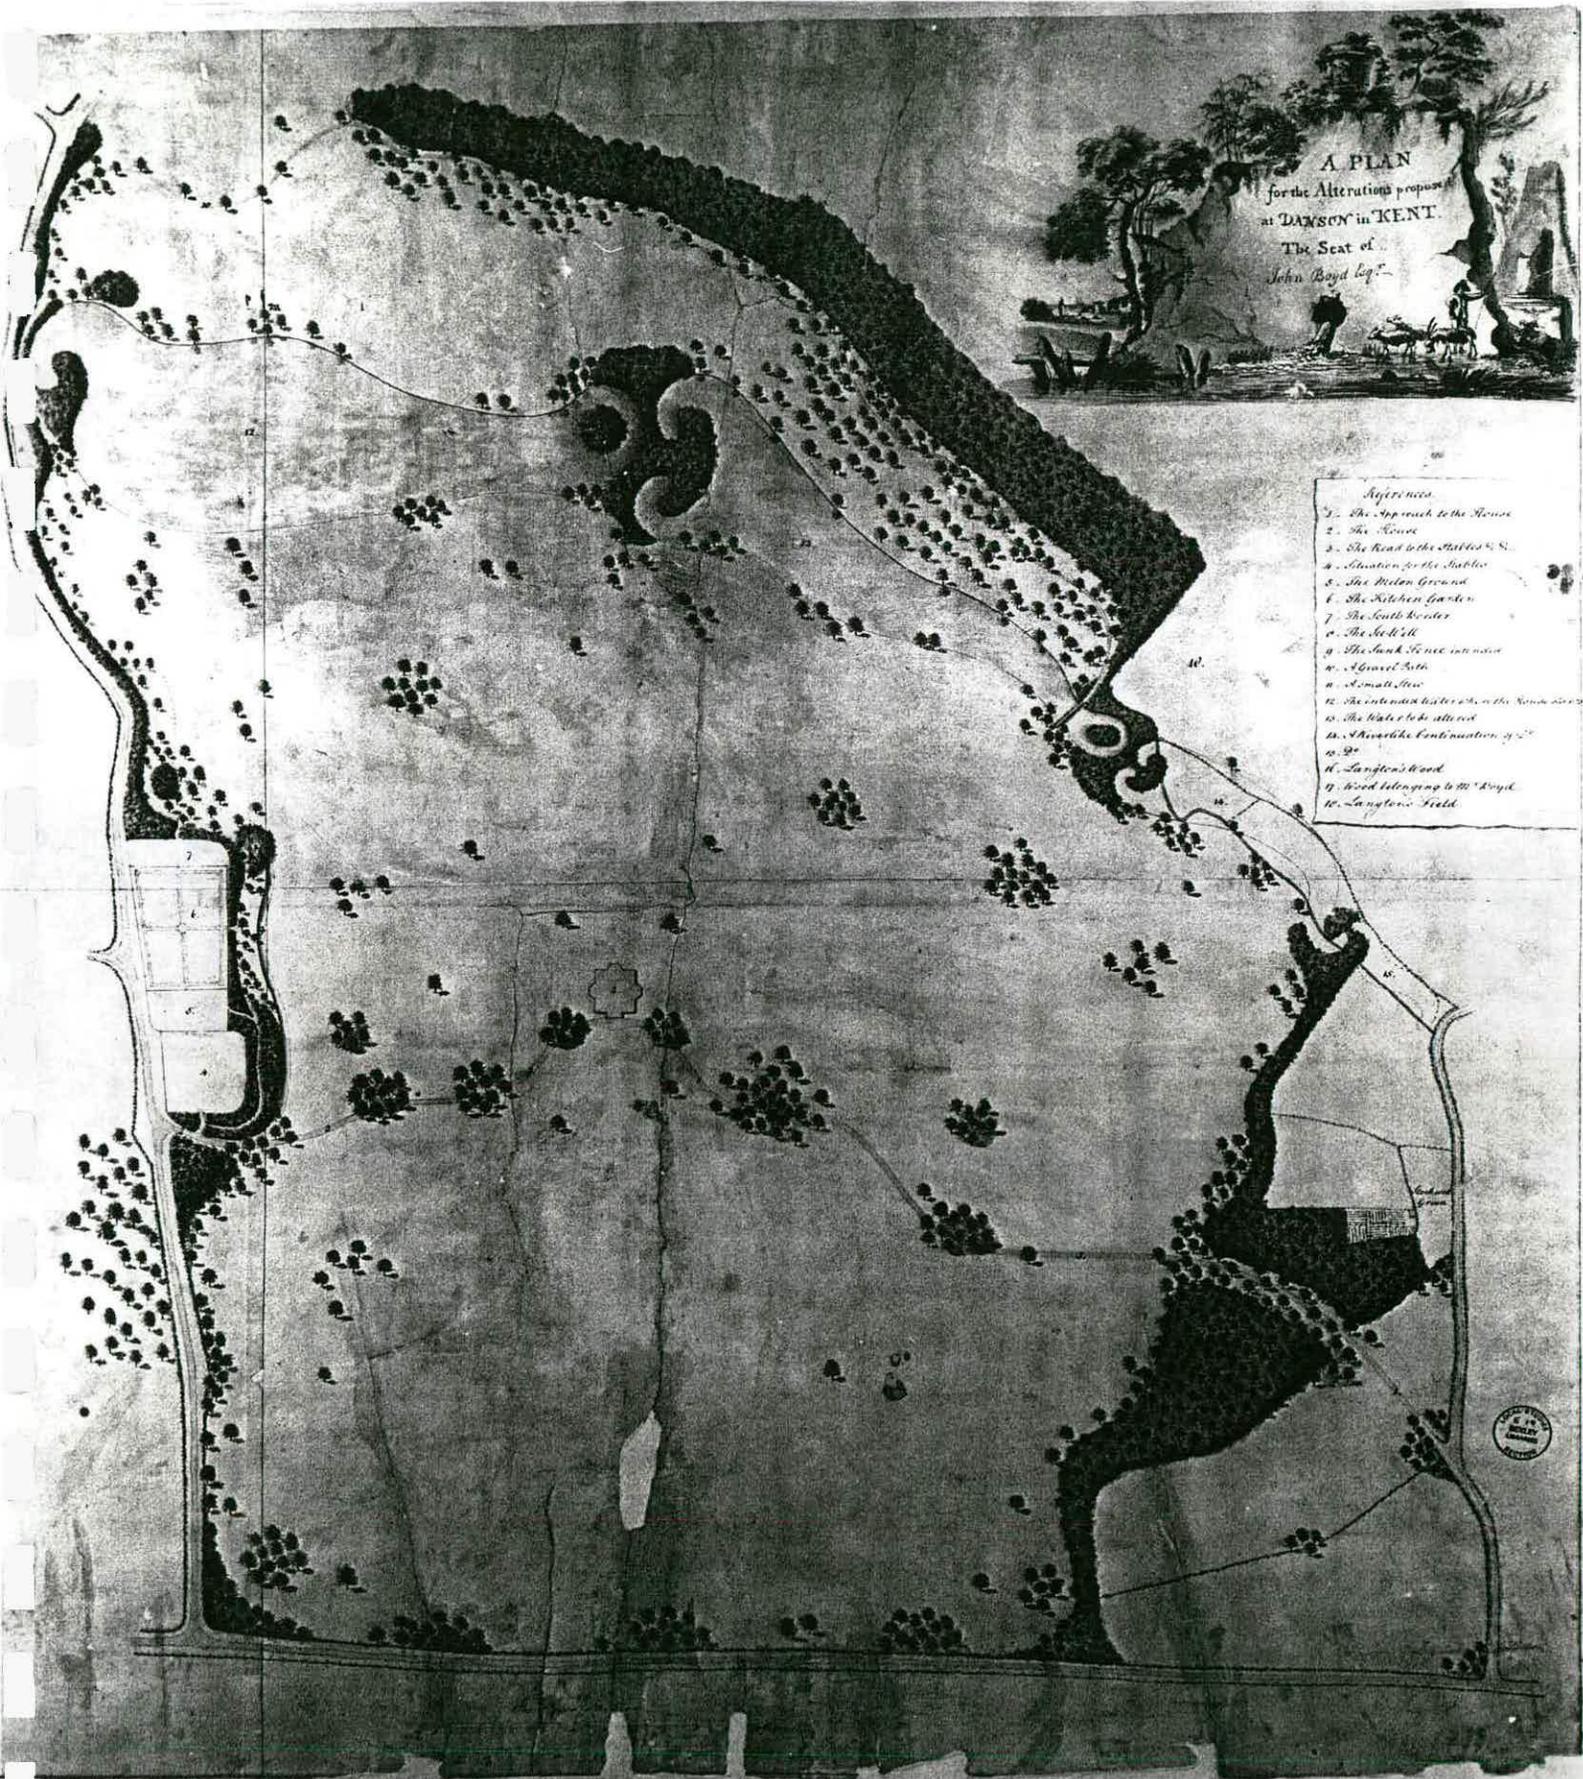
1. A plan for the proposed Alterations at Danson Hill, the Seat of John Boyd Esq. possibly by Nathaniel Richmond and probably dating from 1763.

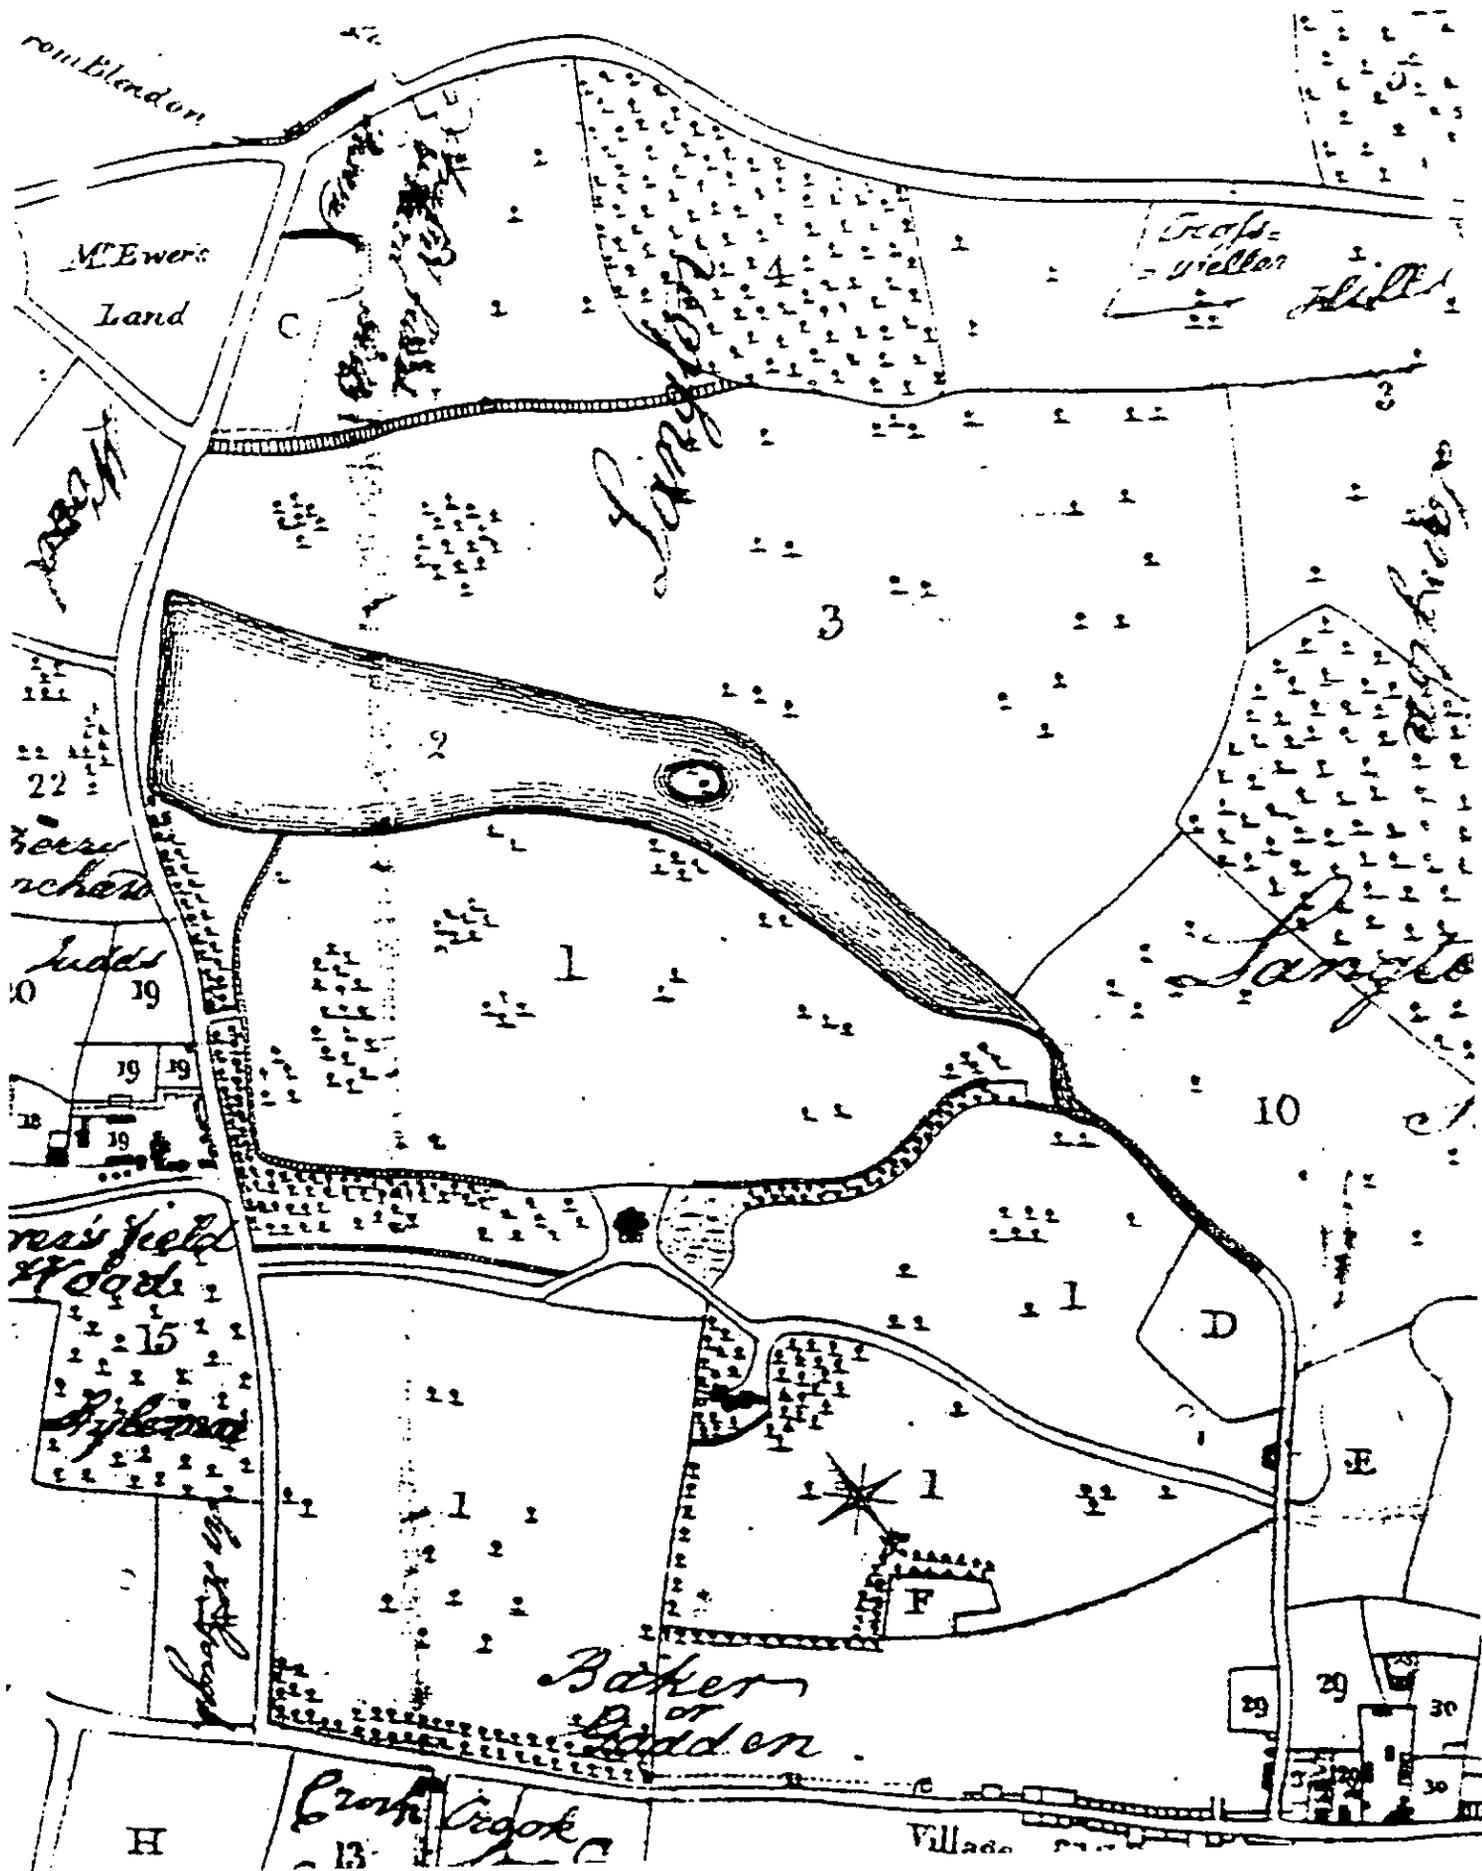
8. Plan of an Estate called Danson in the County of Kent, now in the Local Studies Collection at Hall Place, Bexley. Dating from 1805.

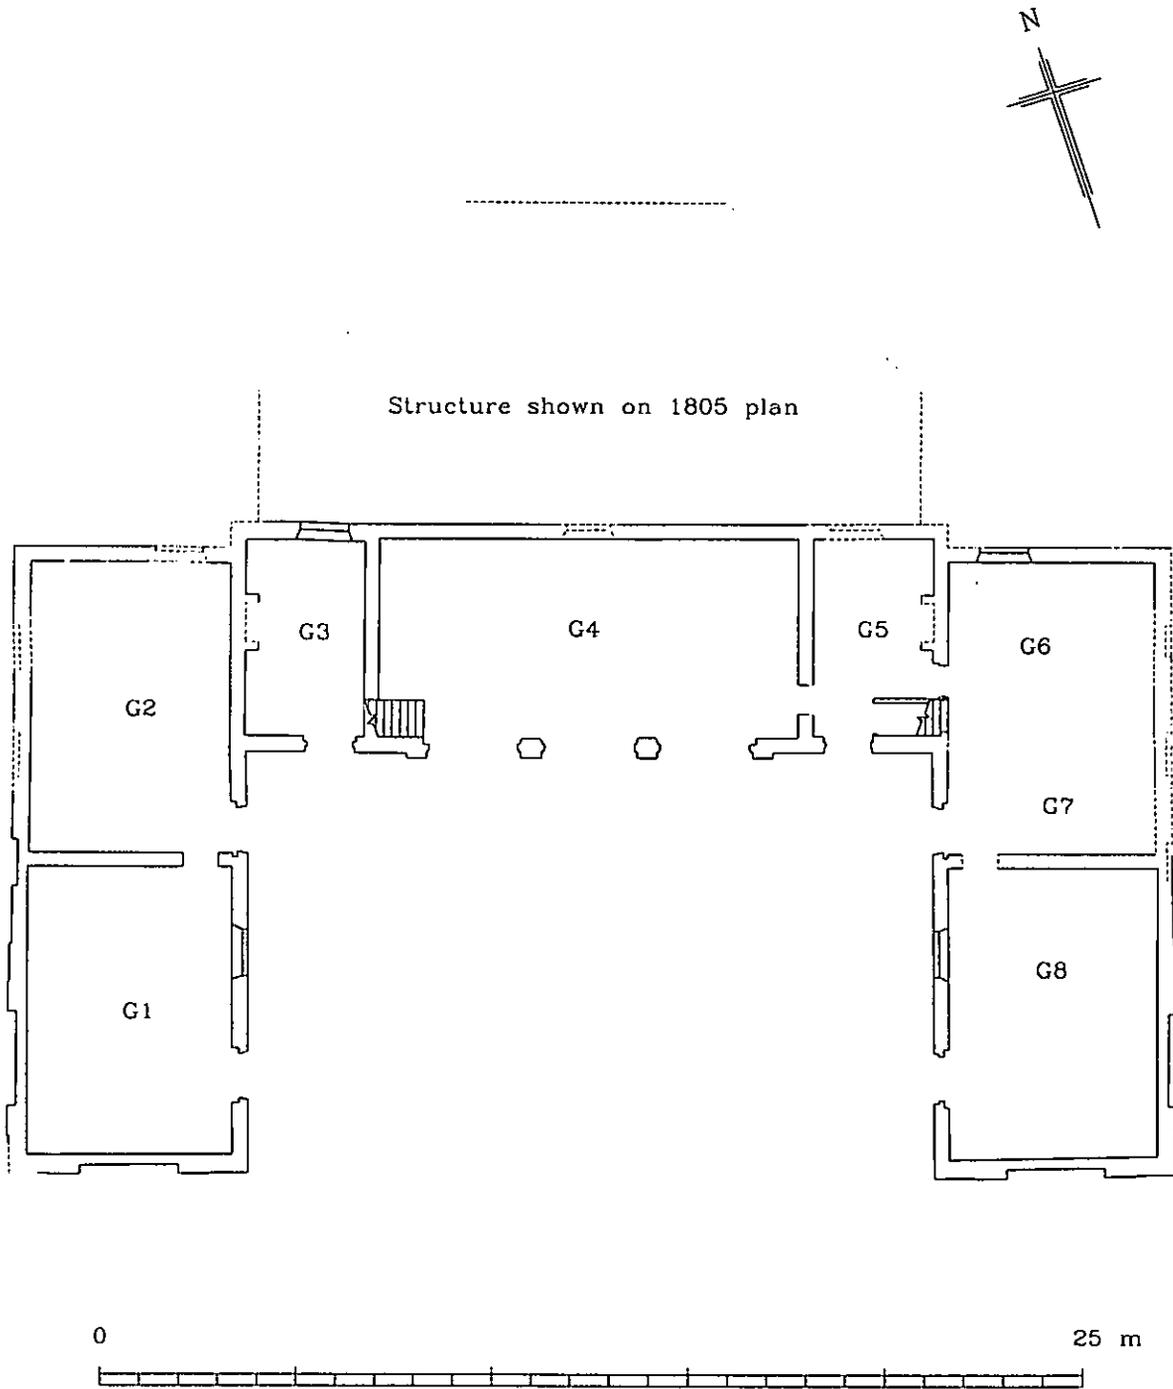
9. Reconstructed ground plan of the stable block as built c1804, scale 1:200.

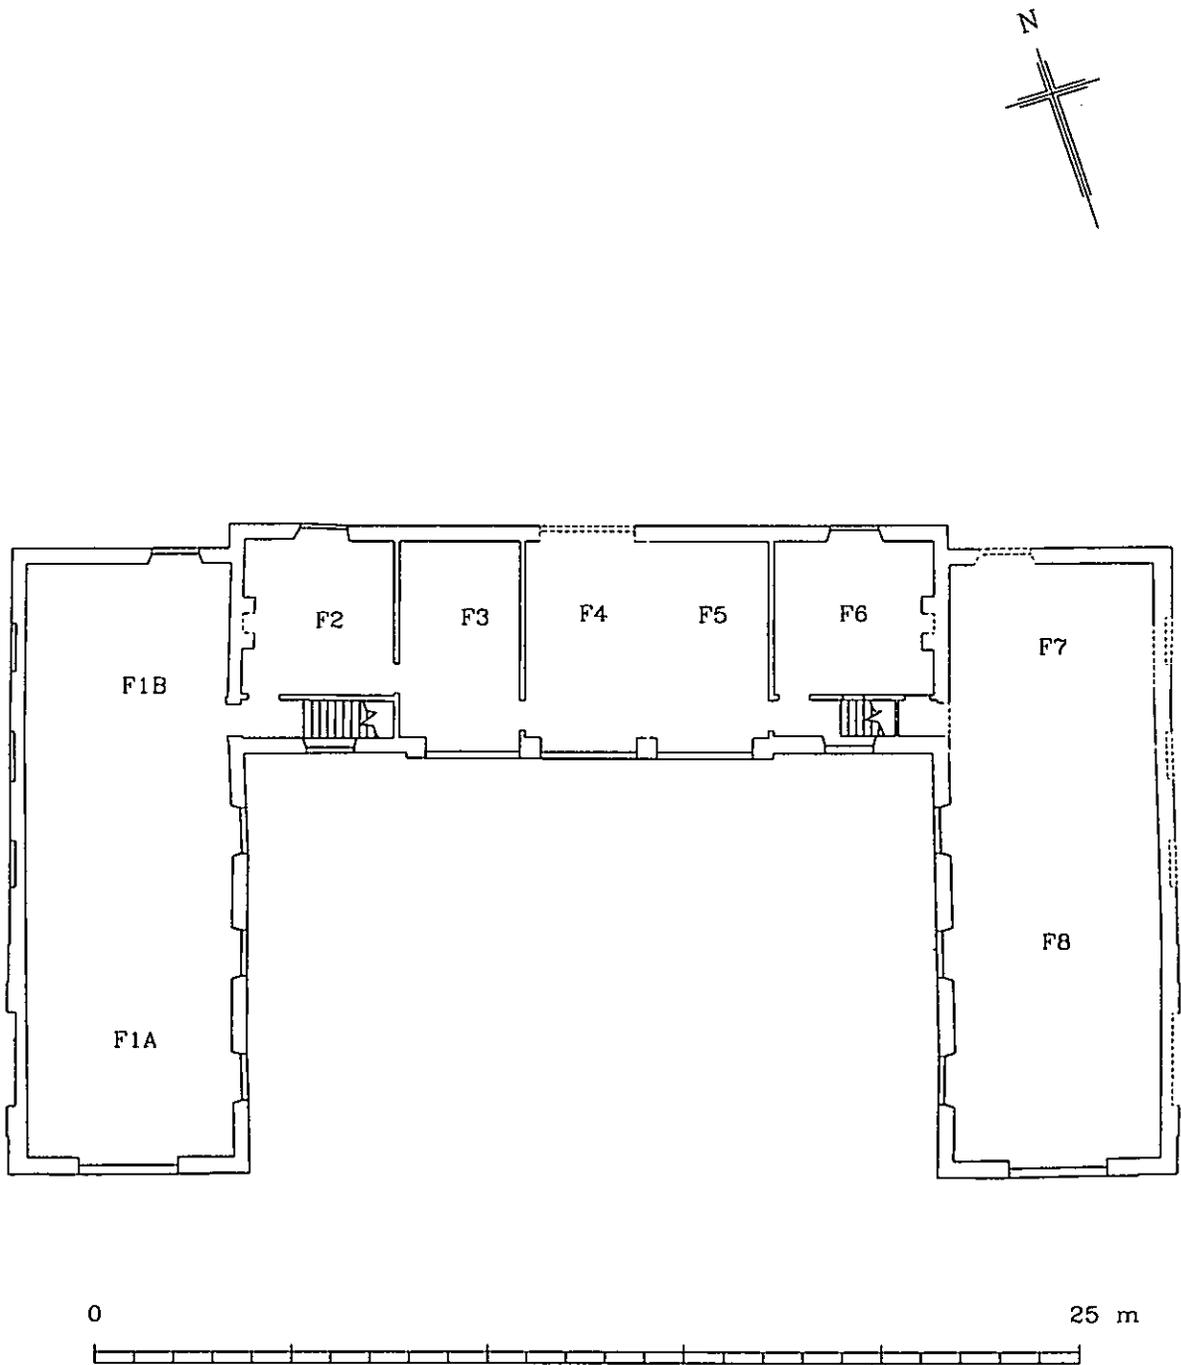
10. Reconstructed first floor plan of the stable block as built c1804, scale 1:200.

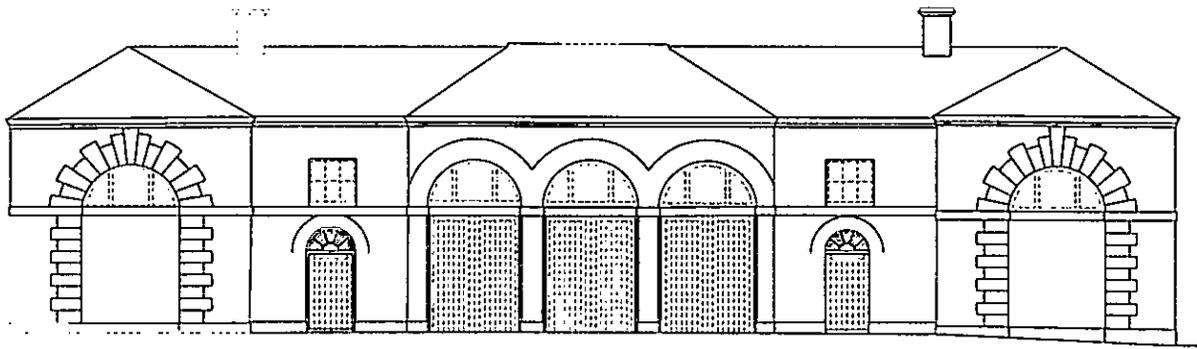
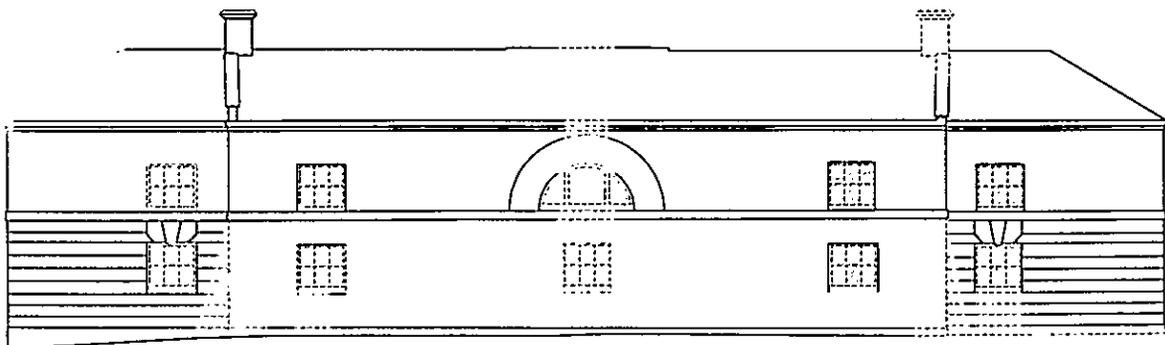
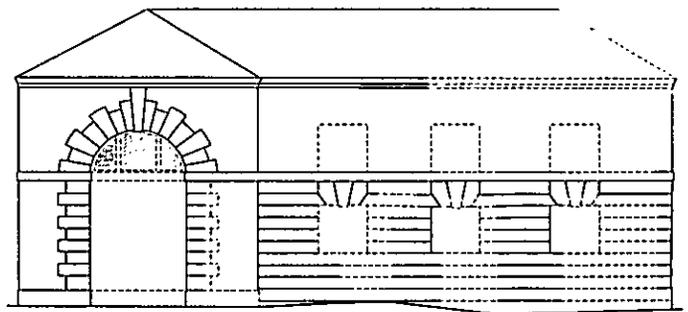
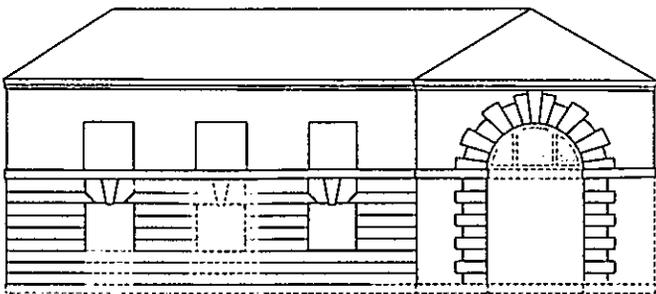
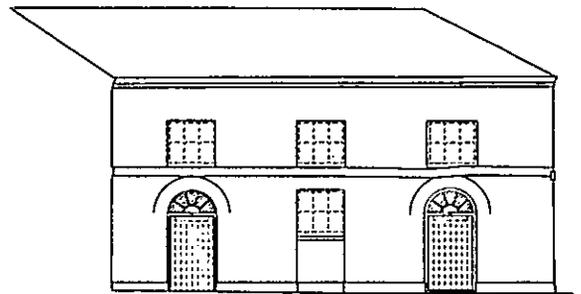
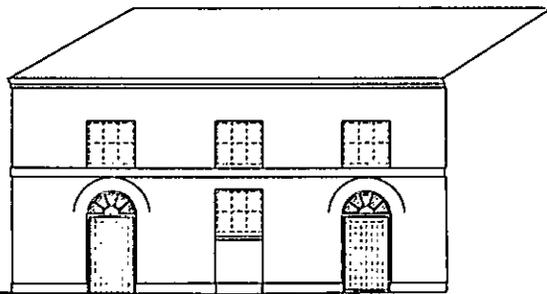
11. Reconstructed elevations of the stable block as first built c1804, scale 1:200.

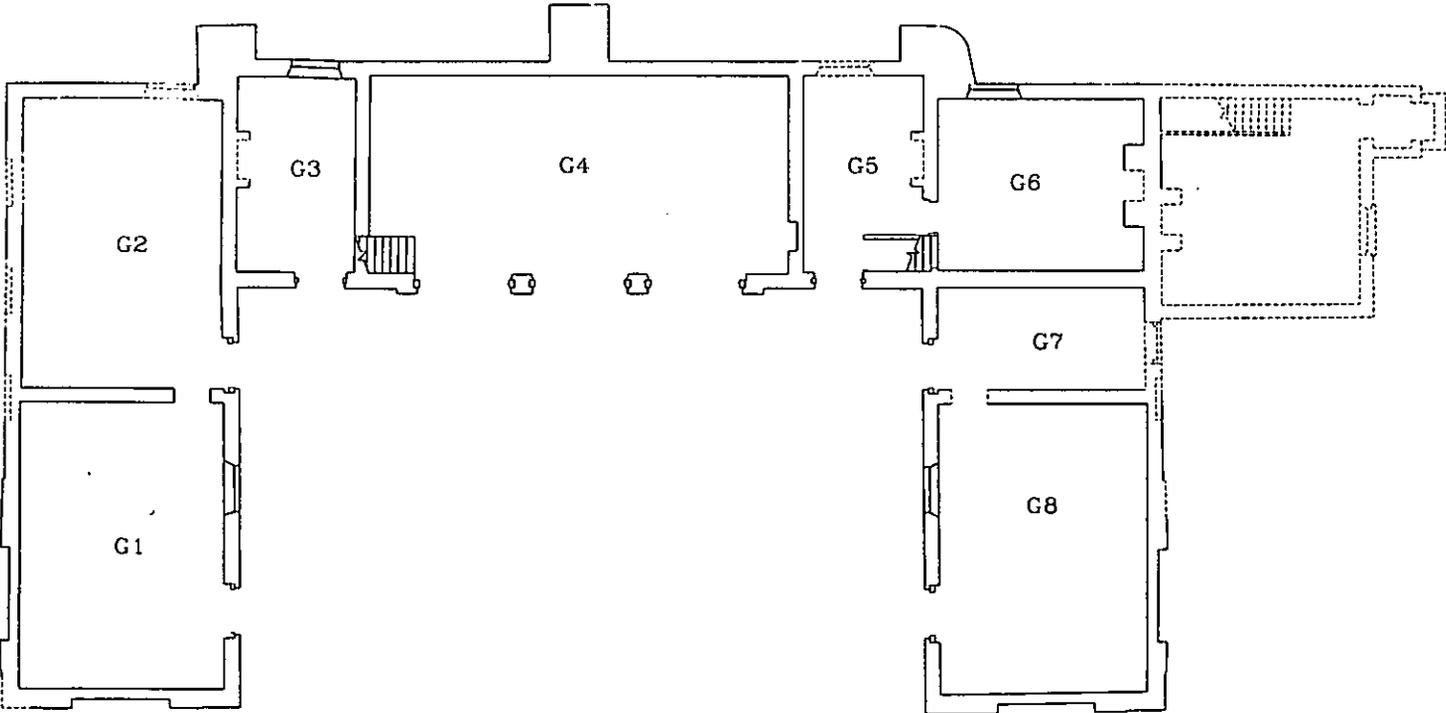
14. Reconstructed ground plan of the stable block after the additions of c 1860

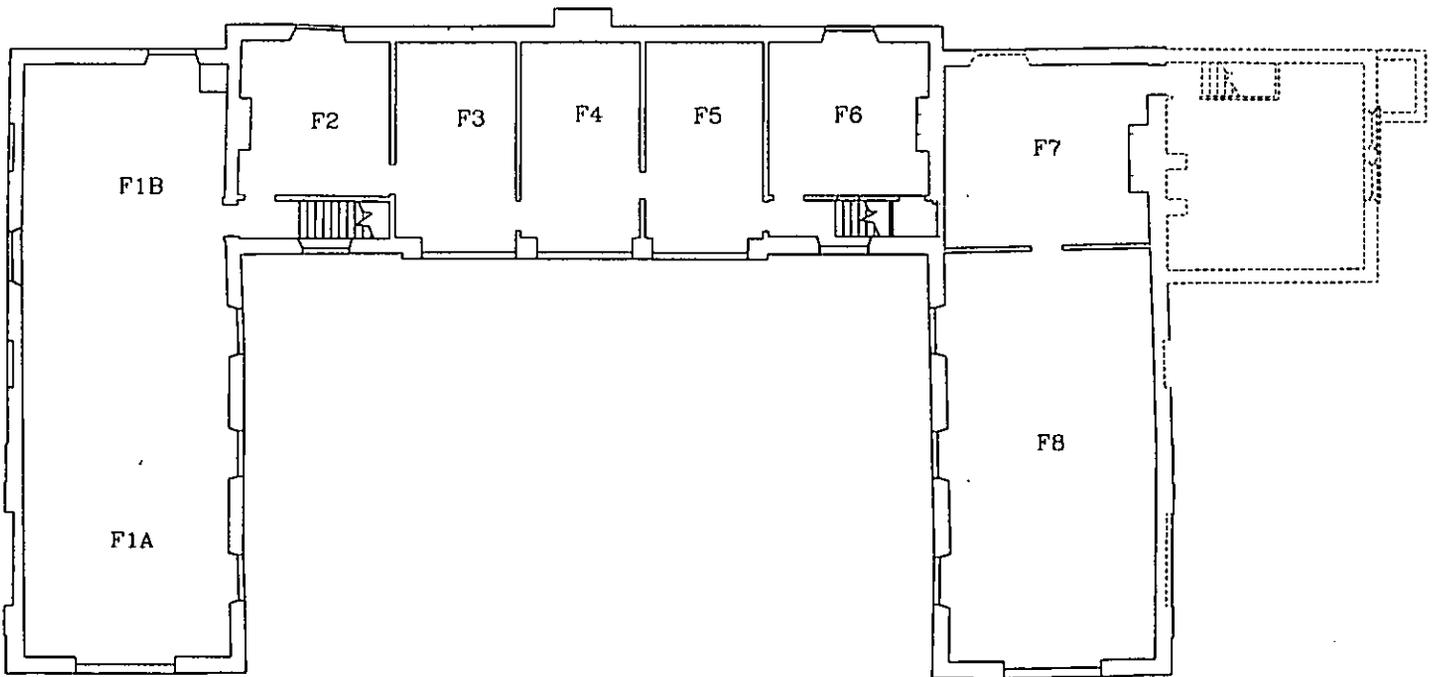
15. Reconstructed first floor plan of the stable block after the additions of c 1860

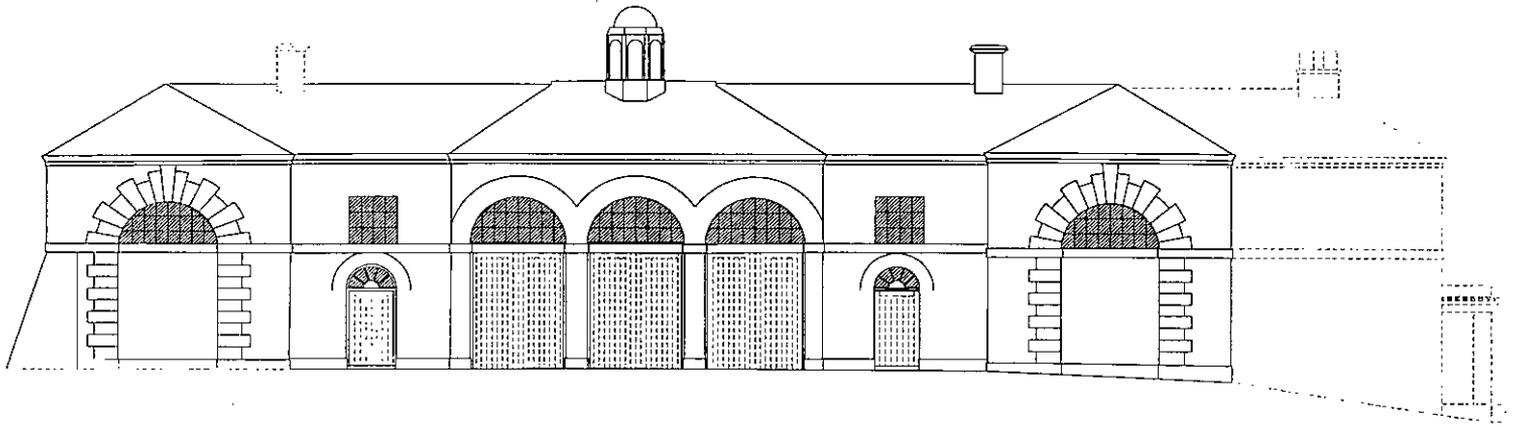
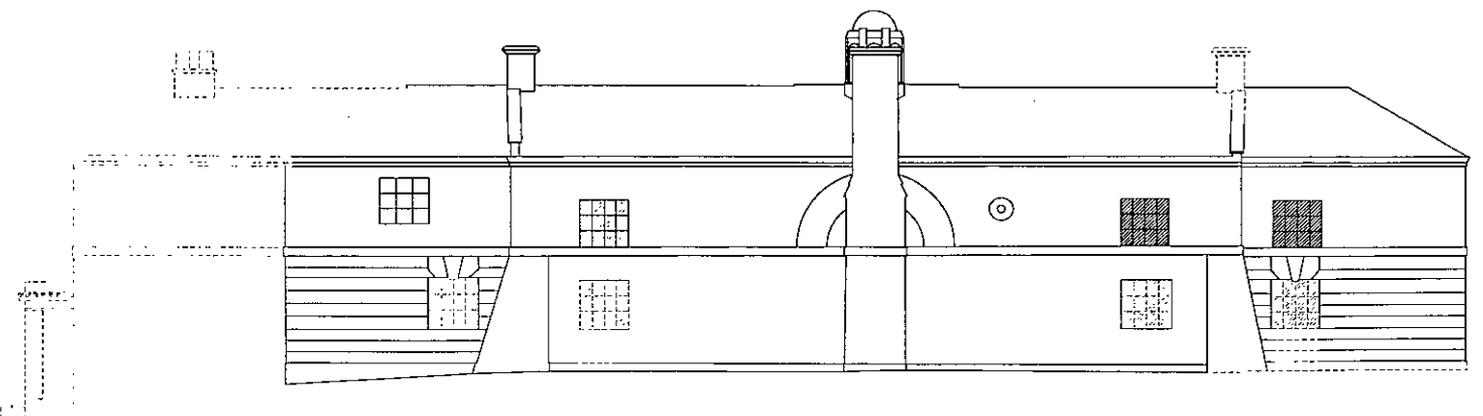
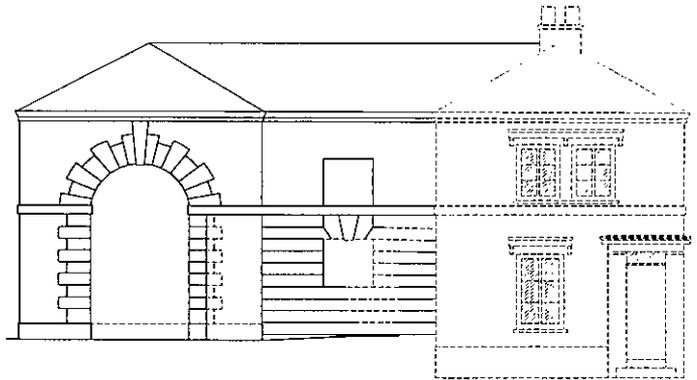
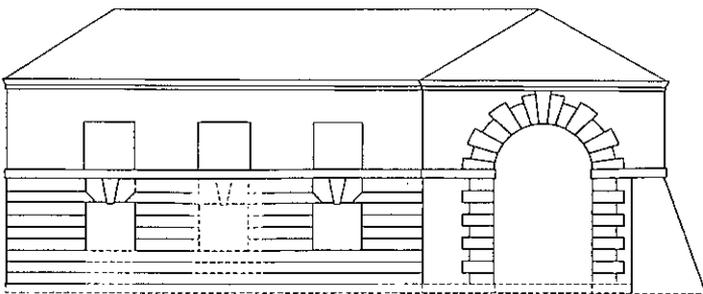
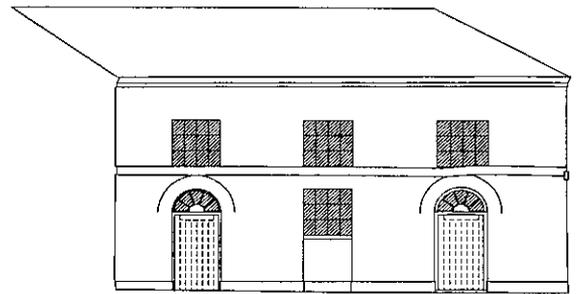
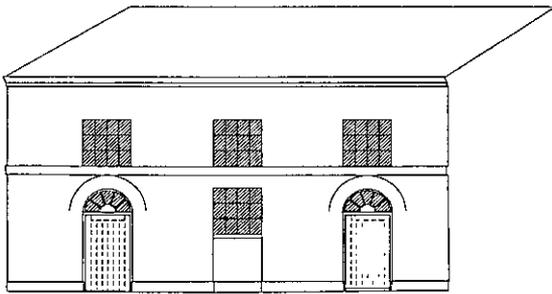
16. Reconstructed elevations of the stable block after the additions of c 1860

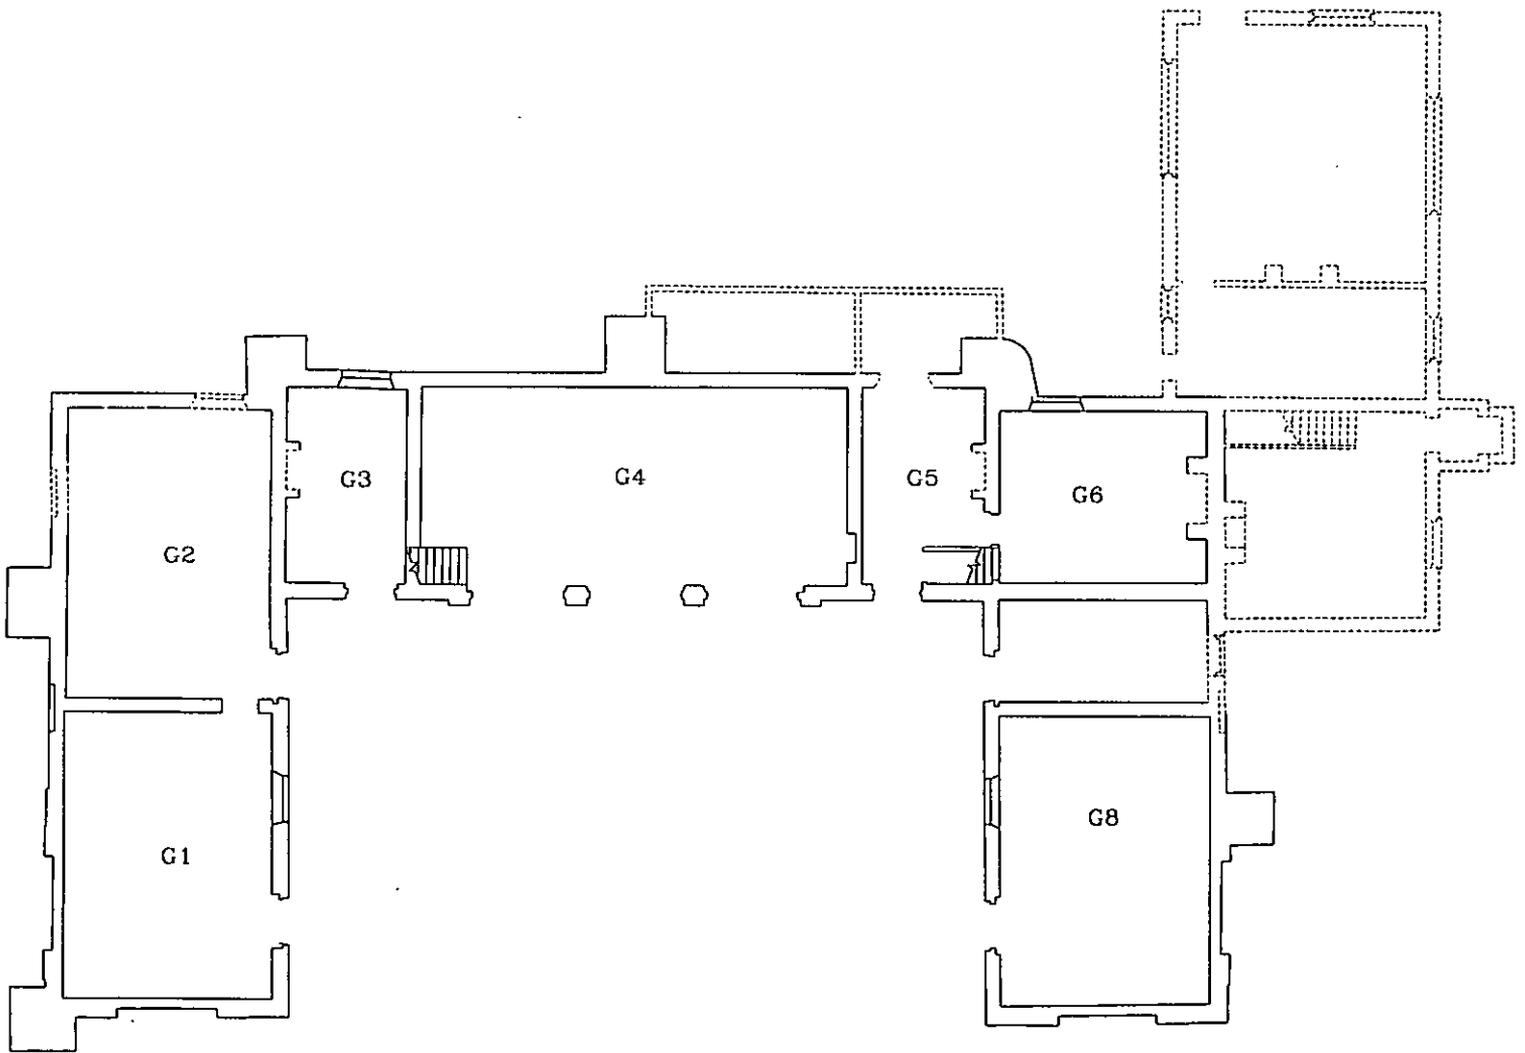
18. Reconstructed ground plan of the stable block after the additions of c 1890, scale 1:200

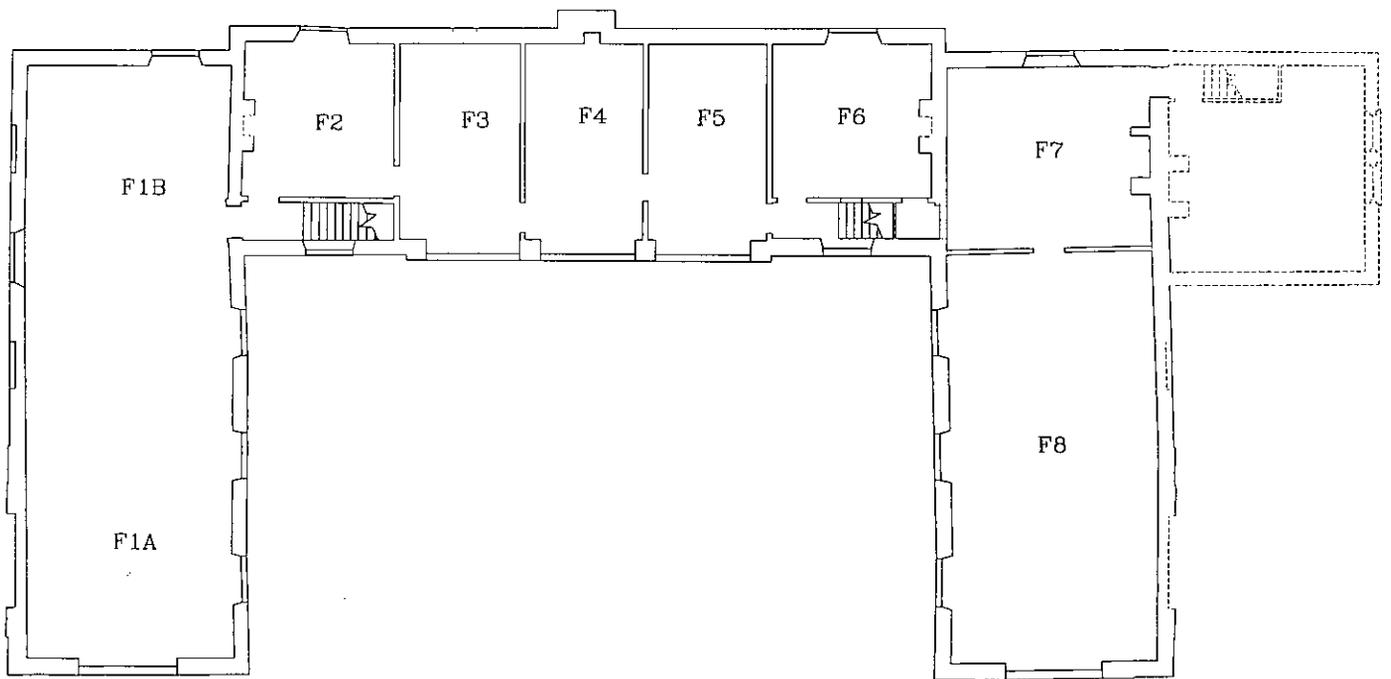
19. Reconstructed first floor plan of the stable block after the additions of c 1890, scale 1:200

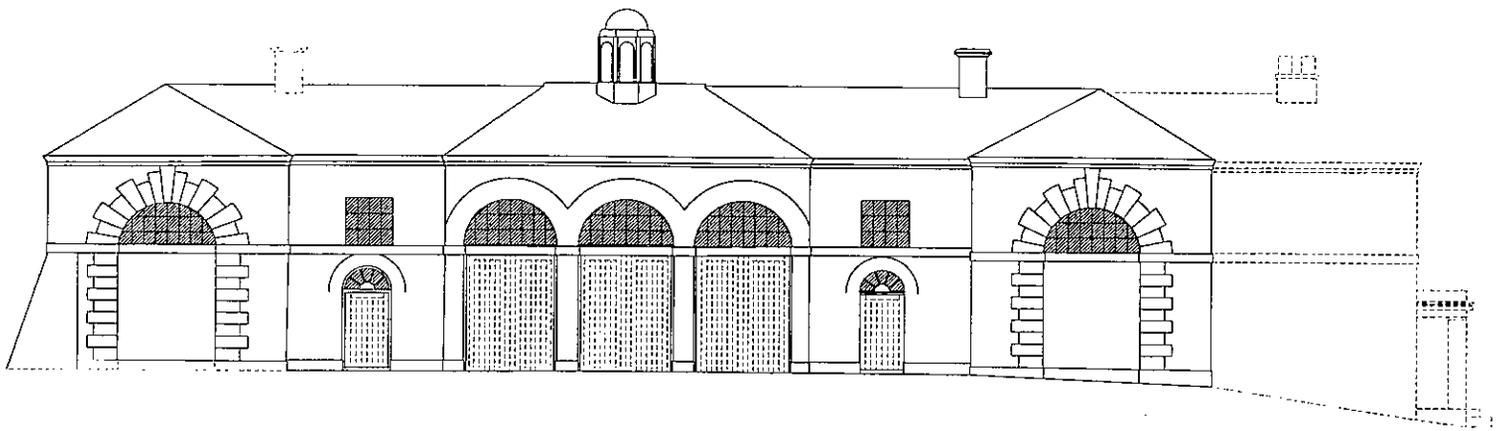
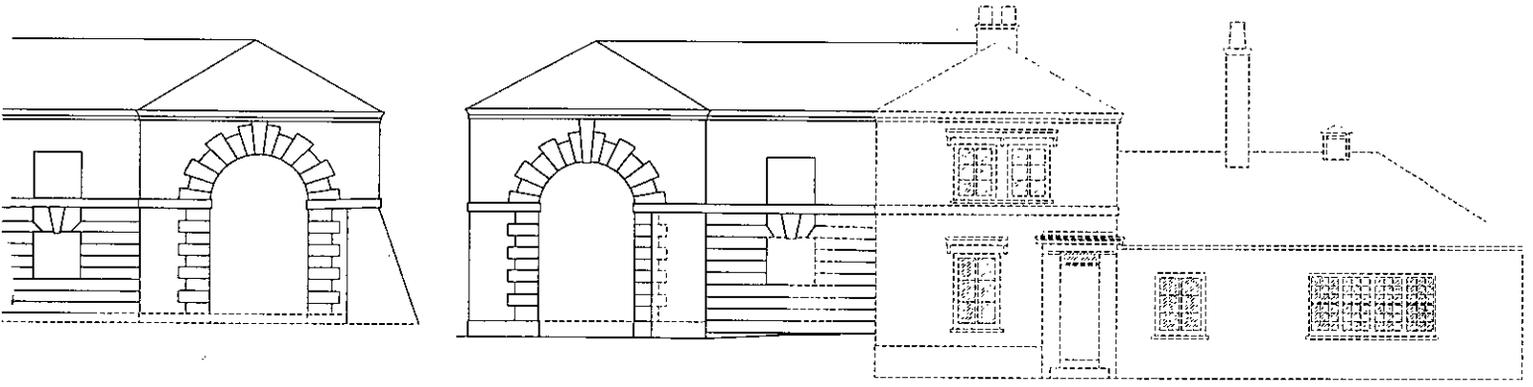
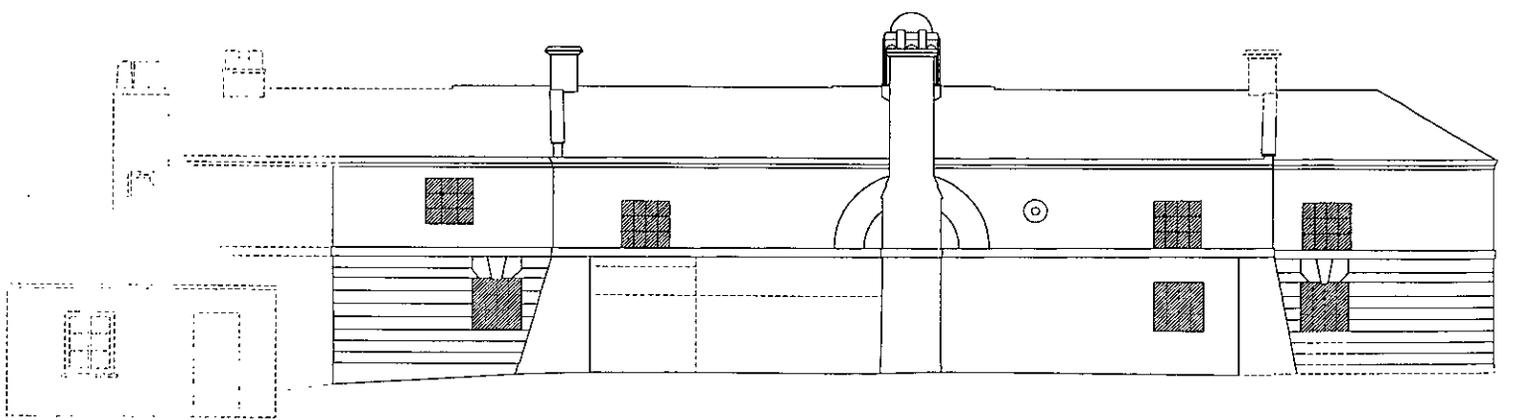
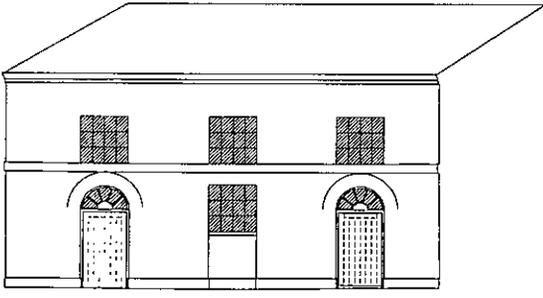
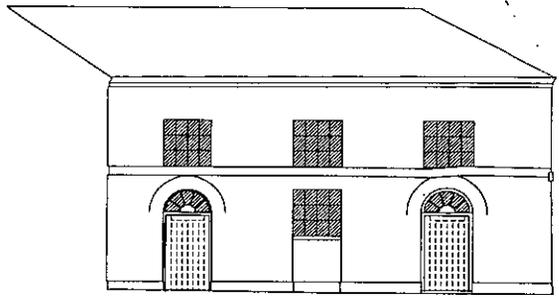
20. Reconstructed elevations of the stable block after the additions of c 1890, scale 1:200

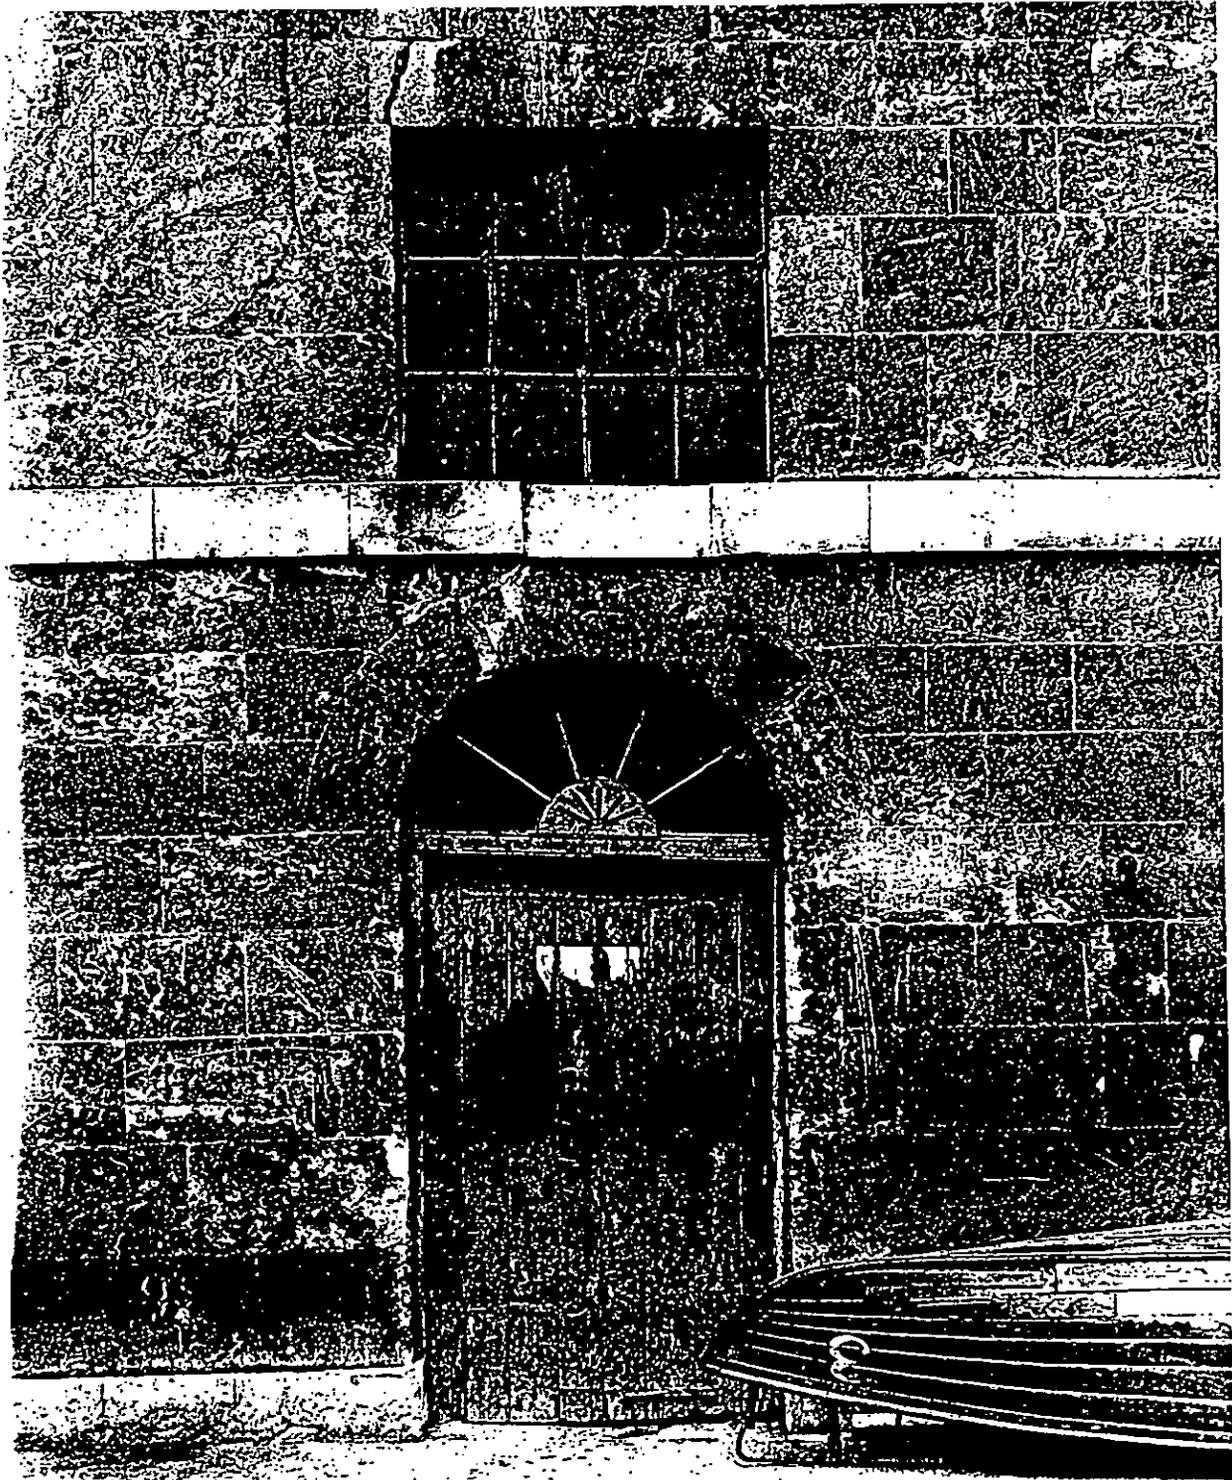
25, Photograph of a door facing into the courtyard, c 1955?, National Building Record, RCHME

The original timber door frames to the small, round-headed doors in the side wings facing onto yard survive *in-situ*. The two doors in the north wing either side of the coach house have been altered by the insertion of smaller frames probably in the 1920s. The fan-lights above these doors with ovolo moulded glazing bars are primary. The leaves for the smaller doors have probably been replaced, but the originals are shown in photographs in the RCHME National Building Record. They appear to have been of vertical tongue and groove construction with a top rail.

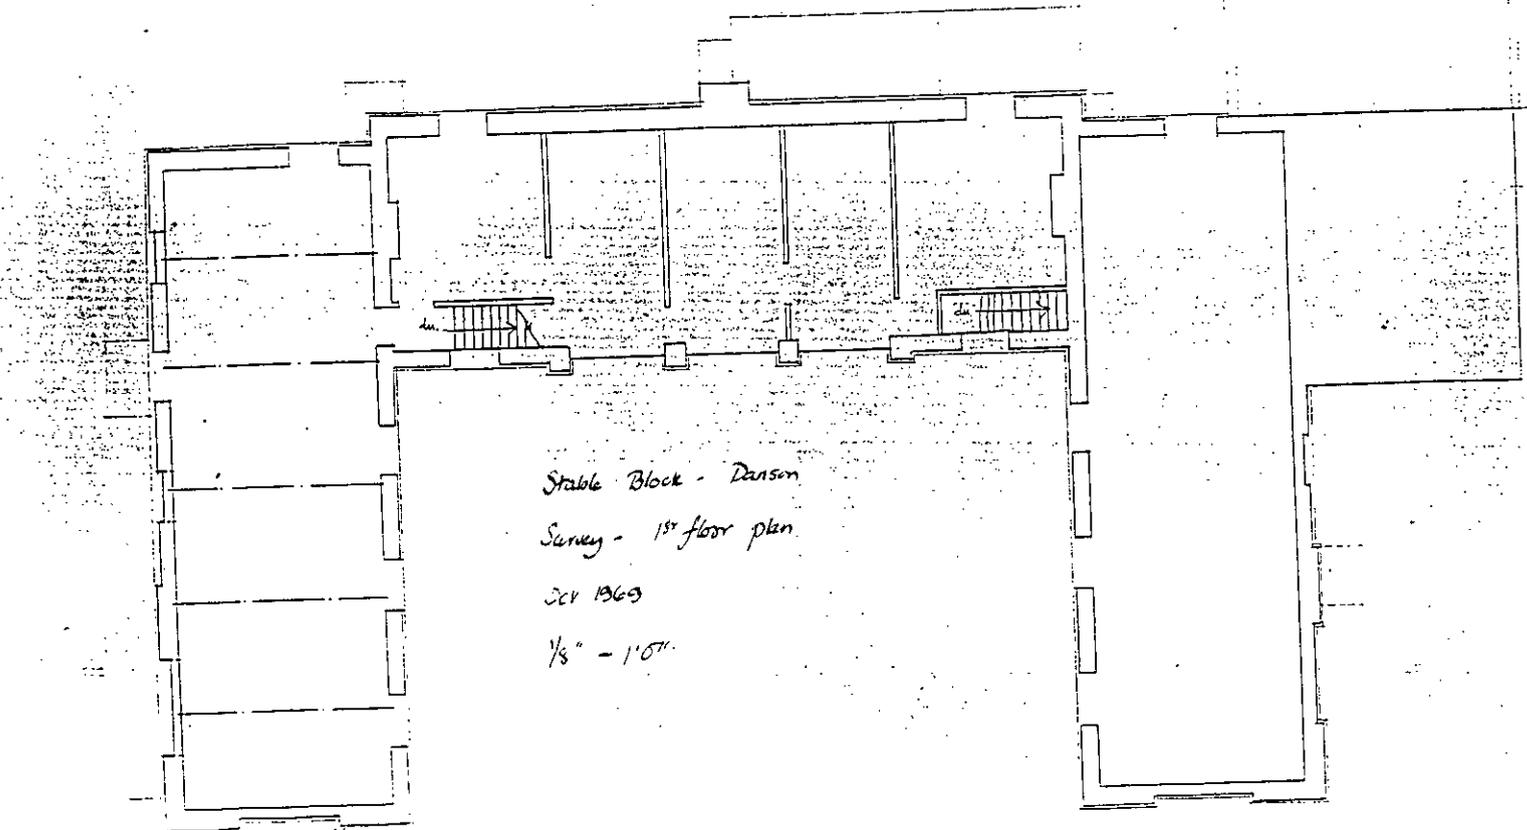
27. Survey drawing from October 1969, drawn at 1/8" = 1' first floor plan
