THE COACH HOUSE, STABLES
AND OFFICES IN
DANSON PARK, BEXLEY

*An Assessment of the Surviving Fabric
and its Setting*

Richard Lea and Chris Miele

Historical Analysis & Research Team
Reports and Papers (First Series, 6)
1996

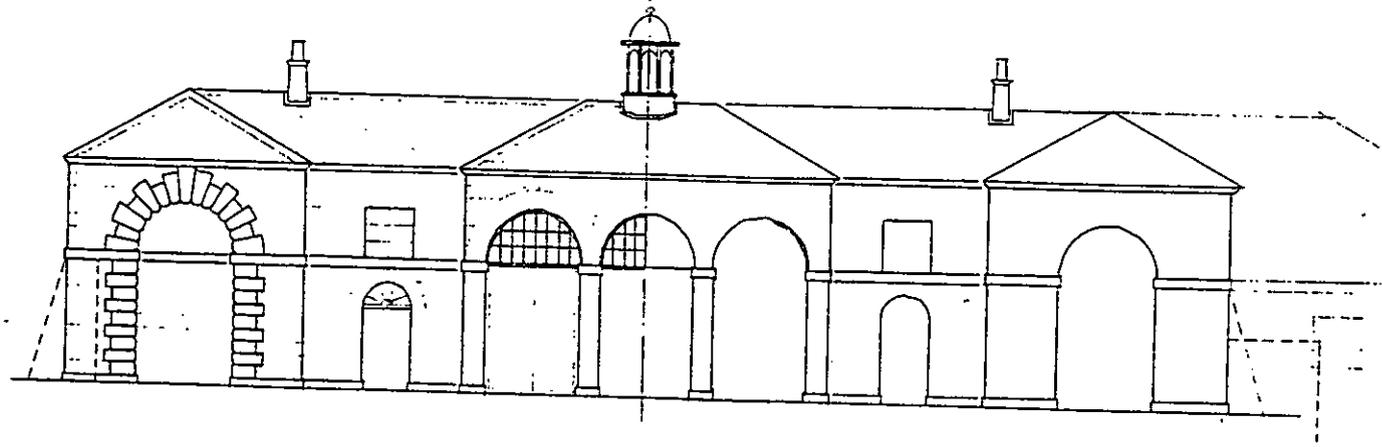
SOUTH (ENTRANCE) ELEVATION.

Stable Block, Danson.
Survey
Oct. 1969
1/8" = 10'

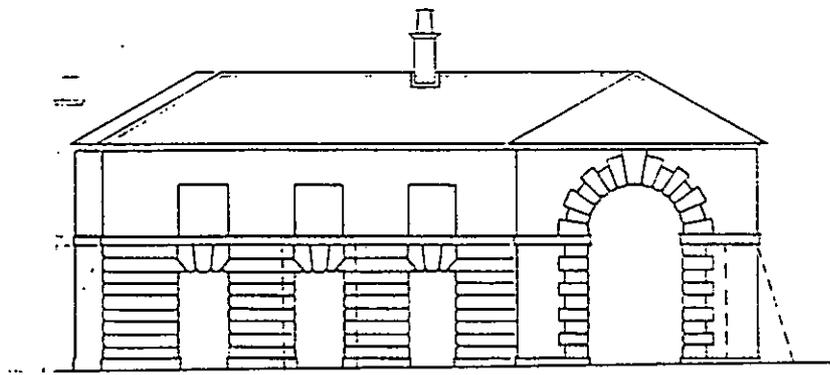
WEST ELEVATION.

Stable Block - Broom
Surrey
Oct 1969 1/8" = 1'

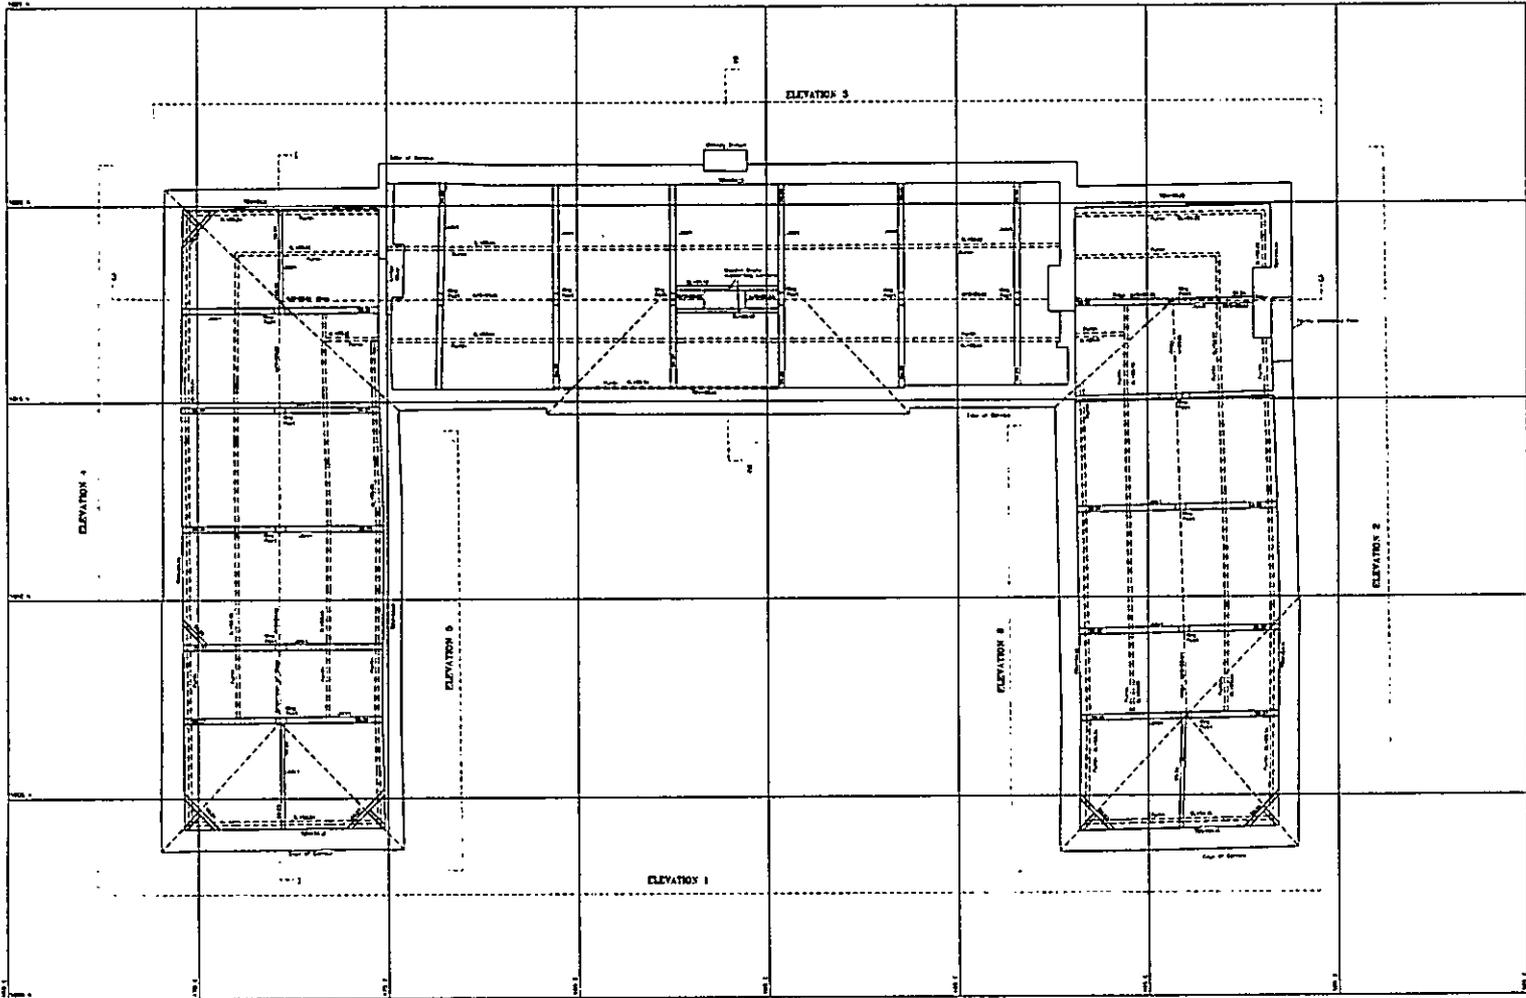
32. Plan of the loft, as surveyed in 1994, scale 1:200

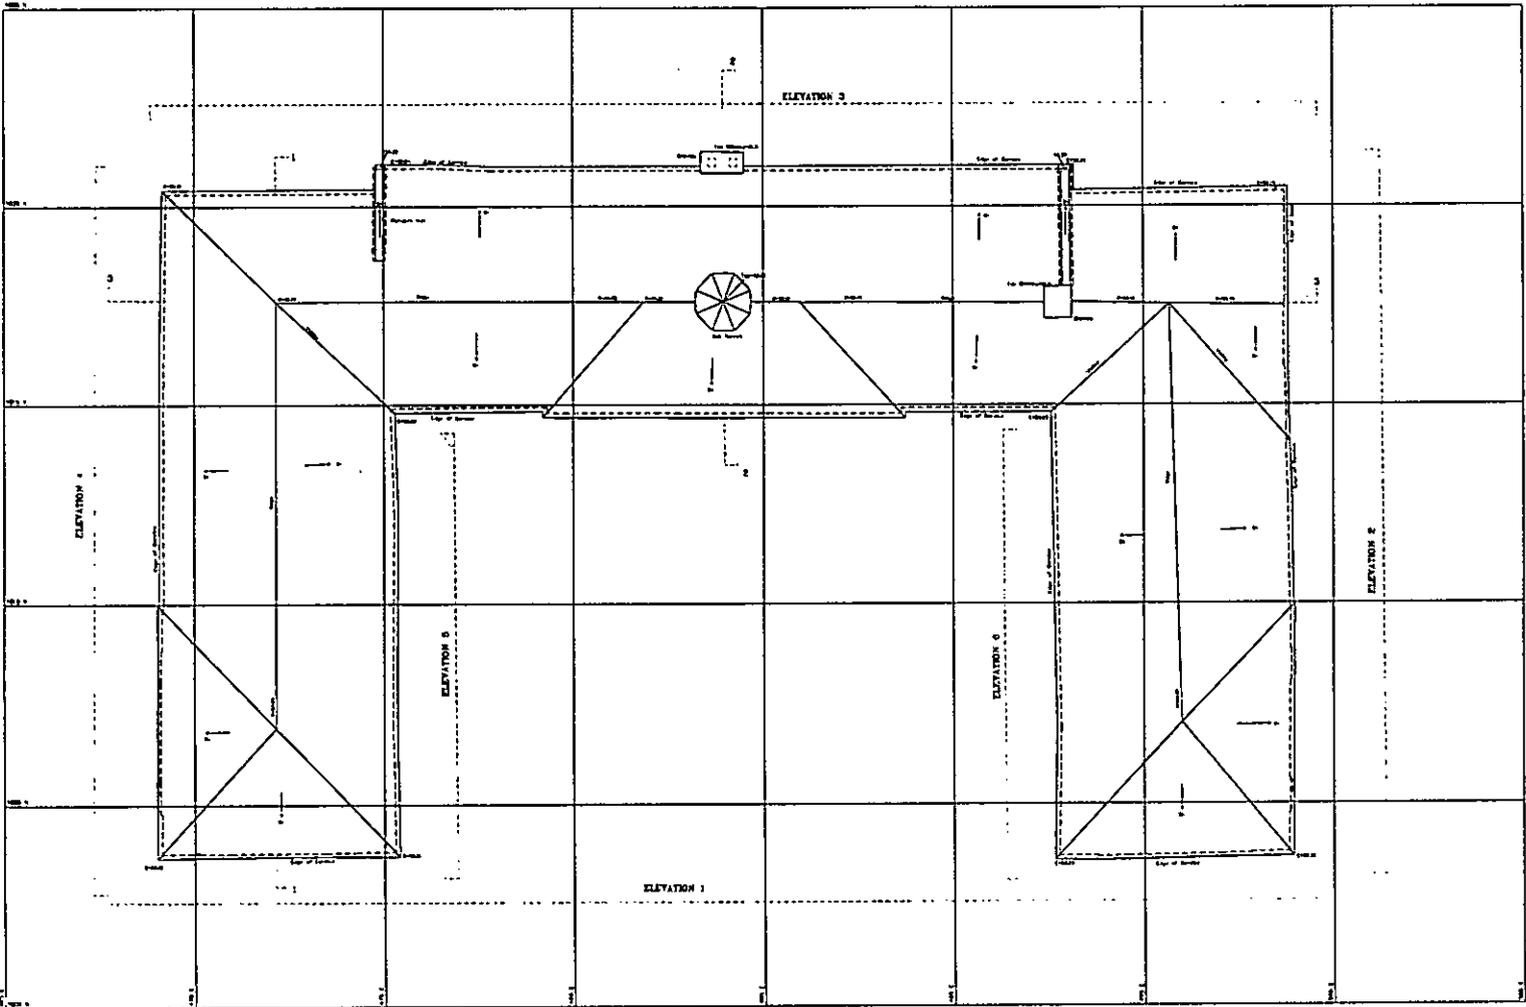
33. Plan of the roof, as surveyed in 1994, scale 1:200

2.2.4 Repairs to the roof

The inscription '*J. TEDD 1863*' on the diagonal strut of the northernmost truss in the west wing suggests that repairs to the roof were carried at this date. However, as discussed above, it is suggested that, although the present trusses probably date from the period c1863, their form replicates that of the 1805 roof. The full extent of the repair work implied by this inscription is however not clear. It is possible that it relates to the refixing of boards and tiles. A dendrochronological date for the trusses would possibly resolve the extent of the works to the roof in 1863.

The extent of the repairs to the roof of 1863 could possibly be resolved through the use of dendrochronology but close examination, recording and analysis will also be required.

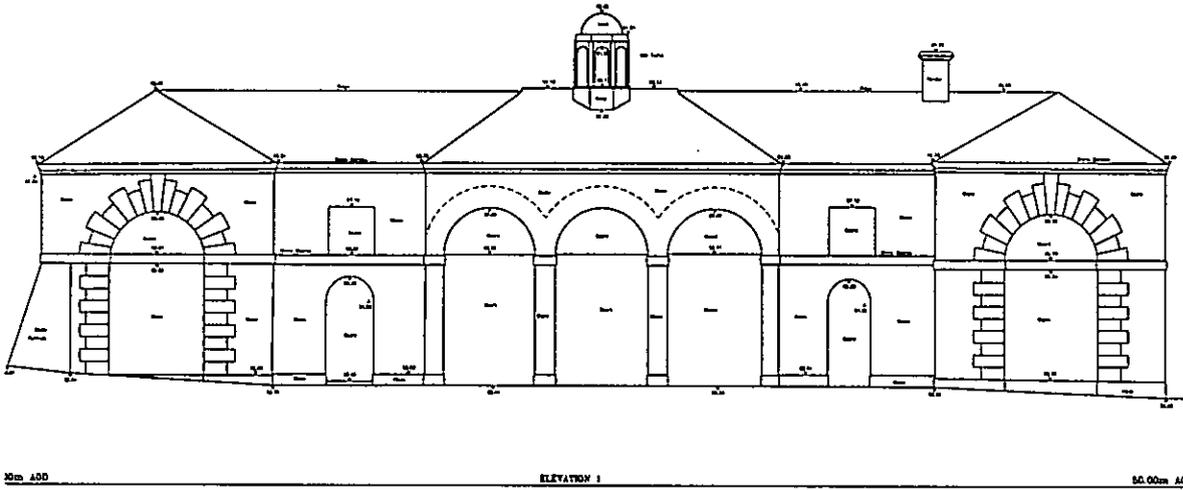
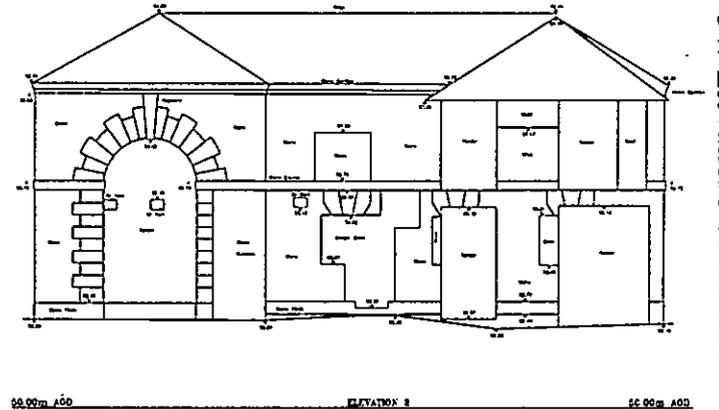
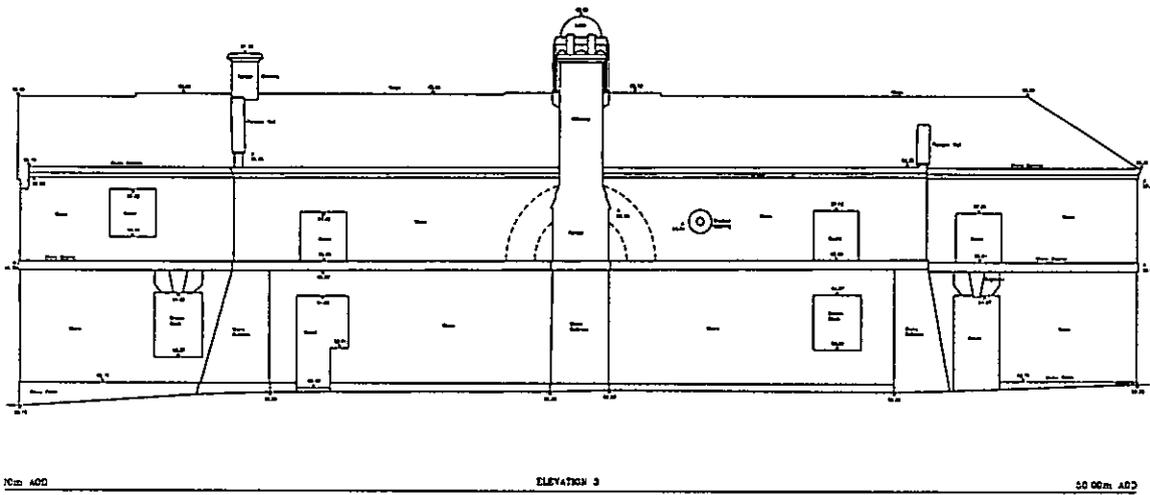
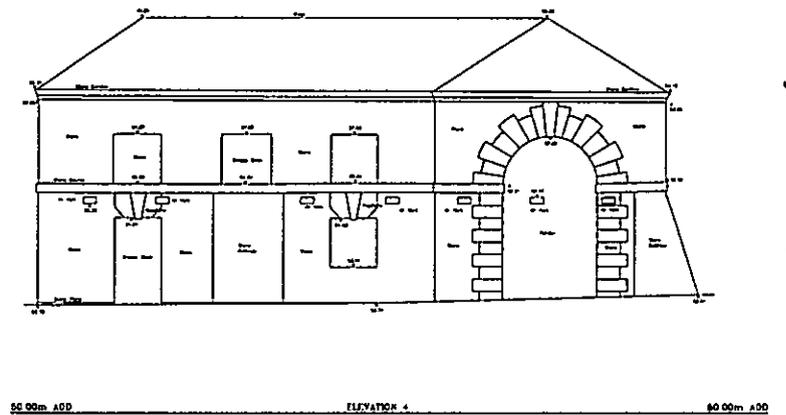
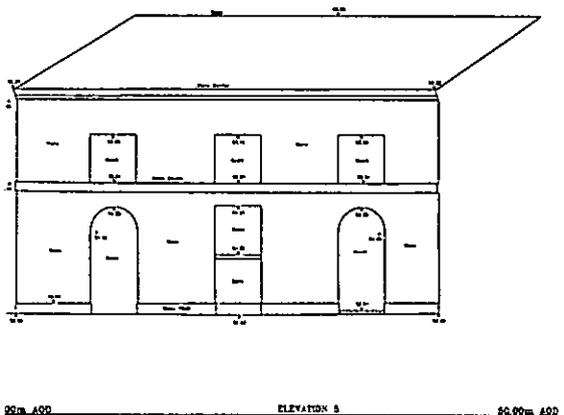
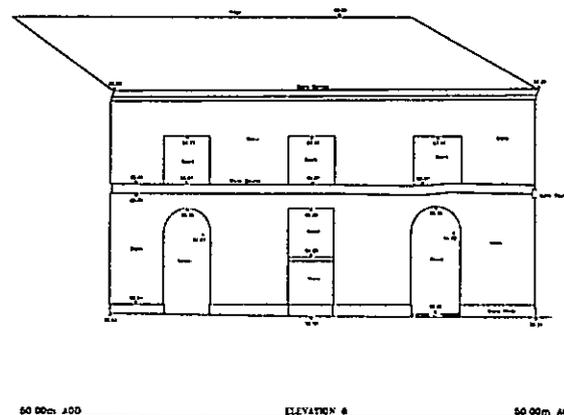
34. Elevations of the stable block as surveyed in 1994, scale 1:200
