Latton Priory Farm, North Weald Bassett, Essex: Historic Landscape Investigations

Discovery, Innovation and Science in the Historic Environment

Latton Priory Farm in the ancient parish of Latton, south of the area which from 1947 became Harlow New Town, contains, preserved within its agricultural buildings, the remains of the early 14th century priory church of St John the Baptist. The date of this small Augustinian priory's foundation, along with the identity of its founder, in common with many small houses of the Augustinian order are unknown, however it is likely that a priory has existed on the site since the late 12th century. The church of St John the Baptist and its attendant claustral buildings appear, from the remains of the priory church's crossing, nave and transepts to have been completely rebuilt in the early 14th century, and sat within a trapezoidal precinct defined on all four sides by a wet moat. The rebuilt priory, one of 11 Augustinian houses founded in Essex after the priory of St Julian and St Botolph Colchester in 1104-06, was surprisingly grand given its very small community, which at the time of its foundation numbered just three brethren and throughout it

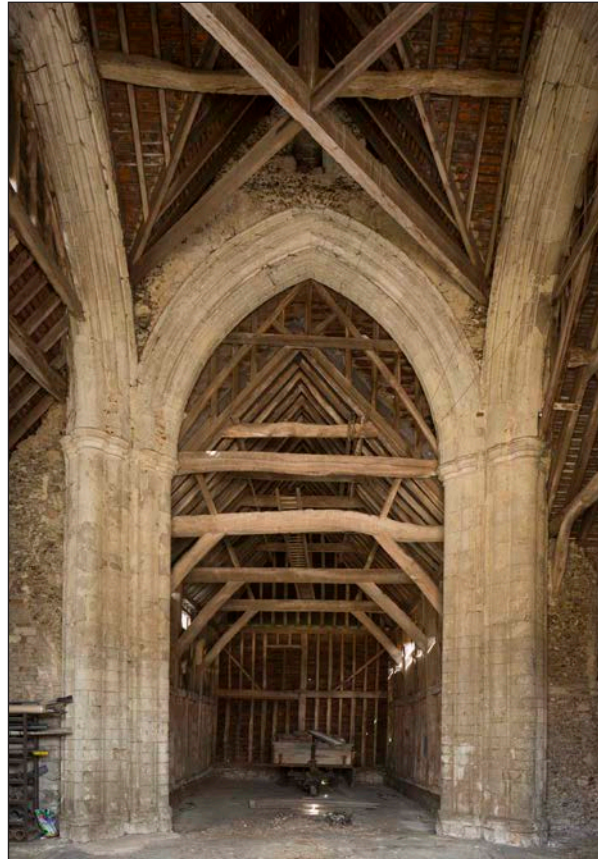
Figure 1: The crossing of Latton Priory looking east towards the barn which marks the location of the former presbytery. © Historic England, Patricia Payne, DP173640

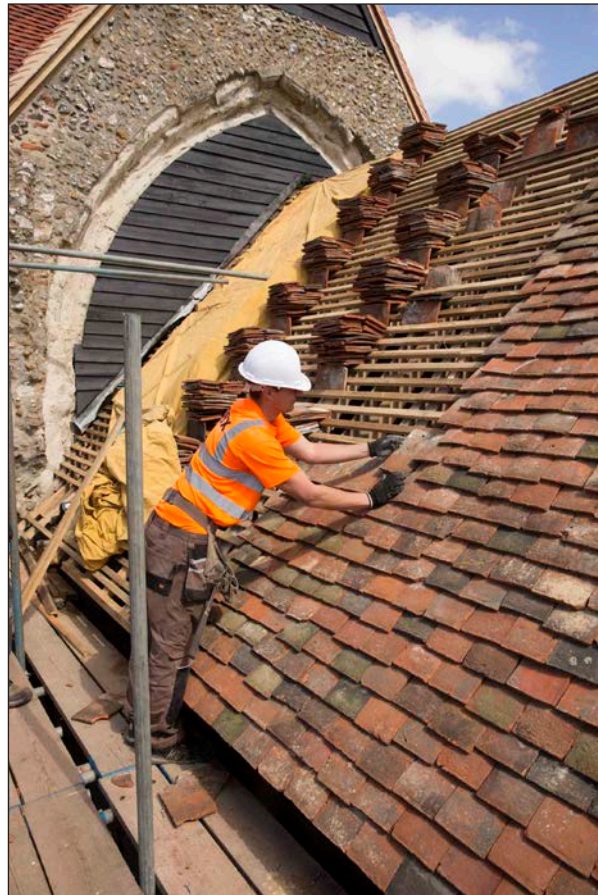
Figure 2: Work to replace the peg-tile roof of the east barn during May 2016. The exposed and heavily weathered crossing arch can be seen behind. © Historic England, Patricia Payne, DP182391

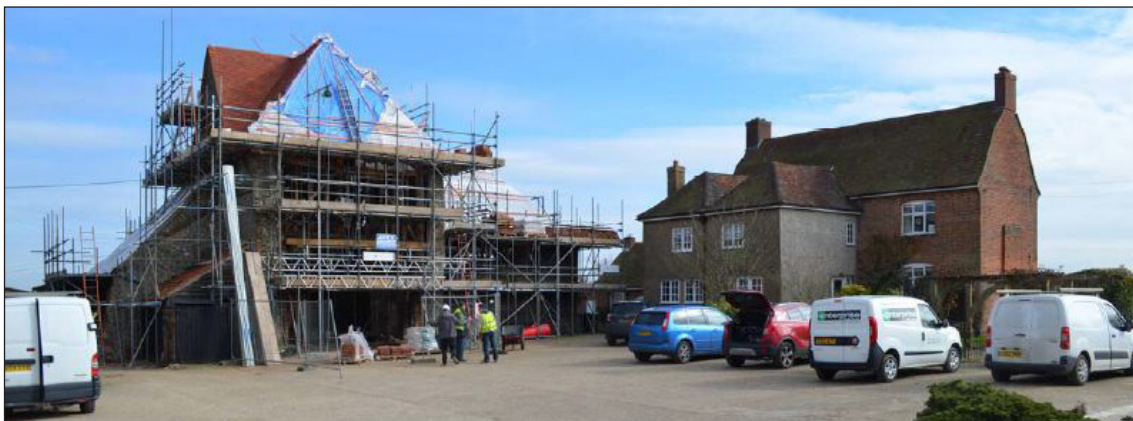
Figure 4: The former priory church of the St John the Baptist and the 18th century farmhouse define the eastern and southern sides of the farmyard. © Historic England, Matthew Bristow

The agricultural buildings of Latton Priory Farm are grouped around a rectangular yard orientated roughly east to west. The truncated remains of the priory church occupy the eastern edge of the yard with the stub nave walls indicating that the foundations of the lost elements of the 14th century church lie beneath a concrete yard surface. The earlier of the two post-medieval barns extends eastwards from the crossing of the former church, occupying the location of the eastern arm of the church, (henceforth called the presbytery as it is in RCHM[E] account and list description) which topographical drawings indicate stood until at least 1778.⁴ Immediately to the east of this barn lay the former eastern arm of the moat which surrounded the inner precinct of the priory. The early-19th century barn extends southwards from the crossing, constructed around the altered walls of the former south transept which is documented to have collapsed in about 1806.⁵ Single-storey lean-to barns, added at a later date, adjoin the north and south sides of the east barn and the northern stub wall of the nave (Figure 4).

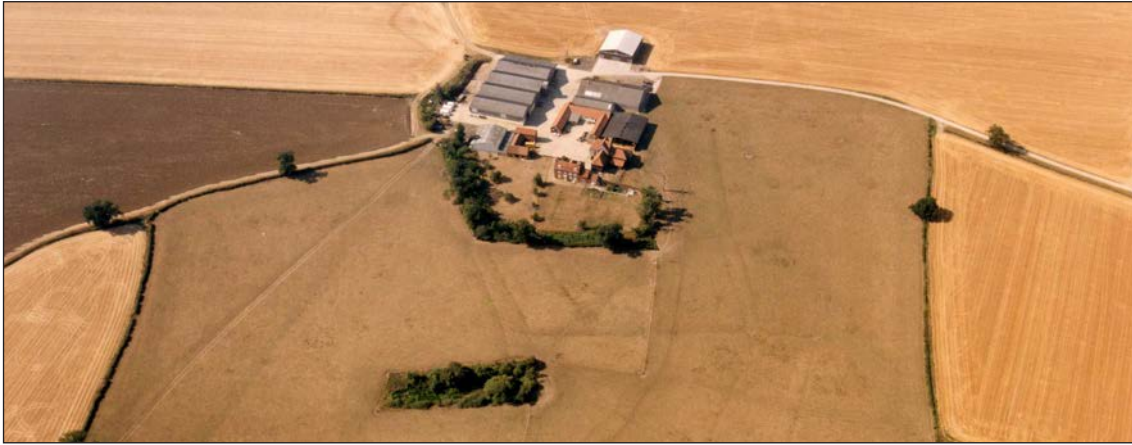
Figure 5: Oblique aerial view of Latton Priory Farm from the south in 1995. The wood-lined arms of the moat and southern pond are clearly visible as are the earthworks which define the scheduled area. The remains of the priory church occupy the south-eastern corner of the farm yard. © Essex County Council, EXC 16586/12

Immediately to the south of the farmhouse, a trapezoidal shaped area laid to lawn marks the supposed location of the priory's inner precinct. Historically defined on all four sides by a wet moat, the western and southern arms of the moat survive in 2018, while the northern arm and its causeway, depicted on a map of 1616, now lie beneath the farmyard and barns, though its location is indicated by a short section which is shown on the 1986 Ordnance Survey map.¹¹ The eastern arm of the moat is depicted on the Ordnance Survey map of 1920 and was filled in after the Second World War, though its location remains discernible as earthworks (Figure 5).

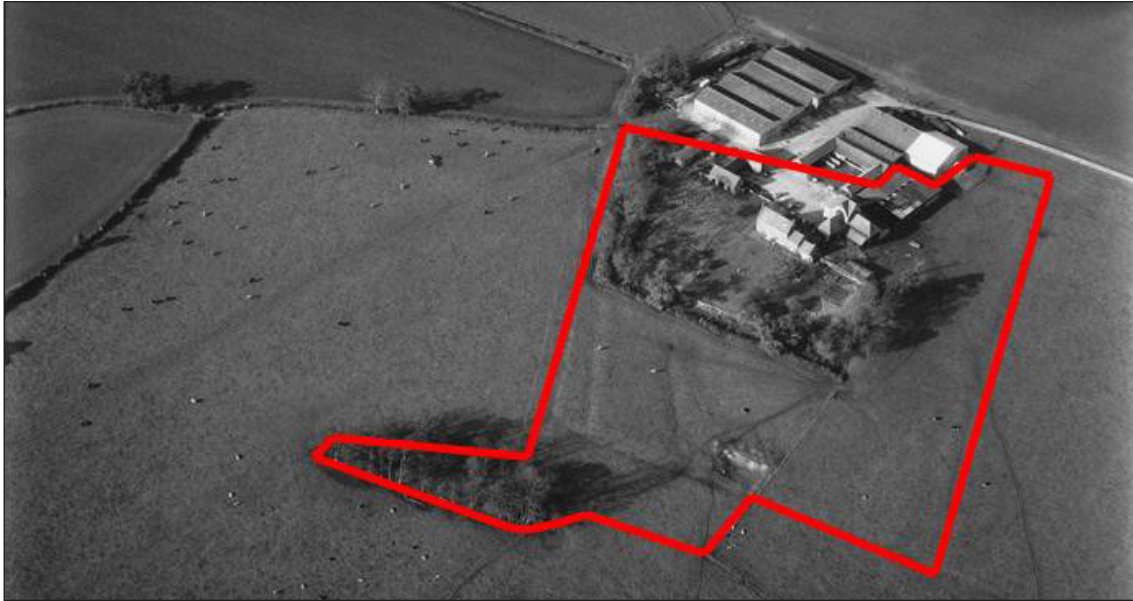
Figure 6: The boundaries of the scheduled area superimposed onto an aerial photograph taken in 1995. © Historic England, OS_95631 085

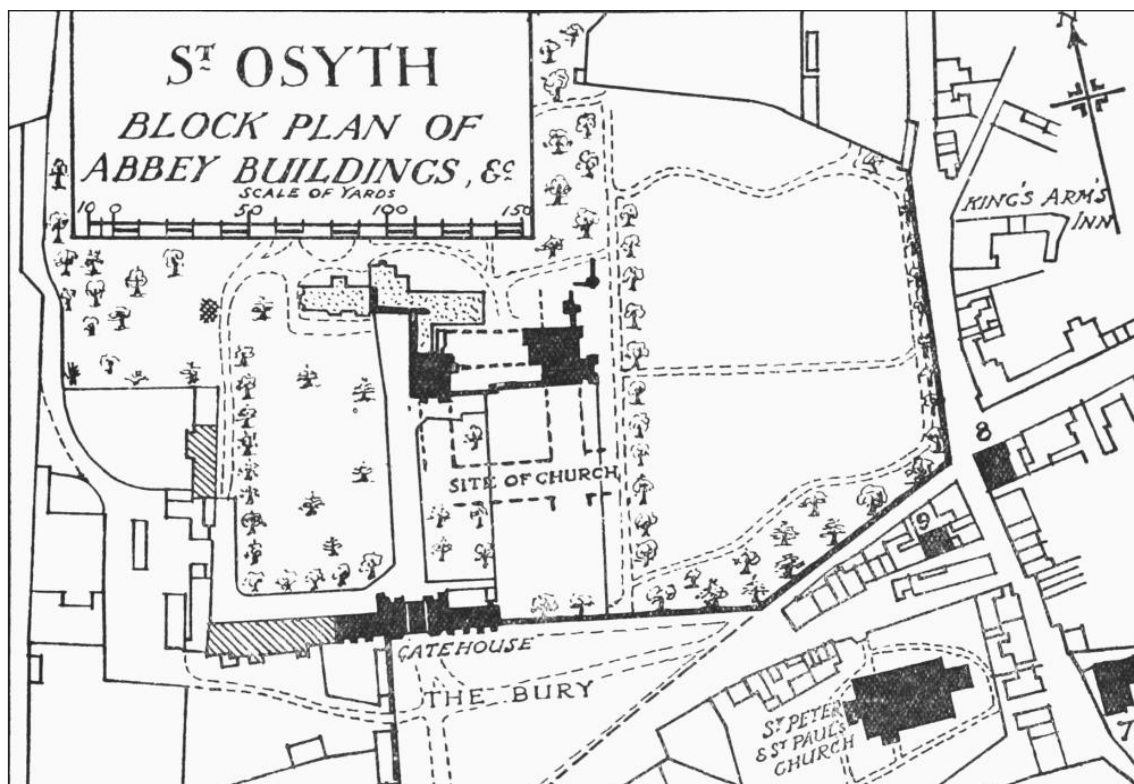
Figure 13: A block plan of the buildings of St Osyth priory showing the location of the 'Bury', believed to be the site of the annual wool fair. © RCHME, Historic England

This appears to identify the ‘Forbury’ as the outer court, or part of the outer precinct of Reading Abbey and confirm that the two fairs, granted respectively during the reign of Henry I and in 1205, were held there.⁸¹ Similarly, to the south-west of the Benedictine priory founded by Reading Abbey in the 12th century at Leominster, Herefordshire, Ordnance Survey maps name an open area as the ‘Site of the Forbury’.⁸² The direct association with Reading and the documented grant by Henry I of a chartered fair to the Church of St Mary, Reading to be held at Leominster on the feast day of St Peter and St Paul, indicates a further example of a Forbury forming the outer court of a monastic precinct with the specific function of staging annual fairs.⁸³ Of even greater relevance is the ‘Bury’ at the Augustinian abbey of St Osyth, Essex. The ‘Bury’ at St. Osyth, named as such by the 16th century but likely of far greater antiquity, comprised a large triangular area of about 2 a. situated to the south of the priory precinct, immediately adjacent to the abbey gatehouse and to the west of the site of St Osyth’s market place. In the Middle Ages the ‘Bury’ was likely the site of St Osyth Abbey’s wool fair, although unlike Latton’s fair and St Osyth’s market, there is no documented charter or license to confirm this (Figure 13).⁸⁴

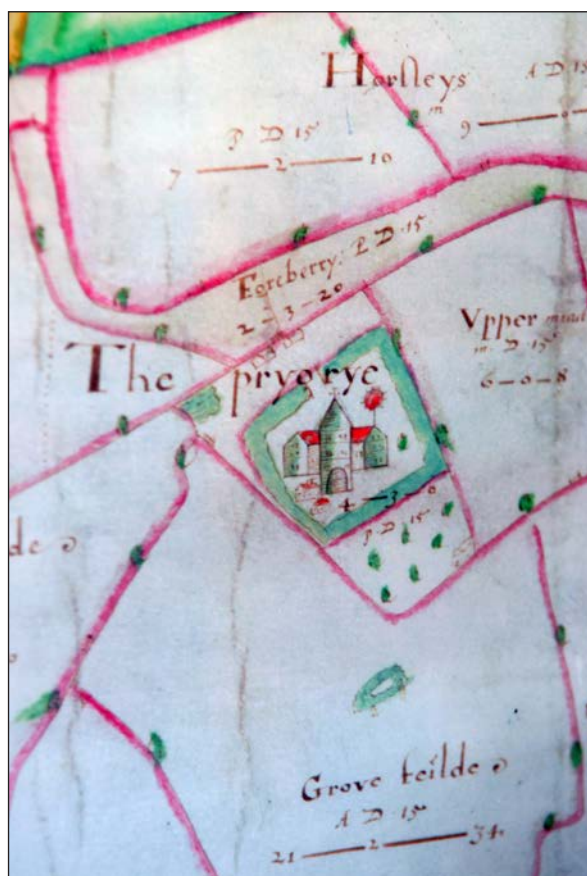
Figure 14: Extract from a 1616 estate map of Latton showing the 'Foreberry' to the north of the priory precinct. Reproduced by courtesy of Harlow Museum

Immediately to the north of the Priory are the slight earthwork traces of an elongated wedge-shaped area which is now partially obscured by the modern farm buildings on the northern edge of the farm. Centred at TL 4665 0660, it measures c. 275m east-west and 30m wide (though likely to have been at least 45m north-south at its widest point). Marked as the Foreberry on the 1616 estate map, this is likely the site of an annual fair granted by Edward III in 1332 (see Figure 14).¹¹⁵

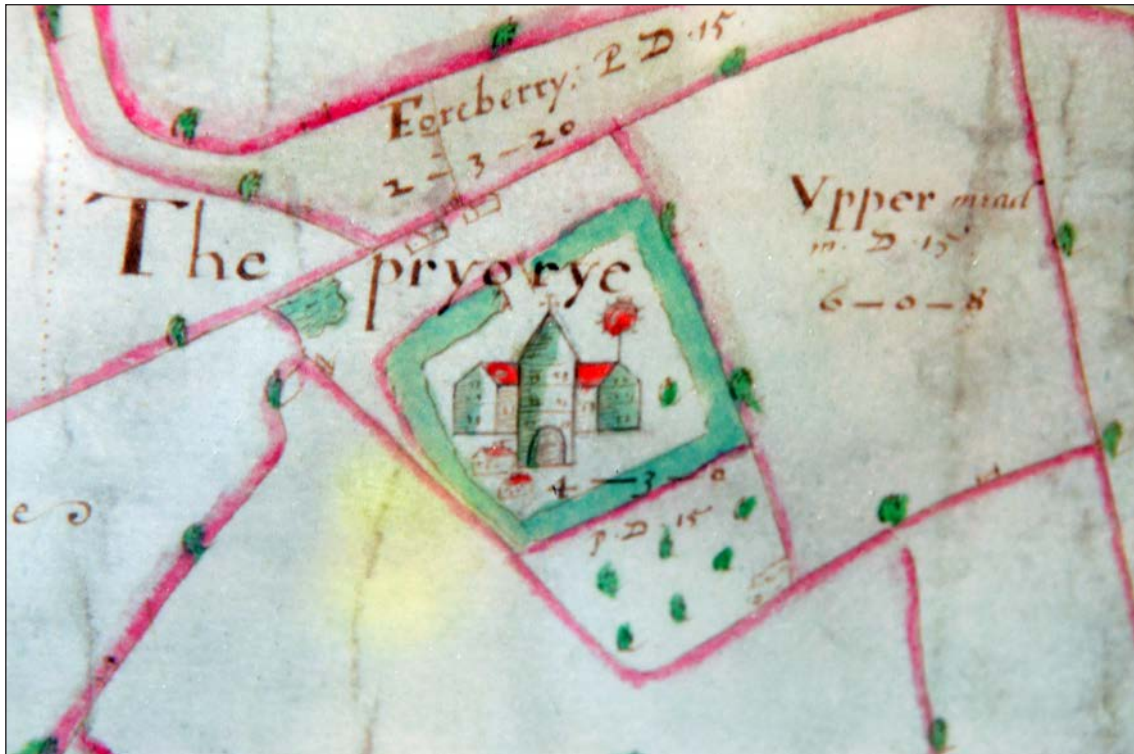
Figure 15: Extract from a 1616 estate map of Latton showing the priory precinct largely intact within its moat. Reproduced by courtesy of Harlow Museum

The survey and accompanying map of 1616 depicts the former priory church as a complete cruciform structure with what appears to be a tower with a pyramidal roof rising to three stages above the central crossing (Figure 15).⁹⁶ The scale and orientation of the crude vignette prevents accurate conclusions being drawn and it is difficult to confidently state whether the drawing depicts the church aligned accurately east to west with the nave and presbytery shown as being of roughly equal lengths and of a uniform height, or rotated through 90 degrees and shown with two extant transepts. The depiction is more schematic than the accompanying depictions of Latton Hall and Mark Hall houses but if the priory church is aligned accurately then the 1616 map does appear to show that the majority of the priory remained intact at that time. If the orientations are indeed accurate, the small range shown extending westwards from the southern transept may be the *Frater* or refectory building which formed the southern wing of the cloister and into the remains of which, the farmhouse was built in the early 18th century.⁹⁷ A second smaller building depicted to the south of the church may be one of the barns or ancillary structures mentioned in the survey, but may also indicate that the Prior's lodgings, likely located to the south of the cloister, may have also still stood into the 17th century. The 1616 map depicts the priory church enclosed on all four sides by a wet moat, with access via a causeway in the northern arm. This causeway aligns with a pair of building depicted to the north, likely the stables or other outbuildings mentioned in the survey.⁹⁸

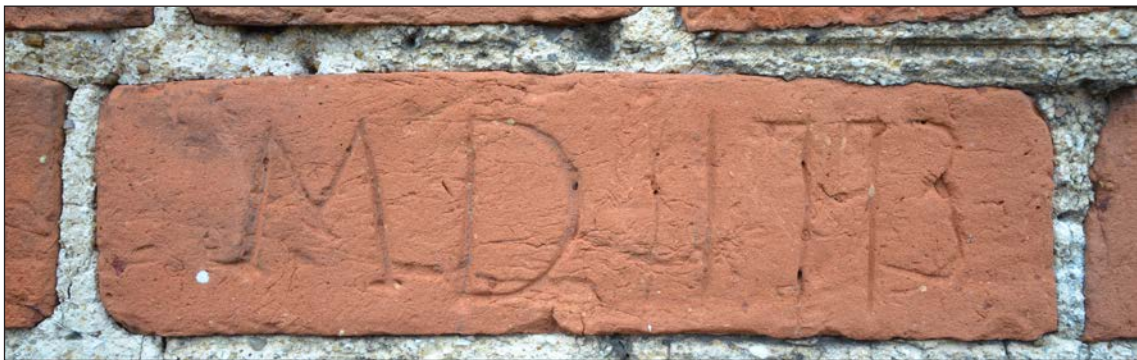
Figure 16: A brick in the southern wall of the farmhouse at Latton Priory Farm bearing the inscription MD 1773. © Historic England, Matthew Bristow

Peyton Altham died in 1741 and settled the Latton estate on his wife Maud, who in turn, following the death of their eldest sons without issue in 1765, released the estate to their surviving son, William Altham.¹⁰³ A brick located in the lower courses of the southern wall of the farmhouse bearing the date 1773 and the initials MD may imply that the rebuilding of the farmhouse described by Francis Grosse in 1778 occurred during William Altham's short ownership of the estate which lasted until that year when he sold it to William Lushington (Figure 16). William had made considerable alterations to Mark Hall house, so it is likely that his work extended to improvements at Latton Priory Farm.¹⁰⁴

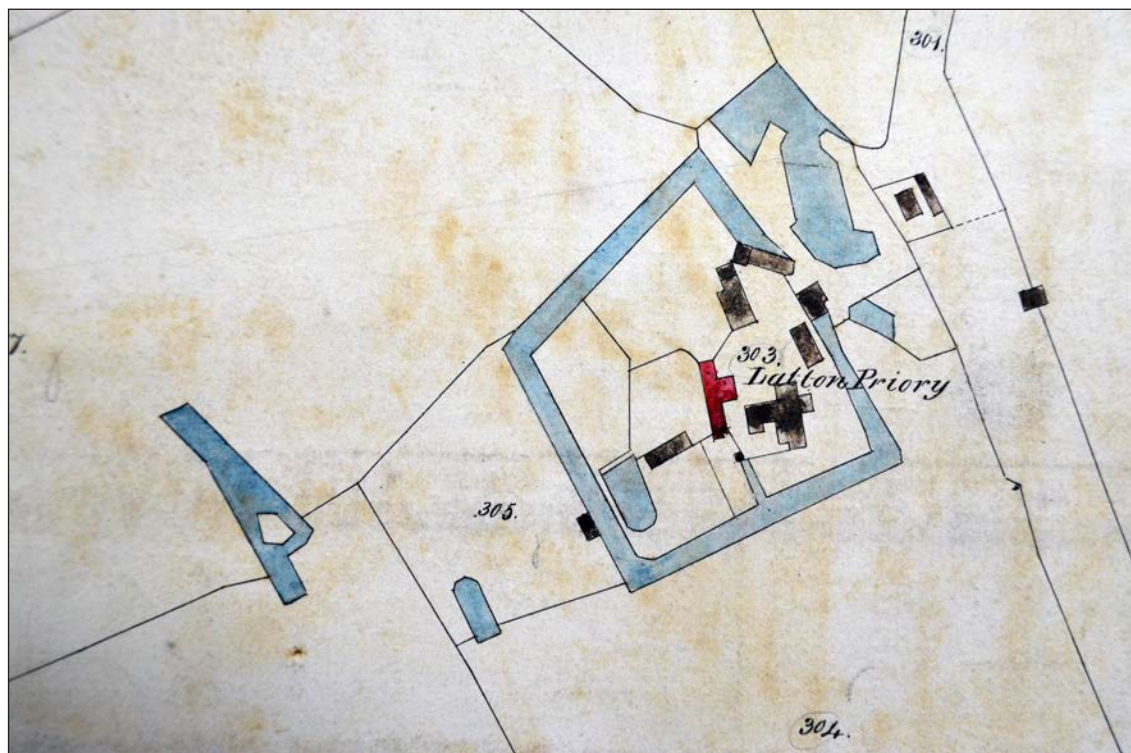
Figure 17: A section of the 1839 tithe map of Latton parish showing the former priory estate. © National Archives, IR 30/12/197

estate with the estates of Latton Hall and Mark Hall which his father had purchased for him in 1819.¹⁰⁷ Joseph Arkwright held the Latton Priory estate until his death in 1864 and was likely responsible for the expansion of the priory farm in the form of the brick granary to the west of the priory church and cow sheds to the north (Figure 17).

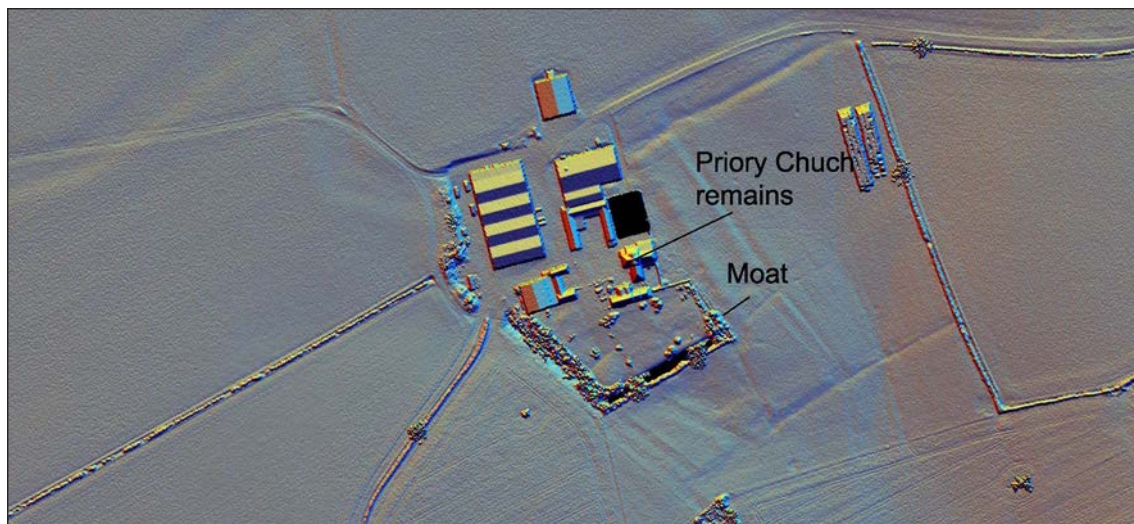
Figure 18: The earthwork remains of Latton Priory visible on lidar. (DSM) © Historic England; Source Environment Agency (December 2001)

The south-west and south-eastern arms of the moat can be seen in their entirety along with the southern half of the eastern side. A short spur of the north-western side extending from the north-western corner was visible on RAF vertical photographs taken in 1955 prior to this portion being in-filled and is obscured by expansion of the farm buildings to the north. The remainder of the north-western side has also been in-filled at some point in the past. Lidar suggests the presence of the northern half of the north-eastern arm of the moat (Figure 18).

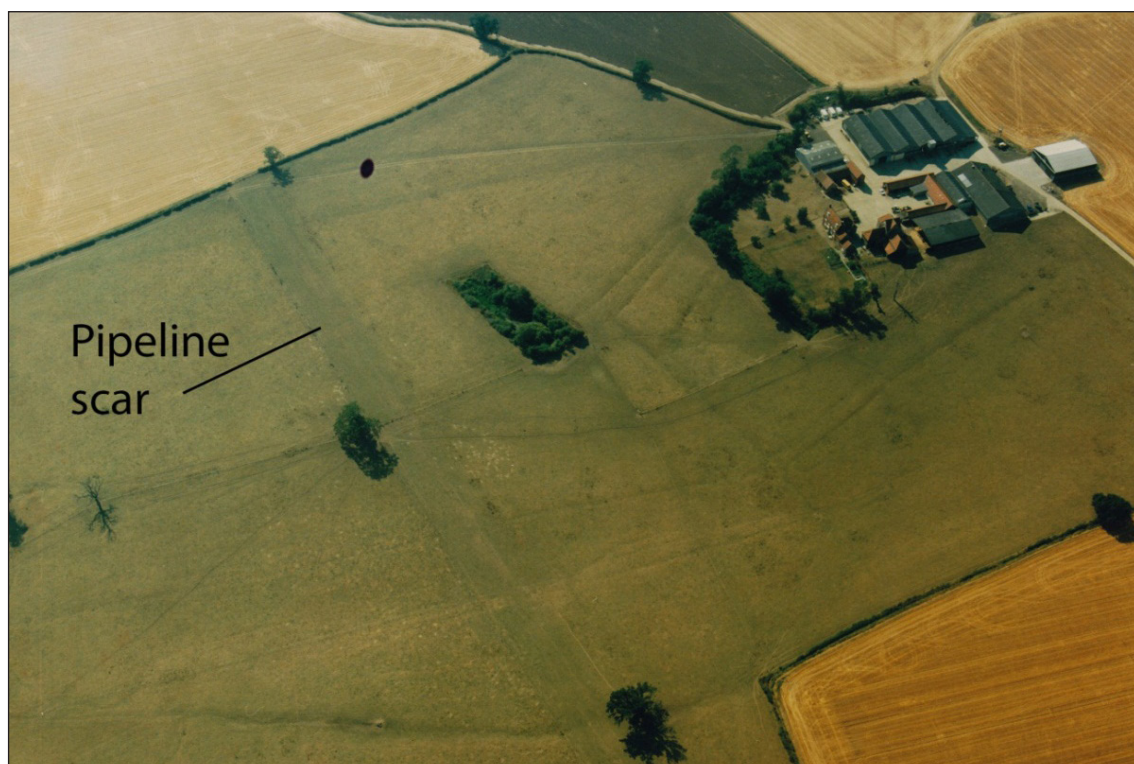
Figure 19: Latton Priory Farm and surrounding remains of the medieval Priory complex visible as slight earthworks. The overgrown remains of the moat can be seen to the left of the farm and the rectangular fishpond in the centre of the photograph. © Essex County Council, EXC 165586_13 11-AUG-1995

The course of a gas pipeline excavated in 1992 cuts ENE-WSW through the fields to the south of the priory in the direction of Rivett's Farm.¹¹⁴ The course of the pipeline can clearly be seen on aerial photographs taken in 1995-6 as a scar in the vegetation. It can also be seen on the lidar images as a potentially confusing low linear bank (Figure 19).

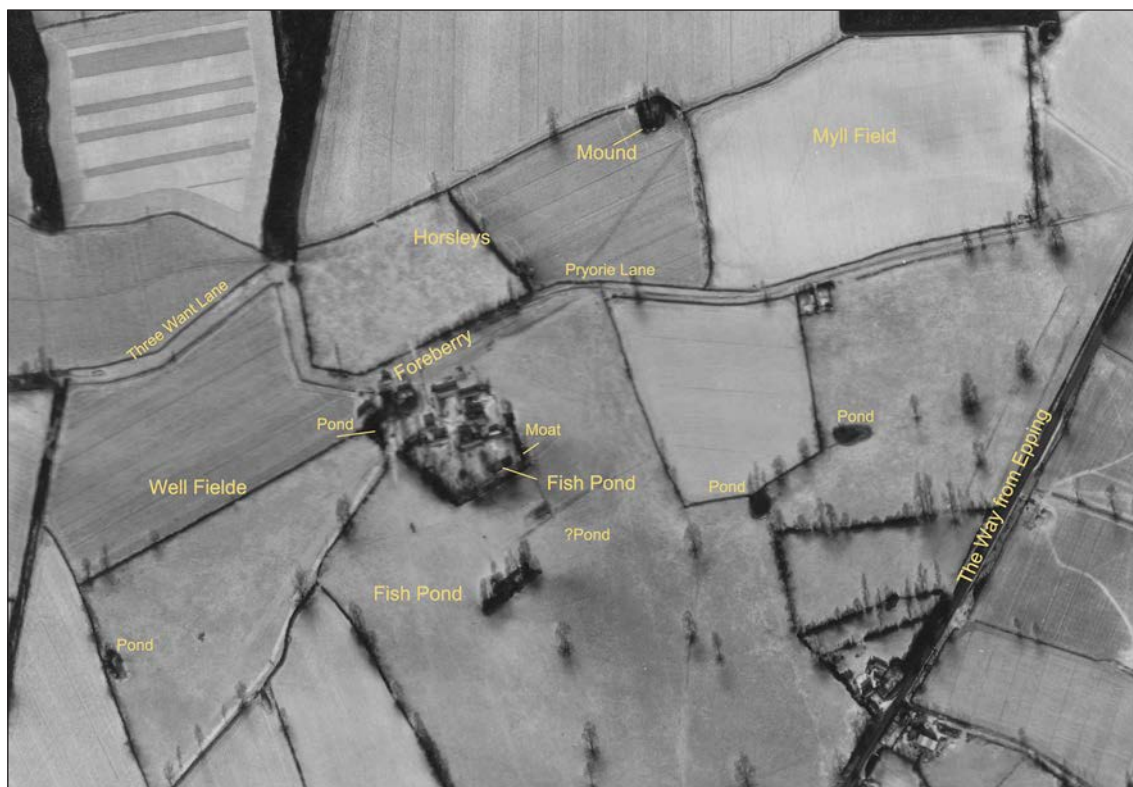
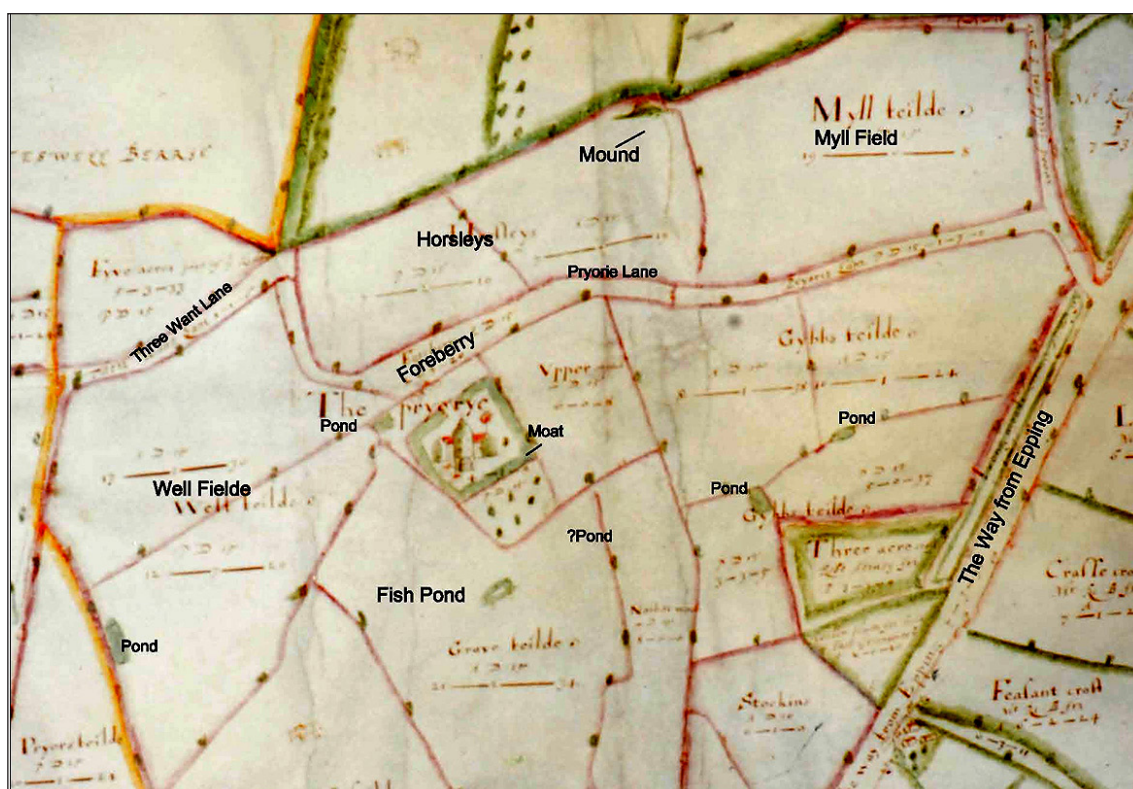
Figure 20: Extract of RAF V542/131 0082 17-FEB-1955 Historic England RAF Photography (top) showing the remains of Latton Priory and Latton Priory Farm as it appeared in 1955, and the Latton Priory Estate Map of 1616 (bottom). Reproduced by courtesy of the Essex Record Office, T/M 453/2

A large rectangular fishpond c. 60m x 15m lies approximately 85m south of the moat at TL 4661 0638. This is now overgrown with the vegetation/tree growth, but judging by the most recent aerial photographs, it still appears to hold water and has a small island towards its eastern end. A number of ditches can be seen between the moat and this pond, at least one of which may form part of the water management system linking the moat and pond. Another pond is visible to the north-east at TL 4665 0646. This is recorded on the 1:10,000 scale OS map as a pond, but not on the current Ordnance Survey Mastermap and is not noted on the 1616 map of the estate. This may suggest either that it was no longer in use as a pond at this time, or that it was established as a pond in a natural low point amongst the earthworks of the Priory remains at some time after the 17th century map was surveyed (Figure 20).

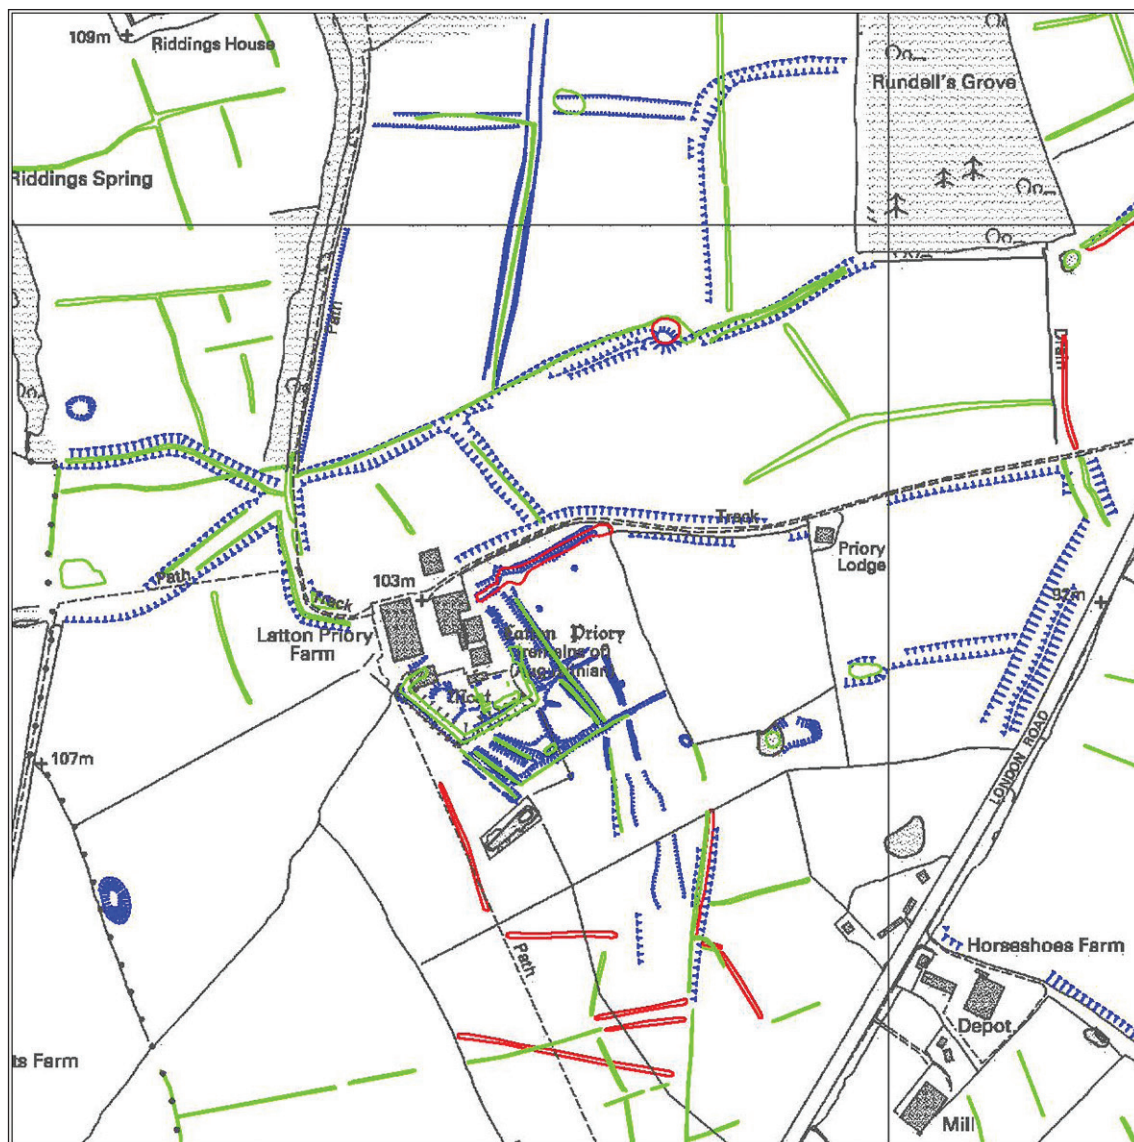
Figure 21: The remains of Latton Priory and surrounding tracks and field boundaries mapped from lidar and aerial photographs. Base map © Crown Copyright and database right 2016, all rights reserved. Ordnance Survey licence number 100024900

Historic RAF photographs and recent lidar show several broad lanes leading out of the eastern and western sides of the 'Foreberry'. The eastern arm (known as Pryorie Lane) extends eastwards c.480m towards the junction with the main B1393 - 'The Way from Epping (1616)'.¹¹⁶ Earthworks traces of what may be the former course of the Epping road can be seen as an embanked narrow strip along the western side of the current road immediately south of this junction. Further south, more traces of the road survive where it skirts the southern edge of the remains of a group of four parallel strip fields known as 'Hermits' in 1616. At the western end of Foreberry the track extends northwards, probably heading in the direction of Harlow, following the suggested course of a Roman road. From this a branch marked as 'Three Want Lane' heads south-west in the direction of another moated site at Rye Hill located at TL 4536 0665 (Figure 21).

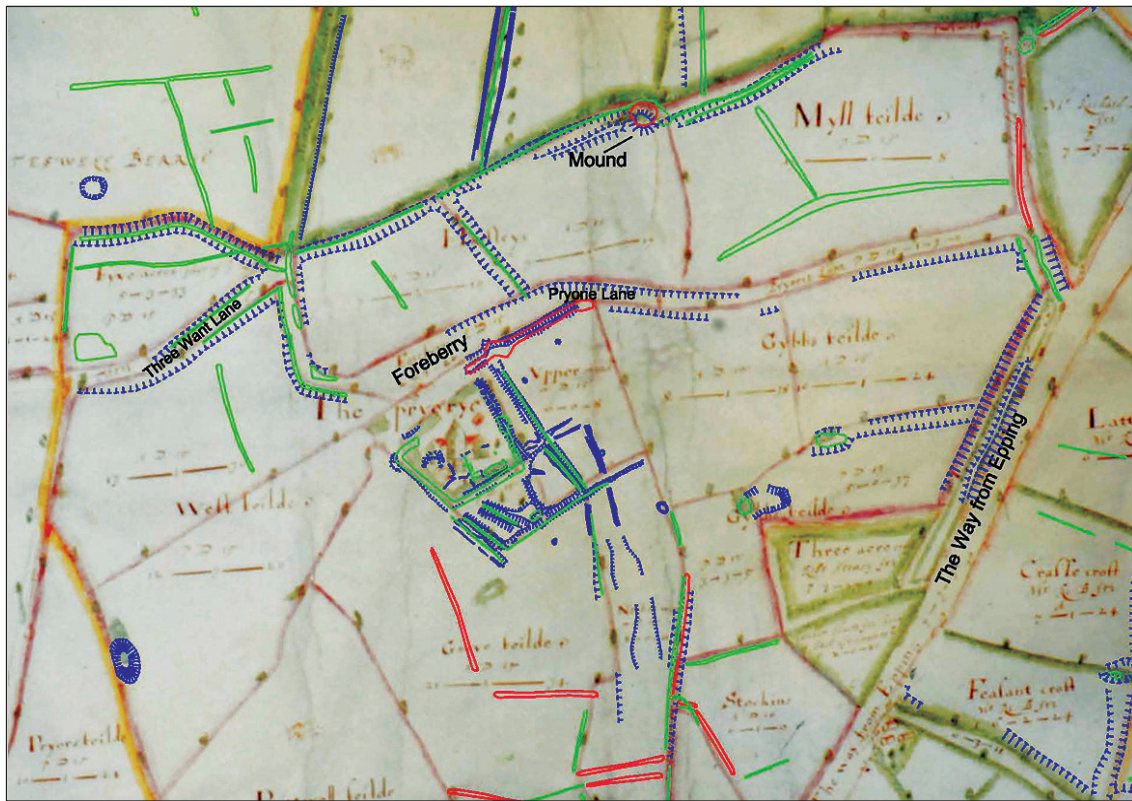
Figure 22: Transcribed remains of the Priory and surrounding tracks and field boundaries overlaid to the 1616 map of Latton Priory Estate. Reproduced by courtesy of the Essex Record Office, T/M 453/2

The lidar has revealed the remains of a number of similarly undated tracks seen as slight earthworks in the landscape surrounding the Priory forming a network of routes presumably linking former holdings and settlements (Figure 22).

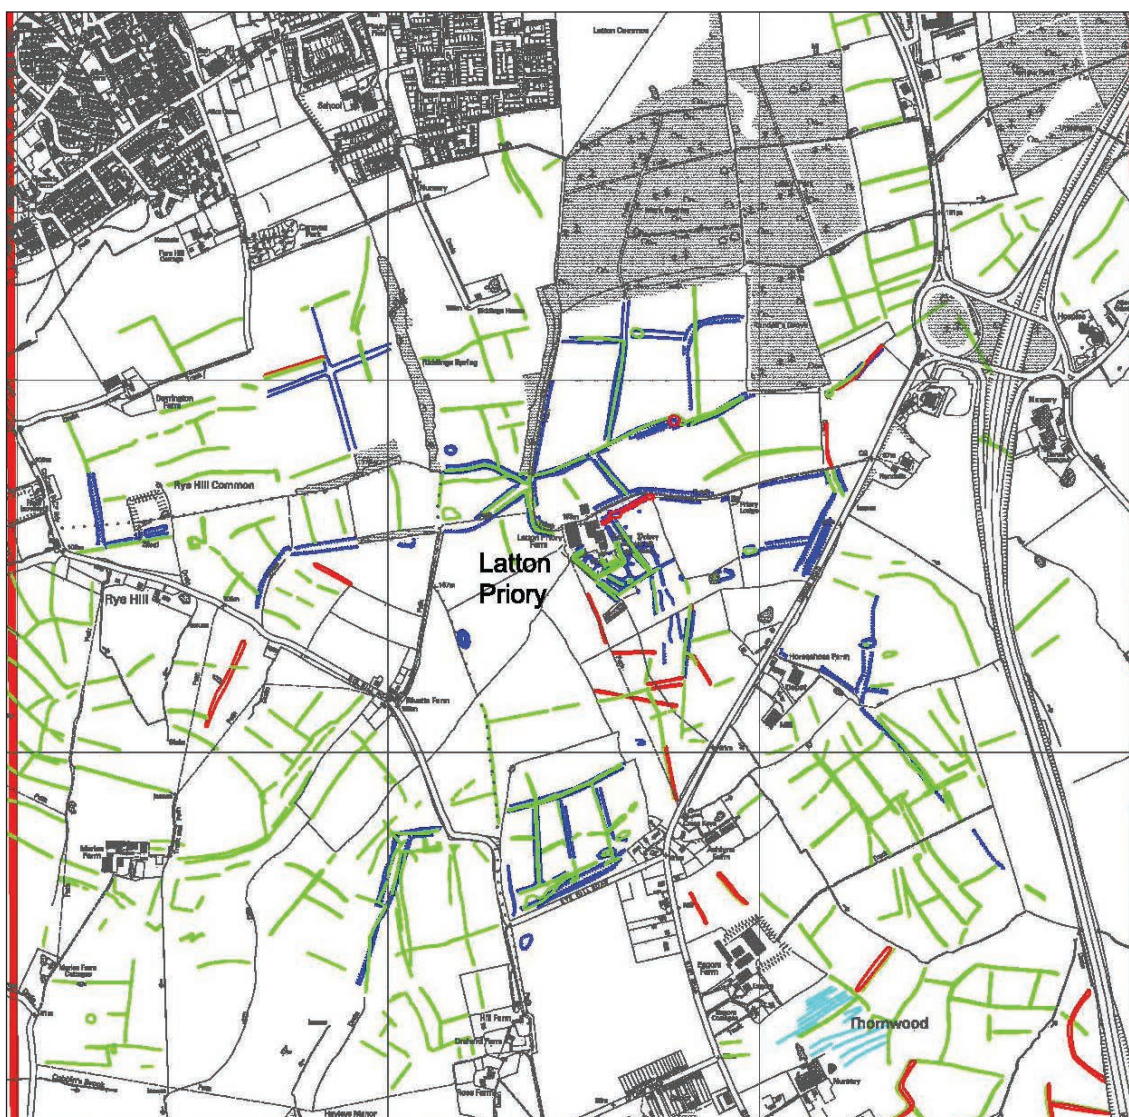
Figure 23: All archaeological remains mapped from lidar and aerial photographs around the former Priory of Latton. Base map © Crown Copyright and database right 2016, all rights reserved. Ordnance Survey licence number 100024900

Aerial photographs (including Google Earth satellite imagery) have revealed the extensive cropmark remains of former field boundaries within the larger modern field system. These represent the remains of probable medieval or post-medieval field systems with associated integrated trackways. Most of the boundaries were defined by ditches and probably hedged. A number of present field boundaries are clearly remnants of this earlier landscape (Figure 23).

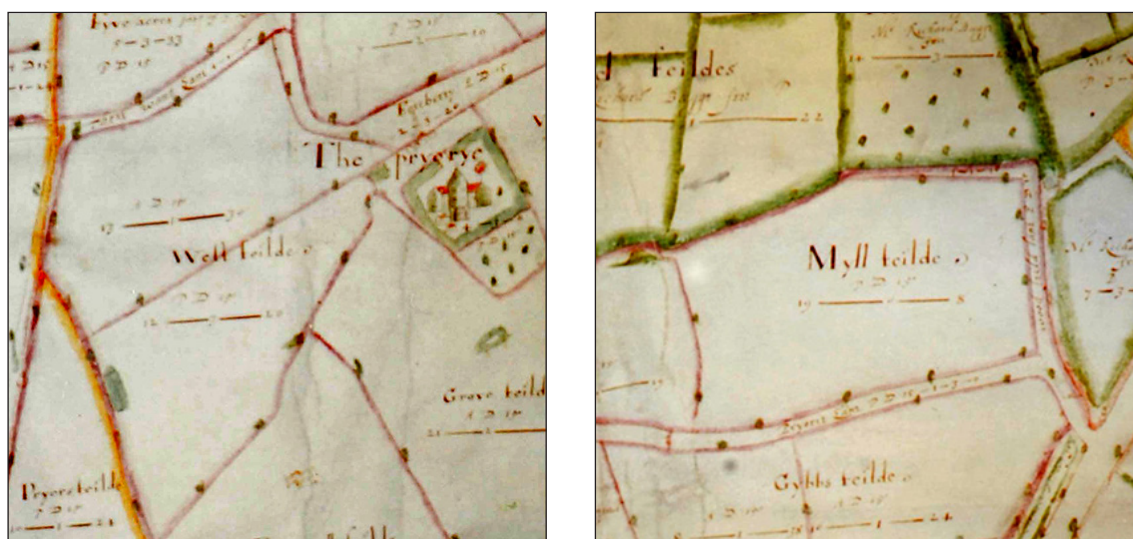
Figure 24: Extracts of 1616 Estate map of Latton Priory illustrating Well Fielde and Myll Fielde. Reproduced by courtesy of the Essex Record Office, T/M 453/2

field names. These field names hint at earlier activities and landscape features. Of note are the Well Field and Mill Field, both located close to the Priory (Figure 24).

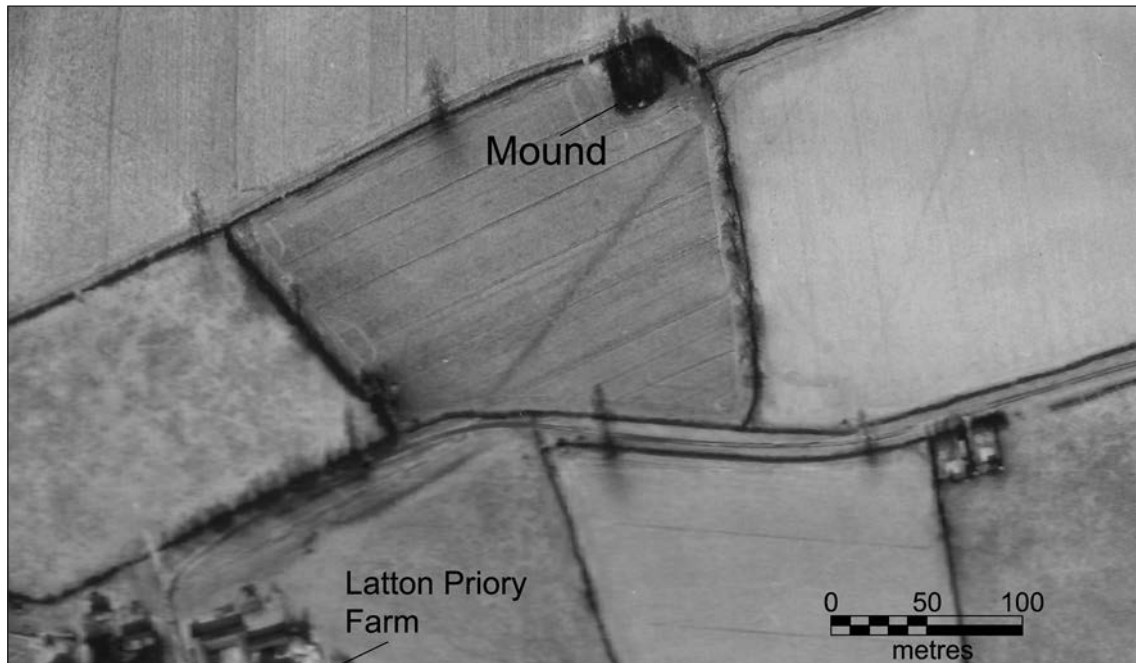
Figure 25: The earthwork mound within a small clump of trees to the north-east of Latton Priory Farm in 1955 prior to levelling and ploughing. Extract of RAF V542/131 0082 17-FEB-1955 Historic England RAF Photography.

The aerial survey identified one potential Bronze Age site in the vicinity of Latton Priory - a mound located on the northern edge of Horseleys to the north-east of the Priory site at TL 4677 0687 (mentioned above as a potential windmill mound). This appears as a slight mound between 27m and 30m across on lidar images, and as a circular cropmark in 2001 suggesting a plough-levelled mound with a hint of an encircling ditch measuring approximately 27m in diameter (Figure 25)

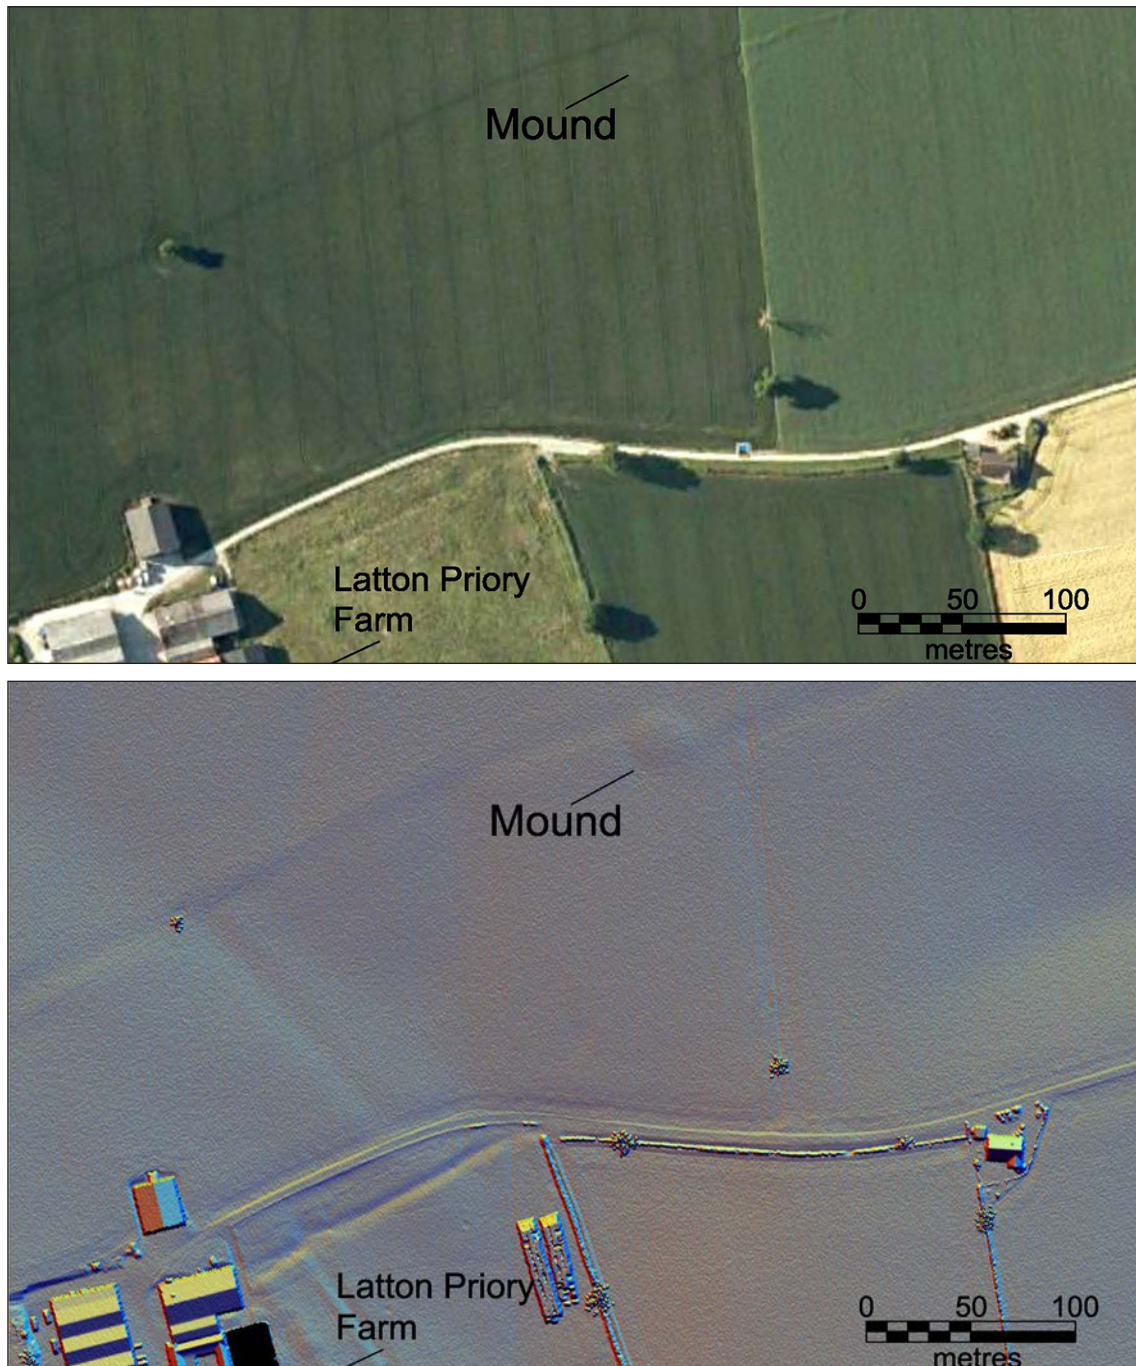
Figure 26: Traces of mound visible as a cropmark in 2009 (Google Earth 2009 - accessed 17/10/2016) (top) and lidar (below) indicating slight earthwork traces of the mound surviving in 2001. © Historic England; Source Environment Agency (December 2001)

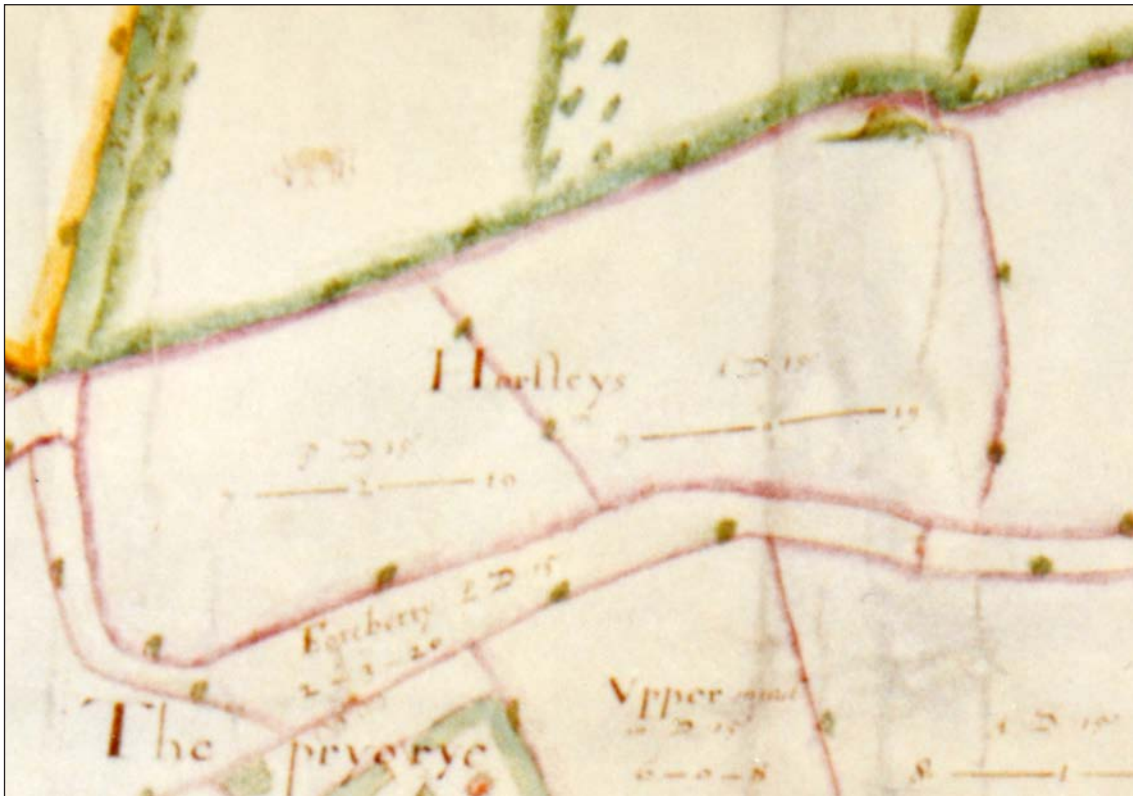
Figure 27: The mound at Latton recorded on the 1616 Estate map in the north-eastern corner of the field named Horsleys. The field boundary to the north is clearly depicted curving around the mound. Reproduced by courtesy of the Essex Record Office, T/M 453/2

clearly around the mound, clearly indicating that the mound predated the boundary. This relationship between the field boundary and the mound was also recorded on the 1616 estate map. Finds from a 'ploughed-out barrow north of Latton Priory' have been reported to the Essex SMR/HER; comprising a Roman coin of Constantine II (AD337-340), a possible Roman metal weight and assorted pottery.¹¹⁸ Though the finds are uncorroborated, this might support the idea of a Roman origin for the mound or, perhaps, evidence of reuse of an earlier barrow in the Roman period.

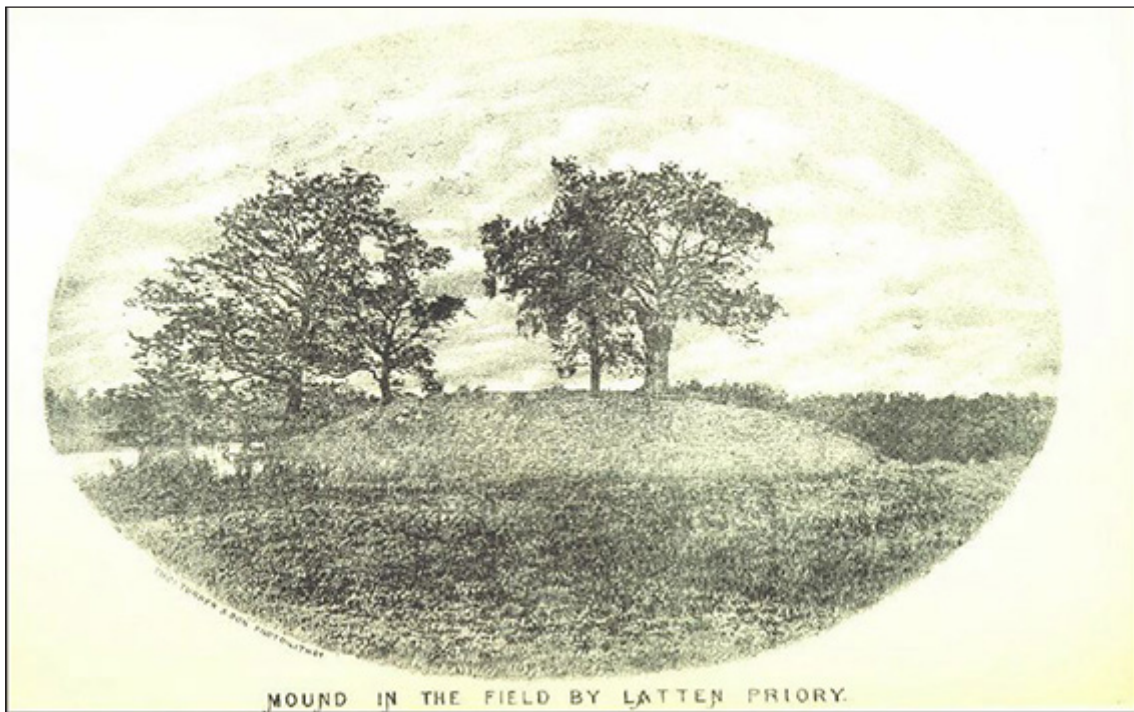
Figure 28: A photolithograph of the Latton mound taken in the latter half of the 19th century and published in Extracts from the Minutes of the Epping and Ongar Highways Trust 1769 – 1870, published 1891.
