Latton Priory Farm, North Weald Bassett, Essex: Historic Landscape Investigations

Discovery, Innovation and Science in the Historic Environment

Latton Priory Farm in the ancient parish of Latton, south of the area which from 1947 became Harlow New Town, contains, preserved within its agricultural buildings, the remains of the early 14th century priory church of St John the Baptist. The date of this small Augustinian priory's foundation, along with the identity of its founder, in common with many small houses of the Augustinian order are unknown, however it is likely that a priory has existed on the site since the late 12th century. The church of St John the Baptist and its attendant claustral buildings appear, from the remains of the priory church's crossing, nave and transepts to have been completely rebuilt in the early 14th century, and sat within a trapezoidal precinct defined on all four sides by a wet moat. The rebuilt priory, one of 11 Augustinian houses founded in Essex after the priory of St Julian and St Botolph Colchester in 1104-06, was surprisingly grand given its very small community, which at the time of its foundation numbered just three brethren and throughout it

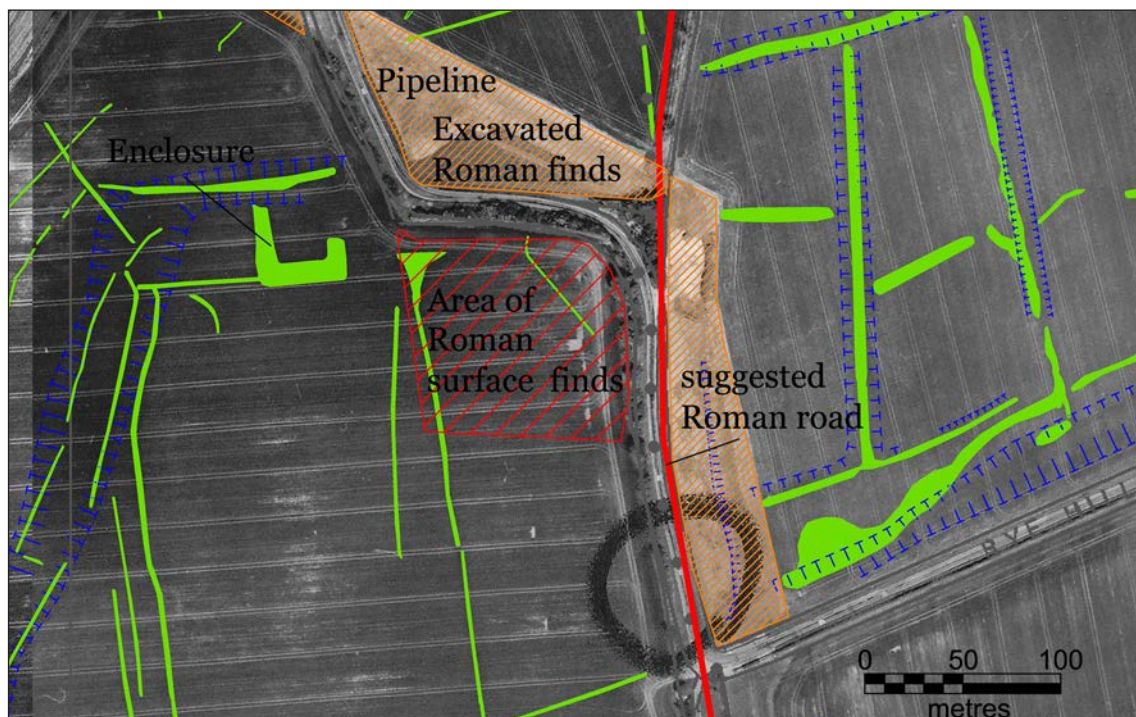
Figure 29: Transcription of the possible enclosure adjacent to an area of Roman surface finds (outlined in red) and suggested course of a Roman road (red line). The course of a gas pipeline excavation is (outlined in orange). Extract of OS/00945_3251 08-APR-2000

A number of cropmarks within a field 850m south-west of the Priory, appear to be the remains of medieval or post medieval field boundaries. Amongst them appears to be an incomplete broad-ditched rectangular enclosure in the region of 45m across at TL 4612 0575. The southern side and parts of the western and northern sides and south-western and south-eastern corners are visible. The relationship between the enclosure and the linear boundaries is not clear. The boundaries themselves are undated, but could be the remnants of medieval/ post medieval fields. The site lies 50-60m to the west of the given location of Roman finds identified in the 1960s at TL 462 057, just inside and to the south of a bend in Rye Hill Road. They comprised Roman brick, tile and pottery and a quantity of 16th-17th century Staffordshire slipware.¹¹⁹ Further finds of Roman brick, tile, late 3rd to 4th century pottery and slag were identified during the excavations for a gas pipeline to the north and east in 1999, all suggesting the presence of a large area of Roman occupation.¹²⁰ The course of a possible Roman road from Harlow to Epping passes the site along the line of the parish boundary and a short north-south portion of the Rye Hill Road to the east (NRHE 1044015). Though no trace of any Roman road material was identified during the pipeline excavations, it did confirm the existence of the Roman road further to the south, on the same alignment. Further traces of an agger have also been identified to the north of Latton Priory on the western edge of Mark Bushes, thought to be evidence of the same Roman road heading towards Harlow (Figure 29).¹²¹ The undated boundaries and trackways and the course of the Roman road and parish boundary all have a shared alignment suggesting contemporaneity or some degree of continuity between route-ways and landscape divisions.

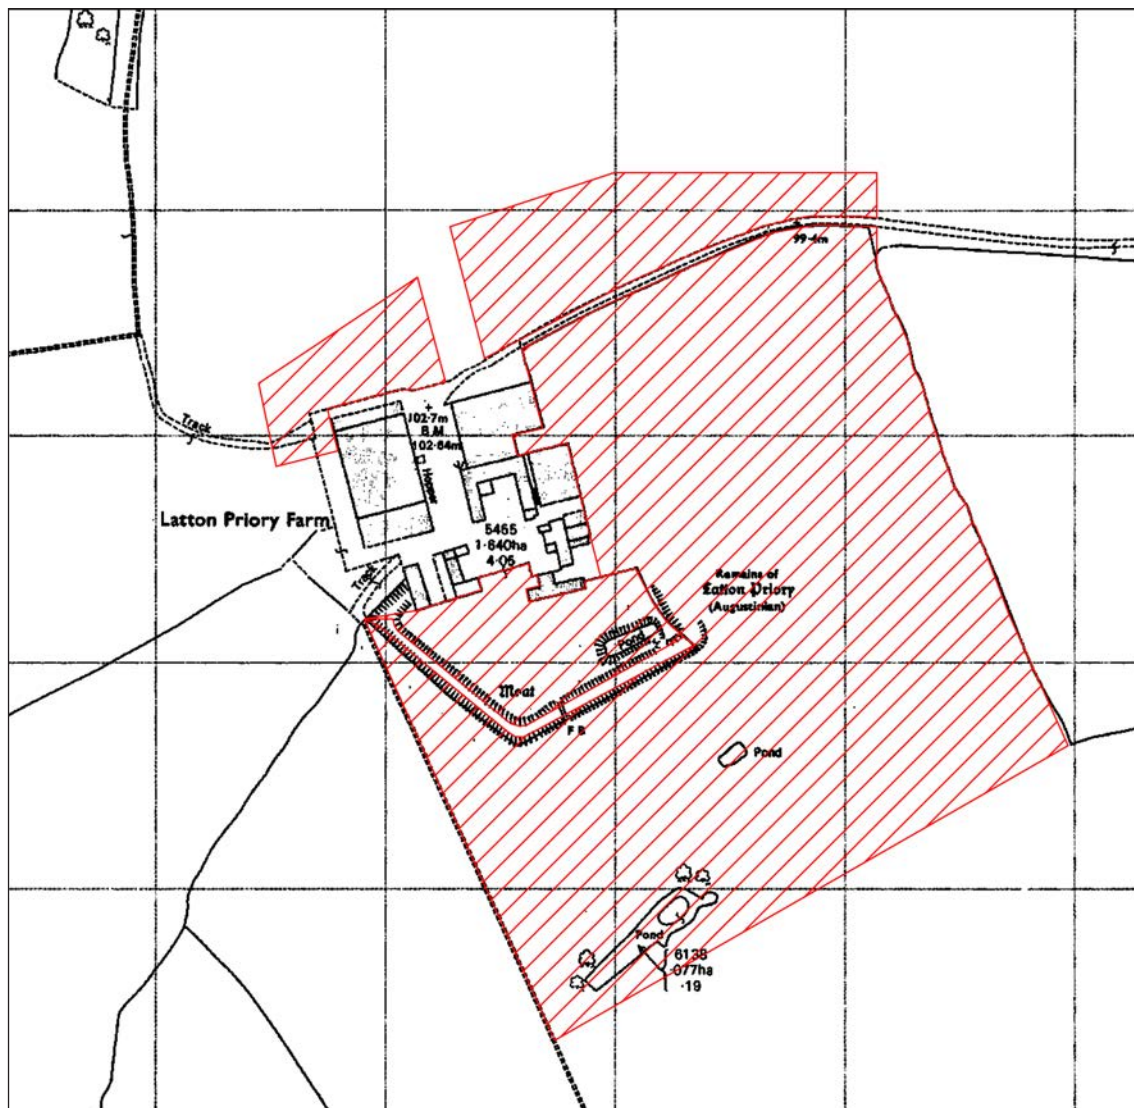
*Figure 30: The area which comprised the earthwork survey denoted by coloured hatching
Base map © Crown Copyright and database right 2016, all rights reserved. Ordnance
Survey license number 100024900*

The survey area comprised four main sections which when combined accounted for the entirety of the scheduled ancient monument and extended eastwards to include a number of clear linear earthworks outside of the scheduled area (Figure 30). The survey area, which covered some 5.7 ha (14.4 a) was divided into four areas comprising the inner and outer precincts of the priory, the eastern approach to the priory and supposed site of a chartered fair, the wider landscape of the post-medieval priory estate and the priory's fish pond and remains of its water management system.

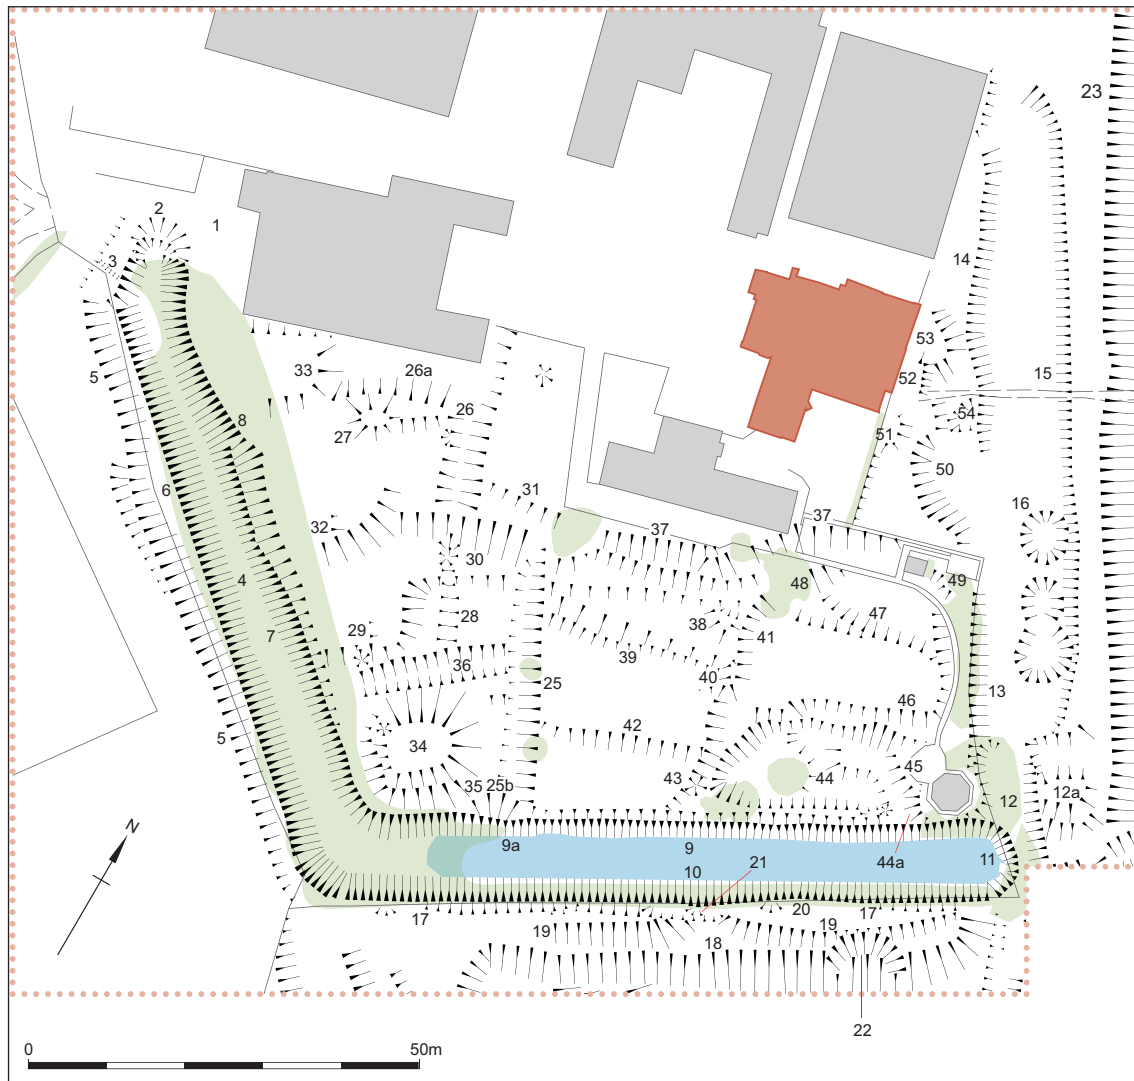
Figure 31: Features within the moated inner precinct © Historic England

The moat surrounding the inner precinct was originally roughly trapezoidal in form with the longest side to the NNW, though this has now been completely lost beneath farm buildings and yards. The broadly parallel arm to the SSE still held water along most of its length and most of the south-west arm survived to a considerable depth. Both were obscured in several places by dense vegetation. The ENE arm has been filled in but can be traced within the field to the east of the farm. This generally lay under rough grass. For simplicity's sake the cardinal points will be used as far as clarity will allow (Figures 31 and 32).

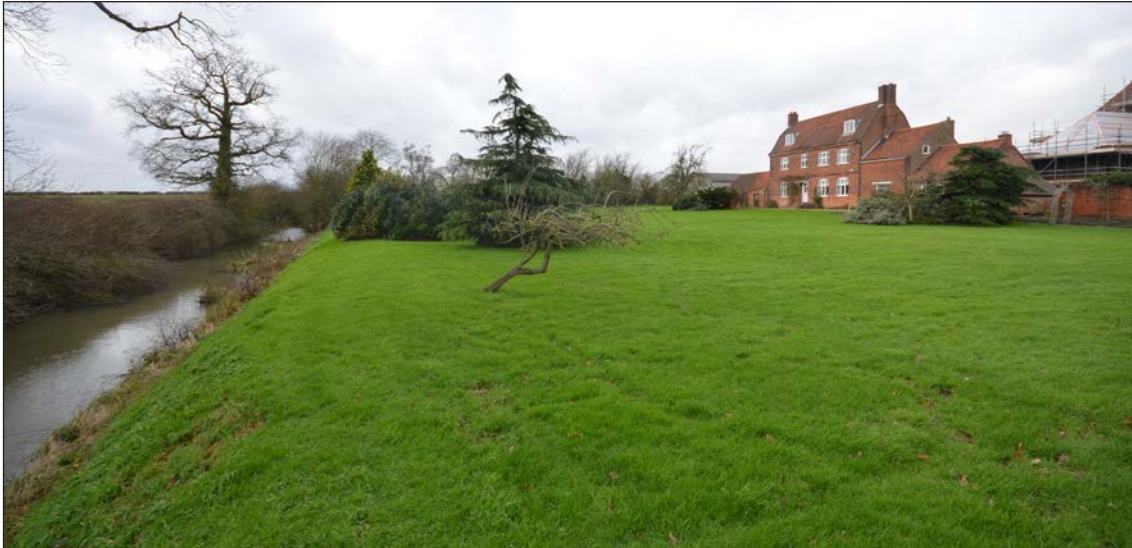
Figure 32: The moated inner precinct, now the farmhouse garden, from the south west.
 © Historic England, Matthew Bristow

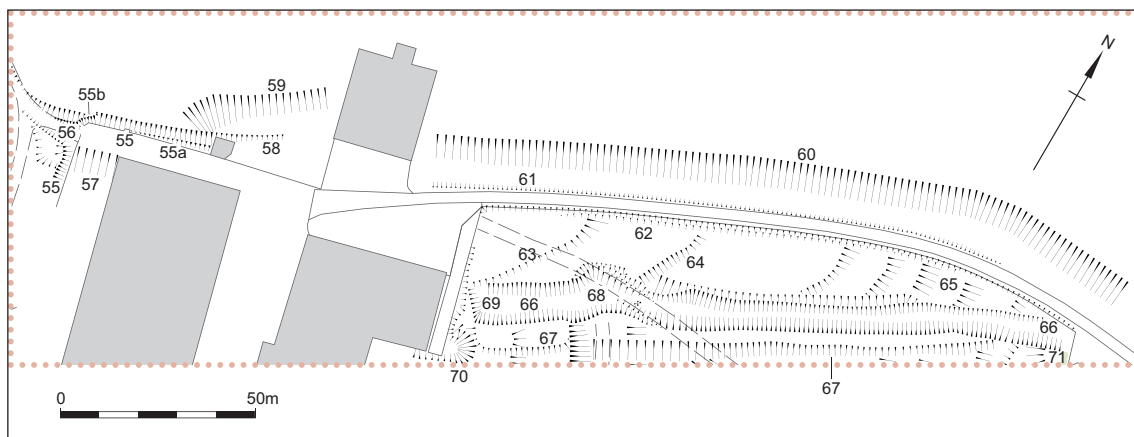
Figure 33: Features within the 'Foreberry' © Historic England

The Foreberry, as named on the 1616 map and shown as a roughly triangular area to the north and north-east of the priory precinct, adjoins the north-east corner of Latton Priory Farm and extends ENE away from the yard. The modern, concrete covered vehicle access track leading from the B1393 to the farm runs through the eastern half of the Foreberry before entering the farm yard (Figure 33).

The western half of the Foreberry as shown on the 1616 map was, for the most part obscured beneath the concrete surface of the farm yard and the modern buildings occupied by Olympic Foods and was not surveyed. A few features were recorded here, all modern.

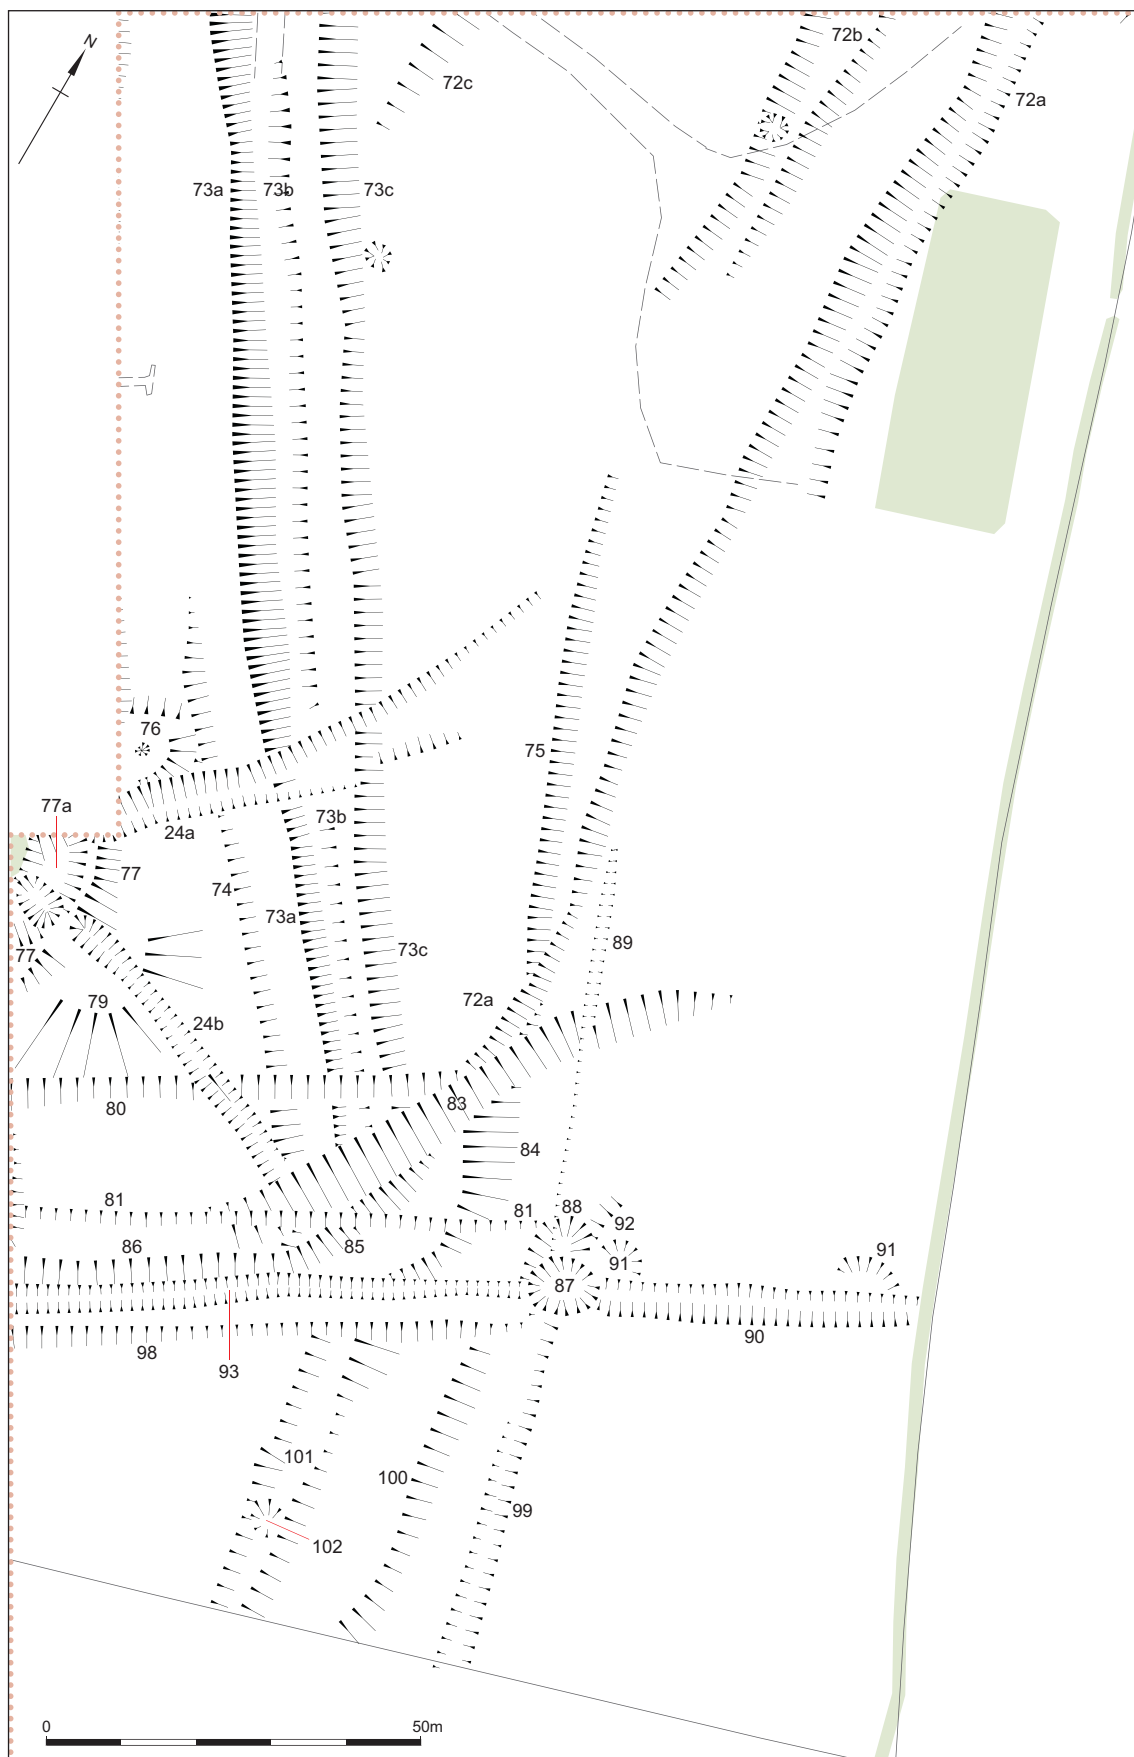
Figure 34: Features within the 'Upper Mead' © Historic England

The 'Upper Mead' as named on the 1616 map and survey comprises a roughly rectangular field extending south-west from the southern boundary of the Foreberry to a barbed wire fence level with the fish pond in the south-west of the site. An entrenched field boundary to the east marked the extent of the survey and is a perpetuation of the boundary shown on the 1616 map. Upper Mead extends as far west as the in-filled eastern arm of the moat and the modern farm yard. At the time of the survey, this area consisted entirely of rough pasture which obscured detail but was otherwise without impediments to the survey save for a large stack of hay bales in the north-east corner (Figure 34).

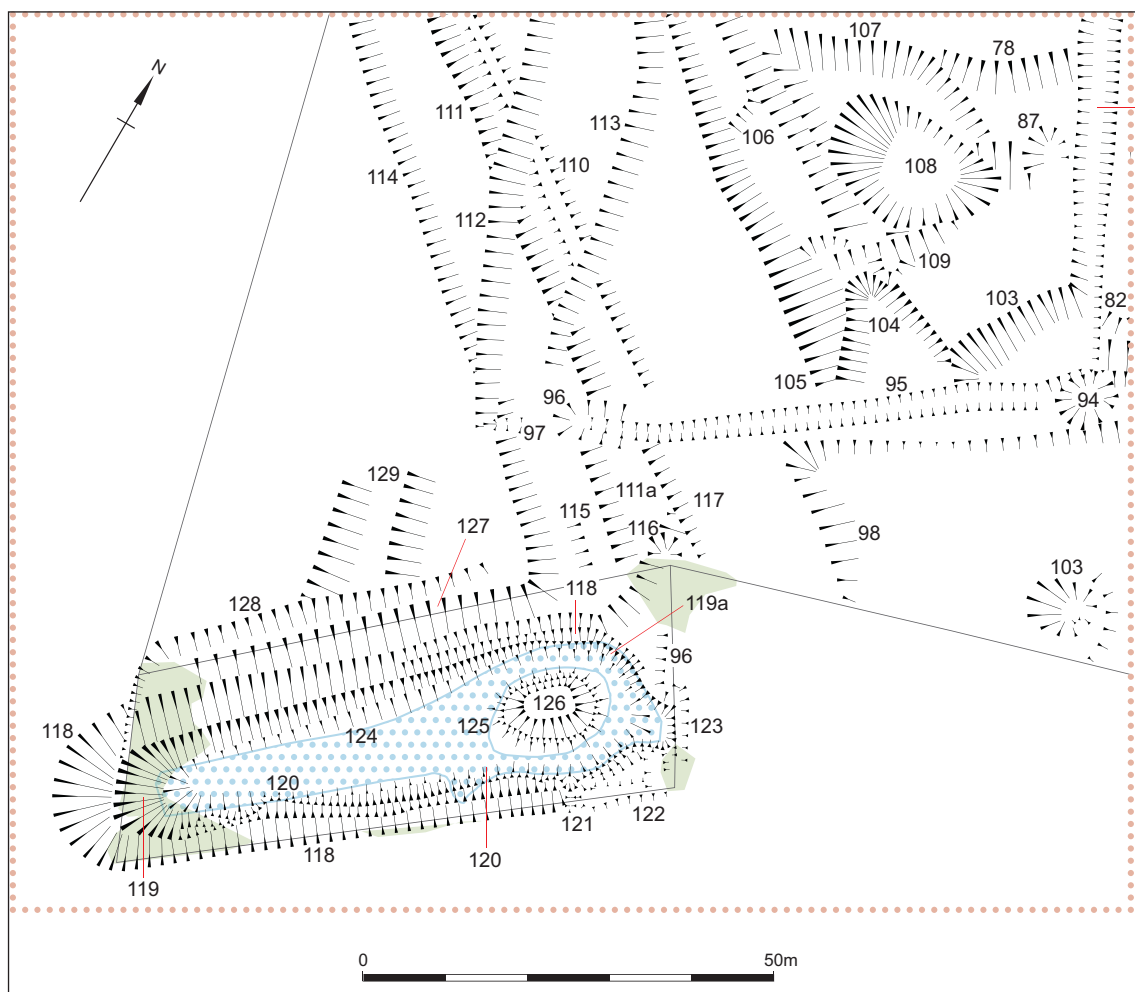
Figure 35: Features within ‘Grove Field’ © Historic England

Grove Field as named on the 1616 map is shown as a large, open field to the south and west of the moated precinct, with an enclosed orchard to the north and a large pond at its centre.¹²² Grove Field has subsequently been sub-divided by a footpath which extends SSE from the south-west corner of the moat and by barbed wire fences which extend from the pond to the ENE, defining the southern limited of the surveyed area and to the north-west defining the western limit. The area between the southern arm of the moat and the fishpond and barbed wire fence was more undulating than the other surveyed areas and fell more appreciably from south-west to north-east across the site. This area was for the most part under rough pasture and the earthworks were not masked by dense vegetation. The fishpond was closely surrounded by reasonably dense trees with significant ground-lying vegetation which did not mask the features but did make recording them challenging (Figure 35).

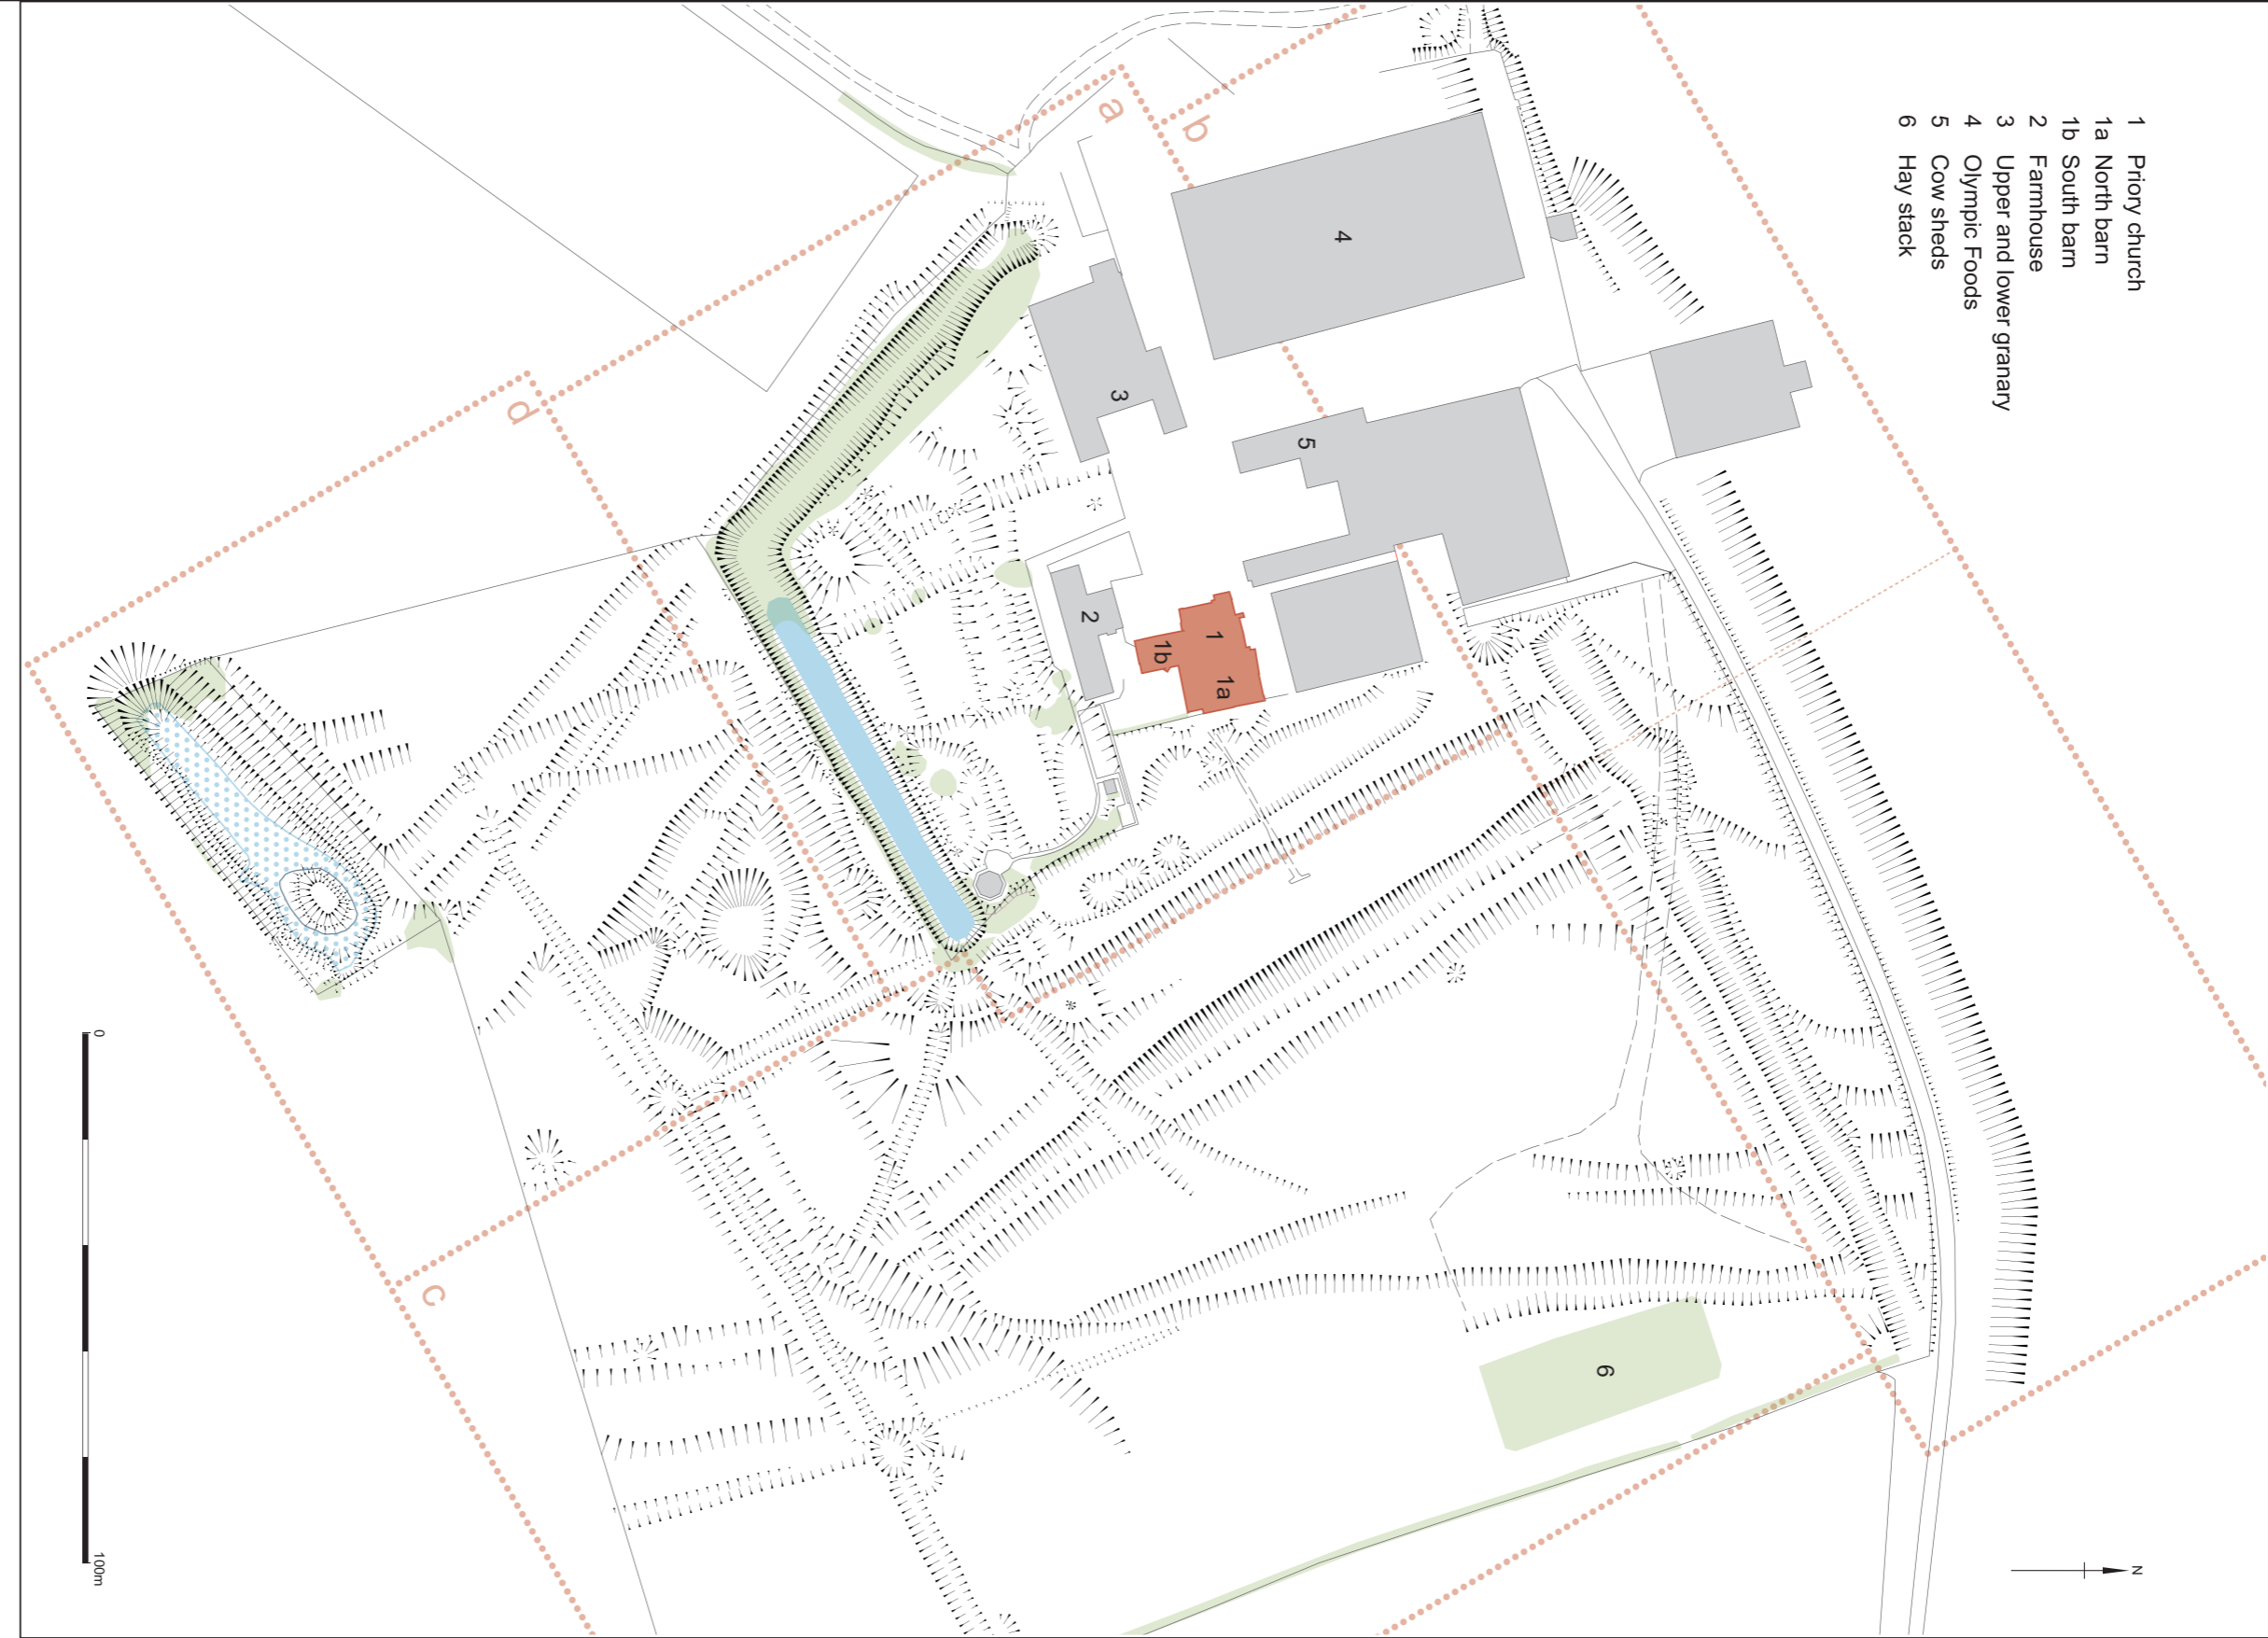
Figure 36: Earthwork survey reference plan © Historic England

Numbers in square brackets refer to Figures 32-35. See also Figure 30 for the extent of the survey and Figure 36 for the complete survey drawing.

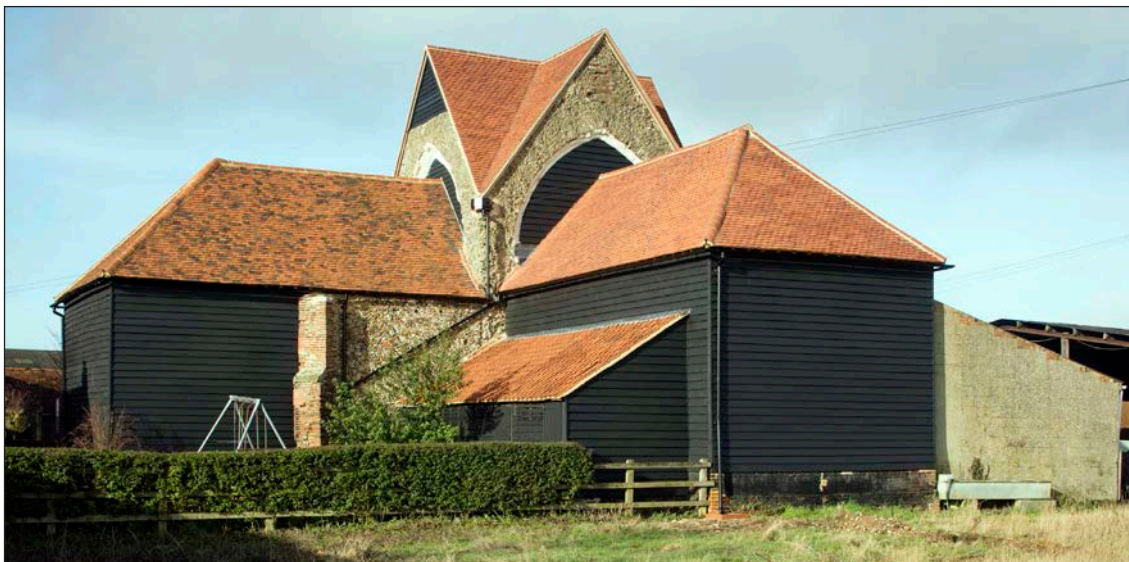
Figure 37: The church of St John the Baptist from the east following the Historic England funded consolidation work. © Historic England, Patricia Payne, DP217024

The surviving elements of the medieval priory church describe a footprint which measures 15.3m from the southern end of the surviving south transept wall to the truncated northern end of the north transept and 19.9m from the western end of the truncated nave to the eastern wall of the east barn which is assumed to mirror the footprint of the former presbytery. This footprint is initially difficult to reconcile with measurements published in Storer's 1809 account of the priory. Storer states that prior to the collapse of the south transept, an event which pre-dated his account by three years, the priory church measured 66ft (20.1m) from north to south and 54 ft (16.5m) for west to east.¹²⁴ On initial inspection, these measurements are difficult to reconcile with the surviving footprint of the church which, save for the collapse of the south transept, has been little altered since the replacement of the presbytery after 1778. However, the west to east dimension can be reconciled if the stub walls of the nave are not included as part of the footprint of the priory church. These truncated walls are approximately 3.4m in length and their deduction from the overall west to east dimension of the existing structure produces a figure of 16.5m from the nave crossing arch to the eastern end of the east barn. The north to south dimensions provided by Storer are far harder to reconcile and suggest that the remains of the priory church were more extensive prior to the collapse of 1806 and that about 5m have been removed collectively from the north and south transepts. It is clear from comparison of the depictions of the north transept in 1765 and 1818 that its length was reduced when it was cut back, its north window, wall and buttresses removed and a lean-to thatched roof and weather boarded wall added.¹²⁵ This work however, is unlikely to have reduced the length of the north transept by any more than 1m, leading to the conclusion that either Storer's measurements are incorrect or the southern transept extended four to five metres further south than the surviving east wall and brick buttress suggest.

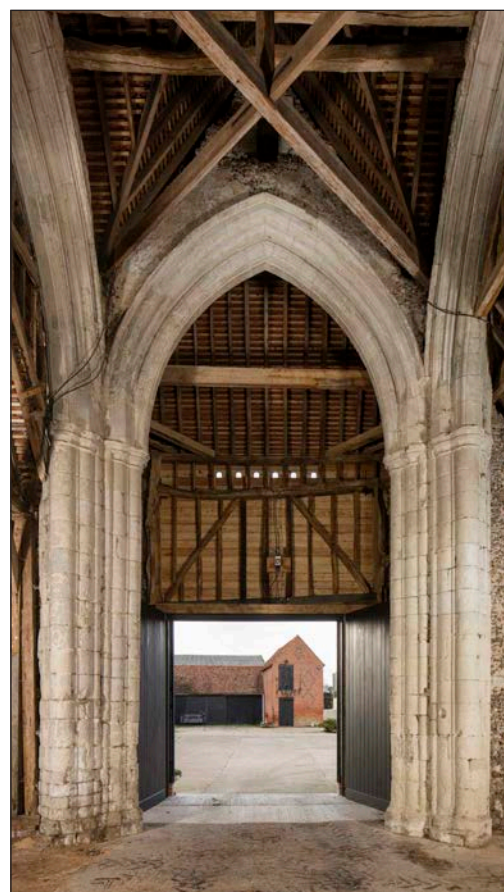
Figure 38: The crossing of Latton priory church looking west through the truncated nave to the modern farm yard beyond. © Historic England, Patricia Payne, DP217018

The most complete surviving element of the priory church of St John the Baptist is the central crossing with which the truncated nave, transepts and east barn intersect. Four arches with internal spans of 4.2m rise to an apex 8.7m above the cobbled floor surface and are of a style characteristic of the early 14th century (Figure 38). Constructed of either Reigate stone, a soft greensand stone, easy to work but highly susceptible to weathering, or more locally sourced clunch, the arches were described by Holman as being, ‘Of free stone curiously done’.¹²⁶ The responds of the crossing arches are moulded and each respond has three attached shafts describing a trefoil with moulded bases and capitals. The intersection of the responds at each corner of the crossing is defined by chamfered stops at the same level as the capitals. Springing from the capitals, the two-centred arches over the crossing are of two moulded orders with labels above, which once terminated in label stops, though these are now difficult to discern.¹²⁷ The west-facing stone of the crossing arches is heavily weathered and decayed, attesting both the long absence of the barn doors which formally hung between the stub walls of the nave and the soft nature and propensity for decay of the Reigate stone.

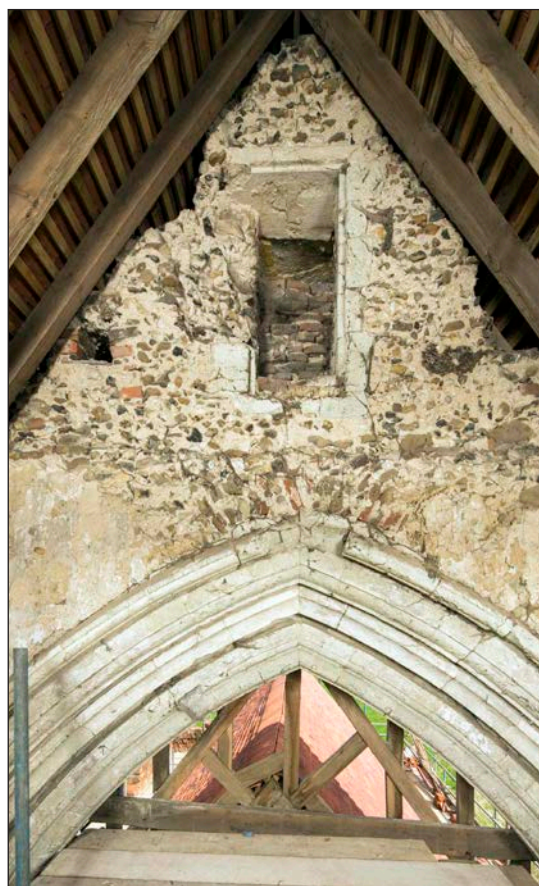
Figure 40: The east opening above the crossing arch into the chancel. © Historic England, Patricia Payne, DP182397

The eastern and western walls of the tower above the crossing arches retain rectangular openings beneath the gables created by the truncation of the tower. Both of these openings are framed with worked blocks of Reigate stone with a moulded recess. The opening to the east is more complete than that to the west, though the latter remains open with a view into the remnants of the nave while the eastern opening has been blocked with brick, an in-filling which is visible externally as a patch above the apex of the east barn roof (Figure 40). The function of these openings is not obviously apparent as their location, just above the crossing arches likely meant that they were below the level of the presbytery and nave rooflines and looked down into those areas of the church. Additionally, if the joist sockets to the north and south walls and corresponding lips to the east and west walls indicate the location of a floor level within the tower, the sills of these openings would have been level with the floor. This may suggest that the sockets and floor level are entirely post-medieval.

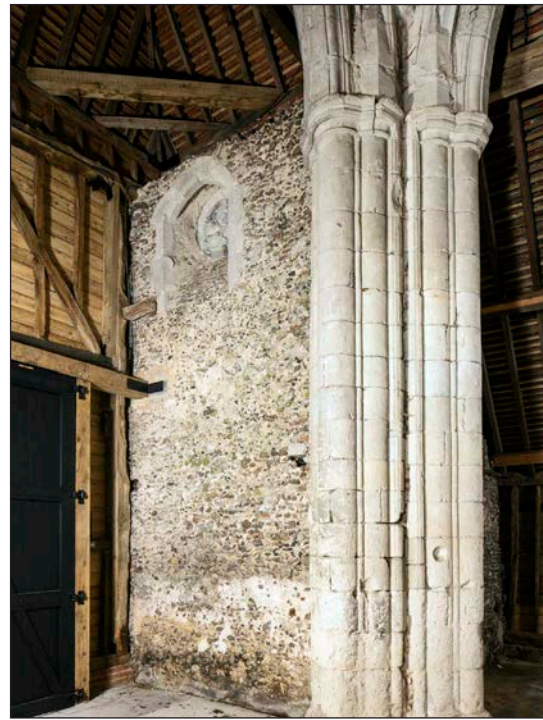
Figure 41: The blocked sexfoiled clerestory window in the north stub wall of the nave viewed from inside the crossing.
© Historic England, Patricia Payne, DP217019

The raking line of a former pent roof on the western wall of the north transept, a corresponding string course beneath a sexfoil clerestory window in the stub remains of the nave's north wall and the blocked doorway in the western wall of the north transept leave little doubt as to the existence of a structure north of the nave (Figure 51). The style of the clerestory window and the absence of evidence for a raising of the nave roof, indicates that a clerestory was part of the early-14th century scheme and therefore so was a structure beneath it. This conclusion is further supported by the two-centred arched doorway into the north transept which is also consistent with an early-14th century date. As mentioned above, a single north aisle has also been viewed as characteristic of Augustinian priory churches which developed from aisleless cruciform plans in line with evolutions in the plan forms of parish churches and in order to match the aspirations of wealthy patrons who sought a more extravagant monument to their patronage.¹³⁷ The established interpretation of the priory church at Latton has been that the church rebuilt in the early-14th century did include a north aisle, however closer examination of the surviving fabric would seem to preclude this. The principal impediment to the existence of an aisle is the absence of evidence for an arcade springing from the north-western crossing pier. The 3.2 metres of northern nave wall which survived the conversion of the church to a barn are of entirely solid construction and shown no signs of rebuilding beneath the level of the clerestory window. This suggests that there was no arcade and that the structure to the north of the nave was not an aisle but was a separate room. The confirmation by the rere-arch that the opening in the west wall of the north transept was a doorway and not an open arch also supports the interpretation that beyond lay a room. The lack of arches and arcading appear to eliminate both a north aisle and a small north chapel and imply an outshut beneath a pent roof. It is highly likely that instead of an aisle, the structure between the nave and north transept was a porticus and if so, the plan of the priory church of Latton is directly comparable to that of the Augustinian priory of St Mary in the Meadow, Beeston Regis, Norfolk (NGR TG 16756 42801). The aisleless priory church, a characteristic of the Augustinian order (see above) required the brethren to negotiate the choir stalls which traversed the crossing in order to access the north transept. Early Augustinian churches often incorporated small porticuses or passages to allow direct access to the transepts from the nave. By the late 12th century new Priory Churches were being designed with north aisles and earlier churches were having north aisles added. If the rebuilt priory church at Latton retained the aisleless nave and porticus arrangement with doors linking the nave and north transept via the porticus, then it, like Beeston Regis was markedly old-fashioned in its design.¹³⁸ It has also been suggested that the porticus at Beeston Regis was a northern sacristy, an hypothesis which is likewise plausible at Latton.

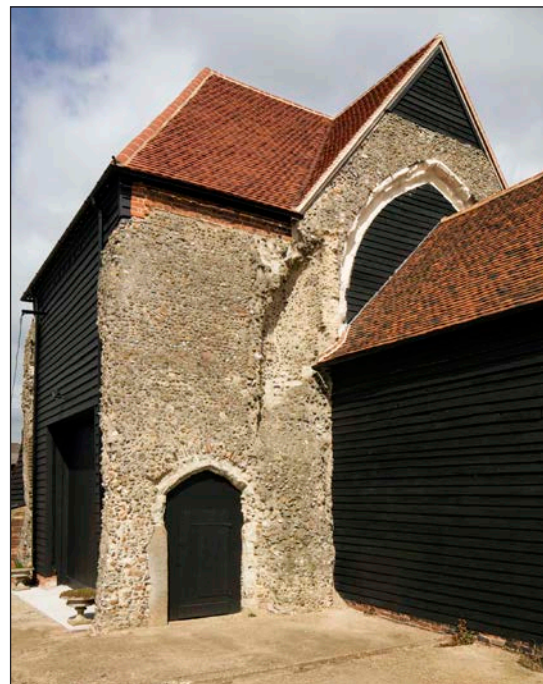
Figure 42: The deep scar west of the south transept crossing arch indicating the former location of a stair turret.
© Historic England, Patricia Payne, DP217007

Above and to the east of the processional doorway at the intersection between the nave and the south transept, a deep scar indicates the former location of a circular stair turret (Figure 42). It does not appear to have descended to floor level and looks as though it rose from above the cloister walk to the upper stages of the tower. The inner curve of the turret is clearly visible within the outer fabric of the nave wall as is the line of the stair winders. Both the 1778 engraving which illustrates Francis Grosse's account of Latton and the 1809 engraving of the priory from the south published as part Storer's Topographical Cabinet, show an opening into the stair turret, though the depictions vary wildly in the size and character of the opening.

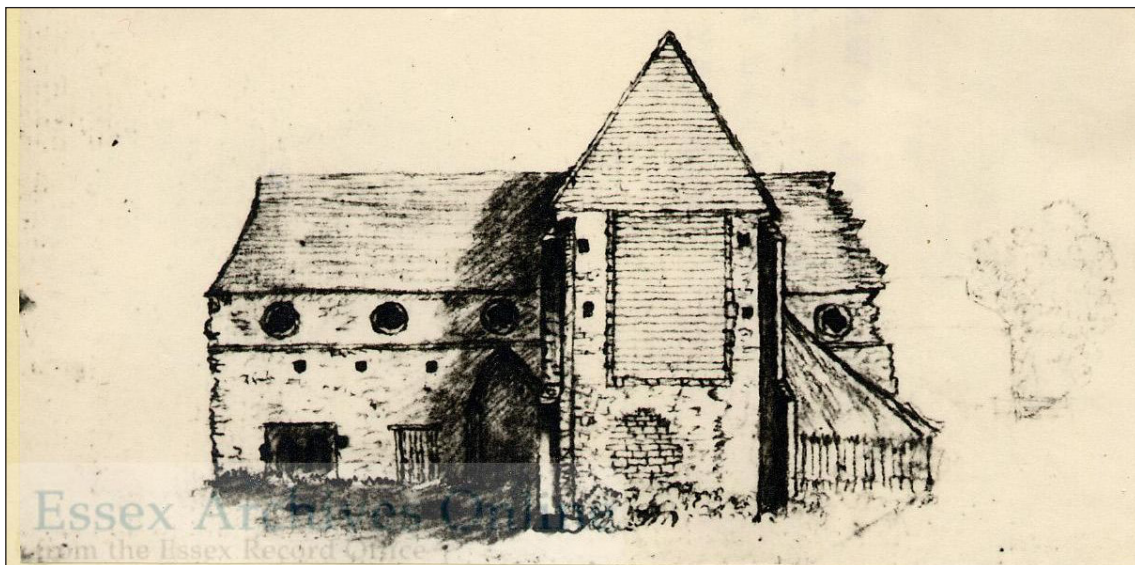
Figure 43: The remains of Latton priory church from the north in September 1765. Reproduced by courtesy of the Essex Record Office, I/Mb/211/16

Nothing remains of the former presbytery which appears to have survived until at least 1809 but had been replaced by the current timber-framed barn by 1818.¹³² Two depictions of the presbytery, one, a copy of a crude pencil drawing of the priory church from the north made in 1765 and the other the engraving produced in 1778 for Francis Grosse's account, do show the extant structure shortly before its demolition. There are issues of scale and perspective associated with both depictions, however they do provide invaluable information about the appearance of the medieval presbytery. The depiction of the northern elevation of the presbytery made in 1765 and copied in 1771 shows a structure which is roughly proportionate to the timber-framed barn which replaced it. Most interestingly, the depiction shows that the clerestory suggested by the blocked sexfoiled window and stringcourse surviving to the northern wall of the nave, continued along the length of the presbytery, with three circular sexfoiled windows shown (Figure 43). This confirms the one possible interpretation drawn from the 1616 map that the nave and presbytery were of equal height but also suggests the presence of a structure to the north of the presbytery which necessitated the clerestory above. The 1765 drawing also depicts, though far from clearly, a tall and wide, blocked two-centre, pointed arch rising to the stringcourse above at the western end of the presbytery's northern façade. This arch and surviving evidence of a corresponding blocked arch on the eastern façade of the north transept, (see below) when taken in conjunction with the evidence for the clerestory above, strongly suggests the presence of a north chapel (see below), which is of a contemporary date to the rebuilt priory church. To the east of the blocked arch, the drawing shows a simple timber door beneath a flat lintel which was likely a later insertion to access the eastern end of the church following the removal of the chapel and the conversion to a barn. The easternmost bay of the presbytery appears to have been lit from the north by a two-light, square-headed mullioned window, though it is impossible to comment on the nature of the tracery and it is possible that this window is a later replacement.

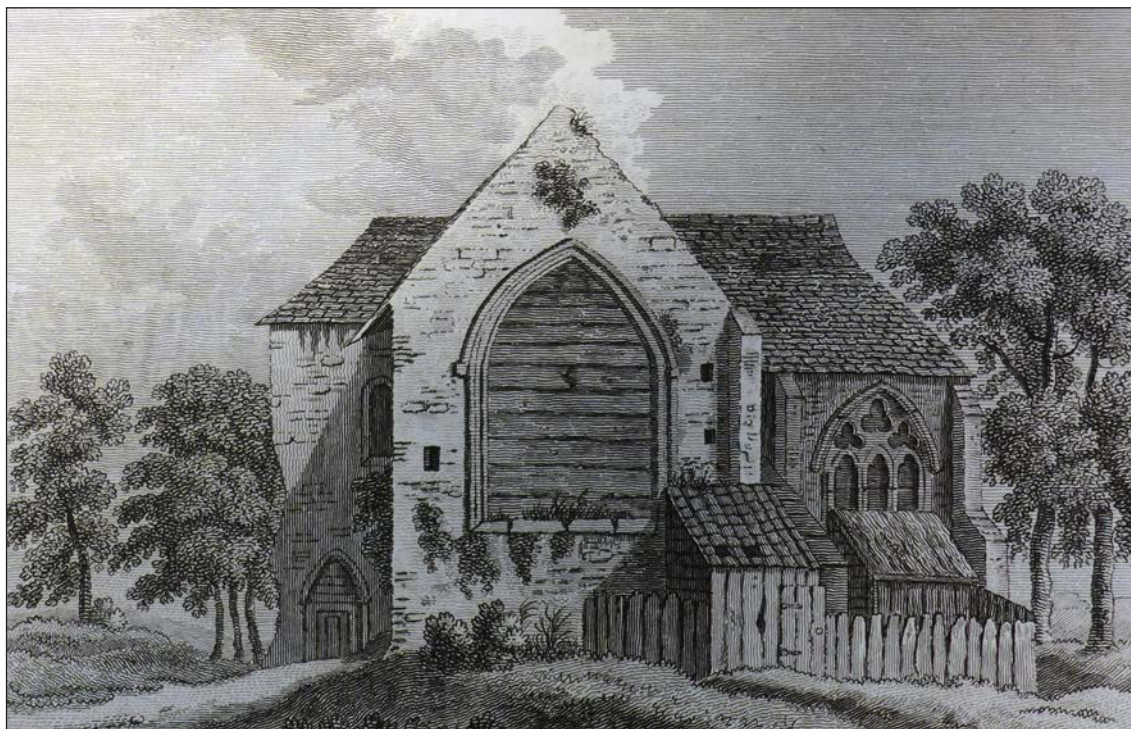
Figure 44: An engraving of Latton priory church from the south published in a pamphlet of 1778 by Francis Grosse. © Essex Record Office, LIB/PAM 1/9/16

The engraving of Latton Priory church from the south, included as an illustration in Grosse's 1778 pamphlet, is more detailed than the 1765 depiction and no less revealing about the nature of the presbytery. Despite obvious issues with scale and proportion, the engraving confirms conclusions drawn from the 1765 depiction and details the nature of the presbytery window tracery (Figure 44). The depiction of the southern façade of the priory again suggests that the rooflines of the nave and presbytery rose to the same height and that the roof over the presbytery was tiled and half-hipped. It also suggests that the clerestory windows shown on the north façade were not present on the southern elevation and that the roof over the presbytery was asymmetrical, extending further on the southern side than the northern as shown in the engraving. It is possible however, given the substantial alterations to the priory church made during its conversion to a barn, that the clerestory level had been removed from the southern wall of the presbytery. Either way, the 1778 engraving shows that the southern elevation of the presbytery was divided into two bays by a central buttress and that a buttress adjoined the south-east corner of the structure. The perspective chosen for the composition prevents any comment being made on the western bay, however the easternmost bay is clearly depicted and shows the window which lit the presbytery from the south. A two-centre pointed arch window beneath a label with stops, the window is of three lights with trefoiled heads with three trefoiled eyelets above and is of a geometric design entirely consistent with the early-14th century, reinforcing the conclusion that the entire priory church was rebuilt at that time. The window is large, the arch rising to the eaves of the roof, level with the tops of the buttresses and appears to be of the same character as the window shown in the southern wall of the adjacent south transept.¹³³

transept wall depicted by Storer and there is no reason to suspect that this wall has been further cut back. Sitting above the present floor surface, a large stone with mortared fabric which corresponds with the rest of the transept appears to describe the southern return of the south transept. Francis Grosse's 1778 depiction, although of questionable proportions, appears to confirm that by the 18th century, the south transept did mark the southern terminus of the east range of the cloister and that no remnants of the chapter house, dorter range or latrines survived. Grosse's depiction also documents the south window of the south transept which is - like the other extant remains of the priory - of the early-14th century and comprised a two-centred arched head with moulded capitals and a moulded label with label stops above. (See Figure 44).

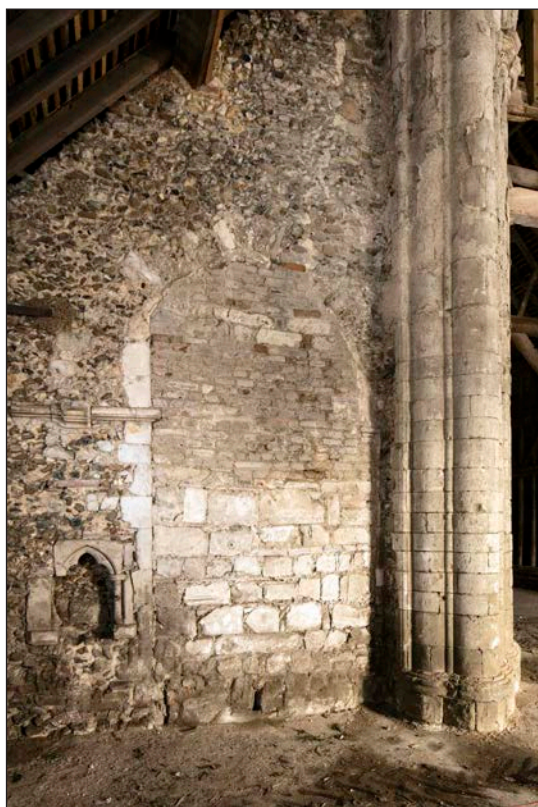
Figure 45 (Left): Heavily altered and remade arch in the east wall of the north transept. It likely accessed a north chapel. © Historic England, Patricia Payne, DP217025

At the intersection between the east wall of the transept and the north-east corner of the crossing, a blocked-two centred pointed arch - stylistically consistent with the crossing arches - evidences the location of a structure between the transept and presbytery, most likely a north chapel. The responds of the arch, like the arches of the crossing, had attached shafts, the simple moulded capitals of which survive *in situ* both externally to both responds and internally to the southern respond. The internal face of the northern respond has been heavily altered and attests to post-medieval rebuilding of the northern part of the transept (Figure 45). The internal span of the arch (1.784m) is noticeably narrower than the external span (2.053m), the latter retaining both its shafted responds and capitals (Figure 46). The northern internal respond has been 'made up' of pieces of worked squared stone, changing the profile of the arch and flattening it. The scar of the former arch profile and line of the respond can be discerned within the fabric of the eastern wall and corresponds to the external proportions of the arch. A piece of moulded stone within a string course which the scar passes through may be the northern capital surviving roughly *in situ*. Below the string course the scar of the respond passes through a piscina of 14th century character, further confirming that the eastern wall has been much altered. The arch has been in-filled with a combination of post-medieval brickwork and irregular sized blocks of worked, squared stone. The stones bear the striations of medieval tooling and may have originally formed part of the north chapel, the presbytery or nave. Within the fill of stone blocks, the *ex situ* drain of the piscina, set on its side with the circular drain facing outwards, further evidences a phase of post-medieval rebuilding. The piscina, although clearly reconstructed and *ex situ*, has shafted jambs and a trefoiled head consistent with an early-14th century date,
