Latton Priory Farm, North Weald Bassett, Essex: Historic Landscape Investigations

Discovery, Innovation and Science in the Historic Environment

Latton Priory Farm in the ancient parish of Latton, south of the area which from 1947 became Harlow New Town, contains, preserved within its agricultural buildings, the remains of the early 14th century priory church of St John the Baptist. The date of this small Augustinian priory's foundation, along with the identity of its founder, in common with many small houses of the Augustinian order are unknown, however it is likely that a priory has existed on the site since the late 12th century. The church of St John the Baptist and its attendant claustral buildings appear, from the remains of the priory church's crossing, nave and transepts to have been completely rebuilt in the early 14th century, and sat within a trapezoidal precinct defined on all four sides by a wet moat. The rebuilt priory, one of 11 Augustinian houses founded in Essex after the priory of St Julian and St Botolph Colchester in 1104-06, was surprisingly grand given its very small community, which at the time of its foundation numbered just three brethren and throughout it

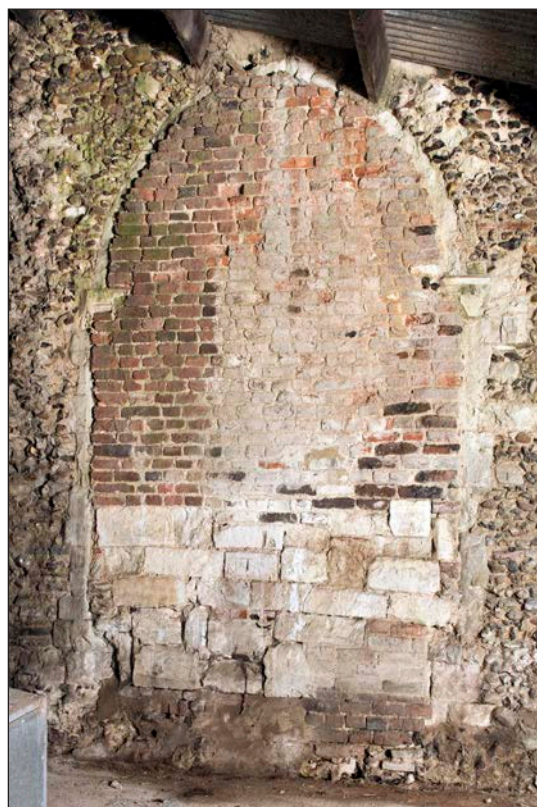
Figure 46 (Right): The arch between the north transept and north chapel from the east. © Historic England, Patricia Payne, DP217027

At the intersection between the east wall of the transept and the north-east corner of the crossing, a blocked-two centred pointed arch - stylistically consistent with the crossing arches - evidences the location of a structure between the transept and presbytery, most likely a north chapel. The responds of the arch, like the arches of the crossing, had attached shafts, the simple moulded capitals of which survive *in situ* both externally to both responds and internally to the southern respond. The internal face of the northern respond has been heavily altered and attests to post-medieval rebuilding of the northern part of the transept (Figure 45). The internal span of the arch (1.784m) is noticeably narrower than the external span (2.053m), the latter retaining both its shafted responds and capitals (Figure 46). The northern internal respond has been 'made up' of pieces of worked squared stone, changing the profile of the arch and flattening it. The scar of the former arch profile and line of the respond can be discerned within the fabric of the eastern wall and corresponds to the external proportions of the arch. A piece of moulded stone within a string course which the scar passes through may be the northern capital surviving roughly *in situ*. Below the string course the scar of the respond passes through a piscina of 14th century character, further confirming that the eastern wall has been much altered. The arch has been in-filled with a combination of post-medieval brickwork and irregular sized blocks of worked, squared stone. The stones bear the striations of medieval tooling and may have originally formed part of the north chapel, the presbytery or nave. Within the fill of stone blocks, the *ex situ* drain of the piscina, set on its side with the circular drain facing outwards, further evidences a phase of post-medieval rebuilding. The piscina, although clearly reconstructed and *ex situ*, has shafted jambs and a trefoiled head consistent with an early-14th century date,

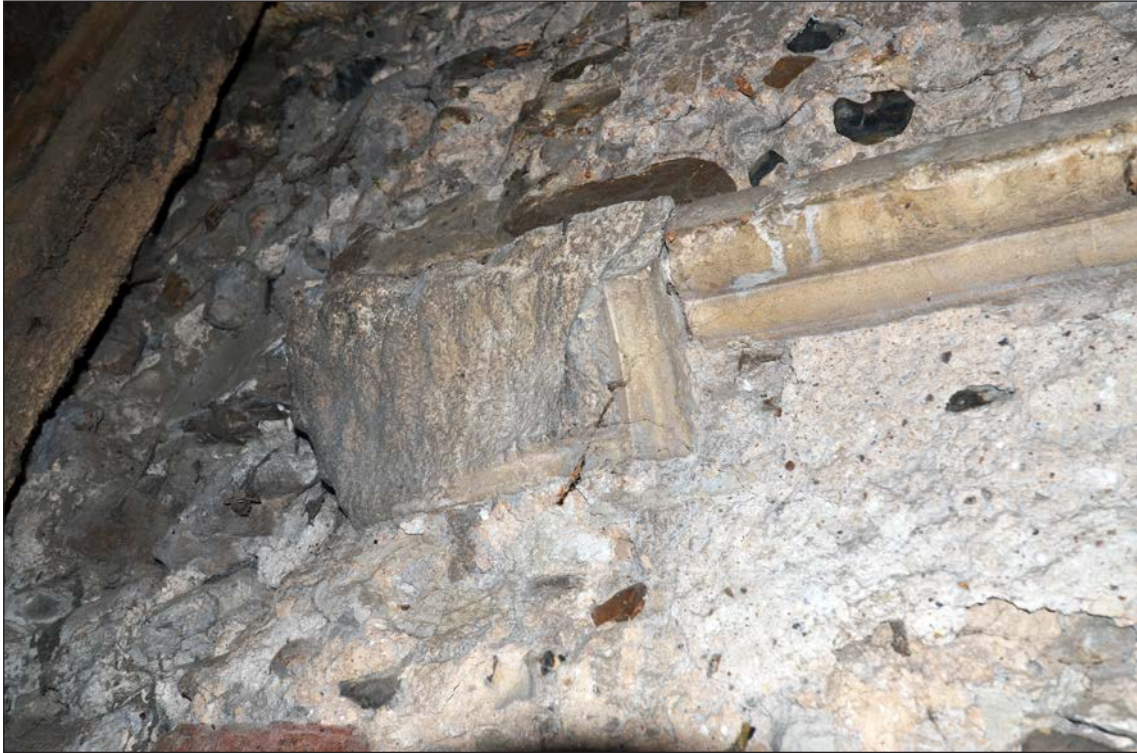
Figure 47: Ex situ worked stone used to remake an internal stringcourse. One piece may contain the fragment of a rib. © Historic England, Matthew Bristow

At the same height as the capitals of the former arch into the north chapel, a string course can be observed on the internal eastern and western walls of the north transept and the exterior of the eastern wall. Although the moulded stone in line with the scar of the former arch respond may be the capital of the removed arch respond, the rest of the string course is made up with *ex situ* pieces of moulded stone. On such piece of stone, set at the northern end of the east wall's string course, may retain the truncated remains of a rib from a vaulted ceiling (Figure 47). It is clear that this fragment and the pieces which make up the east wall's string course have been reused from elsewhere within the church or claustral buildings. However the *ex situ* string course in the north transept aligns with the *in situ* capital of the arch into the north chapel and the *in situ* string course and window sill in the south transept (see below), indicating that it likely represents an original feature.

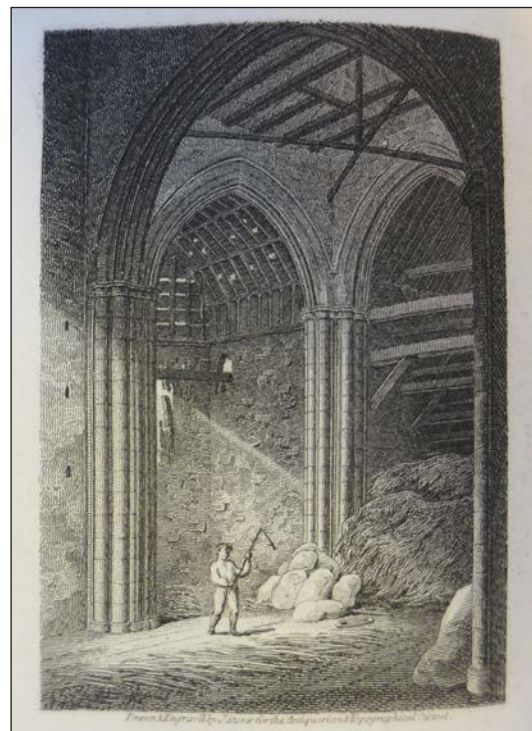
Figure 48: The interior of Latton priory church looking north-east as depicted by Storer in a publication of 1809. © British Library

depicted on the south transept, it was likely a moulded, two-centred arch with labels above, consistent in style with the crossing arches and an early-14th century date.¹³⁵ The Storer depiction of the interior of the north transept published in 1806 depicts what would appear to be a seven-cant coupled rafter roof with straight rather than curved soulaces (Figure 48).¹³⁶ Tree-ring dated examples of this roof type cover a wide date range and were used in both secular and ecclesiastical contexts and as such this type of roof could also be consistent with a single-phase rebuild of the early-14th century.

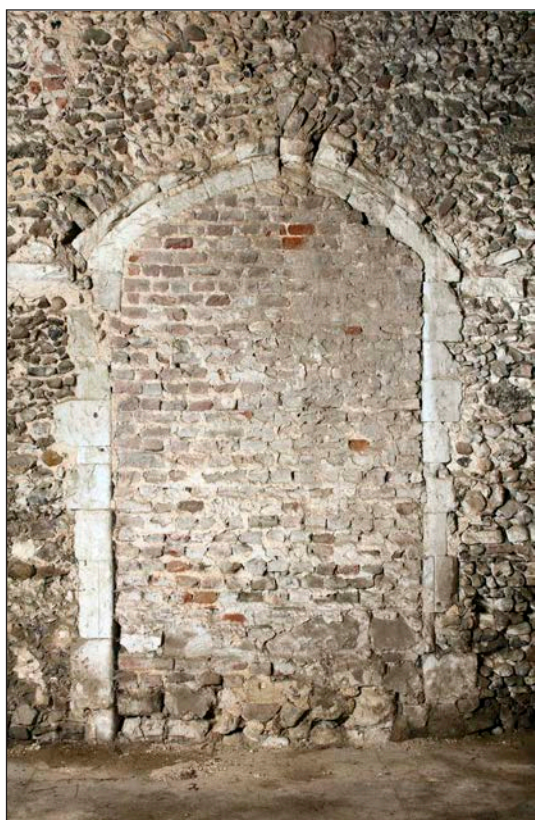
Figure 49 (Left): The rere-arch of the doorway between the north transept and the room north of the nave. © Historic England, Patricia Payne, DP217023

Within the western wall of the north transept, a blocked doorway appears to confirm the existence of an aisle, chapel or other structure north of the nave. The eastern side of the doorway has a flat, four-centred arch and the western side of the doorway has a two-centred arch consistent in style with an early-14th century date (Figures 49 and 50). The four-centred arch, the apex of which is lower than the apex of the two-centred arch, is likely a supporting rere-arch and contemporary in date with the pointed two-centred arches of the 14th-century rebuilding. Widely seen in parish churches on the inside of porch doorways, the presence of a rere-arch confirms that the blocked opening in the west wall of the north transept was not an open arch but an arch built with a rebate to contain a door and as such beyond it lay a separate room rather than a different liturgical space such as an aisle or chapel.

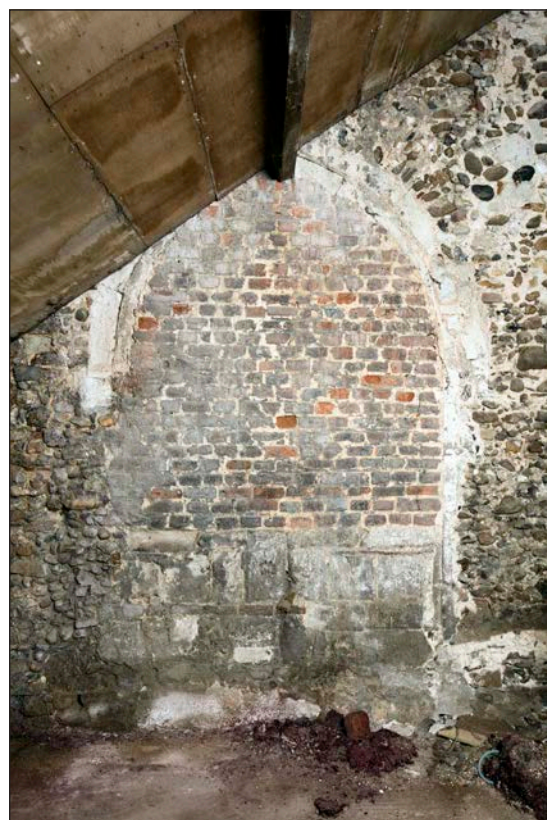
Figure 50 (Right): The west side of the doorway between the north transept and the room north of the nave. © Historic England, Patricia Payne, DP217024

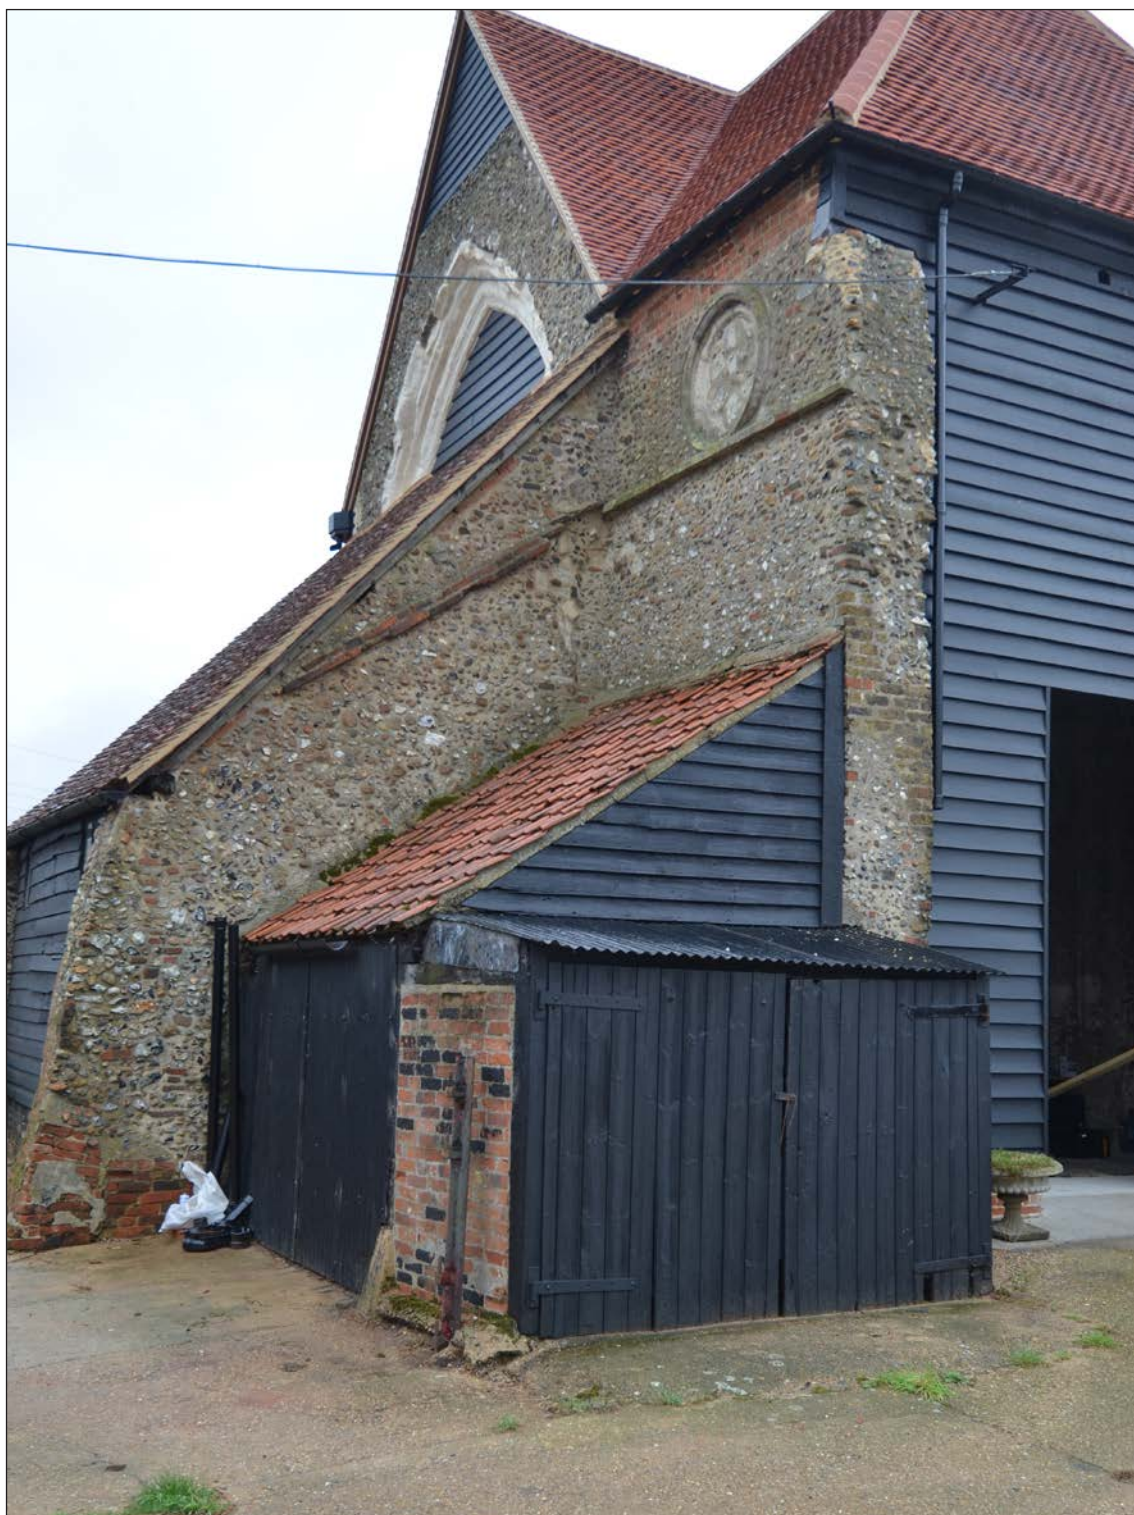
Figure 51: The blocked sexfoiled clerestory window, stringcourse and scar of roofline.
©Historic England, Matthew Bristow

The raking line of a former pent roof on the western wall of the north transept, a corresponding string course beneath a sexfoil clerestory window in the stub remains of the nave's north wall and the blocked doorway in the western wall of the north transept leave little doubt as to the existence of a structure north of the nave (Figure 51). The style of the clerestory window and the absence of evidence for a raising of the nave roof, indicates that a clerestory was part of the early-14th century scheme and therefore so was a structure beneath it. This conclusion is further supported by the two-centred arched doorway into the north transept which is also consistent with an early-14th century date. As mentioned above, a single north aisle has also been viewed as characteristic of Augustinian priory churches which developed from aisleless cruciform plans in line with evolutions in the plan forms of parish churches and in order to match the aspirations of wealthy patrons who sought a more extravagant monument to their patronage.¹³⁷ The established interpretation of the priory church at Latton has been that the church rebuilt in the early-14th century did include a north aisle, however closer examination of the surviving fabric would seem to preclude this. The principal impediment to the existence of an aisle is the absence of evidence for an arcade springing from the north-western crossing pier. The 3.2 metres of northern nave wall which survived the conversion of the church to a barn are of entirely solid construction and shown no signs of rebuilding beneath the level of the clerestory window. This suggests that there was no arcade and that the structure to the north of the nave was not an aisle but was a separate room. The confirmation by the rere-arch that the opening in the west wall of the north transept was a doorway and not an open arch also supports the interpretation that beyond lay a room. The lack of arches and arcading appear to eliminate both a north aisle and a small north chapel and imply an outshut beneath a pent roof. It is highly likely that instead of an aisle, the structure between the nave and north transept was a porticus and if so, the plan of the priory church of Latton is directly comparable to that of the Augustinian priory of St Mary in the Meadow, Beeston Regis, Norfolk (NGR TG 16756 42801). The aisleless priory church, a characteristic of the Augustinian order (see above) required the brethren to negotiate the choir stalls which traversed the crossing in order to access the north transept. Early Augustinian churches often incorporated small porticuses or passages to allow direct access to the transepts from the nave. By the late 12th century new Priory Churches were being designed with north aisles and earlier churches were having north aisles added. If the rebuilt priory church at Latton retained the aisleless nave and porticus arrangement with doors linking the nave and north transept via the porticus, then it, like Beeston Regis was markedly old-fashioned in its design.¹³⁸ It has also been suggested that the porticus at Beeston Regis was a northern sacristy, an hypothesis which is likewise plausible at Latton.

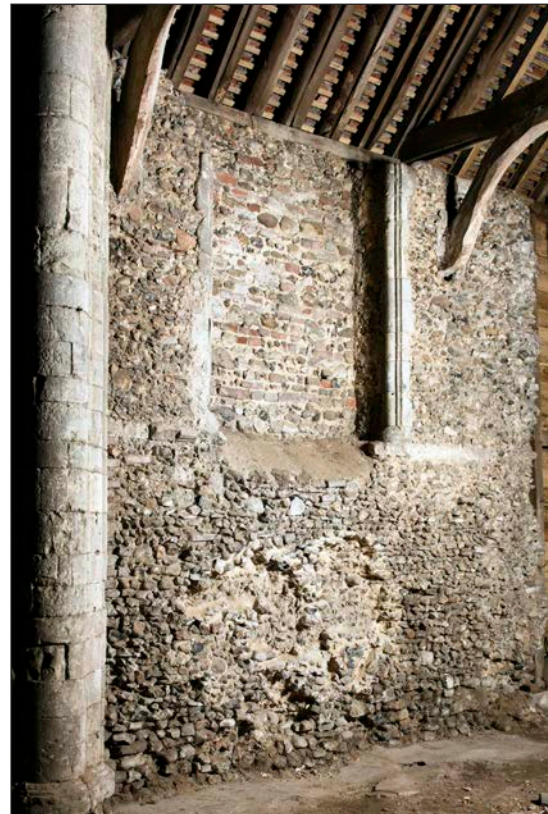
Figure 53 (Right): The east wall of the south transept, the only part of the priory south of the crossing which survives into 2016. © Historic England, Patricia Payne, DP217028

The east wall as depicted by Storer in c.1806 appears to remain largely intact. An *in situ*, though heavily degraded, moulded internal string course at a corresponding height to the remade string course in the north transept and capital of the blocked north chapel arch, extends from the crossing to the end of the upstanding masonry wall (Figure 53). The string course forms the sill of a blocked window with shafted splays. The head of the window has been destroyed, lost when the upper levels of the east wall were cut back following the collapse, though Storer's depiction shows that the window formerly had a two-centred arched head with moulded capitals and a moulded label with label stops above.¹⁴¹ The northern splay of the window is heavily degraded, however the southern splay is far better preserved, retaining its moulding profile and detail to the shaft base at sill level. The style of this window is entirely consistent with the early-14th century, reinforcing the likelihood of a single phase of rebuild.

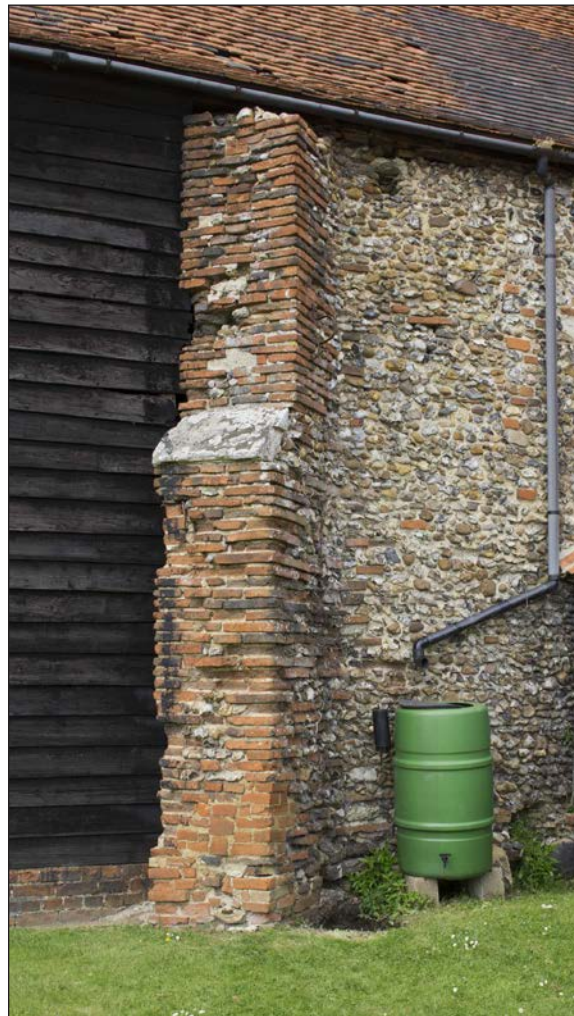
Figure 54: The brick buttress at the south-east corner of the south transept. Although heavily altered and repaired, it is possible that it is comprised largely of bricks dating from the late-12th century and manufactured at Waltham Abbey. © Historic England, Patricia Payne, DP173631

As detailed above, almost all of the medieval fabric extant within the remains of the priory church of St John the Baptist, dates from the early-14th century and attests to a complete rebuilding of the priory at that time. The major exception is a heavily altered and repaired diagonal buttress to the south-east corner of the south transept (Figure 54). The buttress, much repaired with post-medieval bricks is a diagonal buttress, mostly comprised of large, rectangular tile-like bricks measuring 300mm x 170mm x 45mm. These bricks have previously been interpreted as reused Roman material or at the very least as 'bricks of the Roman type', however their dimensions do not fit into the typology of Roman bricks proposed by G Brodribb in 1987.¹⁴² Furthermore, several of these bricks have broken or eroded edges allowing examination of their cores, which in most cases were darker and reduced. This indicates that these bricks are in fact a type of medieval 'Great Brick' and not Roman bricks which both tend not to have reduced cores and which have a greater tendency to warp during firing.¹⁴³ Comparison of the dimensions of the bricks which comprise the transept buttress with other excavated examples of medieval great brick suggests that they are most directly comparable to bricks excavated by P J Huggins at the monastic grange of Waltham Abbey. P J Huggins' excavations at Waltham identified a range of brick types which in length varied from 290mm to 380mm, in width from 145mm to 195mm and in thickness from 32mm to 90mm.¹⁴⁴ Huggins concluded that bricks of the thinner type - namely those between 32mm and 50mm in thickness – were earlier in date. Thinner bricks, used in the stylobates, were discovered during the excavation of 'Building I' in the monastic grange,

likely constructed c.1200 and of 'Building X' which may date from soon after the re-foundation of the abbey in 1177.¹⁴⁵ The bricks used in the buttress at Latton fall in the middle of the size ranges of bricks manufactured and discovered at Waltham Abbey and are of the thinner variety suggesting that they date from c.1200. This would imply that the buttress to the south transept incorporates reused material from the first priory church constructed on the site.

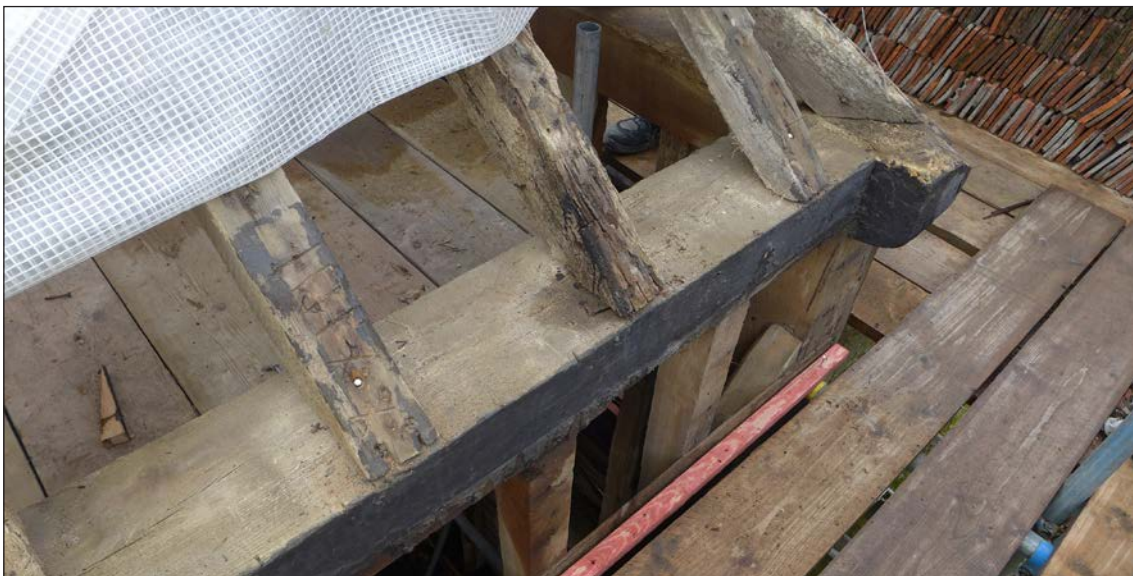
Figure 55: The transverse (east gable) wall plate is shown on the left with the longitudinal wall plate on the right (which extends beyond the end gabled wall). © Historic England, Elizabeth Chamberlin

The timber framing utilises normal assembly, where the tie-beam is seated on top of the wall plate, rather than beneath it. There is, however, a form of normal assembly which is of a more primitive type and is not fully integrated – this is known as longitudinal assembly. In longitudinal assembly, the longitudinal rows of posts or wall frames are assembled first, the plates are laid along the tops of the posts and finally the tie-beams are placed transversely across the plates.¹⁵⁶ This method of longitudinal assembly can be seen in the construction of the east barn – particularly in the relationship between the longitudinal wall plates and the gable-end transverse wall plate (Figure 55). The wall plate of the east gable wall of the barn has been fitted in-between the two parallel longitudinal wall plates – the two longitudinal wall plates extend just beyond the face of the east gable wall.

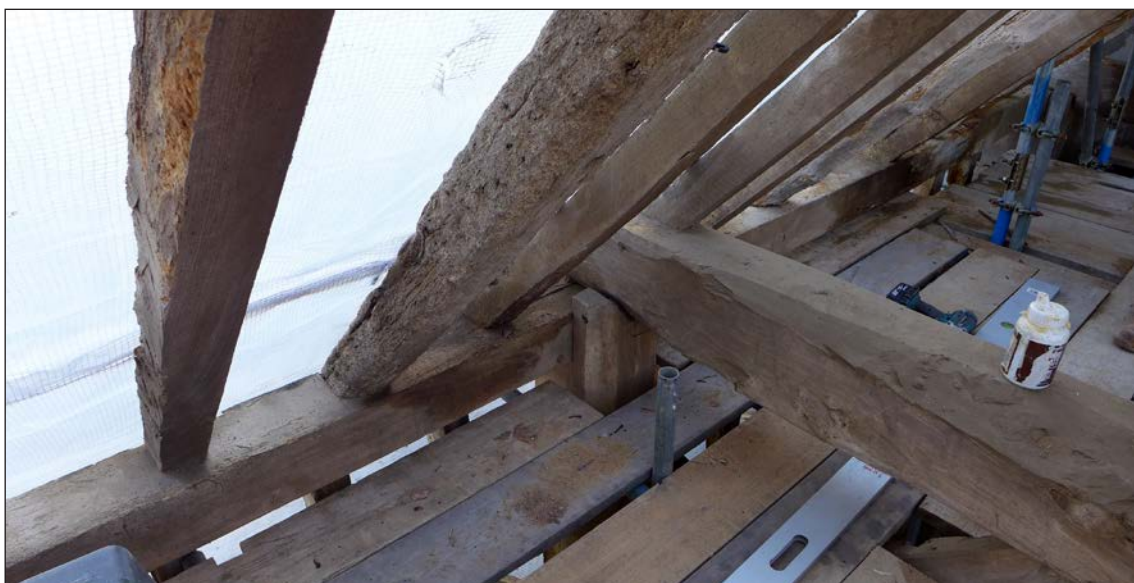
Figure 56: Tiebeam **II** (south side of barn). The top of the jowled post has been roughly shaped to receive the tiebeam –this is probably due to the position of scarf joints in the wall plate at this precise location. © Historic England, Elizabeth Chamberlin

The way in which tie-beam **II** relates to the wall-plate and posts is also rather clumsy, where the form of the post-head and tying joints for the tie beams differs from what would usually be expected. On closer inspection, however, the non-standard relationship between the post and tie beam probably relates to the fact that there is a scarf joint in both the north and south wall plates at this location. Scarf joints are often positioned close to a post, but in this instance the position of the scarf joint at the same position as the post and tie-beam has necessitated a different (if rather clumsy) method of joint assembly. It should be noted that there are two scarf joints to the longitudinal wall plates; the first is by the easternmost tie-beam **I** at the eastern end of the barn, although the arrangement of post, tie-beam and wall plate is not quite as clumsy as that shown in tiebeam **II** (Figures 56 and 57).

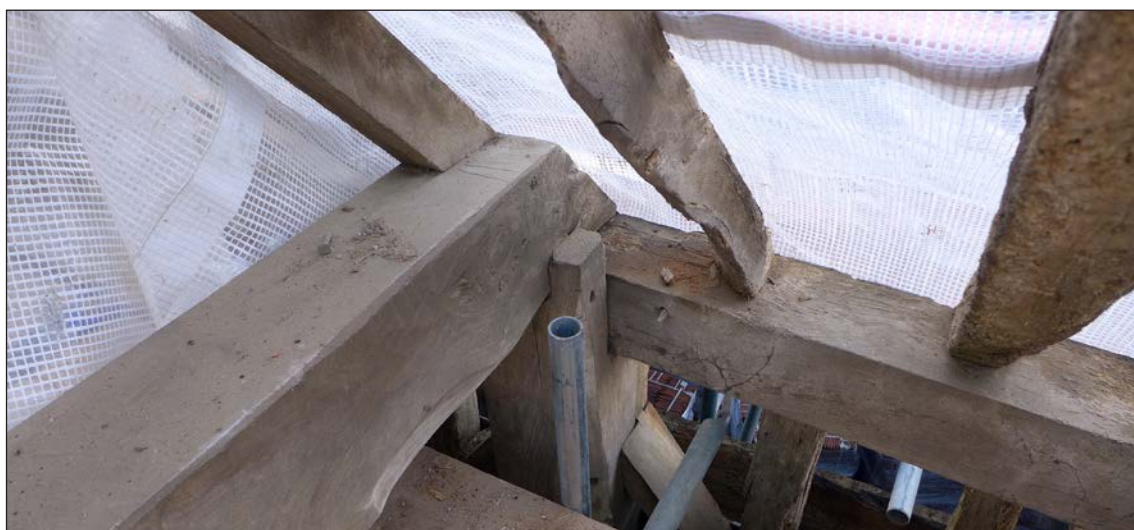
Figure 57: Tiebeam **II** (north side of barn). Top of post is jowled & extends beyond top of wall plate. Tiebeam is seated into the top of the jowled post. © Historic England, Elizabeth Chamberlin

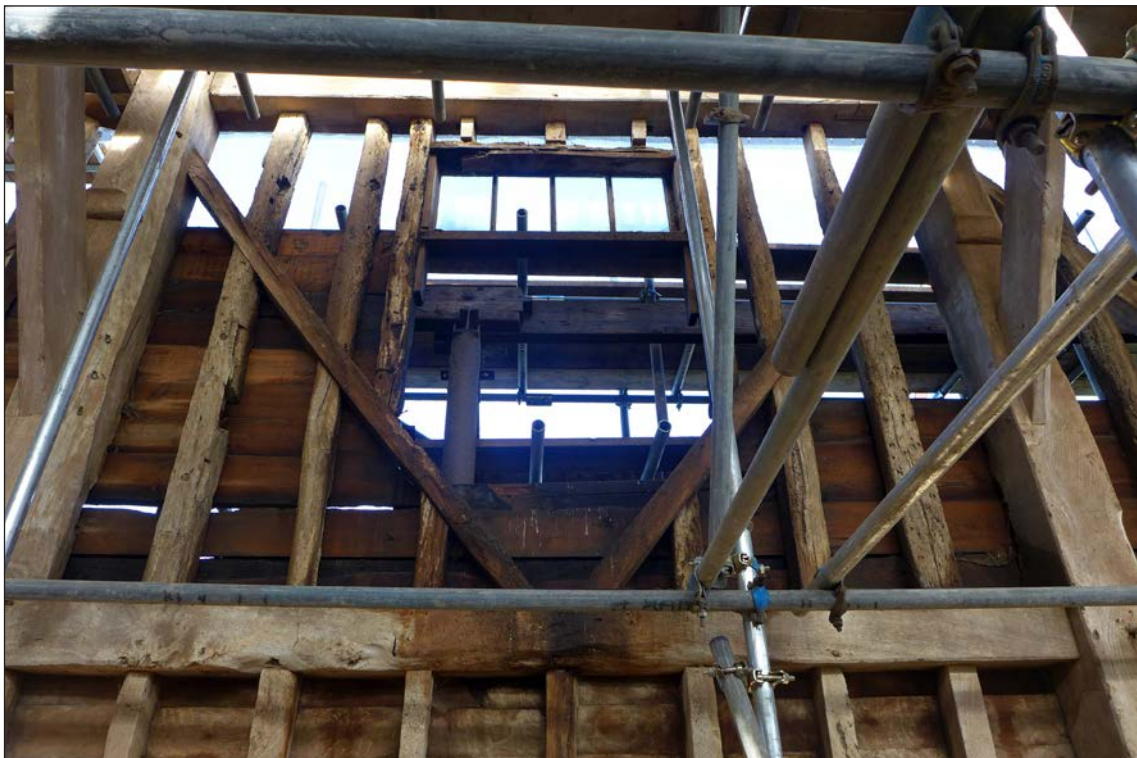
Figure 58: *Inserted window in N wall of East Barn. Three chocks inserted above head of window to support the position of the frame. The mortice holes for the tenons of the original studs are just visible to chocks 1 and 3. © Historic England, Elizabeth Chamberlin*

A large window opening has also been inserted in the centre of the north elevation, just below the level of the eaves. There is evidence for the mortice holes in the soffit of the wall plate, where three studs have been removed to accommodate the window and three short chocks inserted in their place (Figure 58).

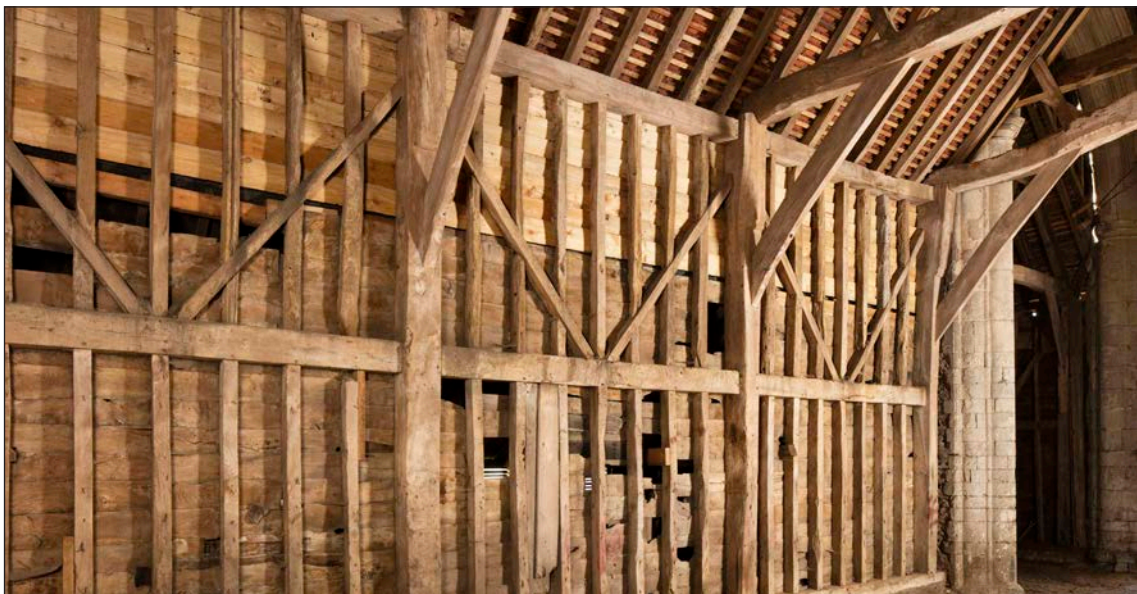
Figure 59: Close studding and tension bracing above the mid-rail. Internal view of south wall of east barn. © Historic England, Patricia Payne, DP217030

The trusses are arch braced from principal post to tie-beam and are roughly straight, rather than convex. According to Martin & Martin straight braces became popular in the 18th century and were increasingly used from the mid-17th century onwards (Figure 59).¹⁶⁶

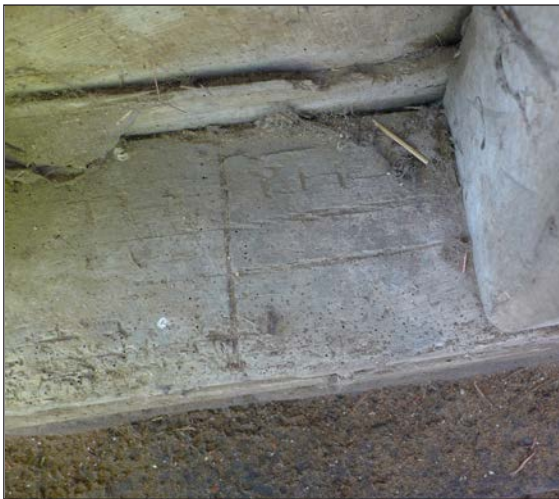
Figure 61 (Left): Roman numeral to the scarf joint of the sill beam immediately adjacent to the post appears to read **PII** (the horizontal stroke between the two **II** marks appears to be a natural mark in the timber). To the left of the image is another carpenters' mark, which appears to show a **III**. © Historic England, Elizabeth Chamberlin

The sill beam & wall plates are also marked with carpenters' marks. The scarf joint of the sill beam immediately adjacent to the Post II appears to be marked **PII** (although this might be read as **III**) and the adjoining timber on the other side of the scarf joint is marked **III**. The marks on the sill beams and wall plates all take the form of chiselled roman numerals, like the posts (Figures 61 & 62).

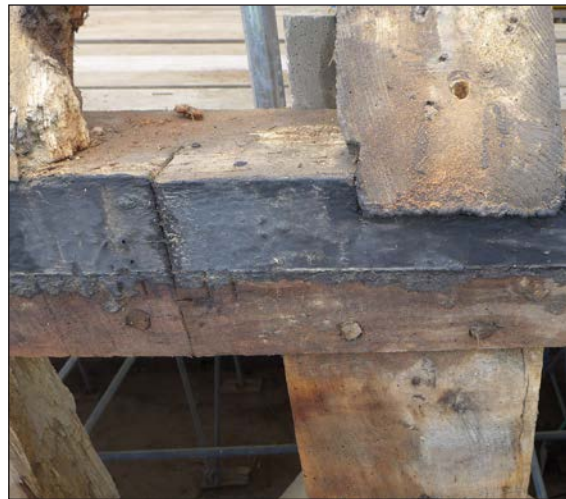
Figure 62 (Right): North wall plate of East Barn (exterior face). Scarf joint of wall plate is marked with the roman numerals **II** to either side. © Historic England, Elizabeth Chamberlin

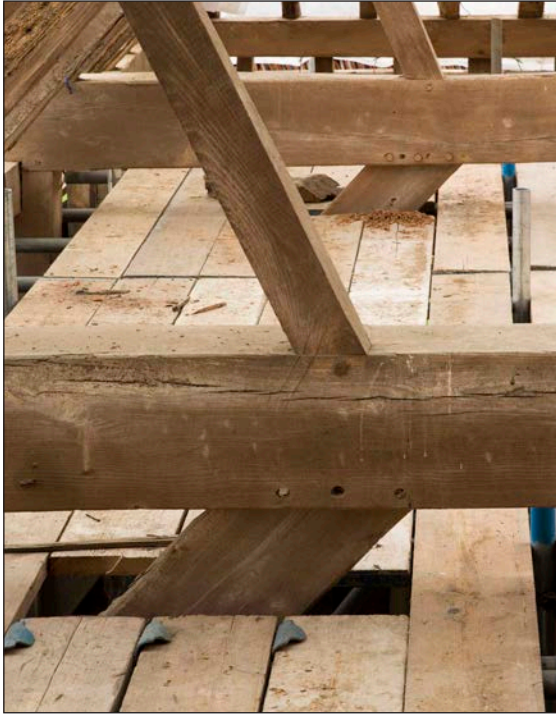
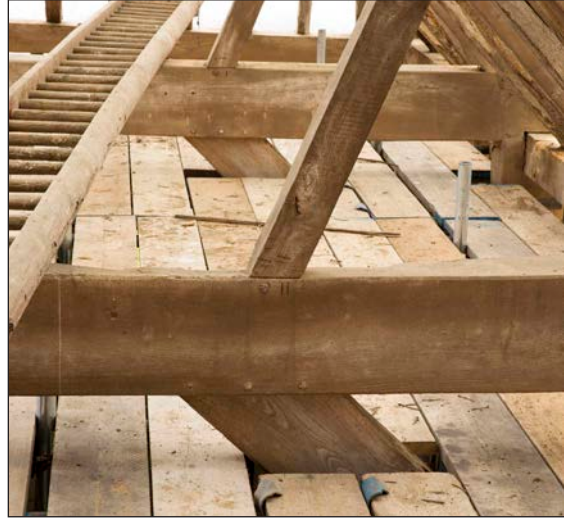
Figure 63: Two views of the carpenter's marks in the East Barn.

The sequence of carpenters' marks to the roof structure of the East barn is fairly complex and differs in orientation to the numbering sequence of the principal posts below. The principal trusses are marked with chiselled roman numerals and these run in sequence from east to west. The first tie-beam and principal rafter at the easternmost end of the barn is numbered **I**, however the form of the roman numeral differs between the north and south sides. Along the southern side they take the form of chiselled roman numerals, however at the northern side, the roman numerals are elongated and scribed with a race knife (Figure 63).

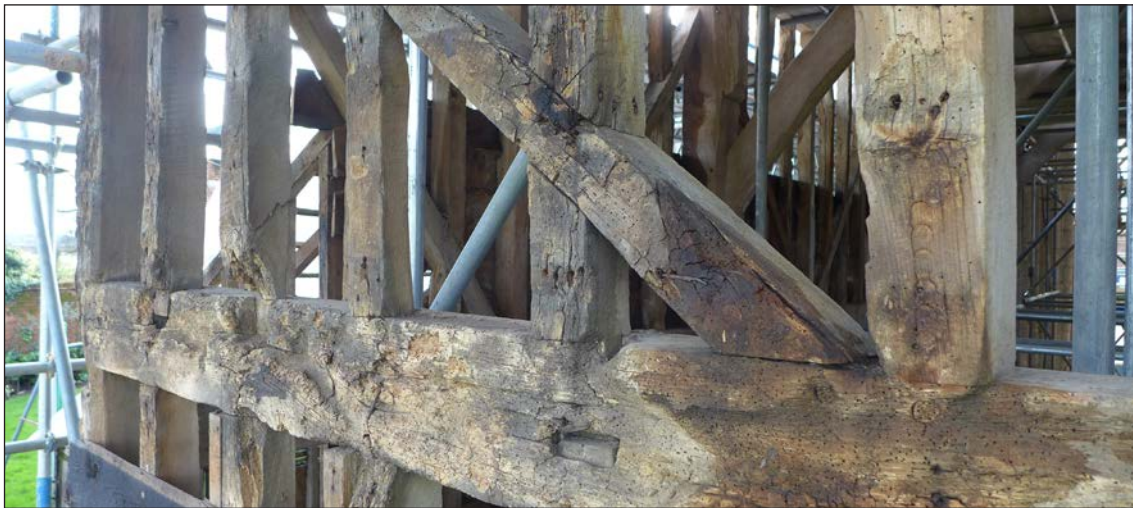
Figure 64 (Above): East elevation of East gable wall of barn, upper level, south side. The numbering of the studs and struts is consecutive, strut 4 is numbered 'CCCC', the raking strut immediately adjacent to it is numbered CCCCC and the next stud CCCCCC. © Historic England, Elizabeth Chamberlin

The form of the carpenters' marks to the upper level, above the end girt of the east gable wall differs, depending upon which side of the frame the studs were located. Here, roman numerals were also used to mark the relationship between the raking struts and the associated studs. Gouge-stamped marks were used to the south side of the intermediate post and long scribed roman numerals to the north. As already noted (in the description of the East barn), the position of the raking struts in the east gable wall is asymmetrical and this is to accommodate an original window in the upper level of the end frame (Figures 64 & 65).

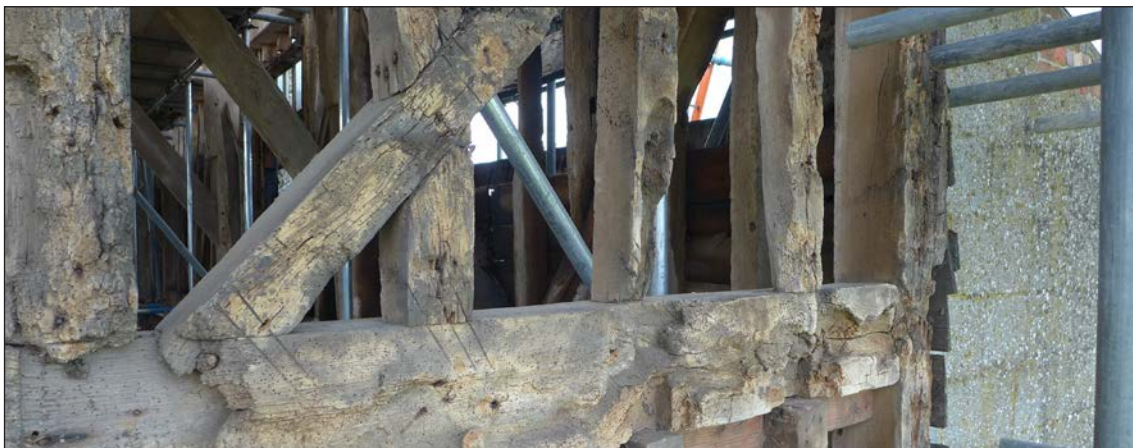
Figure 65 (Below): East elevation of End Girt, north side, with long scribed carpenters marks to stud and strut. © Historic England, Elizabeth Chamberlin

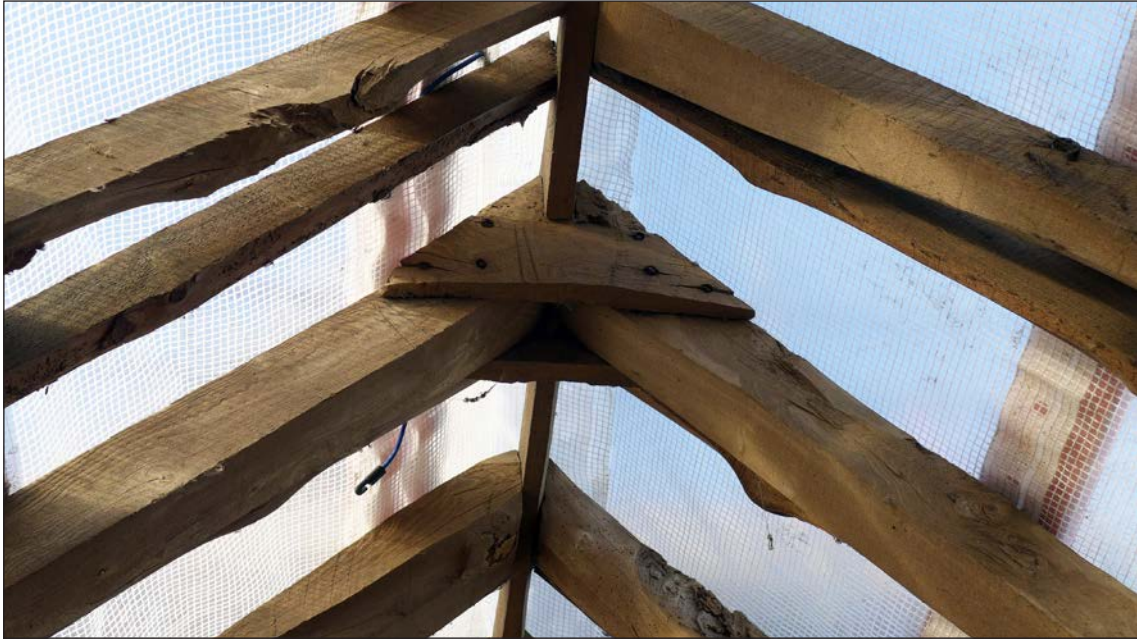
Figure 66: Apex of South Barn roof, with ridge plank and nailed saddles. There appears to be a scribed carpenter's mark on the saddle. © Historic England, Elizabeth Chamberlin

The south barn is attached to the south crossing arch of the priory church, however the roof of the barn is hipped at its southern end. The barn is roofed with plain tiles. The barn has a simple collar rafter roof with clasped purlins, strengthened at a later date with the addition of raking queen struts. The apex of the roof has saddles, which are nailed onto the rafters and which provide support to the ridge plank. This is entirely different to the east barn, where the rafters are all pegged at the apex and there is no ridge piece. The barn also incorporates a large number of re-used timbers, as can be seen in the figures 66 & 67.

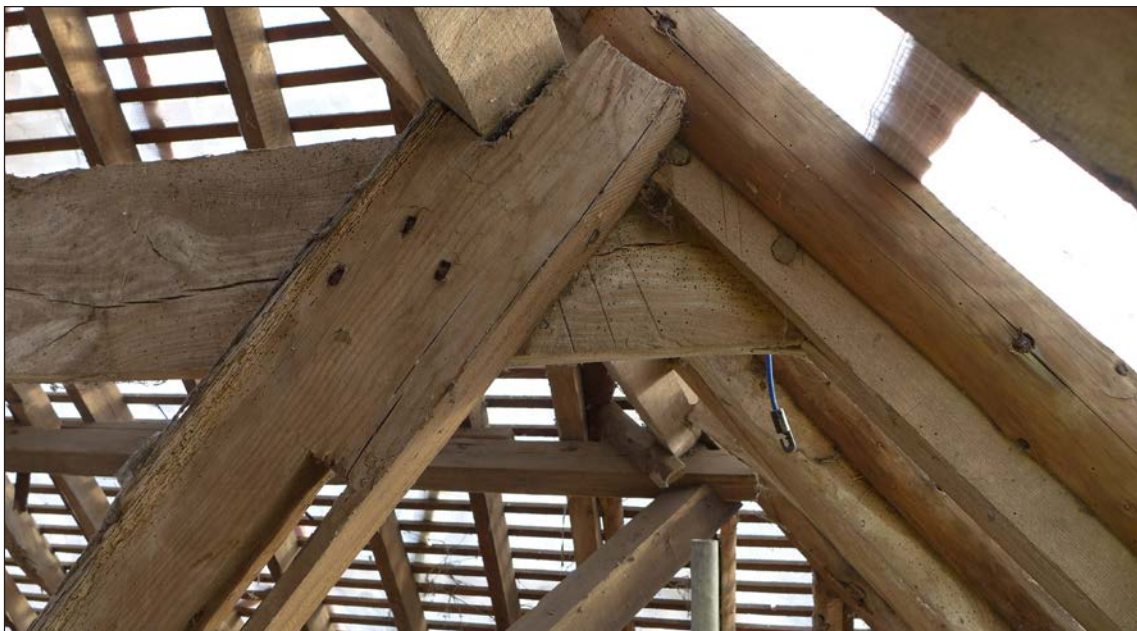
Figure 67: South Barn, raking strut inserted to provide additional support to purlin. The strut and the additional piece added to strengthen the rafter overlie the scribed carpenter's marks beneath. Note the original pegged construction of the rafter and collar and the use of nails for timbers added at a later date. © Historic England, Elizabeth Chamberlin

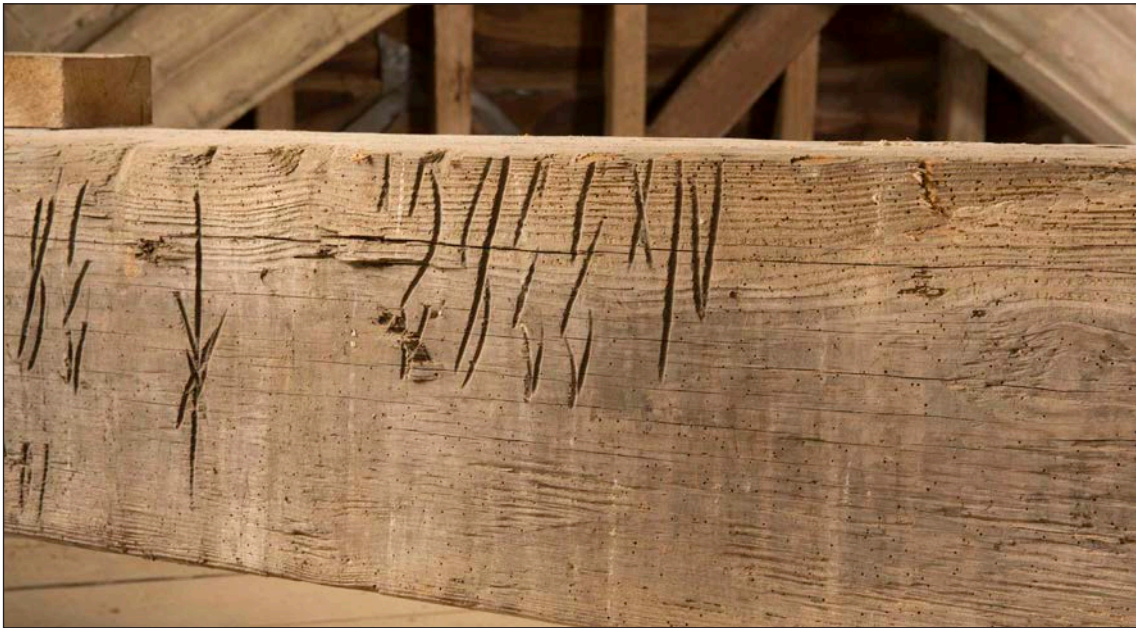
Figure 68: Carved number string xN3382 and port mark for finest quality Gdansk timber, followed by 38. © Historic England, Patricia Payne, DP182407

The scissor beam shows evidence for both bracking and tally marks. Bracking marks denoted the quality and origin of the timber and the tally mark represented a number. The marks have been scribed with a race knife. The beam on which the bracking marks can be seen has been inverted. There is a tally mark with the three vertical strokes, all crossed, then a space and two more vertical strokes. Vertical marks, crossed are thought to represent multiplies of ten¹⁷⁴ therefore the marks at Latton would represent the number 32. The tally marks are followed by a gap before the bracking marks. The bracking marks are made up of a number string Nx3382 followed by a mark raised above the character line. This symbol is similar to a St

Andrew's cross with a long vertical line through the middle. There is then a further number, which looks like a highly stylised number 3 and 8 with two vertical strokes above. The symbol which is similar to a cross can clearly be identified as the mark for the port of Gdansk in Poland. The mark is raised above the character line and the vertical line extending above and below it can be clearly seen. The fact that the mark is not truncated and the mark is raised above the character line indicates that this is Gdansk timber of the first grade.¹⁷⁵ The timber is a type of softwood – probably pine (Figures 68 & 69).

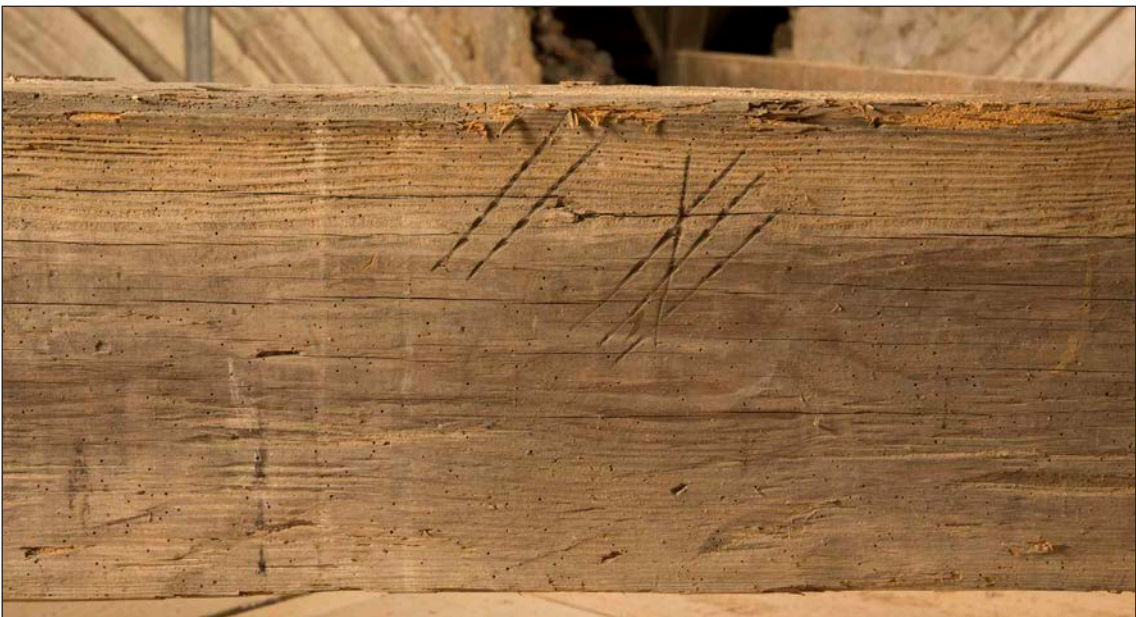
Figure 69: Carved tally mark. © Historic England, Patricia Payne, DP182406

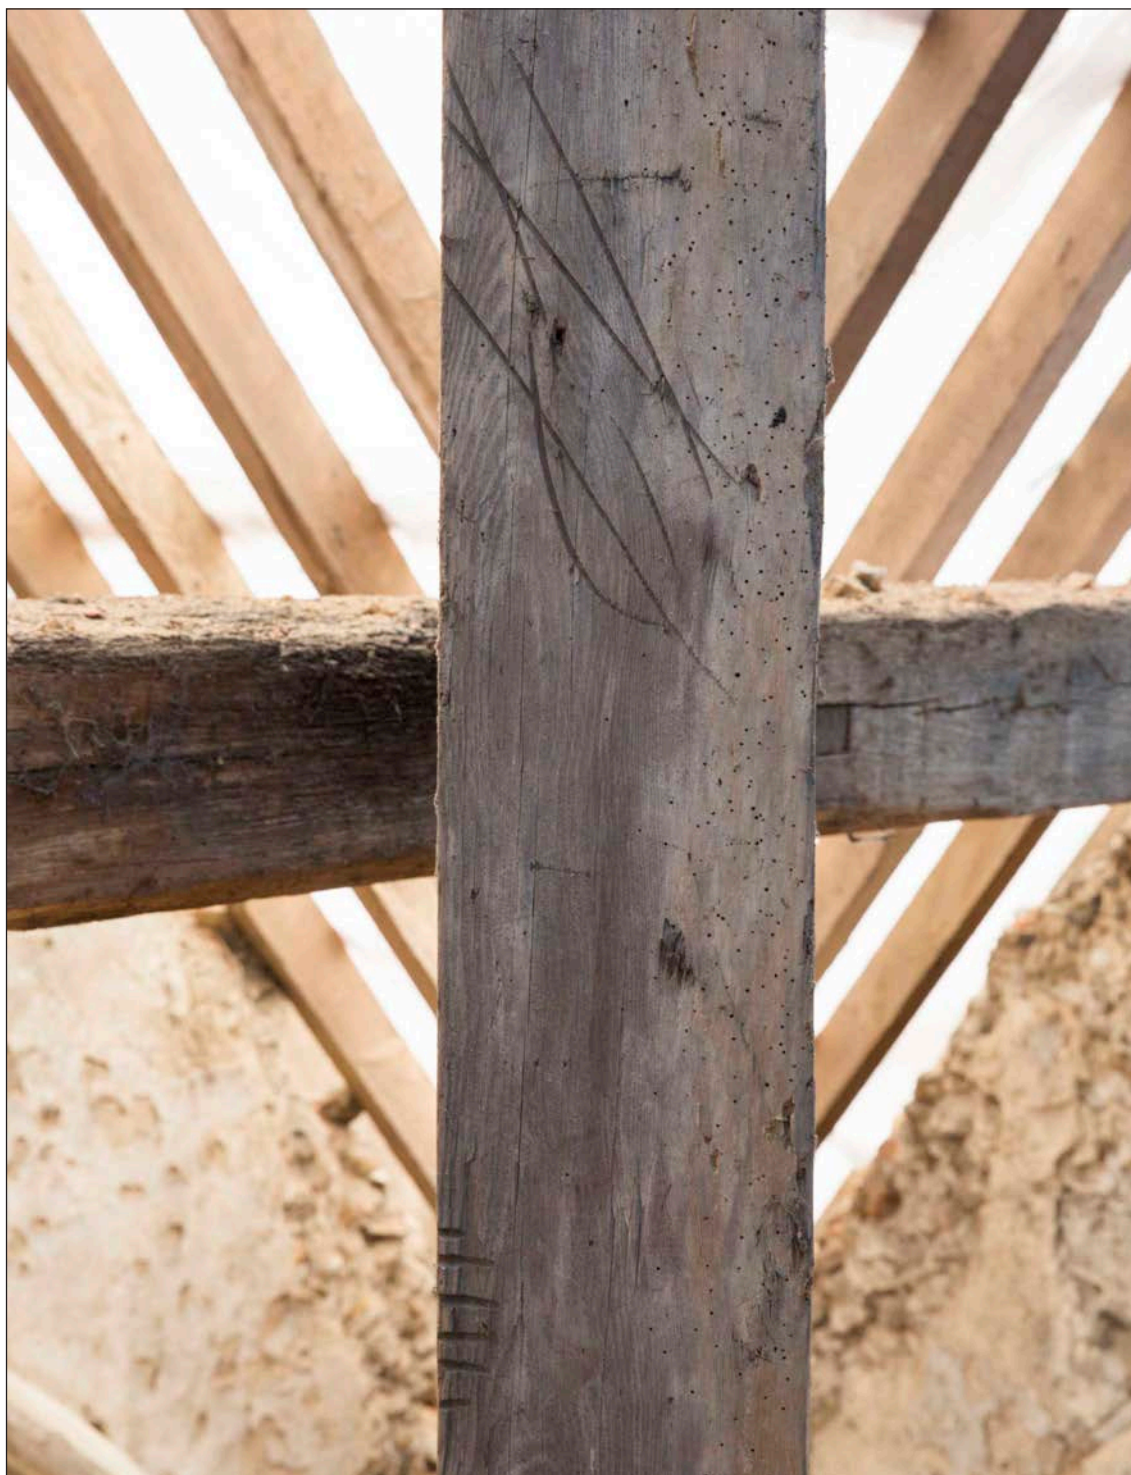
The mast of the crossing is also marked with a Baltic timber mark, however it is not as easy to distinguish what is being represented. There are six vertical lines along the edge of the timber, which have been truncated when the timber has been cut to size and there is a further set of marks with vertical strokes and a curving shape as shown in Figure 70.

Figure 70: Baltic timber marks on the vertical mast over the crossing. © Historic England, Patricia Payne, DP182048
