Latton Priory Farm, North Weald Bassett, Essex: Historic Landscape Investigations

Discovery, Innovation and Science in the Historic Environment

Latton Priory Farm in the ancient parish of Latton, south of the area which from 1947 became Harlow New Town, contains, preserved within its agricultural buildings, the remains of the early 14th century priory church of St John the Baptist. The date of this small Augustinian priory's foundation, along with the identity of its founder, in common with many small houses of the Augustinian order are unknown, however it is likely that a priory has existed on the site since the late 12th century. The church of St John the Baptist and its attendant claustral buildings appear, from the remains of the priory church's crossing, nave and transepts to have been completely rebuilt in the early 14th century, and sat within a trapezoidal precinct defined on all four sides by a wet moat. The rebuilt priory, one of 11 Augustinian houses founded in Essex after the priory of St Julian and St Botolph Colchester in 1104-06, was surprisingly grand given its very small community, which at the time of its foundation numbered just three brethren and throughout it

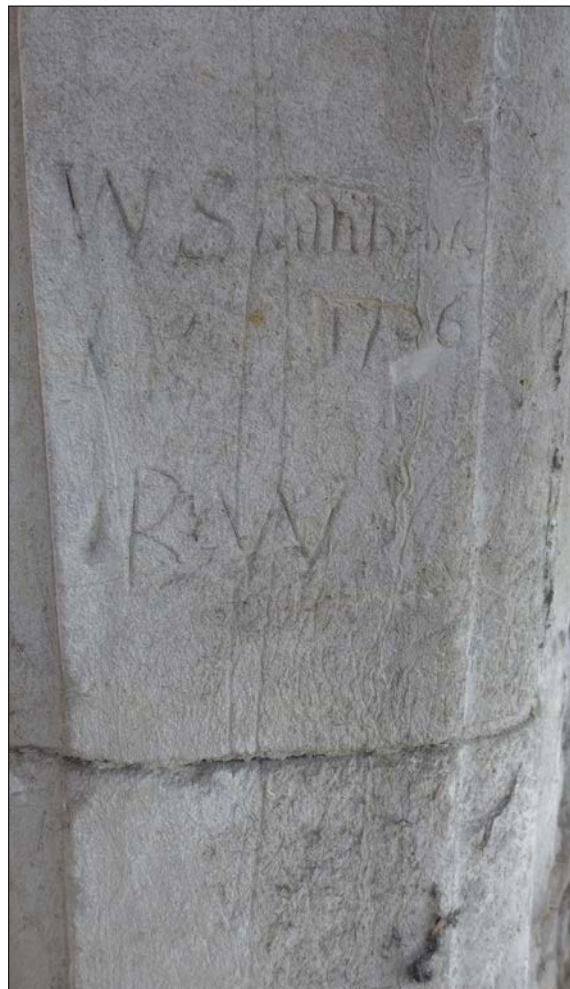
The earliest piece of graffiti with a date scribed next to it is apparently of early-18th century origin. This is located high up on the soffit of the arch on the west side of the north transept arch. The name *W Stallibras* and the date *1706* has been inscribed beneath it, in the same script (Figure 71).

Figure 71: Graffiti of *W Stallibras* with the date of *1706*. The initials *R.W* have been inscribed beneath it, perhaps a later date.
© Historic England, Elizabeth Chamberlin

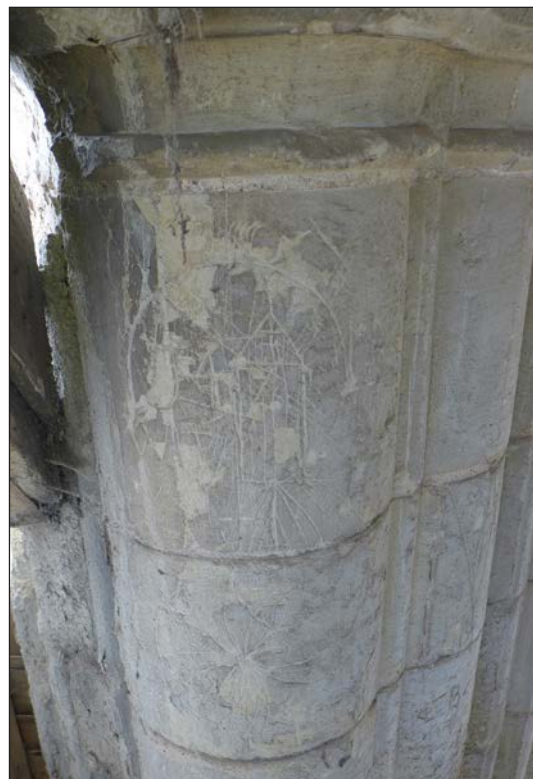
In addition to initials, dates and details of crop yields there are also many examples of pictorial, geometric and symbolic or potentially apotropaic graffiti. High up on the south transept crossing, there is a graffito of a post mill – complete with all four sails and the ladder up to the mill (Figure 72). A circle has been inscribed over the top of the post mill graffito, although it is difficult to be certain about the order in which the cut circle and the post mill were made. Perched on top of the circle is what appears to be a stylised bird – with five long curving tail feathers. There are also a number of VV symbols, one above the other. The graffiti is located high up on the west side of the transept crossing, on the stone just beneath the corbel of the south transept arch. This single piece of ashlar contains layers of graffiti – both pictorial and symbolic. This is not the only example of a post mill graffito found in an ecclesiastical context – another example has been identified at St Mary's Church, Dalham in Suffolk.¹⁷⁷

Figure 72: Graffiti depicting a post mill, stylised bird, cut circles, daisy wheel and WW symbols. © Historic England, Elizabeth Chamberlin

Well Field lies immediately to the west of the Priory and, though recorded on the 1616 map of the estate, no well or well house is mentioned on this or subsequent maps. It may be that a well had been located either within the field or at the margins at in the medieval or post medieval period, but had fallen out of use by 1616. There is a large pond at the western edge of the field, and it is possible that such a pond rather than a true well was the local source of water giving the field its name. The 17th century map notes Myll Fielde the north-east of Latton Priory. The absence of any obvious nearby watercourse would seem to preclude the presence of a watermill in the vicinity, and there is no indication of a mill site either from map evidence or from archaeological remains. However, it is possible that an earthwork mound in the north-eastern corner of the adjacent field (17th-century field name: 'Horseleys') could have been the location of a post mill. Graffiti scratched into the stonework high in the roof of the remains of the Priory church at Latton depicts a medieval post mill on a mound, which might suggest there was such a mill in the vicinity – possibly occupying the mound, see Figure 72. However, this doesn't resolve the problem of why the adjacent field should be named Myll Fielde.

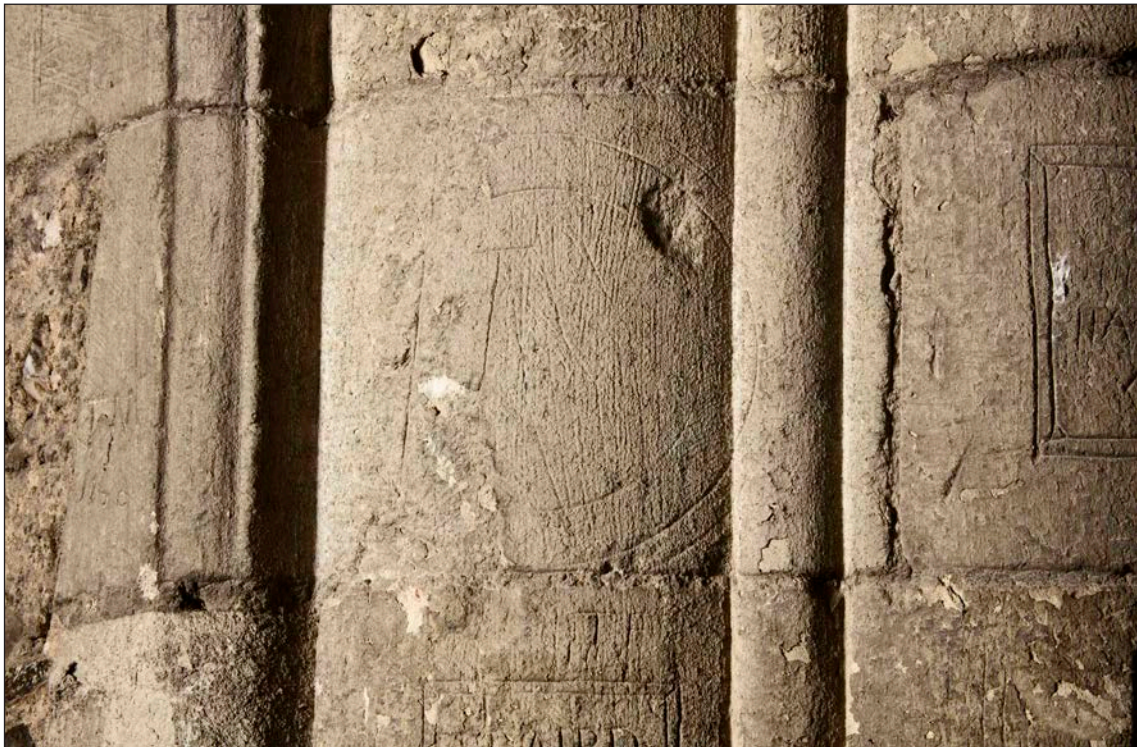
Given the length of time which it would have taken for the masons to have constructed the Priory, it is possible that they could have been responsible for many of the compass drawn marks – particularly as many of these were made high up on the piers of the transept – meaning that they were made either before the stones were in place or by those with the means to access these locations. It is acknowledged that masons were not the only people with the means to access these locations, since once any barn is piled high with a stored crop, this in itself allows the upper parts of a structure to be accessed (Figure 73).

Figure 73: The compass drawn concentric circles are just visible above the double frame in the centre of the photograph. © Historic England, Patricia Payne, DP217021

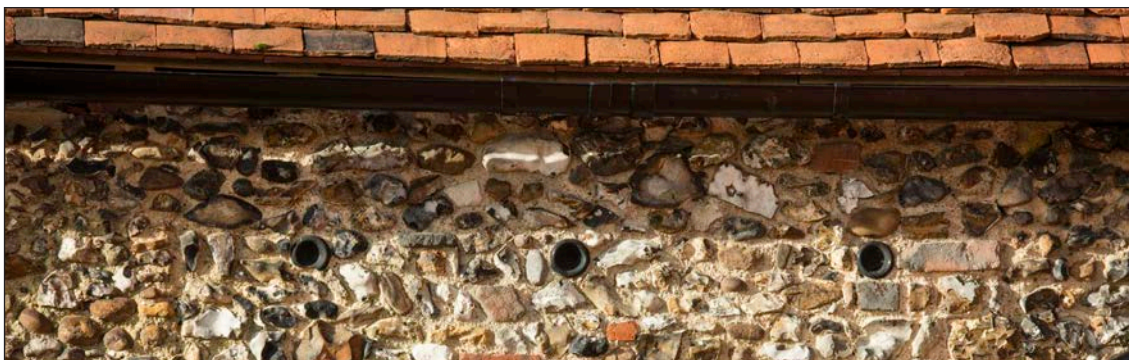
The flint walling in the east wall of the south transept has three glass bottle ends incorporated into the wall at a high level – the bottles are clearly handmade, with deeply-dished bases. They are aligned in a row (Figures 74 & 75). It is possible that these bottles relate to the repair and isolated rebuilding works to the wall, following the collapse of the south transept in the early years of the 19th century. It is thought that the south transept collapsed in c.1806 and therefore it is possible that these bottles relate to an early-19th century phase of consolidation of the structure, following the collapse. Bottle ends incorporated into flint walling have been identified in other early-19th century contexts. There is an example of wine bottles used to decorative effect at Gable Cottage, Marsh Lane, New Buckenham, where the bottles have been placed to form the date of construction of the cottage of 1820.¹⁸⁷ Another example of the use of bottle ends in the decoration of a wall can be found at Coleshill in Buckinghamshire and dates to 1809.¹⁸⁸ Curiously, at the other side of the crossing and set within the stub wall of the north side of what remains of the Nave of the Church there are two bottle necks. These are clearly deliberate placements and it is tempting to liken their use to a ‘topping-out’ ceremony or at least a personal means of signifying the consolidation work.

Figure 74: Bottles in wall. © Historic England, Patricia Payne, DP217012

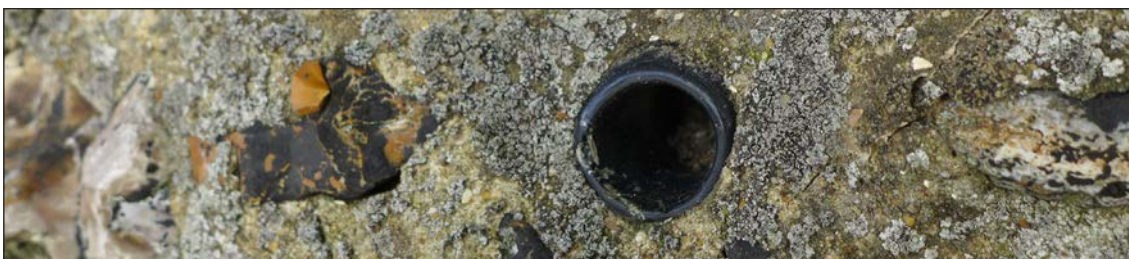
Figure 75: Bottle necks in the wall. © Historic England, Elizabeth Chamberlin

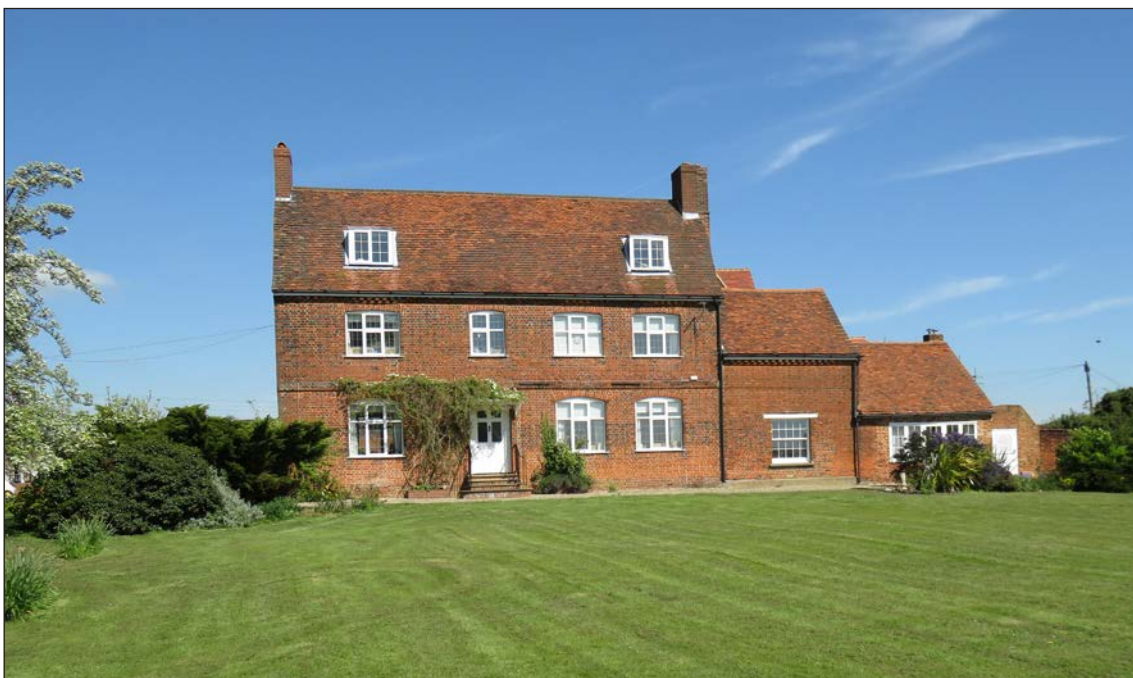
Latton Priory Farmhouse lies to the south-west of the remains of the priory church and is predominantly a building of the late-18th century (Figure 76). Constructed of red brick in Flemish bond beneath a tiled gambrel roof with dormers, the farmhouse was rebuilt in the late-18th century following the collapse of the south-wall of the house which preceded it. This first farmhouse at Latton was constructed in the early-18th century and was, according to testimony of Grosse, built into the remains of the former priory *frater* incorporating some of its extant fabric which was ‘of the same materials’ found in the priory church. An inscribed brick dated 1773, set low down in the south wall of the farmhouse may date this rebuilding.

Figure 76: Latton Priory Farmhouse from the south-west in 2016. © Historic England, Kathryn Morrison

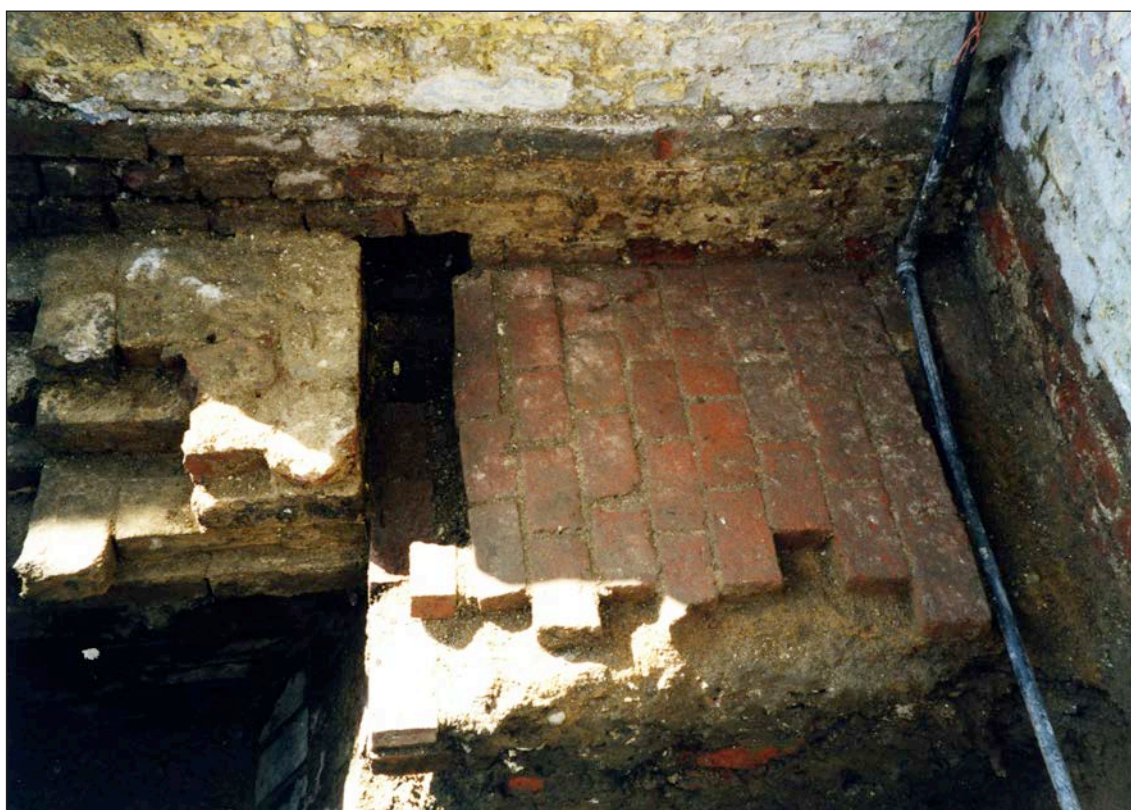
The farmhouse was extended to the east in two phases during the early 19th century. The easternmost phase, comprising a single-storey brick lean-to housing a large bread oven, was rebuilt to redress subsidence which required new foundations be dug. During these small-scale excavations, multiple phases of floor surface were uncovered and beneath the earliest layer, a brick and masonry lined drain which passed under the lean-to from the south-west, continuing beyond the farmhouse towards the eastern arm of the moat (Figure 77). Though no archaeological recording was undertaken, it was concluded at the time that the archaeological deposits below the floor surfaces pre-dated the earliest phase of the farmhouse and that they related to the pre-dissolution priory. Given the location of the lean-to at what was once the south-eastern corner of the priory cloister, it is likely that this excavation uncovered evidence of the priory latrines or *reredorters* and the precinct drain which served them (see below).

Figure 77: Photograph taken during the excavation of new foundations for the eastern extension of the farmhouse. The excavations exposed several former floor surfaces and evidence of the priory reredorters and precinct drain. © Jacky Brown

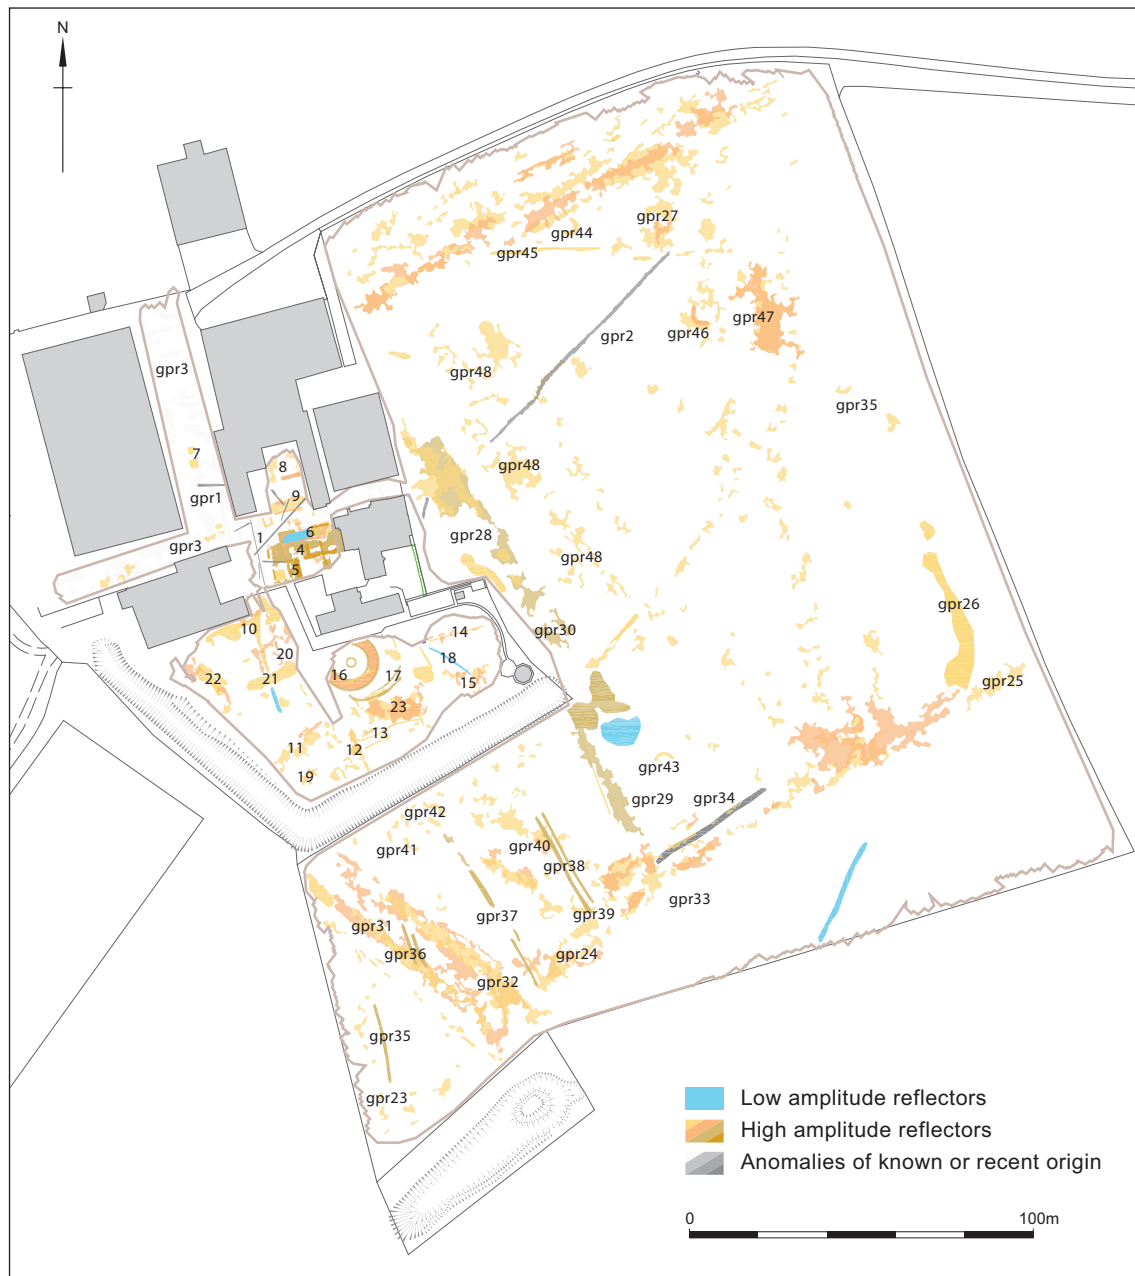
A graphical summary of the significant GPR anomalies, [gpr1-48], discussed in the following text, are shown superimposed over the topographical survey in Figure 78. A number of services [gpr1] were detected, particularly within the farmyard, but also include the possible location of the cess-pit soak away drain [gpr2] for the farmhouse in the wider precinct. Strong linear reflections suggest the survival of wall-footings related to the nave [gpr4], potentially extending an additional 15m from the upstanding remains of the priory church, and a possible western arm of the cloister [gpr5] heading south towards the farmhouse. An area of more complex responses [gpr6] may, tentatively, provide some evidence for a north aisle or other structure although the response here is more fragmented than either [gpr4] or [gpr5]. Some areas of high and low amplitude response may represent floors or voiding respectively within the structural remains associated with both [gpr5] and [gpr6], although there may be some uncertainty depending on the construction base of the overlying jointed concrete pavement. The wider farmyard area appears to be dominated by a combination of services and the concrete pavement.

In the lawned area south of the farmhouse within the moat, there was generally a good correlation between the GPR responses and the analytical earthwork survey with high amplitude anomalies replicating the linear depressions, [gpr10] and [gpr11], and scarps [gpr12-14]. Some of these anomalies correspond with boundaries [gpr12] shown on the historic mapping, together with an in-filled pond [gpr15], and the original kerbed, circular turning circle including central ornamental planting outside the house [gpr16].¹⁹⁴ Evidence for structural remains is slight, with only fragmentary anomalies associated with the building platform proposed from the earthwork survey at [gpr19], and some tentative rectilinear form to the response at [gpr20]. More amorphous areas of high amplitude response, [gpr21] and [gpr22], are found in the vicinity of [gpr20], with a similar anomaly in front of the farmhouse at [gpr23]. Both [gpr22] and [gpr23] are comparatively shallow with no apparent topographic expression or well defined rectilinear wall-type reflections, suggesting they are more likely to represent rubble spreads, possibly due to more recent garden landscaping.

Figure 78: Summary of significant GPR anomalies, April 2016. © Historic England, Geophysics Team

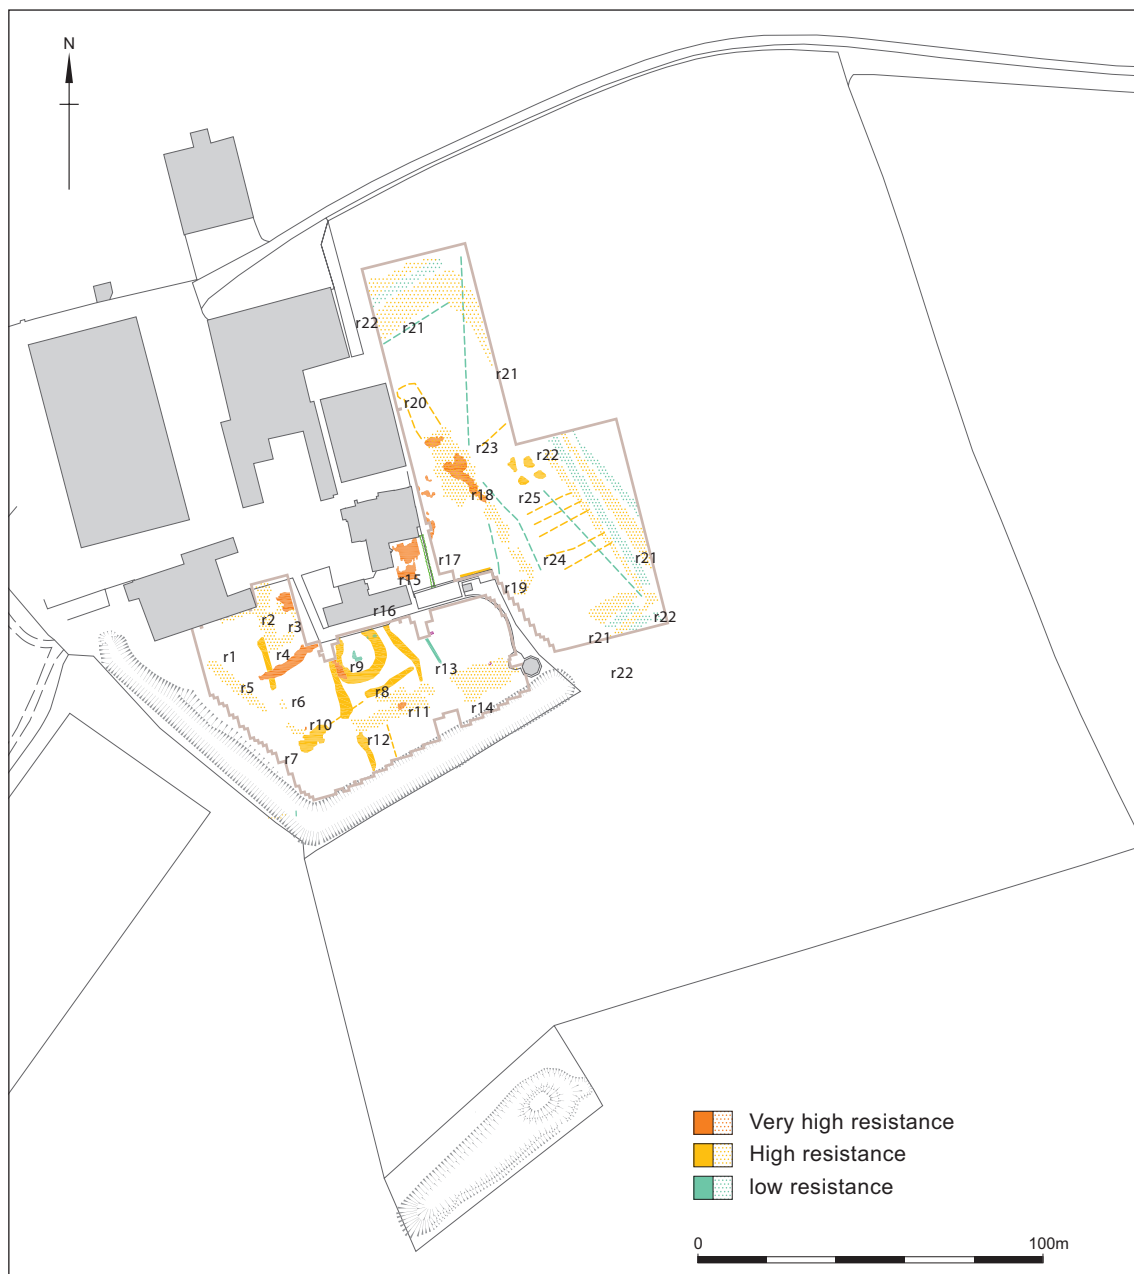
A graphical summary of the significant earth resistance anomalies, [r1-24], discussed in the following text, are shown superimposed over the topographical survey on Figure 79.

Within the lawned area south of the farmhouse, rectilinear high and low resistance anomalies [r1-4] correspond with the GPR results, together with a weaker linear [r5] heading south, and a curvilinear high resistance response [r6] that correlates directly with [gpr21]. Whilst these anomalies might represent a former garden design, gravel paths or paved surfaces, they could be indicative of structural remains. A linear anomaly [r7] corresponds with [gpr11] and a scarp recorded in the earthwork survey, although the supposed building platform immediately to the south is devoid of any earth resistance response to corroborate [gpr19]. The driveway or turning circle [gpr16] is replicated by [r8] with the central ornamental planting indicated by a low resistance anomaly [r9]. Further sub-rectangular anomalies, [r10-12], may relate to former garden boundaries and sub-divisions shown on the historic mapping, although [r12] corresponds with [gpr23], and could possibly represent more significant structural remains or rubble spreads. A narrow linear anomaly [r13] (cf [gpr18]) to the east could represent a ditch, planting feature or possibly a drain from the farmhouse heading towards the in-filled rectangular pond, shown as a very slight increase in the background resistance [r14] (see figure 79).

Figure 79: Summary of significant earth resistance anomalies, April 2016. © Historic England, Geophysics Team

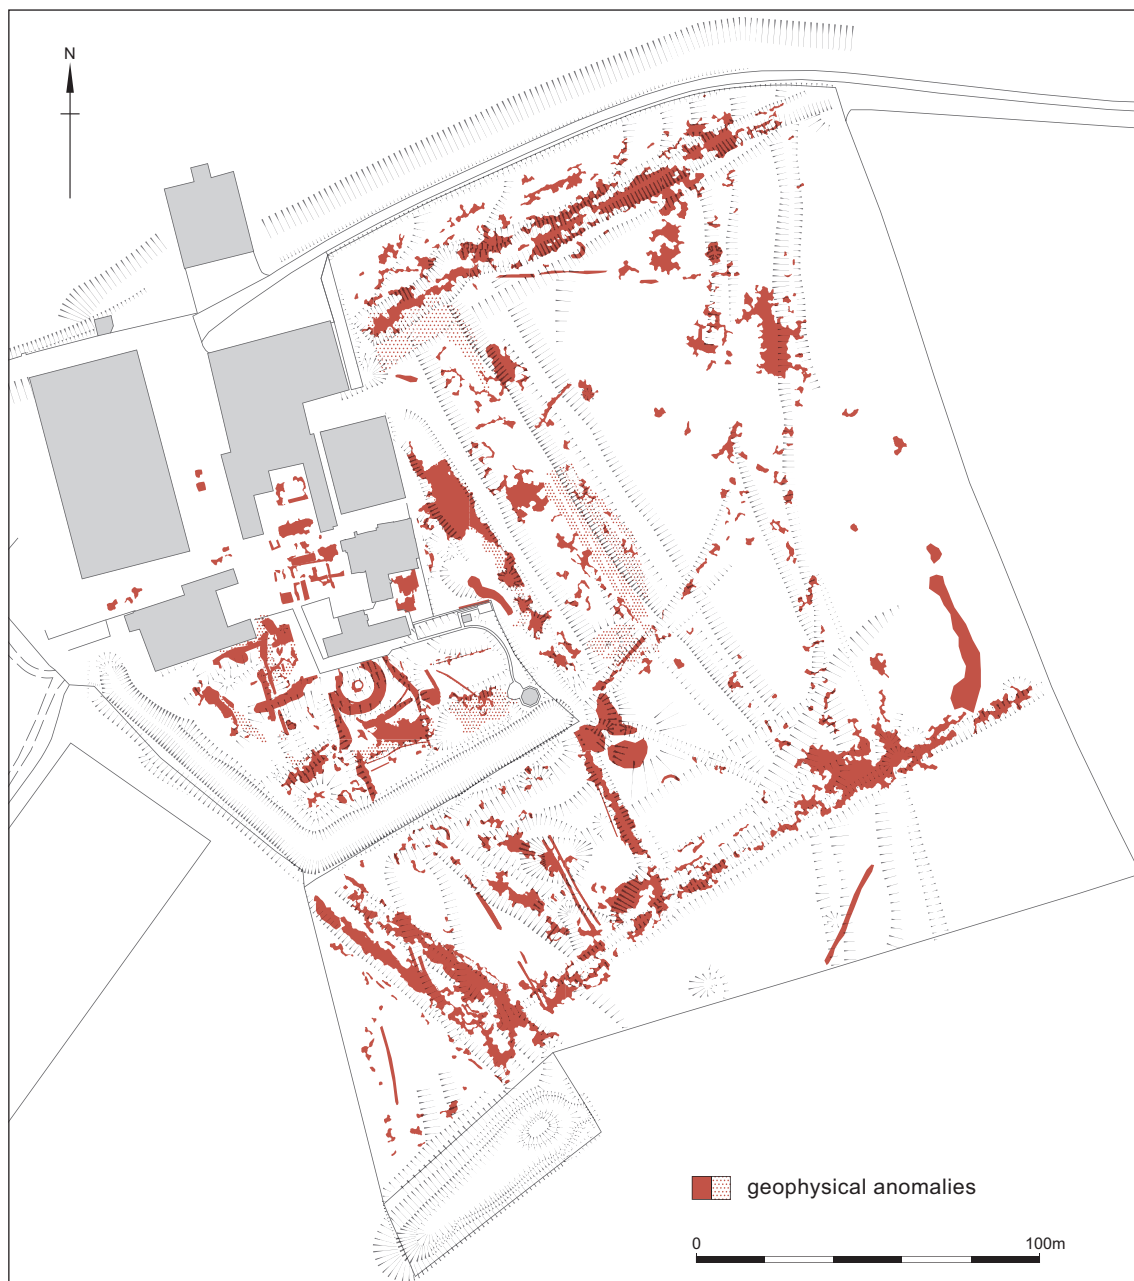
An area of high resistance [r17] adjacent to the east wall of the priory church probably relates to rubble deposits and the response to an open exploratory test pit against the side of the building. To the east the former moat is defined by a high resistance response most pronounced at [r18], corresponding to [gpr28], becoming less well defined to the south [r19], and much weaker to the north [r20] presumably due to varying deposits of rubble infill along its course. A much weaker response was recorded over the earthworks within the survey area, visible most clearly in the processed data as tentative banks and ditches [r21] and [r22], and fragmented linear anomalies at [r23] and [r24]. The high resistance anomalies at [r25] correspond to test pits opened to locate drainage (Figure 80).

Figure 80: Summary of significant geophysical anomalies and earthworks, April 2016.
 © Historic England, Geophysics Team

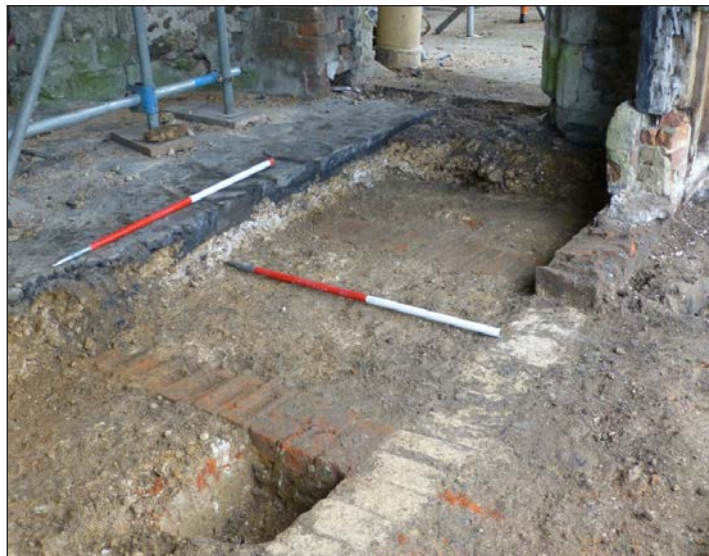
Ahead of the construction of a reinforced concrete footing to support the new barn doors and door frame between the stub walls of the former nave, the threshold measuring c.5.35m by 2.05m was excavated by hand to a depth of 250mm. The barn floor in the area of the main barn doors was excavated by hand removing the yellow sandy clay hoggin sub-floor deposits. The material comprised a chalky white and yellow sandy clay matrix with c.30% medium sized irregular flint cobbles and large gravel fragments measuring c.40-80mm. At a depth of c.250mm a series of six modern red brick wall footings were uncovered. The bricks formed a footing layer on top of the natural yellow clay with flints (Figure 81). The bricks were bedded with frogs visible in most cases except for one of the walls close to the medieval doorway where the bricks were bedded on edge. The south and northernmost brick footings demarked bays 530mm and 550mm respectively with the other bays varying between 1010mm and 1030mm in width. The bays were all internal to the barn butting up to a low brick footing which was all that survived of a low wall below the former barn doors.

Figure 81: Archaeological evaluation in the threshold of the stub nave showing footings of brick bays.

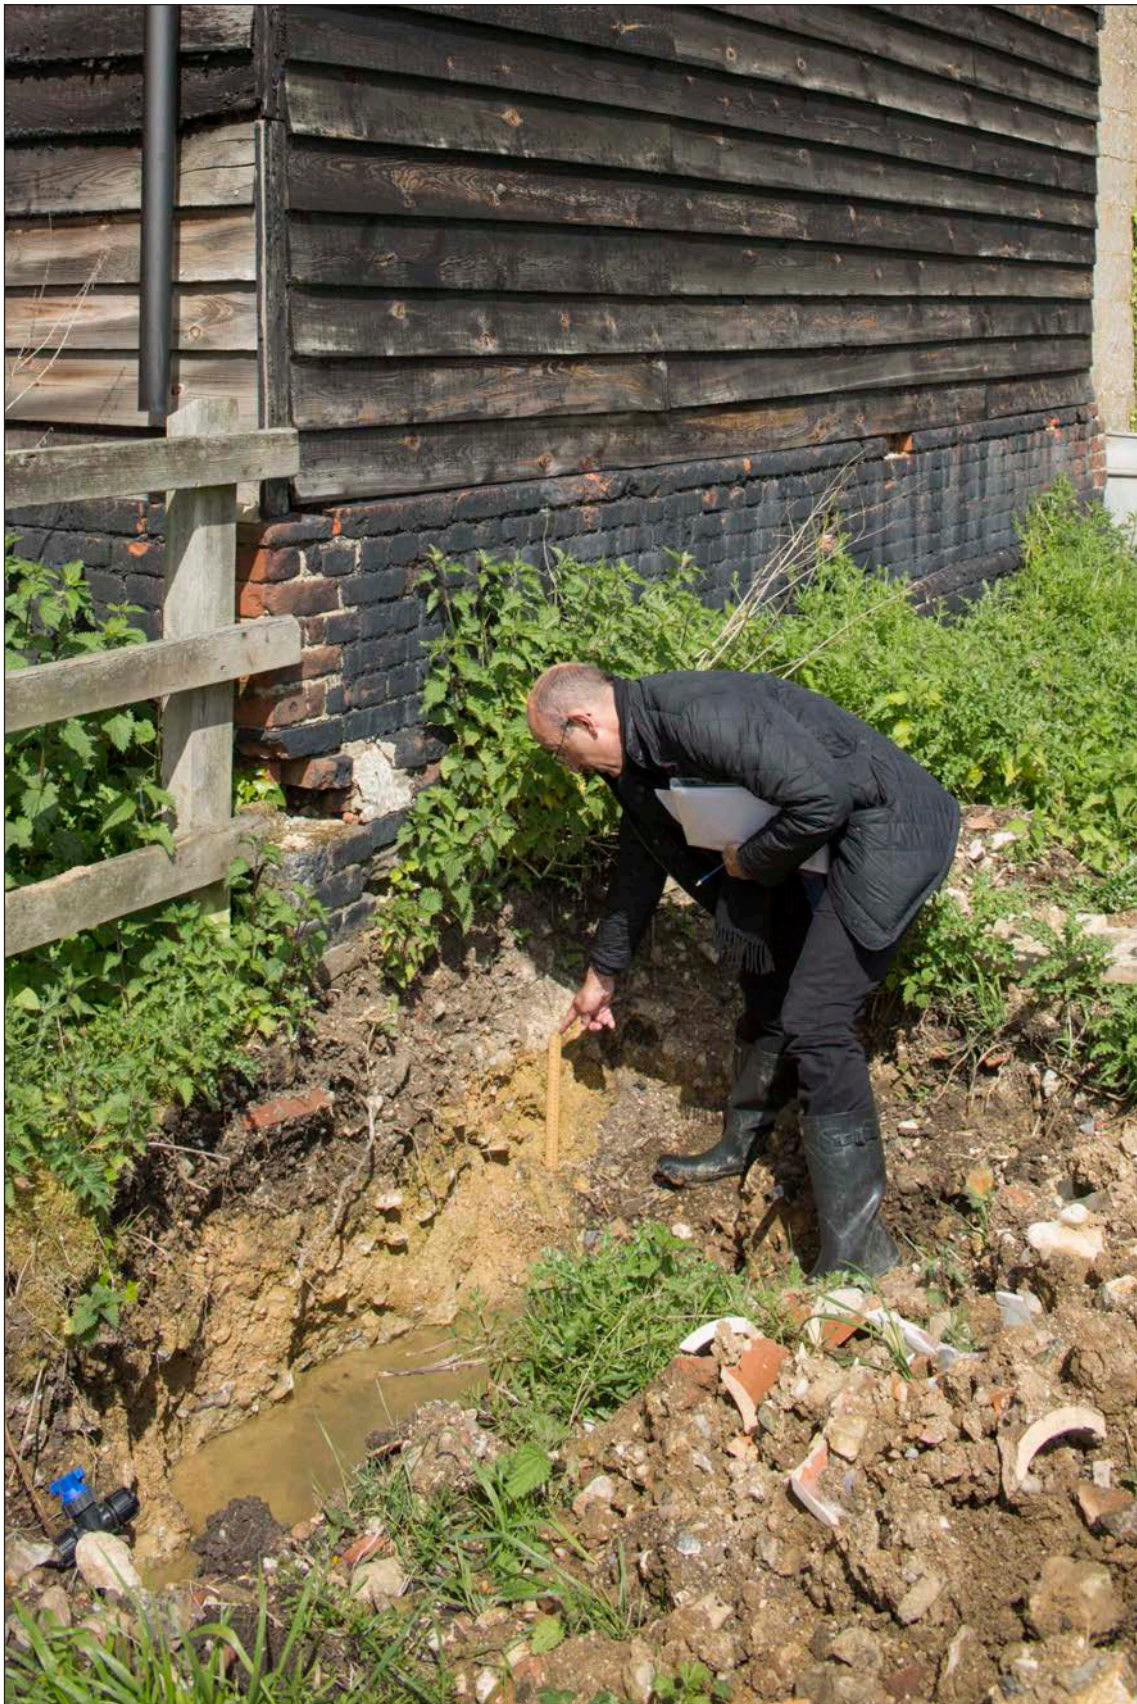
Additionally, three small test pits were excavated to test the subsoil. One inside the former priory church, measuring 330mm north-south and 350mm east-west and 270mm deeper than the brick footings layer, exposed the subsoil immediately below the brick course. The second two test pits were ovoid in shape and excavated outside of the east wall of the east barn to a depth of 500mm (Figure 82). They measured 400mm by 330mm to the south and 380mm by 480mm to the north and exposed dirty grey clay with flints apparently re-deposited farmyard deposits. Modern nails were the only finds aside from a single stray Tudor brick located in the sub-floor close to the threshold to the south.

Figure 82: Archaeological evaluation to the east of the east barn. © Historic England, Patricia Payne, DP173634

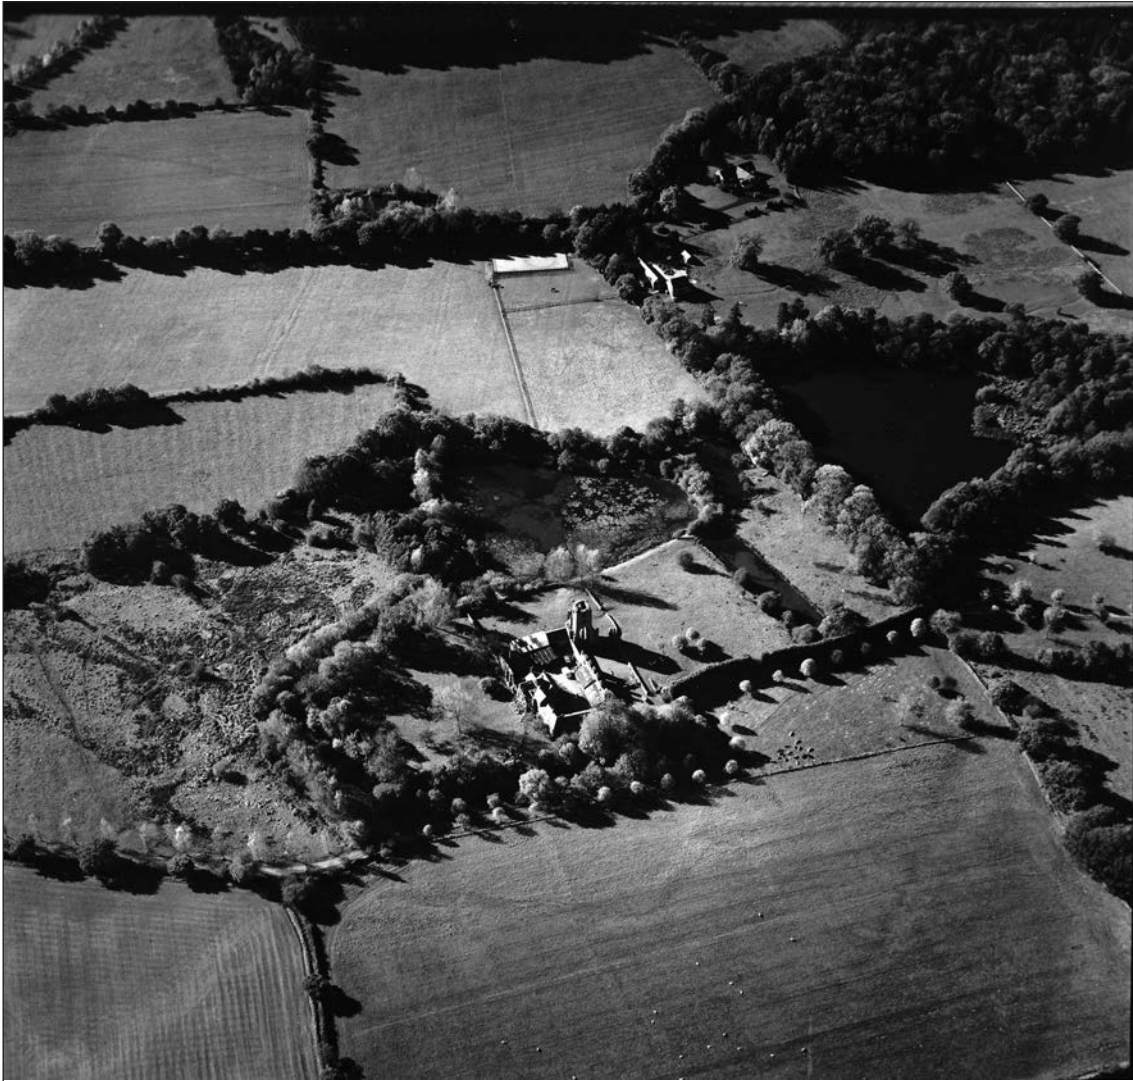
Figure 83: Aerial view of Ulverscroft priory, Leicestershire showing the remains of its extensive moat. © Historic England

The largest surviving earthwork feature and that with the clearest interpretation is the moat which surrounded the priory's inner precinct. Fully moated Augustinian priories were reasonably rare, however a number of examples including Ulverscroft, Leicestershire (NGR SK 5012312710), Michelham, Sussex (NGR TQ 55893 09322) and Norton, Cheshire (NGR SJ54866 83061) are directly comparable to Latton, while Waltham Abbey and Maxstoke (discussed above) both had moated elements to their sites (Figure 83).²⁰⁰ Moats were generally cut around monastic houses for two reasons: to carry excess water away from low-lying sites by lowering the water table and employing a connected drainage ditch, and to serve in the place of a ditch or precinct wall to provide security and create the isolation demanded by monastic life.²⁰¹

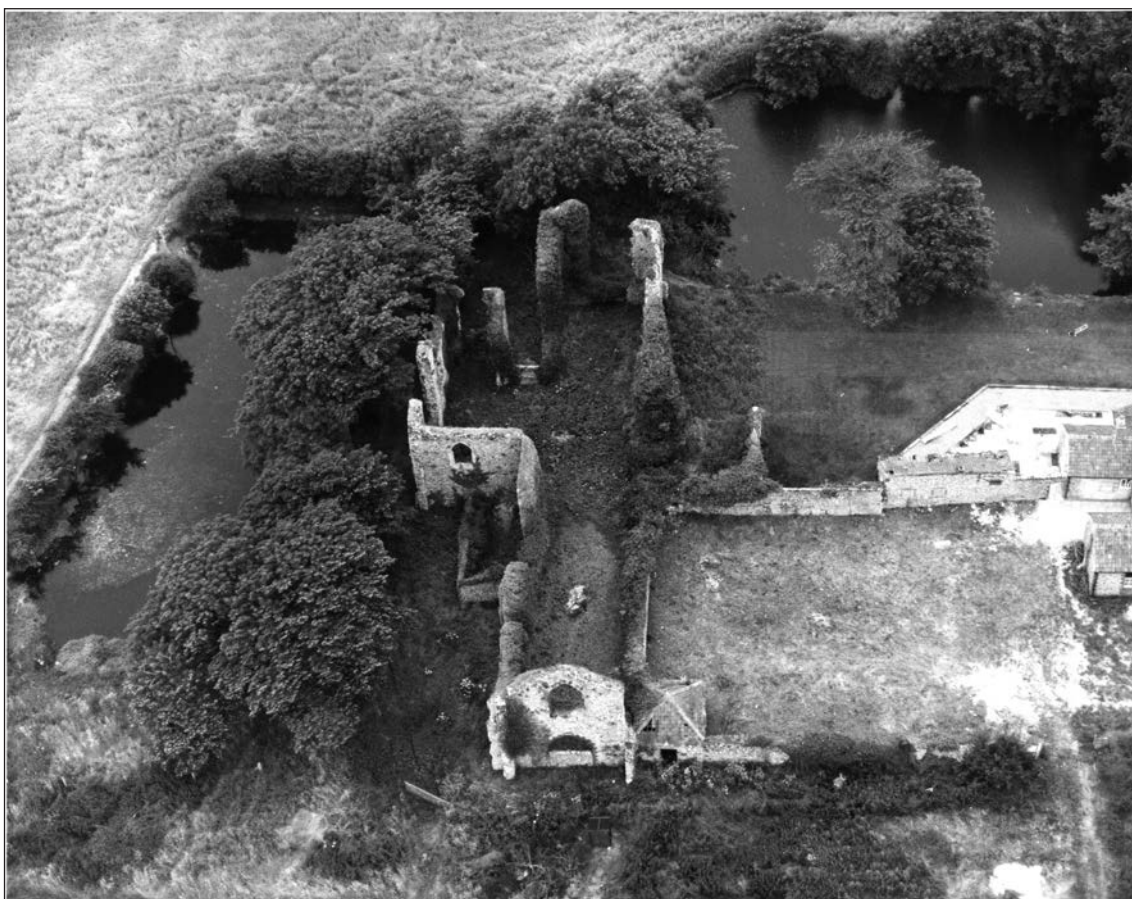
Figure 84: Aerial view of the remains of the Augustinian priory of St Mary in the Meadow, Beeston Regis, Norfolk. Directly comparable to Latton in proportion, date and layout, this view clearly shows the porticus between the north transept and the nave.
© Norfolk County Council

The GPR survey of the farmyard was successful in locating the foundations of the lost nave [GPR4] extending on the same alignment some 17.5m to the west from the truncated stub walls. The GPR survey also seemed to confirm the presence of a structure adjoining the nave to the north, although the anomalies recorded were more disturbed in this area. It is most likely that this feature [GPR6] was a porticus or sacristy and not a north aisle as the latter would have necessitated the construction of an arcade and both the stub north wall of the nave and the foundations identified as [GPR4] indicate that the north wall was solid and not arcaded (Figure 84).

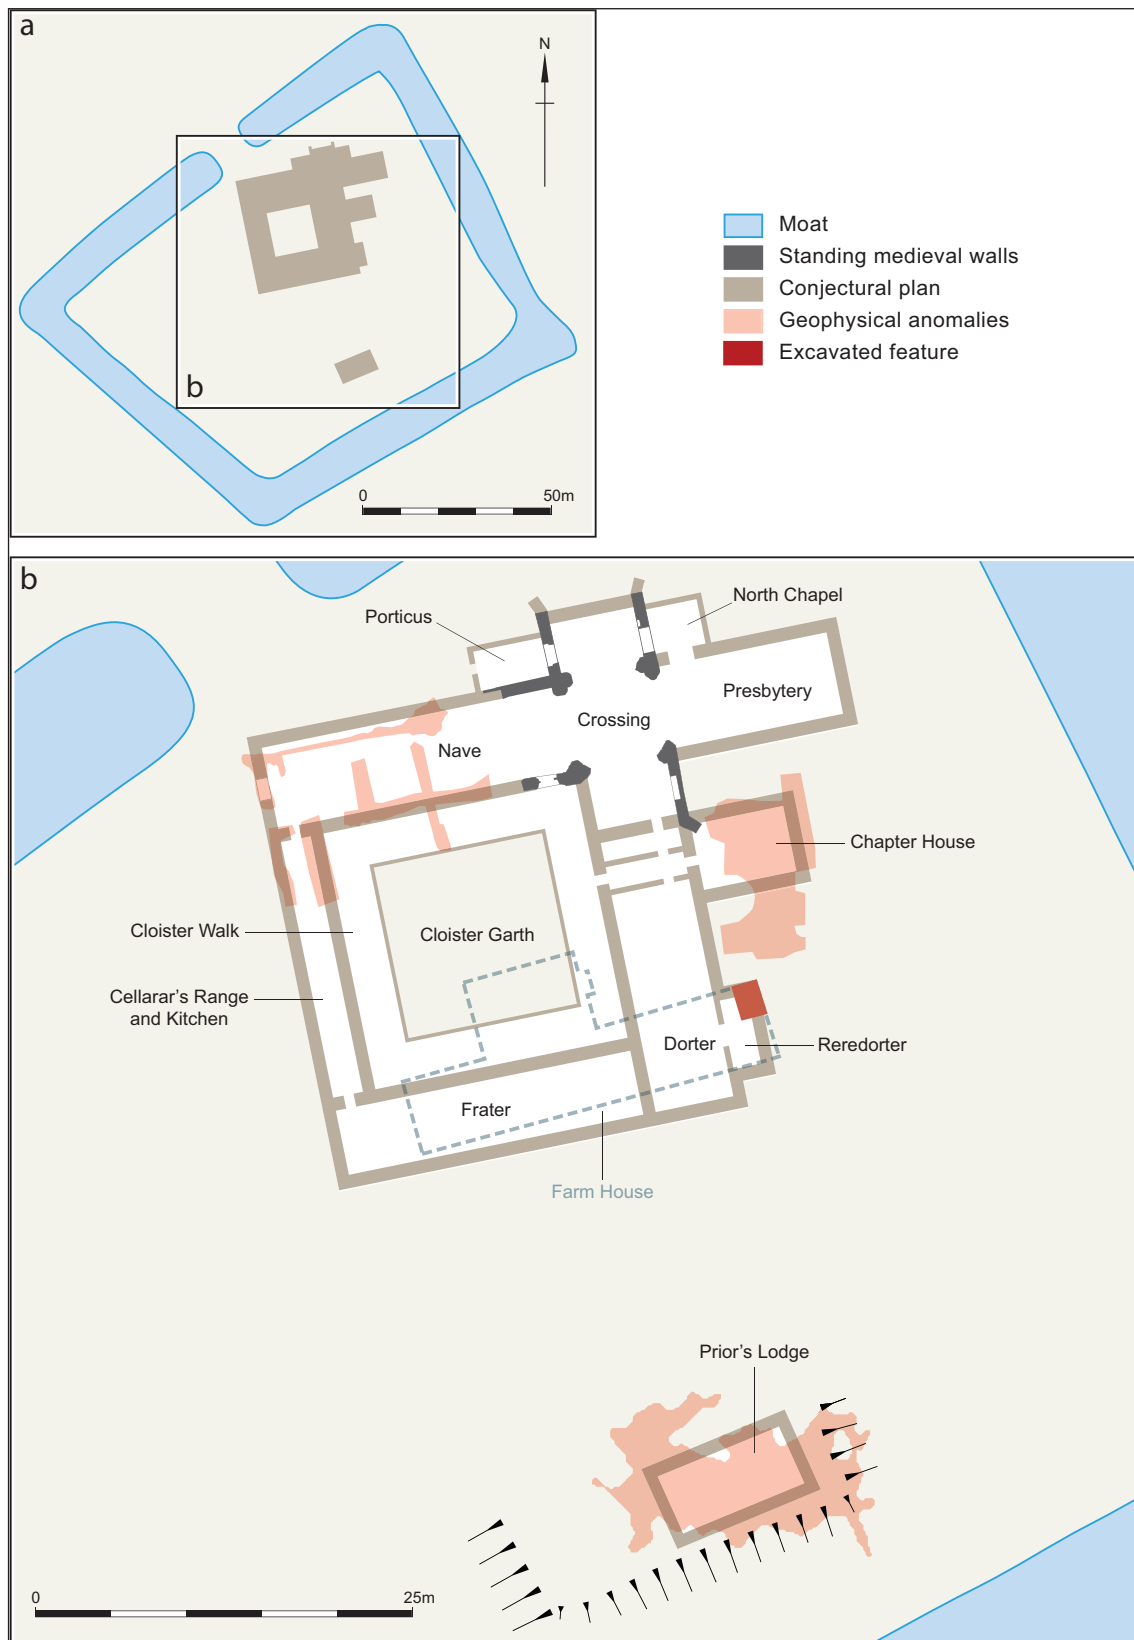
Figure 85: Conjectural reconstruction plan of Latton priory, plotting the upstanding remains of the priory church and significant geophysical anomalies against a standard Augustinian priory plan © Historic England

The earth resistance survey, conducted in conjunction with the GPR survey of the yard, also identified two large anomalies which may identify the location of a chapter house at Latton. In most abbeys and priories, the chapter house - which formed the main meeting space for the brethren - formed part of the cloister's eastern range, usually located to the south of, and on the same alignment as, the presbytery. During the earth resistance survey of the small lawned area south of the east barn, two high resistance features [R15] and [R16] were identified. Though the anomalies don't describe a coherent set of building foundations, it is possible that they represent a former floor surface and or a spread of demolition debris. In both cases, and given the location of the anomalies, it is likely that the small lawned area marks the location of a small chapter house.

No evidence, in either the surviving fabric of the priory church or identified during the geophysical surveys, can be presented for the nature or extent of the eastern range of the cloister. The eastern processional doorway strongly suggests that the cloister walk extended along the eastern side of the cloister, but no conclusions can be drawn regarding the character of this range. Assuming a standard Augustinian priory plan, the eastern range likely comprised the *dorter* or dormitory for the canons resident at Latton. This range would have extended south from the transept to join the *frater* range to the south and may have been at first-floor level, extending above the chapter house, slype (passageway), and sacristy adjacent to it, and accessed directly from the priory church via the night stair.²⁰⁷ If the dormitory was at first floor level, the space below would likely have been vaulted and entered directly from the cloister. At the southern end of the east range would most likely have been the latrines, or to call them by their more common 19th century term, *reredorters*, entered directly from the dormitory.²⁰⁸ The latrines were typically arranged over two floors - though may have been more modest at Latton - and situated at the south-eastern corner of the east range and arranged to allow the main precinct drain to pass through the ground floor, flushing away waste without the drain passing through the cloister or close to the church.²⁰⁹ (Figure 85). Excavations to facilitate new foundations for the lean-to extension at the east end of the house appeared to uncover both earlier floor surfaces and a drain lined with brick and masonry passing under the farmhouse extension from the south-west. This would appear to confirm the location of the latrines in their typical position at the south-eastern corner of the cloister.

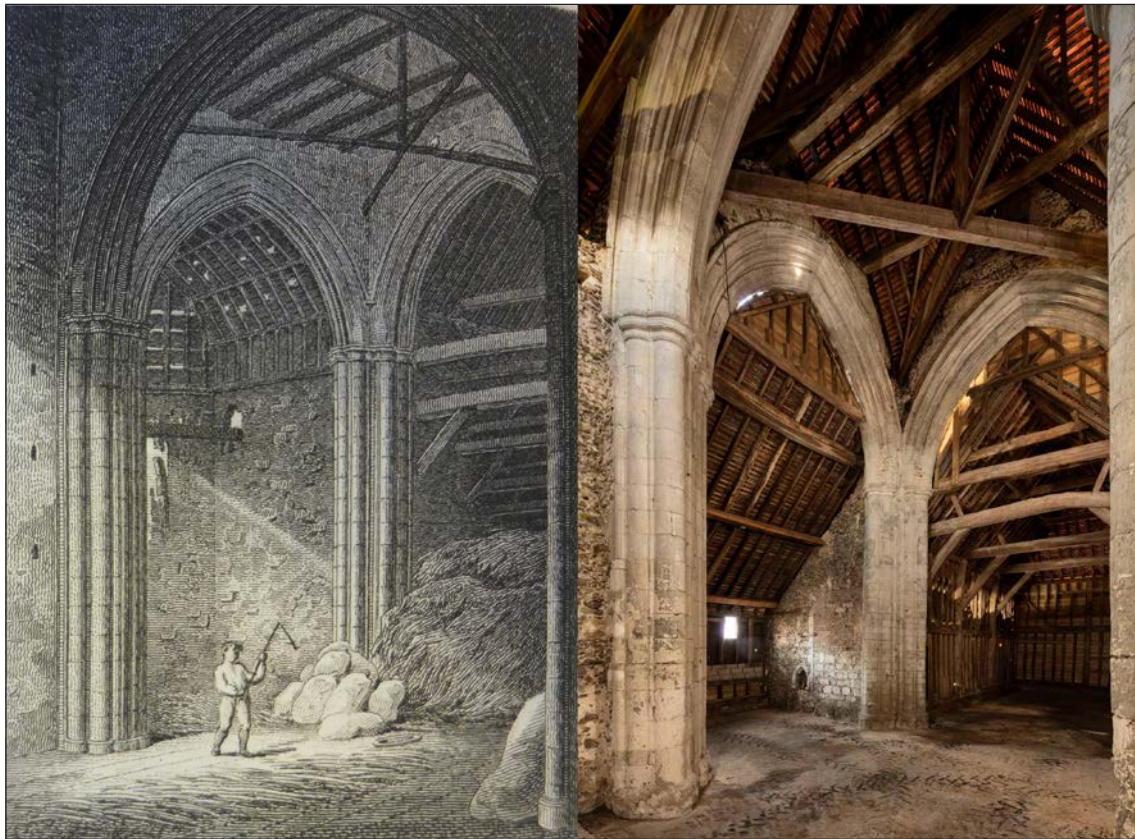
Figure 86: A comparison of the roof over the east barn as depicted by Storer in 1809 and as extant in 2017. The arrangement of the roof trusses appears to be the same in both images, though in the Storer depiction, the roof sits above the apex of the crossing arch, seemingly atop masonry walling implying that the roof predates the barn and was reused.
© British Library and Historic England DP217013

The numerous topographical depictions of the 1760s and 1770s confirm that the presbytery of the priory church remained up-standing until the end of the century, though the north chapel and north sacristy had already been removed. The most enigmatic of these depictions is Storer's 1809 view of the interior of the crossing which appears to depict a clasped side purlin roof of a near identical arrangement to the present east barn roof, sitting atop masonry walls at a height above the apex of the crossing arch. The implication is that the east barn roof is older than the east barn and that it was reused when the presbytery was taken down (Figure 86). Though this interpretation is supported by the nature of the roof design, prevalent in Essex from the late 17th century, and contemporary structural issues associated with the eastern hip of the roof, the complete and matching sets of carpenter's marks on both the roof trusses and vertical posts of the barn's walls suggest that the two elements of the barn are contemporaneous. The east barn has jowled principal posts with ogee shaped rounded jowls, a feature widely used in the east of England on barns constructed during the early 18th century, but which continued to be used into the 19th century. As the barn can be no earlier than the 1778 depiction of the extant stone presbytery, the east barn may date from c.1800 and be of a slightly outdated design with a roof arrangement which few would have been constructing at that date. Storer's depiction of the collapsed south transept published in 1809 may even be interpreted as depicting no structure at all on the site of the presbytery, pushing the construction of the east barn firmly into the 19th century. While the design of the east barn's frame might support a 19th century date, the roof must be earlier adding credence to the interpretation that it was reused. Henry Warren's 1817 depiction of the crossing from the east which depicts a roof of completely different character to the present barn roof which sits above the apex of the crossing arch and spans a width which takes in the former arch between the north chapel and transept, must

The presbytery of the priory church was depicted in both 1765 and 1778, though by the time of Storer's engraving of c.1806 it appears to have been demolished and been replaced by a timber-framed barn of similar proportions. The framing of the barn is consistent with a late-18th century date and it is probable that the demolition of the presbytery and the construction of the barn took place as part of major improvements to the Latton Hall and Mark Hall estates made by Lushington before he sold the priory estate to Thomas Glyn in 1786. The Glyns were likely responsible for the final major phase of alterations to the priory church, which involved the construction of a barn to the south of the crossing following the partial collapse of the south transept, an event documented by Storer in 1809. The replacement barn was of a similar style to that which replaced the presbytery but of a far cruder nature seemingly confirming that they were not contemporaneous.
