Latton Priory Farm, North Weald Bassett, Essex: Historic Landscape Investigations

Discovery, Innovation and Science in the Historic Environment

Latton Priory Farm in the ancient parish of Latton, south of the area which from 1947 became Harlow New Town, contains, preserved within its agricultural buildings, the remains of the early 14th century priory church of St John the Baptist. The date of this small Augustinian priory's foundation, along with the identity of its founder, in common with many small houses of the Augustinian order are unknown, however it is likely that a priory has existed on the site since the late 12th century. The church of St John the Baptist and its attendant claustral buildings appear, from the remains of the priory church's crossing, nave and transepts to have been completely rebuilt in the early 14th century, and sat within a trapezoidal precinct defined on all four sides by a wet moat. The rebuilt priory, one of 11 Augustinian houses founded in Essex after the priory of St Julian and St Botolph Colchester in 1104-06, was surprisingly grand given its very small community, which at the time of its foundation numbered just three brethren and throughout it

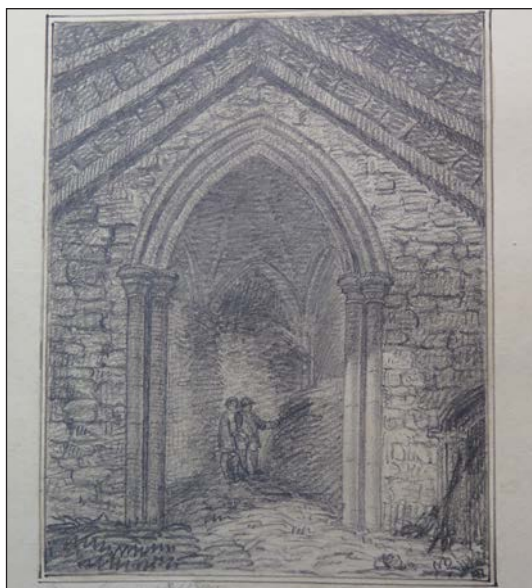
Figure 87: An interior view of 1817 of the crossing of Latton Priory from the east by Henry Warren. By kind permission of the Society of Antiquaries of London

surely have been an imagined perspective (Figure 87).²¹⁹

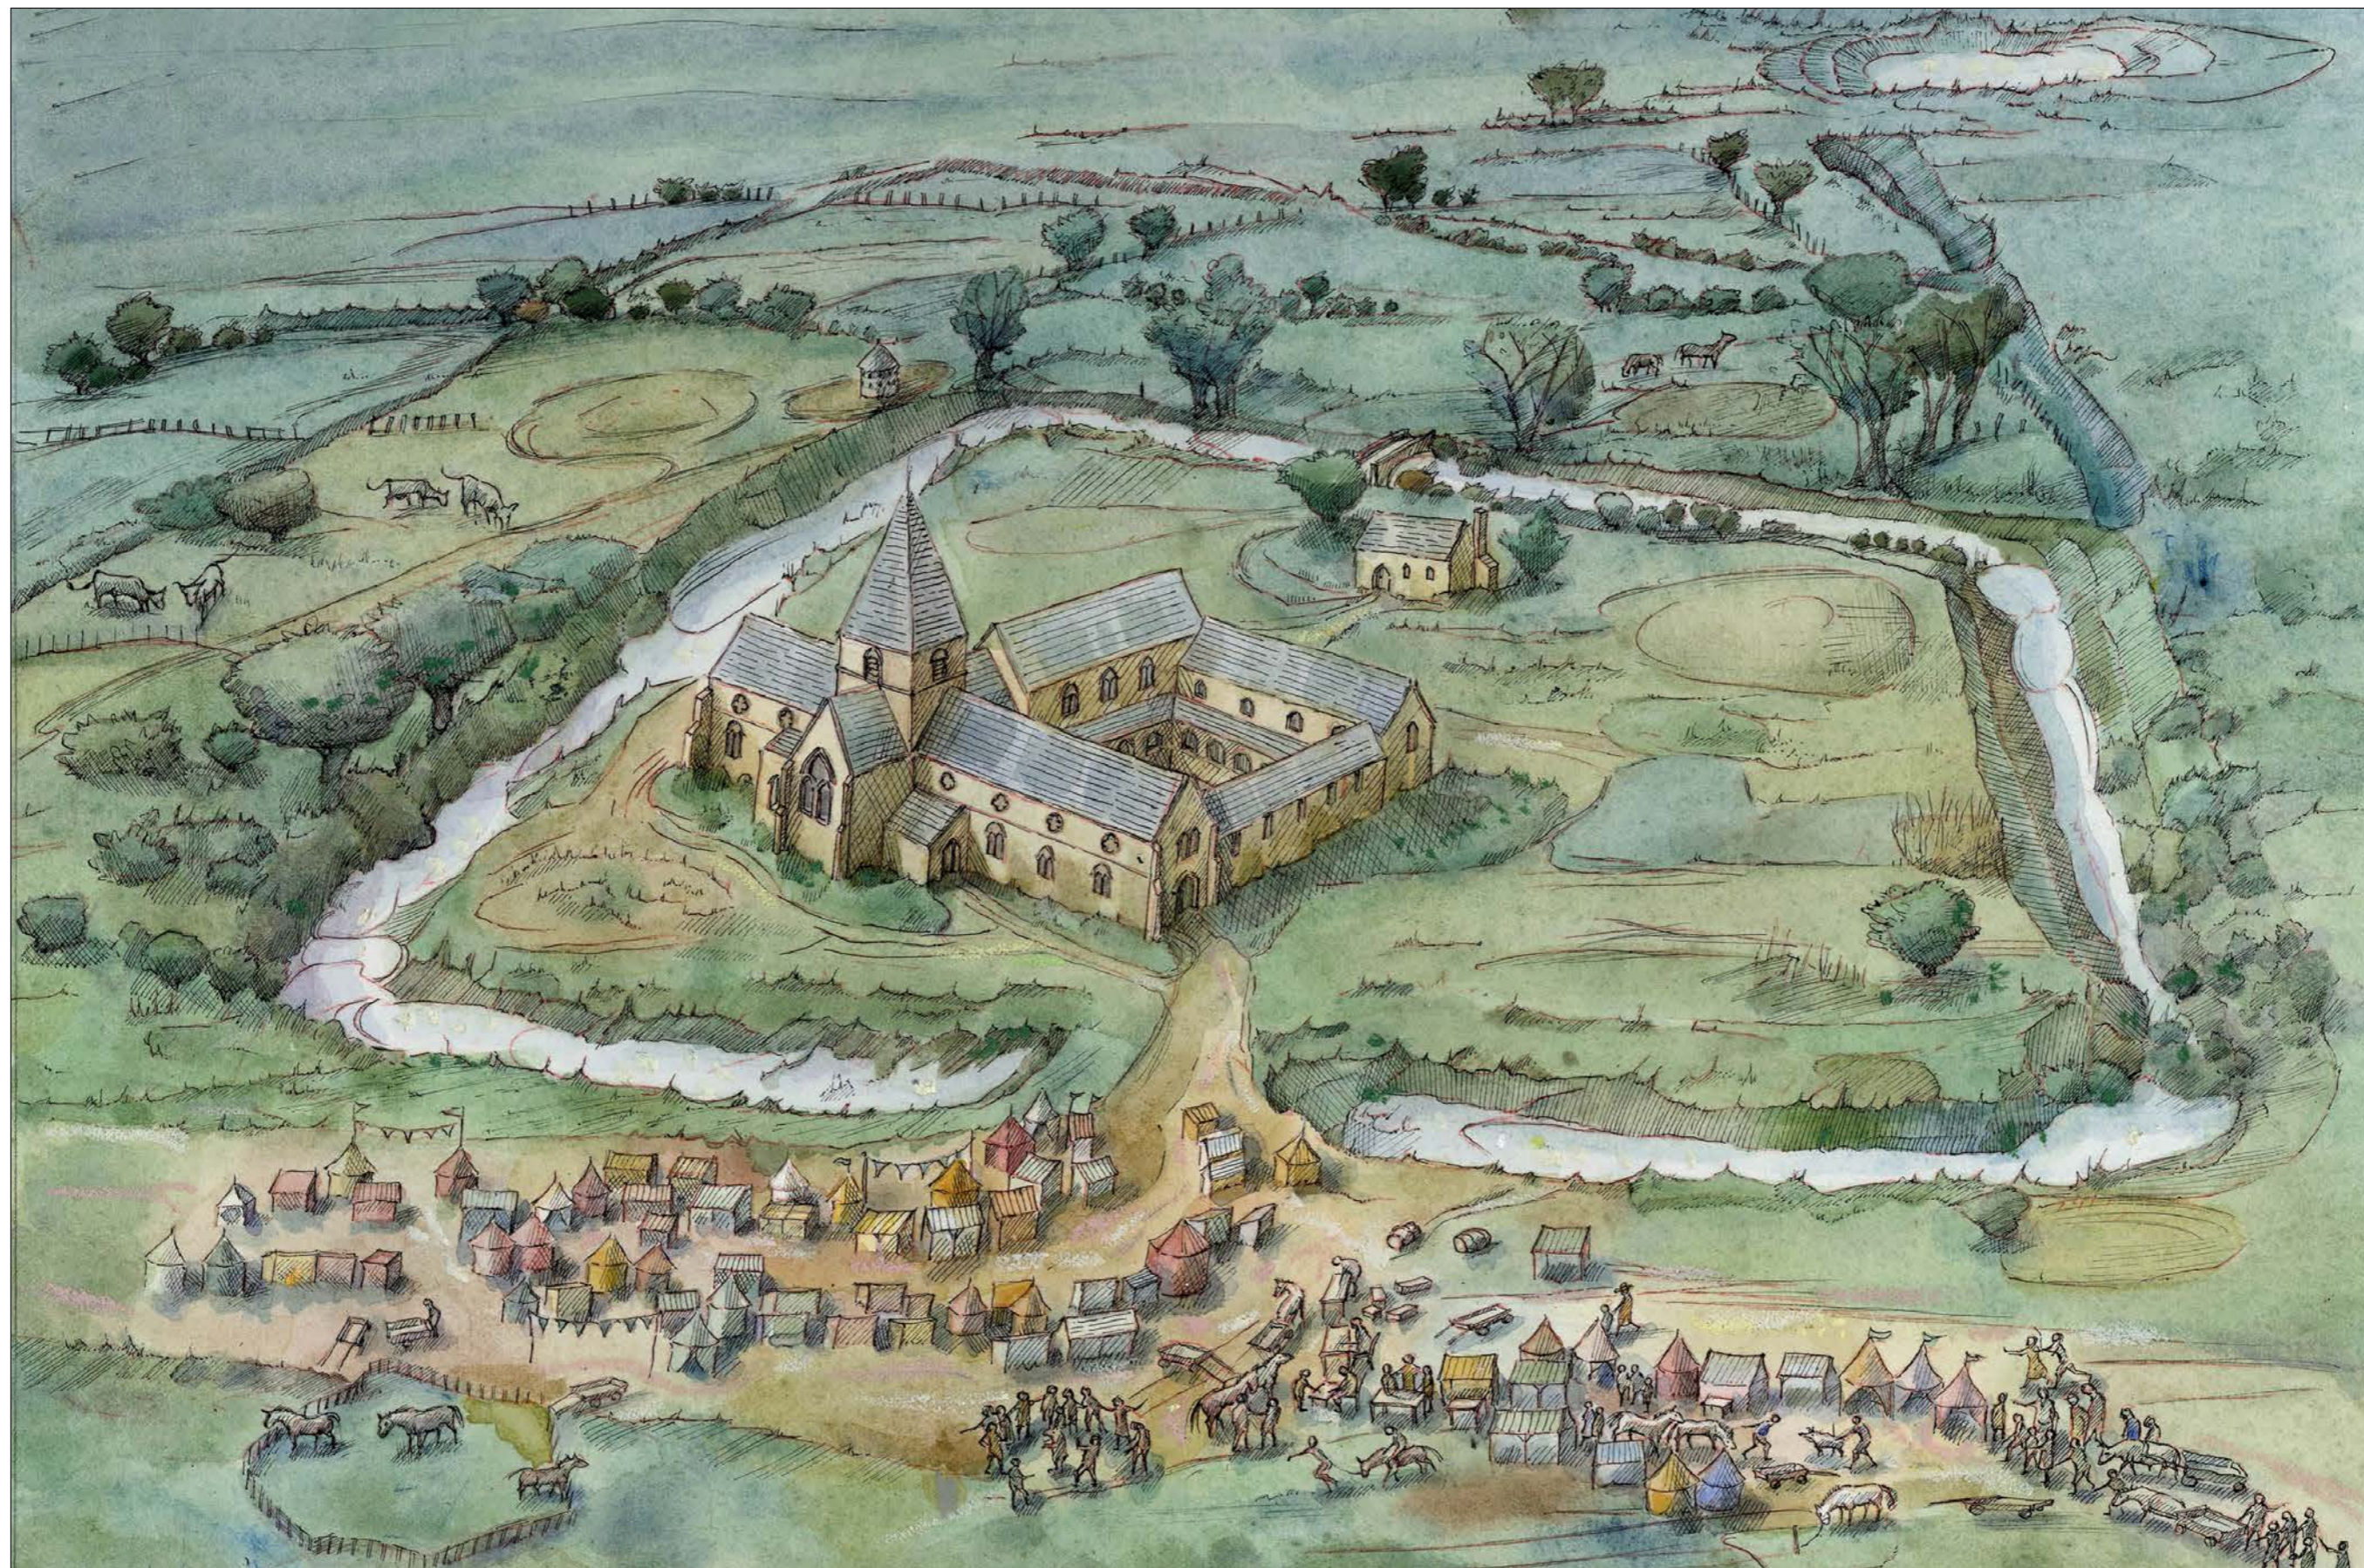
Figure 88: Latton Priory as it may have looked on the 29th August 1335. Following the rebuilding of the priory church, its inner precinct and its claustral buildings after the acquisition of the priory's patronage by Augustine Le Waleys in 1317, Waleys was in 1332 granted license to hold an annual fair on the feast day of the Decollation of St John the Baptist. The fair likely took place in the 'Foreberry', a triangular enclosure to the north of the moat which defined the inner precinct containing the priory church, cloisters and the Prior's lodgings. © Historic England, Judith Dobie

When complete, the rebuilt priory church of St John the Baptist would have measured about 36.5m (120ft) east to west, been cruciform in plan and comprised a central crossing with three-stage tower above, nave and presbytery with clerestory, north and south transepts, a north chapel and north porticus. The surviving processional doorway in the south wall of the nave, west of the crossing and the geophysical evidence for the western range of a square cloister indicates that following the rebuild the priory church would have formed part of a classic Augustinian priory plan with a square cloister formed by a *dorter* or dormitory range to the east, extending south from the southern transept, a Cellerars' range with kitchen to the west, and a *frater* or refectory range, including the *lavatorium* to the south (Figure 88). It is likely, though not confirmed by the geophysical survey that there was also a chapter house which would have been located to the east of the eastern arm of the cloister, south of the presbytery. South of the cloister, there may have been a separate building which served as the prior's lodgings. This is inferred by the depiction of the priory in 1616 and by geophysical anomalies and the faint traces of a corresponding building platform within the present lawned gardens. Latton's plan would likely have been exceptionally similar to the Augustinian priory of St Mary in the Meadow, Beeston Regis, Norfolk, which like Latton had a church measuring about 40m in length, had both a north chapel and porticus and which, like Latton, failed to attract further benefactions and only ever had a very modestly sized community.²²¹

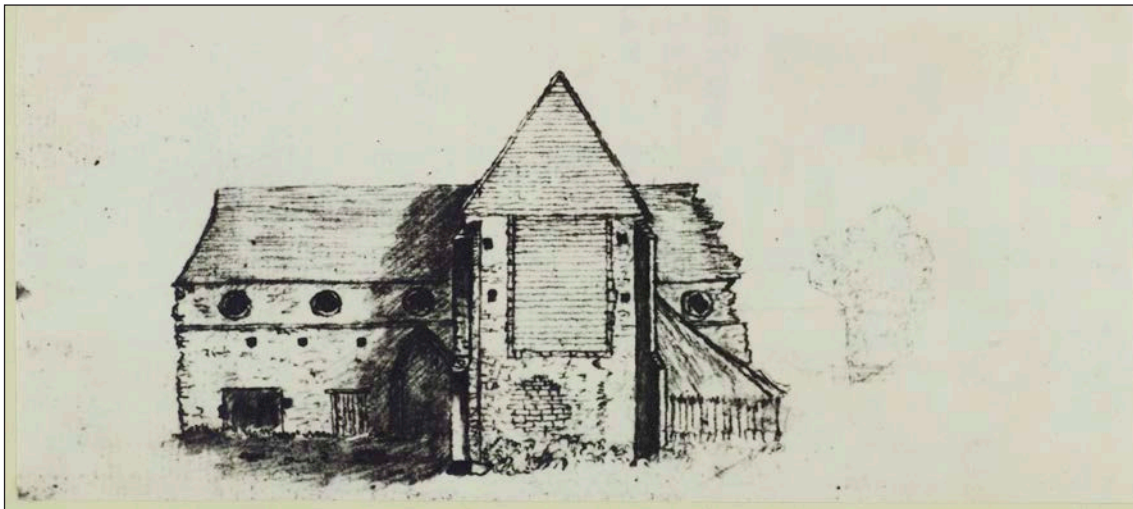
The remains of Latton priory church from the north in September 1765. Reproduced by courtesy of the Essex Record Office, I/Mb/211/16

The earliest detailed depiction of the site is a copy of a line drawing, illustrating the north elevation of the priory church. The drawing is dated March 1771, however the accompanying handwritten text on the drawing states that this is a copy of an original drawing, dated 12 September 1765. The drawing shows the north elevation of the priory church, with the north arm of the priory crossing and presbytery of the church extant. Another late-18th century depiction of the site, an engraving by Sparrow, shows the south elevation of the church. The engraving is dated 10 January 1778 and was printed as part of leaflet on Latton Priory by F Grosse. The engraving shows the south elevation of the crossing – with both the south crossing of the church and the presbytery intact and a large traceried window between two buttresses at the east end of the presbytery. The 1778 depiction provides clear evidence that neither the east nor south barns were extant by this date. There are further sketches of Latton Priory, dating to the 1770s which were made by Edward Forster, an Essex merchant and naturalist and which were photographed by C O Harvey. The handwriting on the one of these sketches, dated 1775 and photographed and published by Harvey in 1971, is remarkably similar to the handwriting on the unsigned sketch of 1771 mentioned above. The view on the 1775 sketch depicts the south elevation of the church, with the south transept and presbytery intact, as shown in the view by S Hooper of 1778.

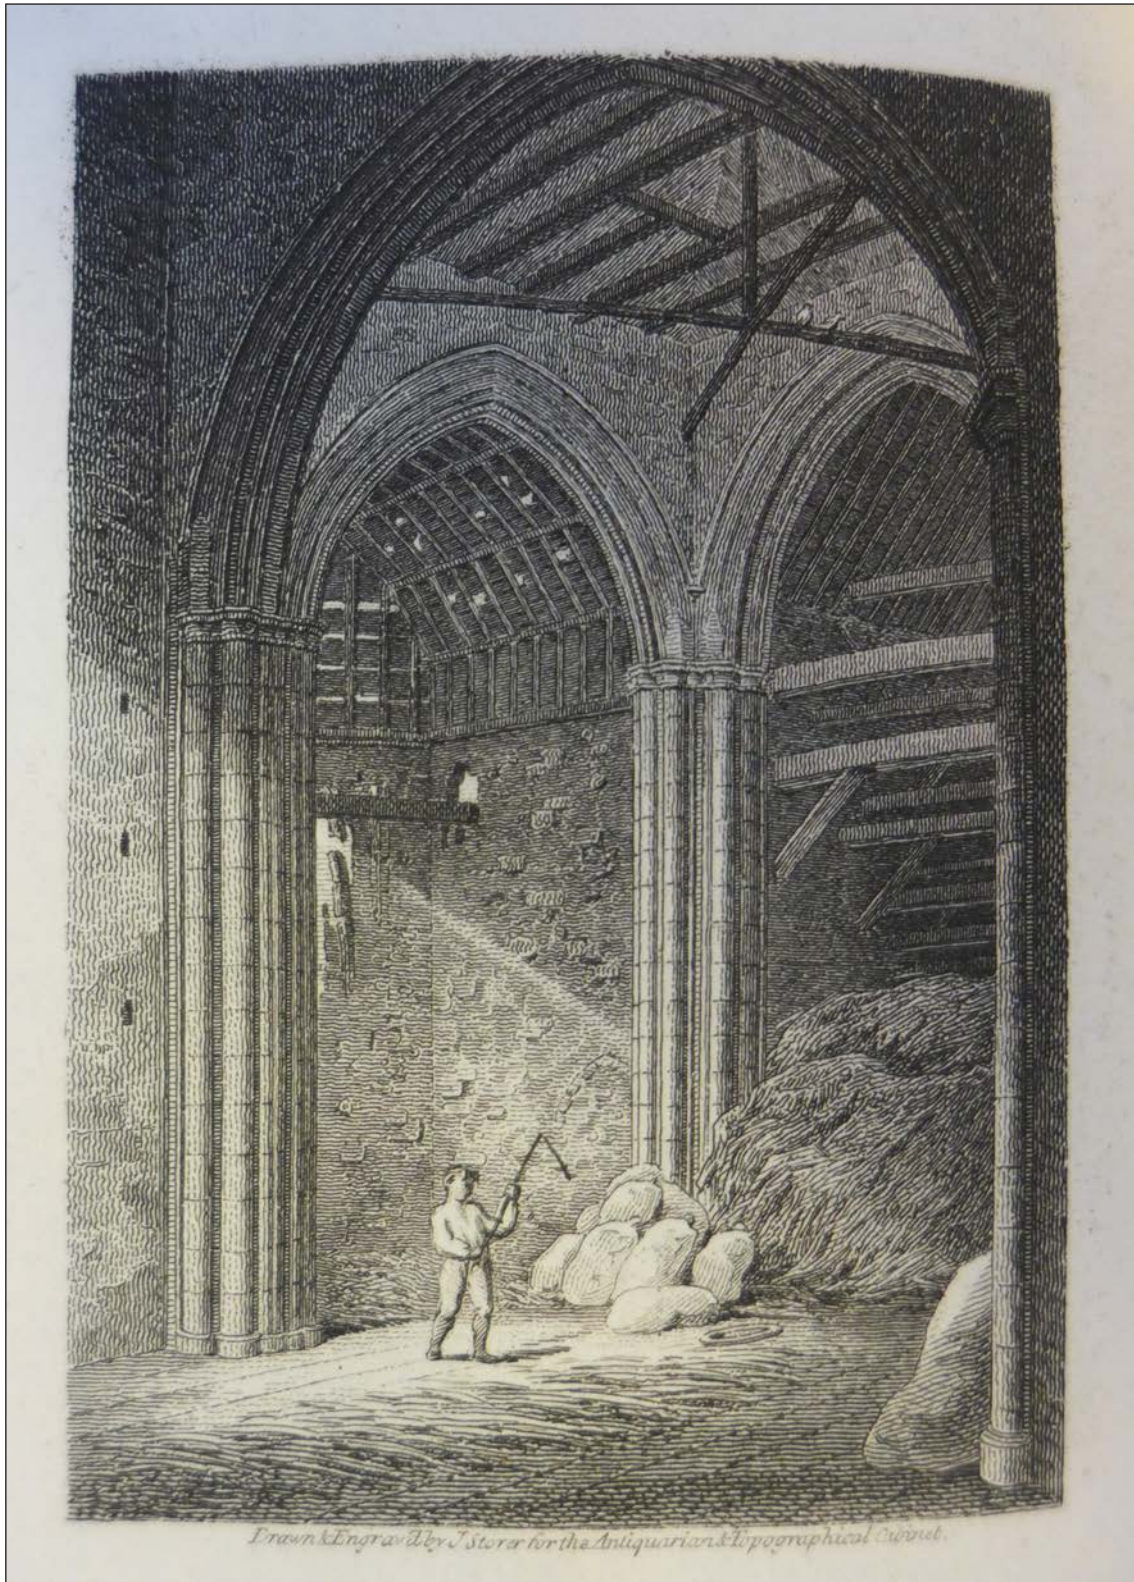
The interior of Latton priory church looking north-east as depicted by Storer in a publication of 1809. © British Library

Later depictions of the site were published in 1809 in *The Antiquarian and Topographical Cabinet* by J Storer. The engraving by Storer shows the first internal view of the church. The view looks towards the north-east corner of the crossing. A roofed structure is depicted in the position of the presbytery of the church. The north wall of the east side of the structure is shown in deep shadow, with braces disappearing into what appears to be a solid wall. The position of the tie-beams

and braces is very similar to the roof structure which survives to the present day. It is possible that these braces and tie-beams could be the braces and tie-beams of the timber-framed east barn, however the artist has not drawn the posts and studs of the north wall of the barn and has instead depicted what appears to be a solid masonry wall.

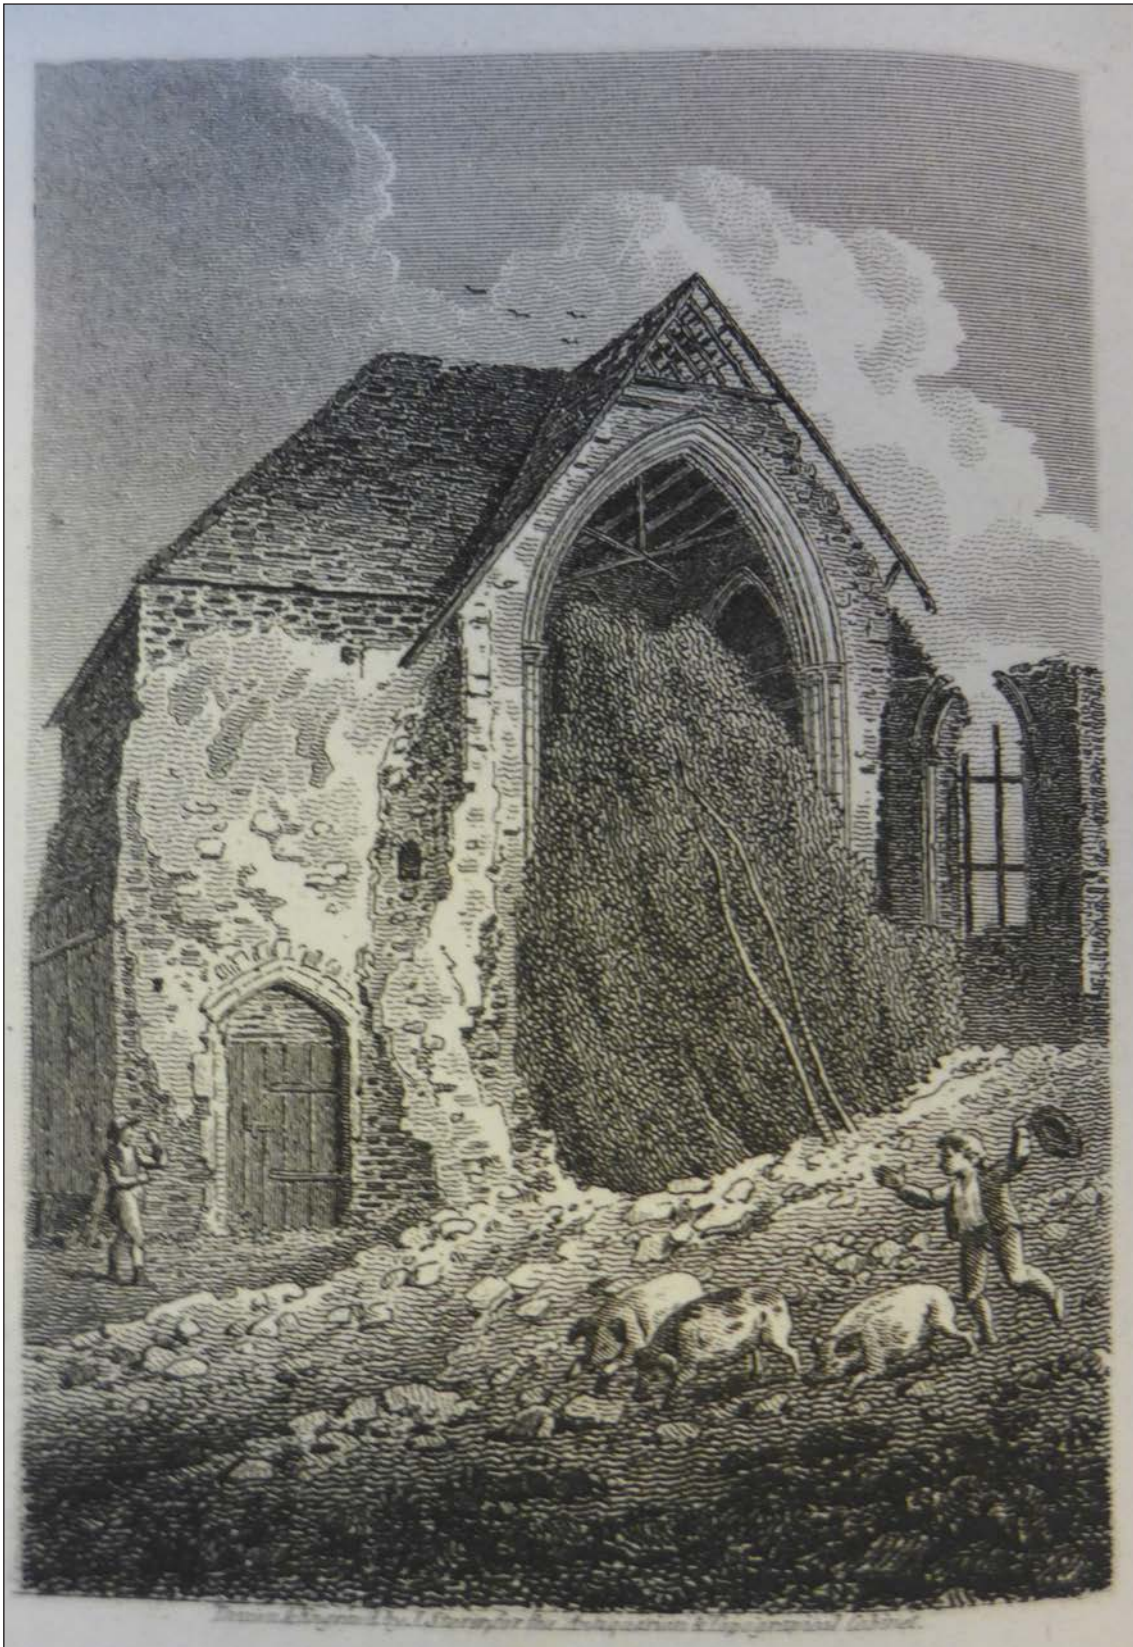
The remains of Latton priory church from the south-west following the collapse of the south aisle as depicted in an engraving by Storer published in 1809. © British Library

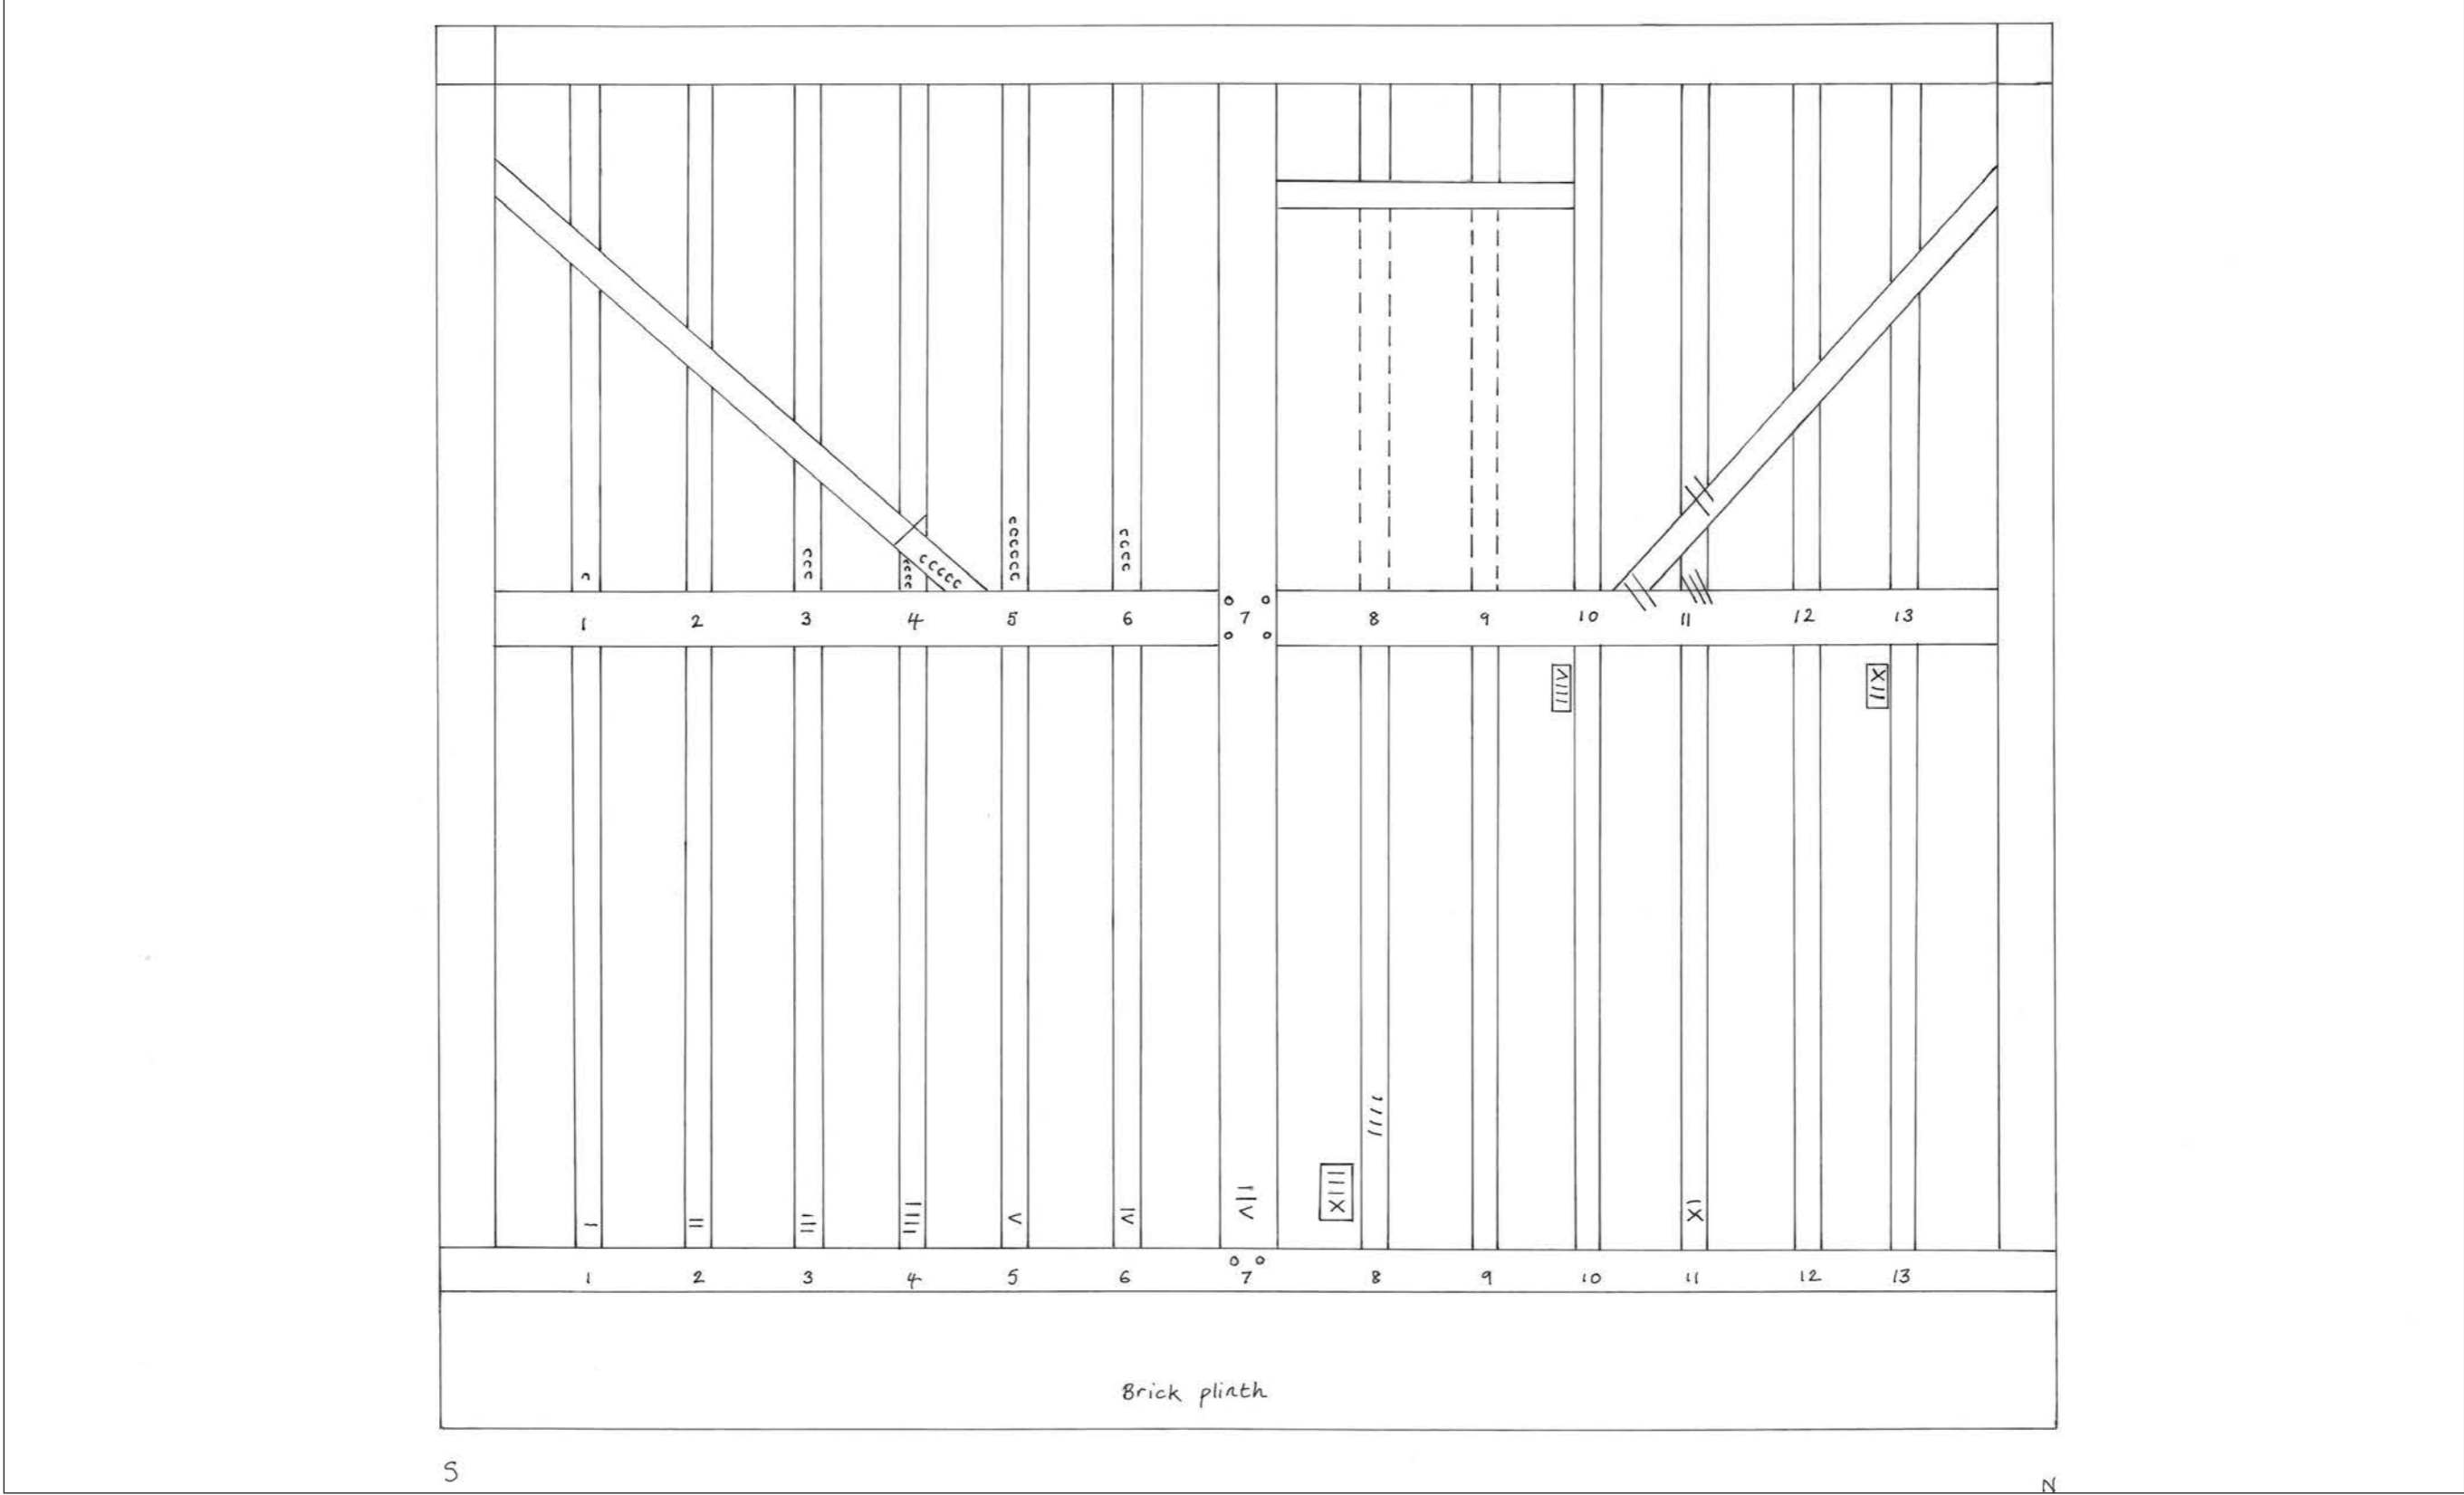
Internal elevation of the east wall of the east barn. © Historic England, Elizabeth Chamberlin

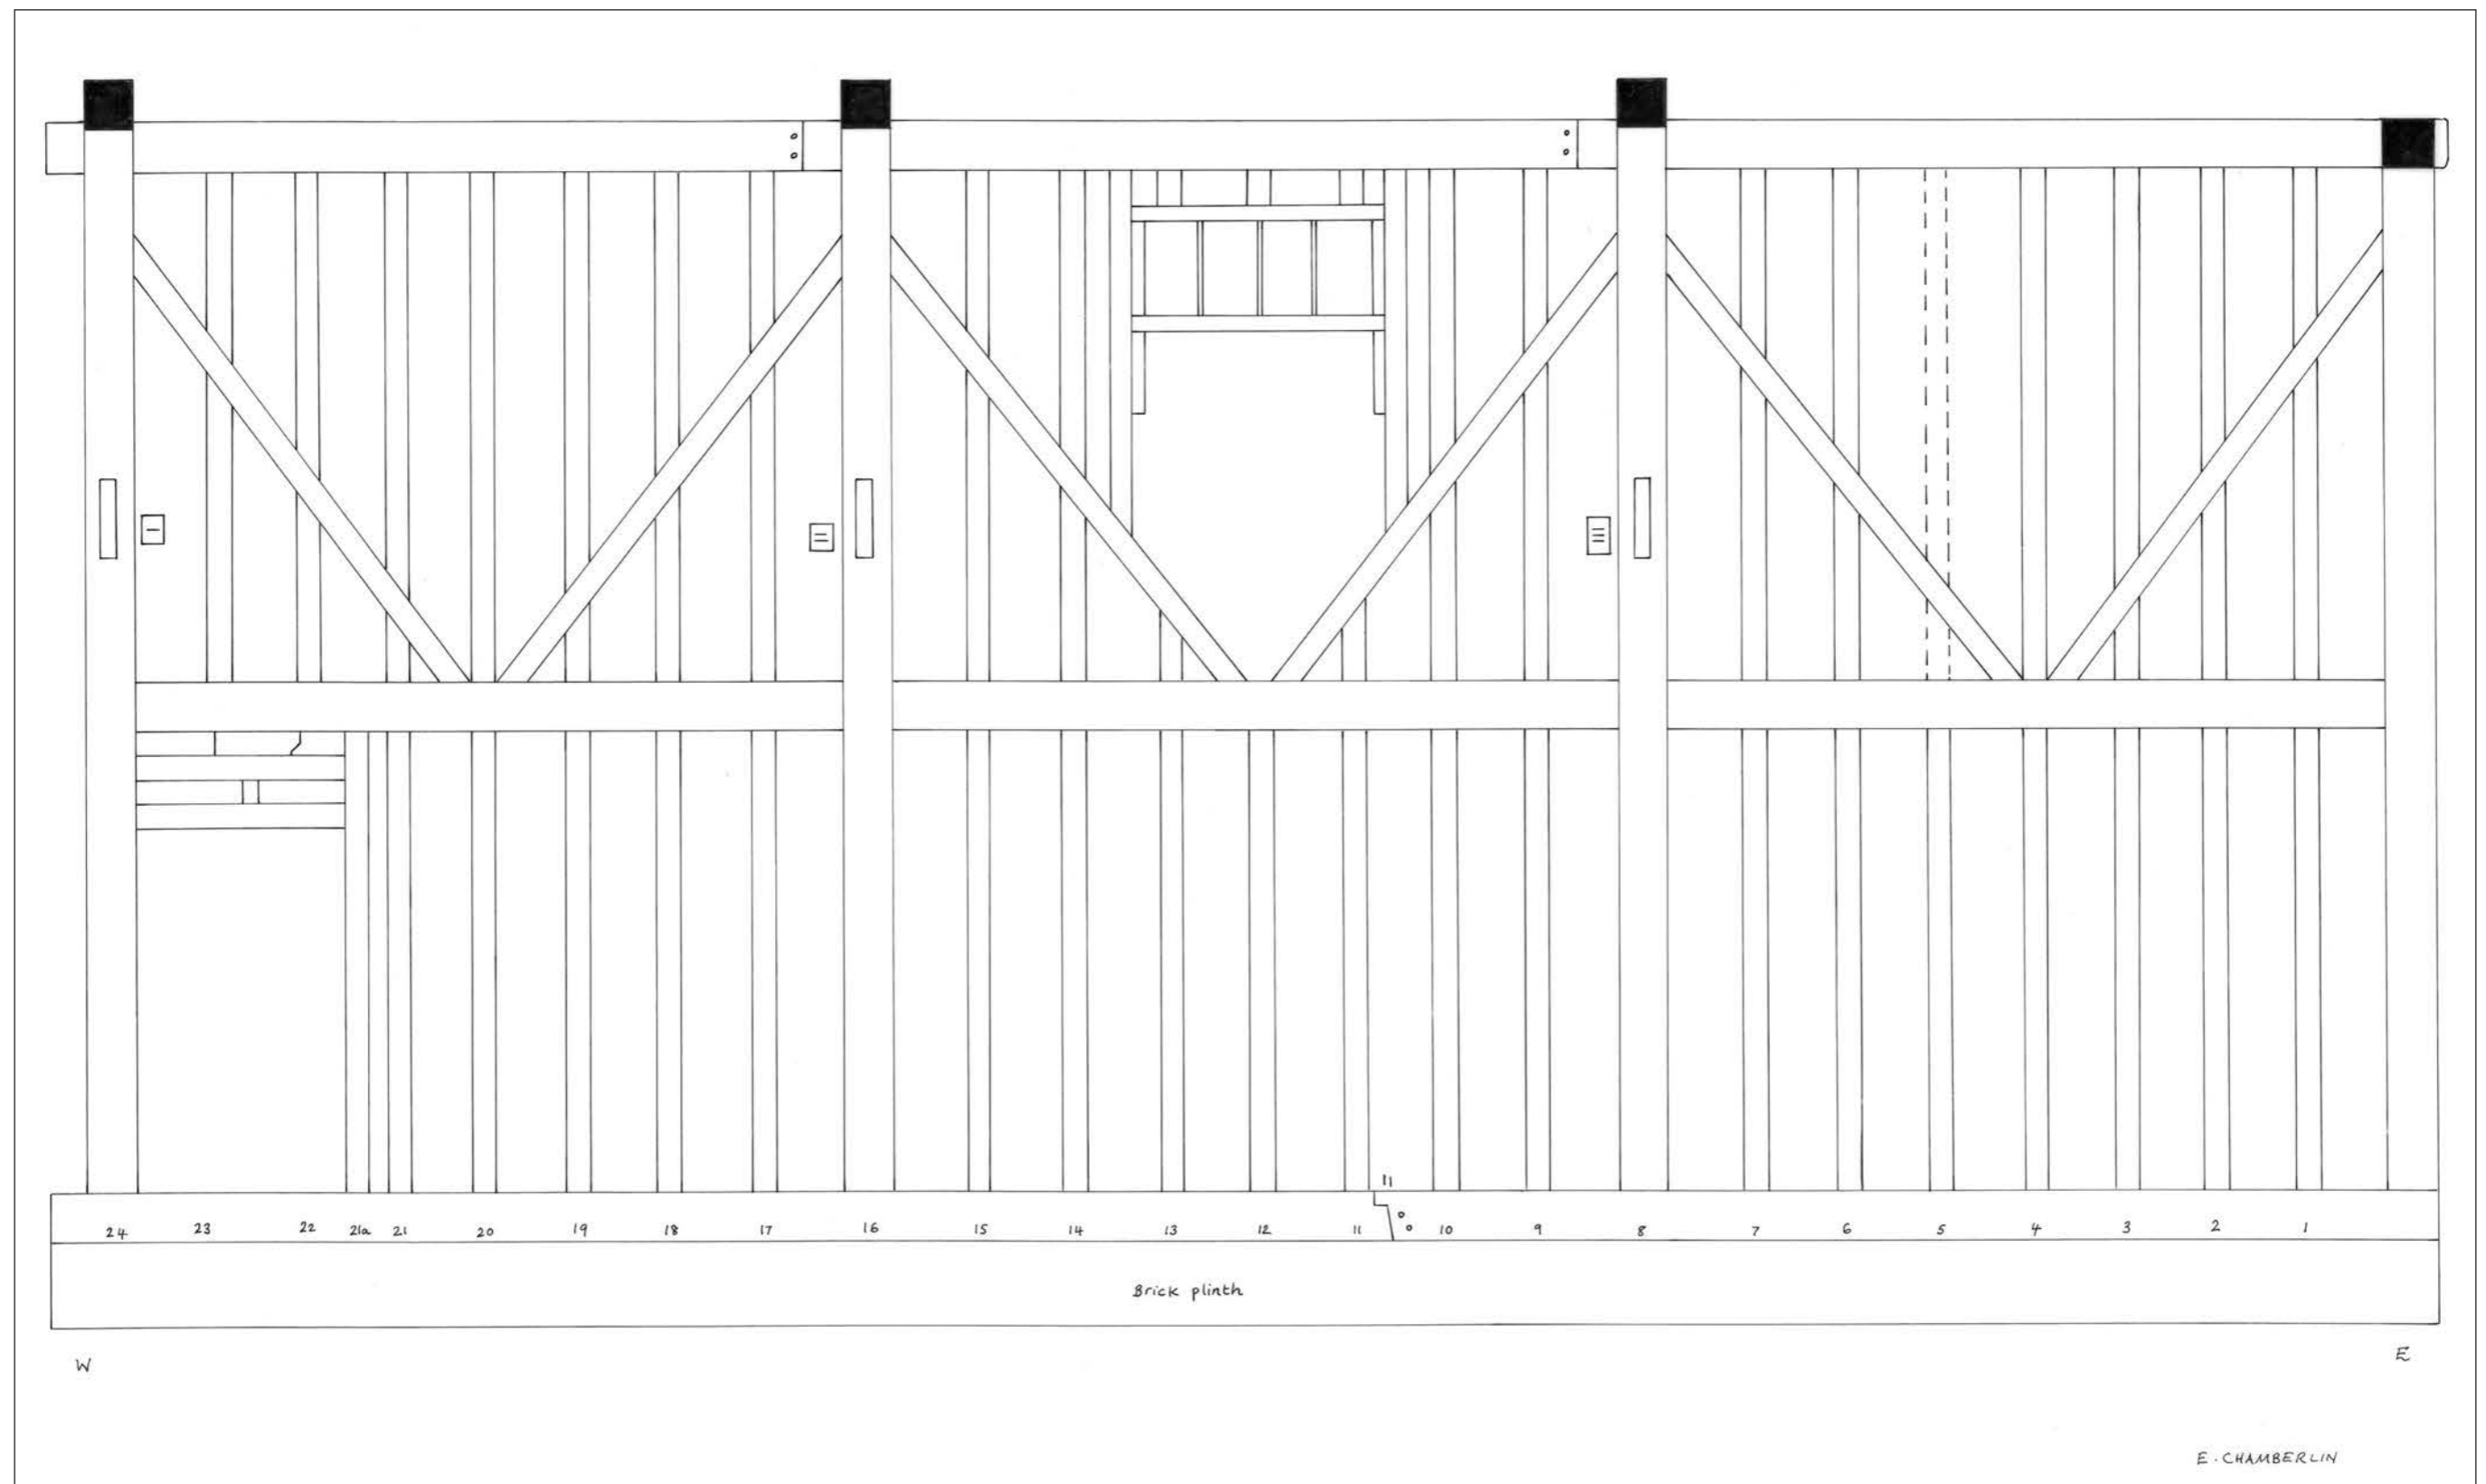
Internal elevation of the north wall of the east barn. © Historic England, Elizabeth Chamberlin

Schedule of timbers – North side of roof structure -East Barn			
Number	Description	Evidence for re-use?	Saw Marks?
1	Jack rafter. Poor condition, nailed on		
2	Jack rafter. Poor condition, nailed on		
3	Jack rafter. Numerous nails hammered into side of it. Nailed on.		
4	Jack rafter. Empty mortice, still with peg. Nailed on, also a peg further up	Re-used.	
5	Jack rafter. Empty 'through' mortice for through brace. Nailed on.	Re-used.	
6	Jack rafter. Two empty mortices (neither are through mortices)	Re-used.	
7	Jack rafter. Many nails, cut off. Two mortices; bottom mortice is empty with peg hole; top mortice still has part of the tenon & the peg in it.	Re-used.	
8	Rafter. Replaced as part of works, but old timber still present on site & checked for signs of re-use.	No signs of re-use.	
9	Principal rafter. Clear evidence for setting out marks. Dimensions 8cm by 10 cm. Clasped purlin adjacent to collar. The rafter is morticed & tenoned into the large tie-beam. Scribed carpenter's mark to top of tie-beam \.	No signs of re-use.	Saw marks – widely spaced and at an oblique angle.

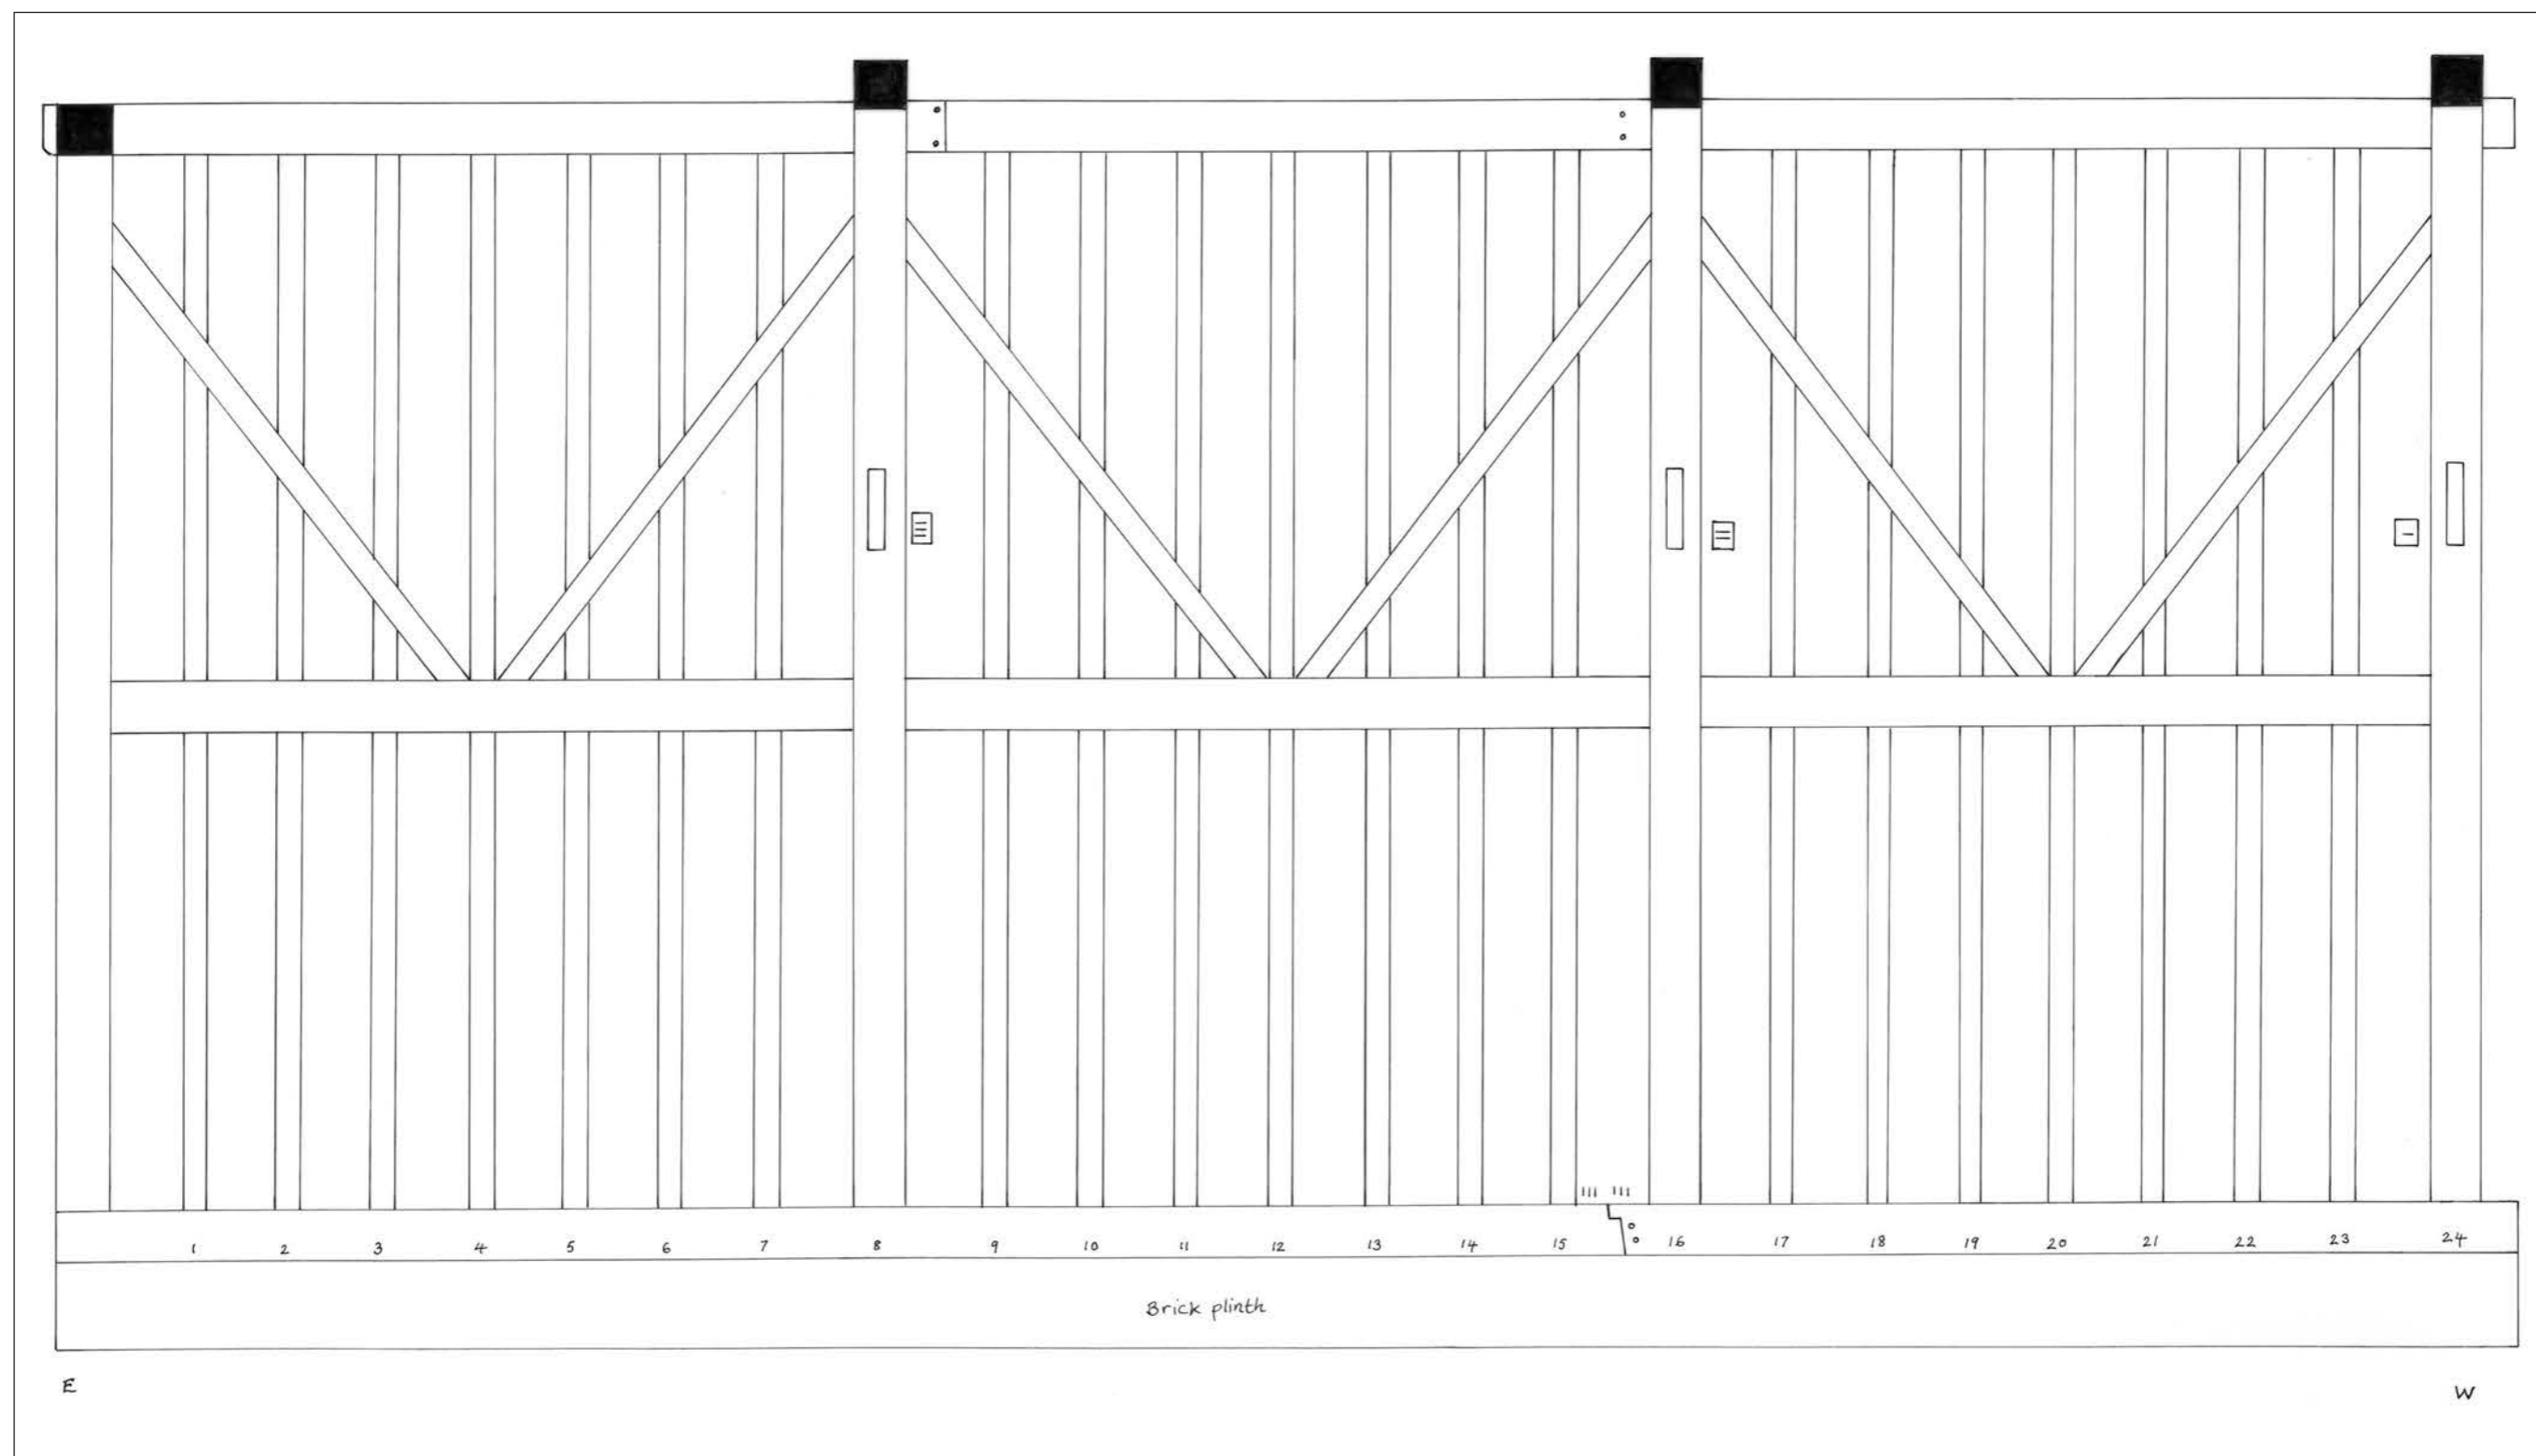
Internal elevation of the south wall of the east barn. © Historic England, Elizabeth Chamberlin

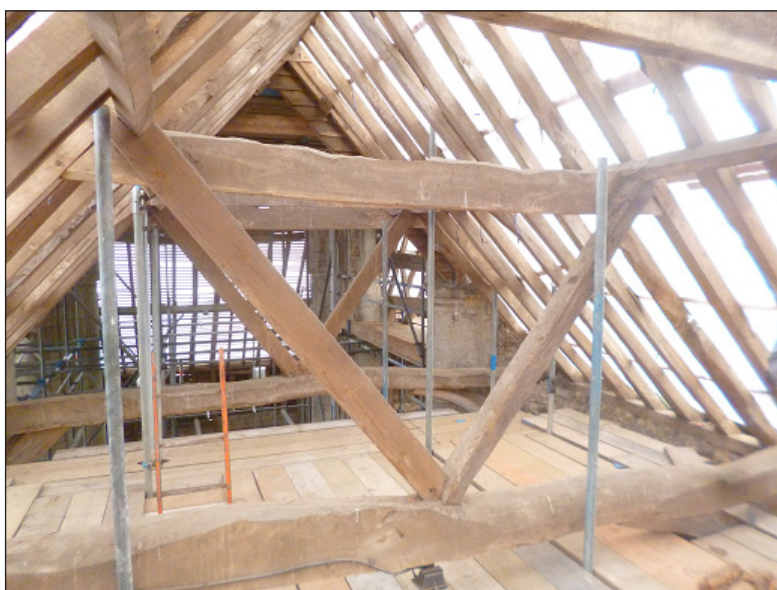
Fig 1: View of typical roof truss (all elm)

Your reference (<i>phase</i>)	Roof
Description of phase or feature (<i>please attach plan for showing location & photos</i>)	
Roofs generally of principal rafter with tiebeam and collar trusses with raking queen struts from tie to collar. Trusses support single purlins which in turn support common rafters (Fig 1). Additional, diagonally set (pine?) timbers used at central crossing. Almost all these roof timbers are believed to be of elm, though some common rafters may be of pine and some other type of softwood. None of the roof timbers appear to be of oak.	
How many timbers could potentially be sampled?	150+ elm timbers 15+ pine/other timbers
How many rings do the timbers have? (approx)	30 to 50+ (elm) 40+ to 100+ (pine/other)

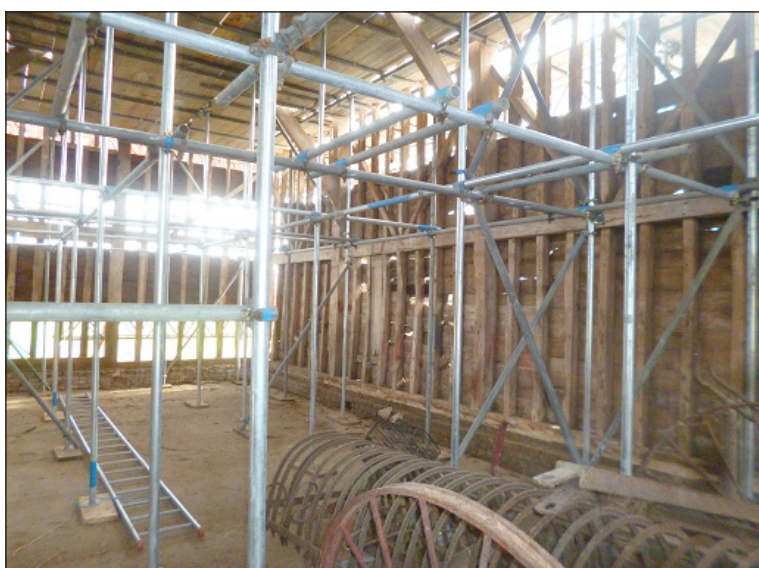
Fig 2: View of the wall framing (mostly elm)

Your reference (<i>phase</i>)	Timber framing
Description of phase or feature (<i>please attach plan for showing location & photos</i>)	
Framing of posts, sill-beams, cross-rails, and studs, with some diagonal bracing (Fig 2). Again, almost all this framing is believed to be of elm, though there may be one or two timbers of pine and some other type of softwood. However, amongst this framing, there are a few oak timbers forming two main posts, two or three studs, and possibly a short cross-rail to the front of the building, plus a sill beam to one side (Fig 3a/b). A further oak timber, used as a lintel, is now ex-situ (awaiting disposal) but is stored on site (Fig 3c). In addition there are three, probably reused, oak beams to the ceiling of the crossing (Fig 3d). It is possible, though unlikely, that one or two further timbers may be uncovered.	
How many timbers could potentially be sampled?	150+ elm 5+ pine/other softwood 8 – 12 oak
