Latton Priory Farm, North Weald Bassett, Essex: Historic Landscape Investigations

Discovery, Innovation and Science in the Historic Environment

Latton Priory Farm in the ancient parish of Latton, south of the area which from 1947 became Harlow New Town, contains, preserved within its agricultural buildings, the remains of the early 14th century priory church of St John the Baptist. The date of this small Augustinian priory's foundation, along with the identity of its founder, in common with many small houses of the Augustinian order are unknown, however it is likely that a priory has existed on the site since the late 12th century. The church of St John the Baptist and its attendant claustral buildings appear, from the remains of the priory church's crossing, nave and transepts to have been completely rebuilt in the early 14th century, and sat within a trapezoidal precinct defined on all four sides by a wet moat. The rebuilt priory, one of 11 Augustinian houses founded in Essex after the priory of St Julian and St Botolph Colchester in 1104-06, was surprisingly grand given its very small community, which at the time of its foundation numbered just three brethren and throughout it

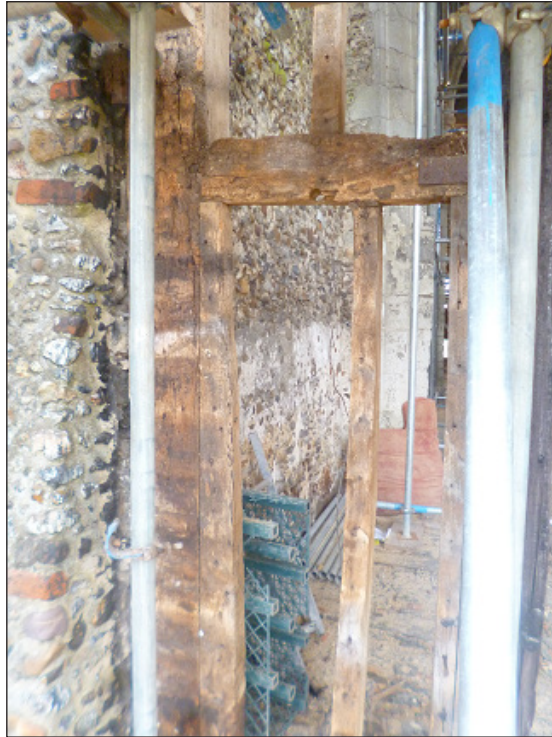
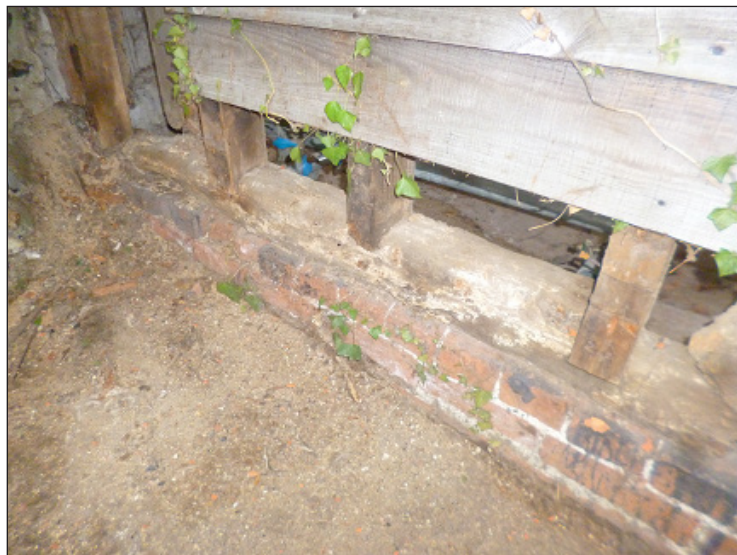
Figures 3a/b: View of the oak posts and studs (top) and the oak sill beam (bottom)

How many rings do the timbers have? (approx)	30+ to 50+ (elm) 50+ (pine/other) 40+ to 60+ (oak)
What is the approx size of the timbers?	20X20 cms (oak posts/ceiling beams/sills) 10X10 cms (oak studs) 15X10 cms (oak ex-situ beam) 20X20 cms (elm posts/sills) 10X10 cms (elm studs/rails) 10X10 cms (pine/other studs)
Details of timbers (<i>eg sapwood/bark edge/fastgrown, etc</i>)

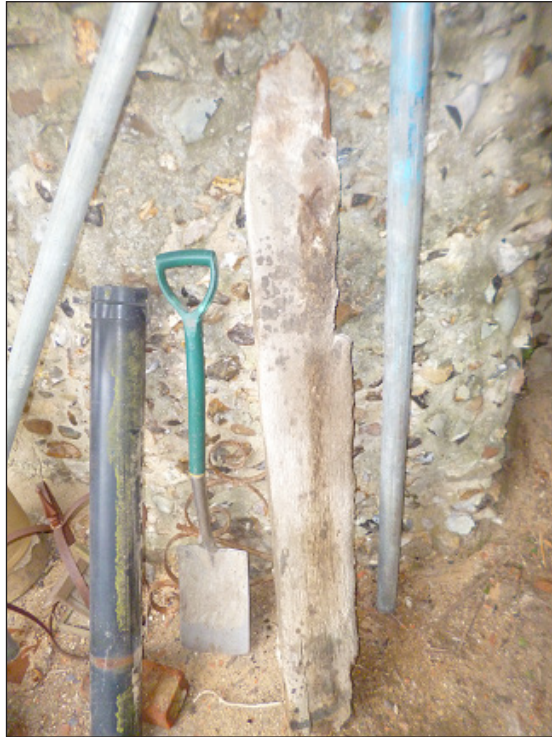
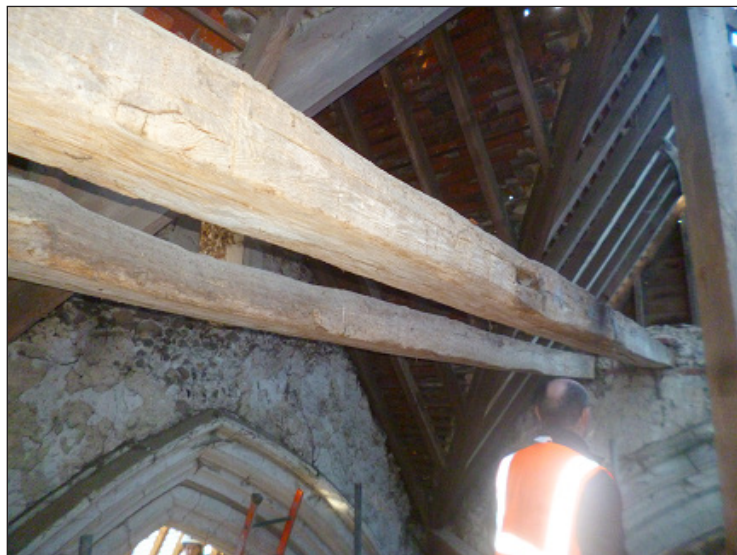
Figures 3c/d: View of the oak ex-situ timber (top) and the oak ceiling beams to the crossing (bottom)
