BELSAY CASTLE, NORTHUMBLERLAND Site Archive Completion and Assessment for Belsay Castle evaluation, June 2018

Site Archive Completion and Assessment For Belsay Castle evaluation, June 2018

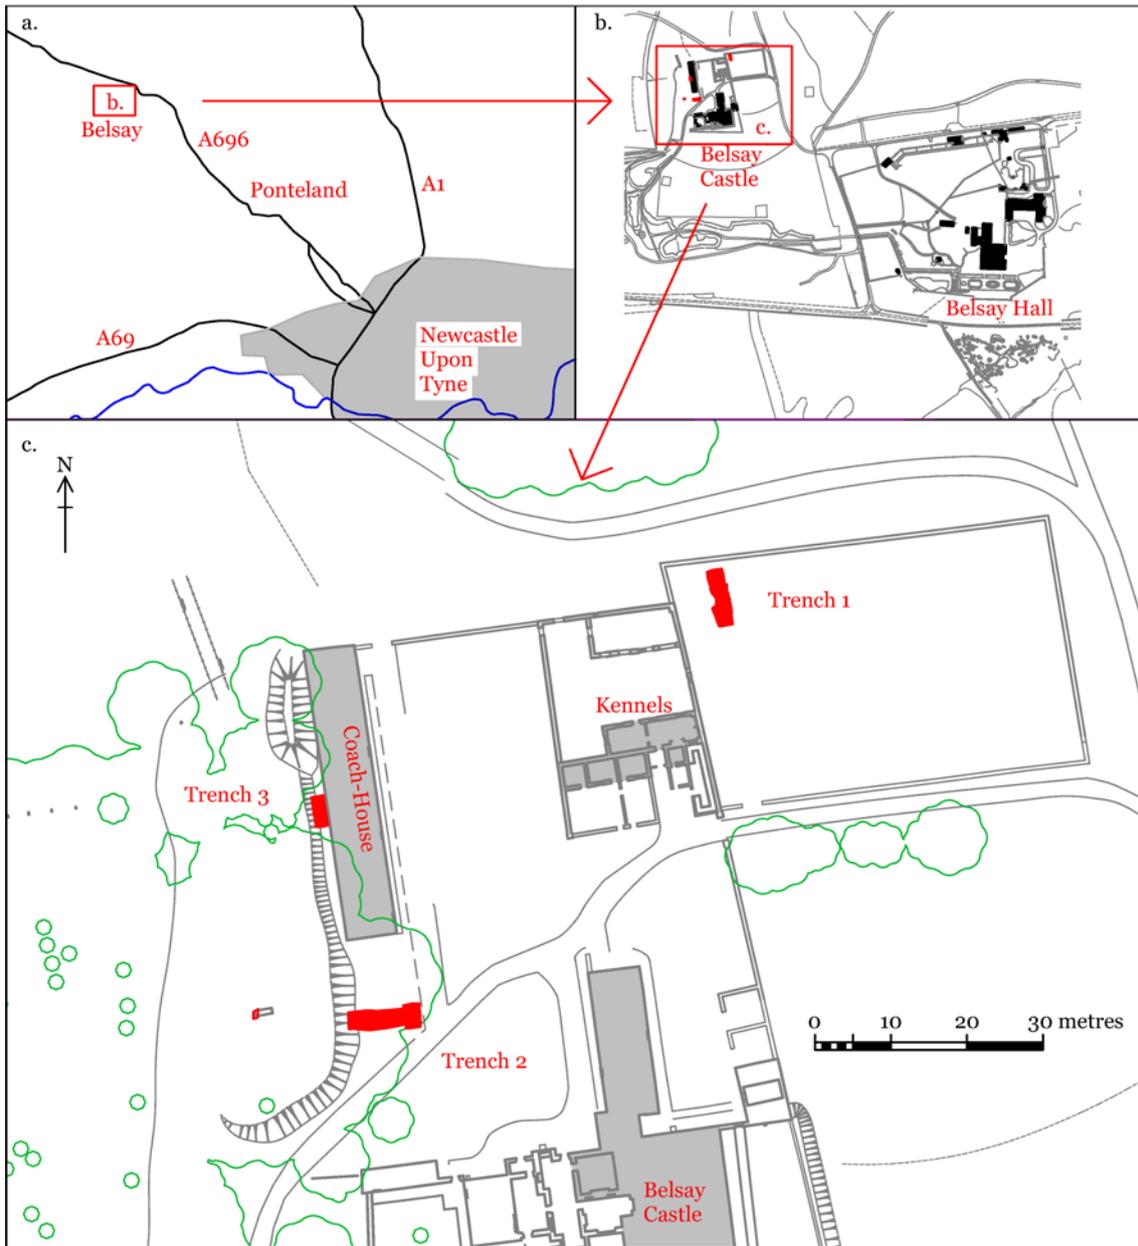
Figure 1: Site and trenches location plan.

At the time the evaluation project design (Cromwell 2018) was being developed the plan was to submit a Stage 2 bid to HLF in the autumn, leading to urgency to carry out the evaluation in May or June 2018 at the latest. The project design proposed four trenches (see Fig 1) – one behind the coach-house to explore the west side, two to the south of the gable-end of the building (to work around an existing tree), and a fourth in the orchard. Each was to be opened by machine under watching-brief to remove modern topsoil before hand-excavation of archaeologically significant features by a small team. In the event it proved impossible to place a trench near the gable wall, north of the tree, so this trench was dropped. Excavation ran for three weeks, from 11-29 June. All trenches were duly backfilled at the end.

Trench 1 (see Fig 1) was located in the northwest corner of the orchard, extending south from the north wall in order to catch the ‘trackway’ feature reputed to run around the perimeter as seen on the early OS maps and reported in the 1985 excavations (Kerr 1985, 1986 & pers. comm.)(Fig 2). The southern third of the orchard is in the Schedule area, so was avoided.

Trench 2 was placed on the small open green south of the coach-house (see Fig 1). This wedge of land is dominated by a large tree, so the trench had to be located 9.5m away from the south gable wall. It measured 9.2m long by 3.2m at its widest. Because the west end extended into a bank of soil the overall depth below ground surface tapered from 0.75m at the west to 0.3m at the east. The east end of the trench was extended slightly to expose the walls that originally appeared in section.

Trench 3 was placed on the west side of the coach-house to look at the wall footings and general soil profile, since this area might be reduced in height to accommodate a terrace in the new café scheme. (Figs 1 & 11) The 4m x 1.6m trench was placed against the centre of the back wall, directly under an area of sagged and repaired brickwork that corresponds with 1980s photos of roof collapse. It should be noted the entire area behind the building is approximately 1.4m above the threshold height on the east face of the building.

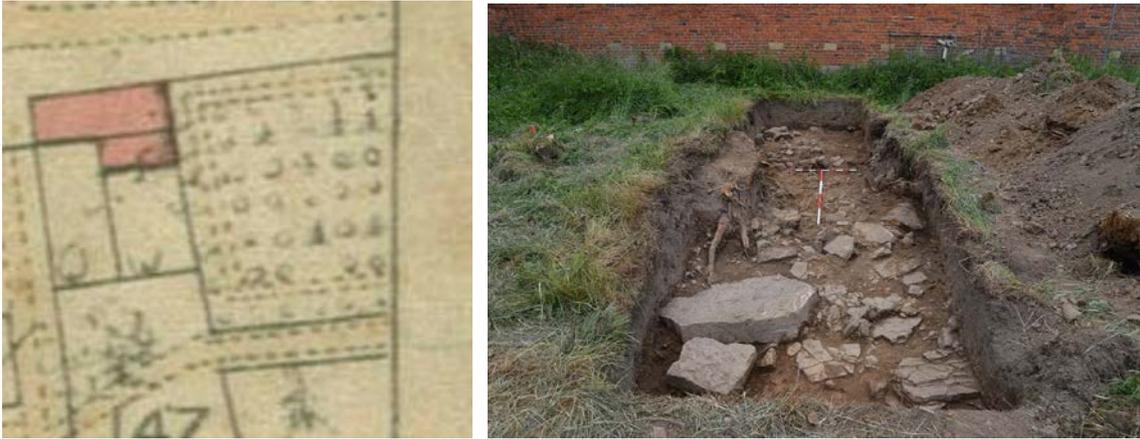
Figure 2 (L): Orchard path from 1st Ed OS map.

Figure 3 (R): Trench 1 looking north. Stump is visible on left of trench.

The trench measured 2m wide by 7.4m long, with its edges 2m south of the north orchard wall and 4.2m east of the west wall - the presence of modern materials piled against the walls prevented closer contact. (Fig 3, Fig 5)

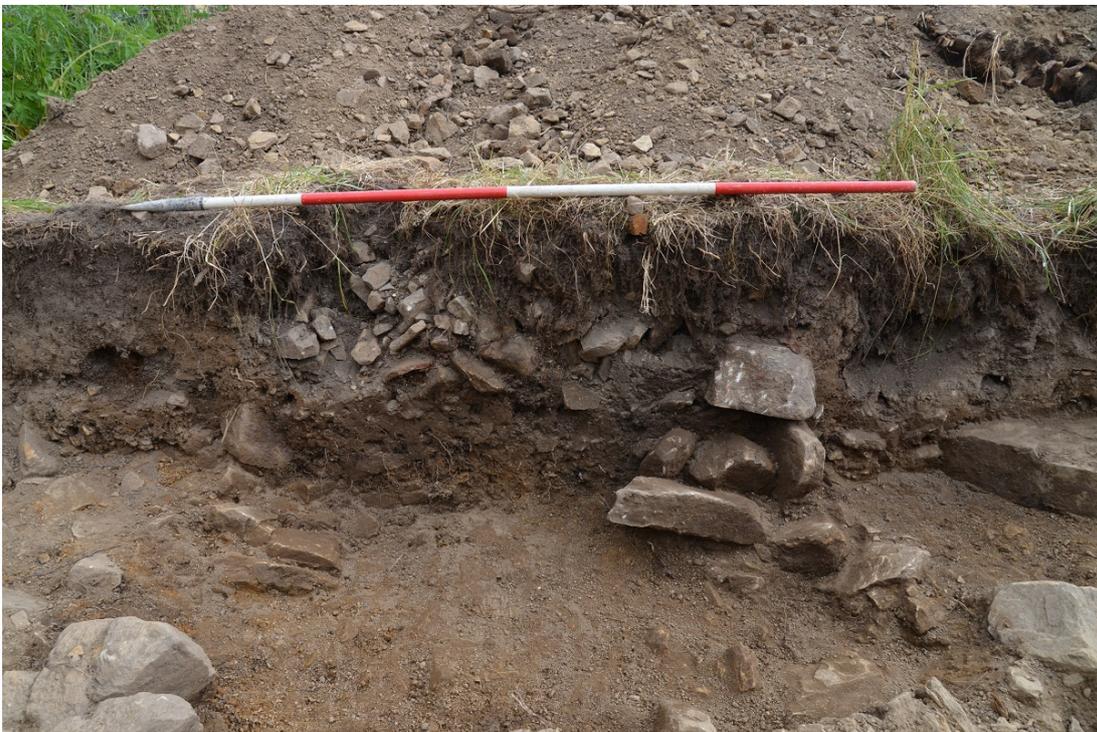
Figure 4: Linear feature seen in east section of Trench 1.

Below the modern turf (91006) was a brown soil (91001) through which a single large linear feature [91003/91004] was cut. This feature spanned the width of the trench, starting 2m from the north edge, and was 1.9m across, with a depth of 0.5m. It was filled with brown soil mixed with large amounts of stone fragments, as well as occasional fragments of what appeared to be ceramic roof tile. A large tree root had grown along the feature. Below the soil (91001) was a band of subsoil (91002) approximately 0.2m thick, which in turn overlaid the top of the boulder clay natural (91005) across the entire trench. The boulder clay contained extremely large stone fragments, some measuring over 0.5m in both width and length, and started approximately 0.6m below present ground surface.

The sole feature was interpreted as a possible robber trench where a wall was demolished and its foundations quarried for re-usable stone, before being backfilled with whatever fragments were deemed unwanted (Fig 4). The alignment of this feature suggests it might be an earlier north wall to the orchard, lining up with the northeast corner of the Castle enclosure wall (Fig 5). The present north wall is made of handmade bricks on its south façade and stone on its north, and runs 6m north of the perimeter wall, with a definite corner at its west end where it turns south to meet the stone perimeter wall. There was no sign of the ‘trackway’ (Fig 2) within the trench seen on the first-edition OS 25inch map (LXXVIII.4, published 1866) – either this ran in the narrow 2m gap between the trench and wall, or it did not exist at this location.

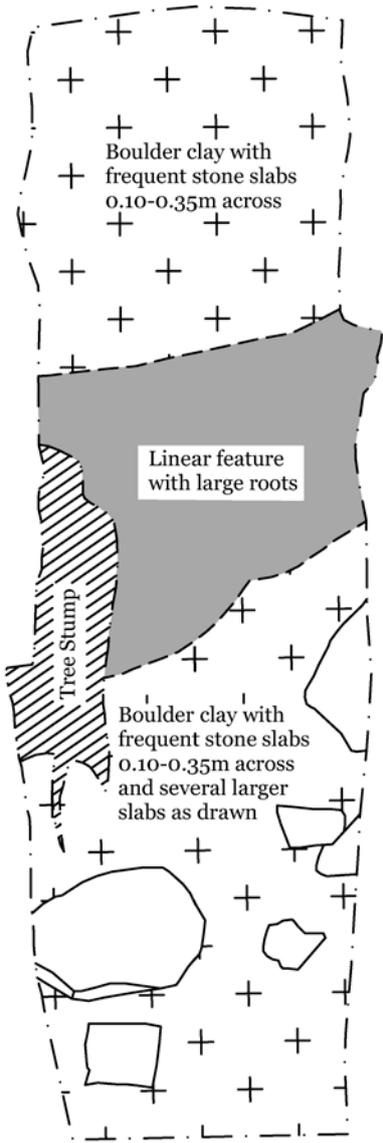
Figure 5: 1:50 Plan of Trench 1 showing linear feature [91004].

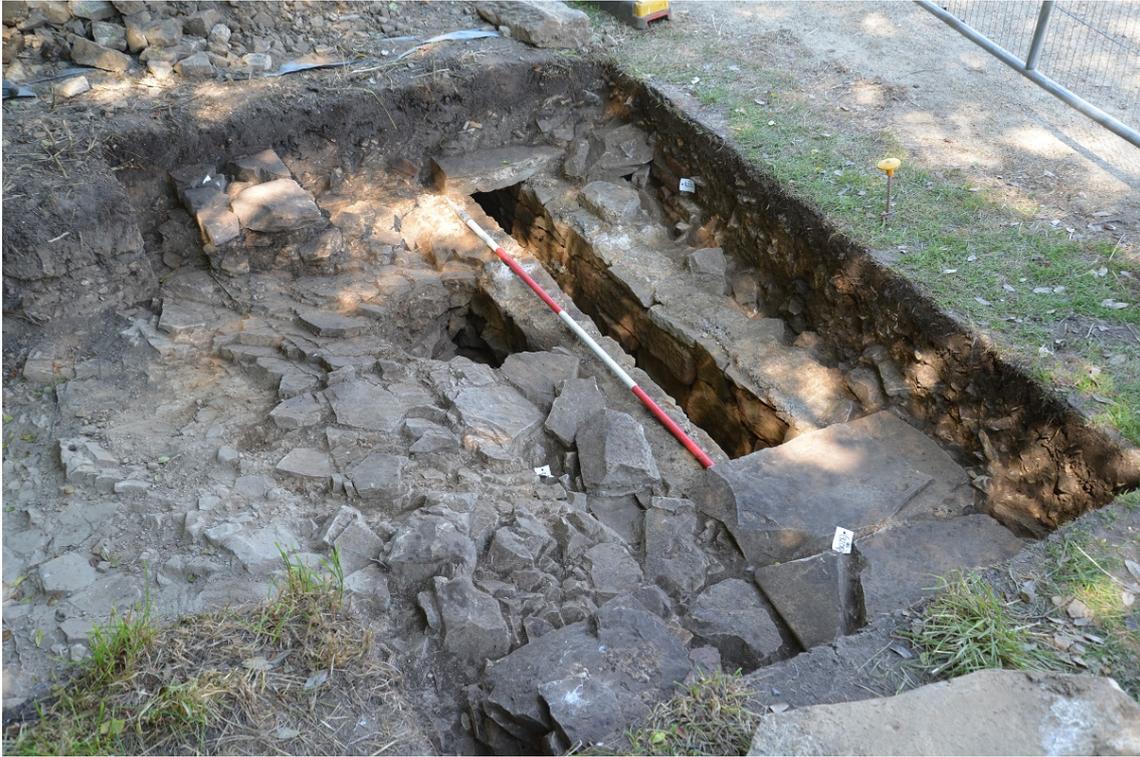
Figure 6: Trench 2, drain 92020 (opened) and wall 92009 (two stumps at either side of trench).

East wall [92009] survives to a height of two courses at the south, but only one at the north, and is 0.4m wide. There is a gap in the wall that nearly corresponds to the trench as originally machined, hence the need to extend half a metre in both directions to examine the wall. The north portion is a bit ragged, but the south part has a clear straight edge at the gap, confirming that there was a planned opening here. It stands on a fill of small stone fragments (92011) in a cut [92013].

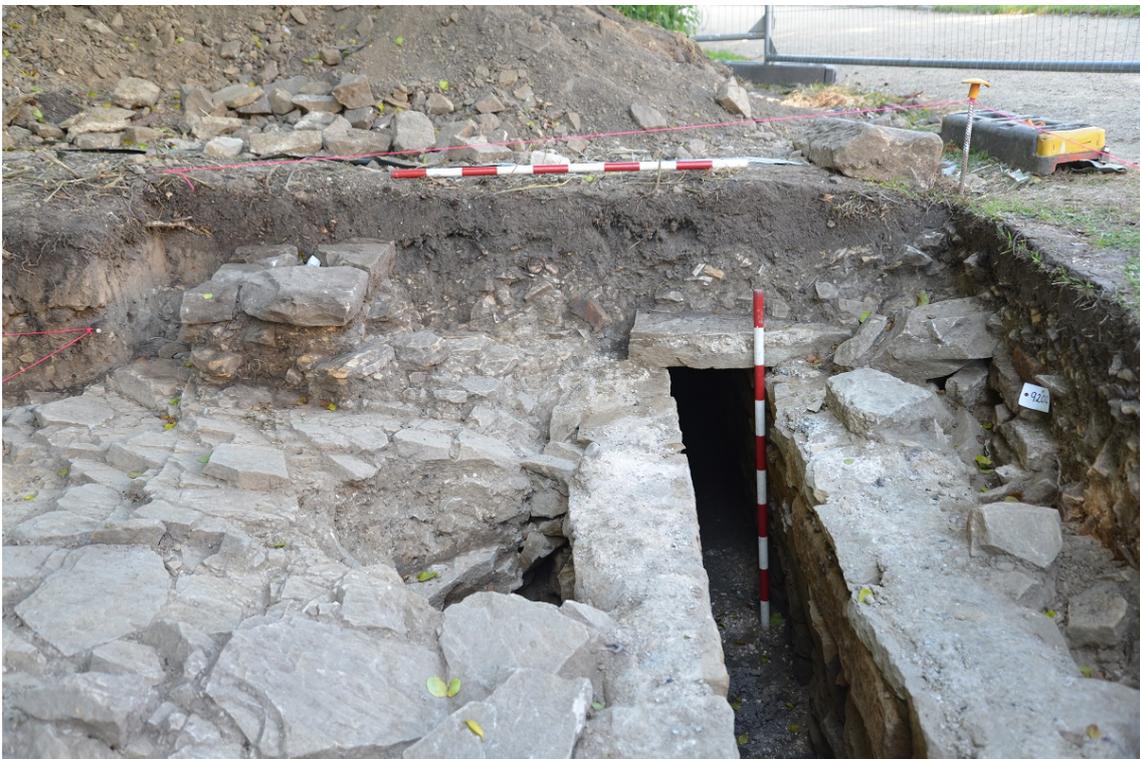
Figure 7: Trench 2, drain 92020 (opened) and wall 92009 on left.

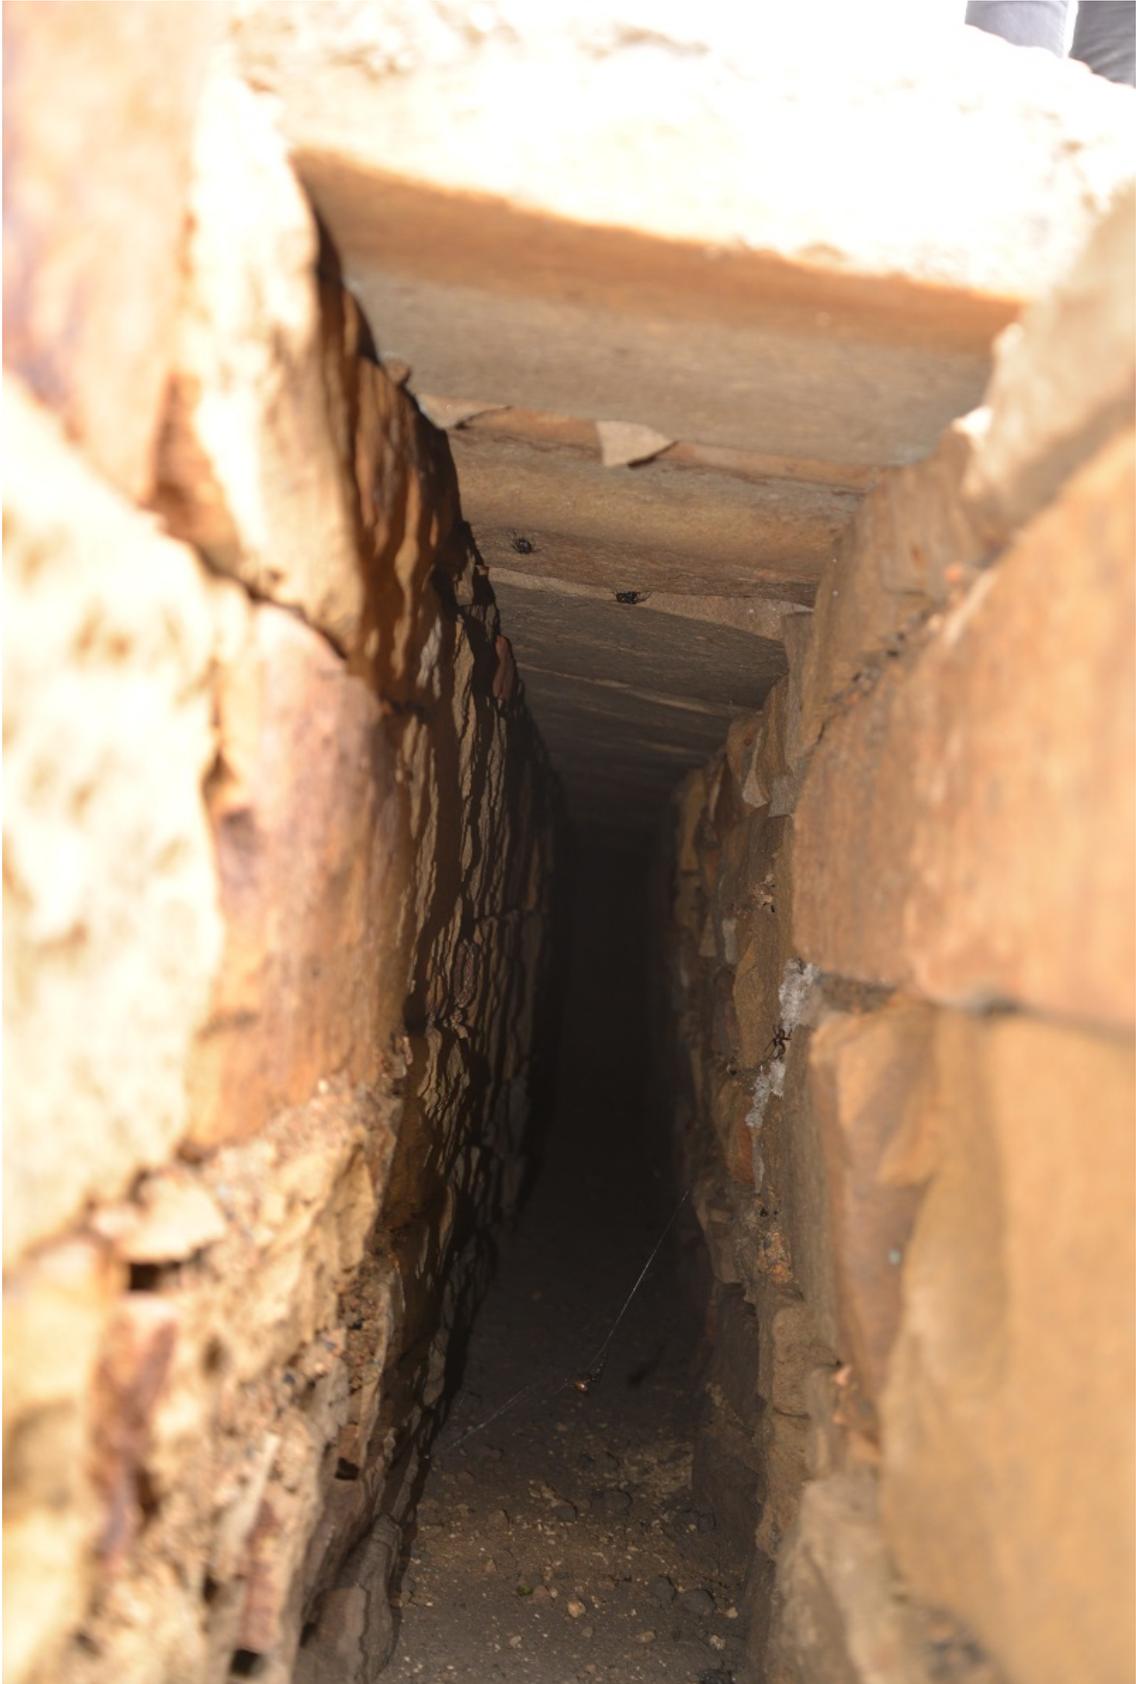
Figure 8: Trench 2, view inside drain 92020, looking north towards coach-house.

Below the topsoil the east end of the trench was covered by soil layer (92005), which butted up to the earlier wall [92009] and sealed the drain. Below the soil was a line of rectangular slabs [92010] that formed the drain capping. Some of these slabs were clearly recycled masonry from other buildings, a phenomenon seen elsewhere such as at Apethorpe Hall in Northamptonshire (excavated by author in 2007). The drain is built of two stone walls, with a channel 0.2m wide by 0.8m deep to a stone base, and had only a thin layer of silt at the bottom (Fig 10). At least one opening was seen in the east side wall near the base, indicating side-channels running out under the gravel path. The drain stands in a cut [92021] filled with a mix of soil and stone fragments (92022) that clearly laps over the cut and foundation fill of the east wall, indicating it was added some time after the wall (and its attendant structures?) had been built. The line of the drain was observed for a number of metres in both directions (Fig 8), and appears to run along the front of the coach-house. The southern extent is less clear, but it lines up with a large resistivity anomaly (r5) from the recent geophysical survey (Linford, N, P Linford, and A Payne, 2017), just north of the surviving manor ruins, and this may be a deep sump. At the north end of the drain the slabs were covered in mortar (92017), and the end of a brick wall [92012] was seen in the east section, standing just east of the slabs. It appears that at some point after the drain was constructed a brick structure was built running east under the current gravel path, and there may have been some work to investigate the drain that led to the slabs being mortared back into place. This brick structure stands almost directly above a side-channel opening seen in the wall of the drain. A soil-filled deposit (92018) was seen in section south of the bricks, also covered by (92005).

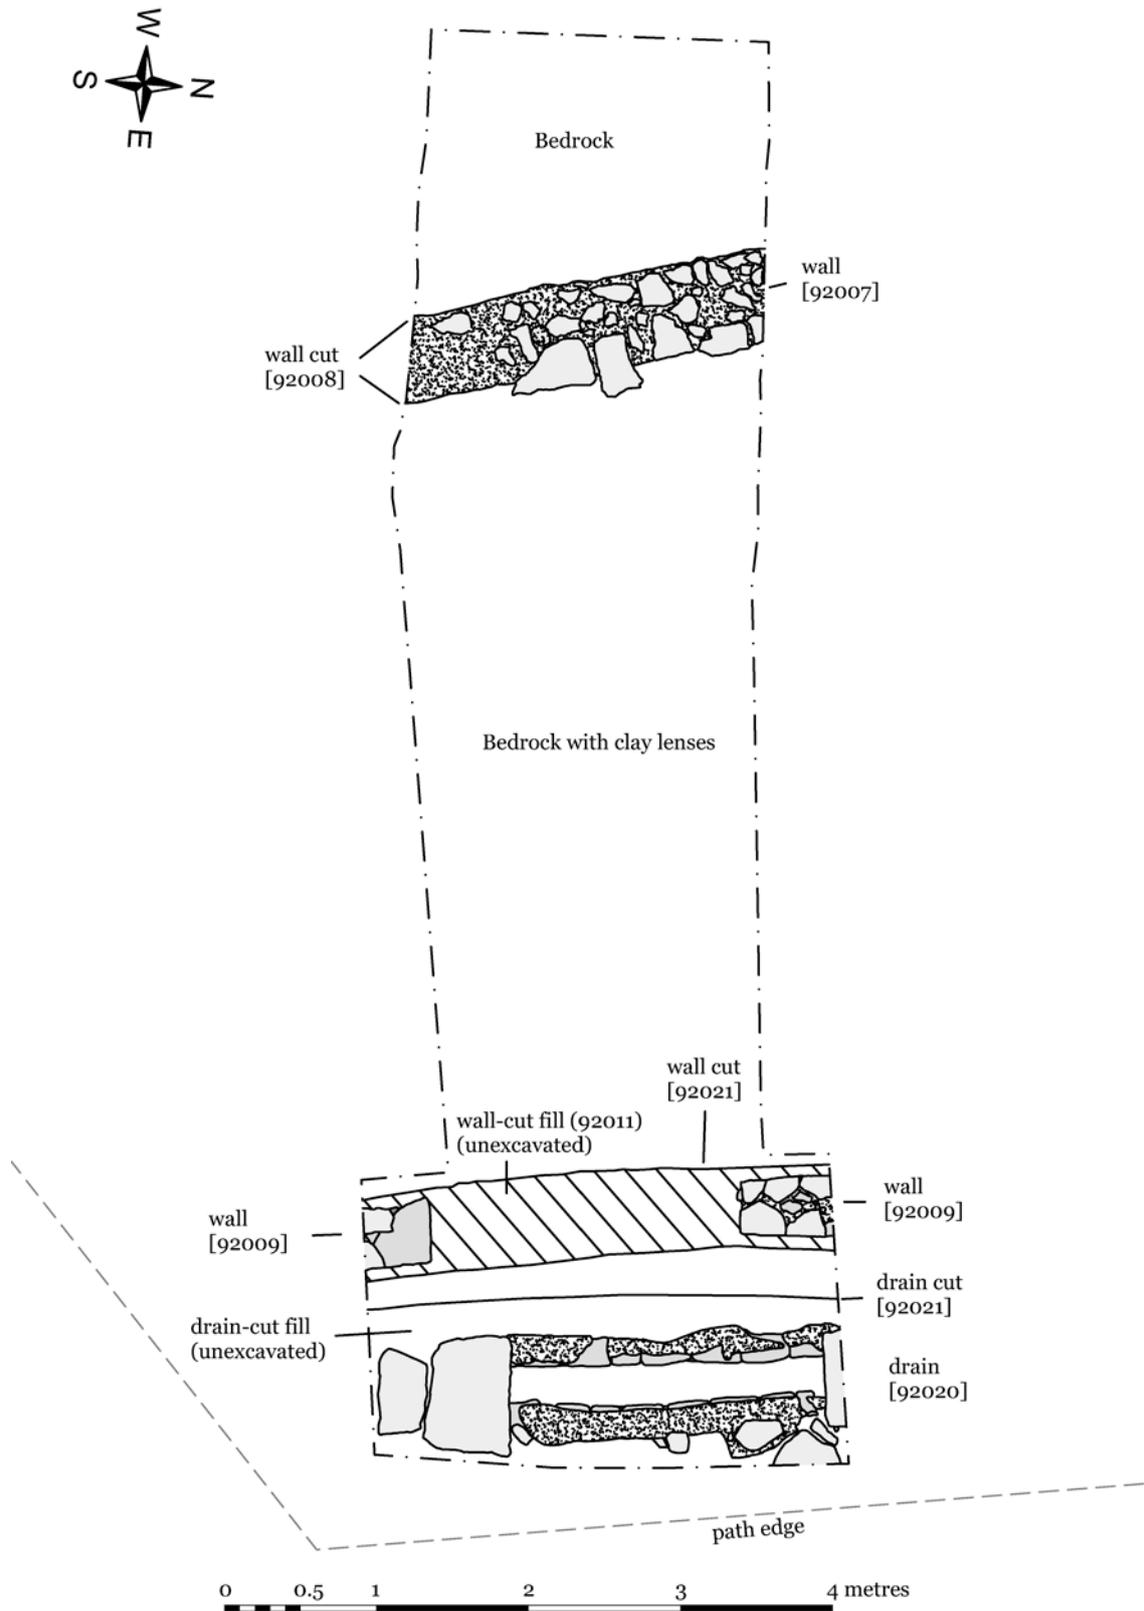
Figure 9: Plan of Trench 2 showing drain at bottom, walls 92009, and wall 92007.

The three key features in this trench were the footings of a wall [92007] near the west end, another wall [92009] near the east end, and a drain [92020]. (Fig 9)

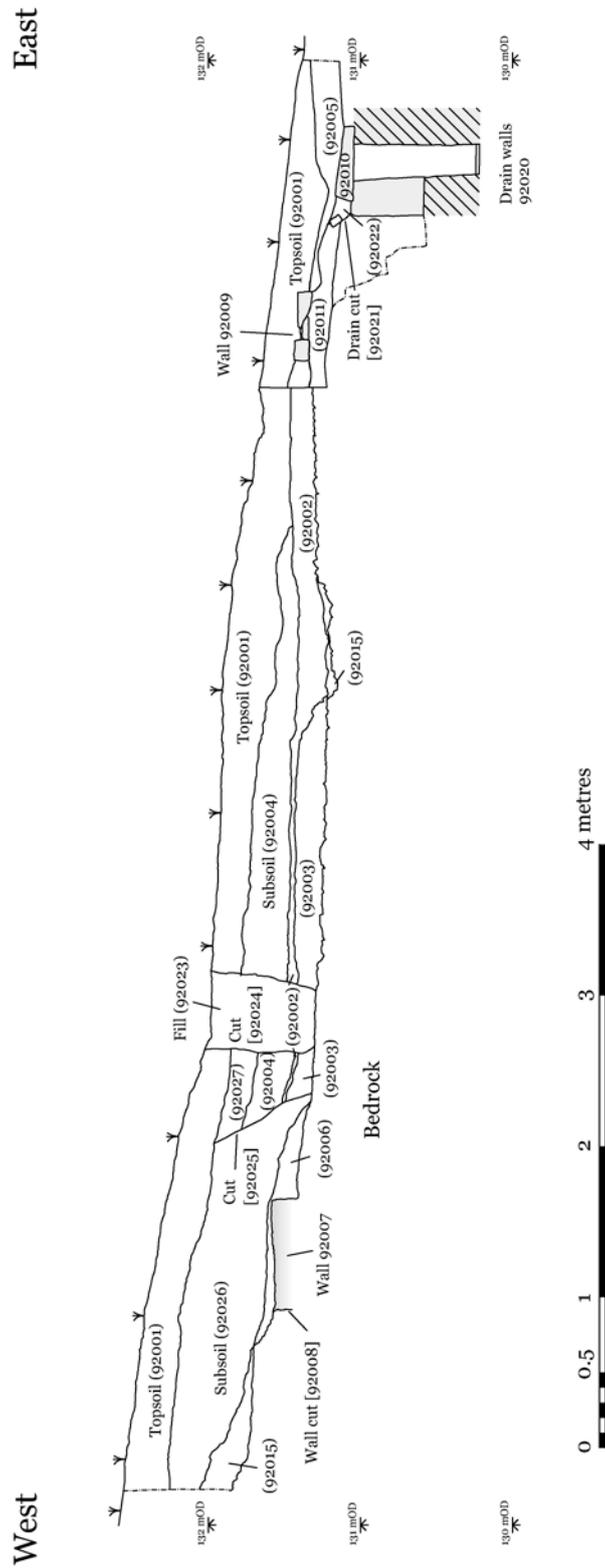
Figure 10: South-facing section of Trench 2, looking north towards coach-house, showing walls 92007, 92009, and drain 92020.

Below the modern turf the most recent feature was a deep narrow cut [92024] and fill (92023) in the middle of the north edge of the trench that extended down to bedrock at the base of the trench, effectively dividing the north side in half. It cut into the topsoil (92001) that effectively sealed all the archaeological deposits. (Fig 10)

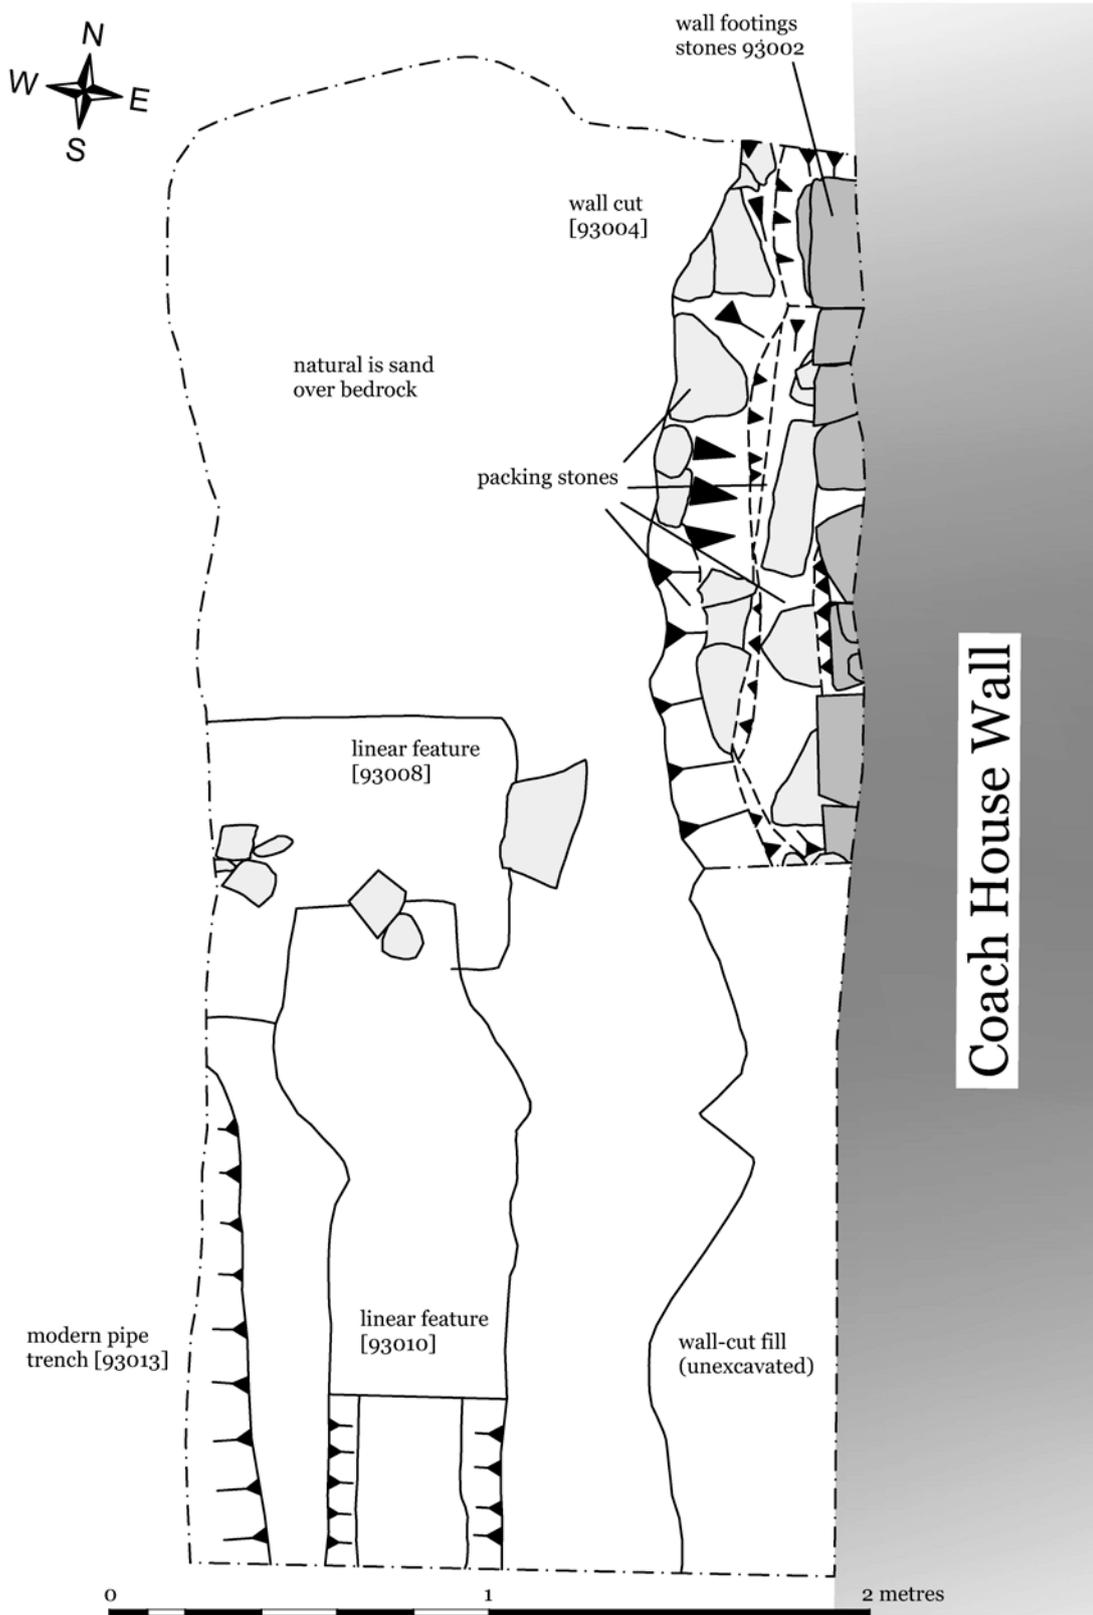
Figure 11: Plan of Trench 3, showing wall cuts and modern pipe trench.

The wall cut was divided into two records - cut [93004] in the north half of the trench and cut [93016] in the south - because there appeared to be a distinct curving-in towards the wall in the middle, suggesting two different digging actions working in from opposite ends. (See Fig 11) Wall cut [93004] was filled with a brown soil (93003) that had large stones packed into the base of the cut. The upper reaches of the fill were distinctly more friable than the topsoil, but aside from a lack of stones it was impossible to see the difference between fill and topsoil, suggesting it was a recent cut backfilled with topsoil. The result is that it is unclear if any original wall-cut fill remains due to re-excavation in recent times. Where the cut continues down into the yellow sandy natural soil the outer edge is lined with stones – it is unclear if these are natural or perhaps the lining of an earlier feature whose contents have been removed.

An L-shaped linear feature [93010] ran up the middle of the trench from the south edge to just beyond halfway, before turning a right-angle away from the building and exiting the west edge of the trench. This cut was 0.5m wide by 2.3m long, and had a flat bottom that cut through the yellow natural sand to expose blue clay similar to the natural clay found in Trench 2. The fill (93009) was similar to the brown topsoil. This feature was cut by the modern service trench that encompassed the entire west edge of the trench, but sat over the fill of the southern wall cut. Unfortunately there was a lack of dating evidence that might allow better phasing. The function of this feature is uncertain. (Figs 11, 15, 16)

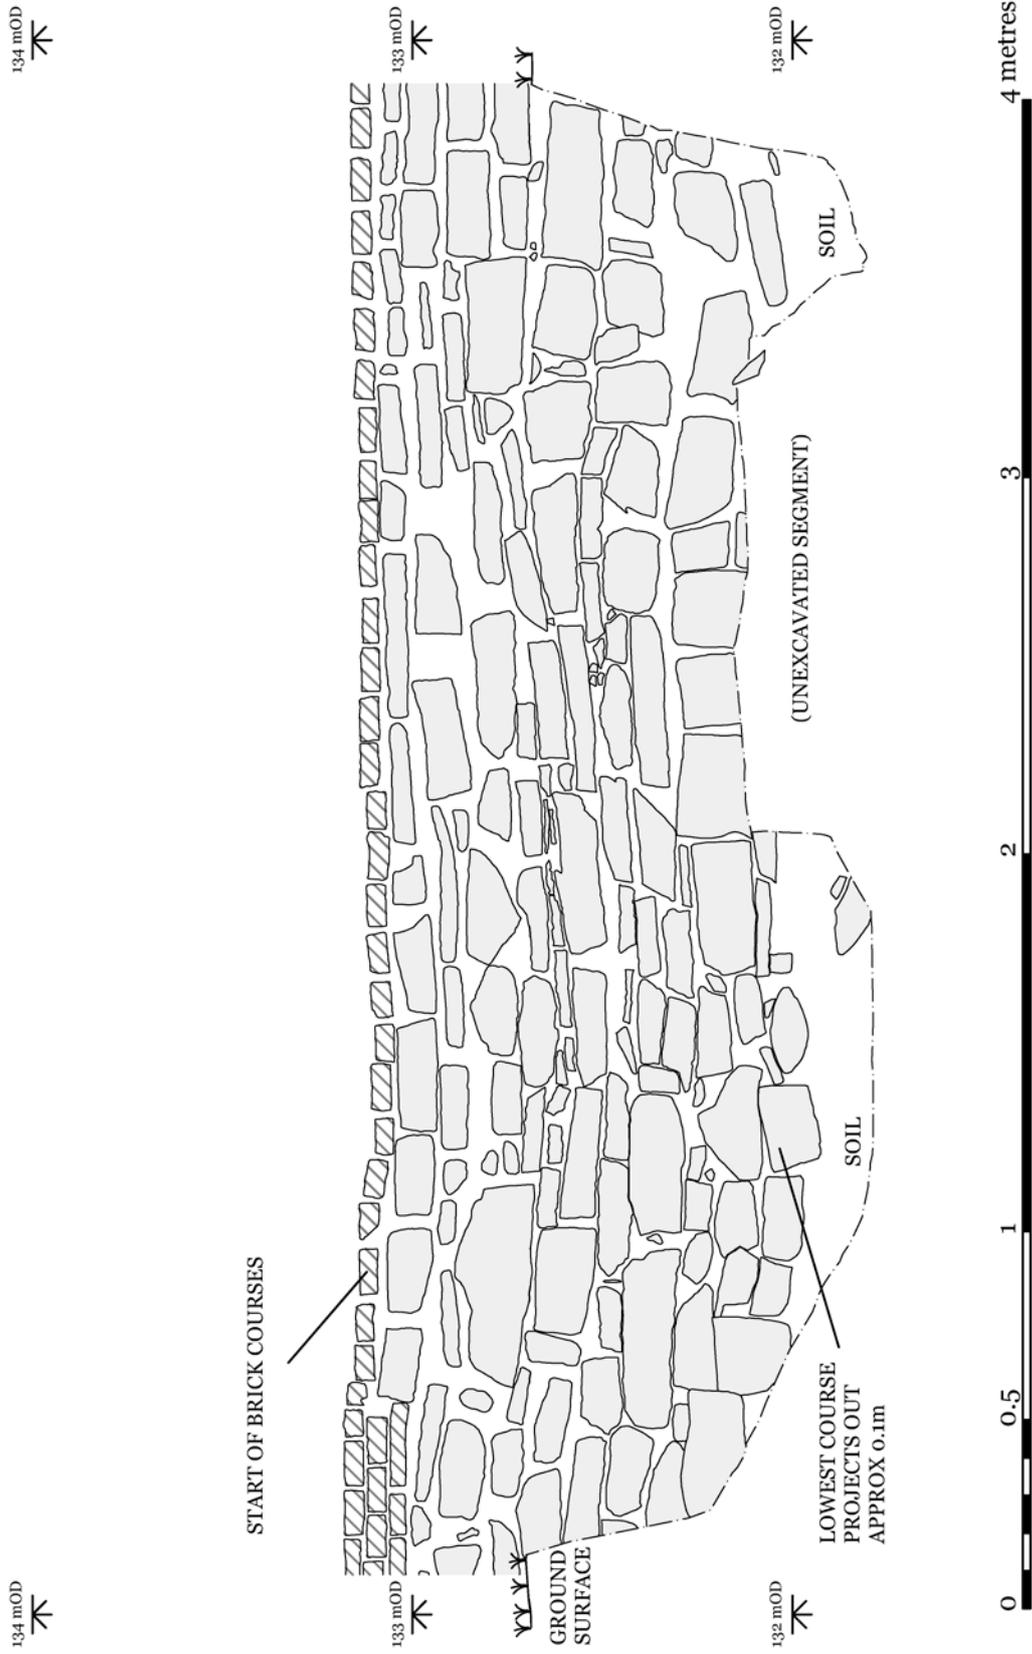
Figure 12: Elevation of the wall foundations, looking east.

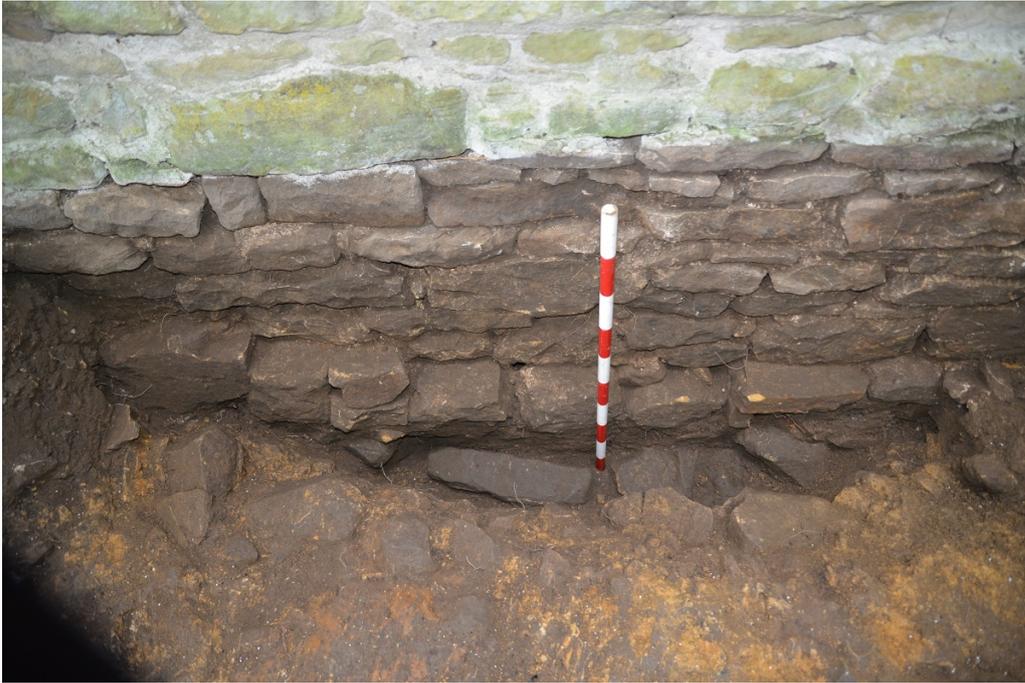
Figure 13: Wall footings (north end).

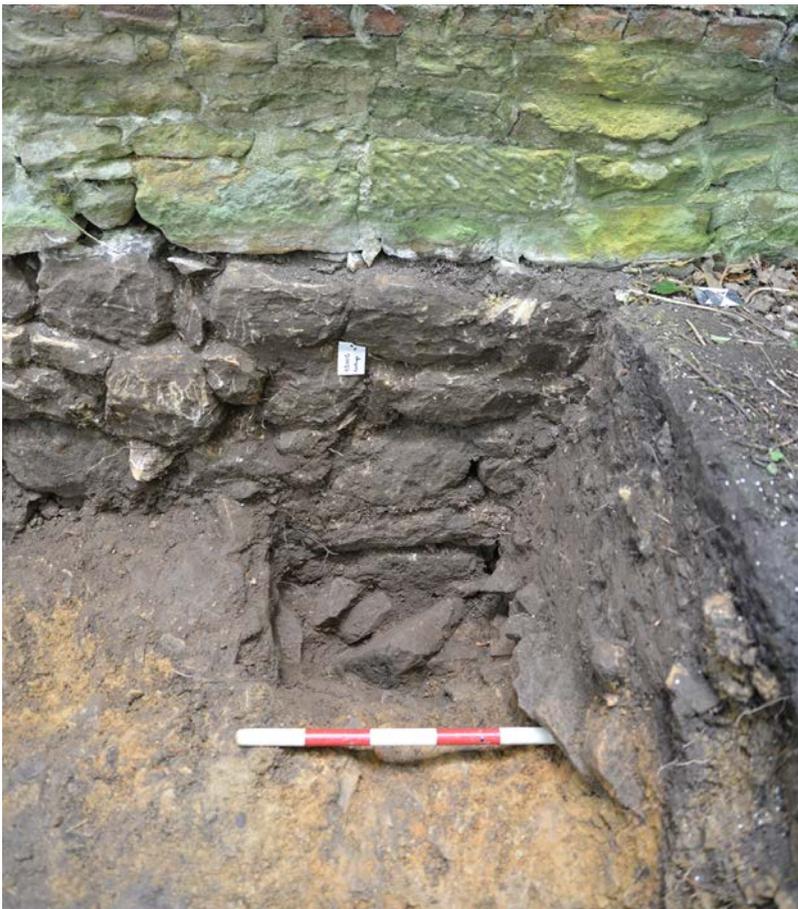
Figure 14: Wall footings (south end).

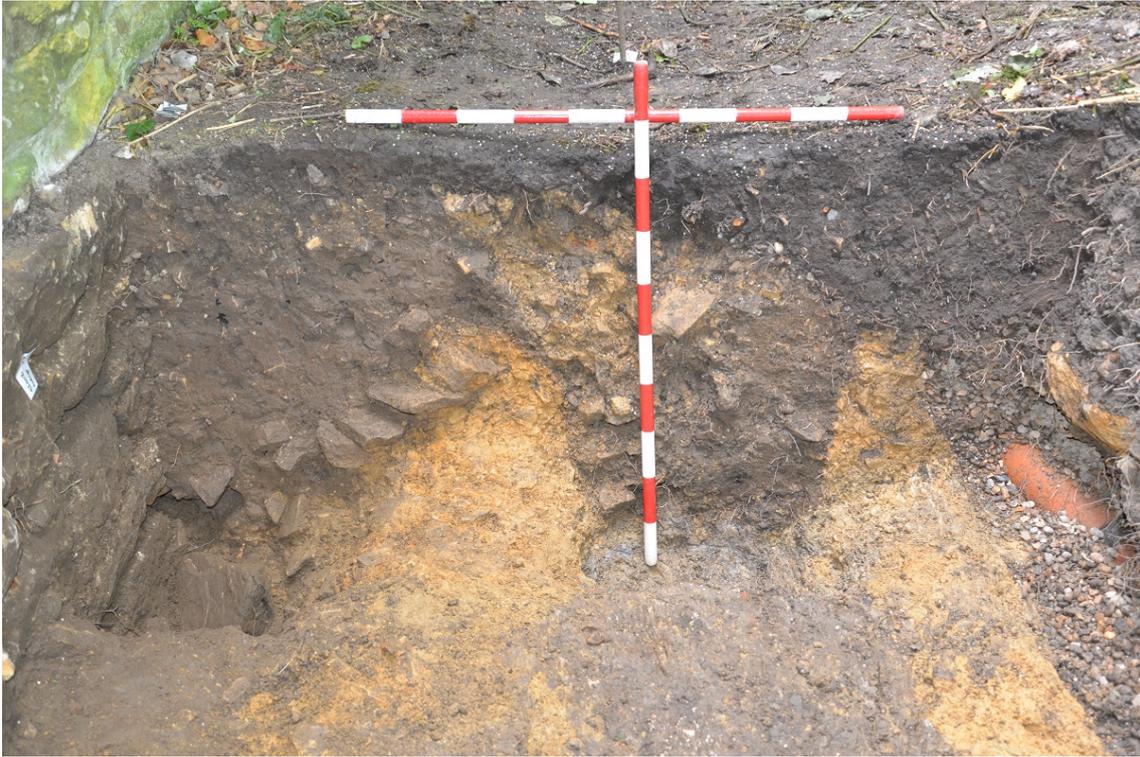
Figure 15: Section at south of Trench 3.

Wall cut [93016] at the south end of the trench seems to pre-date the other cut, and is itself cut by a later feature [93021] with a yellow fill (93020) that was originally thought to be the upper fill of another linear cut feature [93010]. (Figs 15 & 16) This section of wall cut has a distinct line of stones at its edge, suggesting they were placed in before the soil infill (93015). Again, this does not appear to be a construction cut, and suggests there is a history of trenches being dug to examine the wall footings.

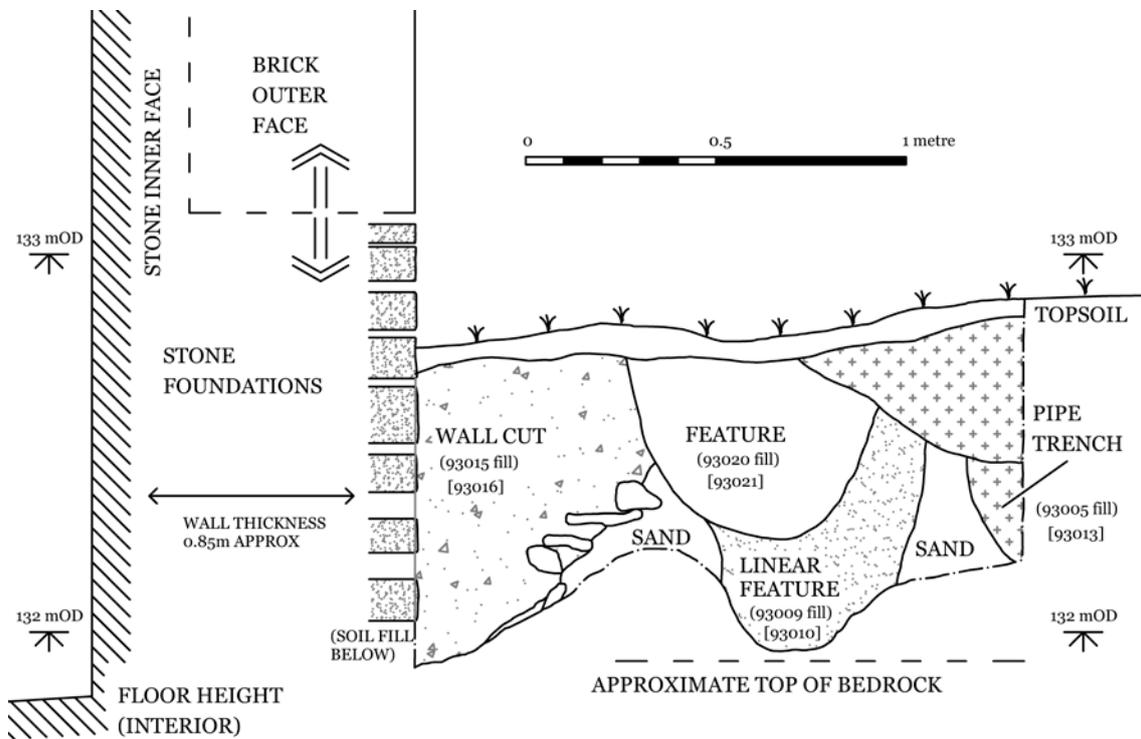
Figure 16: Section at south of Trench 3 looking south, with coach-house floor added.

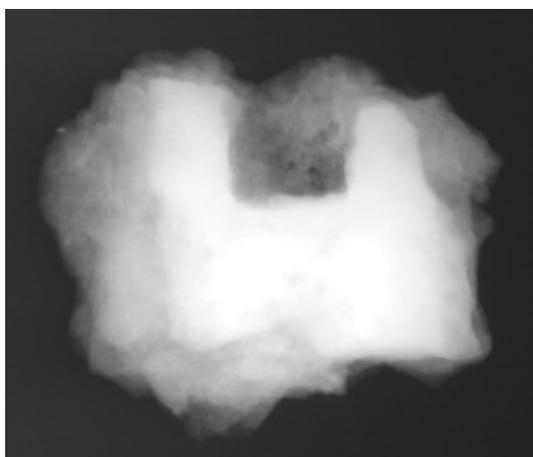
Figure 17: SF3002

Visually, SF3002 and SF3003 appear as conglomerates of corrosion and soil. X-radiography reveals that they are objects: SF3002 is very dense and only some of the form is visible. The form of SF3003 is clearly visible on the plan and side view X-radiographs.

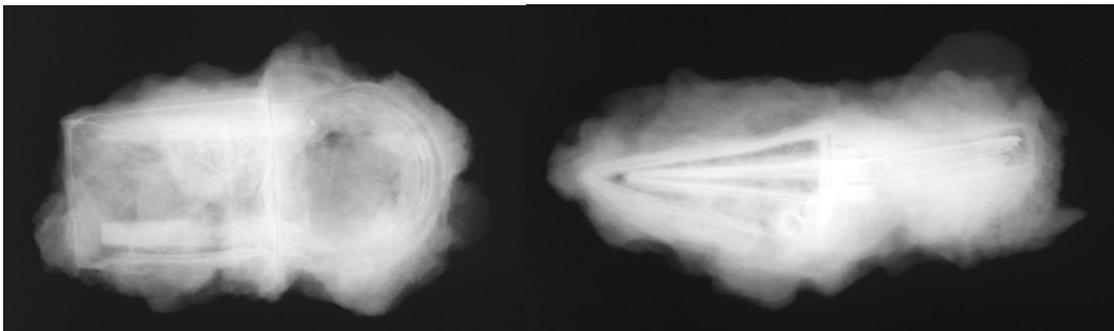
Figure 18: SF3003
