Former Central Stores of Bishop Auckland Co-operative Society,
80 Newgate Street, Bishop Auckland, County Durham
Historic Building Report

HISTORIC BUILDING REPORT

Alastair Coey Architects

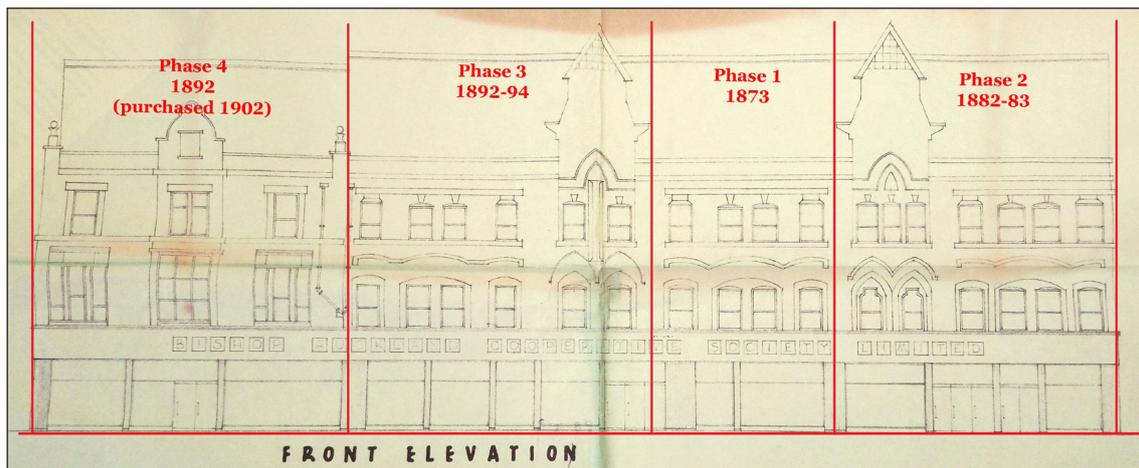
Figure 2: Front elevation of the Bishop Auckland Co-operative Society central stores, Newgate Street 1961, annotated to show the phased development of the street front.

The Bishop Auckland Co-operative Society opened its first shop on South Church Lane before moving to a shop on Newgate Street in 1862.¹ This first premises on Newgate Street was demolished in 1873 and was replaced by the earliest section of the replacement building, which is represented by a four-bay section in the midst of the existing street frontage, illustrated by Figure 2. During the following decades these premises were expanded through purchases of neighbouring shops and their replacement, first to the north (1882-83) and then to the south (1892-94). The final addition to the Newgate Street elevation was a further premises to the south, dated 1894, purchased by the Society in 1902. The street frontage provided a remarkable variety of retail showrooms and served as the ‘public face’ of the Bishop Auckland Co-operative Society.

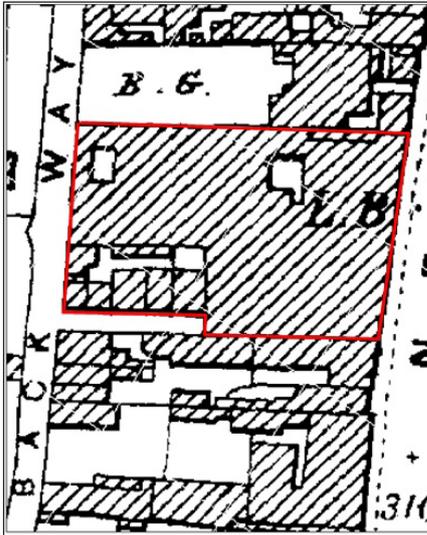
Figure 8: The co-operative stores in 1897, following the expansion in 1892-94. Reproduced from the 1897 Ordnance Survey map, 1:2500

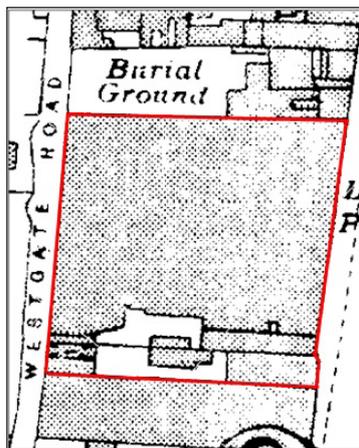
Figure 9: The co-operative stores in 1939. 1:2500. (© Crown Copyright and database rights 2019. All rights reserved. Ordnance Survey Licence Number 100019088)

As with many co-operative societies, the Bishop Auckland Co-operative was sufficiently diverse in its departments to remain financially stable into the middle of the 20th century and continued to maintain its central Newgate Street premises. The Ordnance Survey map published in 1939 shows the footprint of the central stores at its height, with additional area purchased since the publication of the 1897 map (Figure 9). Surviving proposals for a general reorganisation of the stores on

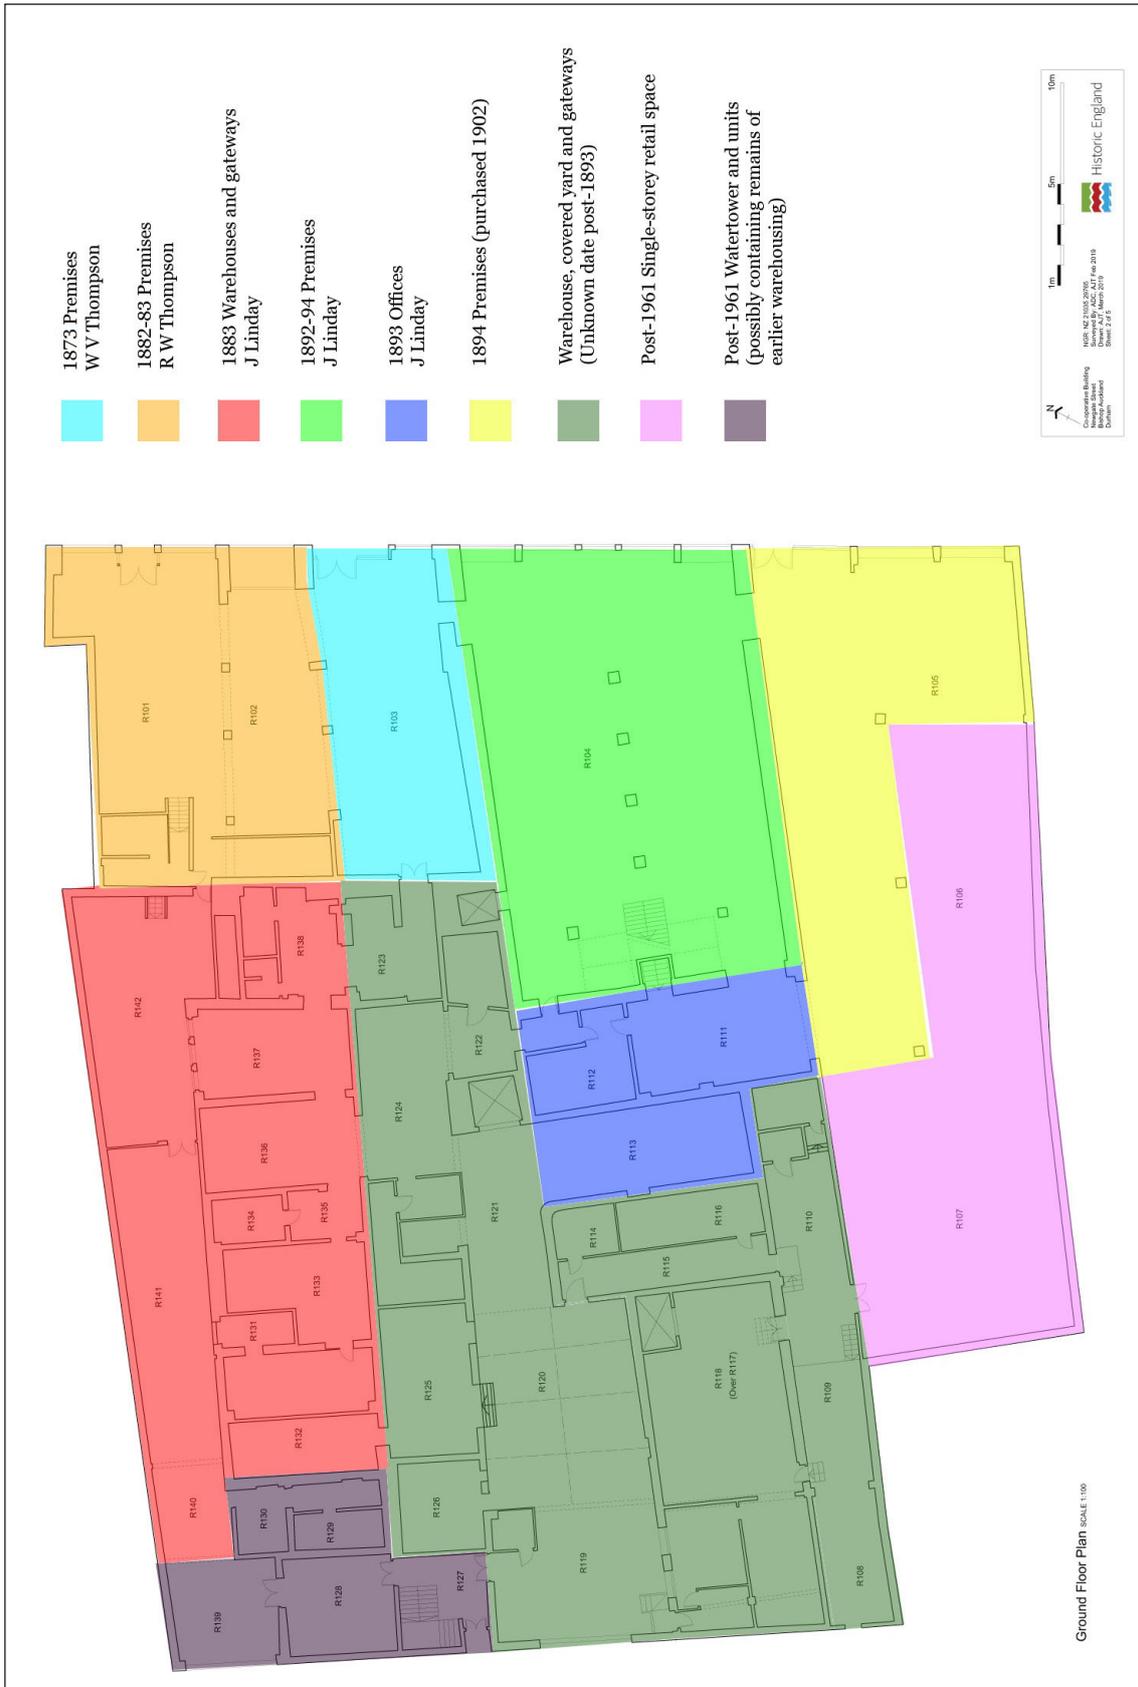
Figure 10: Colour coded block plan of the co-operative stores site showing the principal phases (Drawn by Alastair Coey Architects © Historic England)

The Co-operative building as it stands today is a phased three-storey building with a long street frontage, which is the result of at least four phases of expansion – the first involving the demolition and replacement of the original premises in 1873, extended to the north in 1882-83, to the south in 1892-94, and finally expanding in 1902 to occupy an adjoining building of 1894, which forms the southern extremity of the current street-fronted premises (see Figure 2). This was augmented by various phases of development to the rear, formerly a mixture of yards and cottages, involving the development of stores, packing areas and offices that supported the retail units along the street frontage, divided by ‘gateways’ which allowed cart movement between the spaces (Figure 10). The main phasing of this development is outlined in detail below; it was a warehouse in 1863, a large range of warehouses and offices in 1883, further offices in 1893, and another new three-storey warehouse, possibly in 1901, replaced by a water tower later in the 20th century.

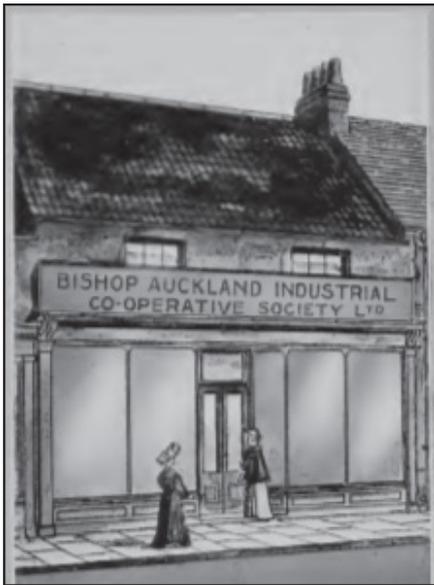
Figure 11: An illustration of the first Co-operative Society shop in Newgate Street, 1862. (From Readshaw 1910, 73: Publication out of copyright)

The published history of the Society states that from its foundation in 1860 the Society operated for about two years from rented premises on South Church Lane, but was soon in a position to purchase its own property. After lengthy negotiations, on 3 September 1862, 84 Newgate Street was purchased for £720. The property comprised a two-storey terraced building with a street-fronted shop with first-floor accommodation and a rear kitchen.⁸³ Figure 11 shows an illustration of the first premises in Newgate Street, taken from Readshaw’s history. It is not certain how historically accurate this illustration might be, and it is likely that it is an artist’s impression prepared *circa* 1910, but it gives a sense of the modest scale of the first store and its surrounding buildings.

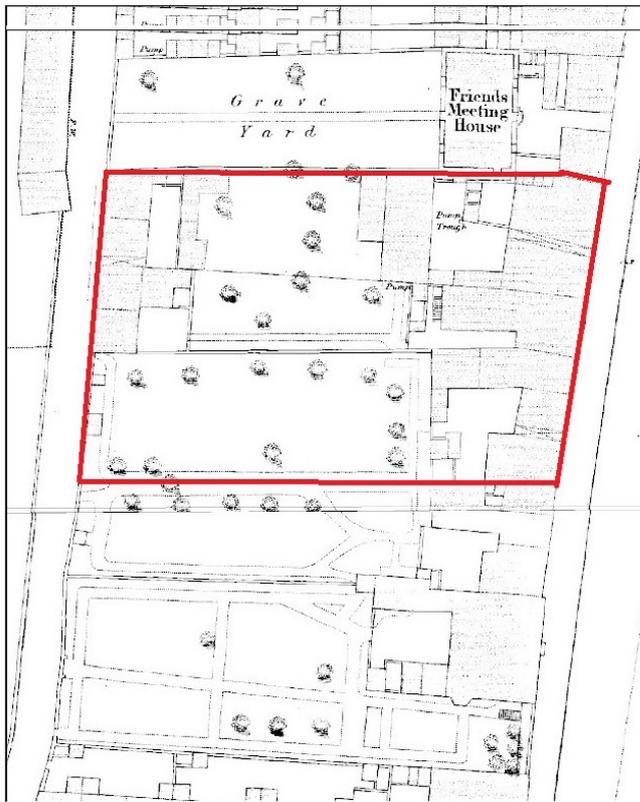
Figure 12: The site of the central stores in 1857, prior to its development. It shows a range of small premises with rear plots. Reproduced from the 1857 Ordnance Survey map, 1:500

The first edition Ordnance Survey map, published in 1857, confirms that Newgate Street was already substantially laid out by the mid-19th century, having a continuous street line and generous rear plots to most buildings (Figure 12). At the time of the establishment of the co-operative premises in 1862, the area immediately to its north was occupied by a Friends’ Meeting House and burial ground and, further north, by various small-scale buildings, including ‘cottages’ and an independent chapel which faced onto a narrow lane, Great Gates, which links Newgate Street and Back Way. To the south, a mixture of modestly-scaled commercial and domestic premises faced onto Newgate Street, with yards, workshops and low-rise warehousing behind. Generally, the surrounding buildings shown on the 1857 map have now been replaced with various, mainly two-storey

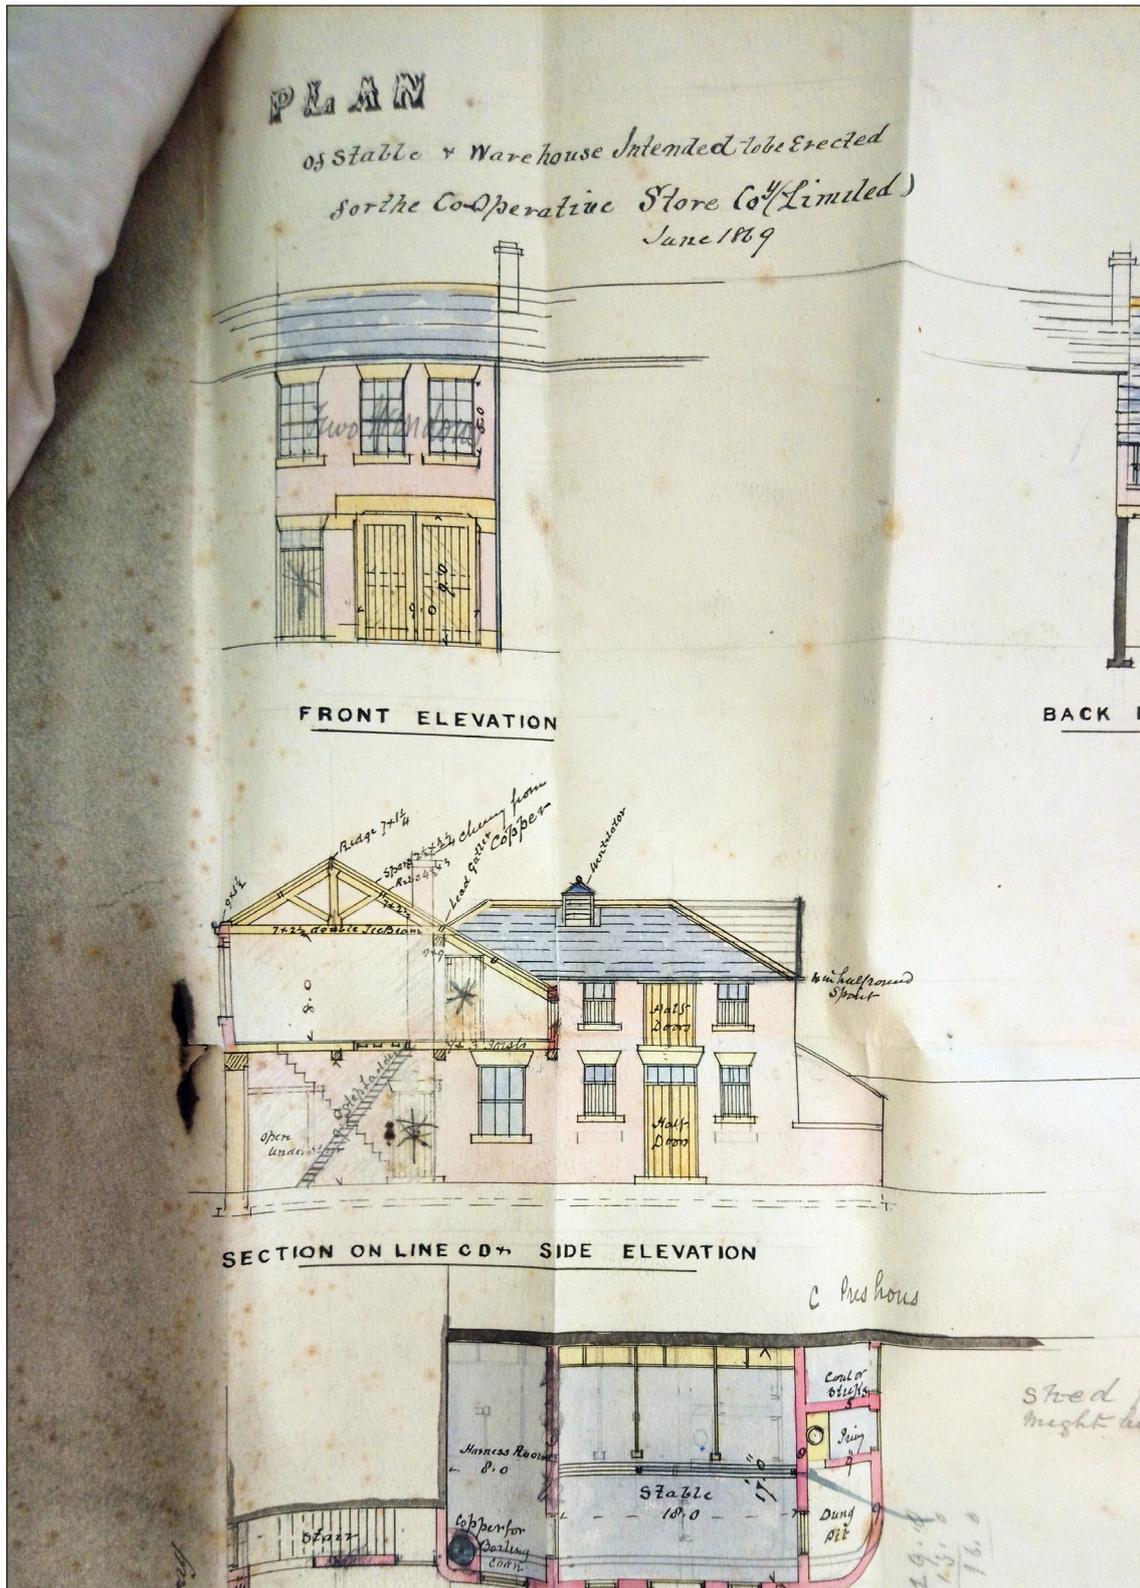
Figure 13: New stables and warehouse on Back Way, drawn by J D Thompson, 1869 (UD/BA 432/73 Bishop Auckland Urban District Council. Reproduced by permission of Durham County Record Office (DRO))

The next alterations to the site on Newgate Street came when plans were submitted in June 1869 for a modest warehouse and stables 'intended to be erected for the Co-operative Store Ltd' by James D Thompson, architect (Figure 13).⁹⁰ An outline of the several Thompson architects involved at the co-operative stores is given in the following section. The stable complex had a two-storey frontage onto Back Way with a cart-entrance, having stabling and harness room for three horses in the east return with haylofts and corn store above. However, although the plans are marked 'approved' it is not clear if this structure was actually constructed: no known

physical evidence identifies it and the first reference to stabling in Readshaw's narrative is in 1875, when the Society constructed stables on Durham Street (then King Street; interestingly on land purchased from a Mr James Thompson).⁹¹ If the stables at the central stores were built, they appear to have been substantially demolished by 1883, the date of the first available plans of the rear warehouses, and were perhaps damaged by the fire noted above. The proposals were intended to be built where the Co-operative's original plot behind Newgate Street met Back Way: Thompson's plan has 'C Preshous' written on the plot across the boundary wall to the north and Readshaw notes that Nos 85 & 86 (immediately north of the original plot) were occupied by Mrs Preshous when they were purchased by the Society in 1880.⁹²

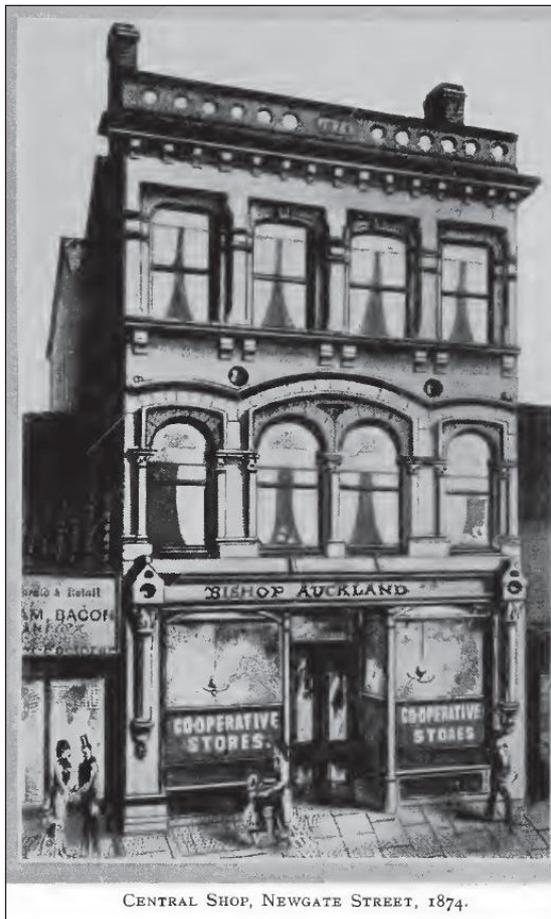
Figure 14: (a) Photograph of W V Thompson's 1873 building for the Bishop Auckland Co-operative Society Stores, Newgate Street, photograph dated 1874. (From Readshaw 1910, 147: Publication out of copyright) (© Historic England, photograph: Alastair Coey Architects, 2019)

spaced, plain moulded consoles. The roof structure, which appears to align with the roof of Block B to the north, seems to closely resemble that shown on an early photograph (see Figure 14a) and is probably original to the 1873 building. At the front, east side, a parapet gutter drains to externally routed downpipes; the central valley appears to drain to internal downpipes and, to the rear, west side, the back slope drains to eaves gutters.

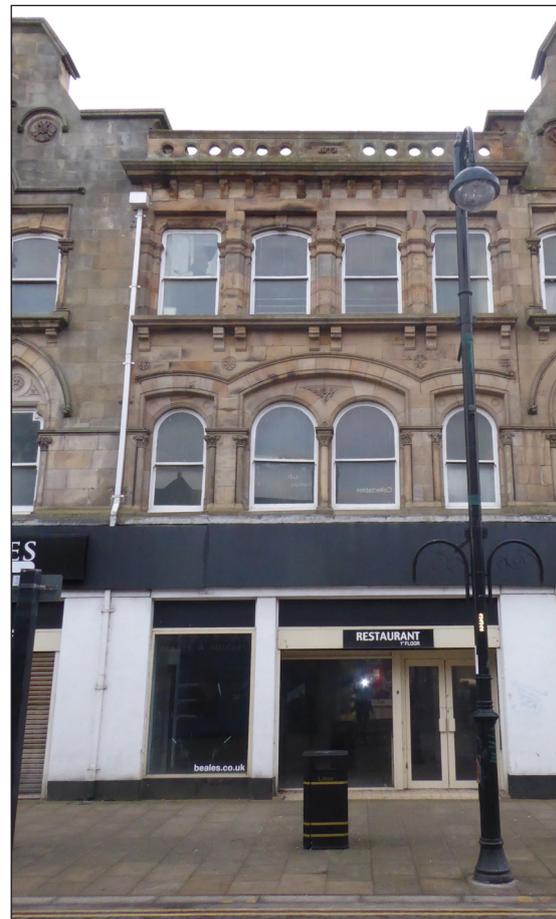
Figure 14: (b) The 1873 building in the context of the other extensions (© Historic England, photograph: Alastair Coey Architects, 2019)

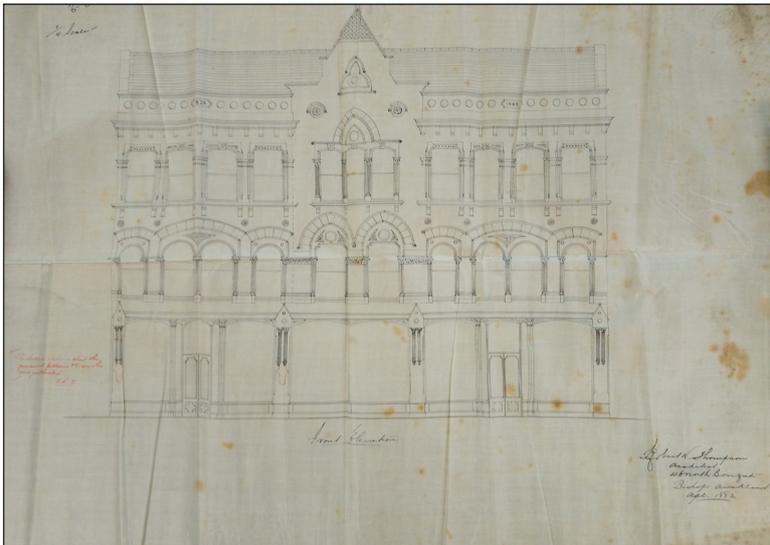
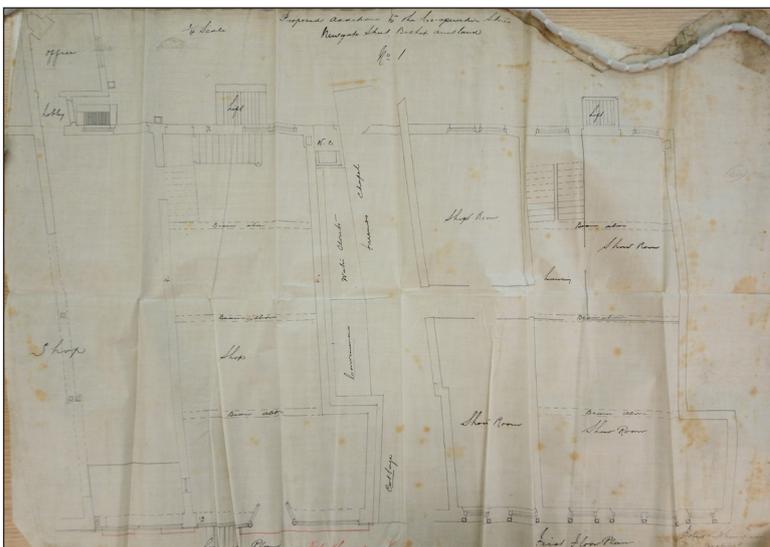
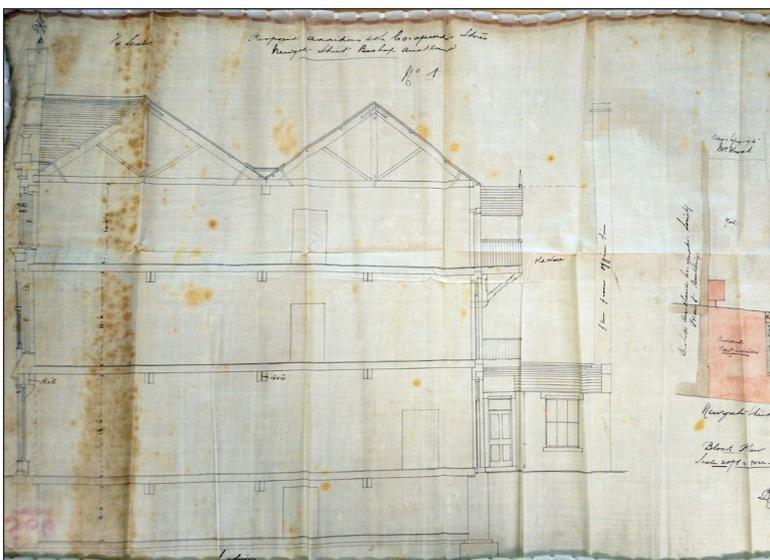
Figure 15: R W Thompson, (a) Front elevation to Newgate Street. Note that the four bays to the left belong to the earlier building. (UD/BA 432/538 Bishop Auckland Urban District Council. All reproduced by permission of Durham County Record Office (DRO))

Figure 15: R W Thompson, (b) First- and second-floor plans. (UD/BA 432/538 Bishop Auckland Urban District Council. All reproduced by permission of Durham County Record Office (DRO))

Figure 15: R W Thompson (c) Sectional view of the proposed extension to the Bishop Auckland co-operative stores in 1882. (UD/BA 432/538 Bishop Auckland Urban District Council. All reproduced by permission of Durham County Record Office (DRO))

The architect's drawings for the 1882-83 street frontage extension are held in Durham County Record Office, and signed by Robert W Thompson (*circa* 1850-1896) (Figures 15a, b and c). The tenders were appointed to G H Bell for masonry; Thomas Manners for joinery; S Kirby for plasterwork; W Pulford for slating; Messrs Cooke and Bell for plumbing; and Mr Pallister for painting, all local tradesmen of Bishop Auckland. The new stores were completed in April 1883 at a cost of £1,877-4s.¹⁰⁷

Thompson deliberately designed the new building to create a symmetrical composition incorporating the earlier building, the four-bay section to the north side of the centrepiece being almost identical to the 1873 structure (*see* Figure 15a). This design choice was somewhat unusual for a co-operative stores building, which tended to expand in stylistically distinct phases.¹⁰⁸ The centrepiece is characterised by a pointed gable, which succeeds in giving the whole a rather more Gothic appearance than the original block, which has a more classical composition. Its execution as planned is confirmed by the photograph of 1883 included as Figure 16. The ground-floor retail frontage was composed of three bays separated by pedimented consoles and with central recessed entrance doorways in the end bays, each containing double doors flanked by fluted columns. As above, this shopfront was completely remodelled in the latter half of the 20th century and no physical evidence appears to survive of the fabric that pre-dated it.

than counters.¹²³ Plans of the 1882-83 stores (see Figure 15b), supported by the physical evidence of partition walls, down-stands and inserted structural columns, indicate that the growing range of departments originally operated as largely self-contained units, usually stretching the depth of the main range as a single space (Figure 25). Again, this was fairly typical for the gradual evolution of a late 19th- / early 20th-century retail premises, in contrast to the large open department store arrangement which emerged in the first few decades of the 20th century, and which influenced the rearrangements to the Bishop Auckland stores in the 1960s. Each of the Newgate Street phases functioned fully for retail purposes at ground-floor level, whilst the upper floors were a mixture of additional show room and retail departments, as well as operational spaces including offices, stock rooms and staff rooms.

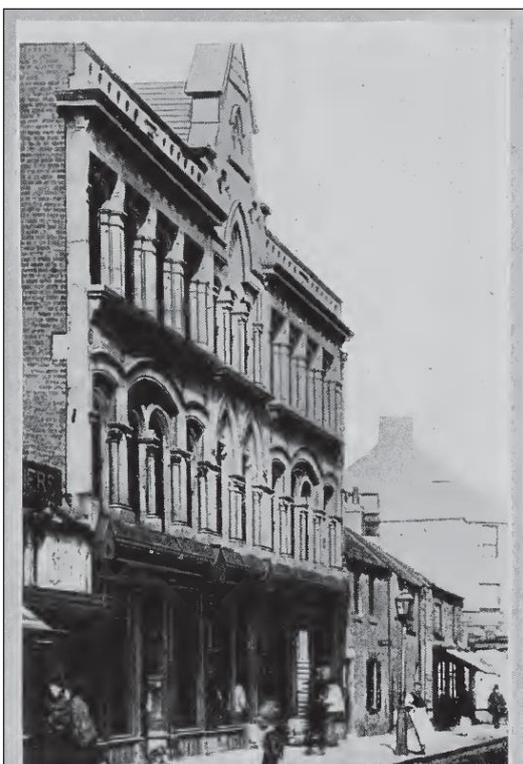
Figure 16: View of the extended Bishop Auckland co-operative stores, Newgate Street, 1883. (From Readshaw 1910, 151: Publication out of copyright)

it still does today (see Figure 16). Thompson's plans show that on the ground floor the party wall to the 1873 premises was removed, replaced with columns (now encased in modern finishes) and the existing shop space extended into part of the new building (in the two bays topped by the gable), while the shop to the north was physically separate, although accessible from inside (Figure 18). At first-floor level the spaces were subdivided into smaller showrooms.

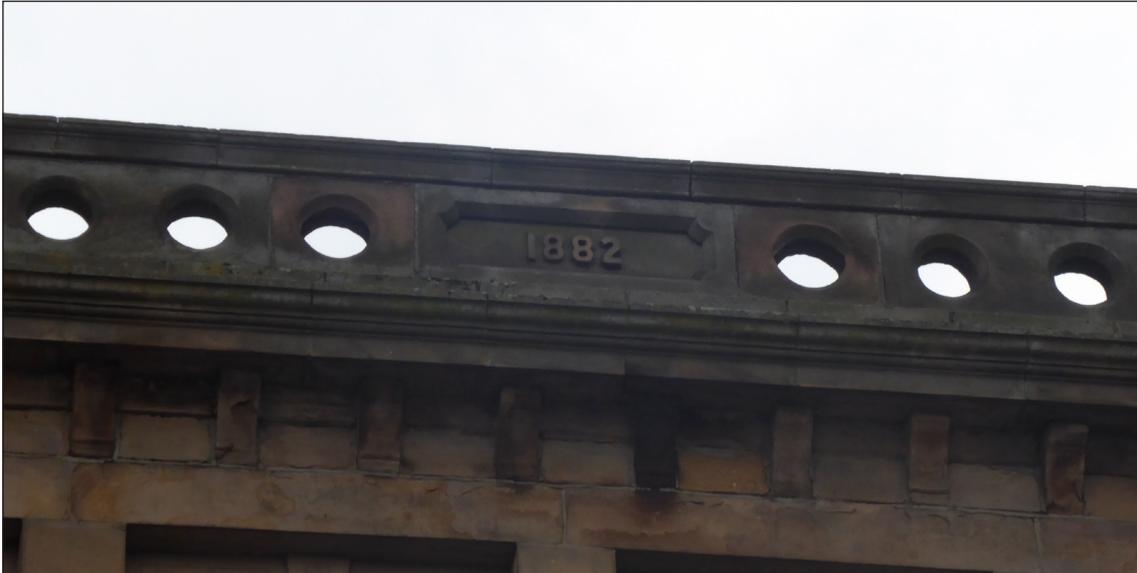
Figure 17: Detail of the datestone from the 1882-83 extension (© Historic England, photograph: Alastair Coey Architects, 2019)

The slate roof is concealed behind the street-fronting parapet, identical to the 1873 building with a central embossed date stone flanked by six chamfered circular perforations (Figure 17). Curiously, the date stone reads '1882' although as noted above, the building was not completed until the following year. This may have been because the date stone was completed at an early stage, or perhaps because the final completion may have been behind schedule. Like the adjoining original building, the roof has a double pitch and is carried on two rows of king post trusses. A comparison of Thompson's drawings with the building today indicates that the plan of the 1882-83 building is largely unchanged. It seems that the small rectangular projection to the north-east was included simply to enable the fourth bay to be built to ensure symmetry with the 1873 wing. This projection is shown abutting a 'cottage', and the new building clearly towered above its neighbours as

The slate roof over the main building is concealed behind a street-fronting parapet identical to that on the 1873 building. It contains a central embossed '1882' date stone flanked by six chamfered circular perforations (see Figure 17). The roof has an 'M' profile which the 1882 drawings show was carried on king-post trusses bearing on a central north-south spanning beam. At the front, east side, a parapet gutter drains to externally routed downpipes while the central valley appears to drain to internal downpipes. To the rear, west side, the back slope drains to eaves gutters.

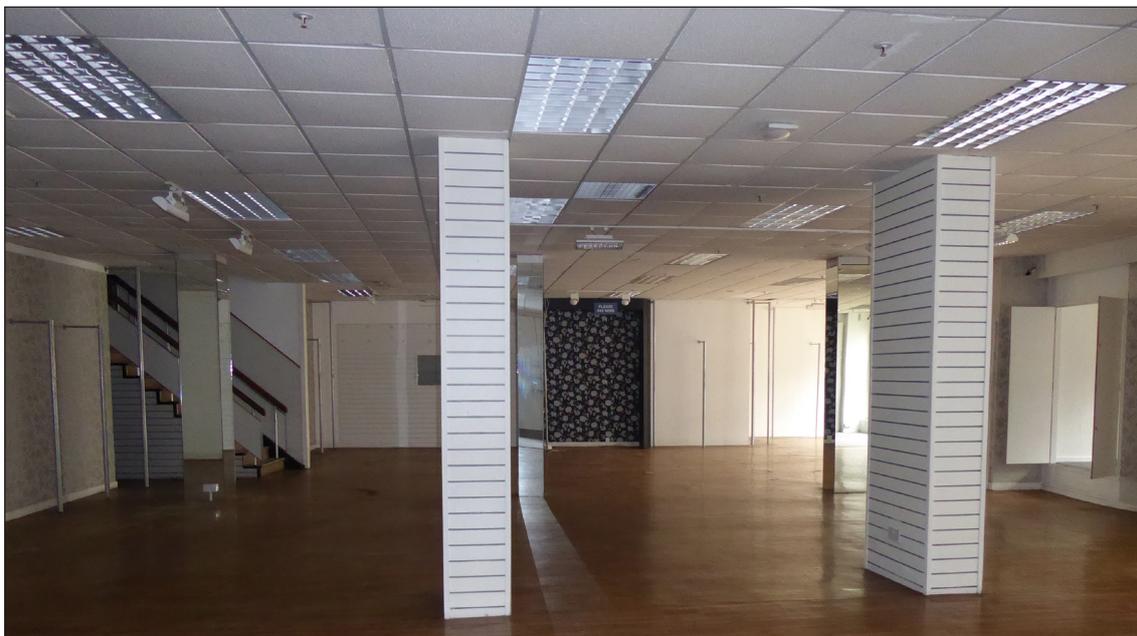
Figure 18: Columns with later facings at the division between the 1873 and 1882-83 blocks (© Historic England, photograph: Alastair Coey Architects, 2019)

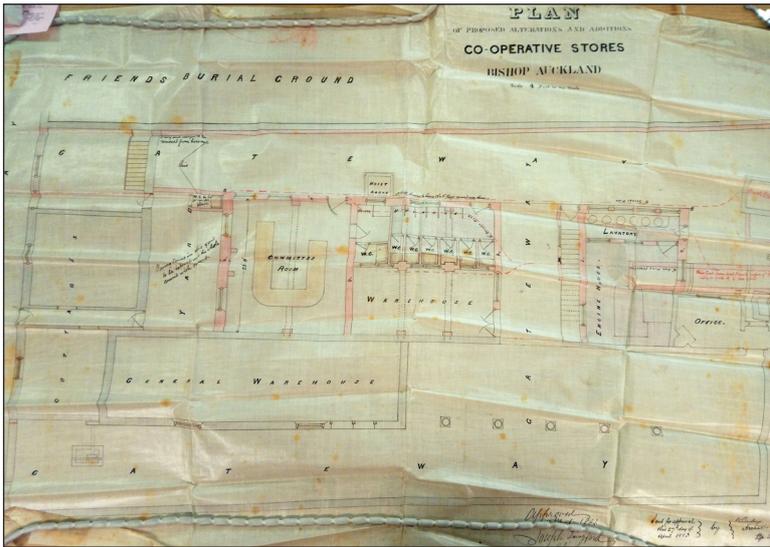
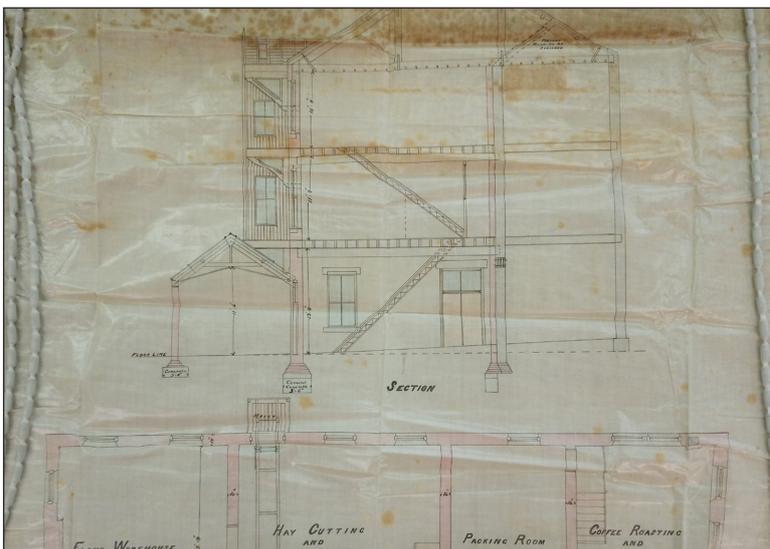
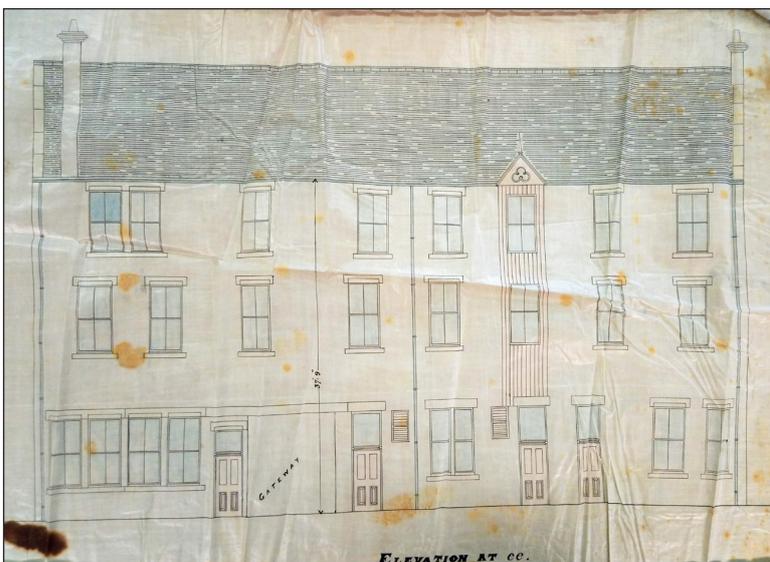
Figure 19: (a) James Linday's ground-floor plan of warehouse and office extensions, Newgate Street, 1883 (UD/BA 432/547 Bishop Auckland Urban District Council. Reproduced by permission of DRO)

Figure 19: (b) James Linday's second floor plan and section, Newgate Street, 1883 (UD/BA 432/547 Bishop Auckland Urban District Council. Reproduced by permission of DRO)

Figure 19: (c) To the rear of the extended co-operative stores, Newgate Street, 1883 (UD/BA 432/547 Bishop Auckland Urban District Council. Reproduced by permission of DRO)

Linday's warehouse and associated offices comprised a linear three-storey building of functional appearance, beneath a slated roof with stone verges having chimneystacks at either end. Windows were unevenly spaced, and a hoist was located to the west of centre on the north elevation, housed within a timber sheeted gabled outshot which rose from the first floor, and served the range of processing, packing and storage rooms on the first and second floors. This building is shown on the plan to be detached from the main front block, and surrounded on three sides by 'gateways' or passageways, for ease of circulation. Although there has been remodelling, these are still evident in the extant arrangement of the building; the north gateway is shown to have been designed to have a glazed roof, although there is no evidence to show whether this was built as constructed; the area remains covered, but by a late 20th-century timber structure (Figure 21). The plans also usefully illustrate the diversity of produce

and processing provided by the Society at the time, with dedicated spaces for flour and hay storage, corn and grain crushing, coffee roasting and grinding, engine rooms and packing rooms. The ground-floor plan shows two cottages lining Back Way (now Westgate Street) and bounding the warehouse yard to the west; at this time the cottages were not in the ownership of the Society, but were purchased in 1887 to facilitate additional extensions, and presumably demolished some time later.¹¹³

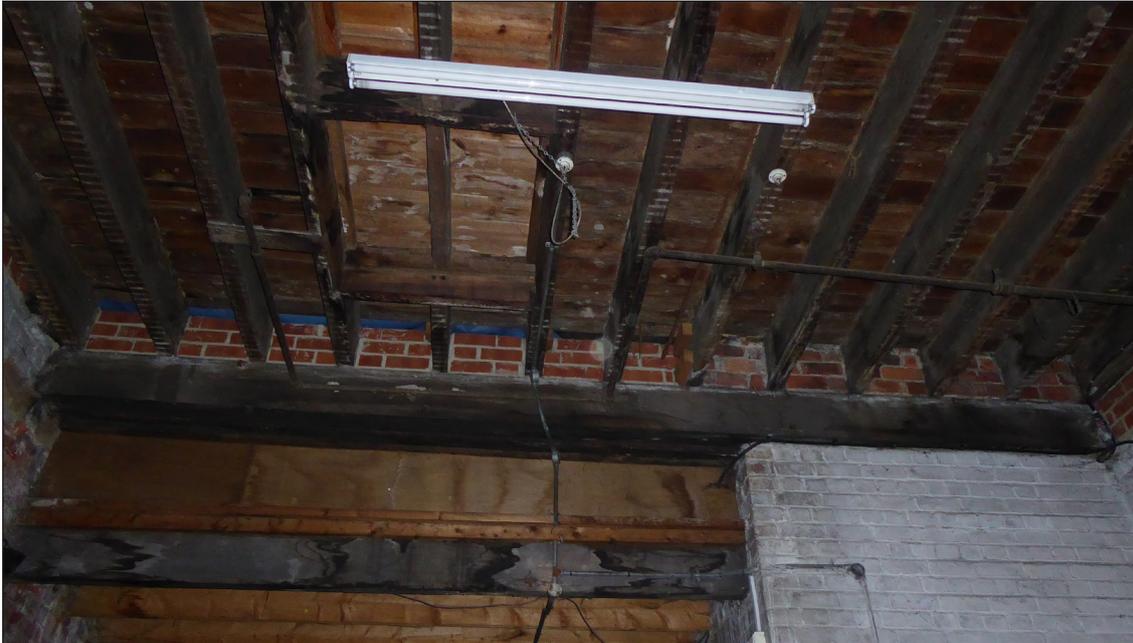
Figure 21: The timber structure covering the north gateway (R140-142) (© Historic England, photograph: Alastair Coey Architects, 2019)

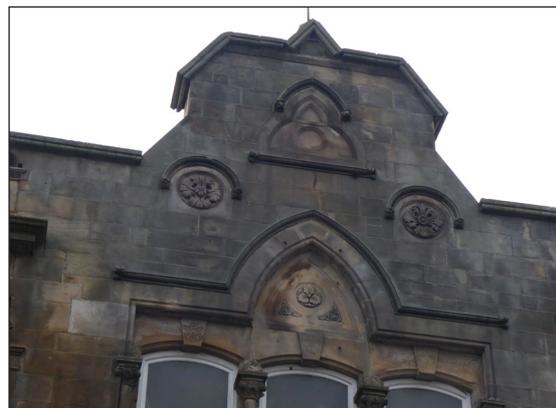
Figure 23: Detail of truncated central gable to 1892-94 section (© Historic England, photograph: Alastair Coey Architects, 2019)

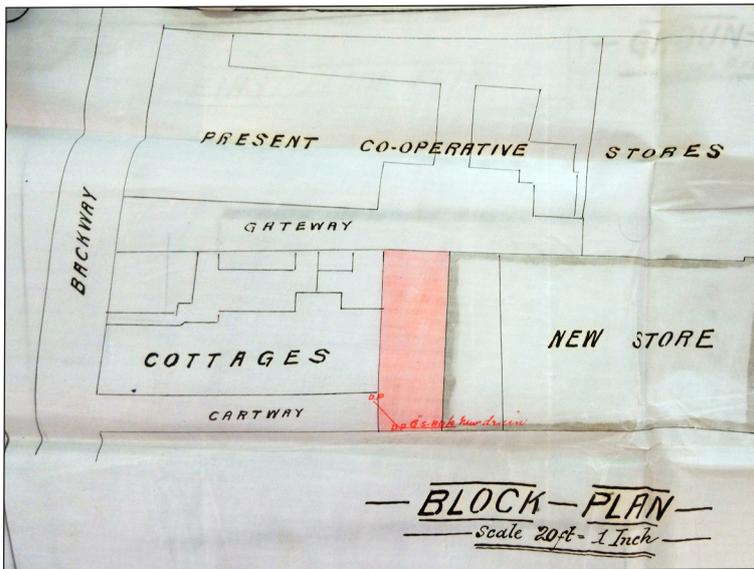
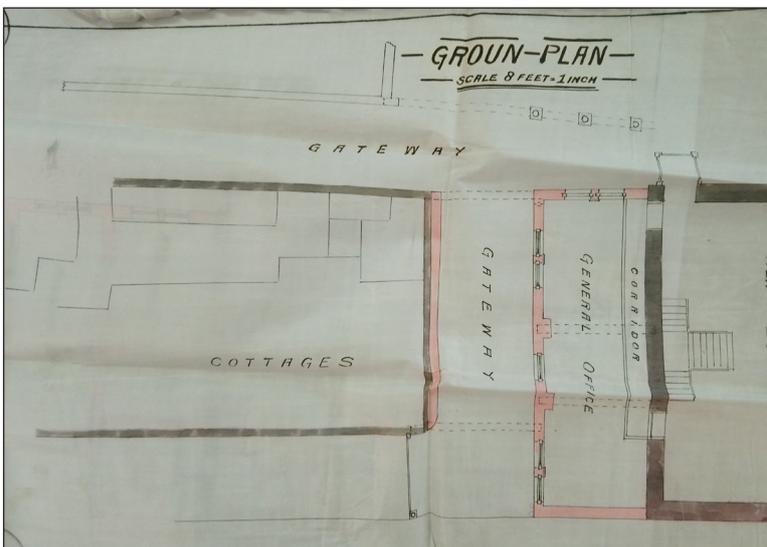
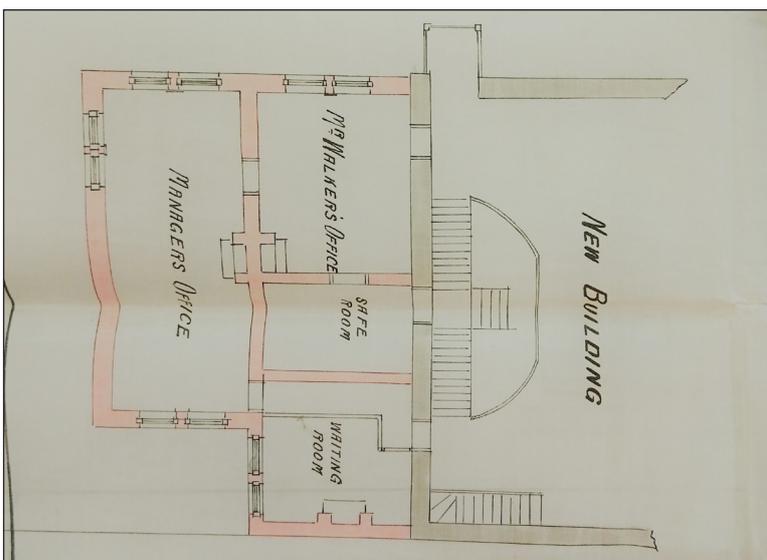
Figure 24: (a) Block plan of Lindsay's proposed plans of 1893 for the existing site to rear of the 1892-4 block. (UD/BA/432 690 Bishop Auckland Urban District Council. Reproduced by permission of DRO)

Figure 24: (b) Ground-floor plan of Lindsay's proposed plans of 1893 for the existing site to rear of the 1892-4 block. (UD/BA/432 690 Bishop Auckland Urban District Council. Reproduced by permission of DRO)

Figure 24: (c) First-floor plan of Lindsay's proposed plans of 1893 for the existing site to rear of the 1892-4 block. (UD/BA/432 690 Bishop Auckland Urban District Council. Reproduced by permission of DRO)

Alterations to this scheme were made during the erection of the new building, comprising changes at the rear to the existing arrangement of cottages and an existing 'cartway'. These plans are somewhat ambiguous and may reveal Linday's lack of formal training as an architect (Figures 24a, b and c). His accompanying letter to the Local Board of Health, dated 3 July 1893, confirms that the extensions on Newgate Street designed in 1892 were 'now in progress', and expresses the desire of the Committee to have the existing cottage to the rear pulled down, 'so as to enable them to have their cartway where the cottage is, and the cartway shown in the drawings already submitted to you made into offices, thereby disposing of the offices on the second floor' (see Figure 20).¹¹⁶ This cartway was presumably intended to provide a link to the warehouses of 1883, and the proposed first-floor offices are marked on the drawings as 'waiting room', 'safe room', 'manager's office' and 'Mr Walker's Office'; all are shown to have a fireplace with the exception of the safe room, which was accessed from Mr Walker's office only.¹¹⁷ Henry Kellett was the general manager at the time and Mr John Walker had been the head clerk since 1883.¹¹⁸ This extension can be identified today on plans of the stores and the bifurcated staircase lines up with the one surviving in the shops housed in the 1892-94 building, the structural fabric of which seems to be original. The various offices located here were in use for retail space when the building closed (R111 & R112). The first-floor offices and strong room, shown in roughly their original (1893) configuration in the 1961 survey plan, have since been knocked through into a single space (R208) connecting through to the front shops.

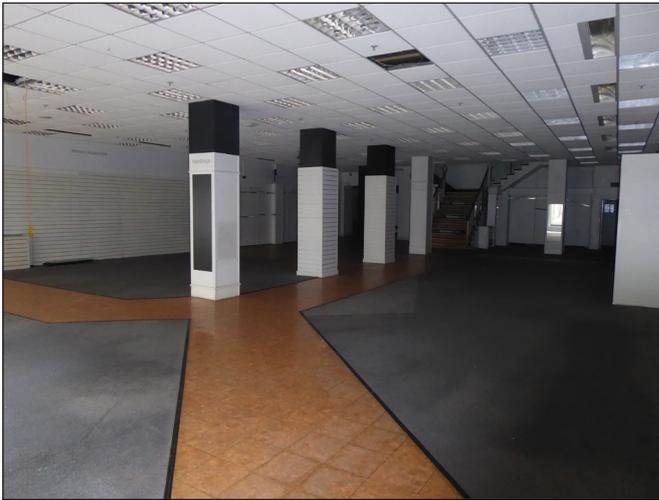
Figure 25: Interior view of R104 in the 1892-94 block looking west from the north-east corner (© Historic England, photograph: Alastair Coey Architects, 2019)

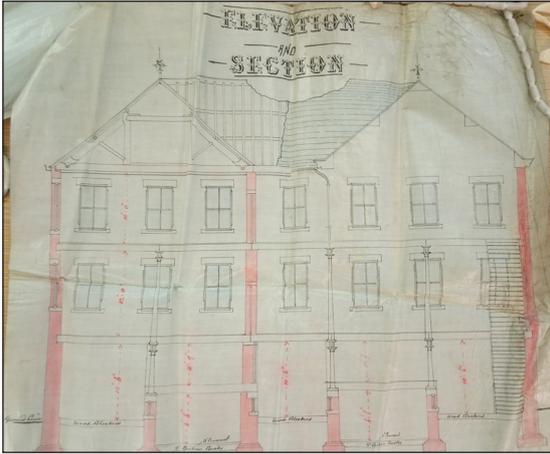
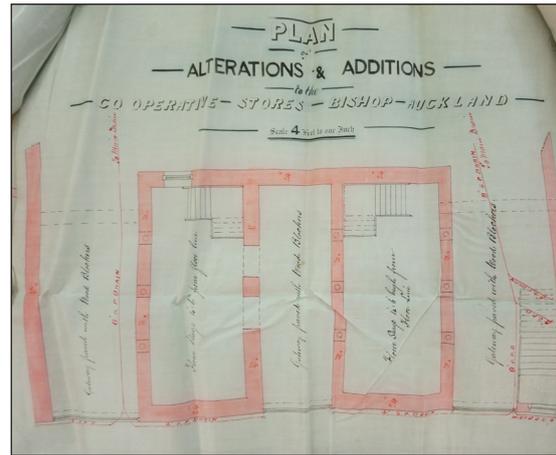
Figure 26: (a) Elevation and section of undated Co-operative warehouses on Back Way to the rear of the central stores. (UD/BA 432/671 Bishop Auckland Urban District Council. Reproduced by permission of DRO)

Figure 26: (b) Ground-floor plan of undated Co-operative warehouses on Back Way to the rear of the central stores. (UD/BA 432/671 Bishop Auckland Urban District Council. Reproduced by permission of DRO)

no dates of submission or approval and no architect's signature (Figures 26a and b).¹²⁴ The elevation drawing depicts a three-storey gabled warehouse situated on Back Way adjacent to the Friends' Burial Ground. The ground floor incorporates three covered gateways, each of which was paved with 'wooden blockers'. Only the 'wooden blocker'-paved northern gateway survives today, leading to the rear of the 1882-83 shop building with the site's brick boundary wall to the north. The central gateway appears to have been a cul-de-sac accessing the 'flour stages' and cellars to either side, while the southern gateway appears to have replaced the stables described above and provided access to the yard behind Block A. With the exception of one east/west cross wall, to the north side of the central gateway, most of the ground and first floors were open, having iron columns which carried the upper floors. A staircase, located at the south end, rose through the full height of the building. Part of the function of the new building must have been to provide more storage space for flour, as the plans and sections show 'flour stages' elevated 1.2m above the wooden blocker floors which form mezzanine levels, presumably elevated to facilitate loading and unloading of vehicles and to keep the flour free from pests. Overlaying the plans for the warehouse onto James Linday's warehouse drawings from 1883 indicates that the proposal was probably intended to be built at the end of that warehouse, incorporating the two existing gateways and replacing the pair of cottages shown there (Figure 27). These may be the pair that Readshaw notes were tenanted by the Society, then purchased for £350 in 1887 and 'kept in reserve for the next extension'.¹²⁵ Chronologically, the next extensions were Linday's 1892-94 expansions on Newgate Street. The Record Office drawings register shows that the proposals fall amongst other submissions from 1892 and there are some similarities in the presentational style of the drawings to those signed by Linday, who was the Society architect at that time. It is possible that this warehouse formed part of the extensions that took place in 1892-94: the cost of these works, £7,891-31s, by

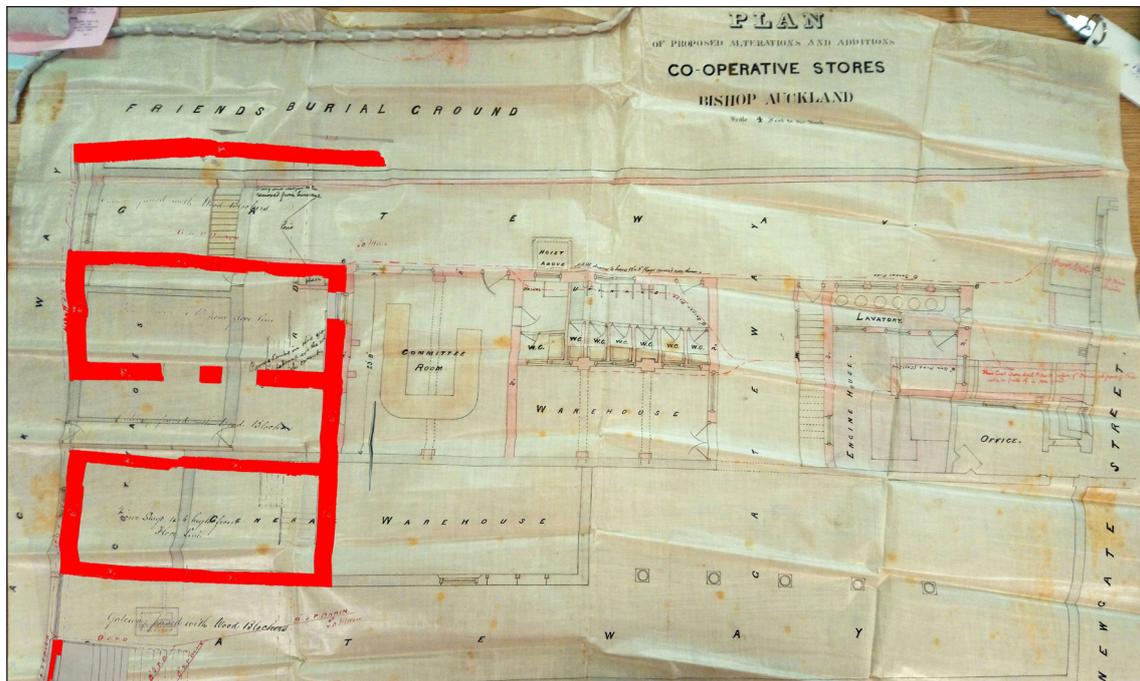
Figure 27: Overlay of the undated warehouse plans onto Linday's plans for the 1883 warehouse and gateways (UD/BA 432/547 Bishop Auckland Urban District Council. Reproduced by permission of DRO)

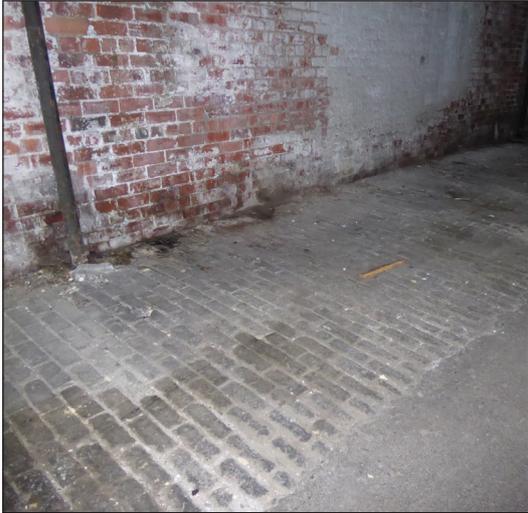
Figure 28: Floor covering of wooden blockers in R141 (© Historic England, photograph: Alastair Coey Architects, 2019)

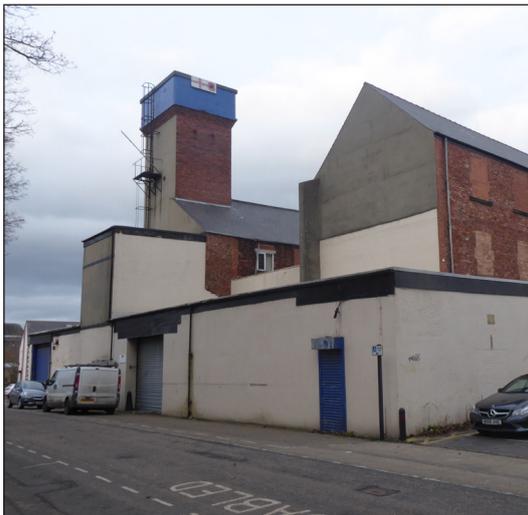
Figure 29: View of the co-operative buildings from Back Way showing the late 20th-century water tower (L) and the undated warehouse behind the 1892-94 block (R) (© Historic England, photograph: Alastair Coey Architects, 2019)

committee's requirements from Livesay's alterations and extensions were 'separate roads of ingress and egress, cellars, warehouse, stockrooms, packing-room, and manufacturing rooms' and these needs, especially for cellars and improved access, are fulfilled in the undated proposal drawings.¹³² The 1961 survey plans show that at that date flour was still stored in a three-storey building at this location although it appears to have been much altered from the proposal drawings. Some of the most useful physical evidence is the survival of the 'wooden blockers' shown on warehouse plans to pave the gateways which gives an indication of where these gateways were (Figure 28). Readshaw states that the alterations at this time 'provided a most useful area of yard space, and splendid warehousing, stocking and manufacturing rooms, which have proved of great value'.¹³³ This, the wooden blockers located elsewhere in the gateways and his earlier statement that 'other two sites outside' were inspected prior to construction suggest that the warehouse discussed above was not the only change made at this time.¹³⁴ It is worth noting here that the three-storey warehouse to the rear of the 1892-94 extensions (comprising R115-118, R210-211, and R327) is also otherwise unaccounted for in Readshaw's history and would have been constructed following the demolition of cottages shown by Lindsay in his plans for the office extension of 1893 (Figure 29).¹³⁵ It is possible that this was built as part of the same extensions and alterations.

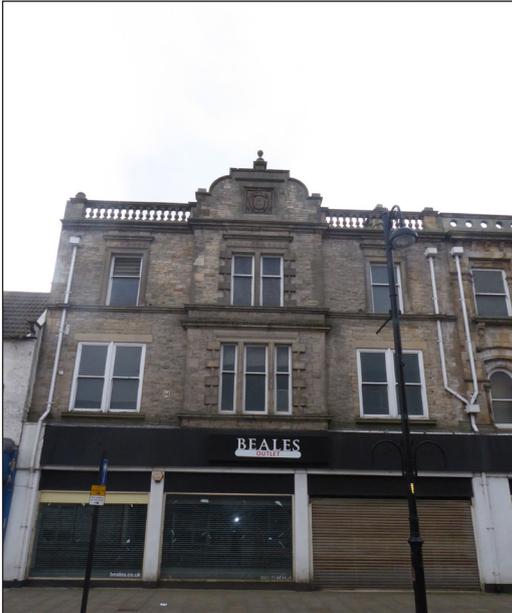
Figure 30: The 1894 building purchased from C Manners in 1902 (© Historic England, photograph: Alastair Coey Architects, 2019)

proportion and palette, being of three storeys (although without basement) and three bays wide, it is quite distinct in style (Figure 30). Although now unified with the phased façade by the continuous replacement shop frontage, the upper storeys are of squared and snecked sandstone rubble, distinguished by a central breakfront crowned by a handsome curvilinear pediment with cartouche breaking a balustraded parapet, and finished with polished ashlar quoins. All windows are rectangular, with single-pane sashes, those to the second floor having moulded sandstone architraves with entablature. The central windows are further embellished with Gibbsian-style blocked jambs. Like the 1892-94 block, the gable here has been truncated, having originally had an upper curvilinear section topped by the surviving urn (see Figure 35).

According to Readshaw (who was now writing of events well within his own recall), it was deemed that 'the front premises were well built and in good condition, and of a design and style similar to the other front buildings of the society, and so required not outward alterations to fit them for their purpose.'¹⁴¹ Whilst the date stone should be treated with appropriate caution, it suggests that the building had originally been built in 1894. Upon acquisition by the Co-operative Society in
