Former Central Stores of Bishop Auckland Co-operative Society,
80 Newgate Street, Bishop Auckland, County Durham
Historic Building Report

HISTORIC BUILDING REPORT

Alastair Coey Architects

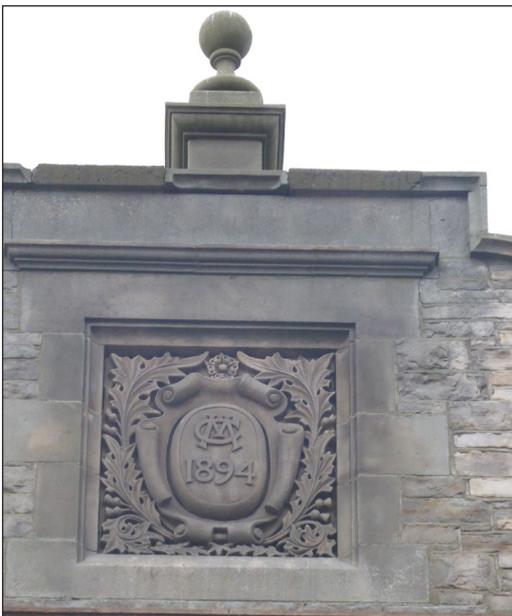
Figure 31: Detail of the gable cartouche with the initials 'CM' for Christopher Manners (© Historic England, photograph: Alastair Coey Architects, 2019)

proportion and palette, being of three storeys (although without basement) and three bays wide, it is quite distinct in style (Figure 30). Although now unified with the phased façade by the continuous replacement shop frontage, the upper storeys are of squared and snecked sandstone rubble, distinguished by a central breakfront crowned by a handsome curvilinear pediment with cartouche breaking a balustraded parapet, and finished with polished ashlar quoins. All windows are rectangular, with single-pane sashes, those to the second floor having moulded sandstone architraves with entablature. The central windows are further embellished with Gibbsian-style blocked jambs. Like the 1892-94 block, the gable here has been truncated, having originally had an upper curvilinear section topped by the surviving urn (see Figure 35).

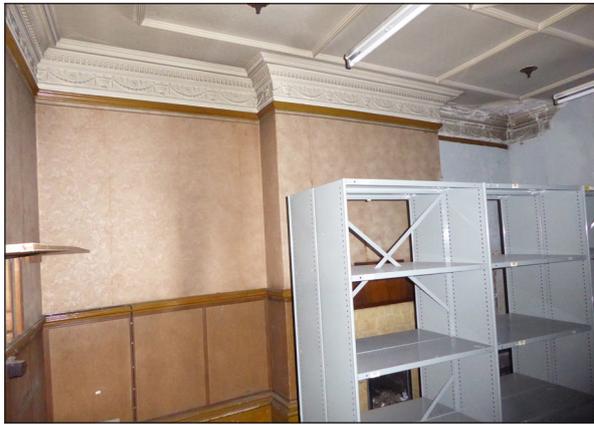
Figure 32: Plasterwork and chimneypiece in the first-floor manager's office (© Historic England, photograph: Alastair Coey Architects, 2019)

1902, the building was refitted to provide two butcher's shops and a tailoring department on the ground floor (shown by later plans of 1913 to be side-by-side, see Figure 33) whilst upper floors were refitted for staff purposes including Committee and Manager's rooms on the first floor, and meeting and staff-rooms on the second floor.¹⁴² Various elements of original fittings and finishes in these managerial rooms survive today, including geometric linoleum flooring, a neoclassical-style plasterwork ceiling, a chimneypiece to the Manager's office, and wood grained joinery and textured glass in both rooms (Figure 32). Notably, the

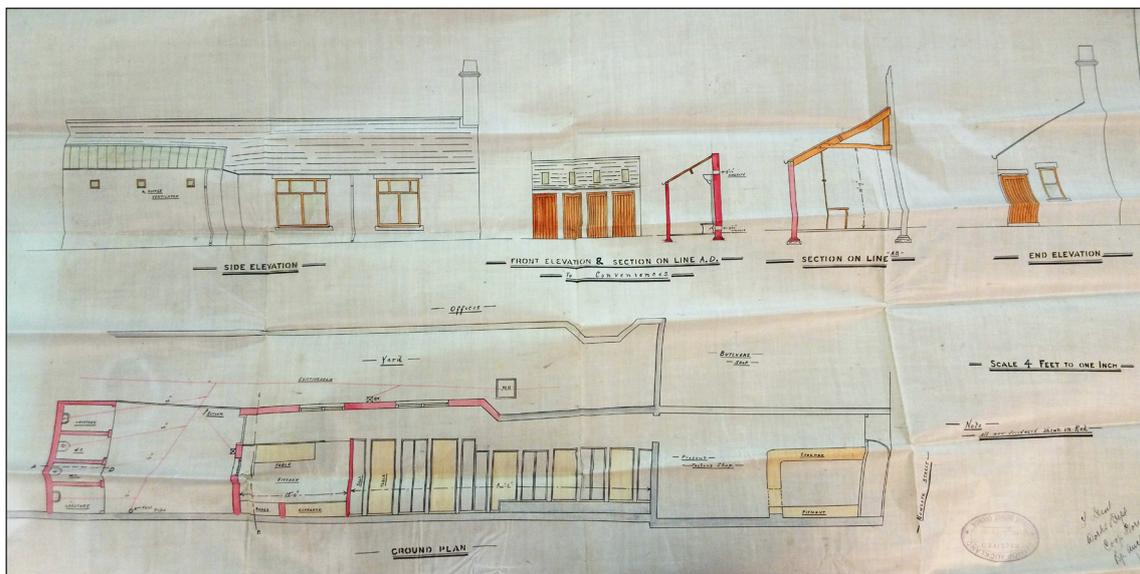
Figure 33: Thomas Dent's 1903 approved drawings for the cafeteria extension to the rear of the existing tailor's department (UD/BA 432/1336 Bishop Auckland Urban District Council. Reproduced by permission of DRO)

About a decade after this refitting, approved plans of 1913 by Thomas Dent show that a single-storey public cafeteria was built to partially abut the rear of the newly remodelled premises, extending into the yard from the rear of the tailoring department, and accommodating five tables, kitchen and toilets (Figure 33).¹⁴³ Thomas Dent had been an employee in the joinery department and was by 1913 the manager of the Society's building department.¹⁴⁴ A narrow access yard remained between the cafeteria and the adjoining gateway and offices to the north side. On the survey drawings from 1961 the cafeteria is still visible and by then had been expanded into the yard to provide extra kitchen facilities with the dining space stretching into the adjoining plot to the north (Figure 34). Although it is unclear whether the accompanying proposal plans in October 1961 were executed, they indicate the intention to combine the existing confectionary shops, butchery, mercery and cafeteria (all in the 1894 building) into a single menswear department (see Appendix 2). Certainly,

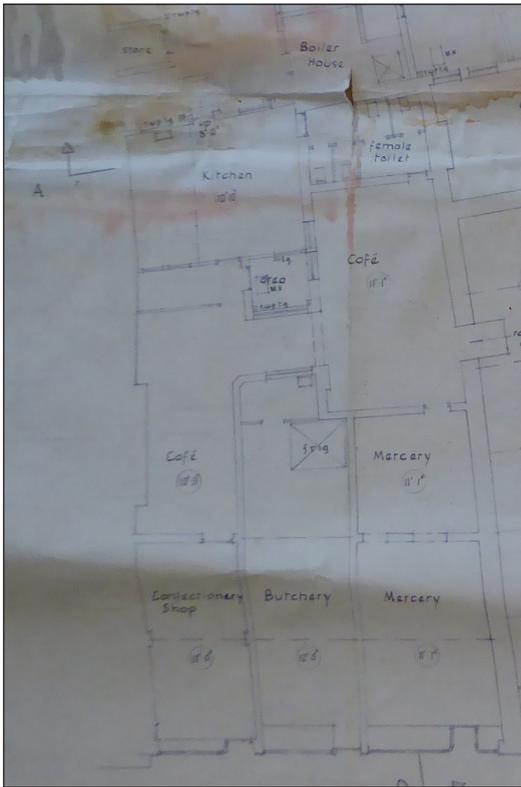
Figure 34: Detail of R A Thomas's 1961 survey drawings showing the cafeteria to the rear of the 1894 block.

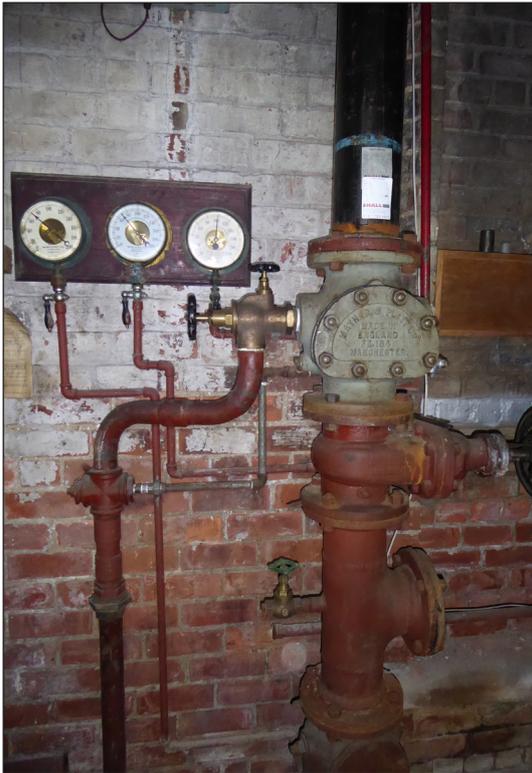
Figure 36: Pipework and dials associated with the Mather and Platt sprinkler systems (© Historic England, photograph: Alastair Coey Architects, 2019)

In June 1907, plans were submitted showing the arrangements of water supplies from the town mains for the installation of a Grinnell sprinkler system by Messrs Mather and Platt of Park Works, Manchester; the plans were approved in April 1908 (Figure 36).¹⁴⁸ The Grinnell system was patented in 1890 by Frederick

Grinnell, who developed a glass disc sprinkler system that has formed the basis of all subsequent sprinkler systems, including those in use today.¹⁴⁹ The firm of Mather and Platt, the installers of the system in Bishop Auckland, was established in 1845, and in 1883 had acquired the manufacturing rights to the Grinnell system outside of the United States of America.¹⁵⁰ It is worth noting here that the water tower at the rear of the Co-operative complex was not built to pressurise this sprinkler system, which was originally connected to mains water supply. In 1911, the Co-operative premises, comprising the plots of 89-92 Newgate Street, were valued with a total site value of £22,500, including buildings and machinery of £11,340.¹⁵¹

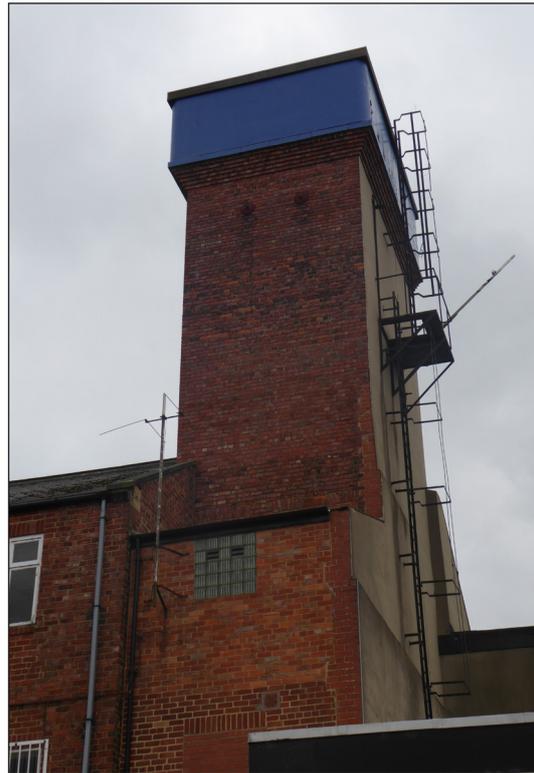
Figure 37: The water tower at the north-west of the co-operative complex (© Historic England, photograph: Alastair Coey Architects, 2019)

It may have been around this time that the brick water tower on the west gable of Lindsay's 1883 warehouse extension was added (Figure 37). It seems to have been omitted from the 1961 plans, as the external brickwork shows no obvious break between the lower courses and the water tower itself to suggest that it was a later 20th-century addition. The plans do, however, indicate a three-storey warehouse in this location with an internal staircase which may have been the result of early 20th-century alterations to Livesay's warehouse built *circa* 1903, and these could have included the addition of the new water tower. It is possible to offer a rough date for the tower itself thanks to the water tank it contains, which is shown in an advertisement of 1949 in *Grace's Guide to British Industrial History*. The

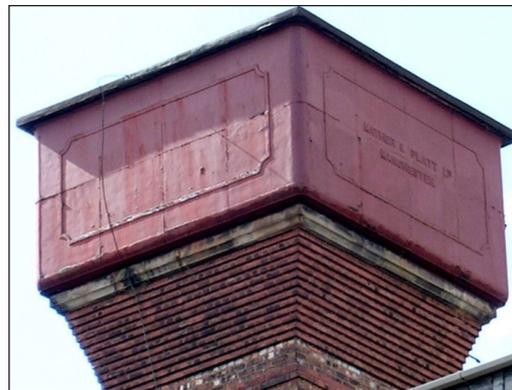
Figure 39: Mather and Platt water storage tank on a wide corbelled base, Central Manchester (see bibliography entry Tweedie, A I (ed) and 'Mather and Platt'. Reproduced by permission of 'Grace's Guide to British Industrial History')

poster reveals that the tank was manufactured by Mather and Platt, the same company that installed the Grinnell sprinklers in 1908, and shows a sectional, internally-flanged, cast-iron tank with quadrant corners similar to the one on top of the tower. This suggests that the Bishop Auckland tower was erected in the 1940s when these tanks were being manufactured (Figure 38). *Grace's Guide* also gives an example of another Mather and Platt water storage tank on a building in Central Manchester. Although the precise location is unknown, it displays an even more exaggerated corbelled course to carry the tank than the one on the Bishop Auckland tower and the online caption suggests this was utilised to reduce the overall footprint of the tower (Figure 39).

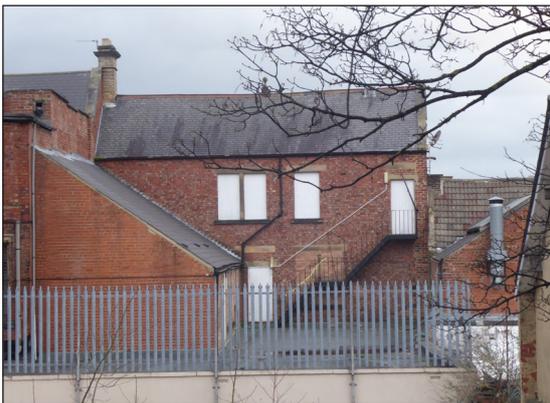
Figure 40: View of the rear of the 1894 building bought in 1902 no change according to the 1961 plans (© Historic England, photograph: Alastair Coey Architects, 2019)

rear windows of the committee room have been retained, despite the openings being blocked to install a rear fire stair, probably towards the end of the 20th century (see Figure 40).

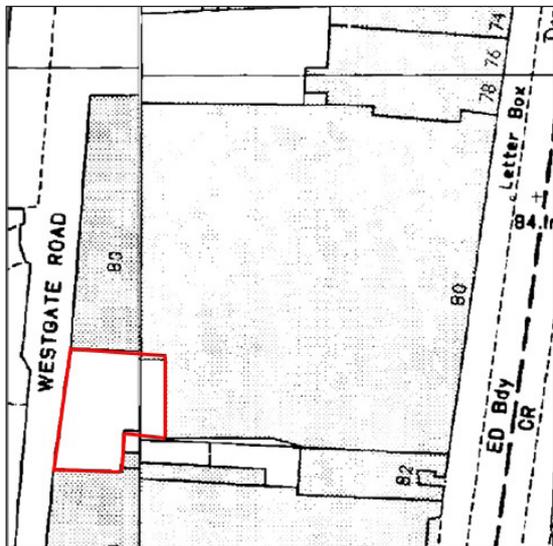
Figure 43: Extract from the 1:1250 Ordnance Survey map published in 1980 showing the area demolished to the south-west of the site (© Crown Copyright and database rights 2019. All rights reserved. Ordnance Survey Licence Number 100019088)

At some point between 1961 and the OS map revision published in 1980, two further noticeable changes were made (Figure 43). One is the extension of the ground-floor retail space in the 1894 building, comprising a single-storey flat-roofed structure replacing the earlier cafeteria, kitchen and yards (Figure 44). This is still visible on 21st-century plans and in the surviving fabric. It is possible that this alteration was executed as an alternative to Thomas' abortive proposal to increase retail space on the upper floors in this area. The 1980 OS revision also shows that a small portion of the complex in the south-west corner had been demolished. The 1961 plans show that this was a two-storey structure containing

bacon houses and cheese room to the ground floor, with sewing and alteration rooms above. It is now in use as a small car park, and this was presumably the space's intended original function.

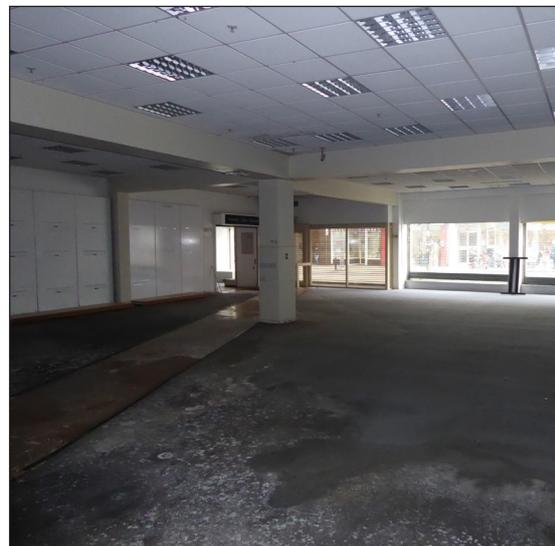
Figure 44: The expanded ground-floor retail space in the 1894 building bought in 1902, which replaced the former cafeteria and kitchen (© Historic England, photograph: Alastair Coey Architects, 2019)

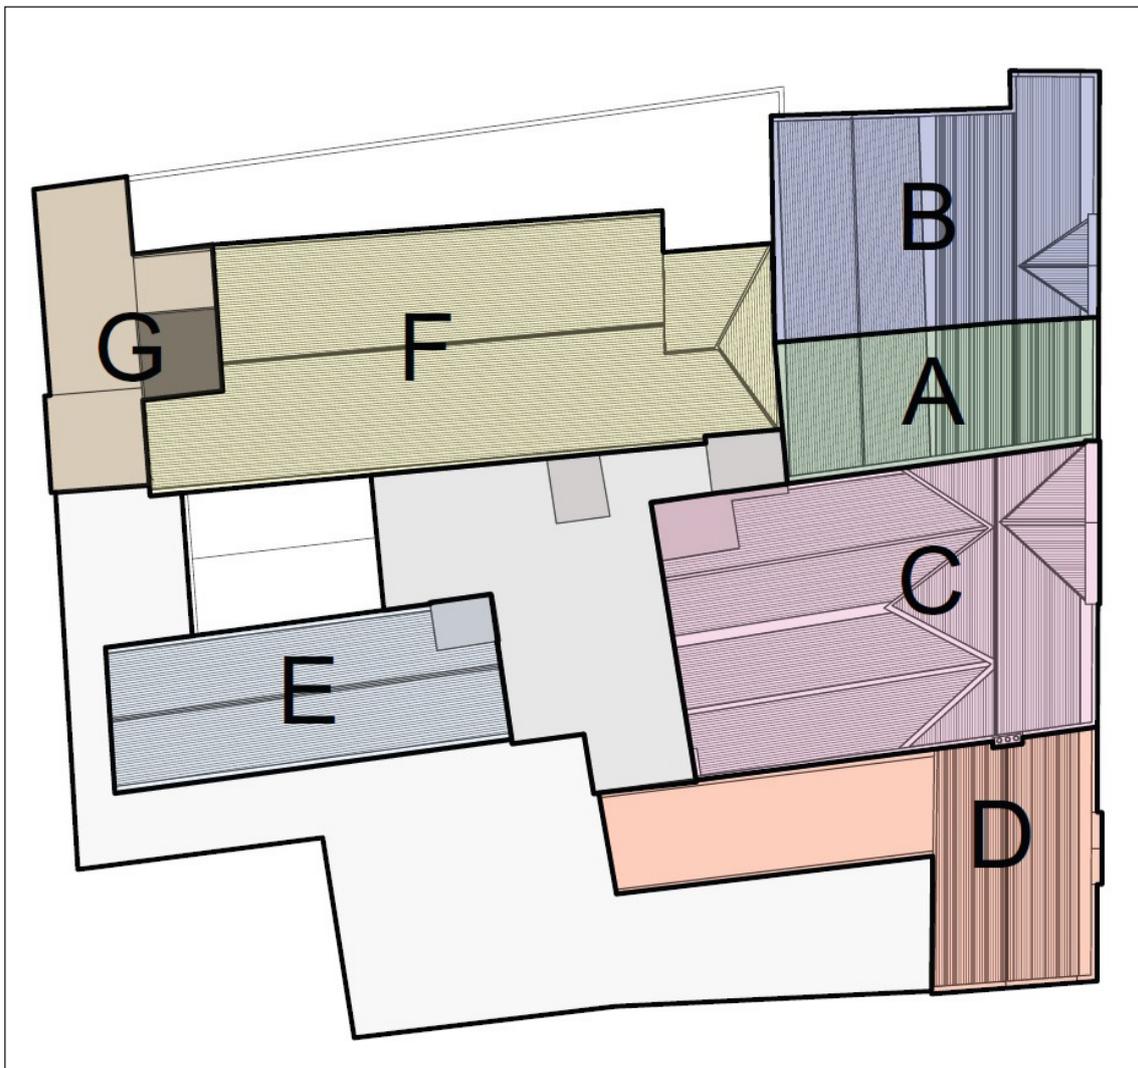
Figure 45: Labelled block plan of the Bishop Auckland Co-operative central stores (Drawn by Alastair Coey Architects © Historic England)

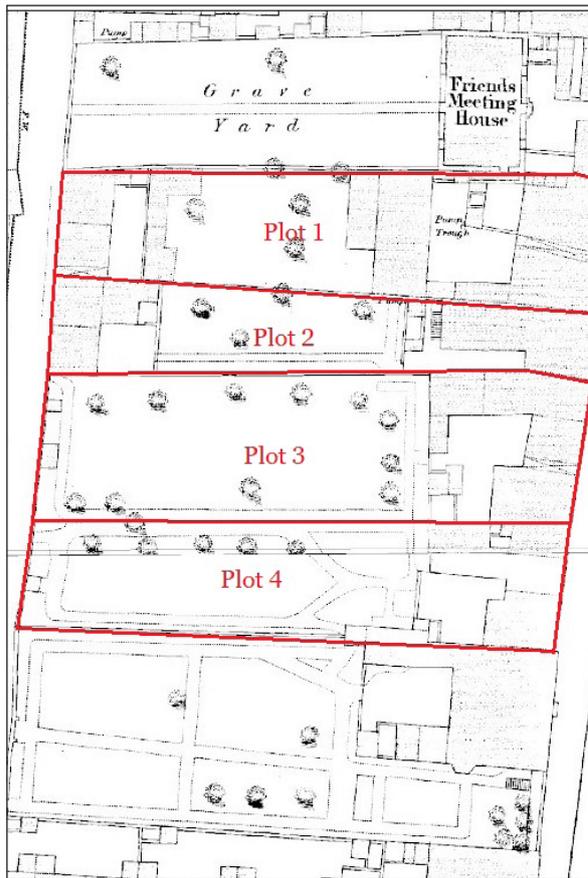
Figure 46: The site of the central stores in 1857, marked with plot divisions discussed in the Historic Fabric Analysis. Reproduced from the 1857 Ordnance Survey map, 1:500

Before development of the co-operative stores complex began in the late 1860s, the site comprised four plots, of varying width, each extending from Newgate Street to Back Way. The 1857 Ordnance Survey map clearly defines the four plots, which hereafter will be referred as Plots 1 to 4, with the northernmost being Plot 1 and the southernmost being Plot 4 (Figure 46). The 1857 map shows buildings fronting onto Newgate Street, each with outbuildings and yards behind and extensive gardens extending further to the west. A row of four cottages faced directly onto Back Way at the west end of Plots 1 and 2. The northernmost three of these survived beyond the 1883 warehouse development but were demolished before 1900 and their sites absorbed into the complex. More cottages were built perpendicular to Back Way on Plot 3 between 1857 and 1893 and these had a 'Cartway' to the south which led to the rear of Block C, returning northwards to the yard behind Block A.¹⁷²

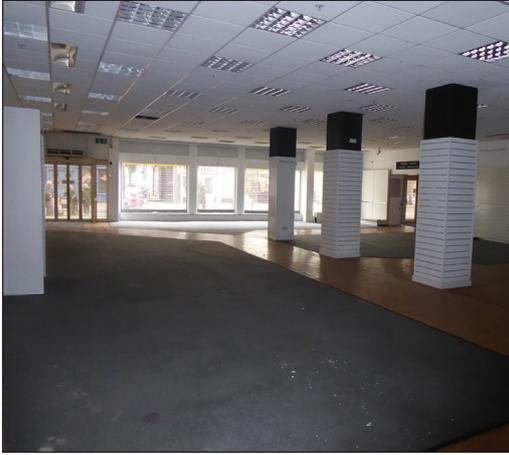
Figure 47: Interior of R104 looking east showing modernised shop finishes (© Historic England, photograph: Alastair Coey Architects, 2019)

The three sales area floors in Blocks A-D were subjected to periodic refurbishment with the final iteration probably being carried out in the late 20th or early 21st centuries. A relatively consistent range of floor, wall and ceiling finishes was adopted throughout ground- (R101-R106 and R111), first- (R202-R205) and second-floor (R301-R303) levels (Figure 47). The exposed grid-pattern mineral tile suspended ceiling incorporates integrated modular fluorescent light fittings, downlighters, spot lights and fire suppressant sprinkler heads. During the course

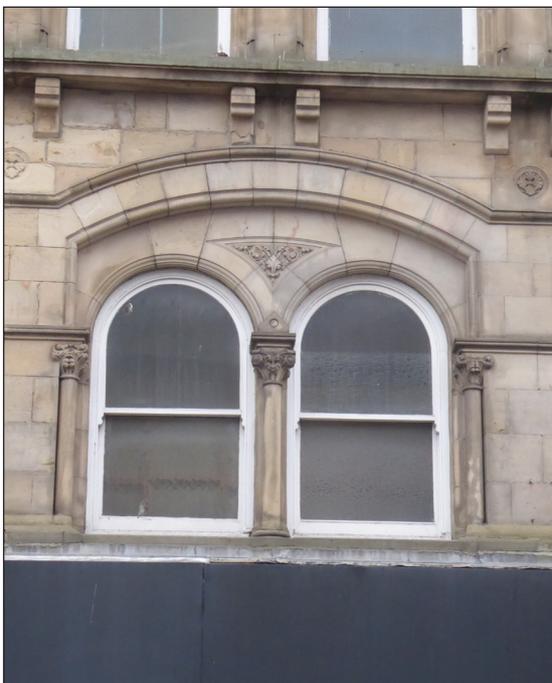
Figure 48: First-floor windows on the 1892-94 building (exterior of R204) (© Historic England, photograph: Alastair Coey Architects, 2019)

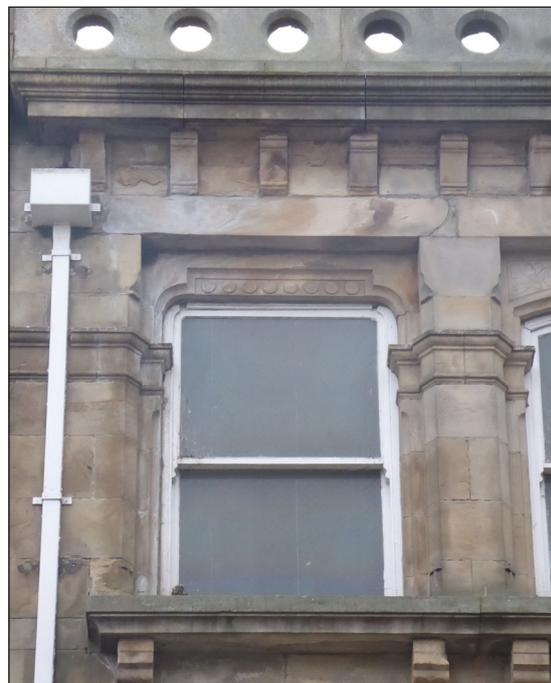
Figure 49: Second-floor windows on the 1892-94 building (exterior of R303) (© Historic England, photograph: Alastair Coey Architects, 2019)

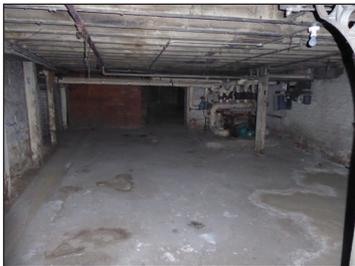
Figure 50: R003 looking west and showing raised platform with heating system (© Historic England, photograph: Alastair Coey Architects, 2019)

The main basement space, R003, occupies the full footprint of the three-storey building above. The concrete floor appears to be of late 20th- or early 21st-century origin. A raised concrete plinth in the north-west corner contains pipes and valves, probably related to a redundant heating system (Figure 50). The north wall is penetrated by an opening, containing ledged and sheeted double doors, connecting the basement of Block A to the basement of Block B, presumably formed at the time of construction of the newer block. To the east of this opening the wall is of limewashed rubble stone which steps slightly northwards towards its east end (Figure 51). To the west, the wall is constructed mainly in limewashed brick returning at the west end to the west wall and an opening into R005. The brick walling to the south of this opening is of much more recent origin and forms the north wall of the base of the lift shaft introduced as part of the post-1961 renovations; the lift shaft is not accessible from the basement. The south wall is built

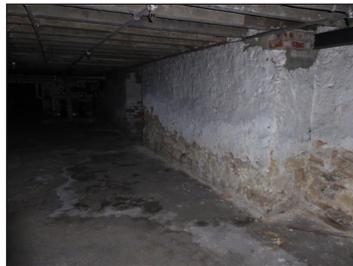
Figure 51: Limeswashed rubble construction in the north wall of R003 (© Historic England, photograph: Alastair Coey Architects, 2019)

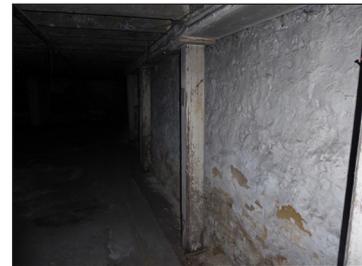
Figure 52: The inserted timber beam and posts on the south wall of R003 (© Historic England, photograph: Alastair Coey Architects, 2019)

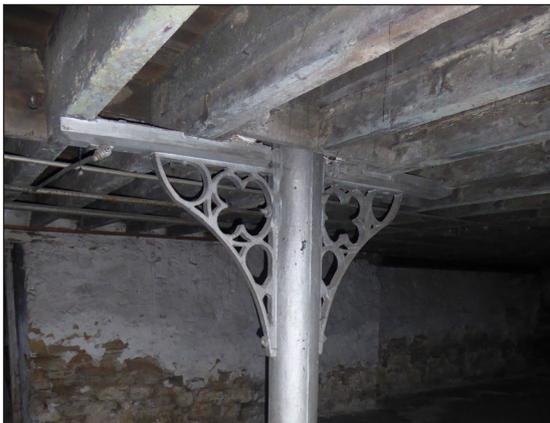
Figure 53: The centrally located iron column in R003 (© Historic England, photograph: Alastair Coey Architects, 2019)

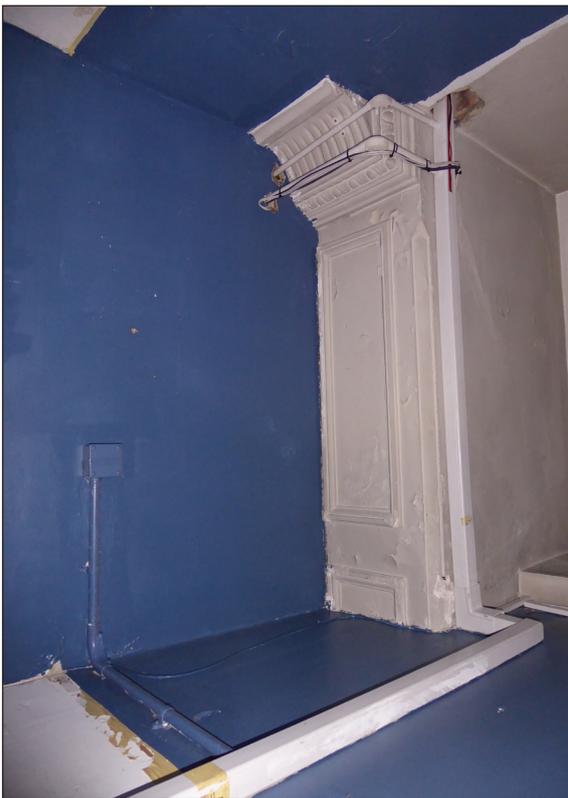
Figure 55: The remains of the paneled soffit in the reduced opening between R103 and R123 (© Historic England, photograph: Alastair Coey Architects, 2019)

A large opening in the west wall of R103, which leads to R123, has been reduced in size by the insertion of the lift shaft to the south and now contains a pair of modern flush doors. Above the opening, the north portion of a two-panel decorative plaster soffit survives, the remainder of the panel being absorbed into the structure of

the brick lift shaft to the south (Figure 55). What remains visible is carried on a wide fluted plaster console with egg and dart enrichment. This feature may be of a late 19th-century date or could be related to the alteration work associated with construction of Block B, which was added in 1882-83. It certainly suggests that R123, which now is bounded by plain painted brick walls, was originally of enough significance to merit decorative panelling (Figure 56). Part of the bottom flange of a substantial riveted iron beam, which carries the south wall of the original long narrow general warehouse to the west on Plot 2 (now absorbed into Block F), protrudes at ceiling level on the south wall and continues westwards through R121, 122 and 124. The 1961 survey shows the space, now occupied by the lift shaft and R123, in use as an office with a covered yard to the west.

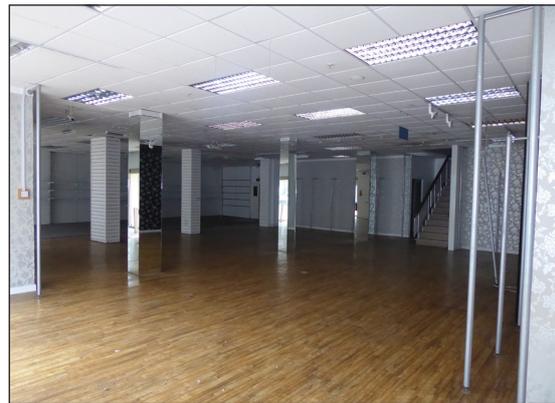
Figure 57: Interior of R102 and 103 looking south-west from R101 (© Historic England, photograph: Alastair Coey Architects, 2019)

The main ground-floor space, R103, has been substantially modernised in the late 20th or early 21st centuries (Figure 57). The floor is finished with wood-effect vinyl sheet walkways bounding two carpeted display areas, all laid on the late 19th-century timber floorboards which survive beneath. The columns on the line of the former north wall, inserted in 1882-83, are now encased by horizontally grooved display panelling and the wider encasement to the east conceals the pair of columns referred to above. The west end of the north wall, west wall and south wall are all lined with modern shelving display panelling. A suspended ceiling conceals the late 19th-century ceiling bays which are finished with a later painted anaglypta paper.

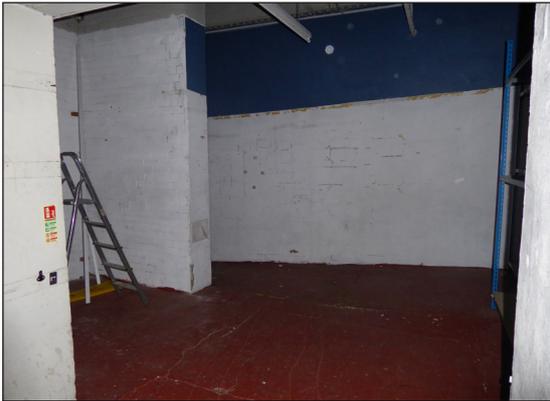
Figure 58: Interior of R203 looking east showing modern shelving to north and south (© Historic England, photograph: Alastair Coey Architects, 2019)

The 1961 survey shows this area in use as ‘Boot and Shoe Department’, a function which continued as ‘Footwear Department’ in the post-1961 restructuring. Today this space has also been refitted. The floor is finished with wood-effect vinyl sheet concealing the late 19th-century flooring which probably survives below (see above). The north and south walls are lined with modern shelving display panelling

set out from the structural walls (Figure 58). The opening in the north wall, leading to R202, was formed with the construction of Block B while the opening in the west end of the south wall, containing a pair of glazed aluminium sliding doors leading to R204, and the wide opening to the north side of the west wall, with steps leading up to R216, were both formed as part of the post-1961 restructuring (Figure 59). The east wall retains late 19th-century plasterwork including pole mouldings on the splayed reveals of the four sash windows. The central pair of windows is set below a segmental arch. Again, the late 19th-century ceiling is concealed above a late 20th- or early 21st-century suspended ceiling.

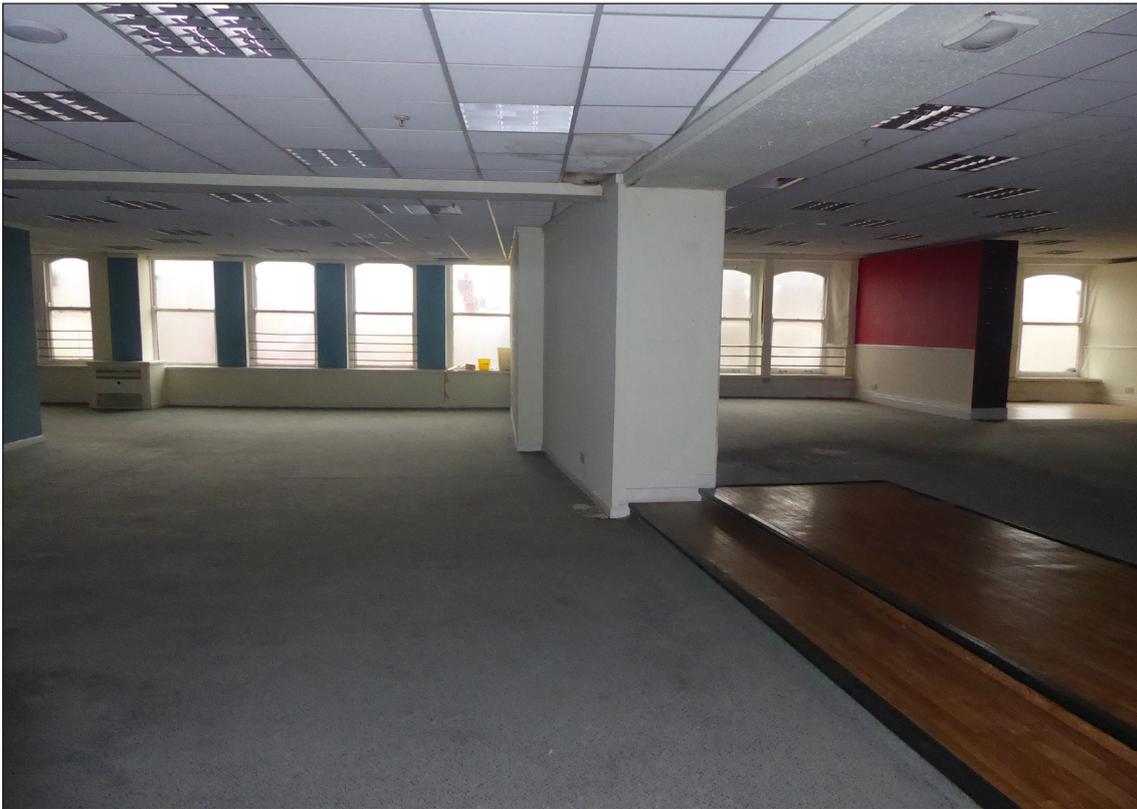
Figure 60: Interior of R302 and R303 with stepped opening between (© Historic England, photograph: Alastair Coey Architects, 2019)

Today the floor is carpeted, concealing the original flooring which probably survives below (*see above*) (Figure 60). All walls are plastered and painted. The internal faces of the late 19th-century sash windows on the east wall are visible although the window linings have been removed and replaced with modern plasterwork. A suspended ceiling conceals the roof structure.

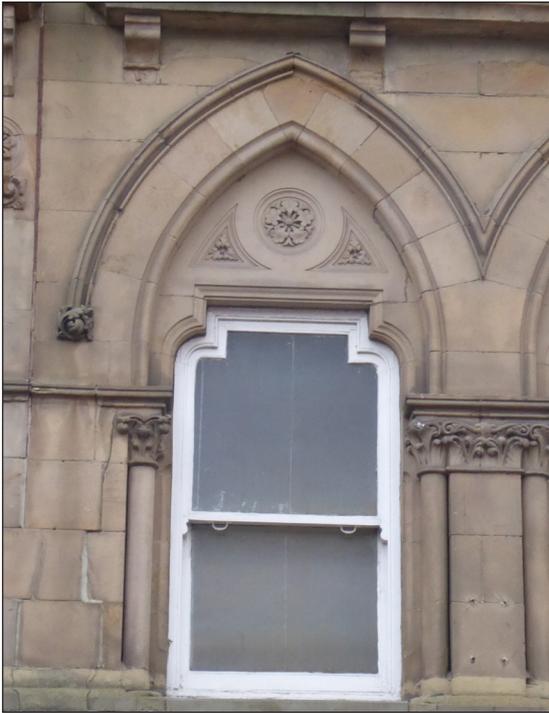
Figure 61: First-floor window on the 1882-82 building (exterior of R202) (© Historic England, photograph: Alastair Coey Architects, 2019)

The ground-floor shopfront was completely remodelled in the latter half of the 20th century and no evidence appears to survive of what pre-dated it. The historic illustrations from Readshaw's book indicate that the handsome glazed shopfront proposed by R W Thompson was executed, again following the earlier section designed by his brother in 1873. The shopfront arrangement created by this extension was a symmetrical composition of three bays separated by pedimented consoles with central recessed entrance doorways in the end bays, each containing double doors flanked by fluted columns. At first floor the centrepiece has two shouldered window openings with one over one recessed sash windows set below

pointed-arch hood mouldings terminating in carved label stops and containing carved enrichments in the tympana (Figure 61). At second floor, three recessed segmental-headed one over one sash windows are grouped on a continuous projecting moulded sill course carried on four, equally-spaced, plain moulded corbels separated by colonnettes and set in a rectangular opening broken by a central upward-projecting pointed arch containing carved enrichment (Figure 62). Above, an unusual stepped pediment contains square diamond relief panels and other carved embellishments.

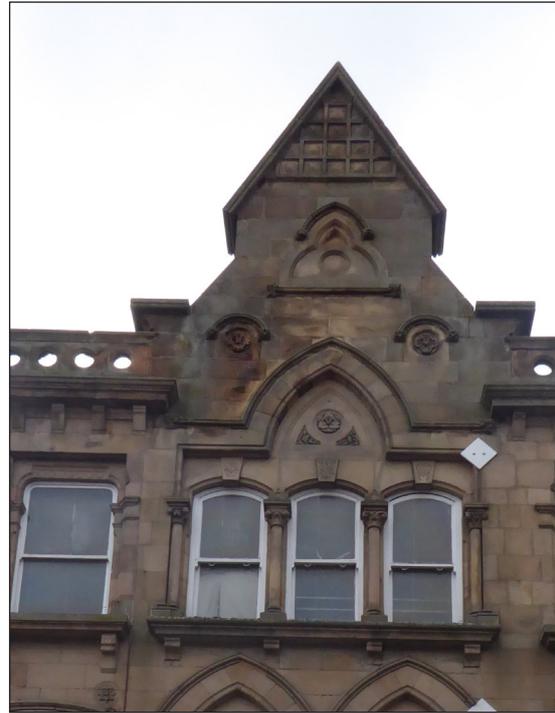
Figure 62: Second-floor windows (exterior of R301) and gable on 1882-83 building (© Historic England, photograph: Alastair Coey Architects, 2019)

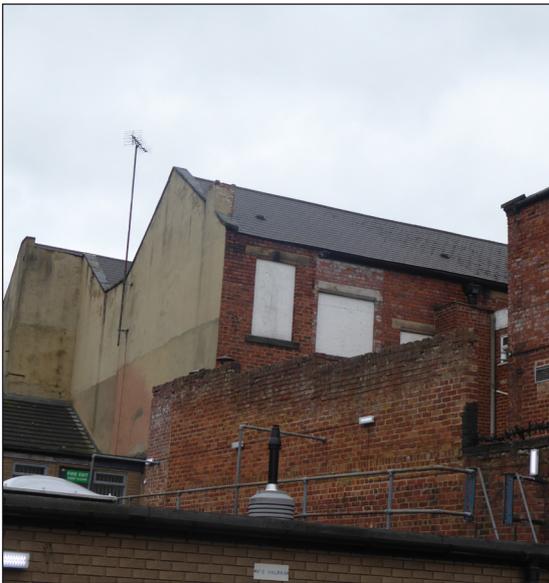
Figure 63: The rendered north end elevation of the 1882-83 building and part of the warehouse of Block F (© Historic England, photograph: Alastair Coey Architects, 2019)

The west (rear) elevation, and presumably the north gable (now rendered), were constructed in red clay brick laid in stretcher bond with intermittent header courses

(Figure 63). A late 19th-century rear second-floor window opening and staircase half-landing window survive along with the second-floor opening into the lift shaft (Figure 64). Each has a sandstone sill and stop-chamfered lintel. All three openings are now sheeted over. The line of the former lift shaft/hoist is further defined at second-floor level by square recessed fixing holes and lighter coloured brickwork. Further evidence of original openings in the west elevation, infilled with brick probably in the late 20th century, can be seen at ground level from R142 (Figure 65).

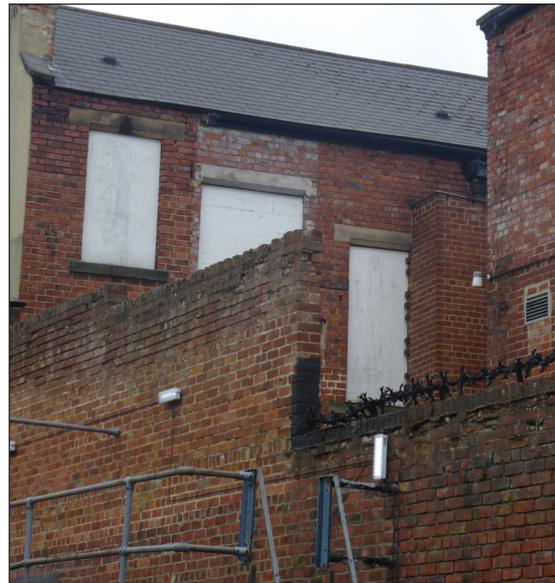
Figure 64: Blocked up second-floor window (left), opening onto former lift shaft (centre) and half-landing window (right) on the rear of the 1882-83 building (© Historic England, photograph: Alastair Coey Architects, 2019)

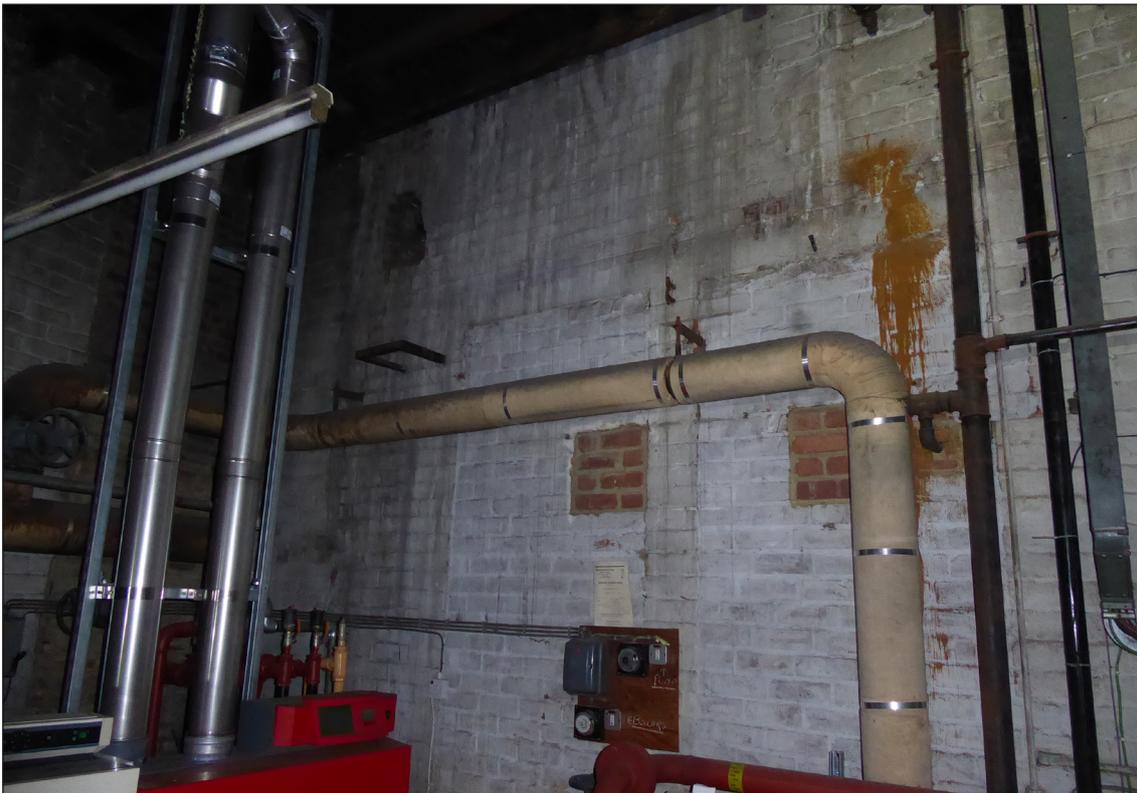
Figure 65: Blocked up openings at ground-floor level on the west elevation of the 1882 building (now within R142) (© Historic England, photograph: Alastair Coey Architects, 2019)

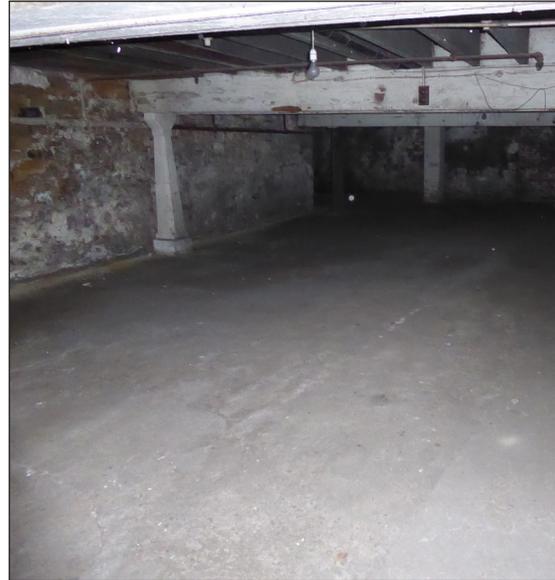
Figure 67: Interior of R001 looking east (© Historic England, photograph: Alastair Coey Architects, 2019)Architects, 2019)

The walls of R001 are of limewashed rubble stone. The north wall, including the north-east projection, west and east walls survive substantially unaltered (Figure 67). An opening in the west wall, presumably the opening to the 1882 staircase, has been infilled with stretcher course brickwork during the 20th century. On the east wall an opening, which on the 1882 plans seems to extend to a chamber under the pavement on Newgate Street, has also been bricked up. Unlike the opening to the west, the brickwork here is laid in English bond, showing remains of limewash, and may have been closed up in the early 20th century. The south wall has been substantially altered. The original opening connecting R001 and R002 has been bricked up and two substantial 'I' section steel beams, extending almost the full length of the wall, have been placed side-by-side on a concrete base formed on top of the original stone wall which has been reduced in height (Figure 68). These beams were introduced as part of the post-1961 restructuring to carry the three steel columns at ground and first floor, which allowed the north and south compartments to be interlinked, and a single column at second floor to carry the central roof valley beam.

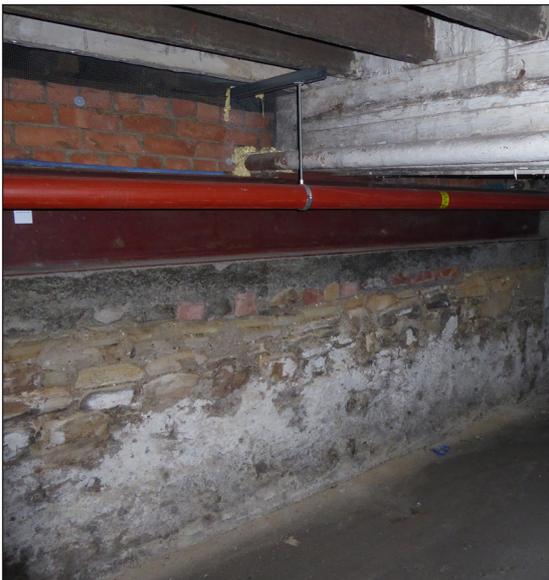
Figure 68: The north side of the blocked up opening between R001 and 002 with steel I-beam inserted above original wall (© Historic England, photograph: Alastair Coey Architects, 2019)

Figure 68: The north side of the blocked up opening between R001 and 002 with steel I-beam inserted above original wall (© Historic England, photograph: Alastair Coey Architects, 2019)

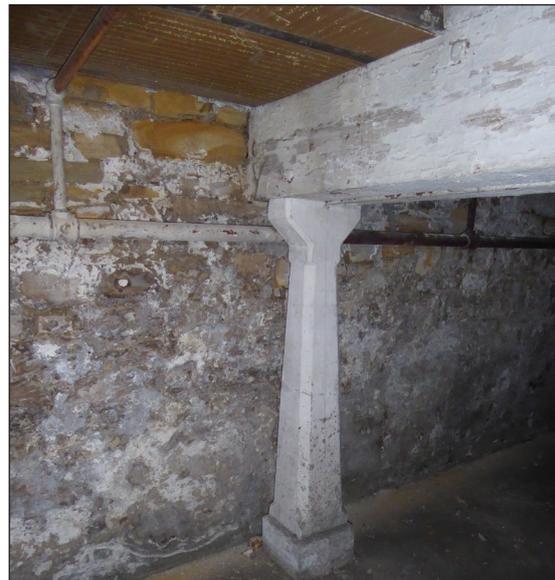
Figure 69: Timber post carrying the north end of the central beam in the ceiling of R001 (© Historic England, photograph: Alastair Coey Architects, 2019)

Figure 69: Timber post carrying the north end of the central beam in the ceiling of R001 (© Historic England, photograph: Alastair Coey Architects, 2019)

The central of the three north-south-spanning fitch beams carrying the ground-floor joists is supported at its north end by a square-section limewashed timber column which tapers inwards from its base with chamfered corners, set on a raised masonry plinth, introduced around the end of the 19th century, presumably to address concerns over timber decay in the end bearing of the beam (Figure 69). The third, easternmost, beam is also supported at its north end but by a steel 'I' section stanchion, clearly a later intervention likely dating to the early 20th century (Figure 70). A lath and plaster ceiling, applied to the underside of the floor joists, has been removed, exposing the underside of the ground floor boards.

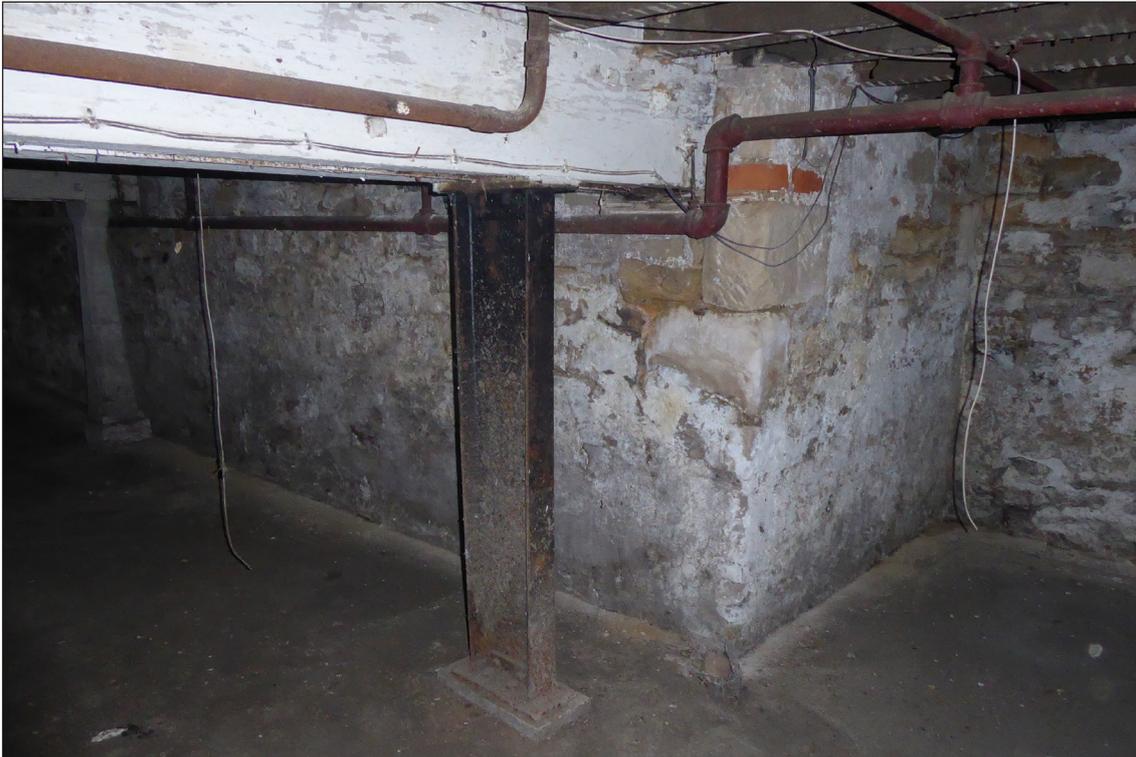
Figure 70: Steel stanchion carrying the north end of the east beam in the ceiling of R001 (© Historic England, photograph: Alastair Coey Architects, 2019)

Figure 70: Steel stanchion carrying the north end of the east beam in the ceiling of R001 (© Historic England, photograph: Alastair Coey Architects, 2019)

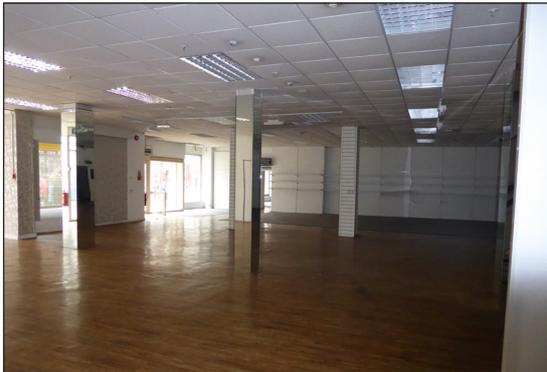
Figure 71: Interior of R101, 102 and 103 looking south-east (© Historic England, photograph: Alastair Coey Architects, 2019)

Figure 71: Interior of R101, 102 and 103 looking south-east (© Historic England, photograph: Alastair Coey Architects, 2019)

As existing, the floor is finished with wood-effect vinyl sheet (Figure 71). Changing cubicles are located against the west wall south of the staircase. The three columns on the line of separation between the north and south compartments are encased by mirrored glass and walls are dry-lined and finished with paint or wallpaper. A suspended ceiling conceals the steel beams inserted in the northern compartment as part of the post-1961 re-structuring (Figure 72).

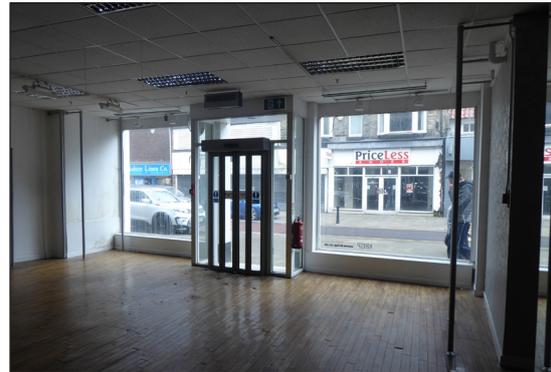
Figure 72: Interior of the shopfront entrance to the 1882-83 building (R101) (© Historic England, photograph: Alastair Coey Architects, 2019)

Figure 72: Interior of the shopfront entrance to the 1882-83 building (R101) (© Historic England, photograph: Alastair Coey Architects, 2019)

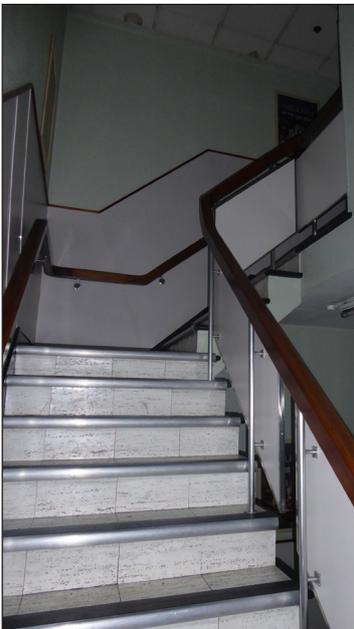
Figure 74: Interior of the staircase (R201) ascending to the second floor (© Historic England, photograph: Alastair Coey Architects, 2019)

The post-1961 re-structuring saw removal of the Tea Room, the staircase and the stairwell wall between the two compartments. The opening into the female toilets was built up. Existing columns and beams on the line separating the two compartments were retained and a third column was introduced to support the widened opening. The opening where the stairwell had been removed was infilled with new flooring. The new open-plan floor layout was designated 'Footwear Department' and a new stairwell occupied the north-west corner (Figure 74).

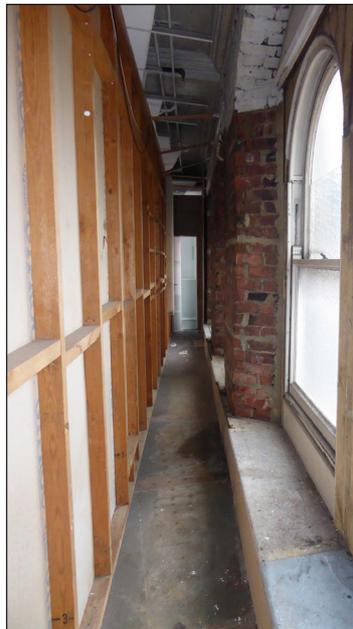
Figure 75: View north behind the stud wall at the east side of R202, showing the timber windows (© Historic England, photograph: Alastair Coey Architects, 2019)

and steel beams inserted in the northern compartment as part of the post-1961 re-structuring. A false wall, constructed from timber studwork, closes off the east side of the space from the east window wall (Figure 75). From within the void between the false wall and east wall it can be seen that original plasterwork between and around the sash windows has been removed, exposing the brick wall structure. It is also possible to see here the east side of the original lath and plaster ceiling, down-stand beam and moulded cornice above (Figure 76).

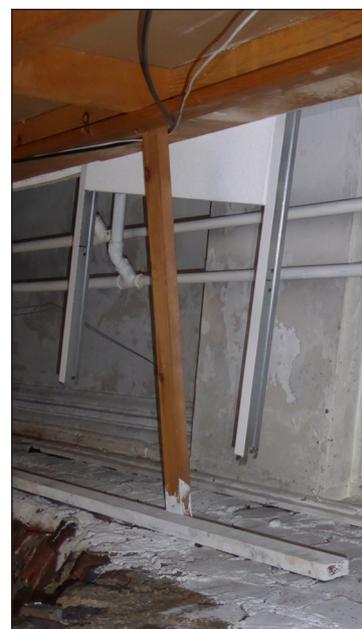
Figure 76: Detail of the original cornicing above the suspended ceiling in R202 (© Historic England, photograph: Alastair Coey Architects, 2019)

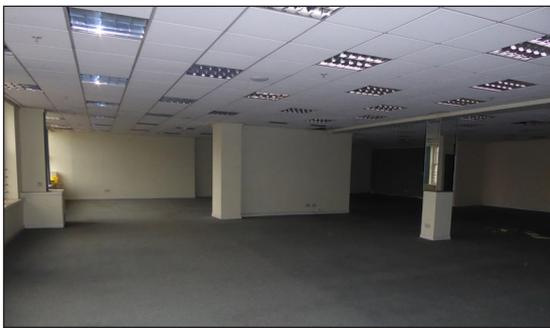
Figure 77: Interior of R301 looking south-west to R302 (© Historic England, photograph: Alastair Coey Architects, 2019)

The floor space here is now finished with carpet (Figure 77). The central column is encased and mirrored, walls are plastered and painted and a suspended ceiling conceals the roof structure. Timber sash windows, with plain plastered square reveals and substantial window boards, are exposed on the east wall (Figure 78).

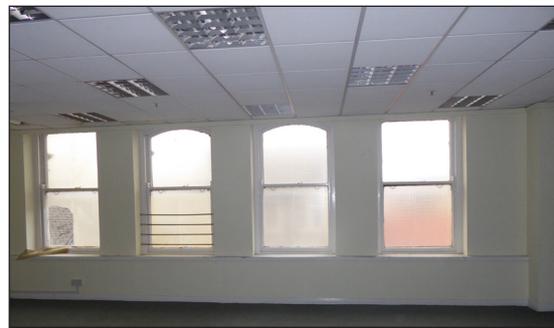
Figure 78: Timber sash windows in R301 (© Historic England, photograph: Alastair Coey Architects, 2019)

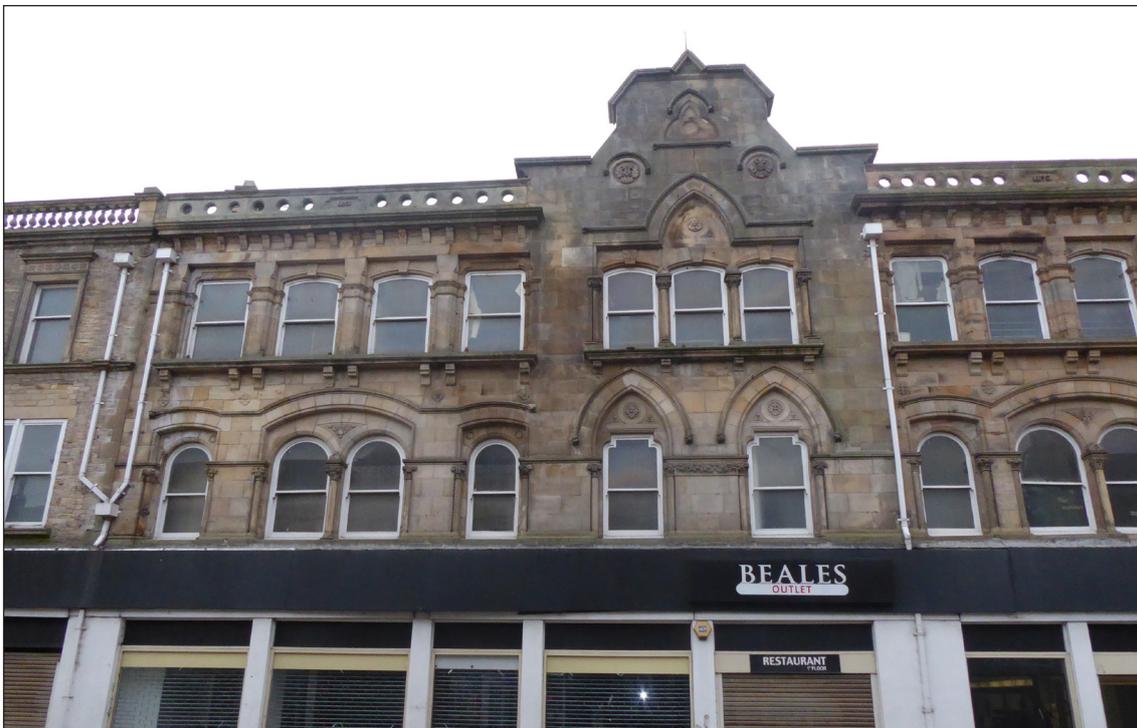
Figure 79: The exterior of the 1892-94 building (Block C) on Newgate Street (© Historic England, photograph: Alastair Coey Architects, 2019)

The main volume of Block C has a double-pitch slate roof concealed behind the street-fronting parapet. The 'M'-profile gabled roofs, with a central valley and perimeter gutters, are set behind tall brick parapets to the north and south, and there is a return structure to the west, perpendicular to the front roof. A flat-roofed lift motor room, now redundant, projects above the north-west corner marking the location of a lift shaft, shown on the 1961 survey drawings but subsequently removed from all floor levels of the interior as part of the post-1961 re-structuring. At the front, east side, a parapet gutter drains to externally routed downpipes. The return roof parapet and central valley gutters drain through outlets in the west gable onto the flat-roof of the three-storey extension to the west.
