Former Central Stores of Bishop Auckland Co-operative Society,
80 Newgate Street, Bishop Auckland, County Durham
Historic Building Report

HISTORIC BUILDING REPORT

Alastair Coey Architects

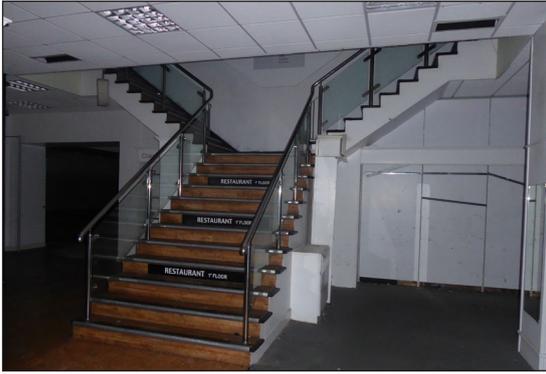
Figure 80: The modernised bifurcated staircase on the ground floor of R104 (© Historic England, photograph: Alastair Coey Architects, 2019)

The main building was constructed with timber floors resting on riveted iron beams carried on iron columns. A bifurcated public staircase, which rises through all floors, is centrally located against the west wall, splitting from a single central flight after the first half landing (Figure 80). Modernisation of the late 19th-century staircase has included removal of the balustrading, replaced in glass and stainless steel, and re-covering of the treads with carpet and stair nosings.

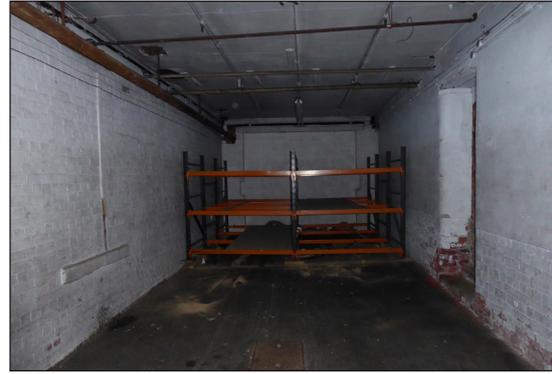
Figure 81: The former covered 'gateway' (R113, looking south) to the west of the 1882-83 building and below R208 (© Historic England, photograph: Alastair Coey Architects, 2019)

By the 1961 survey the 'General Office' and 'Corridor' had been re-configured as one space designated 'Grocery Packing'. Steps led up to raised staging at the north end and what appears to be a chimney breast is shown projecting from the south wall. The windows in the west wall, which had looked into the covered 'Gateway', had been blocked although projecting stone sills of the former windows can still be seen from R113 (see Figure 81).

The former 'Gateway', R113, has a macadamed surface (see Figure 81). The east wall is of limewashed brickwork with alternating header and stretcher courses. It contains evidence of the former window openings to R111 and 112 referred to above and which are presumed to have been blocked in the early 20th century. A former vehicular entrance in the south wall to R110 has been blocked with concrete blocks. Late 19th-century brickwork, identical to the east wall, can be seen on the lower part of the west wall while the upper section has been rendered. At its north end the west wall terminates in a quadrant corner formed in brick rising to a sandstone corbel which converts the quadrant to a right angle to provide a bearing for the beam over the opening from R121. An opening in the centre of the west wall has bullnose corners to the reveals and sandstone steps which rose to R116 in Block E before the back of the recess was blocked with brick. The original lath and plaster 'Gateway' ceiling survives (Figure 93).

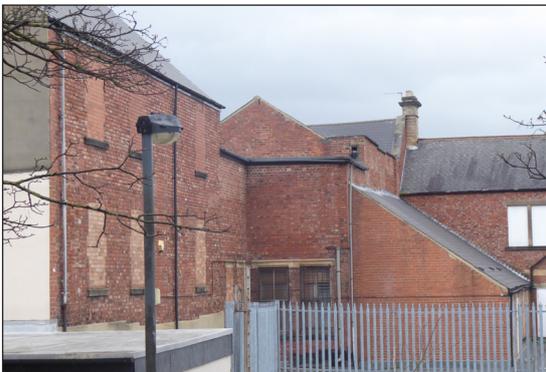
Figure 82: View of the west elevation of the 1892-94 building showing the windows of the 'Waiting Room' (centre) and blocked south windows of the 'Manager's Office' (to their left). Both rooms now form part of R208 (© Historic England, photograph: Alastair Coey Architects, 2019)

While construction of the block was underway, Lindsay submitted revised plans showing a two-storey brick extension, 'L'-shaped on plan, with a double-pitch slate roof, to be added to the west (rear) of the new building. This apparently required demolition of the easternmost cottage of the row perpendicular to Back Way, to allow a new north-south 'Gateway' (R113) to pass below the west part of the first floor of the new extension and connect with an existing east-west 'Gateway' to the south of Block F and west of Block A (Figure 81). Original first-floor window openings belonging to this extension can still be seen in the south-west corner of the surviving fabric consisting of a pair of two over two sash windows with stop-chamfered sandstone lintels

and sandstone sills facing west ('Waiting Room') and two windows facing south ('Manager's Office'), also with sandstone lintels but subsequently blocked with brick in the mid- to late 20th century (Figure 82).

In the late 20th century, a flat-roofed second floor was added over Lindsay's two-storey extension (see Figure 82). This new extension also extended over the north-east projection from Block E and the formerly open east-west 'Gateway' further north (R121). The work involved removal of the pitched roofs over Lindsay's extension and removal of the lean-to roof over the Block E extension. Part of the west wall of the three-storey building can be seen from the upper windows in Block F. The newest portion is built in red brick in English garden wall bond rising to a

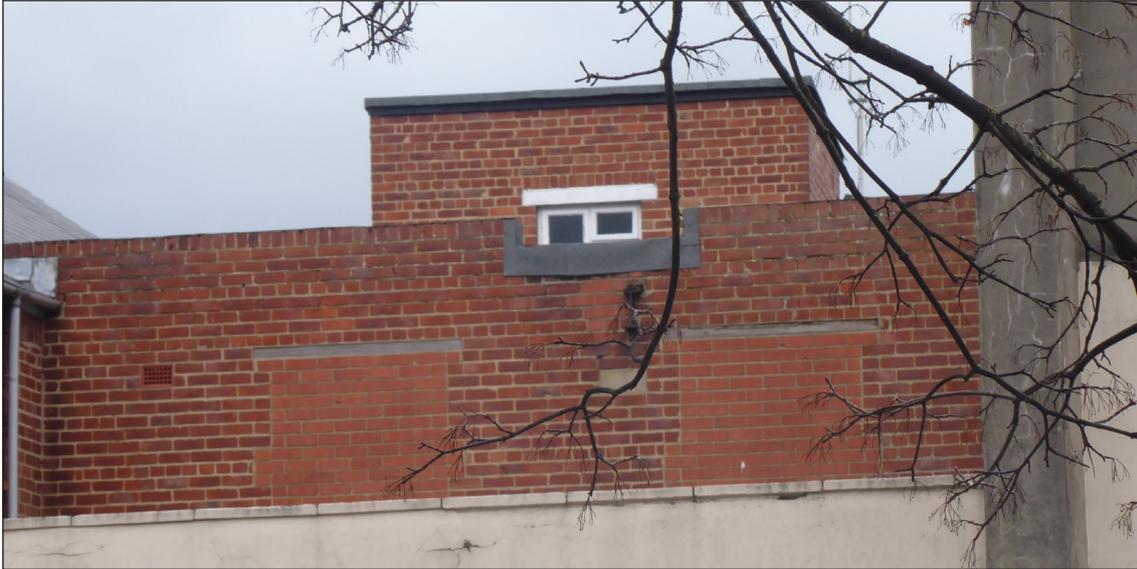
Figure 83: Blocked windows and parapet to the rear of R306 (© Historic England, photograph: Alastair Coey Architects, 2019)

Post-1961 re-structuring work included infilling the eastern half of the east-west 'Gateway' with a three-storey extension which accommodated a 'Public Lift' at its east end and a 'Goods Hoist' at its west end, the flat-roofed motor rooms of which project above the main roof level (Figure 83).

parapet capped with a header course coping (Figure 83). The line of the former lean-to roof over the north-east abutment of Block E can also be seen incorporated into and below the new work as can two former second-floor window openings, each with exposed pre-stressed concrete lintels, now built up with red brick.

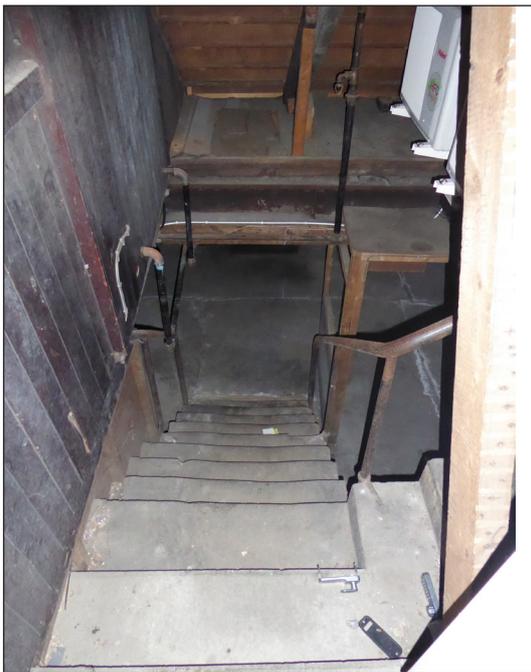
Figure 84: The staircase from R111 down to R004. The treads to the right form part of the earlier route of the staircase descending from under the main staircase in R104 (© Historic England, photograph: Alastair Coey Architects, 2019)

The basement was originally accessed by an 'L'-shaped staircase from R104 directly below the south return leg of the main staircase. It had sandstone treads and a simple tubular steel balustrade with widely-spaced balusters which are lead-caulked into the treads (Figure 84). At some point after 1961 it was reconfigured as a straight flight accessed from R111 with the new top treads formed in concrete. Some original stained and varnished vertical tongue and groove and 'V'-jointed sheeting lining the side walls survives but has been removed from the soffit of the main staircase above.

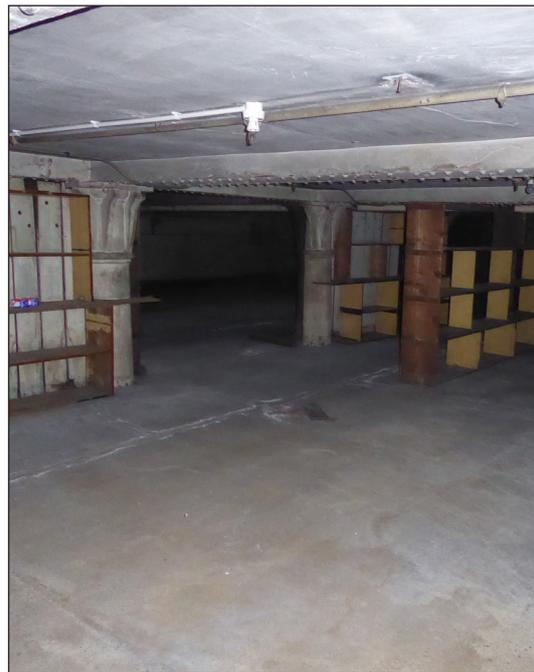
Figure 85: R004 looking north-west showing the two columns offset from the centreline (© Historic England, photograph: Alastair Coey Architects, 2019)

The concrete floor in R004 appears to be of 20th-century origin and is almost certainly contemporaneous with the post-1961 re-structuring. An east-west, centrally located row of five wide squat circular cast-iron columns, each with an eight-finned capital, carry a grid of substantial riveted iron beams which support the ground floor slab (Figures 85 and 86). At the west end two columns are offset from the centre line to facilitate the central location of the public staircase above.¹⁷³ North, east, south and west walls are faced in white glazed stretcher-bond brickwork. The glazed brick walling returns, with quadrant corners, into the reveals of the opening in the north wall, which contains sheeted timber double doors leading to R003 in Block A (Figure 87). The east wall contains a number of openings which have been blocked with red brick and are matched with recesses formed in the floor slab above. The purpose of these openings is not known but may indicate the location of pavement loading trap doors. The cast concrete ground-floor slab has a thin plaster finish.

Timber staging, to isolate stored goods from a potentially damp floor, is arranged around the perimeter walls and the central row of columns (*see* Figures 85 and 86). Various arrangements of timber shelving encapsulate the columns. Hand-written lettering on the glazed brickwork including 'High Street Spennymoor', 'Shildon' and 'Ferryhill' indicates the branch stores of the Co-operative Society to which goods were to be delivered (Figure 88). A small office, located to the north of the staircase with thin timber walls, is entered from the east and has a splayed, north-east facing wall containing eight glazed panes. The base of the redundant brick lift shaft shown on the 1961 survey survives in the north-west corner. The west wall to the south of the staircase contains electrical distribution switchgear with labels such as 'Drapery, windows & hardware department' and 'Mercery, Committee Rooms & Butchery' (Figure 89).

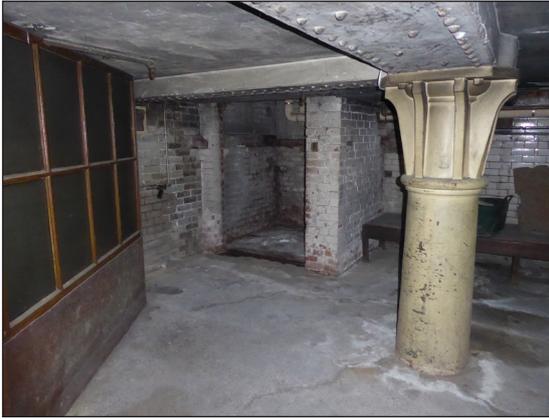
Figure 86: Detail of a column in R004 with timber staging behind (© Historic England, photograph: Alastair Coey Architects, 2019)

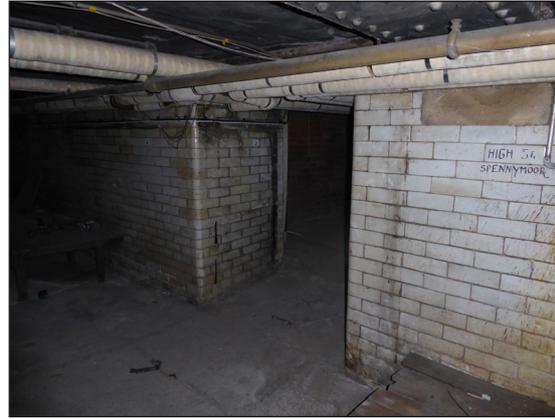
Figure 87: Opening leading into R003 showing glazed brick walling and sections of timber staging (© Historic England, photograph: Alastair Coey Architects, 2019)

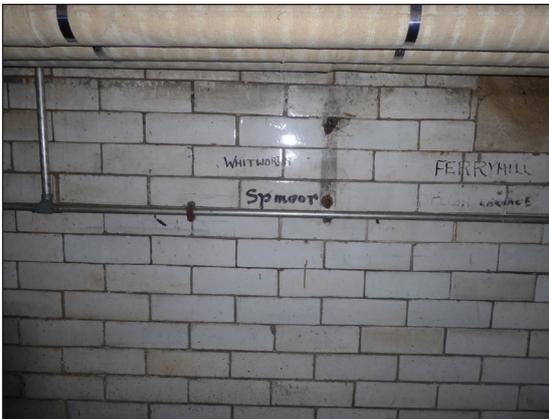
Figure 88: Glazed brick walling with the names of branch stores written on the walls for organising storage (© Historic England, photograph: Alastair Coey Architects, 2019)

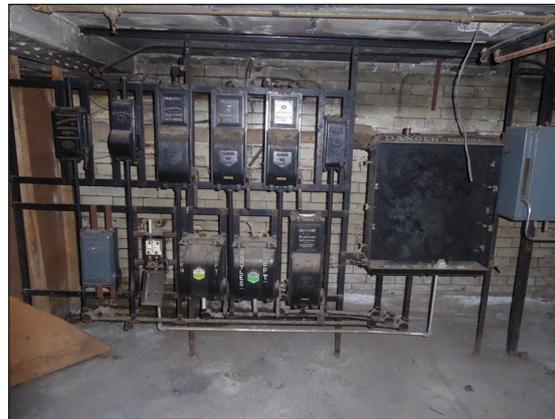
Figure 89: Electrical switchgears to the west wall of R004 (© Historic England, photograph: Alastair Coey Architects, 2019)

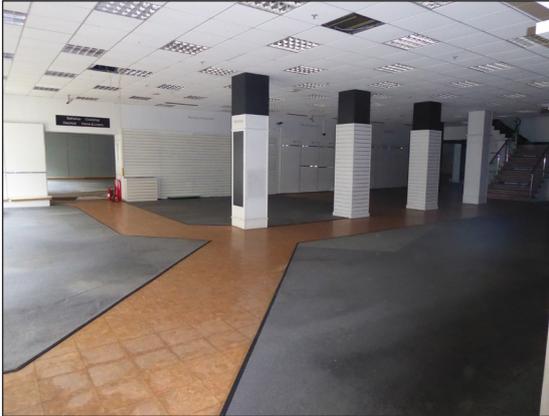
Figure 90: The modernised interior of R104 showing the opening into R105 (© Historic England, photograph: Alastair Coey Architects, 2019)

Today, the sales area, R104, has been altered. The floor is finished with vinyl tile and sheet covered walkways passing through three carpeted display areas all laid on the original timber floorboards which survive beneath (see Figure 90). Columns are encased by horizontally-grooved display panelling and the north, south and west walls are lined with modern shelf display panelling. A suspended ceiling conceals the original lath-and-plaster ceiling bays which are decorated with painted anaglypta paper. The column capitals can also be seen within the void.

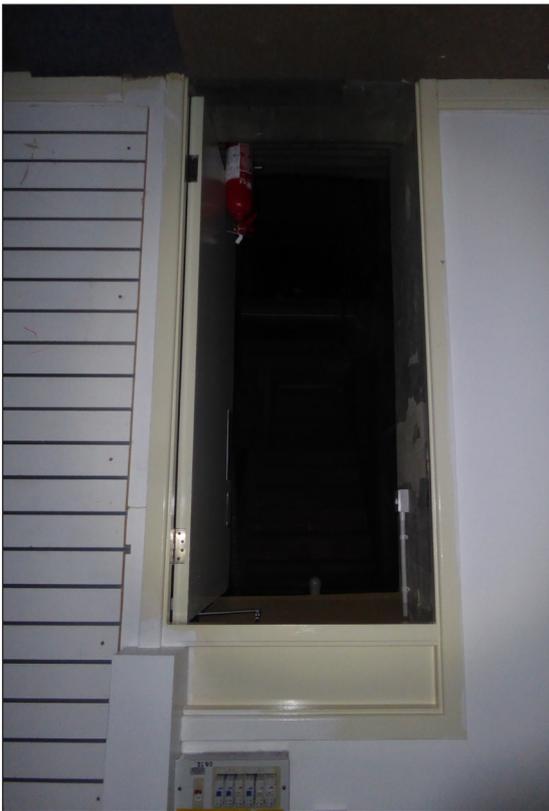
Figure 91: The entrance in R111 to the staircase descending to R004 (© Historic England, photograph: Alastair Coey Architects, 2019)

In R111, it is presumed that the wide openings in the east wall into R104 and south wall into R106 were introduced in the late 20th century. A doorway at the north end of the east wall leads to the re-configured staircase which descends to the basement and a doorway in the north wall leads to R112 (Figure 91). The southern half of the floor is finished with thermoplastic tiles and the northern half with carpet. The north, south and west walls are lined with modern shelving display panelling although two late 19th-century piers, which carry east-west spanning beams, can be seen projecting from the west wall. A suspended ceiling conceals the original lath-and-plaster ceiling bays and beams.

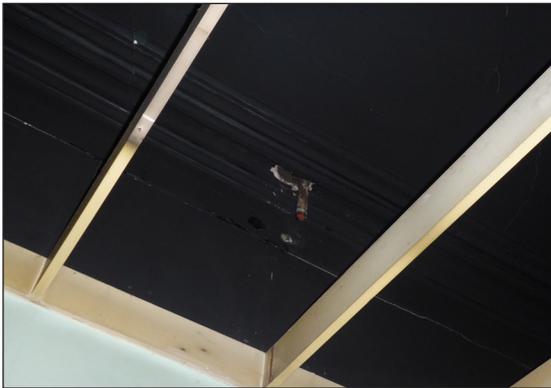
Figure 92: Moulded cornicing above the suspended ceiling in R112 (© Historic England, photograph: Alastair Coey Architects, 2019)

R112 is separated from R111 by a lightweight partition. The floor is surfaced with linoleum and a ramp in an opening in the north wall rises approximately 400mm to R122, walls are plastered and painted and the suspended ceiling, formed from pine

sheeting, probably dating from the 1970s, conceals the late 19th-century lath and plaster ceiling and moulded cornicing relating to the 1892-94 layout (Figure 92).

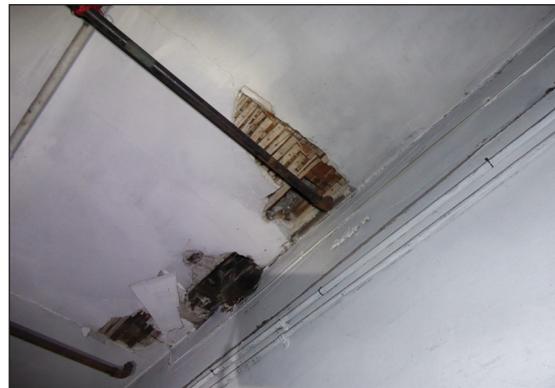
Figure 93: The original lath and plaster ceiling in the 'gateway' (R113) (© Historic England, photograph: Alastair Coey Architects, 2019)

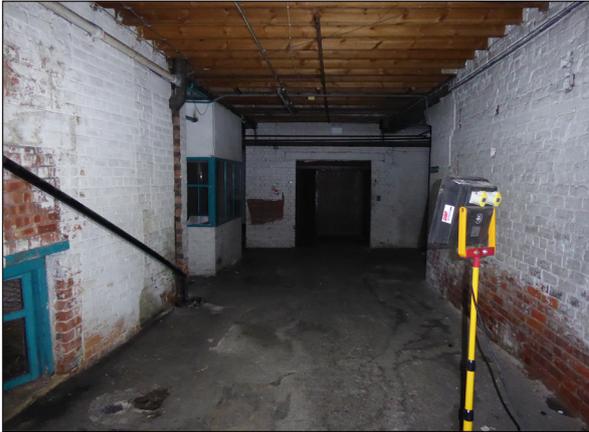
Figure 94: Interior of R121 looking east (© Historic England, photograph: Alastair Coey Architects, 2019)

R121 occupies the eastern half of the former east-west 'Gateway' (Figure 94). Macadamed paving slopes down from west to east towards the goods hoist with its iron concertina gate, walls are of limewashed brickwork and exposed north-south spanning timber joists, dating from the post-1961 re-structuring, carry

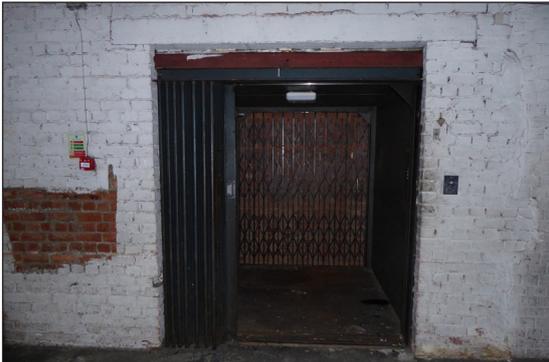
Figure 95: The goods hoist with iron concertina gate at the east end of R121 (© Historic England, photograph: Alastair Coey Architects, 2019)

timber floorboards the underside of which are visible (Figure 95). The external face of the brick north wall of the goods hoist structural shaft incorporates a cast-iron column (facing into R124), which carries a substantial riveted iron beam, supporting the south wall of the original long narrow warehouse on Plot 2 (now absorbed into Block F). Interestingly, the capital of this column is almost identical, though of a smaller profile, to the columns in the basement of the 1892-94 building, suggesting they came from the same manufacturer (Figure 96 and see Figure 86). It is the only remaining one of five shown as pre-existing on Linday's 1883 plan in the location of the south side of R124.

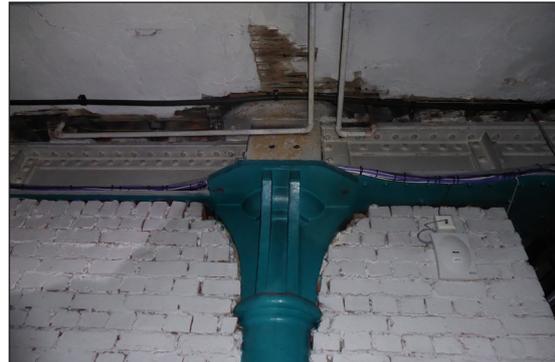
Figure 96: A capital of one of the cast-iron columns in R121 (© Historic England, photograph: Alastair Coey Architects, 2019)

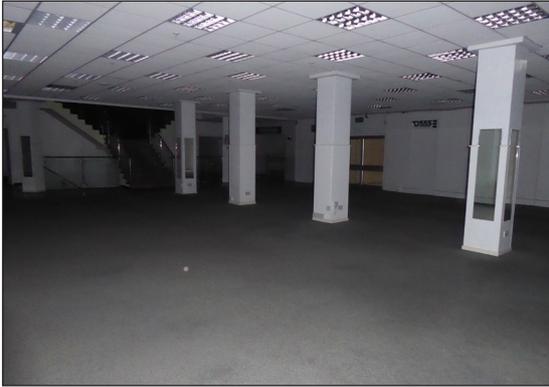
Figure 97: Interior of R204 looking north-west with the staircase at the west end (© Historic England, photograph: Alastair Coey Architects, 2019)

Today, the floor of the sales area, R204, is finished with carpet and, around the stairwell, wood-effect vinyl sheet, both laid on the original timber floorboards which survive beneath (Figure 97). The columns have square plain plaster encasements. The north wall has aluminium sliding doors to the east of the public lift entrance, leading to R203 in Block A. To the west of the lift a wide flat-headed opening contains stepped and ramped access leading through R215 to the restaurant area (Figure 98). The windows within the front elevation are concealed behind a full-height partition which excludes all natural light from the sales area and prevents

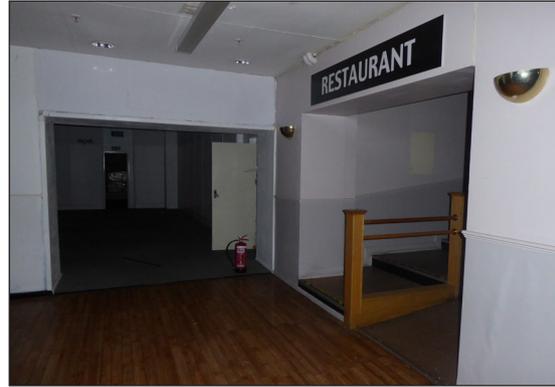
Figure 98: The opening and ramp into R215 and looking into R208 from R208 (© Historic England, photograph: Alastair Coey Architects, 2019)

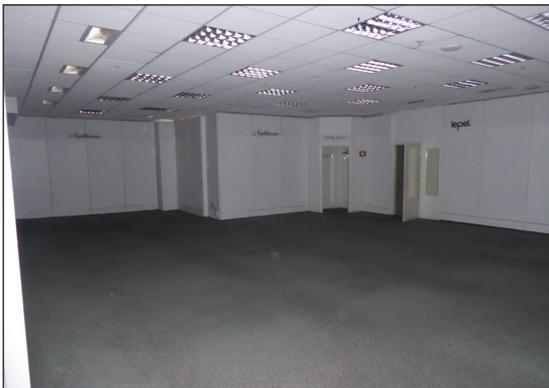
Figure 99: Interior of R208 looking south-west (© Historic England, photograph: Alastair Coey Architects, 2019)

R208 has also been fitted with carpeted floors, plastered walls and suspended ceiling concealing all earlier finishes (Figure 99). The west wall contains two door openings. That to the south gives on to a timber staircase rising to R210 in Block E and that to the north, which opens into R213, is set in a partition wall which infills the former wide opening shown on the 1961 survey.

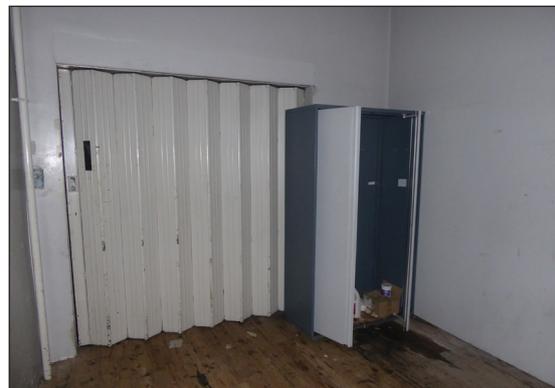
Figure 100: The replacement steel concertina door to the goods hoist in R212 (© Historic England, photograph: Alastair Coey Architects, 2019)

R212 is a lobby serving the east side of the goods hoist constructed as part of the post-1961 re-structuring. The flooring is unfinished pine floorboards and walls and ceilings are finished with gypsum plaster. The hoist concertina door is a modern sheet steel version rather than the older iron gate version which exists at ground floor (Figure 100).

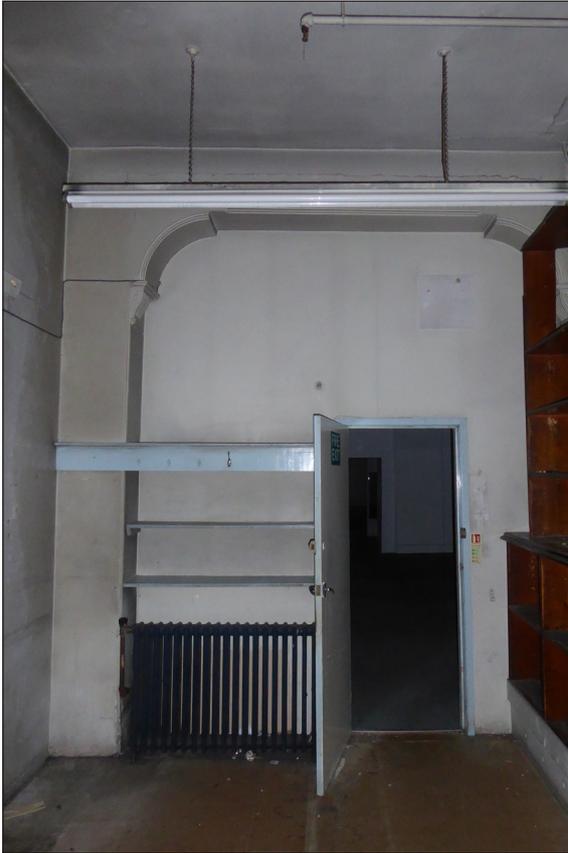
Figure 101: The east wall of R213 showing the shouldered-arch opening into R208 (© Historic England, photograph: Alastair Coey Architects, 2019)

R213 is the first floor of the north-east abutment to Block E. It has a plain sheeted floor, plastered walls and lath and plaster ceiling. The south and west walls are lined with fixed shelving. The east wall contains the wide shouldered-arch opening to R208 and has original moulded reveals with paired consoles carrying inward facing quadrants supporting a flat soffit (Figure 101). This arch is not visible from within the modernised shop interior of R208. It was presumably formed in the early 20th century with the construction of the north-east abutment on Block E (replacing two west-facing windows in the Manager's Office shown in Figure 24c) and this space is shown as a north-west extension of a 'General Office' on the 1961 survey. A one over one sash window, visible at the south side of the west wall of R213, has been blocked with brick in the late 20th century on the outside although the original sandstone sill and lintel survive. A square-headed opening, formed in the north wall, leads to R214.

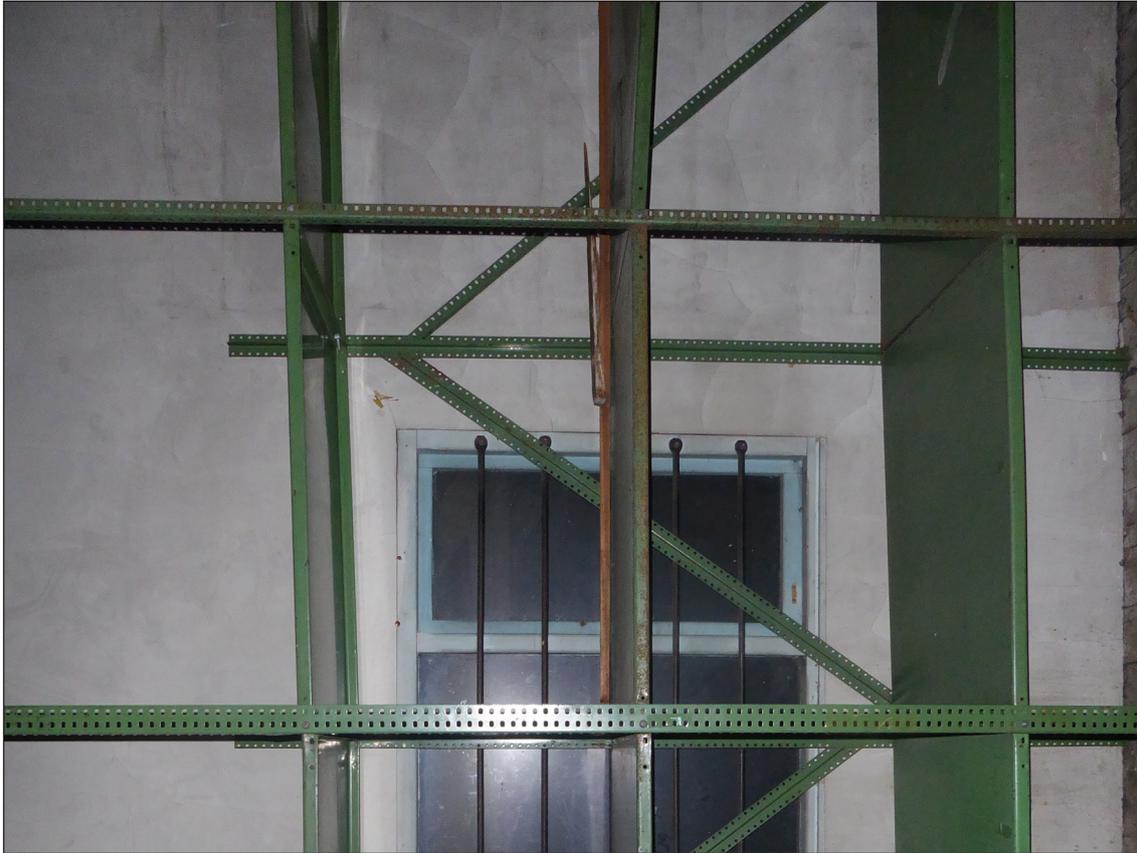
Figure 102: The casement window in the west wall of R214 overlooking R120 (© Historic England, photograph: Alastair Coey Architects, 2019)

R214 is a long, narrow, nondescript room, built *circa* 1990 as part of the work involved in adding a second floor above R208. The new room enabled new lift doors to be installed on the west side of the hoist shaft in addition to the existing opening on the east side. R214 also connects with R213 to the south and Block F to the north. The flooring is unfinished pine floorboards laid on north-south spanning joists which are visible from R121 below. The north, south and west walls and ceiling are finished with gypsum plaster but the east wall retains the exposed, previously external, brickwork of the hoist shaft in which the new lift door opening has been inserted. Two steps up to a lobby projecting from the west end of the north wall leads to R220 in Block F. The west wall contains a late 20th-century casement window which can also be seen on the north wall of the interior of R120 (Figure 102 and *see* Figure 158).

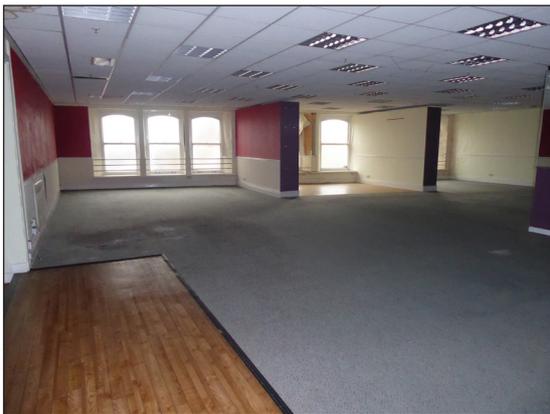
Figure 103: Interior of R303 looking east and showing the non-structural piers between windows (© Historic England, photograph: Alastair Coey Architects, 2019)

R303 has been refitted and was most recently in use as an open-plan sales area (Figure 103). The floor is finished with carpet and, around the stairwell and opening to R302, wood-effect vinyl sheet, all laid on the original timber floorboards

which survive beneath. The three columns have square plain plaster encasements with mirror panels fixed to the upper portions. The north, east and south walls are wallpapered and have dado rails. Two non-structural piers project perpendicular from the east wall and two from the south wall and are presumed to have been installed in the late 20th century to subdivide the display space. Original late 19th-century sash windows, with plain plastered reveals and thick sill boards, are exposed on the east wall. The two wide openings, to either end of the west wall, each have two full-width steps up into R306 and must have been formed when the new second floor was added *circa* 1990. The suspended ceiling probably conceals the original roof structure above.

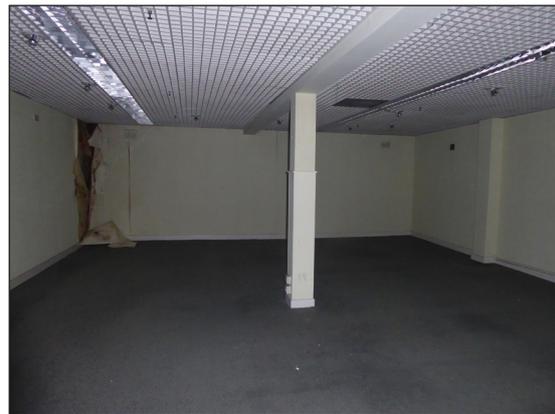
Figure 104: Interior view of the north-west portion of R306 looking west and showing the column and steel beam (© Historic England, photograph: Alastair Coey Architects, 2019)

The sales area comprising R306 appears to have been constructed *circa* 1990 as it is not shown on either the 1961 survey or the post-1961 restructuring drawings. The floor is carpeted, walls are papered and an open grid suspended ceiling conceals the flat roof above (Figure 104). A single central column carries a steel 'I' beam which spans from the south-west corner of the goods-hoist structural shaft to the middle of the west wall, through which it protrudes to be visible on the outside. A protrusion from the west wall of the goods hoist shaft may mark the location of a set of lift doors, now removed. Although from the interior no evidence can be seen of two windows in the west wall, they are visible from the outside and are now blocked with late 20th-century red brick but, unusually, with timber lintels (*see* Figure 84). Two wide openings at either end of the east wall lead down two steps to R303 and double flush doors in the north wall, adjacent to the west wall, lead to R307.

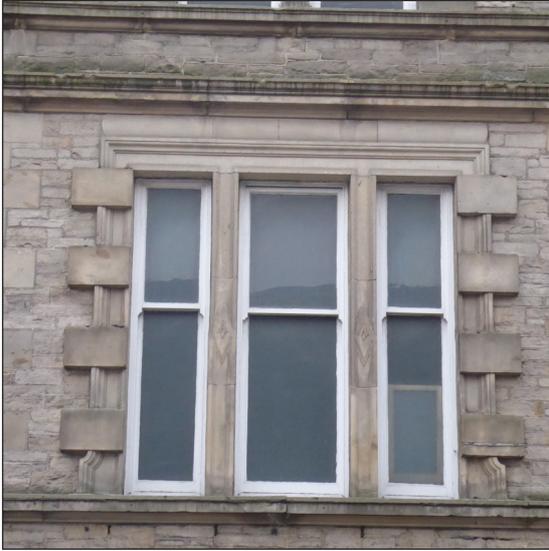
Figure 105: The central tripartite first-floor window on the 1894 building (Block D) (© Historic England, photograph: Alastair Coey Architects, 2019)

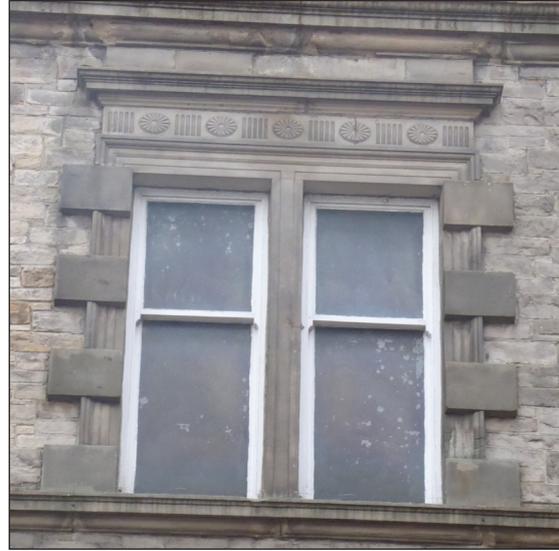
Figure 106: The central second-floor windows on the 1894 building (Block D) (© Historic England, photograph: Alastair Coey Architects, 2019)

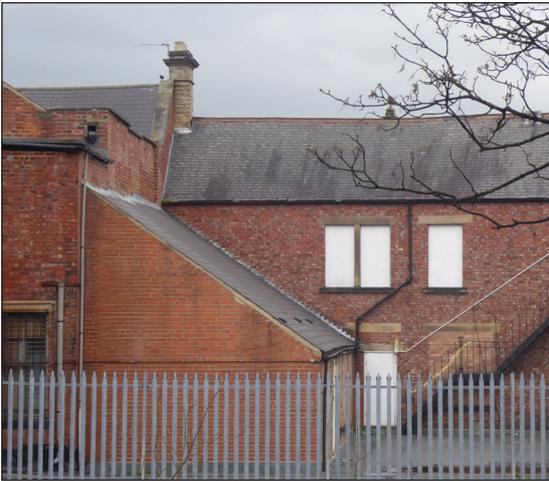
Figure 107: The west elevation of Block D showing the inserted fire staircase and blocked windows (© Historic England, photograph: Alastair Coey Architects, 2019)

A two-storey return, with mono-pitch slate roof and brick walling in an irregular English garden wall bond, projects from the rear north-west corner of the three-storey front building and abuts the south side of Block C (Figure 107). The west wall of this return must have been re-built and the roof replaced after 1990 as it is

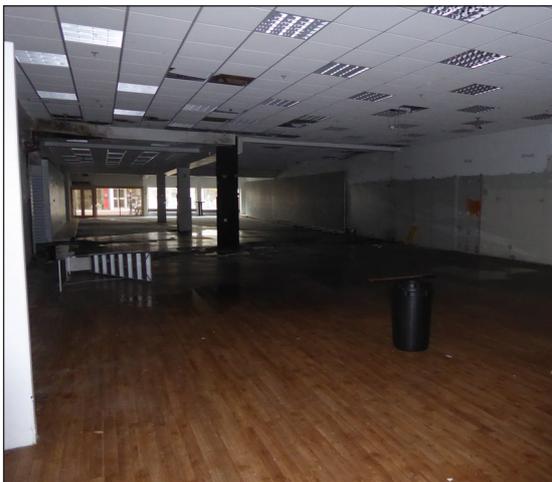
Figure 108: Interior of Block D looking east through R107, 106 and 105 (© Historic England, photograph: Alastair Coey Architects, 2019)

Three columns in R106 carry steel beams which support the south wall of the two-storey return building (Figure 108). The east side of R106 is open to R105 and the west side to R107. Columns and down stand beams are encased in plasterwork, and the floor is finished with a wood-effect vinyl sheet walkway bounded by two carpeted display areas. The north and south walls are lined with display panelling. A square-headed opening at the west end of the north wall leads to R111. A suspended ceiling conceals the underside of a composite timber flat-roofed structure above.

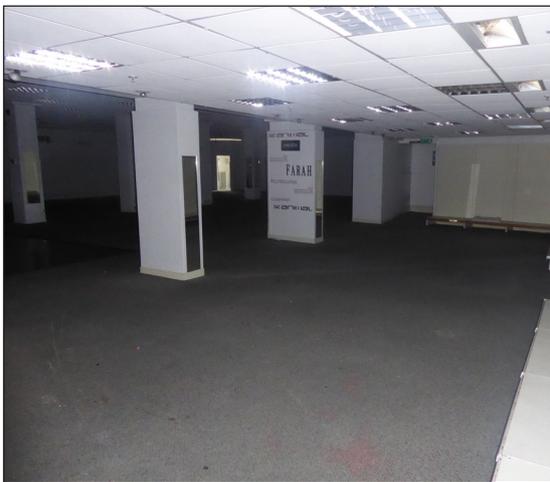
Figure 109: Interior of R205 looking north-east into R204 (© Historic England, photograph: Alastair Coey Architects, 2019)

Today, R205 is a single space designated 'Sales Area' (Figure 109). The floor is carpeted, the north wall has been substantially removed to create three wide square-headed openings into the sales area of R204 and the south, east and west walls are lined with display shelving. A flush fire escape door at the west end of the south wall opens onto the ground-floor flat roof. A suspended ceiling conceals the mono-pitch roof structure above. The lobby and male toilet which comprise R207 have been converted to use as a store. The west wall has exposed brickwork which appears to confirm that this wall was rebuilt at the same time as the second floor was added to the adjoining room (R208) in the late 20th century.

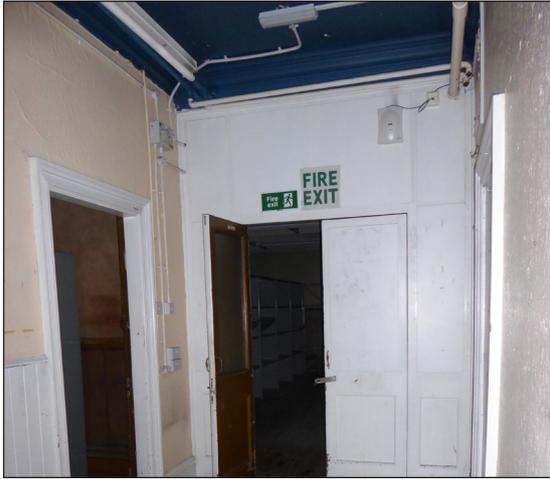
Figure 110: View looking south behind the partition at the east end of R205 with the doors to R209 and 206 (© Historic England, photograph: Alastair Coey Architects, 2019)

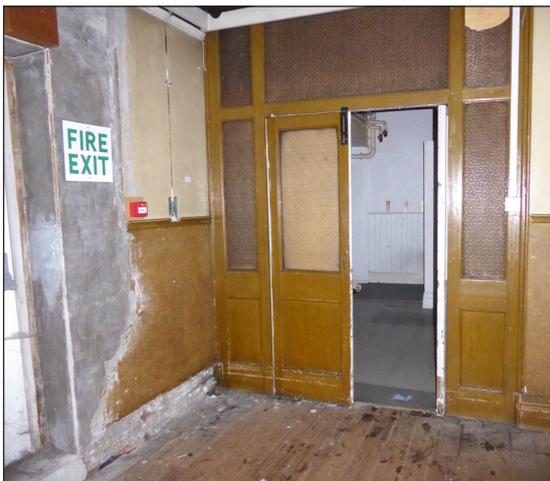
Figure 111: The door in R206 looking north (© Historic England, photograph: Alastair Coey Architects, 2019)

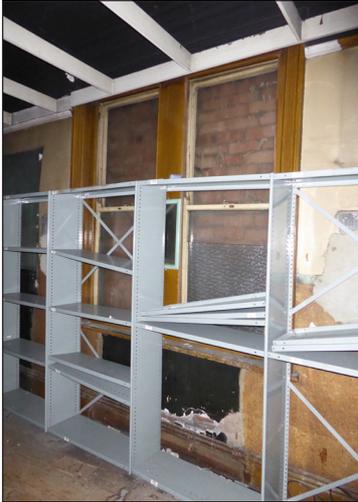
Figure 112: Shelving obscuring blocked windows on the west wall of R206 (© Historic England, photograph: Alastair Coey Architects, 2019)

In the main building the layout shown in 1961 survives essentially intact. The corridor has an open-topped toilet cubicle in its north-east corner. The floor is finished with thermoplastic floor tiles, walls are plastered above a vertically-sheeted timber dado and the ceiling is lath and plaster with a moulded cornice (Figure 110). A four-panel door in the east wall leads to R209, the former Managing Secretary's Office, and a panelled door in the west wall formerly opened into R205 but is no longer visible within that room (the surround of the latter door is on the right of Figure 110). In the south wall the late 19th-century half-glazed double-doors, on double-action floor springs with side lights and fanlights, are set in a glazed screen and open into the former Board Room, R206 (Figure 111). In R206, late 19th-century softwood floorboards on east-west spanning joists are exposed. Walls have moulded skirtings, scumbling below a moulded dado and plain plaster above. A lath and plaster ceiling, down stand beams and moulded cornicing can be seen above an open-grid suspended ceiling and are probably original to the 1890s. A fire escape door onto the flat roof is located in a crudely formed opening at the north end of the west wall. Further south a late 19th-century coupled two over two sash window with moulded architrave has been blocked with brick on the outside in the late 20th century (Figure 112). Further

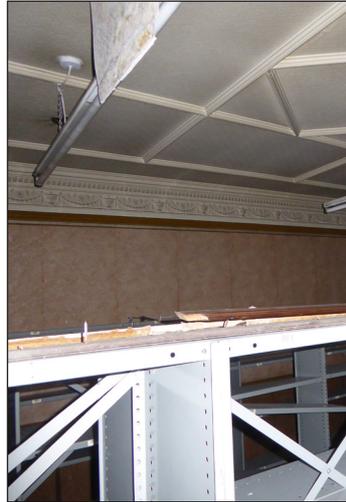
Figure 113: The north wall and chimneybreast of R209 showing the frieze, cornice and ceiling (© Historic England, photograph: Alastair Coey Architects, 2019)

with anaglypta wallpaper and sub-divided into panels (the four corner panels containing gas light bosses) separated by mouldings, and the ceiling is bounded by a moulded and dentilled cornice with a shallow frieze containing swags and urns (Figure 113). The four-panel door has bolection mouldings (Figure 114). Joinery work has woodgrained finish and the dado is scumbled. The north wall contains a projecting chimney breast containing an early 20th-century Art Deco-style fireplace with hardwood surround and tiled inset and hearth (Figure 115).

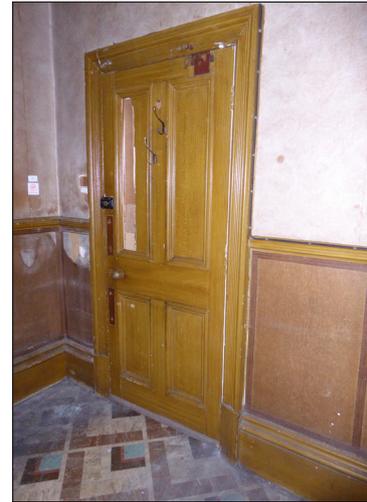
Figure 114: The door of R209 with bolection mouldings (© Historic England, photograph: Alastair Coey Architects, 2019)

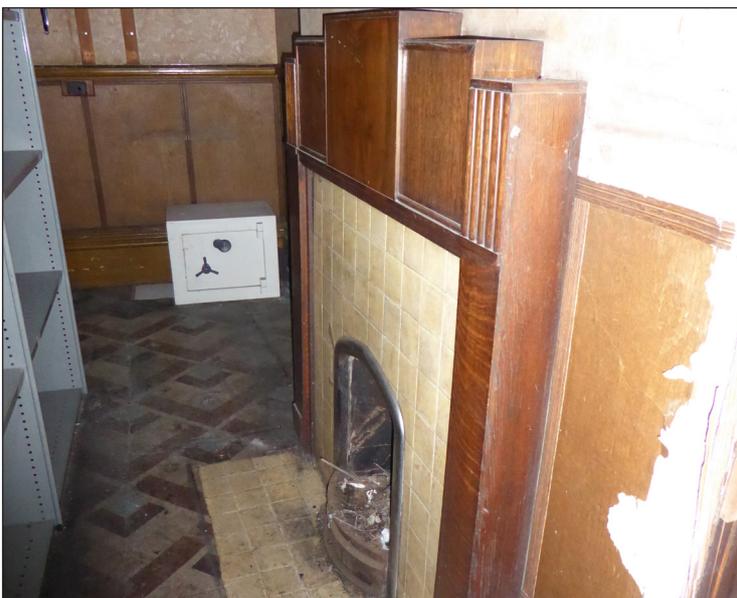
Figure 115: The timber Art Deco-inspired surround to the fireplace in R209 (© Historic England, photograph: Alastair Coey Architects, 2019)

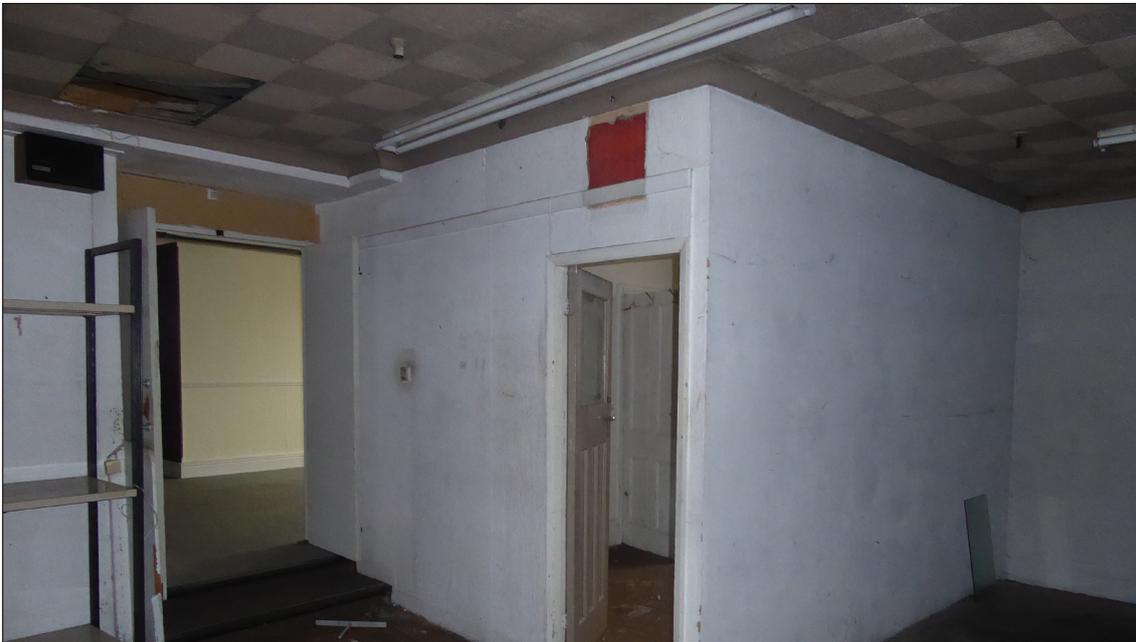
Figure 116: Interior view of R304 looking north-east to R305 (© Historic England, photograph: Alastair Coey Architects, 2019)

The 1961 survey drawings designated R304 'Carpets and Bedding' and R305, the north-east corner of the space, as 'Telephone Room' (Figure 116). Both rooms appear to have been refurbished *circa* 1970 and were last used for storage. R304 has plywood flooring, plain plastered walls and a fibre-based ceiling tile system fixed directly to the 19th-century lath and plaster ceiling. The north wall contains double flush doors opening from Sales Area R303. The two northernmost window openings on the west wall have been sheeted over and a third window opening at the south end of the wall has been lowered and a flush fire escape door installed, which opens onto a steel staircase descending to the flat roof below. Two window openings on the east wall have been partially blocked in the early 21st century. Partial collapse of the ceiling allows the late 19th-century timber roof structure and underside of the slating to be glimpsed.

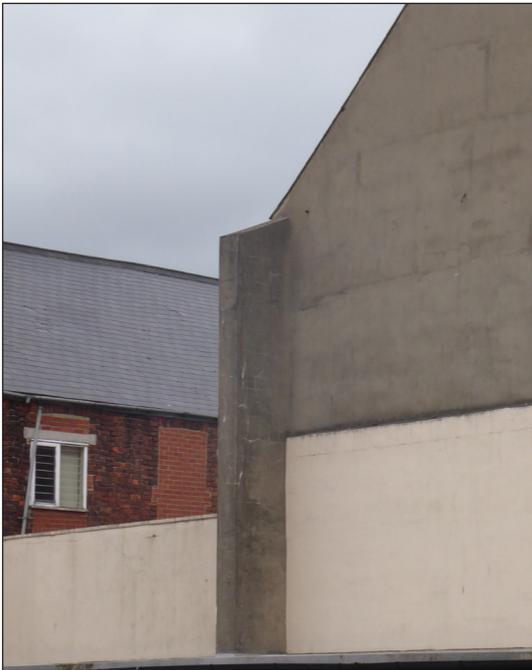
Figure 117: View of the warehouse comprising Block E from the south-west on Westgate Road (© Historic England, photograph: Alastair Coey Architects, 2019)

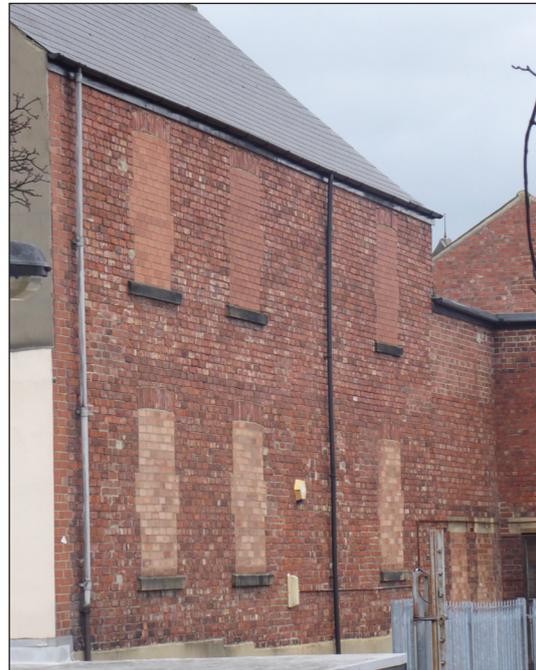
Figure 118: The south wall elevation of Block E showing blocked windows (© Historic England, photograph: Alastair Coey Architects, 2019)

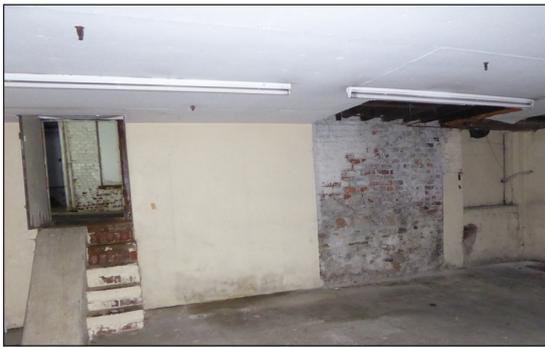
Figure 119: The east compartment of the semi-basement (R117) showing the steps to R120 and the site of the hoist in the north-east corner (© Historic England, photograph: Alastair Coey Architects, 2019)

The eastern compartment has plastered walls (Figure 119). The ceiling is formed by a sheet material fixed to timber joists. The compartment is accessed at the west end of the north wall from R120 by a flight of five steps, each with sandstone treads on brick risers. The steps have on their west side a concrete ramp, presumably introduced to facilitate handling of goods into and out of the semi-basement. The vertical timber-sheeted enclosure of the hoist shaft, which was located in the north-east corner, has been removed and the ceiling aperture crudely infilled. An opening in the north wall indicates the hoist was accessed from R120, which would have been an open yard or 'Gateway' before the space was roofed over in the mid-20th century before 1961. The south wall contains an opening leading to R110 up a short ramp.

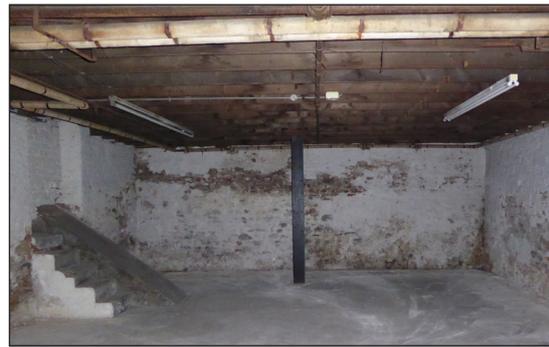
Figure 120: The west compartment of the semi-basement (R117) looking west showing the blocked up steps to R108 (© Historic England, photograph: Alastair Coey Architects, 2019)

The western compartment has limewashed rubble stone walls (Figure 120). A blocked opening in the south wall contains six steps up to R108 with on its west side a concrete ramp, similar to that in the eastern compartment. An opening on the north wall has been blocked with brick in the late 20th century; the ceiling joists are trimmed at this location suggesting this was an access point from R119. At the west end of the compartment a relatively new 'I' section steel stanchion penetrates to the floor above (R118), where it is encased and provides mid-span support for a north-south spanning beam, the purpose of which is not clear. North-south spanning timber joists are exposed revealing the underside of timber floorboards of the floor above (R118).

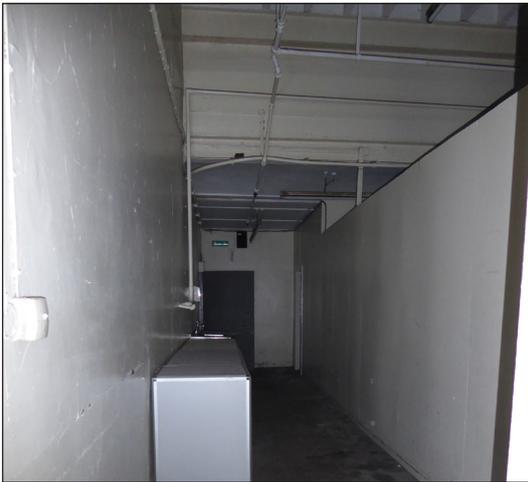
Figure 121: The corridor (R115) looking north to the door into R120 (© Historic England, photograph: Alastair Coey Architects, 2019)

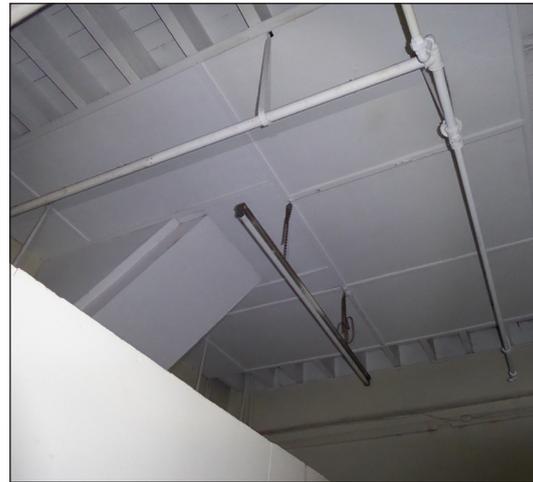
Figure 122: The ceiling of R116 showing the underside of the staircase between R208 and 210 (© Historic England, photograph: Alastair Coey Architects, 2019)

The ground floor of Block E sits approximately 1200mm above the upper level of the paved 'Gateway' to the north, possibly to aid the provision of access to a semi-basement rather than a full basement in R117. The 1961 survey drawings show a 'Confectionery Store' at the west end with a staircase rising to the first floor against the west wall. The central space is occupied by a 'Biscuit Store' on the south side and 'Tobacco Store', 'Cloaks' and 'Tea Room' arranged along the north wall with a 'Hoist' in the north-east corner. The south wall is shown with three openings separated by two cast-iron columns from a 'Covered Yard', now R108 and R109. On the east side of the north-south dividing wall are located a 'Mess Room' and 'Grocery Warehouse' in the space now occupied by R114, R115 and R116 (R114 is located in the north-east abutment to Block E and is described under Block C). These three interconnected spaces are sub-divided by a north-south-spanning partition wall, which does not rise full height, and has a wide corridor on its west side opening to R120 at the north end and R110 at the south end (Figure 121). To the east side of the partition are two rooms, R114 to the north and R116 to the south. The floor is concrete throughout and the east and west walls are finished in plaster. The ceiling of the west section, R115, is a segmental masonry arch carried on two east-west spanning beams, considerably lower than R114 to the north and R116 to the south. This formed the floor of the former 'Strong Room' shown above it on the 1961 survey. The ceiling of R116 has a central sheeted section subdivided into rectangular panels while the perimeter margins are open, exposing the ends of the north-south spanning joists and the underside of the first-floor floorboards. On the east side can be seen the plastered soffit of a short staircase which rises from R208 in Block C to R210 in Block E (Figure 122).

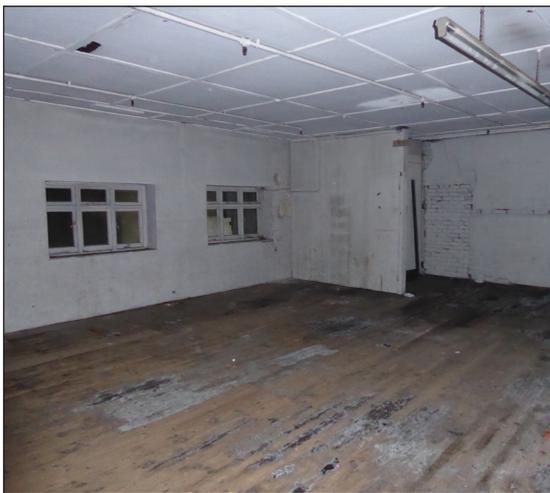
Figure 123: R118 looking north-east showing the casement windows in the north wall (© Historic England, photograph: Alastair Coey Architects, 2019)

The eastern part of this space has the early 20th-century pine boarded floor laid on north-south spanning joists and bearing some evidence of the previous subdivisions. Evidence of the hoist enclosure remains in the north-east corner. The north wall has two casement windows and a third opening to the west of these, shown on the 1961 survey, has been blocked and plastered over (Figure 123). The east wall contains a blocked door opening, adjacent to the hoist, which appears to have opened into R116 but is not shown on the 1961 survey drawings. The south wall has the two circular cast-iron columns which carry steel beams that bear on a brick end pier to the east and support the south external wall of the floors above (Figure 124). The central bay contains at its west side a low door which opens to timber steps down to Room R109. The openings between the columns have been infilled with concrete blockwork. The ceiling is sheeted with a panel material with strapped joints.

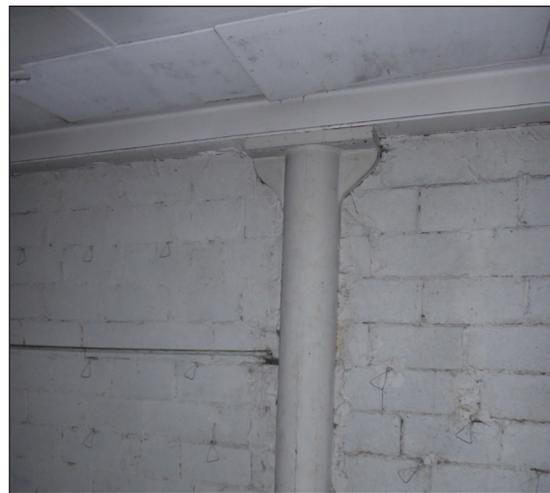
Figure 124: One of the cast-iron columns in the south wall of R118 carrying a steel beam (© Historic England, photograph: Alastair Coey Architects, 2019)

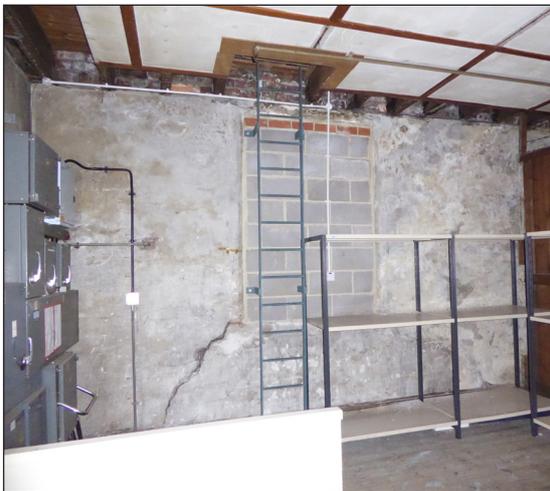
Figure 125: The south wall of R210 showing the blocked window, steel ladder and electrical distribution boards to left (© Historic England, photograph: Alastair Coey Architects, 2019)

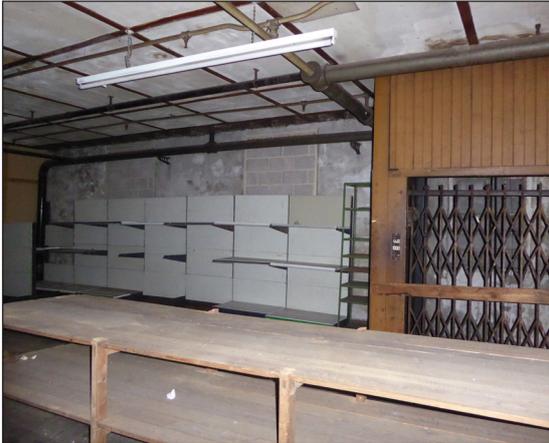
Figure 126: The north wall of R211 showing the blocked windows and hoist shaft (© Historic England, photograph: Alastair Coey Architects, 2019)
