Former Central Stores of Bishop Auckland Co-operative Society,
80 Newgate Street, Bishop Auckland, County Durham
Historic Building Report

HISTORIC BUILDING REPORT

Alastair Coey Architects

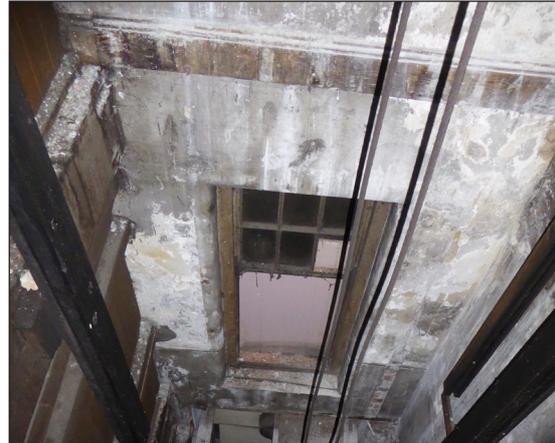
Figure 127: Internal view of the hoist shaft showing remains of a sash window on the floor below (© Historic England, photograph: Alastair Coey Architects, 2019)

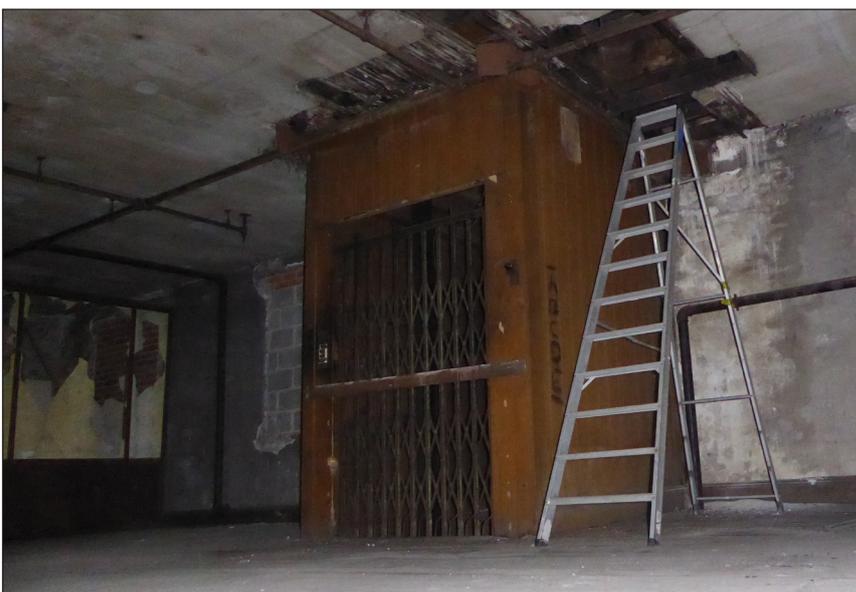
Figure 128: The hoist shaft in R328 and blocked windows in the north wall (© Historic England, photograph: Alastair Coey Architects, 2019)

The 1961 survey designates R328 as 'Grocery Warehouse' accessed from the storage rooms to the west, demolished in the late 20th century. The floor has early 20th-century original pine floorboards laid on north-south spanning timber joists (Figure 128). Window openings in the lime-plastered north and south walls have been blocked with late 20th-century concrete blockwork. The west wall has an applied sheeted finish similar to that in R211. The hoist shaft retains its original iron concertina gate. The ceiling is lath and plaster.

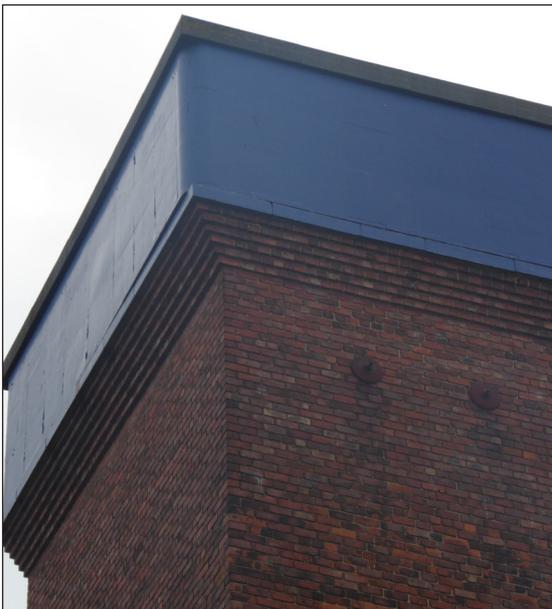
Figure 129: View of the water tower storage tank from the north-west showing the tank panels and corbel-course (© Historic England, photograph: Alastair Coey Architects, 2019)

At some later point, possibly in the 1940s, the water tower, which remains a prominent feature of the complex, was added on the south side of the yard above the west gable of Linday's building and the north side of the west end of the 'General Warehouse' building.¹⁷⁴ The tower rises about four metres above the ridge of the main building before six corbel courses step out to carry a masonry base for the round-cornered cast-iron tank (Figure 129). The purpose of a corbelled projection, two and a half bricks wide, above the ridge is not known (see right hand side of Figure 130). The north, east and south walls have exposed English garden wall bond brickwork. A steel, hooped access ladder with an intermediate platform to accommodate the corbelled projection is mounted on the smooth-rendered west elevation.

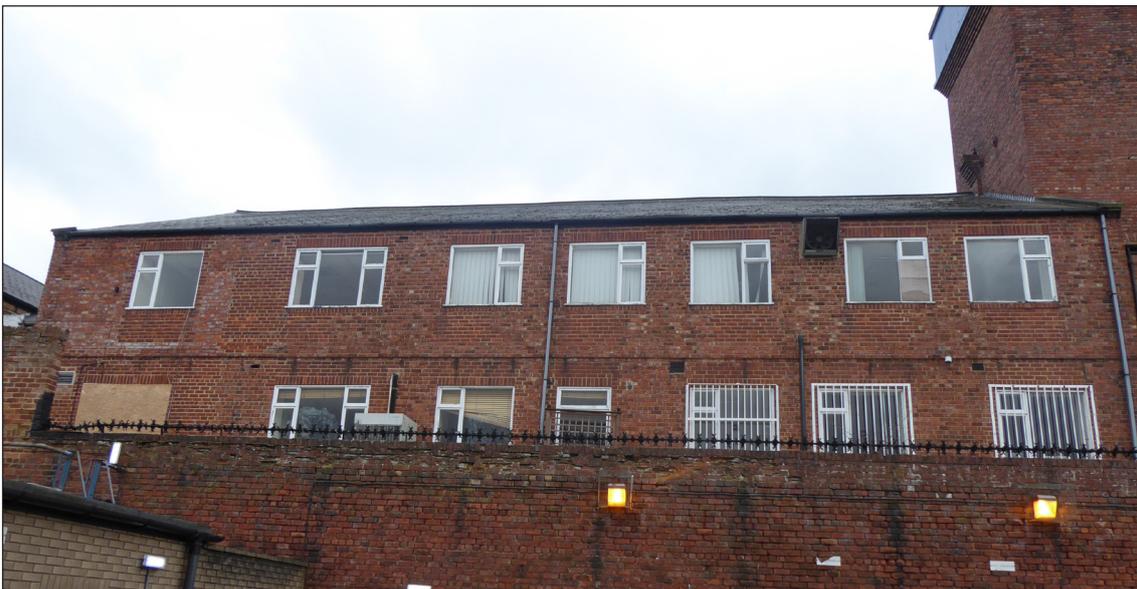
Figure 130: North elevation of the 1883 warehouse (Block F) with replacement casement windows (© Historic England, photograph: Alastair Coey Architects, 2019)

Linday's drawings show the north elevation of the new three-storey main building was eight bays wide and had two over two sash windows with sandstone sills and lintels. A bracketed hoist projected on the first and second floors of the third bay from the west gable. Both gables had two windows at each floor level. The post-1961 restructuring work radically altered the window openings on the first and second floors of the north and south elevations of Block F. Late 19th-century sash windows were removed and new, wider openings with brick soldier course lintels and header course sills containing casement windows were introduced (Figure 130). The blocked openings of the former windows, infilled with late 20th-century brick, can still be seen.

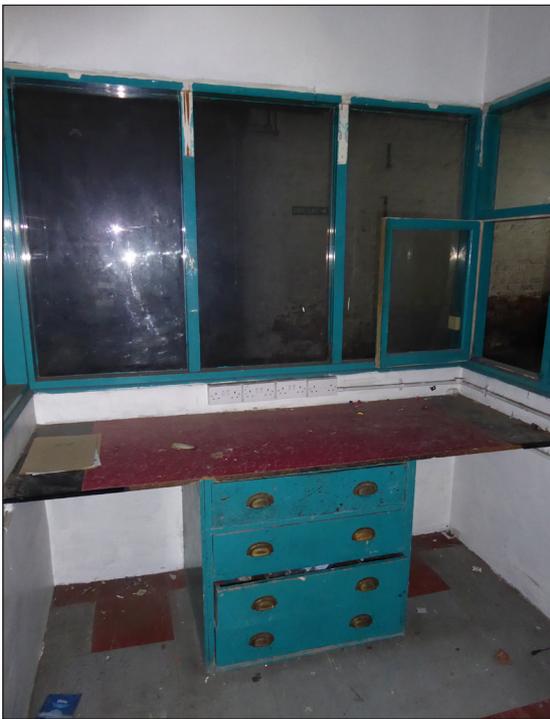
Figure 131: The office in R124 looking south out of the windows into R121 (© Historic England, photograph: Alastair Coey Architects, 2019)

1961 plan as 'Detergent Store'. The office, probably a dispatch office, was expanded from a smaller office shown in 1961 and constructed in single skin brickwork. The office is entered from the east side and has full-width windows to the east, south and west walls (Figure 131). A door in the north wall of the office leads to a narrow corridor with shelving against the north wall. A step up at an opening at the west end of the corridor leads into the former detergent store. Floors are formed in concrete, late 19th-century lime plaster survives on the north wall of the corridor and the east and west walls of the detergent store and portions of the late 19th-century lath and plaster ceiling also survive. The original door opening to the former detergent store in the south wall has been blocked in brick in the late 20th century. To the west of the office, a narrow space opening off R121 is paved with the original wooden 'blockers' and houses a set of antique W&T Avery floor weigh scales (Figure 132). The west wall is finished with lime plaster and the ceiling is lath and plaster.

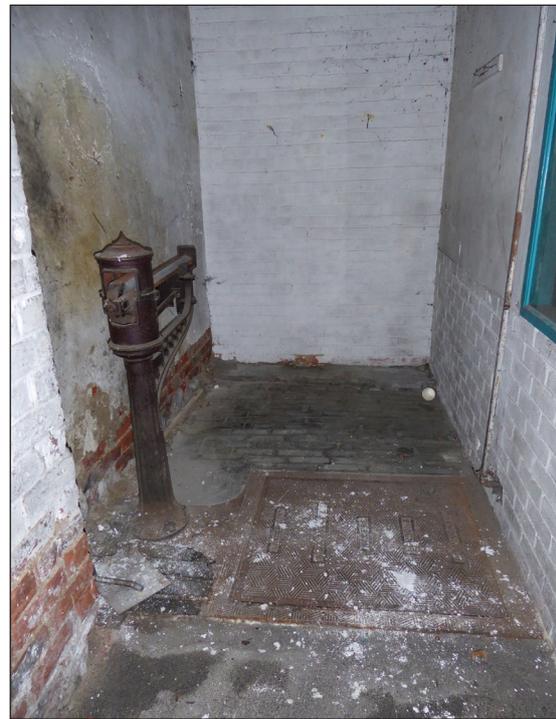
Figure 132: The narrow space to the west of the office showing the W&T Avery scales and wooden blockers behind (© Historic England, photograph: Alastair Coey Architects, 2019)

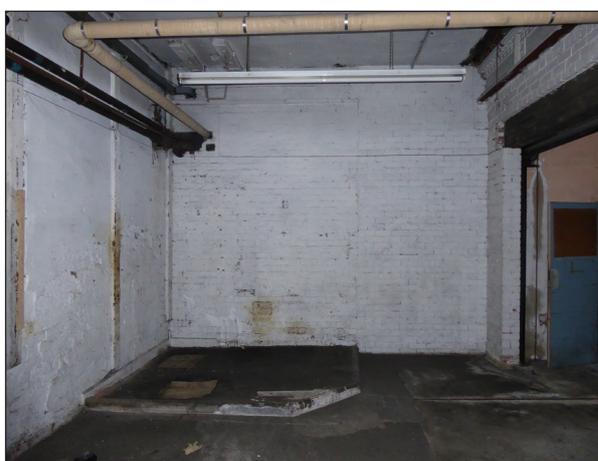
Figure 133: The east wall of R124 with the bricked up entrance to R123 to the right (© Historic England, photograph: Alastair Coey Architects, 2019)

To the east of the office the remainder of R124 has a macadamed floor with, in the north-east corner, a raised rectangular area bounded by a raised bullnose kerb laid to fall to a manhole and grating in the corner. It is not known what purpose this served (Figure 133). The north wall has a square-headed opening into R136 with a substantial timber beam as its lintel. It is also not known what purpose was served by five, equally-spaced, floor to ceiling vertical timber lathes fixed to the lime-plastered north wall, east of the opening to R136. To the east, the opening to the south of the brickwork pier between R123 and R124 has been infilled with a full-

height, single-leaf, brick wall which now separates the two spaces (see Figure 133). The brick south wall to R123 and R124, which infills the voids below the riveted beam, is contemporaneous with the construction of the hoist and lift shafts in Block C as part of the post-1961 re-structuring work. The wide, square-headed opening from R124 to R122 has a substantial timber beam as its lintel. All brickwork in this area is painted white. The ceiling is lath and lime plaster on north-south spanning joists. Two short planks spanning east-west and parallel to each other are fixed to the ceiling soffit in the north-east corner directly above the rectangular drain area described above. A 'U'-shaped steel strap, which is fixed to the planks, may have been used to suspend something over the drain (see top of Figure 133).

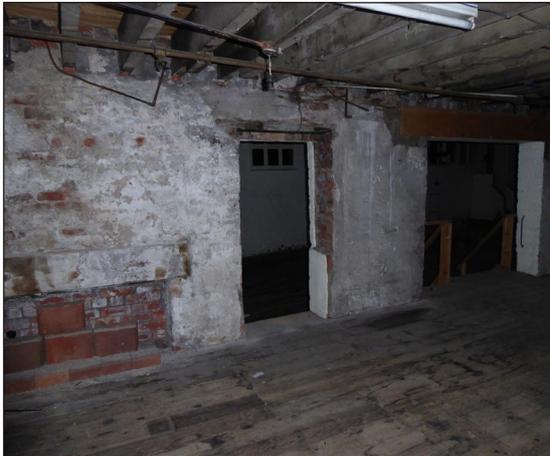
Figure 134: Interior of R125 looking south-west into R120 (© Historic England, photograph: Alastair Coey Architects, 2019)

Today, R125 has what appears to be late 19th-century timber floorboards on north-south spanning joists over a semi-basement (Figure 134). The floor is approximately one metre above the sloping macadamed surface of R120. The brick north wall, which is the north wall of the 'General Warehouse' (circa 1876), is plastered and limewashed. A door opening has been formed at the west side and leads to R132. Further east, a darker rectangular plaster panel coincides with a trimmed opening in the floor above and patched floorboards in the floor showing the location of a hoist now removed (Figure 135). The east wall is plastered and limewashed. The south wall has three square-headed openings. At the east end the lintel soffit is approximately 500mm above floor level and, inexplicably, the opening continues down allowing the semi-basement to be entered through a pair of small timber framed meshed gates (not accessed). The upper part of the opening is blocked with late 20th-century brick. The narrow central opening is directly above another opening to the semi-basement and the wider opening to the west is accessed by a flight of timber steps from R120. The brick west wall, which is constructed in English garden wall bond, stops short of the floor joists above. North-south spanning timber joists with mid-span herringbone struts appear to be late 19th-century and did not have a plastered ceiling. The new appearance of the underside of the floorboards above suggest these were replaced towards the end of the 20th century.

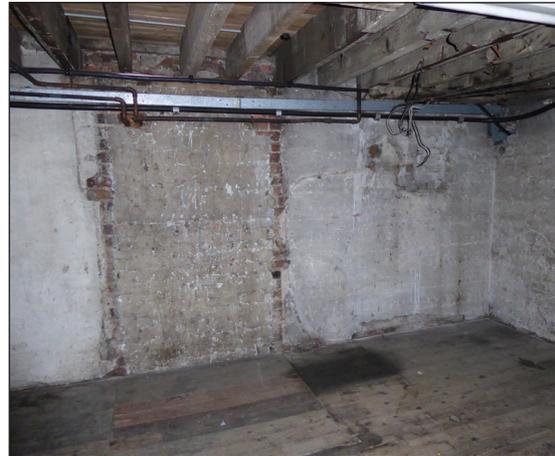
Figure 135: The site of the former hoist in the north wall of R125 (© Historic England, photograph: Alastair Coey Architects, 2019)

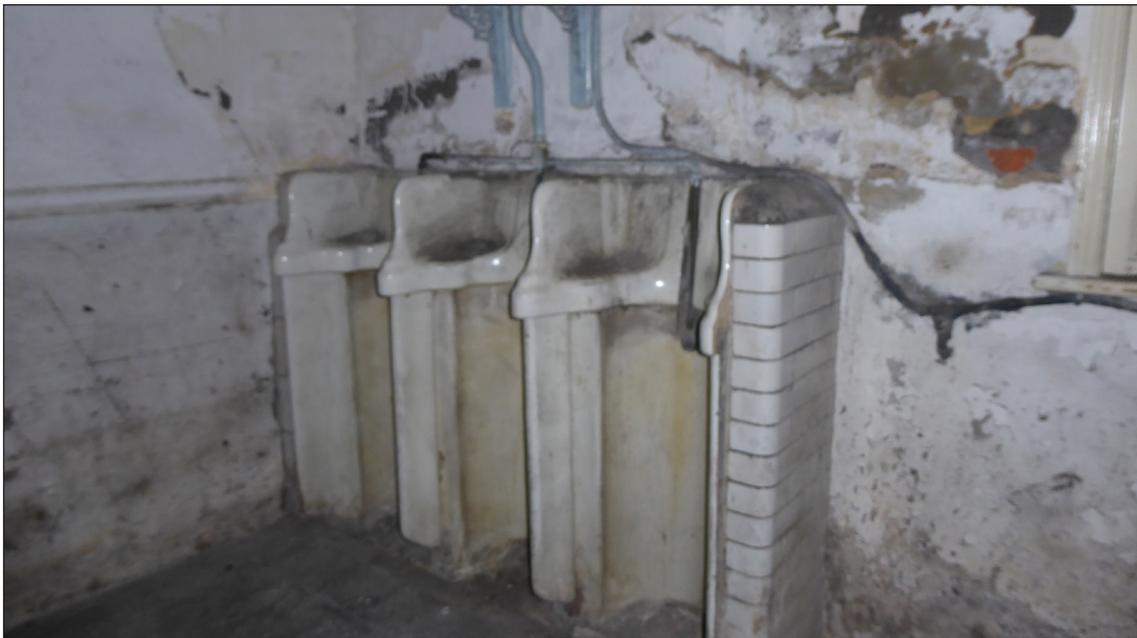
Figure 136: Porcelain urinals and cistern in R126 (© Historic England, photograph: Alastair Coey Architects, 2019)

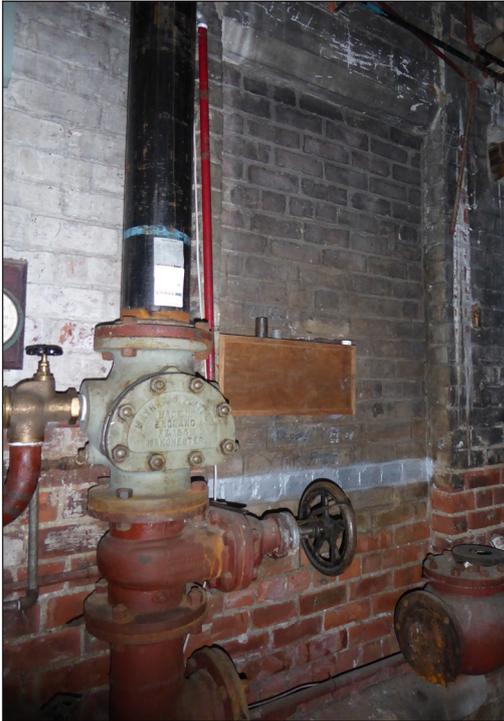
Figure 137: The east wall of R129 showing the blocked window to R132 and pipework relating to the 1908 Grinnell sprinkler system (© Historic England, photograph: Alastair Coey Architects, 2019)

west wall may be part of the rear wall of one of the Back Way cottages. The original toilet door openings in the north wall have been blocked with late 20th century brick. The ceiling of both compartments appears to be chipboard sheeting. The eastern compartment has, mounted on the east wall, control valves and pipework related to the Grinnell sprinkler installation which served the entire complex. A printed instruction sheet, prepared by the manufacturer Mather and Platt Ltd and entitled 'Automatic Sprinkler and Fire Alarm Installation', is pasted to the wall. This appears to be dated 20 February 1943, which may be the date the system was installed or updated from the 1908 installation. As noted in Section 2 it may also have been Mather and Platt that was responsible for manufacture of the water tank and is possible that the two features were installed at the same time. The western compartment contains back-up battery packs and electrical switchgear set against the south and west walls.

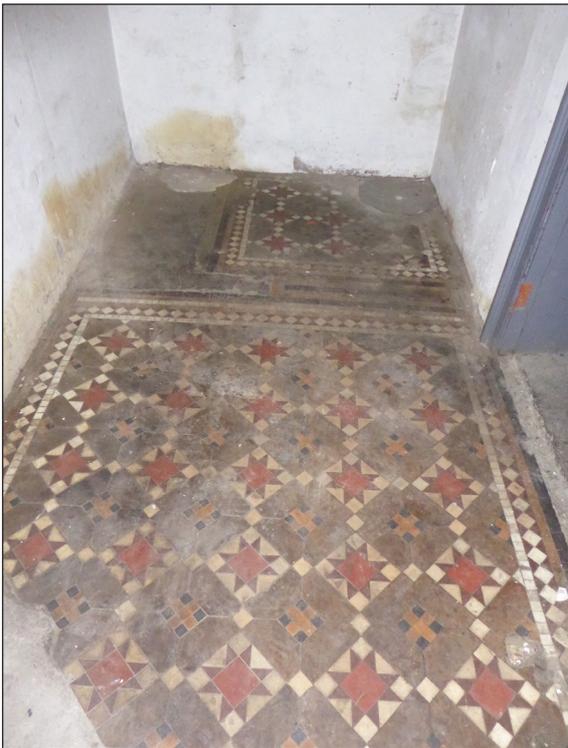
Figure 138: The polychromatic tiled flooring in R131 (© Historic England, photograph: Alastair Coey Architects, 2019)

Today, R131 has been reconfigured as a lobby serving the former Committee Room (R132). The original polychromatic floor tiling survives bearing evidence of a toilet and urinal, shown on Linday's drawing, which have long since been removed (Figure 138). All walls have been re-plastered with gypsum plaster and door openings post-dating the 1961 plans have been formed in the north wall, from R141, and the west wall, from R132, while the opening to R133, shown in 1961, has been closed and plastered over. The ceiling has a gypsum plaster finish.

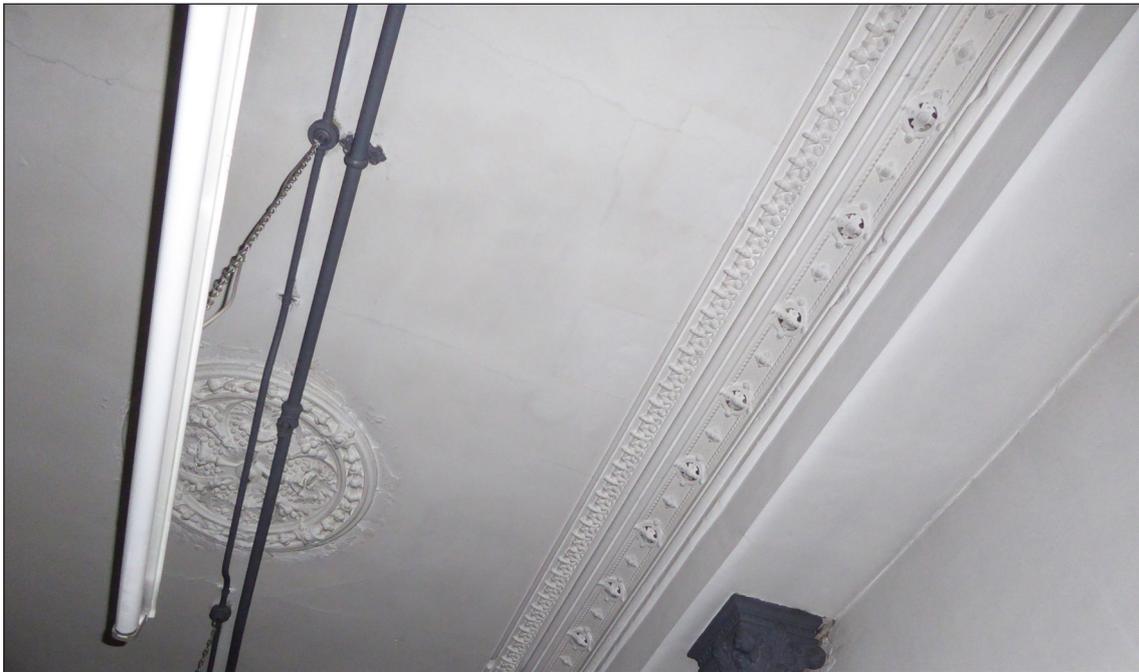
Figure 139: The ceiling plasterwork in the east compartment of R132 showing the cast-iron column on the west wall (© Historic England, photograph: Alastair Coey Architects, 2019)

into the toilet, R131, described above. The west wall had a central fireplace flanked by windows which overlooked the yard to the west. A centrally located cast-iron column with decorative moulded base and Corinthian capital supported the flat soffit of the beam above (Figure 139). The 1961 survey drawings show the west side of room had been converted to a 'Soap Store' which had a timber boarded platform 1.4m above the floor level of the eastern compartment. An opening which had been formed in the south wall had a ramp down to the sugar store. The eastern compartment which is designated 'Empties' was entered from the north gateway through the original doorway. A flight of steps rose to the north end of the platform

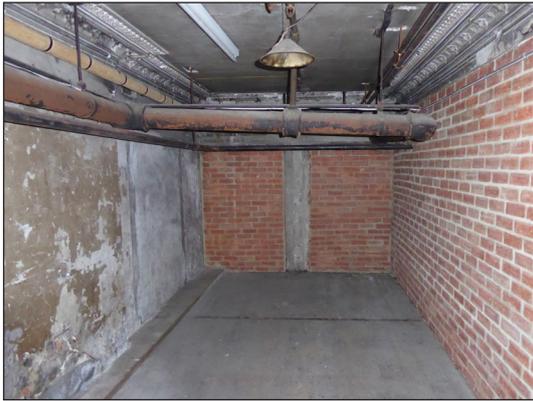
Figure 140: Interior of the west compartment of R132 looking north (© Historic England, photograph: Alastair Coey Architects, 2019)

.Today, the room is fully sub-divided by a north-south spanning single-leaf red brick wall constructed in the late 20th century which is plastered with gypsum plaster on its east side and rests on a north-south spanning 'I'-section beam (Figures 140 and 141). The soap store platform remains as the floor of the western compartment, presumably at the level of the 'I'-section beam (visible in the western compartment), and the floor of the eastern compartment is unfinished concrete. Window openings in the western compartment have been infilled but much of the late 19th-century wall plaster, lath and plaster ceiling, moulded and enriched cornicing and highly decorative ceiling roses survive (Figure 142).

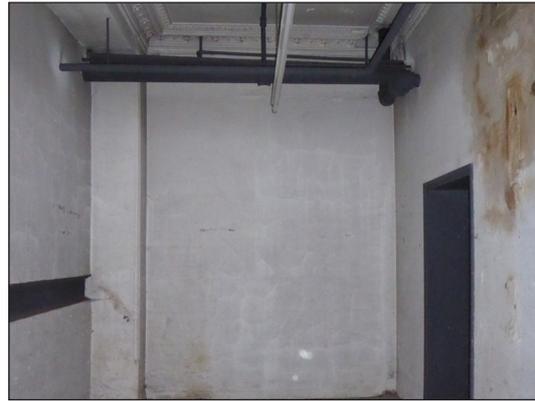
Figure 141: Interior of the east compartment of R132 looking north (© Historic England, photograph: Alastair Coey Architects, 2019)

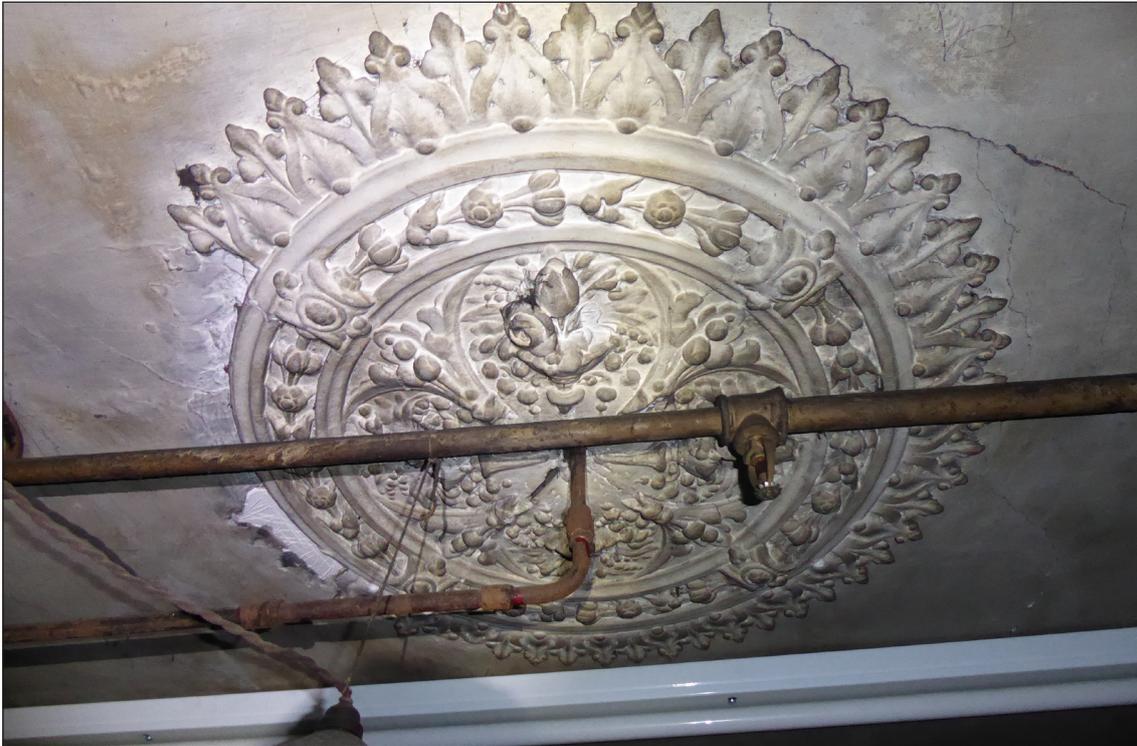
Figure 142: Detail of the ceiling rose in the west compartment of R132 (© Historic England, photograph: Alastair Coey Architects, 2019)

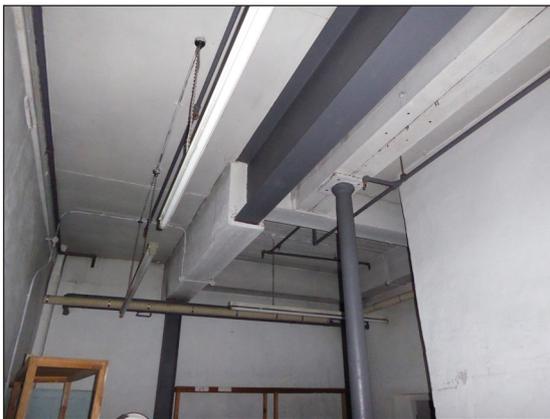
Figure 143: Interior of R133 looking south showing the column supporting the fitch beam and R131 partitioned off to the right (© Historic England, photograph: Alastair Coey Architects, 2019)

century west, north-south spanning, fitch beam has been removed but otherwise the beams survive. A circular cast-iron column, manufactured by the Bishop Auckland engineering company Lingford Gardiner and Co., is located at the south-east corner of the walls to R131 and supports the south end of the truncated fitch beam above (Figure 143). The ceiling has a gypsum plaster finish.

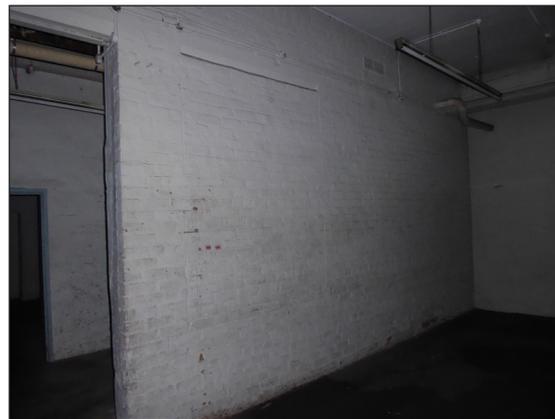
Figure 144: The window between R135 and R136 visible in the west wall of R136 and probably blocked in the early 20th century (© Historic England, photograph: Alastair Coey Architects, 2019)

The former tobacco store, R134, is entered through a central doorway in the south wall. The floor is concrete and the walls and ceiling have been re-plastered with gypsum plaster. R135 also has a concrete floor and gypsum plastered walls and ceiling. Evidence of the window which overlooked the former gateway now comprising R136 can be seen from R136 (Figure 144). It was blocked with brick probably in the early 20th century and does not appear on the 1961 survey drawings.

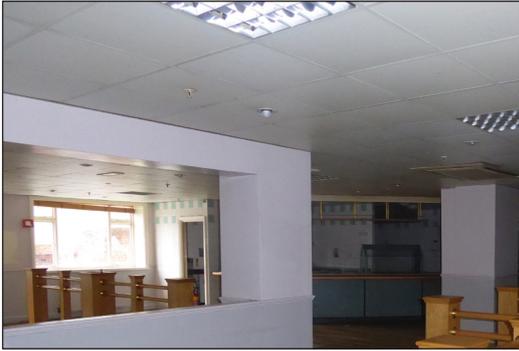
Figure 145: The late 20th-century restaurant looking east from R220 into R221 and R216 (© Historic England, photograph: Alastair Coey Architects, 2019)

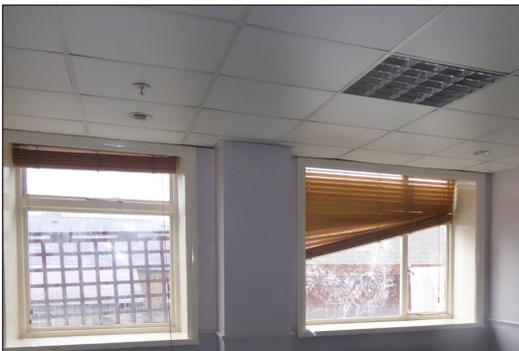
Figure 146: Windows in the north wall of R221 (© Historic England, photograph: Alastair Coey Architects, 2019)

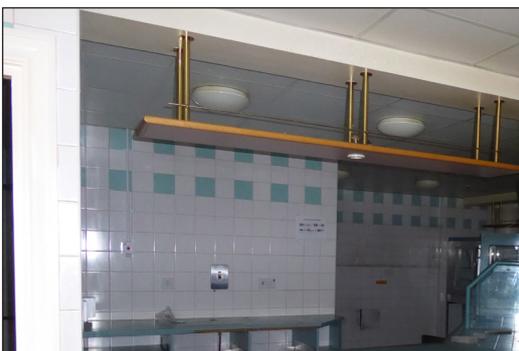
Figure 147: The restaurant kitchen counter in R221 (© Historic England, photograph: Alastair Coey Architects, 2019)

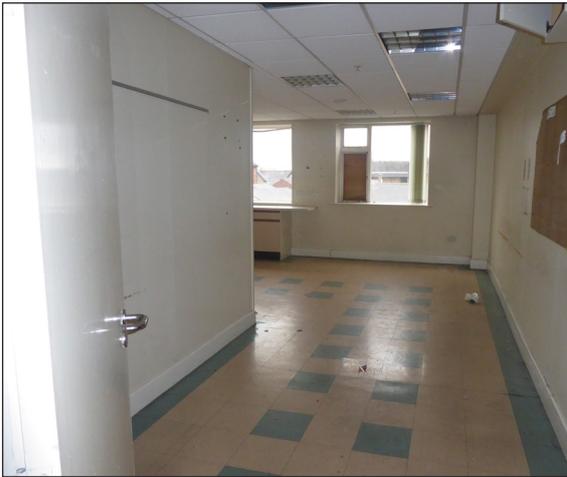
Figure 149: View from the doorway of R324 (marked 'Staff Room' on the 1961 plans) looking north (© Historic England, photograph: Alastair Coey Architects, 2019)

re-plastered and painted (Figure 149). Suspended ceilings in R314-R317, R319, R320, R321, R324 and R325 have exposed grid tiles identical to those in the main sales areas; all other ceilings have perforated Asbestolux concealed grid tiles.

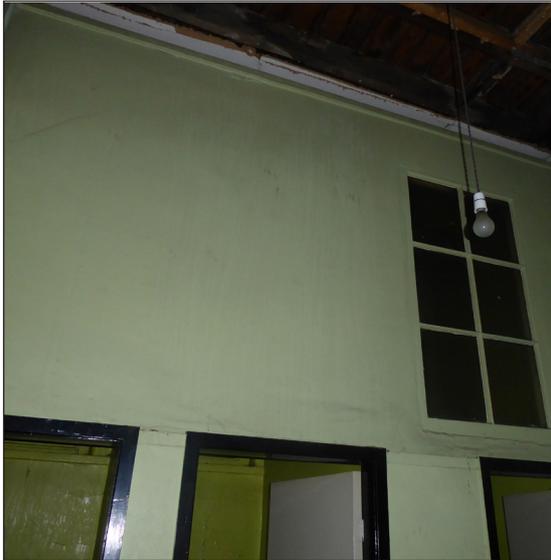
Figure 150: View of the north wall of R323 with a remaining window and the three toilet cubicles (© Historic England, photograph: Alastair Coey Architects, 2019)

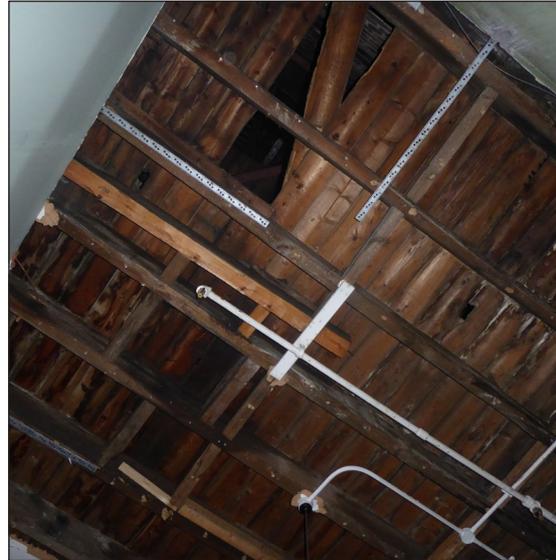
Figure 151: The exposed timber structure of the ceiling of R323 forming a floor in the next stage of the water tower above (© Historic England, photograph: Alastair Coey Architects, 2019)

The 1961 survey drawings show this room designated as ‘Male Toilet’. It was accessed from three directions. An opening in the east wall led to the corridor to the south of Shoe Repairs in the Main Building. An opening in the south wall gave onto a staircase which descended to the first floor of the General Warehouse, and steps up to an opening in the south end of the west wall led to a ‘Flour Store’ in Block G. The north wall contained three windows and three toilet cubicles are shown against the wall (Figure 150). The post-1961 re-structuring saw the introduction of a lobby to the opening from the south and the east and west openings both being blocked. Today, the floor is finished with thermoplastic tiles, walls are painted plaster and the ceiling has exposed east-west spanning timber joists with the underside of the boards above exposed (Figure 151).

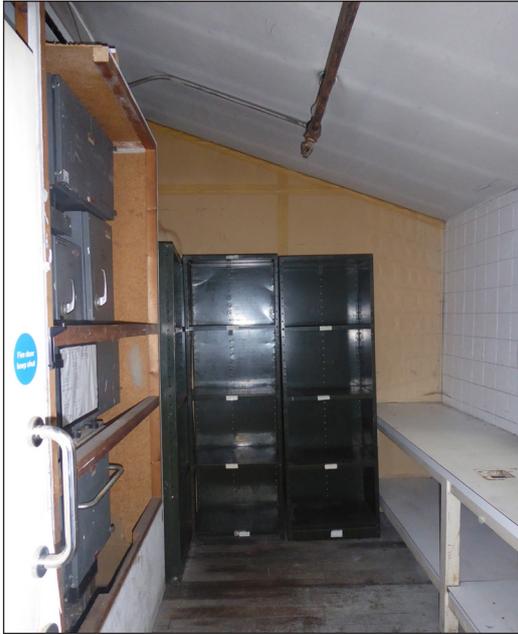
Figure 152: Interior of R327 looking west with electrical distribution boards on the south (left) wall (© Historic England, photograph: Alastair Coey Architects, 2019)

R327 is shown on the 1961 survey drawings as an annex to a shoe repair room (R324). The plans show no rooms in this position on the lower floors, suggesting that R327 bridged the space between Linday’s warehouse and the (now demolished) west warehouse at second-floor level. The room is entered through a doorway in the east wall from R324. The floor is finished with linoleum sheeting, and walls and sloping ceiling are gypsum plastered (Figure 152). Electrical distribution boards are mounted on the south wall. The north wall is tiled and contains a glass-block window.

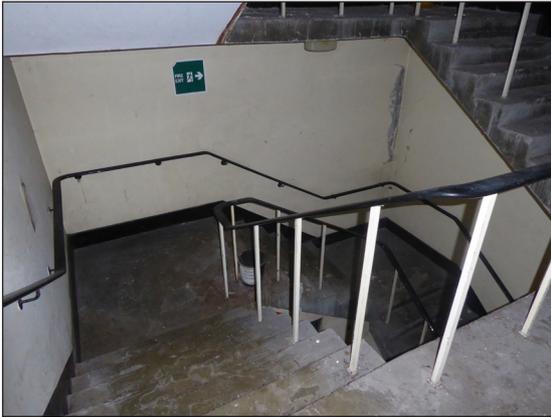
Figure 153: The concrete stairwell R127 at first-floor level (© Historic England, photograph: Alastair Coey Architects, 2019)

The 1961 re-structuring proposals show a number of proposed alterations and it is known that some of these – for example, the new concrete staircase in R127 – were executed (Figure 153). It is not known when a decision was taken to remove

The 1961 survey shows a 'Potato Store' in the location of R127 and R128 which now are separated by a one-brick-thick wall. R127 contains the base of a cast concrete staircase with a steel balustrade and plastic hand rails, which rises through three floors. The staircase and the dividing wall to R128 were introduced as part of the re-structuring proposed in the October 1961 plans. In R127, the staircase is now roofed-over a short distance above the top landing; this change presumably took place at the same time as the demolition of the surrounding three-storey warehouse in the late 20th century. The stairwell is accessed from Westgate Road through a set of double doors in the west wall. Double doors on the east side of the south and north walls open into R119 and R128 respectively. The floor is concrete and walls are plastered and painted. Evidence of window openings might be found behind the plasterwork of the west wall. R128 also has a concrete floor. The north, east and west walls retain some original brickwork, lime plaster and evidence of previous openings which are now blocked with late 20th-century brick. At ceiling level timber joists with mid-span herringbone strutting span east-west. The underside of timber boards, once first-floor floorboards, is exposed and probably now forms a base for the waterproof membrane of the flat roof above. The underside of the joists show that a lath and plaster ceiling has been removed. A centrally-positioned trimmed opening on the north side of the ceiling appears to have been a hatch between ground and first floors.

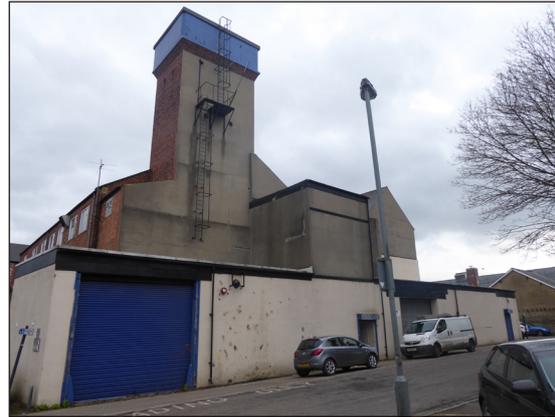
Figure 154: Rear elevation of the co-operative complex showing the square-headed gateway entrances now with steel doors (© Historic England, photograph: Alastair Coey Architects, 2019)

most of the first floor and the entire second floor and install a new flat roof over the remaining ground-floor and stairwell spaces, but it is likely to have occurred after the 1961 re-structuring programme. The surviving front elevation drawing attributed to Livesay shows eight over eight sash windows to all three floors (see Figure 26a). Each window opening had a segmental brick arch and three-course sandstone sill. The square-headed archway entrances to the north and south yards each remain as shown on the elevation drawing (Figure 154).

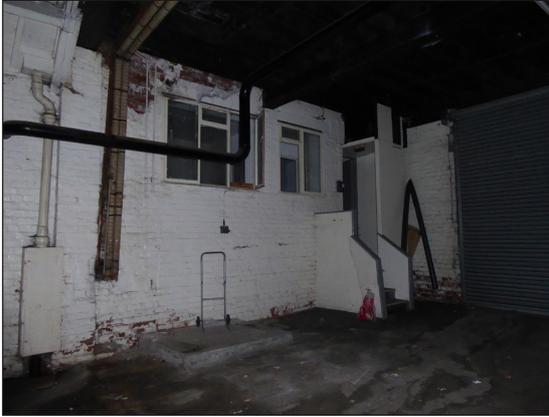
Figure 155: The interior of the covered yard at R119 looking south-west (© Historic England, photograph: Alastair Coey Architects, 2019)

R119 is a wide arrival area (Figure 155). A small dispatch office is located against the north wall in the north-east corner. A chute device is connected from an opening in the floor above which could be winched up or down (Figure 156). The apparatus, capable of being raised and lowered and presumably used for handling bags of flour from the 'Flour Room' above, is housed in the centre of the north side of the former floor. A macadamed surface slopes down from west to east. A rectangular raised concrete plinth abuts the south wall and a timber staircase in the south-east corner rises approximately 1260mm to the lobby of R118. North, south and west walls have paint on English garden wall bond brickwork. The carriage arch has a modern roller shutter door. Two casement windows have been installed in the south wall. Blackened east-west spanning timber joists are supported at mid-

span by a north-south spanning beam. The underside of timber boards, once first-floor floorboards, are exposed and probably now form a base for the waterproof membrane of the flat roof above. Two parallel 'I'-section steel beams carry the joists' ends and would originally have also carried the east wall of the upper floors.

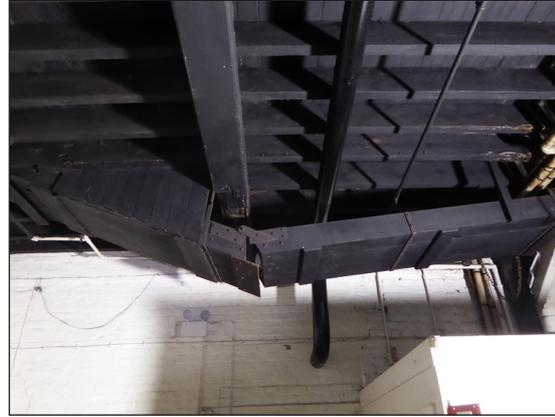
Figure 156: A timber chute in the ceiling of R119 (© Historic England, photograph: Alastair Coey Architects, 2019)

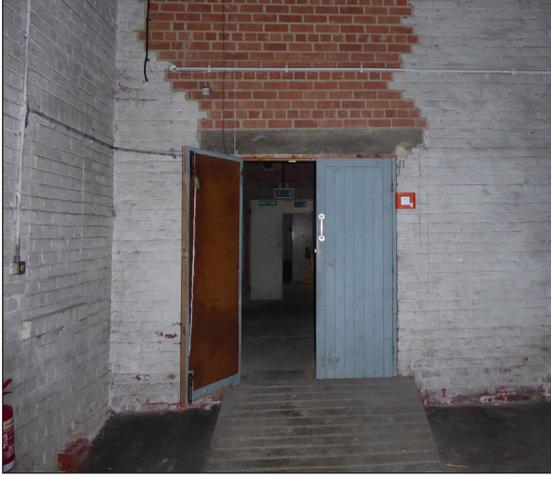
Figure 157: The interior of R139 looking south in R128 (© Historic England, photograph: Alastair Coey Architects, 2019)

R139 has a ribbed concrete ramp down to a macadamed surface (Figure 157). The north gable wall, east wall, south wall and west wall all have limewashed brickwork. The carriage arch has a modern roller shutter door. The east wall contains evidence

of a former window opening to the lobby R130. At ceiling level, timber joists with mid-span herringbone strutting span east-west. The underside of timber boards, once first-floor floorboards, is exposed and probably now forms a base for the waterproof membrane of the flat roof above. The underside of the joists show that a lath and plaster ceiling has been removed. A centrally-positioned trimmed opening in the floor above the carriageway appears to have been a hatch between ground and first floors.

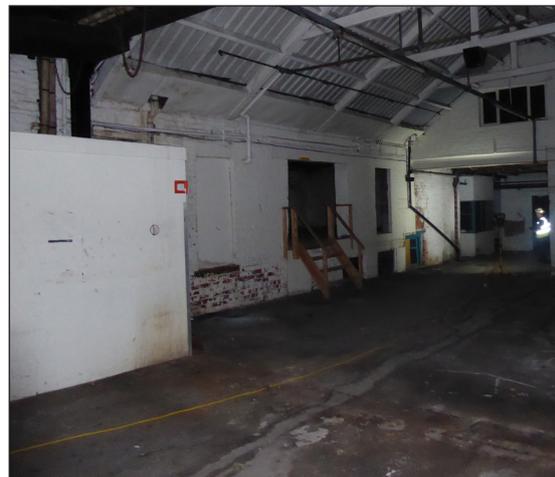
Figure 158: Interior of the covered yard (R120) looking east in R121 with the internal window to R214 above (© Historic England, photograph: Alastair Coey Architects, 2019)

R214 is a long, narrow, nondescript room, built *circa* 1990 as part of the work involved in adding a second floor above R208. The new room enabled new lift doors to be installed on the west side of the hoist shaft in addition to the existing opening on the east side. R214 also connects with R213 to the south and Block F to the north. The flooring is unfinished pine floorboards laid on north-south spanning joists which are visible from R121 below. The north, south and west walls and ceiling are finished with gypsum plaster but the east wall retains the exposed, previously external, brickwork of the hoist shaft in which the new lift door opening has been inserted. Two steps up to a lobby projecting from the west end of the north wall leads to R220 in Block F. The west wall contains a late 20th-century casement window which can also be seen on the north wall of the interior of R120 (Figure 102 and *see* Figure 158).

The 1961 survey drawings designate this space as 'Covered Yard' but the date of construction is not known (Figure 158). The macadamed surface which slopes downwards from west to east may originally have been paved with 'wooden blockers'. The painted brickwork walls to the four sides have been described under their respective Blocks. The east end of the double-pitch roof abuts the west wall of Block C (where the casement window into R214 can be seen in the upper wall) and the west end abuts the south wall of Block G. The painted timber roof structure comprises four 'A' trusses, with iron strap reinforced joints, which carry four in-line purlins to each side of the central ridge. The roof covering to the top four bays has been replaced with modern profiled metal sheeting; however, the

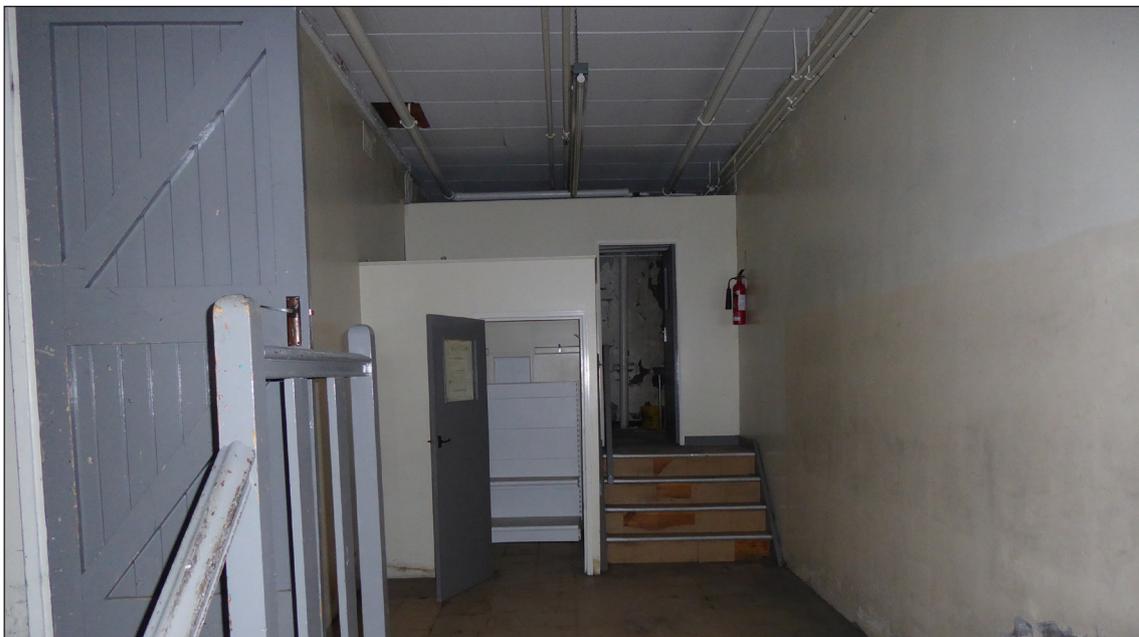
Figure 159: Interior of storage space R110 looking east (© Historic England, photograph: Alastair Coey Architects, 2019)

The long narrow space occupied by R109 and R110 is also shown as a 'Covered Yard' on the 1961 drawings. It was a single space with an entrance onto Westgate Road and R110 and R113 formerly connected with each other around the east end of Block E. R109 and R110 were subdivided from R113 by a masonry wall in the late 20th century and latterly served as a store (Figure 159). The paved surface of R109 is concrete and, at the west east end, a metal balustrade guards the drop to R110. The floor of R110 is finished with thermoplastic tiles. The north and south walls of both spaces are of painted brickwork and the ceiling has 600mm x 600mm fibre tiles fixed to the underside of the flat roof structure. In R110 a flight of ten concrete steps rise in the south-west corner to R109. Another set of (timber) steps on the north wall rise to R116 in Block E. To the east end of R110 is a small temporary store and office approached by a flight of four steps. A set of double flush doors in the south wall lead to R109 in Block D.

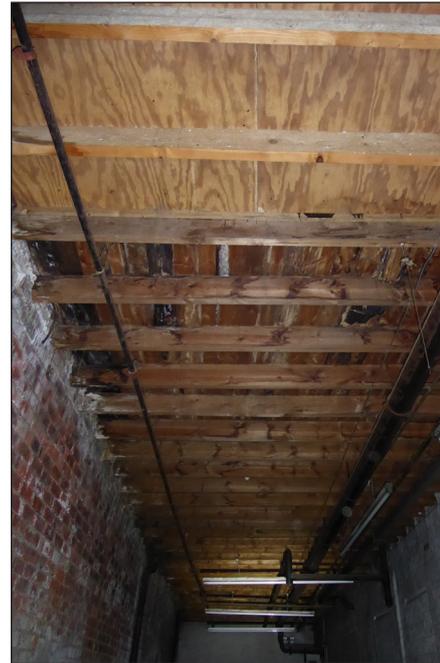
Figure 160: Timber ceiling joists and boards in R141-142 looking east (© Historic England, photograph: Alastair Coey Architects, 2019)

Linday's 1883 drawings for Block F show R140-R142 with a double-pitch glazed roof carried on an 'A' truss roof structure bearing on the north wall of Block F and the north boundary wall. This has been removed and replaced with a flat roof consisting of plywood decking on timber joists, a change which seems to have occurred prior to the 1961 survey (Figure 160). The paved surface, which slopes down from west to east, is macadamed but retains evidence of the late 19th-century 'wooden blocker' paving (Figure 161 and *see* Figure 28). The north and south walls are painted red brick. A north-south spanning brick wall with a set of double doors at its south side, separates R141 and 142. The south-east corner of R142 contains two redundant toilet cubicles and, in the wall to the west, three painted-over windows which looked into R137 with sandstone sills and splayed lintels (Figure 162). A 21st-century (apparently functional) floor-mounted boiler and calorifier is located in the north-east corner. A steep flight of timber steps on the east side of R142 lead down to the basement (R001) of Block B. The opening in the floor is protected by a brick parapet wall.

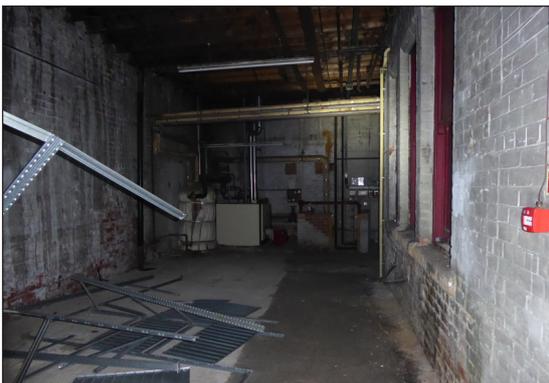
Figure 161: Interior of R142 showing tarmacadamed floor and the entrance to basement R001 (© Historic England, photograph: Alastair Coey Architects, 2019)

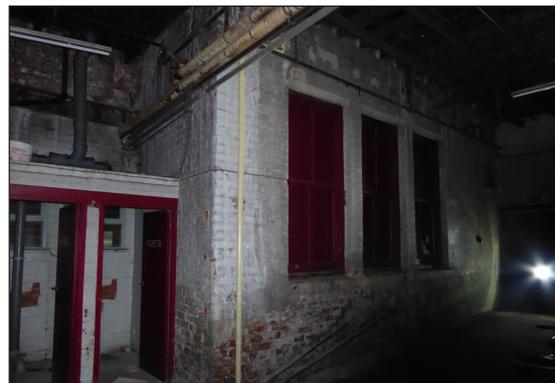
Figure 162: View from R142 of the blocked windows in the north wall of R137 (© Historic England, photograph: Alastair Coey Architects, 2019)

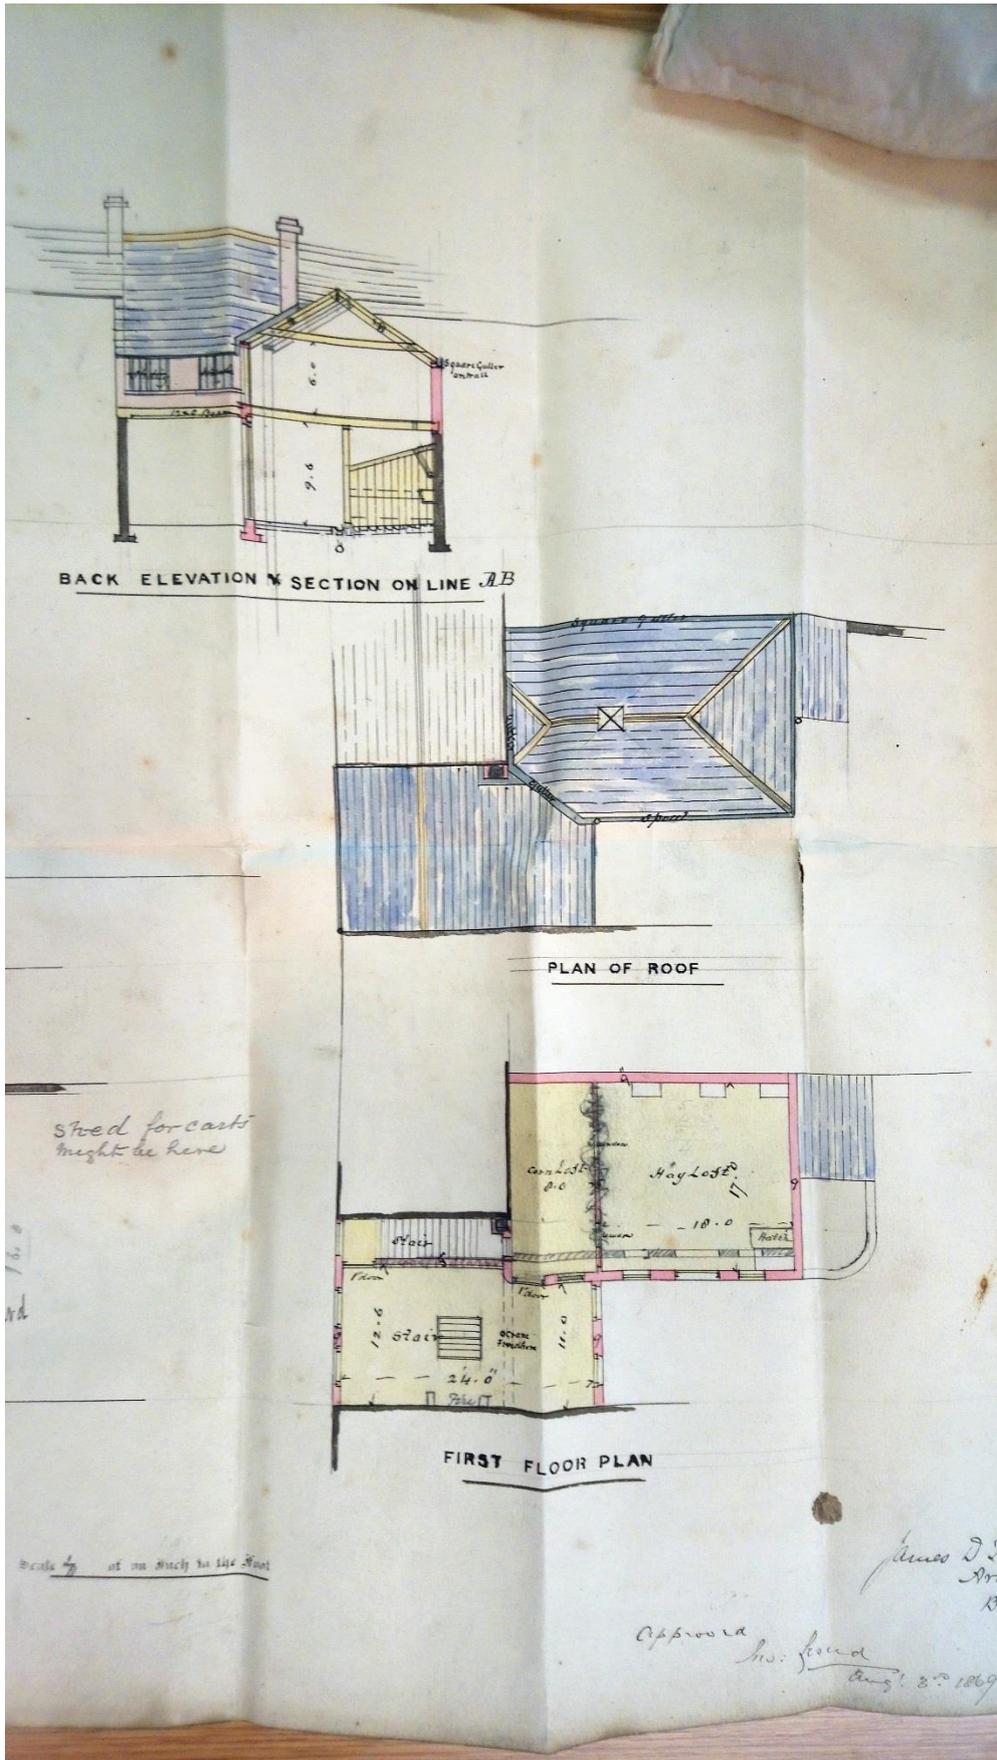
B: Back Elevation Section on line AB; Plan of Roof; First Floor Plan

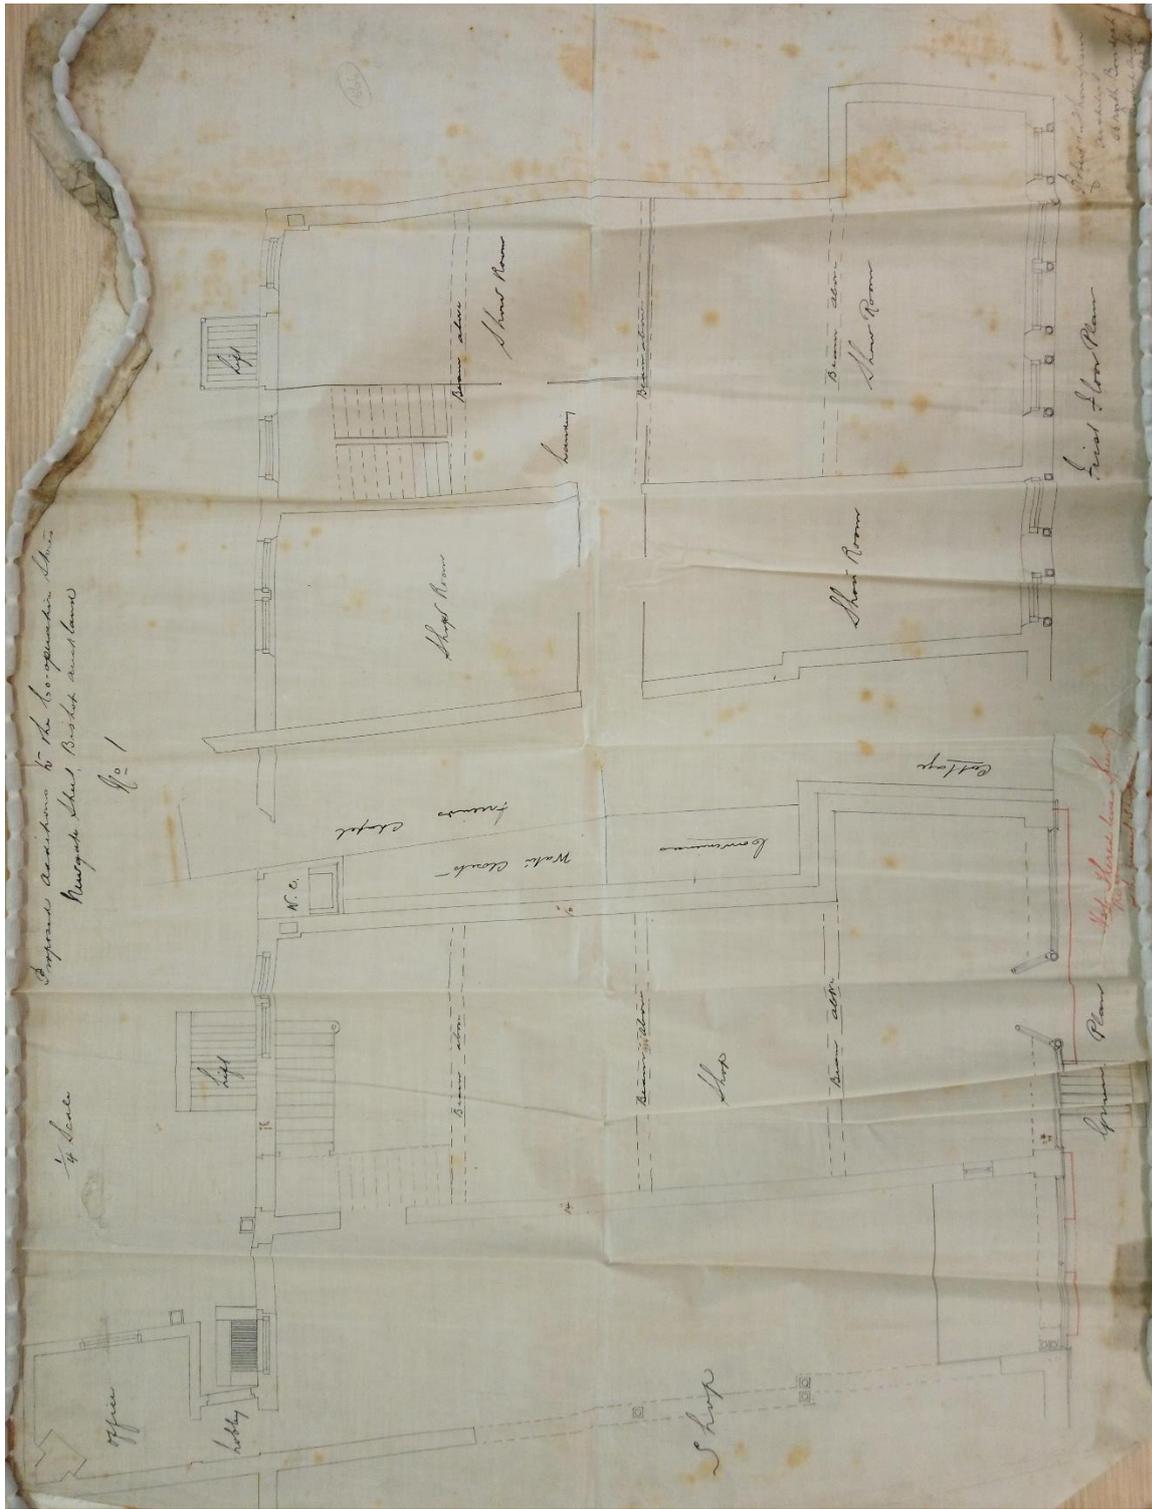
C: Ground-flan; First Floor Plan
