Former Central Stores of Bishop Auckland Co-operative Society,
80 Newgate Street, Bishop Auckland, County Durham
Historic Building Report

HISTORIC BUILDING REPORT

Alastair Coey Architects

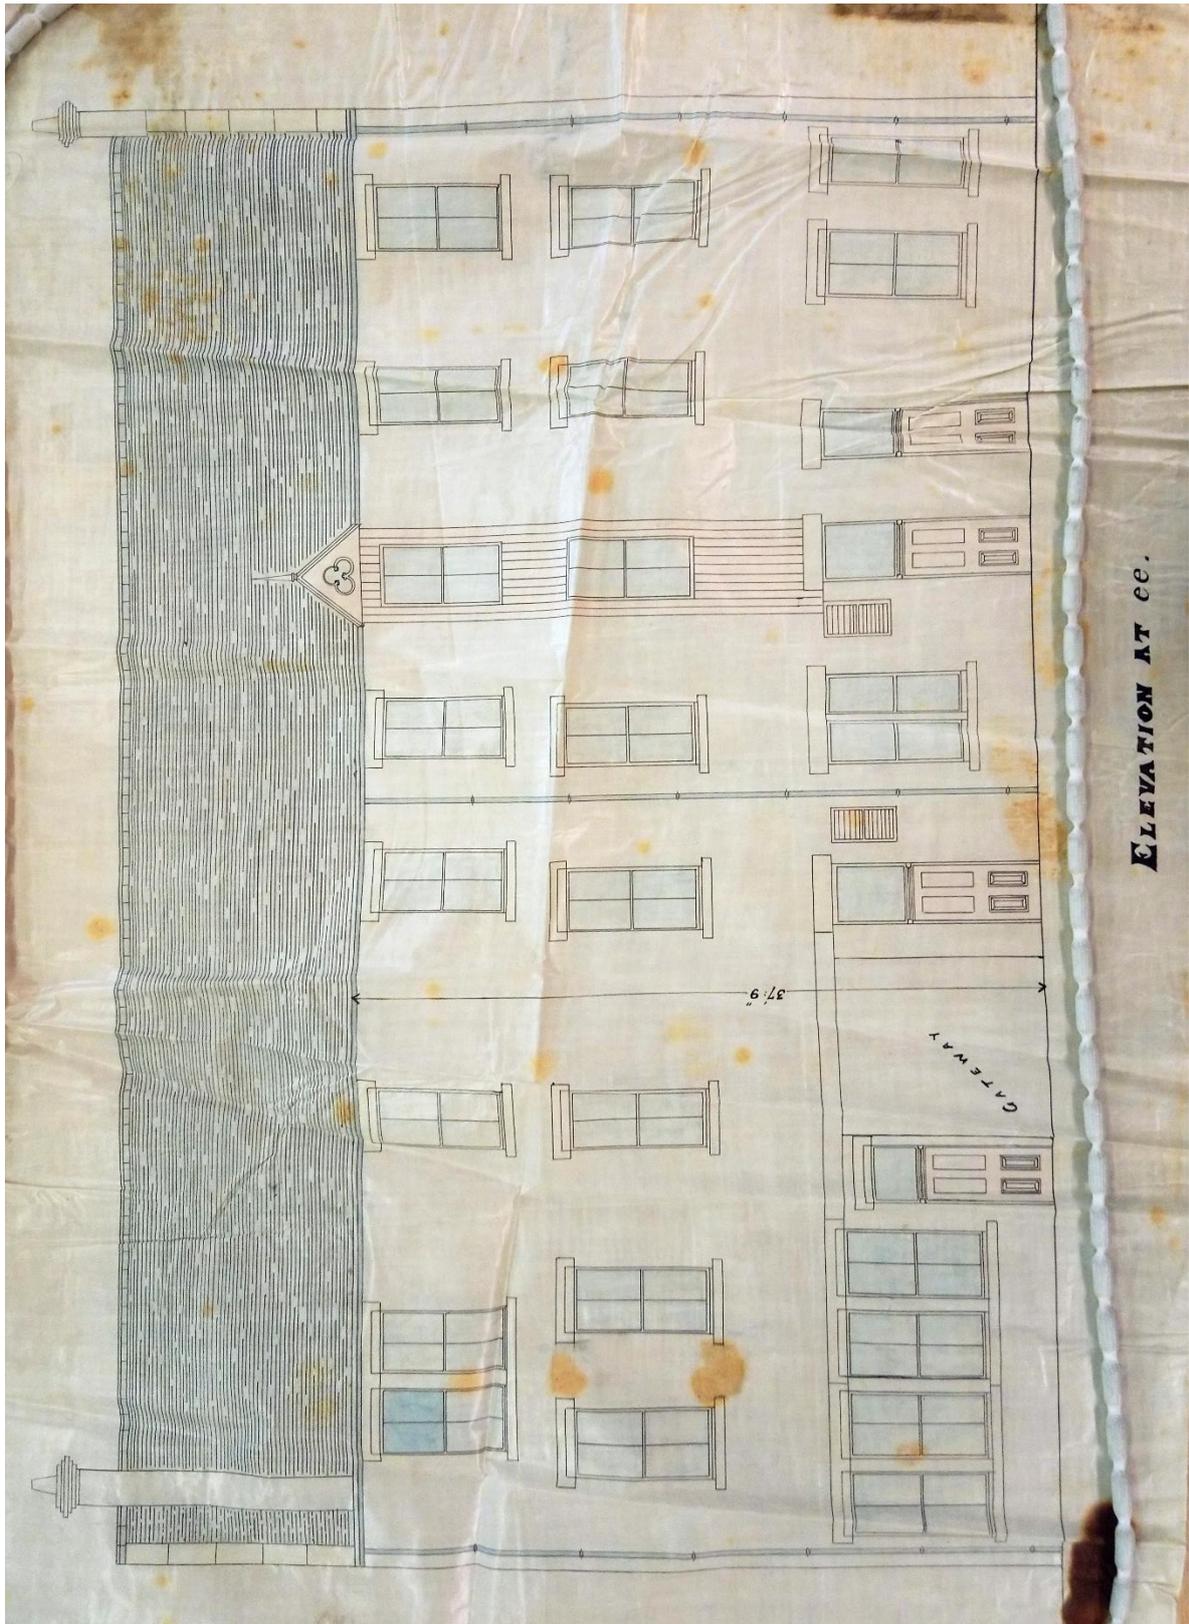
B: Elevation at EE

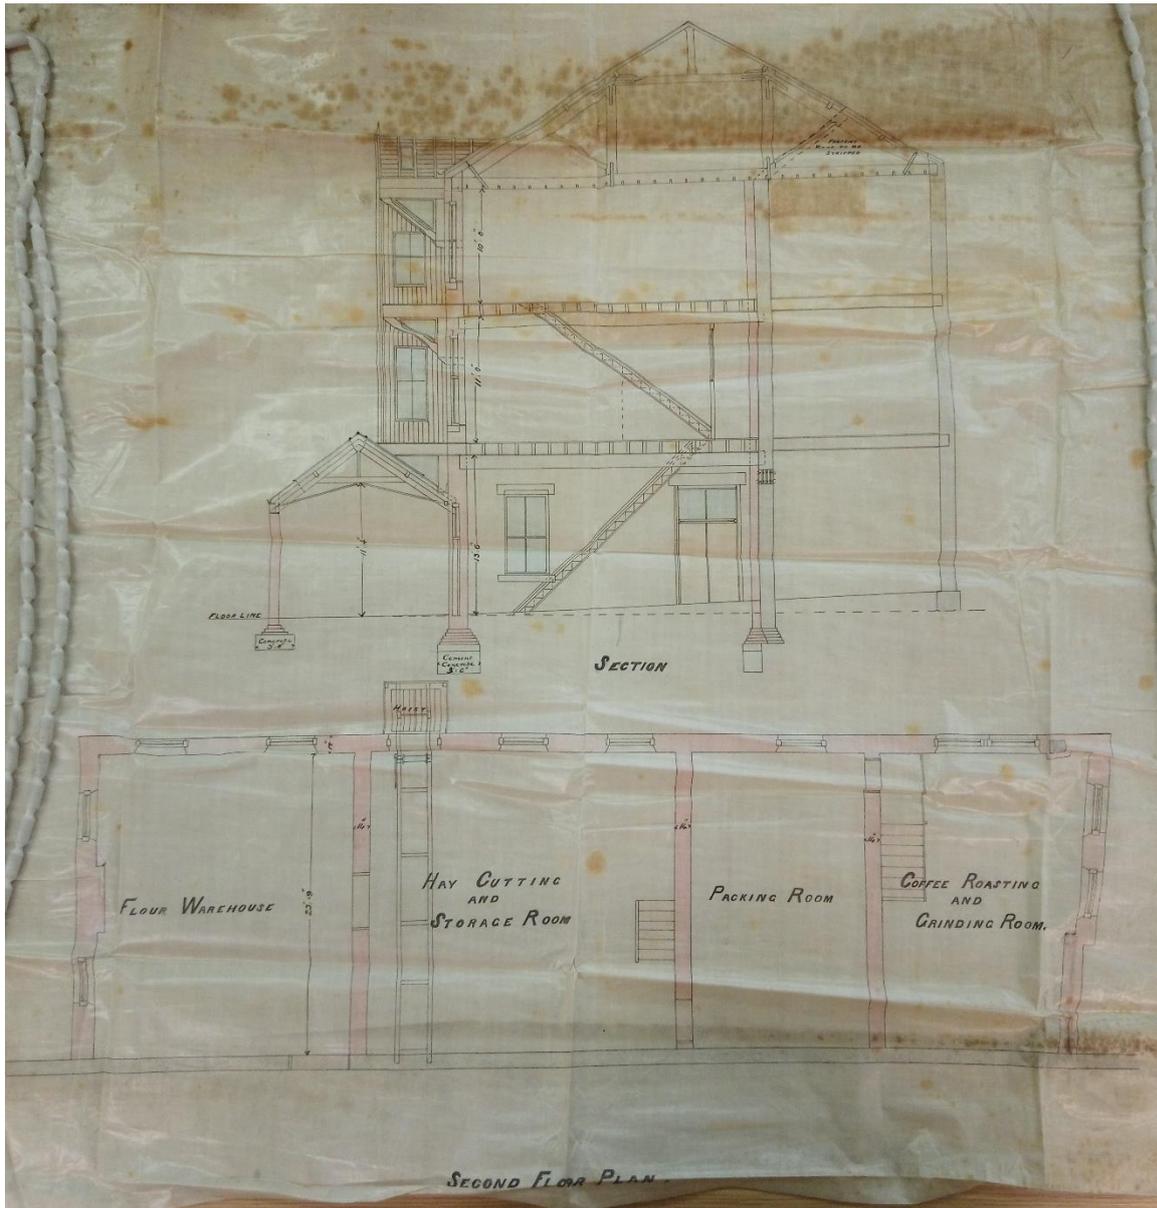
C: Section; Second-floor Plan

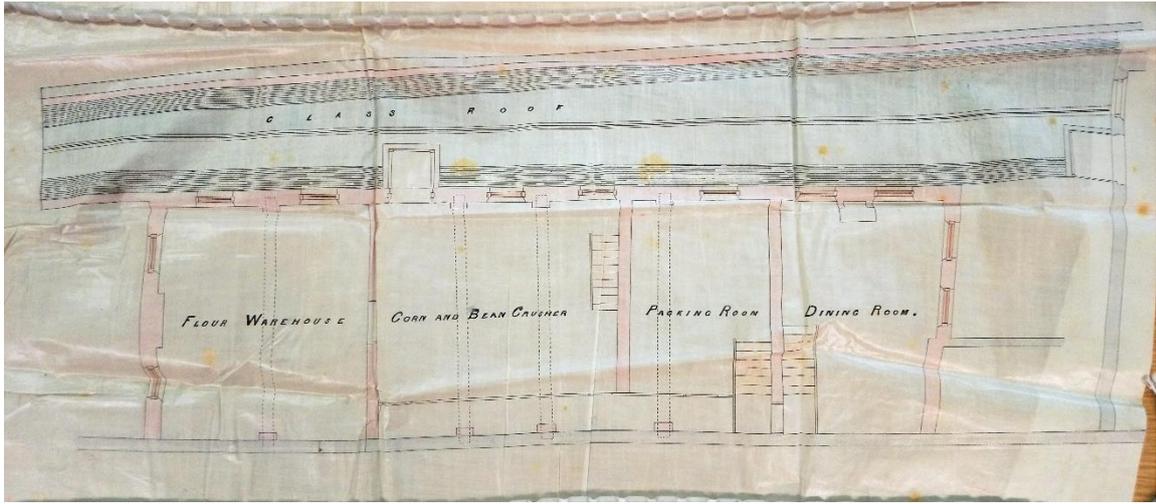
D: First-floor Plan

The first-floor layout of the General Warehouse is not shown on Linday's 1883 drawings. The Main Building is shown, however, with four spaces, each the full depth of the building and separated from each other by 355mm thick brick cross walls. From west to east these are labelled 'Flour Warehouse' (part-R228), 'Corn and Bean Crusher' (part-R221, 222 and 223), 'Packing Room' (part-R221) and 'Dining Room' (part-R221).

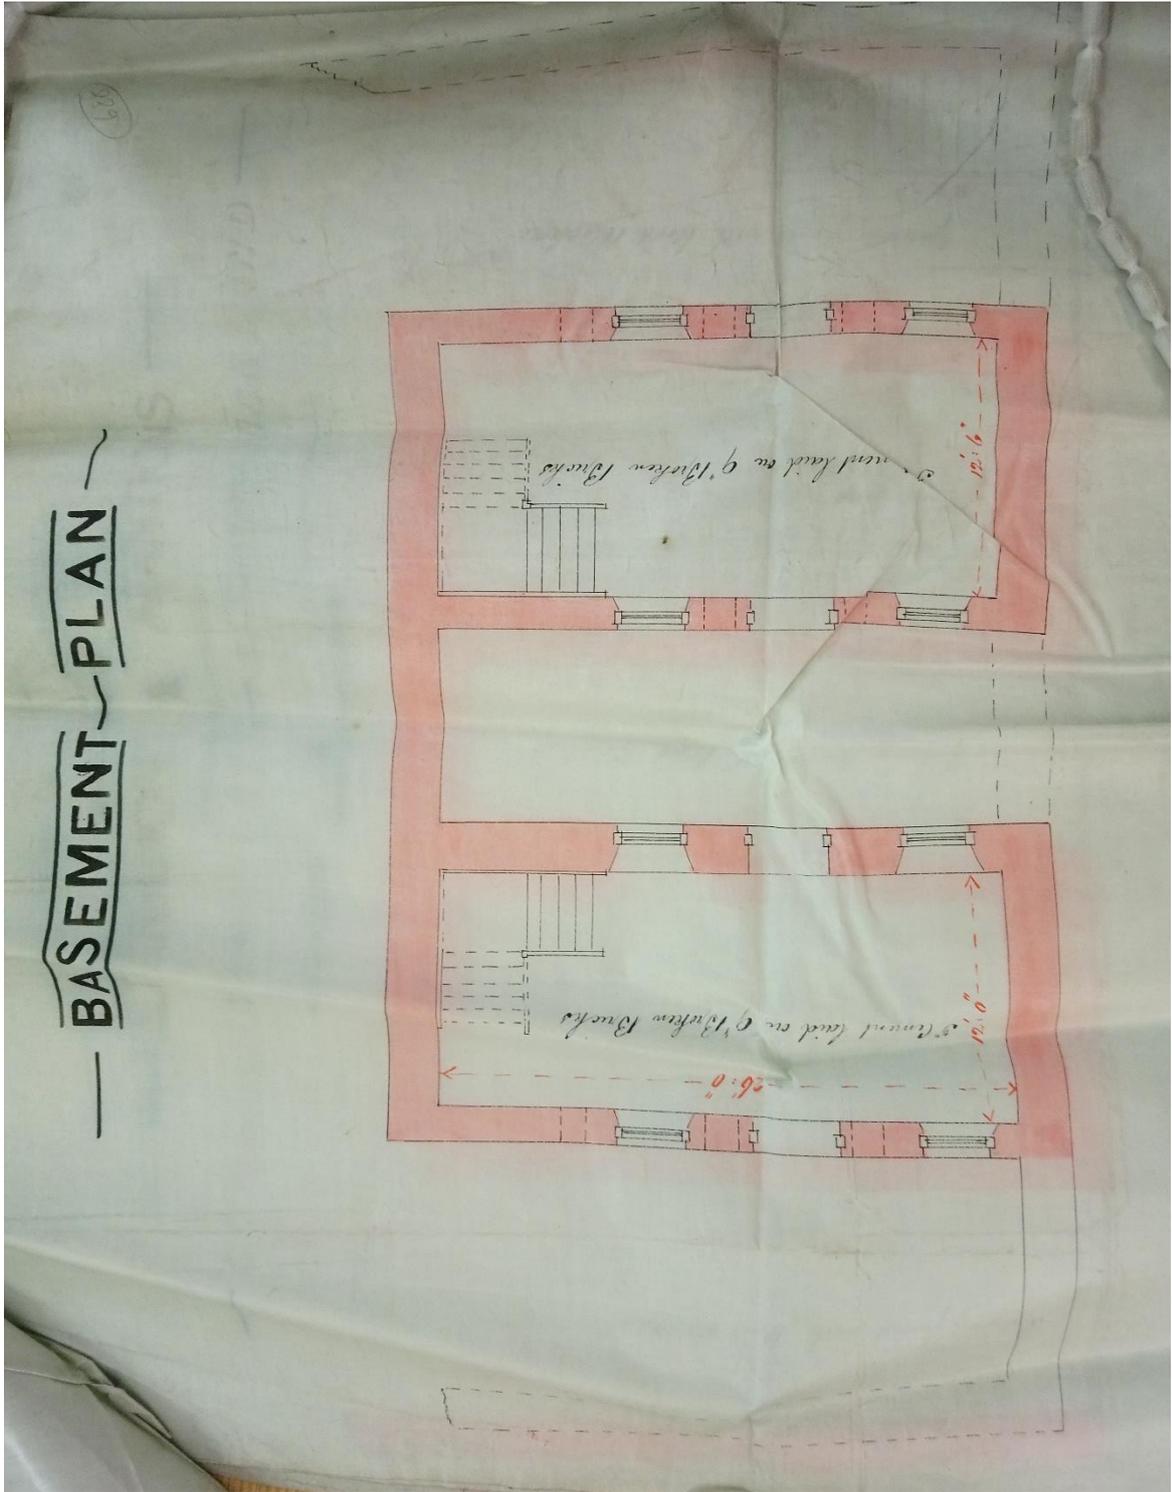
A: Basement Plan

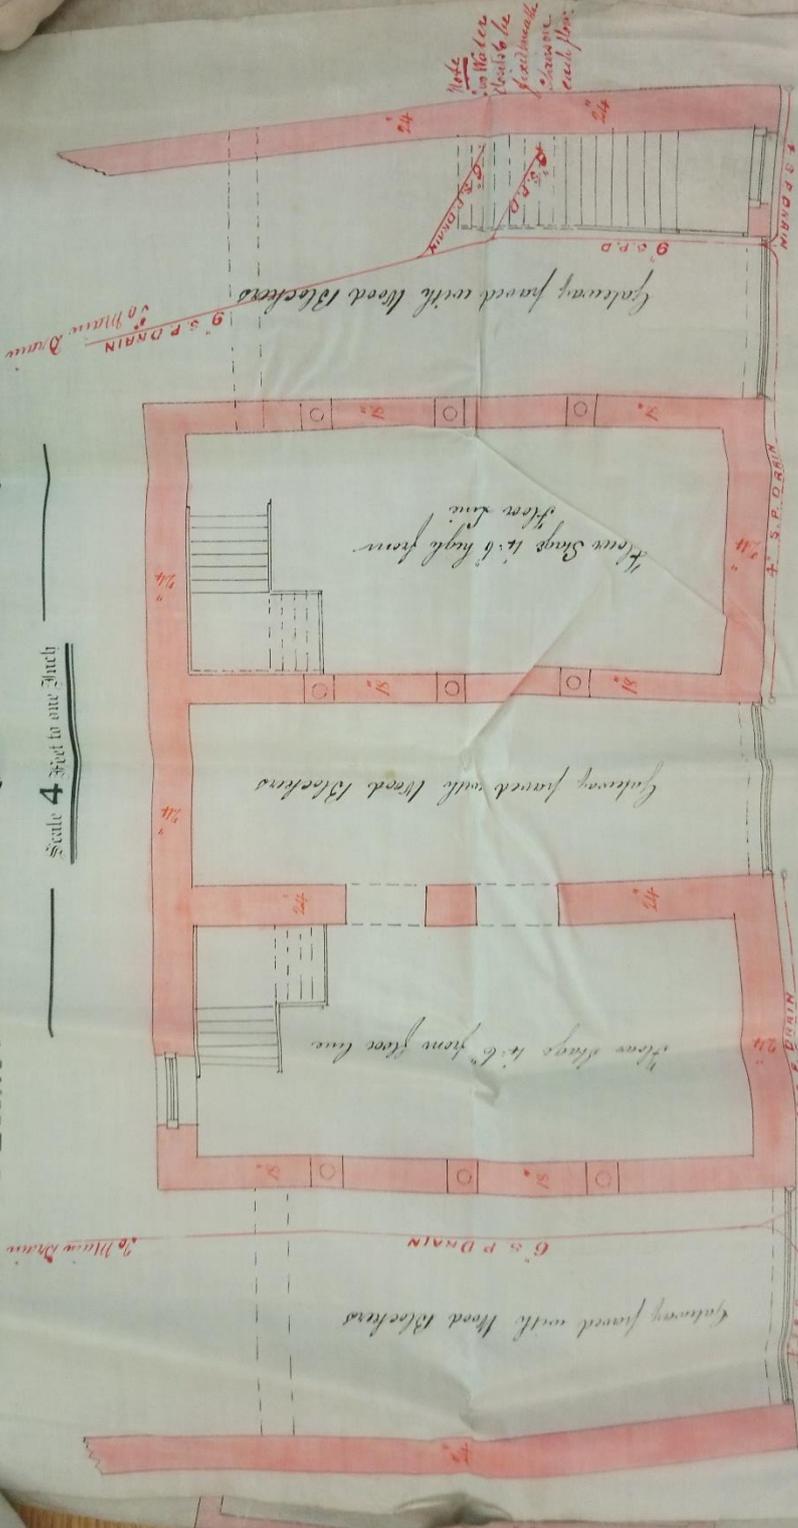
B: Ground Floor Plan

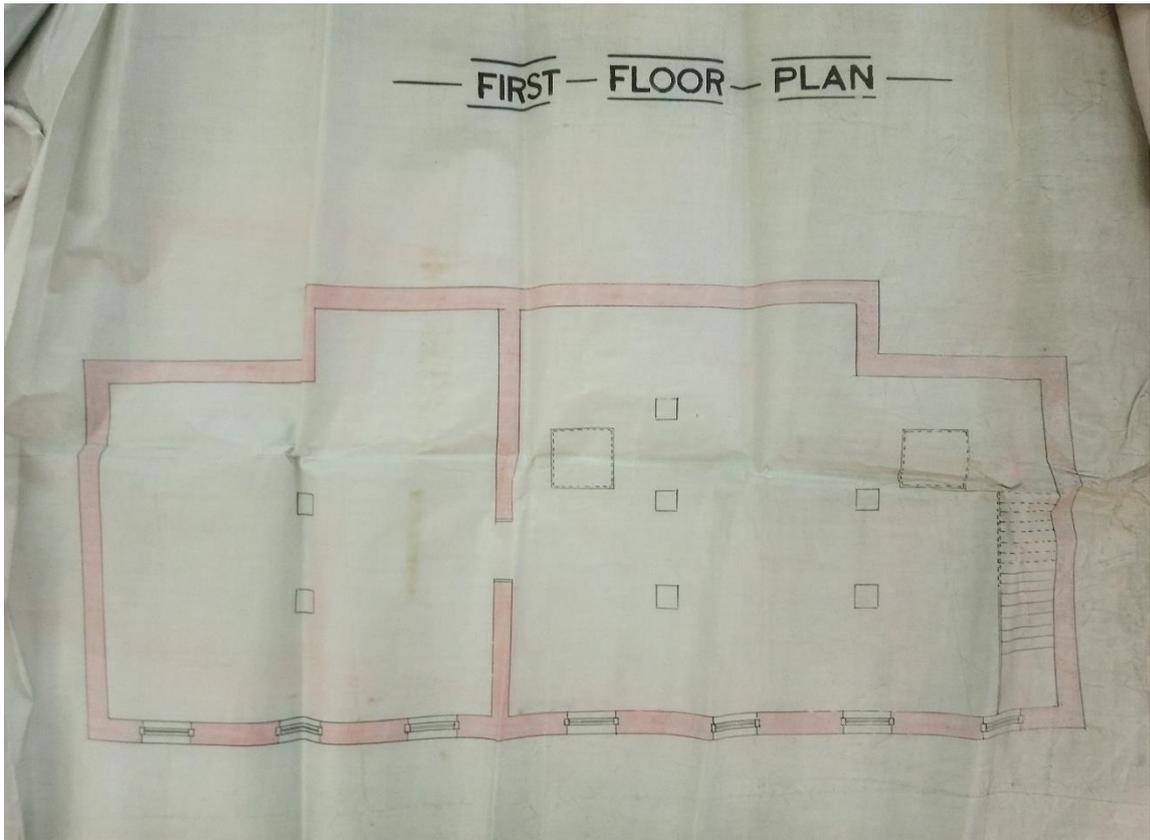
C: First Floor Plan

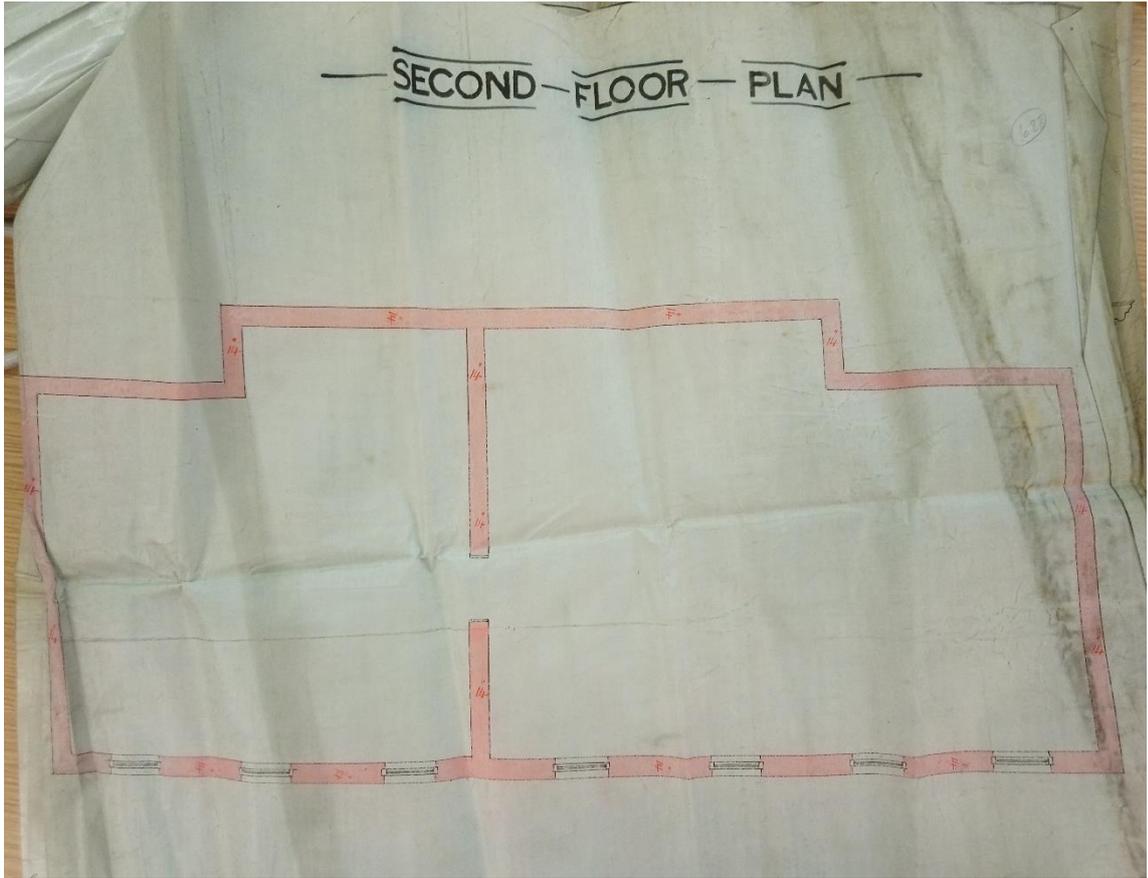
D: Second Floor Plan

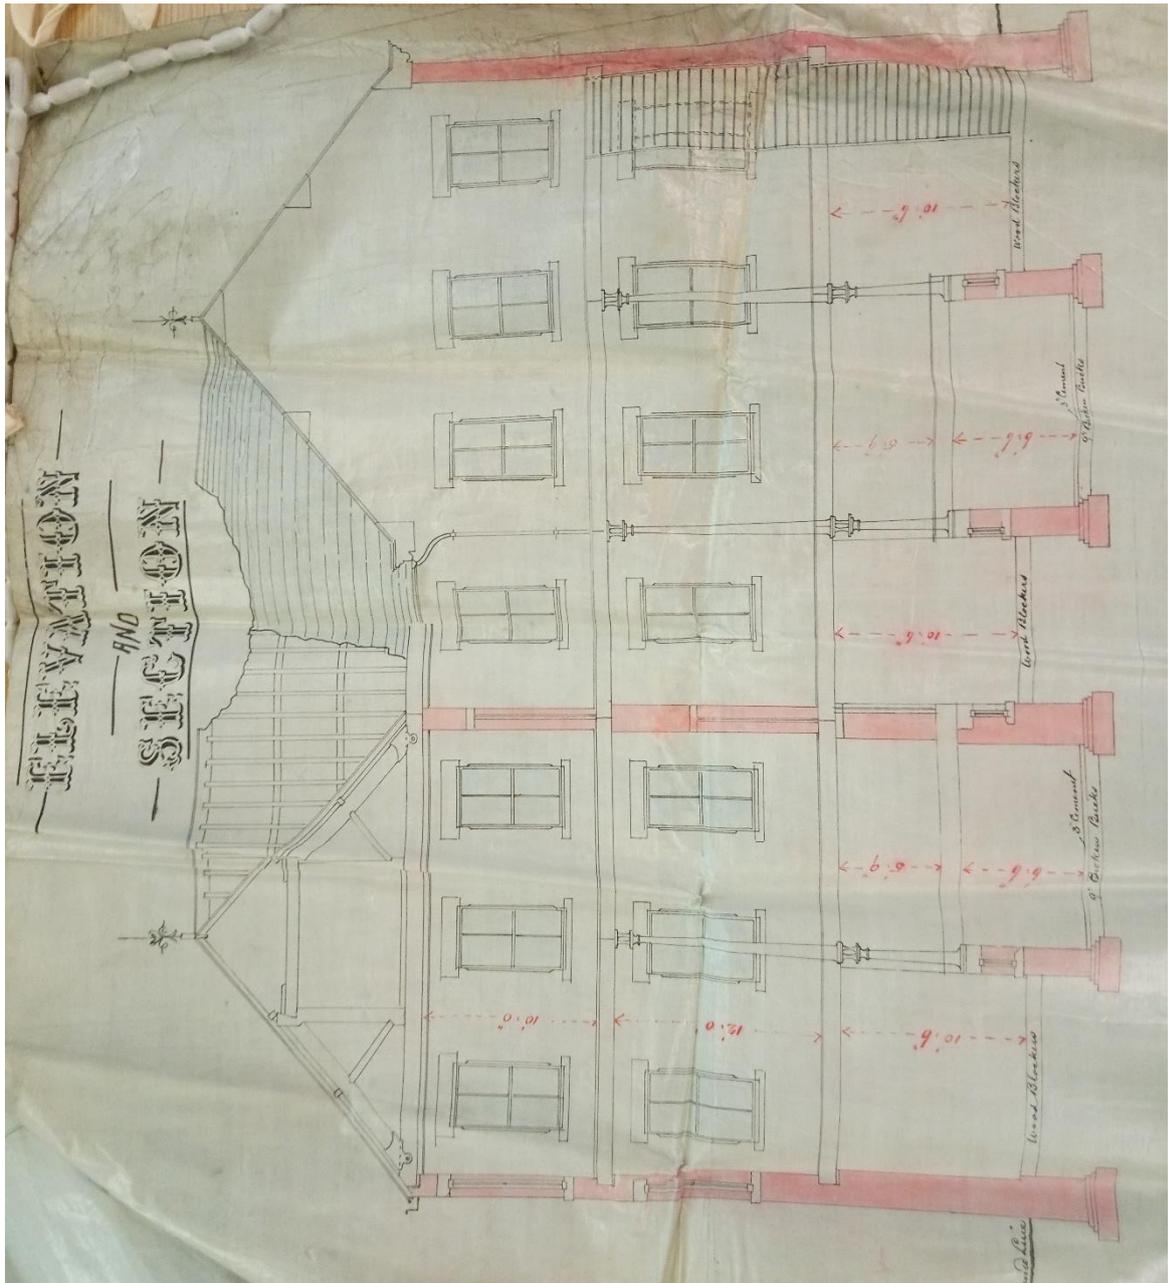
E: Elevation and Section

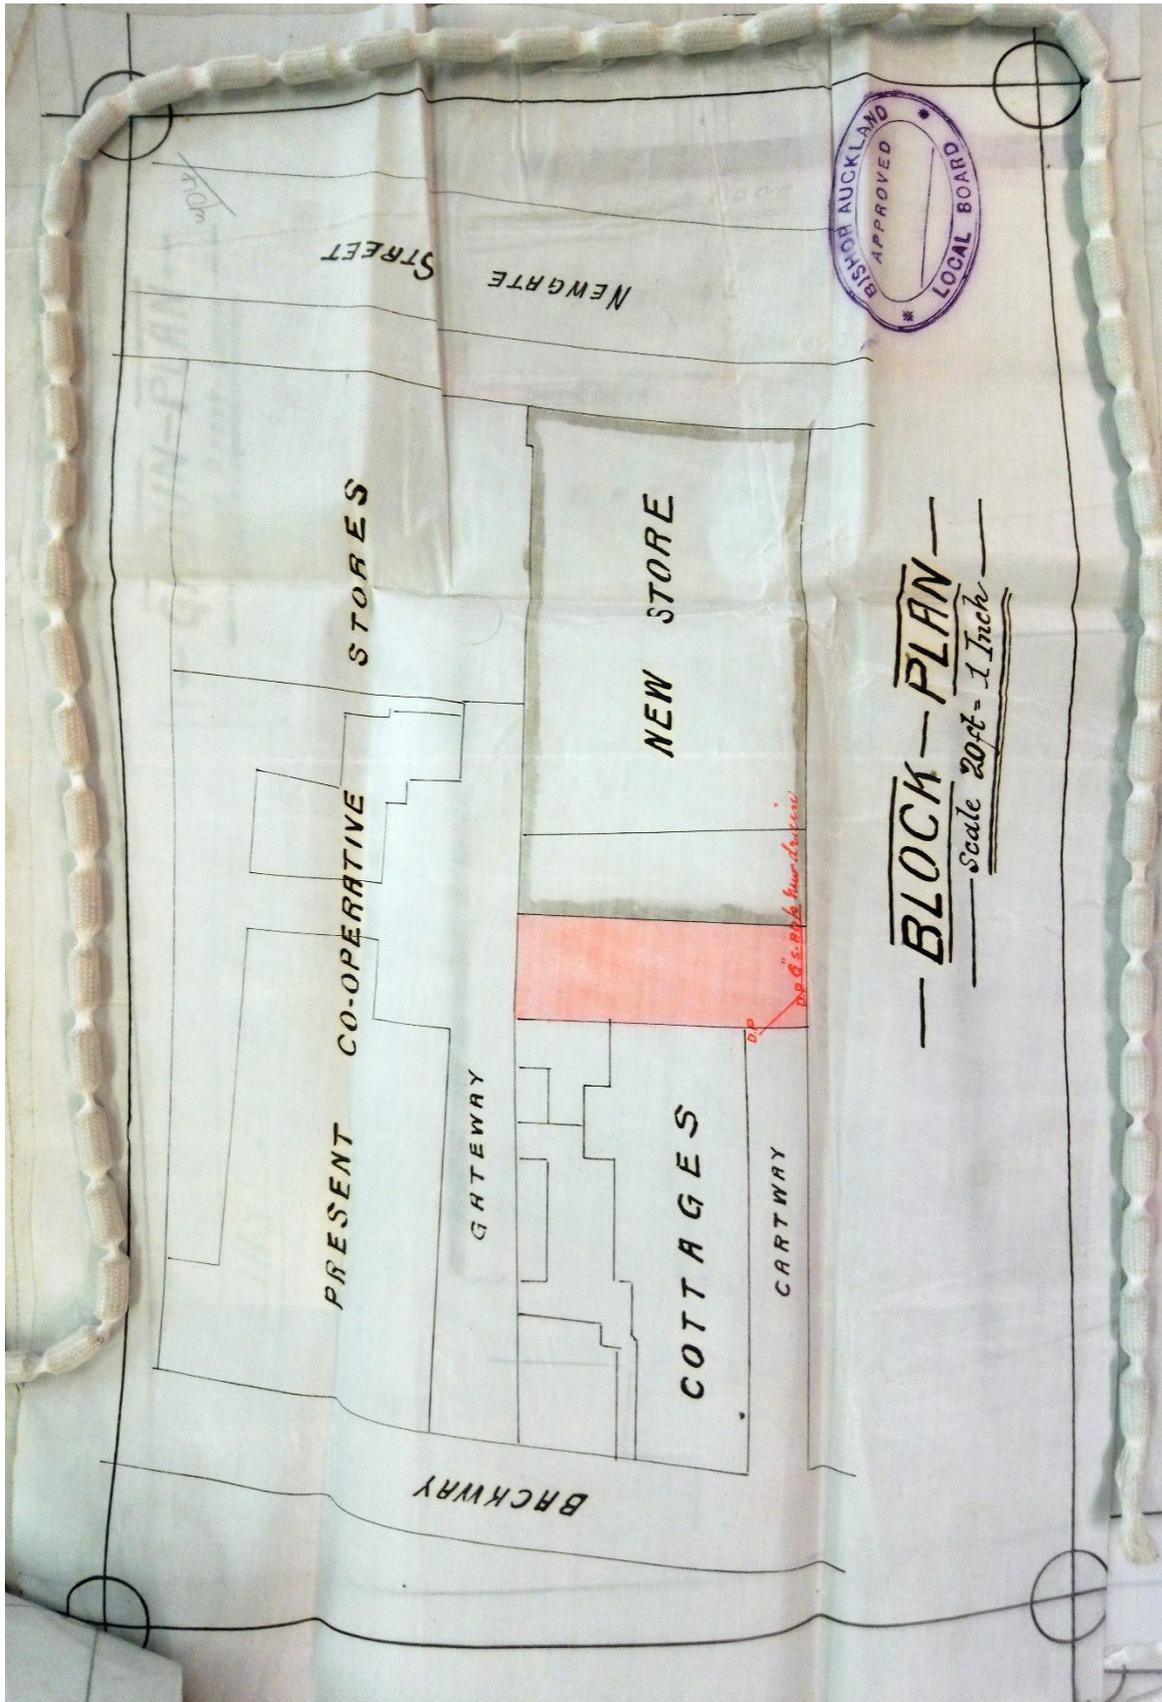
A: Block Plan

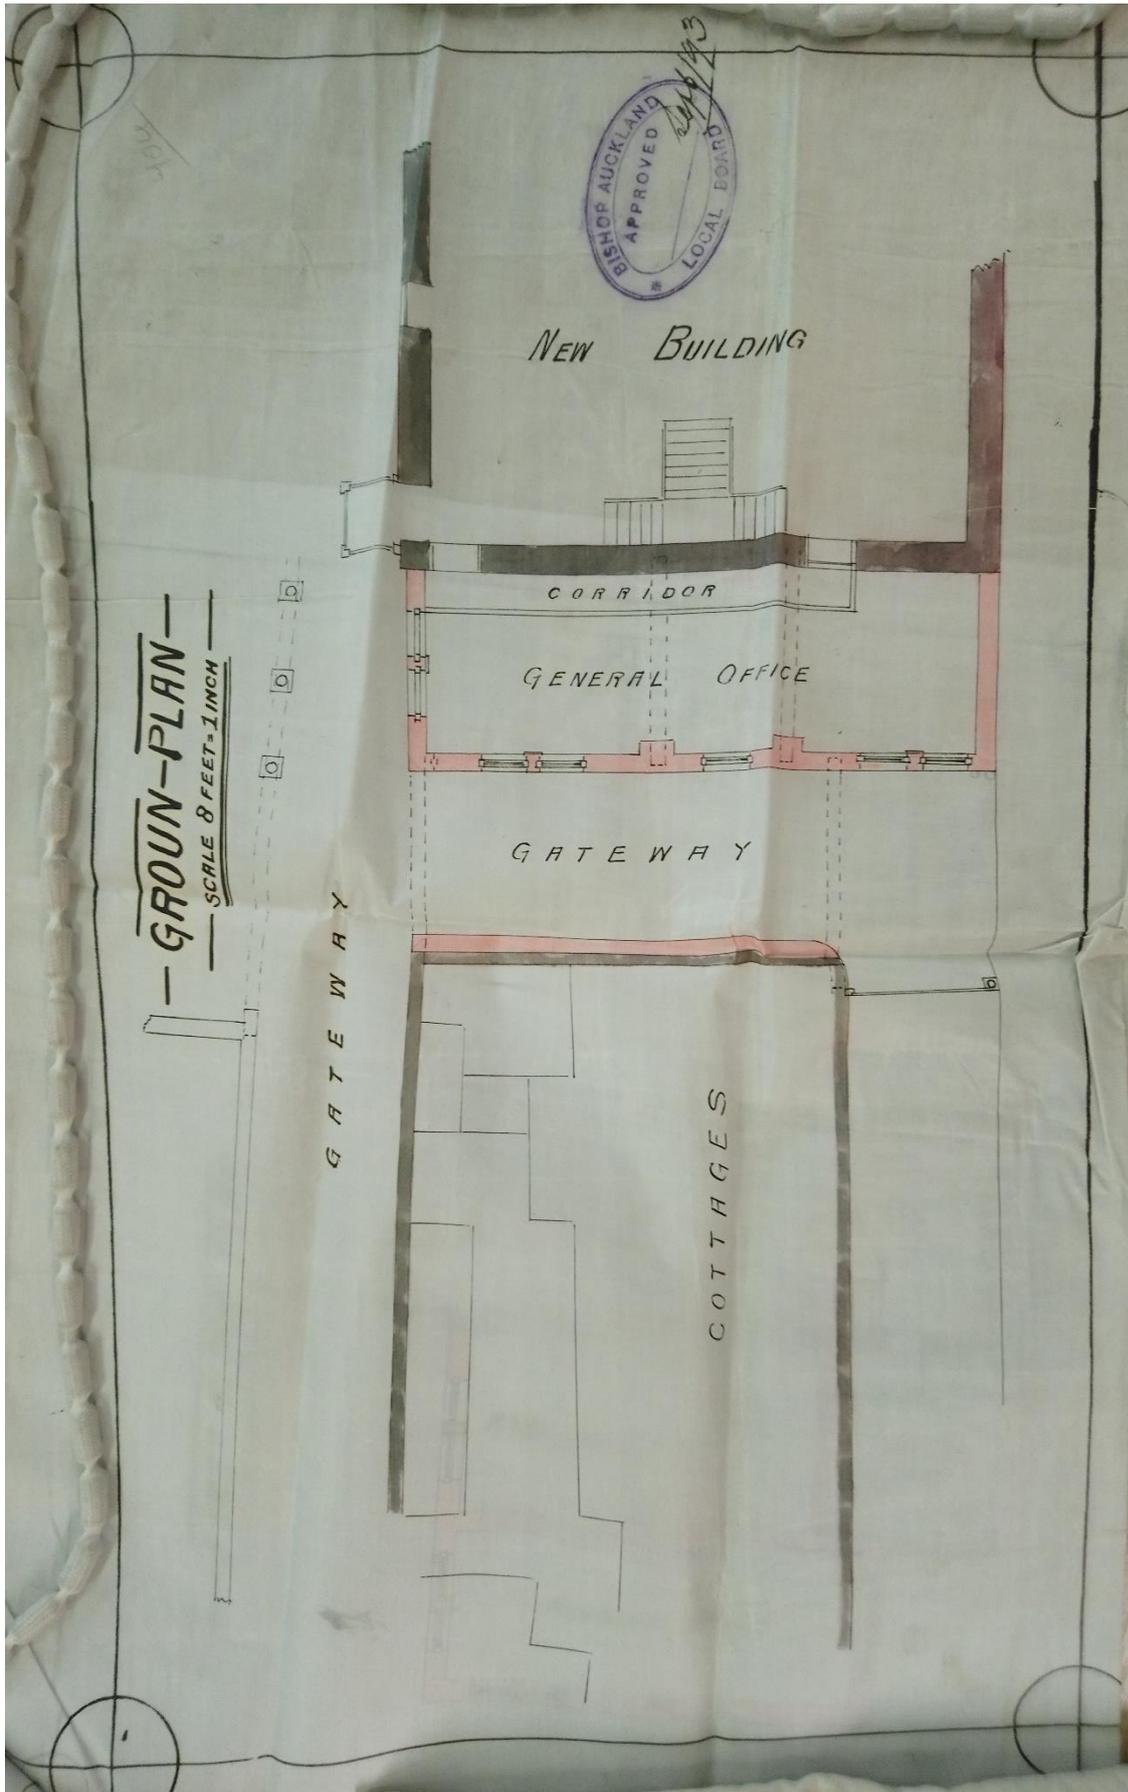
B: Ground Plan

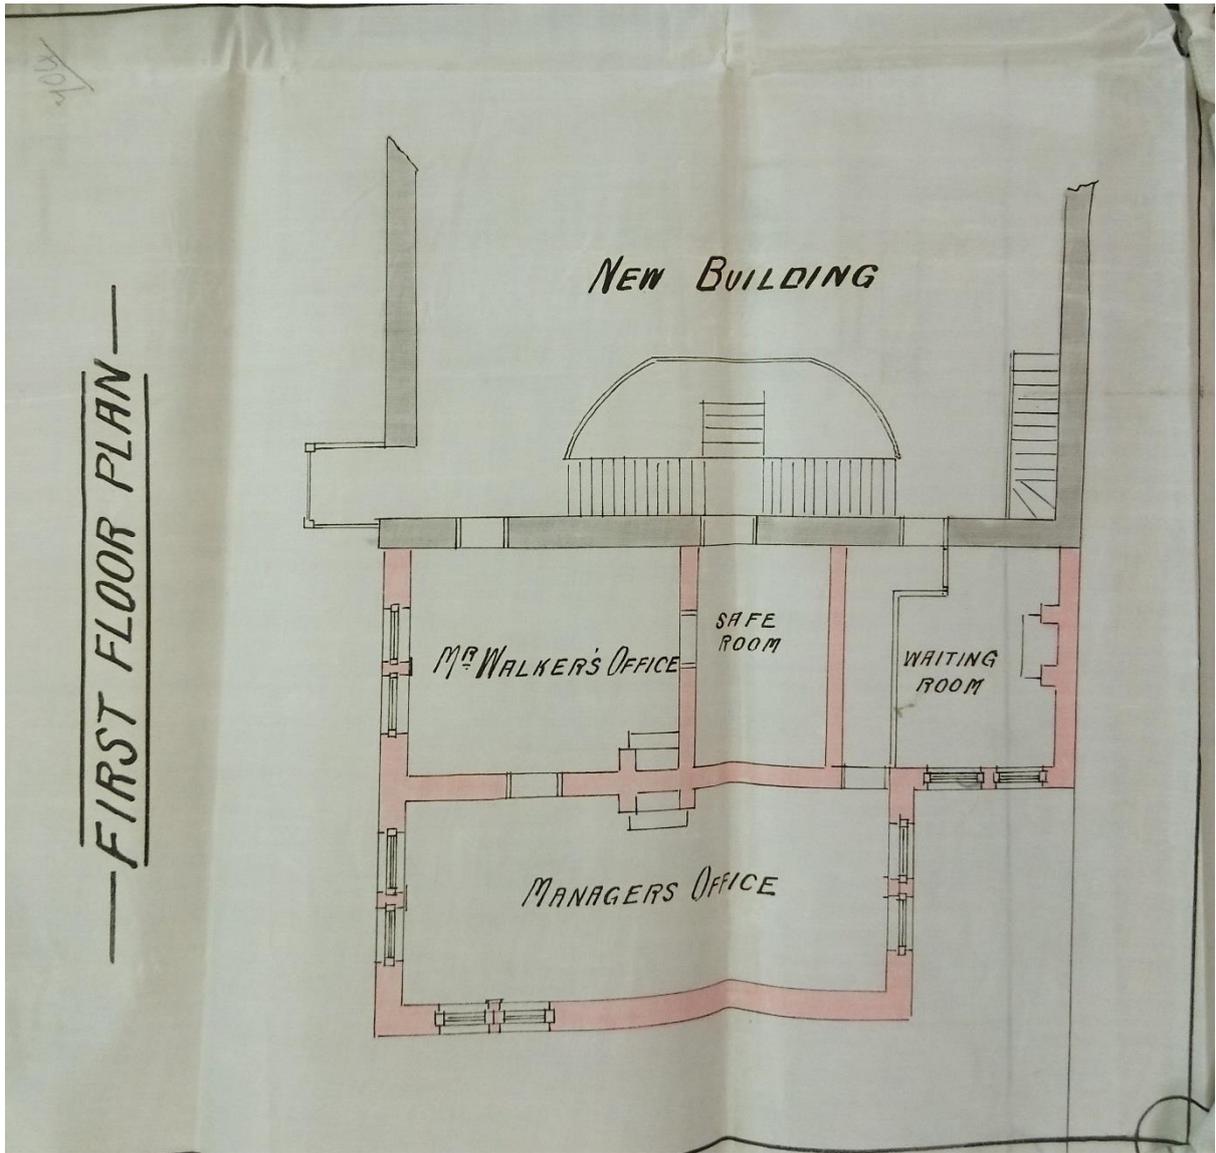
C: First Floor Plan

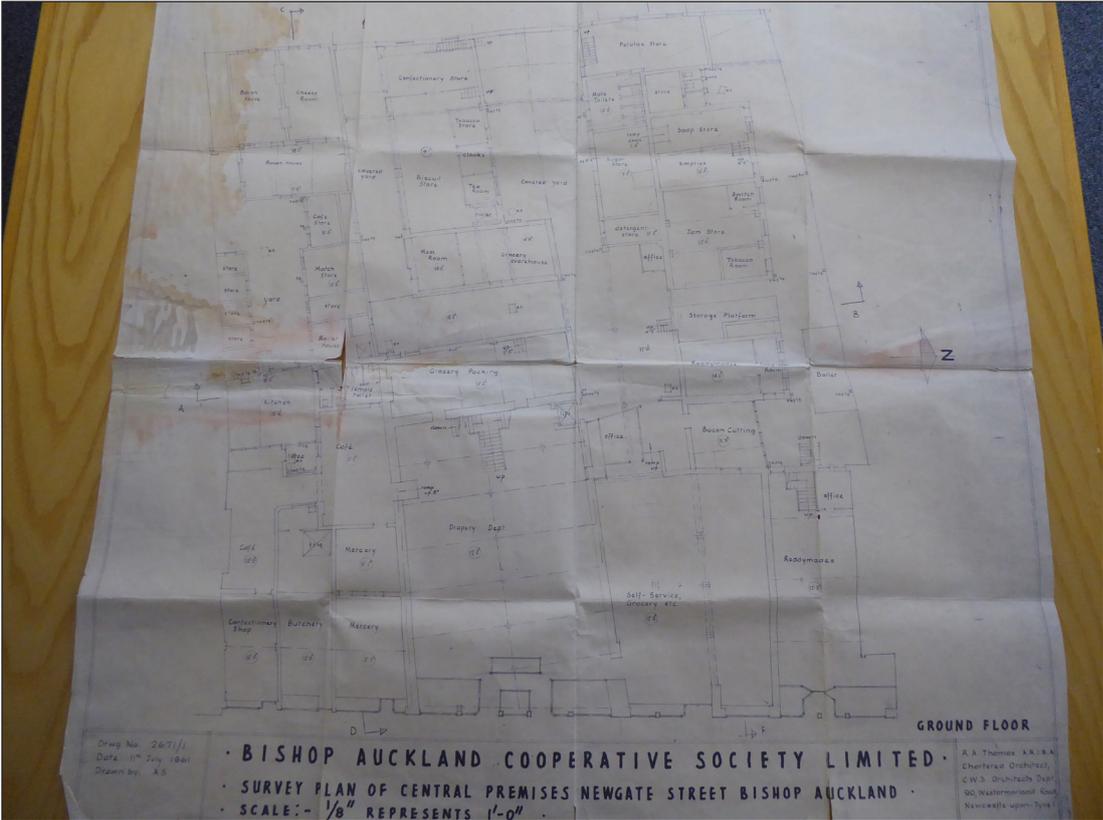
Plans as existing drawn in 1961

A: Ground Floor

The 1961 survey ground-floor plan shows a covered carriageway, R108, between a 'Cheese Room' to the south and 'Confectionery Store' to the north, which was at a higher level and open to the carriageway which continued east into a covered yard. Today, the carriage arch has been built up in red brick, the paved surface is concrete and the north, south and west walls are of painted brickwork. The south wall contains a square-headed opening which has also been built up in red brick. 600mm x 600mm fibre tiles line the carriageway soffit. The 'Confectionery Store' which is now the area occupied by the west end of R118 is described under Block E.

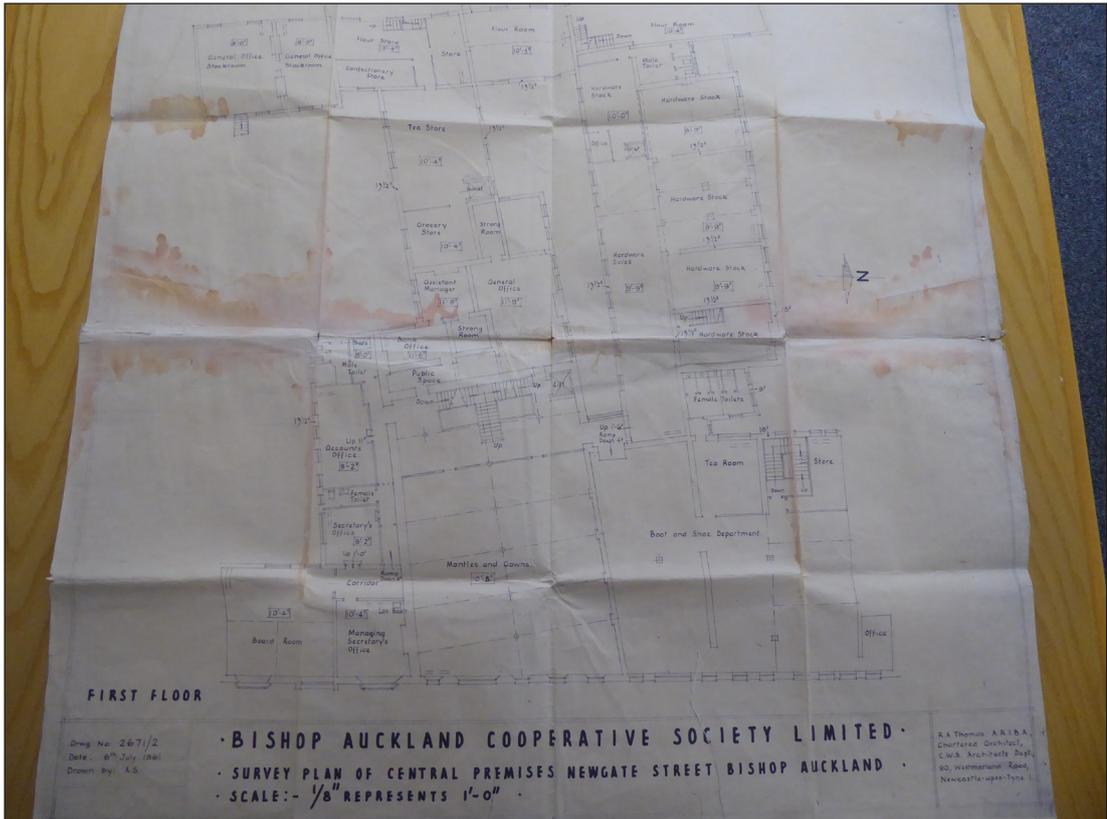
B: First Floor

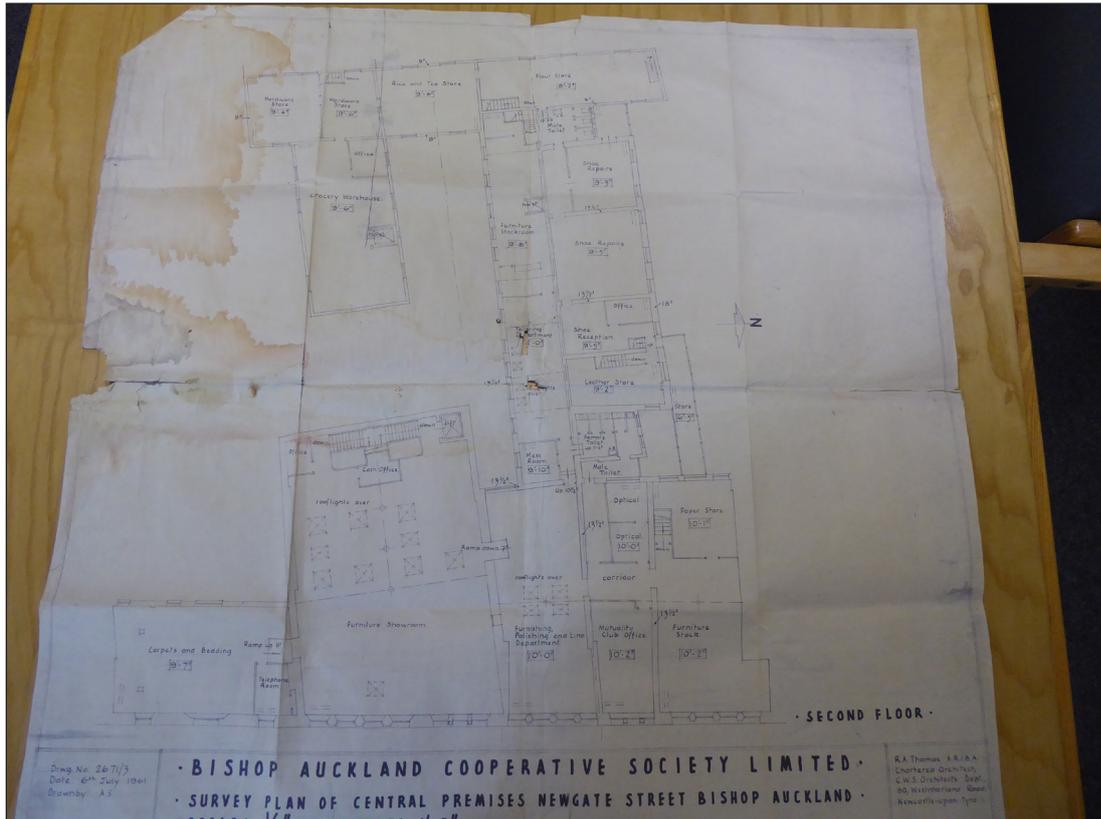
C: Second Floor

The 1961 survey drawings showed that, by this time, the second floor had also found new uses but, again, had not been altered physically to a great extent. The Main Building on this floor was given over to shoe repairs. The two eastern compartments were designated for repairs, the former Packing Room was now 'Shoe Reception' with a small office in the north-west corner, and the Coffee Roasting and Grinding Room had become a 'Leather Store'. The east side of the General Warehouse was now a 'Tailoring Department' accessed in the north-east corner from Block A. A 'Mess Room' was located at the east end of this space. The roof structure appears to have been exposed in the main tailoring room and two pairs of roof lights, positioned between trusses, provided additional natural light. The west side of the General Warehouse was designated 'Furniture Stockroom' with the hoist centrally-located on the north wall. A dog-leg staircase in the north-west corner led from 'Hardware Stock' on the floor below to another 'Male Toilet' located in the water tower.

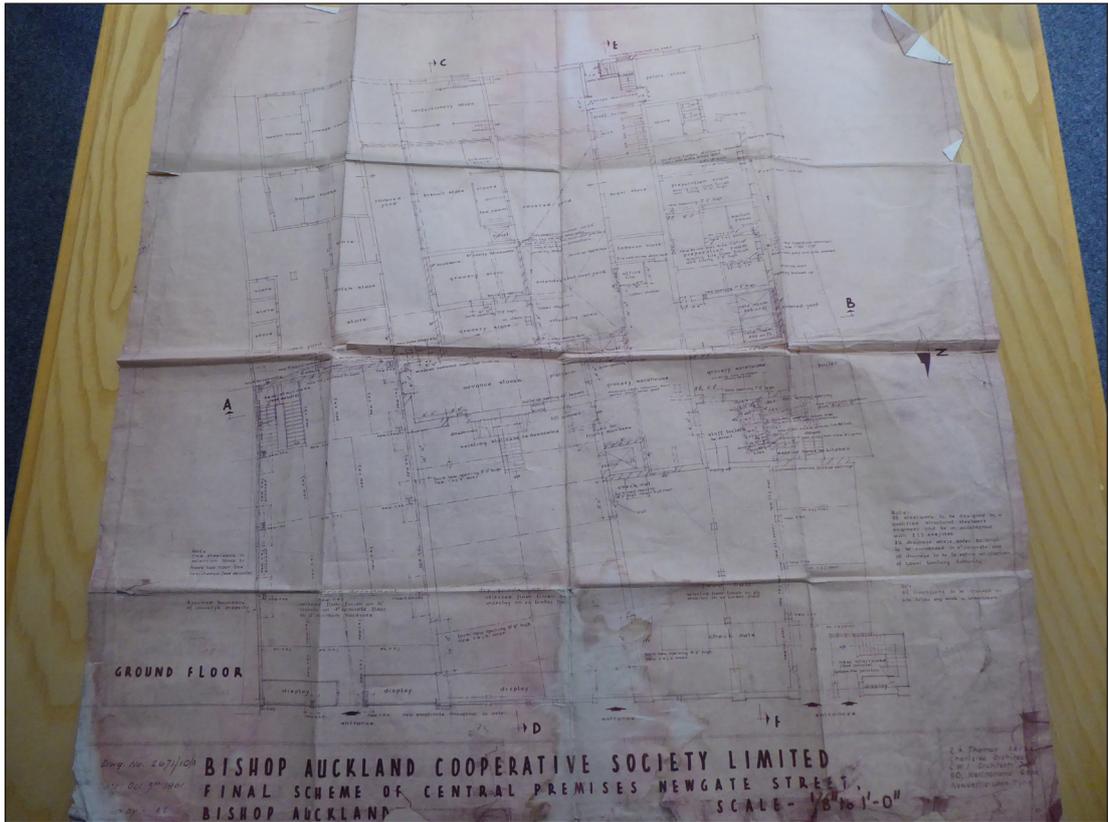
A: Ground Floor

Proposed plans as proposed in 1961
