Former Central Stores of Bishop Auckland Co-operative Society,
80 Newgate Street, Bishop Auckland, County Durham
Historic Building Report

HISTORIC BUILDING REPORT

Alastair Coey Architects

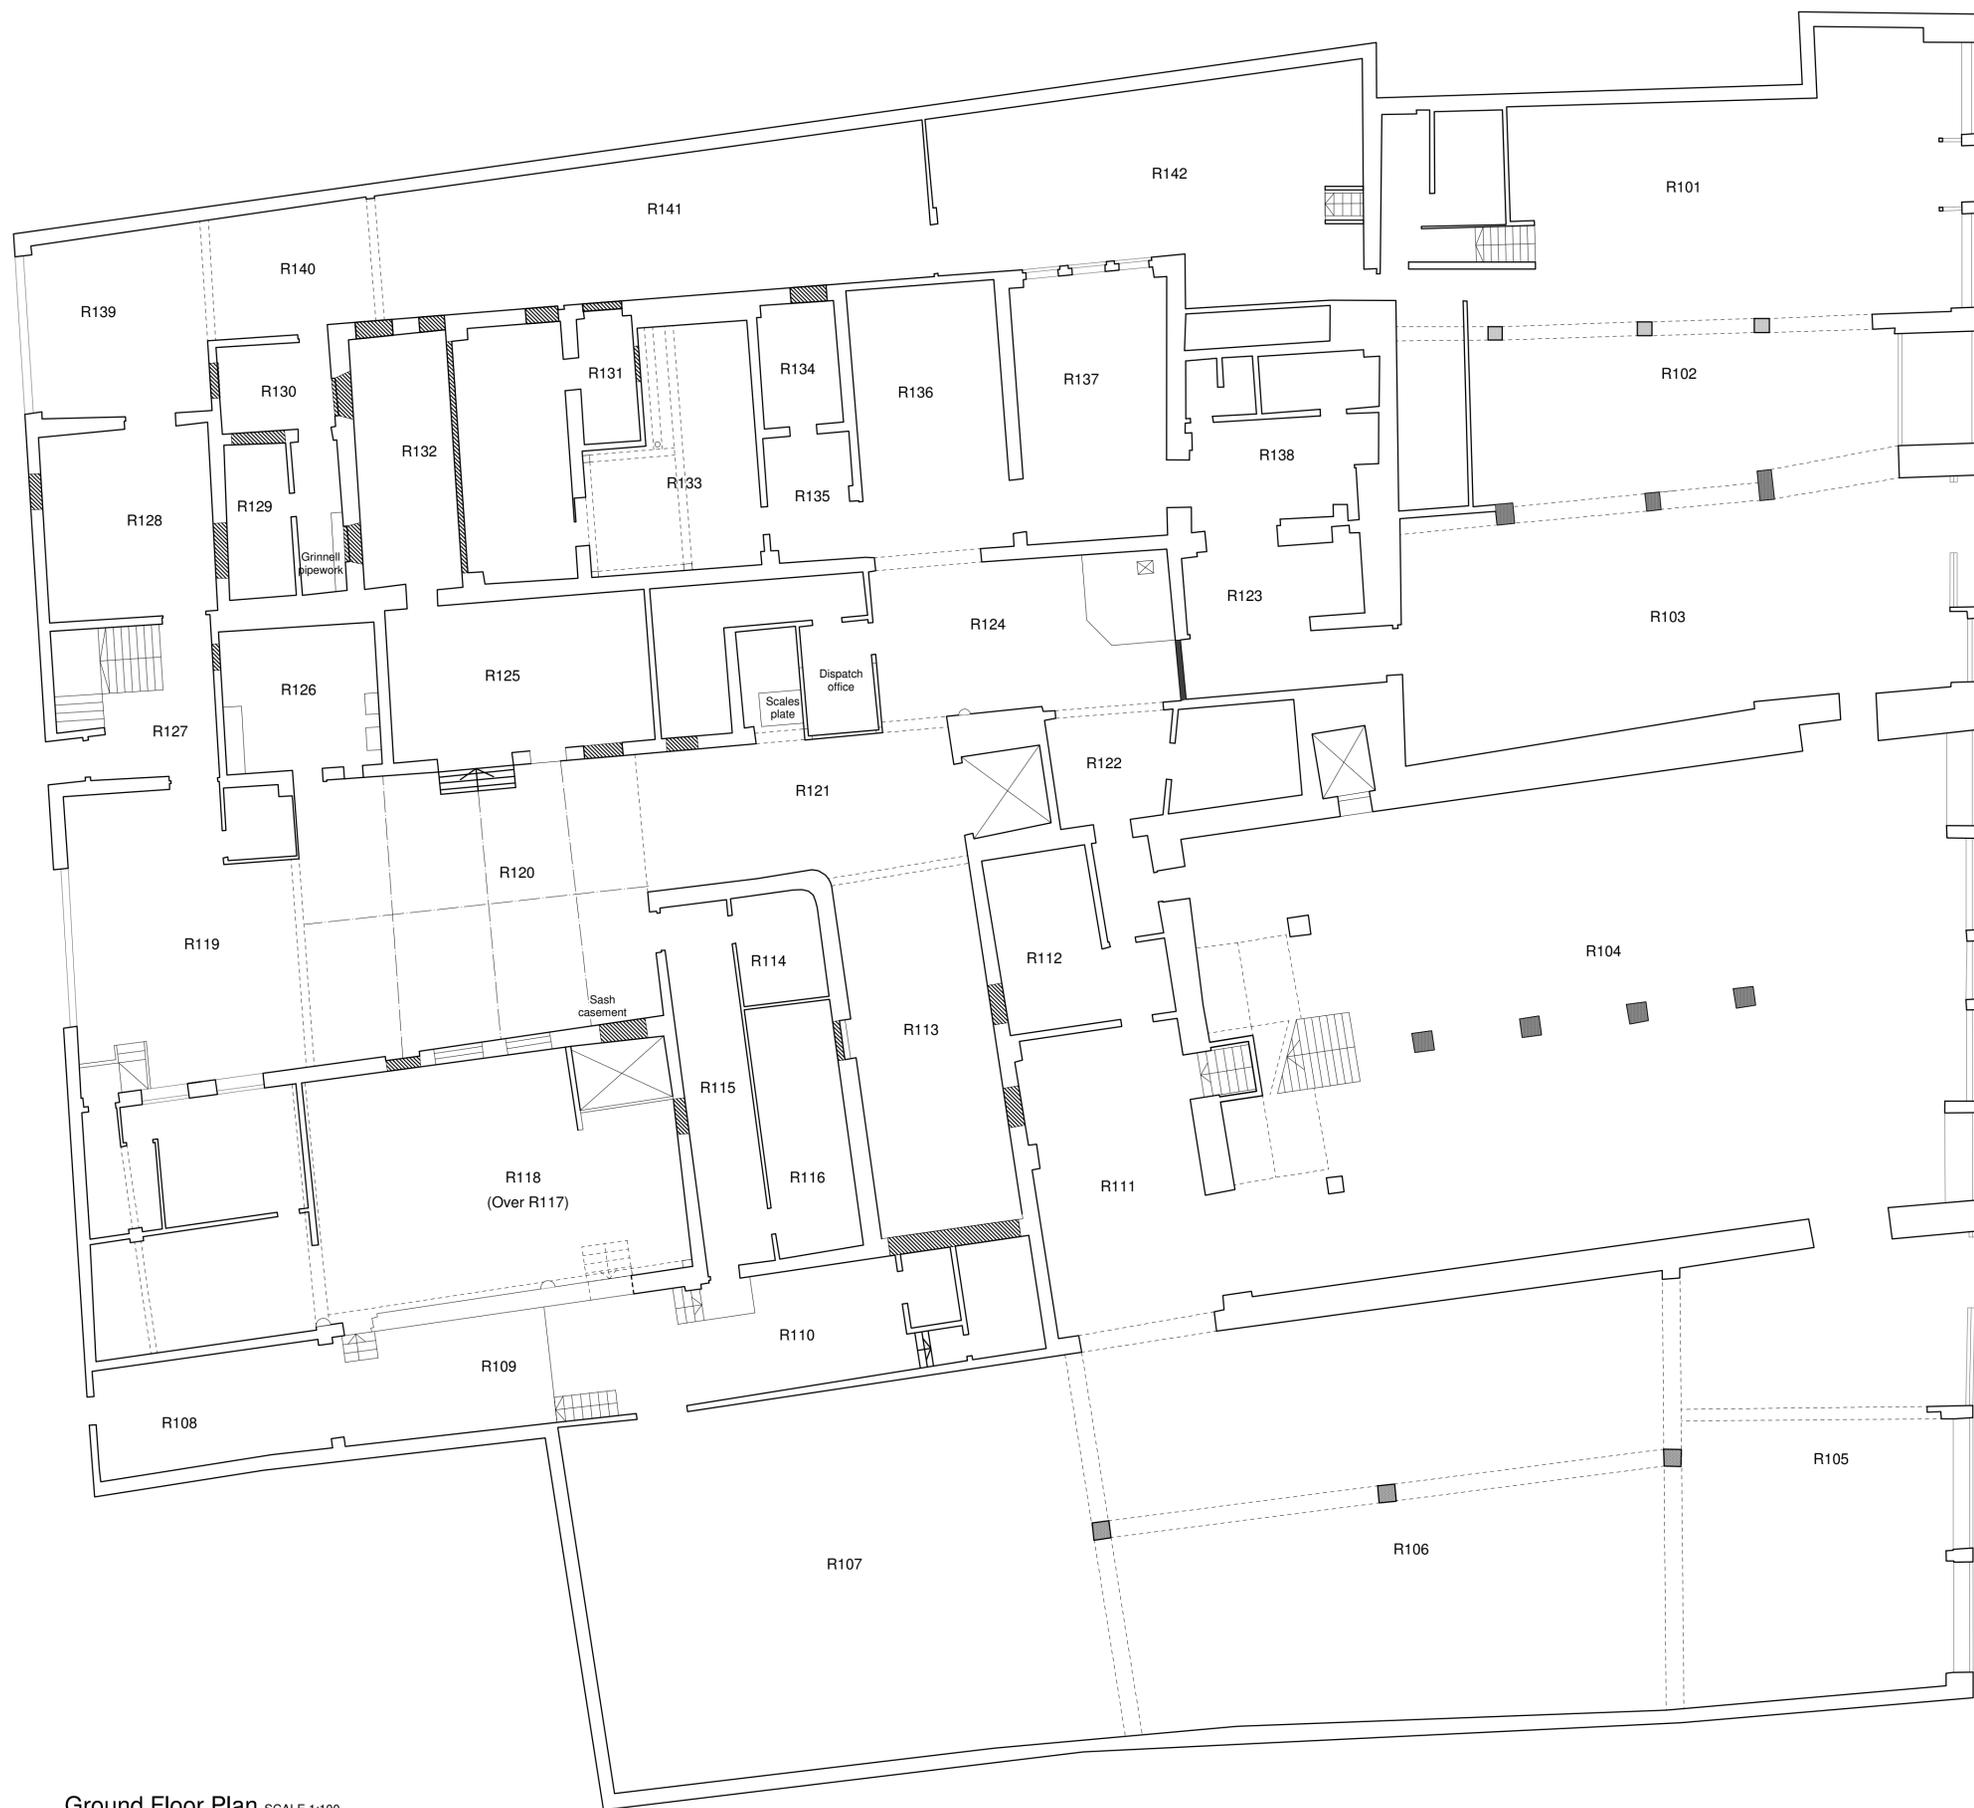
Ground Floor Plan SCALE 1:100

NGR: NZ 21035 29765
Surveyed By: ADC, AJT Feb 2019
Drawn: AJT, March 2019
Sheet: 1 of 5

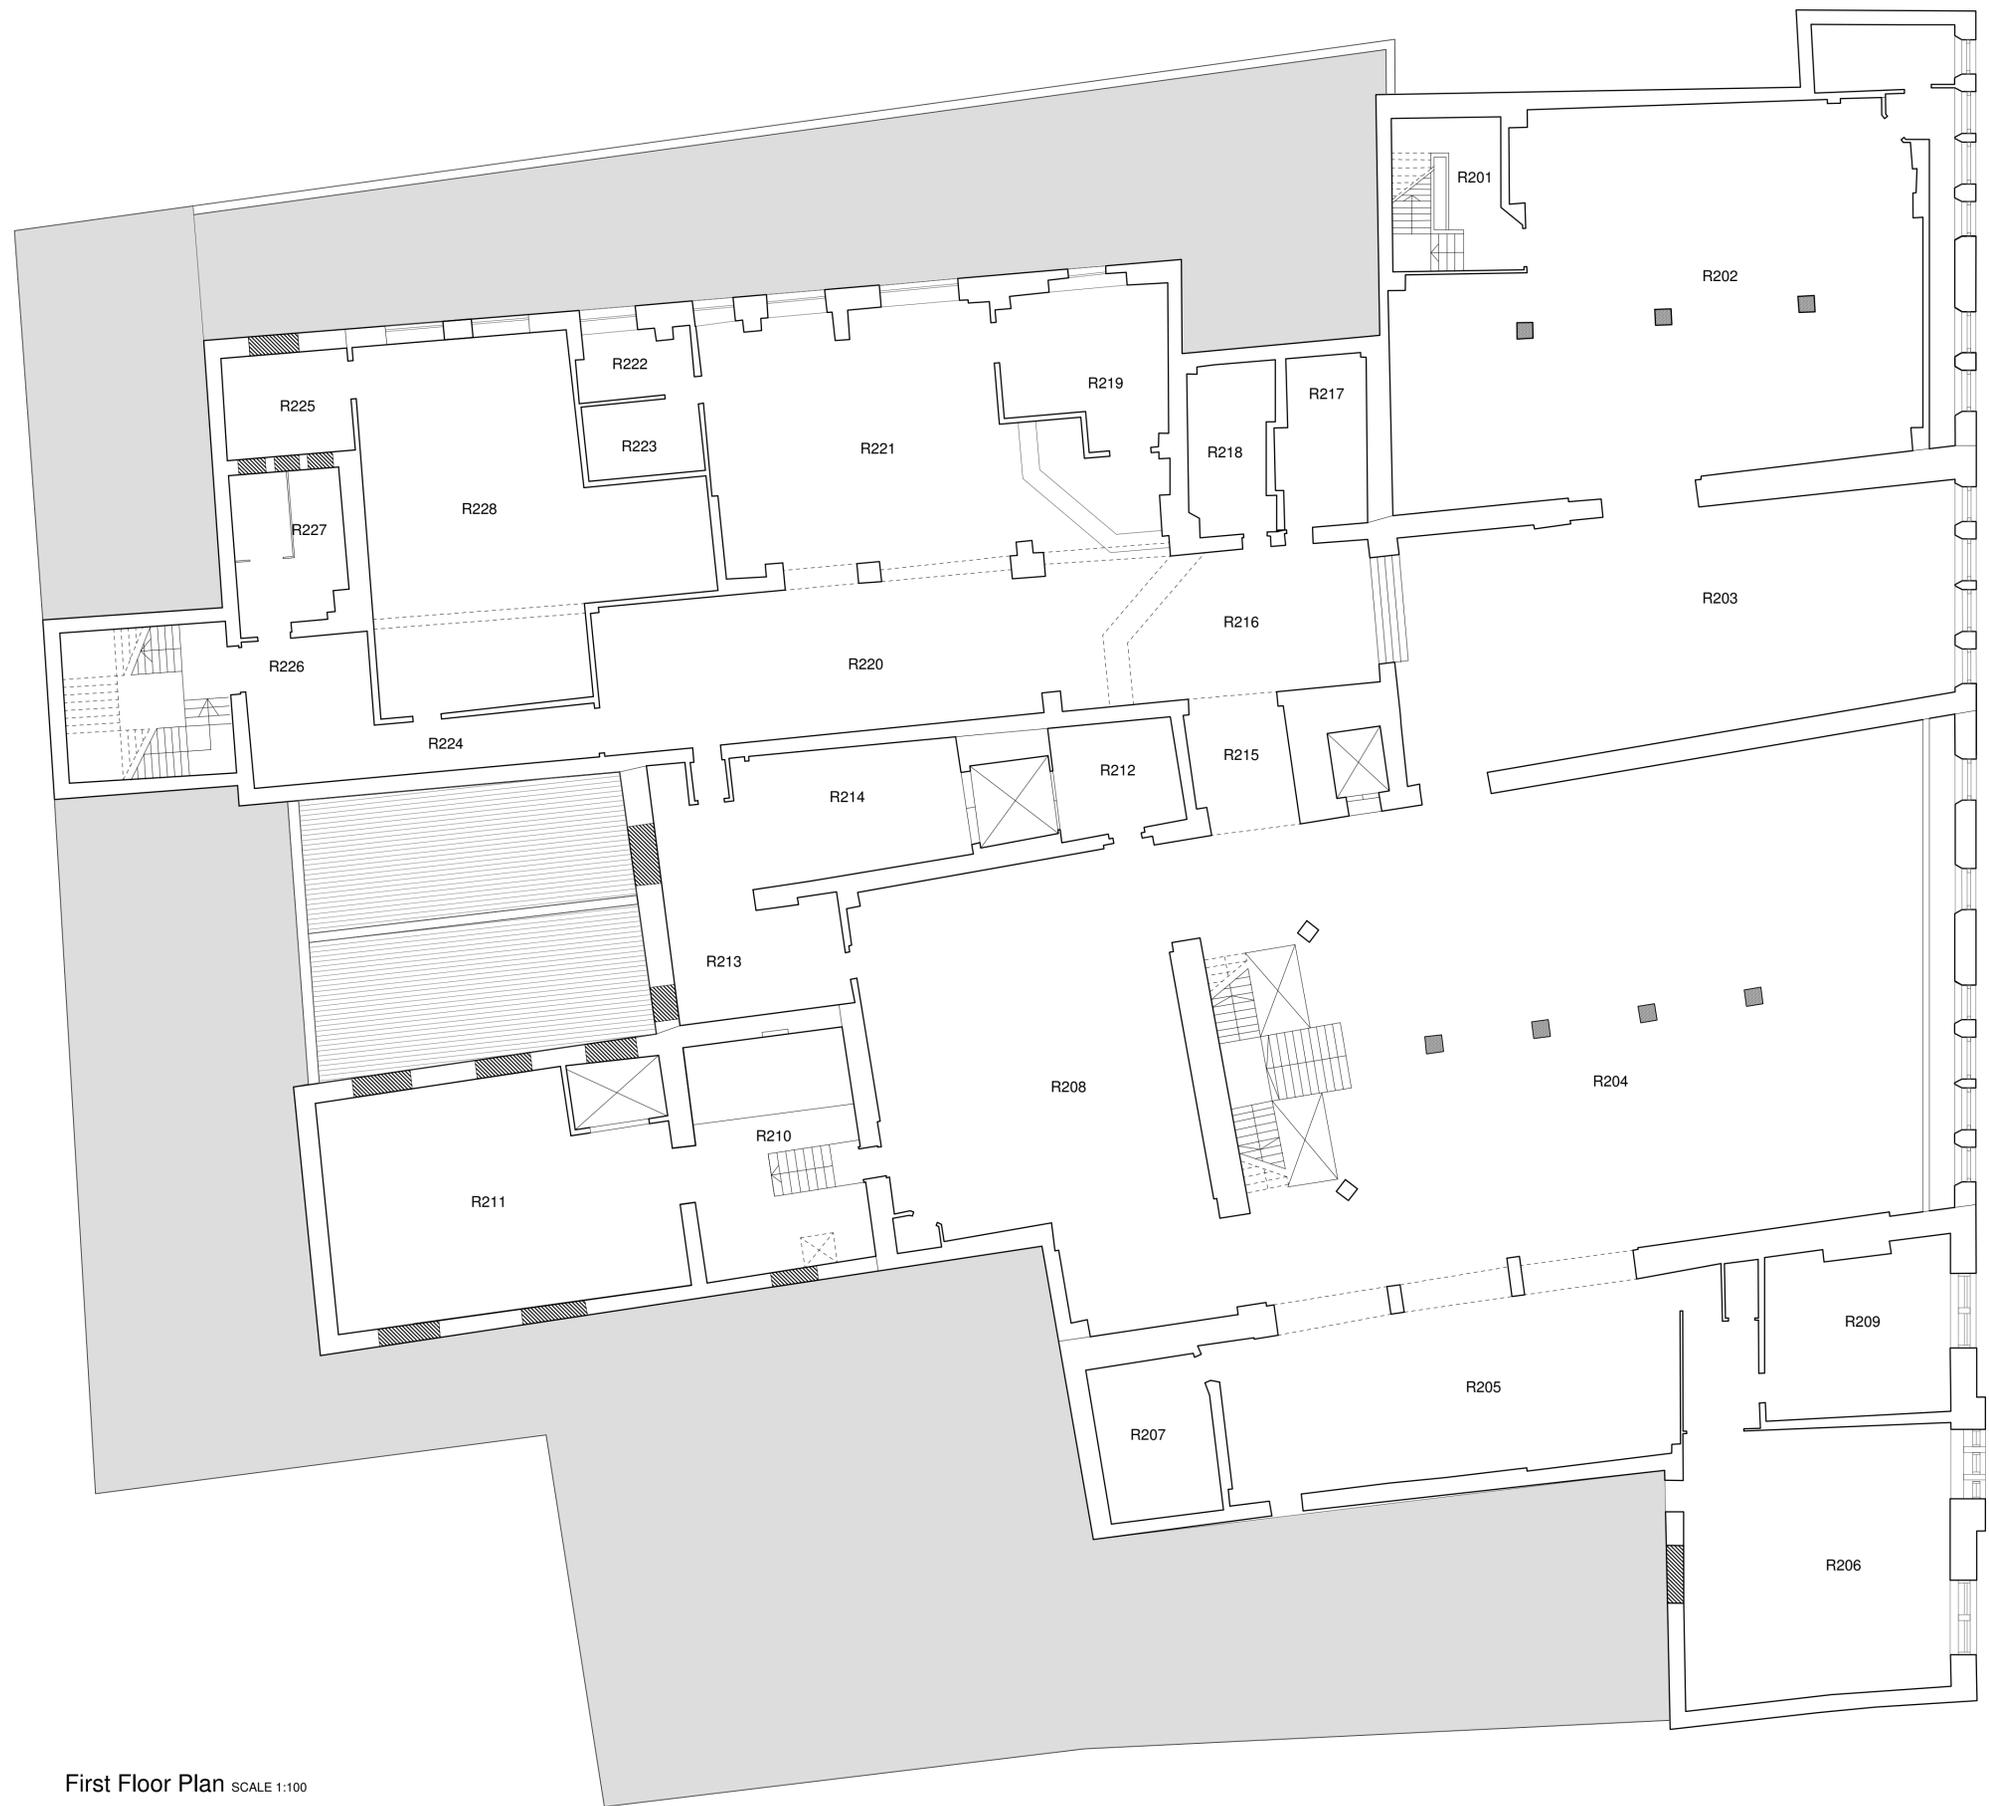
First Floor Plan SCALE 1:100

- Blocked up opening
- Plaster encased column
- Display panelling encased column
- Mirror encased column

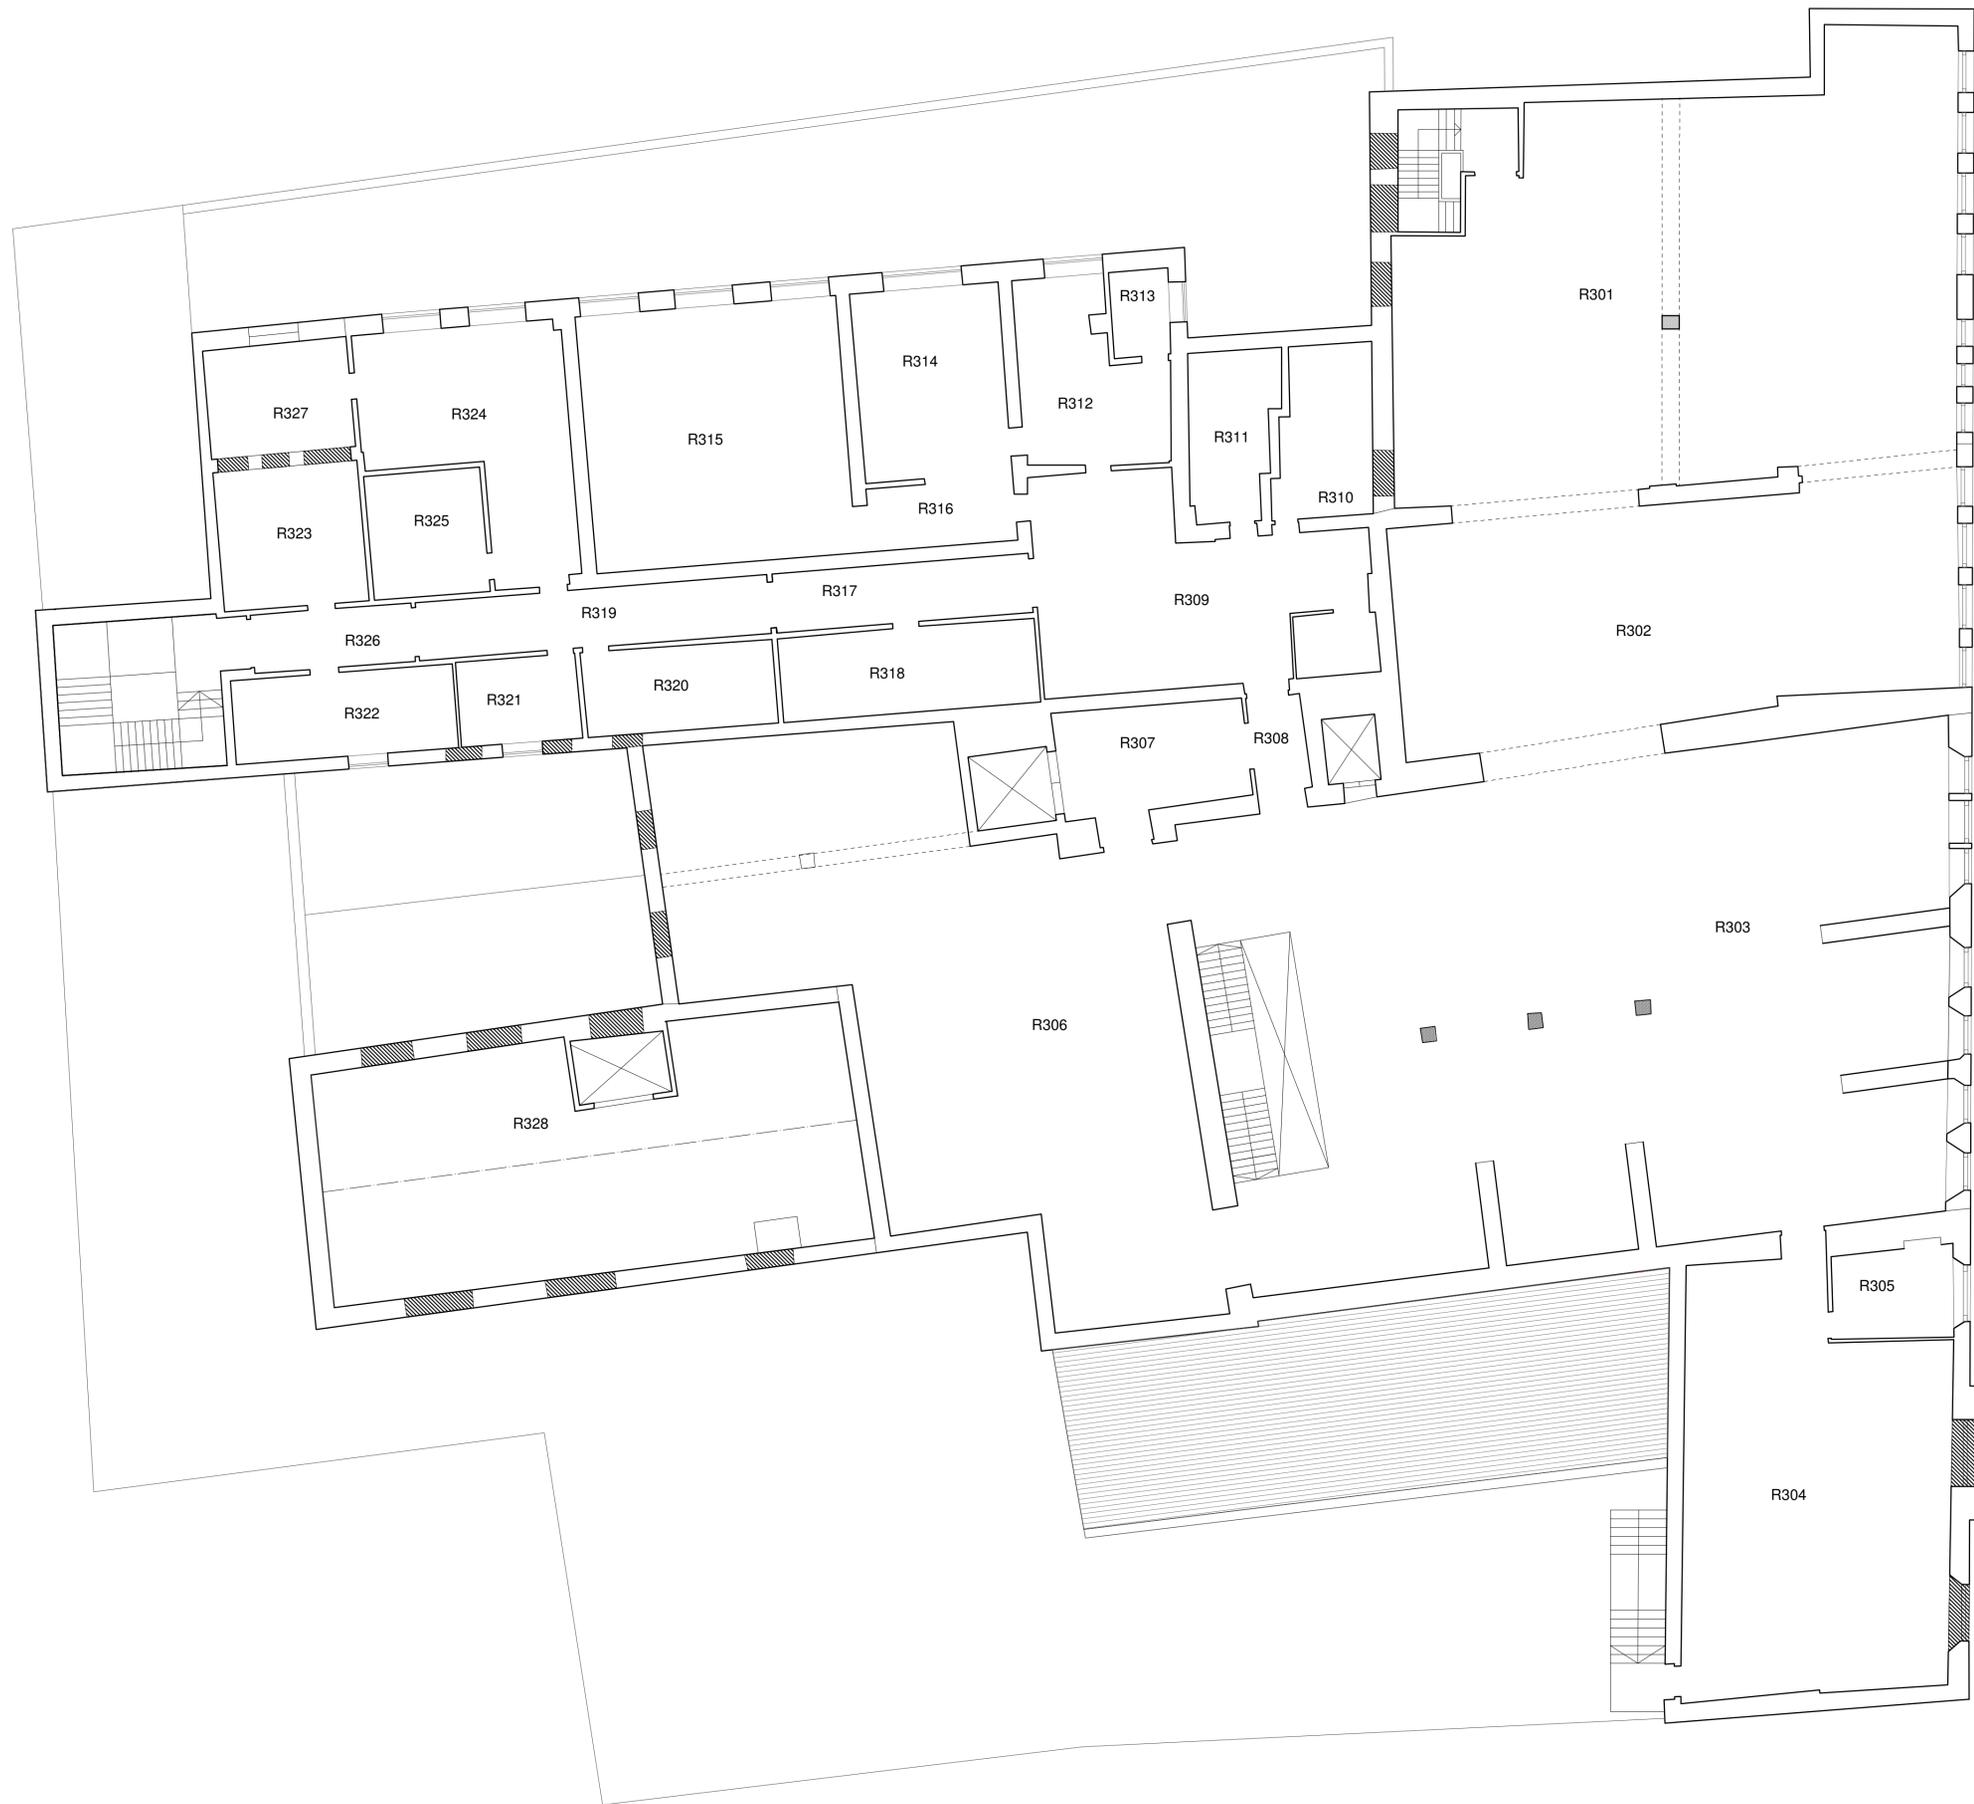
Second Floor Plan SCALE 1:100

NGR: NZ 21035 29765
 Surveyed By: ADC, AJT Feb 2019
 Drawn: AJT, March 2019
 Sheet: 3 of 5
