ST MARY'S MARSHES, HOO ST MARY, MEDWAY, KENT AN ASSESSMENT OF THE LATE 19TH-CENTURY EXPLOSIVES MAGAZINES

St Mary's Marshes, Hoo St Mary, Medway, Kent An Asssessment of the Late 19th Century Explosives Magazines

NGR: TQ 7991 7899

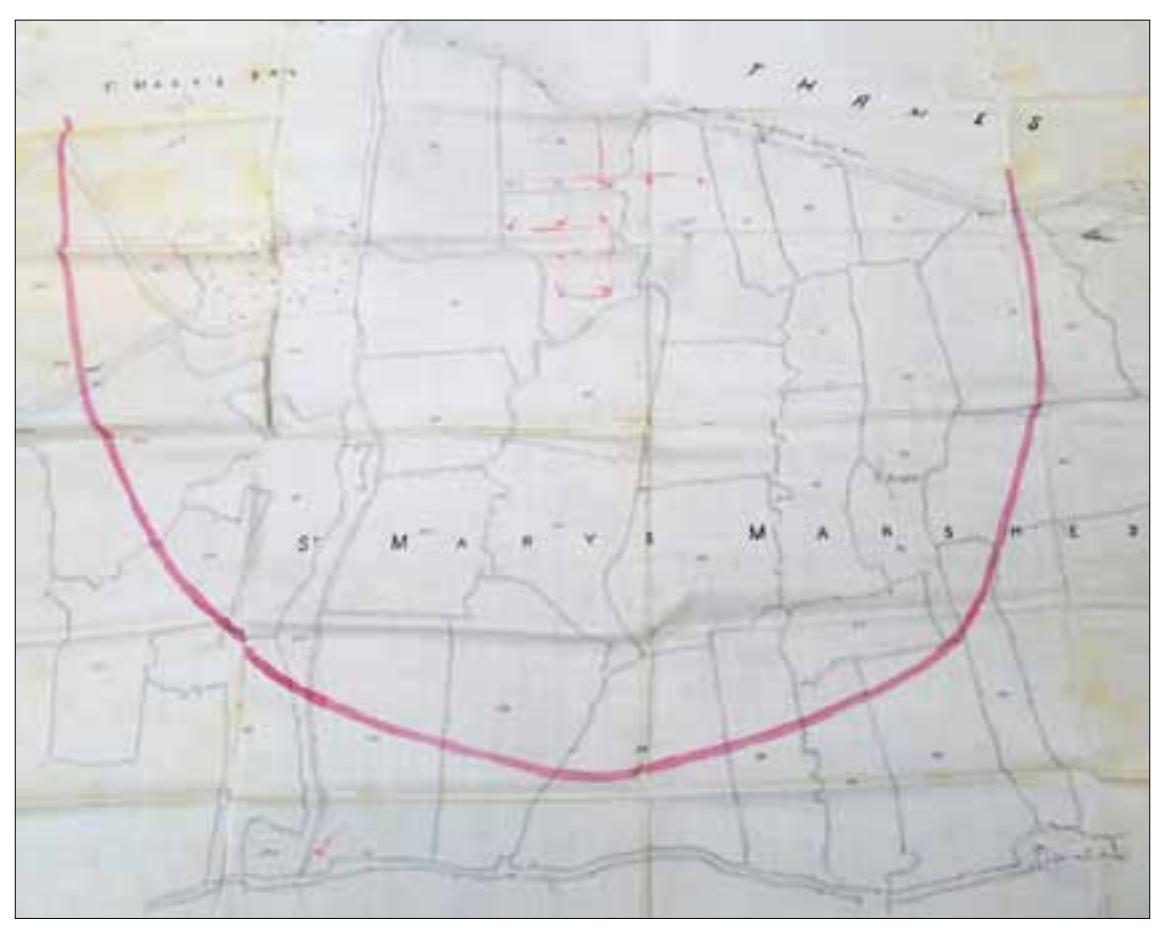
Figure 2: Plan showing the exclusion zone around the proposed site, where further building would not be permitted, and the location, to the south-west, of the proposed caretaker's cottage which was never built (MALSC DRc/Egz/151/2 – Permission of the Dean and Chapter of Rochester).

Correspondence held in the archives of the Dean and Chapter of Rochester Cathedral demonstrates that a series of explosives stores, tramways and a caretakers cottage were being planned for land at St Mary's Marshes by late 1891 (MALSC DRc/Egz/151/1). Only an acre of land was thought to be needed for the actual site of the magazines, though a large exclusion zone of 324 acres, where no houses should be built, would be necessary and it seems that there was some initial local opposition to the locating of the magazines on the marshes (Figure 2).

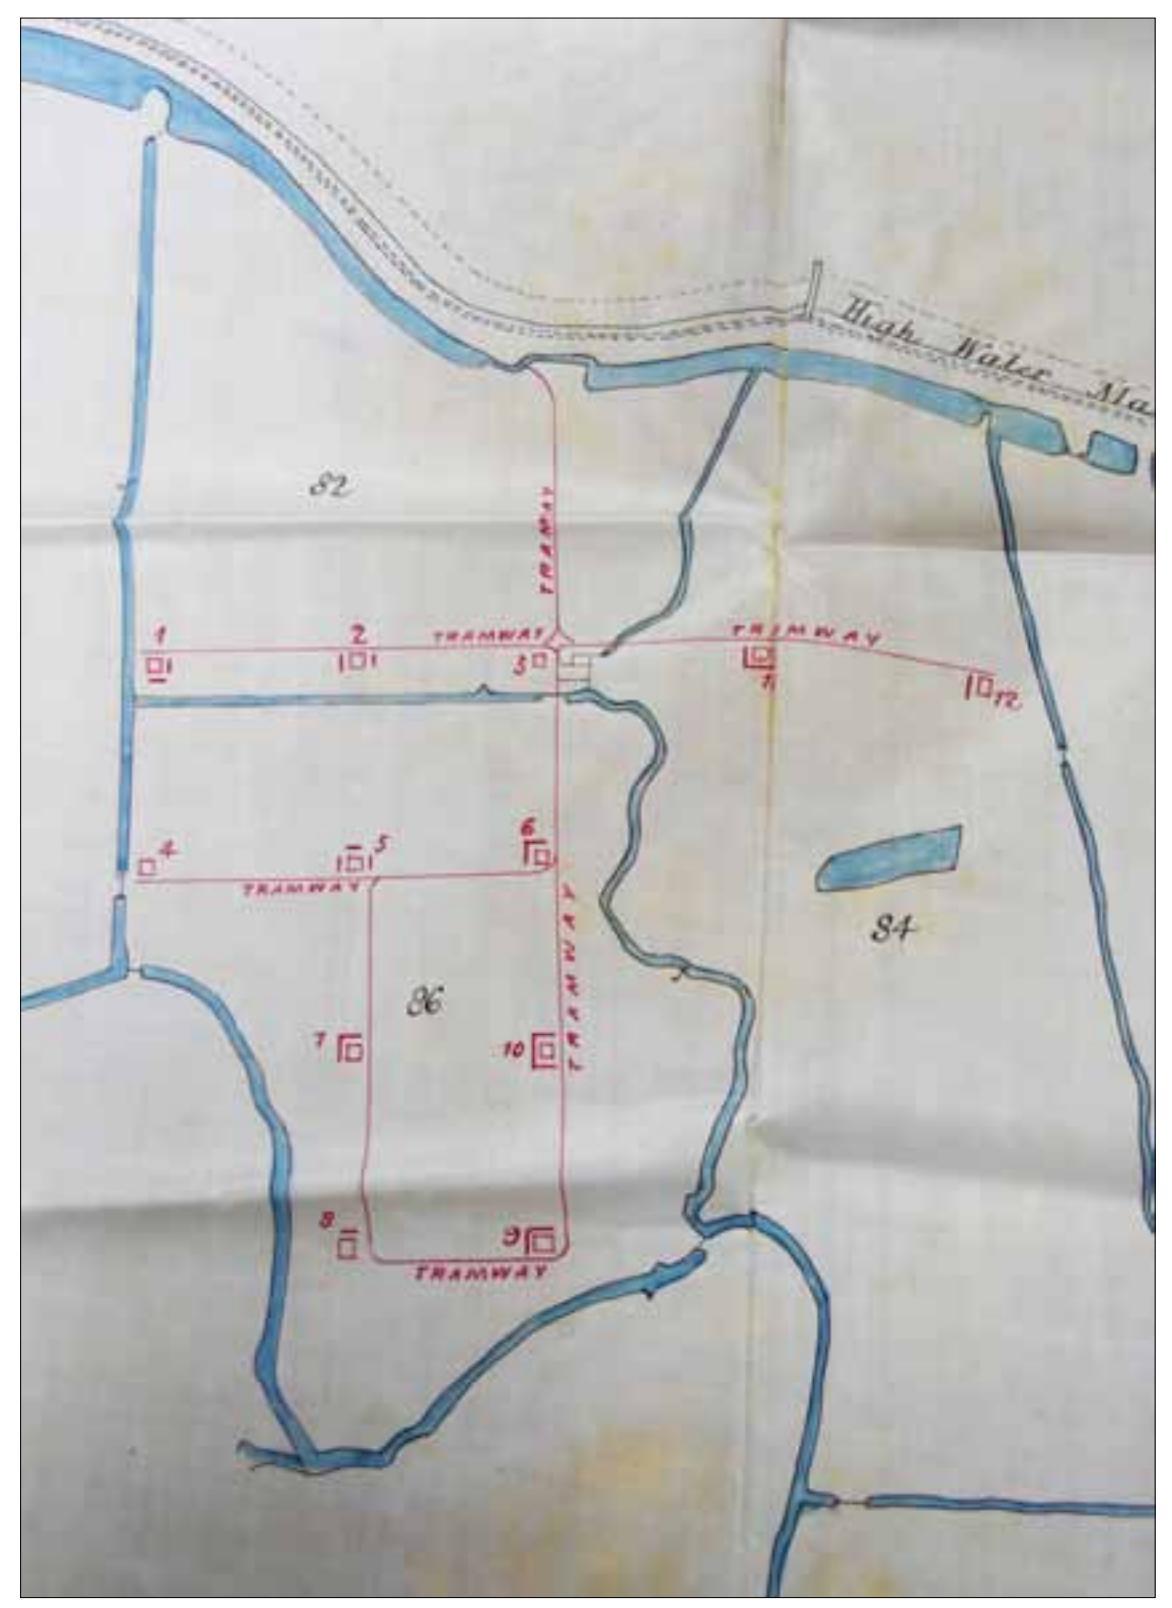
Figure 3: The planned layout of the site from the 1892 lease showing the proposed arrangement of 12 magazines with individual bund layouts and the suggested tramway network (MALSC DRcEgz 151/2 – Permission of the Dean and Chapter of Rochester).

The plans that accompany the lease (MALSC DRc/Egz/151/2) depict a layout which does not appear to have been fully realised (Figure 3). The proposed layout consisted of 12 magazines occupying three separate parcels of land in an irregular, though geometric, arrangement. The magazines are linked to each other and to the river by a tramway and all have varying arrangements of earthwork bunds depending on their particular position in relation to the other magazines. A second plan marks the extent of the exclusion zone around the site where no new building would be permitted, restricted land adding up to over 440 acres, more than originally anticipated (Figure 2). This plan also shows a proposed caretaker's cottage to the south-west of the site (TQ 7966 7792) that was never built.

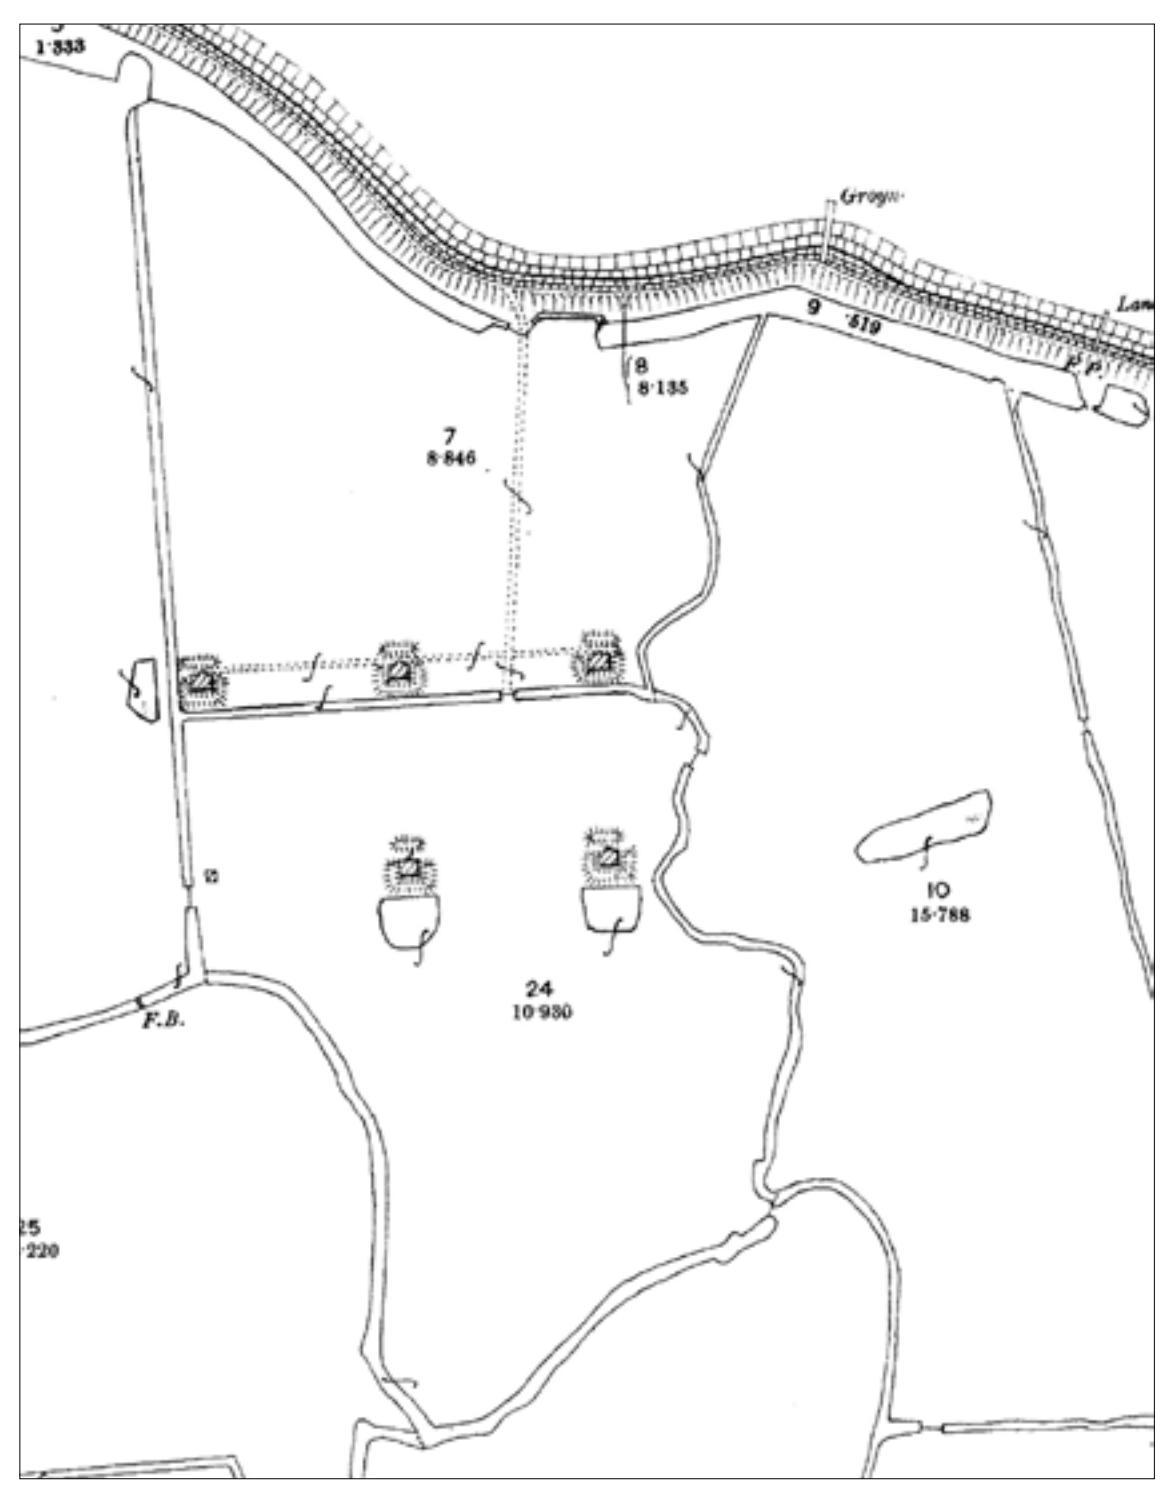
Figure 4: The Ordnance Survey 2nd edition 25 inch map (revised 1895 published 1897) showing the first phase of construction of the magazine complex. © and database right Crown Copyright and Landmark Information Group Ltd (All rights reserved 2013) Licence numbers 000394 and TP0024

The 2nd edition 25 inch Ordnance Survey map, revised in 1895 and published 1897, shows that five magazines had been built, three arranged along an existing east-west drainage ditch and two to the south (Figure 4). All five are surrounded by earthwork bunds and the three to the north are linked via an east-west track (possibly a tramway) which leads to a north-south track that heads directly to the river. The two magazines to the south and the mostly westerly of the three northern magazines have large ponds adjacent, presumed to be borrow pits for the earthwork bunds. A small building, approximately 12 feet square and located beyond the western end of the two magazines to the south, may represent the packing shed mentioned above.

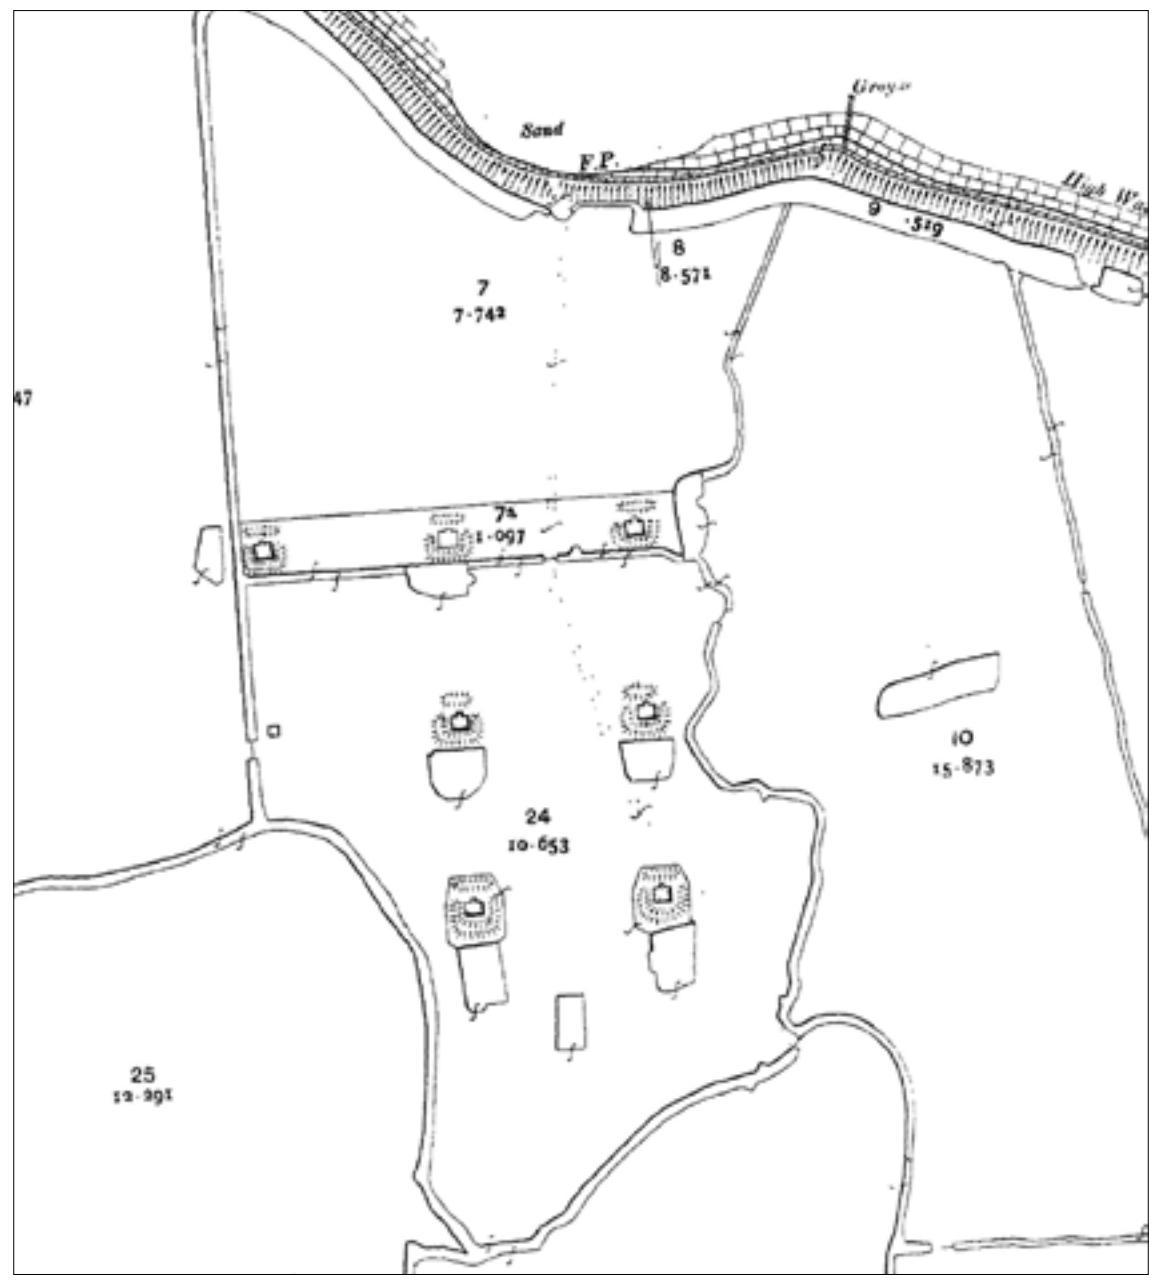
Figure 5: The Ordnance Survey 3rd edition map (revised 1906, published 1908) which shows the additional two magazines that were constructed to the south of the first five buildings. © and database right Crown Copyright and Landmark Information Group Ltd (All rights reserved 2013) Licence numbers 000394 and TP0024

The two additional magazines are depicted to the south of the initial group on the 3rd edition 25 inch Ordnance Survey map (revised 1906 and published 1908; Figure 5). These extra magazines are also depicted with earthwork bunds and associated borrow pits. In addition, these two magazines are depicted within their own fenced enclosure and, by 1906, a fence has also appeared around the three northern magazines. Two further borrow pits have also appeared, one adjacent to the middle of the three northern magazines and a square one at the southern end of the site. The track can be seen continuing across the southern half of the field and heading for a causeway across the drainage ditch in the south-eastern corner of the field. The small square structure (which may represent the packing shed) is also still shown on the western side of the site, close to the drainage ditch. An additional pond or possible borrow pit is also visible to the south of the southern row of magazines. This pond and an associated earthwork have been identified from aerial photographs as the possible site of a never-completed eighth magazine (Ed Carpenter, EHA (NMR) TQ77NEI81).

Evidence from the historic Ordnance Survey maps may suggest that it was the central magazine of the northernmost row which was destroyed by the fire. The Ordnance Survey 3rd edition map (revised 1906, published 1908) depicts this magazine with a much thinner line than the others (Figure 5) and on the Inland Revenue map of 1910 (which used the same 1906/1908 Ordnance Survey base map) the same magazine is not hatched suggesting that, unlike the others, it is no longer roofed (TNA IR124/6/9).

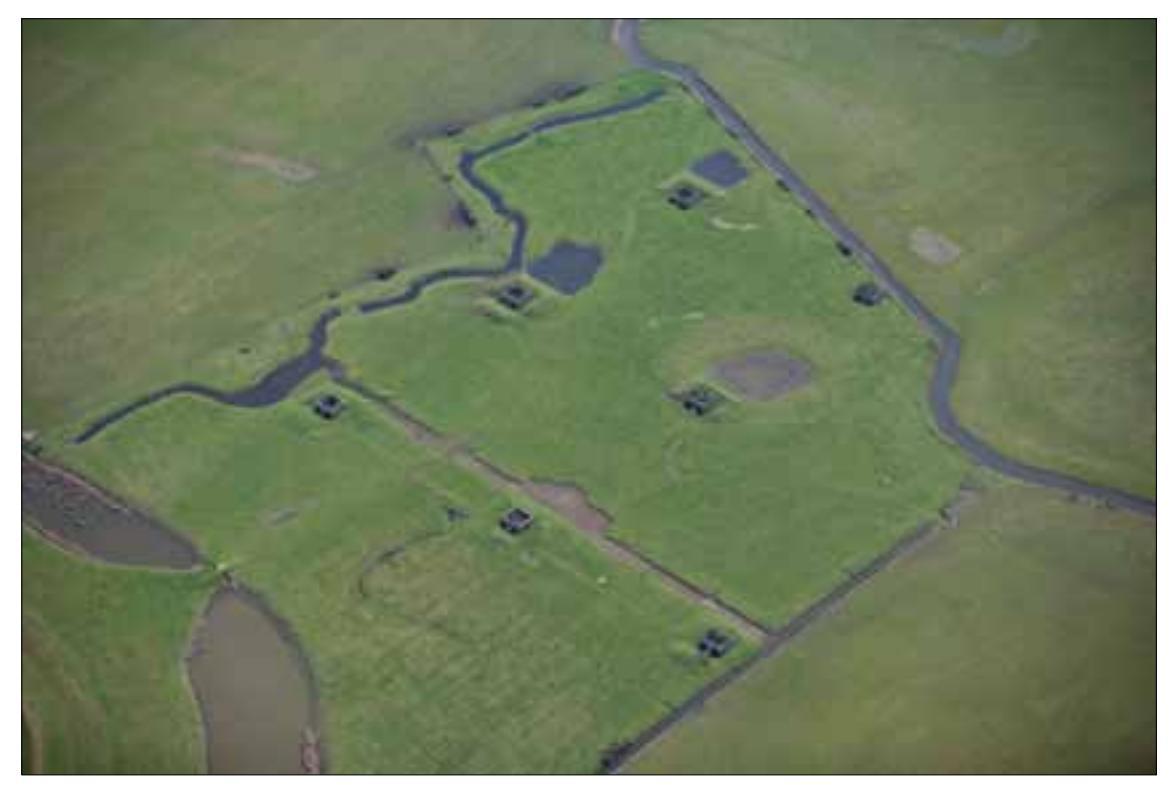
Figure 6: The magazine complex as seen from the north-west. NMR 26598/0190 6-APR-2010 English Heritage

The site consists of seven almost identical concrete buildings (see Figures 6 and 7). The magazines are arranged in a grid pattern with a distance of approximately 70m between each magazine. The magazines are all approximately 7.1m by 6.2m in plan and 4m in height to the apex of the gable (see Figures 21, 22 and 23). There are no discernable differences in size between the two phases of construction suggested in the previous section. Each building is formed of coarse mass concrete around 0.45 m in thickness which was covered externally with a concrete render 1cm thick and incised with an 'ashlar block' design (Figure 8). The two most southerly magazines and the eastern magazine of the central row all show a pink staining of the concrete render on the eastern elevation, perhaps caused by differential weathering.

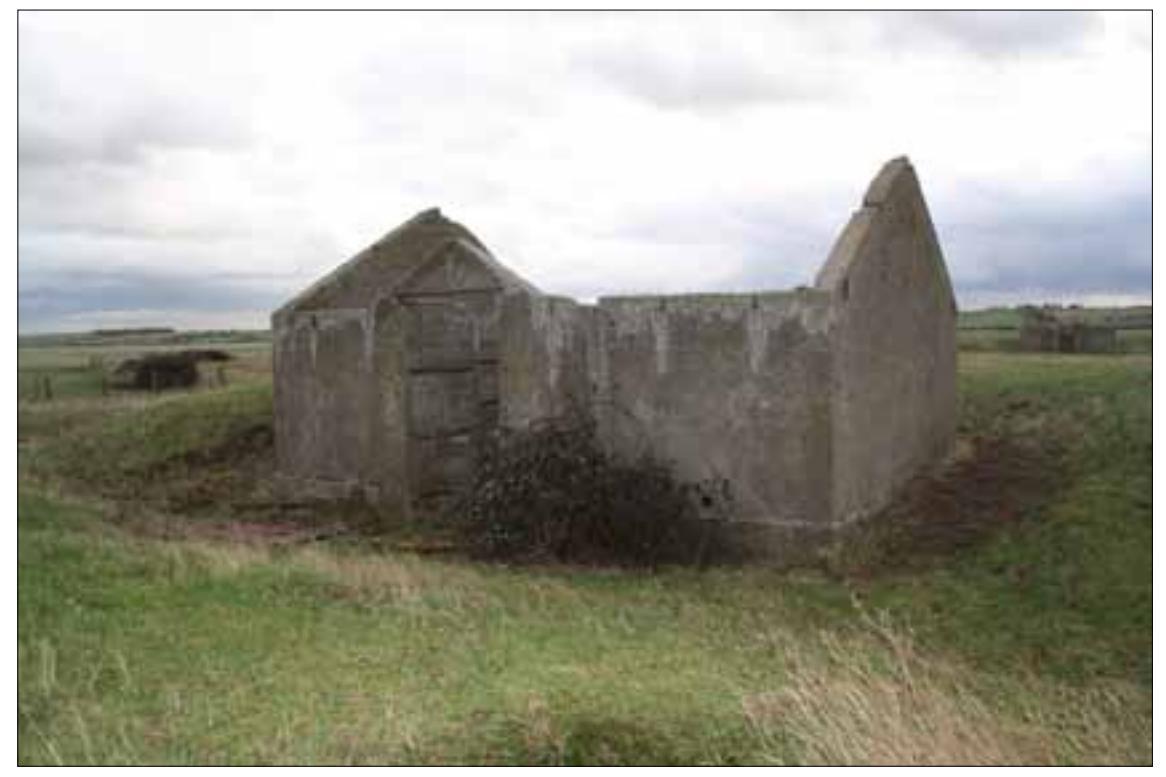
Figure 7: An example of a typical magazine building (eastern magazine in central row).

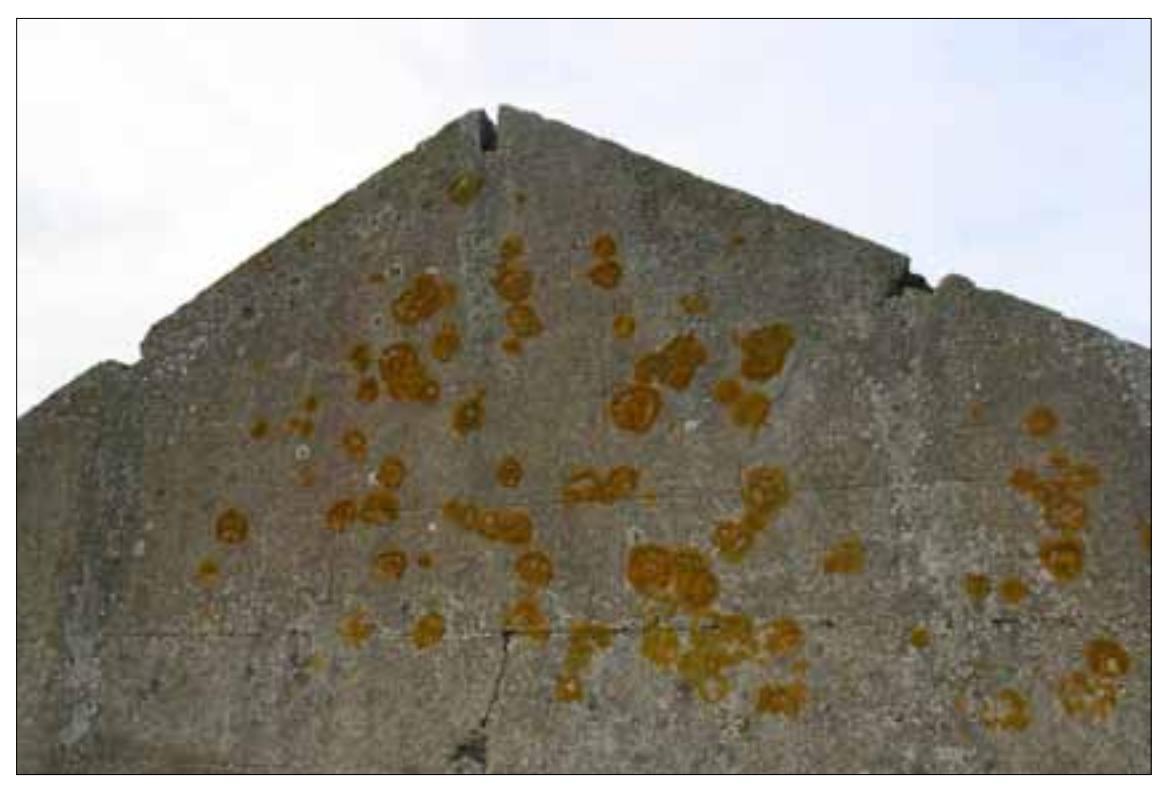
Figure 8: Gable end of a magazine showing the 'ashlar pattern' incised into the concrete render and the three slots which carried the roof purlins.

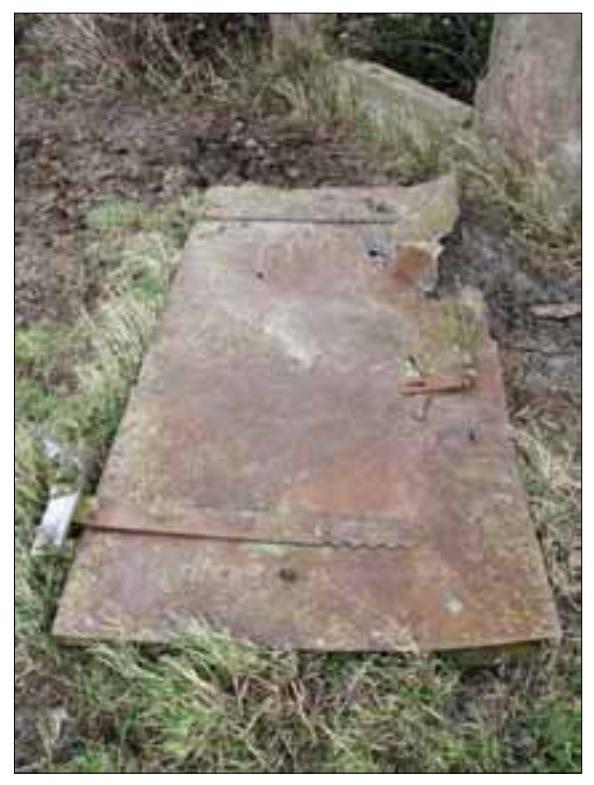
Figure 9A: Surviving metal-clad wooden magazine door.

Each of the buildings has a centrally placed entrance porch in its northern elevation which originally had a wooden door covered with metal sheet and held by pintel hinges on to a wooden frame (Figure 9A), the slot for which is clearly visible. When open the magazine doors may have been secured with a hook located on the eastern porch elevation at a low level, which was possibly linked by a cord or chain to the small iron loop visible on the outer metal panel of the door that survives (Figure 9B). Each porch had a pitched roof with a concrete gable. A slot which carried the porches' wooden roof ridge is visible at the apex of the porch gable. No evidence of an inner door, described in the Explosives Inspector's report as having been visible on the brick magazine (Desborough 1905, 3), was noted.

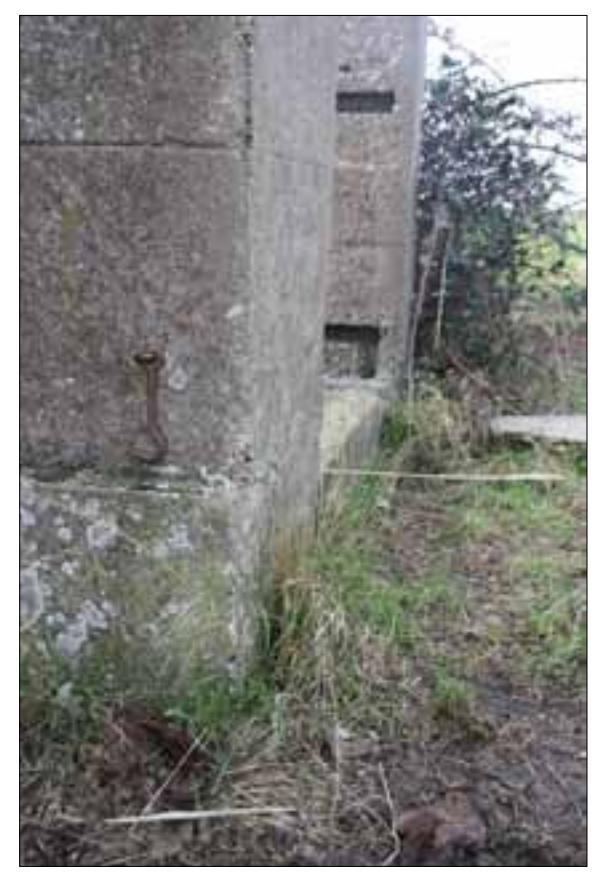
Figure 9B: Hook on east elevation of porch for securing door when open.

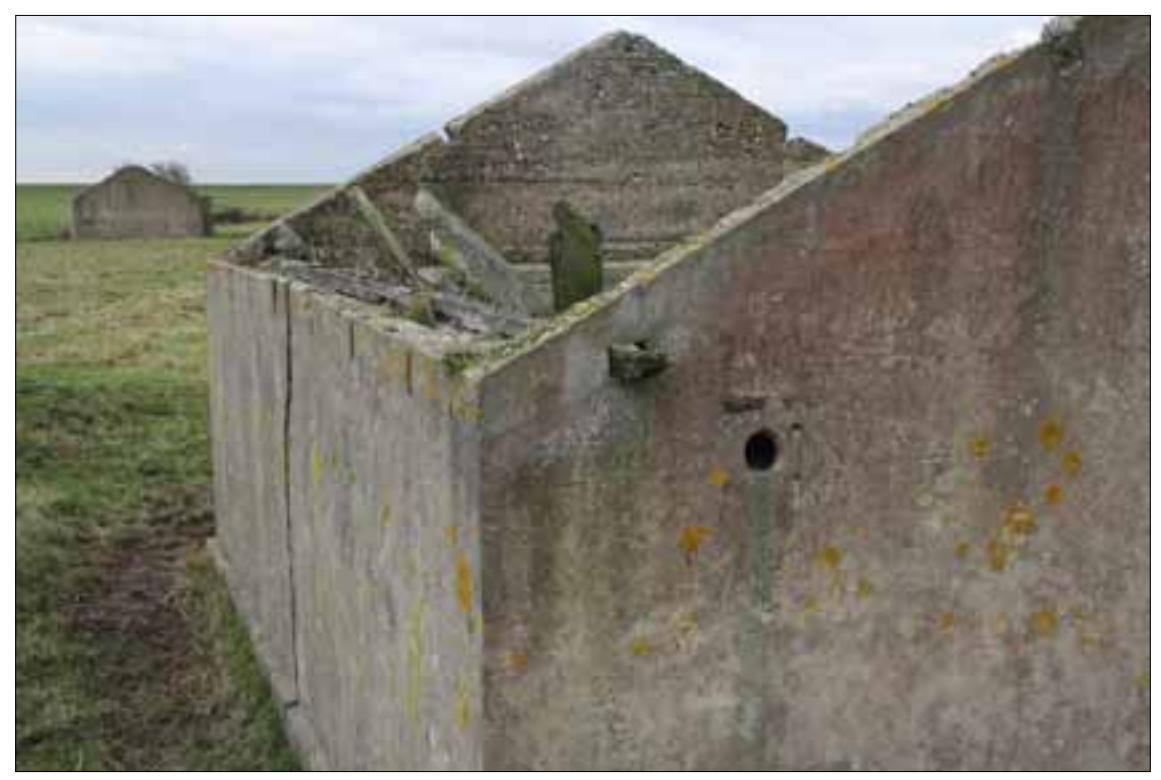
Figure 10: Surviving roof timbers in the magazine to the extreme south-east of the site indicate the position of the pole plate which protruded through both gables and carried the rafters. Evidence for some form of cover over the ventilation pipe in the east elevation is also visible.

Gable ends to the main east and west elevations indicate that the buildings had pitched roofs with wooden frames. Square holes on either side of both gables indicate the position of two wooden pole plates, to support the rafters, which ran the length of the north and south elevations just above eaves height and protruded beyond the gable end (Figure 10). Three slots on each gable, one at the apex and two mid-pitch, indicate the position of the ridge plate and purlins which carried the roof. Similar slots are visible at eaves level in the north and south elevations where the wooden roof rafters protruded to form the eaves. Remains of the collapsed timber roof within a number of the structures show that the roof rafters had an element of detailing on the end that would have been visible. Small holes which run internally across the base of the gables may indicate the position of a ceiling (Figure 11). Evidence for a slate roof covering survives on the ground in and around the magazines, though drips of bitumen on the exterior of the magazine to the extreme south-east of the site suggest that patch repairs may have been made to its roof at some point.

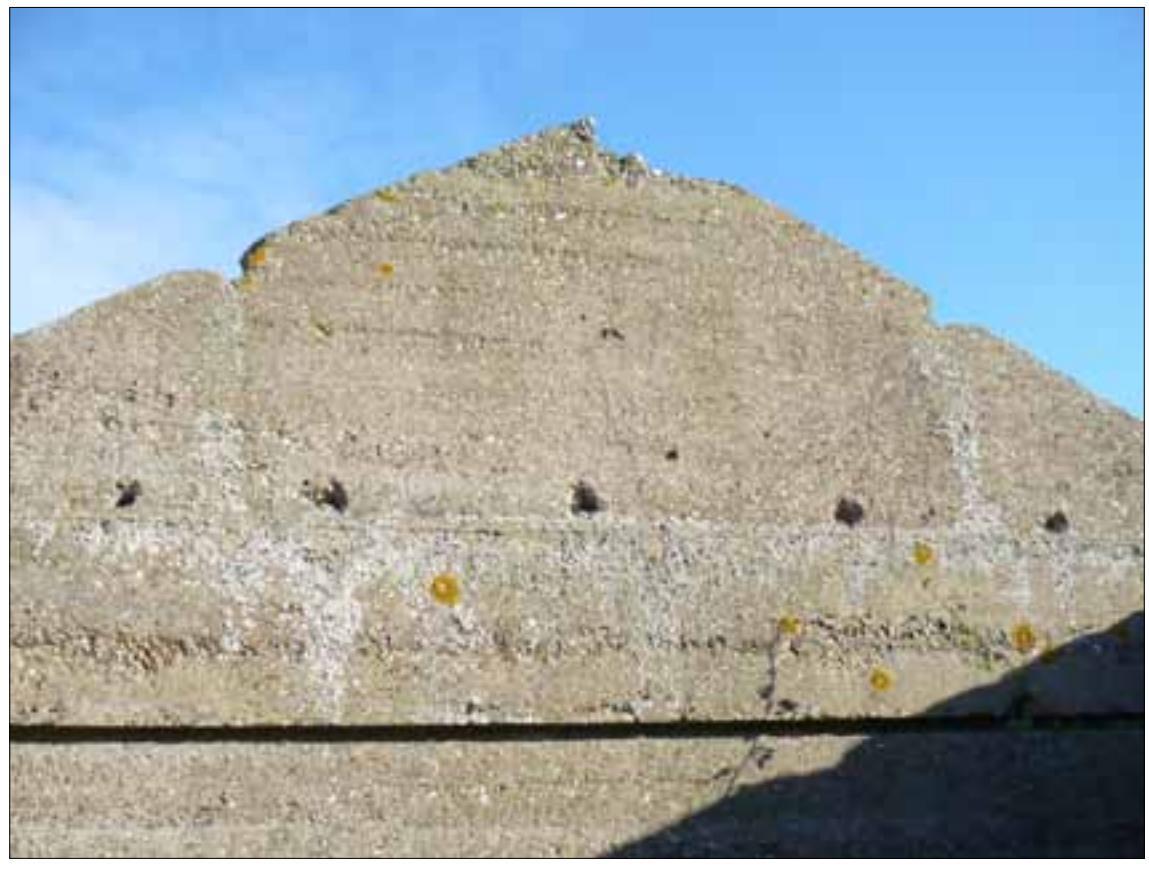
Figure 11: Small holes on the interior surface at the base of the gables that may indicate the position of a ceiling.

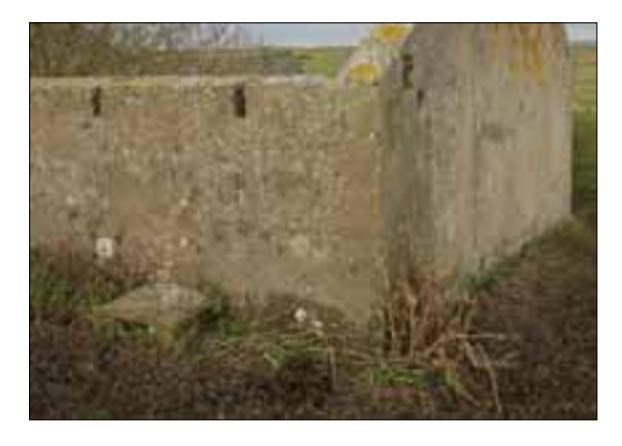
Figure 12A: An example of the concrete ventilation shafts visible buried in the bunds on the south elevation of the most northerly row of magazines.

There are some notable variations in the form of the bunds between the different rows of magazines. On the most northerly row of magazines the protective bunds are thrown up against the rear (southern) magazine elevation, to a height of around 1.2m in the case of the magazine to the extreme north-west of the site. The height of the bund allows the concrete cap of the vent on the rear of the magazine to remain visible (Figure 12A), suggesting that the vent has determined the height of the bund (NB this concrete cap is missing on the adjacent magazine to the east).

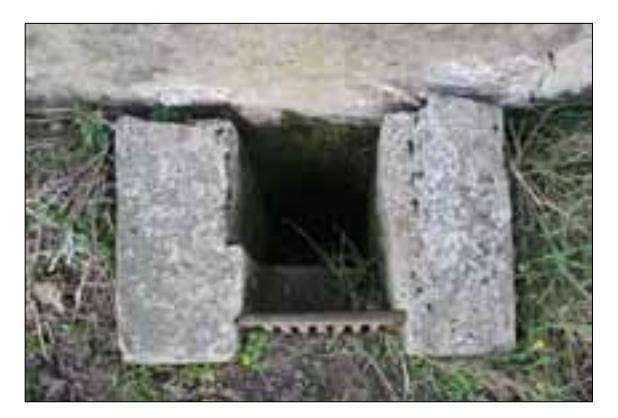
Figure 12B: A concrete ventilation shaft with the cap removed.

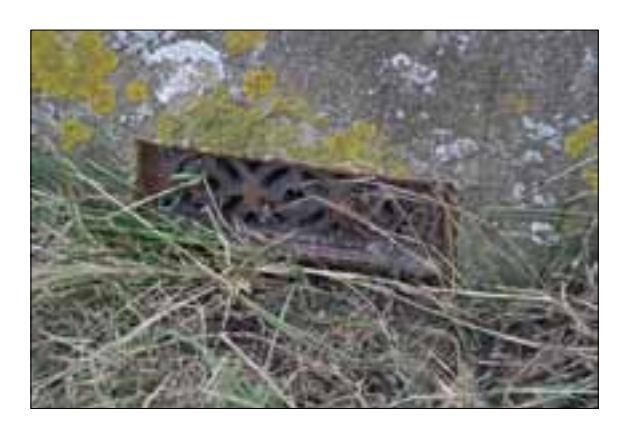
Figure 13: An example of the air bricks visible in the northern elevations of the magazines to the west and east of the porch.

Good ventilation was vital in the storage of explosives. Pairs of air bricks (or holes where they were located) are visible at ground level to the east and west of the door on the northern elevation of the magazines. At least two types of air brick were used: red unglazed bricks and brown glazed bricks (Figure 13). Curving ceramic pipes are visible on each building, at eaves level in the eastern gable at its southern end and in the western half of the southern elevation at a low level (Figure 14). The lower portion of each pipe is blackened internally. The pipes are probably related to the magazines' ventilation systems. Witness marks appear to indicate that the pipes in the eastern elevation had some sort of square external fitting, possibly a grill (Figure 10). Evidence for a different form of ventilation is also visible on the most northerly row of magazines. These magazines all have evidence for two (only one is visible on the most westerly magazine) rectangular-section concrete pipes buried vertically into the protective bund against the eastern and western ends of the southern elevation (Figures 12A and 12B). These vents originally had a concrete cap and metal grill in their southern face. This type of vent is not visible on the magazines further to the south and may relate to variations in the configuration of the bunds (see below). These vents could relate to the ventilation of the wooden floor.

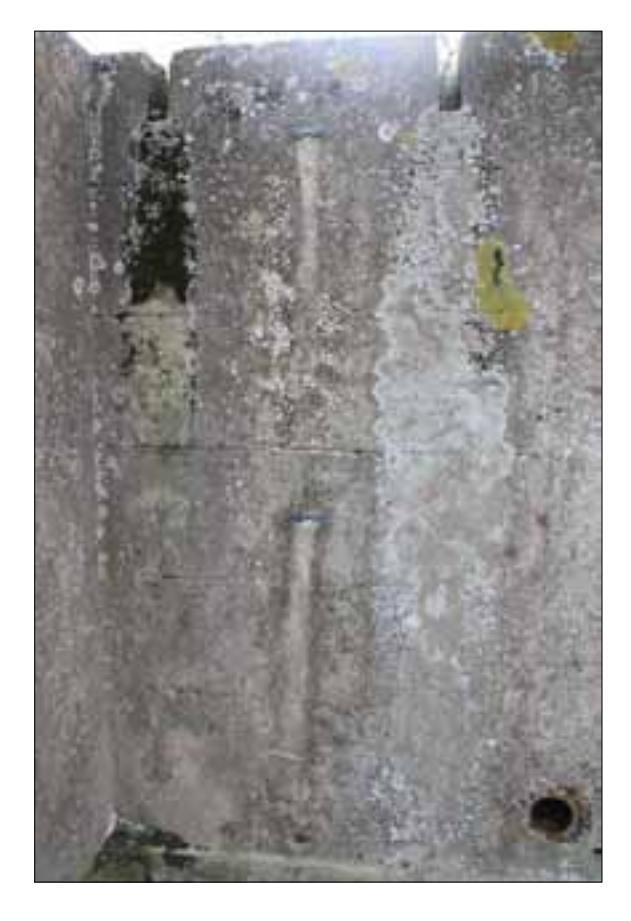
Figure 14: An example of the copper alloy fixings for the lightning conductors which were attached to each magazine. The ceramic vent pipe to the east of the entrance porch can also be seen.

Apart from the various types of ventilation there is little other external detail on the magazines. Evidence for lightning conductors in the form of a column of three copper alloy fittings is visible to the west of each magazine entrance porch (Figure 14) and other witness marks of unclear function are visible to the east.

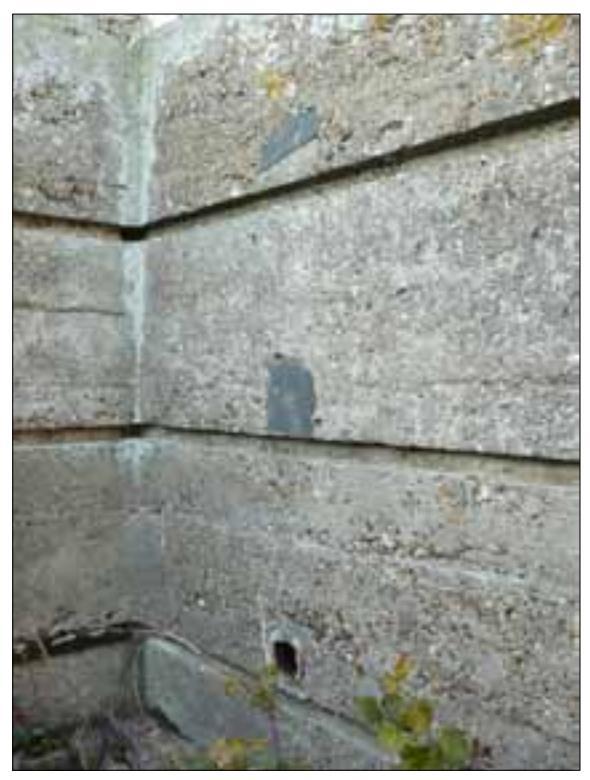
Figure 15: The internal slots which carried batons on to which wooden anti-spark 'matchlining' would have been fixed. Pieces of slate can be seen embedded in the interior face of the southern wall above a ceramic pipe. This may be related to the external concrete ventilation shaft seen on the southern elevation of some of the magazines.

Internally, three slots 5.5 cm wide run horizontally around the entire internal wall surface of the magazines (Figure 15), one 0.27m above floor level and two equally spaced 0.65m (2 feet) apart above that. The slots carried the batons for some sort of 'anti-spark' wooden cladding (match-lining). Some of the batons can be seen surviving *in situ*. A dwarf concrete wall running east-west across the centre of the buildings carried a floor, probably supported on the slightly protruding plinth at the base of the building (Figure 16A). Similar supporting concrete walls can be seen within the porch area of the building (Figure 16B). Slots in the plinth in each of the internal corners may have carried floor joists, as seen surviving in the magazine to the far south-east of the site. There are occasional pieces of slate attached to the walls which appear to be vertically aligned with a pipe in the southern wall of the magazines (Figure 15).

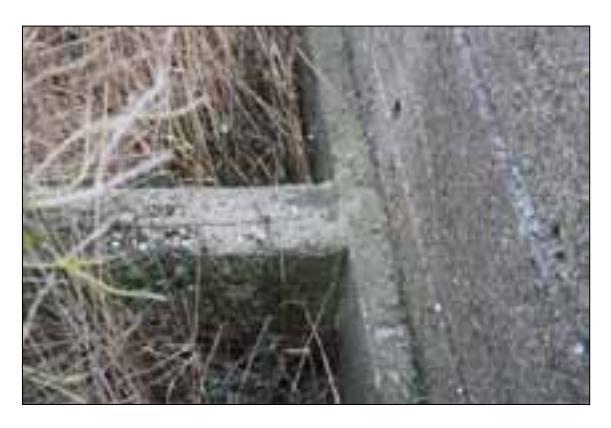
Figure 16A: East-west concrete dwarf wall which supported a floor.

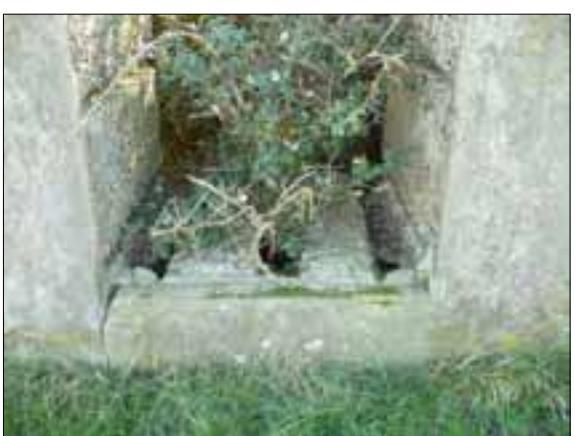
Figure16B: Concrete floor supports within the entrance porch.

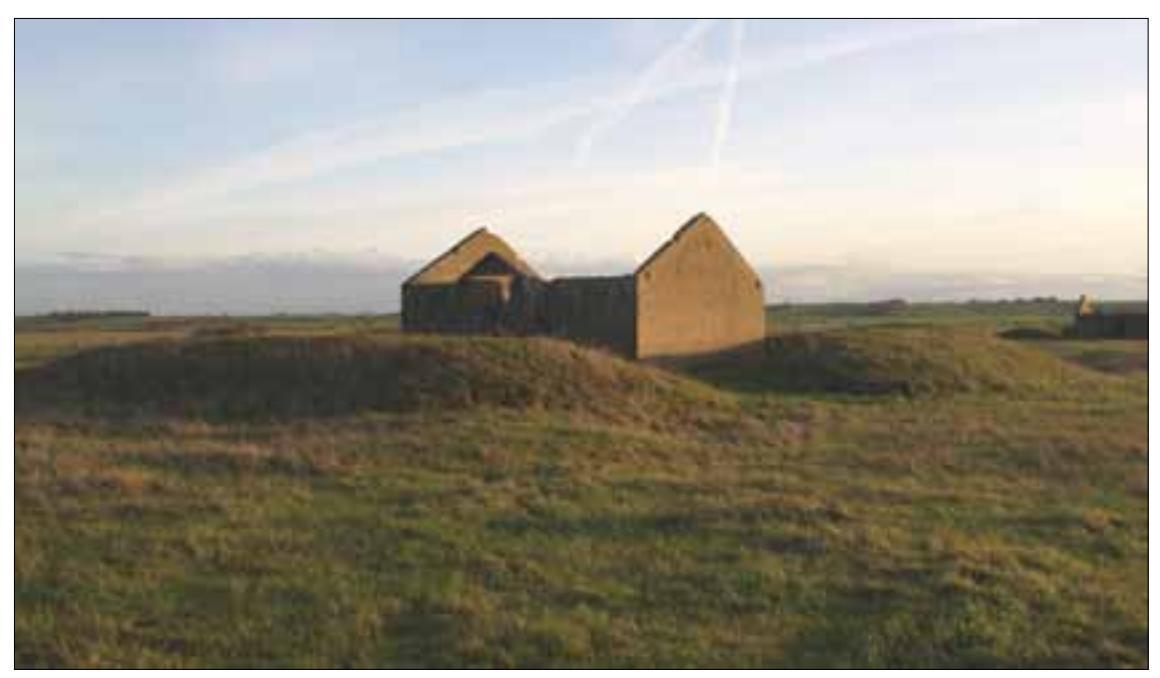
Figure 17: A surviving example of the earthwork bund which originally protected all the magazines (eastern of central two magazines).

On the 3rd edition 1908 Ordnance Survey map (Figure 5) all of the seven magazines are shown with a protective U-shaped earthwork bund around their western, eastern and southern sides with a separate linear bund to the north allowing access to the magazine entrance from the east and west. These earthworks were intended to minimise the impact of accidental explosions. Today the earthworks of the three most northerly magazines survive; to the south the westernmost of the next two magazines has lost its northern bund and possibly had the northern ends of its southern bund truncated; and to the south again, the bund of the westernmost magazine has been levelled on all sides and the northern bund of the eastern magazine has been removed whilst the southern bund has been truncated at its northern ends on both sides (Figure 17). The bund arrangements do not reflect the complex layouts proposed on the 1892 plan that accompanied the lease (MALSC DRcEgz 151/2; Figure 3).

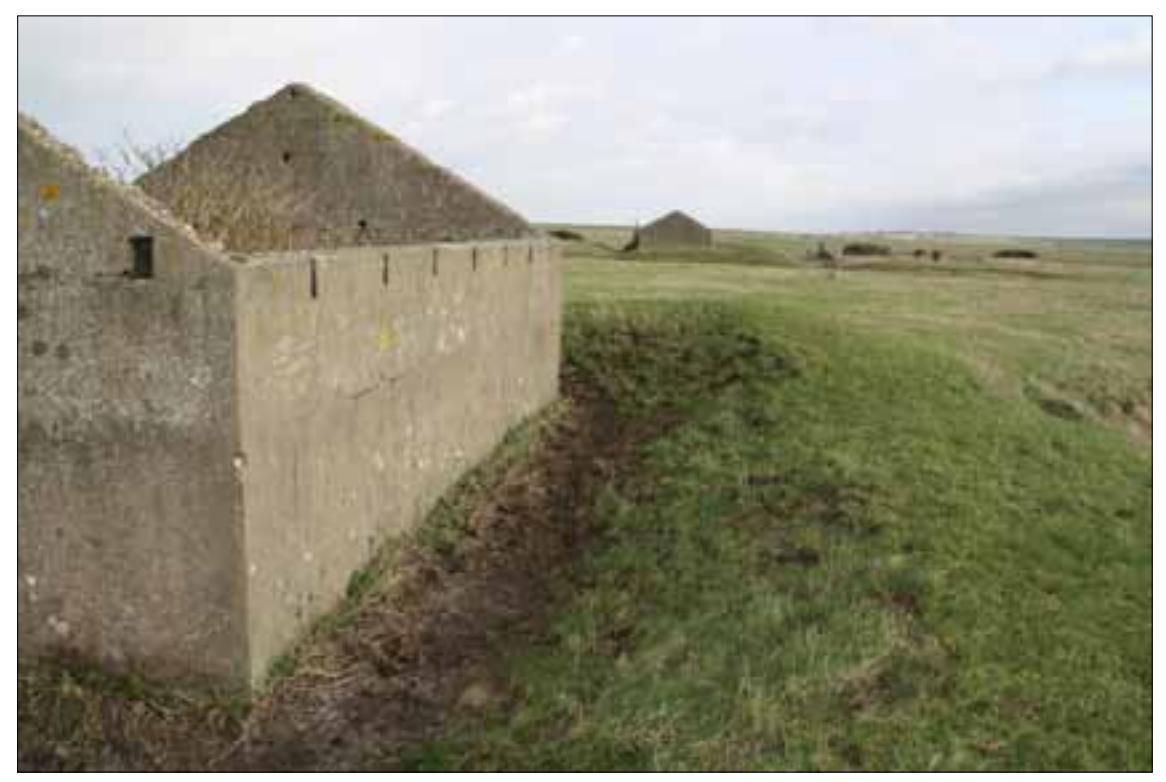
Figure 18: The western magazine of the central row has a clear gap between its southern elevation and the protective bund, in contrast to the row of magazines to the north.

bunds. As no vents are visible on the rear (southern) elevation of these magazines (or on the westernmost of the two southern magazines where the bund has been levelled) the gap may have been intended to allow for a less elaborate form of ventilation (Figure 18).

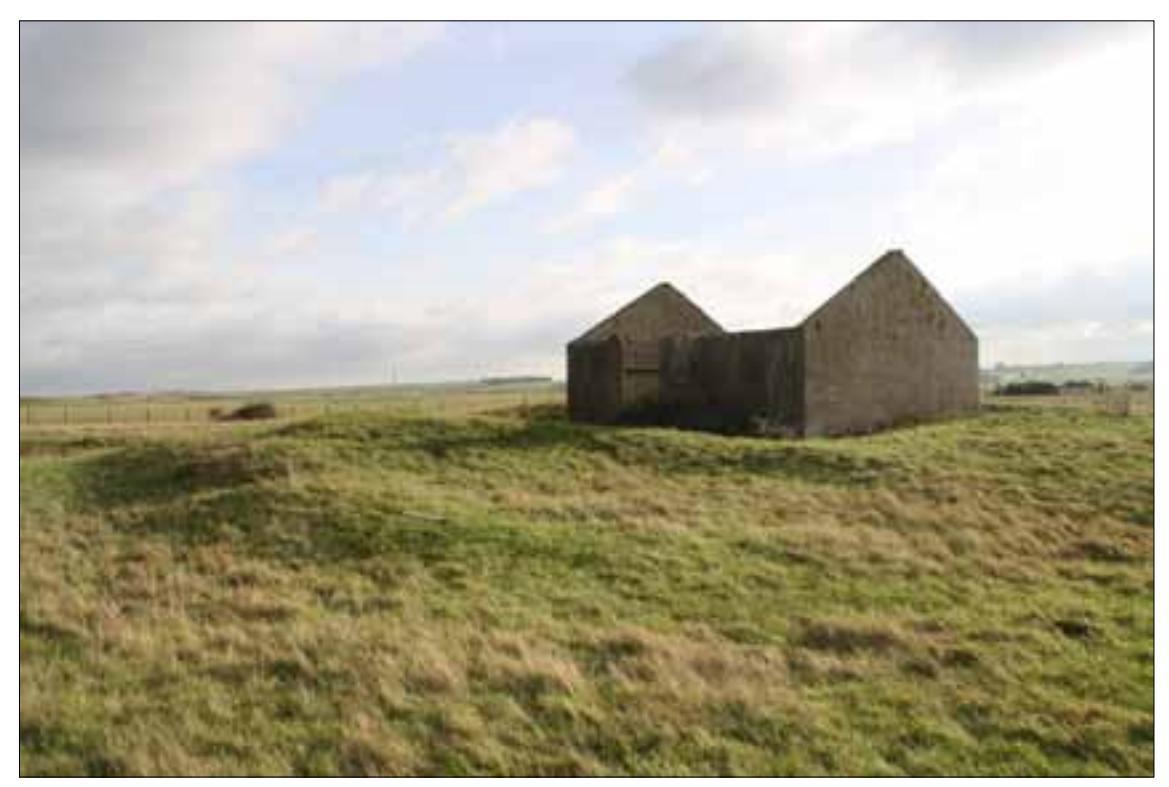
Figure 19: Location of possible building which post-dates the closure of the magazine complex, immediately to the north of the most easterly of the three northern magazines.

Evidence of another small structure survives to the north of the most easterly magazine of the northern row. At the western end of the northern earthwork bund which protects the door is a neat square scoop, 4m north-south by 3.6m east-west (Figure 19). Any structure which was located in this position must post-date the use of the magazine for explosives storage as a building would not have been permitted in such close proximity. Another possible platform was noted to the north of the eastern of the two magazines in the central row.

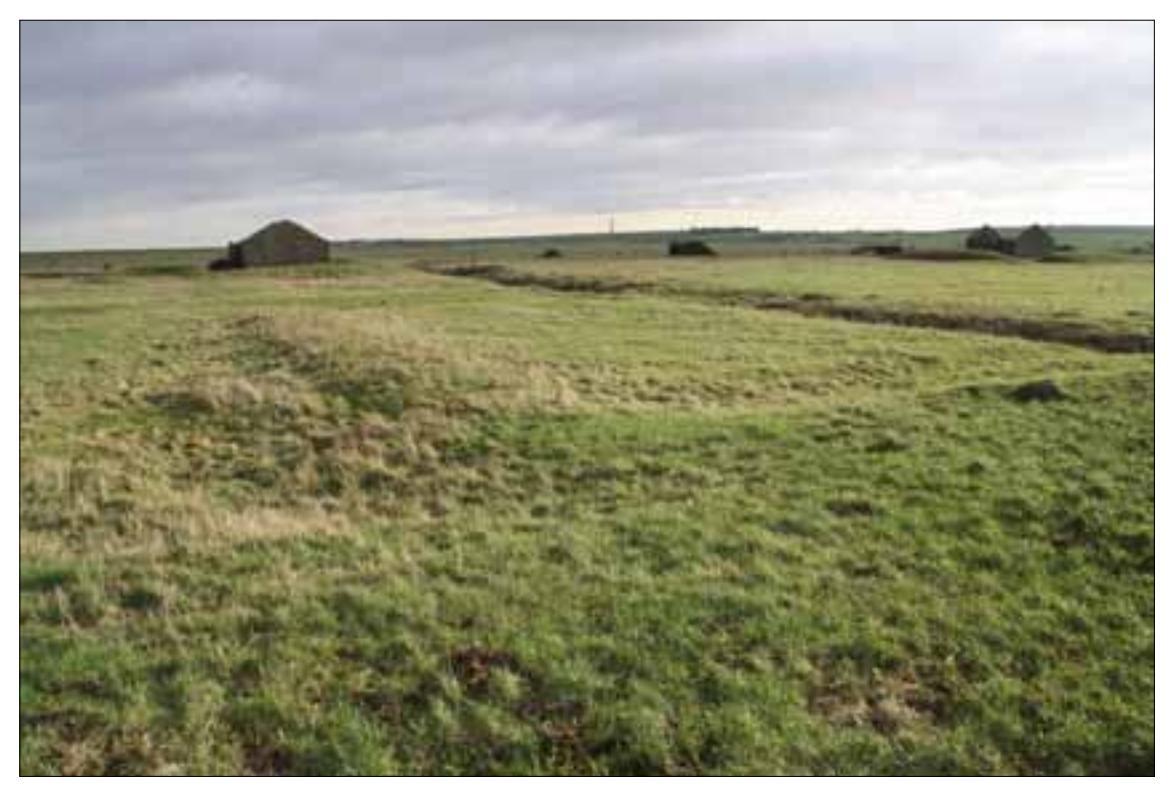
Figure 20: Embanked trackway which runs east-west between the northernmost row of magazines. It is truncated by the main north-south access track before it reaches the easternmost magazine.

An embanked trackway runs through the gaps in the bunds of the three most northerly magazines to link them together (Figure 20). Between the most north-westerly magazine and the one to the east, this track is roughly 3.5m wide at the base and 1.8m at the top. It does not directly align with the gap in the north-west bund, perhaps suggesting that it was constructed before the bund. As the track heads east towards the most easterly magazine it widens to 4.2m at its base and 2m at the top before being cut by the main north-south track into the site. There is no evidence of embanked tracks linking the other rows of magazines or the suggested site of the packing shed.
