ST MARY'S MARSHES, HOO ST MARY, MEDWAY, KENT AN ASSESSMENT OF THE LATE 19TH-CENTURY EXPLOSIVES MAGAZINES

St Mary's Marshes, Hoo St Mary, Medway, Kent An Asssessment of the Late 19th Century Explosives Magazines

NGR: TQ 7991 7899

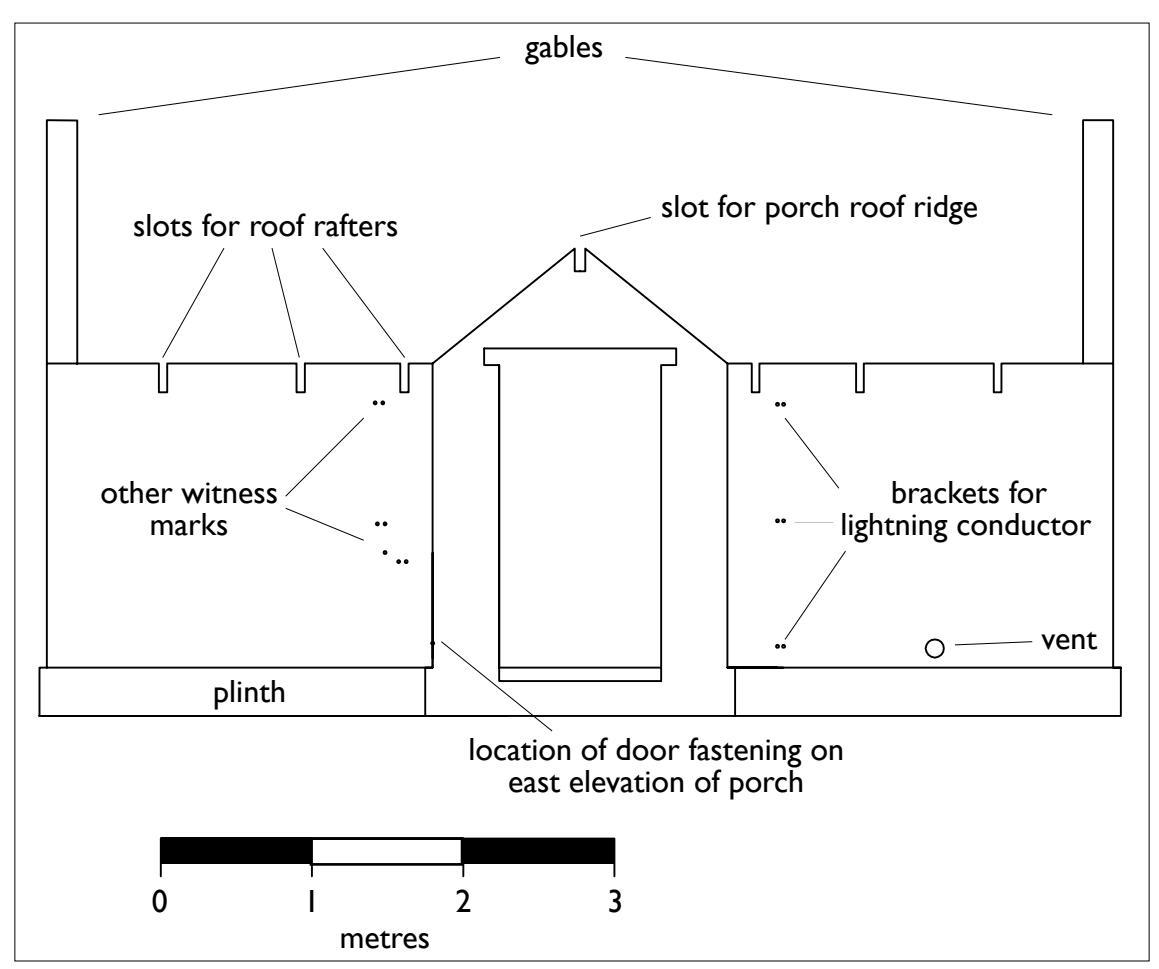
Figure 21: North elevation of explosives magazine (eastern magazine of central row measured).

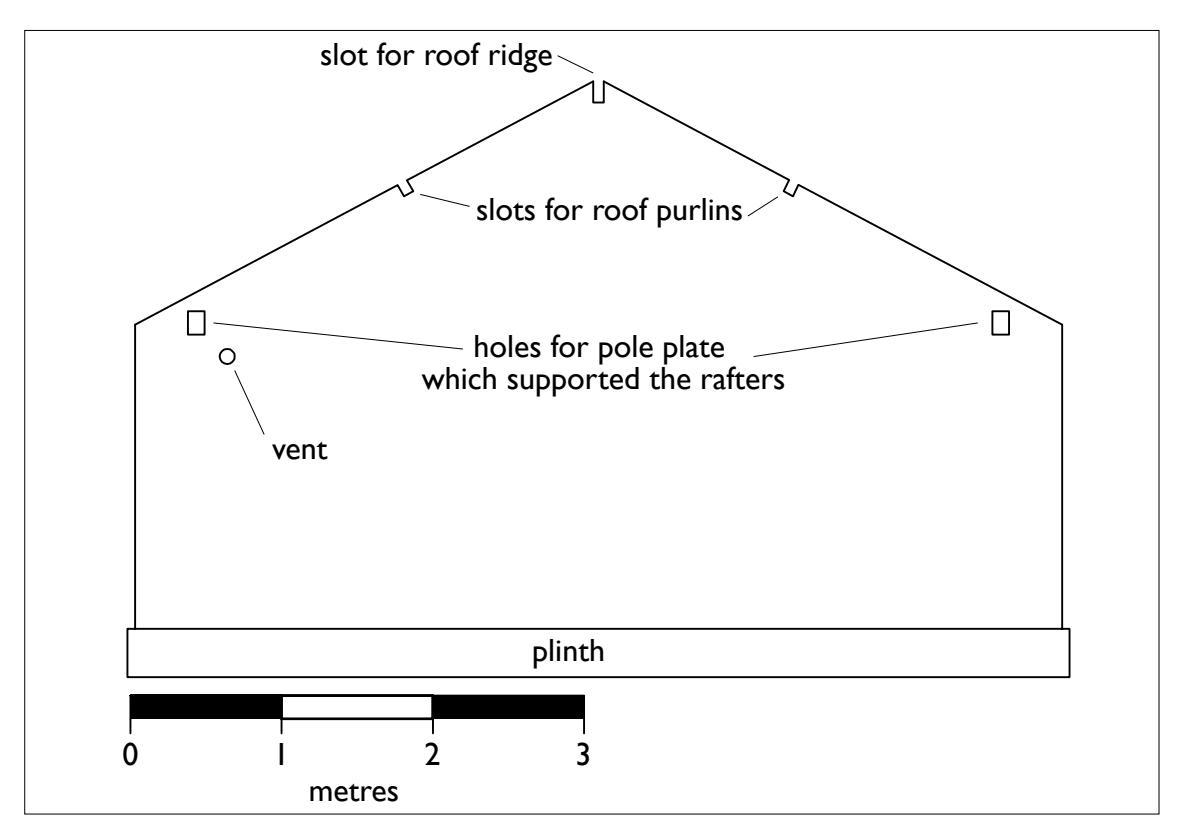
Figure 22: East elevation of explosives magazine (eastern magazine of central row measured). © ENGLISH HERITAGE 52 - 2013

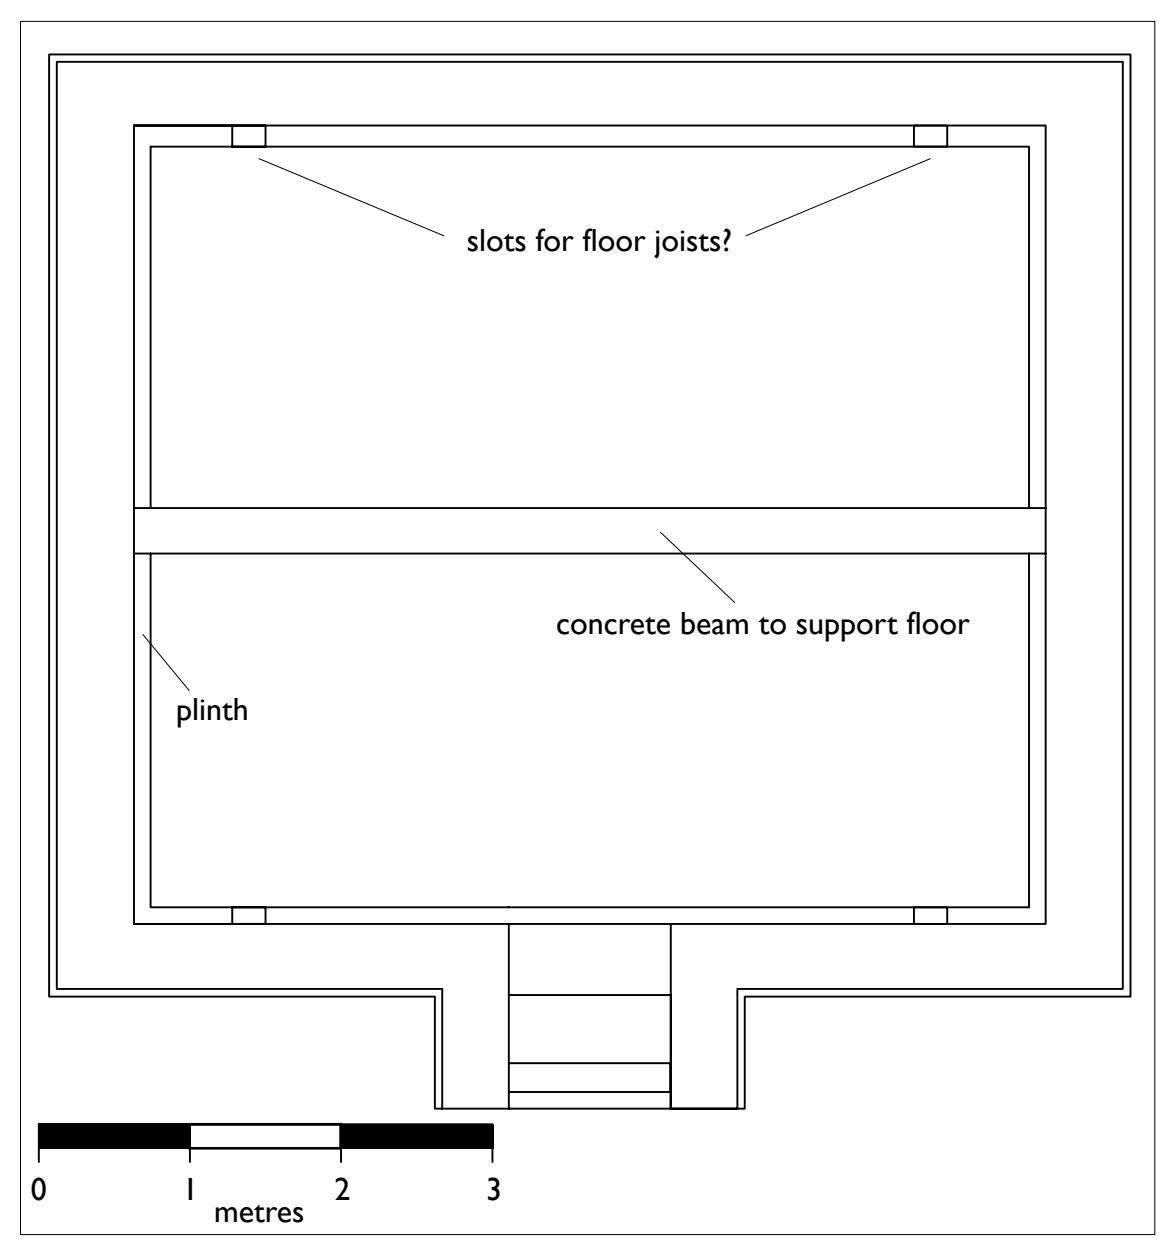
Figure 23: Floor plan of explosives magazine (eastern magazine of central row measured)
