**RESEARCH REPORT SERIES no. 22-2014**

# DANDRA GARTH, GARSDALE, CUMBRIA TREE-RING ANALYSIS OF TIMBERS

# SCIENTIFIC DATING REPORT

Alison Arnold and Robert Howard

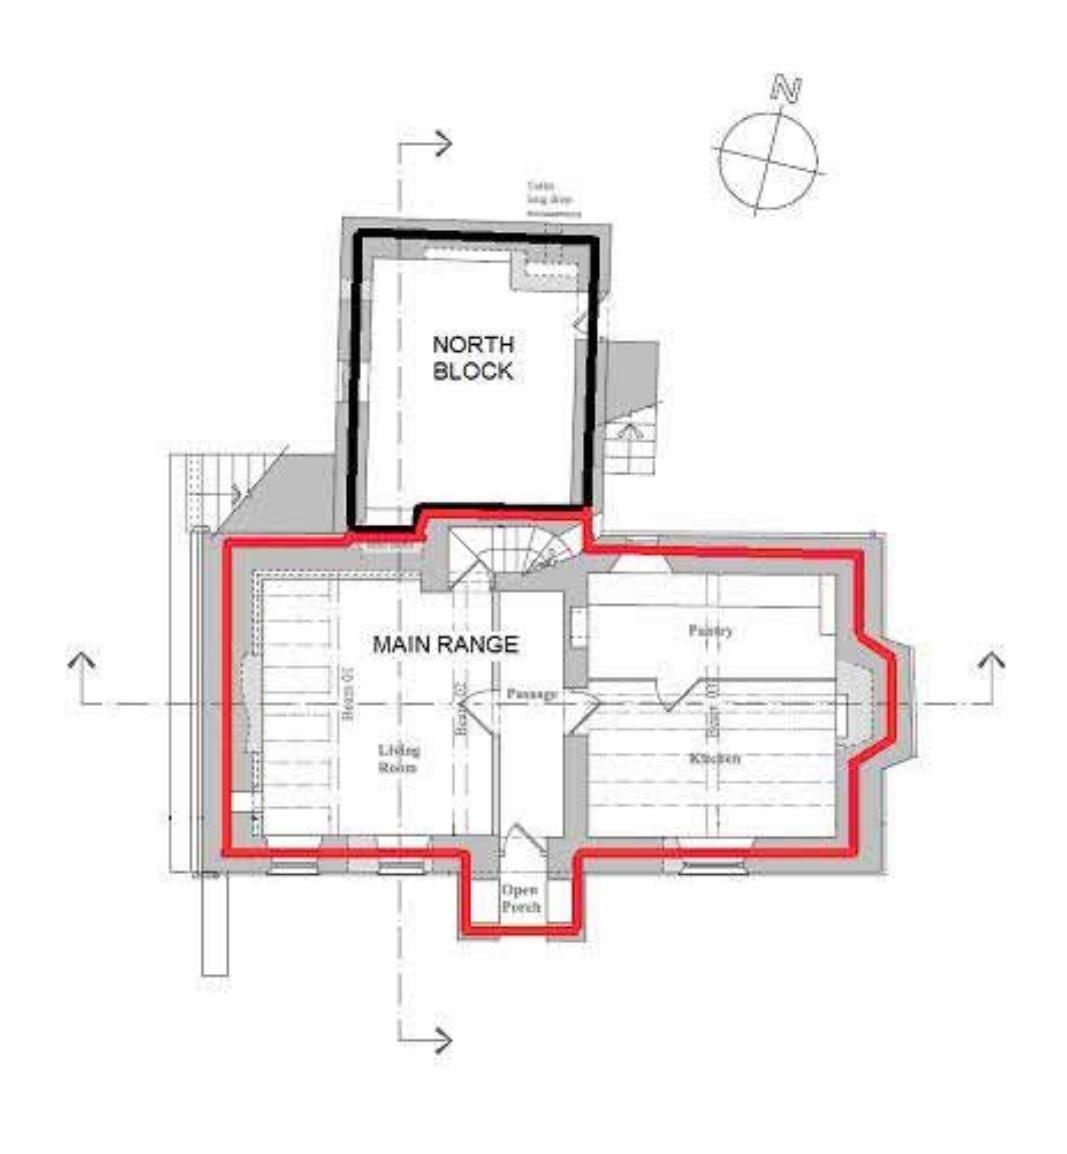
Figure 4: Plan of Dandra Garth (Paul Crosby Architect, annotated by PFR)

Dandra Garth is a Grade II\* listed farmhouse, situated in Garsdale in the Yorkshire Dales National Park (Figs 1–3). It is an inverted 'T' shaped plan (Fig 4) with a main east-west aligned range of three storeys and three bays, and with a smokehood in the western end of the attic. Behind this main range, set slightly off-centre, is a short, north block which is thought to have been a gabled wing originally but now has a catslide roof continuous with that of the main building. Both ranges are built of roughly-coursed and roughly-squared stone under a low-pitched flagged roof.

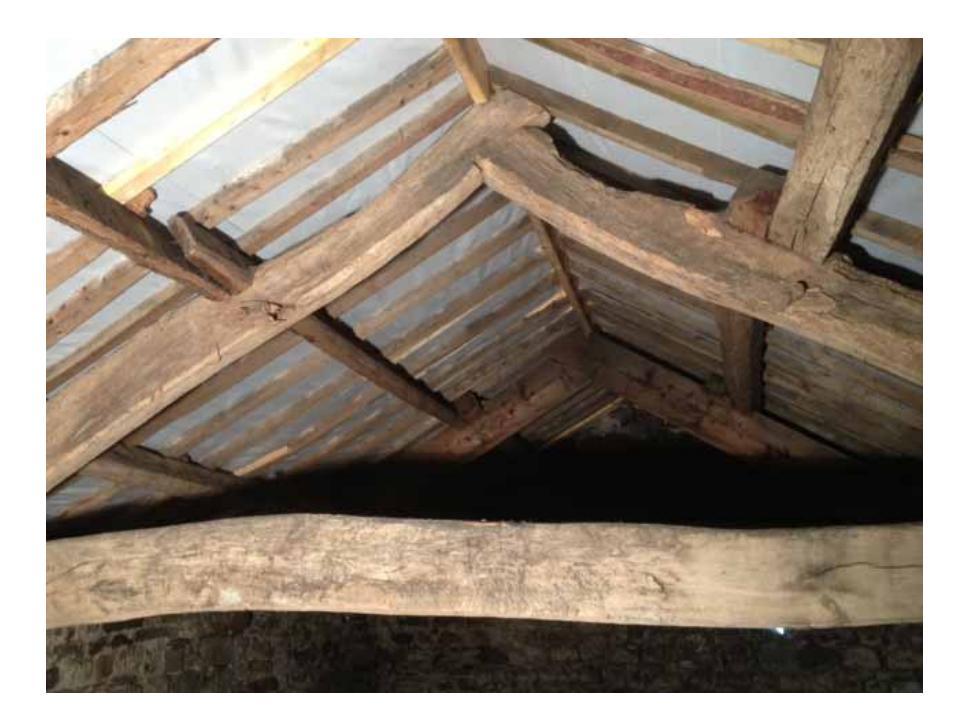
*Figure 5: The roof, with truss 2 in the foreground, photograph taken from the west (Alison Arnold)*

The extant roof is of three trusses, the easternmost one (truss 3) is of softwood whilst the other two are oak. The trusses consist of principal rafters, tiebeams, and slightly arched collars (the collar of truss 2 is no longer *in situ* but lies amongst other beams to one side). There is a double row of purlins to each side and a ridge board (Fig 5). This present roof replaced an earlier upper-cruck one; the cut off remains of two of these blades can still be seen at first-floor level and in the attic. Other roof timbers have redundant mortices and are thought to represent reused timber from the original roof; the chimney lintel can also be seen to have a cut out, perhaps for a lap joint, and may again be from the original roof (Fig 6).

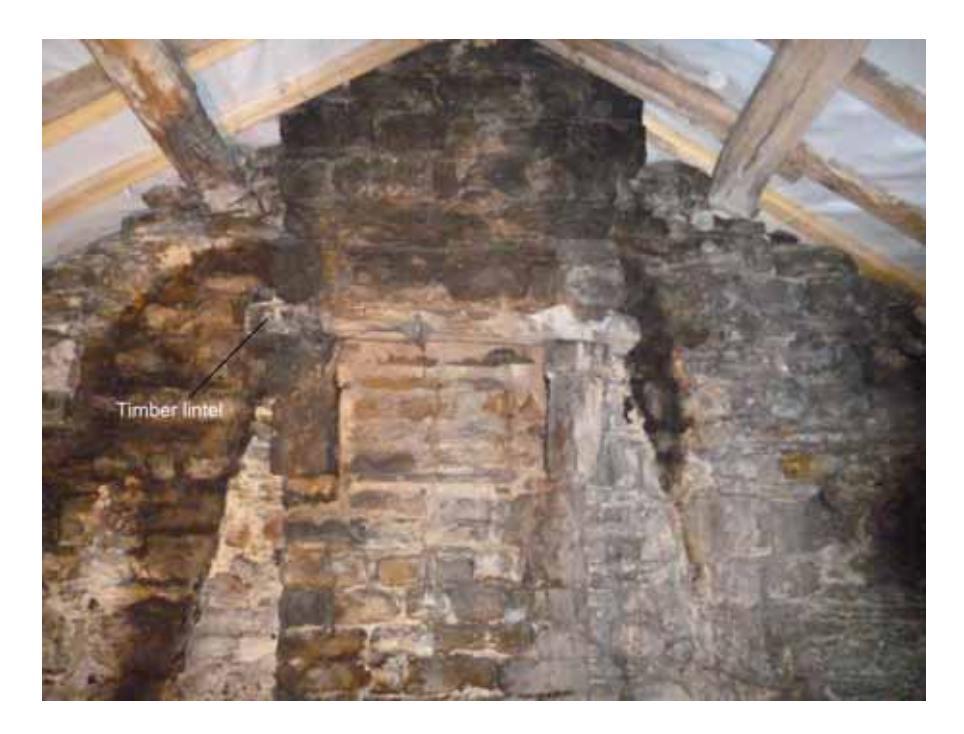
Figure 6: Chimney stack with timber lintel, photograph taken from the east (Alison Arnold)

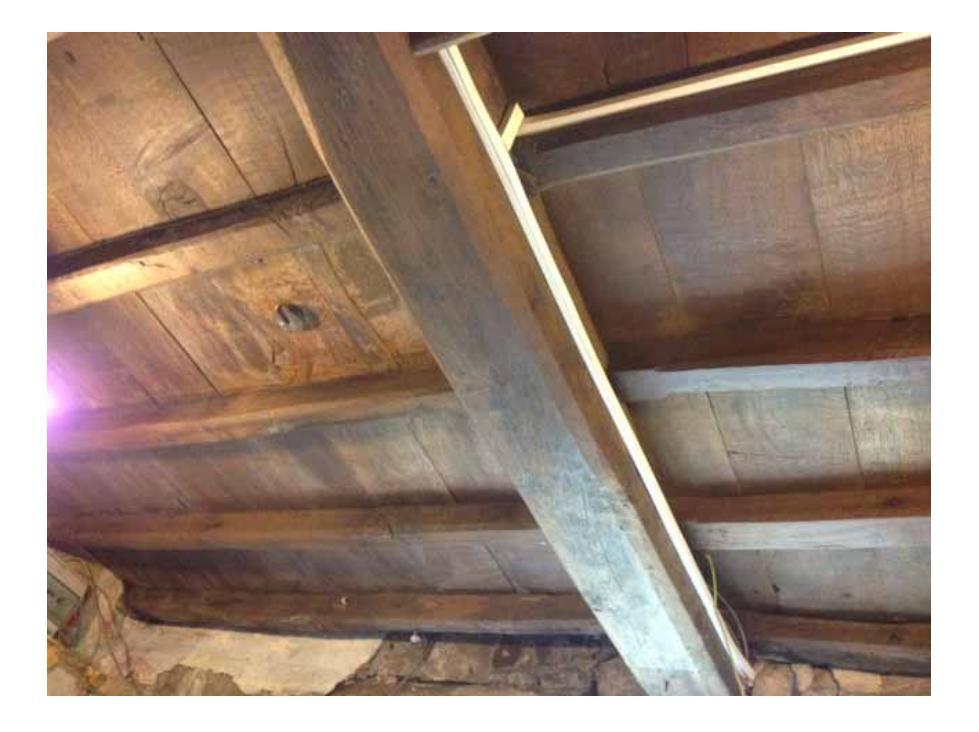
*Figure 7: First-floor frame, viewed from below in the kitchen, photograph taken from the north-west (Alison Arnold)*

The first-floor frame is visible from ground-floor level and can be seen to consist of, in the living room, two, heavy, main north-south, chamfered beams. The north end of beam 02 (Fig 4) is carried by the lintel of the door into the mural stair. In the kitchen there is a third main beam (03) with chamfers and stepped stops, the south end of which rests on a heavy lintel over the window. Either side of this main beam (03) are a series of smaller common joists, some of which are chamfered and others left square (Fig 7). The attic-floor frame is partly visible in the attic where floorboards are loose or missing and again consists of main beams and common joists, some of which are chamfered and some simply squared (Fig 8).

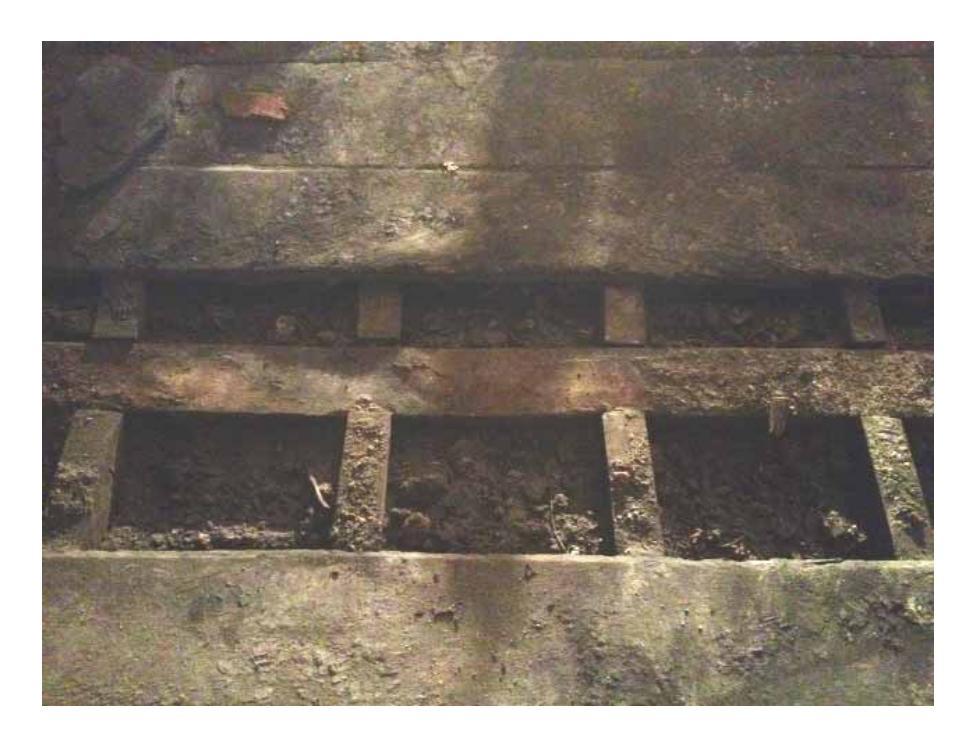
Figure 8: Attic-floor frame, viewed from above (Alison Arnold)

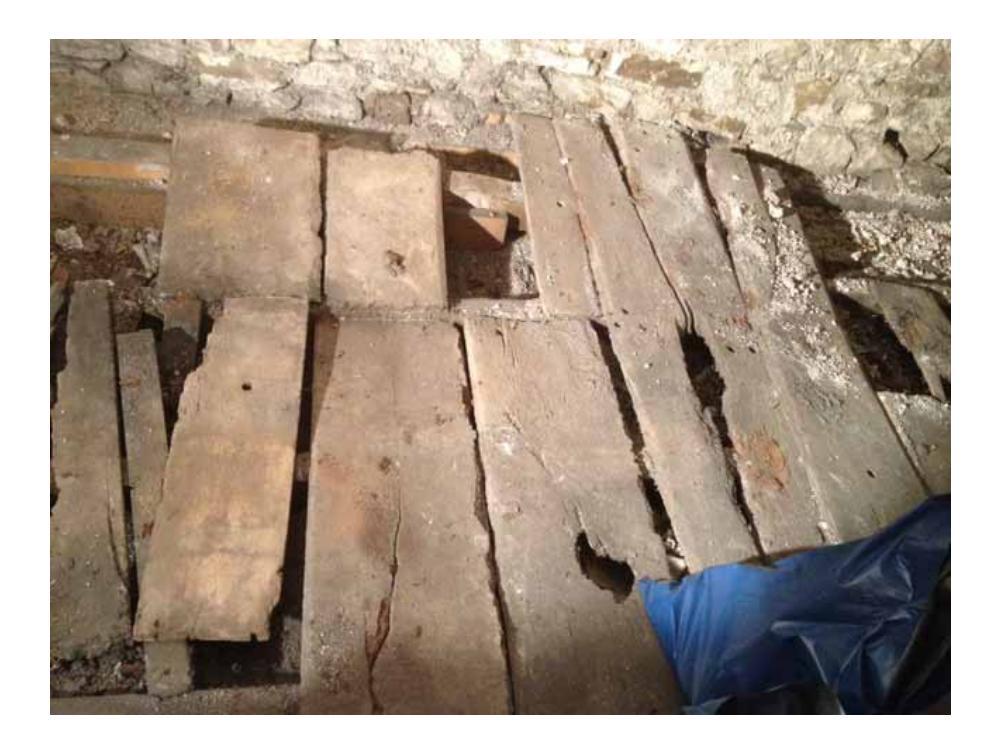
Figure 9: Attic floorboards, some of which can be seen to have peg holes (Alison Arnold)

The first floor has broad, oak floorboards pegged to the joints beneath. It was noted that the joints between sections of boarding did not appear to have a relationship with the partitioning above (Ryder 2012). In the attic there are further floorboards of varying character, although some do resemble those seen below, others are still pegged in position and some are loose (Fig 9).

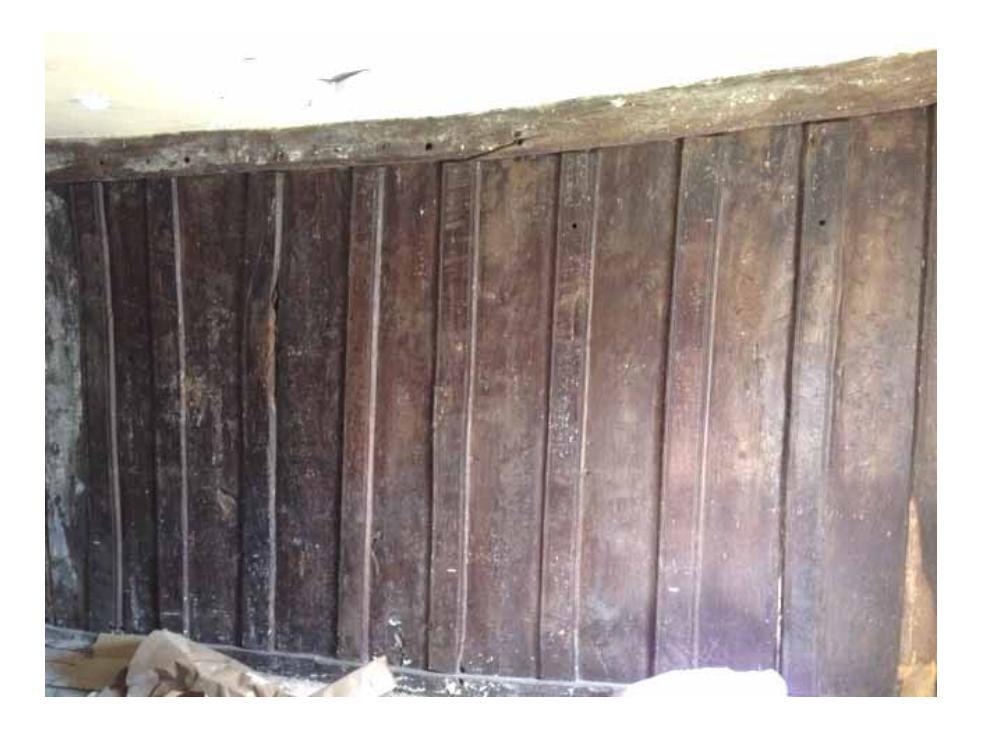
Figure 10: Plank-and-muntin screen, photograph taken from the west (Alison Arnold)

At first-floor level there are two transverse plank-and-muntin partitions (Figs 10 and 13) which would have divided the space into three rooms, with a third longitudinal partition creating a corridor. The northern part of the eastern partition has been removed and a later partition installed, dividing the eastern room into two. The older partitions consist of moulded studs, grooved, to take intermediate planks.

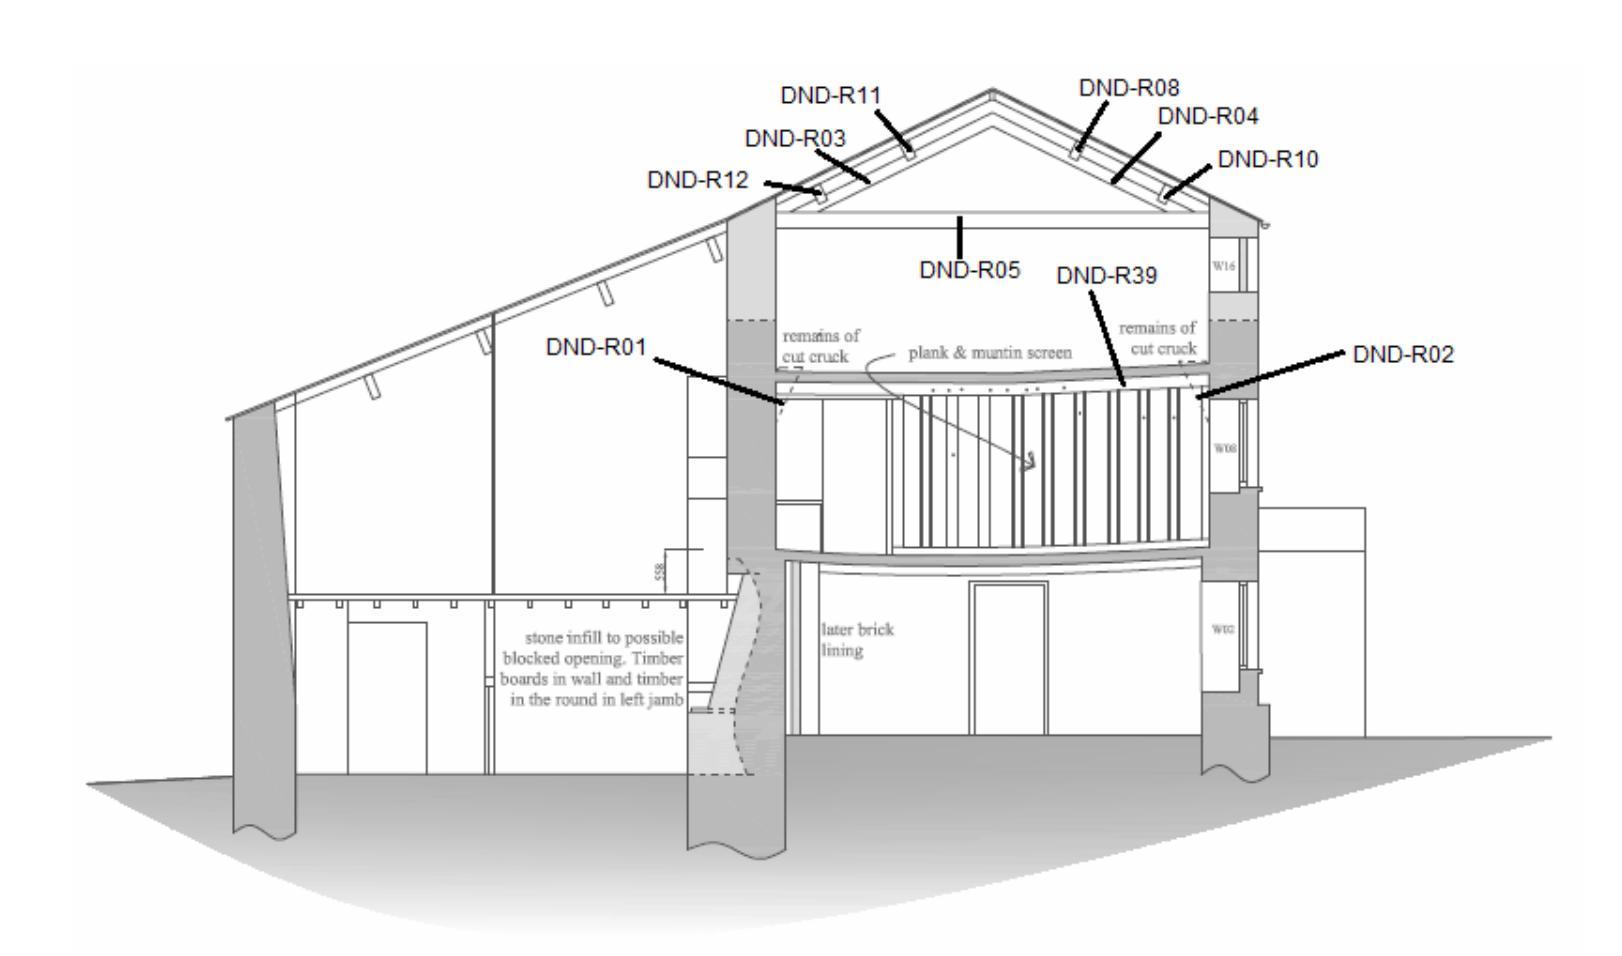
Figure 11: Section looking east, showing truss 1 and the location of samples DND-R01–05, DND-R08, DND-R10–12, and DND-R39 (Paul Crosby Architect, annotated PFR)

first (DND-R45), followed by a new set of measurements after the crack to the end of the plank (DND-T45). The location of measured *in situ* samples and partition planks was noted at the time of sampling and marked on Figures 11–15. Further details relating to the samples can be found in Table 1.

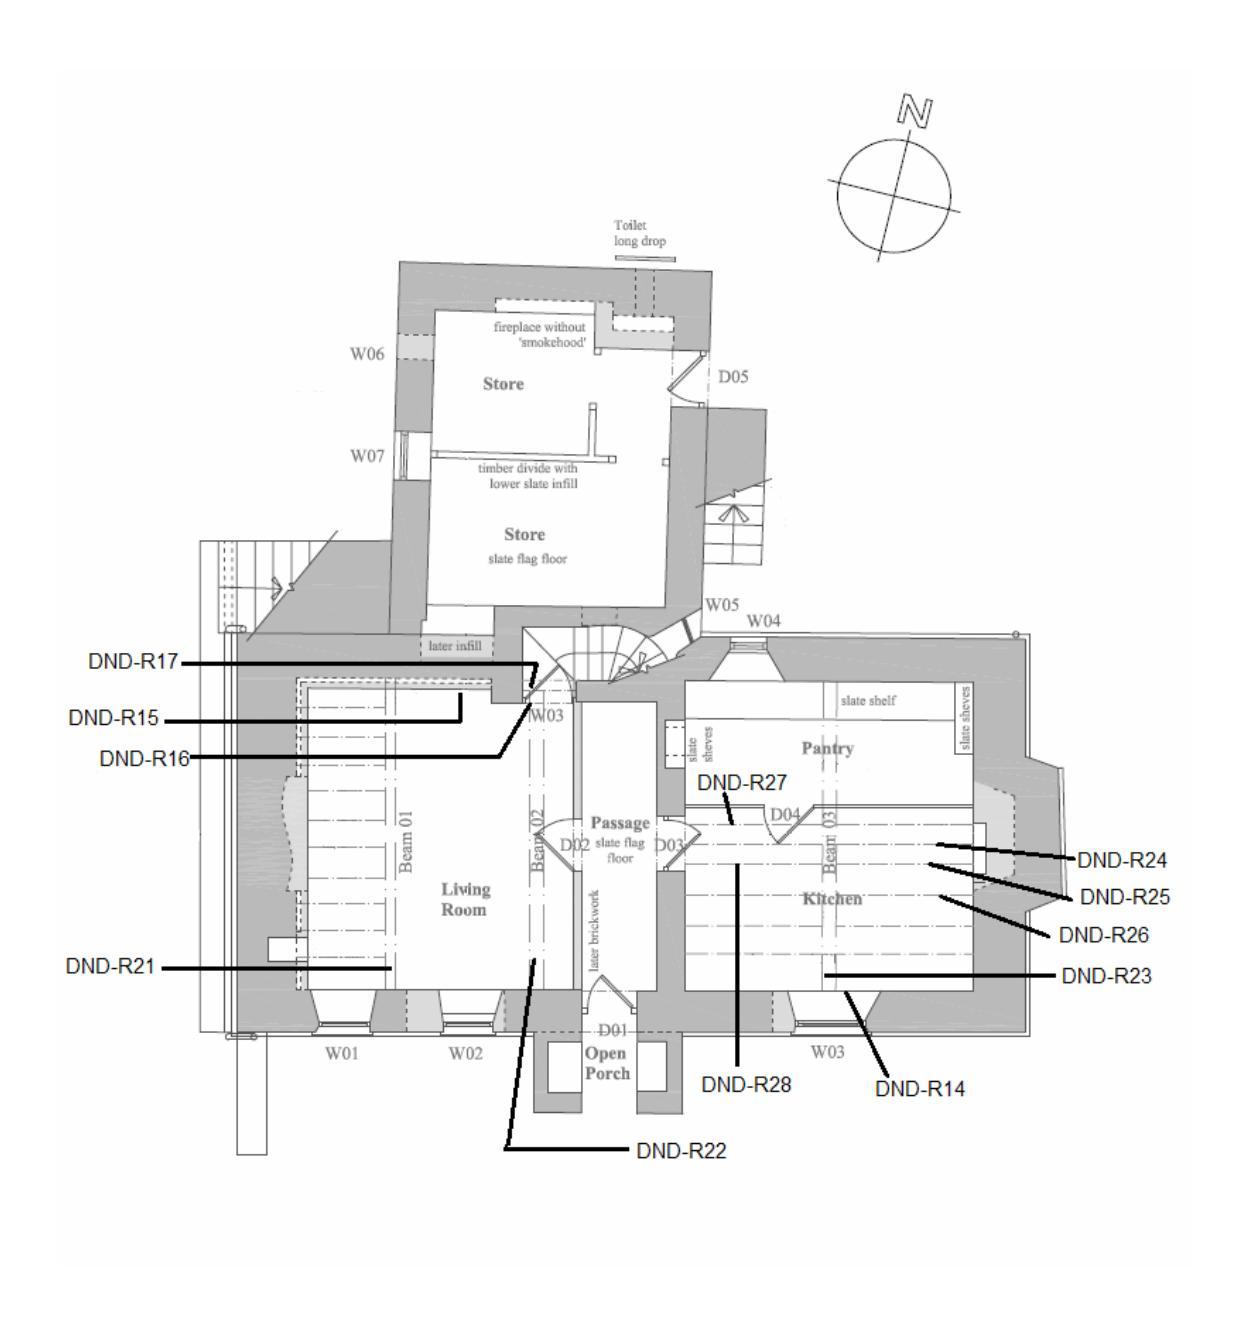
*Figure 12: Ground-floor plan, showing the location of samples DND-R14–17 and DND-R21– 8 (Paul Crosby Architect, annotated PFR)*

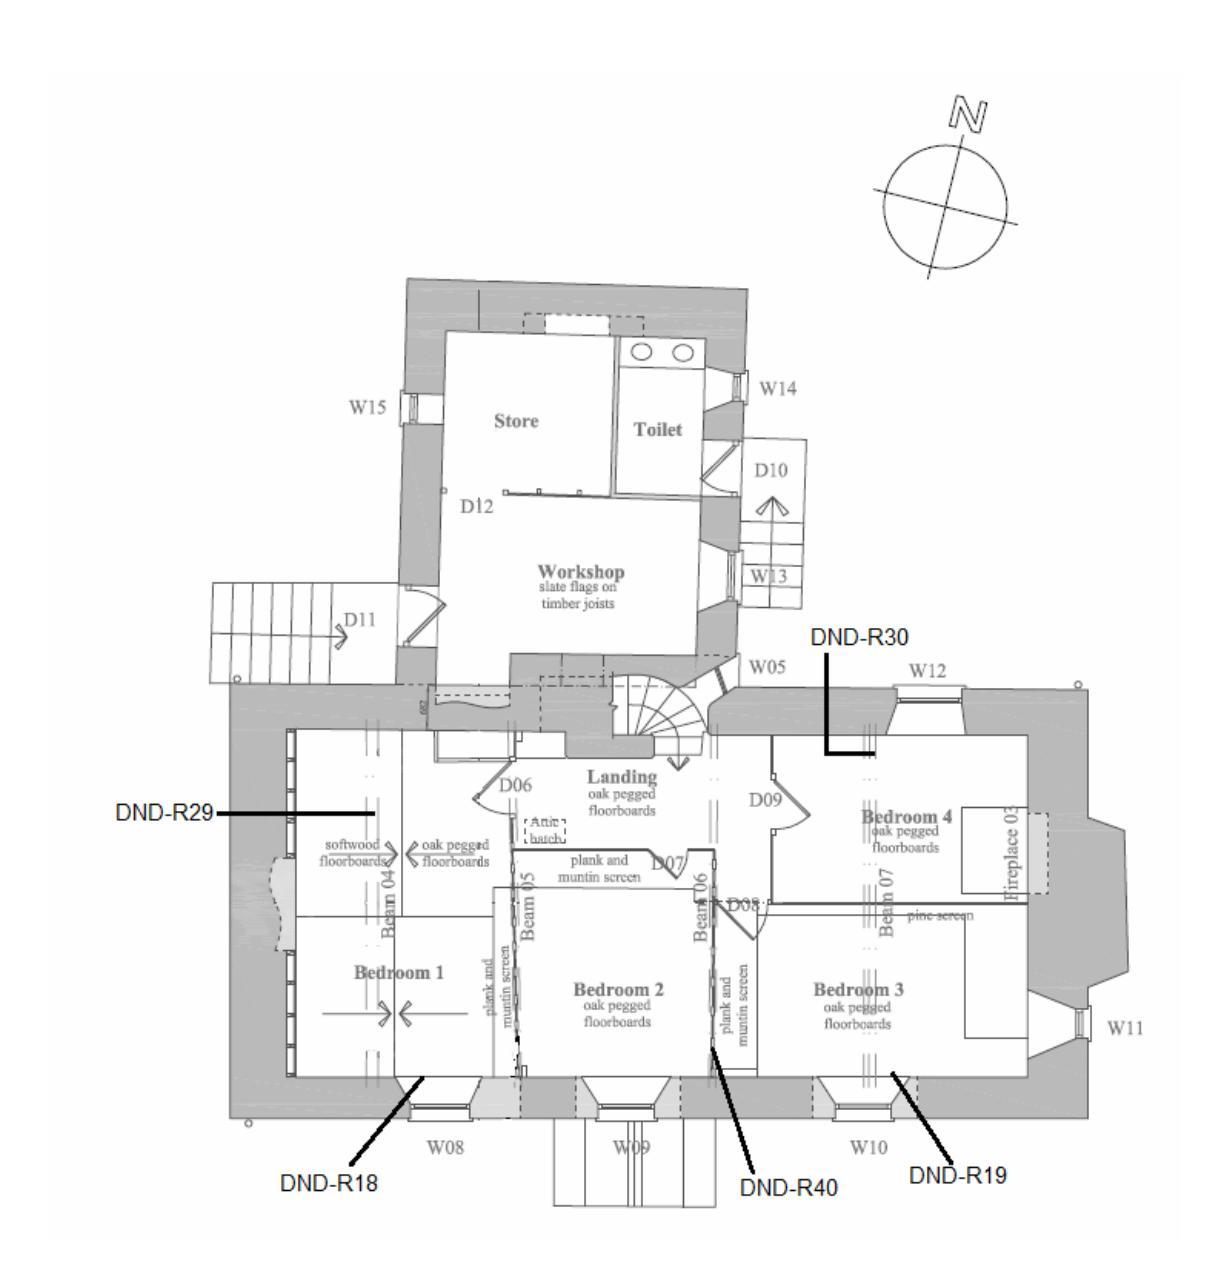
*Figure 13: First-floor plan, showing the location of samples DND-R18–19, DND-R29–30, and DND-R40 (Paul Crosby Architect annotated PFR)*

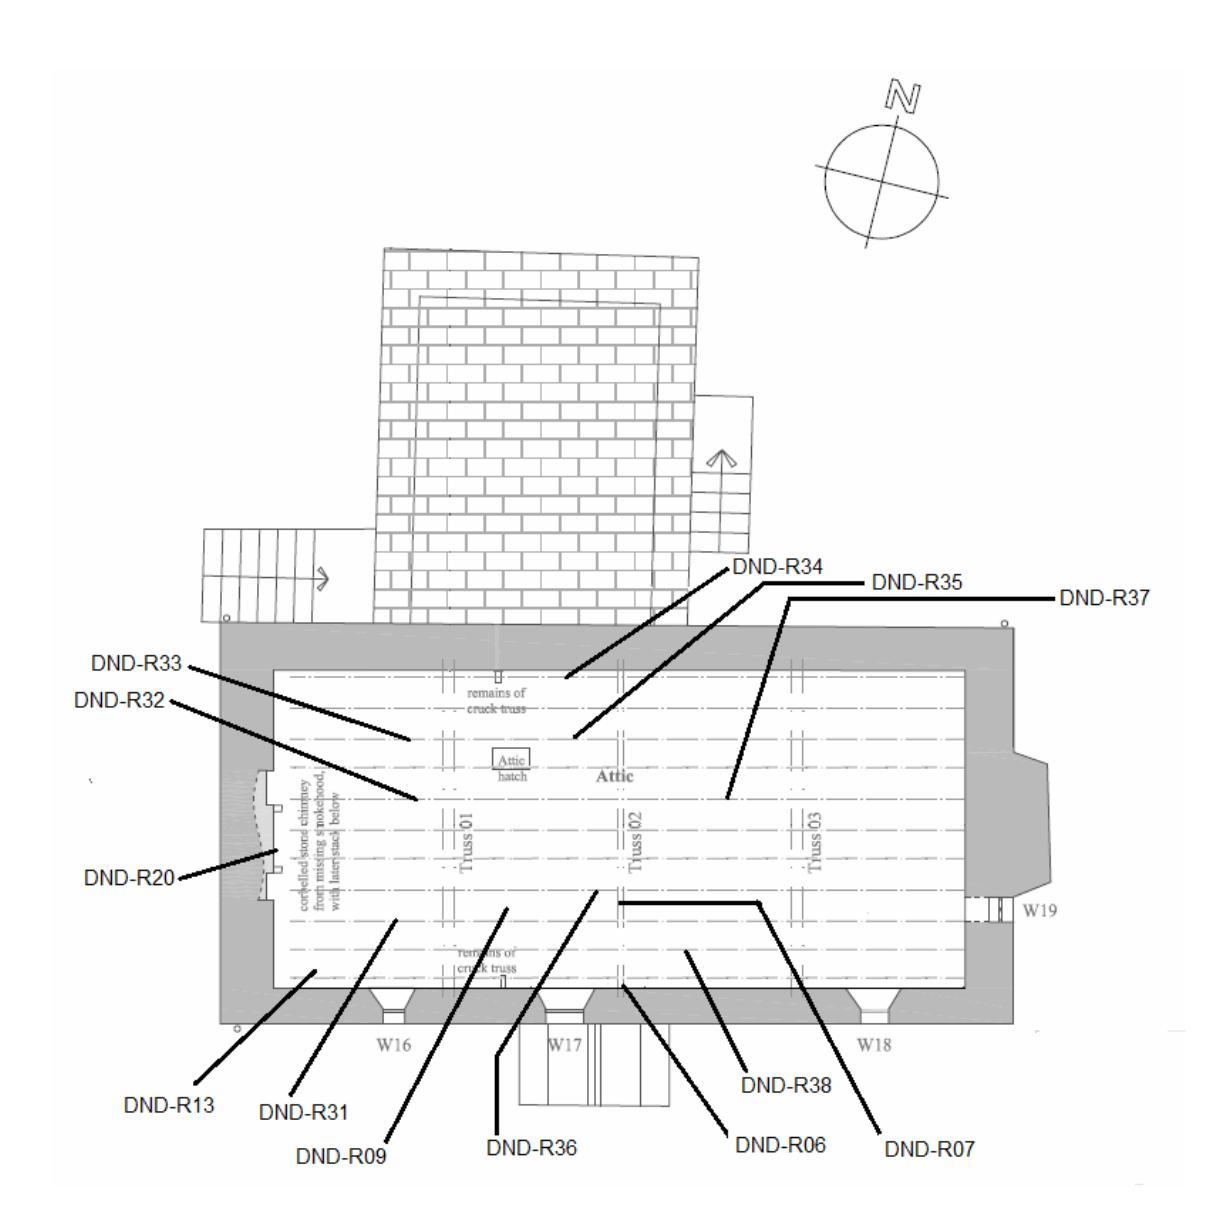
*Figure 14: Attic-floor plan, showing the location of samples DND-R06–07, DND-R09, DND-R13, DND-R20, and DND-R31–8 (Paul Cosby Architect annotated PFR)*

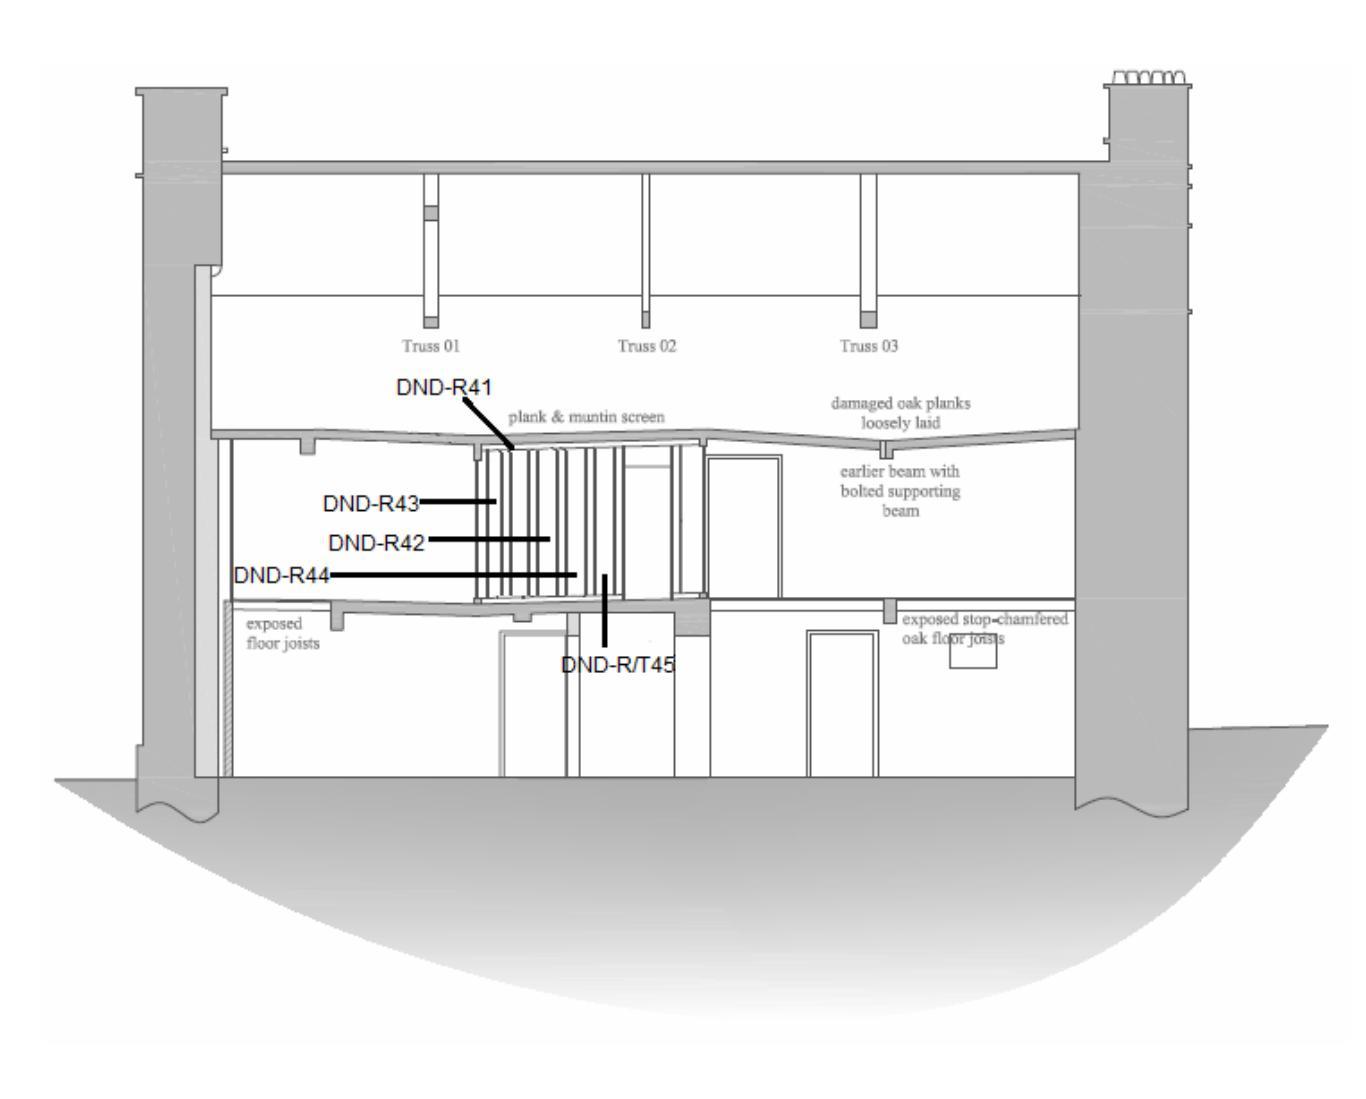
*Figure 15: Long-section through the house, showing the location of samples DND-R41–5 (Paul Crosby Architect, annotated PFR)*

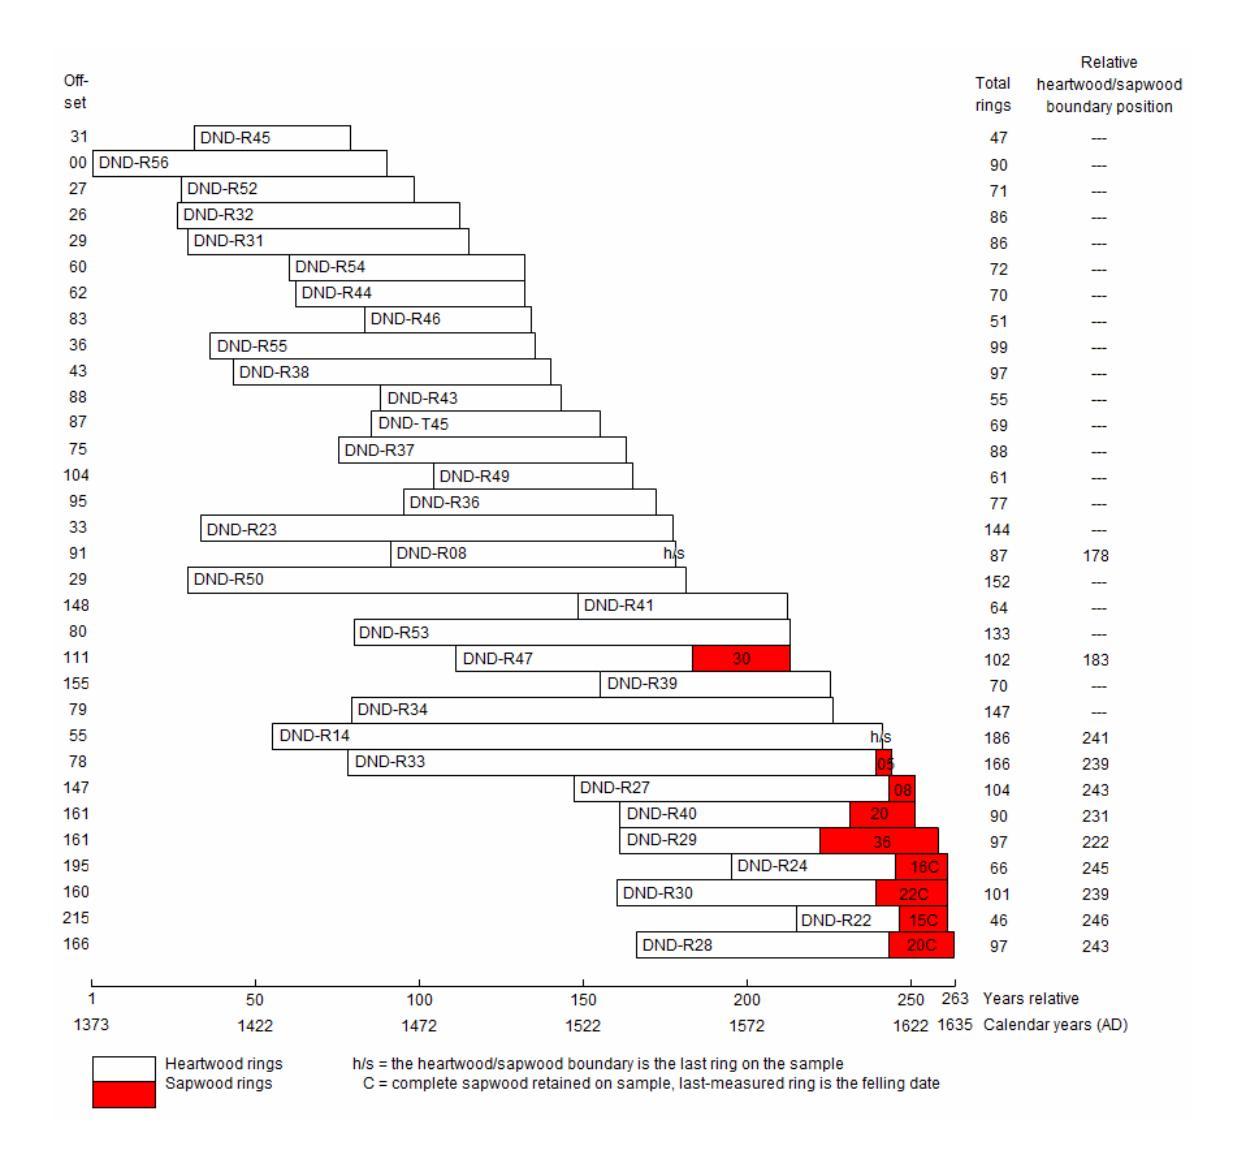
Figure 16: Bar diagram of samples in site sequence DNDRSQ01

Firstly, 32 samples (including the inner and outer sets of measurements from a single partition plank, DND-R45 and DND-T45) from all areas matched each other and were combined at the relevant offset positions to form DNDRSQ01, a site sequence of 263 rings (Fig 16). This site sequence was compared against a series of relevant reference chronologies for oak where it was found to span the period AD 1373–1635. The evidence for this dating is given in Table 2.

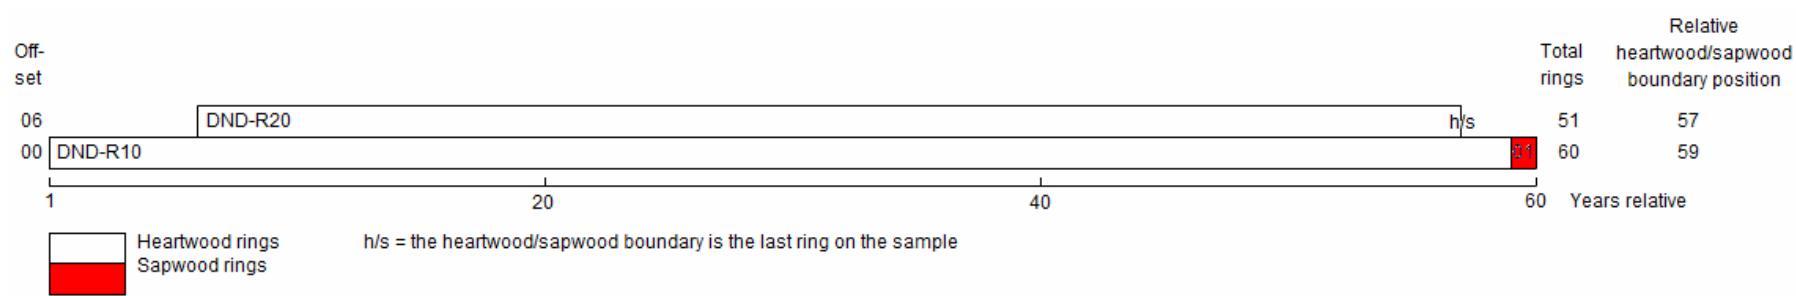
Figure 17: Bar diagram of samples in undated site sequence DNDRSQ02

Two samples, one from a reused roof timber and one from a chimney lintel in the attic, grouped to form DNDRSQ02, a site sequence of 60 rings (Fig 17). This site sequence was compared against a series of relevant reference chronologies for oak but could not be securely matched and so remains undated.

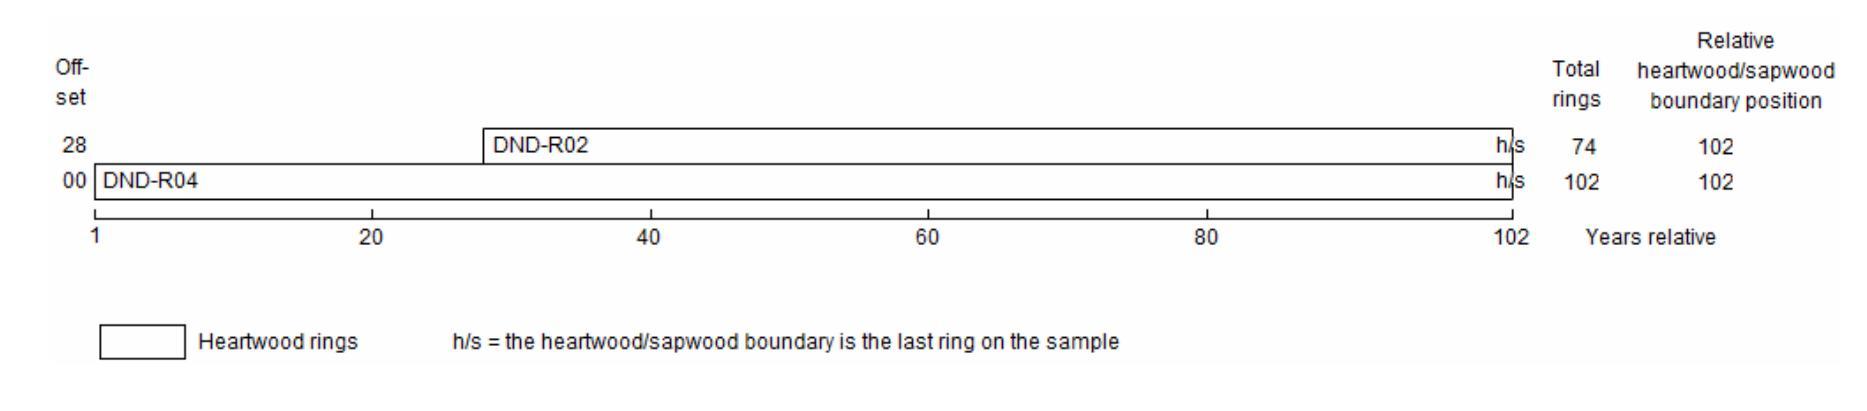
Figure 18: Bar diagram of samples in undated site sequence DNDRSQ03

Finally, two further samples from the roof matched each other and were combined to form DNDRSQ03, a site sequence of 102 rings (Fig 18). Attempts to date this site sequence and the remaining 15 ungrouped samples were unsuccessful and all remain undated.

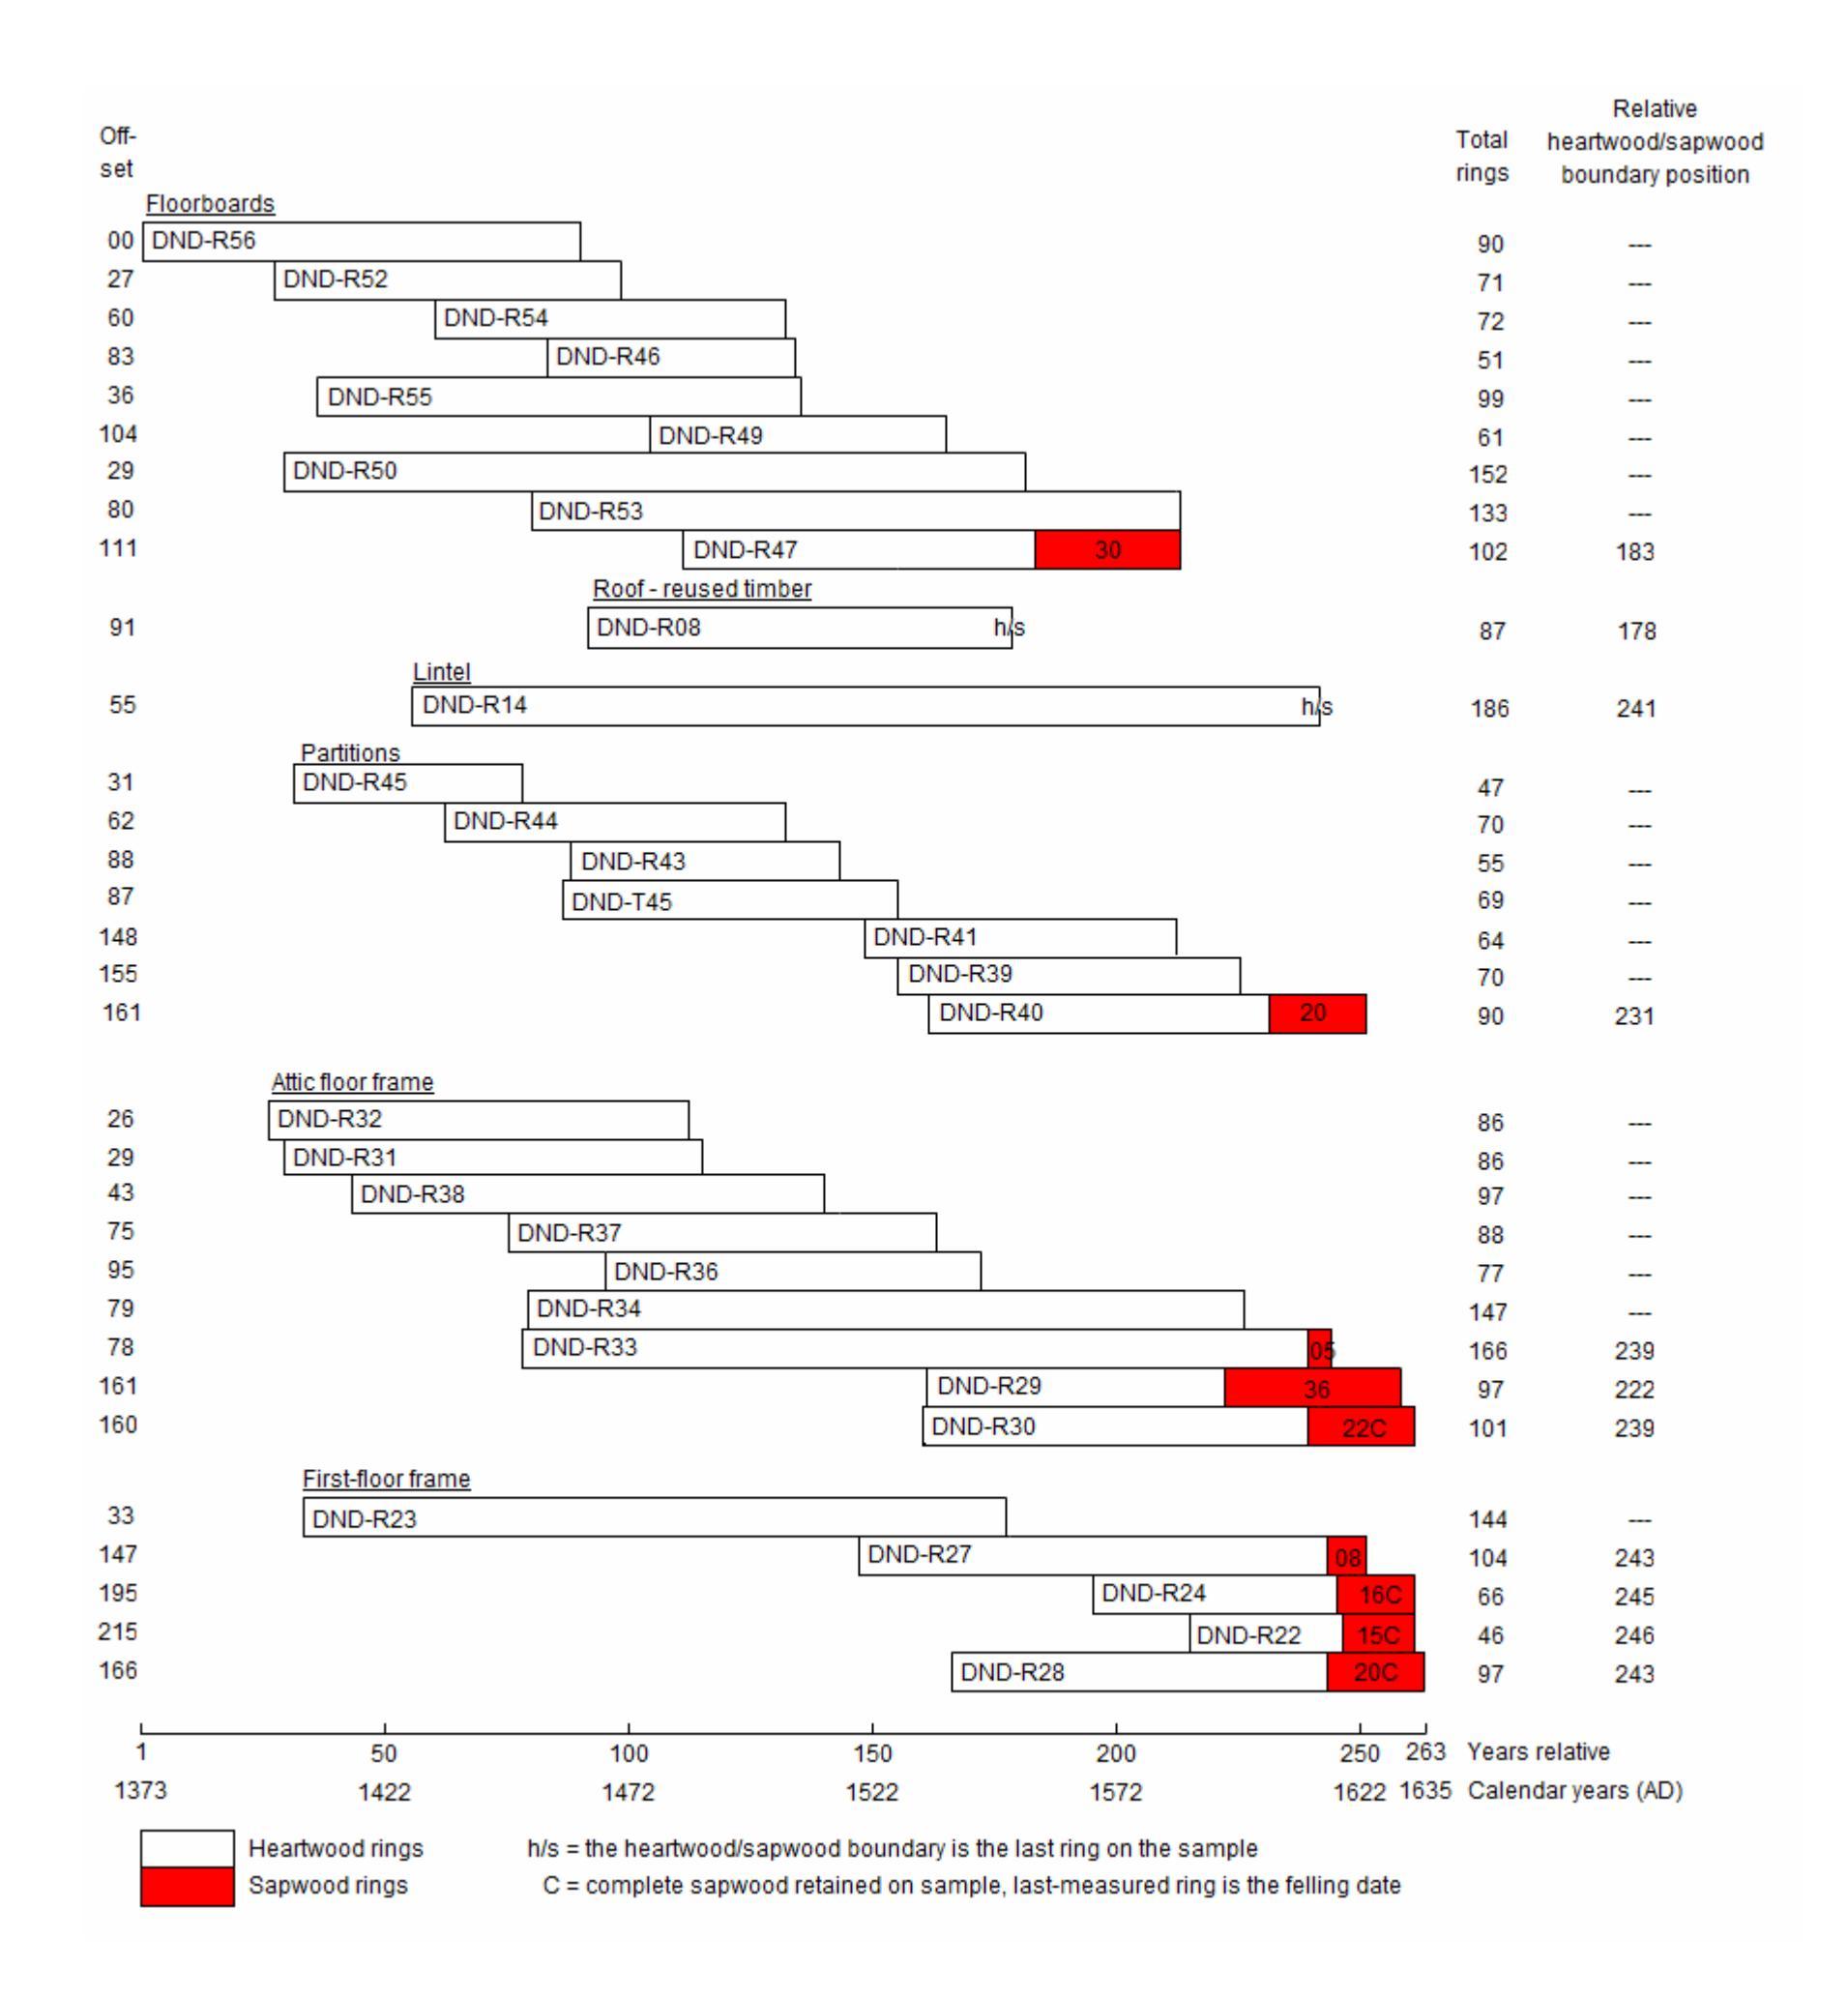
Figure 19: Bar diagram of all dated samples, sorted by area

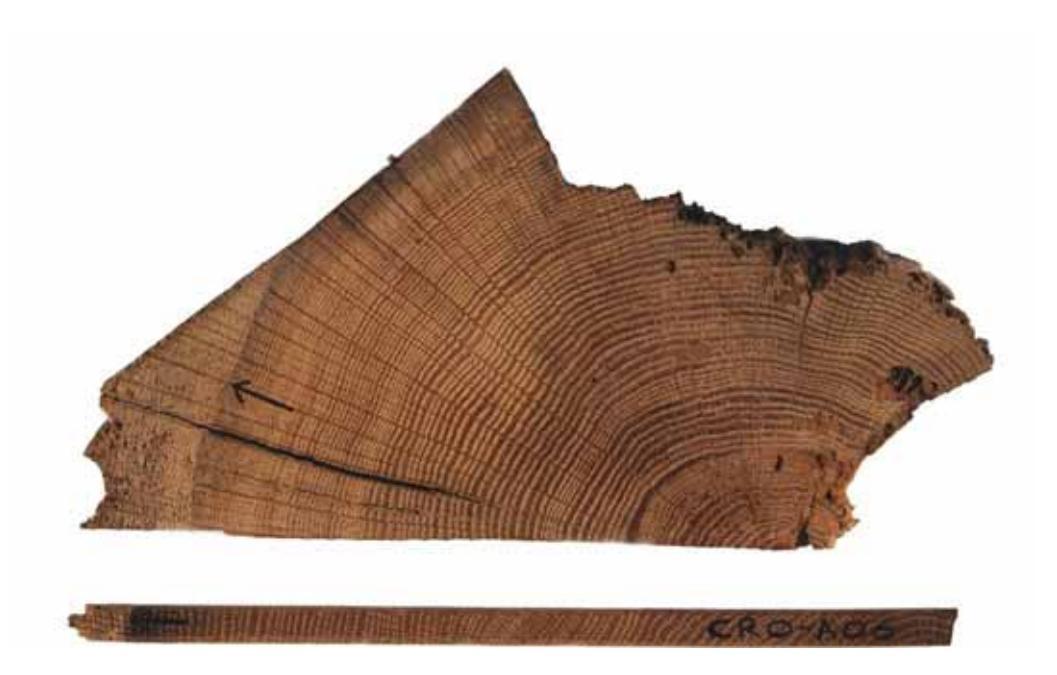
*Figure A2: Cross-section of a rafter, showing sapwood rings in the left-hand corner, the arrow points to the heartwood/sapwood boundary (H/S); and a core with sapwood; again the arrow is pointing to the H/S. The core is about the size of a pencil*
