**RESEARCH REPORT SERIES no. 22-2014**

# DANDRA GARTH, GARSDALE, CUMBRIA TREE-RING ANALYSIS OF TIMBERS

# SCIENTIFIC DATING REPORT

Alison Arnold and Robert Howard

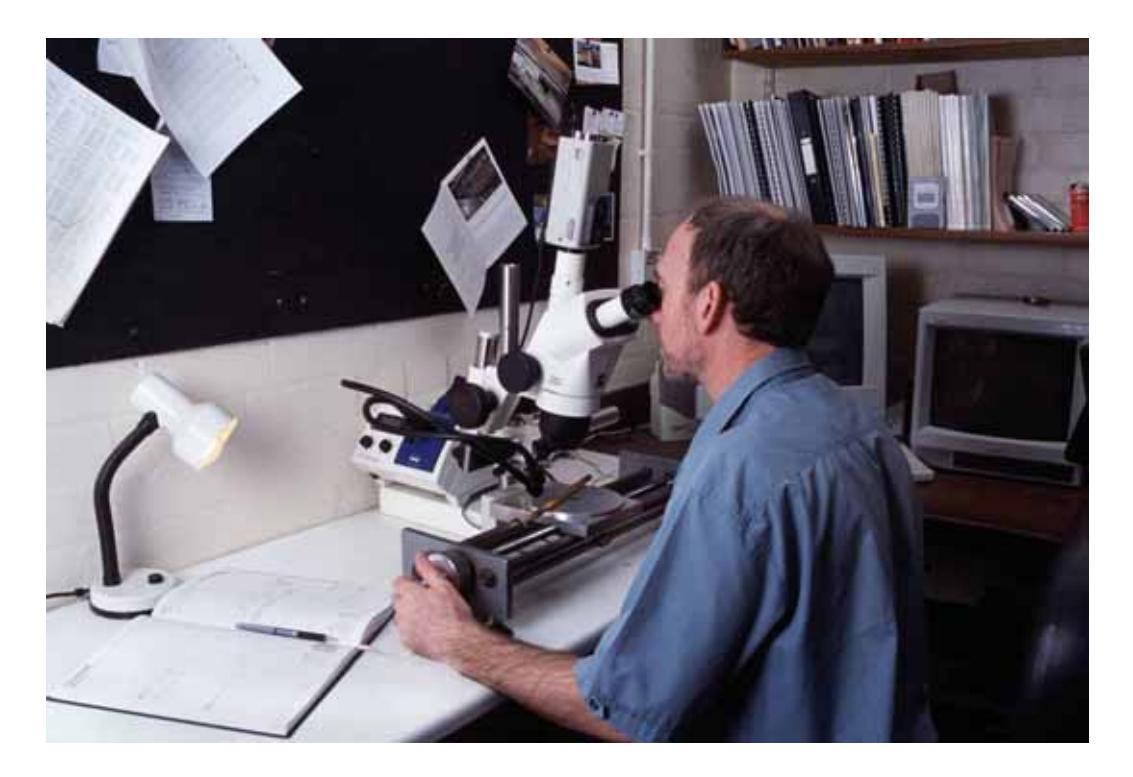
Figure A3: Measuring ring widths under a microscope. The microscope is fixed while the sample is on a moving platform. The total sequence of widths is measured twice to ensure that an error has not been made. This type of apparatus is needed to process a large number of samples on a regular basis

2. Measuring Ring Widths. Each core is sanded down with a belt sander using medium-grit paper and then finished by hand with flourgrade-grit paper. The rings are then clearly visible and differentiated from each other with a result very much like that shown in Figure A2. The core is then mounted on a movable table below a microscope and the ring-widths measured individually from the innermost ring to the outermost. The widths are automatically recorded in a computer file as they are measured (see Fig A3).

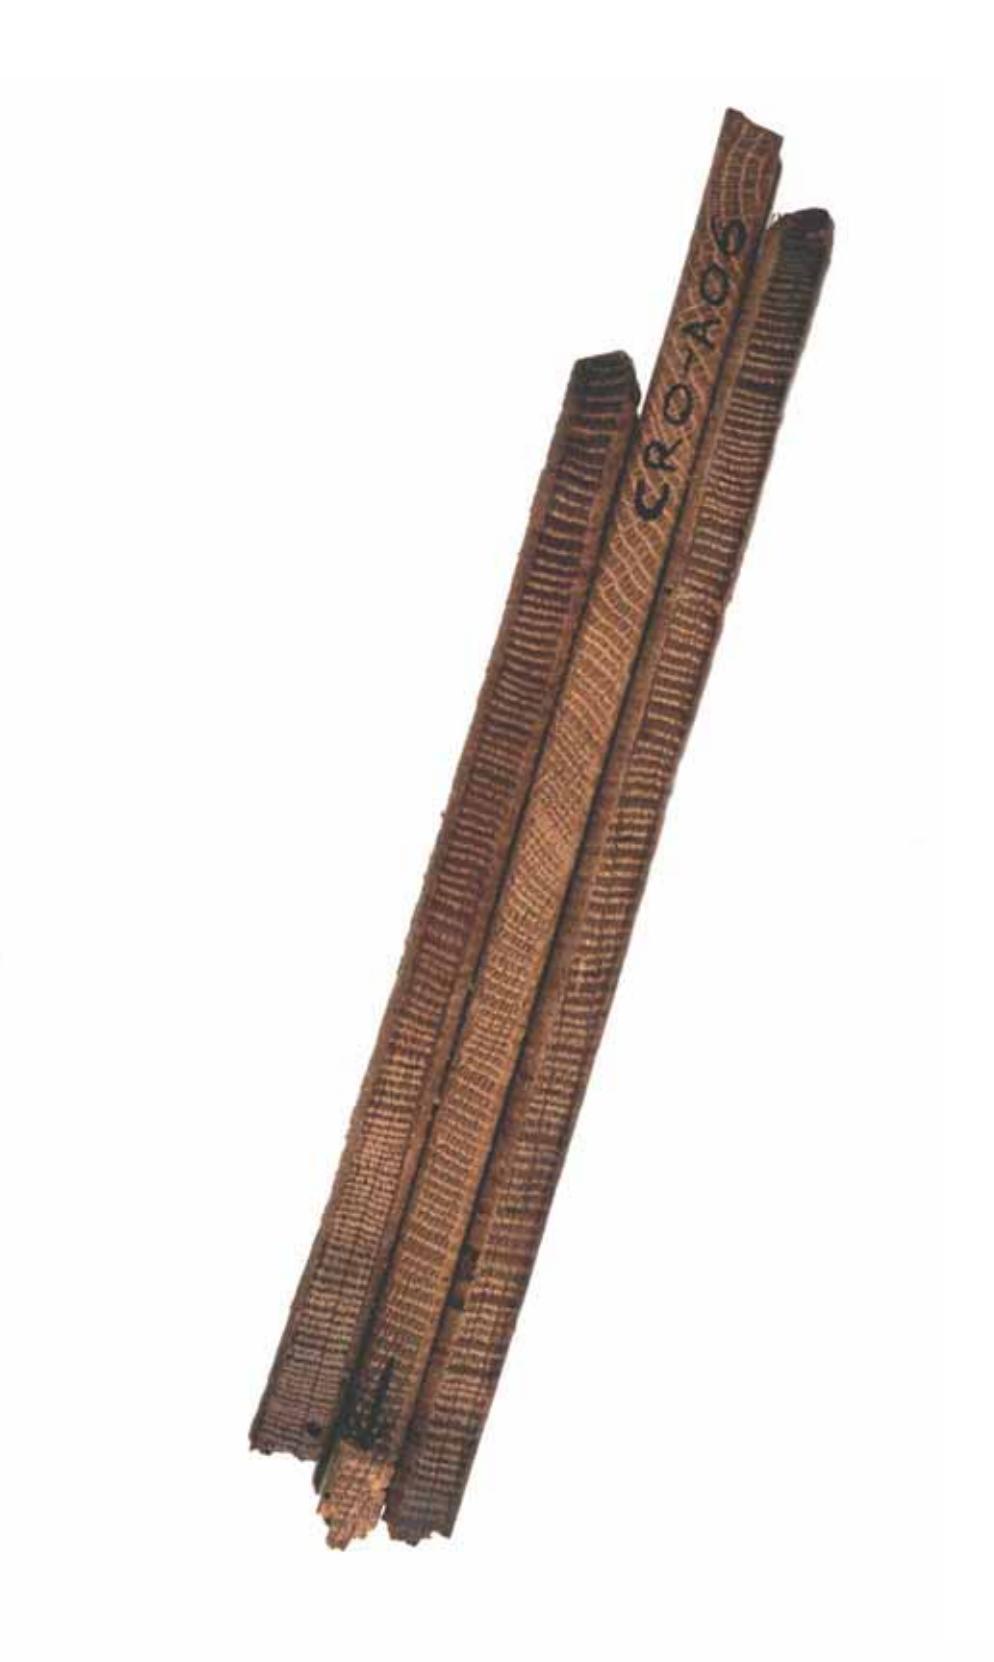
Figure A4: Three cores from timbers in a building. They come from trees growing at the same time. Notice that, although the sequences of widths look similar, they are not identical. This is typical

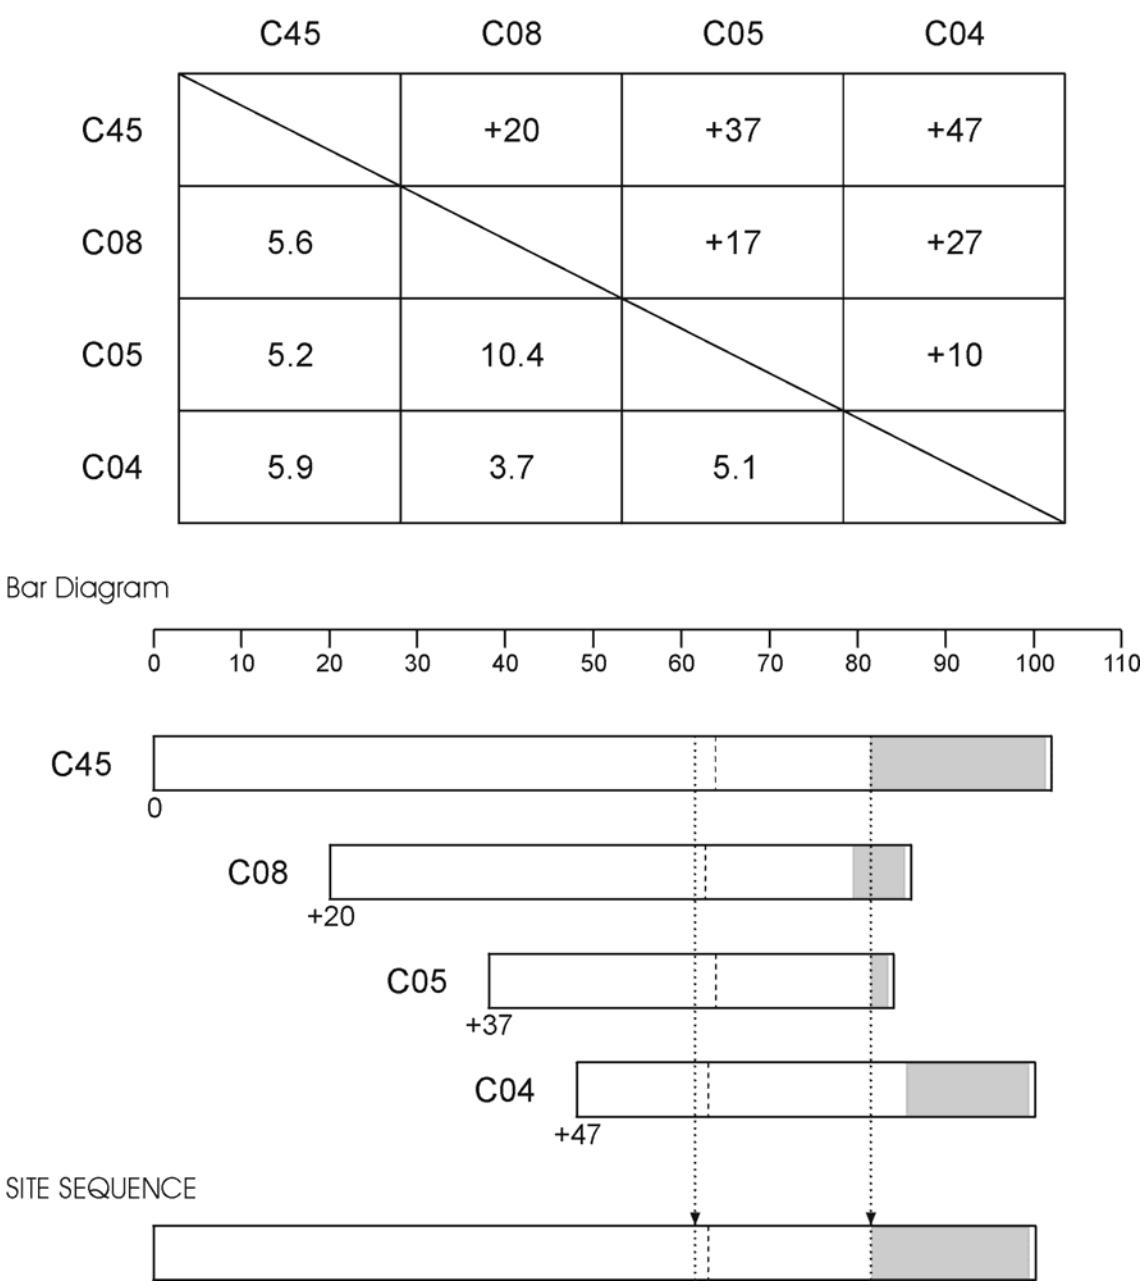
# *Figure A5: Cross-matching of four sequences from a Lincoln Cathedral roof and the formation of a site sequence from them*

The bar diagram represents these sequences without the rings themselves. The length of the bar is proportional to the number of rings in the sequence. Here the four sequences are set at relative positions (offsets) to each other at which they have maximum correlation as measured by the *t*-values. The *t*-value/offset matrix contains the maximum *t*-values below the diagonal and the offsets above it. Thus, the maximum *t*-value between C08 and C45 occurs at the offset of +20 rings and the *t*-value is then 5.6. The site sequence is composed of the average of the corresponding widths, as illustrated with one width.

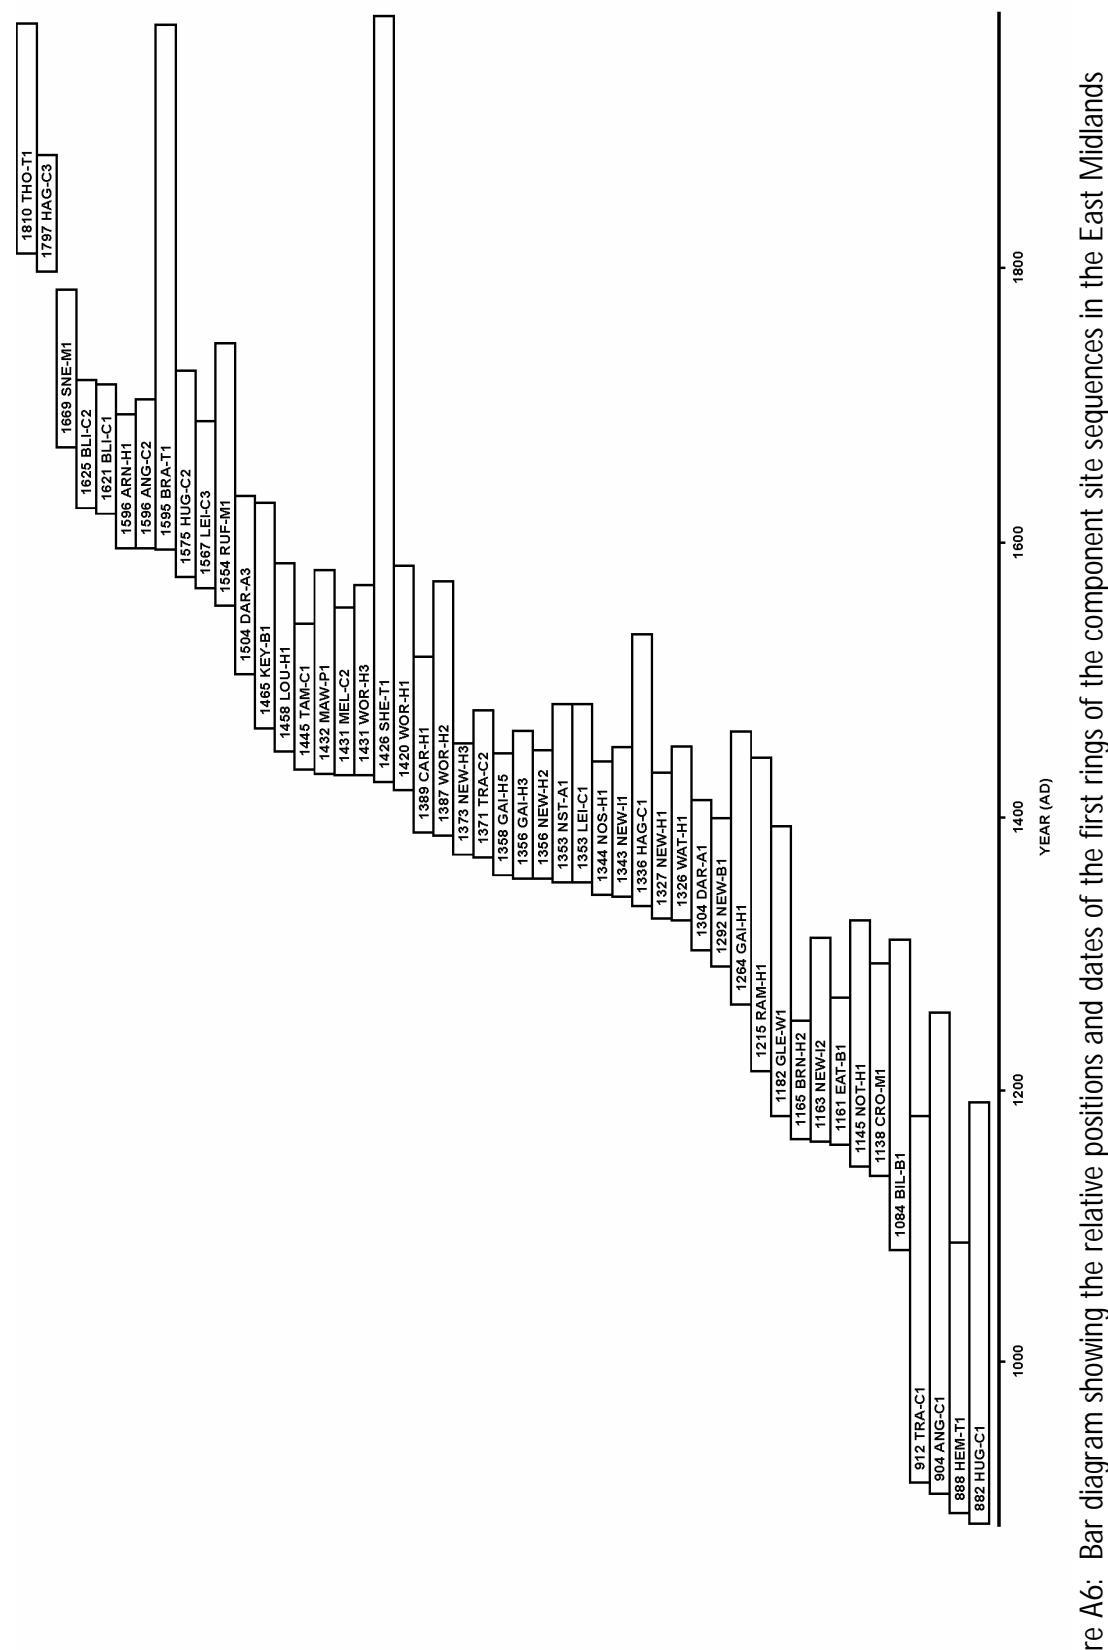
Figure A6: Bar diagram showing the relative positions and dates of the first rings of the component site sequences in the East Midlands Master Dendrochronological Sequence, EM08/87

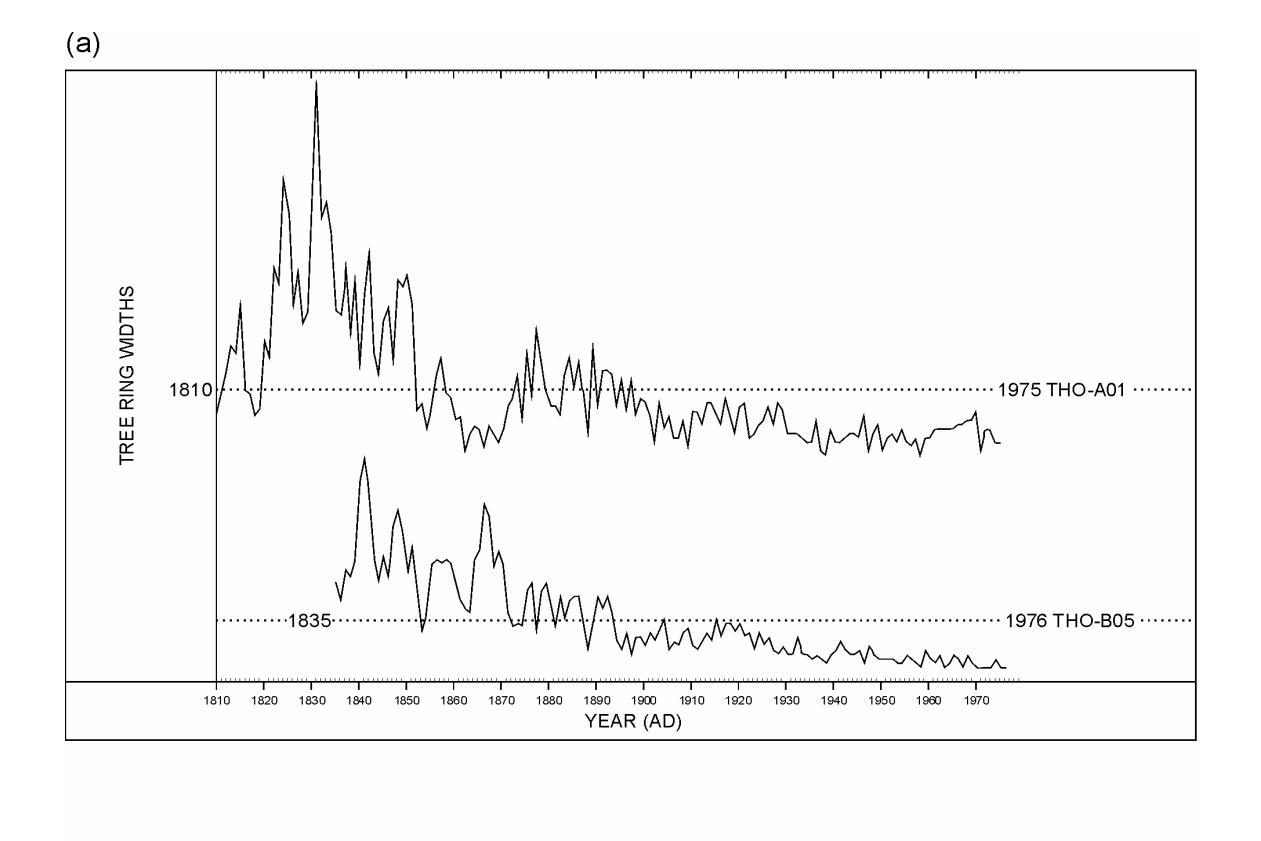
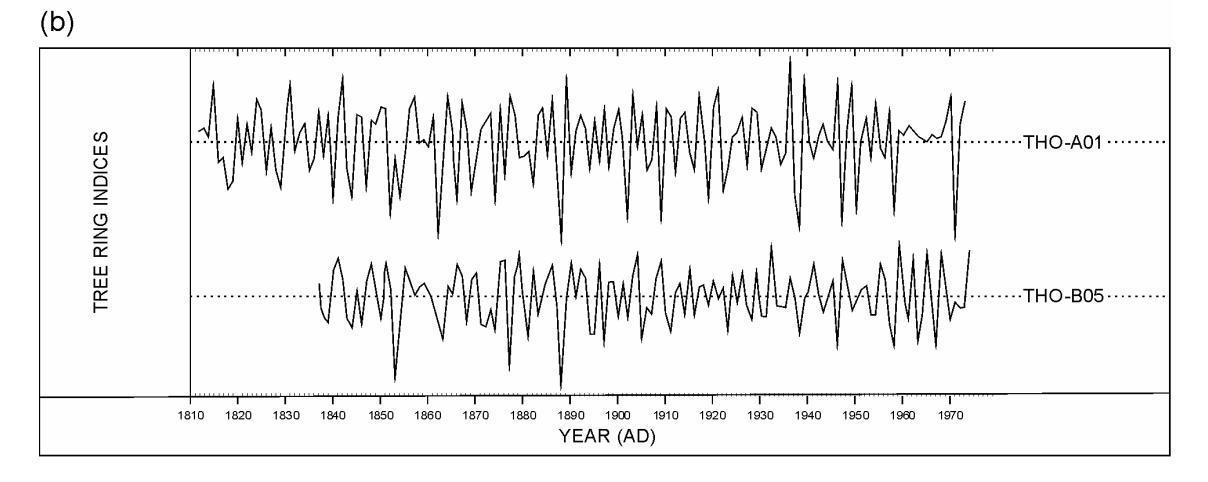
# Figure A7 (a): The raw ring-widths of two samples, THO-A01 and THO-B05, whose felling dates are known

Here the ring widths are plotted vertically, one for each year, so that peaks represent wide rings and troughs narrow ones. Notice the growth-trends in each; on average the earlier rings of the young tree are wider than the later ones of the older tree in both sequences
