ENGLISH HERITAGE

HERITAGE AT
RISK
REGISTER
2011

SOUTH EAST

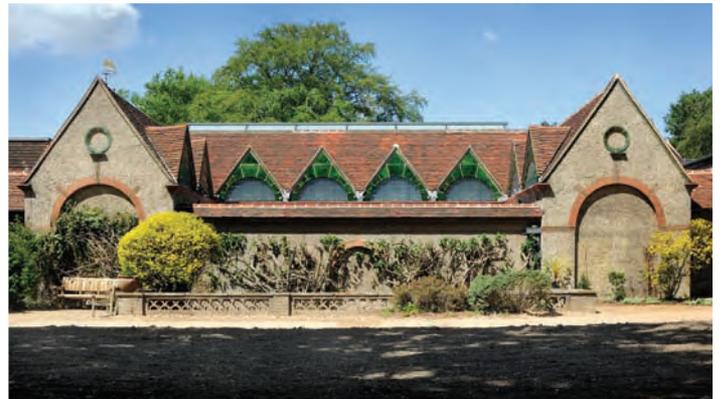
WATTS GALLERY, COMPTON, SURREY

The Watts Gallery was on the Heritage at Risk Register from 2006-2010, and reopened to the public in 2011 after an £11 million restoration project.

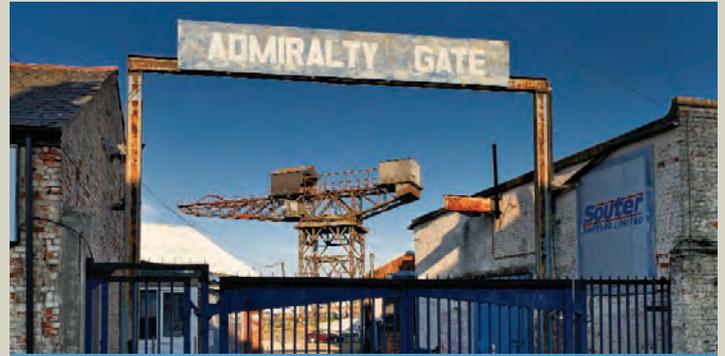
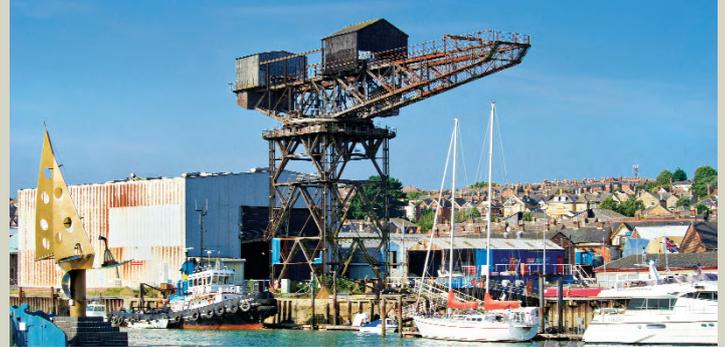
HAMMERHEAD CRANE, COWES, ISLE OF WIGHT

On the Heritage at Risk Register since 2008, this giant cantilever dockyard crane of 1912 is seriously at risk from decay and neglect. English Heritage is supporting the council by offering to underwrite the costs of serving an Urgent Works Notice on the owners to immediately address the most rapidly deteriorating elements of the structure.
