ENGLISH HERITAGE

HERITAGE AT
RISK
REGISTER
2011

SOUTH WEST

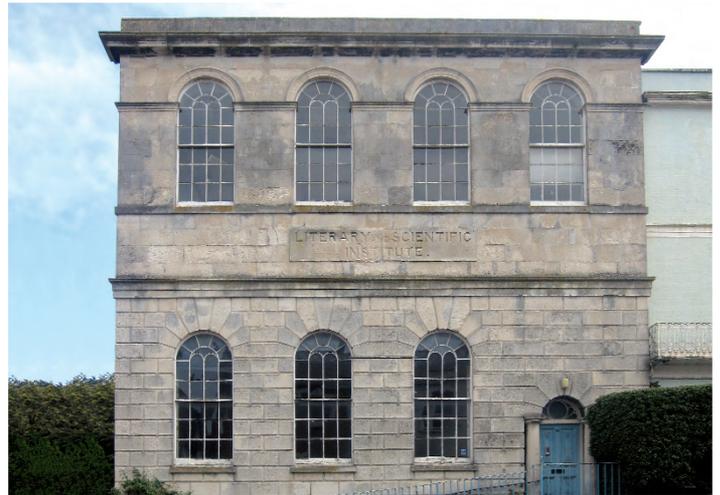
LITERARY AND SCIENTIFIC INSTITUTE, BRIDPORT, WEST DORSET

Making progress: The Bridport Area Development Trust will develop a project to repair the Literary and Scientific Institute and to find a new use consistent with its original purpose.

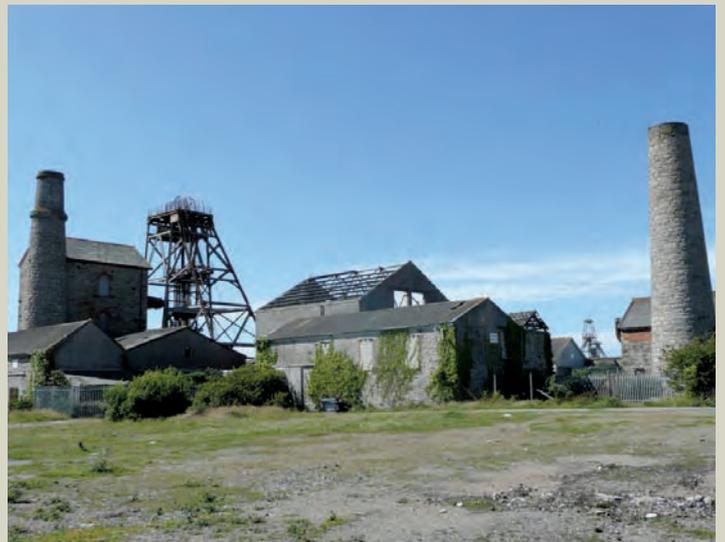
ROBINSON'S SHAFT, SOUTH CROFTY, CORNWALL

Robinson's Shaft complex is an early C20 development at the last working tin mine in Europe. The complex has suffered from redundancy, neglect and vandalism, but with significant public funding, it will be the centrepiece of a regeneration project to provide work, employment and greenspace for former mining communities
