ENGLISH HERITAGE

HERITAGE AT
RISK
REGISTER
2012

SOUTH EAST

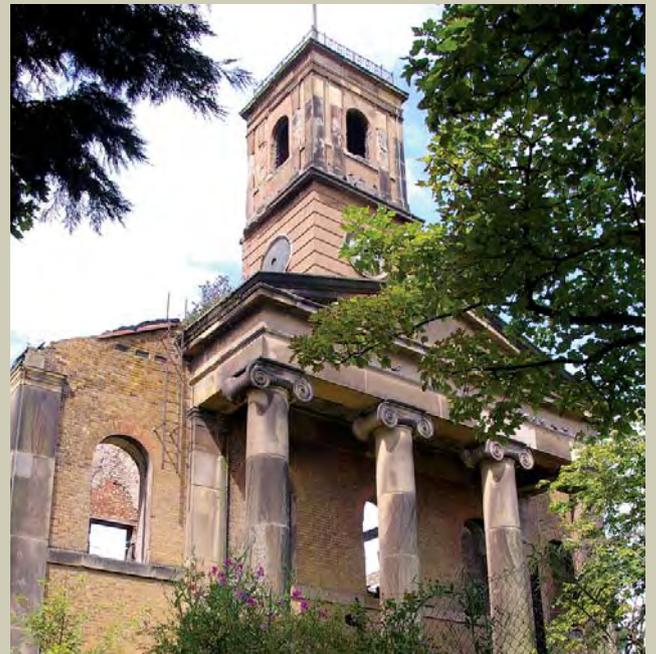
DOCKYARD CHURCH, SHEERNESS, KENT

Built to serve the new Sheerness Dockyard and now a grade II* listed building at risk, the former St Paul's church has lain empty since 1970. English Heritage is supporting Swale Borough Council's plan to compulsorily purchase the church so that a building preservation trust can restore it to beneficial use.
