ENGLISH HERITAGE

HERITAGE AT
RISK
REGISTER
2013

WEST MIDLANDS

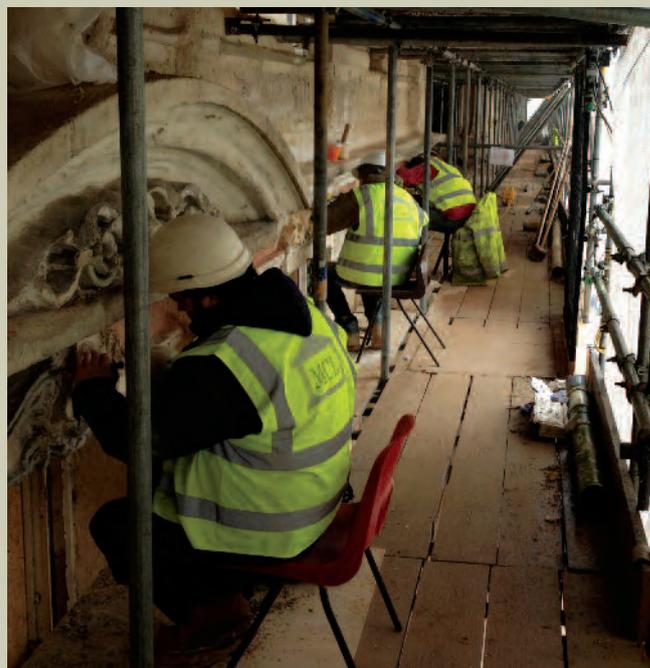
GRAND HOTEL, BIRMINGHAM

With the help of a grant from English Heritage, masons are working to chip away coatings of cement-based repairs and paints from the façade of the Grand Hotel in Birmingham. They are uncovering and repairing the original stonework and making the elevation stable to remove the building from risk.

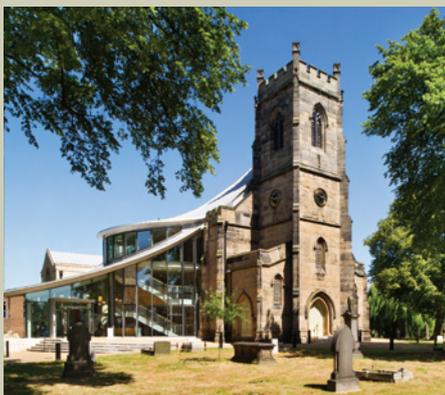
ST BARNABAS CHURCH, ERDINGTON, BIRMINGHAM

In 2007 an arson attack destroyed the church roof and the interior. The building was added to the Heritage at Risk Register in 2011 when places of worship were first added to the Heritage at Risk Register. For six years the congregation worshipped in a series of temporary locations while plans were made, funds were raised and repairs were carried out. The fire had destroyed the roof entirely and damaged the walls so that they could no longer take the load of a new roof. After much debate, a scheme which conserved as much of the historic building as possible and replaced missing elements with contemporary architecture was approved.

The church was put on English Heritage's Heritage at Risk Register in 2011. It has been removed in 2013 following full repair and re-opening.
