ENGLISH HERITAGE

HERITAGE AT
RISK
REGISTER
2014

EAST OF ENGLAND

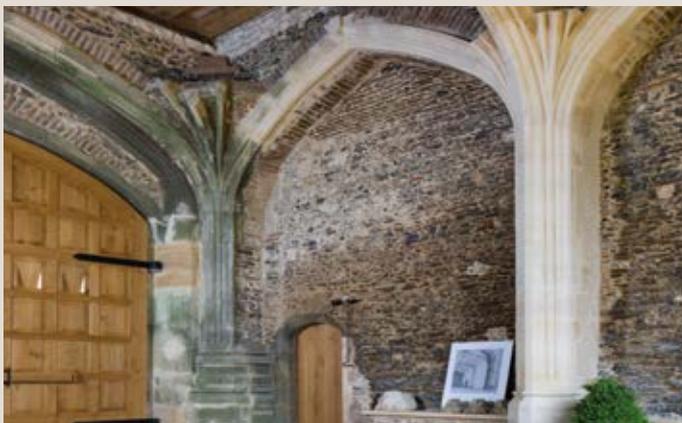
REMAINS OF AUGUSTINIAN PRIORY GATEHOUSE, PENTNEY, NORFOLK

the first floor structure and vault over the carriageway and the upper parts of the two internal supporting walls had collapsed. As a result, the outer walls had lost structural integrity. Parapets and upper masonry were all in precarious condition, with strong likelihood of further collapse. Some internal scaffolding had previously been erected in an attempt to brace the external walls, but the central gate passage was buried in places by up to 2 metres of collapsed material.

Pentney Priory Gatehouse was on the Buildings at Risk Register from 1998. It was removed this year following a significant scheme and two phases of repair. In January 2012, a Project Development grant was offered from English Heritage. Work began immediately, project managed by the owner, on the erection of internal and external scaffolding, and a temporary roof. At the same time, an archaeological brief was agreed and the excavation of collapsed stonework began under close archaeological supervision.

Phase 2 repair works were confined to imperative external and internal structural repairs, high and low level masonry, and the provision of a roof. This has restored structural integrity to the upper sections of the medieval stonework, ensured adequate rainwater disposal and prevented further loss of internal surfaces and finishes. The owners undertook further works in order to bring the building back into use as an events or wedding venue. All works were completed by December 2013.

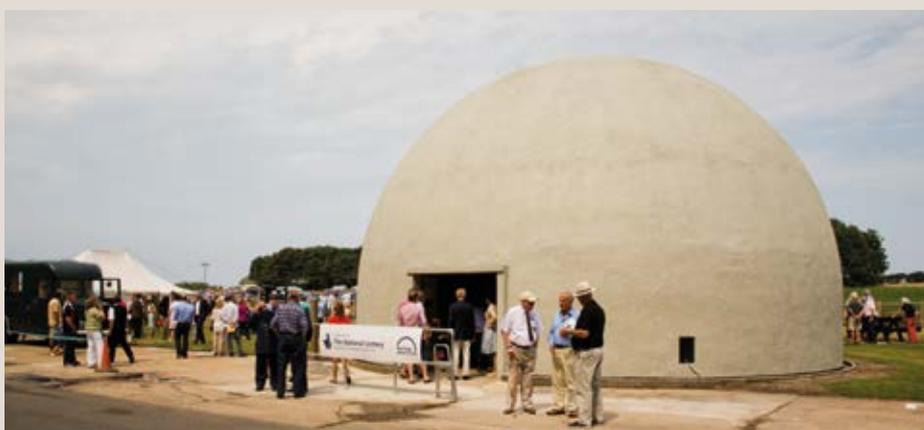
LANGHAM AIRFIELD DOME TRAINER, LANGHAM, NORFOLK

The dome was only in use for the second half of the second world war and has deteriorated steadily since the closure of the airfield. The concrete had carbonated and no longer gave protection to the main reinforcing steelwork, which had begun to rust and expand, thereby breaking the concrete and allowing further water penetration. This led to extensive rusting internally and the failing of the plasterwork. All services and equipment were missing.

No. Langham Dome was on the Heritage at Risk Register from 1998 to 2013. The conservation and restoration works have been completed and the dome has been removed from the Register this year. The repair and preservation of rusting ferro-concrete structures is a highly technical and specialist business, but it has been successfully achieved at Langham Dome to an exemplary standard.
