ENGLISH HERITAGE

HERITAGE AT
RISK
REGISTER
2014

SOUTH EAST

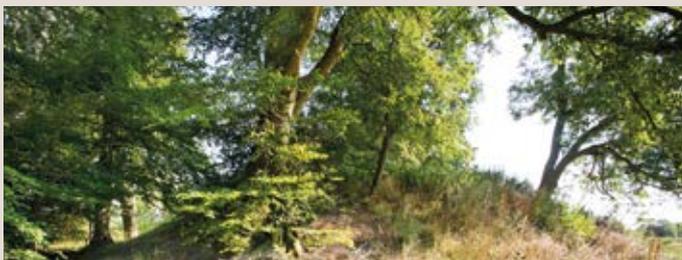
BESBURY LANE BOWL BARROW AND SHIPTON BARROW, WEST OXFORDSHIRE

Volunteers will monitor the sites and clear vegetation. At Besbury the beech trees were left as they are now mature and have probably caused all the damage they are likely to whilst growing. The trees also make an impressive contribution to the landscape. They will be monitored for any signs of instability, and monitoring for badgers will be undertaken. These monitoring and management arrangements are being facilitated by English Heritage.

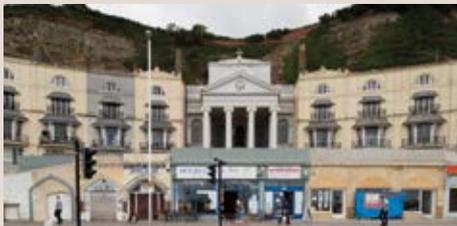
PELHAM ARCADE, HASTINGS, EAST SUSSEX

Much of the lantern light has been covered in different materials and is badly damaged, causing water ingress to the shops below. Further water ingress problems have been caused by the access road to St Mary in the Castle and the Pelham Crescent properties. The roof/road has been patchily repaired over the years and has suffered damage through the use of heavy motor vehicles, for

English Heritage has been working closely with Hastings Borough Council since early 2010. A joint grant scheme has been made available to the owners of the individual shops in order to address urgent repair works to the lantern light and to restore the 19th century rusticated façade. The scheme also includes fitting new shop fronts in a Gothick style, to make a more unified appearance.

Much progress has been made with grant-aided repair works to the lantern light and other urgent repairs at several units, including 6, 7 and 8. Work here was completed in late summer 2014 and this part of the arcade is now open as the café to St Mary in the Castle. The café also acts as the entrance to St Mary in the Castle, with access through an underground passage. Grant offers have also been made to two other owners, but works have not yet begun on site. Hastings Borough Council has been working hard to encourage the remaining owners to join the scheme so that the repaired arcade can once again be a proud focal point for the seaside resort of Hastings.
