ENGLISH HERITAGE

HERITAGE AT
RISK
REGISTER
2014

WEST MIDLANDS

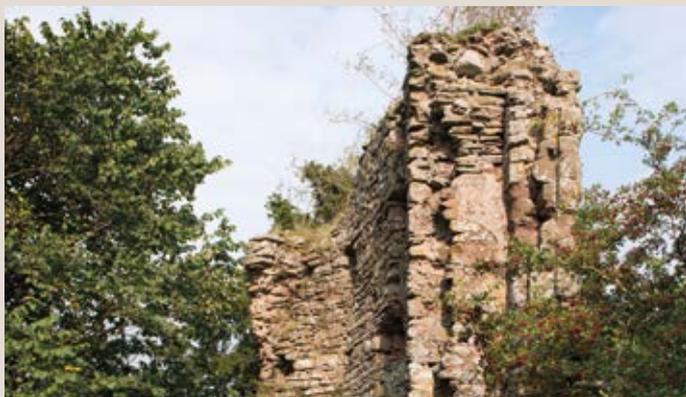
SNODHILL CASTLE, SNODHILL, HEREFORDSHIRE

Snodhill Castle has been at risk since 1998; it is one of our top ten priorities in the West Midlands. The prime concerns are the unstable condition of some sections of the walls to the bailey and the keep. The motte is also home to badgers whose sets have undermined the walls. Unmanaged trees have collapsed, crushing areas of wall beneath them to the point where the remains of the keep and great hall are under threat. Ivy infests the remains of the bailey towers.

In 2013 English Heritage helped to negotiate a long lease of the castle to the locally based Vivat Trust. Vivat organised volunteers to carry out vegetation clearance and English Heritage had the monument fully surveyed. Our engineers and architects have inspected the upstanding remains and identified priorities for urgent stabilisation works. We will be working with the Trust over the next year to undertake a more detailed condition survey, design a programme of urgent repairs and source funding. At the same time, we hope to explore the scope for a community based Heritage Lottery Fund project. This would deliver longer term conservation and management of the site with improved access, interpretation and community involvement.
