ENGLISH HERITAGE

HERITAGE AT
RISK
REGISTER
2009

WEST MIDLANDS

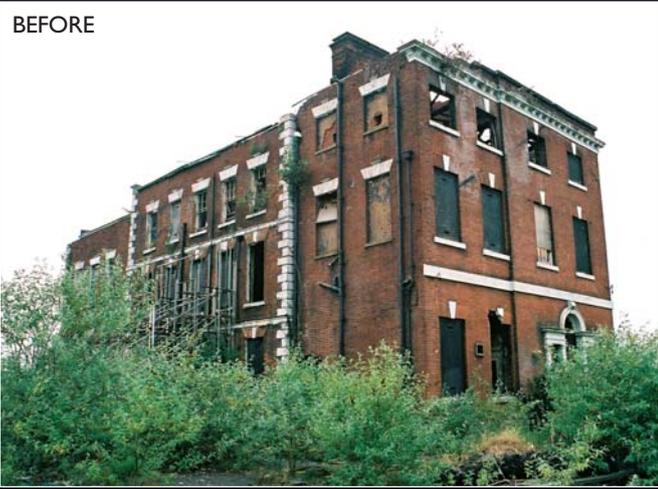
MOLINEUX HOTEL, WOLVERHAMPTON

Built as an elegant Georgian residence for the local ironmaster, Benjamin Molineux, in the 1720s, the building became a hotel in the late 19th-century. After a long period of decline it was one of the first buildings to be placed on the Buildings at Risk Register. In 2004 it was acquired by the City Council, since when English Heritage, the Regional Development Agency and City Council have jointly funded essential repairs and restoration of key elements of the interior. The final phase of works, supported by the Heritage Lottery Fund, comprised the adaptation and extension of the building to form the City Archives and Local Studies Centre. Main image © Donald Insall Associates

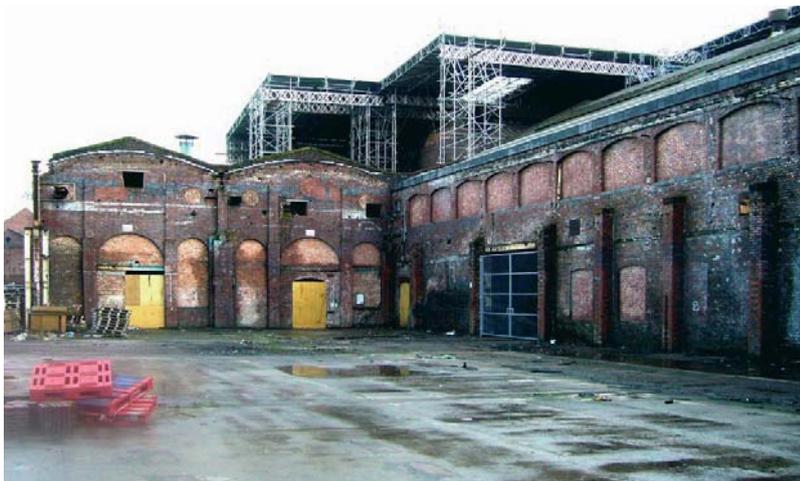
SOHO FOUNDRY, SMETHWICK

The Soho Foundry was built in 1794-5 for Matthew Boulton and James Watt to manufacture steam engines more efficiently, but today the huge interiors are empty and derelict. In 2007 a business plan concluded that there was considerable scope for a regeneration project involving new uses such as sport, leisure and light business. Meanwhile, the structures were at risk of collapse. English Heritage therefore entered into a funding partnership with the owners and the local authority to make the main foundry building weather-proof and structurally stable while a long-term solution is being worked up.

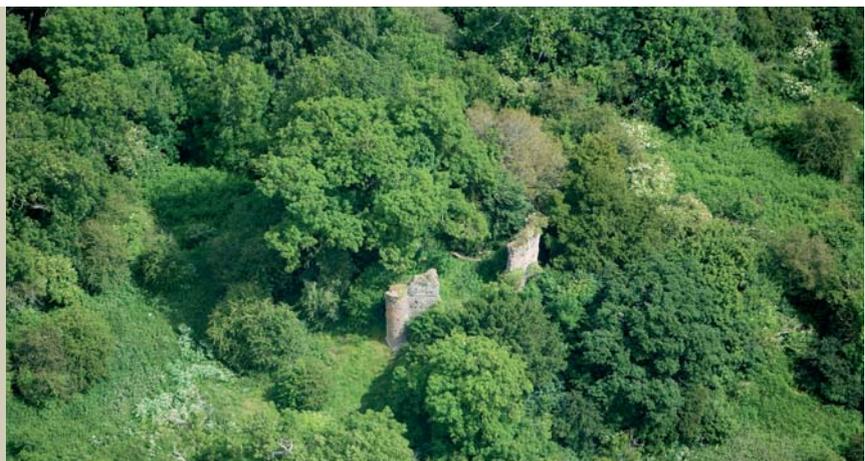
SNODHILL CASTLE IN HEREFORDSHIRE

Since its private purchase in the 1970s this important medieval border castle has been totally neglected, with the masonry visibly deteriorating, cracks widening, and the site swamped with invasive vegetation. Once the focal point of a small rural community it has become virtually inaccessible. Unfortunately all efforts to engage with the owners have thus far been unsuccessful.

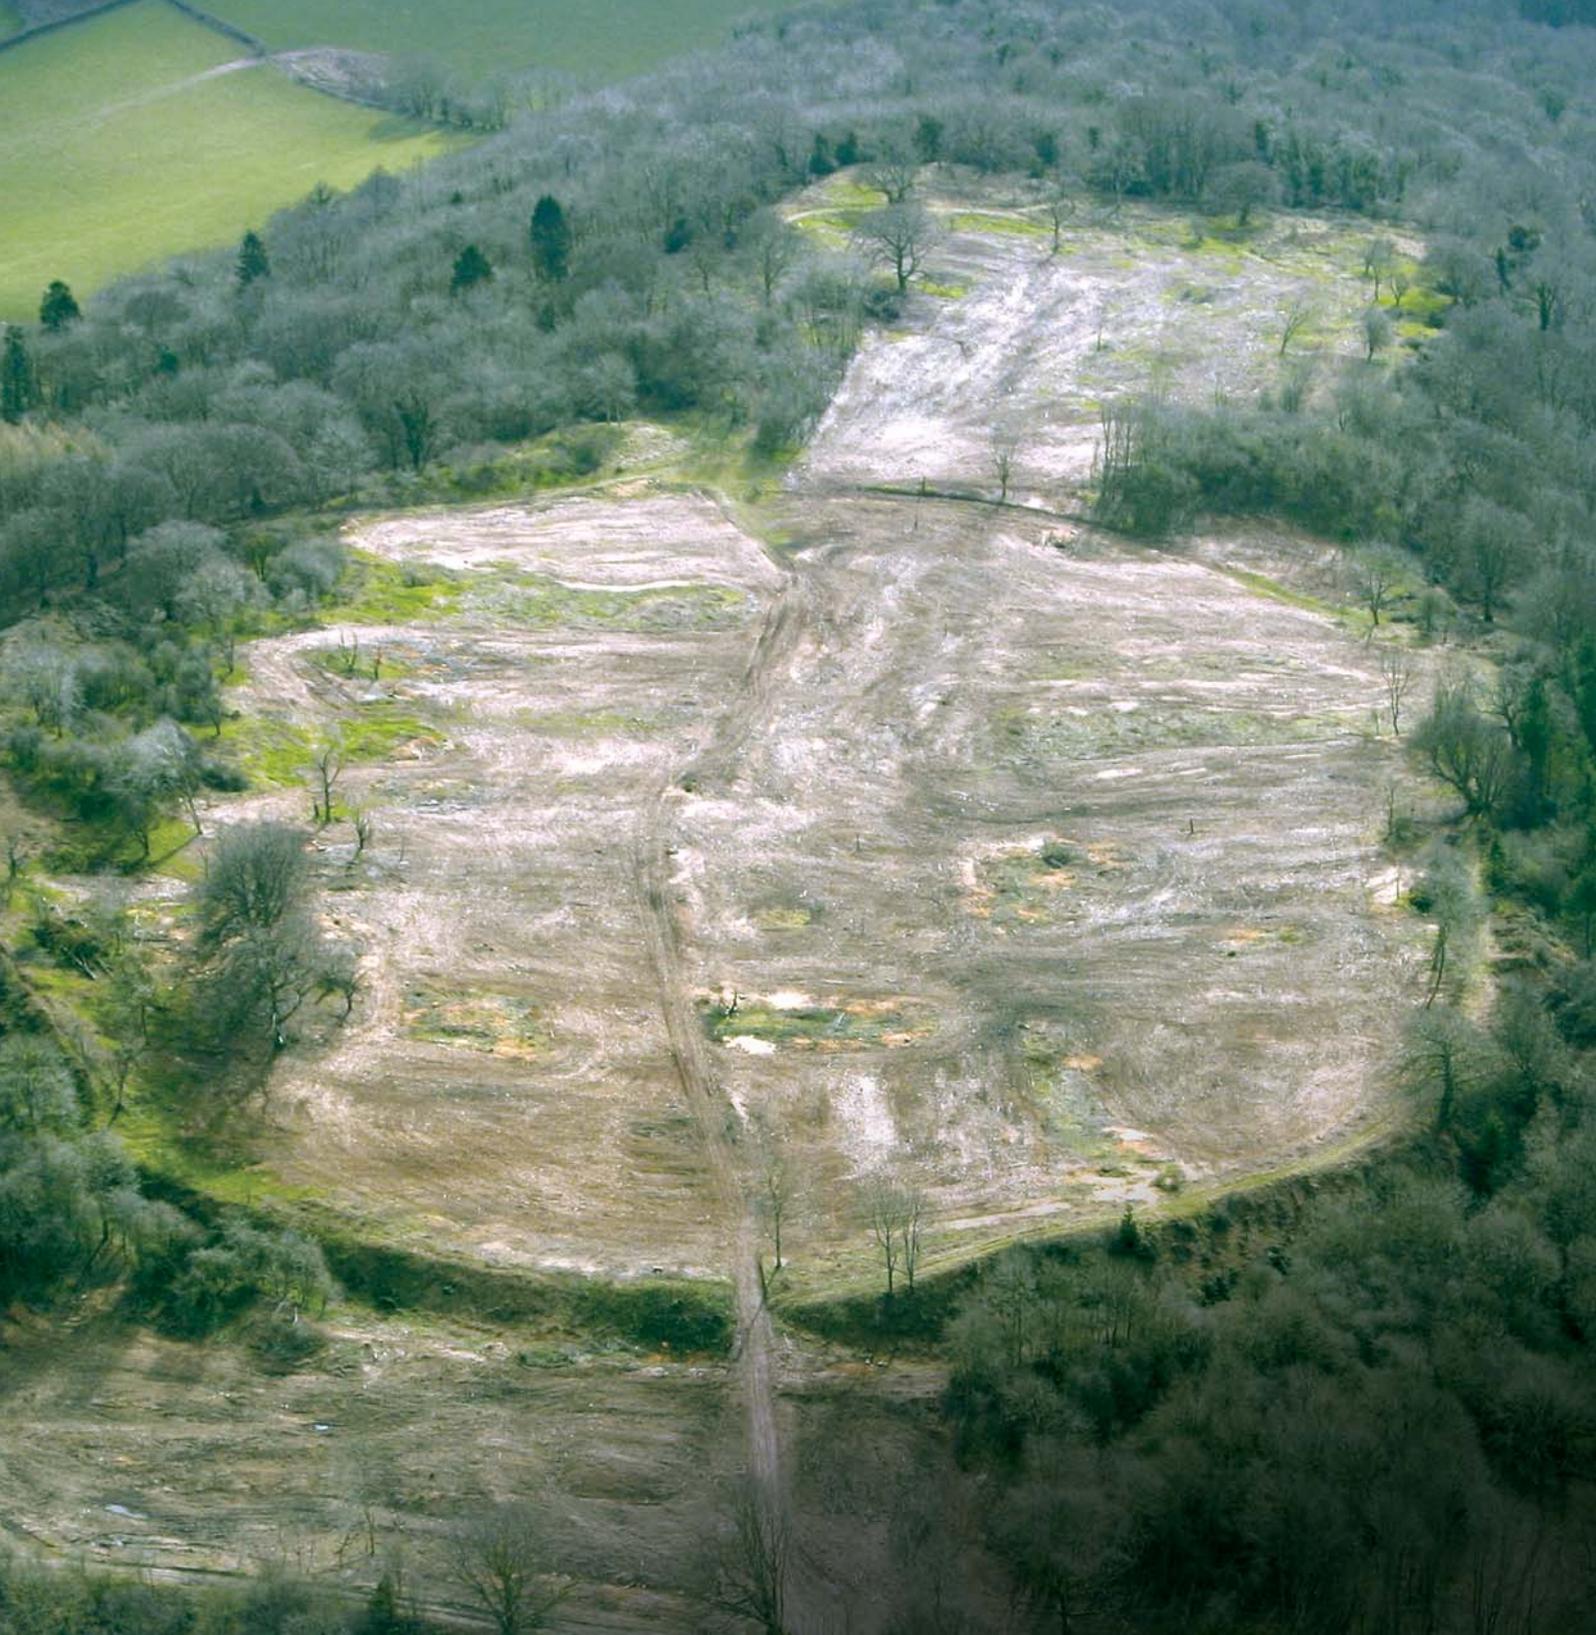
LITTLE DOWARD CAMP, HEREFORDSHIRE

This Iron Age hill fort lies in a strategic position high above the Wye Valley. In the mid-20th century the interior was planted with conifers and the well-preserved earthwork became invisible. After extensive discussion between Herefordshire Archaeology and the site's new owner, the Woodland Trust, the conifer plantation was felled and the monument revealed anew. Limited fencing and a new water supply will allow a grazing herd of cattle to help control vegetation and allow the land to return to a traditional mix of upland pasture, managed scrub and veteran trees for long-term public enjoyment.

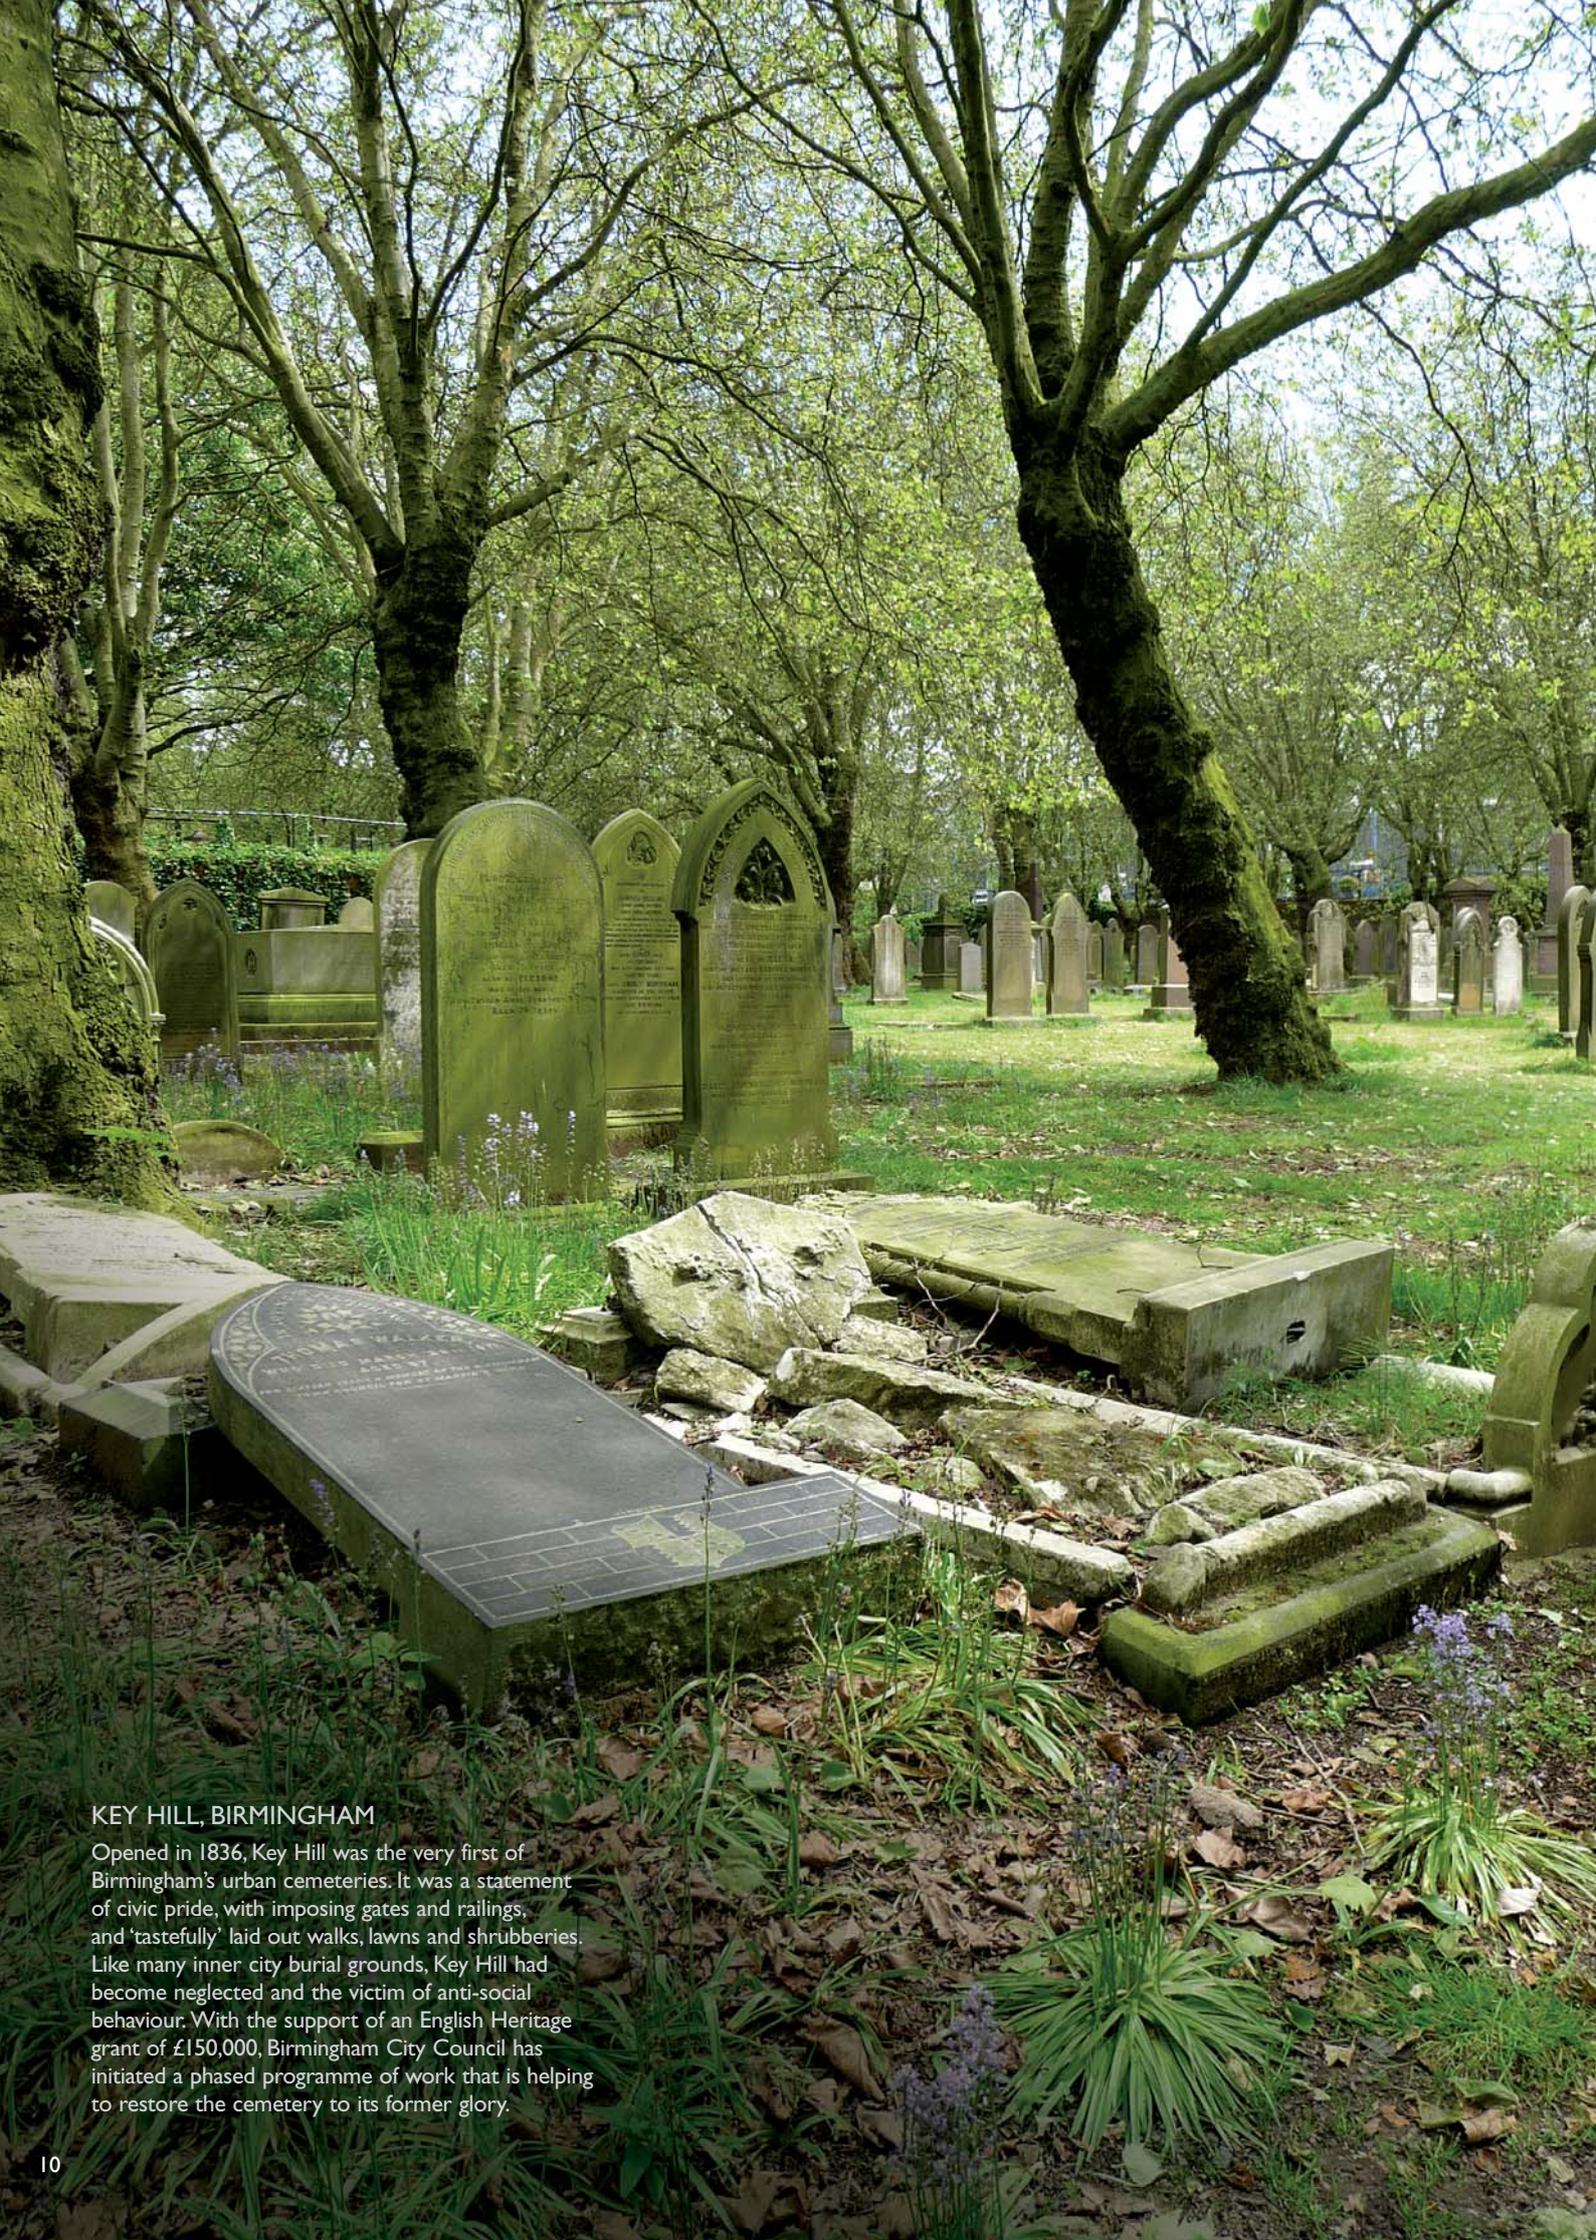
KEY HILL, BIRMINGHAM

Opened in 1836, Key Hill was the very first of Birmingham's urban cemeteries. It was a statement of civic pride, with imposing gates and railings, and 'tastefully' laid out walks, lawns and shrubberies. Like many inner city burial grounds, Key Hill had become neglected and the victim of anti-social behaviour. With the support of an English Heritage grant of £150,000, Birmingham City Council has initiated a phased programme of work that is helping to restore the cemetery to its former glory.

In the West Midlands we are already working with Birmingham City Council to grant-aid the restoration of the important but vulnerable 19th-century cemetery at Key Hill in the city's Jewellery Quarter. In future we hope to engage with our many partners across the region to formulate similarly creative solutions to other landscapes at risk.

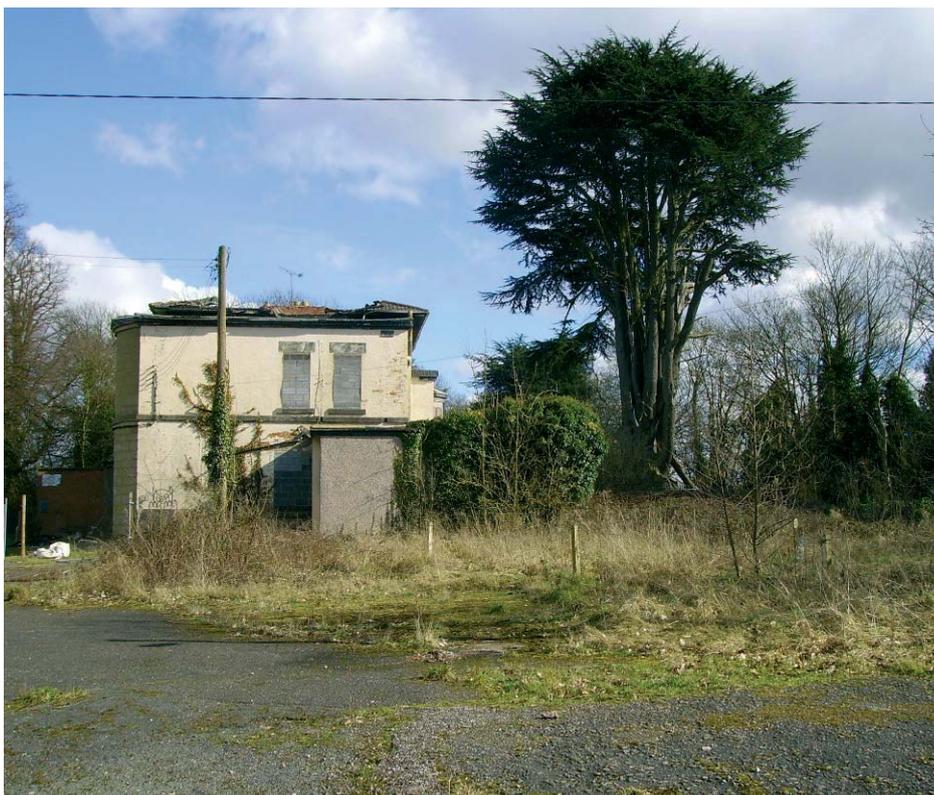
RYTON HOUSE NEAR COVENTRY

An estate in miniature: woodland belts, shrubberies, lawns, lakes, and an orchard formerly surrounding an elegant Regency villa. The villa itself, in recent years occupied by the British Legion, is now boarded up and derelict. The grounds (Grade II), already encroached upon by unsympathetic extensions to the house and hard standing for cars, appear to have been abandoned. It is believed that some of the garden fabric, including estate railings and balustrading, has been stripped from the site. Nevertheless, this rare survival of bourgeois garden design of the early 19th century deserves a better fate.

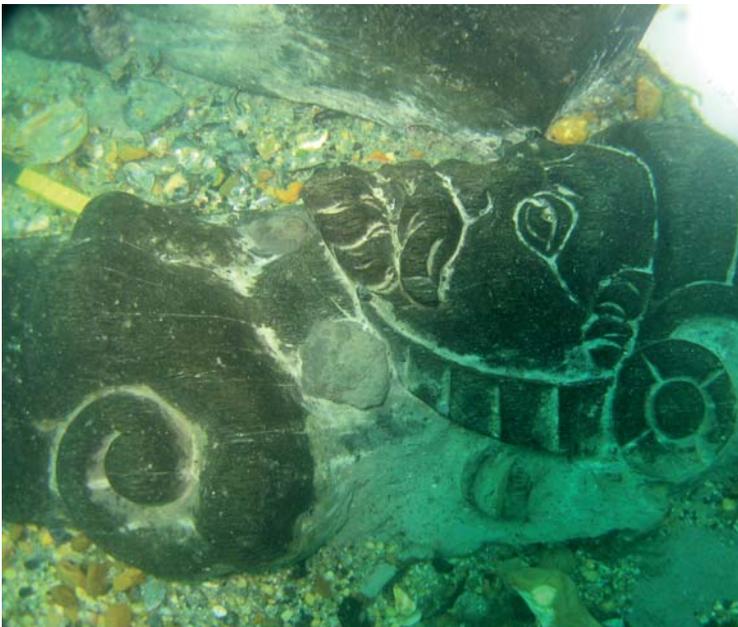
SWASH CHANNEL WRECK, DORSET

In October 2004, archaeological assessment work in advance of channel deepening in Poole Harbour led to the discovery of this previously unrecorded wreck. A recovered fragment of Rhenish stoneware and the general form of the surviving structure of the vessel both suggest an early 17th-century ship, probably an armed vessel. Because of its national significance, the wreck was designated in December 2004. However, it is unstable and subject to dramatic shifts in exposure. Monitoring by Bournemouth University showed that 300mm of sediment had been lost across the site in just two years, resulting in the exposure of further sections of the ship to the destructive force of the sea. The vessel is now deemed to be at risk and English Heritage is working with Bournemouth University to implement a management plan to mitigate the loss. © Bournemouth University

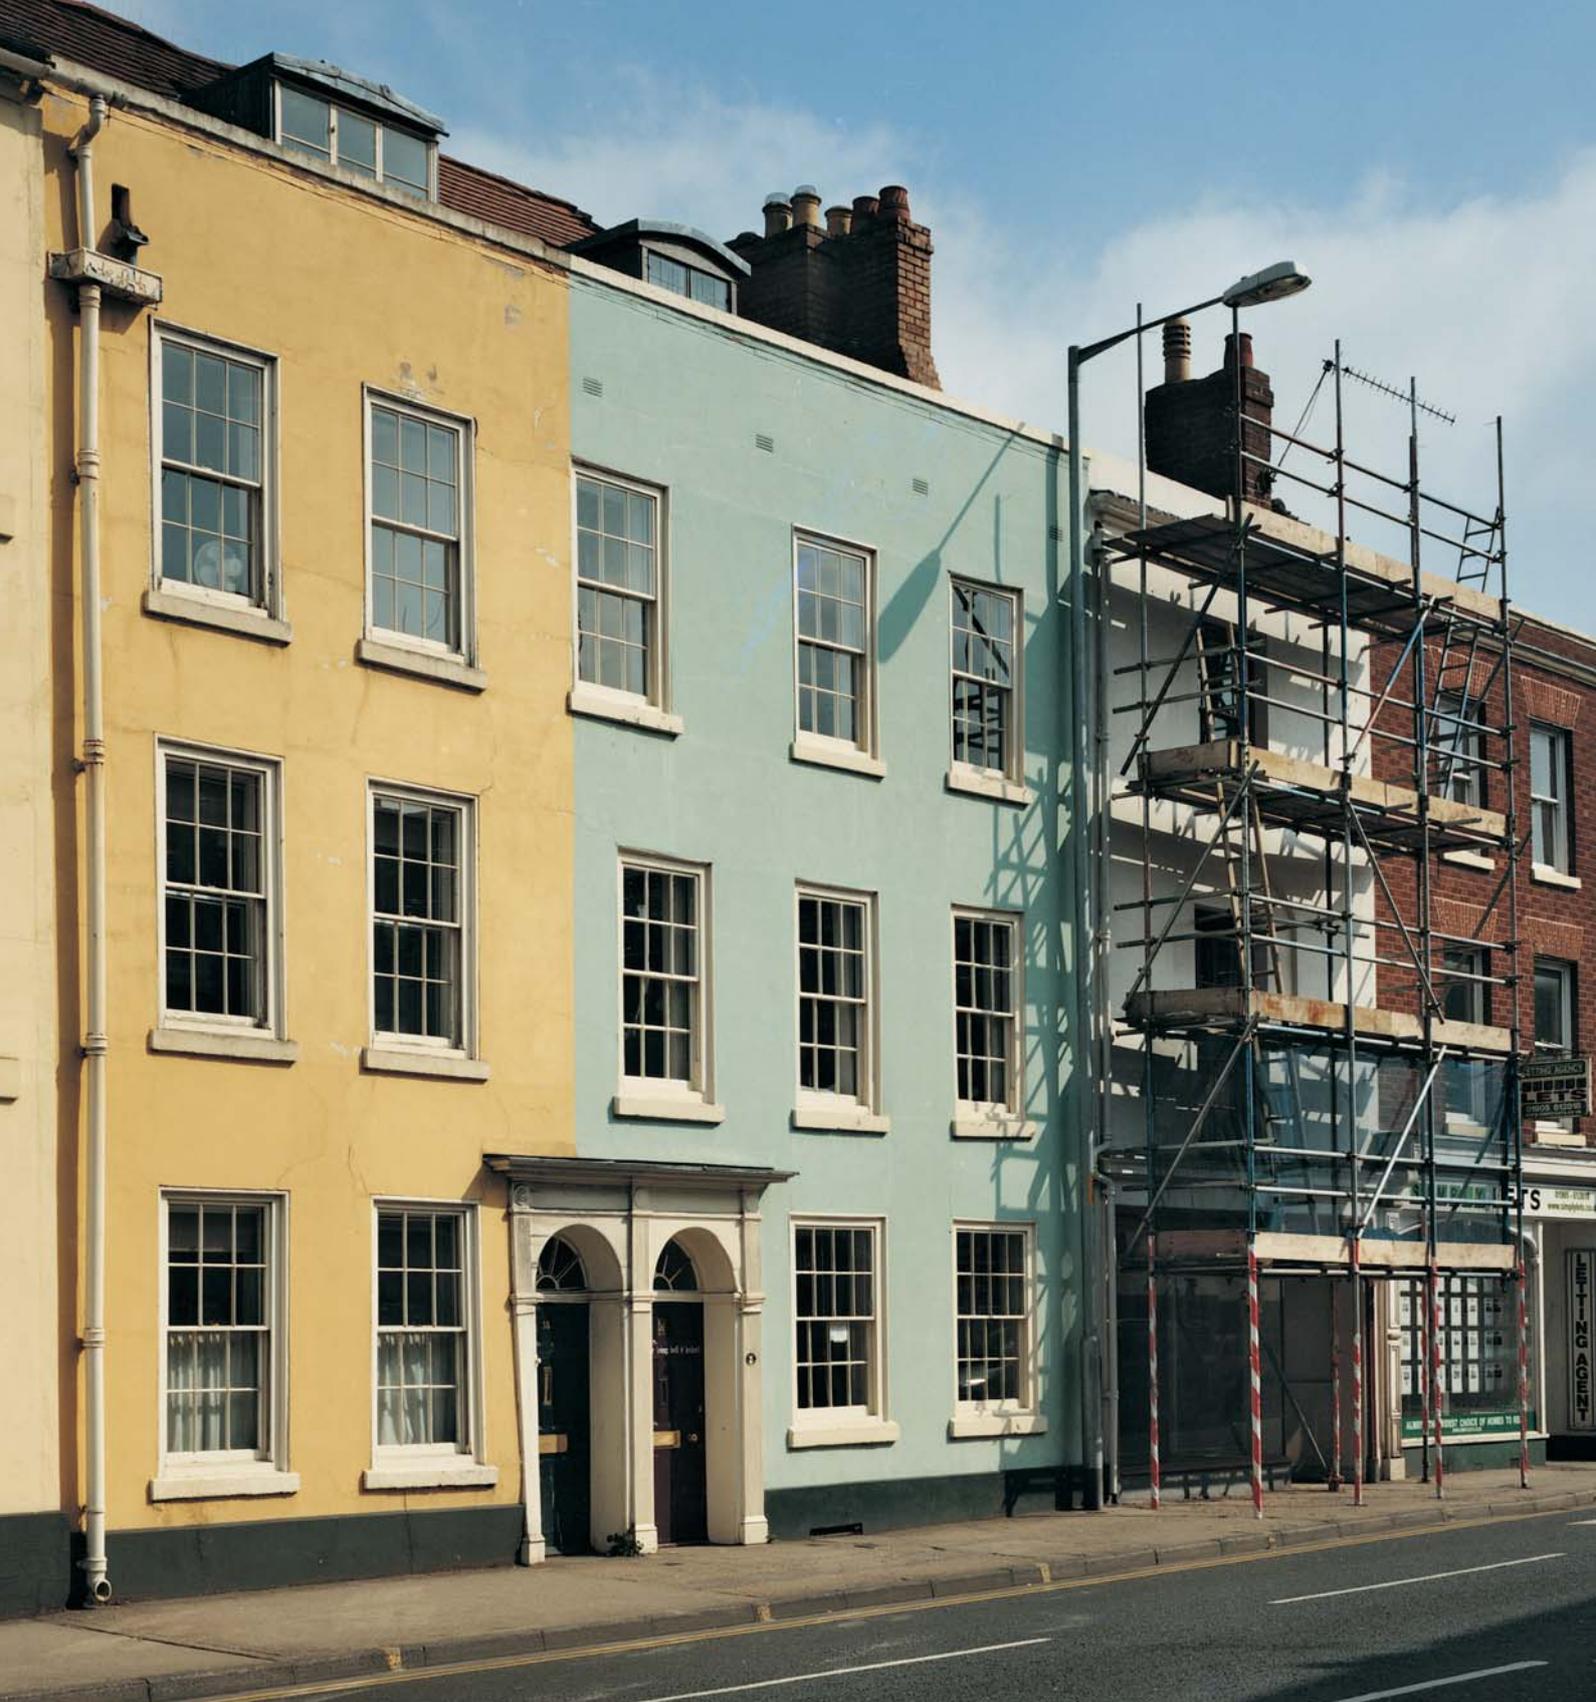
FOREGATE STREET AND THE TYTHING, WORCESTER

Despite its great architectural and historic interest, many of the area's buildings are in poor repair or have suffered ill-considered alterations. In 2007 Worcester City Council and English Heritage entered a partnership to reverse the area's steady decline. With grant funding of £100,000 per year for three years, 21 properties have already had works completed or are targeted for treatment. Building fabric has been repaired, unsuitable alterations reversed and vacant upper floors brought back into use.

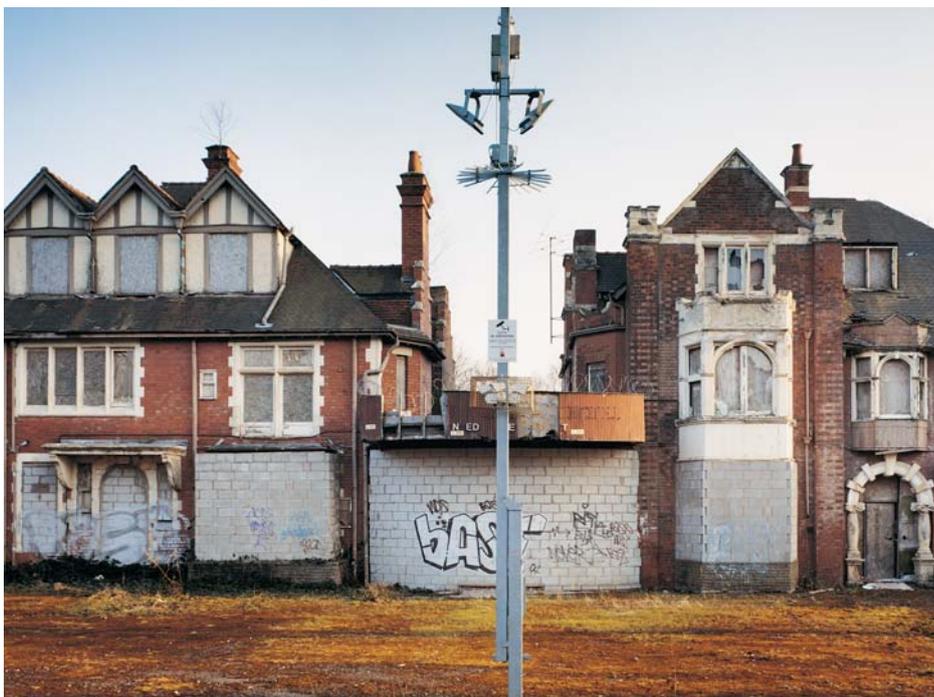
BARNSELEY ROAD, BIRMINGHAM

In Birmingham's generally prosperous suburb of Edgbaston, the Barnsley Road conservation area is mostly well looked-after but rendered 'at risk' by a pocket of dereliction and decay. A group of seven large properties, some previously in hotel use, present a grim picture to the many people who pass the site each day on the busy Hagley Road. Despite the best efforts of the local authority, economic and institutional hurdles have so far prevented proposals for the reuse of the buildings from coming to fruition.
