Historic England

Stained Glass Windows

Managing Environmental Deterioration

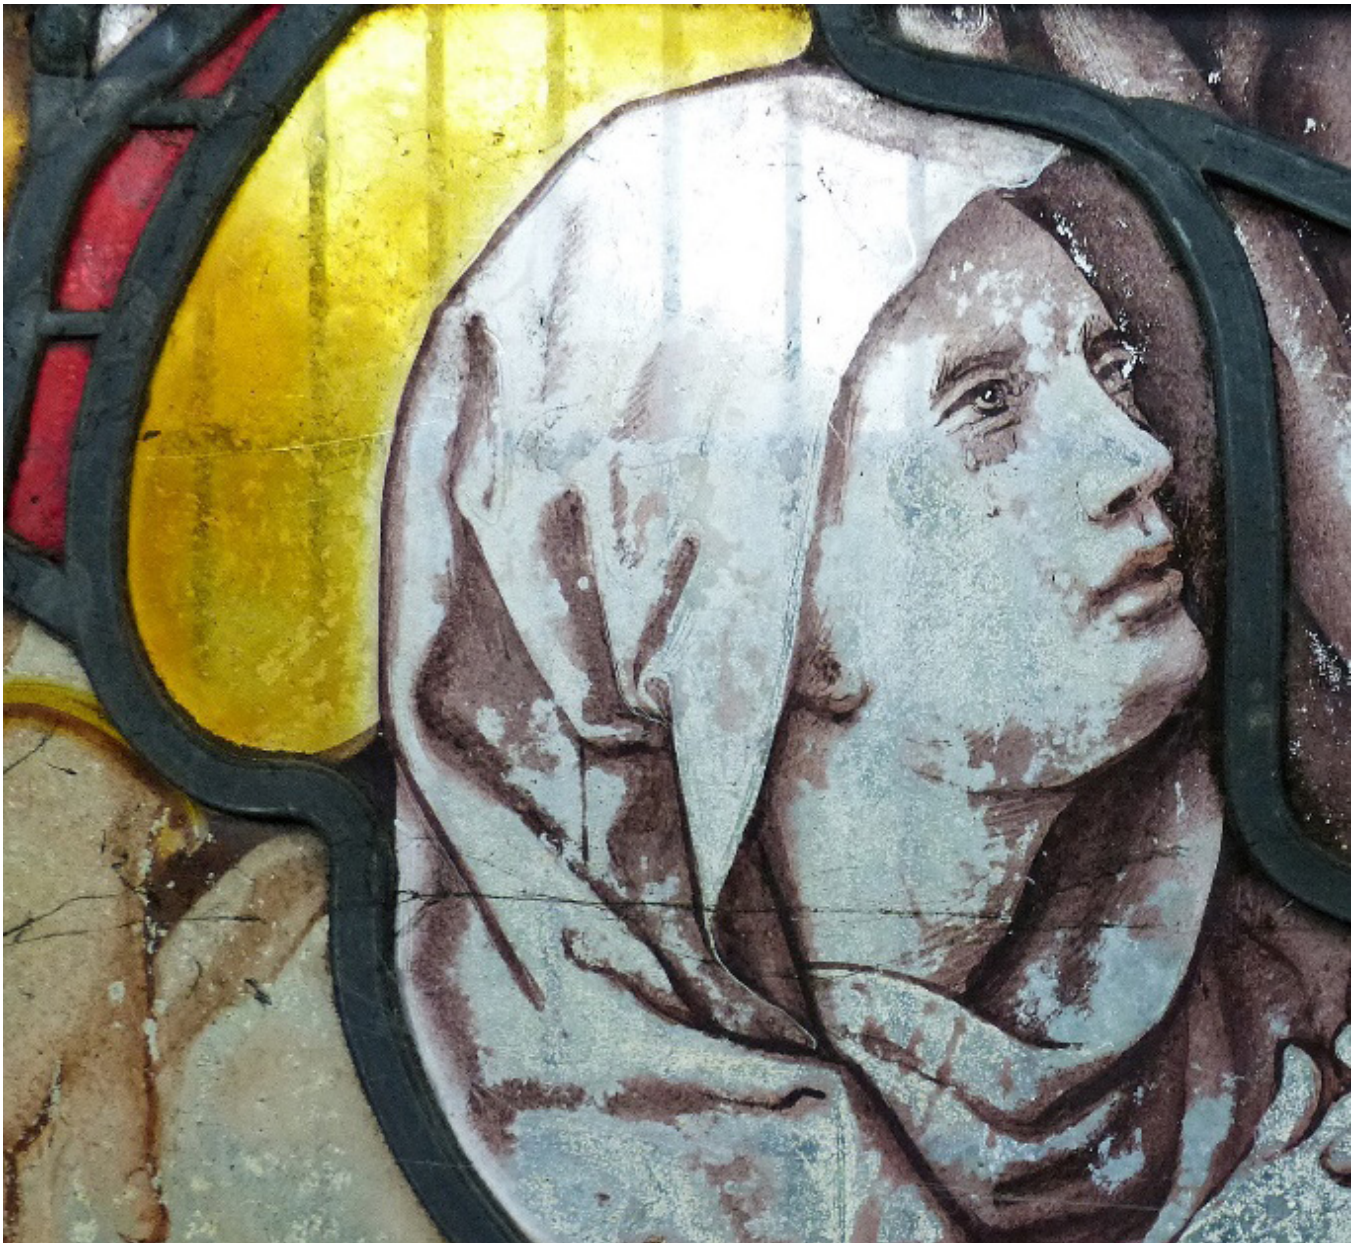
Front cover
Exposure to the building environment is the major cause of stained glass deterioration. Here, moisture has led to the flaking and loss of painted decoration.
(© Tobit Curteis Associates)

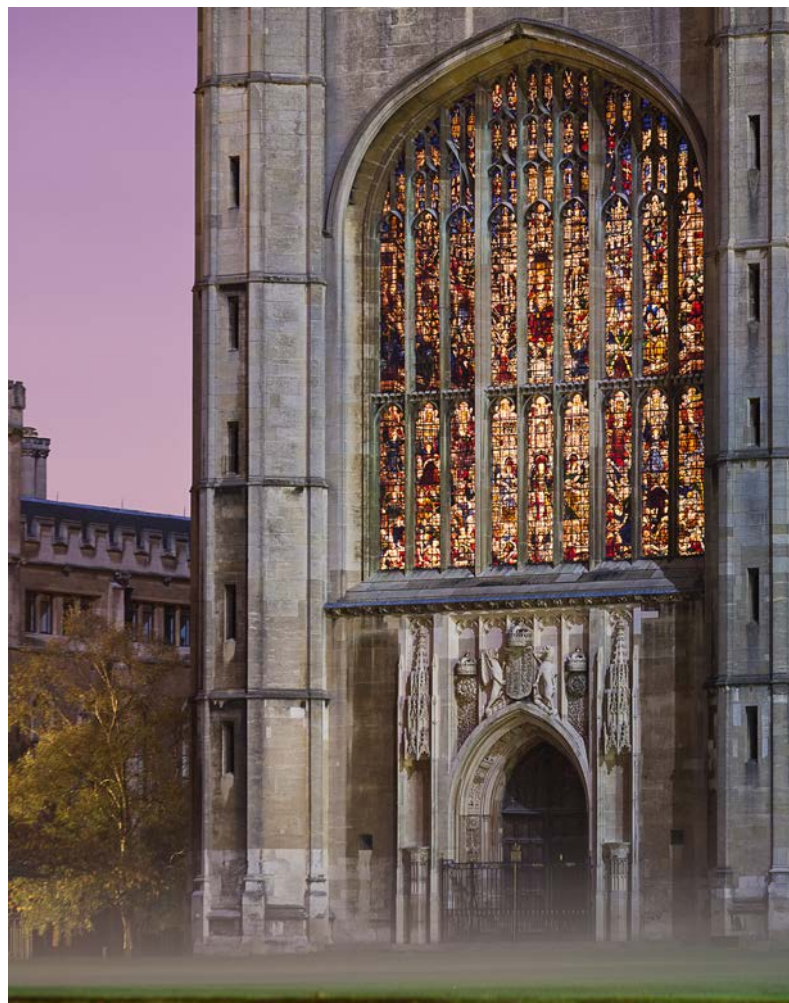
Figures 1–2
King's College Chapel,
Cambridge
Decorative glazing is
not only beautiful from
the interior, but also
contributes greatly to
the exterior views of the
building. During the day,
the reflections from the
many small panes of glass
shimmer and sparkle as
the viewer moves (top); at
night, when lit from within,
the windows glow with
colour (bottom).

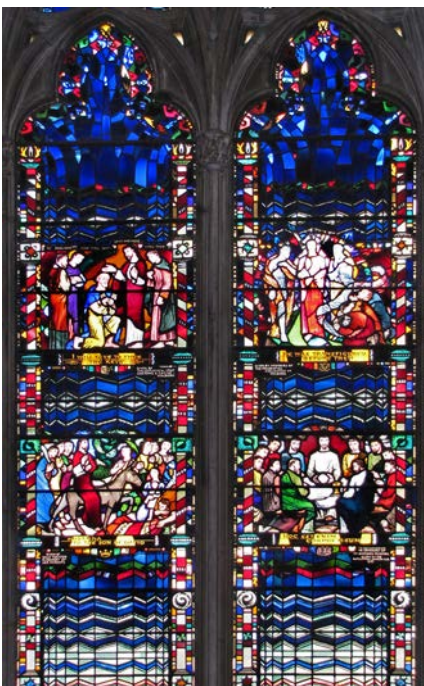
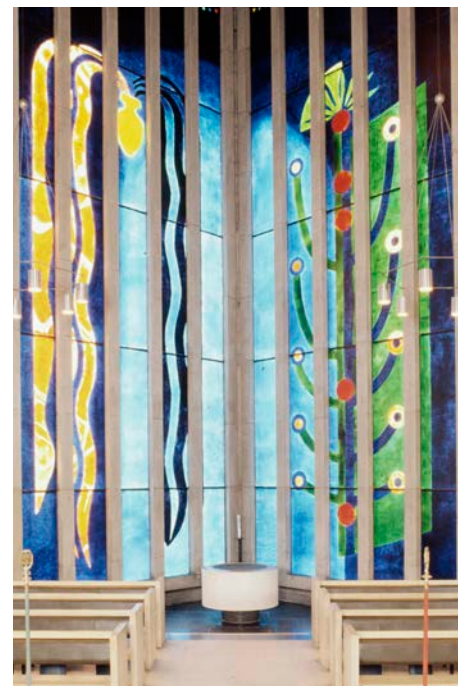
Figures 3–5

A wide range of techniques and materials are used to make decorative windows. Left: London St Etheldreda (Charles Blakeman). By far the most common variant is traditional stained glass, where small pieces of coloured and painted glass are held in a lead matrix that is both functional and decorative.

Over many centuries, glaziers have developed an enormous range of techniques and materials for producing decorative windows, but by far the most common is the familiar 'stained glass' system first developed in medieval Europe. Small pieces of thin glass coloured by metallic oxides are decorated with various translucent and opaque coatings and paints, which are either fired onto the glass in a kiln, or (very rarely) applied 'cold'. The decorated pieces are then joined together to make panels by being slotted into 'comes' or 'calmes' (strips of soft metal – usually lead – cast or milled to make an 'H' in cross section). The comes are then soldered together to form a panel. The 'net' of lead is not merely functional, but a critical part of the design. Since at least the 16th century, special 'lead-light' cements have been used to stop rainwater penetrating the finished window.

The completed panels are slotted into a 'glazing groove' cut into the window frame and tracery, which are most often stone. They are usually supported and made more resistant to wind by fastening them to metal support bars. The tracery and metal supports are also a critical element of the design.

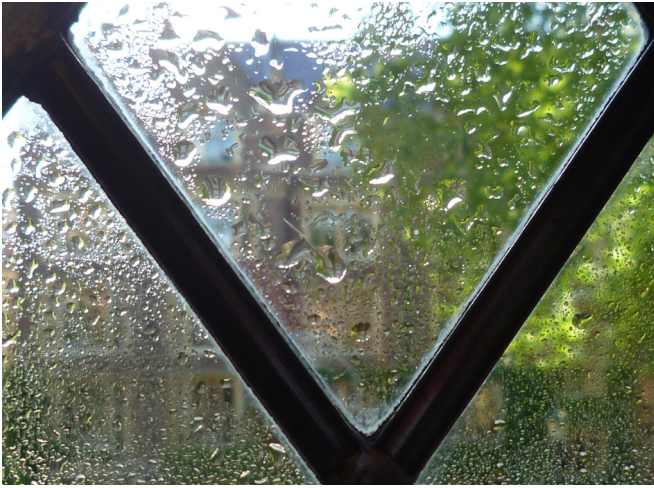
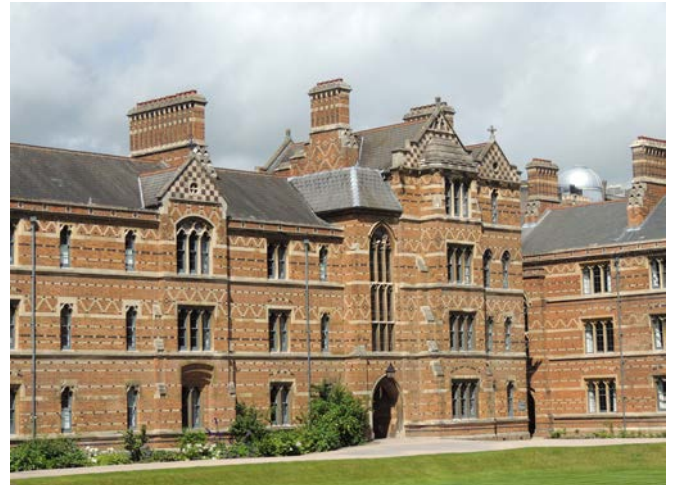
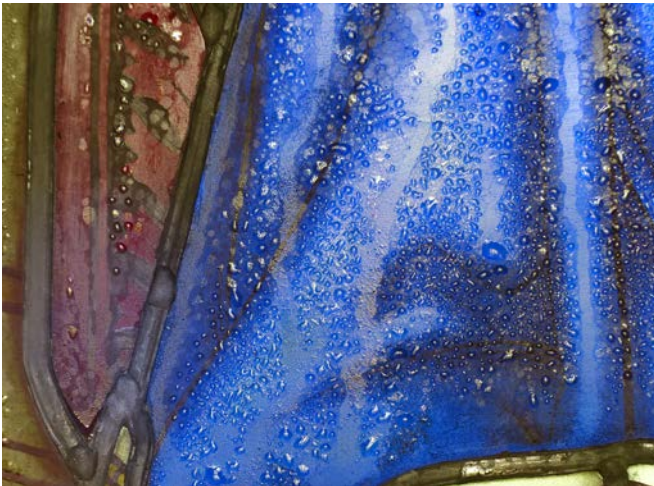
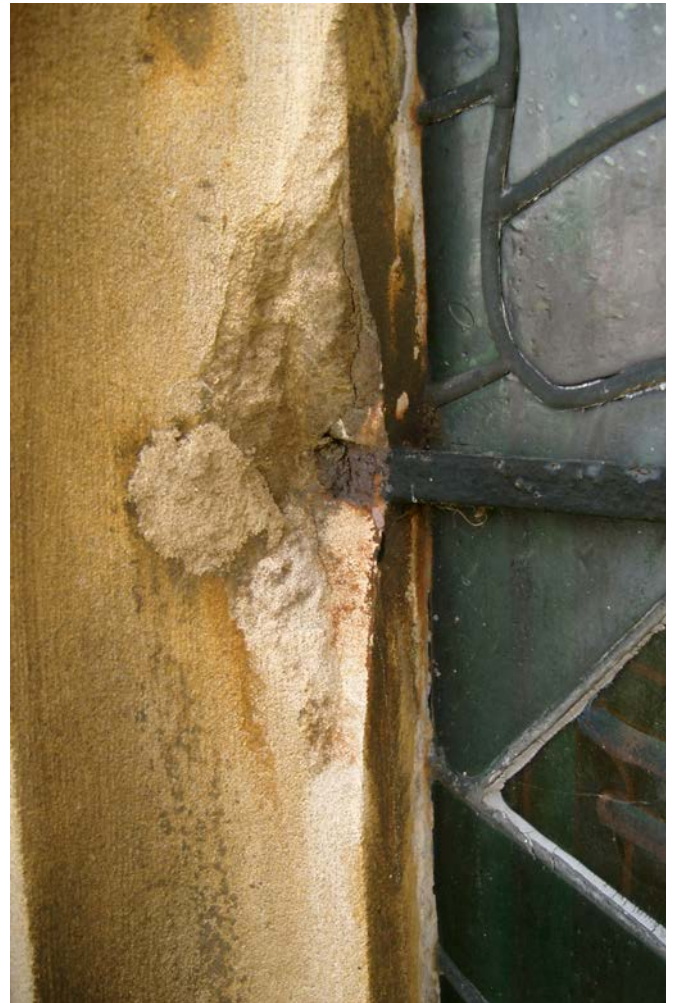
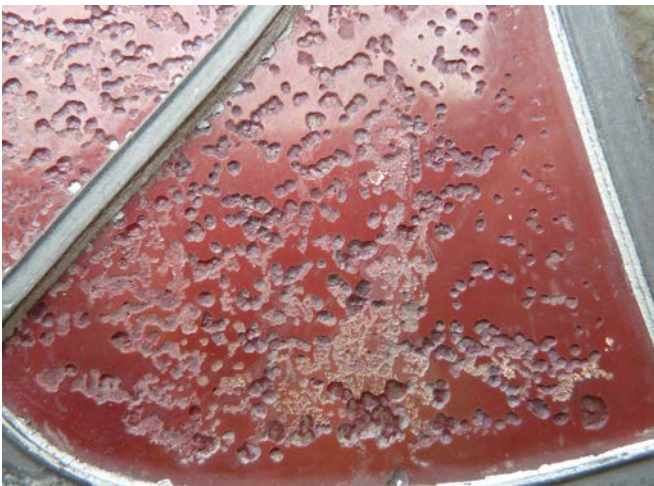
Figures 7-11

Sources of moisture

Since glass, metal and glazing cements are all impermeable, rain hitting a stained glass window will run down, collecting into a flow that will then be quickly drawn in through any open joints or fine cracks (top left). Traditional building detailing (such as string courses and hood mouldings) were developed alongside glazing to divert rainwater running down the façade, reducing the amount of water reaching the glass (top right). Glass and metal both transfer heat very easily, so when glazing is cooled by the wind and outdoor temperatures, it can easily lead to condensation on the interior of the window, especially if the building is damp (middle left). Whatever its source, water is critical to many types of deterioration, including pollutant attack, microbial growth, corrosion of the glass and the lead matrix (bottom left), and corrosion of metal components such as iron ferramenta and unprotected grilles. Rust can severely damage the stone in which the corroding iron is embedded (bottom right).

If rainwater is able to penetrate around the ends of any supporting ironwork set into the window surrounds or mullions, the iron may start to corrode and expand, causing 'rust-jacking', which can easily break apart the stone. Some *dalle-de-verre* windows incorporate embedded iron reinforcing bars, putting them also at risk of corrosion cracking. Any timber components (such as frames) will begin to decay if they remain wet for prolonged periods.

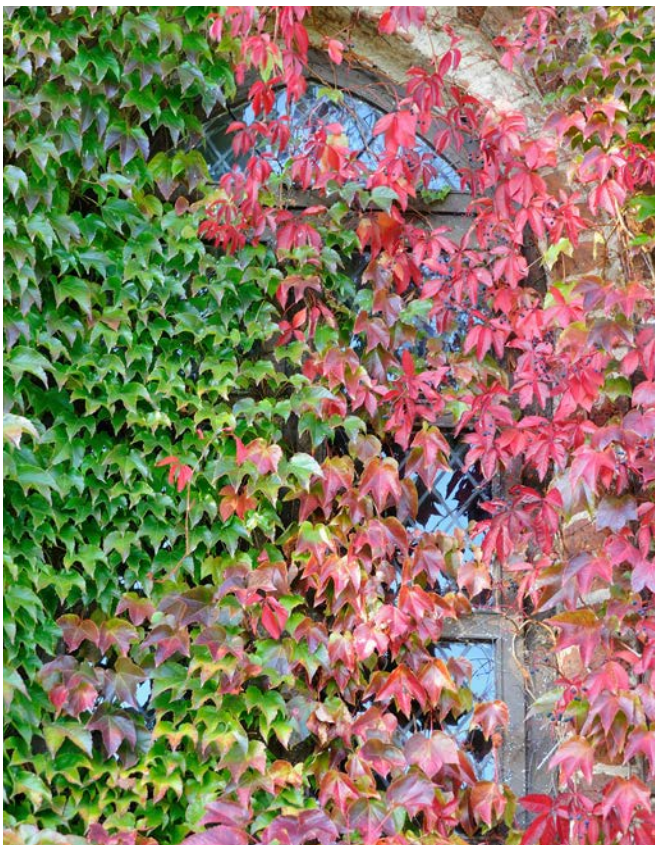
Left: Plants should be kept away from the glass, and nearby trees assessed regularly to ensure there is no risk from branches.

Right: Projectile damage may be the result of mowing or strimming nearby without sufficient care. Deliberate vandalism is a very serious risk in certain locations, and becomes more likely whenever the building does not look sufficiently well cared-for.

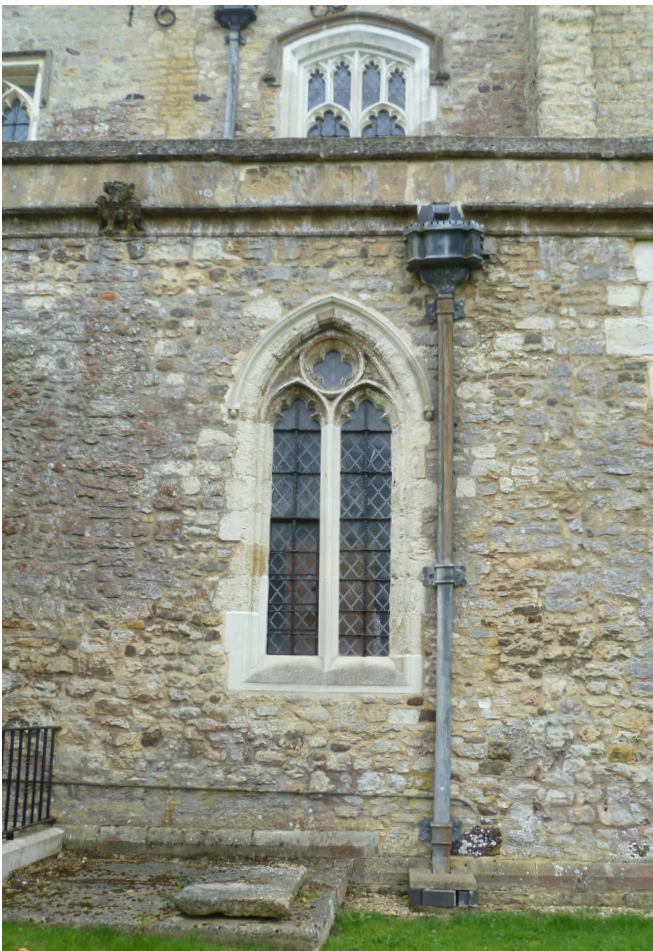
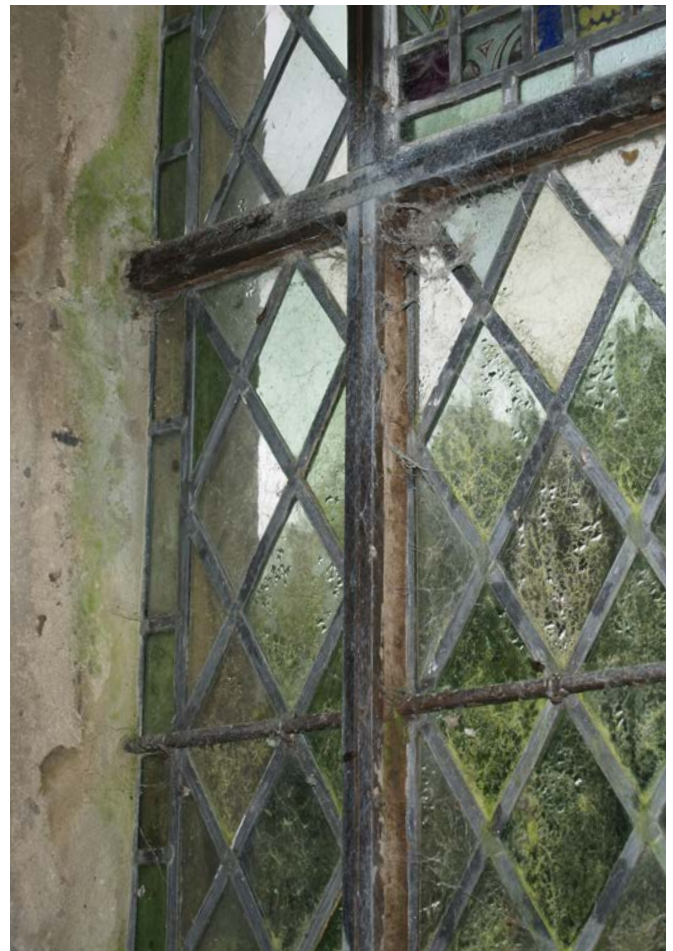
Figures 15–16
Building maintenance is critical to preserving stained glass
Poor maintenance, including leaking rainwater goods, not only increases the risk of water hitting the exterior of the window (left), but even more importantly greatly increases the risk of condensation on the interior (right).

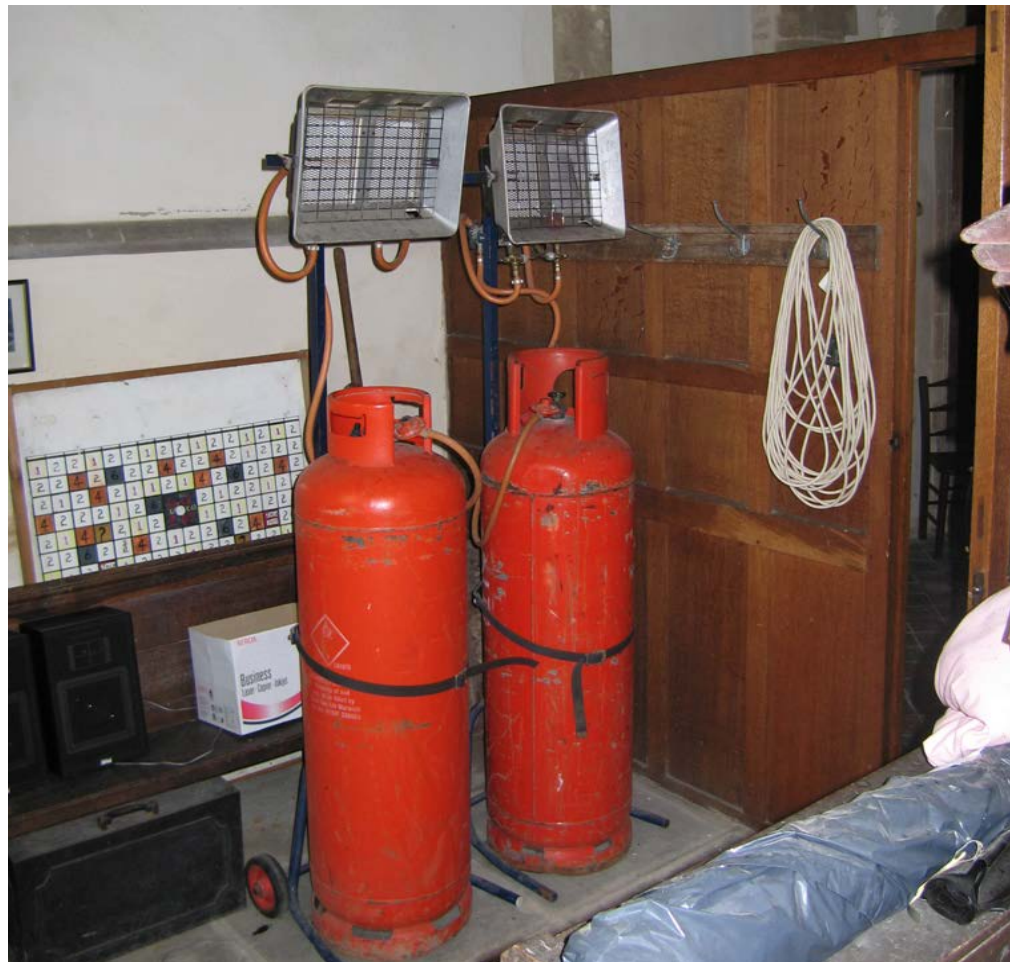
Figure 18
Heaters running on bottled gas are a serious source of indoor moisture, adding to the risk of condensation.

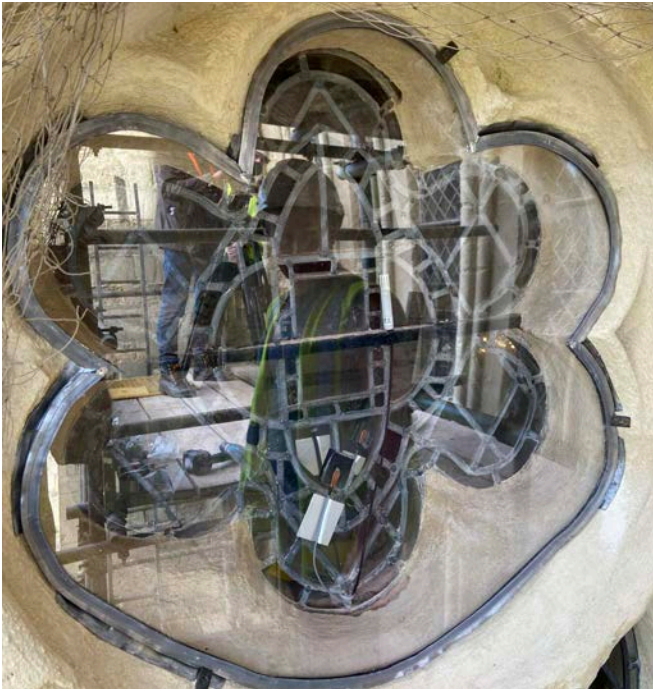
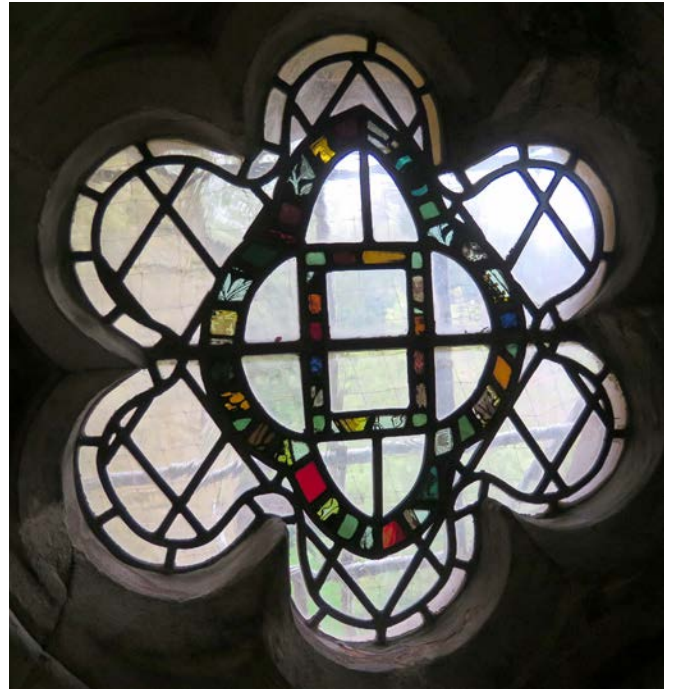
Figure 22-25
 An example of layout for the tracery EPG with the historic glass remaining in the original glazing grooves and the modern glass mounted externally.

For tracery lights, the stained glass can be left in-situ and the modern glass can be installed externally, with a lead skirt dressed back to the stonework to minimise air leakage. Some quarries in the stained glass are then tilted forward or removed to allow airflow (as shown in figures 24 & 25). Alternatively, the stained glass can be moved forward and supported on a new frame with a lead skirt applied to the sides to seal against the stonework, leaving ventilation openings along the top and bottom. While this can allow some stack effect, the height of the installation is rarely enough to provide significant airflow. However, as the area being ventilated is so much smaller than for full EPG even limited airflow is enough to provide effective temperature buffering and control condensation risk.

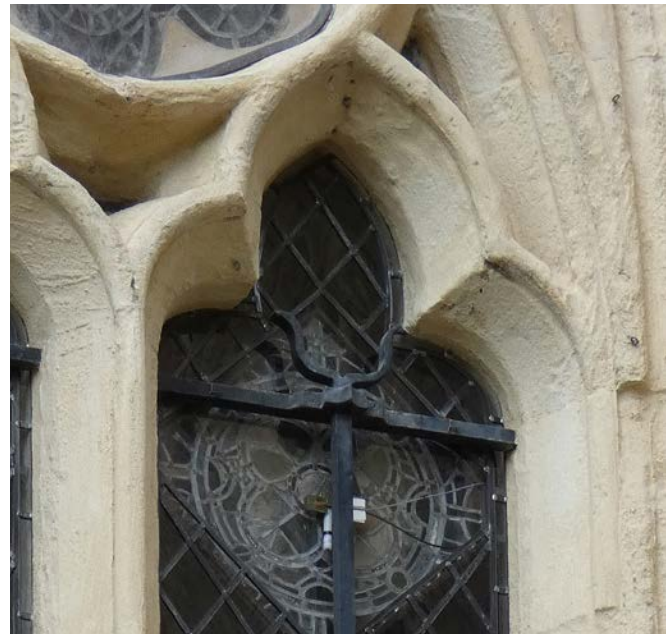
Figure 26-29
An example of partial EPG with the historic glass moved inward on a frame.

To protect an isolated panel of stained glass in a plain-glazed window, it may be necessary to move just the stained glass panel forward and support is using a metal frame fixed to the masonry. The resulting gap in the original window is then filled with modern glass. However, unlike full EPG, it may not be possible to seal the vertical edges around the re-positioned stained-glass panel owing to aesthetic constraints, in which case there will be a gap around the whole panel. While this reduces the possibility of directional airflow, because the sections are comparatively small, uncontrolled air exchange in all directions takes place, maintaining significant thermal buffering.

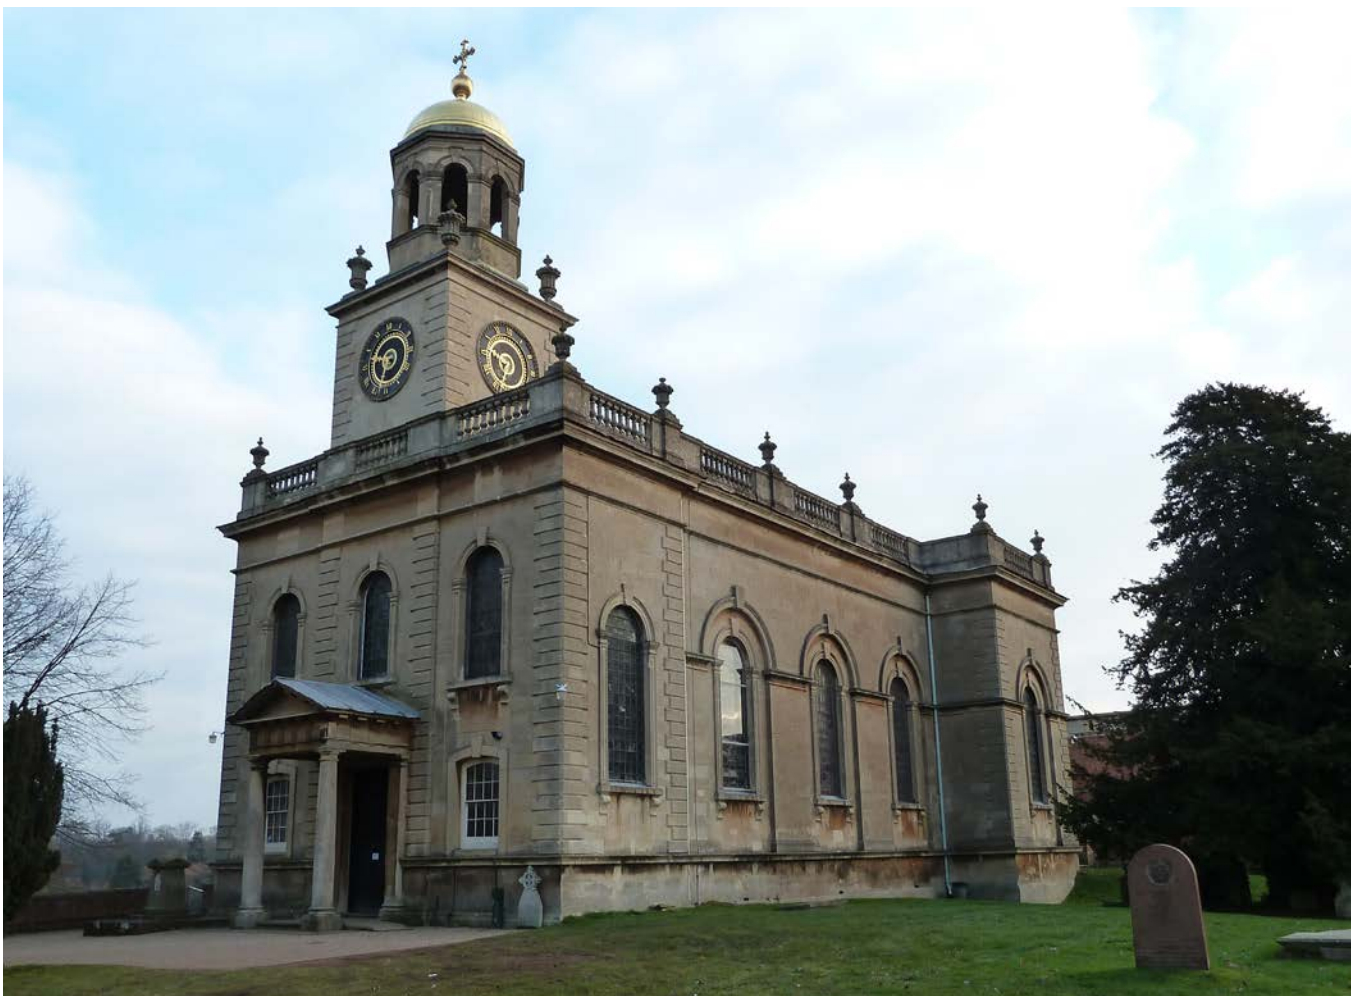
Figure 30

Great Witley Saint Michael and All Angels, Worcestershire

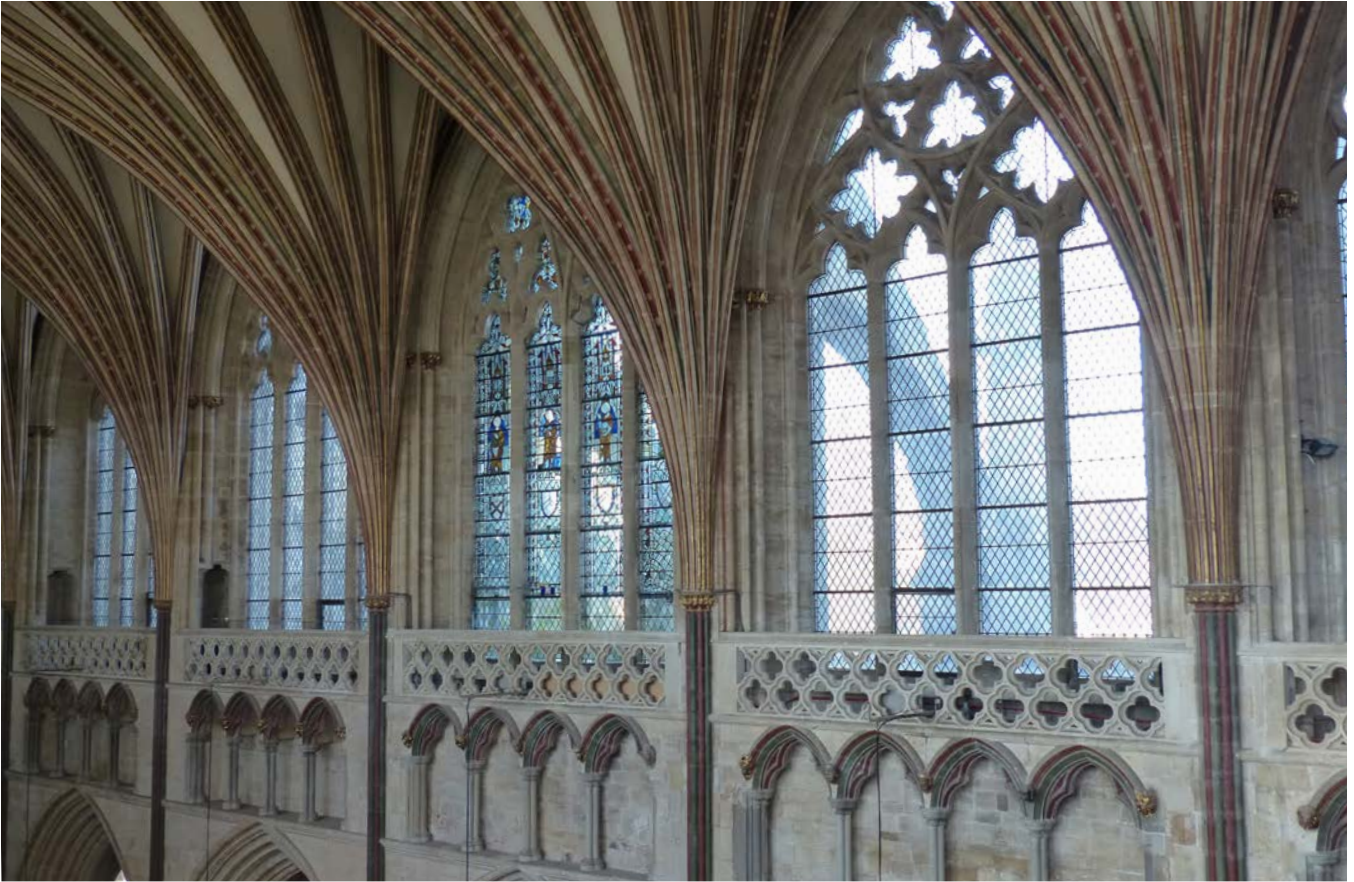
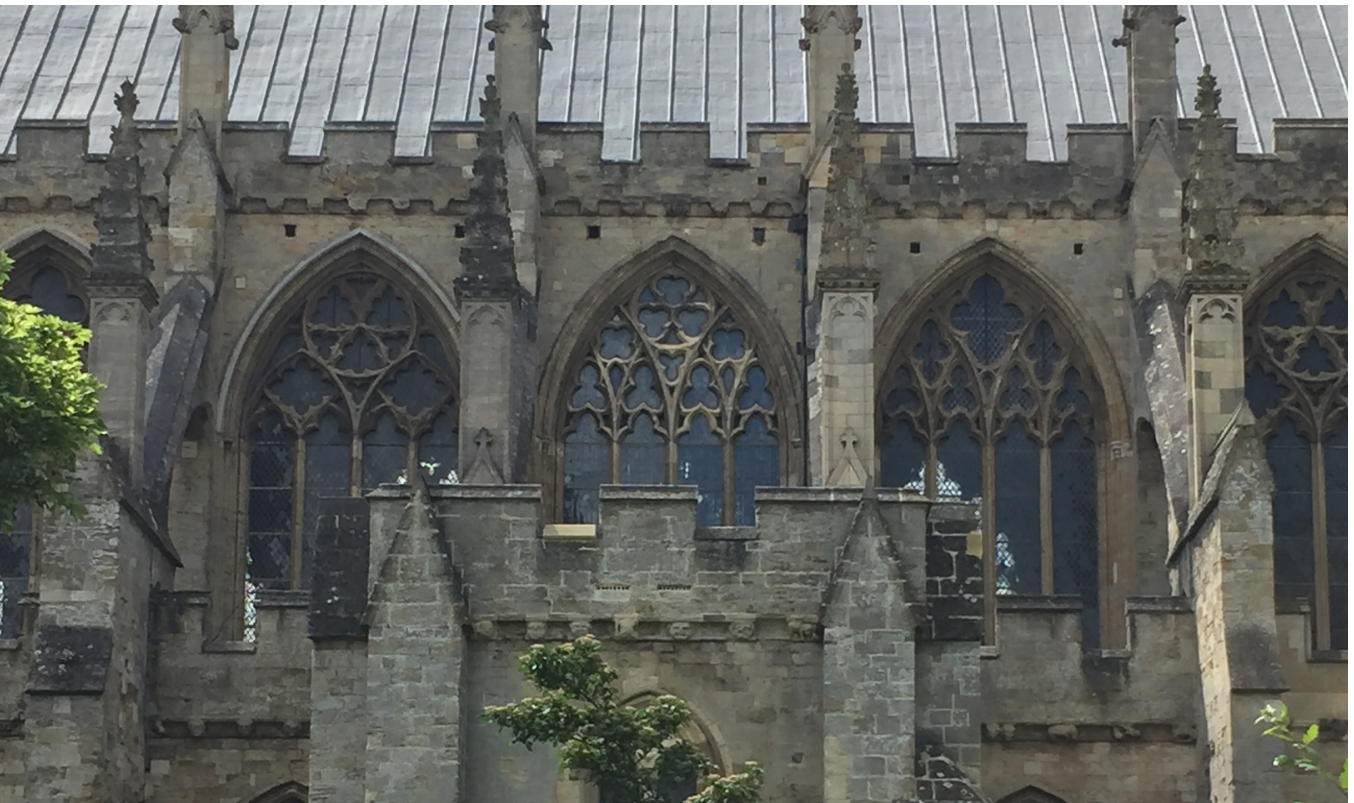
Figures 31-32

The impact of EPG on the interior must be weighed with great care

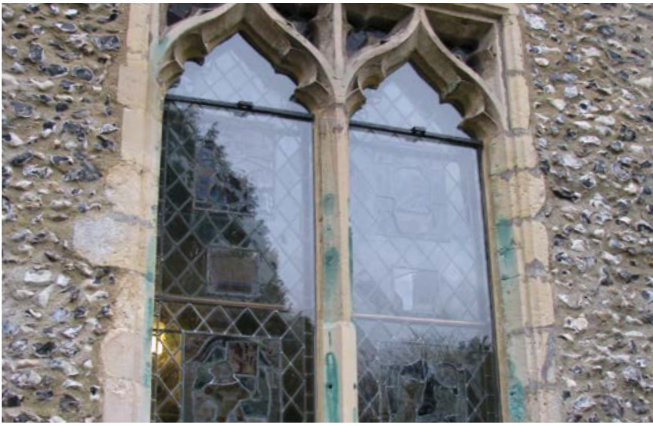
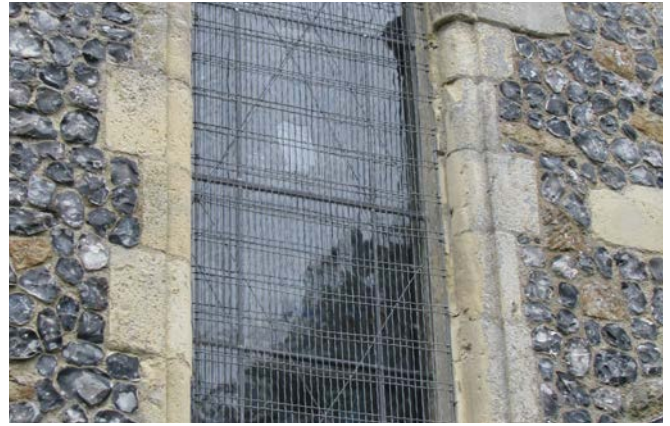
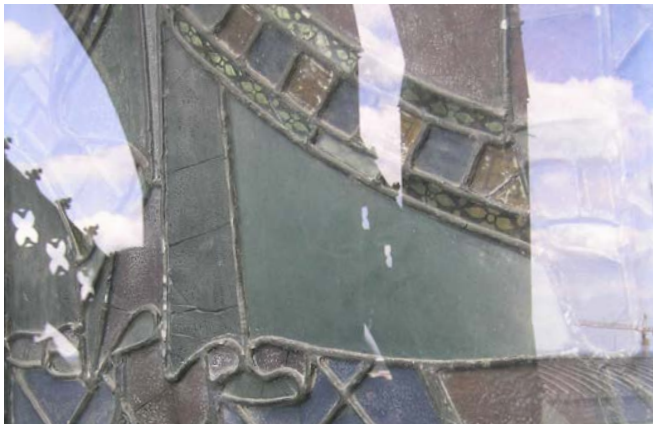
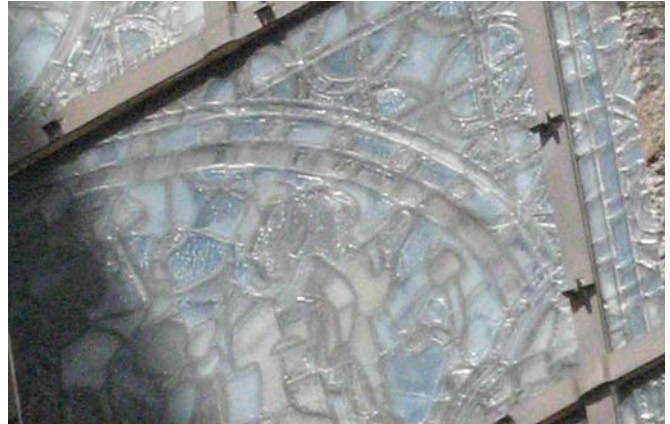
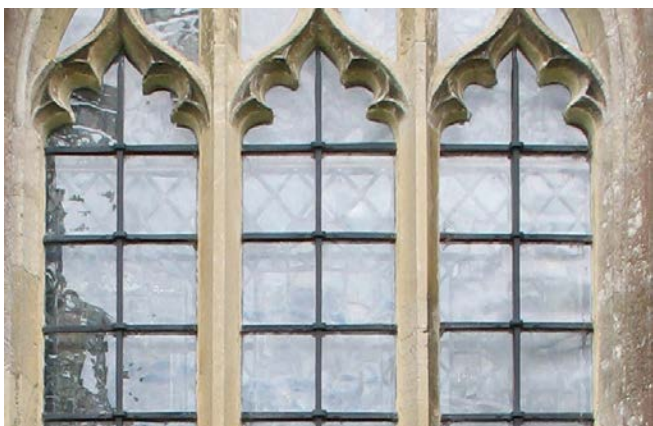
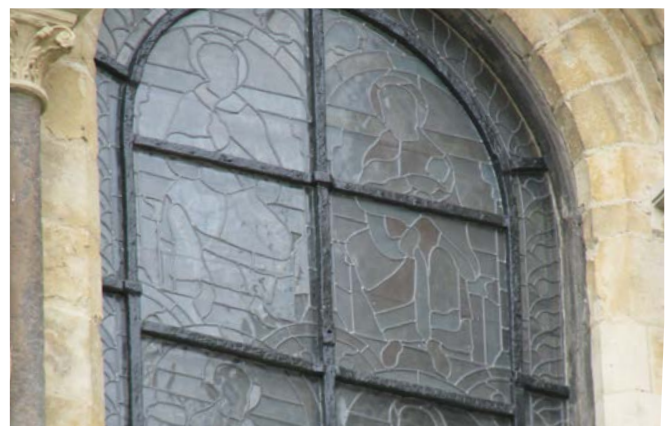
Figures 39–44

Modifying the exterior impact of EPG

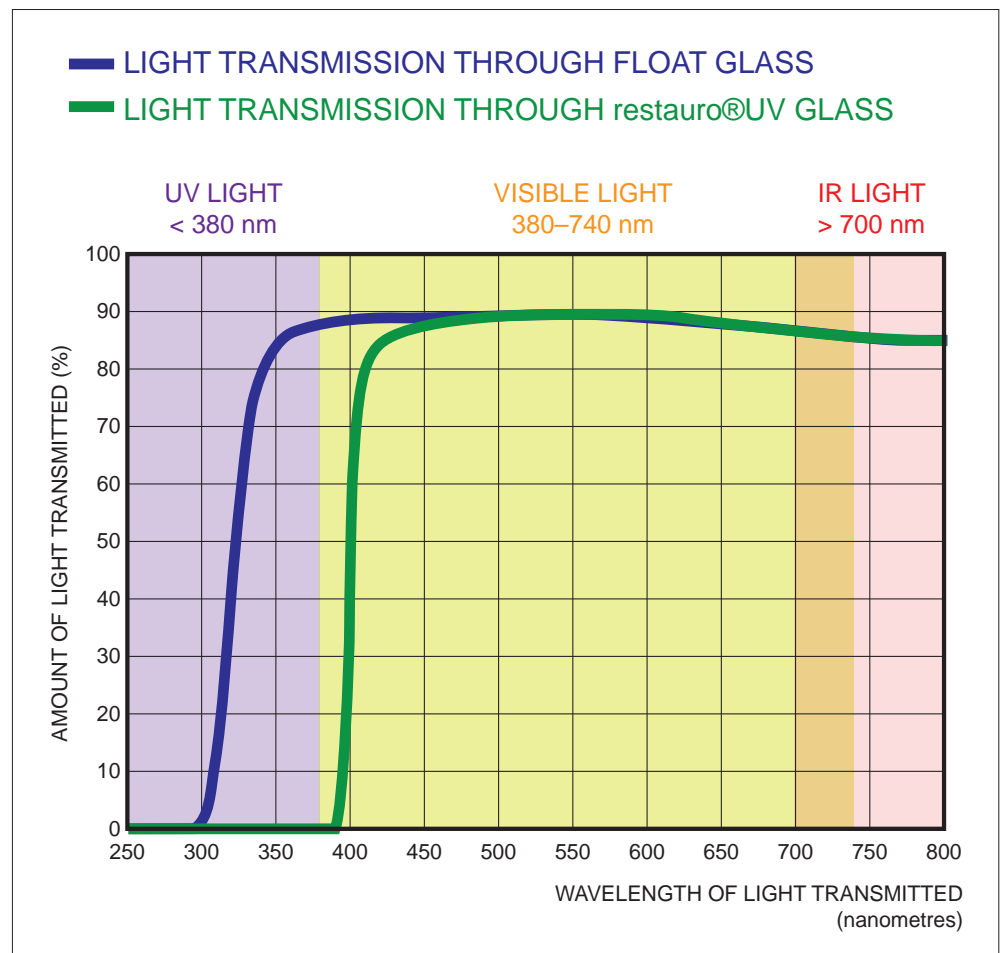
Figure 45
This graph compares the transmission of sunlight through float glass with its transmission through a specialist mouth-blown glass, which is able to filter out the UV component of sunlight reaching the original window. It is important to design filters so that they do not reduce too much of the incoming visible light, since this can affect the colours and intensity of the glass as seen from the interior.

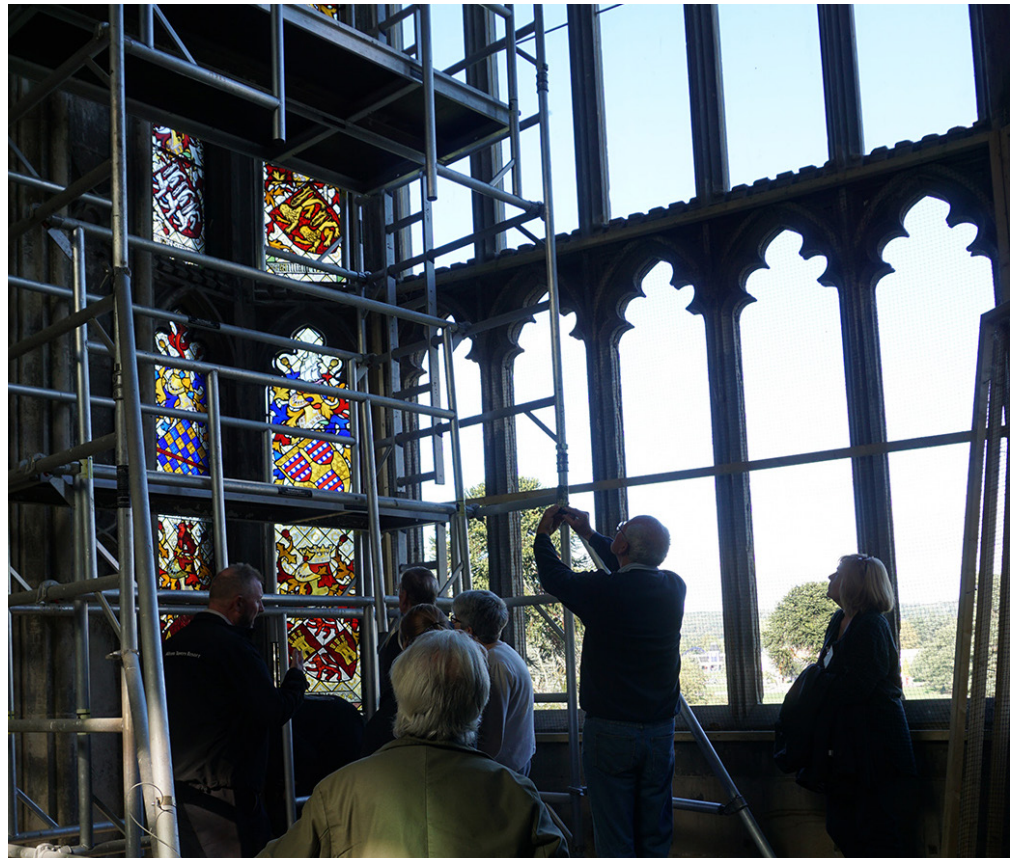
Figure 46
To agree the many details of EPG, including the treatment of the protective glazing itself, the most effective approach is to organise an on-site meeting with all stakeholders. This is particularly effective if it is possible to discuss *in situ* mock-ups of the proposed designs.

Although specialist stained glass conservators can help to cut down the multitude of potential options to a sensible level, for significant buildings there is rarely any alternative to composing mock-up panels, so that different approaches may be judged *in situ*. It is always helpful to invite the relevant authorities and other stakeholders to view and comment on these trials.

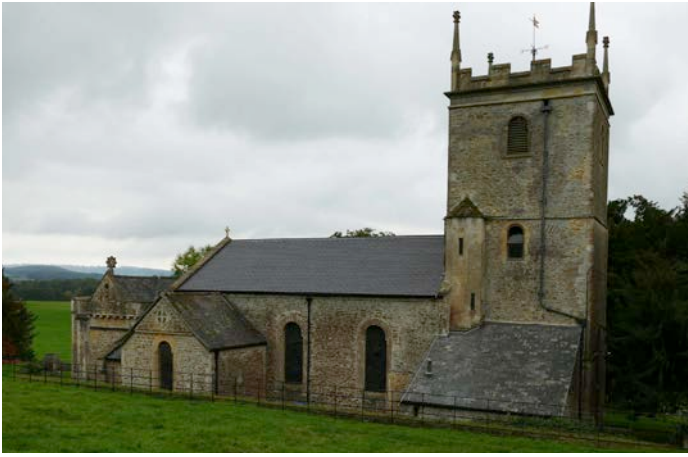
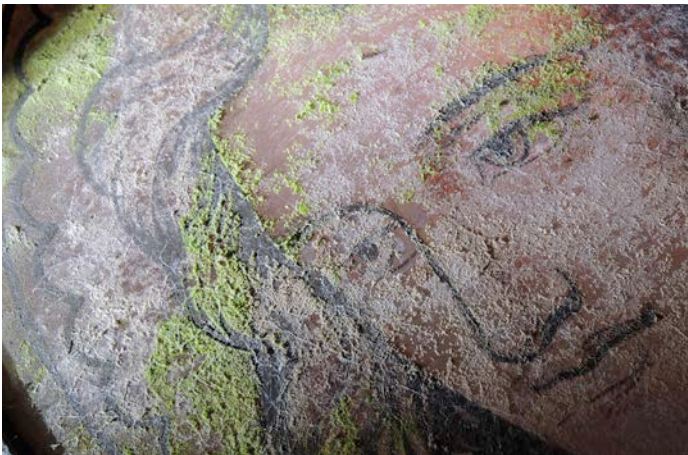
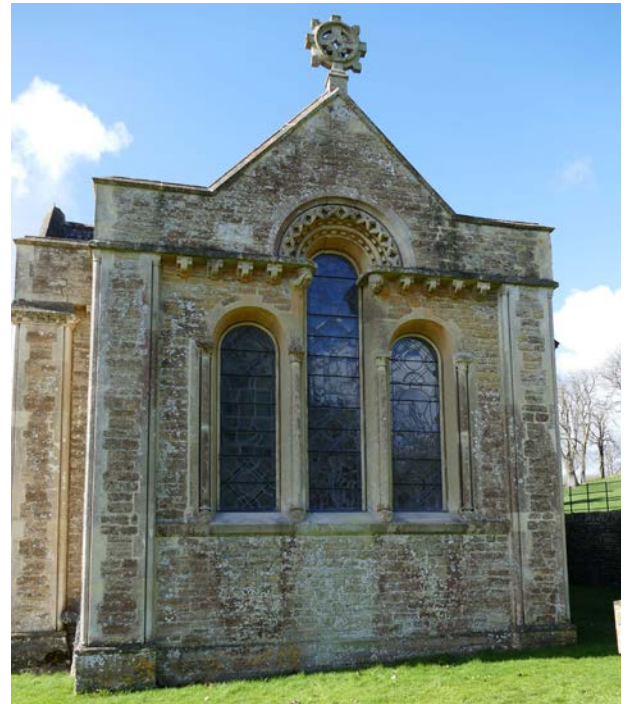
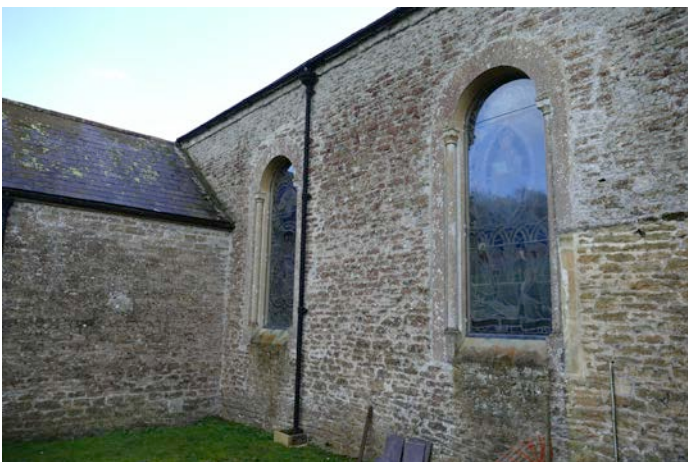
Figures 47–51

The optimum design of the protective glazing is case-dependent

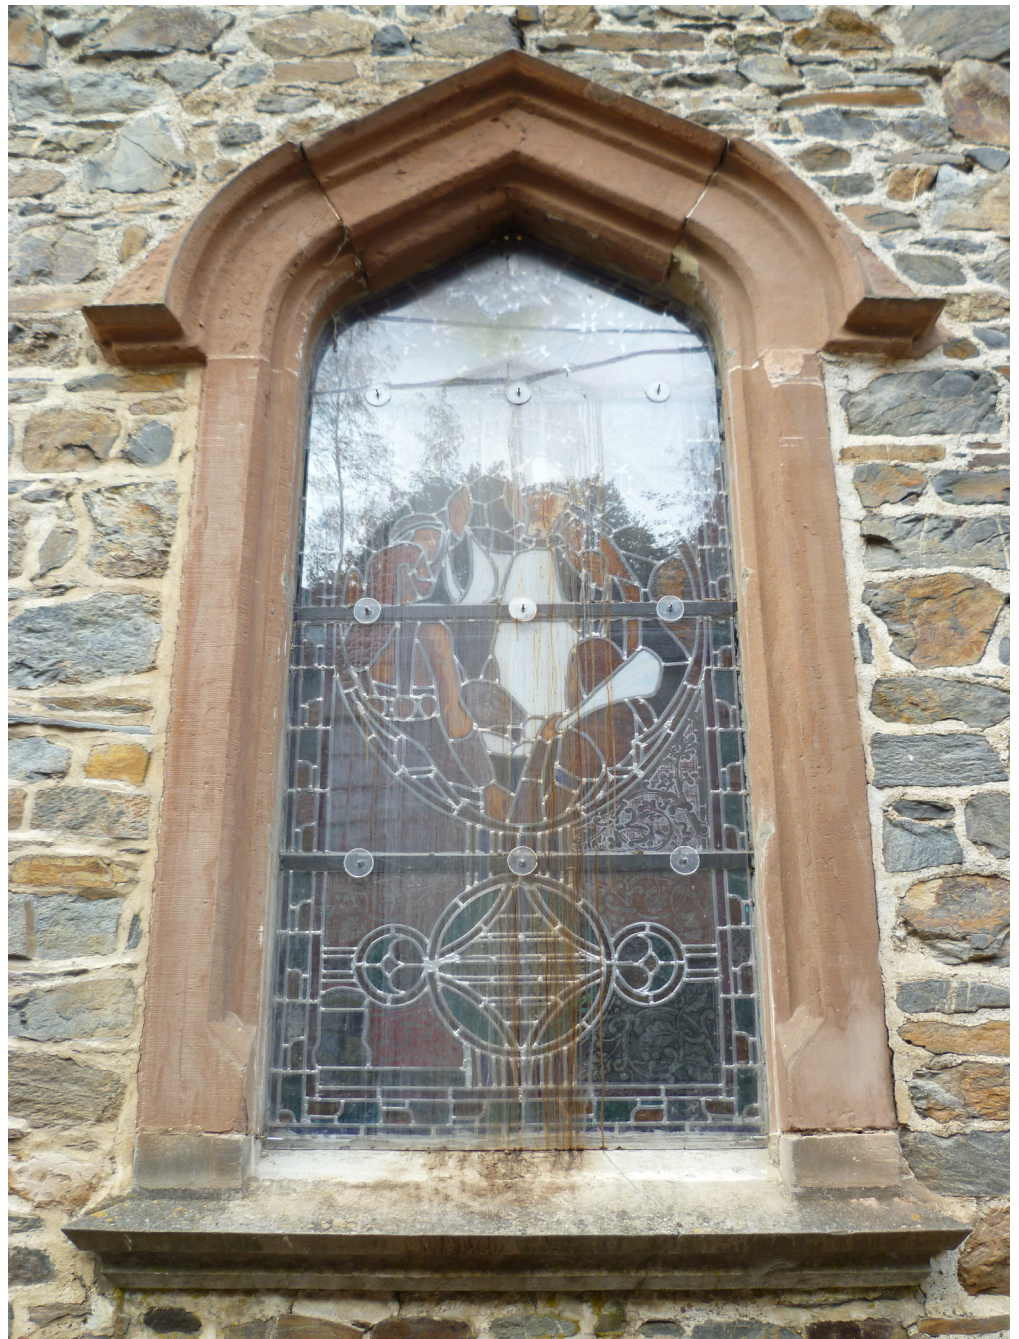
Figure 52
Insects such as wasps and spiders have been observed to nest in unventilated spaces between stained glass and protective sheeting, but there may be some evidence that flying insects are discouraged by the airflow in the EPG interspace. This remains highly uncertain, however.
