PLAITERS' LEA CONSERVATION AREA, LUTON HISTORIC AREA ASSESSMENT

Research Department Report Series 069-2011

HISTORIC AREA ASSESSMENT

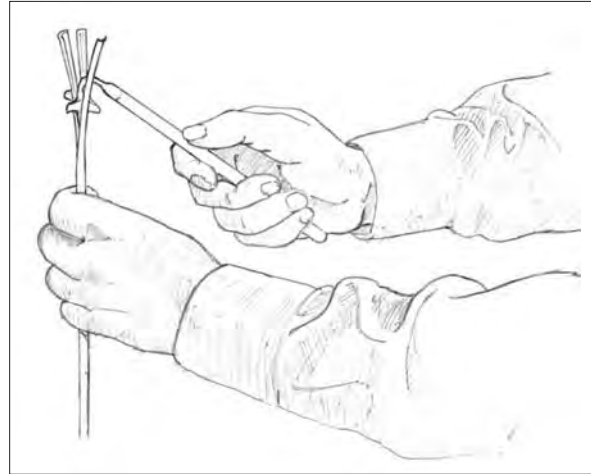
Figure 8 (above). Splitting the straws to form splints.
© English Heritage, Allan Adams.

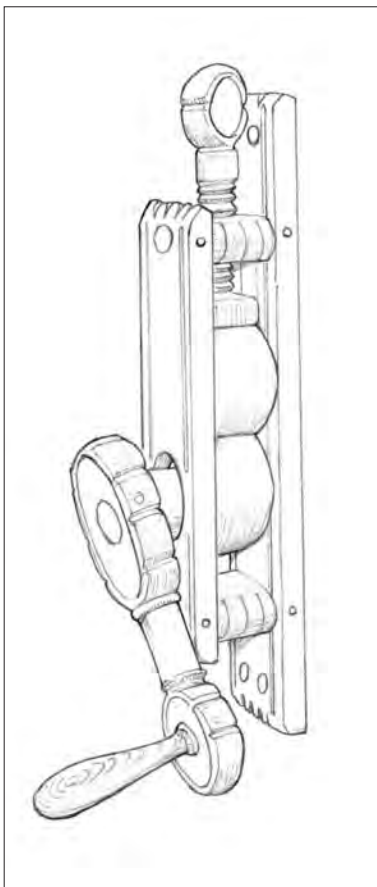
Figure 9. A splint mill,
© English Heritage, Allan Adams.

more commercially viable metal version was created. These simple implements generally had between two and ten spokes and would be inserted at the end of the straw and run down the length, cutting the straw into equally sized splints.³² Before they could be plaited the straws, whole or splints, would be softened in a splint-mill (Figure 9) – a wooden mangle which could be attached to a door frame. Thus prepared and ready for use, the straws could then be plaited.

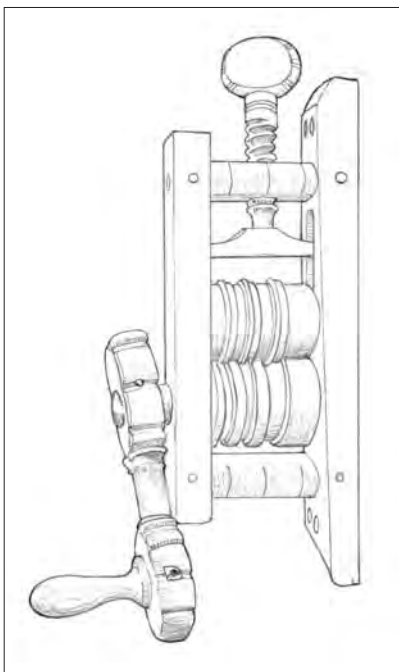
Figure 11. A plait mill.
© English Heritage, Allan Adams.

reached the required length – commonly 20 yards (18m) – it was passed through a plait mill (Figure 11), similar in construction to a splint mill but with grooved rollers to prevent the decorative head of the plait from being crushed – the milling being carried out in the factories or sewing rooms.³⁴ The process of hat manufacture, as opposed to straw plaiting, starts at this point – manufacturers tending to buy coils of plait from the plait merchants dealing in the markets and plait halls.

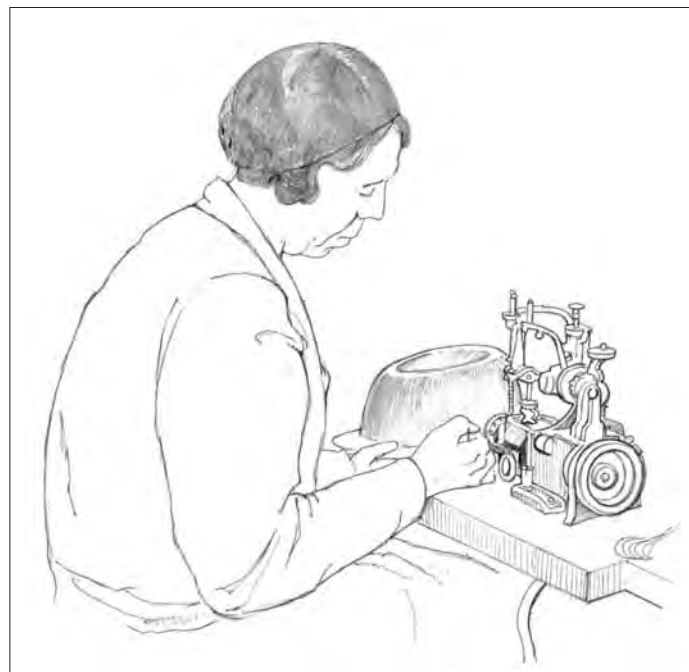
Figure 12. Machine stitching. © English Heritage, Allan Adams.

In order to make a hat, the plait must be sewn in a continuous coil, starting at the crown and ending at the brim (Figure 12). At first done by hand, sewers spent several years as apprentices perfecting tiny stitches that would be almost invisible in the finished item, and learning how to make a hat of the required size and shape. Most of this sewing was done in the home or in small establishments before being sold on to the larger firms.³⁵ The Vyse firm introduced an American sewing machine in 1868, but in order for the stitch to be concealed the plait had to be sewn from the brim and finishing at the crown – an awkward method which made shaping very difficult.³⁶

Machine sewing was improved by the introduction of the *Visible Stitch Machine*, commonly known as the '10-guinea' machine due to its price, by Willcox & Gibbs in 1875, but the visibility of the stitches meant it was only suitable for coarser plaits. It did, however, become very popular, with over 1,500 in use by 1877 and each one capable of sewing a hat in a fifth of the time of hand sewing.³⁷ Further improvements followed, with Edmund Wiseman inventing a concealed stitch machine in 1878, acquired by Willcox & Gibbs in 1886 and soon known as the 'box machine'.³⁸

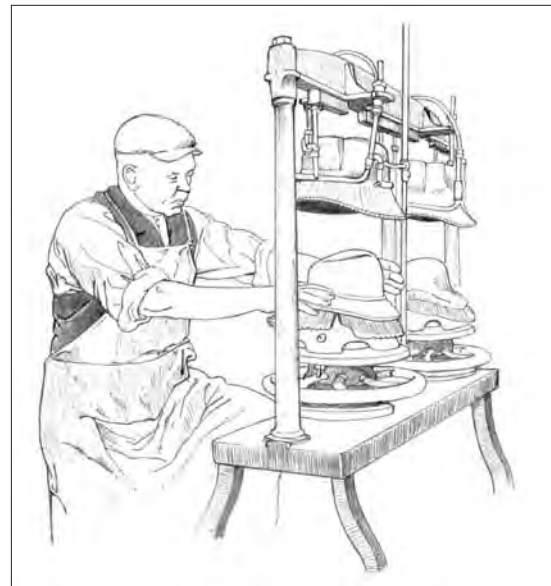
Figure 13. Machine blocking.
© English Heritage, Allan Adams.

After sewing, the roughly shaped hats were blocked into their final shape (Figure 13). At first this was done by hand using smooth stones, known as slicken stones, or box irons heated in a fire, using wooden blocks made from alder or lime which were able to withstand the heat and moisture required to shape the hats around them.³⁹ In the hand blocking process a hat is wetted or steamed and then quickly pulled over the crown of a block and pulled evenly on all sides before it dries. In a hat of complicated shape, the brim may be made separately and attached during the finishing process. Machine blocking was introduced to the industry in c.1860 – although by 1864 only two Luton firms had been converted to machine blocking rather than hand.⁴⁰ Machine blocking was done using screw presses until the invention of hydraulic pressure around 1868 whereby each hat was placed in a metal pan of the required shape within a steam heated chamber, a water-filled rubber bag was then lowered and by exerting equal pressure was capable of quickly shaping the hat against the pan. A popular alternative was to heat 'male' and 'female' blocks using a gas flame and, having first steamed the hat, simply press the two together.⁴¹ Blocking and blockmaking tended to be done by male workers, due in part to the relatively late adoption of mechanisation, long after women had come to dominate as plaiters and sewers.

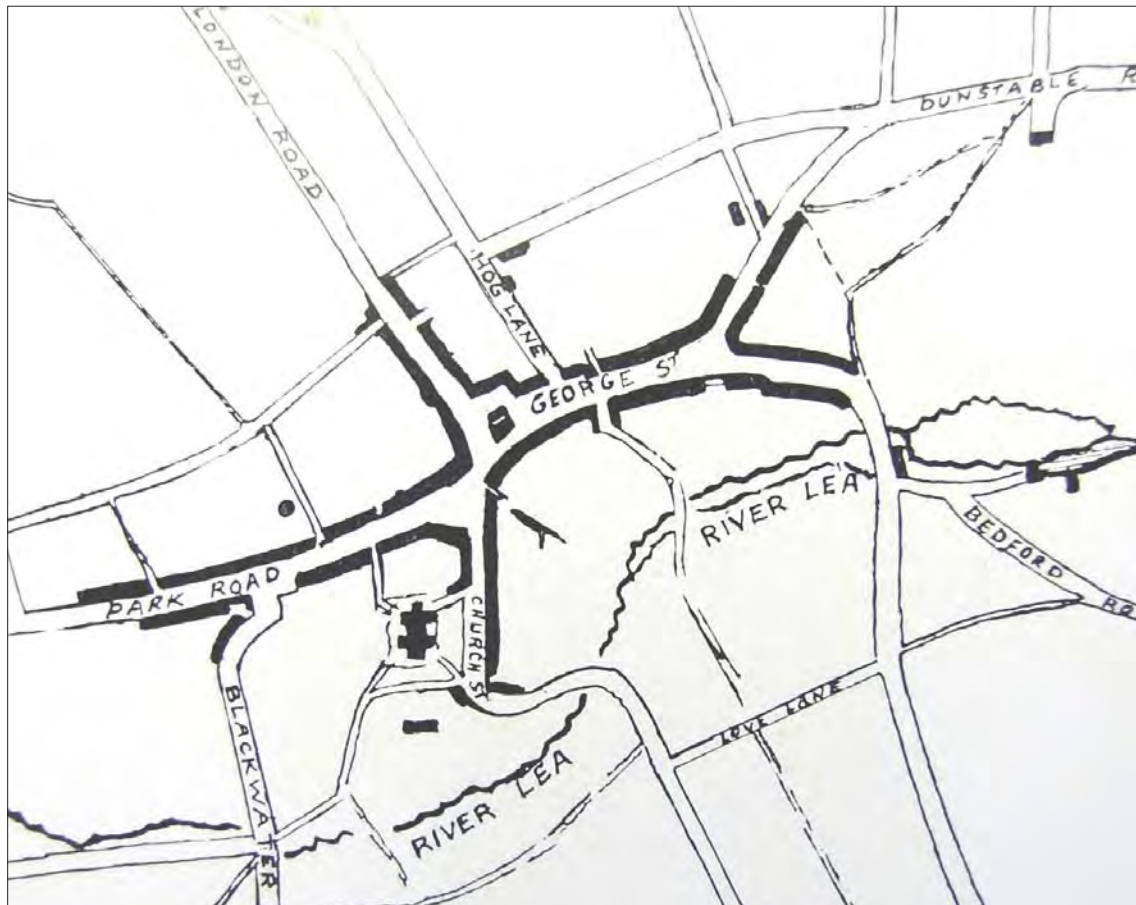
This is, perhaps, the earliest known depiction of Luton town centre and clearly shows that by the start of the 19th century, the main focus of urban development flanked George Street. As seen in Figure 16, the 'H'-shaped layout of streets was already well

established at this time with continuous development of domestic and commercial premises along George Street, Park Road and Church Street. This map shows little (or no) encroachment onto the area that became the hatting district; instead, the Little Moor is traversed by a single north-south route, in all likelihood Barber's Lane. It may well be that this is an early route to the town centre, probably of medieval date and interwoven with the pattern of open field systems on the higher land to the north.

Figure 16. Martha Higgins' plan of 1815. (H. White, 1977, *Luton Past and Present*. White Crescent Press)

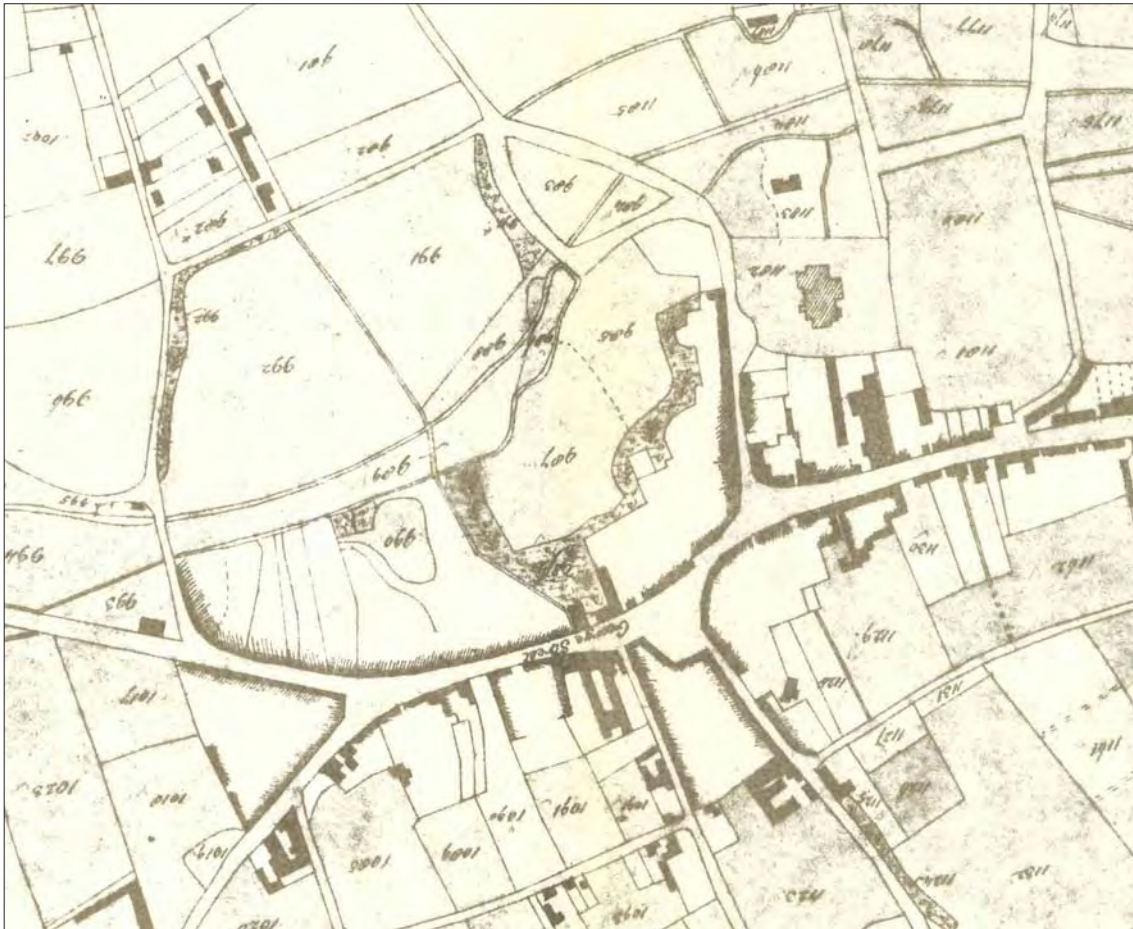
The earliest (accurately) mapped depiction of the town was produced by Brown of around 1839 and depicts the centre of Luton on the eve of substantial change. The street pattern shown here (Figure 17) appears essentially medieval in character and consists of one long street, George Street, which formed part of the main east-west route of communication along the south side of the river. This is, undoubtedly, an ancient route extending south-east to St. Albans and then on to London, crossing the river to the north-west and terminating at Bedford. This map shows that George Street, which is generally narrow, widens at either end where subsidiary routes bifurcate and would appear to have been the hub of medieval Luton. On the west, this space is now occupied by the Town Hall and flanked by roads on the north and south. A more complex arrangement is visible on the east, particularly in the area at the intersection of George Street with Park Street and Church Street, i.e. Park Square. There appears to

Figure 17. Extract from Brown's map of 1839. At this time the area later to host Plaiters' Lea is shown as a well defined enclosure flanked by George Street, Church Street and Bridge Road. Bedfordshire and Luton Archives Service.

Brown's map suggests that Luton developed into a double-row settlement with buildings on either side of George and Park Street, with subsidiary routes feeding into these from the north and south. These smaller tracks and paths are clearly part of a wider network that was inter-woven with the open field system in the surrounding area, especially the chalk downs to the south, and were used to provide access to the market town as well as the river meadows flanking the Lea.

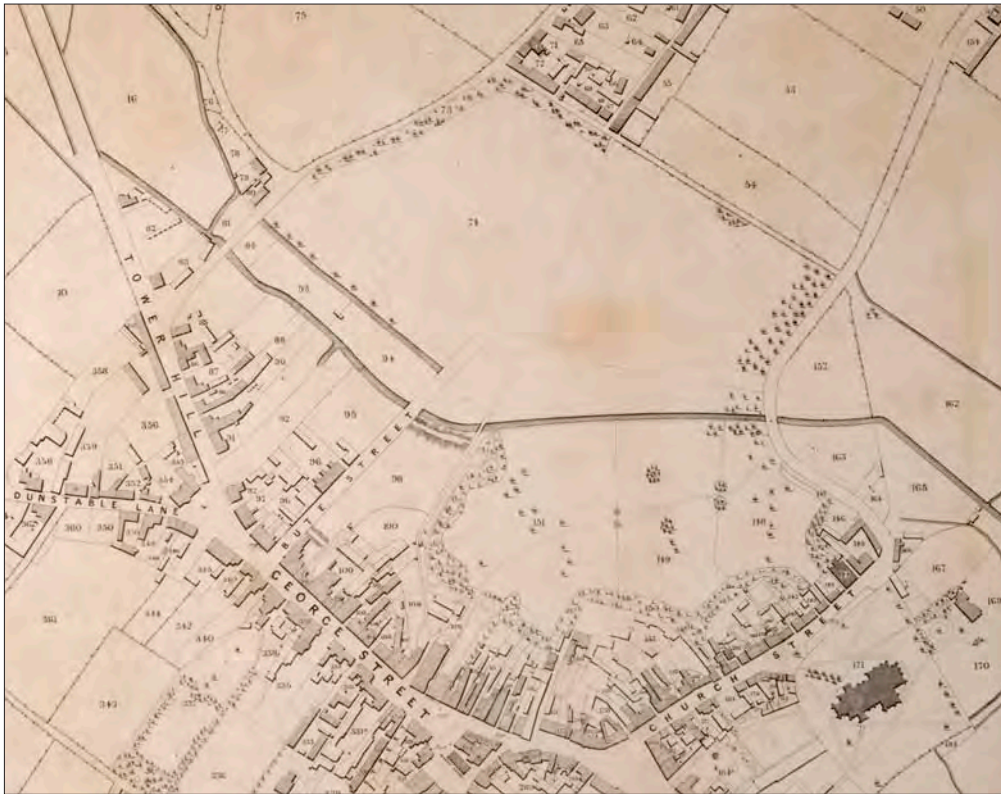
There are two known Tithe maps for central Luton: the first dating to 1842 (Figure 18), with an updated version produced in 1844 (Figure 19), and both very clearly show the encroachment onto formerly common ground along the river valley. The apportionment accompanying the map illustrates that there were a number of business premises fronting both sides of George Street and that many of these either replaced or incorporated parts of earlier houses, public houses and workshops/offices – a number of which had medieval origins.

The current street pattern, with George Street and Church Street dominant, is clearly recognisable. Bute Street, laid out in 1840, is also shown for the first time, with a number of houses, offices, shops and yards clustering close to the junction with George

Figure 18 (above). Tithe Map of 1842.
© Luton Culture.

The pleasure grounds laid out by James Gutteridge, later owned by John Waller, can be clearly discerned at the heart of the Moor. They are fringed by strips of woodland and enclose other deliberately planted stands of trees: in addition, a formal approach leading through the small park from Church Street on the east to the residence on George Street, is evident. This enclosed park later formed the core of the hatting district in Luton. The course of the River Lea through the park is markedly straight and it may well have been canalised as part of the formal garden layout and, perhaps, as an attempt to reduce the threat from flooding. The 1842 Tithe map illustrates a large earthen bank flanking the south side of the river immediately to the west of Bute Street – this is still visible by Barber's Lane as a change in ground level and, again, this may well have been an attempt at flood control.

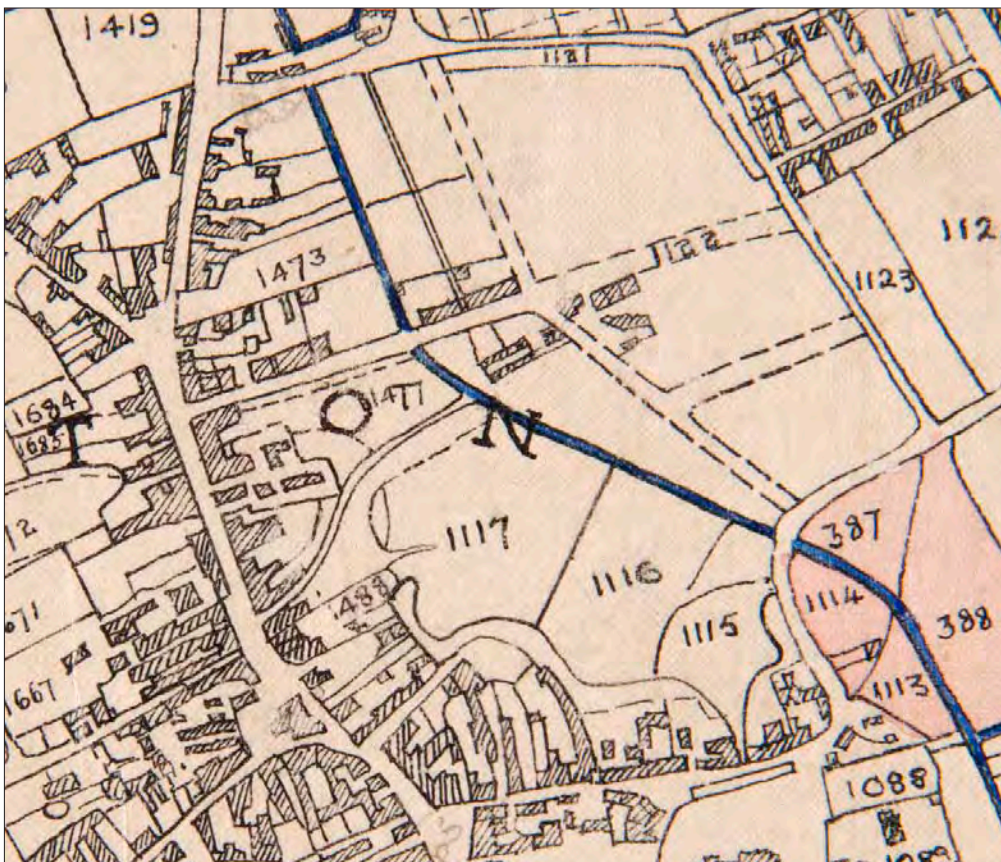
Figure 19 (below). Excerpt from Tithe update of 1844.

Development within Luton and, specifically, in the area of Plaiters' Lea Conservation Area, gathered pace dramatically in the years succeeding the 1842 survey. The Tithe map update of 1844, whilst less detailed than the earlier version, demonstrates the scale of change in the area of Little Moor. Development had extended further north along Bute Street and included two substantial buildings or terraces – one where the Vyse factory was later built and another since replaced by the DSS offices. Indeed, Bute Street is shown as extending beyond the intersection with Guildford Street, towards High Town, and there is a cluster of buildings on the north-eastern corner of the intersection. A triple range is shown and this incorporates the George II public house as well as an isolated building, closer to the road junction, which was replaced in 1889 by the Walter Gurney & Son hat factory at 64 Bute Street.

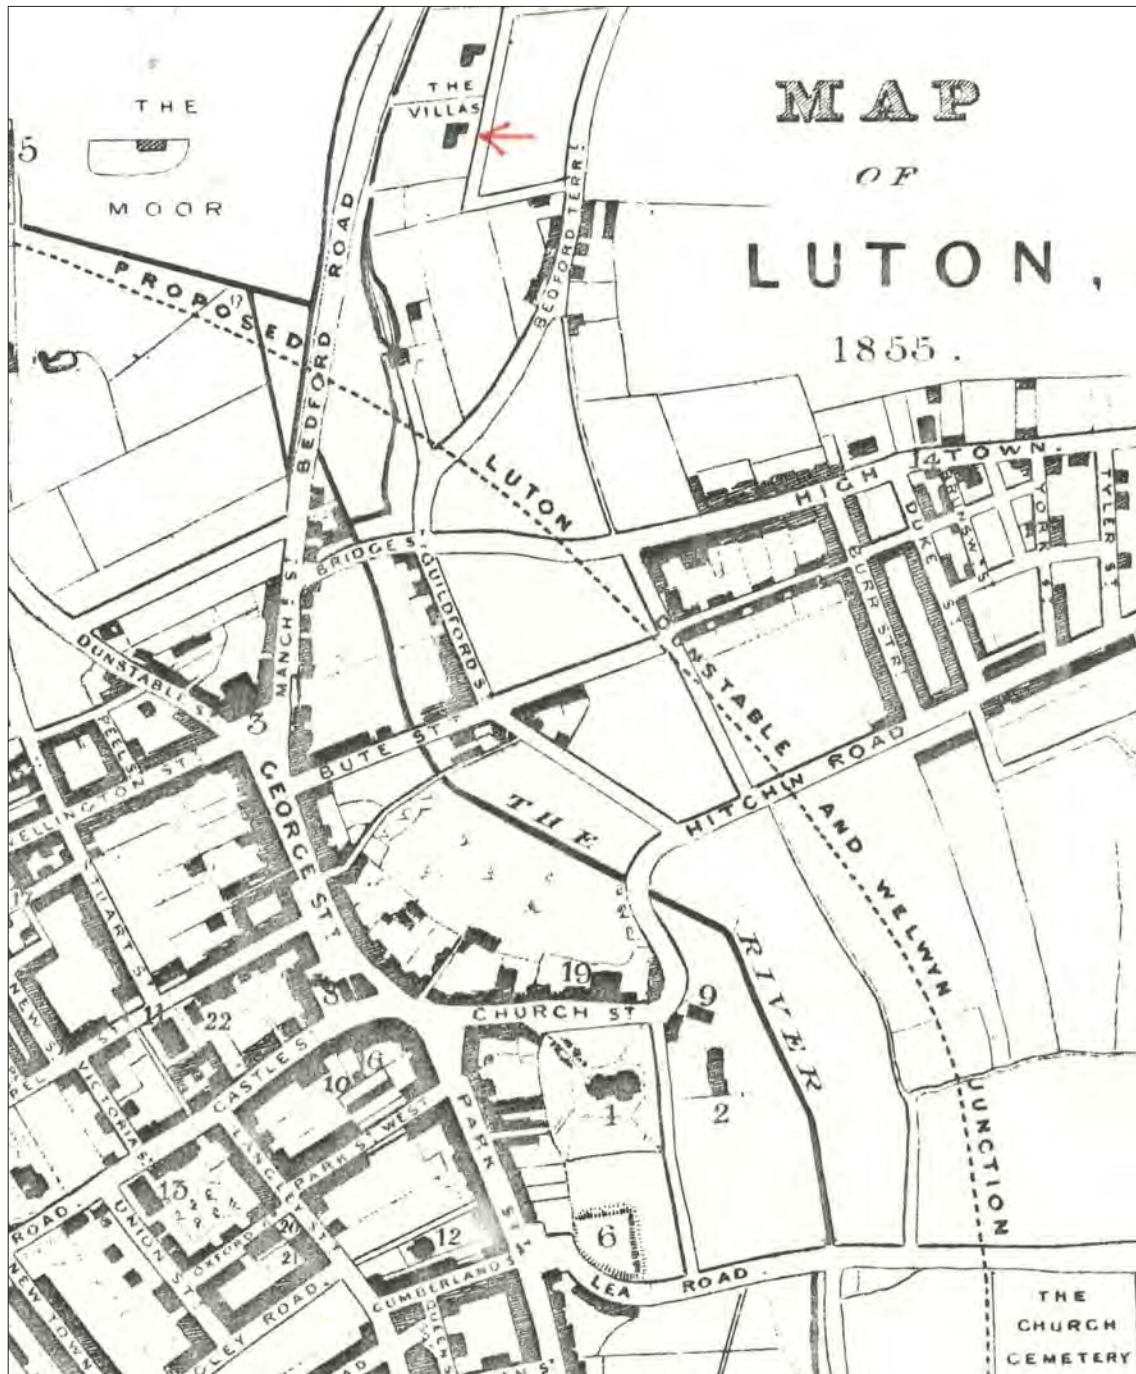
This map, in particular, documents the spread of development along the south side of Guildford Street to the west of the intersection with Bute Street (Figure 20). A discontinuous range of buildings is shown extending west to the junction with Bridge Street – those closest to Bute Street are likely to have been hat and straw plaiting premises (they are on the site of Elliot's felt and straw hat factory and the Nott straw hat factory on Goad's map of 1838); the remainder were domestic. The majority of these, apart from the Nott factory, have been replaced by modern buildings and the (now closed) multi-storey car park.

Figure 20. Todd's map of 1855 shows significant development in the area of Plaiters' Lea.
 (Frederick Davis, 1855, *A History of Luton, with its Hamlets etc. Luton.*)

Much of the area subsequently comprising Plaiters' Lea Conservation Area is still shown as parkland on this map. The full course of Barber's Lane, extending parallel to, and east of, Bute Street, is clear and there is a concentration of buildings at its northern end close to the intersection with Guildford Street. The listed hat factory at 47 Guildford Street is shown as well as the short range of buildings to the south, on the west side of the Lane.

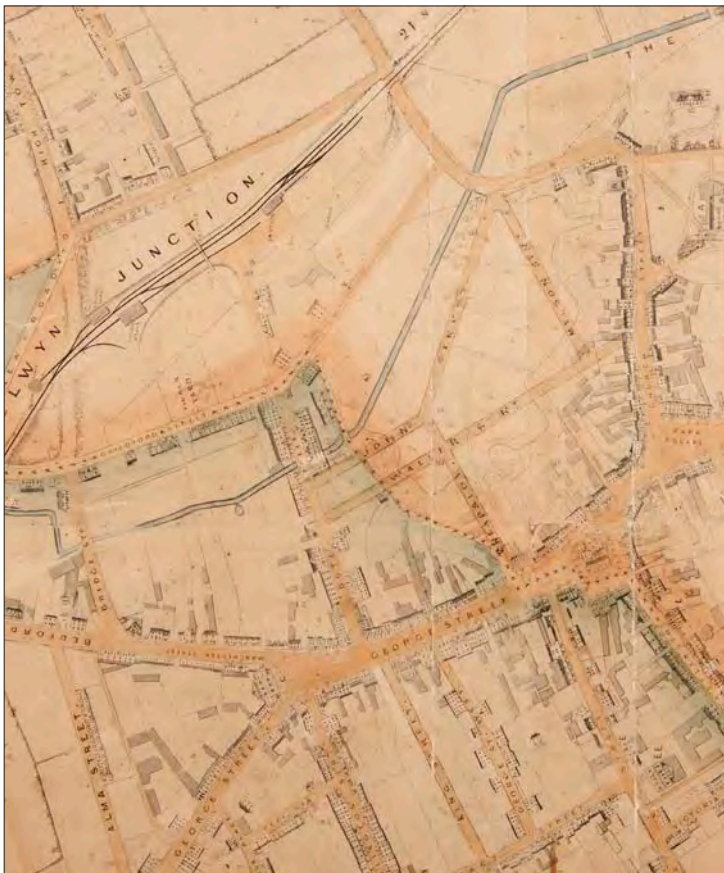
These maps are remarkably useful as they show rapid development in the town in the 1860s. Individual buildings are illustrated in detail, with front elevations particularly well defined. Large factories, smaller workshops, public houses, domestic residences, and places of worship can be discerned and are articulated by a series of newly constructed streets. Waller Street, John Street and Melson Street were laid out in c.1859 following the death of John Waller. These all crossed Cheapside which ran north from George Street but which was, originally, a formal approach to the park here. Both sides of Bute Street are shown as being heavily developed with hat factories, and further development, including the Balfour hat factory and its contiguous domestic workshops, had taken place on the north side of Guildford Street, to the west of the Bute Street intersection, by 1868. The remainder of Guildford Street – to the east of the junction – is noticeably under-developed. Only two large buildings are shown: that closest to the road junction is the premises that pre-dated the Gurney hat factory; the three-storey building further east may well be 'The Wheelwright Arms' public house at 34 Guildford Street.

Barber's Lane crosses the river Lea by bridge and a short range of buildings flank its eastern side to the north of the river. The listed hat factory (47 Guildford Street) at the junction of Barber's Lane and Guildford Street is also shown on both maps, as is the range of buildings to the south. Both railway stations to the north of the Plaiters' Lea Conservation area are shown on Corney's map which was updated in 1870. The earliest (that closest to the town), the Luton-Dunstable-Welwyn railway, was opened in 1858; the Midland Railway followed in 1868 and is necessarily absent from the Todd map. The

Figure 21. Todd's pictorial map, last updated in 1862. © Beds RO XI-37-1.

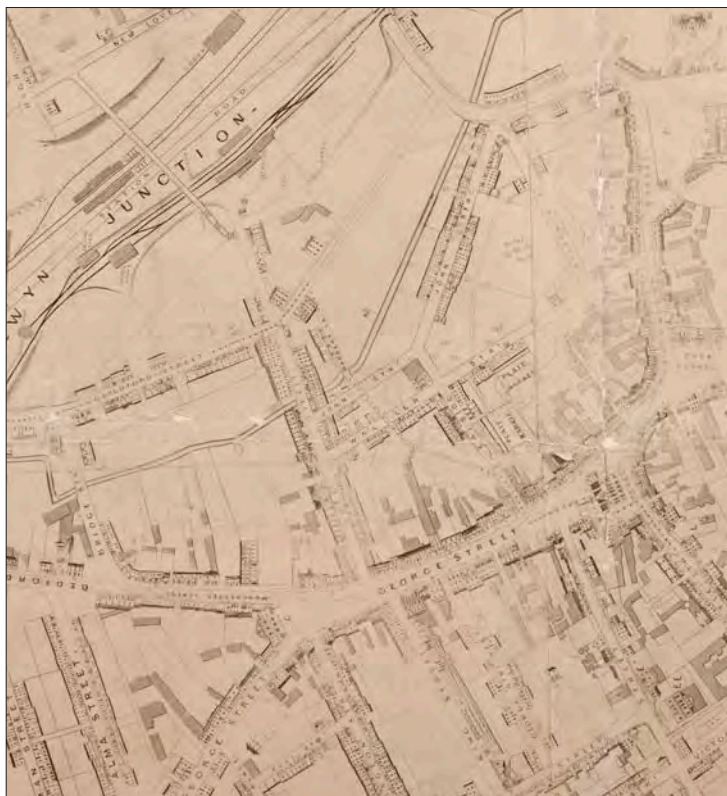
Figure 22. Corney's pictorial map, last updated in 1870. The difference between the two maps clearly illustrates the scale and pace of change within the area. © Beds RO X1-38-1.

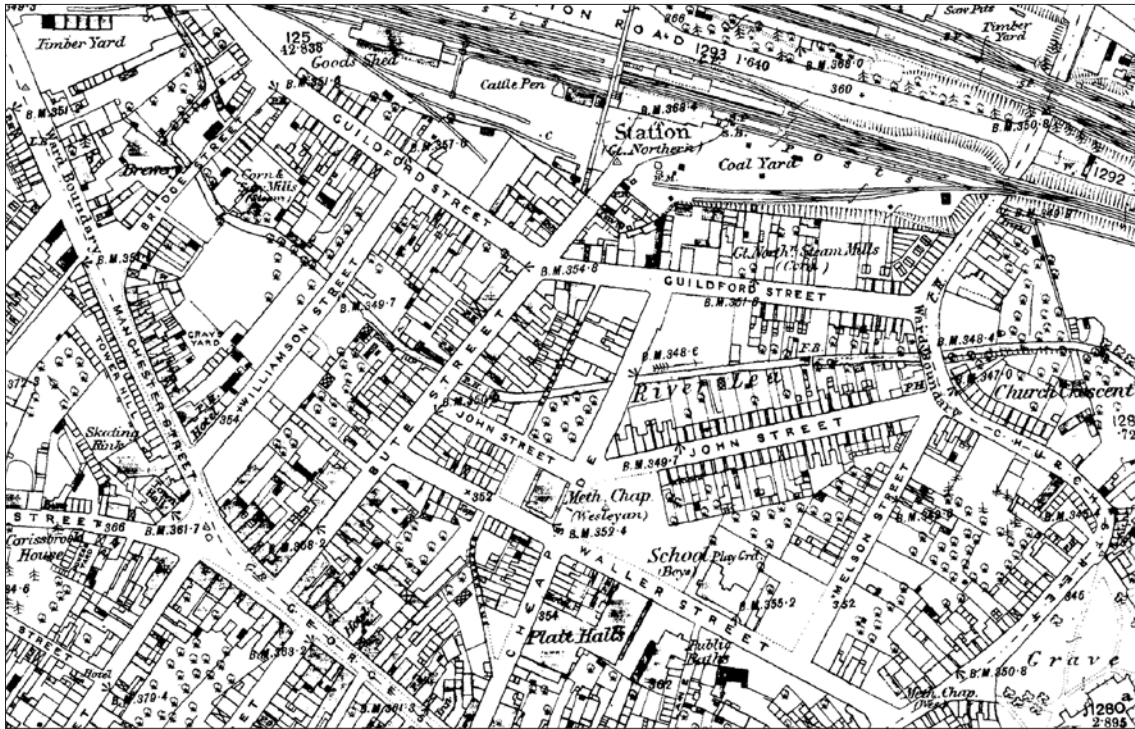
Figure 23 This extract of the OS 1:2500 scale plan of Luton shows that over the course of two decades, development in the hatting and related industries had been rapid.

The 1:2500 Town Plan of 1880 depicts the area of Plaiters' Lea very much as it is seen today (Figure 23). The Arndale has, of course, removed Waller Street but to the north of this the street pattern remains recognisable. The major development is that Cheapside has been extended further to the north and is linked with Guildford Street. Subsequent revisions of the 1:2500 maps in 1901 and 1924 record further development and infill within the area, resulting in the hatting quarter becoming the most heavily built-up area within the town.

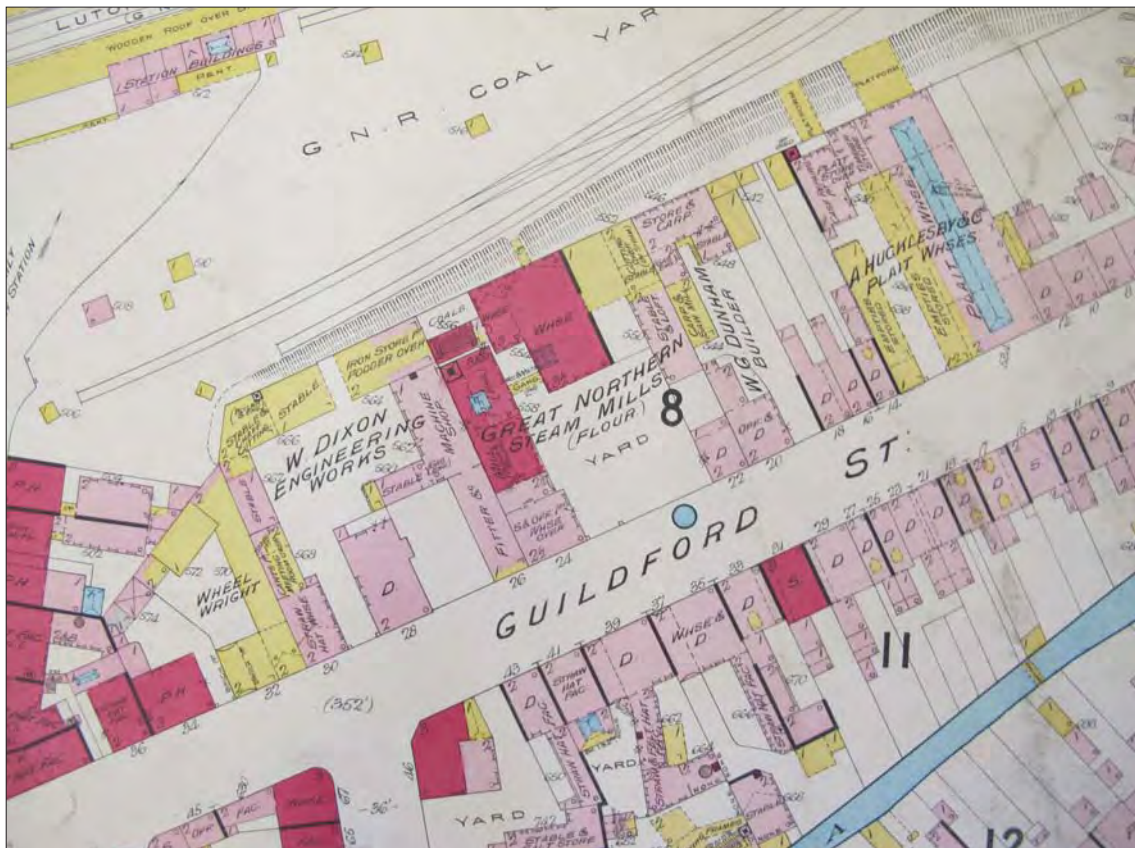
Figure 24. A detail from Goad's 1895 series of insurance maps for central Luton. Bedfordshire and Luton Archives Service.

Goad's Fire Insurance plan of the hatting district in Luton was first produced in 1895 (Figure 24) with regular updates until a final plan in 1958. These sequential plans are remarkably useful in that they provide detail, not only on the form, extent and condition of all buildings at the particular time of survey, but also the changing use and ownership of buildings through time. The use of colour to indicate constructional materials – brick, stone or concrete in pink, wood in yellow, metal in grey, and glass skylights in light blue – was augmented by additional information about locations of doors and windows, number of storeys for each building as well as the nature of party walls.

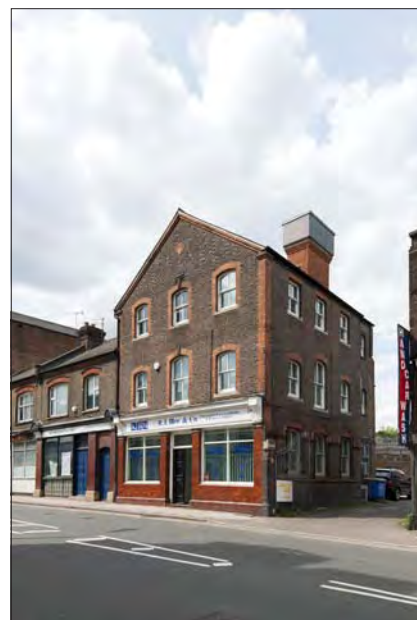
Figure 27. 24 Guildford Street and the entrance to the former Great Northern Steam millyard. © English Heritage NMR DPI46065.

This process of constant re-working and redefinition of existing buildings is a recurring theme in the Conservation Area with many substantial premises witnessing structural alterations and change of function soon after construction. R.J. Blow & Co. at 24 Guildford Street typifies this having been constructed in the 1870s as offices with a second-floor warehouse forming part of the goods yard

adjacent to Luton Railway Station. By the late 1930s, it had been converted to a hat factory and it is, currently, occupied by a firm of accountants (Figure 27). Similarly, the Vyse Factory on Bute Street was built in 1930 following a fatal fire at the original factory which had been an amalgamation of a number of separate workshops, store rooms and showrooms. Shortly after noon on 25th February 1930 a fire broke out – the result of wax being overheated – and within ten minutes the whole building was ablaze. Of the 136 workers on site at the time, eight people perished – nearly all of them had been working as sewers or steamers on the upper floor.¹²⁶ The present building saw production cease in 1956 and became home to the Luton town branch of the TSB, it currently hosts a 'continental' supermarket and a fast food outlet on the ground floor. On the Bute Street approach to the Arndale, many of the earlier shop fronts and ground floors of hat factories and showrooms have been removed or embellished by the addition of new windows, doors and associated fascias. 'The Engine' public house, which is empty and increasingly neglected, is the surviving element of a pair of public houses built here c.1865. The other, 'The Empress', was built over the River Lea conduit and fragments of it – including doorways and window reveals – can be seen in the north wall of the conduit just above water level: this area now hosts a large car park.

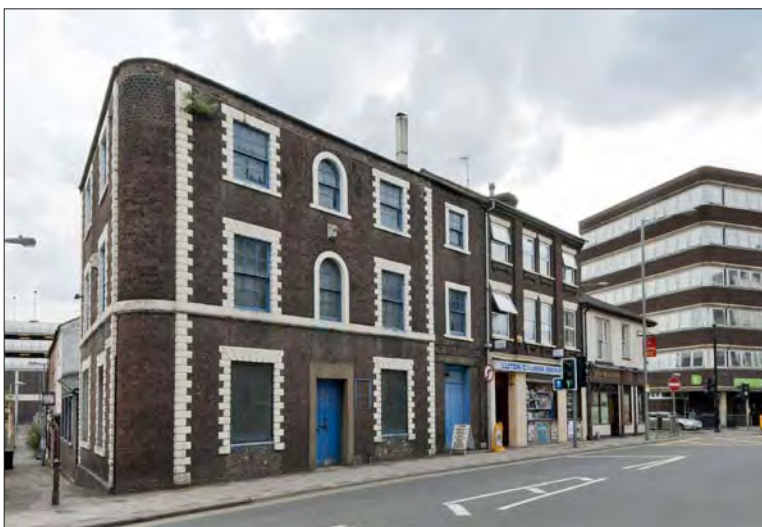
Figure 29. 47 Guildford Street.
© English Heritage NMR
DPI46079.

47 Guildford Street epitomizes many of the characteristics seen in the buildings of this date (Figure 29). A distinctive hat factory supposedly built in the 1860s but very possibly dating to the 1840s, it is largely domestic in appearance, with a low façade embellished with striking white stuccoed quoins and quite unlike any other hat factory in the Conservation Area. The earliest of the smaller domestic scale properties in the area are 23-29 Barber's Lane, a terrace built to house commercial businesses on the ground floor with private living quarters on the two floors above (Figure 30 & 31).

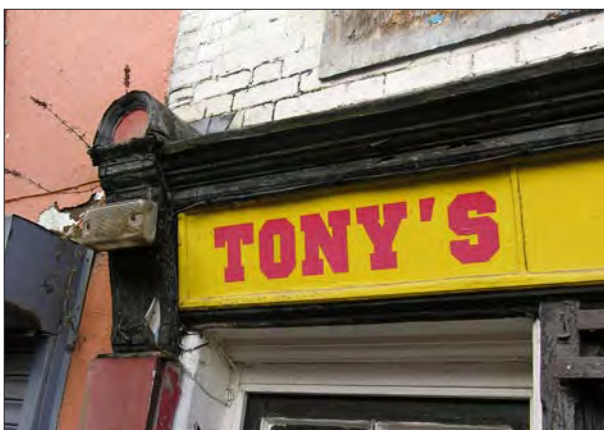
Figure 31. Detail of the fascia and entablature above the shop at 29 Barber's Lane.
© Katie Carmichael.

Originally part of a row of eight properties, only 29 retains its original timber shop front with a moulded central mullion in colonette form with a striking foliate capital, whilst the fascia is flanked by fluted consoles with segmental pediments and lead-flashing. More prominent examples of the domestic form are 66-68 Bute Street, three-storey red brick buildings with brick parapets. A number of sash windows remain – although these appear to be c.1880 replacements of the original glazing – and both have impressive ground-floor shop fronts which incorporate simple pilasters (Figure 32).

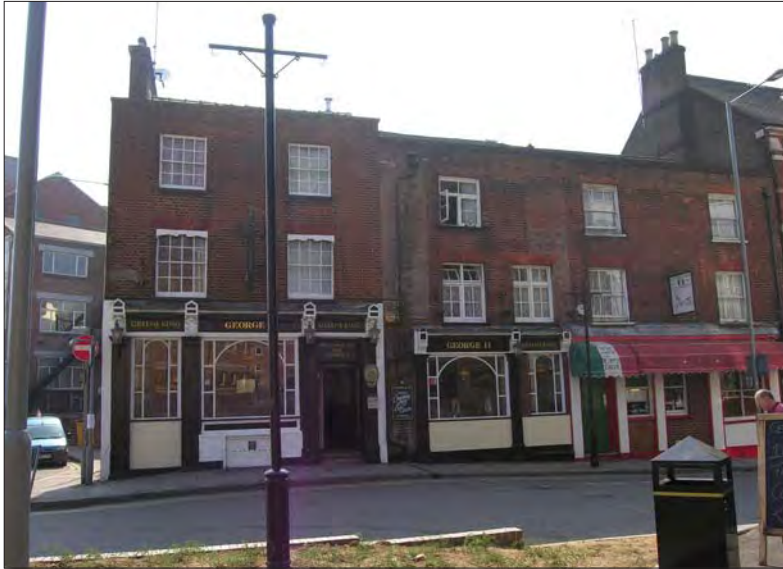
Figure 32. 66-70 Guildford Street. 'The George II' is a later addition to an earlier terrace.
© Katie Carmichael.

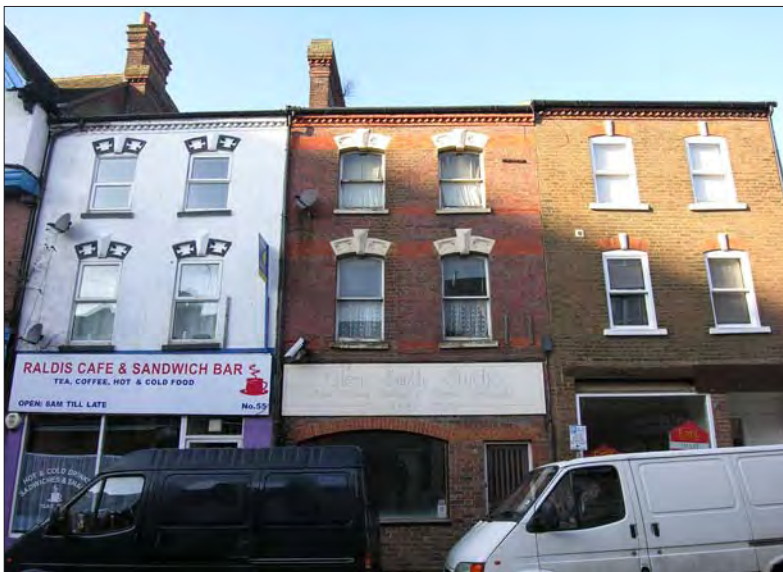
55-59 Cheapside is a three-storey terrace of three individual properties. Built prior to 1880, they feature sawtooth detailing immediately below the eaves and to the tops of the chimney stacks, whilst 55 and 57 have a Maltese cross style motif within the stone window heads. The ground floors of the properties have been substantially altered but it is likely that they originally contained shop windows (Figure 33).

Figure 33. 55-59 Cheapside.
© Katie Carmichael.

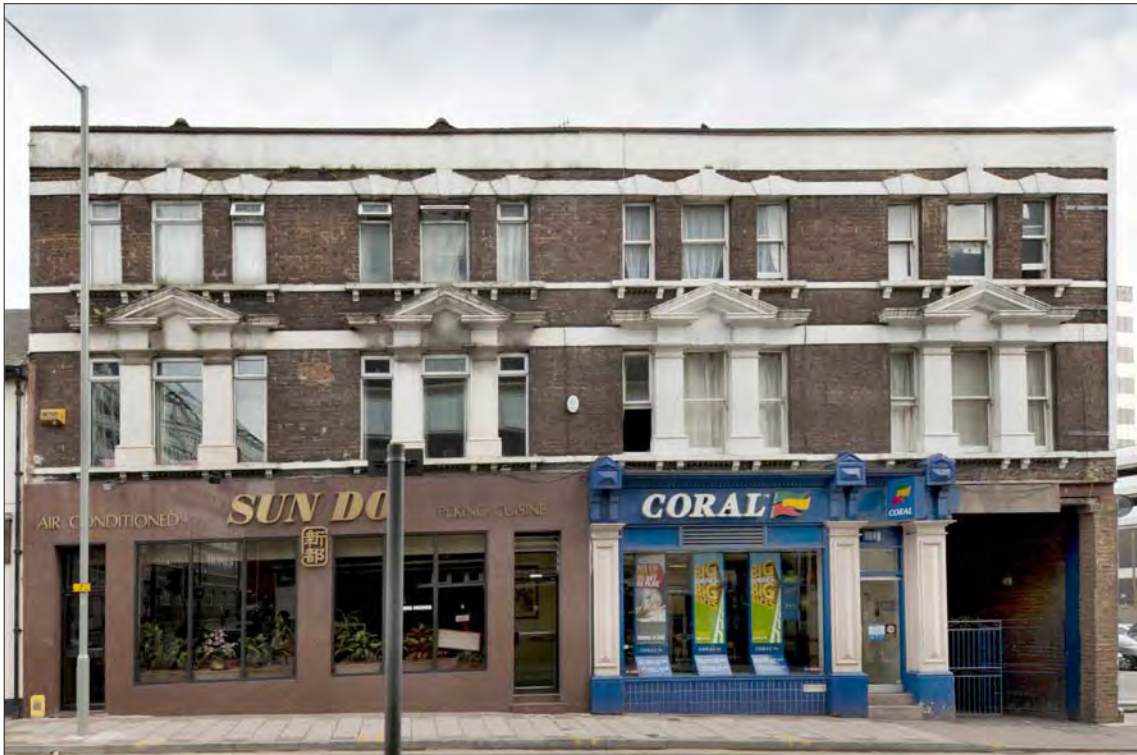
The terrace of four properties at 50-54 Bute Street appears to have been erected in the late 1870s and is an example of speculative commercial development (Figure 34). The bold treatment of the first-floor windows is unique in the area, the triple lights with bracketed sills being divided by heavy pilasters which support a broken pediment. The dark brick of the building contrasts strongly with the white painted rendering of the window surrounds, bands and pediment, creating a noteworthy façade.

Figure 34. 50-54 Bute Street.

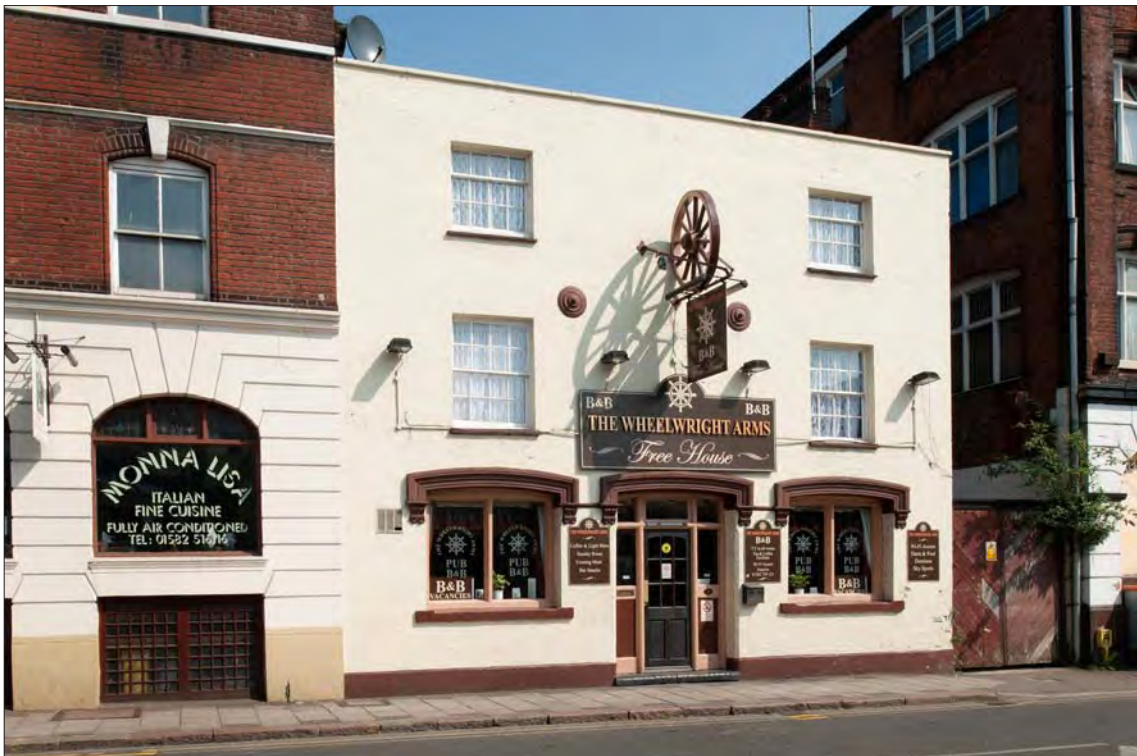
Figure 35. The 'Wheelwright Arms', built c.1840, is one of the most distinctive buildings in the Conservation Area. © English Heritage NMR DPI41931.

'The Wheelwright Arms' is likely to date to c.1840 and repeats elements of design seen at 66-68 Bute Street, being three storeys tall with a plain brick parapet and sash windows (Figure 35). It differs, being a public house, in that it has a wide central doorway to either

side of which is a window with a central stone mullion. The most striking features are the heavily moulded stone hoods supported on brackets running above the windows and doorway – this incorporation of medieval revival elements is unique within the Conservation Area. 55 Bute Street opened as 'The Cooper's Arms' in 1864 but appears to make use of an older domestic, or semi-domestic, pair of buildings dating to around 1840-50. The arrangement of the sash windows, the central doorway and the brick pediment is markedly similar to features seen at 'The Wheelwright Arms' and 66-68 Bute Street, suggesting that they were built at a similar date. 'The Melson Arms', another public house, is a little later in date – opening in 1856¹²⁷ – and is markedly different in style. Located on the corner of John Street and Church Street, two storeys high with a cut off corner and large paned sash windows, it was purpose designed as a public house and is unmistakably Victorian in character.

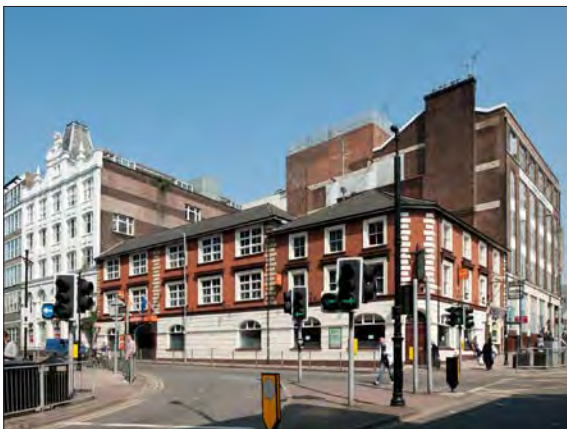
A number of businesses combined domestic and commercial elements to form an eclectic local vernacular style. One such example is 61 Bute Street, now the 'easyHotel', which was built in the 1860s (Figure 36). Here, rusticated stucco has been used to great effect on the ground floor of the building, whilst yellow brick quoins to the first and second floors further enliven the façade. The sash windows are all surrounded by architraves, the first-floor windows surmounted by moulded brick cornices on consoles – lending a somewhat domestic air to the property. In contrast, 36 Guildford Street sits in a prominent location close the intersection of Bute Street and Guildford Street and its most notable feature is the use of white, banded, rustication in conjunction with a half basement and raised ground-floor wholesale showroom – possibly the earliest occurrence of this in the Conservation Area (Figure 37). The provision of two doors mirrors the arrangement at many other similar properties in the Conservation Area: one providing access to the showroom, the other leading to workshops. The particular style and arrangement of the fenestration, containing large paned sash windows without horns, suggests a date of around 1860-70 and is similar to that seen on other buildings within the area, such as 15 Guildford Street. Indeed, the use and treatment of the rustication is another feature which appears repeatedly within the Conservation Area and on buildings of almost every period.

Figure 36. The easyHotel. © English Heritage NMR DPI41936.

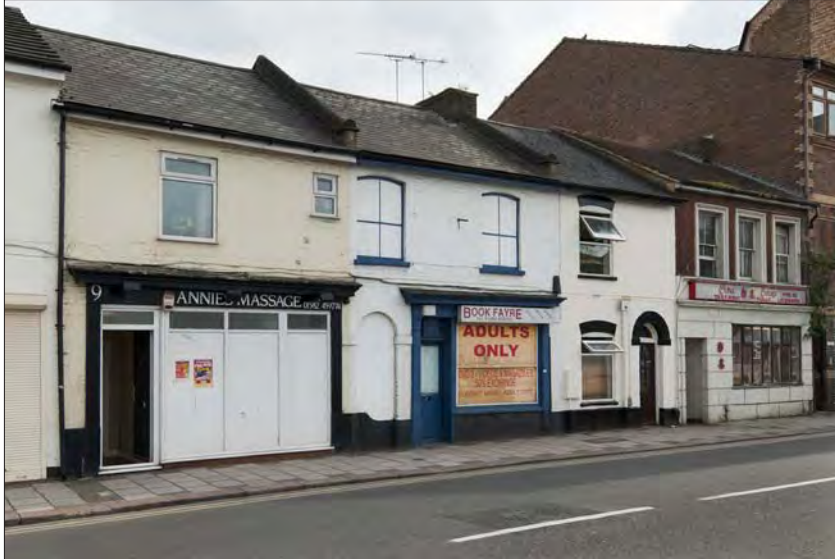
Figure 38. 9-15 Guildford Street. © David McOmish.

5-15 Guildford Street represents what remains of a previously more extensive range of semi-domestic buildings erected in the 1870s (Figure 38). The two-storey properties retain a number of original shop fronts, and 7 Guildford Street – the largest of the terrace – may have been designed as a bakery, and remained in use as a baker’s until at least the outbreak of the First World War.¹²⁸ The most impressive building in the terrace is 15 Guildford Street, now the ‘China Cottage’ takeaway restaurant but listed as the premises of a watchmaker in Kelly’s Directory for 1903.¹²⁹ The upper floor has three relatively large sash windows without horns (as expected in buildings built prior to the 1870s) set within prominent architraves unlike any of the other properties in this area and the ground floor is dominated by rusticated rendering (Figure 39). There are strong similarities between the shop frontages

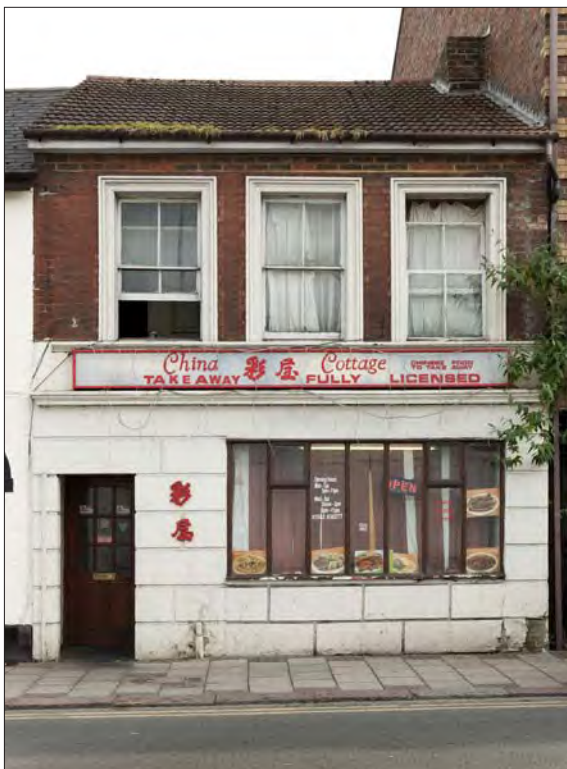
Figure 39. 15 Guildford Street.
© English Heritage NMR DPI46094.

at the eastern end of Guildford Street and that surviving at 29 Barber's Lane, most noticeably the narrow fluted pilasters capped by consoles and miniature segmented pediments: again, rusticated rendering in conjunction with sash windows can be seen at 15 Guildford Street.

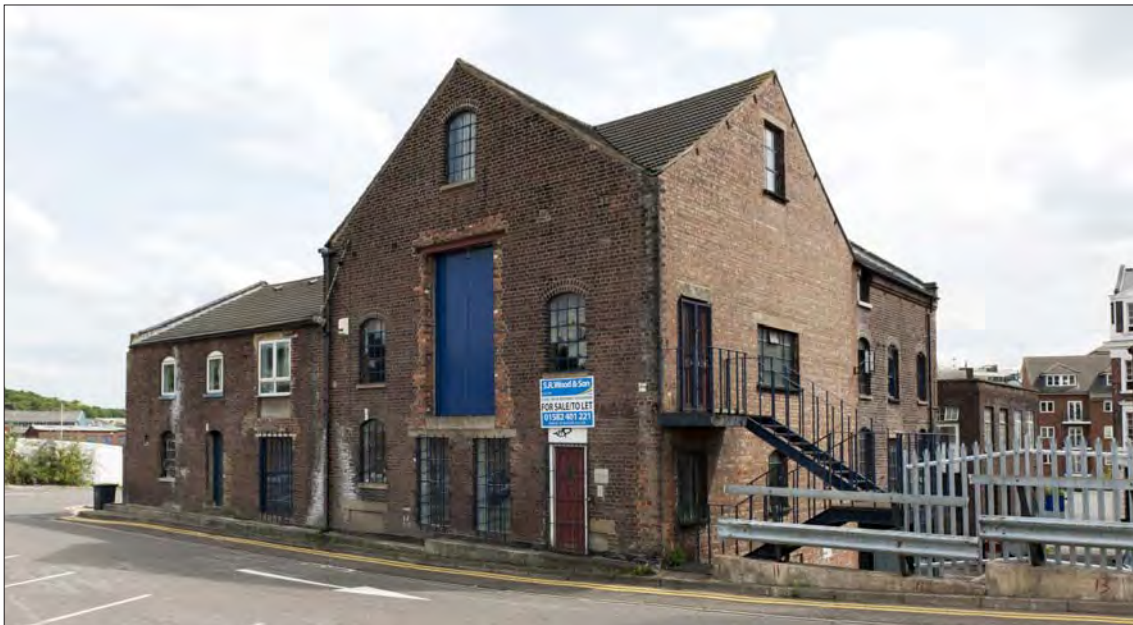
During the last quarter of the 19th century the area close to the railway station emerged as a commercial and industrial hub. Coal and goods yards were established to the south of the Great Northern station and the section of Bute Street closest to them witnessed intense industrial development. Notably, in the late 1870s, this included the W. Dixon Engineering Works (rebuilt as the Bute Mills) and the Great Northern Steam Mills, so-called because of the proximity to the Great Northern railway station. Despite recent demolition and refurbishment in the area, the core of the Great Northern Steam Mills does survive, but in a much altered form. The presence of R.J. Blow & Co's offices at 24 Guildford Street has already been remarked upon, and is one of the very few three-storey properties in the area at this date.

Figure 40. 24a-c Bute Street, a remnant of the Great Northern Steam Mills.
© English Heritage NMR DPI46062.
