PLAITERS' LEA CONSERVATION AREA, LUTON HISTORIC AREA ASSESSMENT

Research Department Report Series 069-2011

HISTORIC AREA ASSESSMENT

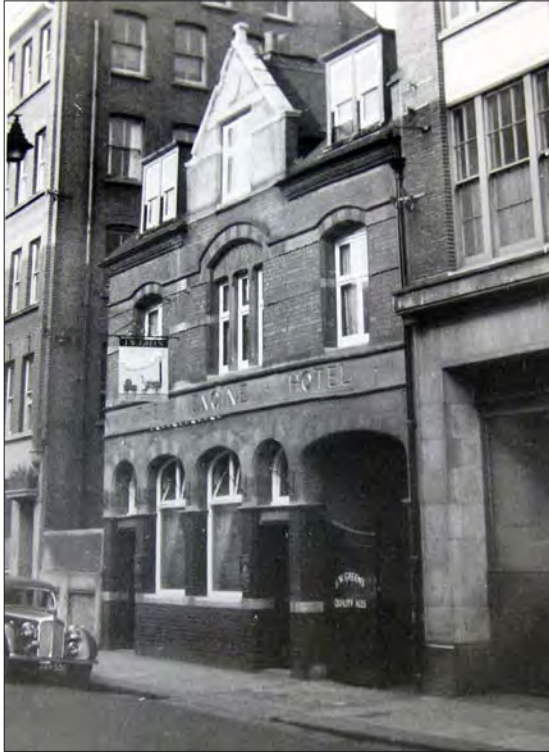
Figure 41. A view of 'The Engine' taken in the early 1930s. Bedfordshire and Luton Archives Service.

A number of new public houses opened near the station around 1870, including 'The Engine', at 43 Bute Street, which was originally built in 1865 but burned down and rebuilt in its current form in 1900 according to an inscription on the gable (Figures 41 and 42). The building is notable for its use of polychromatic brickwork – the Bute Street elevation built using Luton Stock grey bricks with decorative banding, whilst the southern elevation is built in yellow brick with red brick banding. However, many of the features, such as the polychromatic brickwork, segmental window heads and the low relief stencilling in the tympanum above the central window, would suggest a date of c.1865 – therefore the precise extent of the turn-of-the-century rebuilding remains uncertain. Opposite, on the eastern side of Bute Street, was another pub called 'The Empress' built over the river Lea – as previously mentioned this was demolished and only fragments remain visible within the north wall of the conduit.

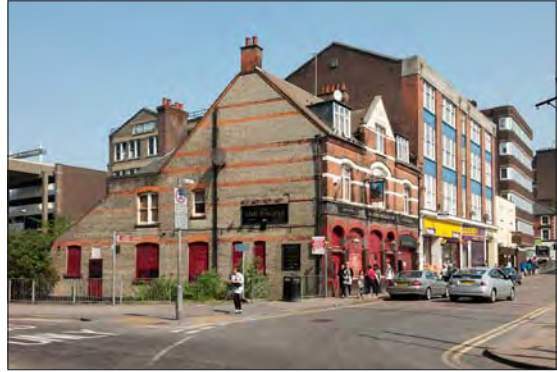
Figure 42. 'The Engine' public house.
© English Heritage NMR DPI41916.

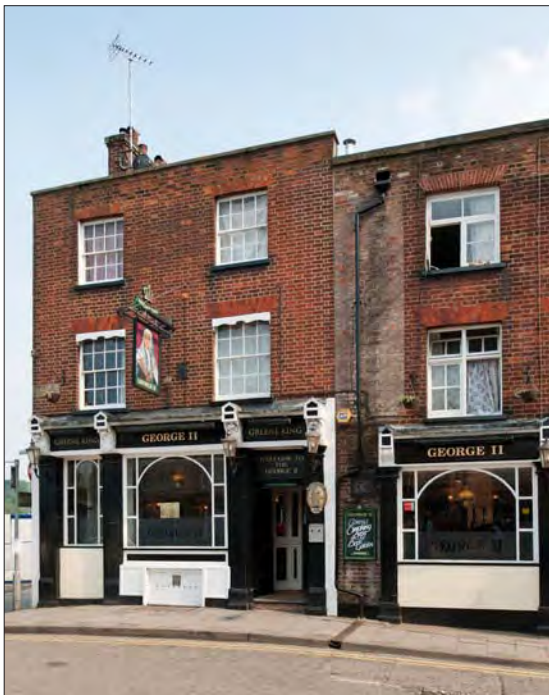
Figure 43, 'The George II', 70 Bute Street.
© English Heritage NMR DPI41922.

'The George II' public house, 70 Bute Street, is clearly a later addition to an existing row – it was built in the 1870s and has a number of fine details such as the valances above the upper windows (Figure 43). The ground-floor pub frontage was added around 1880-90, presumably when the pub expanded to incorporate part of 68 Bute St, and appears to be an attempt to unify the façade. 'The Great Northern', 63 Bute Street, retains a remarkably similar window in its frontage.

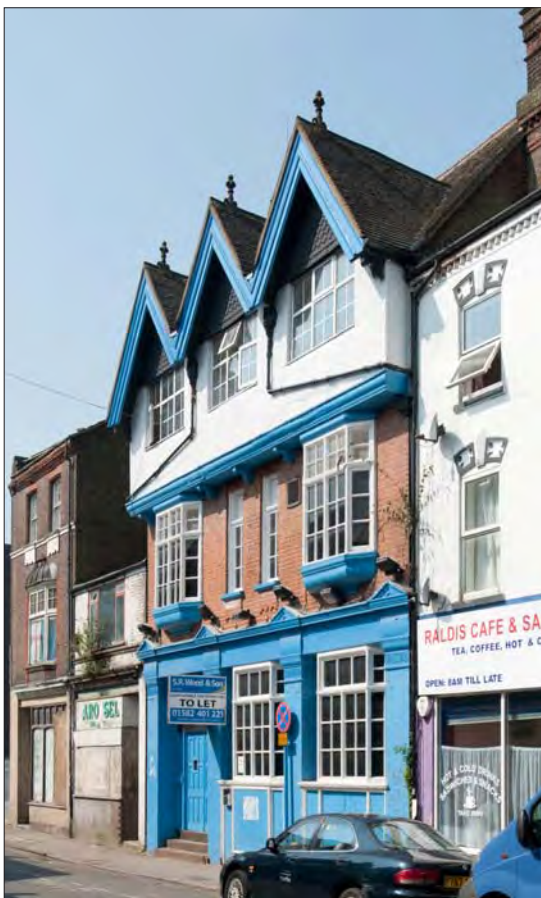
Figure 44. 'The Cowper Arms', 53 Cheapside
© English Heritage NMR DPI41923.

'The Cowper Arms' temperance hotel and coffee house on Cheapside was built in 1882 to provide workers and residents with an alternative to the public houses of the area. It was constructed in the Queen Anne revival style with a jettied upper floor, triple gable and oriel windows with fine shaped aprons beneath (Figure 44 & 45). Similarly, evidence of another ancillary trade supporting the industry is evident at 31 Guildford Street which has a fine shop front, the glazed bricks within the entrance lobby suggesting that it was constructed as a food shop.

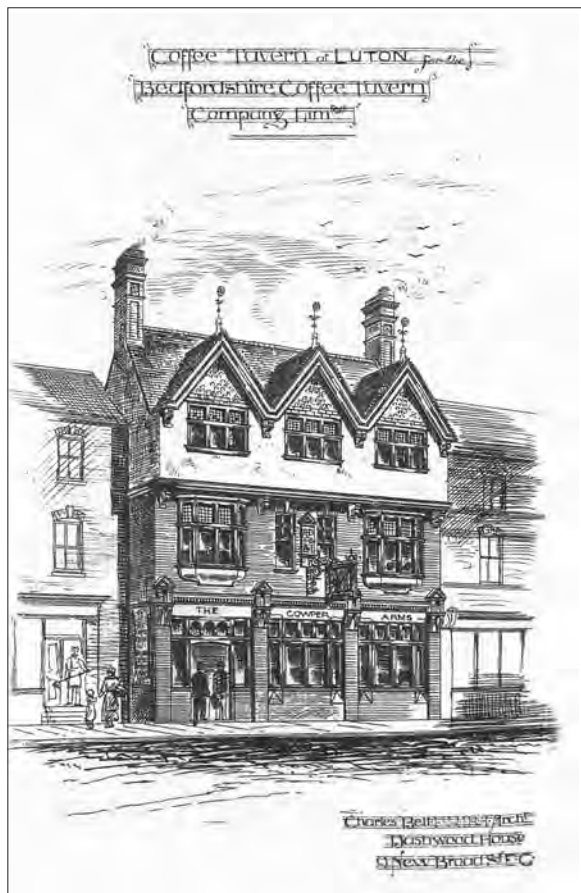
Figure 45. 1882 drawing of 'The Cowper Arms'.
The Builder 1882ii: 498.

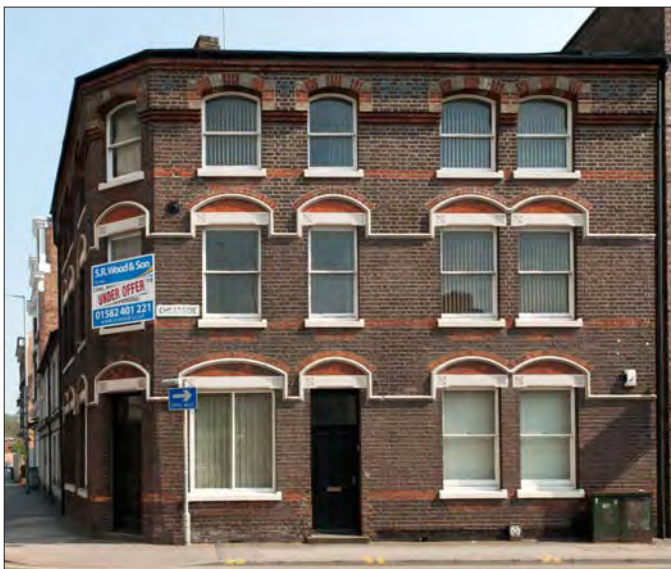
Figure 46. 56 Cheapside was a relatively late addition to the street scene here, being built in a vacant plot at the junction on Cheapside and Guildford Street late in the 19th century.

Domestic, or semi-domestic, properties continued to be built within the area but generally display more architectural detail than previously seen. 54-56 Cheapside is an interesting example of a somewhat eclectic design in the local vernacular tradition, with stone and polychromatic brick used to great effect across all three storeys (Figure 46). The use of small windows with decorated lintels within a continuous string course which arches above each window, as well as the tympana filled with red brick in a herringbone design, suggest it was designed for office or domestic use. The stepped brickwork beneath the eaves is unique within the Conservation Area and forms a hooded feature above each of the upper-floor windows. Built as part of the development of the same plot of land in the 1880s, 52 Cheapside is two storeys high with a small dormer window to the attic. A semi-domestic property, the ground floor consists of a display window

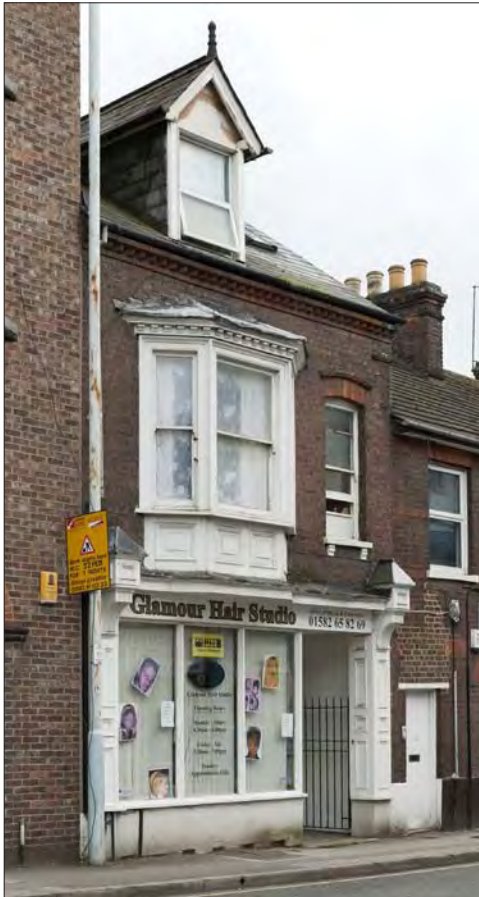
Figure 47. 52 Cheapside
© English Heritage NMR DPI46070.

with recessed lobby, whilst above the display window is a very domestic looking three-cant oriel with plate glass sash windows – suggesting that the room here was used as a parlour (Figure 47). The sawtooth detailing beneath the eaves mimics that seen at 55-59 Cheapside, directly opposite.

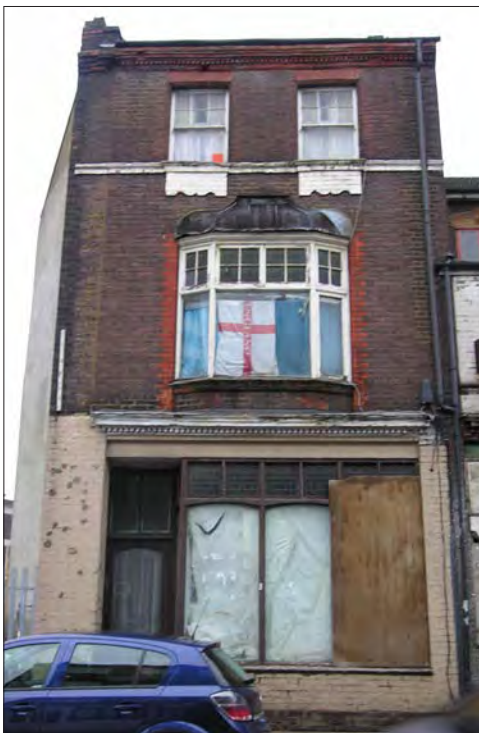
Figure 48 (left). 49 Cheapside was once part of a terrace that extended to the south. © Katie Carmichael

49 Cheapside, which was built in 1899-1900, is, again, semi-domestic in form, using Luton stock brick with red brick detailing but in the Queen Anne revival style, complete with moulded lead canopy above the first-floor oriel window (Figure 48). This three-storey property, built directly above the river Lea and, therefore, necessarily lacking a basement, is notable for its fine shopfront – in particular, a display window with multi-coloured glass transom lights above, with an etched floral design to alternate quarrels creating a checkerboard pattern (Figure 49). The recessed lobby contains the original door and panelling complete with original letter plate. The style of the aprons beneath the windows, and the shape of the oriel window suggest that the form of the building took inspiration from 'The Cowper Arms', or that both were designed by the same builder.

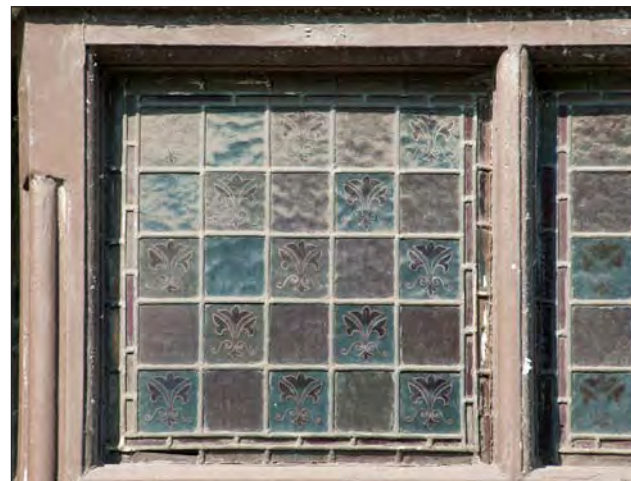
Figure 49 (above). Detail of the transom lights
© English Heritage NMR DPI41924&926.

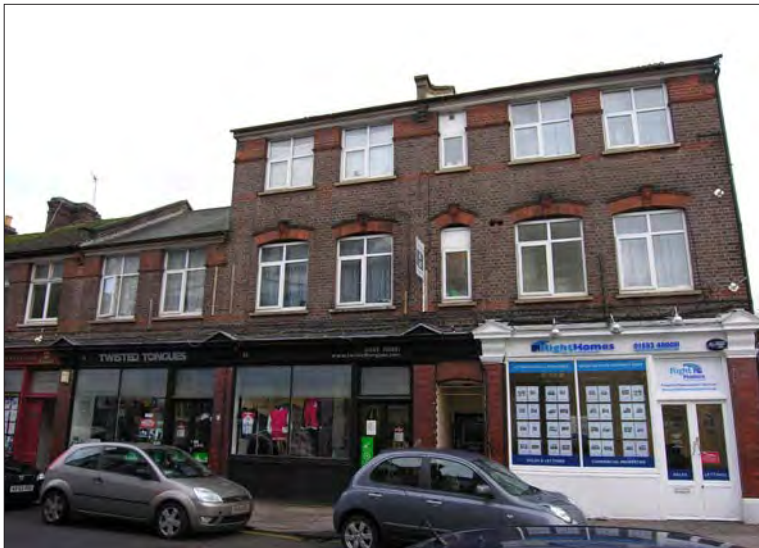
Figure 50. 42-48 Cheapside.
© Katie Carmichael.

42-48 Cheapside may well be another speculative commercial development, designed as a terrace of four individual shops (Figure 50). Unusually for a single development, 46 and 48 Cheapside are two storeys tall whereas 42 and 44 are three storeys tall – perhaps allowing for use by firms of varying sizes and therefore ensuring an income for the builder. The properties appear to have been designed this way deliberately, with an unusual brick scroll motif repeated beneath the eaves of each set of properties. Another example of the quirky vernacular tradition, each property had a matching ground-floor display window with recessed lobby accessed by a set of narrow double doors.

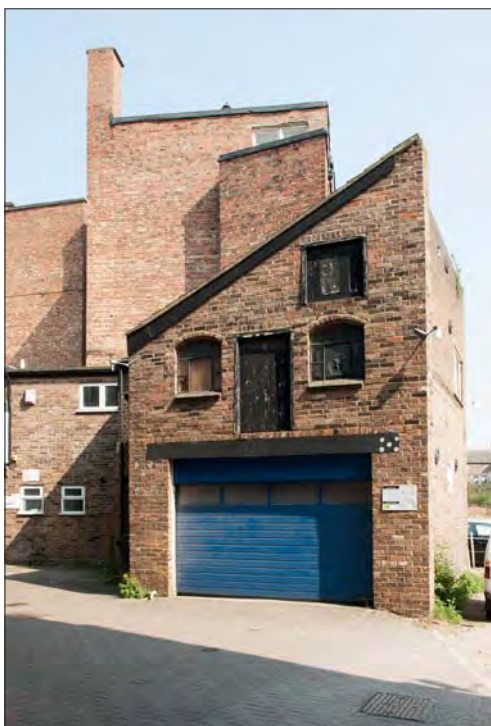
Figure 51. The stables to the rear of 41-43 Guildford Street.
© English Heritage NMR DPI41928.

41-43 Guildford Street, built as part of the development of the land on the eastern corner of Guildford Street and Cheapside in the 1880s, consists of a range of two-storey buildings – an amalgamation of three formerly separate properties. The entire street façade is coated in painted render but the original outline of 41 Guildford Street is clearly identifiable, with a noticeably less steeply pitched roof. 43 was first used as a domestic hat factory, and the rear workshop with associated stables survives (Figure 51). The stable itself has bull-nosed brick window surrounds and fixed metal glazing. It is remarkable given the number of horses employed in the transportation of hats and materials, and how many stables are shown on the earlier maps (e.g. Goad's Insurance map of 1895), that this is the only surviving example within the Conservation Area.

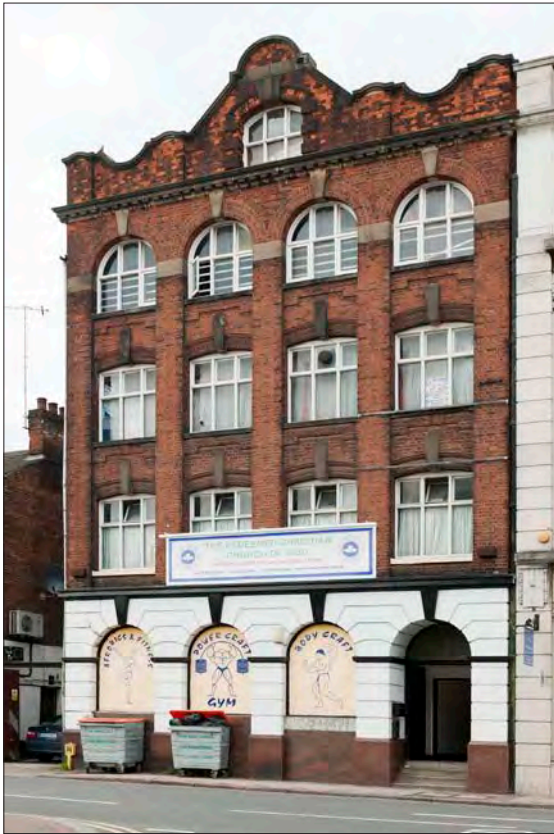
The basic form for hat factories and warehouses in Luton was well established by the last decade of the 19th century, with increasingly elaborate facades on an ever growing scale. 32 Guildford Street, built in the late 1880s, is a striking building of four storeys plus attic and a half basement with raised ground-floor showroom above (Figure 53). Constructed from red brick with a pier and panel façade, the decorative parapet incorporates a shaped dormer with segmental headed window lighting the attic, whilst giant order arches enclose the upper three storeys – lending an almost Neo-Jacobean style to the

Figure 53. 32 Guildford Street
© English Heritage NMR DPI46069

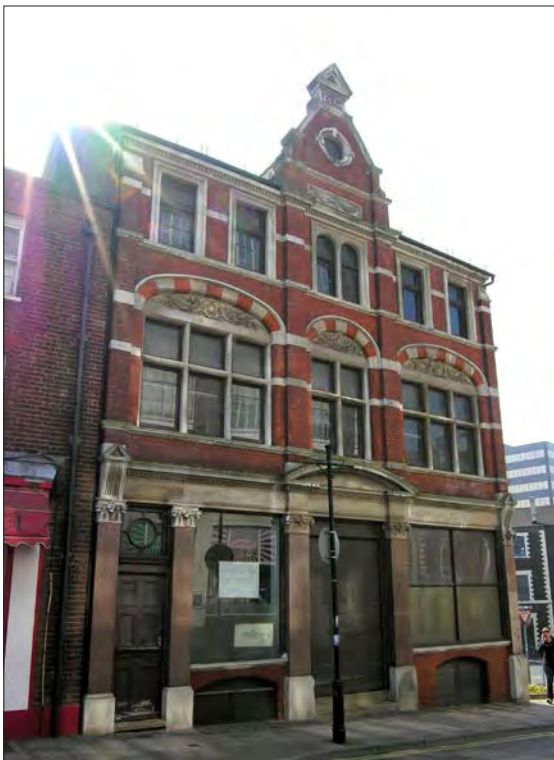
Figure 54. 64 Bute Street: Gurney & Sons.
© Katie Carmichael.

upper floors. The rusticated rendering on the ground-floor provides an immediate contrast to the upper storeys, being more classical in style.

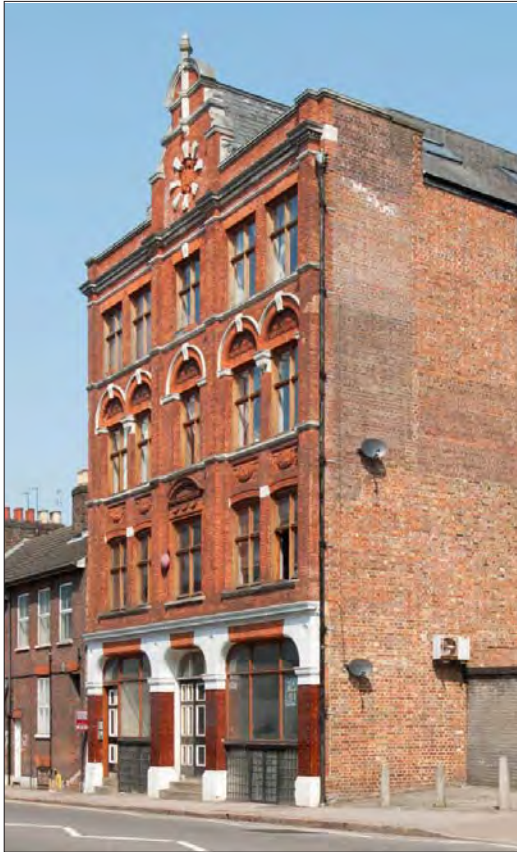
Sitting somewhere between 32 Guildford Street and 64 Bute Street in terms of style, the former Balfour & Sons hat factory at 50 Guildford Street lies just outside the Conservation Area on its west side (Figure 55). Constructed in c.1900 the symmetrical façade displays a remarkable use of red brick and stone, featuring a

Figure 55. The former Balfour & Sons hat factory lies just outside the Conservation Area on the west but it is of a quality that merits inclusion.
© English Heritage NMR DPI41938.

number of Queen Anne revival touches such as terracotta swags whereas the elaborate Neo-Jacobean pedimented gable contains a decorated roundel similar to that at 64 Bute Street. The raised ground-floor showroom windows are situated either side of a central lobby, whilst a trade entrance is provided to the west.

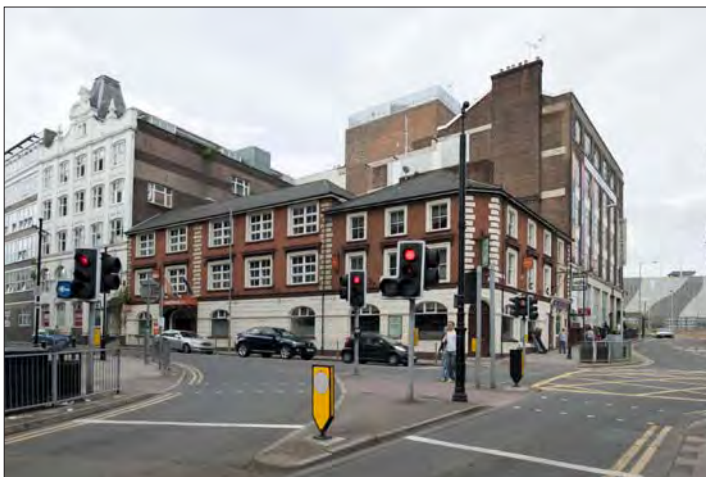
40a Guildford Street, now part of the 'easyHotel', was built in the same style as its earlier neighbour at 61 Bute Street (Figure 47). It was erected in two phases between 1901 and 1905 on a site previously occupied by a number of houses and gardens. Like its neighbour, it is a striking building in red brick with yellow brick quoins and dressings. The ground floor is covered by rusticated render, divided by a horizontal band, with three segmental-headed windows like those at 61 Bute Street, and a matching recessed entrance. As can be seen in the designs for the property, it was designed to blend in with the existing architecture of the town, indicating a respect for the styles and forms already present and a desire to maintain the scale and character of the street (Figure 57).

The first phase saw an extension to the west of 61 Bute Street with windows flanking a pair of narrow doorways set slightly off-centre in the façade. The rusticated banding was carefully matched to the existing building, and the yellow brick quoins carried across the new block.¹³¹ The second extension saw another two bays added to the west of the previously added block, with a cart or vehicle entrance and a window of the ground floor, again set within rusticated banding, and with the windows designed to match the existing ones.¹³²

Figure 56. 40a Guildford Street.
© English Heritage NMR DPI46075.

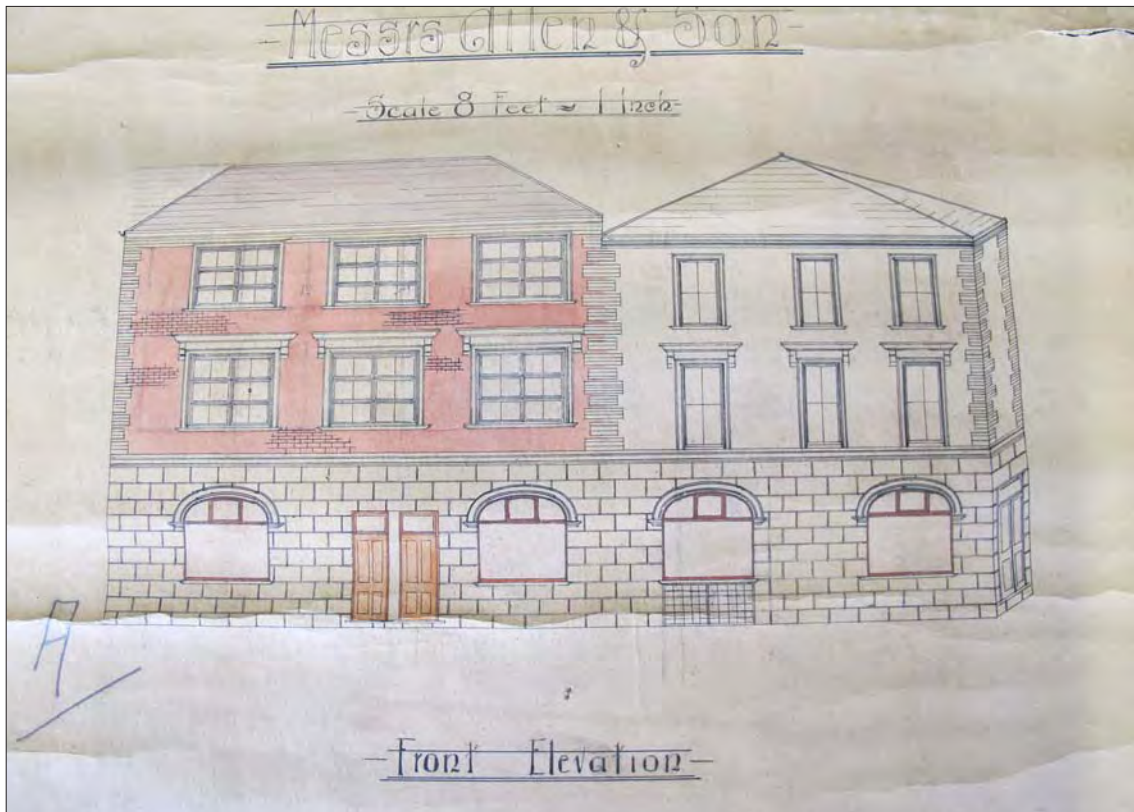
Figure 57. Design plans for the extension to 61 Bute Street. © Luton Culture. Plan Ref. AD/115.

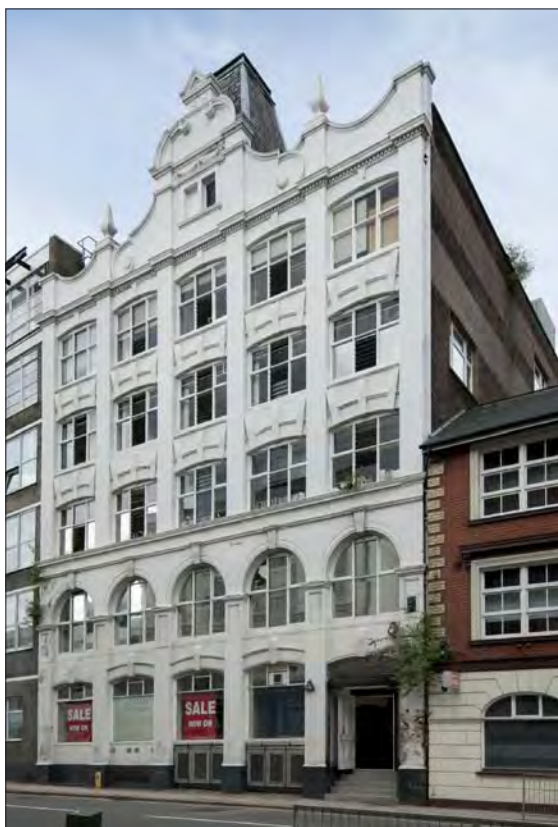
Figure 58. 40 Guildford Street, built in 1905.
© English Heritage NMR DPI46078.

A more bold design is evident at 40 Guildford Street, an imposing hat factory built in 1905 using a cast iron frame with pier and panel façade (Figure 58). The building extends over five storeys plus attic and basement – making it one of the tallest structures in the Conservation Area. The white painted façade is crowned by a complex gabled parapet behind which is a truncated pyramid turret that may once have supported a flagpole. The building is especially notable for its use of a two storey showroom front, with a giant arcade encompassing the half basement as well as the raised first and second floors, serving to distinguish the showroom and offices from the functional factory element on the floors above. As with 50 Guildford Street, the building features many Neo-Jacobean elements, such as the obelisks to either side of the gable, whilst there are also a number of Queen Anne revival touches including the swag above the attic window.

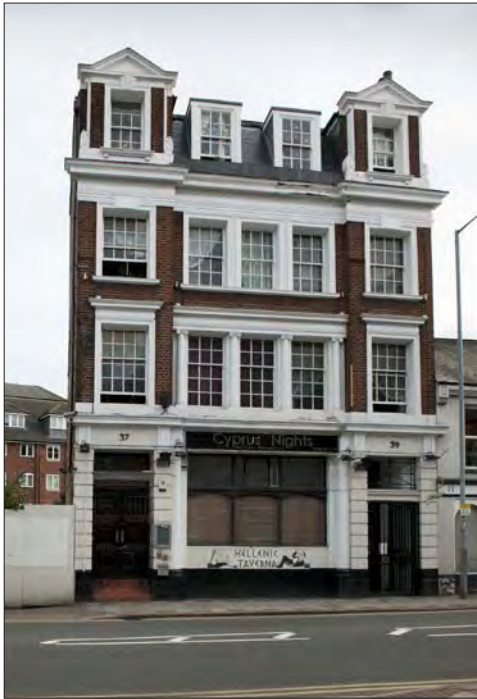
Figure 59. 37-39 Guildford Street.
© English Heritage NMR DPI46095.

One of the most striking buildings within the Conservation Area is the warehouse and factory built for Austin and Co. at 37-39 Guildford Street in 1912 (Figure 59). The style of the street façade – a modified Edwardian Baroque – does not recur on any other building in the Conservation Area. Comprising three and a half storeys, the building is tall and narrow, of brown brick, with white or buff painted dressings and a slate roof. The centre of the façade is recessed between salient lateral bays. At ground-floor level, beneath a plain frieze or fascia articulated by triglyphs, a central show window is framed by engaged Ionic columns and flanked by doorways with rusticated jambs. The doorway to the left have access to a lobby with stairs and a lift, and formed the entrance to the showroom, while that on the right ran through the front block to the factory at the rear. The upper-floor windows, all sashes, have pulvinated friezes; those in the central bay are treated as triplets, with that at first-floor level flanked by Ionic columns. The roof carries four dormers: the pair in the centre have flat tops, while the outer dormers are framed by volutes, crowned by pediments, and contain windows with prominent stepped keystones. The blind gable ends were originally abutted by other structures which followed the street line. The factory wing to the rear is plain and industrial in character, largely faced in Fletton brickwork, with metal-framed windows. It would not originally have been visible from the street, but is exposed due to the loss of neighbouring buildings. This 'backlands' character recurs throughout the Conservation Area as a result of demolitions.

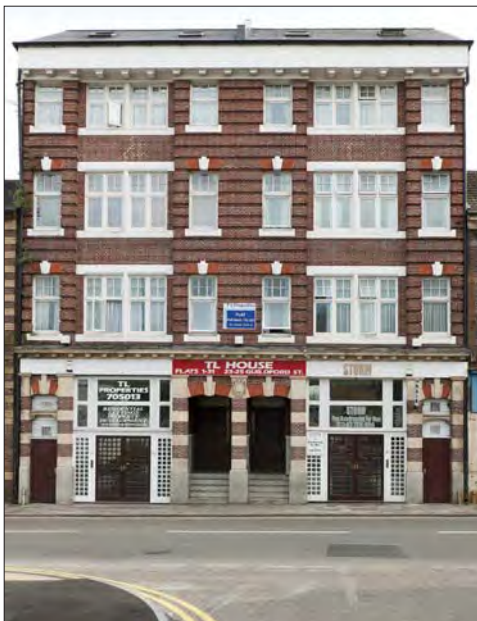
Figure 60. 23-25 Guildford Street.
© English Heritage NMR DPI46098.

covered by a single roof (Figure 60). Of brick and stone with rendered dressings, it has been converted into flats and given a new roof with a high eaves band – this sits rather unhappily above the carefully proportioned and detailed façade. The extensive use of banded rustication on all floors marks continuity with earlier commercial buildings in the vicinity, although this is now executed in exposed brick and stone rather than white-painted stucco or render. Each property comprises a wide central bay, recessed between salient bays, as at 37-39 Guildford Street. In each case, the centre of the ground floor (now remodelled) may have contained a shopfront or showroom window. On the inner side of this is a doorway – reached by a flight of steps, presumably spanning a raised basement – which would have served the street block. On the outer side, an entry with a transom bar probably provided access to the long four-storey factory wings to the rear.

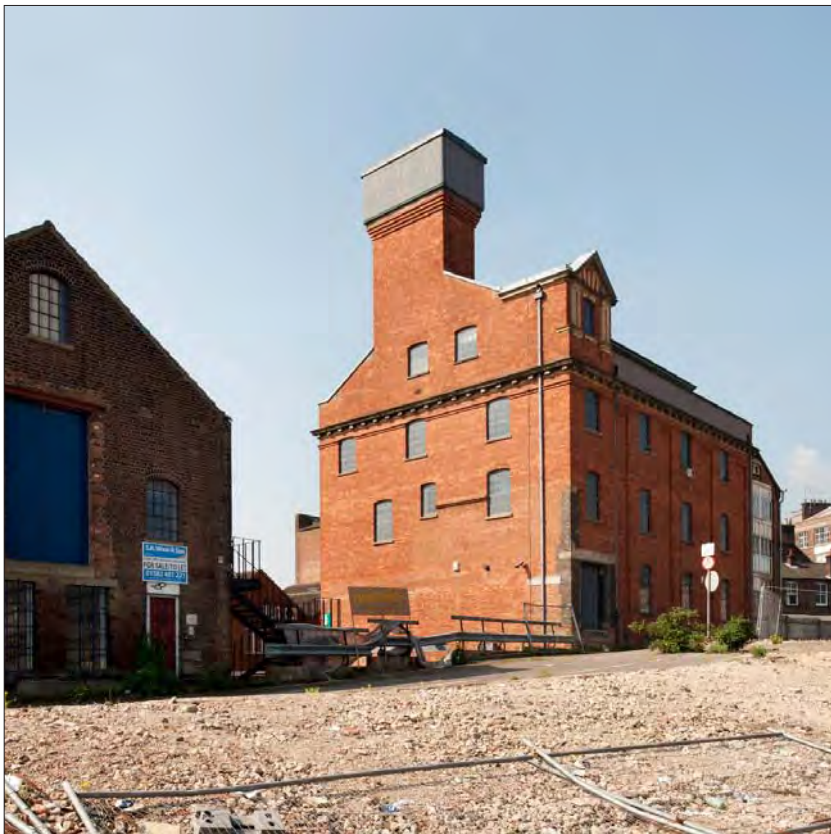
Other trades and small-scale industrial developments emerged in the area to the north of Guildford Street, particularly in close association with the railway goods yards on the south side of the main station. These clustered around two foci – the W. Dixon Engineering Works and the Great Northern Steam Mills – both shown on the Goad Insurance map of 1895. Much of this area was reconfigured with older structures demolished or refurbished as well as new buildings erected, during the first two decades of the 20th century. Principal amongst these are the Bute Mills which were built on the site of the Dixon works. It is one of the most recognisable buildings in the Conservation Area, constructed to a high standard using red brick and four storeys high (Figure 61). The most distinctive element of the building is, however, the iron water tank built on a corbelled brick support. This is a landmark feature, visible from a number of locations across the town centre and is emblazoned with 'Brown Bros', an important milling family

Figure 61. The Bute Mills building is one of the most distinctive structures in Luton.

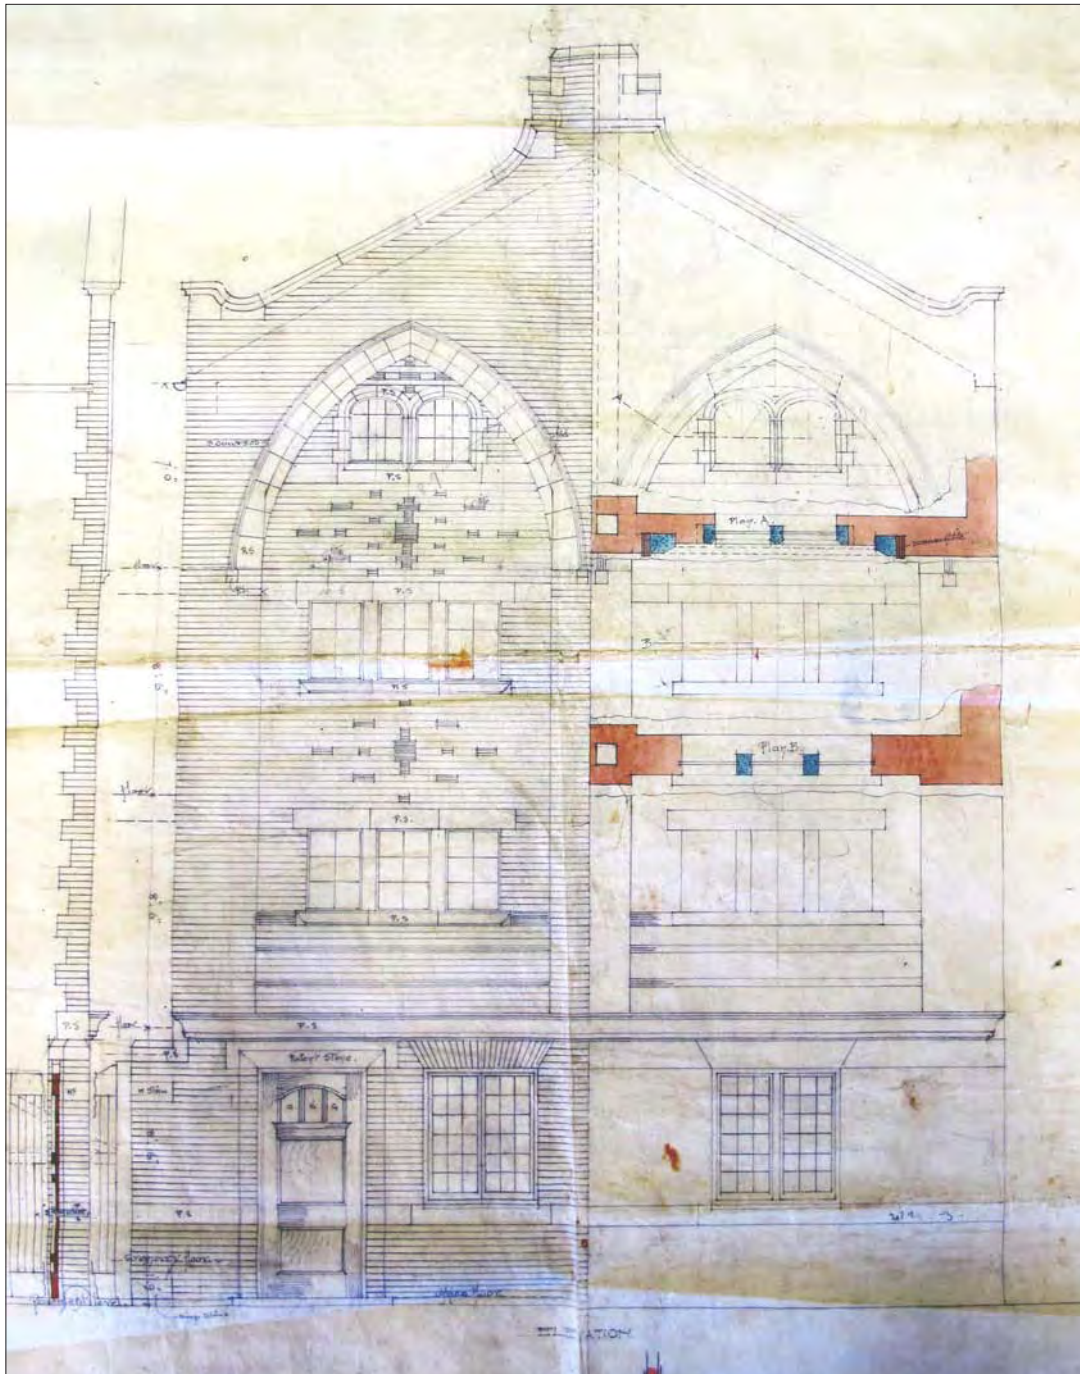
long-established in Luton. The former corn warehouse at 55 John Street is an intriguingly late example of gothic revival design, built for Tomson & Sons corn merchants in c.1913.¹³³ Built using pier and panel construction, the four storey building is dominated by giant order pointed arches springing from the piers to encompass the windows. It has been constructed using a mixture of Luton stock and red brick with concrete details, the panels incorporate decorative tiles which hint at the influence of the arts and crafts movement. Plans for the property drawn up in 1912 by the architect Max Zimmermann (Figure 62) show how well the John Street elevation has survived.

Figure 62. Plans for a new granary on John Street by the architect Max Zimmermann, dated 1912. BRO X843/1168(1)

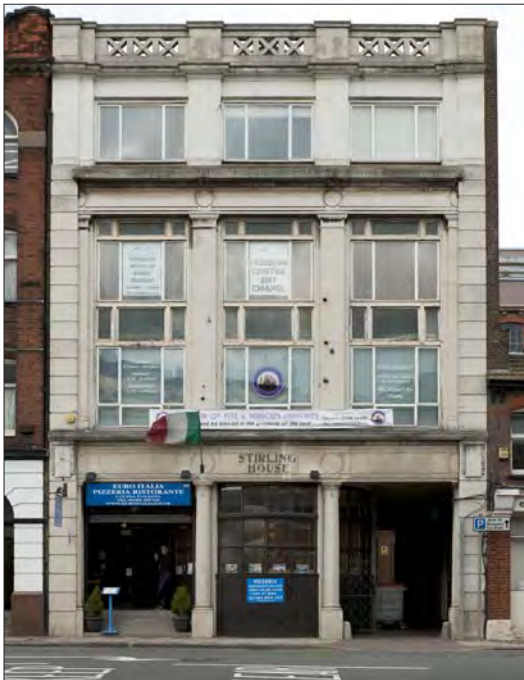
Stirling House, 30 Guildford Street, with its use of concrete render on a rigidly geometric façade, is markedly different in style to all of the earlier properties in the Conservation Area. Erected in 1919 to a design by Basil Deacon, again commissioned by W.G Dunham & Sons building contractors, it is a fine example of Neo-Classical commercial design, where the marginally recessed metal framed glazing panels create a light impression within a bold framework (Figure 63). The ground floor is remarkable in its monumentality with a central bow window framed by Doric columns. To the left, the main entrance is approached via a small flight of stone steps, the side passageway lying to the right of the window. The third floor forms an 'attic' storey, above which is a pierced parapet and, below, a strongly projecting cornice clearly delineating the 'attic' level from the rest of the building. The use of paterae within the entablature and fascia, and the use of pilasters with plain capitals, complete with drops, are all Neo-Classical features much in vogue at the time. However, the incorporation of rusticated render on the outer pilasters once more continues the leitmotif seen on buildings of almost every style and date within the Conservation Area. Designs for the building show that the façade was largely built as shown, the most obvious alteration being the rendering of the inner pilasters which were designed as exposed brick – it is not clear when the change was made (Figure 64).¹³⁴ The plans are annotated with the proposed room functions and are typical in their layout – the basement was to be used for storage; the ground floor had a show room at the front with offices, stairs and the lift in the centre (repeated on each floor) as well as access from the side for delivery of goods and for visiting agents, with a room for the packing and receiving of goods to the rear; the first floor had a work

Figure 63. Stirling House, 30 Guildford Street.
© English Heritage NMR DPI46068.

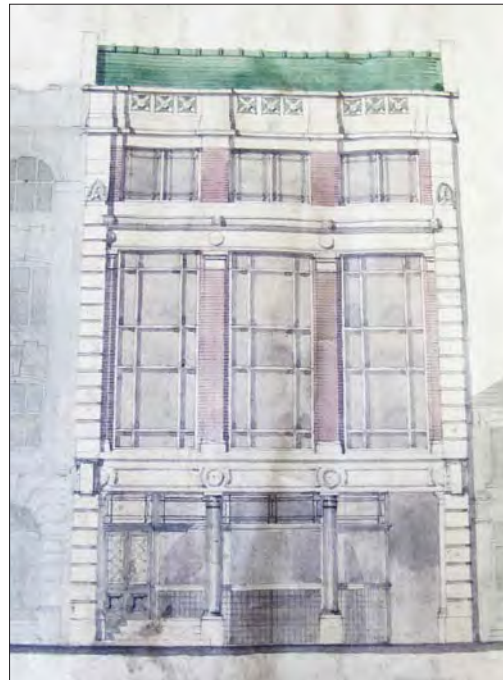
Figure 64. Designs by Basil Deacon.
© Luton Culture.

room to the front with stock room to the rear; the second floor was to have a machine or hand blocking room to the front with a finishers workroom to the rear; whilst the upper floor was designed to house the functions of blocking and stiffening. Such an arrangement made the best use of the space and light available within the building and enabled a logical flow of materials during production.

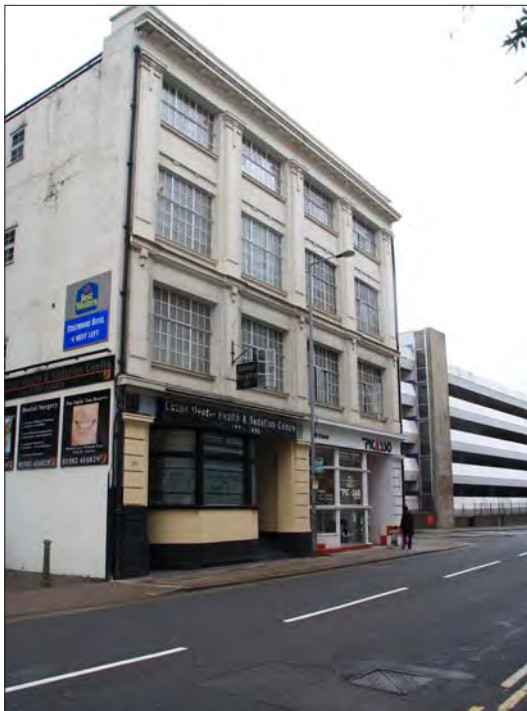
Figure 65 (left). 57-61 Guildford Street.
© David McOmish.

There are strong similarities between Stirling House and the paired arrangement of hat factories at 57-61 Guildford Street, in terms of form, including the use of projecting cornices at different floor levels, large metal-framed windows occupying the full width of the bays, and use of concrete render (Figure 65). Indeed, W.G. Dunham & Sons were once again responsible for commissioning the design. Although the architect of 57-61 Guildford Street is unknown, the close links between the firm and Basil Deacon, as well as the stylistic similarities, suggest that he may have been responsible for the design (Figure 66). Built to house the business of F.E. Shoosmith, previously of 18 Upper George Street,¹³⁵ the building comprises two distinct properties, each a mirror of its neighbour, and whilst there has been much recent renovation the earlier form and fabric remains identifiable. This may well be the earliest surviving example of a 'daylight' factory within the Conservation Area: it was constructed in the 1930s with a concrete frame and finished in a pared down Neo-Classical style with a number of Art Deco inspired details. The upper windows are separated by Doric pilasters, each with a chamfered border. The pilasters feature a 'drop' from the capitals and also at second-floor level where they are incorporated within a string course. The façade is completed by a markedly projecting cornice with modillions. Unusually for a building of this style, the ground floor is dominated by bold, bow, shop windows of the moderne style complete with curved glass and the piers flanking the windows are covered with rusticated render – one of the defining characteristics of building with the Conservation Area of all ages. Undated designs for the property suggest that the fabric of the building has survived relatively intact, save for the re-glazing of the bow windows on the ground floor.¹³⁶

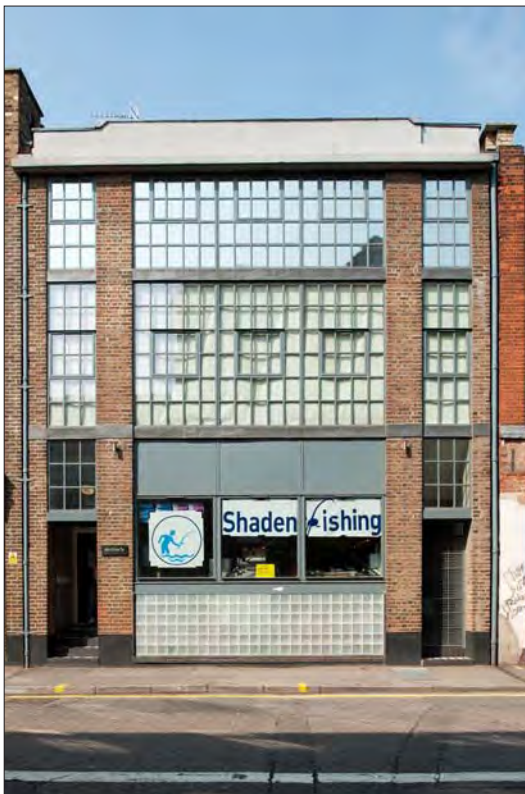
Figure 67 (left). 35-37 John Street.

35-37 John Street is another example of a concrete framed building and is similar in form to 57-61 Guildford Street but is more modern in style, lacking the Neo-Classical detailing seen previously, with a clean and simple façade dominated by glazing (Figure 67). A certificate of completion for the property is dated 31 May 1933 and names Mr H. C. Janes as the builder.¹³⁷ No architect's name is provided, suggesting that the builder may also have been the designer (Figure 68). A symmetrically designed three and a half storey building, with raised ground floor showroom above a half basement, the interior floor levels are clearly articulated by the framing. The glazing occupies the entirety of the space between the piers and consists of large metal-frames divided into multiple small panes. The piers are clad in red brick and the parapet has been rendered. Somewhat unusually the main doorway (to the west) and the passageway (to the east) have been treated equally – the only difference being an extra step up to the main door, with an internal lobby beyond. This helps to create a well balanced design which, despite extensive renovation work in recent years, retains its structural integrity.

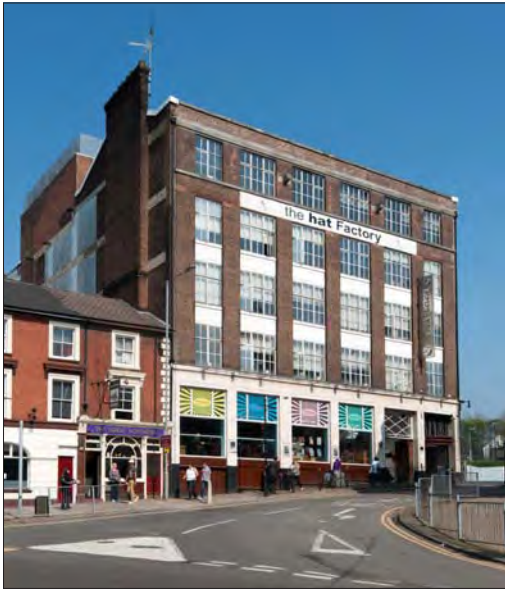
'The Hat factory' at 65-67 Bute Street is probably the largest building within the Conservation Area, and, certainly one of the best known for its links to the hatting industry (Figure 69). It is a good example of a daylight factory built in the 1930s on a previously unseen scale in the vicinity. Another example of a 1930s 'daylight' factory is the four-storey Vyse factory at 47-53 Bute Street, built on a larger scale than earlier hat factories in the area, as it occupied a particularly wide (or double) plot. Here, the Neo-Classical style of the 1920s was eschewed, although decorative fascias appear in the concrete render of the parapet. Instead, the building adopted a Neo-Georgian idiom, which is somewhat at odds with the industrial form of the building. The windows,

Figure 69. 'The Hat Factory', 65-67 Bute Street.
© English Heritage NMR DPI41915.

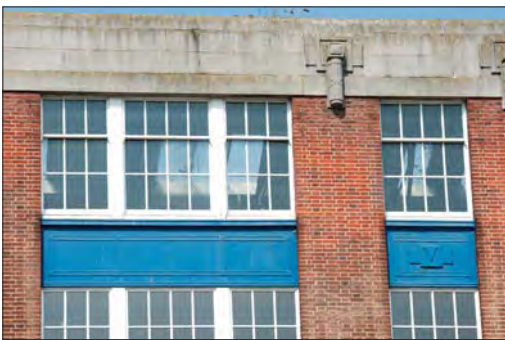
instead of being metal-framed, are small-paned wooden sashes, separated by horizontal metal panels masking the floor levels and displaying, in the narrow central bay, the letter 'V' (Figure 70). The piers are faced in red brick, laid in Flemish bond. The ground floor is divided into three bays containing modern shopfronts and a vehicle entry: the original arrangement here is not known.

Figure 70. Detail of the Vyse factory, 47-53 Bute Street.
© English Heritage NMR DPI41914.

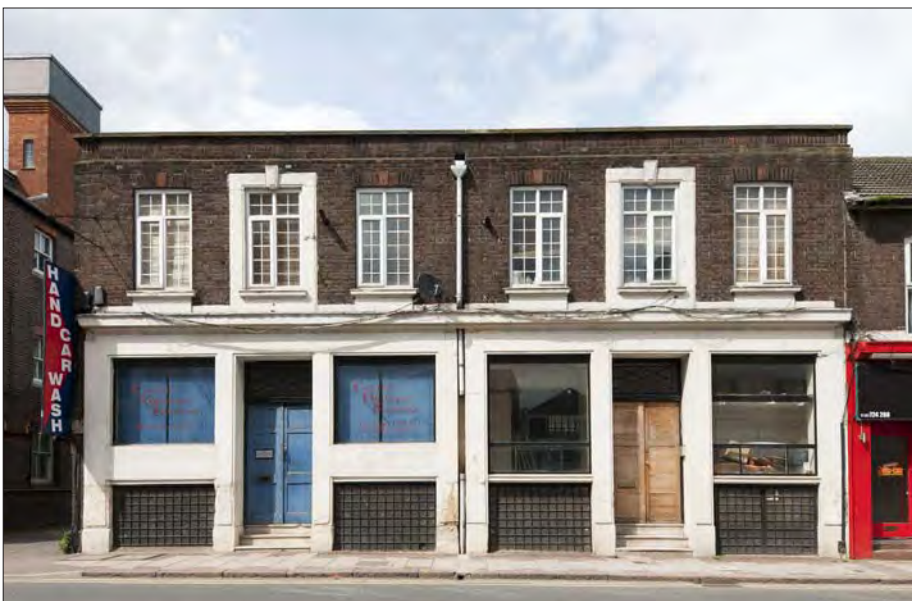
A more conventional example of the Neo-Georgian style that was current in the early 1930s can be seen at 22a&b Guildford Street (Figure 71). This is a small symmetrical pair of premises, two and a half storeys high, of red brick, with a flat roof hidden behind a soldier-course parapet. The commercial function is betrayed by the treatment of the ground floors: each property has a central doorway, reached via steps spanning the basement and flanked by two display windows. These have smooth rendered surrounds, not the banded rustication favoured elsewhere throughout this district. The panelled double doors and fine transom lights survive. Above this, the first-floor windows contain casements, and in each case the central one is emphasised by a broad, rendered frame with a prominent keystone. Building control plans for the building shows that it was designed by B.B. Franklin in November 1931 and approved in January 1932

Figure 71. 22a-b Guildford Street.
© English Heritage NMR DPI46064.

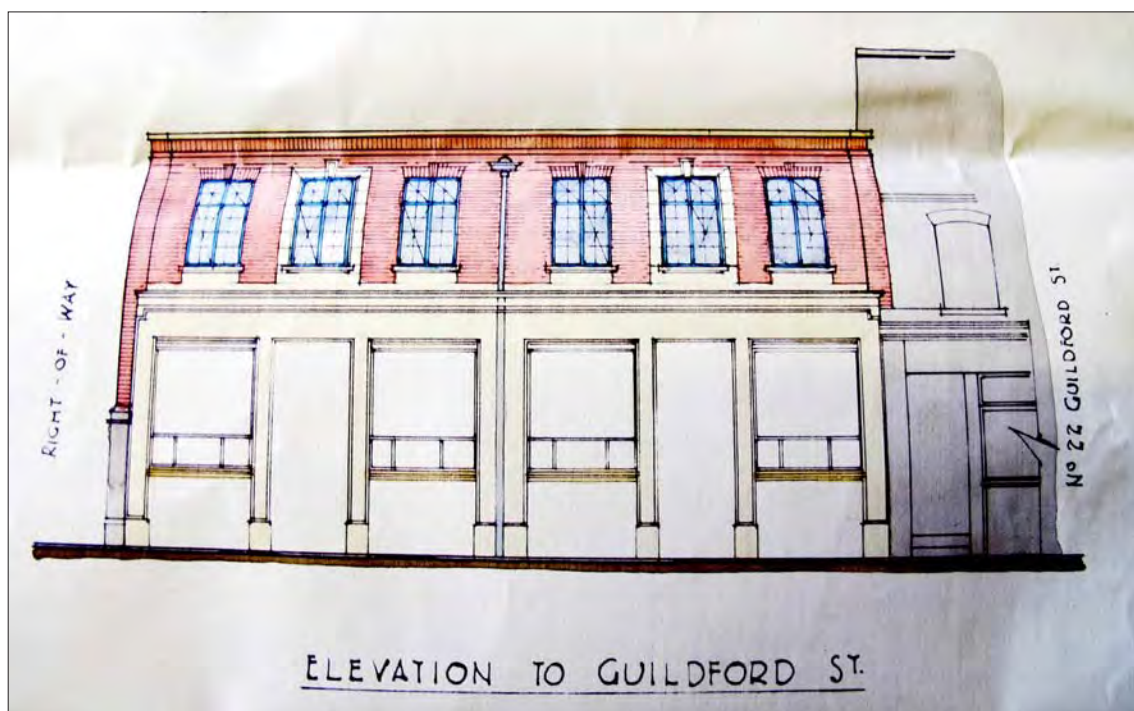
Figure 72. Design for 22a-b Guildford Street, 1932.

(Figure 72). Although the building appears to be a set of identical premises set up for use by two independent businesses, the plans indicate something quite different. The earliest part of the building is the basement and ground-floor on the left (west) – this forming an earlier warehouse. The 1931 plans form an extension to this whereby a matching building was built to the right (east) with basement storage and a ground-floor plait shop with offices, with a first-floor showroom running the width of both properties.¹³⁸ Given the homogeneity of the brickwork it seems likely that the extension was part of a longer term plan carried out shortly after the construction of the warehouse and by the same builder, it also seems likely that the façade of the warehouse was refaced as part of the rebuilding work. The apparent lack of access between the first-floor display room and the warehouse below may indicate that the warehouse was used by a separate firm, or that it was a storage area for a wholesaler making use of the newly built retail premises.

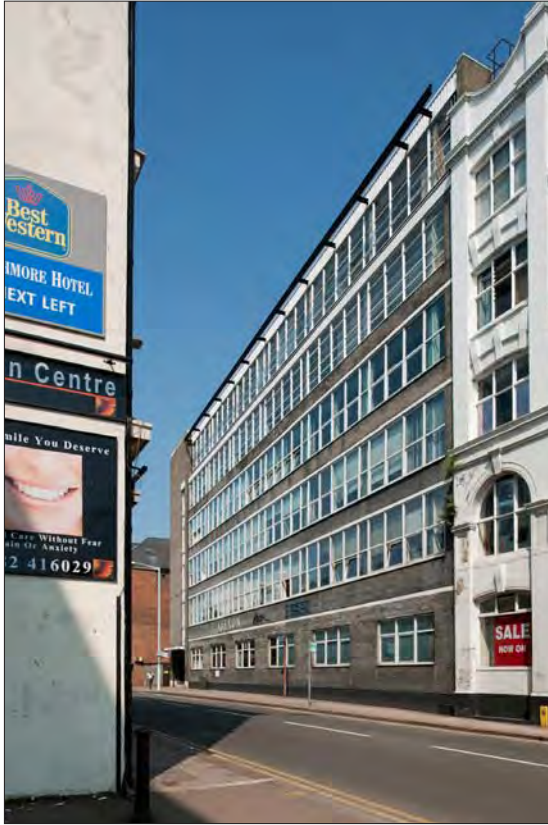
Figure 73 (left). The Alexon Factory, 42-48 Guildford Street.

The Alexon factory at 42-48 Guildford Street is a relatively sympathetic 1960s addition to the streetscape, with horizontal brick bands aligned to the existing floor levels at 40 Guildford Street, reminiscent of 1930s streamline moderne architecture (Figure 73). Another large structure of the same period is the Job Centre at 55 Guildford Street, known as Cheviot House, which is a six-storey office block with a steel or concrete frame clad in dark brick (Figure 74). One of the most noticeable design features is the

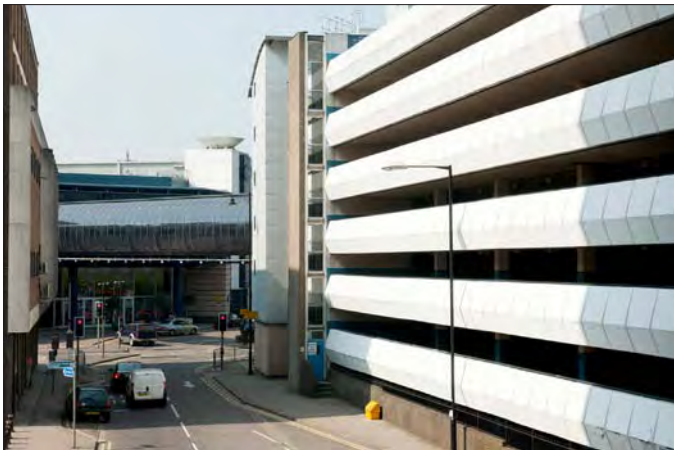
The Library Theatre car park is a six storey car park built in early 1970s and now closed and earmarked for demolition (Figure 75). The heavily modelled v-shaped GRP balustrades to each of the floors impart a powerful horizontality, punctuated by projecting stair towers, which are glazed on the returns and display deeply incised vertical lines on the elevations facing the street. Overall it is a powerful composition compromised by a dwarf brick wall surmounted by equally incongruous, municipal style and rather fussy railings in front of it at pavement level.

Figure 75. View of the rear of the Library Theatre car park. © Katie Carmichael.

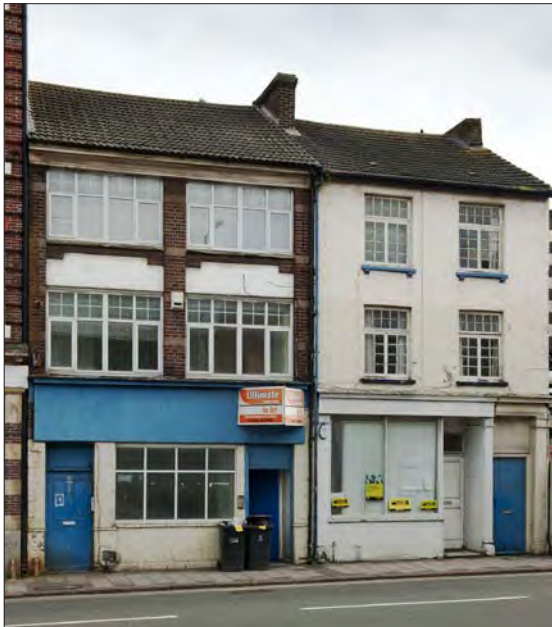
Figure 77 (left). 29 and 31 Guildford Street
© David McOmish.

and very often registered in trades' directories as being in domestic ownership, or occasionally commercial shops, but almost invariably connected to outworkers in the hat trade (Figure 77). Although less elaborate than their grander cousins, they are often noteworthy buildings in their own right – the ground floor arrangement of double entrances and large shop windows being of particular interest as a diagnostic feature of the hat trade.

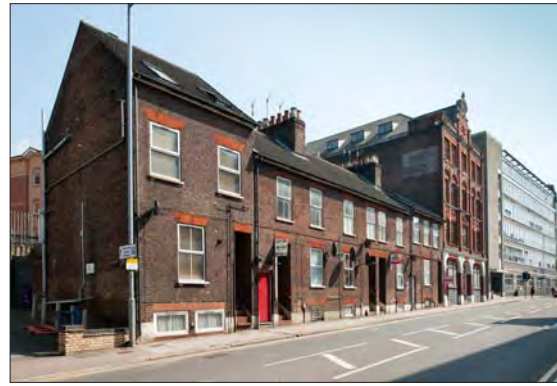
Figure 78 (above). 52-60 Guildford Street.
© English Heritage NMR DPI41939.

The largest density of early, domestic, properties within the Conservation Area, as evidenced on the maps, was concentrated along John Street – close to a number of contemporary hat factories and straw plait manufacturers and warehouses. These are shown very clearly on Corney's map of c.1870 but most have now been demolished and replaced by modern shops and apartments. Another early terrace of houses, built in the 1860s, does survive just outside the Conservation Area at 52-60 Guildford Street, and undoubtedly initially housed outworkers servicing an earlier factory on the site of the Balfour & Sons hat factory, 50 Guildford Street (Figure 78).
