PLAITERS' LEA CONSERVATION AREA, LUTON HISTORIC AREA ASSESSMENT

Research Department Report Series 069-2011

HISTORIC AREA ASSESSMENT

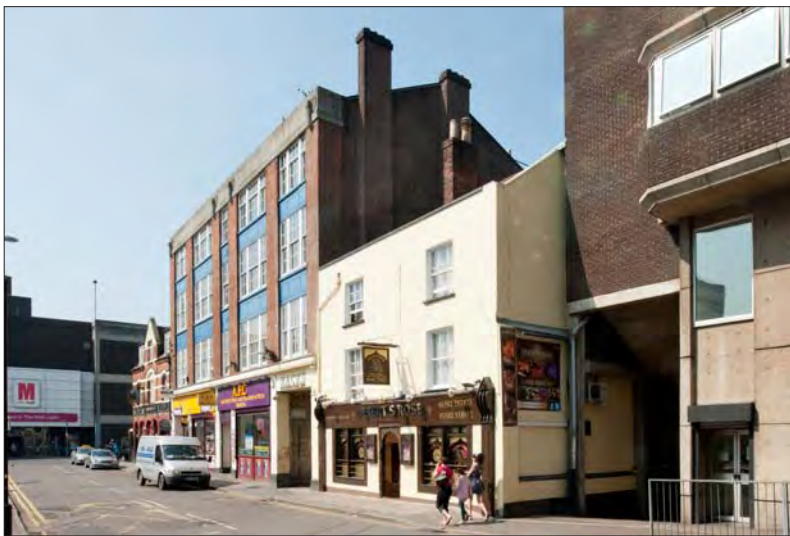
Figure 79. The 'Desert Rose' restaurant, formerly 'The Cooper's Arms', was built in the mid-19th century. The rebuilt Vyse factory lies on its left-hand side in the photograph with 'The Engine' public house beyond this. ©English Heritage NMR DPI41920.

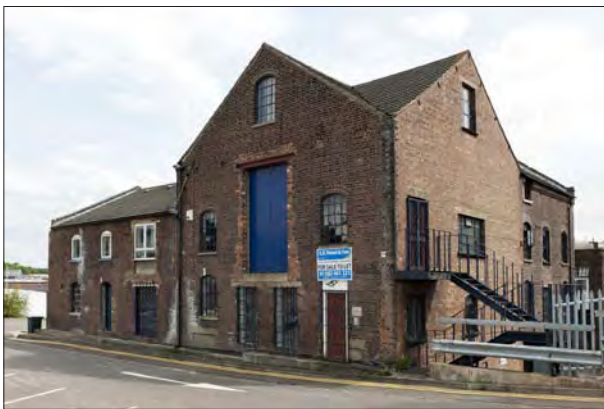
Figure 82. Great Northern Steam Mills to the rear of Guildford Street.

house was built in the late 1850s) and the W. Dixon Engineering Works, now the Bute Mills, lay a little to the north. By far the largest complex, however, was that built for the Great Northern Steam Mills and although this has been heavily altered by subsequent development, the main office block survives as does the core of the mill building too (Figure 71). Both are constructed in dull Luton stock brick with relatively plain façades dominated by small windows with segmented heads. The massive loading bay from the mill survives much altered and a ground-floor level that comprised two large doorways is largely masked by recent blocking as well as a raised road surface. These buildings are best viewed from the modern car park to the north which overlies the former rail yards: the close proximity of the railway station and its goods and coal yards was evidently an influential factor in the rise of these trades in this location.

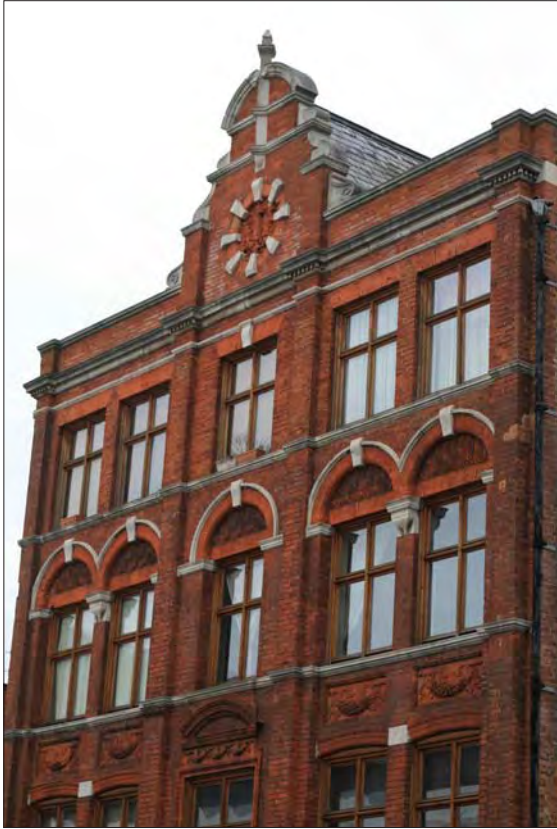
Figure 83. The Balfour factory, 50 Guildford Street.
© Katie Carmichael

The Walter Gurney & Son factory at 68 Guildford Street, the Balfour Hat Factory at 50 Guildford Street, and 40 Guildford Street epitomised this phase of confident expansion in the industry. All three buildings are situated close to the station and its goods yards, and each occupies the location of an earlier factory or building. Their form is fairly typical of factories built at this time, consisting of a basement and ground floor provisioned with large windows, a formal centrally-placed entrance and a smaller passageway to the side. Above this there are three/four storeys plus attic creating a lively street façade in comparison with what had been built in the area previously. Huge effort has been expended in their design and construction with the use of brick and stone with pilasters

and elaborate windows incorporating cartouches and moulded stone swags. Each is further embellished by a shaped gable with a roundel window or similar and additional decorative features.

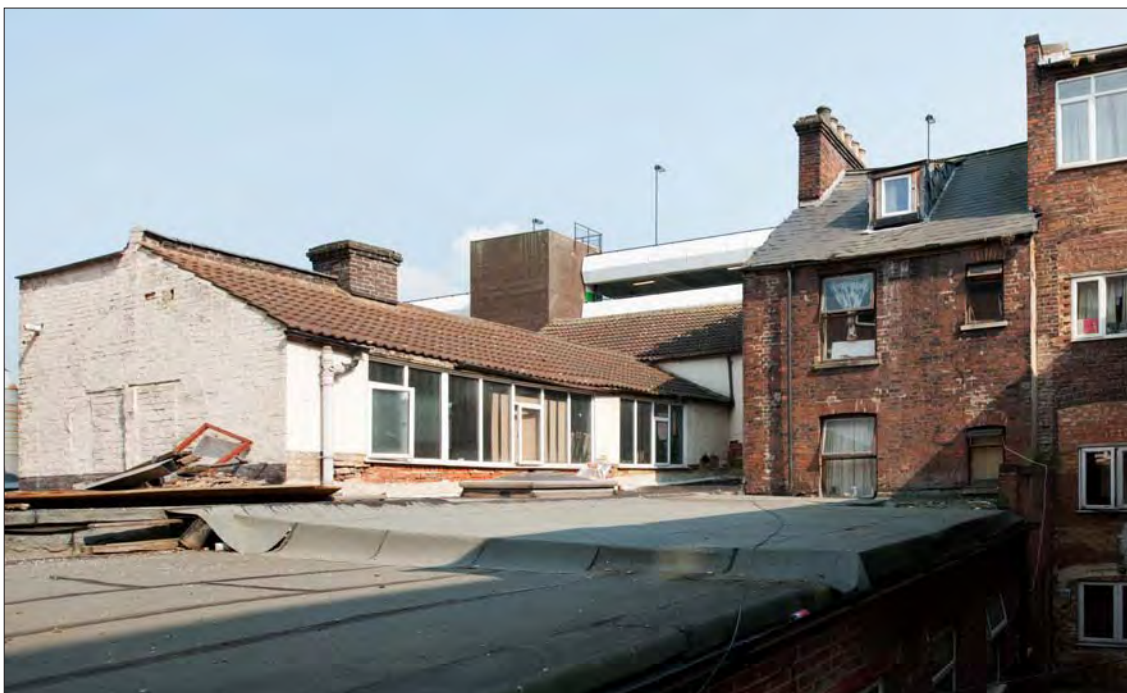
Despite the designation of Conservation Area status and the stated aim to maintain Plaiters’ Lea’s historic role within the proposed ‘Northern Gateway’ development, there are clearly a number of older properties that are currently at risk either from further decay or from insensitive alterations. This, in part, is due to the difficulties that arise in effectively ‘policing’ Conservation Areas but also reflects a lack of appreciation of the area amongst individual property owners and landlords. A particular focus for concern are the properties at 49-51 Cheapside and 29-31 Guildford Street and especially what remains of Melson Street where immediate attention is required. An alarming state of decay is apparent on certain street frontages and is even worse at the rear of the properties where crumbling brickwork and roofs in a state of near collapse are evident.

Figure 86. Buildings in a poor state on Melson Street

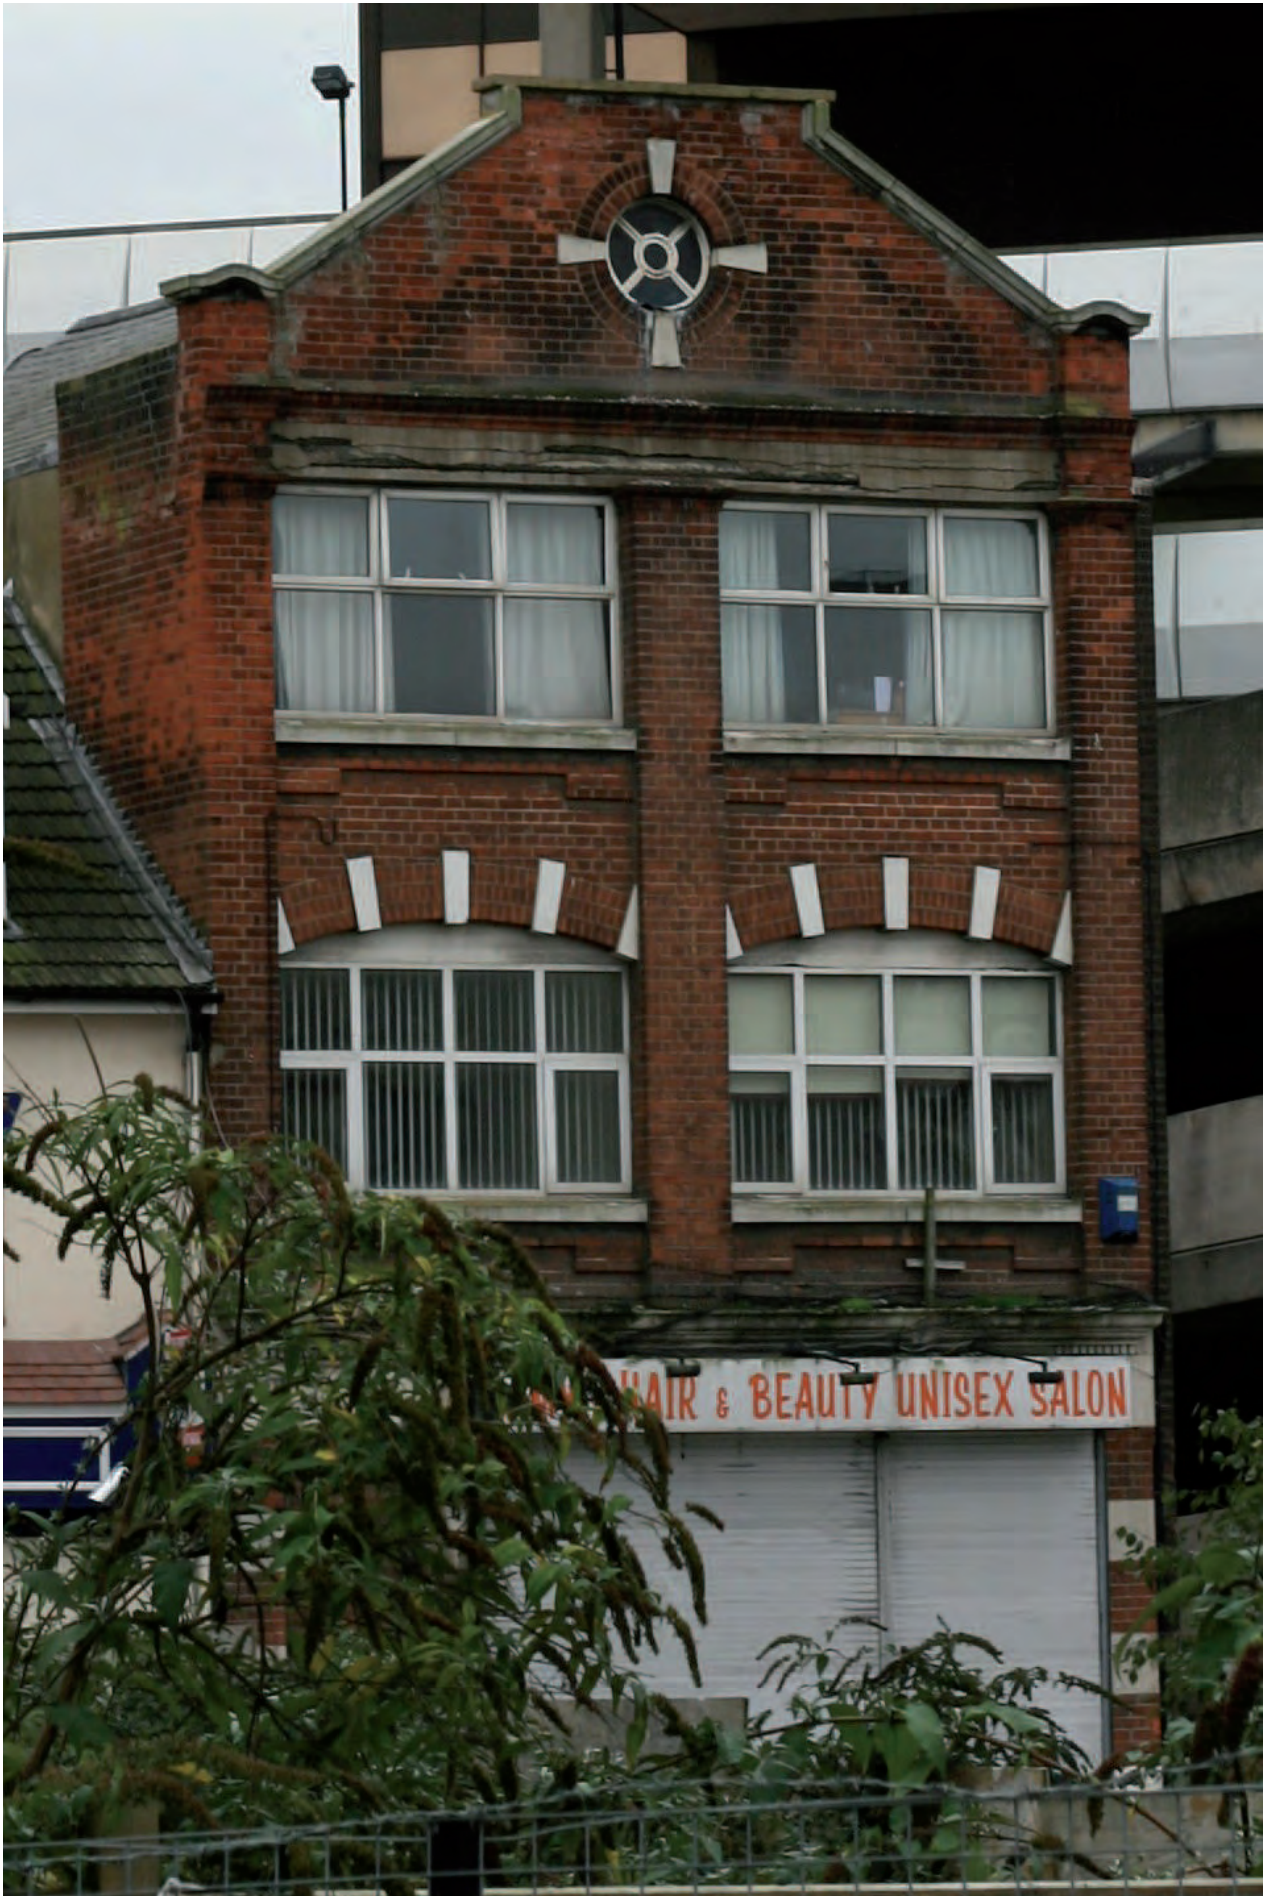
Luton Historic Area Assessment Field Record Sheet

The western elevation of the front building is blind, having been re-clad in brown brick laid in a stretcher bond c.1960. To the rear is a large, flat roofed, three-storey extension in red brick laid in English bond. The western elevation is blind save for a loading bay door and access door, both with concrete lintels. The southern elevation has three straight headed windows to the second floor, two to the first floor with a covered walkway to the east connecting the building to the Armdale Centre. The ground floor is mainly rendered, save for a partially infilled loading bay to the west which is currently in use as a standard door. All of the windows on this elevation have concrete sills. A property of similar dimensions is shown on the 1880 Bedfordshire 1:2500 OS map, and the 1901 OS map shows a building with a small extension to the rear (no larger than a porch/lobby perhaps) with a detached outbuilding along the southern boundary. A major change occurred between 1901 and 1924, with the construction of a single L-shaped extension to the rear of the building, replacing the earlier extension and outbuilding, almost completely filling the available space. Additionally, between these dates the previously open plot of land to the west of the building was built over - this new structure directly abutted the property. The 1938 Goad insurance map of Luton identifies 16 John Street as a straw hat factory with electric powered motors.

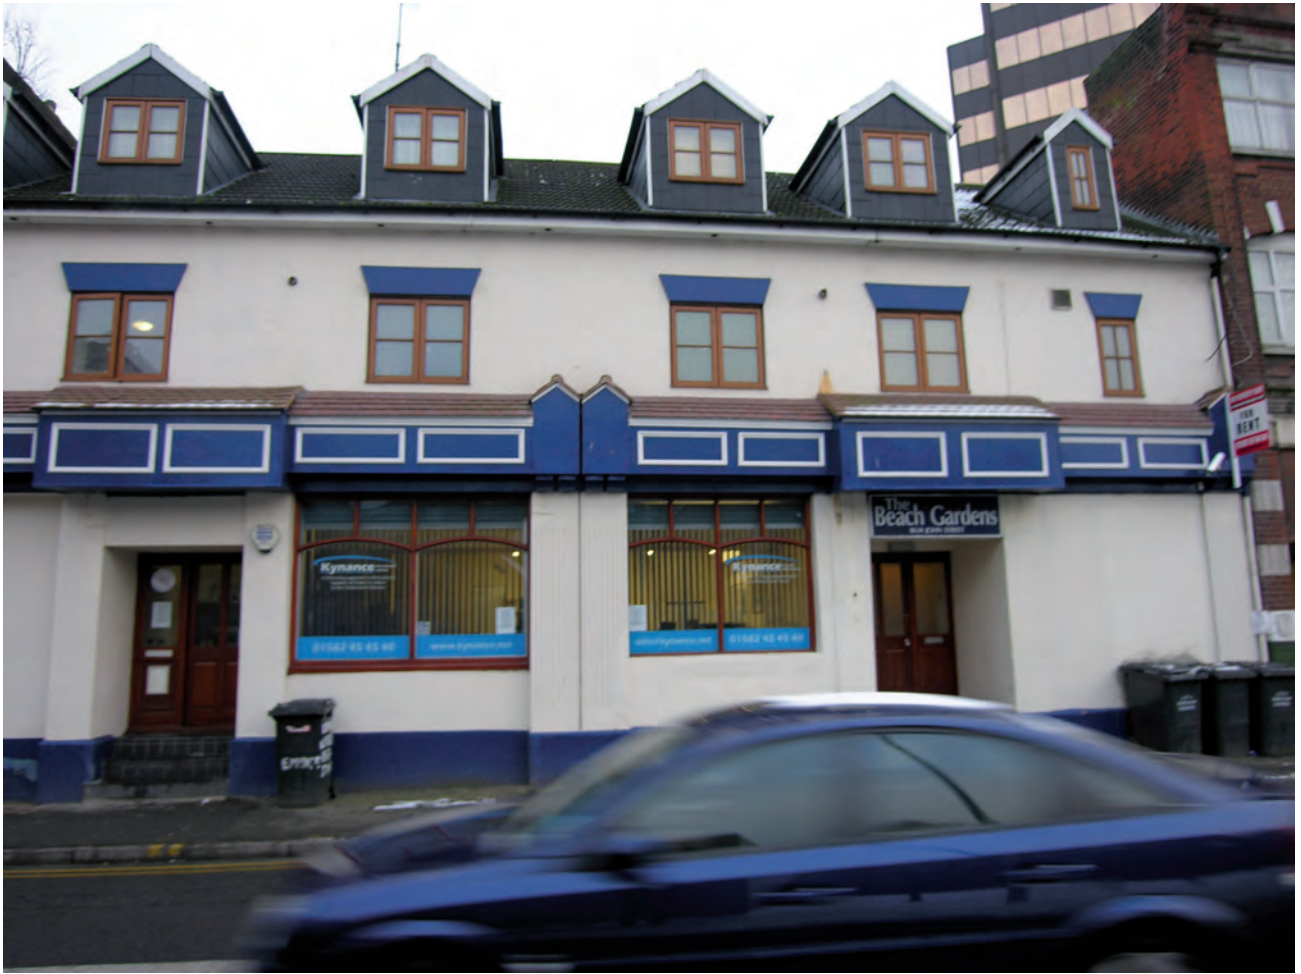
Luton Historic Area Assessment Field Record Sheet

complete with modern pulley (now partially filled in to become a window) in place of the third window, and all with straight heads formed by stone lintels. A two storey extension to the south has recently been demolished, the southern gable wall of the existing building once being connected by a ground and first-floor doorway, now blocked. Above the roof scar of the demolished section is a small window with stone header and sill. The 1880 OS town plan shows that the site originally comprised four domestic scale terraced properties, each with a glazed section across the rear and a small garden - they appear to have been built at the same time as a uniform development with access to the rear of the properties by means of two shared passages, one to the side of 18 John Street and one to the side of 24 John Street. The large extension which runs back from 22 & 24 was built between 1901 and 1924 and blocked the rear access to 22, suggesting that by this time 22 & 24 had been unified for use as a single premises. The Goad insurance plans of 1938 show that all four properties had been merged for use by a single company, with an office in 18, a warehouse in 20 and a hat factory (with electric motors) occupying 22 & 24 as well as the three-storey extension to the rear. The plan describes the four properties as being of two storeys with a basement - the use of the attic is clearly a more recent development.

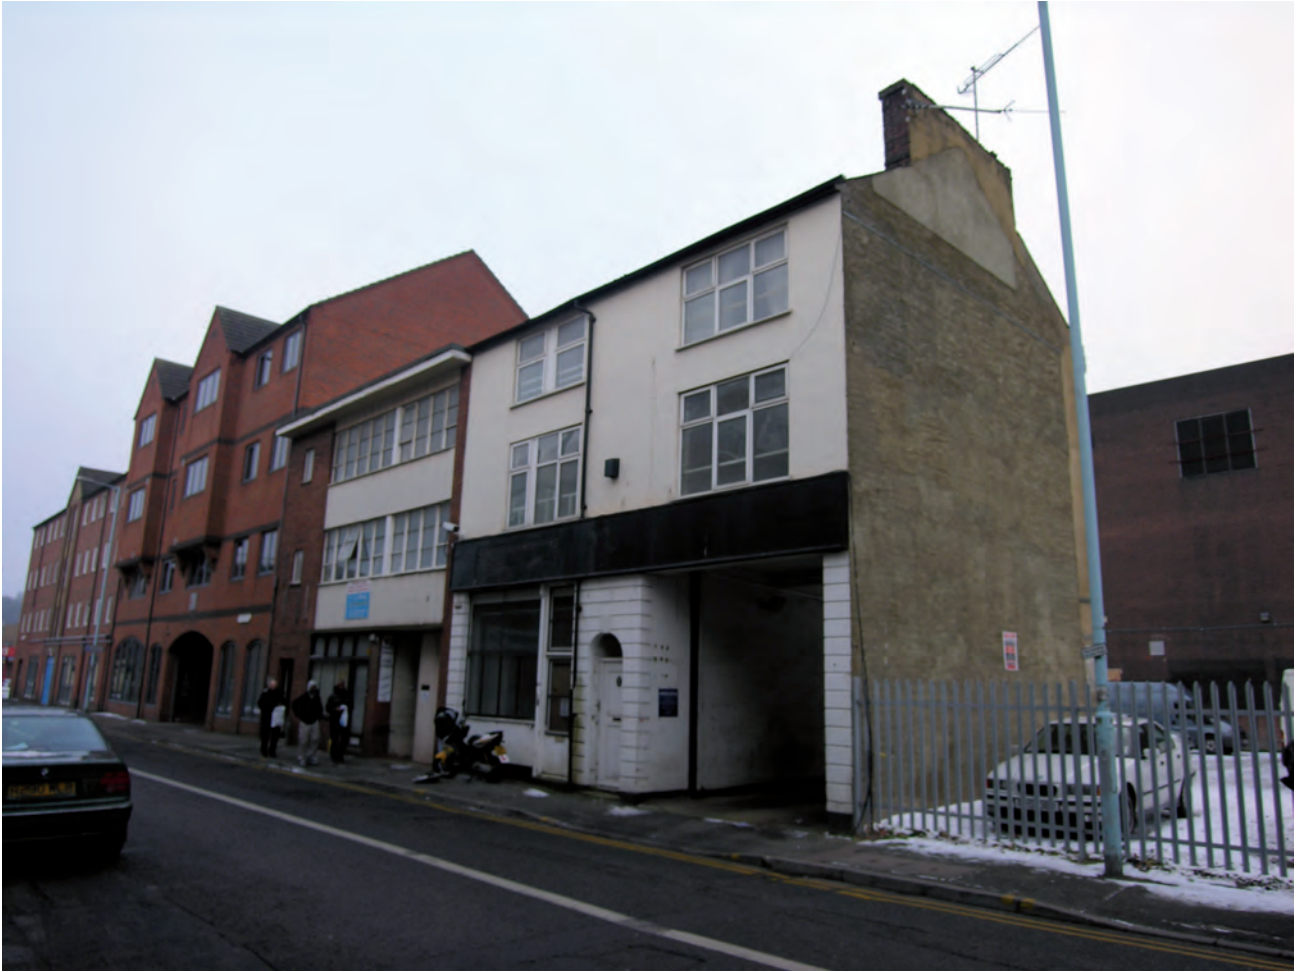
A pair of three-storey buildings, of rendered brick with slate roof. Smooth rendered first and second floors, with one window to each floor per building - all with uPVC replacement casements. Immediately beneath the sill of the first-floor windows is a wide, modern fascia. The ground floor is covered with rusticated rendering, and contains a central doorway providing access to the rear of the properties, to either side of which would have been the shop windows and individual entrances to each property - a modern version of which remains to 34 John Street - whilst the ground floor of 32 John Street has been knocked through to create vehicular access to the yard area behind. The western gable wall is blind - visible due to the demolition of the adjoining property. The rear elevation also contains one large window to the first and second floor of each building, set under straight brick headers, whilst the ground floor of 34 John Street contains a doorway and a blocked window, a later insertion (no quarter bats) at a high level, between the ground and first floors. The exposed brickwork on the western and southern elevations is in Flemish bond, and the central passageway to the rear has been blocked. Miss Casandra Pratt, straw hat machinist and John Pratt, dairyman, resided at 32 John Street in 1890 (Kelly's Directory of Bedfordshire 1890) and 34 John Street was occupied by George Swain, carpenter.

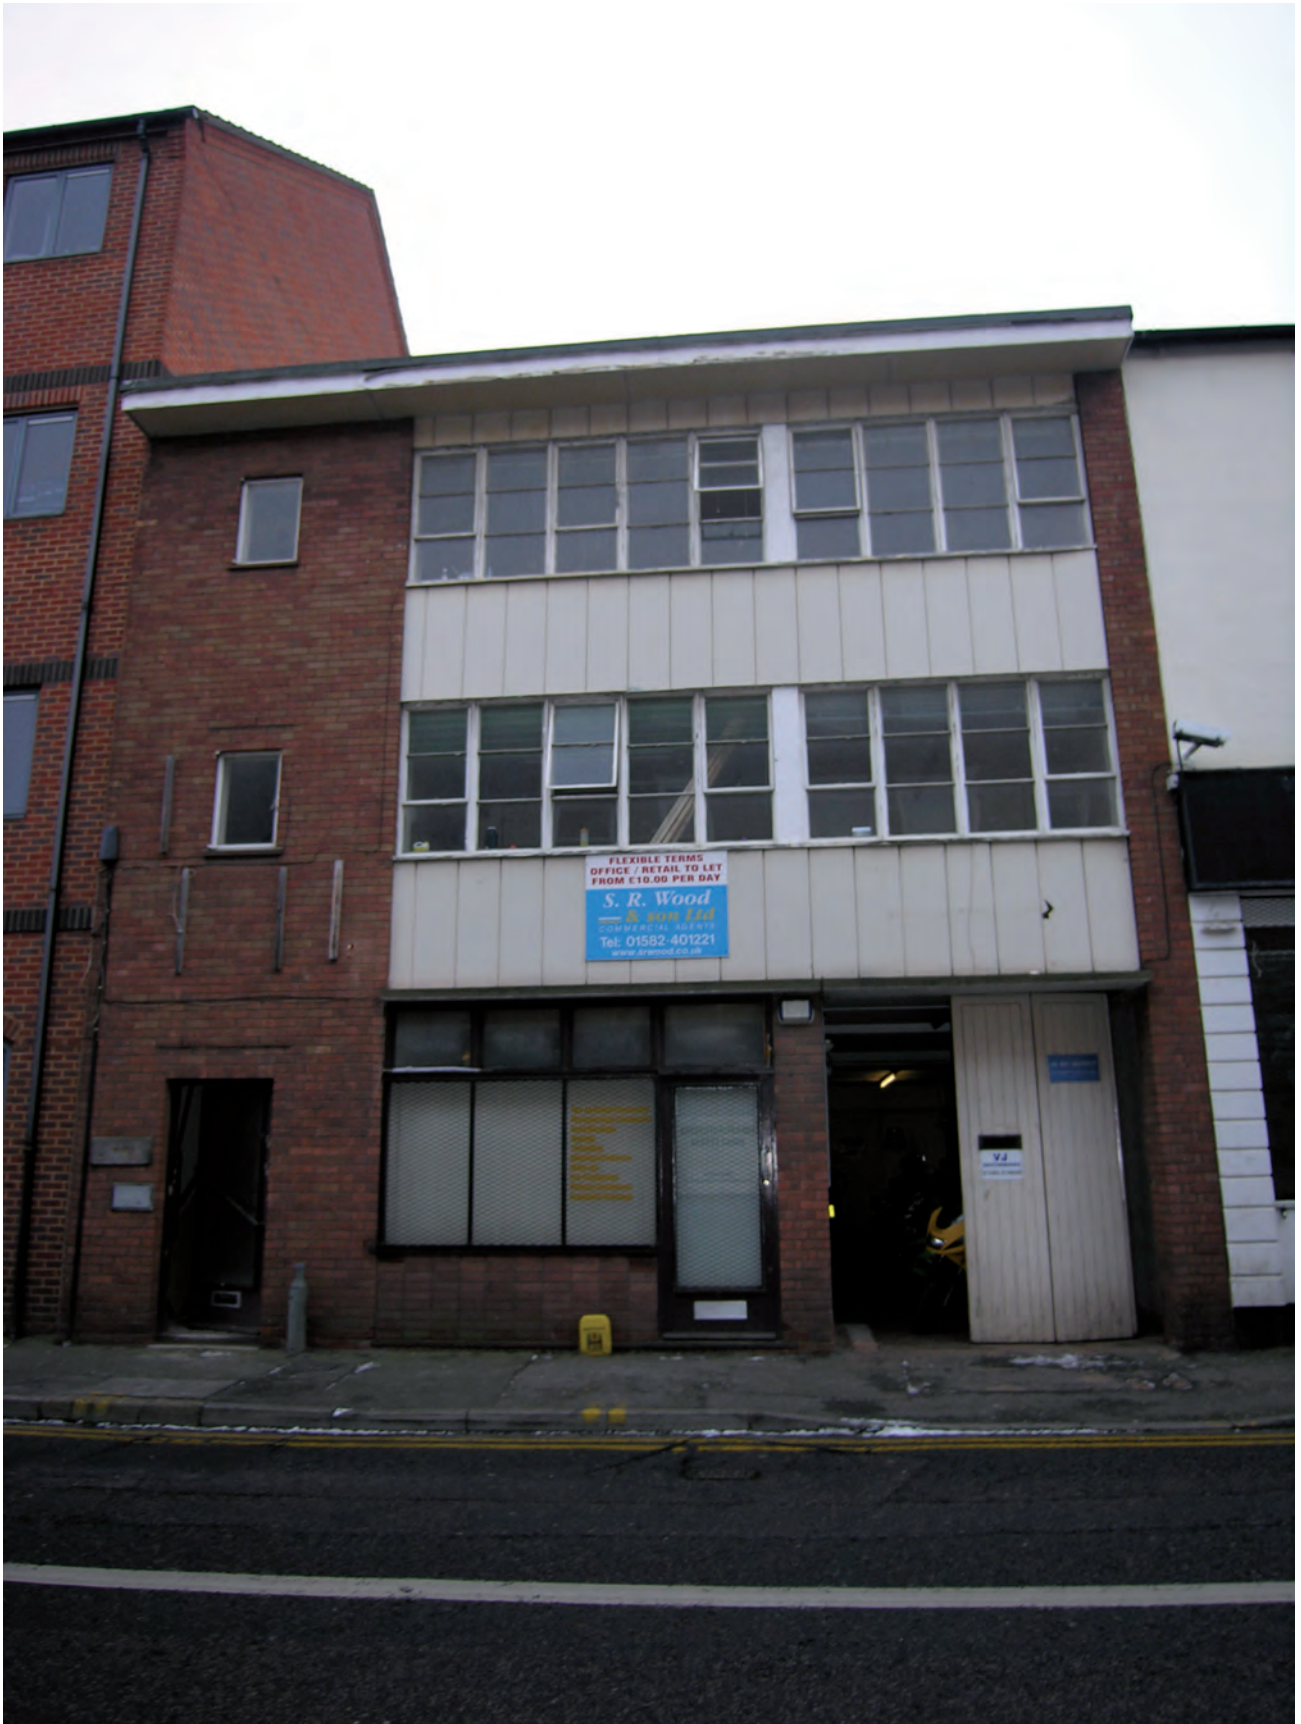
Luton Historic Area Assessment Field Record Sheet

This is a three-storey building erected in the late 1950s or early 1960s with a concrete frame, dark red brick cladding in stretcher bond, and a flat roof. The ground floor consists of a central shop window with door to the right, the bay to the south providing vehicular access into the room behind, whilst the northern bay contains a door giving access to a stairway - suggesting that the ground-floor was used independently from the upper floors. The stall riser beneath the central window is clad with dark red brick in a stack bond - suggesting alteration in the 1970s. The stairway occupies the whole of the northern bay - with a single small window to both the first and second storey. The central and southern bays of both the first and second storeys are dominated by a bank of metal framed windows, each containing three panes, the upper two of which, on every alternate window, are pivot opening. Concrete panels are set beneath each set of windows, and above the second-floor windows - infilling the space between the window heads and the simple projecting cornice. A similar arrangement is seen to the rear of the property - with a brick clad northern bay and the central and southern bays dominated by glazing with concrete panels below - with the addition of a single doorway to the far south of both the first and second floors, linked by an external fire escape. The ground floor is hidden by a flat roofed single-storey extension linking the main building to a single-storey extension with hipped asbestos cement roof which extends to fill the whole of the plot. The building replaces an earlier structure that housed Frederick Ellis, Straw Hat Manufacturer in 1890 and 1898 (Kelly's Directory of Bedfordshire, Hunts and Northamptonshire), remaining in the Ellis family until, at least, the outbreak of World War I.

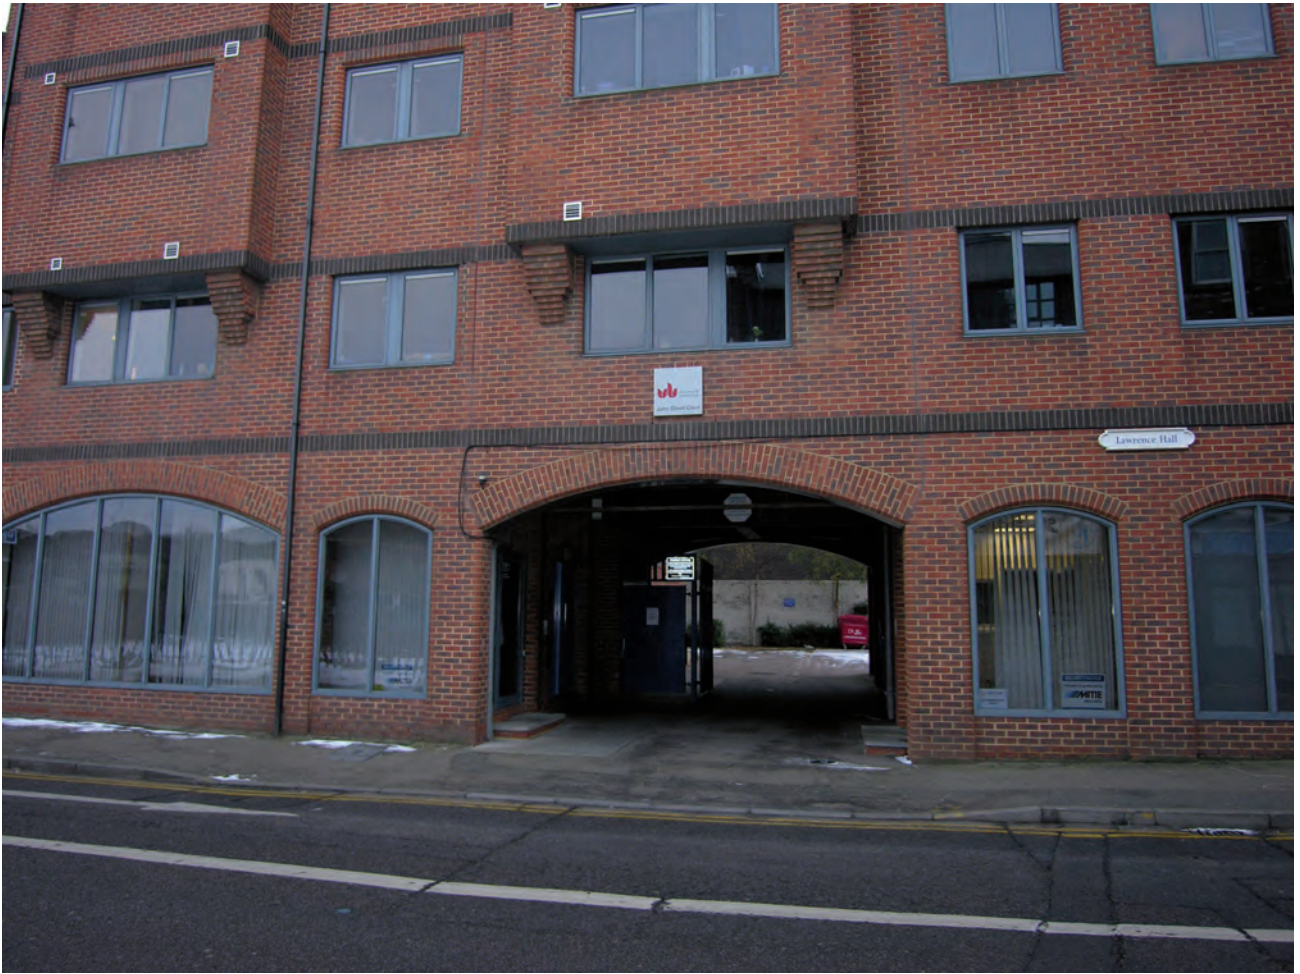
A four-storey steel framed accommodation block with dark red brick cladding laid in stretcher bond with decorative black brick bands. The ground floor is dominated by a central archway providing pedestrian and vehicular access to the rear of the property, flanked by two windows two either side with segmental heads - that to the far east being wider and matching the form of the central archway. Two gabled projections in the form of bracketed oriels extend through the upper two floors, located above the central archway and the larger window to the east. There are five windows to each of the upper floors; all are straight headed casements without sills. The hipped roof is covered in slate, and there are two projecting rear wings, that to the east being the larger of the two. The site was previously occupied by four Victorian terraced properties - Kelly's directories reveal that 40 John Street was occupied by a coal merchant between 1890 and 1914, 44 by a butcher and 46 by a shopkeeper.

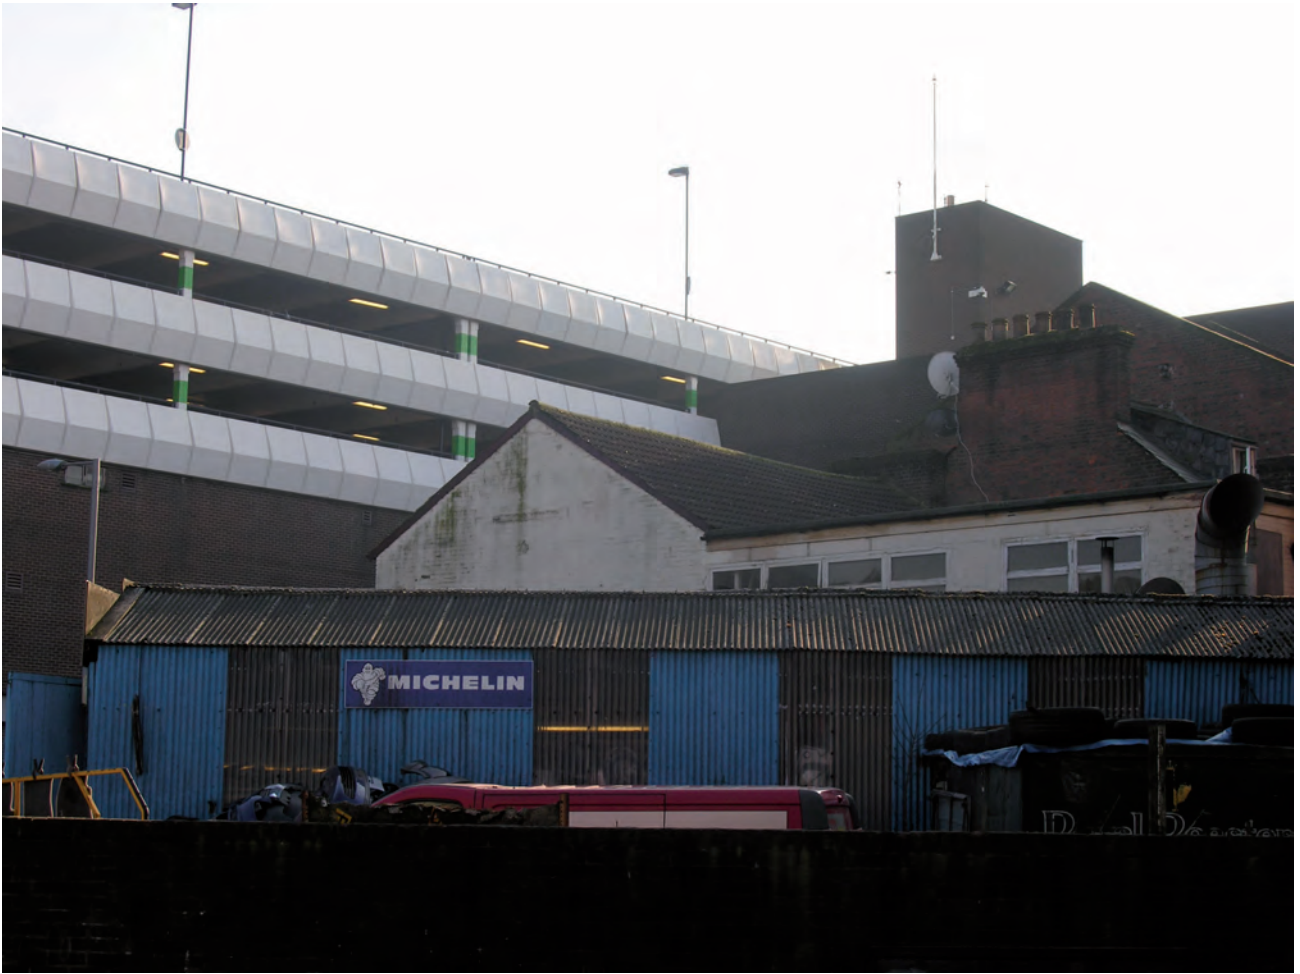
Luton Historic Area Assessment Field Record Sheet

A single storey shed, the garage is entered through double timber doors set into the gable wall facing Melson Street and extends parallel to John Street. The side walls are formed from alternating panels of corrugated iron and corrugated plastic which allows light to penetrate. A number of small lean-to type extensions may be seen to the south of the main building. The site is bounded by a brick wall approx. 6ft high. The garage is located on the site of a foundry (Goad, 1938).

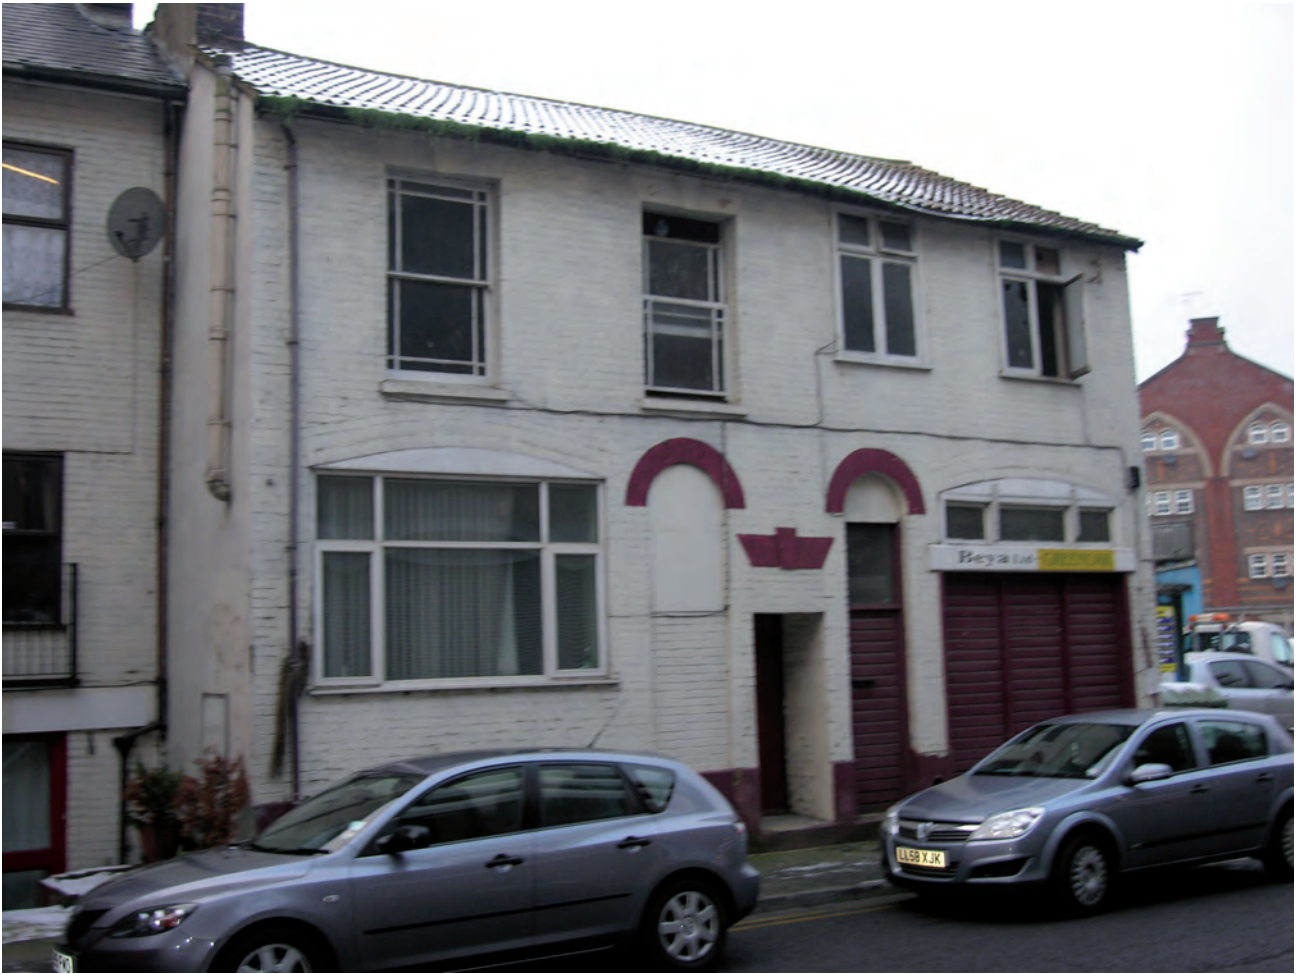
4-6 Melson Street is a pair of two-storey, two-bay properties separated by an entry that appears to run through the building. The walls are of brick, now painted, and there is a double-pitched pantile roof, with an end stack to the south. The entrances flank the through entry and have arched heads. Beyond these were windows under segmental arched heads, now reglazed (left) or converted into a full-height aperture (right). The two first-floor windows to 6 Melson Street appear to be original, being wooden sashes with margin light glazing. They have flat heads with keystones. The window apertures and glazing to 4 Melson Street have been altered. They have been heightened, suggesting serious alterations inside the building, perhaps with a raised floor level. The properties are shown on the OS 1:2500 map of 1880 but not on any earlier drawings and so, were built in the 1870s. 4 Melson Street, was the private residence of Mrs Beasley in 1890 (Kelly's Directory for Bedfordshire, 1890). Goad's Insurance map of 1938 lists 4-6 Melson Street as a 'hat factory'.

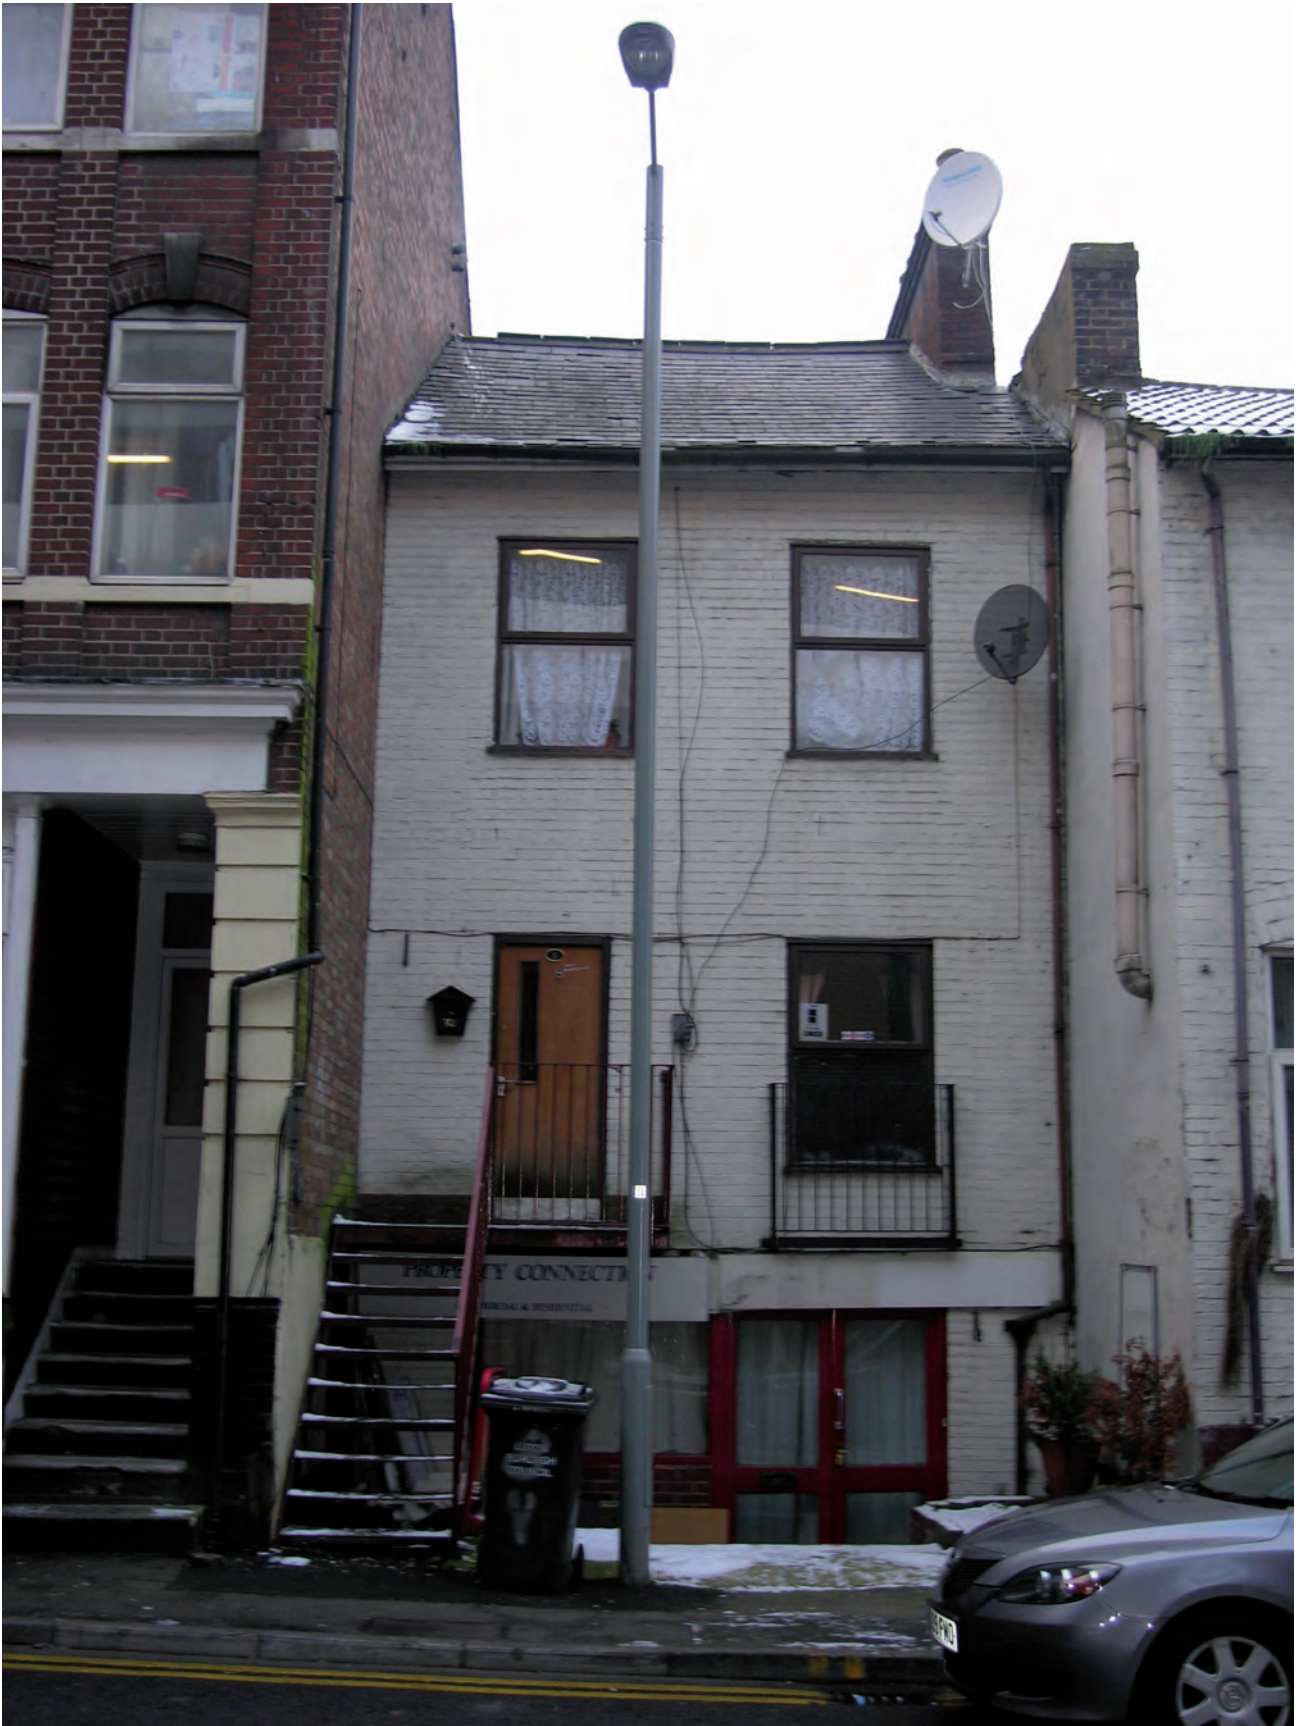
8 Melson Street is a two-bay, two-and-a-half storey terraced property - quite unlike those to either side and set back from the street line. It is built of brick (now painted) and has a slate roof, with an end stack to the north. The half basement accommodates a commercial business (Property Connections), and is accessed down steps. The basement area is spanned by a flight of steps leading up to a doorway. To the right of this is a window protected by a secure iron grill or safety rail. Neither these nor the two upper-floor windows have heads and thus appear to be modern, suggesting the property has been refronted. The property is in a rapidly deteriorating state of disrepair. 8 Melson Street was built in the 1870s - it is depicted on the OS 1:2500 map of Luton town centre published in 1880 but not on Comey's map of 1872. James Morris, a private resident, resided here at the end of the 19th century (Kelly's Directory for Bedfordshire, 1890; Kelly's Directory for Bedfordshire, Hunts and Northamptonshire, 1898; Kelly's Directory for Bedfordshire, Hunts and Northamptonshire, 1903). The Goad Insurance map of 1938 lists it as a hat factory.

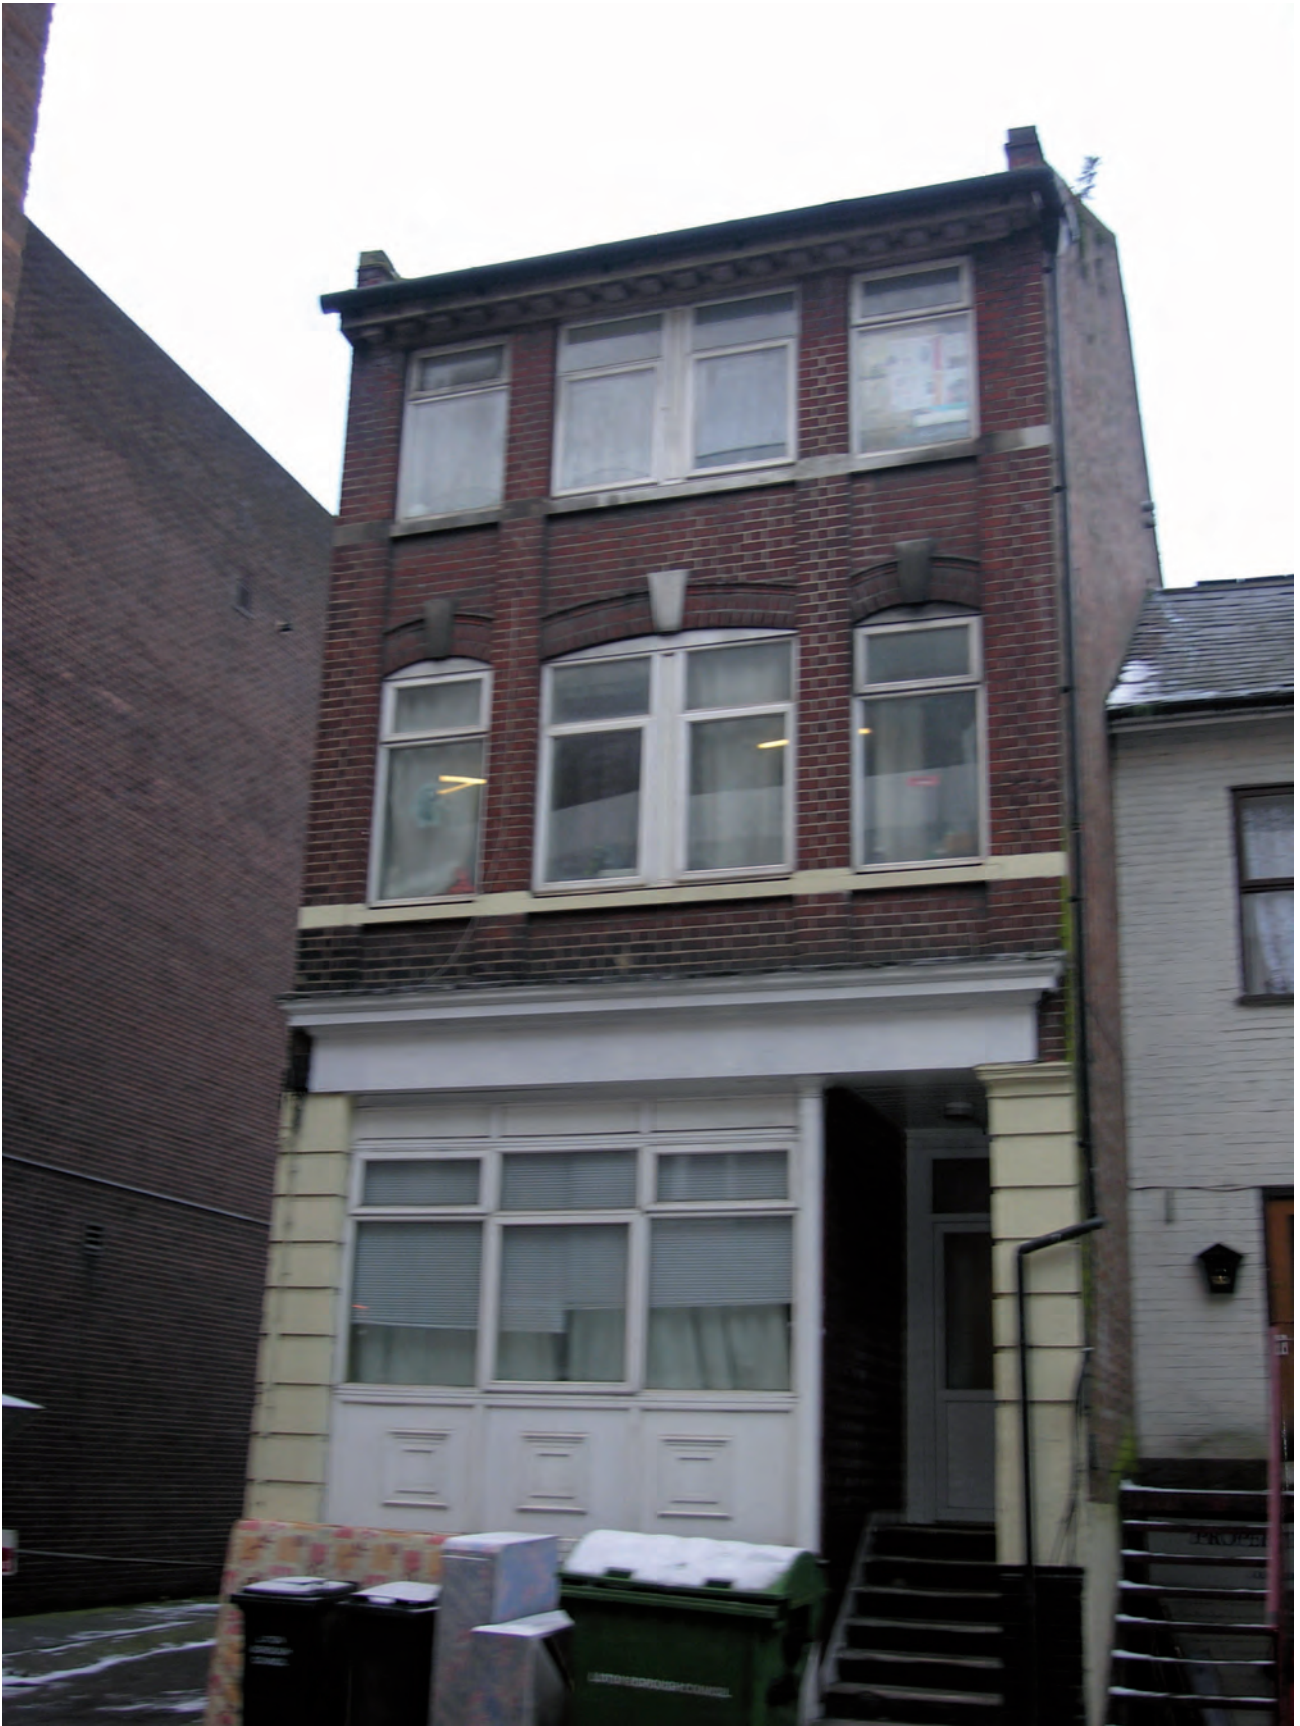
A substantial building is shown here on Corney's map (latest date 1872) but not on Todd's version which immediately pre-dated it (latest date 1862) and the OS 1:2500 map of Luton town centre published in 1880 shows it as part of a lengthy row of commercial/industrial and residential units. Charles Dobbs, straw hat & bonnet manufacturers, were based here in 1903 (Kelly's Directory for Bedfordshire, Hunts and Northamptonshire, 1903) and the Goad Insurance map of 1938 describes it as a 'lining factory'.
