PLAITERS' LEA CONSERVATION AREA, LUTON HISTORIC AREA ASSESSMENT

Research Department Report Series 069-2011

HISTORIC AREA ASSESSMENT

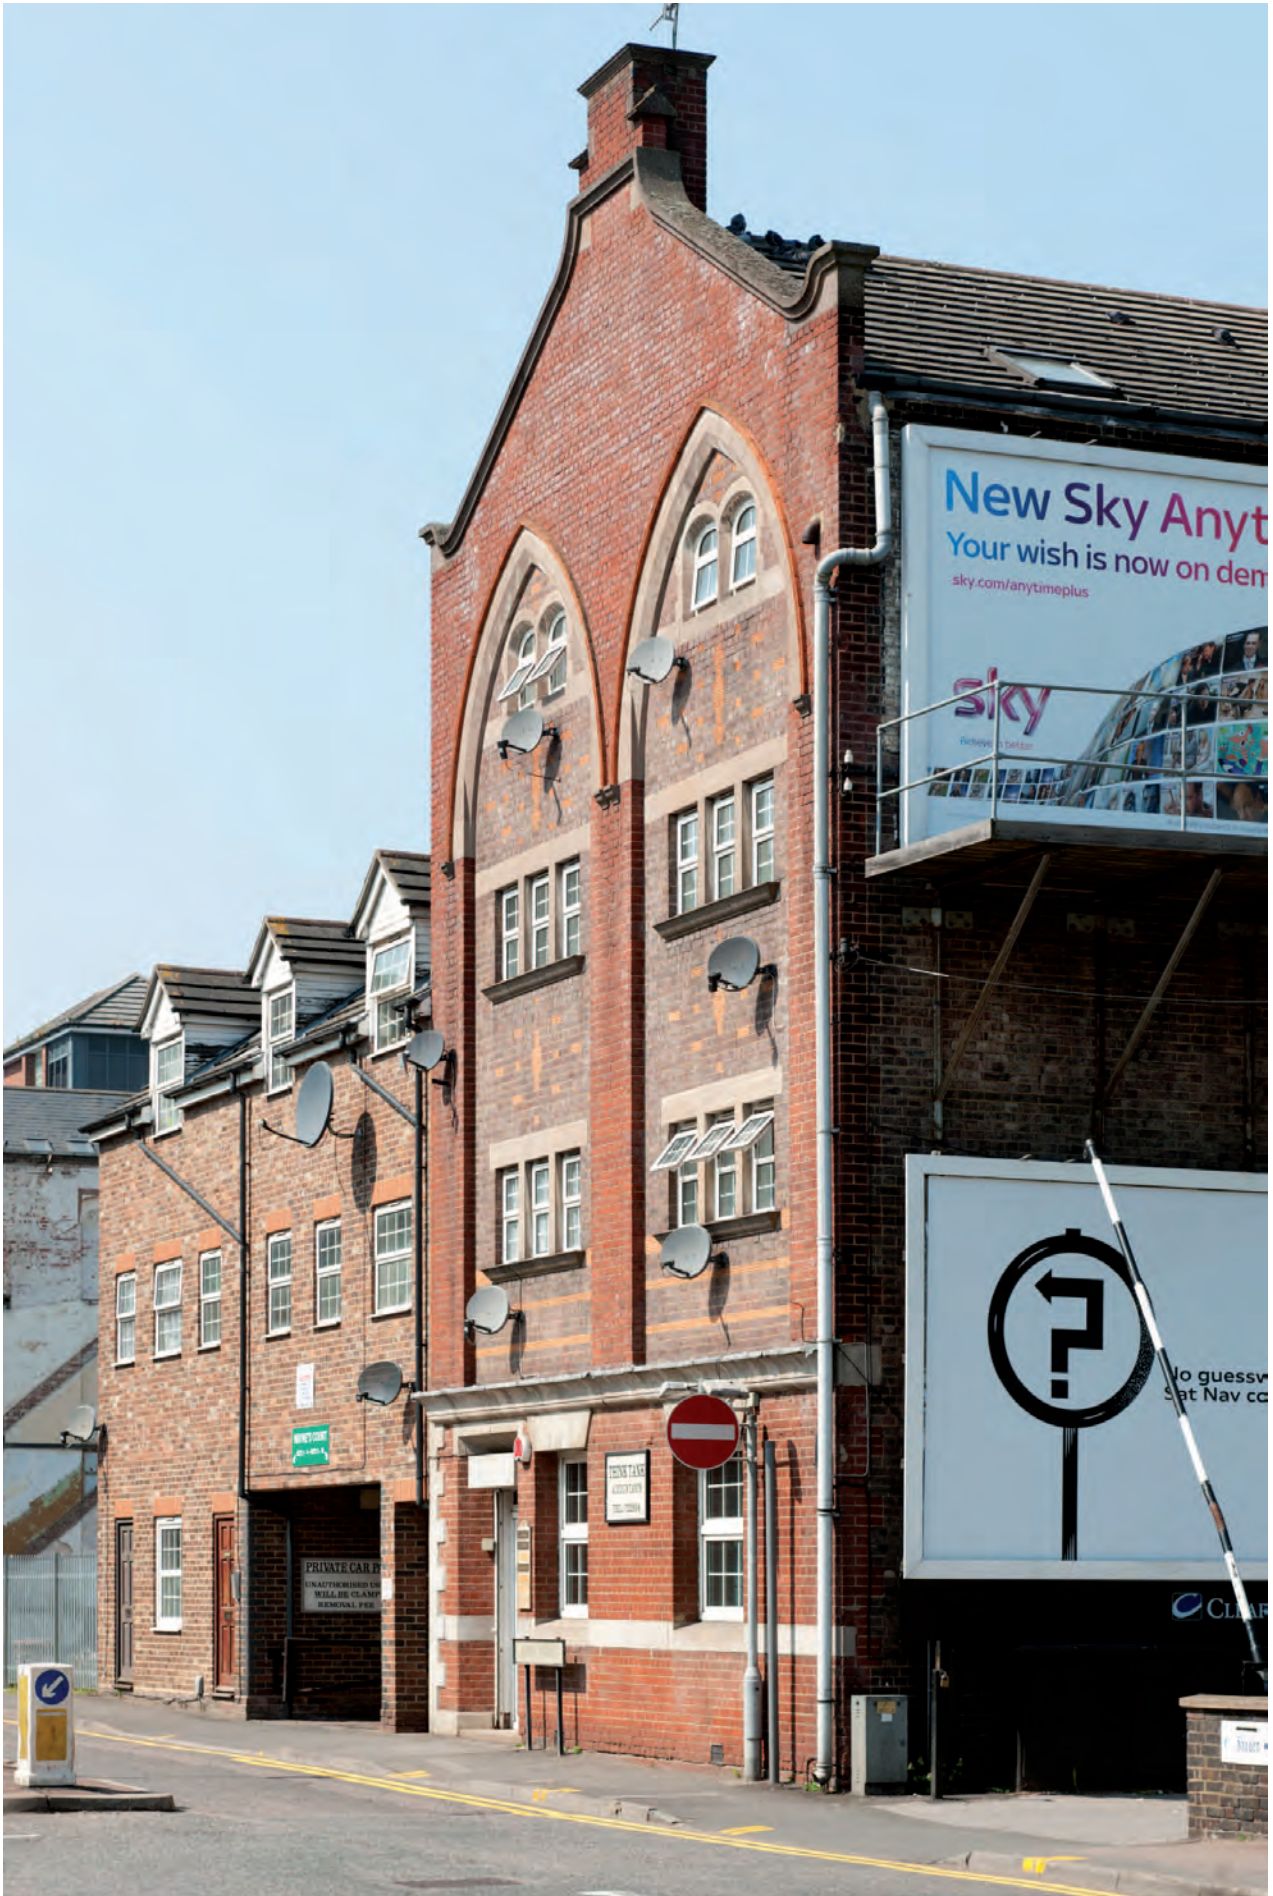
Luton Historic Area Assessment Field Record Sheet

Wayne's Court is a modern two-and-a-half storey development of flats attached to an earlier corn warehouse at 55 John Street. The modern section dates to c.2000 and is built from red brick in stretcher bond under a slate roof. The elevation to John Street has three gabled dormer windows, six first-floor windows and one ground-floor window - all with uPVC frames set beneath red brick soldier course headers. Access to the rear of the building is by way of a vehicular passageway adjoining 55 John Street. The former corn warehouse at 55 John Street is an intriguingly late example of gothic revival design, built for Tomson & Sons corn merchants in c.1913. Built using pier and panel construction, the four-storey building is dominated by giant order pointed arches springing from the piers to encompass the windows. It has been constructed using a mixture of Luton stock and red brick with concrete details. The panels incorporate decorative tiles which hint at the influence of the arts and crafts movement. Save for the addition of a glazed stair turret in the centre of the eastern elevation, a number of satellite dishes and the replacement of the original windows with uPVC frames, 55 John Street retains much of its original appearance.

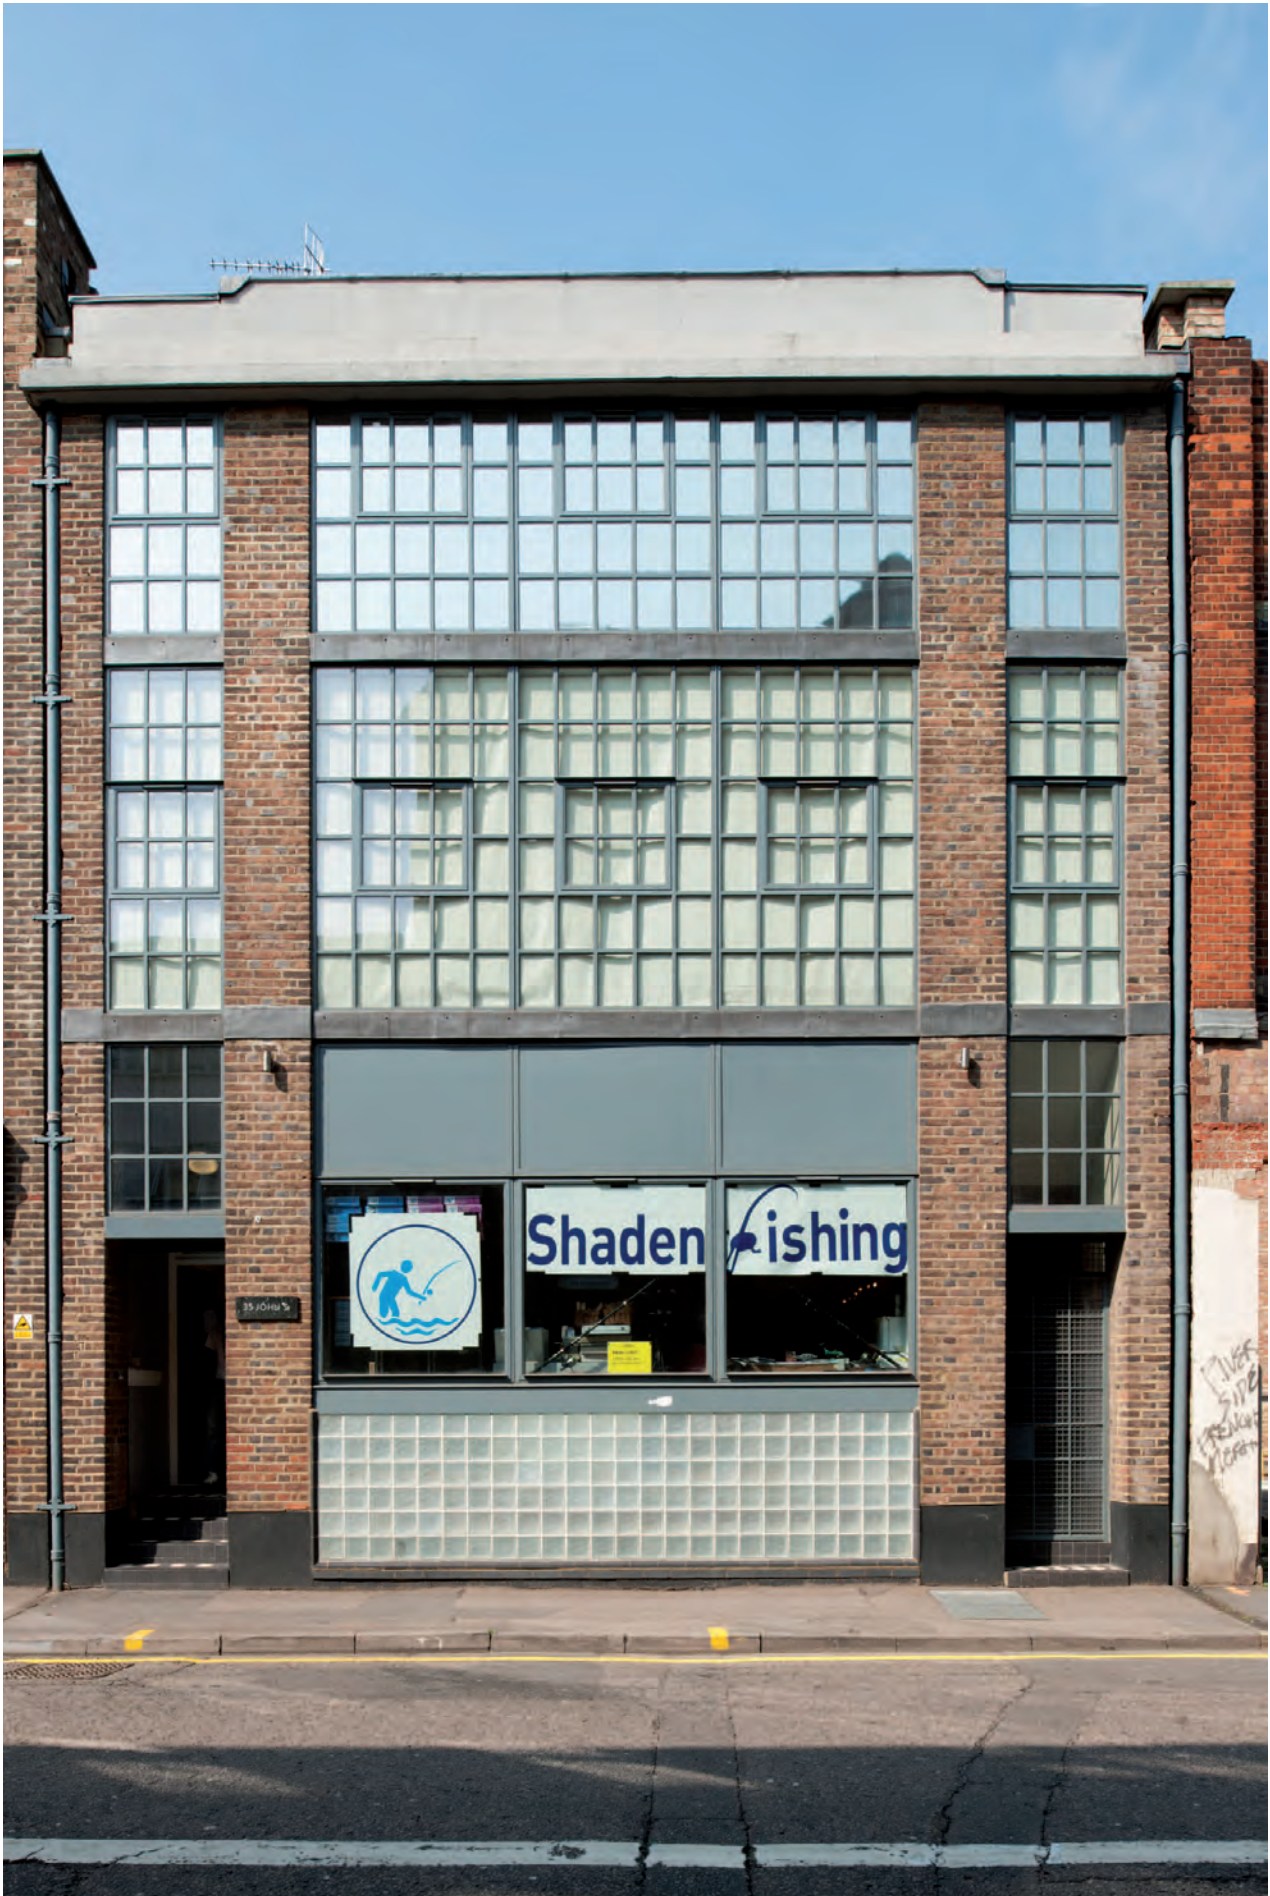
23-33 John Street and 1-20 Auction House Courtyard form a modern (c.2005) development of flats which incorporates the older Auction House at 35 John Street. The John Street frontage has been designed with respect to the plot boundaries of the six terraced properties which once stood here and attempts to replicate this through varying roof lines and false building breaks. Built using yellow brick in a Flemish bond, the windows contain uPVC sash windows and moulded reconstituted stone has been used for the heads and sills. 23 John Street is two storeys high, 25 and 27 are two and a half storeys with dormer windows set into mansard roofs, whilst 29-33 are three storeys high. The ground floor is occupied by a series of commercial units under a continuous fascia. Access to the courtyard is provided by a double gateway at 25 John Street. 35 John Street is a symmetrically designed three and a half storey building, with raised ground floor showroom above a half basement, whose interior floor levels are clearly articulated by the concrete framing. The glazing occupies the entirety of the space between the piers and consists of large metal frames divided into multiple small panes. The piers are clad in red brick and the parapet has been rendered. Somewhat unusually the main doorway (to the west) and the passageway (to the east) have been treated equally - the only difference being an extra step up to the main door, with an internal lobby beyond. This helps to create a well balanced design which, despite extensive renovation work in recent years, retains its structural integrity. A certificate of completion for the property is dated 31 May 1933 and names Mr H. C. Janes as the builder. No architect's name is provided, suggesting that the builder may also have been the designer.

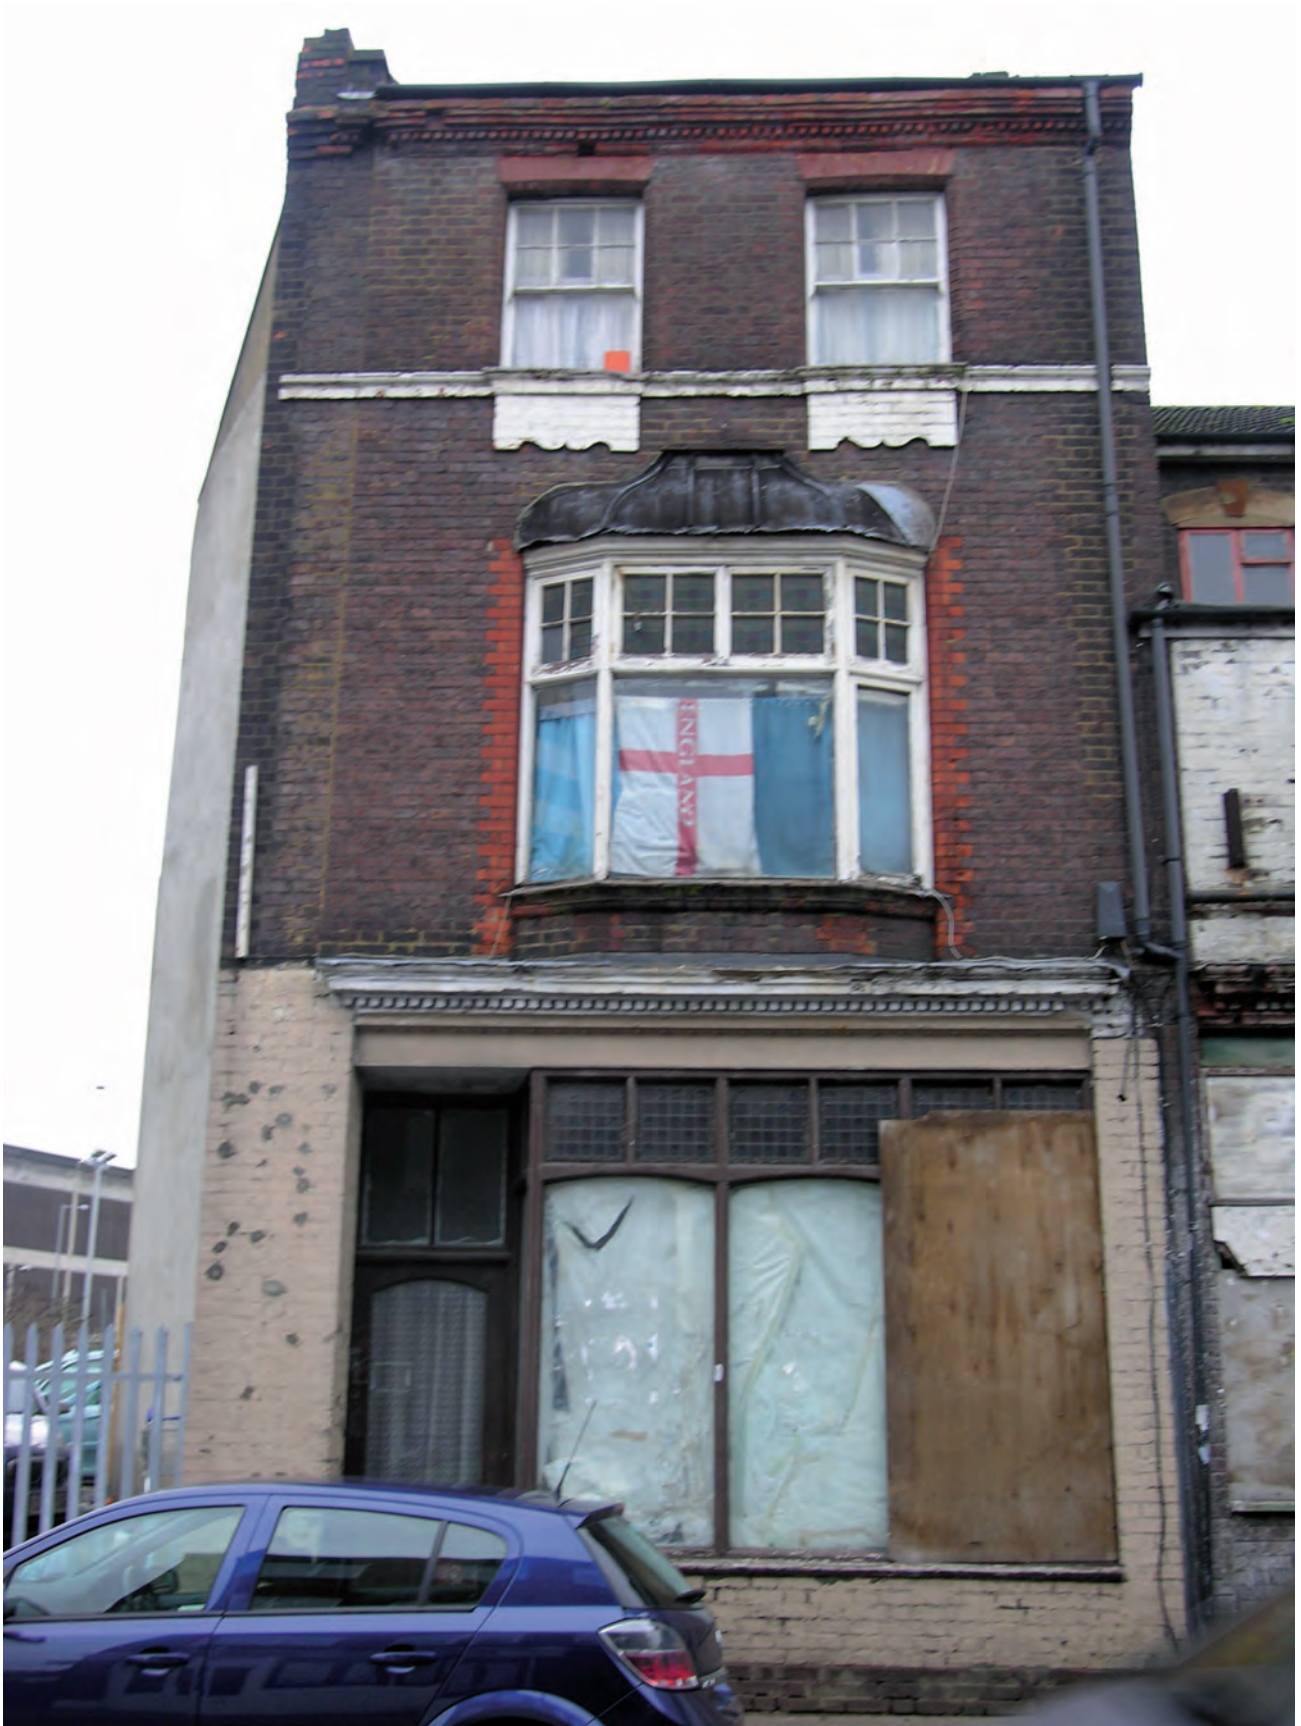
The first floor contains a single canted oriel window with decorative bright red brick detailing and a moulded brick sill. The oriel has a leaded ogee-shaped roof. The windows contains the same coloured transom lights as seen on the shopfront: the central ones open as casement windows and retain their original hinges. There are two sash windows to the second floor with chamfered brick reveals, a moulded brick sill band and shaped aprons below, under red brick chamfered heads which rise to meet the heavily moulded and dentilled brick cornice at the eaves. The clear building break indicates all that remains of 47 Cheapside - a narrow section of wall obscuring the southern elevation of 49. The rear elevation contains two larger and one smaller windows to all floors, with segmental red brick headers and stone sills - the smaller windows lighting the staircase. A ground-floor extension to 51 Cheapside partly obscures the northern-most part of 49, whilst the course of the river Lea underneath the building can clearly be seen to the south - the building being carried above on metal beams.

Kelly's trade directories provide a potted history of the site - in 1898 49 Cheapside was the premises of Meredith & Co, straw hat polish manufacturers (who had been on Cheapside since at least 1890 - according to Kelly's Directory of Bedfordshire 1890), whilst the 1903 and 1910 directories give it as the premises of Peter Davenport, silk merchant. By 1914 the site is used by Thomas Hawkes, straw plait merchant, and the Goad insurance map of c.1938 continues to show 49 as a hat warehouse, with stores in the buildings behind. The property register for 49 Cheapside includes the original conveyance text for the property, dated 2nd September 1899, which states that the owner of the land, a Christine Mary Ordish, had the right to to build over the River Lea, adjoining the southern side of a warehouse belonging to Mr Edmund Wiseman at 51 Cheapside). This suggests that a previous building on the site was replaced in c1899/1900 by the current property.

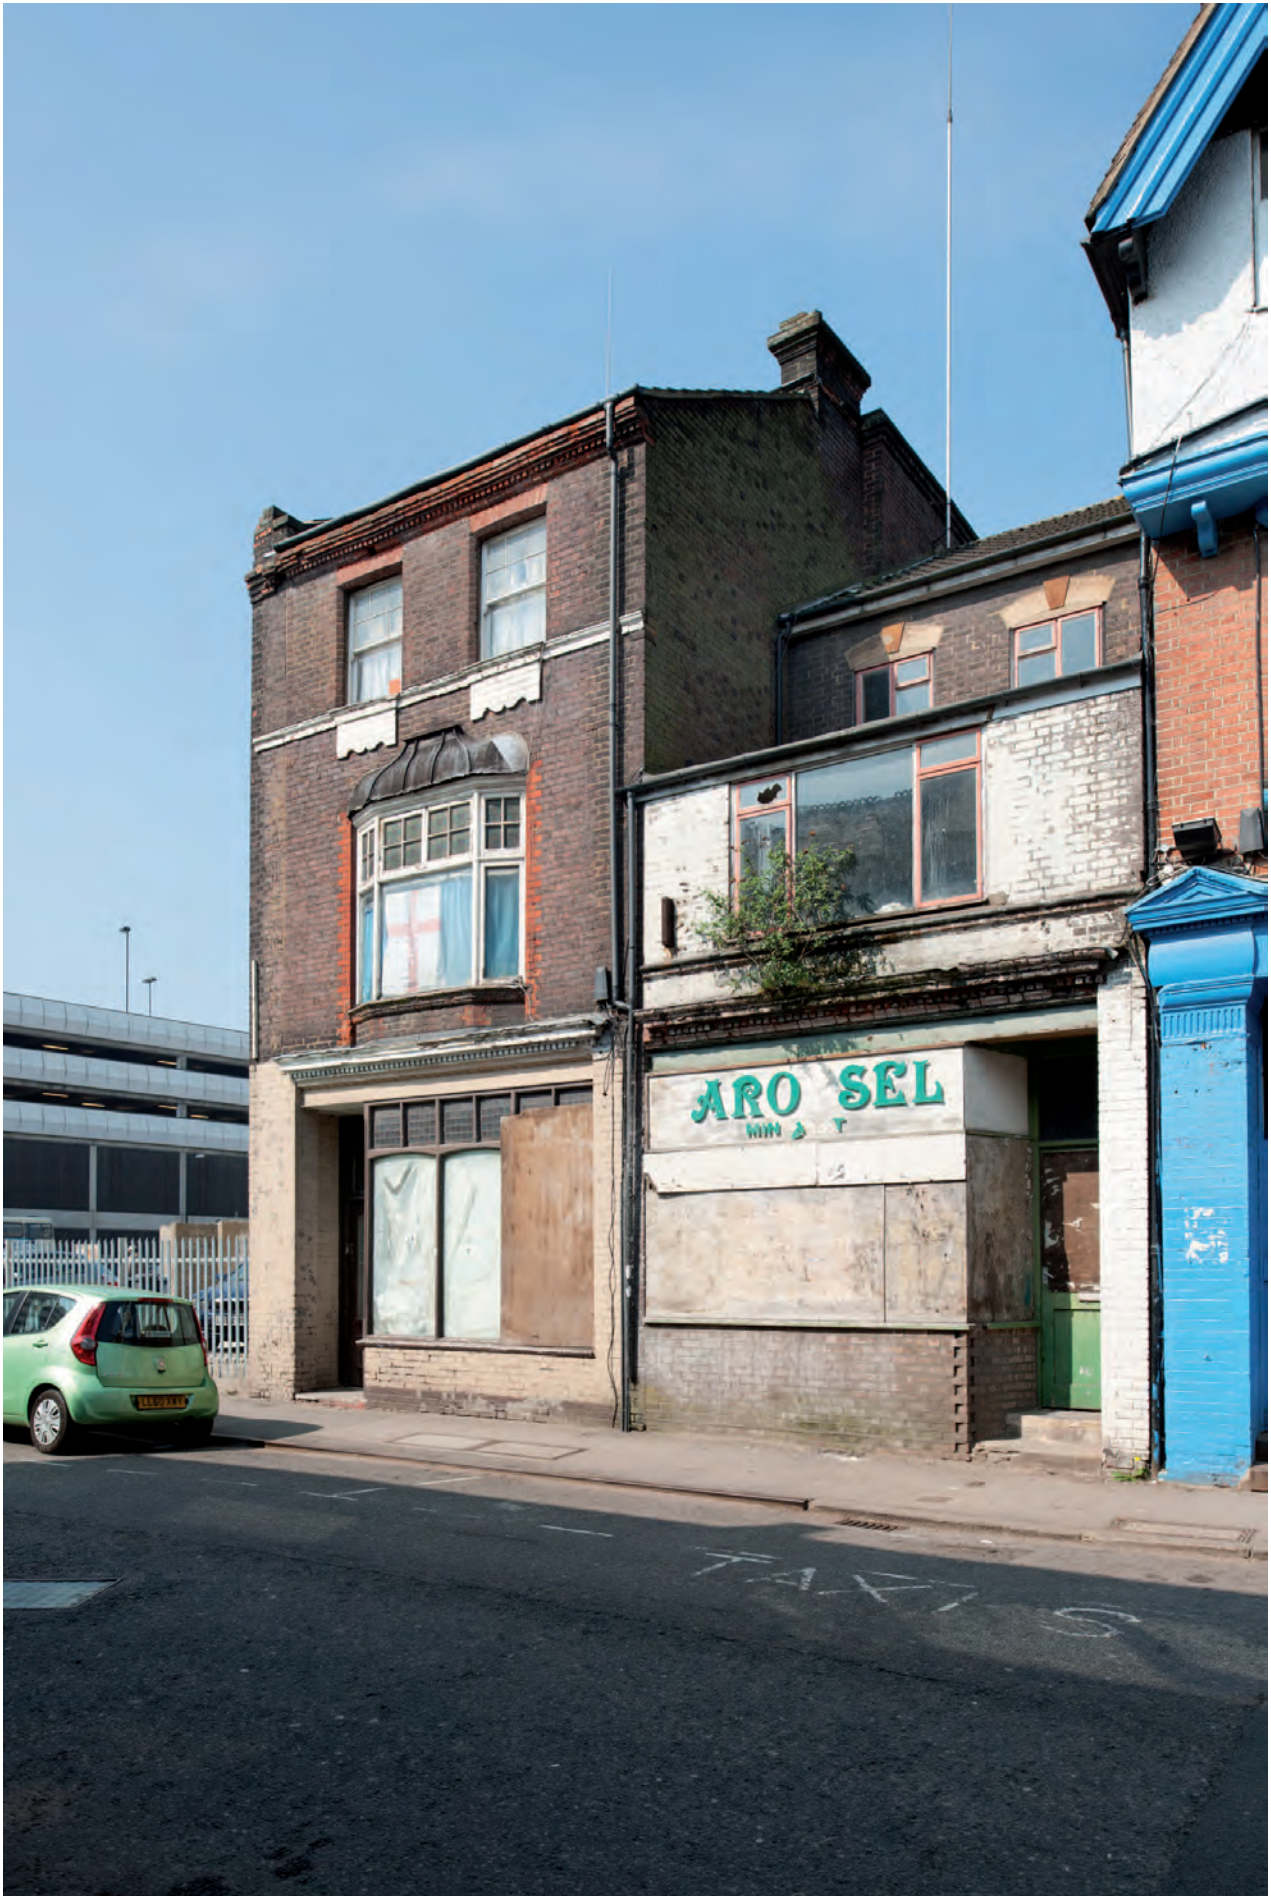
A three-storey building set back from the street, constructed primarily from Luton stock bricks in Flemish bond with a two-storey flat roofed block filling in the space between the main building and the street. The second-floor windows have arched stone heads with a stone key. The glazing has been replaced with mid-20th century timber casements, whilst the picture window on the first floor of the extension has fixed glazing with opening top lights. The front block is also constructed using Flemish bond with a moulded brick cornice. The display window is boarded up, with a Fletton brick stallriser in stretcher bond below. The recessed lobby is accessed via two stone steps. To the rear of the property is a single-storey extension. The 1895 Goad insurance map is the earliest evidence of a building on the site and shows a three-storey building with offices and domestic accommodation fronting Cheapside, a Tinsmith to the rear and a small shop fronting Barber's Lane. By the time of the 1938 Goad map the main building is shown as a restaurant with a hardware store to the rear.

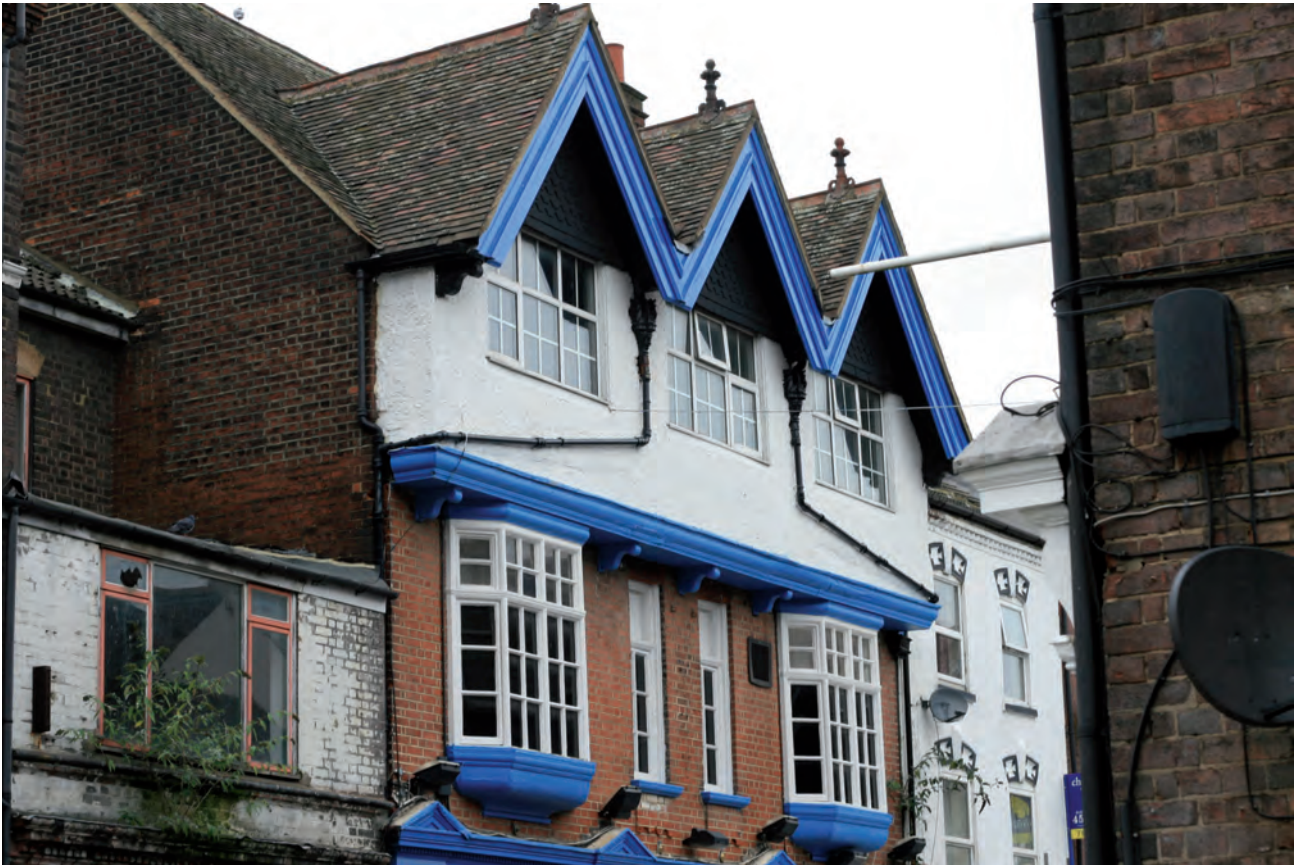
A three-storey building with distinctive Queen Anne revival elements. The three bay eastern (Cheapside) elevation has a triple gable with finials and moulded bargeboards, with fishscale tiles in the apexes of the gables. Decorated rainwater heads beneath the gable valleys provide a date of 1882. The second floor is jettied with a moulded bressumer resting on supporting brackets, the whole being rendered in pebble dash. Within each of the gables is a uPVC window. The first floor is a symmetrical arrangement with outer oriel windows and two single-light windows between, these having moulded brick aprons beneath. The ground floor is arranged with a recessed double doorway to the south, accessed by two steps, with two canted bay windows to the north - simple brick piers articulate the bay divisions. Above the windows and door is a fascia with dentiled cornice, above which are four small pediments in line with the piers below. Beneath the bay windows are loading doors for the basement. A number of extensions project from the rear of the property, reaching as far as Barber's Lane. Internally the building has been much altered - with the additions of bars, toilets etc. Kelly's Directory of Bedfordshire for 1910, lists the premises as being occupied by Clay and Co., Straw Hat Manufacturers. It is listed as being occupied by Charles Clay and Sons Ltd., straw hat trimmings manufacturers in Kelly's Directory of Bedfordshire, Huntingdonshire and Northamptonshire for 1914.

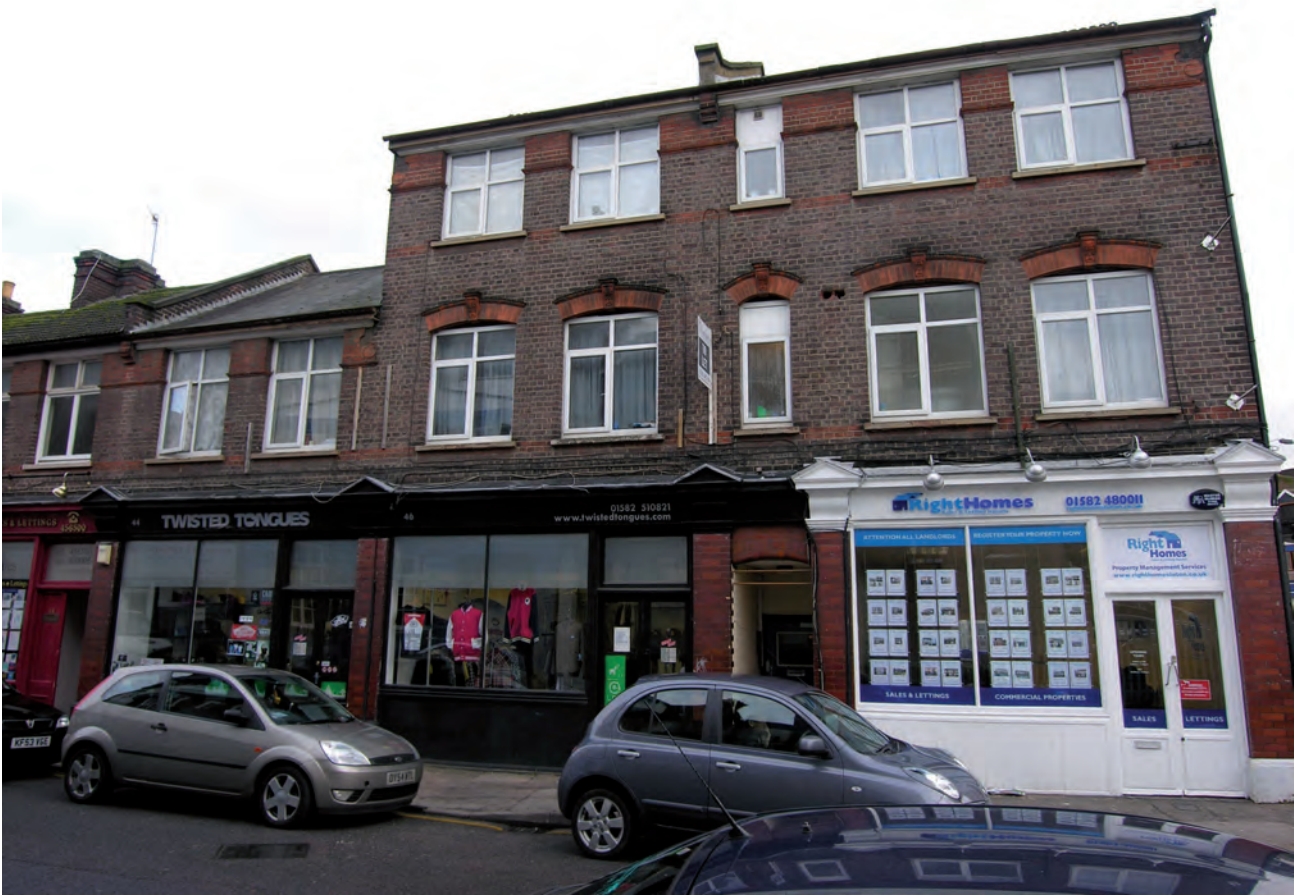
With the exception of 48, all of the windows contain modern uPVC replacement casements. The southern wall of the range is blind, before it reduces to two storeys in height and turns north-east at an angle to meet the rear block of 46 (which also runs at a slight angle), creating a trapezoidal range accessed via the passageway between 42 & 44, with a very small courtyard in the center which now allows access to the flats ranged around it. This courtyard contains a number of blocked and altered windows. Both of the rear blocks contain a number of straight headed windows, some of which are later insertions. A roof scar shows where a further extension once stood to the rear of the northern extension, behind 46. 48 was constructed over the river Lea and does not have any form of rear extension. The properties were built between 1880 and 1901, with the rear extension to 46 in place by 1901, as was most of the southern range although this did not yet connect to 42. The 1938 Goad insurance maps show a straw hat factory on the site, with associated straw plait warehouse in 46 Cheapside and a separately owned straw plait warehouse in 48, with access through to the warehouse, offices and block factory at 50 & 52 Cheapside.

Kelly's trade directory for Bedfordshire, Hertfordshire and Northamptonshire 1898 states that 46 Cheapside was the premises of John Facer, a coal merchant. More information is given in Kelly's 1903 directory, which shows an Alfred Sapwell, straw hat manufacturer, at 42; an Ernest Underwood, straw plait merchant, at 46 and T & J Brodie & Co Limited - paper merchants, color printers and paper bag manufacturers - at 48. In the 1910 directory, Alfred Sapwell is still present at 42, whilst a Henry Webb, manufacturers' agent, has taken over 46. By the time of the 1914 directory much has changed - Alfred Sapwell is now listed as being a straw hat manufacturer occupying 42, 44 and 46 Cheapside - using all three buildings.

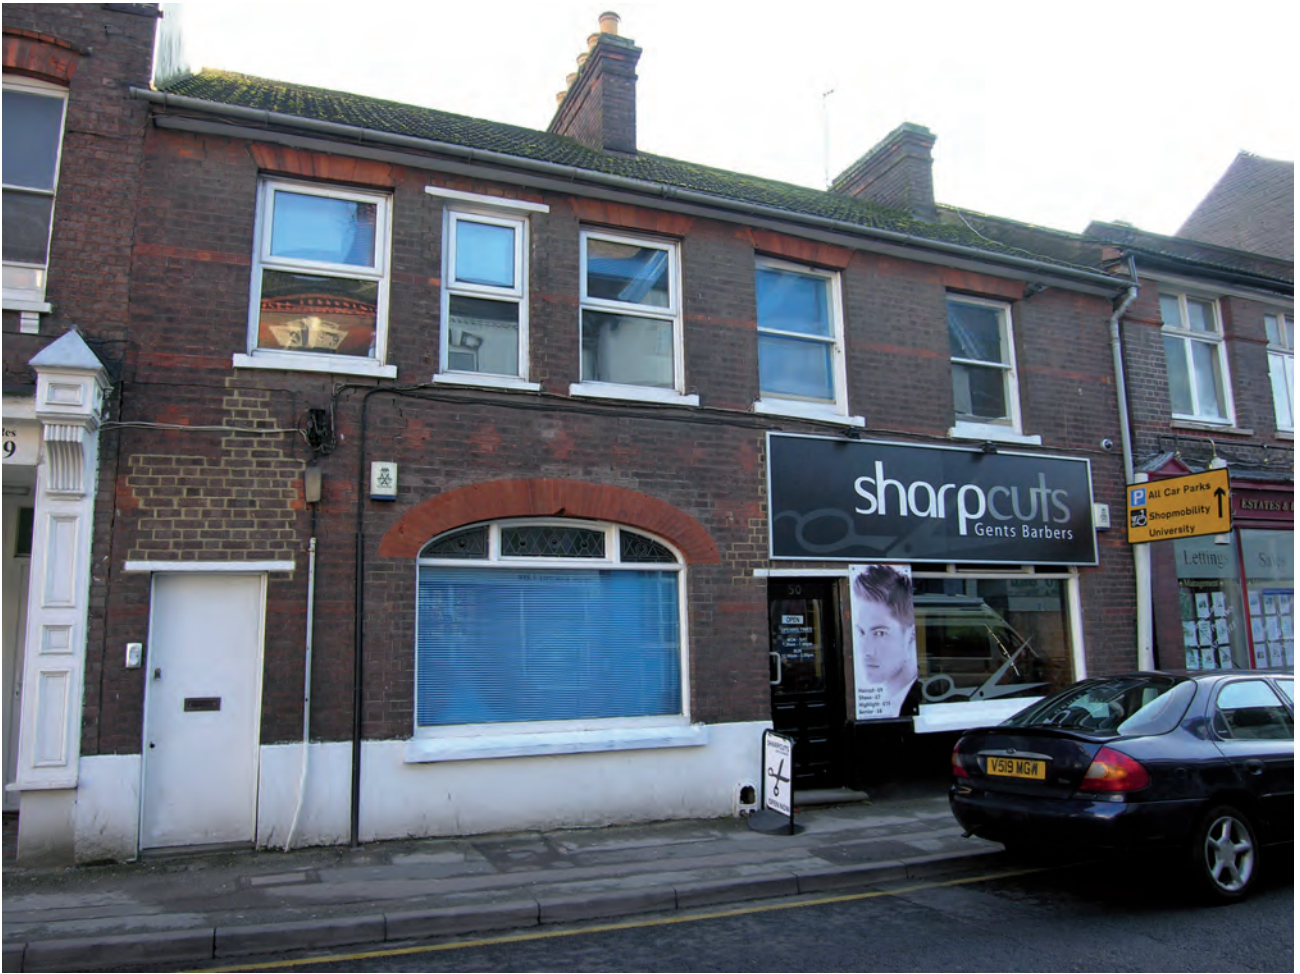
50 Cheapside is a two-storey terraced building, of plum-coloured Luton Grey bricks, with red brick dressings, and a tiled roof straddled by two brick stacks, set on the cross walls. It appears to contain two properties. At ground-floor level, from left to right, is a small doorway, a window, and a shopfront. The head of the doorway may have been remodelled: modern patching in the brickwork above the lintel interrupts a red brick band. The large plate-glass window has a depressed-arched head containing decorative leaded glazing above a transom bar. To its right is a boot scrapper. The shopfront (Sharpcuts Gents Barbers) has a large modern shop sign over a part-glazed entrance door (left) and display window (right). At first-floor level, the two right-hand windows are plate-glass sashes, while the three on the left - including an inserted window flanked by original window openings - have UPVC glazing. Rear not viewed.

The earliest depiction of the structure dates to 1901 when it is shown on the OS 1:2500 scale revision of Luton town centre. In 1903 it was occupied by Frank Moody, engineer and manufacturer of machinery for straw hat manufacturers (Kelly's Directory of Bedfordshire, Hunts, and Northamptonshire, 1903). By 1910, White and Newbold, straw hat manufacturers and George Newbold, coal merchants, were housed at 50 Guildford Street (Kelly's Directory of Bedfordshire, 1910): White and Newbold continued to occupy the building up to the outbreak of the First World War (Kelly's Directory of Bedfordshire, Huntingdonshire and Northamptonshire, 1914). The Goad Insurance map of 1938 lists it as 'Warehouse and offices'.

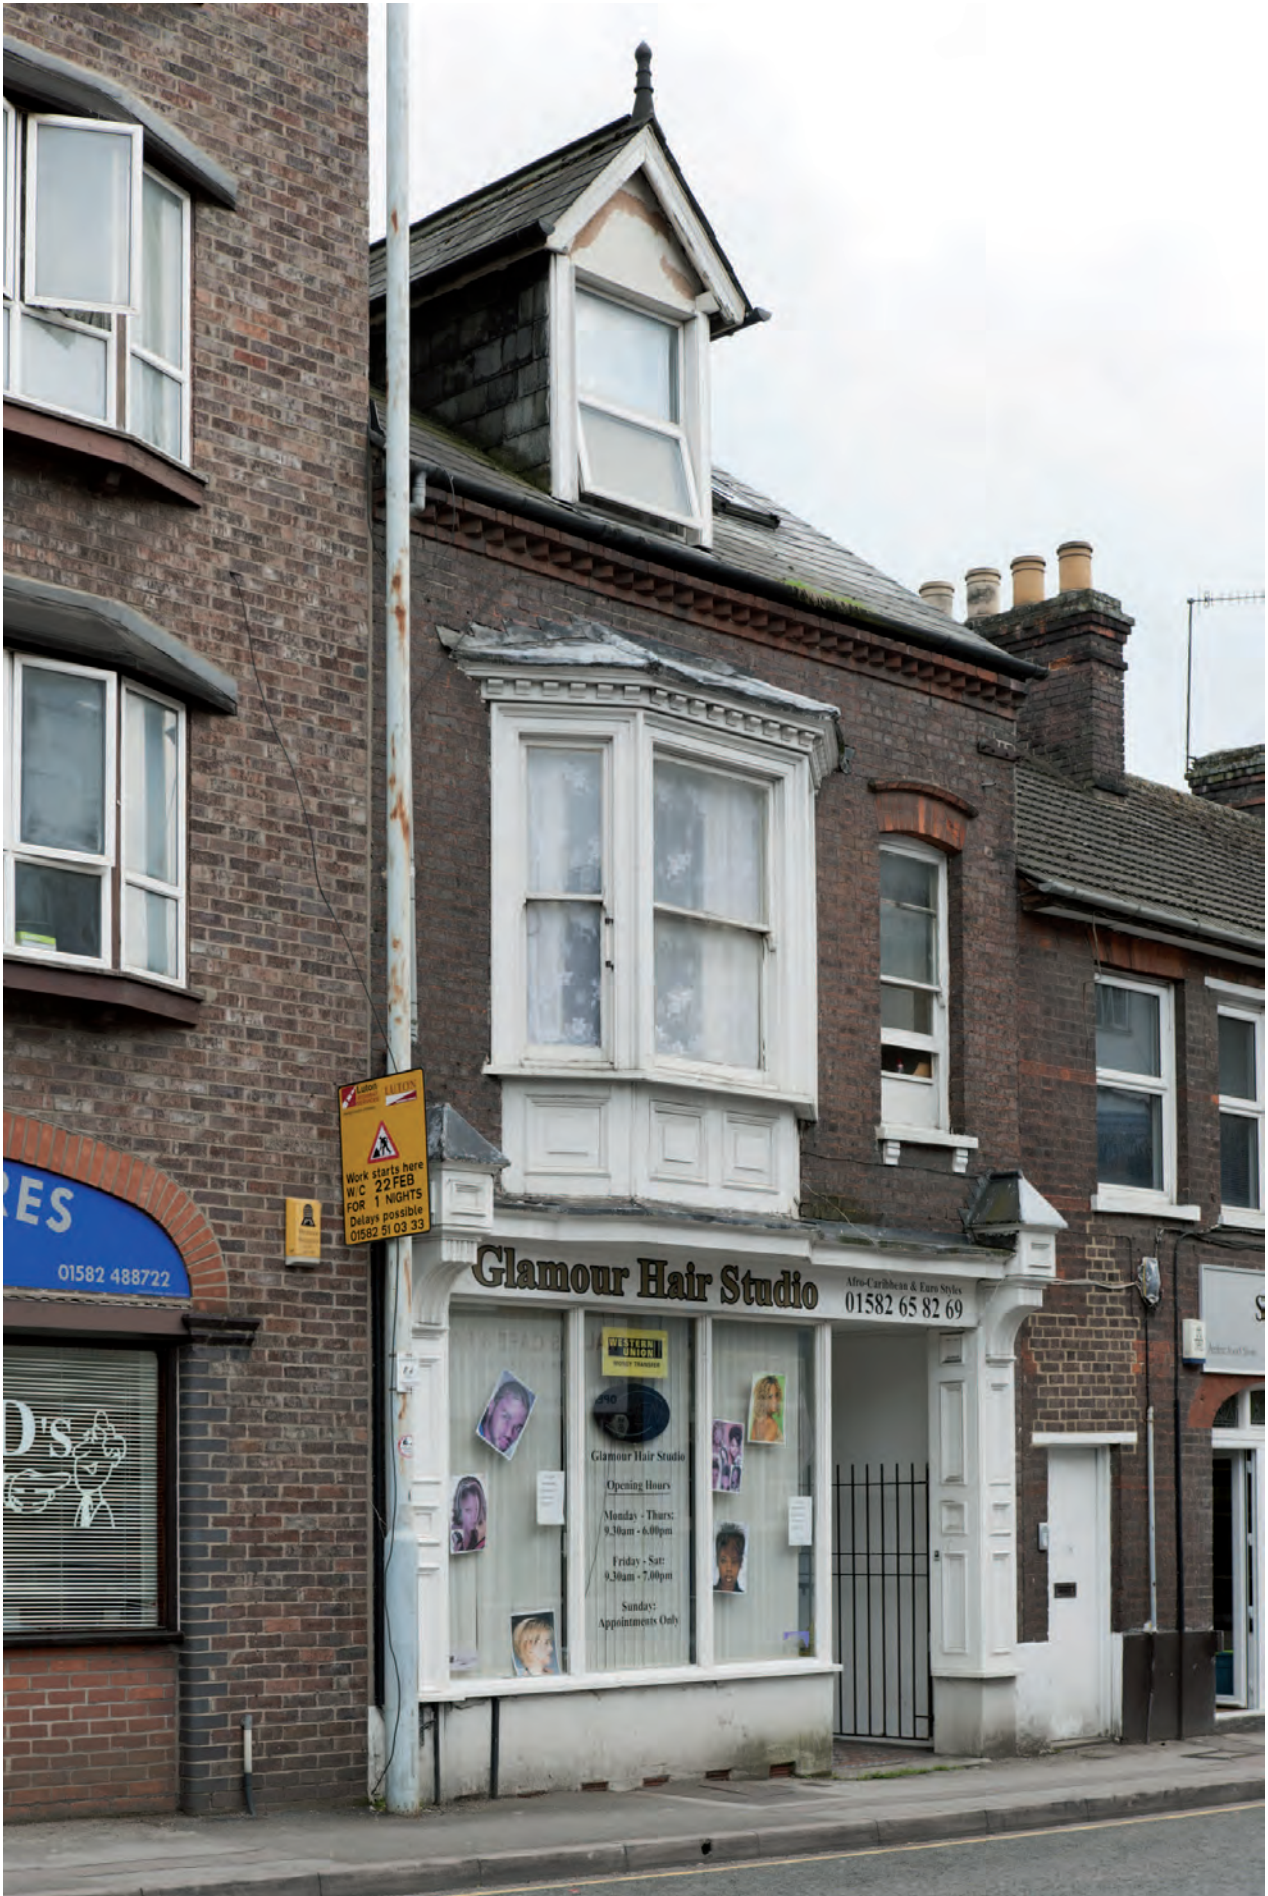
No. 52 Cheapside is a two and a half storey terraced property, apparently built as a single unit with a commercial function on the ground floor, and residential above. It is of plum coloured Luton Greys, with red brick dressings and a slate roof. The full width of the ground floor ('Glamour Hair Studio') is taken up by a shopfront with panelled pilasters and bracketed consoles, framing a tripartite shop window to the left of a gated lobby entrance. The latter has an encaustic tile floor and contains two entrances: one to the shop; the other to the house. There are two first-floor windows. That on the left is in the form of a large-scale canted oriel window, with wooden sash glazing, on a panelled base. It has a dentilled cornice and is covered by a lead roof. The window to the right is smaller. The sill is carried on small brackets, and the segmental head has a projecting label. It contains a wooden sash. Above the oriel is a gabled dormer containing modern glazing; there appears to be a skylight to its right. The eaves are formed of decorative sawtooth brickwork.

A vacant plot is shown on the OS 1:2500 map of Luton town centre dating to 1880 and the building is first shown on the update of 1901. It was occupied by Frederick John Pedley, house decorator, until at least the outbreak of the First World War (Kelly's Directory of Bedfordshire, Hunts and Northamptonshire, 1903; Kelly's Directory of Bedfordshire, 1910; Kelly's Directory of Bedfordshire, Huntingdonshire and Northamptonshire, 1914).

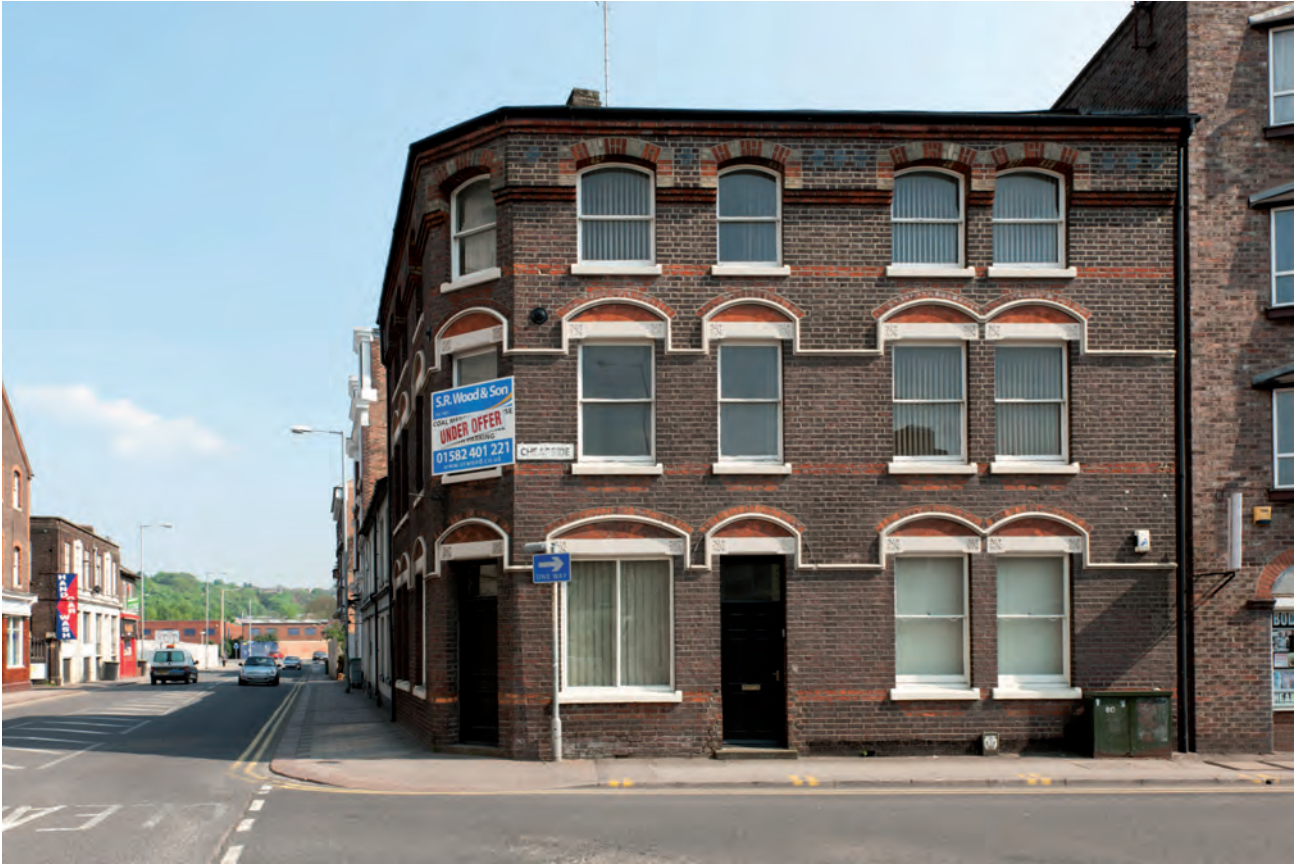
56 Cheapside is a large and imposing building, occupying a prominent corner plot at the junction of Cheapside and Guildford Street, and is notable, primarily, for its highly decorative window surrounds. It is a three storey building with a cut-off corner entrance and a subsidiary entrance to the side of this (on Cheapside), separated by a window. Symmetry is apparent on both façades of the building: on Guildford Street this consists of paired and single sash windows on each floor; on Cheapside, two sets of paired sash windows on each floor. Ground and first-floor windows comprise stone sills and decorated lintels with a continuous band of red brick at sill level. There is a continuous projecting hood moulding above these windows. The intervening space between the flat lintel and the moulding contains a flat, red brick, panel or tympanum. The second-floor sash windows are smaller with stone sills and projecting brickwork in between. The heads are composites of red and yellow brick and there are small black-glazed brick crosses between the windows. The roof is of Welsh grey slate.

56 Cheapside is first noted in Kelly's Directory for 1903 where it is listed as a coal merchant (Kelly's Directory of Bedfordshire, Hunts and Northamptonshire, 1903). A vacant plot is shown on the OS town plan of 1880, and the building makes its first cartographic appearance on Goad's insurance map of 1895: by 1938 it was registered as 'offices and domestic' premises.

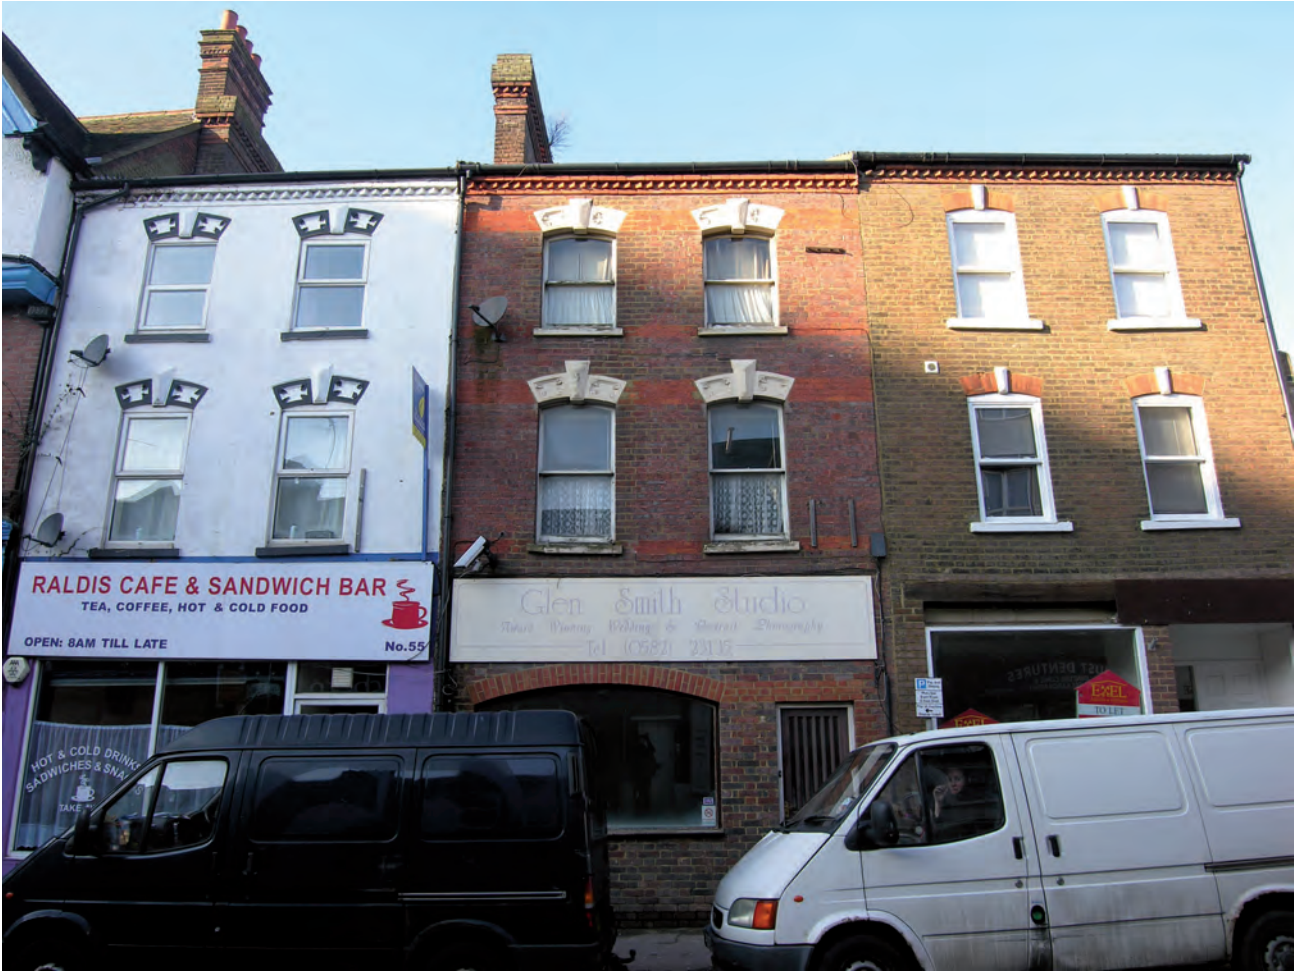
This is a pair of terraced properties, 55-57 Cheapside, each two bays wide and three storeys high, built in plum-coloured Luton brick with red brick and stone dressings. Each has a commercial business on the ground floor. 55 accommodates a café (Raldis Café), with a window and doorway under a large modern fascia. 57 is a photographic studio (Glen Smith Studio), with a frontage of modern brickwork comprising an arched window to the left of a doorway. This may have replaced an older shopfront. On the upper floors, each property is treated in the same manner, although 55 has been painted white with decorative details picked out in black, and has replacement glazing. The original treatment is, therefore, best seen on 57. The windows have segmental heads, with stone lintels carved with stylized Maltese crosses to either side of a chamfered keystone. They contain plate glass wooden sashes. The eaves are of sawtoothed brickwork. Several satellite dishes are attached to the frontage.

These properties were built in the 1870s - absent from Corney's map completed in 1872 but present on the OS 1:2500 map of Luton town centre published in 1880. 55 Cheapside was occupied by William Sleight, straw plait merchant from the end of the 19th century through to the outbreak of the First World War (Kelly's Directory for Bedfordshire, Hunts and Northamptonshire, 1903; Kelly's Directory for Bedfordshire, 1910; Kelly's Directory for Bedfordshire, Huntingdonshire and Northamptonshire, 1914).

57 Cheapside was occupied by Richard Burley, straw hat manufacturer, in 1910 (Kelly's Directory for Bedfordshire, 1910) and Swain & Burley, straw hat manufacturer in 1914 (Kelly's Directory for Bedfordshire, Huntingdonshire and Northamptonshire, 1914). Goad's Insurance map of 1938 lists 55 Cheapside as a 'chemical warehouse'; 57 Cheapside was at the time a 'straw hat factory' with 59 Cheapside.
