PLAITERS' LEA CONSERVATION AREA, LUTON HISTORIC AREA ASSESSMENT

Research Department Report Series 069-2011

HISTORIC AREA ASSESSMENT

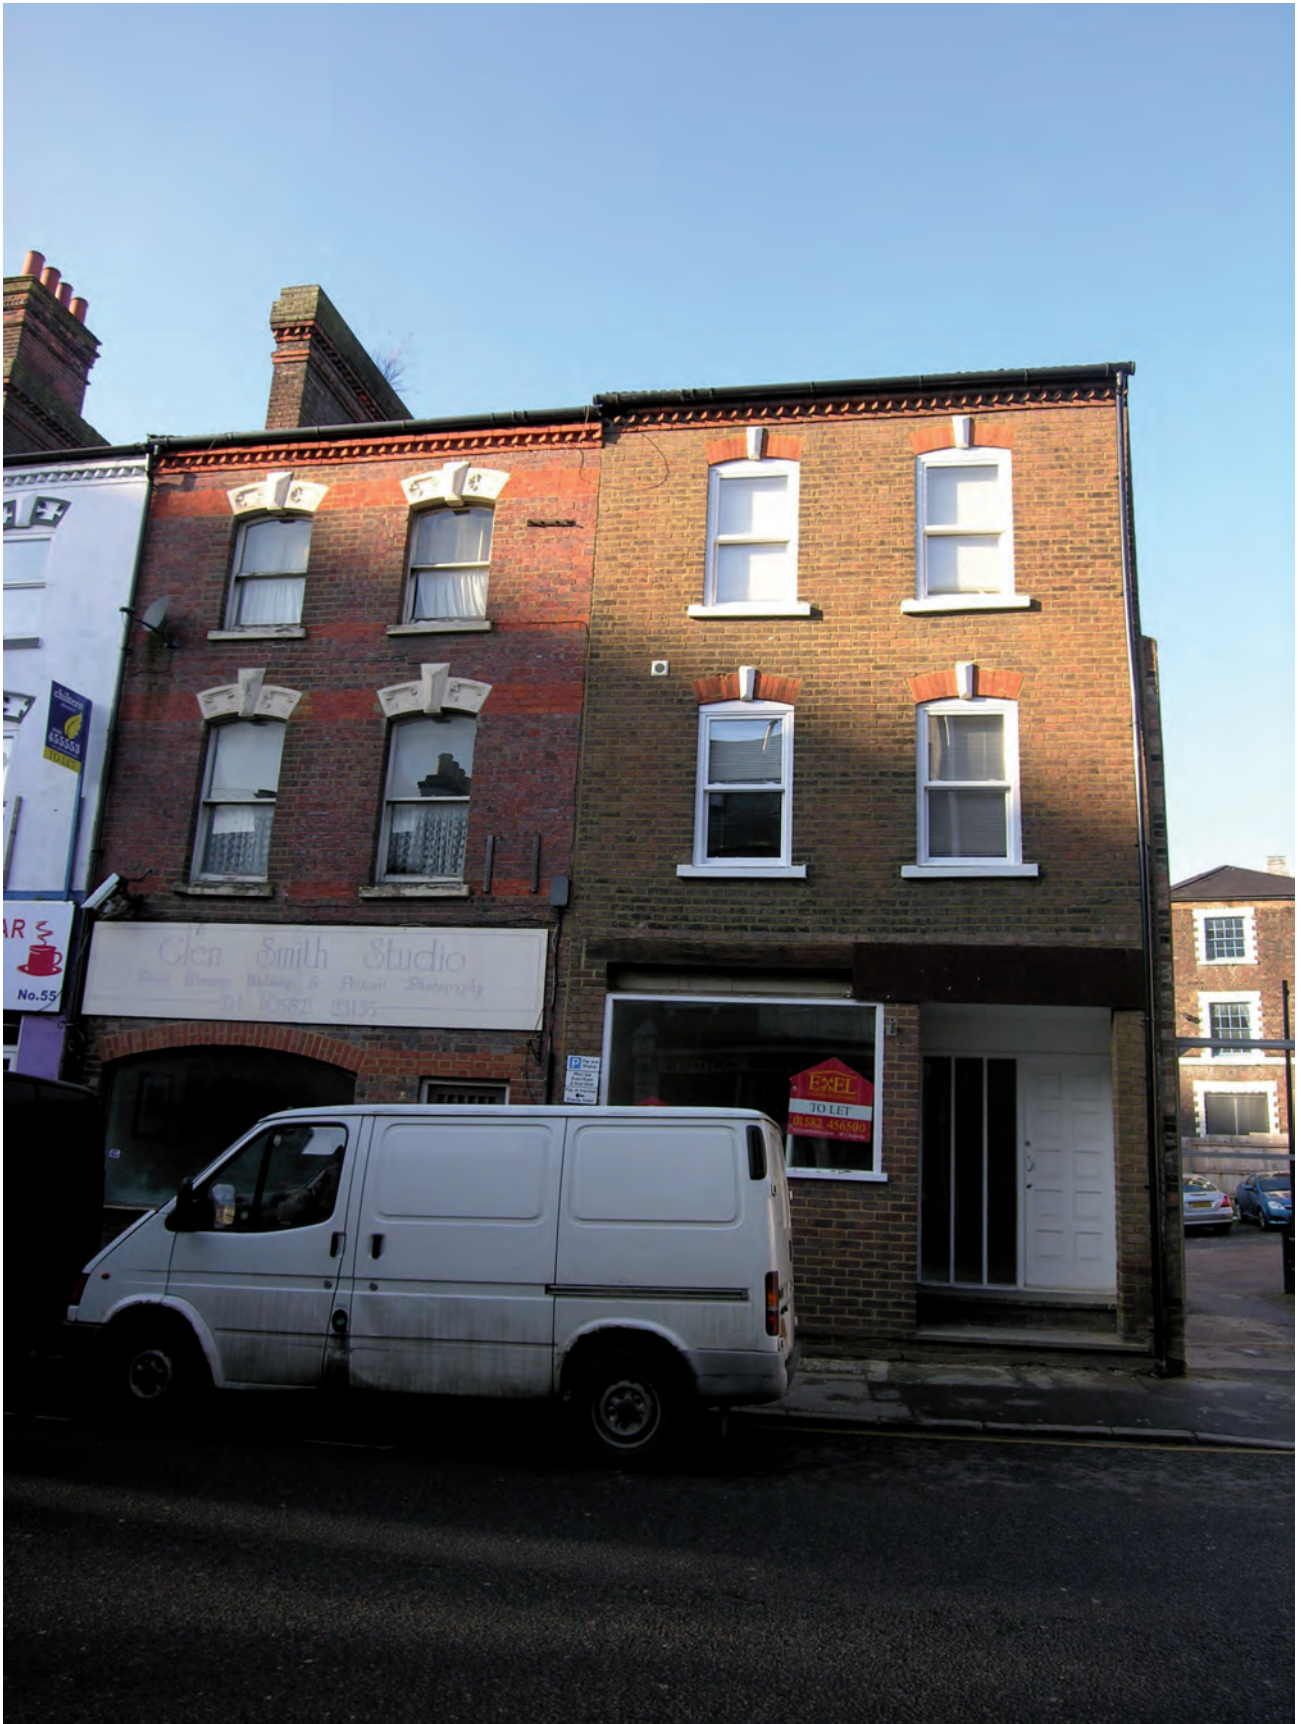
59 Cheapside is a single end of terrace property, two bays wide and three storeys high, of plum coloured Luton Grey bricks with red brick and stone dressings. It is very similar to 55-57 Cheapside, but simpler in style, with a slightly higher second storey. The ground floor may have been occupied by commercial premises, and currently displays a 'to let' sign. It has been converted to residential use, with a window to the left of the entrance. Above this are segmental headed windows with sash glazing. These have chamfered keystones. The eaves are of sawtoothed brickwork. The adjoining building to the north has been demolished.

This property was built in the 1870s - it is absent from Comey's map completed in 1872 but present on the OS 1:2500 map of Luton town centre published in 1880 where it is a component in a short terrace incorporating 55-57 Cheapside. It was occupied by Henry Edwards, tailor, in 1898 (Kelly's Directory for Bedfordshire, Hunts and Northamptonshire, 1898), Walter Edward Brown, straw hat manufacturer, in 1903 (Kelly's Directory for Bedfordshire, Hunts and Northamptonshire, 1903), and from 1910 by the Labour Club & Institute (Kelly's Directory for Bedfordshire, 1910; Kelly's Directory for Bedfordshire, Huntingdonshire and Northamptonshire, 1914). Goad's Insurance map of 1938 lists No. 59 Cheapside as a 'straw hat factory' (conjoined with 57 Cheapside).

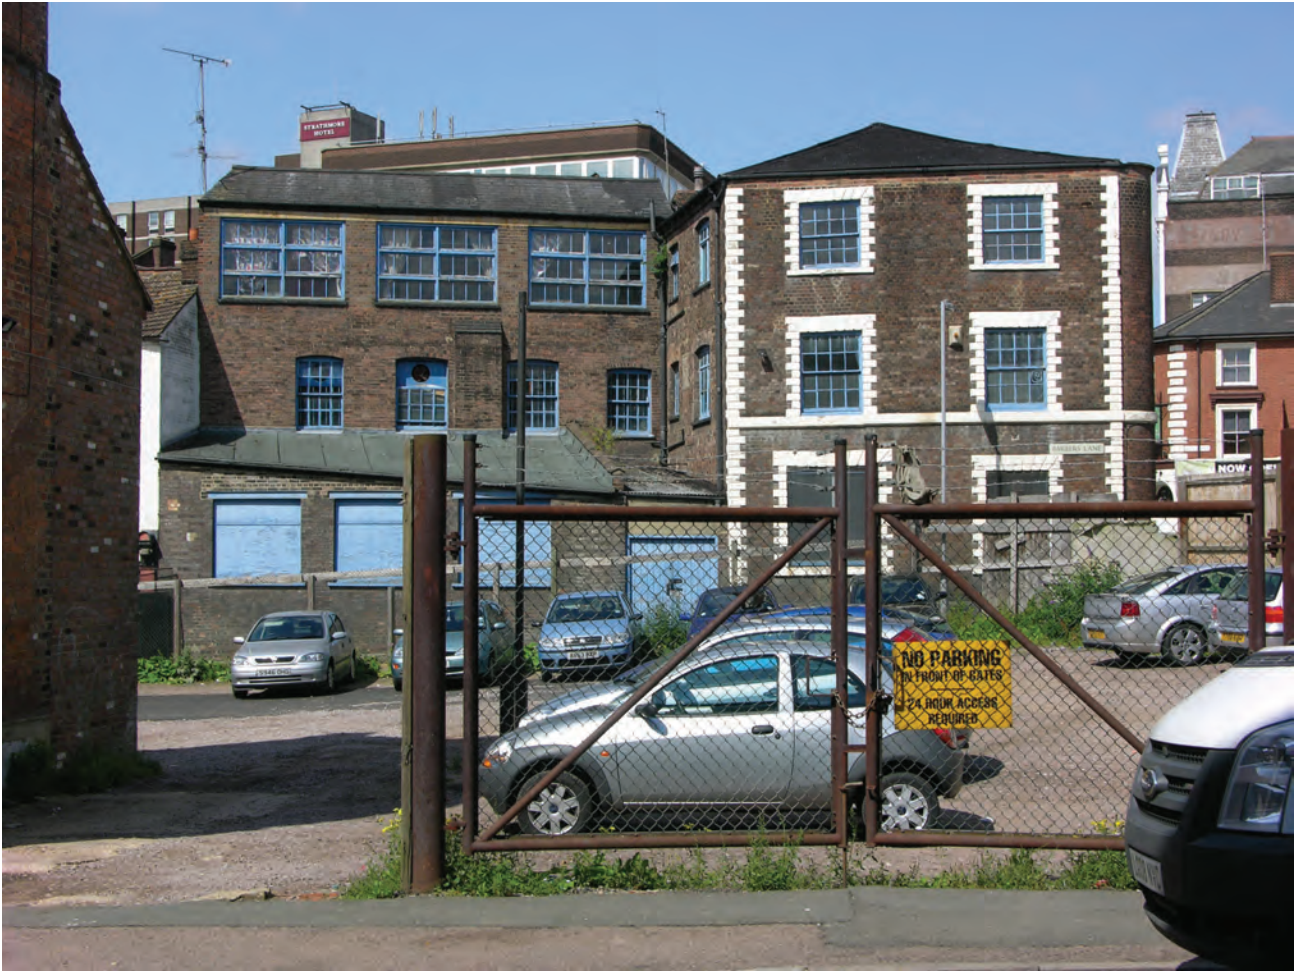
This L shaped plot of land extends behind the rear of numbers 55-59 Cheapside and is currently used for surface level car parking. It was formerly the site of a number of straw hat factories and warehouses shown on both sets of Goad insurance maps as being two or three storeys in height and filling almost all of the available plot.

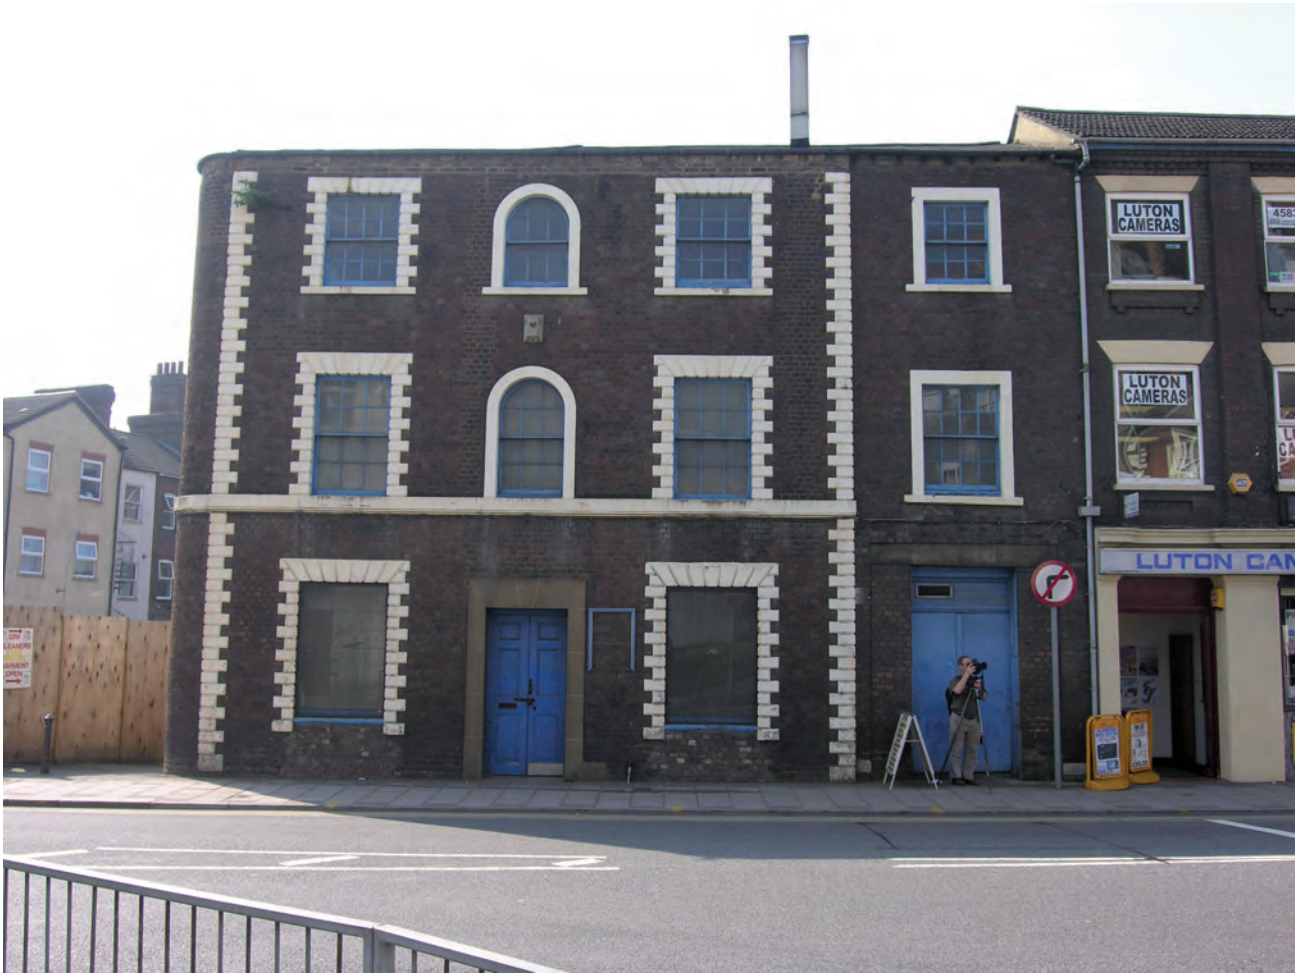
A three-storey building with a slate roof, it is largely 'domestic' appearance, built in Luton Grey bricks with stuccoed quoins. There are four bays to Guildford Street - the bay furthest to the west being clearly delineated from the others. The building curves to the east to continue in another two bays down Barber's Lane. The ground floor on Guildford Street comprises a central, double-door, with a plain rendered, surround and large sash windows on either side. These are notable for their stuccoed quoins and stuccoed gauged heads as well as narrow stone or concrete sills. In addition, there is a prominent and continuous stuccoed plat band at first-floor level. The windows on the first floor all follow the same design, with original wooden sashes, apart from those placed centrally which have arched heads and plain stucco surrounds. The right hand bay features a large ground floor passageway: this incorporates a substantial concrete lintel and it has been narrowed in recent times. The sash windows above this have plain rendered surrounds and narrow stone or concrete lintels.

Supposedly built in the 1860s, the building probably dates to the 1840s. A building of the same dimensions is marked on this location on the updated Tithe map of 1844 and the building is unmistakably shown on Todd's map (first stages produced in 1853, latest in 1862) as a three-storey with four bays, the fourth being clearly delineated as it is seen today.

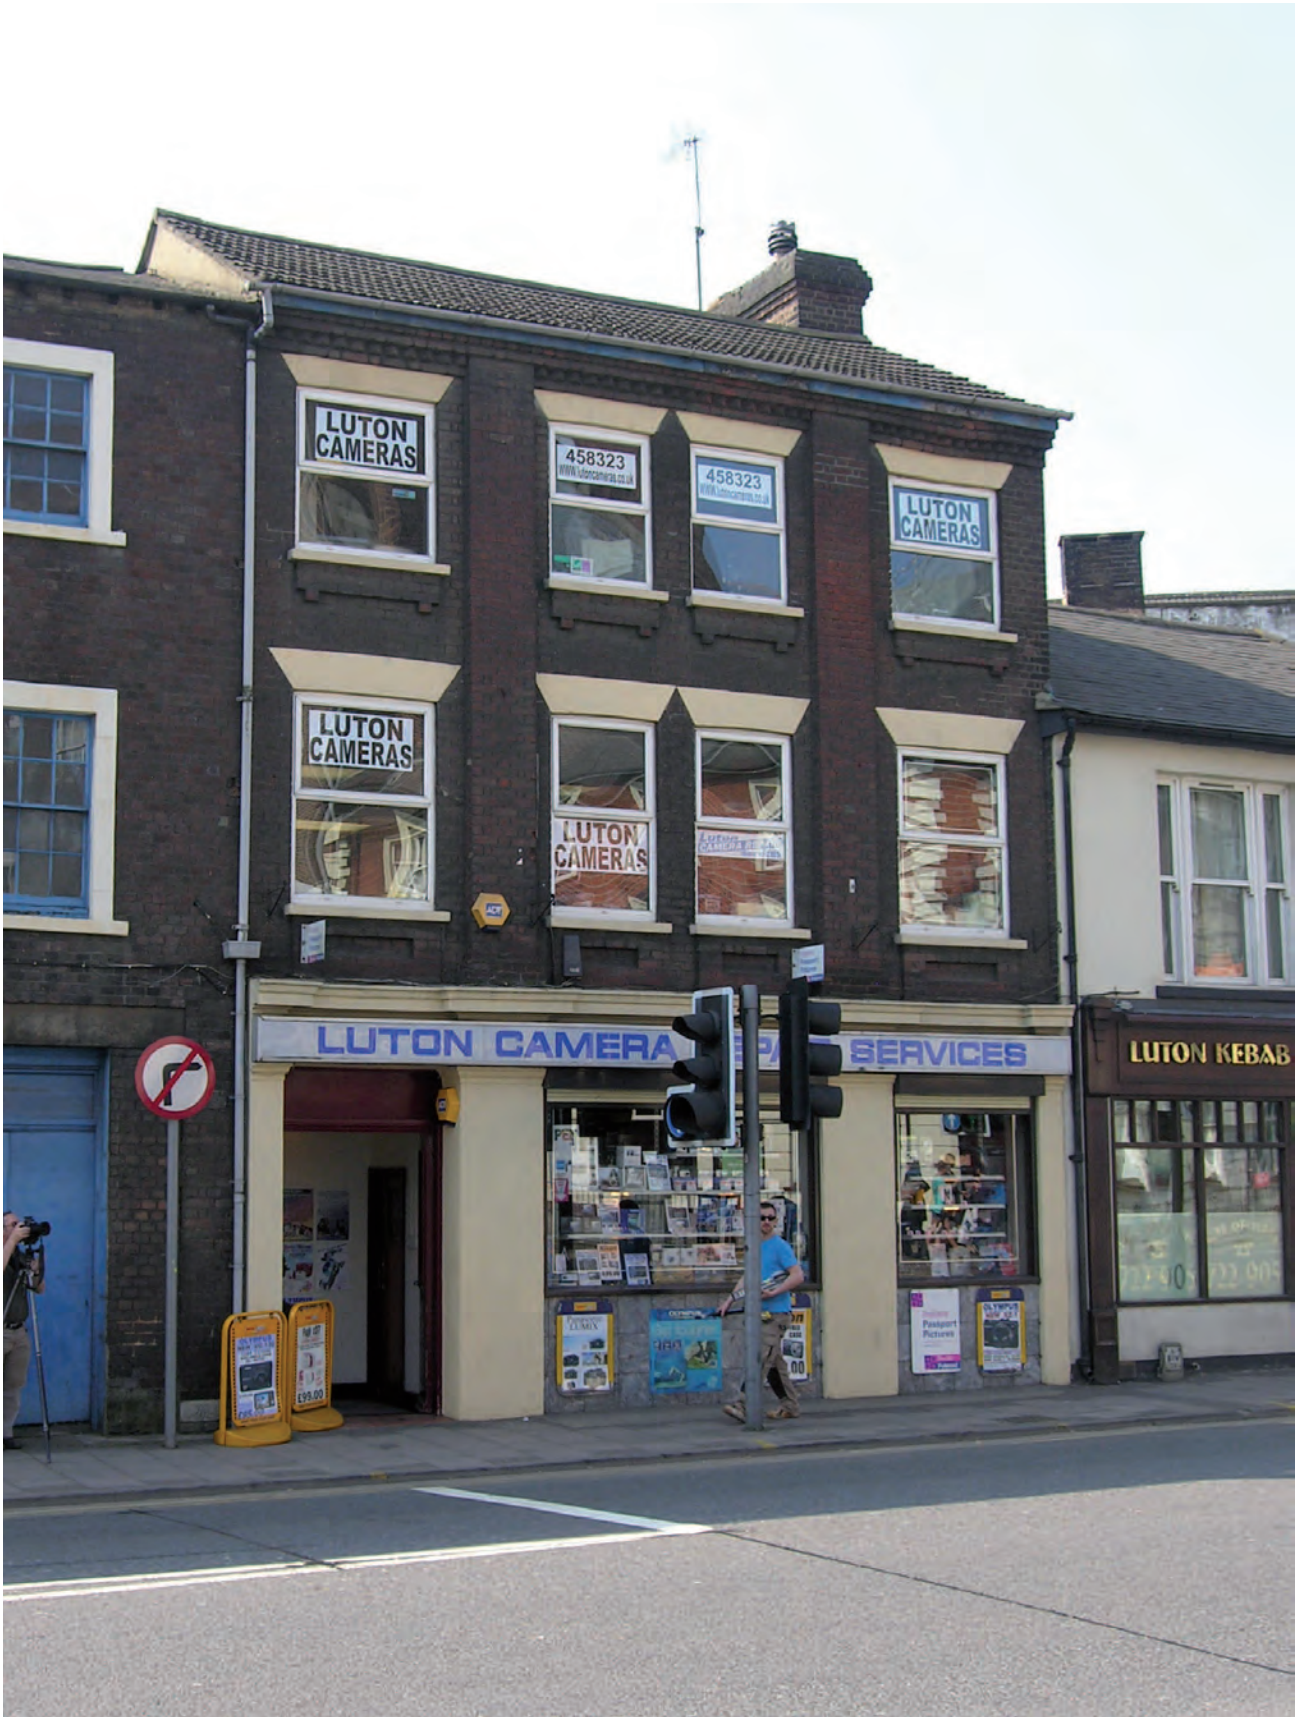
A three-storey building plus basement, it is three bays wide - although the central bay is wider than the outer bays, with paired windows to the first and second floors and single windows outside of these. The ground floor consists of a wide central bay that contains a large window with a tiled stall riser. This is separated from the side bays by rendered flat pilasters capped with capitals. The left-hand bay contains the current, recessed, doorway to the shop, flanked on the left by a pilaster of similar form. The right-hand bay was, originally, a second entrance now blocked with a shop display window and tiled stall riser. The original fascia is hidden behind a modern shop sign but at first-floor level there is continuous band of projecting, moulded, cornice. Both ground floor windows have been heavily modified and all trace of exterior access to the basement has been removed. The central, paired, windows on the first and second floors are separated from the single windows to the side by brick piers - the windows, however, are all of similar form. The original wooden frames have been replaced by uPVC casements. Sills are narrow, in stone or concrete, and the accompanying heads are flat, rendered and gauged. Each window has a simple brick apron below the sill but those under the first-floor windows have recessed, brick-defined, panels. The front elevation is completed at roof line level with a course of brick dentils beneath two projecting courses of brickwork; the roof is clad in modern concrete tiles.

The hat factory at 49 Guildford Street is shown on the 1880 1:2500 town map, but in a much reduced form - it has clearly been extended on a number of occasions since then - and it is depicted as being a component part of the factory at No. 47 on Goad's insurance map of 1895. HC Brown Hat Manufacturers occupied the premises in 1914 (http://www.galaxy.bedfordshire.gov.uk/webingres/luton/0.local/luton_news_directory_1914.pdf) and it remained in use as a hat factory into the post Second World War years. It currently hosts Luton Camera Repair Services.

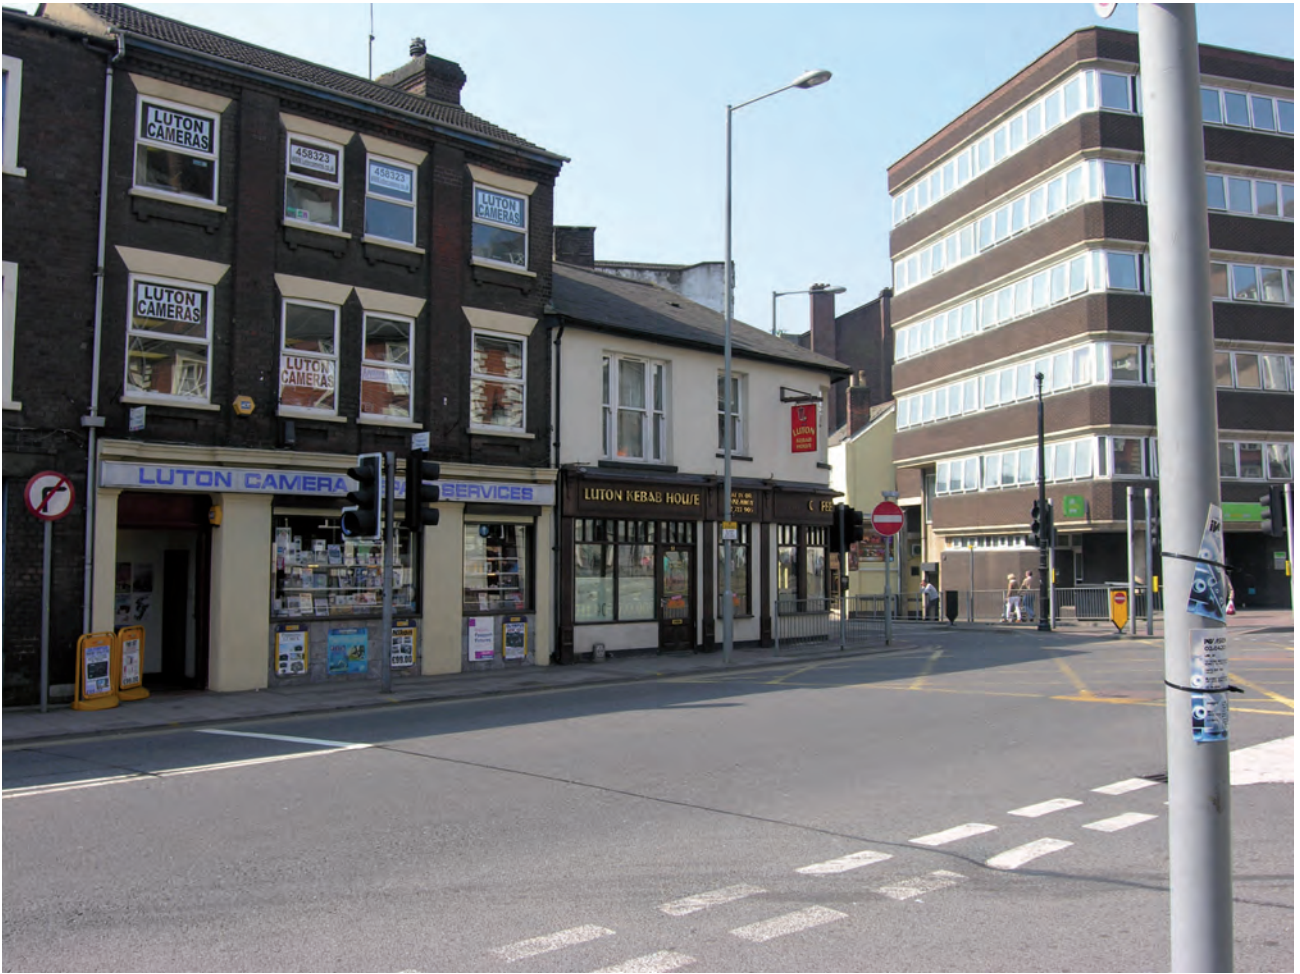
51 Guildford Street is a squat building, dwarfed by 49 Guildford Street on its left. A two storey building with a low-pitched roof in Welsh Grey Slate, it sits in a key location in the Conservation Area - at the junction of Guildford and Bute Street, facing the station approach. The shop front has been substantially altered in recent years but hints of its original form can still be discerned. Currently, it comprises a double, two-light, ground floor window with rendered stall riser and a door to the side. This window has heavy wooden glazing bars with a simple, narrow, wooden sill, and the upper lights are sub-divided into four panes, again, each divided by wooden glazing bars - this arrangement extends to the fanlight above the door. A single window with a quadruple light above lies on the right hand side of the door and the shop front is divided by flat wooden pilasters beneath a wide, modern, fascia with narrow projecting cornice. The pilasters are capped by crude consoles with small pediments. The first floor is dominated by a large tripartite sash window with wooden mullions; the head is not visible beneath the modern paintwork but the sill is a simple, narrow, band of stone or concrete. This window sits directly above the main ground-floor shop window. There is a smaller, two-light, sash window to the right of this and it, similarly, sits directly above the smaller ground-floor window. It is likely that the current ground-floor window and door arrangement is of more recent date - the door, in particular, appears to be a later insertion and the window may well block an earlier cart entrance to the side of the building. The smaller ground-floor window marks the location of an original entrance to the building.

A building is shown on this site on Todd's map which has a latest date of 1862. It is one component of a row of buildings that formerly combined 51 Guildford Street with 56-58 Bute Street. Goad's Insurance Plan of 1895 shows all three as a single unit at that time - as a Plait Warehouse - but it is possible that, based on similarity of form with the 'Cooper's Arms' and the 'Wheelwrights Arms', it was originally a public house. It had certainly been sub-divided into three separate properties by the start of the 19th century. Wallace Bruce Cox, estate agent, occupied 51 Guildford Street in 1903 (Kelly's Directory of Beds, Hunts & Northants, 1903) and in 1910 (Kelly's Directory of Bedfordshire, 1910). It is shown as a single property used as offices on the Goad Insurance Plan of 1938.

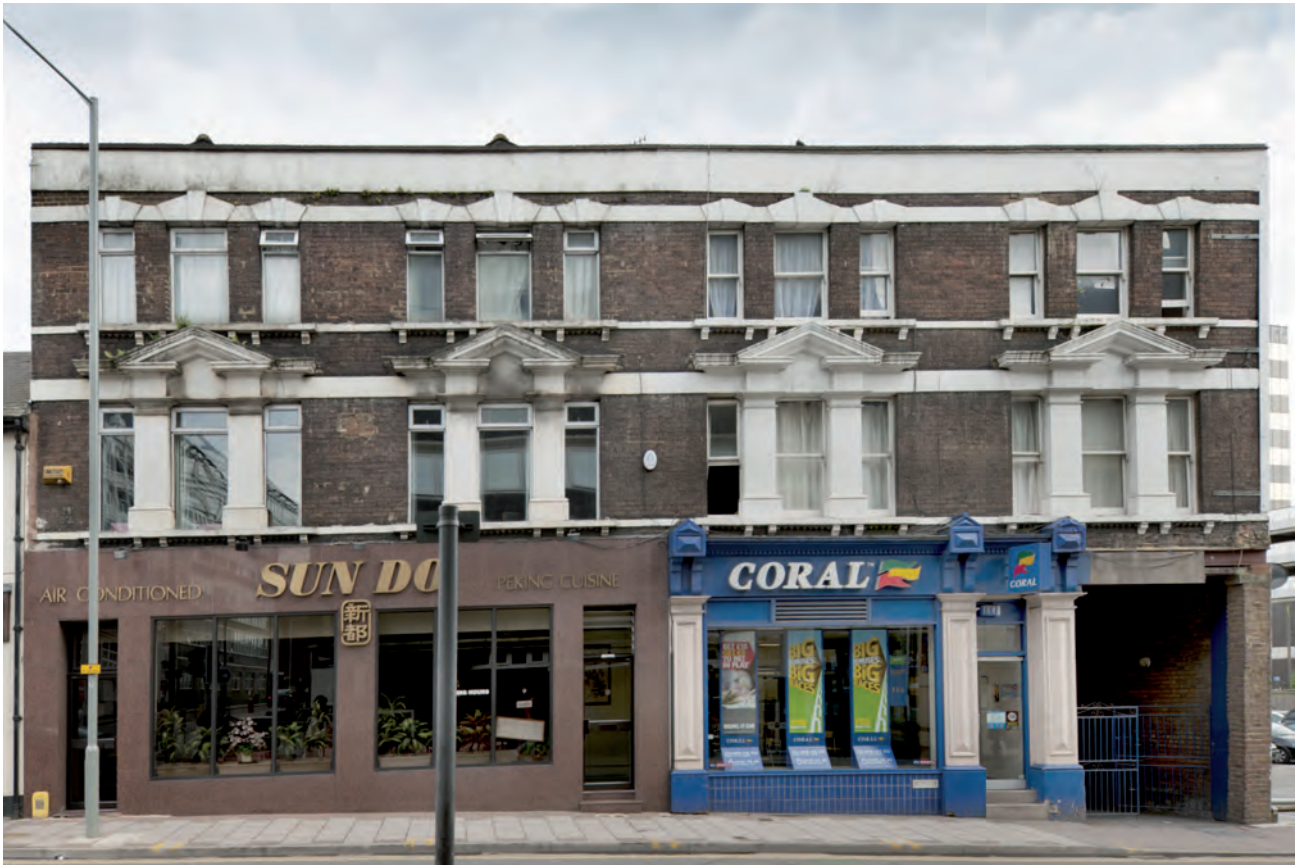
This terrace of four units at 50-54 Bute Street, has commercial usage on the ground floor with residential above. It stands three storeys high, of brown brick with stucco dressings, including a rendered parapet that conceals the roof. Each unit is roofed separately, with a double-pitched roof running at right angles to the street. There are substantial wings behind 50-52 Bute Street. The façade is Baroque in style, with horizontal stucco bands connecting the windows at sill and lintel levels, and with small brackets beneath the sills. The tripartite first-floor windows are topped by prominent pediments, while the second-floor windows, again grouped as triplets, have large keystones. Some windows contain plate glass sashes while others have modern replacement glazing. The ground floor houses two businesses. No. 50 is a betting shop (Coral). The wooden shopfront - with panelled pilasters and bold consoles - comprises a display window to the left of a plate glass shop door. To the right of this is a vehicle entry with gates. 52-54 Bute Street accommodates a restaurant (Sun Do), with a pink granite shopfront containing two doorways, one to either side of two tripartite plate glass windows. The doorway on the right serves the restaurant; that on the left the upper floors. The buildings, in their current arrangement are shown on the OS 1:2500 plan of the town centre produced in 1880. A short terrace of structures is, however, depicted on Todd's map of 1855 with a full terrace on the map update of 1862. The buildings, in their present form, probably belong to the late 1870s: the Goad Insurance map for 1938 list the property as a straw hat warehouse and factory.

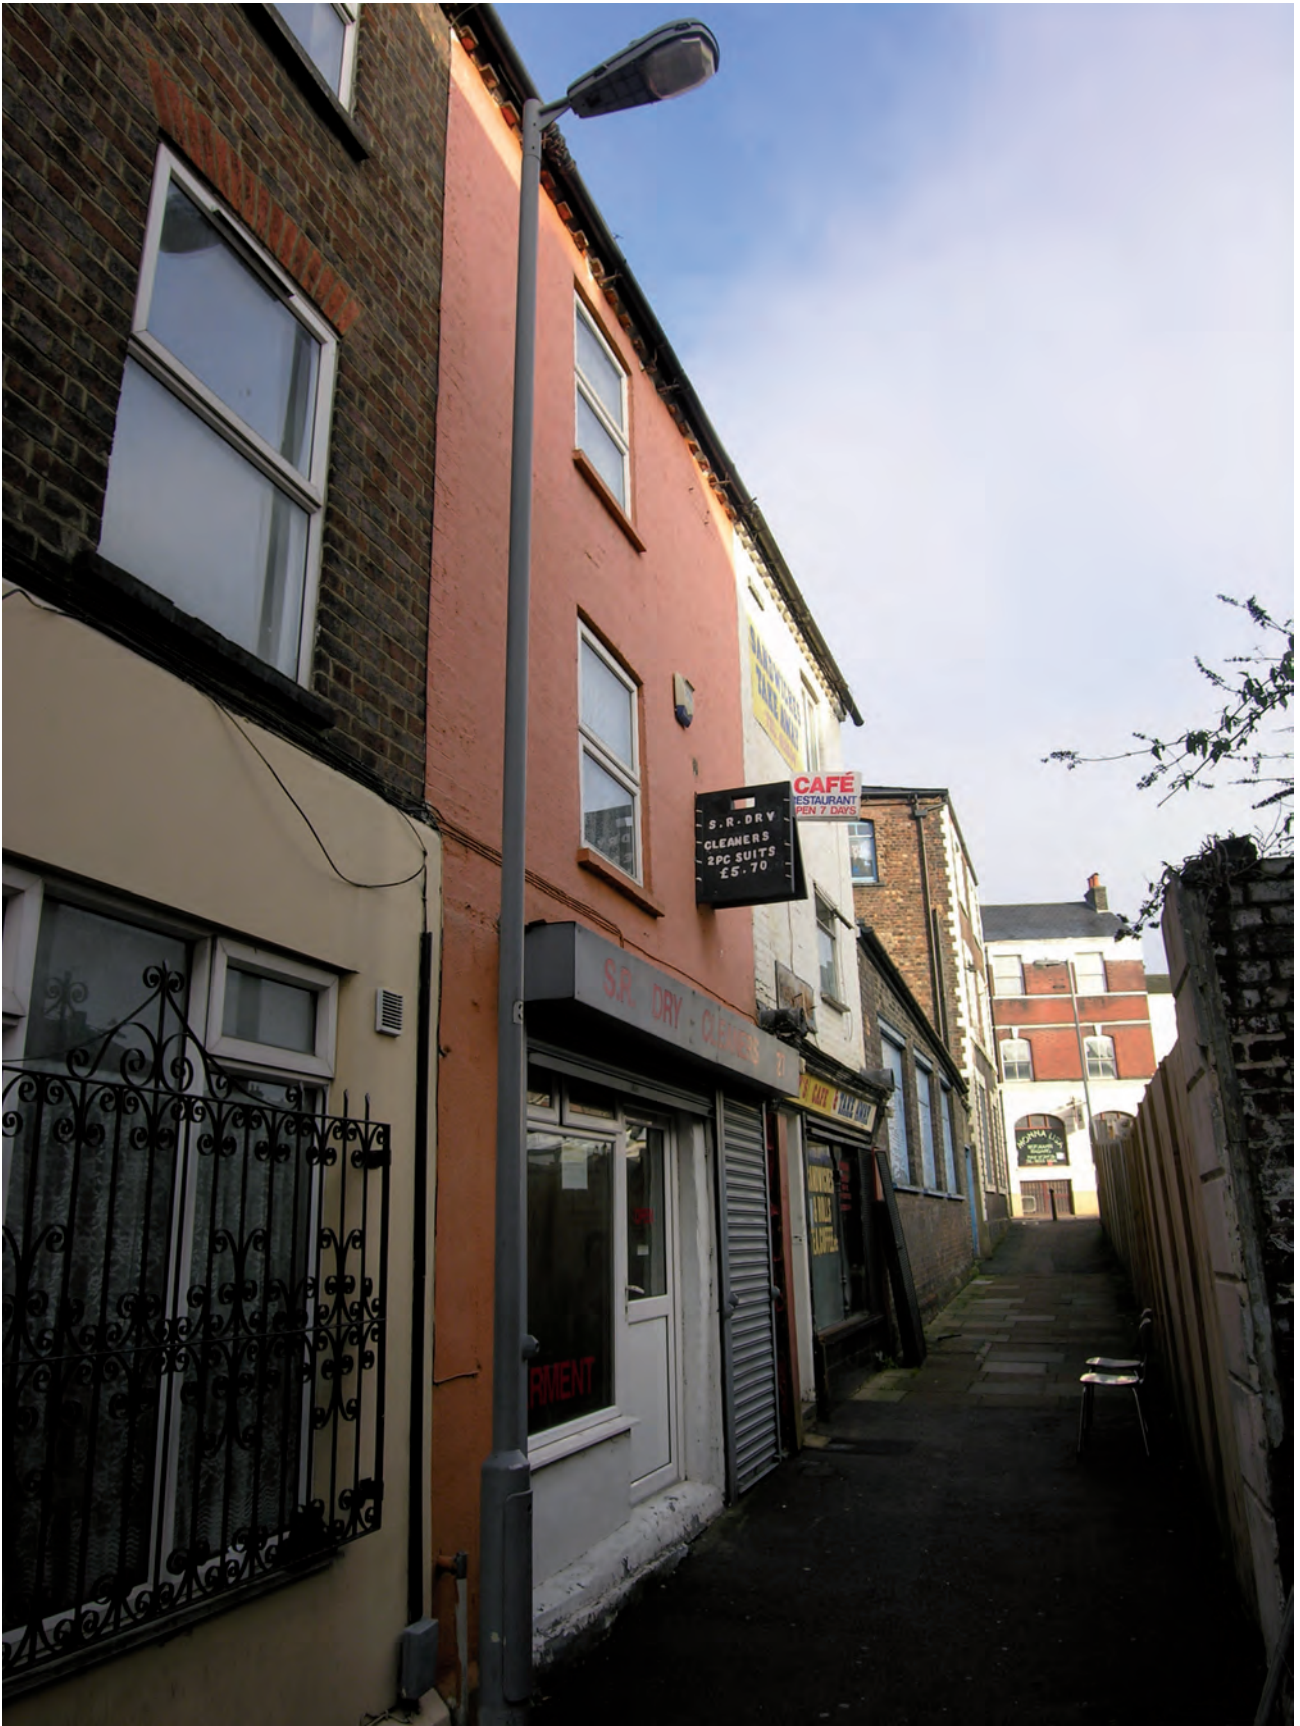
A row of four properties which appear to have been built as part of a terrace. Each building is of three storeys, with no evidence of basements or attics, constructed from Luton stock bricks in Flemish bond. The buildings face east, along Barber's Lane, and the ground floors of this eastern elevation have been heavily modified with the exception of 29 which retains its original shopfront. The roofing material is unclear apart from on 23 Barber's Lane where pantiles are evident. Paired doorways to the properties lie either side of the party walls, to the side of ground-floor windows. The modern replacement doors to 23 & 25 are set in a timber surround and with a fanlight above. Each building has a single window with a shallow segmented head formed by red bricks and with projecting stone sills, aligned above the ground-floor window on both the first and second floors. 25 Barber's Lane differs by having a second first-floor window, above the doorway - this appears to be an insertion. With the exception of the first-floor window of 29 (which contains a replacement timber casement), all the frames are uPVC replacements. The ground floor of 27 has been completely remodelled and the original doorway is hidden behind steel security shutters. 23 and 25 Barber's Lane have also seen substantial modification with original shopfronts infilled and replaced by uPVC casement windows, protected by wrought iron grills. The ground floor of 23 & 25 Barber's Lane is rendered in plain stucco and, together with 27, incorporates a tapering chamfered stone plinth compensating for the sloping away of the ground to the south.

The shop front to 29 remains relatively intact - a black glazed tile stallriser supports a two-light timber framed window with moulded central mullion in collonette form with a foliate capital and flat double cyma reversa bracket. Additional cyma reversa brackets frame the uppermost corners of each light and the window is surmounted by a simple dentiled cornice below a plain, outward-tilting, fascia. Both the fascia and the moulded entablature above are flanked by fluted consoles with segmental pediments and lead-flashing. No visible evidence survives for earlier ground-floor frontages on the other properties due to rendering and painted brickwork. Dentiled eaves are visible on all buildings, a short section of cast iron guttering survives to 29 Barber's Lane whilst the iron supports/brackets for the guttering are visible to the other properties. The blind southern gable wall of 23 Barber's Lane has been rebuilt in mid-late 20th century stretcher bond with buttressing. Access to the rear of the properties is limited but 23 & 25 are pebble-dashed and the fenestration pattern to all properties is eccentric and much altered. A chimney stack is visible between 25 & 27 and at the gable end apex of 29 Barber's Lane. The properties are depicted on the 1880 Bedfordshire 1:2500 OS map and it is evident that they are the remnant of what was once a terrace of eight buildings with yards to the rear, the demolished buildings once standing to the south of 23 Barber's Lane. Subsequent revisions in the OS maps up to the middle of the C20 illustrate an increasingly densely occupied zone with major clearance occurring in the final decades of the C20. Kelly's Directory of 1890 indicates that 23 Barber's Lane was tenanted to Charles Dould, straw hat & bonnet wire maker but by 1914 it was being used by John Walters, news agent. 25 Barber's Lane was occupied in 1903 by John Ager, clothier and seven years later it was in the tenancy of John Wakefield, wardrobe dealer. 29 was owned by Annie Emerson (Mrs) confectioner, in 1910. The Goad insurance map, last modified in 1938, notes that 29 Barber's Lane was by then a restaurant; 27 was an office; 25 produced hat machinery and 23 was an engineering works.

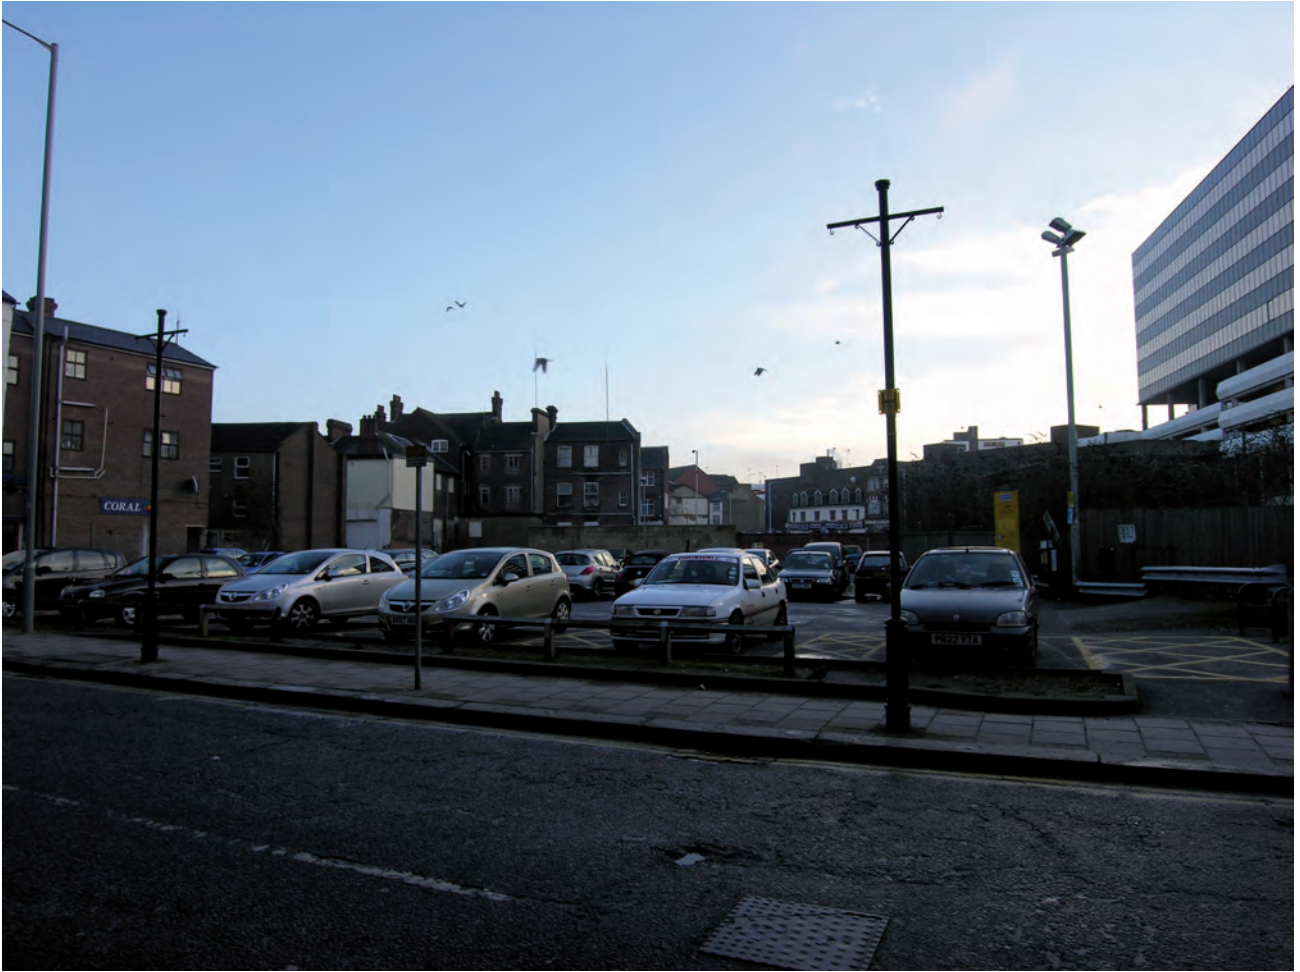
Open-air car park incorporating part of the culvert for the River Lea, occupying a roughly rectangular plot bounded by Bute Street, Silver Street and Barber's Lane to the west, south and east, and by 48 Bute Street to the north. The area to the immediate south of the river Lea is shown on the 1842 tithe map as containing a banked linear structure, running between Bute Street and Barber's Lane. No evidence of this remains, so it is not clear whether it was a remnant of a larger feature, or a relatively modern freestanding feature relating to the river. The 1880 OS map shows a significant number of properties on the plot, including a public house constructed over the river Lea, fronting on to Bute Street - the 1880 town plan identifies this as the 'British Queen'. A number of the properties on the corner of Bute Street and John Street appear to have been amalgamated between 1901 and 1924. None of the OS maps or the town plan show any evidence of the banked feature seen in the 1842 tithe map.

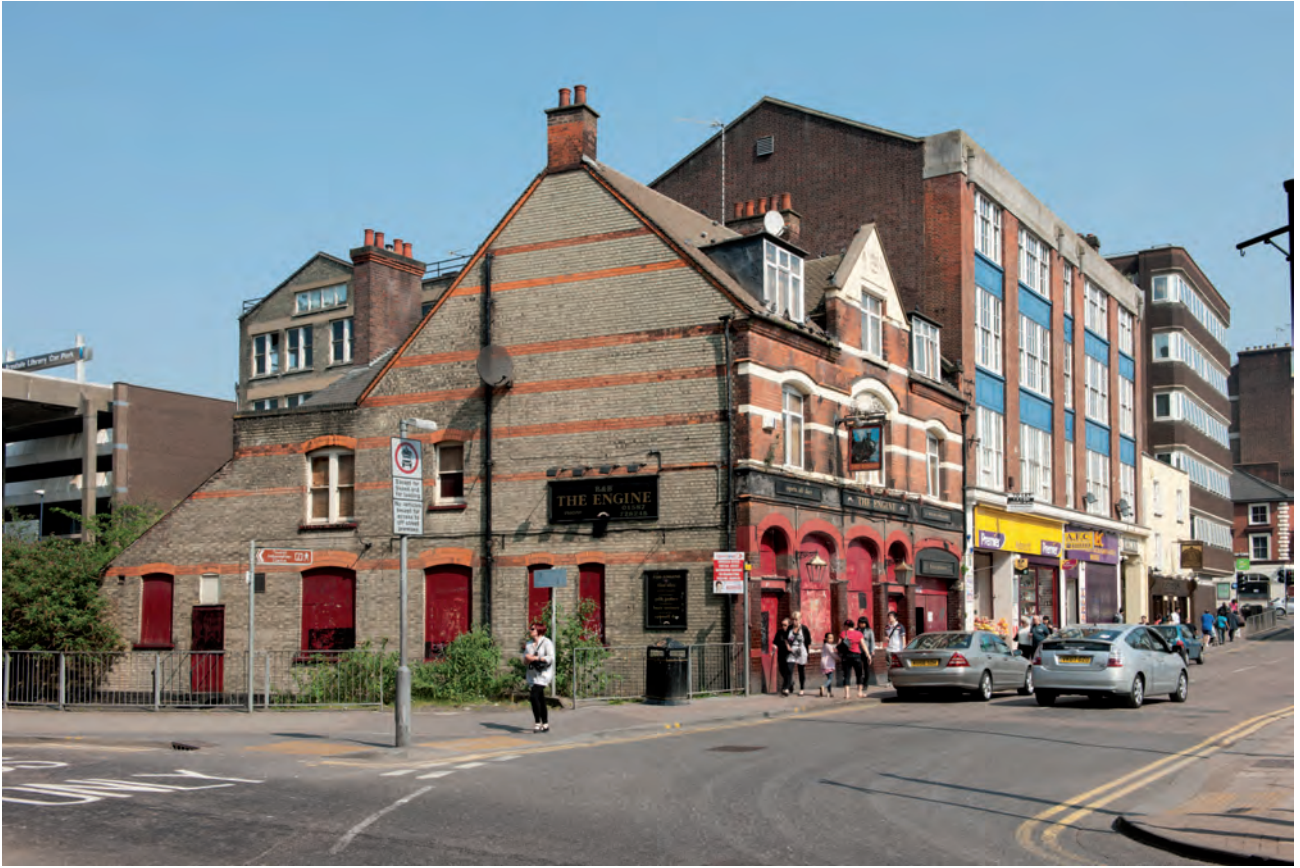
'The Engine' at 43 Bute Street has a decorative façade to Bute Street, with a more plain return elevation to the south-west, facing onto the course of the Lea. It is two and a half storeys high, of brick, with a tiled roof carrying two ridge stacks. At ground-floor level the façade contains an asymmetrical arrangement of five apertures, now boarded up, with stilted arches carried on oxblood coloured glazed brick piers with bullnose corners. The widest archway, on the right, has a depressed head and appears to have been a vehicle entrance. Otherwise, two entrances with round-headed arches flank a pair of windows with depressed arches. Above this the name of the pub is displayed on a plat band defined by horizontal mouldings. The first floor is of red brick with painted stone dressings and segmental-headed windows containing modern glazing. The central tripartite window is higher than those to either side and has a tympanum with incised vine decoration. Above this rises a gabled dormer with a plaque inscribed: 'rebuilt AD 1900'. To either side are flat-headed dormers; these may be modern insertions. The exposed side elevation is of white brick with red bands and contains an assortment of openings with segmental heads, comprising headers embedded in the red brick bands. In form, the rear wing comprises a shallow section of two storeys, with a double-pitched slate roof and a tall end stack built of Luton greys, abutted by a single-storey outshot under a catslide roof. A building is shown on this location on all maps of Luton town centre from, and including, the Tithe update map of c.1844. It may well have been (re)built as a public house in the late 1840s/early 1850s and has remained in a similar use through to the present day - it is currently unoccupied.

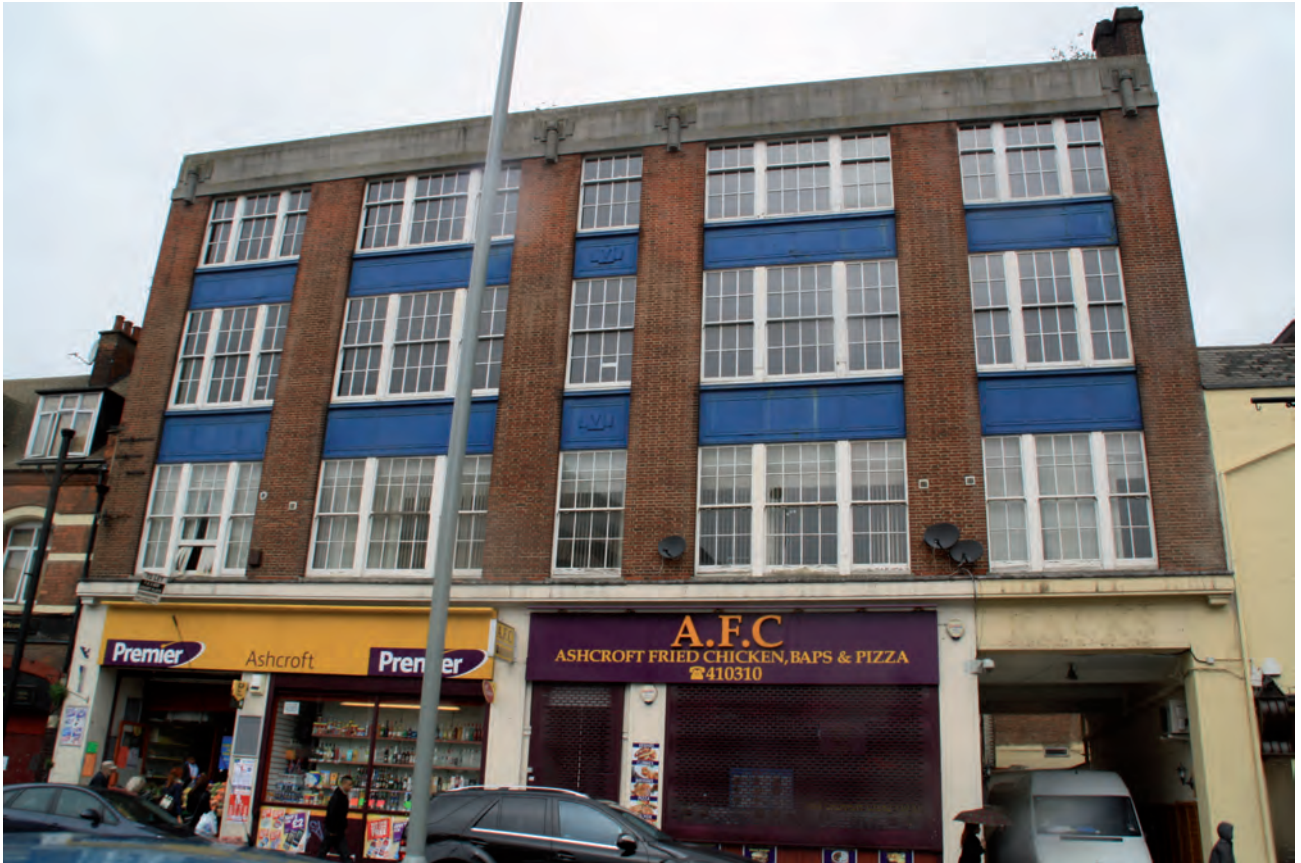
This four-storey structure is an excellent example of a 1930s 'daylight' factory built for the Vyse company in 1930 to replace a row of earlier buildings. It is built on a larger scale than earlier hat factories in the area, as it occupied a particularly wide (or double) plot. Here, the commercial Neo-Classical style of the 1920s was eschewed, although decorative fascias appear in the concrete render of the parapet. Instead, the building adopted a Neo-Georgian idiom, which is somewhat at odds with the industrial form of the building. The windows, instead of being metal-framed, are small-paned wooden sashes, separated by horizontal metal panels masking the floor levels and displaying, in the narrow central bay, the letter 'V'. The piers are faced in red brick, laid in Flemish bond. The ground floor is divided into three bays containing modern shopfronts and a vehicle entry: the original arrangement here is not known. The nature of the buildings it replaced are unclear but a row of structures is shown here on all early maps from at least 1844. The earliest mention of an occupier and trade dates to 1890 when 53 Bute Street was used by Thomas Horley, baker (Kelly's Directory of Bedfordshire, 1890). Thereafter, all of the properties were employed in the hat industry. Thomas Barley, straw hat manufacturer worked out of 47 Bute Street in 1903 (Kelly's Directory of Bedfordshire, Hunts and Northamptonshire, 1903) and the straw hat manufacturers Giddings and Wright were based at 51 Bute Street. The bakers at 53 Bute Street had been replaced by George Neumann, straw hat manufacturer by 1903.

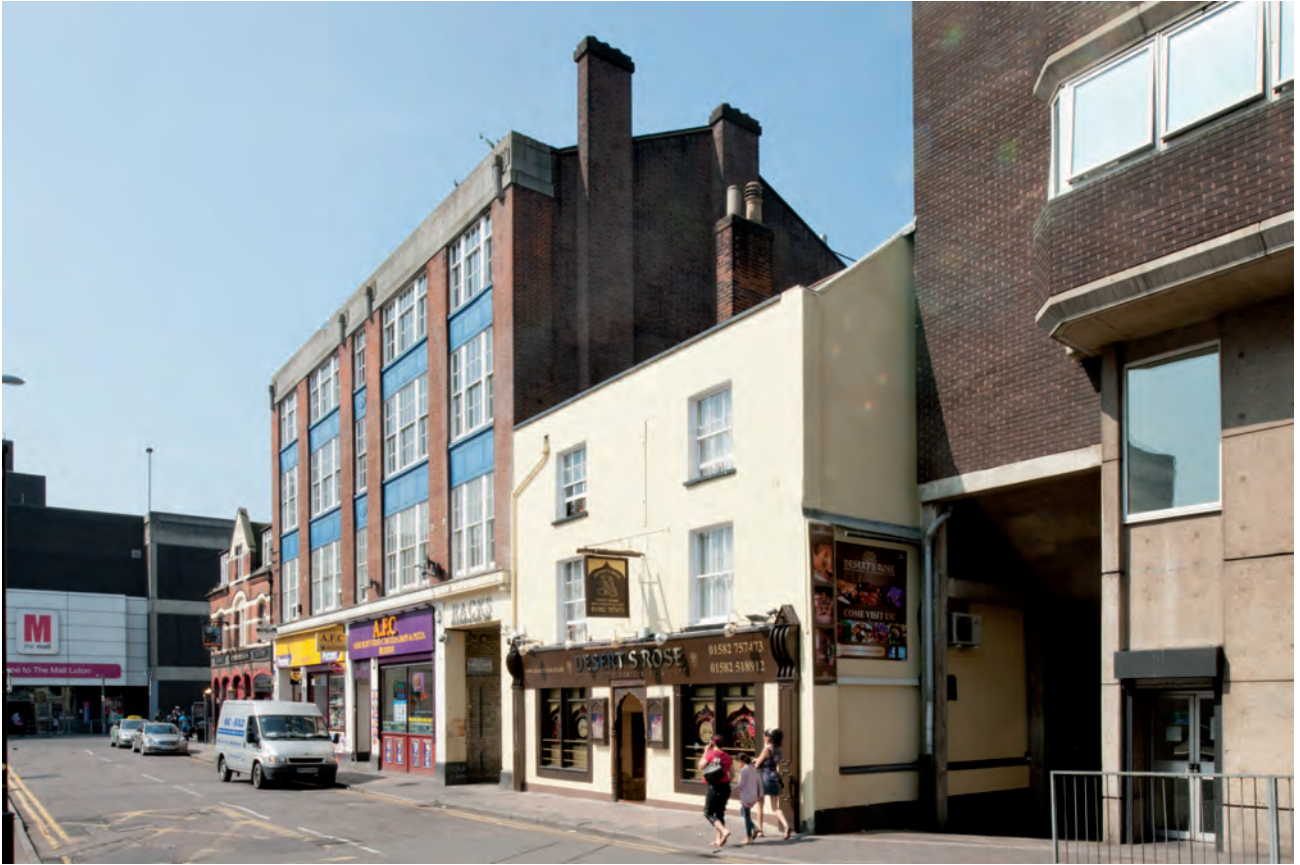
55 Bute Street is a three-storey, two-bay building, with a yellow painted brick façade and a slate roof with red ridge tiles. A red brick stack rises from the front slope of the roof. The entire width of the ground floor contains the frontage of 'Desert's Rose', restaurant and café. This involves a central doorway flanked by windows, within the framework of a shopfront comprising pilasters, consoles, and fascia. The upper-floor windows, two per floor, have flat heads and contain sash glazing, with three lights per sash (three over three). A hanging signs projects from the frontage. A plaque advertising Green King ales reveals that the building was once a public house. Rear not examined.

The earliest date for the building here is unknown but ia structure in this location is certainly shown on the Tithe map update of 1844 and illustrated clearly on all subsequent cartographic sources for this area of Luton. In 1903, the landlord was Francis Edgar Dawson (Kelly's Directory for Bedfordshire, Hunts and Northamptonshire, 1903), Henry Tilbury in 1910 (Kelly's Directory of Bedfordshire, 1910) and William J Taplin in 1914 (Kelly's Directory of Bedfordshire, Huntingdonshire and Northamptonshire, 1914).
