PLAITERS' LEA CONSERVATION AREA, LUTON HISTORIC AREA ASSESSMENT

Research Department Report Series 069-2011

HISTORIC AREA ASSESSMENT

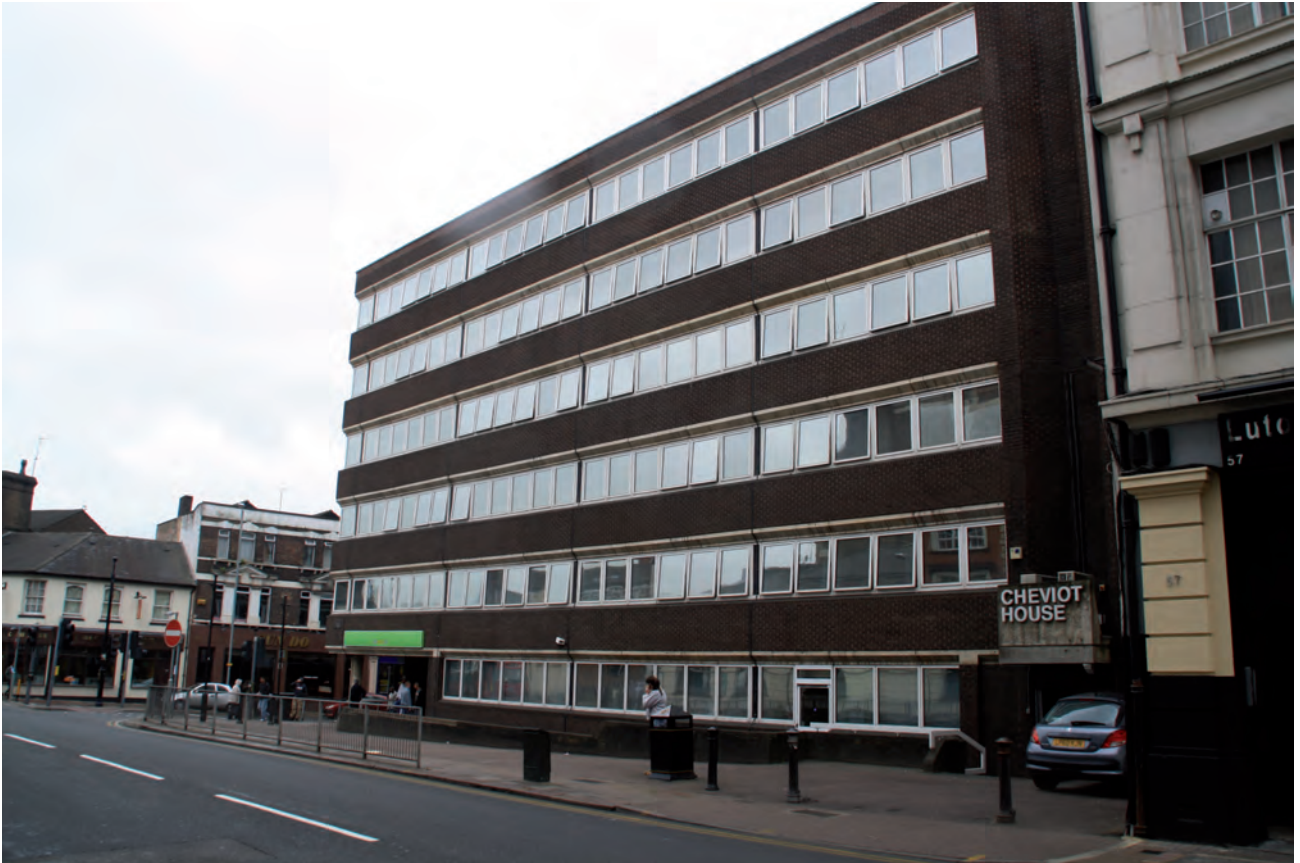
The Job Centre at 55 Guildford Street is also known as Cheviot House. It sits at a crucial junction of the two most important roads through the Conservation Area - Bute Street and Guildford Street. The current building dates to the late 1970s and is a six storey office block with a steel or concrete frame clad in red brick. One of the most noticeable design features are continuous bands of marginally recessed glazing carried around a minimally splayed corner providing a strong horizontal emphasis, an effect which is heightened by the absence of any mouldings or other decoration. It is built on site of a 'once very decorative building of red brick and stone, with gables and bow windows, described as 'new warehouses' in 1907' (Luton Borough Council, 1988, 'Luton Hat Trail 1: The Bute Street Area', p.6) which itself succeeded a range of buildings shown here on the Tithe Map of 1844. It is recorded as the premises of Hamer and Stonebridge straw hat manufacturers in 1910 (Kelly's Directory of Bedfordshire, 1910) and shown as two properties on the Goad Insurance Map of 1938 - a ribbon manufacturer on the corner (53 Guildford Street) and a straw hat manufacturers alongside it (to the west).

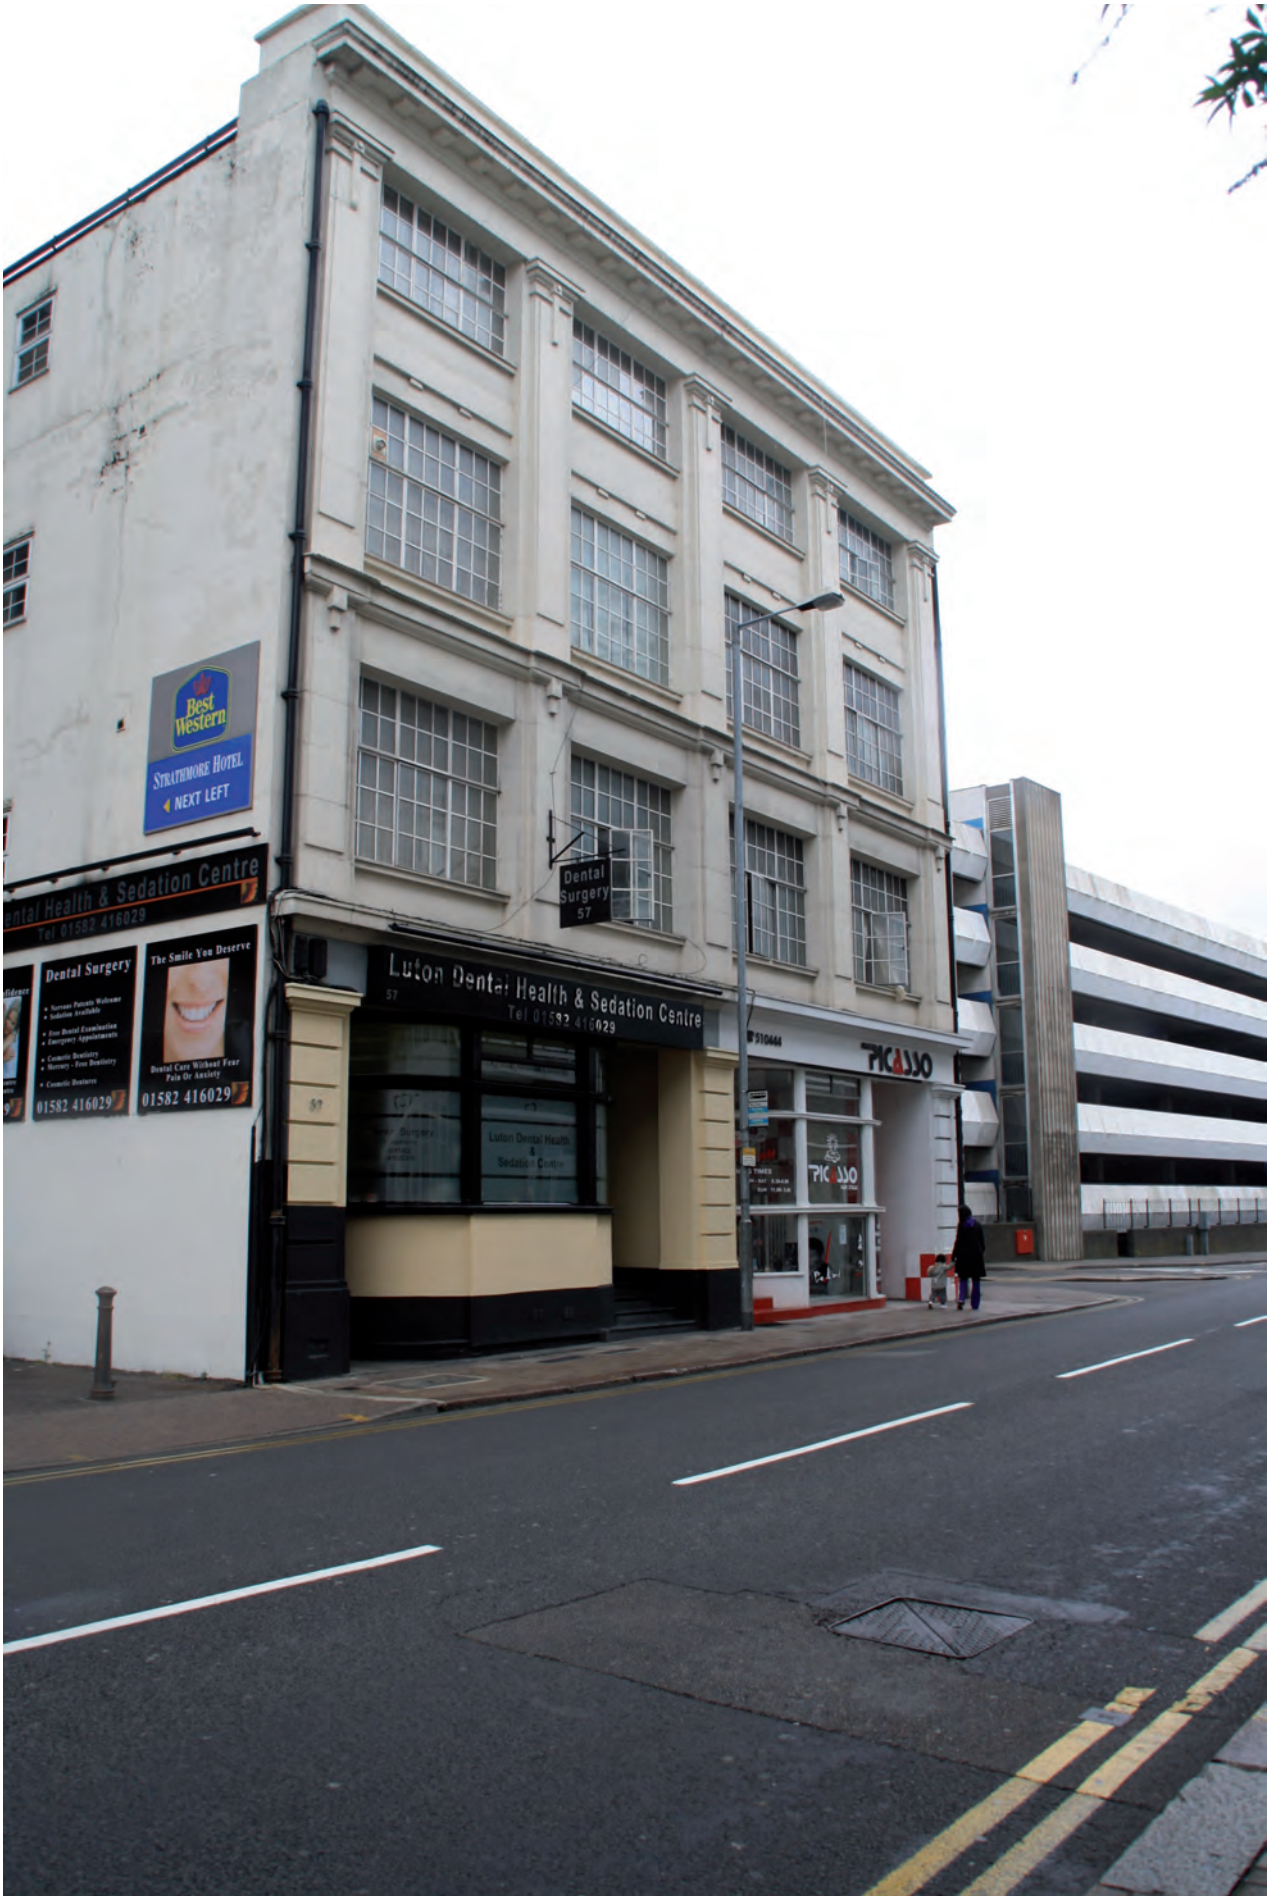
The building comprises two distinct properties, each a mirror of its neighbour and whilst there has been much recent renovation the earlier form and fabric remains identifiable. The ground floor is dominated by what would once have been embedded bow shaped shop windows, recently altered into a more angular form. Each has doors either side of the window accessed via a small flight of steps. The eastern shop window has a rendered stall riser but that to the west is still largely glass fronted. The doors and windows are separated by flat Doric pilasters with horizontal rustication and projecting capitals: the fascia above these extends across both premises and also includes a pronounced cornice. Four bays are evident to the upper floors and the windows are casements with original steel glazing bars. The first-floor windows are separated by flat Doric pilasters, each with a raised panel, and there is a dramatically projecting cornice above the capitals into which elaborate, 1920s style, drops have been incorporated. The second-floor windows are of the same scale and form as those below and they are separated from smaller upper-floor windows by a raised band of render with dentils. The building façade is completed by a markedly projecting cornice with modillions. The roof is in Welsh grey slate.

Three separate properties (57, 59, 61) are shown on the Ordnance Survey 1:2500 plans of 1880 and 1901. Similarly, three properties are depicted here on Goad's Insurance map of 1895. They are drawn as domestic-scale buildings probably related to the hatting or straw plaiting industries. Each is shown as a small terraced property with rear extension on the ground floor. Harry Eustace Hunter, straw hat manufacturer, resided at 57 Guildford Street in 1903 (Kelly's Directory of Beds, Hunts & Northants, 1903) and it hosted William J Rankin, straw hat manufacturer in 1914 (Kelly's Directory of Bedfordshire 1914). Jeffrey Standbridge, straw hat and bonnet manufacturer's was registered at 59 Guildford Street in 1890 (Kelly's Directory of Bedfordshire 1890) and 61 Guildford Street housed Hubbard Guest & Reinmann, architects in 1910 (Kelly's Directory of Bedfordshire 1910) and Copestake, Crampton & Co, merchants in 1914 (Kelly's Directory of Bedfordshire 1914). These are both recorded as 'Hat Factories' on Goad's insurance plan of 1938: at this time 61 Guildford Street was part of the Sunman and Hewson Hat Factory. There are strong similarities between Stirling House, 30 Guildford Street, and the paired arrangement of hat factories at 57-61 Guildford Street - both are built in neo-classical style but the former is earlier. The merging of properties and the refurbishment of the new factories at 57-61 Guildford Street, took place at the end of the 1920s and the resultant building is notable for the inclusion of projecting cornices at different floor levels, and the use of bright rendered concrete.

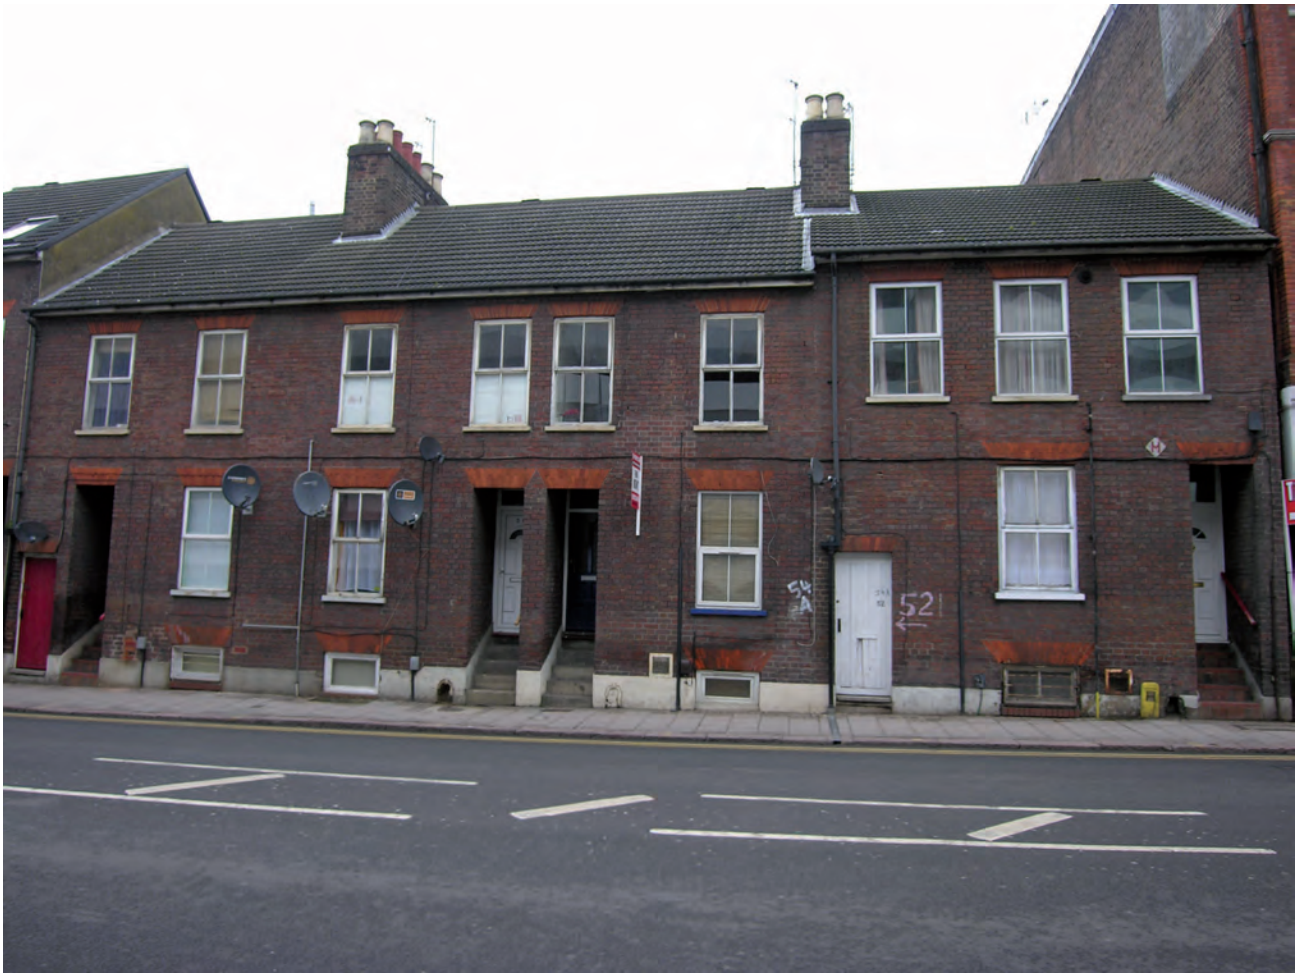
A terrace of five domestic buildings on northern side of Guildford Street - extending in a row to the west of the listed hat factory at 50 Guildford Street. 52-59 were built in a single phase, indicated by continuous brick courses and a lack of building breaks, whilst 60, at the western end, was built at a slightly later date. Built from Luton stock bricks in a Flemish bond with red brick detailing, all of the buildings are roofed with modern pantiles. The typical form for 52-58 consists of a two storey unit with a basement, on a rendered plinth course which widens to the west to accommodate the slope of the ground, with recessed doorway accessed via a flight of five steps with a window to the side, below which is the window to the basement, and two windows to the first floor. Chimney stacks rise between 52 and 54, and 56 and 58, each with twelve chimney pots. The windows and entranceways have flat heads with red brick voussoirs and stone sills to the windows. The predominantly timber sash windows are formed by two lights separated by a horizontal bar, the upper light being hinged to the top, each divided into two panes by a narrow vertical glazing bar. A number of windows have been replaced with uPVC frames. Additionally, there are passageways between 52 and 54 and to the west of 58, providing access to the backyards of these properties. 52 extends over the passageway and is wider than the other buildings with a third first-floor window; the roof of 52 is of a shallower pitch than the adjacent roofs, and the ridge slightly lower.

60 is clearly a later addition to the terraced row - there is a marked building break between it and 58, and a break in the roof line too. Although also constructed from Luton stocks in a Flemish bond, the brick is somewhat darker than seen in 52-58. The building is of two storeys with a basement and attic conversion, the recessed doorway is accessed via a flight of six steps; adjacent to which is a casement window, and two first-floor casement windows all with uPVC. The windows are treated differently to those at 52-58, with bracketed stone sills and a decorative pointed design in the centre of the window heads. The basement is more substantial than previously seen, with two timber-framed windows each of two lights with a central vertical glazing bar, the upper light having attached handles. The heads of these windows are different, running in a continuous red brick soldier course across both windows. The sills for the basement windows also consist of a single row of red brick headers and it would appear that the basement window arrangement has undergone some alteration. Two single light attic windows have been inserted into the roof space, each directly above a first floor window. The western gable wall of 60 is blind and the upper section, close to the apex of the roof, has been rebuilt. The buildings were constructed as part of planned expansion along Guildford Street in the second half of C19, although Guildford Street itself had been laid out prior to 1842 - as shown in the Tithe map of that date. The pictorial map of 1870 depicts the hat factory at 50 Guildford Street as well as 52-58, but there is a vacant space where 60 Guildford Street was later constructed. All the buildings are described as dwellings on Goad's Insurance map of c.1938 and appear to be associated with the hat factory at 50. On this map, 52 is shown as being more substantial than the others in the terrace with a bigger footprint and extension to rear alongside the factory, adjacent to an internal hoist at 50.

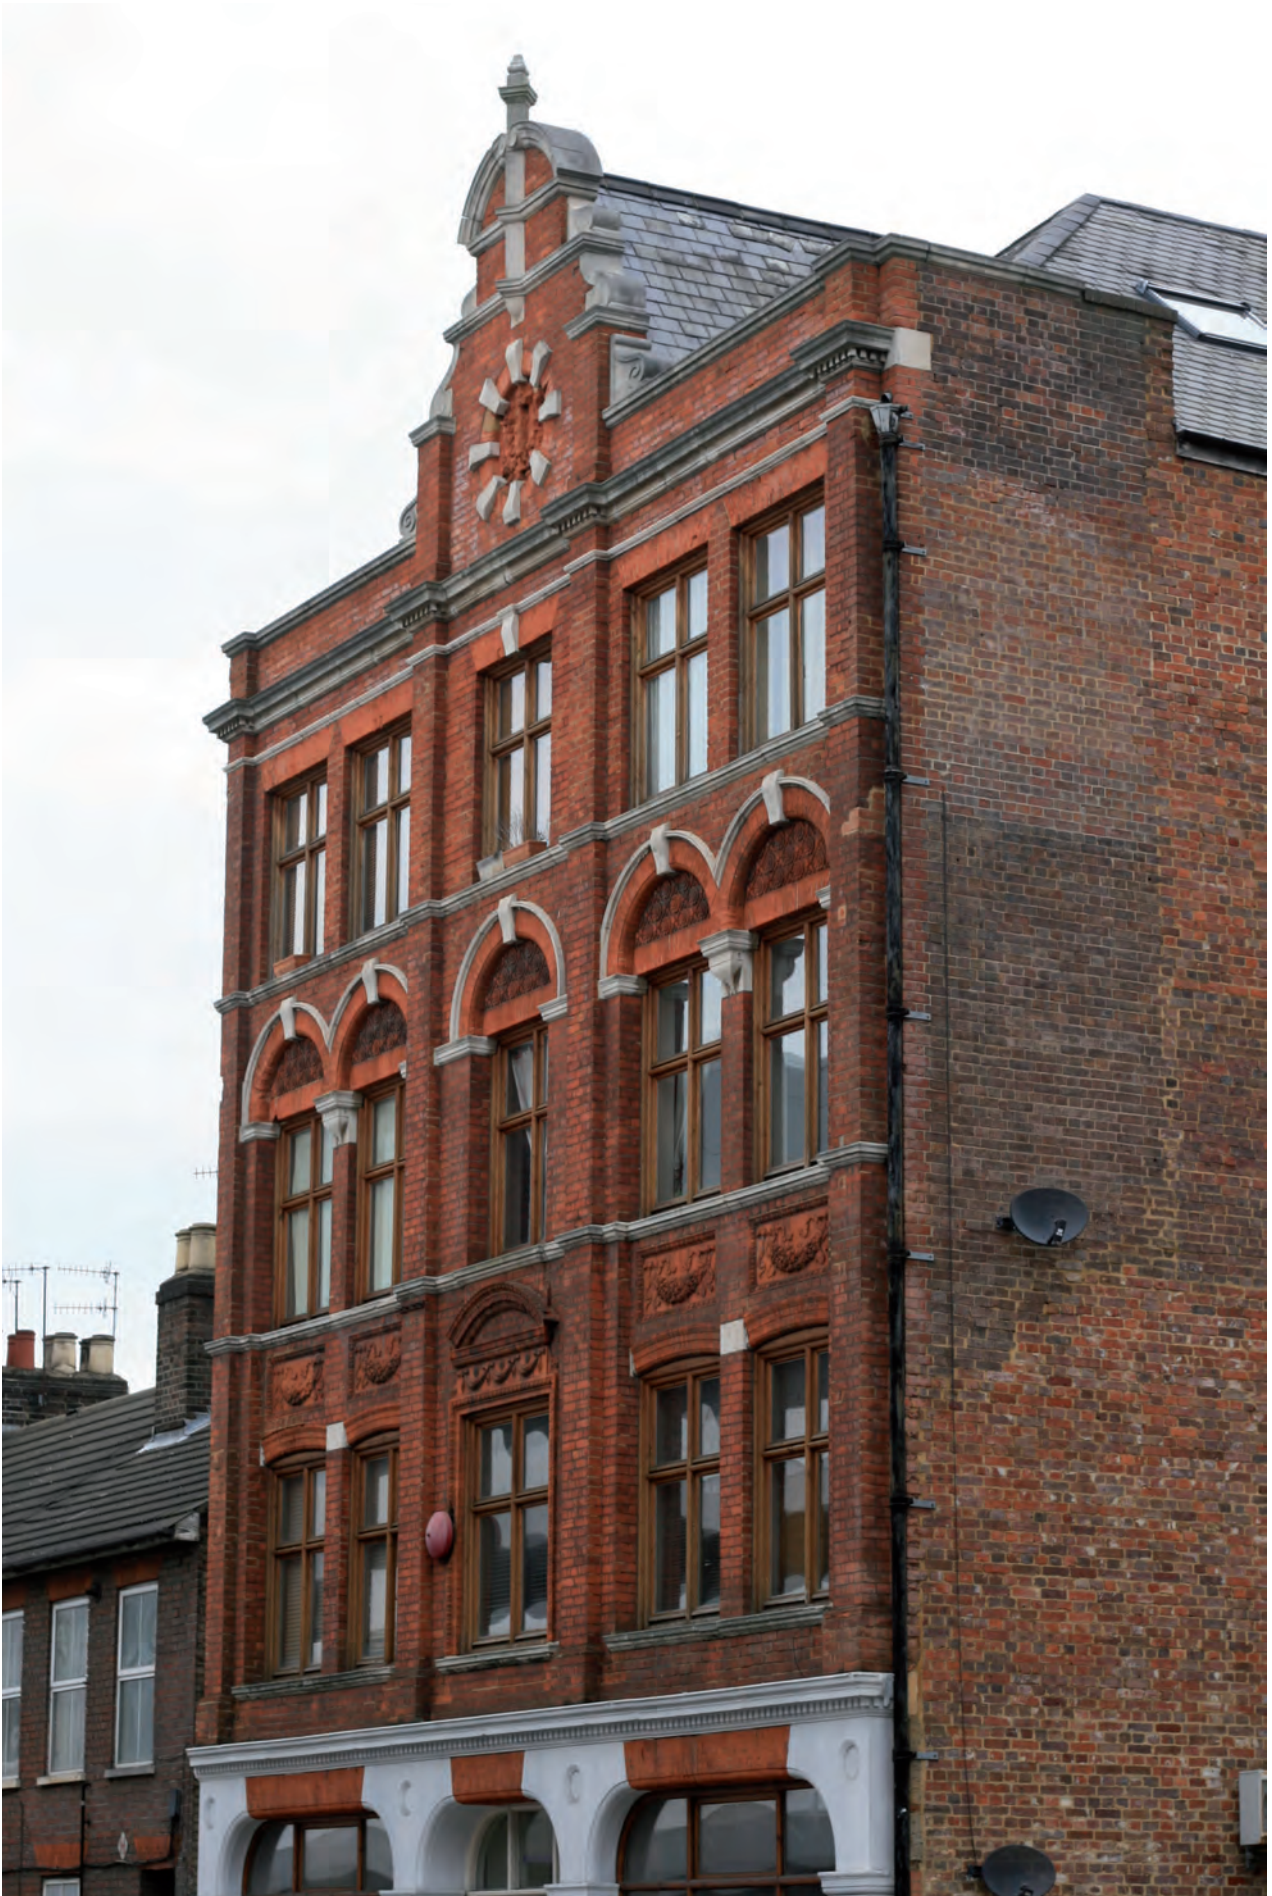
This imposing late 19th-century hat factory/warehouse comprises four floors plus a raised basement and an attic. It is built of brick with a Welsh slate hipped roof, with good quality red brick, terracotta and stone dressings used to create a highly decorated facade in the Queen Anne Revival style. Above the ground-floor shopfront, this facade is divided into three bays by pilasters, with a narrow central bay flanked by wider, or double, bays. The central bay is crowned by a shaped gable which rises through the brick parapet. It is flanked by volutes and contains a terracotta roundel with prominent voussoirs. The ground floor comprises three depressed arches with red brick heads and rendered spandrels with roundels, beneath a dentilled cornice. The main entrance is contained within the central arch, whilst a side doorway and a show window are framed by the left-hand arch. This, together with the larger show window within the right-hand arch, contains small-paned metal-framed prismatic lights and ventilators that serve the basement. The panelled doors are set beneath transom lights, and are accessed by steps spanning the raised basement.

The upper-floor windows are all of cross-mullion type, with wooden frames. The central first-floor window is set within a moulded brick architrave, with egg and dart decoration, beneath a terracotta frieze with swags and a segmental pediment. The simpler flanking windows have segmental heads comprising rows of headers, and are again surmounted by terracotta panels with swags. Above this, on the second floor, all five windows have straight brick heads and decorative terracotta tympana within semi-circular arches with stone detailing. The third-floor windows are simpler, with a stone keystone to the central bay. The attic is lit by skylights in the roof. The blind west elevation is abutted by a terrace of houses, while the east elevation is blind except for a fire escape. This factory was built prior to 1895, when it was shown on Goad's map as the plait warehouse of Durler & Suter. It was taken over by Lambie & Cain around 1905, as a straw hat factory, and continued into the 1990s, as the home of Balfour Hats. David Bevan's PhD thesis of 1992 includes photographs of the interior in use, with storage of materials in the attic and basement, finishing and trimming on the upper floors, blocking on the ground floor, and a display showroom at the front.

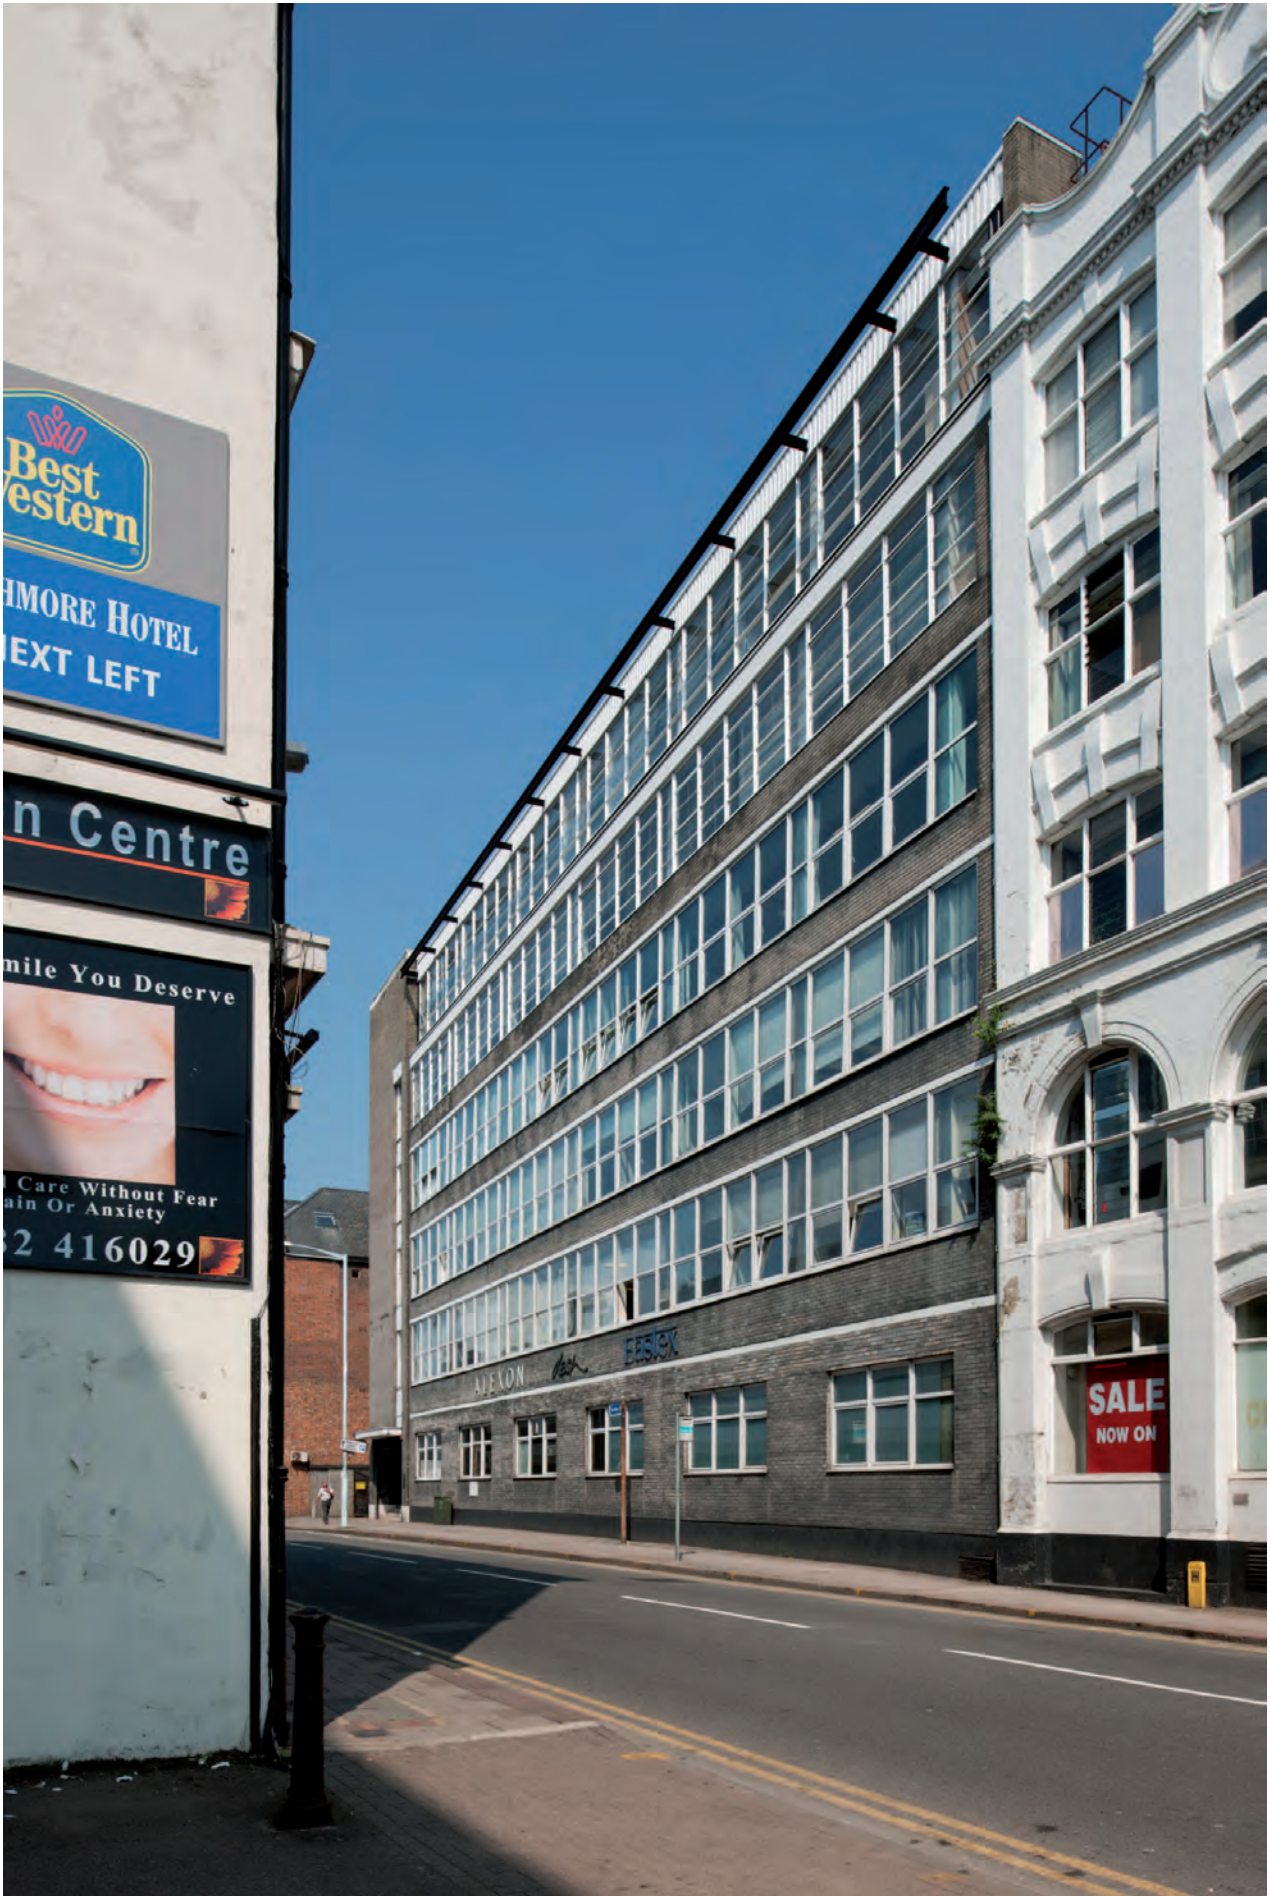
This large, post-war, factory at 42-48 Guildford Street, lies outside the Conservation Area on its north-western periphery. The street façade is notable for its 'horizontality' in sharp contrast to the strong 'vertical' faces of earlier factories, such as the adjacent building, 40a Guildford Street. The constructional design for the Alexon building emphasises the horizontal 'layering' of floors and window lights to the building. It is a six storeys building and six bays are evident on the ground floor: the building entrance and stairwell is at the far left-hand end of the building with the doorway protected by a flat canopy. The factory is built using grey brick and this provides a stark contrast with the white painted, steel window frames. The ground-floor windows are all triple casements with strong glazing bars, the upper lights being smaller than those below. The ground-floor fascia is defined by a narrow concrete band painted white. Above this, the windows on the first to third floors are of a similar form. They extend along the entire length of the building above the ground-floor bays apart from the entrance and are designed to maximise the availability of natural light. Upper and lower lights, as well as separate window panels, are divided by thick, metal, glazing bars painted white - the lower lights are hoppers. Sills are simple, sloping, wooden boards and the heads comprise a continuous course of concrete painted white. The windows on the fourth and fifth floors are equally substantial but they are separated by a concrete band painted white - the uppermost floor is also recessed. Each window consists of five, equally-sized, panes separated by narrow metal glazing bars; the upper lights on the fourth floor are casement windows but there are also hopper lights on the fifth floor.

It was built for the Alexon Group at the end of the 1960s on the site of a vacant plot shown on the Goad Insurance map of 1938. A row of four domestic properties is shown in this location on Comey's map of c. 1872 and had been replaced by a single building with outbuilding, possibly an engineering works with private rail sidings, on the OS 1:2500 plan of 1880. 48 Guildford Street was occupied as a private domestic residence in 1890 by Isaac Clarke (Kelly's Directory of Bedfordshire, 1890) and 44 Guildford Street by Joseph Mardle in 1890 (Kelly's Directory of Bedfordshire, 1890), again as a private residence. Alexon manufactures and sells women's clothing and so maintains many of the manufacturing skills that emerged in the town as a result of hat-making - the group currently use 40 Guildford Street as an outlet shop.

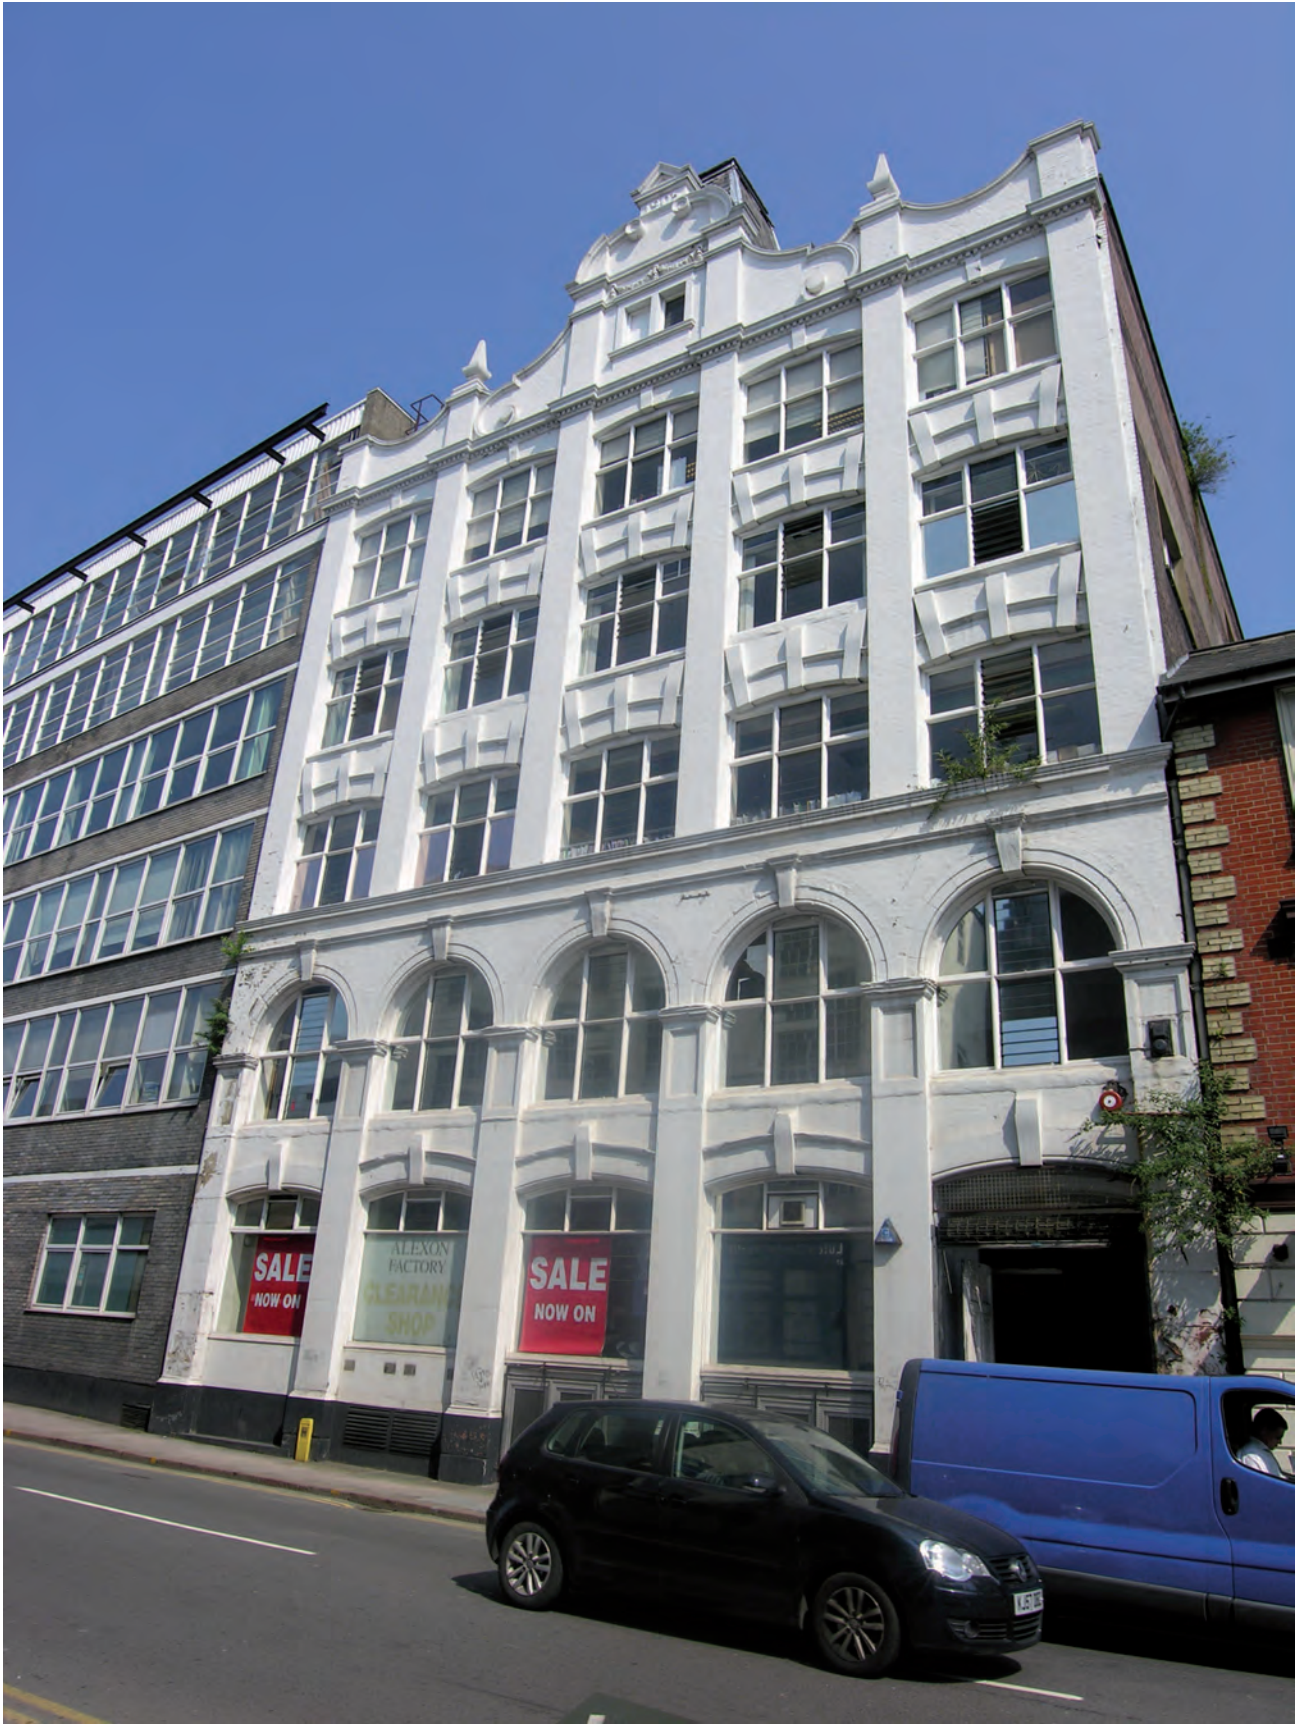
This imposing hat factory was built in 1905 using a cast iron frame with pier and panel façade in debased Jacobean style. At five storeys high plus attic and basement it is one of the tallest structures in the Conservation Area - with a five-bay façade. The colourwashed façade is crowned by a complex gabled parapet behind which is a truncated pyramid turret that would, most likely, have once have supported a flagpole: the gable is surmounted by small pediment bearing a date of 1905. The ground floor currently contains four windows with segmented heads and prominent keystones, with a recessed double door in the eastern bay reached via a flight of five steps. The eastern bay originally contained the secondary entrance, a passageway allowing access to the rear of the property. The two windows to the immediate west of the main entrance have basement lights beneath, whilst the basement window to the west of these appears to have been blocked. The upper three storeys are divided into bays by plain pilasters, each bay containing a single, six-light, casement window with slightly arched heads furnished with substantial triple keys interrupting a projecting moulding - the top-floor windows having single keystones. The central lights in each casement louvered. A moulded sill cornice extends below the second-floor windows. The first-floor windows have arched heads, with single keystones, springing from the capitals of rendered giant order pilasters which encompass the lower two-and-a-half floors.

The building features many Neo-Jacobean elements, such as the obelisks to either side of the gable, whilst there are also a number of Queen Anne revival touches including the swags above the attic window, but is especially notable for its use of a two-storey showroom front, with a giant arcade serving to distinguish the showroom and offices from the functional factory element on the floors above.

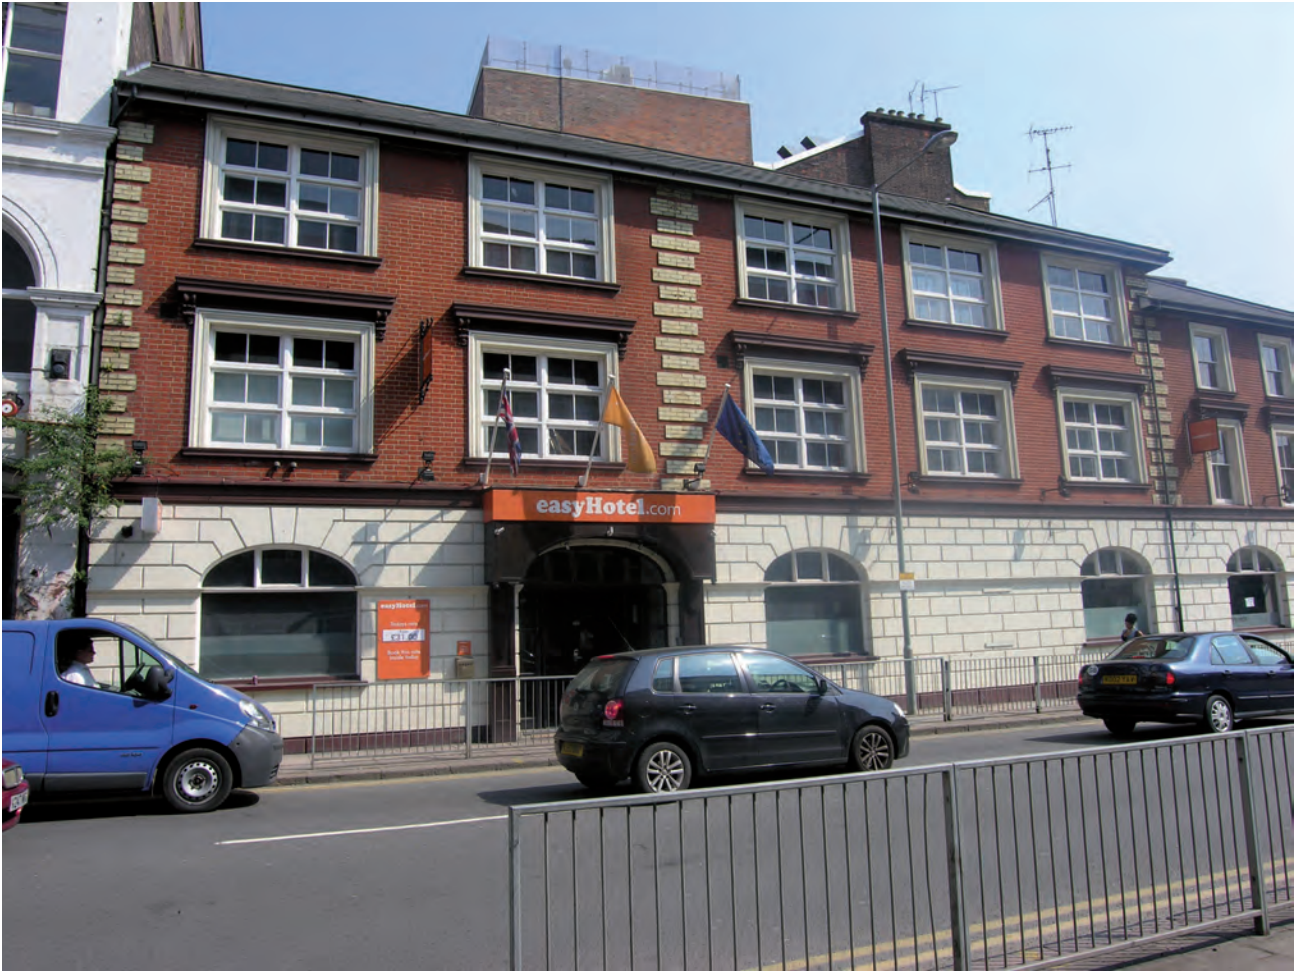
The former hat factory at 40a Guildford Street, now part of the easyHotel, was built in the same style as its earlier neighbour on the corner of Bute and Guildford Street (61 Bute Street). It was erected between 1901 and 1905 on a site previously occupied by a number of private houses and gardens. Like its neighbour, it is a striking building in red brick with yellow brick quoins and dressings but it is three storeys high with five bays. As seen previously, the ground floor is rendered in rusticated concrete, divided by a horizontal band, with three segmental-headed windows like those at 40 Guildford Street, and a matching recessed entrance. It was clearly built to blend in with the existing architecture of the town, indicating a respect for the styles and forms already present and a desire to maintain the scale and character of the street.

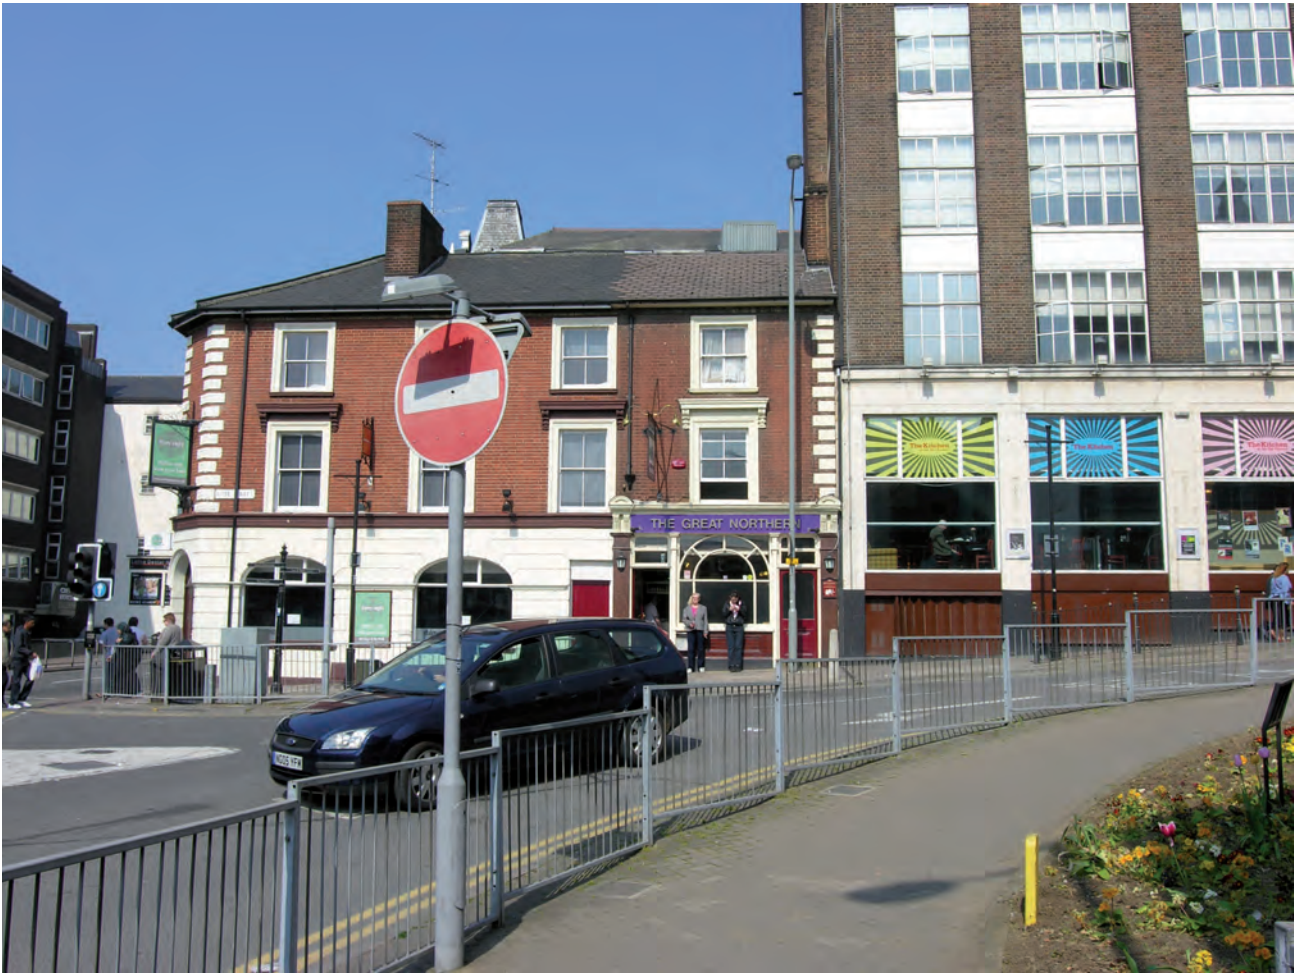
Built in red brick, the three-storey building has four bays along its western elevation on Bute Street, the northernmost of which is currently in use as 'The Great Northern' public house, and three bays along Guildford Street. Rusticated stucco has been used to great effect (mirroring its use on 47 Guildford Street) on the ground floor of the building along with yellow brick quoins to the first and second floors. The main entranceway is on the corner of Guildford Street and Bute Street - the building having a cut-off corner, whilst a secondary entrance is adjacent to 'The Great Northern'. There are two wide headed arched windows to Bute Street and three to Guildford Street.

The property is absent from Todd's map of 1862 but shown in its original form on Comey's map of 1870 before a 1905 addition saw the building extended east along Guildford Street. Kelly's directory for 1903 lists a Mrs. Jane Hume, bakers as residing there at the start of the 20th century (Kelly's Directory of Beds, Hunts & Northants, 1903). Thomas Hume was listed in 1903 as being landlord of the 'Great Northern Inn' (Kelly's Directory of Beds, Hunts & Northants, 1903, p. 130). By 1914 Harold Stansfield is noted as the landlord (Kelly's Directory of Bedfordshire, 1914). The ground floor is notable for its fine glazing - similar to that seen at 'The George II', also on Bute Street.

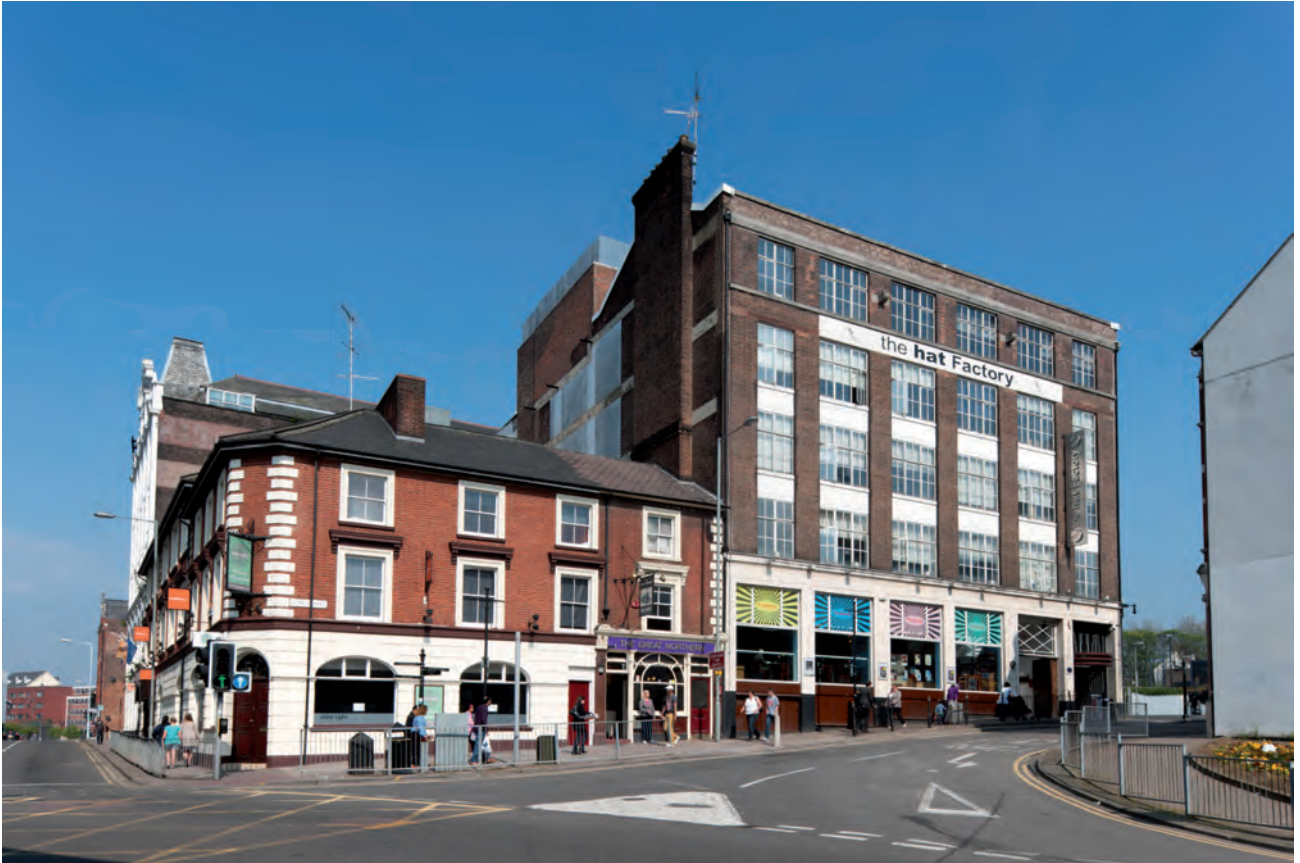
The Hat Factory, 65-67 Bute Street, is a large factory that occupies a wide, sloping site, standing five storeys high and six bays wide. It is faced in brown brick, with a parapet concealing a shallow double-pitched roof, and with a stack rising through the south end wall. The windows are metal framed with opening casements, and are separated by white-painted metal panels at second and third floor levels. Those in the lateral bays are narrower than those in the centre. The four southernmost bays at ground level contain large windows, while the two northernmost contain entrances. Blocked basement lights are also visible. The edges of reinforced concrete floors are visible on the elevations to the north and south. Buildings pre-dating the Hat Factory are shown on a number of cartographic sources but the earliest depiction dates to 1880 when the OS 1:2500 map depicts a number of small properties. The current building dates to the early 1930s and replaced two straw hat manufacturers: Ward & Bonner at No. 67 Bute Street (Kelly's Directory of Bedfordshire, 1910) and A & F Higgins at No. 65 Bute Street (Kelly's Directory of Bedfordshire, Huntingdonshire and Northamptonshire, 1910).

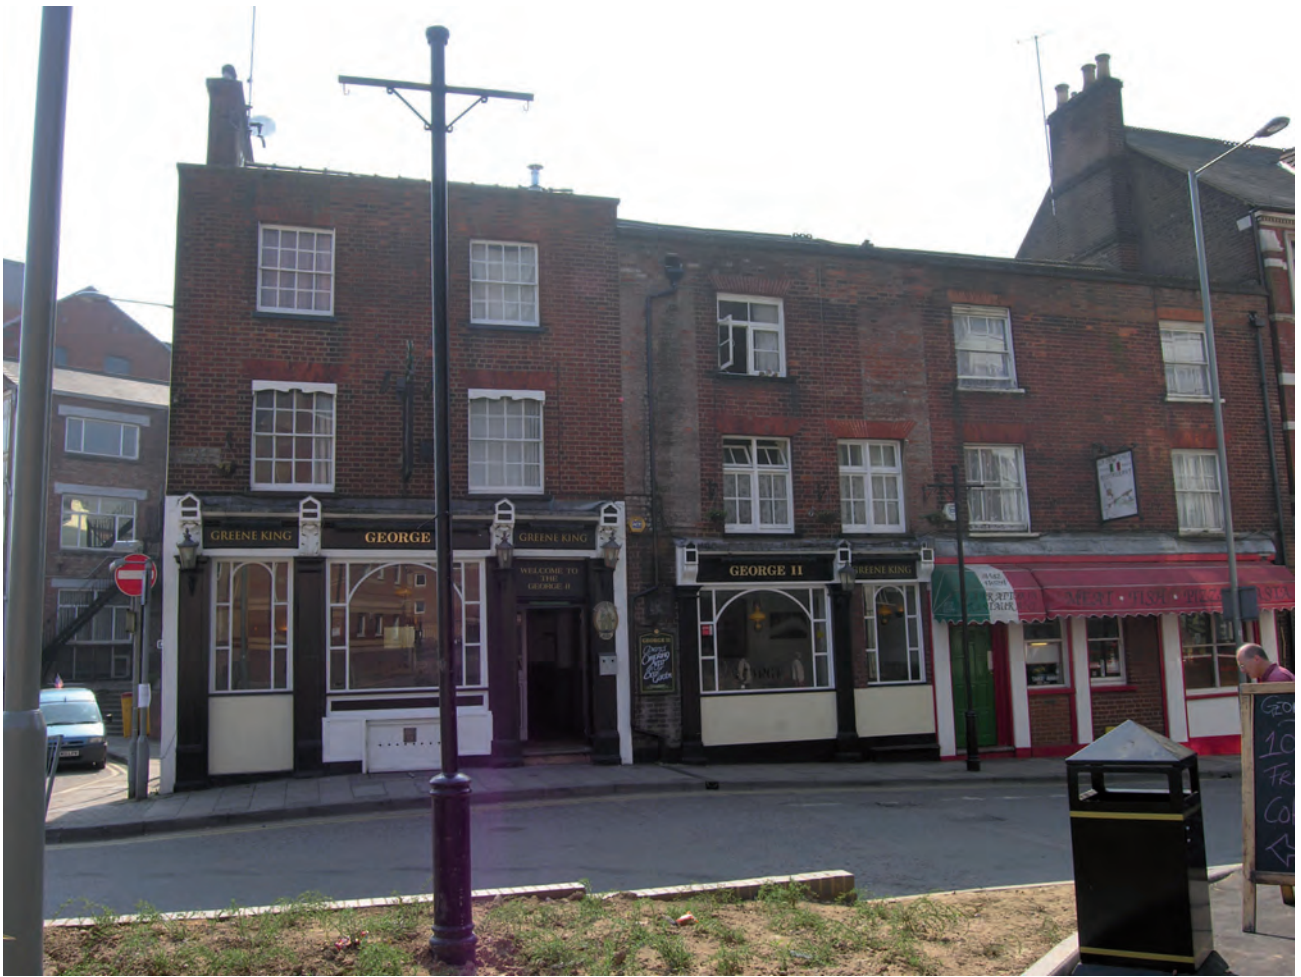
'The George II' public house, 70 Bute Street, sits at the northern end of a row of buildings on the approach to Luton railway station. It was clearly a later addition to an already existing row as the brick courses between it and 68, to its right, are discontinuous. Although 'The George II' was built in the 1870s it has seen extensive renovation on a number of occasions but particularly in the final decade of the 19th century when substantial modifications were made at ground level. It is a three storey building constructed from Luton stock grey bricks, there are two bays on first and second floors. The ground floor is dominated by a large central window with rendered stall riser. The window comprises a large, arched, pane of glass with curved glazing bar, flanked on either side by smaller rectangular panes: the stall riser incorporates a door which provides access to a beer cellar. The central window is flanked on the left by another window of similar form with a rendered stall riser - this may well be a blocked doorway - and the current entrance to the public house is on the right-hand side of the window. All of the ground-floor elements are framed by narrow Doric pilasters crowned by small pedimented consoles - the consoles are particularly noteworthy and consist of single, ornate, acanthus leaves. The entablature is tripartite due to the interruptions of the pedimented consoles but it incorporates a projecting cornice. The first and second-floor windows are simple, double-hung, balanced sashes with red brick gauged heads and simple stone/concrete sills. The first-floor windows, however, are slightly larger and include white painted wooden valences.
