PLAITERS' LEA CONSERVATION AREA, LUTON HISTORIC AREA ASSESSMENT

Research Department Report Series 069-2011

HISTORIC AREA ASSESSMENT

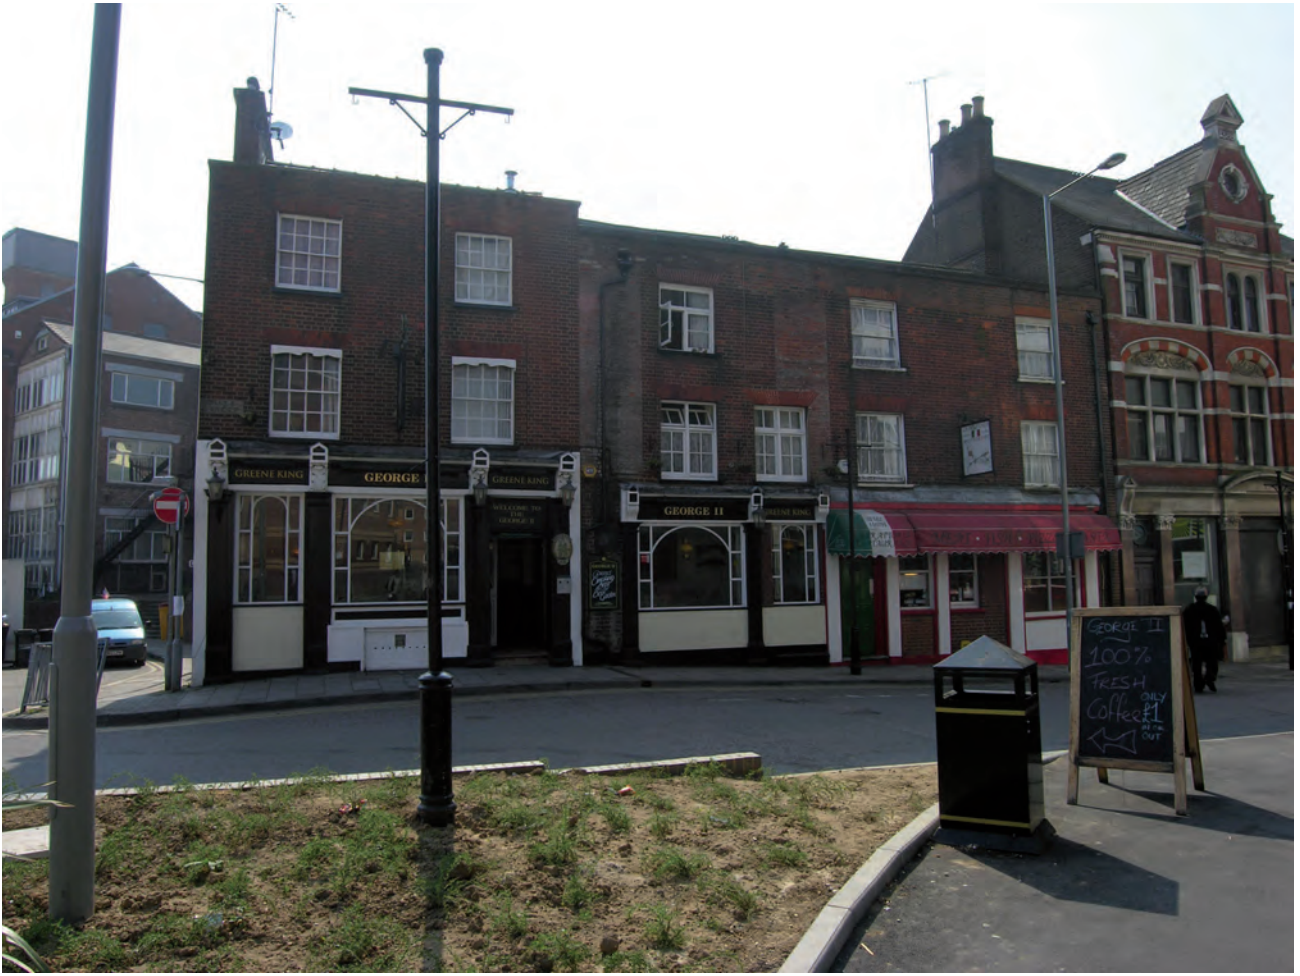
The adjacent window is narrower but of a similar form and was, undoubtedly, a former entrance - a single step up to this still survives. The large window is flanked by narrow, flat, Doric pilasters crowned by ornate pedimented consoles: the entablature includes one other, isolated, pedimented console above the narrow window on the right-hand side.

A terrace of three buildings in this location matching, to a degree, what survives, is shown on the 1844 Tithe map but a more complex arrangement is depicted on the Todd map of the 1860s. Consequently, linking these earlier cartographic depictions to the current layout is difficult. 68 Bute Street is now integrated with the public house and this, together with 66 Bute Street may well be the three-bay building shown on Corney's map of c.1870. 68 Bute Street housed F.J. Cooke & Co. straw hat manufacturer in 1898 (Kelly's Directory of Beds, Hunts & Northants, 1898); Frederick Simpson, straw hat manufacturer, in 1903 (Kelly's Directory of Beds, Hunts & Northants, 1903); and L. Joseph & Sons, feather merchants, in 1910 (Kelly's Directory of Bedfordshire, 1910). It is shown as a straw hat factory on Goad's map of 1938. 66 Bute Street is listed as the Bridge Hotel with Samuel Boutwood as the proprietor in 1898 (Kelly's Directory of Beds, Hunts & Northants, 1898) and in 1903 (Kelly's Directory of Beds, Hunts & Northants, 1903); as the Bridge Hotel, landlord George Alcock, throughout 1910 (Kelly's Directory of Bedfordshire, 1910) and 1914 (Kelly's Directory of Bedfordshire, 1914). It is still shown as a public house on the Goad map of 1938.

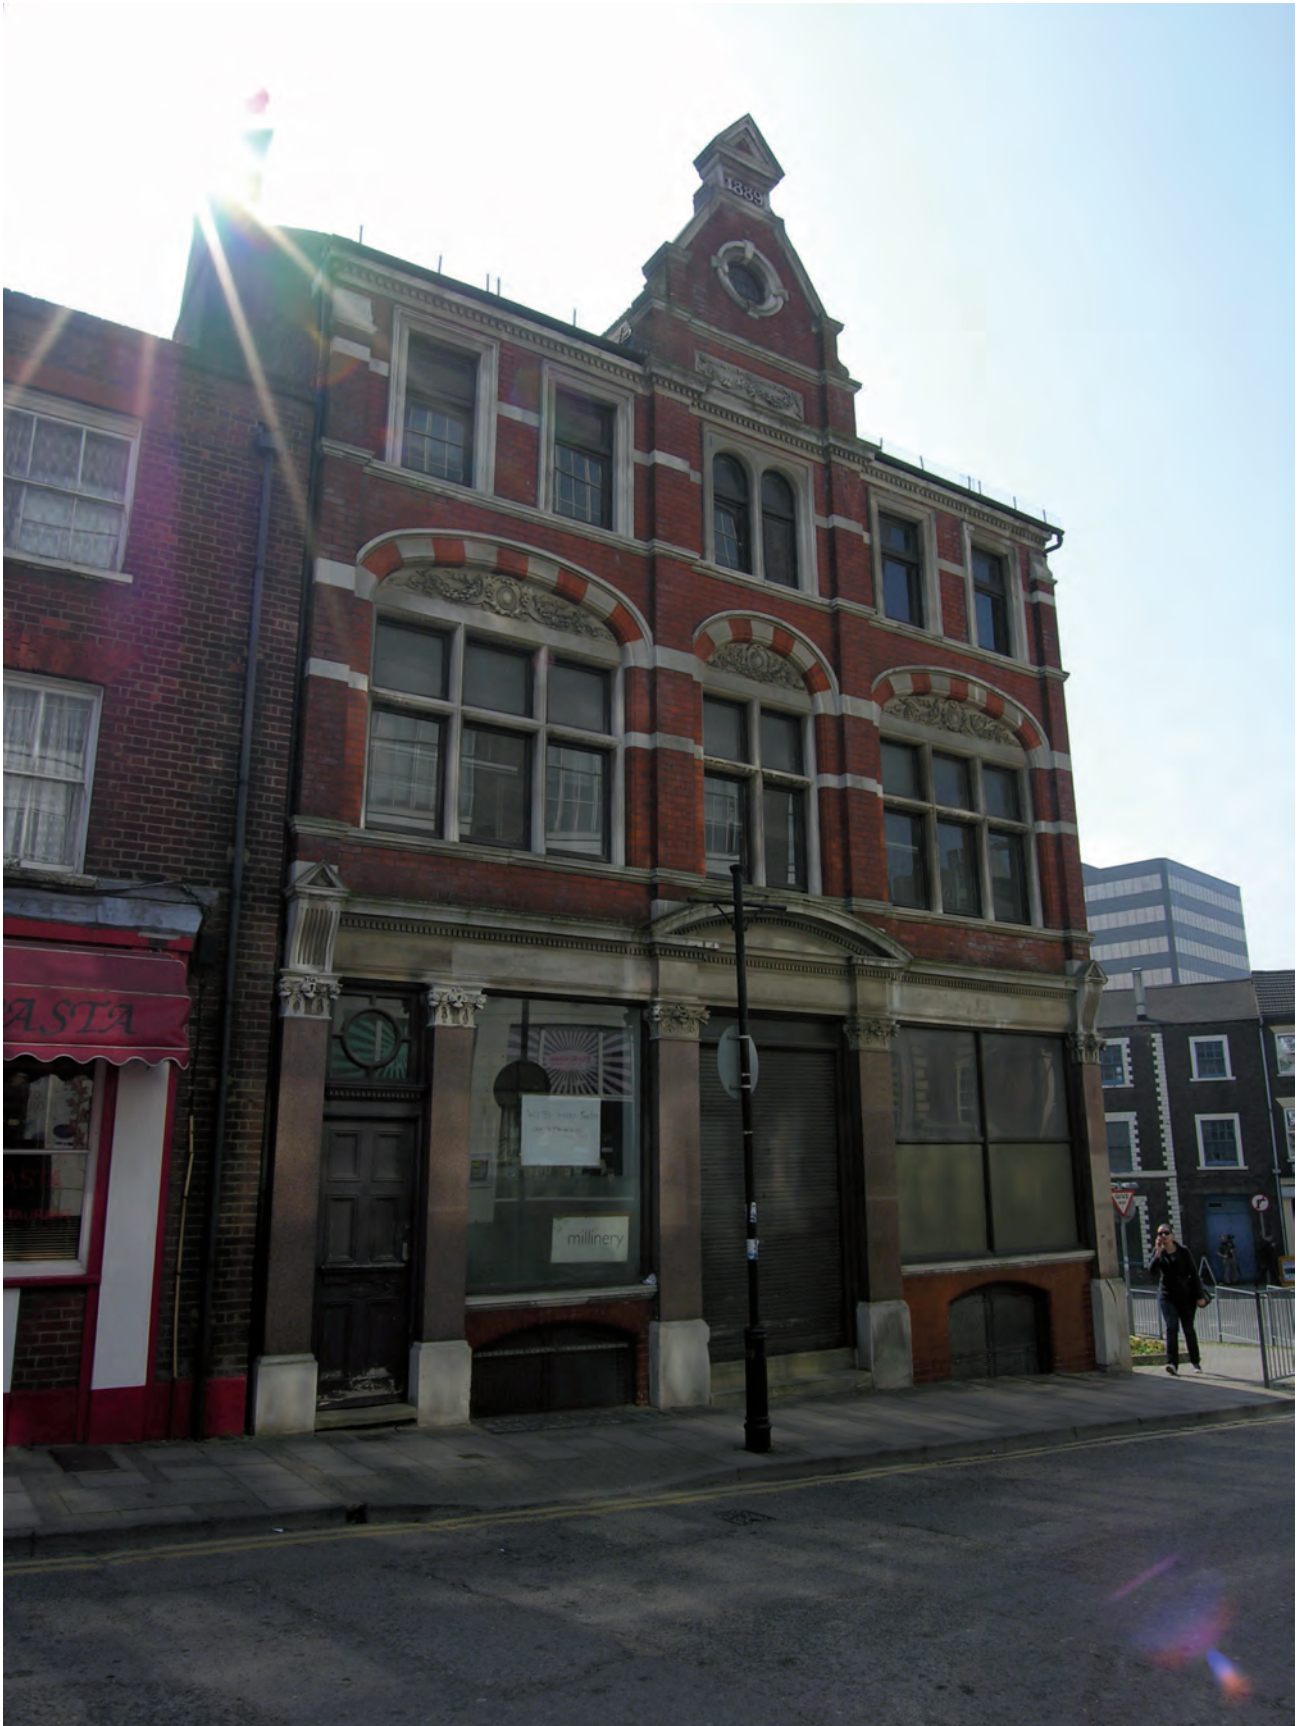
The Gurney & Son hat factory at 64 Bute Street is an exemplar of its type and is one of the most readily identifiable buildings in the Plaiters' Lea Conservation Area. A three storey building plus basement and attic, it was built in 1889 with a complex façade. Constructed in red brick with stone dressings with three bays to Bute Street, the ground floor contains a recessed central lobby accessed by a short flight of steps. This is flanked by display windows beneath which are basement windows set within glazed brick stall risers and to the north of these is the trade entrance. All of these elements are finely crafted, with Corinthian pink granite pilasters resting on stone plinths supporting a continuous stone fascia with a segmental pediment over the entrance, terminating in fluted consoles with pediments. The detail is not confined to the ground floor - the first-floor windows have stone mullions and transoms set beneath shallow tympana containing cartouches and moulded stone swags whilst the second-floor windows in the outer bays are surrounded by stone architraves whilst the central bay contains a twin arched window. The façade is completed by dentilled eaves and a shaped gable containing a date stone of 1889, a roundel window lighting the attic, and a stone plaque with carved swag.

The first known occupant is Charles Haddon Osborne, straw hat manufacturer (Kelly's Directory of Beds, Hunts & Northants, 1903) and cartographic assessments indicate that the building replaced earlier structures on the same plot. It is shown as being occupied by Frank Harden, straw hat manufacturers, on Goad's plan of 1938 but more recently it was under the ownership of William Gurney & Son who are now seeking to convert the factory into domestic accommodation.

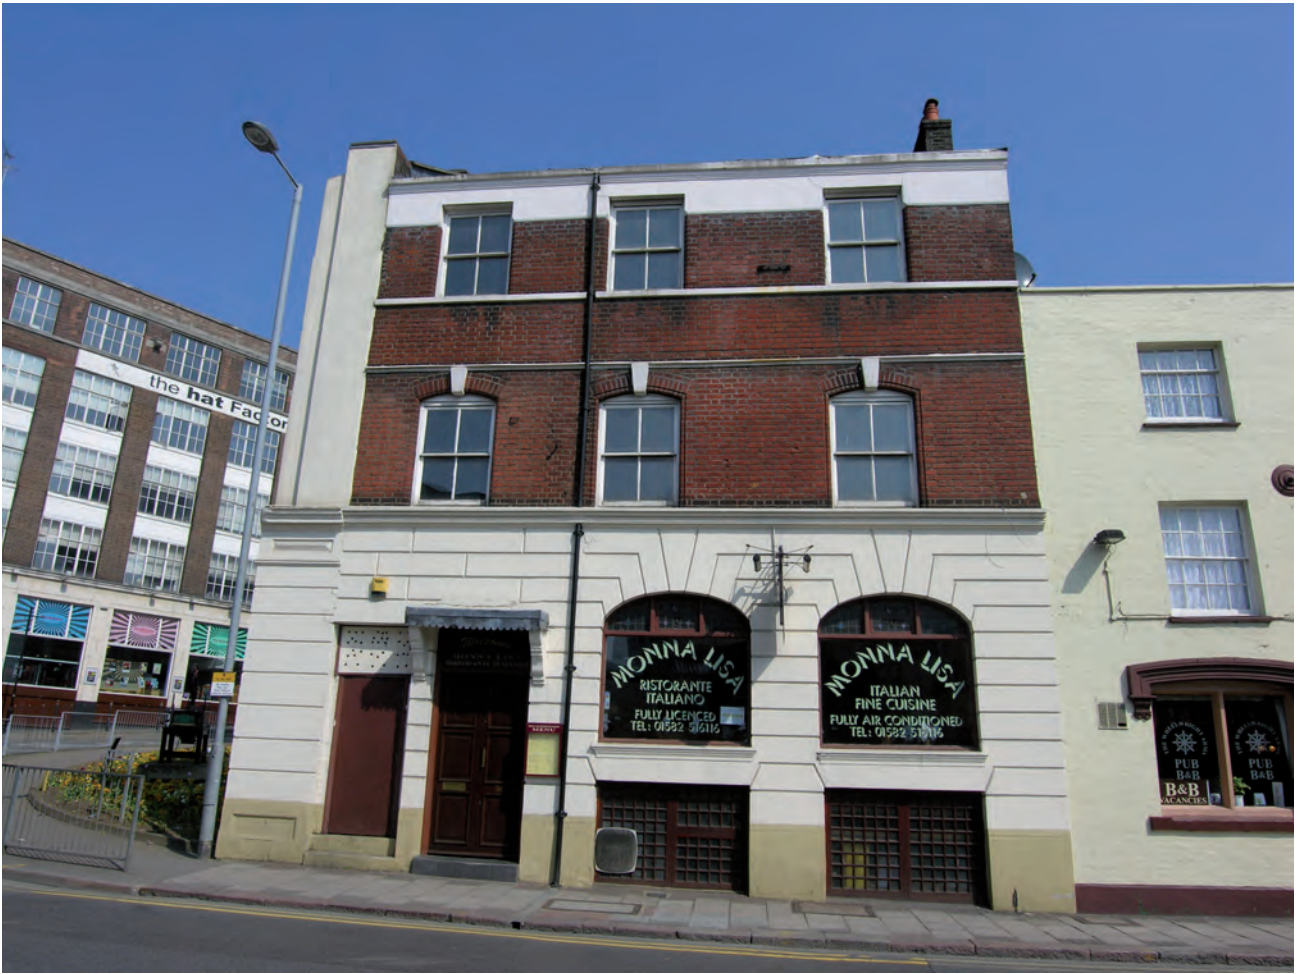
36 Guildford Street, whilst smaller in scale than a number of nearby factories and wholesalers, nonetheless, reflects the predominant architectural styles and motifs of the final decade of the 19th century. The building sits in a prominent location close the intersection of Bute Street and Guildford Street at the hub of the former hatting quarter and is now occupied by an Italian restaurant. A three-storey building with a raised basement, it is built from red brick laid in Flemish bond, with a rusticated render to the ground-floor shopfront. The shopfront consists of two arch-headed display windows with basement lights set immediately below, their size suggesting that they would have allowed for the loading and unloading of bulky raw materials such as straw plait directly from the street. To the immediate west of the windows is the main doorway into the building with a heavily bracketed canopy above, with the secondary passageway to the rear lying to the west of this. The first and second floors each have three windows, slightly misaligned from the windows and main door below, containing simple two-over-two sashes without horns. The first-floor windows have segmental brick heads with a central keystone. Whilst the reveals are formed from moulded brick, the sills form part of the cornice to the rustication and the keystones are incorporated within a moulded string course. The second-floor windows have straight heads set within a flat eaves band, the sills forming part of a simple band. The unusually thick gable wall to the west is the remnant of the party wall of an adjoining building which once stood on the corner of the junction and is, therefore, blind.

The precise construction date is uncertain - changes in the brickwork and style of window on the first floor indicate that the original building was substantially enlarged with the addition of the second floor and the westernmost bay in c.1900. The original layout of the property is unclear as the western bay contains both entrances to the premises and it therefore seems likely that the entire shopfront was remodelled and rendered during this phase. In 1903, Joseph Mardle, straw hat manufacturer, resided here but by 1910 it housed Henry Darler & Sons, straw plait merchants (Kelly's Directory of Bedfordshire, 1910).

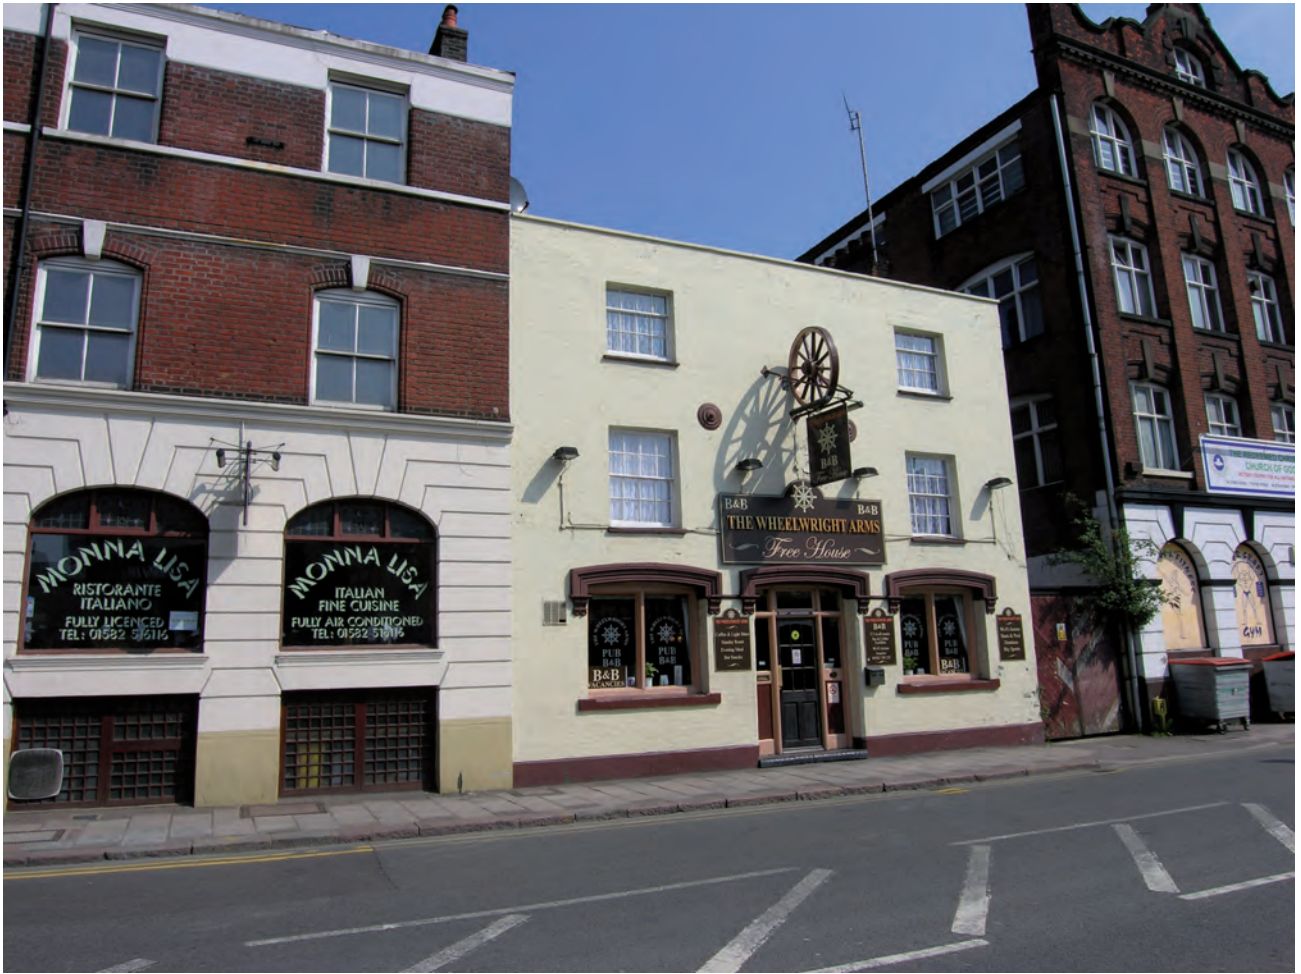
'The Wheelwright Arms' at 34 Guildford Street bears a striking resemblance to 'The Cooper's Arms' on Bute Street and was, similarly, constructed in the middle decades of the 19th century. 'The Wheelwright Arms' boasts a discrete but decorative façade unique, not only in the Conservation Area, but within the town. It is a three-storey building, brick built with a plain brick parapet, all since painted, with double hung sashes to the first and second floors with simple stone sills and straight heads. The ground floor has a central doorway with side and top lights. Either side of the entrance there is a window with a central stone mullion - both windows and the doorway have heavy moulded stone hoods supported on brackets. Access to the rear is by way of a passage, wide enough for vehicles, on the right-hand side of the property.

In 1862 the landlord was also doubling up as a bonnet blocker and herring curer (Luton Borough Council, Luton Hat Trail I: the Bute Street Area, 1988, 4). In 1903, the proprietor was Edward Impey (Kelly's Directory of Beds, Hunts & Northants, 1903, 239), and by 1910 Henry Pocock was the landlord (Kelly's Directory of Bedfordshire, 1910).

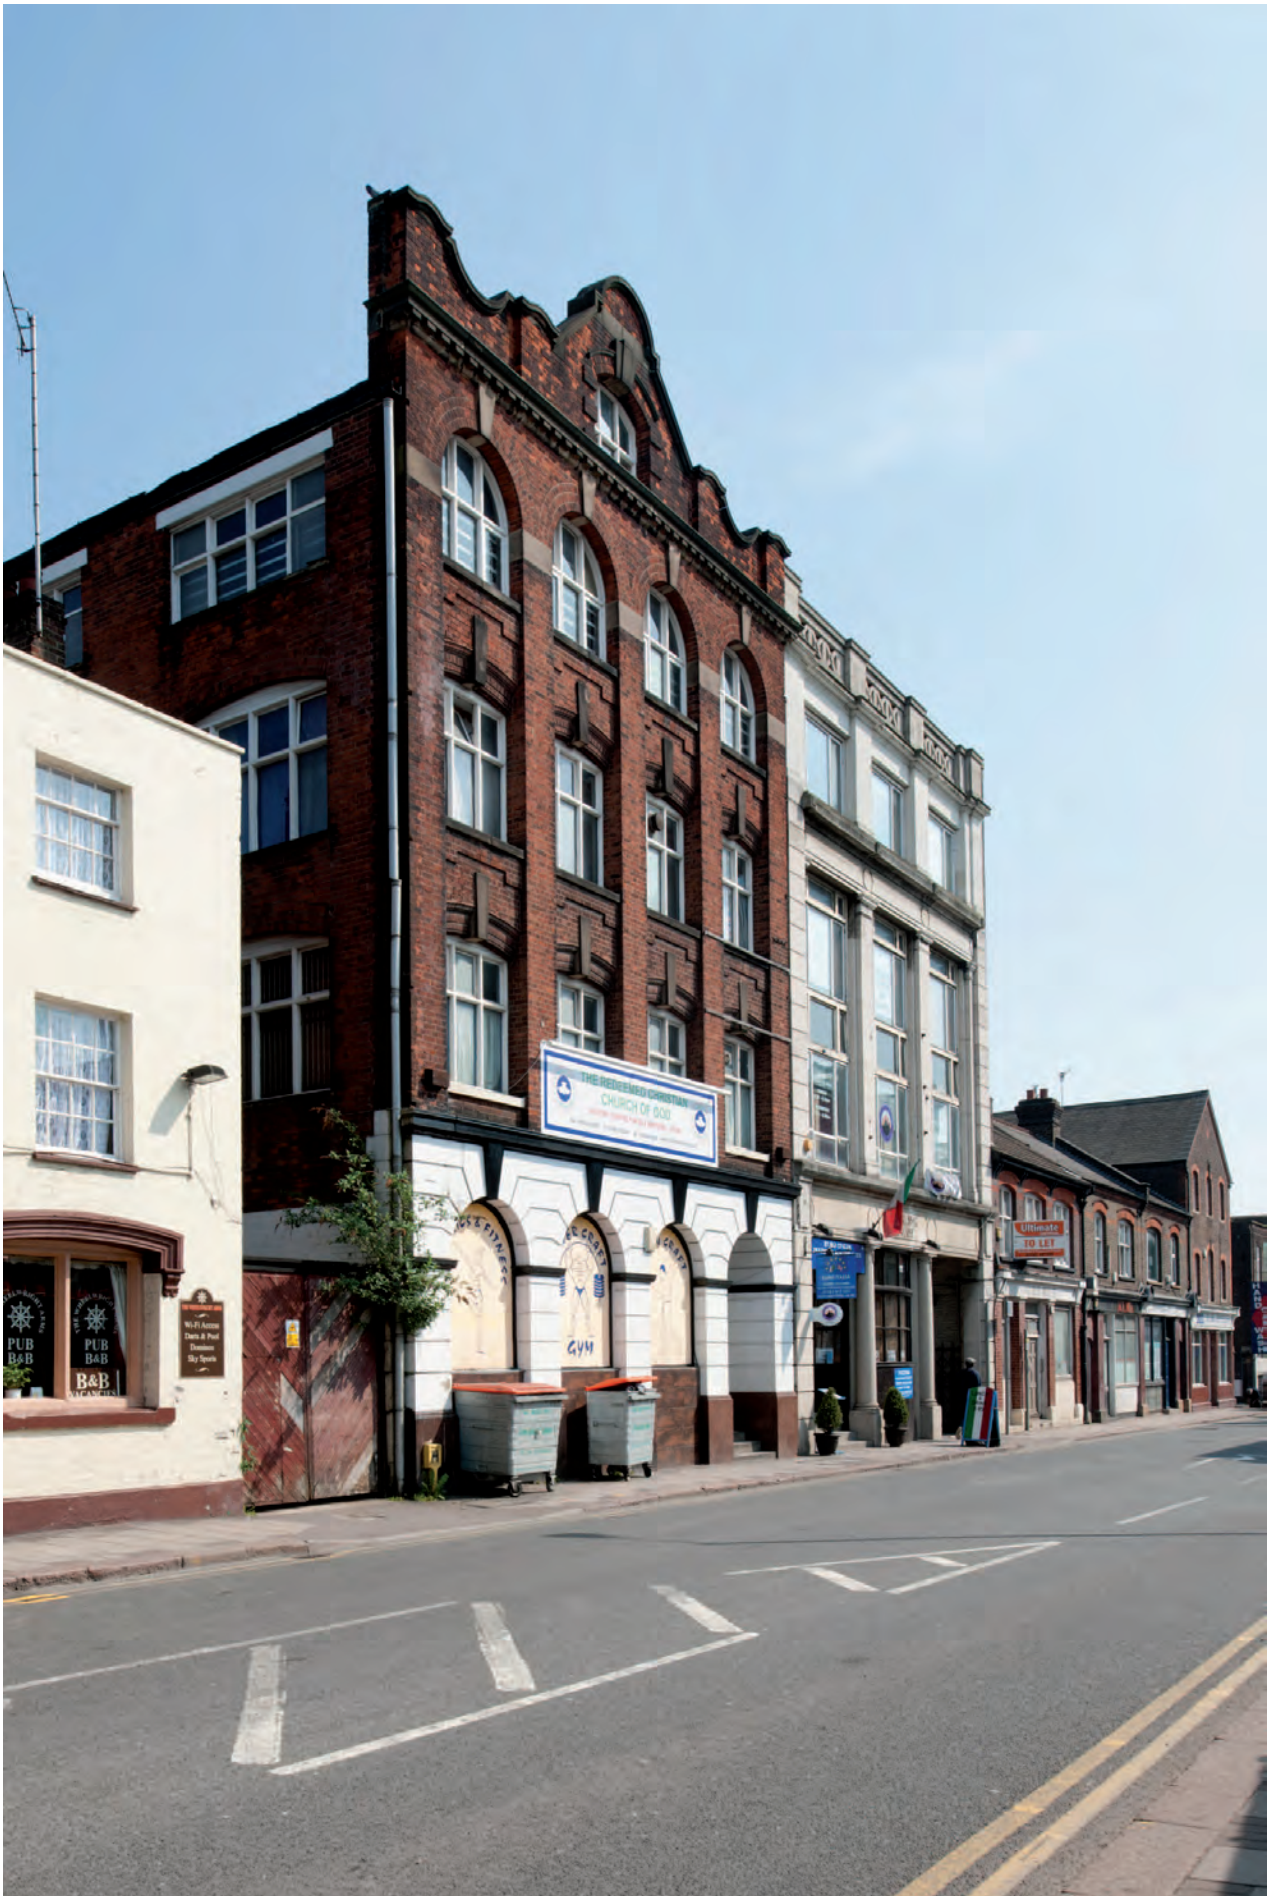
This is a striking building of four storeys plus attic and a basement with raised ground-floor showroom above. Constructed from red brick with a pier and panel façade, the decorative parapet incorporates a shaped dormer with segmental headed window lighting the attic, whilst giant order arches enclose the upper three storeys - lending an almost Neo-Jacobean style to the upper floors. The ground floor is rusticated with deep horizontal grooving and a projecting moulded cornice above and this provides an immediate contrast to the upper storeys, being more classical in style. There are three arch-headed windows (now boarded over) and a door to the east in the same style. The windows and doorway incorporate a key painted black in contrast to the white of the rustication. The second and third-floor windows have moulded segmental brick heads with a prominent keystone and label, containing fixed lights divided by timber glazing bars and incorporating a central hopper within the upper section of each window. The third-floor windows have arched heads with a keystone and below the windows, as on the second floor, are simple brick aprons.

The west side of the building is exposed and the windows on the first to third floors can be seen. Those on the first and second floors are large, wooden-framed, with fixed lights and timber glazing bars, the upper panes of which are hopper windows. They are furnished with substantial segmented heads and simple narrow sills. The windows to the upper floor are smaller but follow the same form with upper hopper lights. In this case, though, the heads are flat and built of stone (or concrete) immediately above the window frame. Again, the sills are narrow in stone or concrete. 32 Guildford Street, the ground floor of which is now used as a gym, has had a varied history. It is built on the site of a property that belonged to Fred and Jesse Hawkes of The Wheelwright Arms next door, and the land it stands on had been used as a wheelwrights until the end of the 19th century. (Luton Borough Council, Luton Hat Trail 1: the Bute Street Area', 1998, 4). By 1914 the current building was home to Stewart Hubbard's straw plait firm and the Goad insurance map of 1938 indicates that it was used for the storage of hoods and other hatting goods, with a hat factory on the upper floor.

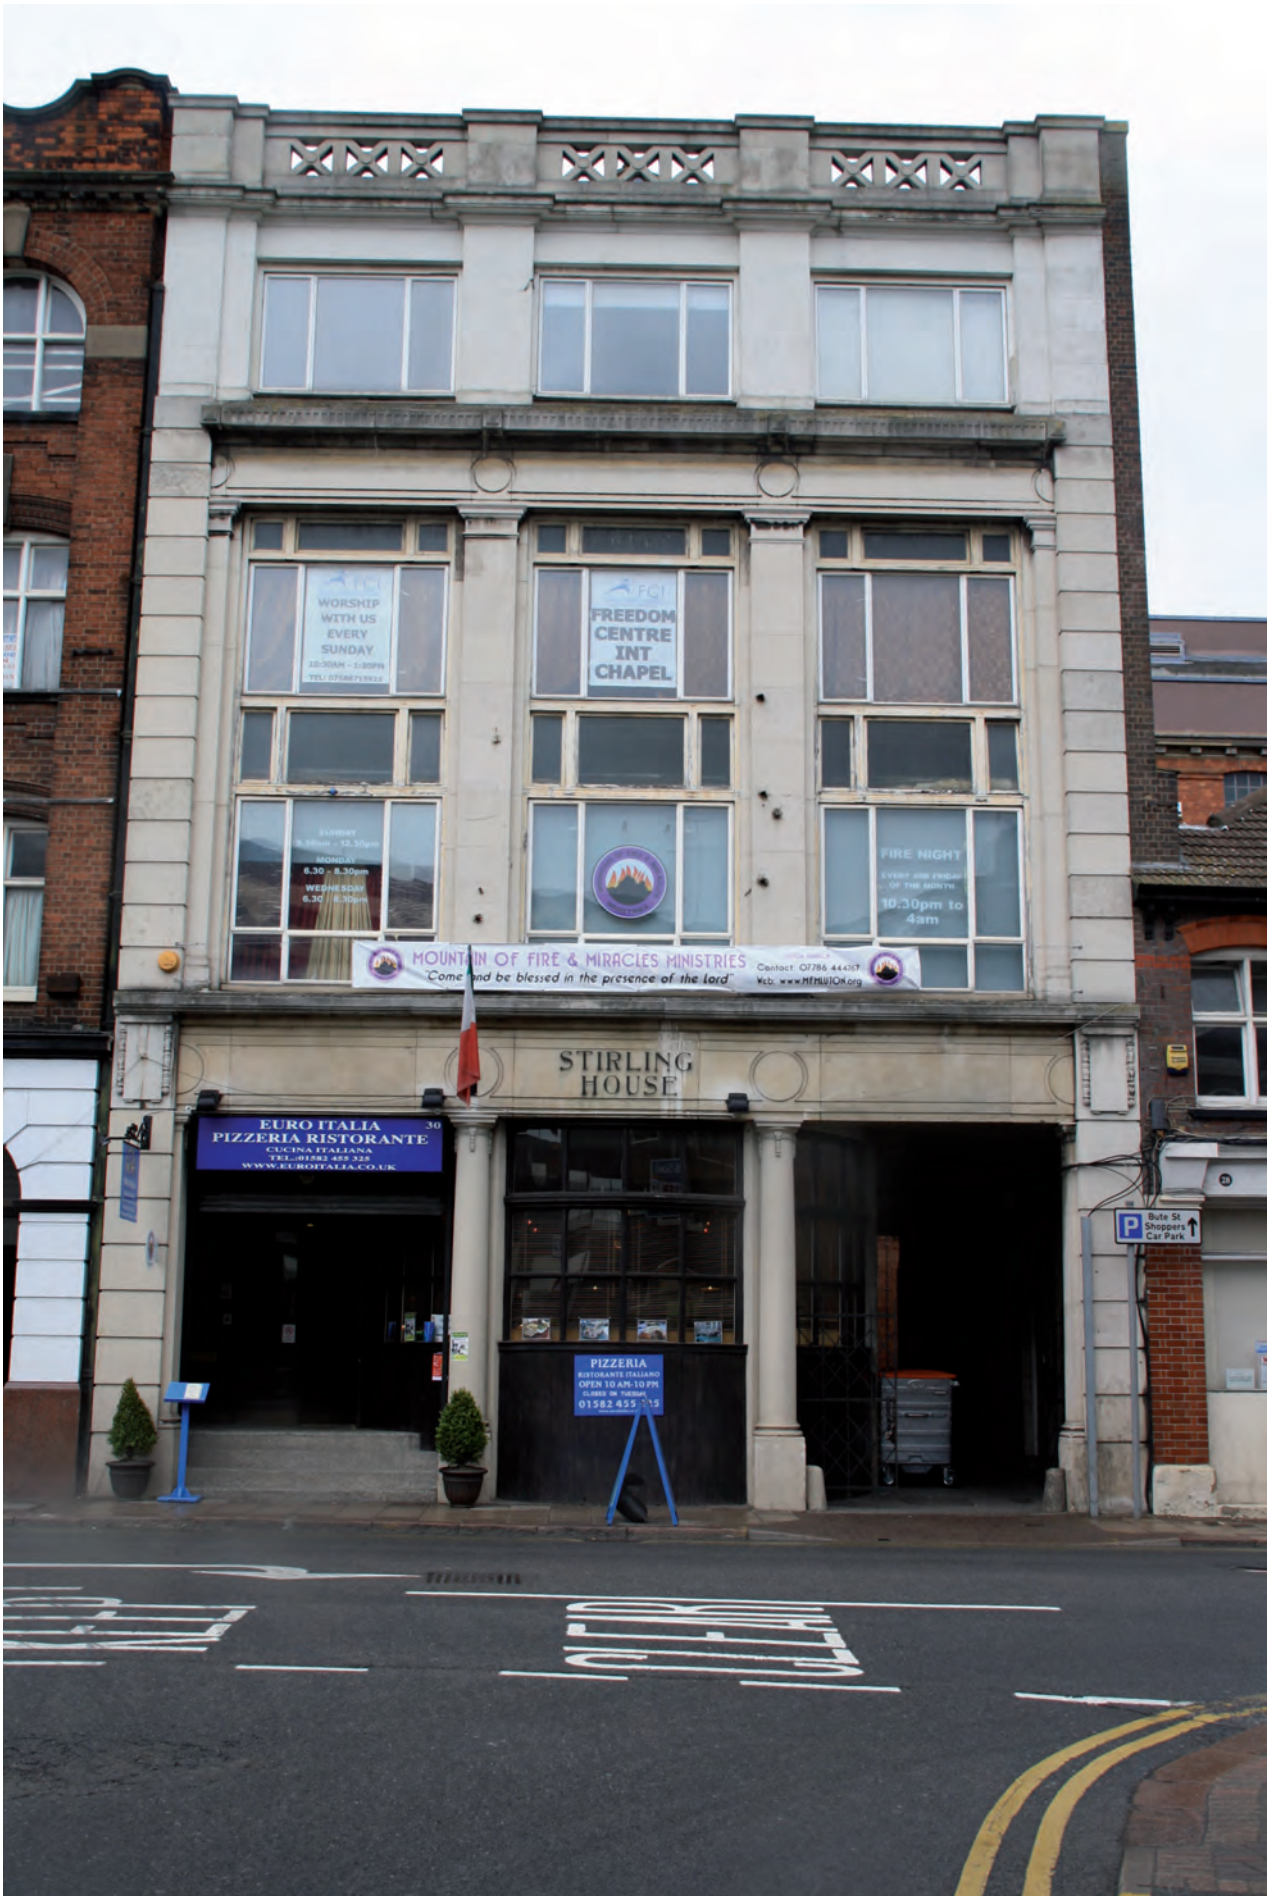
fascia and the façade is crowned by a parapet of concrete in a lattice (or repeating St. Andrew's cross) pattern which is unique within the Conservation Area.

The current building is evidently a rebuild of an earlier structure or, at least, a new building on an old plot. David Dunham, a builder, occupied the address at the time of the 1890 Kelly's Directory of Bedfordshire (Kelly, 1890), and between 1903 (Kelly's Directory of Beds, Hunts & Northants, 1903) and 1914 (Kelly's Directory of Bedfordshire, 1914) it was occupied by a rubber company.

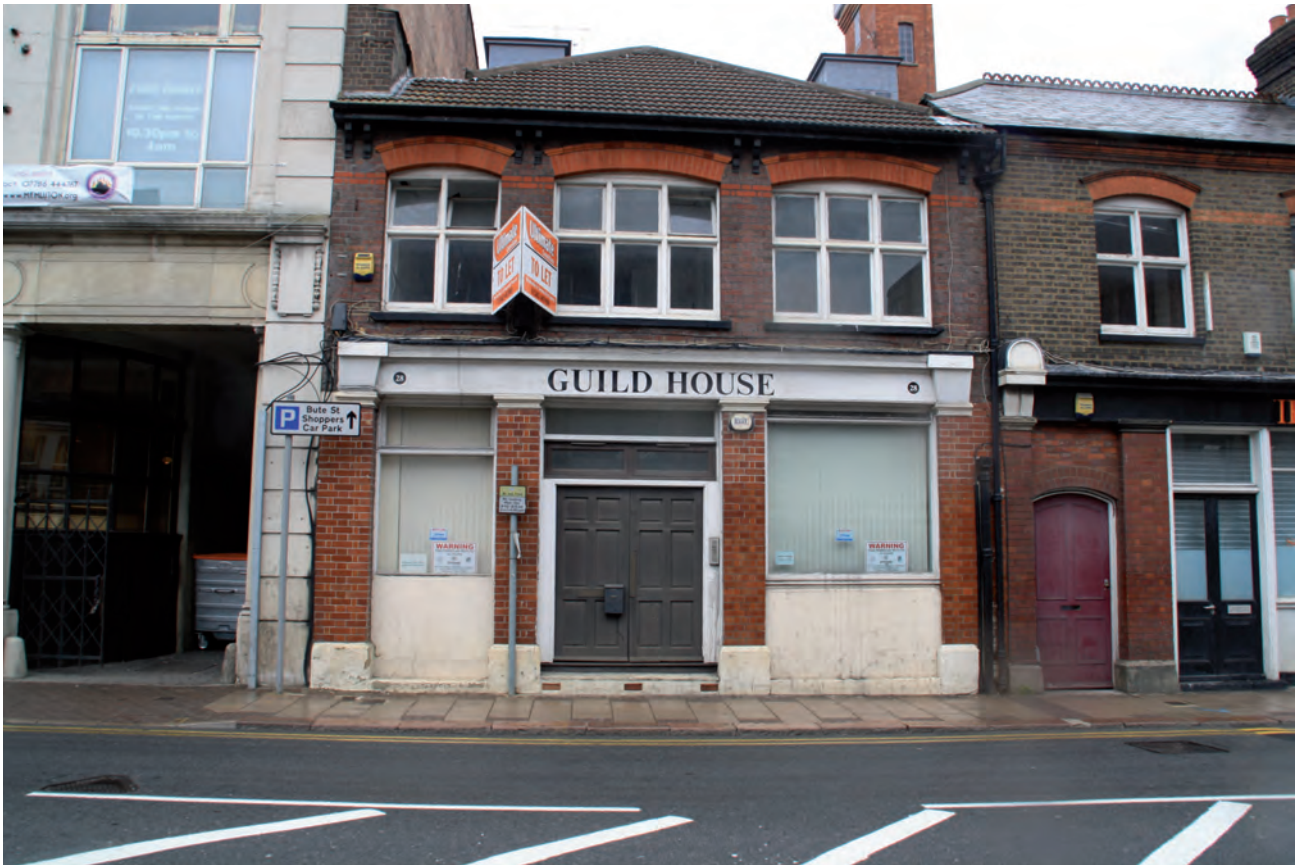
28 Guildford Street (Guild House), is a two storey building plus basement. Built in the 1870s from a dark red brick with lighter red brick detailing under a hipped roof, the ground-floor shopfront consists of a large centrally placed doorway with a window to either side, these being flanked by glazed brick piers. The double door is surmounted by a pair of opening transom lights, with a single fixed fanlight above these. The window to the right (east) of the door is the larger of the two, and would have had basement lights below but these have since been rendered over. The smaller window to the west of the main door was once the side entranceway, as shown in building plans for the adjacent property (Stirling House). There are three first-floor windows, that above the blocked entranceway being narrower than the other two. The segmented heads are made from moulded bright red brick, whilst a bright red brick band connects the windows. Unusually, there are four sets of paired brackets to the eaves - flanking the windows. Mrs Pitkin, straw hat and bonnet manufacturer, is listed here in Kelly's directory for 1903 (Kelly's Directory of Bedfordshire, Hunts and Northamptonshire, 1903).

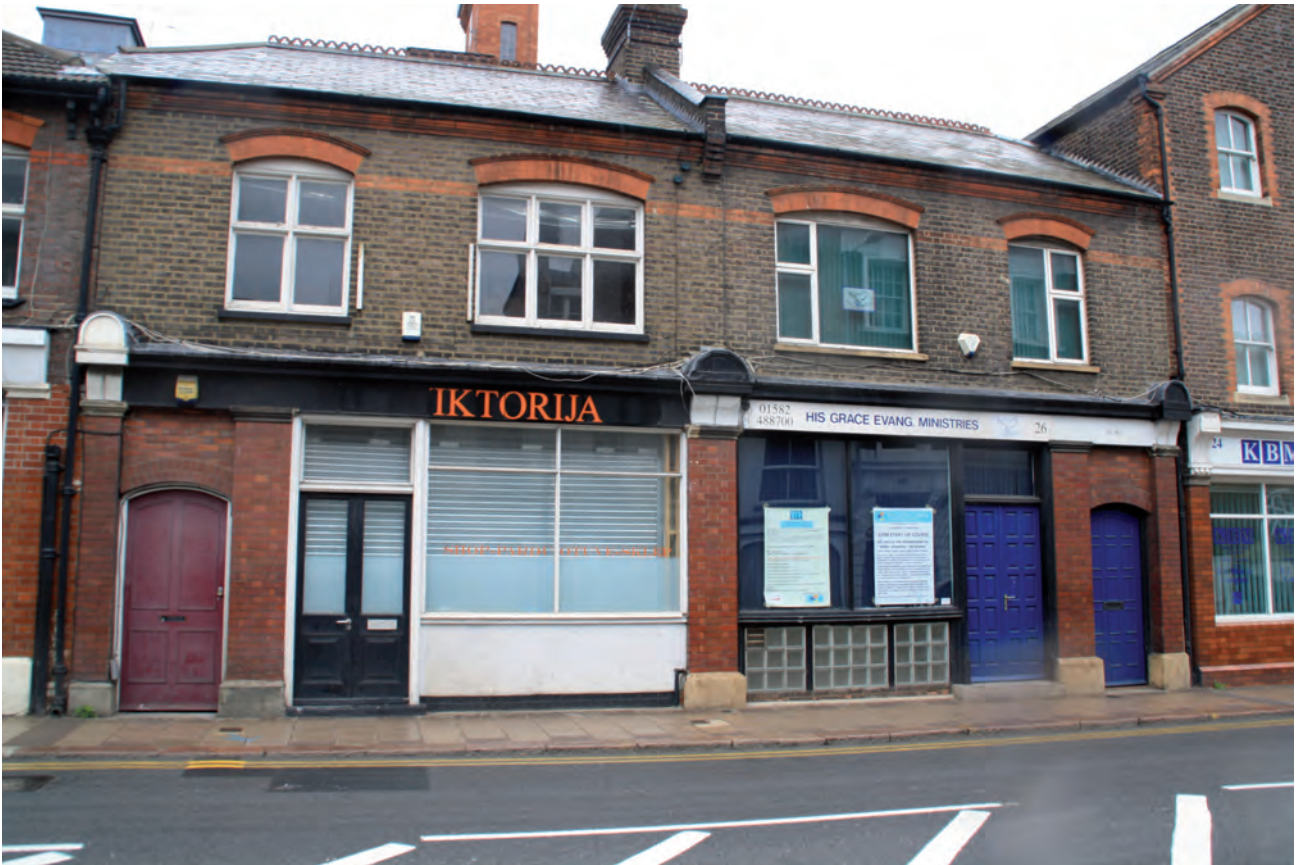
Above the windows is a finely moulded red brick cornice, whilst the Welsh slate roof is enhanced using pierced terracotta ridge tiles. The centrally positioned chimney stack is constructed from Luton stock brick and forms part of the central dividing fire wall.

Goad's insurance map of 1895 shows 28 and 24 Guildford Street, but a vacant plot where 26 and 28a now stand. By the time of the 1901 OS 1:2500 plan these are present, confirming a construction date of c.1900.

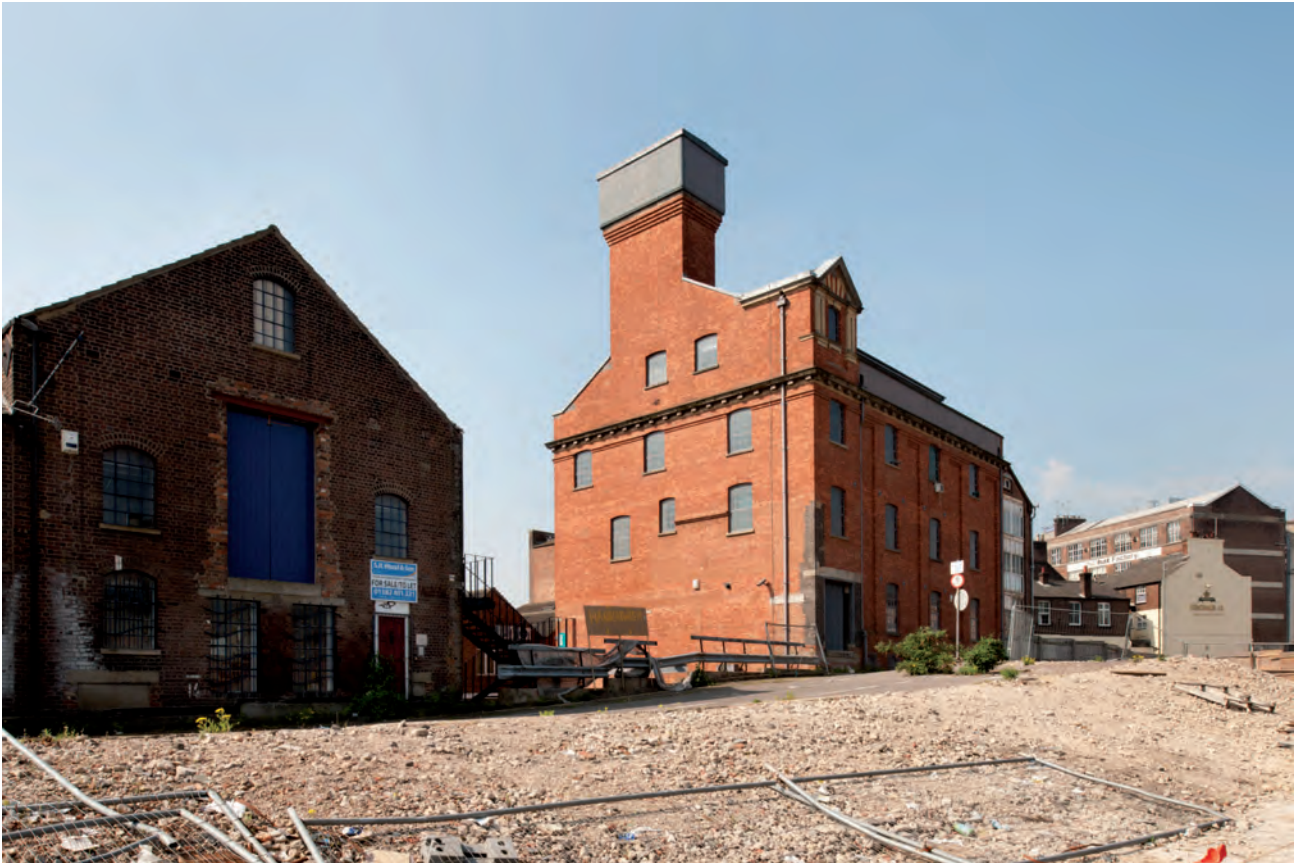
The Bute Mill is one of the most recognisable buildings in the Conservation Area, four and a half storeys high and constructed to a high standard using red brick with yellow brick dressings. The northern and southern elevations are divided into four bays with recessed panels between, each bay contains a single window to each floor save for the ground floor which contains seven windows. The western elevation is not visible, and the eastern gable wall is blind until second-floor level where there are three windows of varying size and position, with three symmetrically arranged windows to the third floor and two set into the apex of the gable above. All of the windows have fixed multi pane glazing, divided by metal glazing bars with opening top lights. The stone cornice is simply decorated with modillions, above which is an attic storey set back behind a parapet - the easternmost bay on the northern elevation rising through this to form a gabled tower with yellow brick pillars flanking a window. The most distinctive element of the building is, however, the iron water tank built on a corbelled brick support. This is a landmark feature, visible from a number of locations across the town centre and is emblazoned with 'Brown Bros', an important milling family long-established in Luton. The mill was built between 1901 and 1924 (OS maps) and is marked on the 1924 map as a 'Steam Mill - Corn'.

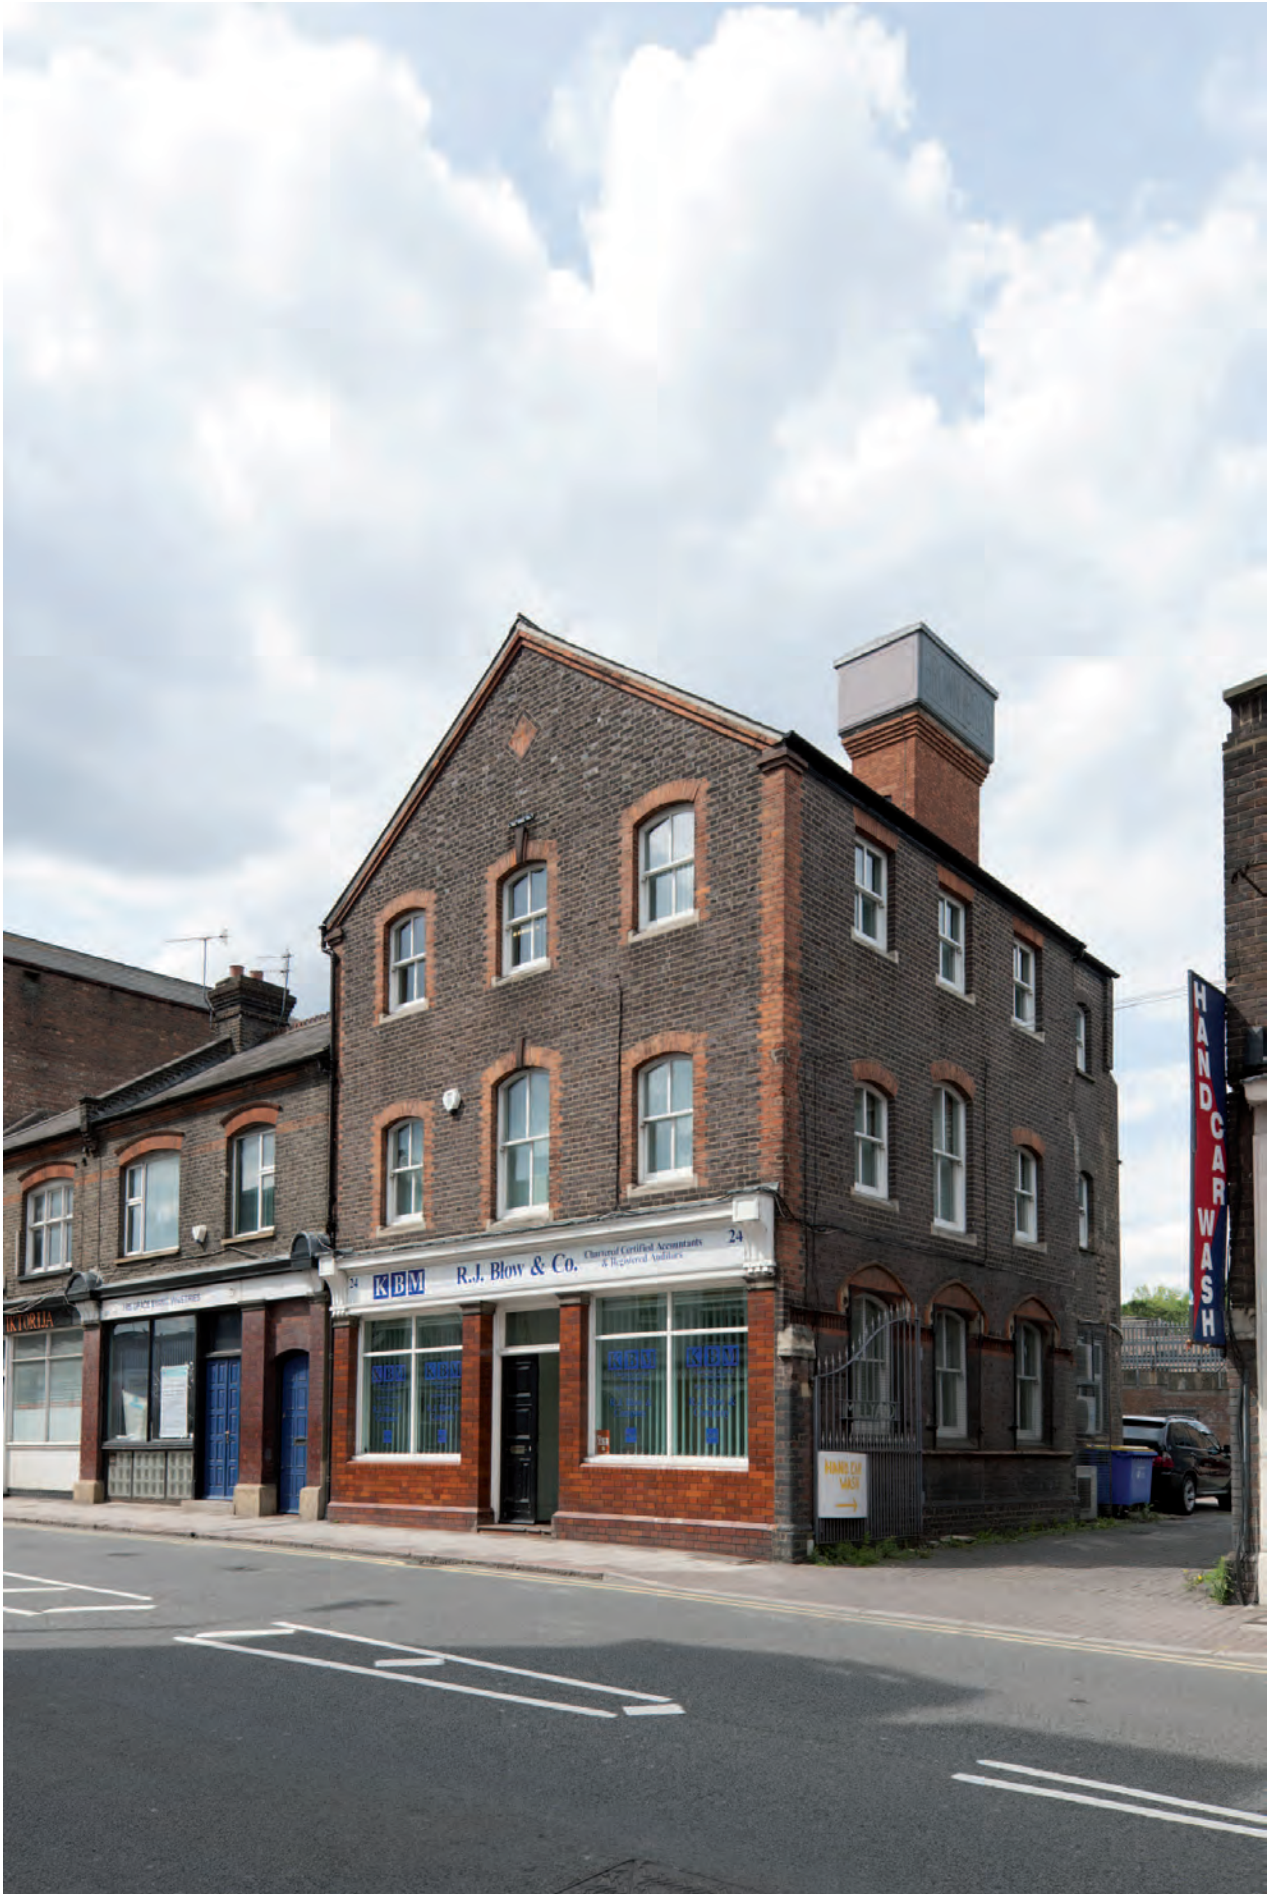
The offices for R.J. Blow & Co. at 24 Guildford Street were constructed in the 1870s as offices with a second-floor warehouse forming part of the goods yard adjacent to Luton Railway Station. By the late 1930s, it had been converted to a hat factory and it is, currently, occupied by a firm of accountants. It is one of a small number of smaller properties in the area constructed in the second half of the 19th century. Only the main block on Guildford Street now survives: Goad illustrates clearly that the hat factory extended northwards to a junction with Bute Street and the railway goods yards there. It is built on three and a half storeys from Luton stock brick with red brick quoins and detailing. The Guildford Street elevation is gabled and contains a symmetrical ground-floor shopfront consisting of a wide double door and rectangular transom light above. Either side of this are large four-pane windows with wooden glazing bars - the windows and doorway are framed by flat Doric pilasters faced with glazed red bricks. The entablature comprises a flat fascia constrained by projecting moulded cornices above and below. All this is bracketed by heavy fluted consoles surmounting the outer pilasters. There are three first-floor windows - each comprising a balanced (two-over-two) sash window in wooden frame. The central window is the larger but each is framed by a red brick window surround with segmental heads and chamfered stone sill - the central window is further embellished by a stone key. The second-floor windows are similar to those on the floor below but, here, all windows are to the same scale. There is a diamond-shaped motif on the gable picked out in red brick.

The side elevation (which flanked the main entrance to the Mill Yard) comprises three windows per floor. The ground-floor windows are more ornate and resemble those at 56 Cheapside. Each of the three windows is of the same size and proportion - sash windows (two-over-two) in wooden frames - and they incorporate chamfered stone sills with a continuous sill course of projecting, moulded, brick. A course of red brick extends across the wall face close to the midpoint of the upper sash and this is surmounted by a decorative projecting brick moulding that arches over a red brick tympanum above each window. There is a plat band at first-floor level: the first-floor window arrangement to the side mirrors that on the street front - a large central window flanked by smaller ones. Again, each incorporates a chamfered stone sill but instead of having full red brick window surrounds have simple red brick segmental heads. The three second-floor windows, which are smaller but similar in proportion, are balanced sashes with chamfered stone sills and flat gauged red brick heads.

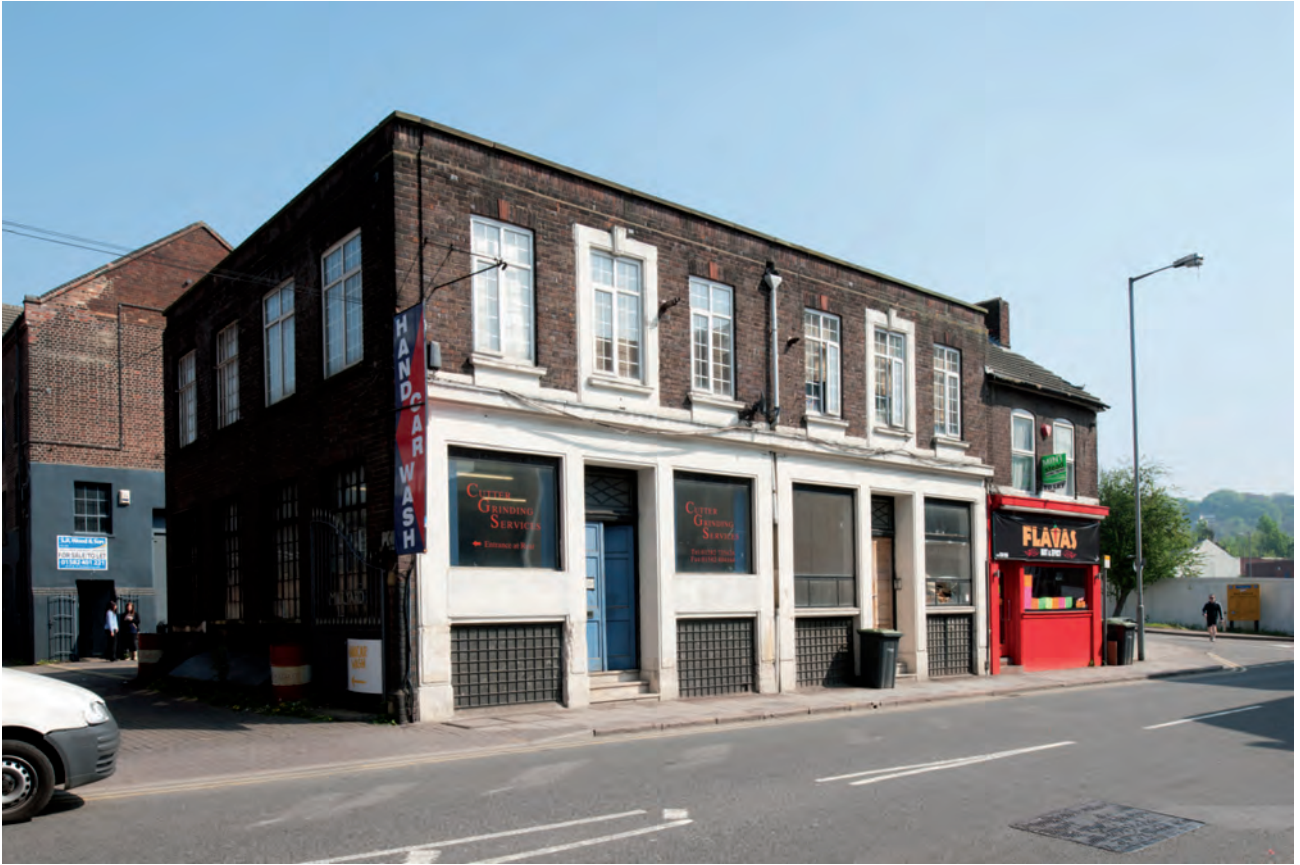
The hat factories at 22a&b Guildford Street are good examples of the Neo-Georgian style that was current in the early 1930s. This is a small symmetrical pair of premises, two and a half storeys high, of red brick, with a flat roof hidden behind a soldier-course parapet. The commercial function is betrayed by the treatment of the ground floors: each property has a central doorway, reached via steps spanning the basement and flanked by two display windows. These have smooth rendered surrounds, not the banded rustication favoured elsewhere throughout this district. The panelled double doors and fine transom lights survive. Above this, the first-floor windows contain casements, and in

each case the central one is emphasised by a broad, rendered frame with a prominent keystone. Building control plans for the building shows that it was designed by B.B. Franklin in November 1931 and approved in January 1932. Although the building appears to be a pair of identical premises set up for use by two independent businesses, the plans indicate something quite different. The earliest part of the building is the basement and ground-floor on the left (west) - this forming an earlier warehouse. The 1931 plans form an extension to this whereby a matching building was built to the right (east) with basement storage and a ground-floor plait shop with offices, with a first-floor showroom running the width of both properties (Wardown Park Museum unclassified building plans - number 2941. Brown's Mill, Guildford Street, Luton: Proposed Additional 1st Floor Storey to Warehouses For the executors of the late W.H. Brown). Given the homogeneity of the brickwork it seems likely that the extension was part of a longer term plan carried out shortly after the construction of the warehouse and by the same builder. It also seems likely that the façade of the warehouse was refaced as part of the rebuilding work. The apparent lack of access between the first-floor display room and the warehouse below may indicate that the warehouse was used by a separate firm, or that it was a storage area for a wholesaler making use of the newly built retail premises.
