PLAITERS' LEA CONSERVATION AREA, LUTON HISTORIC AREA ASSESSMENT

Research Department Report Series 069-2011

HISTORIC AREA ASSESSMENT

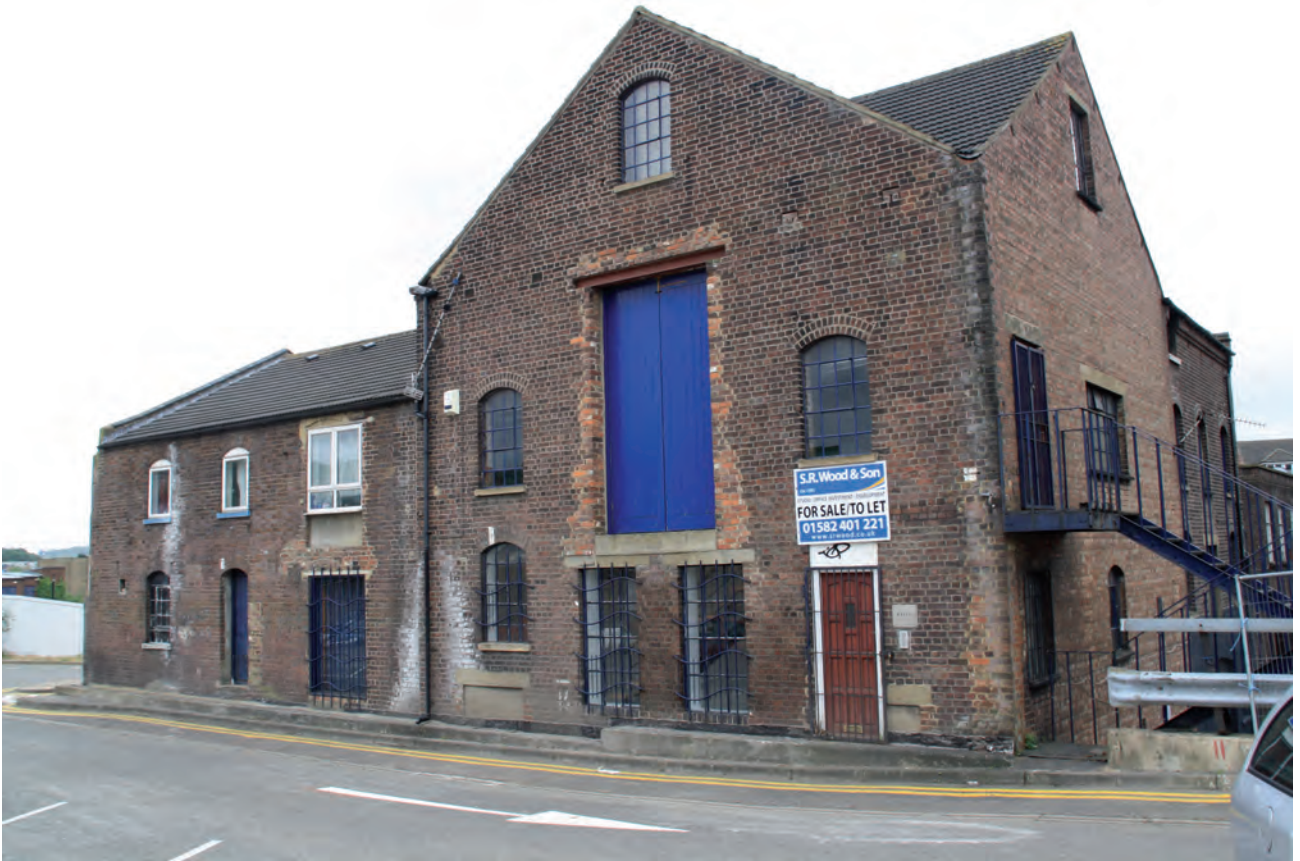
24a-c Bute Street is clearly a surviving component of the former mill dating to around 1870: truncated rafters on the surviving west-facing gable indicate that the building extended to the west, a fact supported by the Goad Insurance plan of 1895. The northern elevation, visible from Bute Street, comprises a mill building and adjacent office or residential block. The residential block to the east of the mill has been greatly altered: the road here has been substantially raised so that the original floor level is now buried and only fragments of the ground-floor window heads can be seen. Indeed, the present door is a modified, formerly first-floor, window. Modern windows have been inserted, but fragments of the original, narrower, segmental heads can still be seen. The larger mill building to the west is dominated by a loading bay on the first floor - this has clearly been enlarged in the past, with the addition of an RSJ and concrete sill. The two blocked and truncated doors close to ground level indicate that the former ground floor of these buildings was significantly lower than the current road level.

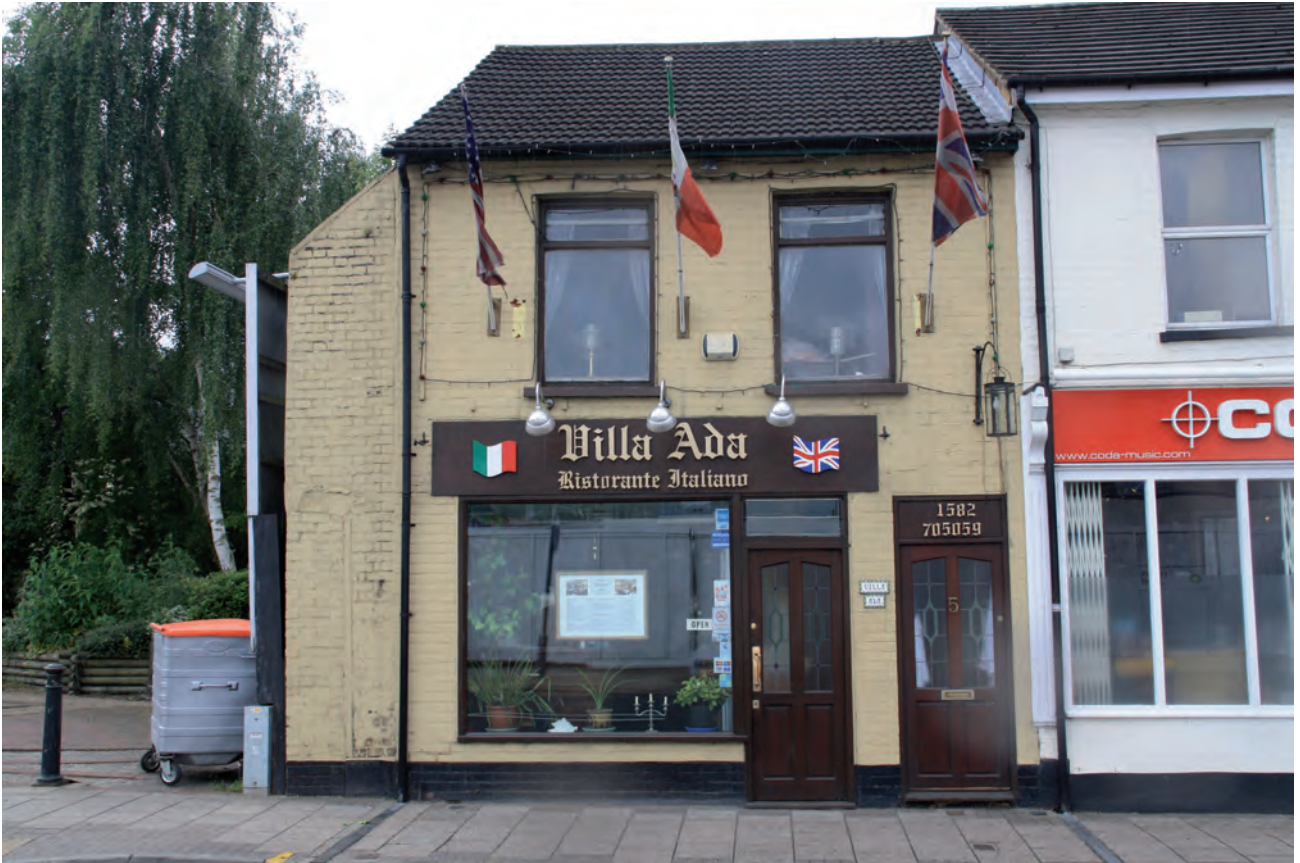
5 Guildford Street is currently at the end of the terrace but three properties to the west (1-3 Guildford Street) have been demolished. A fragment of wall abutting the left-hand gable is all that remains of the rest of the terrace. The house (and terrace) were built in the 1870s. Although now very much integrated with the terrace that extends to the west, discontinuous brickwork between it and 7 Guildford Street indicates that it is a separate build. The original form of the façade has been heavily altered - new doors and window on the ground floor; new window frames on the first floor - but the overall character of the building remains recognisable and is built on two storeys with a large, single, ground-floor window and two smaller windows on the upper floor. Irregular brickwork on the left-hand side of the ground floor window suggests that this is a more recent insertion - probably an enlargement of a smaller window on the scale of those on the upper storey. There are two doorways on the ground floor - one immediately to the left of the large window (and currently the entrance to the restaurant) is the former access to the main house; a second doorway adjacent to the main entrance provides access to a rear courtyard and backyard extension - quite probably a workshop. All of the fixtures and fittings for the windows and doors are modern replacements; the first-floor windows are fixed and each comprises two lights. Exterior paintwork masks other detail but each window has a simple stone or concrete sill and a flat, stone or concrete, head. The current fascia is also a recent addition.

It was recorded as the domestic residence of a Mrs Thompson in 1898 (Kelly's Directory of Bedfordshire, Hunts and Northamptonshire, 1898), and it is entirely likely that it doubled as a domestic straw plaiting workshop.

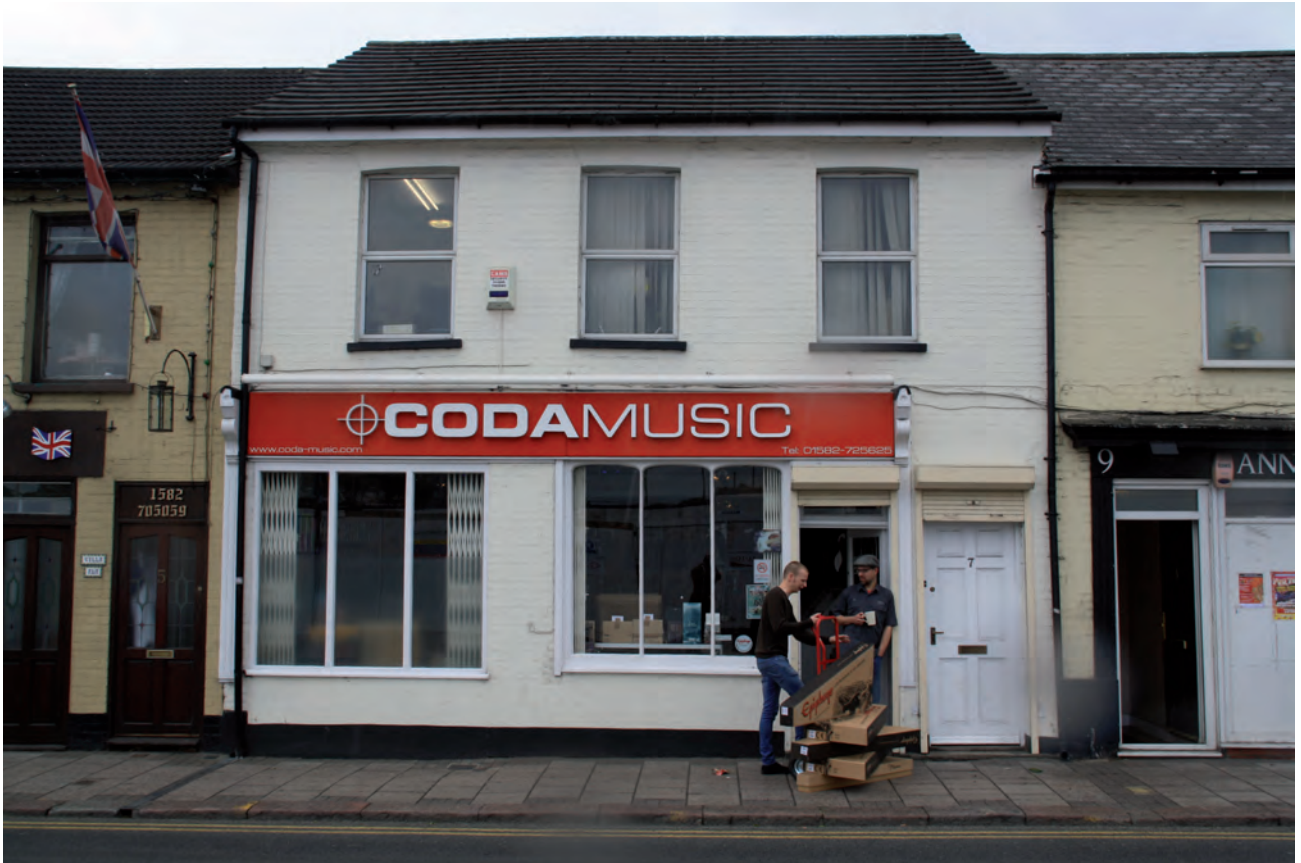
Constructed as part of a terrace in the 1870s, probably as a purpose-built bakery - trade directories indicate that as early as 1898 it was occupied by James Ansell, baker, and remained in use as such until at least the outbreak of the First World War (Kelly's Directory of Bedfordshire, 1914). It is a taller building than its neighbours on either side, and wider too, perhaps reflecting its original commercial usage. It is on two storeys and has two wide windows with two side-by-side doors on the ground floor and three windows on the first floor. The upper-storey windows, which are arranged in a symmetrical manner, comprise two-lights in uPVC frames and each has a simple stone or concrete sill. Although the heads have been painted they appear to be flat (tapered) stone or concrete rather than brick. The ground floor is dominated by two, large, display windows. Alterations to the brickwork indicates that the left-hand window is a more recent insertion and it is wider and taller than the window to its right. Similarly, it has clearly undergone some alteration and the disturbed brickwork visible beneath the sill suggests that it has been reconstructed. Both comprise three lights - that on the left with simple wooden glazing bars (mullions); to the right more complex with narrow wooden glazing bars and shallow segmental heads - with simple wooden sills. The fascia extends over both windows and is framed by small pedimented consoles at the heads of narrow plain pilasters. The main entrance lies to the west this window, with a secondary entrance immediately adjacent to the main doorway providing access to the rear of the property. All the doors and windows, with the exception of the earlier display windows, have been replaced with uPVC surrounds.

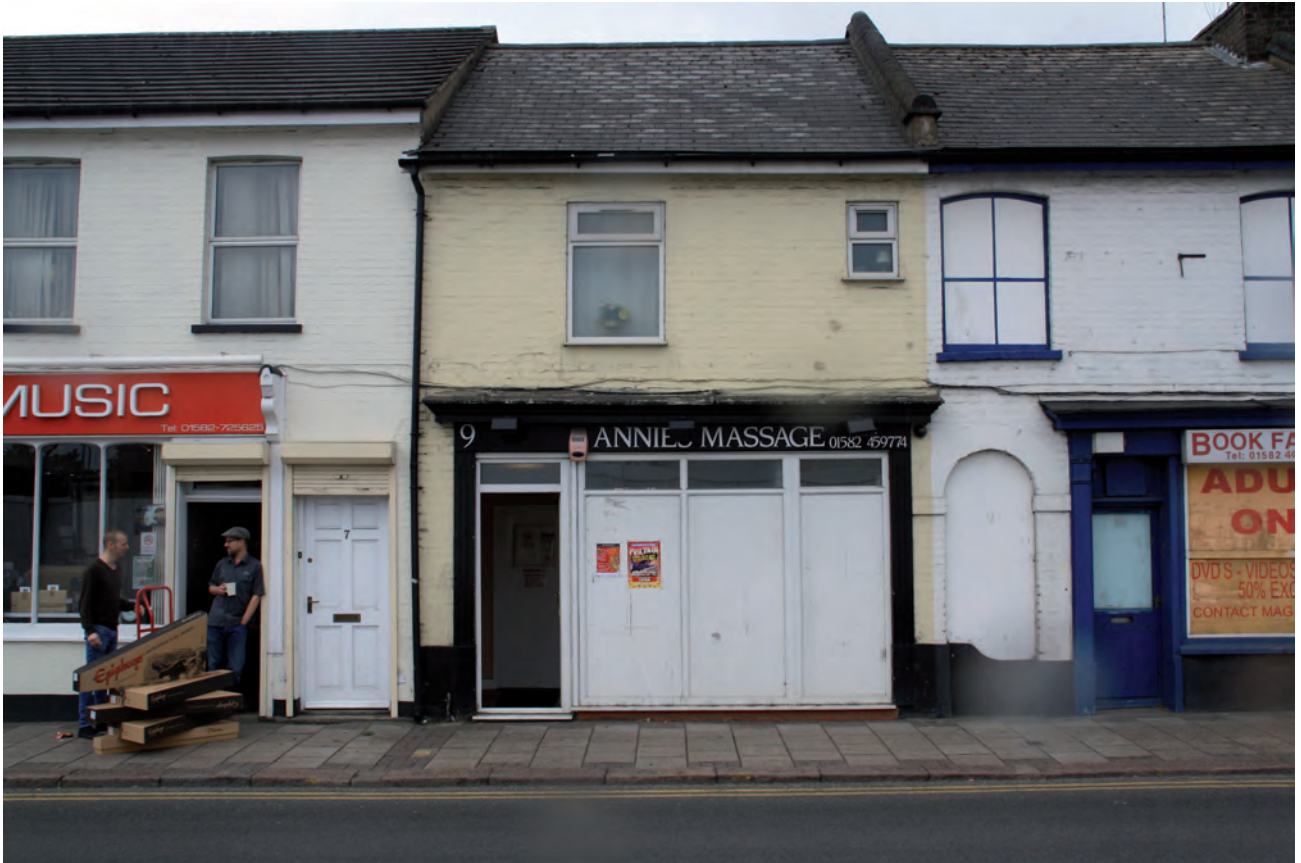
9 Guildford Street is part of a group of three buildings (9-13 Guildford Street) constructed in the 1870s - all three properties clearly having been built at the same time as evidenced not only by the repeating form of the windows but also by the continuous brick coursing and roof height. It is on two storeys with a large ground-floor shop window, now blocked and with a single doorway. The window is currently tripartite but with a wide glazing bar to the right hand light. All are flanked by simple flat, fluted, pilasters with a plain fascia above - an original shopfront. A dramatically projecting moulded cornice completes the ground floor. There are two windows on the upper floor, both uPVC casements, but the irregular brickwork suggests that they have seen much alteration. The smallest, presumably for a lavatory, is a later insertion, judging by disturbance to the brickwork beneath the sill as well as crude flat head above. The larger of the two windows sits eccentrically within the modified opening underscored by the fact that the segmental head is off-set from the current window alignment.

The property was described as being owned by Frank W Harrison and Co, furriers, in 1910 (Kelly's Directory of Bedfordshire, 1910), and has been heavily altered, so much so that the style of the original street frontage, as well as the internal arrangement, is hard to discern.

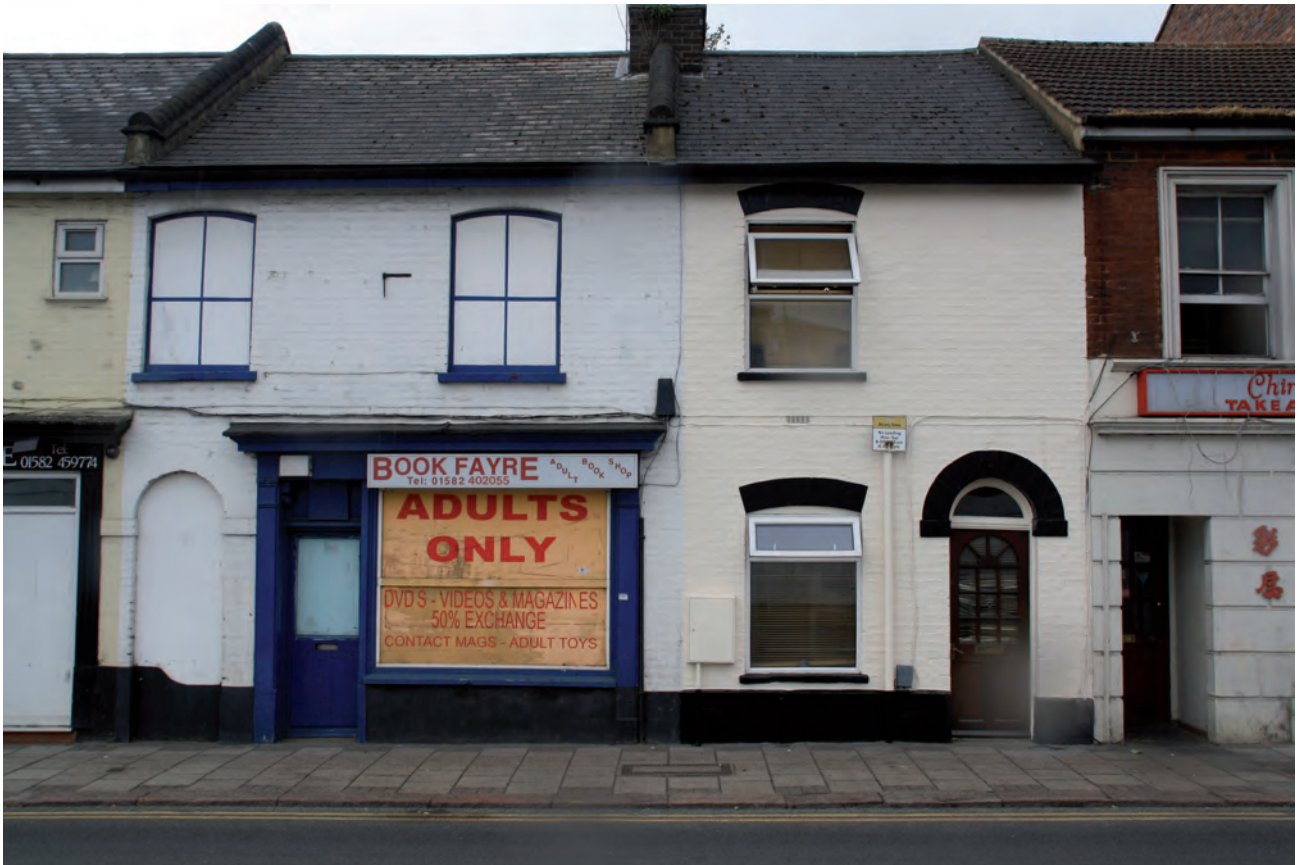
11 Guildford Street was built in the late 1870s, it is built on two storeys with two windows on the upper floor. The façade to number 11 is very similar to that at 9 Guildford Street and consists of a large display window with two entrances (shop and rear access) to the east. The eastern entry, which presumably provided access to the rear of the property, is now blocked but it is a fairly narrow and high portal with a round headed arch resting on top of impost. The shopfront itself has been altered recently but is dominated by a plain fascia and projecting moulded cornice supported by narrow pilasters. The now boarded-up shop window incorporates a low brick stall riser beneath a wooden sill. There are two first-floor windows, each with segmented brick heads and simple stone sills, with one window above the passageway leading to the rear of the property and a second window above the shop window.

Miss Emily Howard, a milliner, resided here in 1903 but it soon changed ownership and was listed as belonging to a shopkeeper in the 1910 and 1914 trades' directories (see, for example, Kelly's Directory of Bedfordshire, 1914).

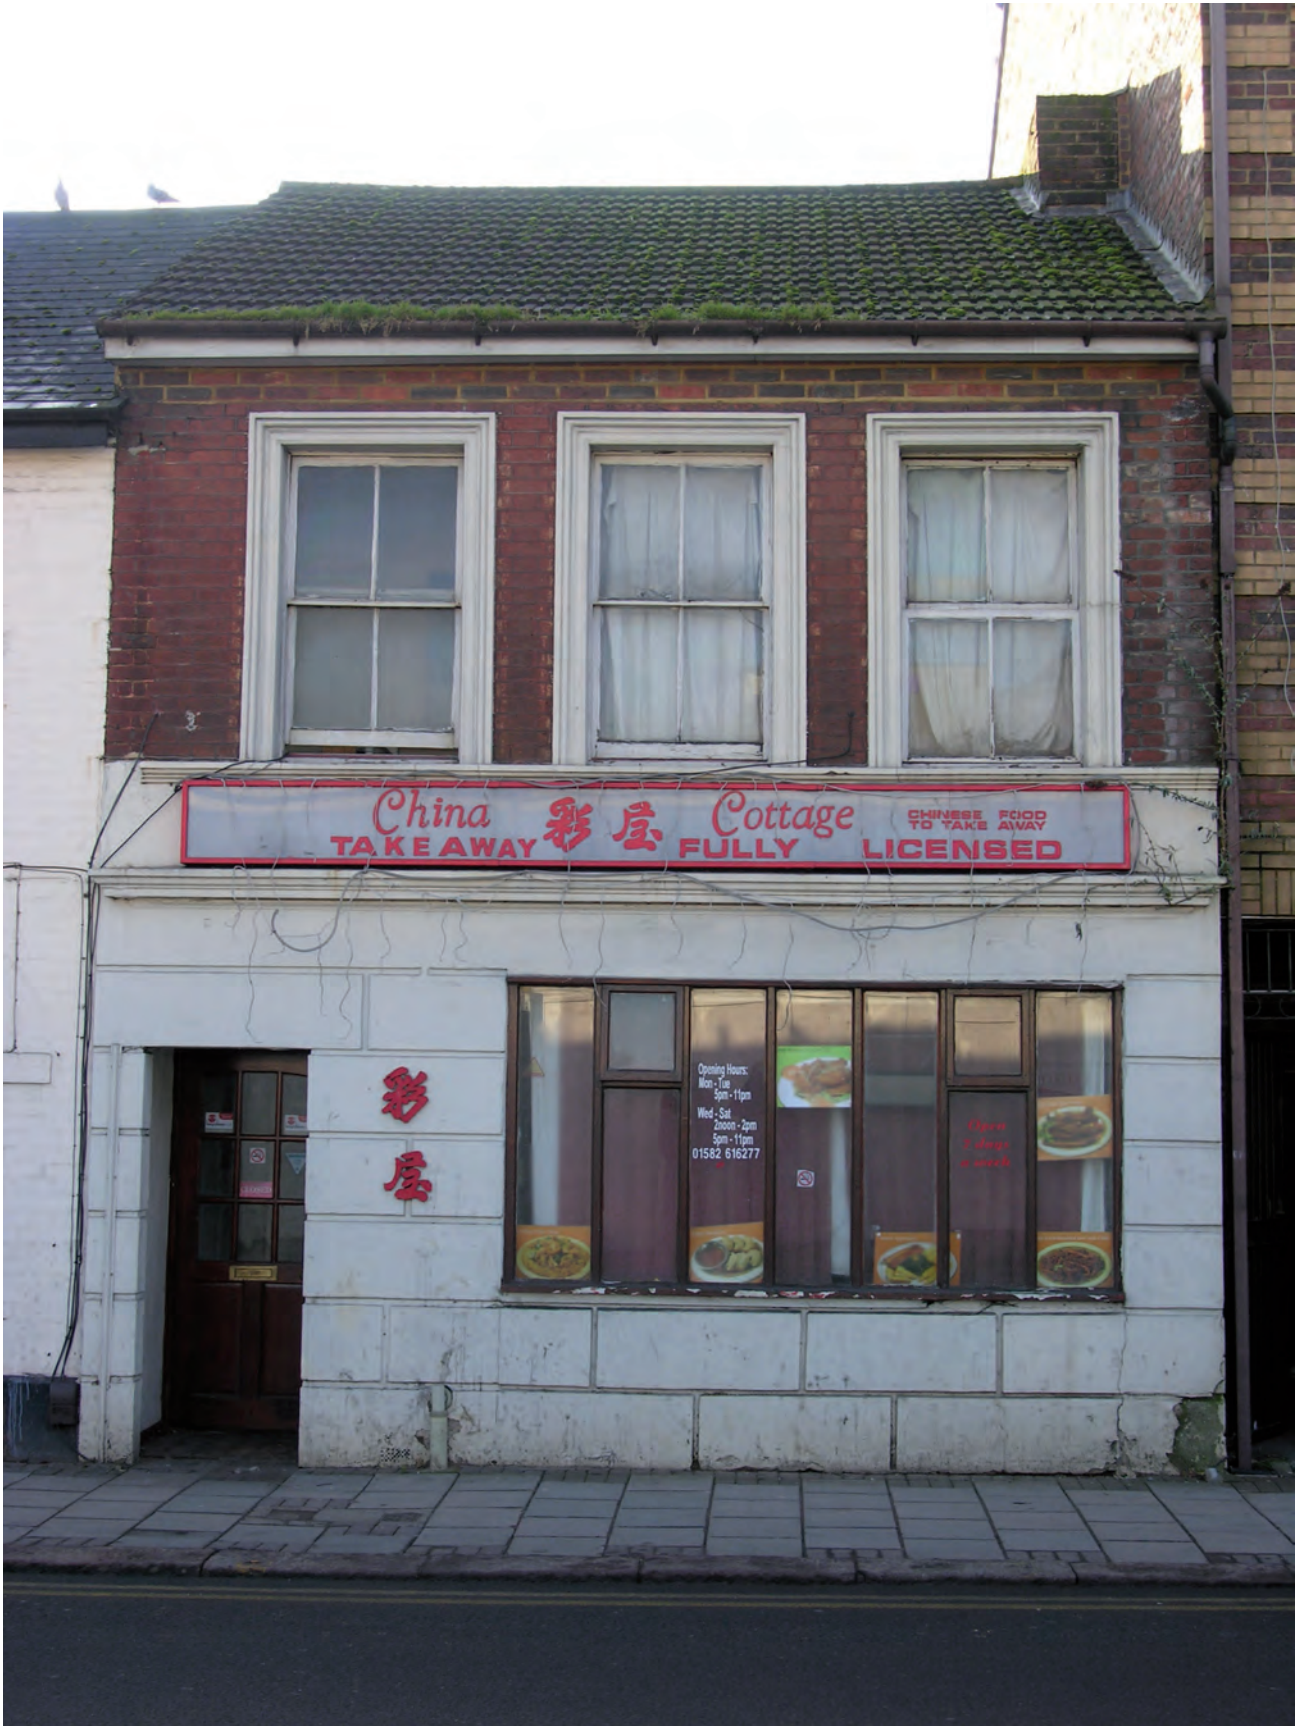
15 Guildford Street is the most substantial and impressive building in this terrace (nos. 9-15). It is built of two storeys: the upper floor has three large balanced sash windows with no horns (two-over-two) set within prominent moulded, wooden, architrave surrounds, heavier and more ornate than those seen in other contemporary and similarly-sized properties in the Conservation Area. Renovation to the brickwork above the windows - there are two heavily pointed courses directly above them - indicates more recent alterations to the cornice and eaves of the building. This may well have included raising the roof to a new height with a lesser pitch: interestingly, this has only affected the front section of the roof as the rear slope corresponds with that of adjacent properties in the row. The ground floor is dominated by a shop window with vertical wooden, glazing bars separating seven lights, and has a recessed doorway to the left. The surround is rendered in heavy, rusticated, concrete with an entablature above. This comprises a wide fascia flanked, above and below, by strong projecting mouldings.

It is now the China Cottage takeaway restaurant but was listed as the premises of a watchmakers in Kelly's Directory for 1903 (Kelly's Directory of Bedfordshire, Hunts and Northamptonshire, 1903).

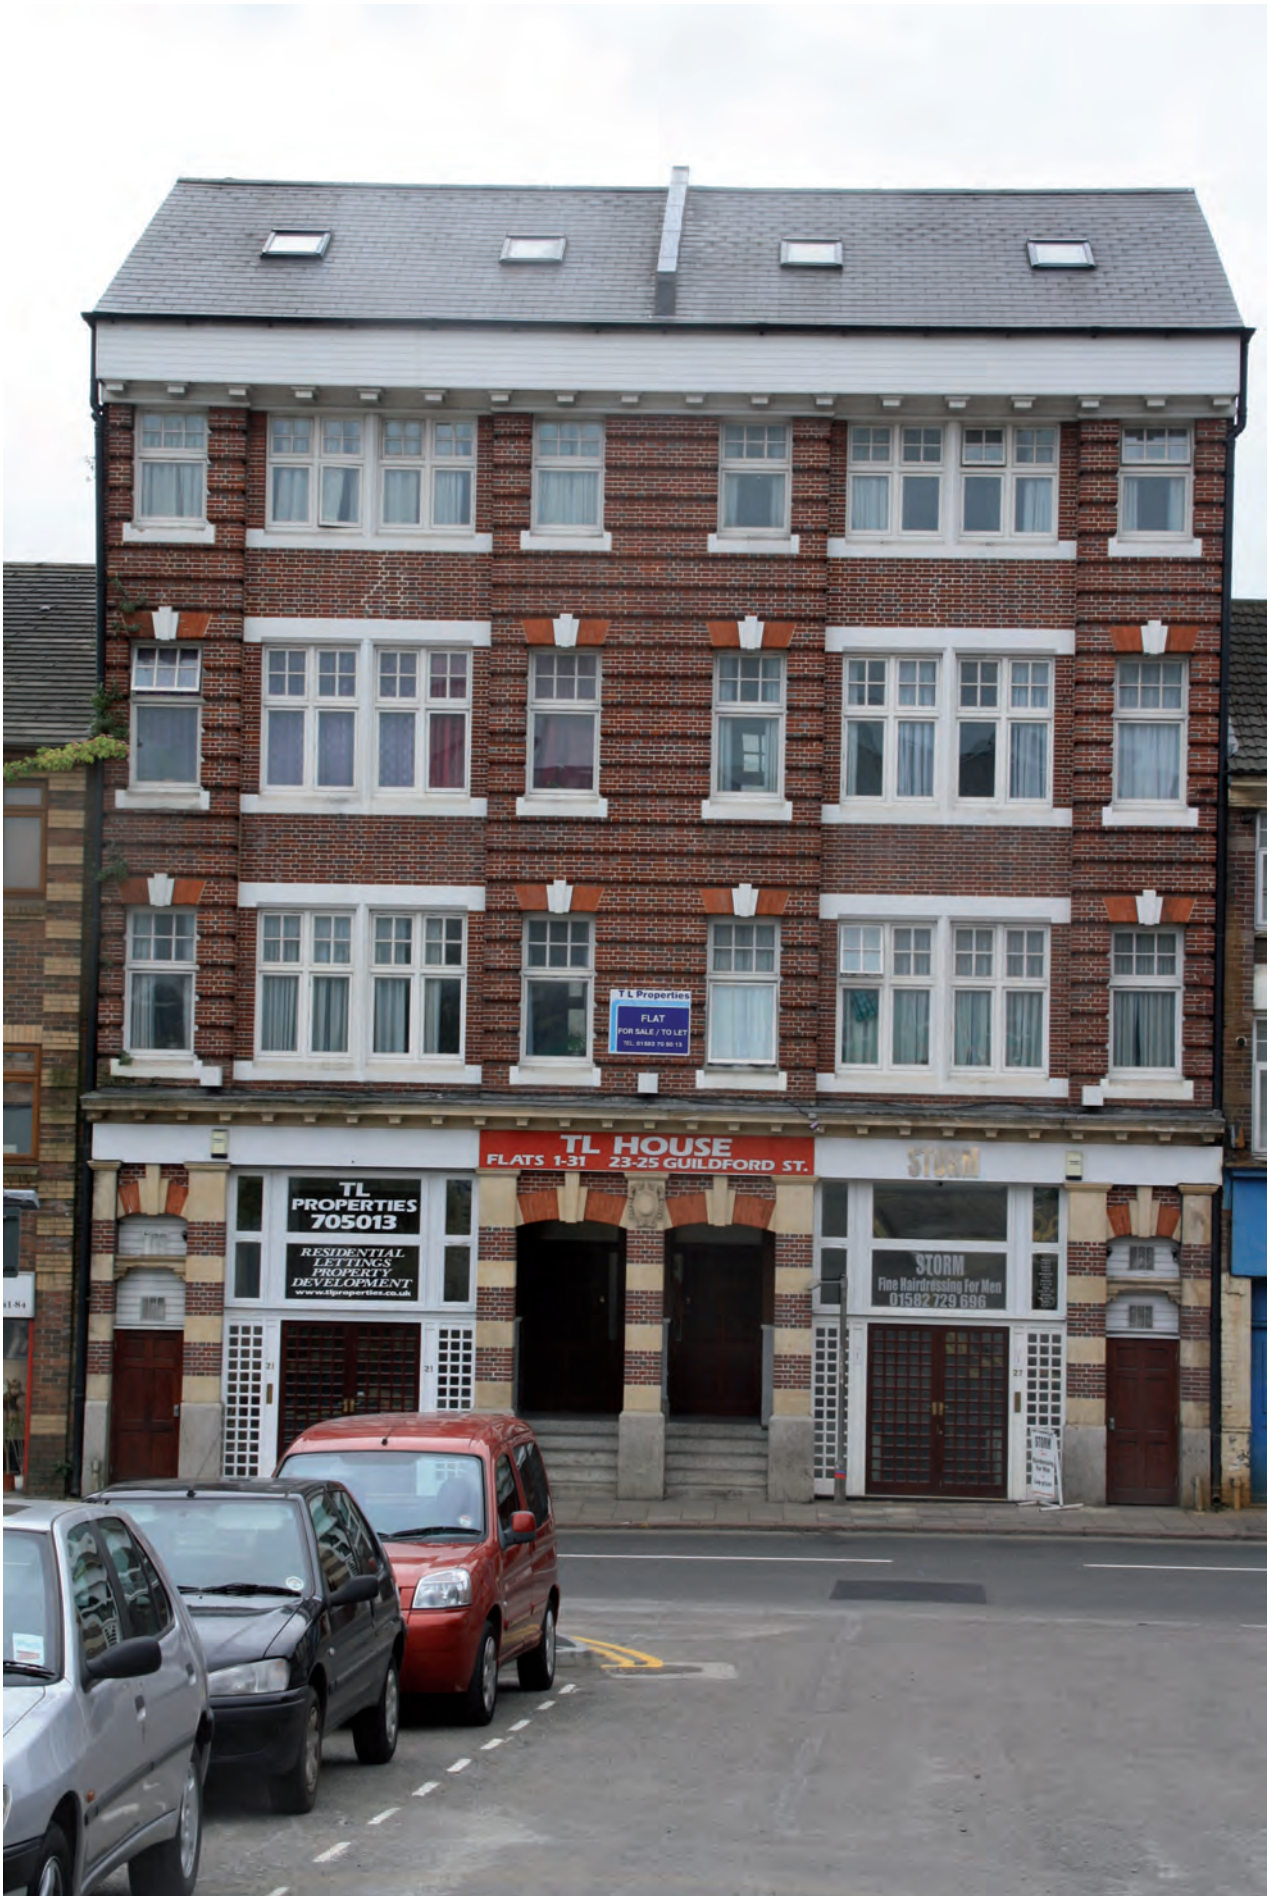
23-25 Guildford Street is another impressive building dating to c.1910-20, comprising two symmetrically-arranged four-storey premises separated by a party wall but covered by a single roof. Of brick with stone and rendered dressings, it has been converted into flats and given a new roof with a high eaves band - this sits rather unhappily above the carefully detailed façade. The extensive use of banded rustication on all floors marks continuity with earlier commercial buildings in the vicinity, although this is now executed in exposed brick and stone rather than white-painted stucco or render. Each property comprises a wide central bay, recessed between salient bays, as at 37-39 Guildford Street. In each case, the centre of the ground floor (now remodelled) may have contained a shopfront or showroom window. On the inner side of this is a doorway - reached by a flight of steps, presumably spanning a raised basement - which would have served the street block. On the outer side, an entry with a transom bar probably accessed the long four-storey factory wings to the rear.

23 Guildford Street was occupied by Down & Pope, straw hat and bonnet manufacturers, in 1910 (Kelly's Directory of Bedfordshire, 1910). Before the reconstruction of the building in the early 20th-century, 25 Guildford Street was occupied by Arthur Trott (Kelly's Directory of Bedfordshire, 1890): in 1910 it was occupied by George Mardling, boot and shoemaker (Kelly's Directory of Bedfordshire, 1910). The first OS depiction of the re-built and extended factory, amalgamating two buildings by this stage, dates to 1921 and Goad 1938 illustrates a large straw hat factory extending to the line of the river Lea conduit on the south.

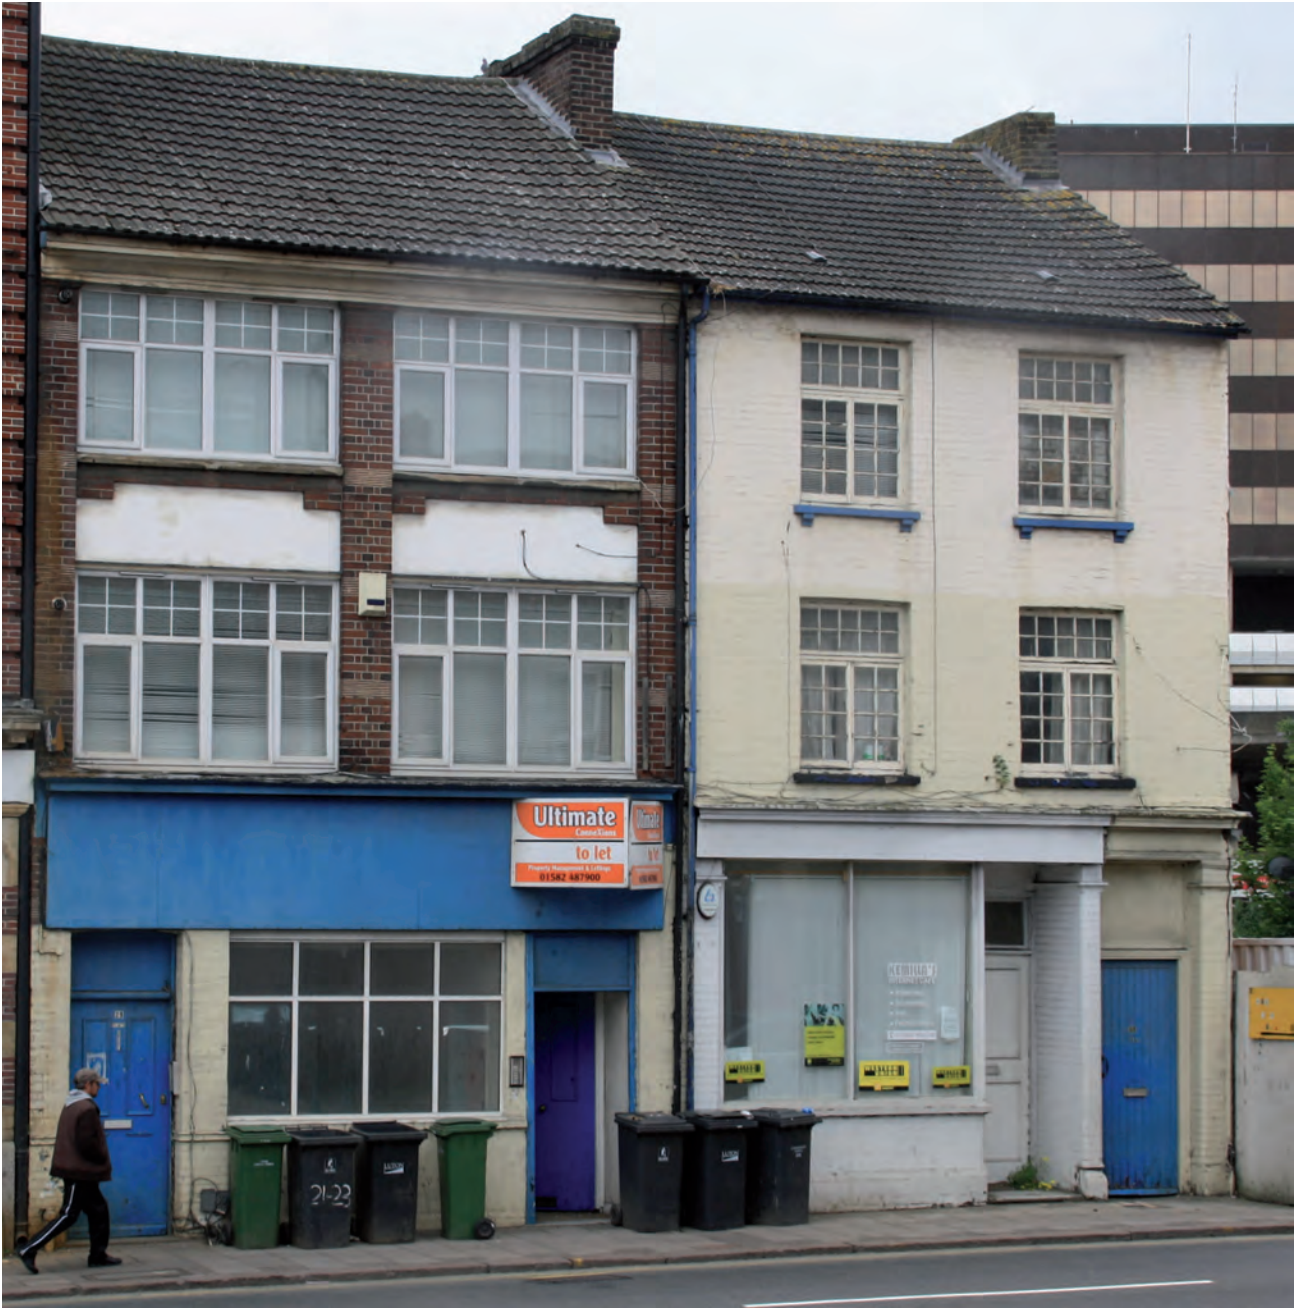
29 (on left of photograph) and 31 Guildford Street are good examples of small-scale production alongside larger premises. They were constructed as two separate buildings, judging by the discontinuous brickwork, but 29 is the larger of the two buildings. 29 Guildford Street is a three storey building, with no apparent basement. The ground floor comprises a relatively small window positioned centrally, which now contains frosted glass and with wooden glazing bars separating four, one over one, lights. The stall riser is rendered and there is a small moulded sill at the junction with the window. There are two doors, one on either side of the window but early architectural features are missing or masked due to recent refurbishment. Nonetheless, the left hand one may well be the original panelled door, which also incorporates a large, rectangular, transom light, flanked on either side by simple brick piers. Detail of the door on the right is hidden by a modern security shutter, but it, too, incorporated a large transom light. This doorway provided access to a substantial rear range, taking up almost the entire plot and stretching back to the river Lea. A large and obtrusive modern fascia hides any earlier entablature. The first and second floors each have two wide bays flanked by brick piers which have been embellished by the incorporation of narrow bands of tiles. The brickwork and mortar is notable as it is similar to that used in the adjacent hat factory (23-25 Guildford Street). The windows on each floor are of a similar form, consisting of four lights each in a four-over-one arrangement. The outer, lower, light in each window opens as a casement but all other elements are fixed. No sills or heads are incorporated with these windows, instead there is a large rendered plain panel above each. The windows on the upper floor are of the same width as those

31 Guildford Street, similarly, is three storeys but the ground-floor arrangement is significantly different. This is dominated by a large two-light display window with a recessed doorway on the right-hand side and another outside of this: the former provided access to the shop and the latter, access the working areas on upper floors and in the backyard. There is no hint on the pavement of a basement and the brick stall riser is capped by the stone sill beneath the window. The recessed doorway incorporates a large, rectangular, transom light and the shopfront is flanked by glazed brick piers capped by a simple moulded cornice. A modern fascia obscures much of the original detail above the shop window but it formerly extended across the entire building frontage. The glazed bricks within the entrance lobby suggest that it was constructed as a grocer's shop. The arrangement of the casement windows on the first and second floors is symmetrical: each window, set within a relatively deep reveal, comprises two casements of eight panes each above which is a light of ten panes. The first-floor heads have been painted over but are flat, gauged, bricks and the sills are narrow, painted, stone or concrete. The second-floor windows are of the same form but the gauged brick heads are narrower and the irregular brickwork at this level, and above, suggests that the wall here has been re-built, perhaps as a result of work being undertaken on the roof. The stone or concrete sills on the upper floor are supported on simple stone brackets.

The properties are both marked as 'domestic' on Goad's insurance map of 1895 but each is depicted with a substantial rear extension. 29 was recorded as a straw hat manufacturer in Kelly's 1903 Directory (Mrs Henrietta Boss); 31 was a shop in same directory (Mrs Louisa Cooper) (Kelly's Directory of Bedfordshire, Hunts and Northamptonshire, 1903). On Goad's Insurance map of 1938, 29 was incorporated as part of the straw hat factory complex at 23-25 Guildford Street; 31 is shown as a plait warehouse with substantial rear extension and another, isolated, plait warehouse at the end of the property alongside the Lea. Both buildings are shown in their present form on the OS 1:2500 town map and stand in marked contrast to the much larger factories and premises on either side of Guildford Road.

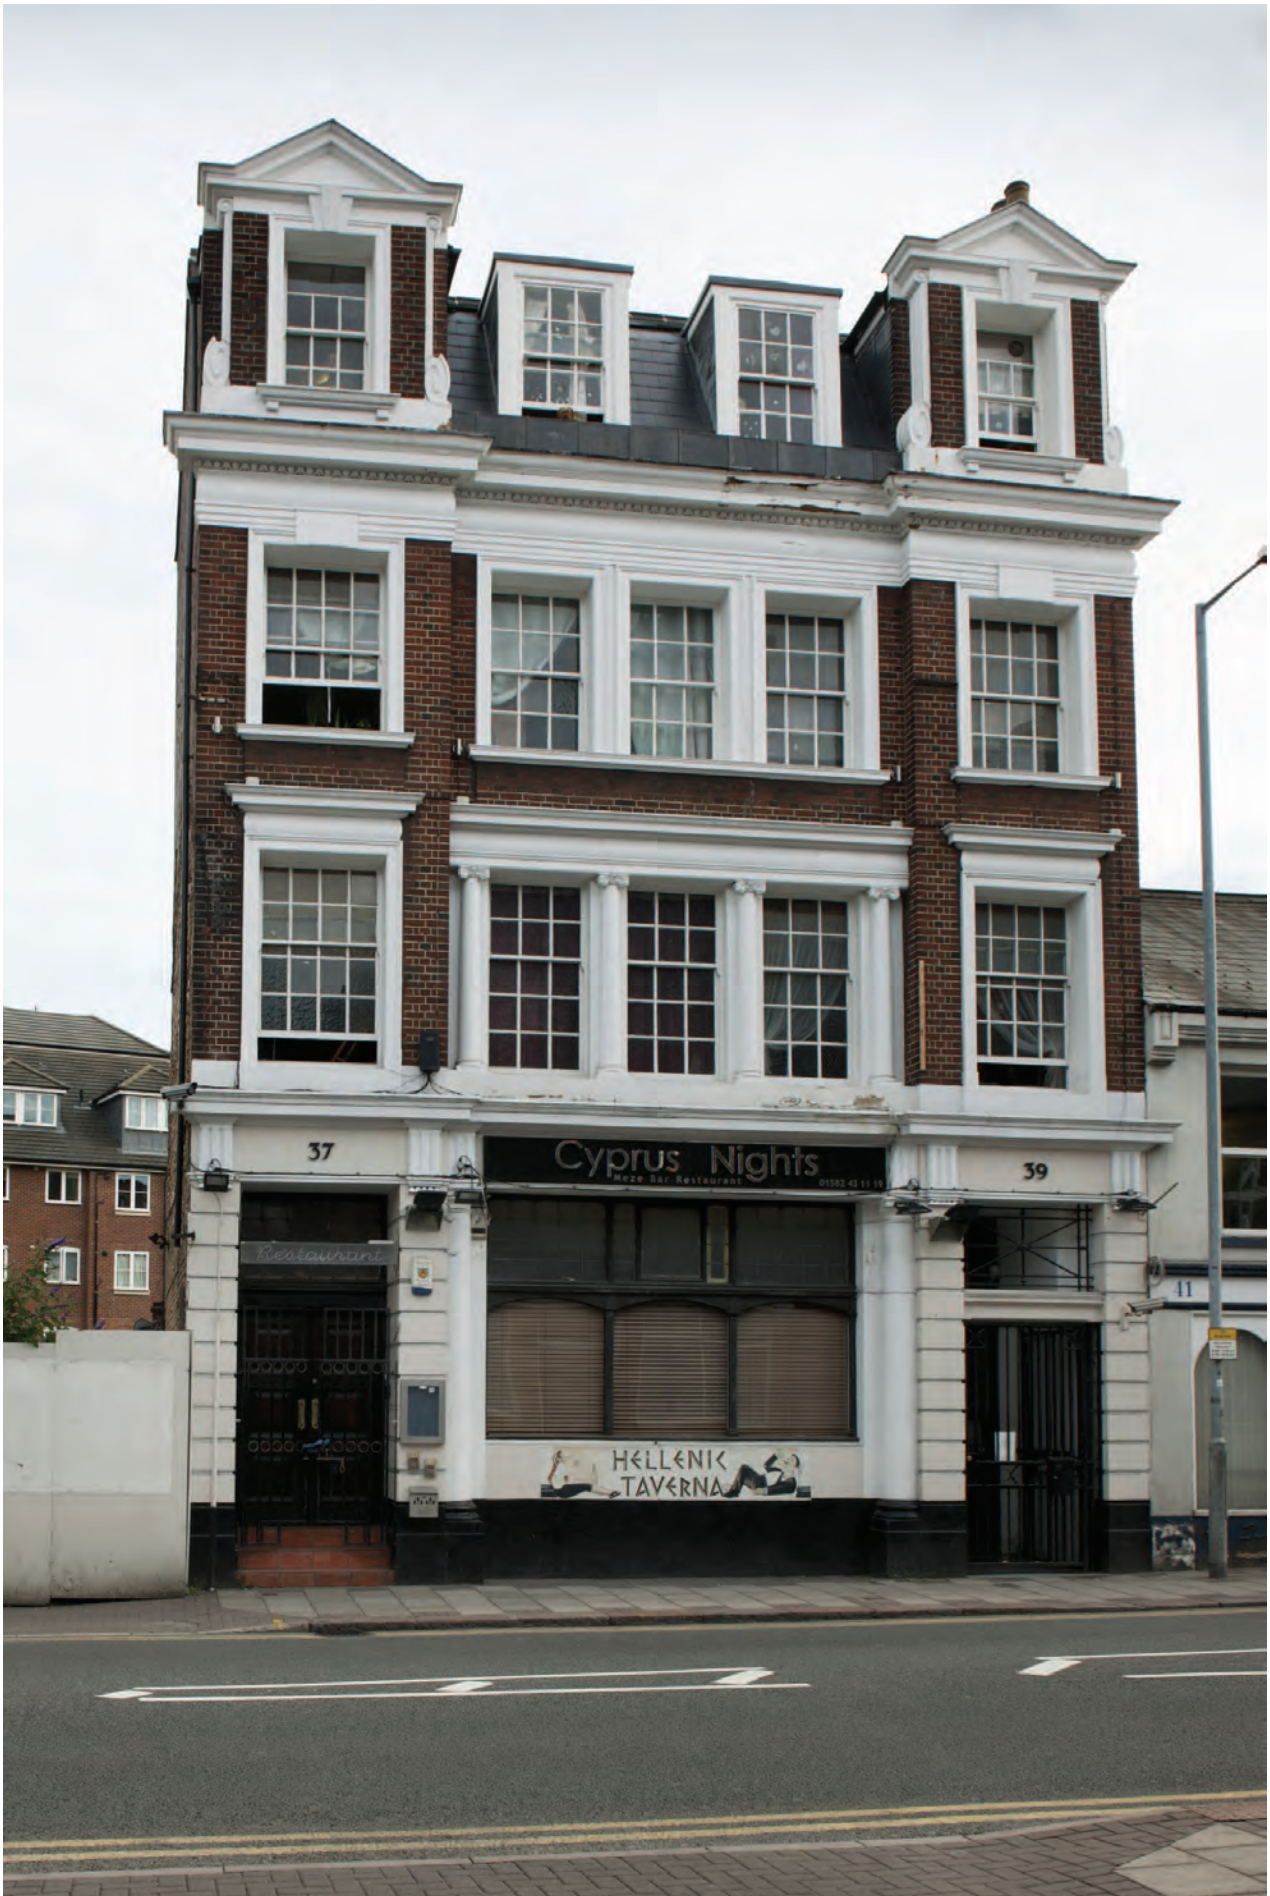
One of the most striking buildings within the Conservation Area is the warehouse and factory built for Austin and Co. at 37-39 Guildford Street in 1912. The style of the street façade - a modified Edwardian Baroque - does not recur on any other building in the Conservation Area. Comprising three and a half storeys, the building is tall and narrow, of brown brick, with white or buff painted dressings and a slate roof. The centre of the façade is recessed between salient lateral bays. At ground-floor level, beneath a plain frieze or fascia articulated by triglyphs, a central show window is framed by engaged Ionic columns and flanked by doorways with rusticated jambs. The doorway to the left gave access to a lobby with stairs and a lift, and formed the entrance to the showroom, while that on the right ran through the front block to the factory at the rear. The upper-floor windows, all sashes, have pulvinated friezes; those in the central bay are treated as triplets, with that at first-floor level flanked by Ionic columns. The roof carries four dormers: the pair in the centre have flat tops, while the outer dormers are framed by volutes, crowned by pediments, and contain windows with prominent stepped keystones. The blind gable ends were originally abutted by other structures which followed the street line. The factory wing to the rear is plain and industrial in character, largely faced in Fletton brickwork, with metal-framed windows. It would not originally have been visible from the street, but is exposed due to the loss of neighbouring buildings.

At the rear of the building, a flat-roofed three storey block abuts the main building on the west. This is of two-bays, with the narrower (and lower roofed) bay on the west. The size and position of the windows suggest that this is probably a stairwell with WCs to the west.

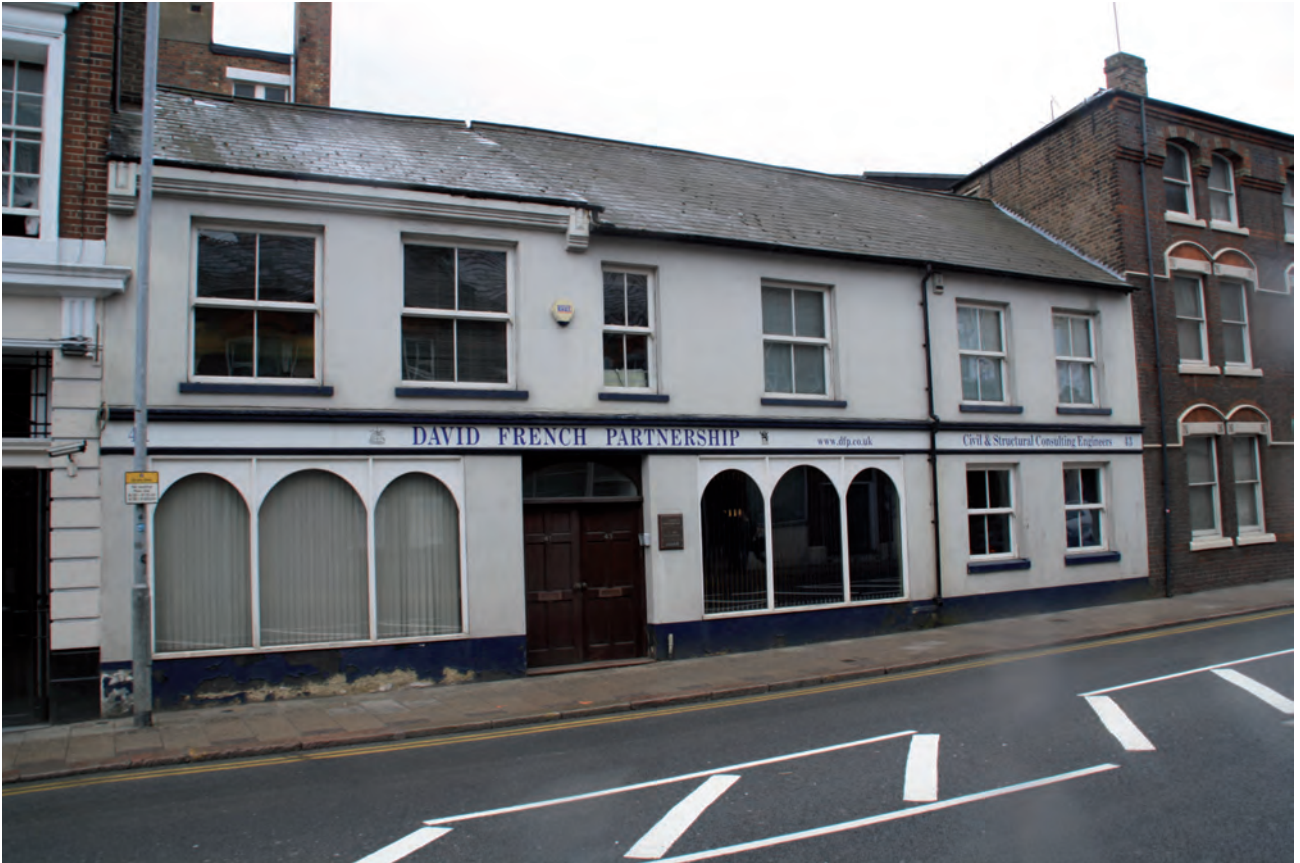
This building is notable on account of the heavy, moulded, projecting cornice above the first-floor windows. The cornice is bracketed by consoles employing the same decorative motifs. The first-floor windows to the middle section of the range, formerly 43 Guildford Street, comprise two sash windows, each two-over-two, that on the left is the narrower of the pair. Again, the window heads are not visible and the sills are narrow in stone or concrete. The first-floor windows to the 1930s extension on the right-hand side of the range are, similarly, simple, two-over-two sashes.

41 Guildford Street has had a varied history - on the Goad plan of 1895 it is noted as a domestic residence. It was the residence of Thomas William Norman, photographer, in 1903 (Kelly's Directory of Bedfordshire, Hunts and Northamptonshire, 1903), and of a straw hat manufacturer, Arthur Woodfield, in 1910 (Kelly's Directory of Bedfordshire, 1910). 43, by contrast, is referred to as a domestic hat factory in 1895 with a rear workshop connected to stables and a large yard too. Cornelius Terry resided here in 1898 (Kelly's Directory of Bedfordshire, Hunts and Northamptonshire, 1898) and Herbert Dimmock in 1903 (Kelly's Directory of Bedfordshire, Hunts and Northamptonshire, 1903), both straw hat manufacturers. By the time of the 1938 Goad insurance map it is shown as a garage with yard to the rear.

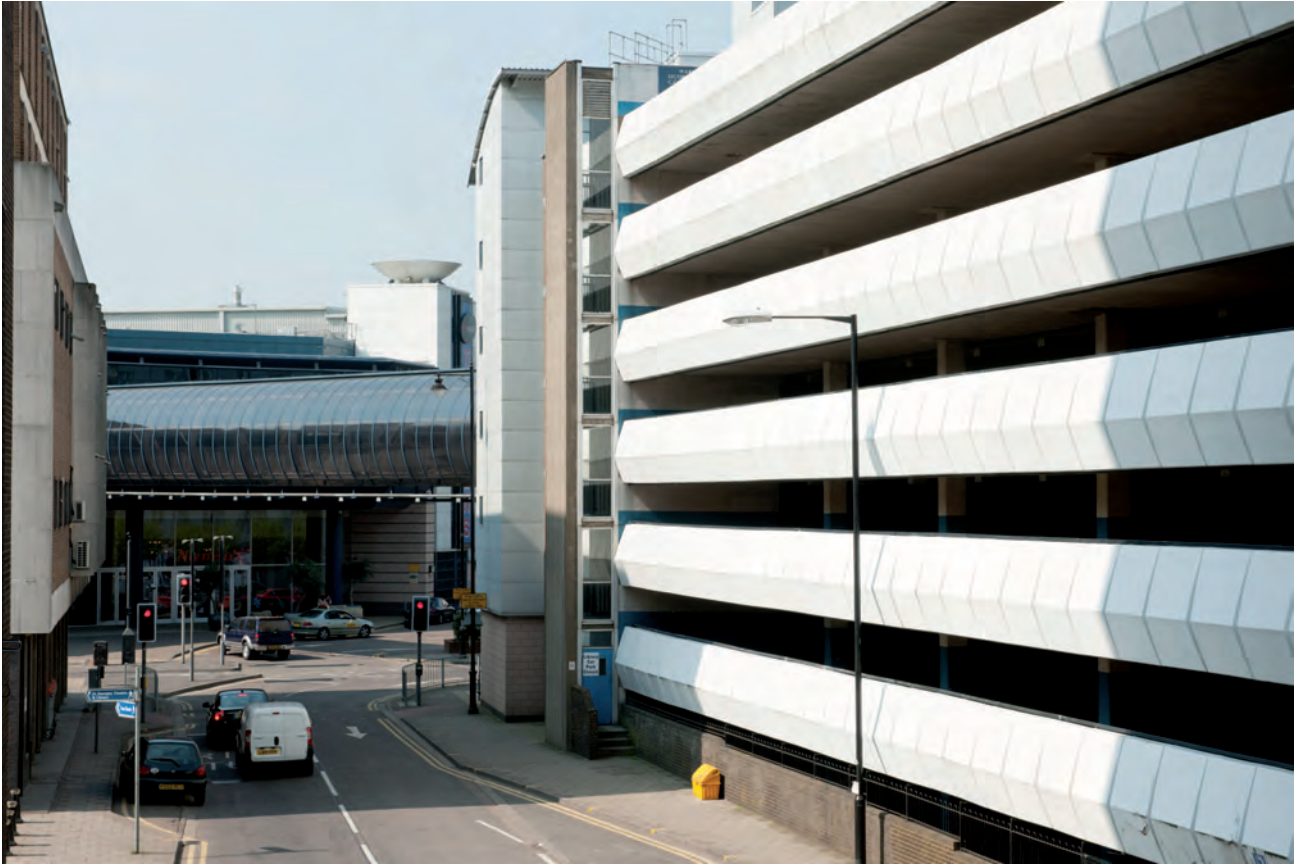
This car park was built on the site of a number of demolished hat factories and domestic workshops, shown on a series of maps from the mid-19th century onwards. The Library Theatre Car Park is a six storey, split level, car park with 12 levels, built in early 1970s and now closed and earmarked for demolition. The heavily modelled V-shaped fibreglass panels to each floor impart a powerful horizontality efficiently punctuated by projecting stair towers, which are glazed on the returns and display deeply incised vertical lines on the elevations facing the street. It is not possible to gain access to the interior. Overall it is an impressive composition, but an out-of-keeping dwarf brick wall is surmounted by equally incongruous, municipal style and rather fussy railings in front of it at pavement level.
