PLAITERS' LEA CONSERVATION AREA, LUTON HISTORIC AREA ASSESSMENT

Research Department Report Series 069-2011

HISTORIC AREA ASSESSMENT

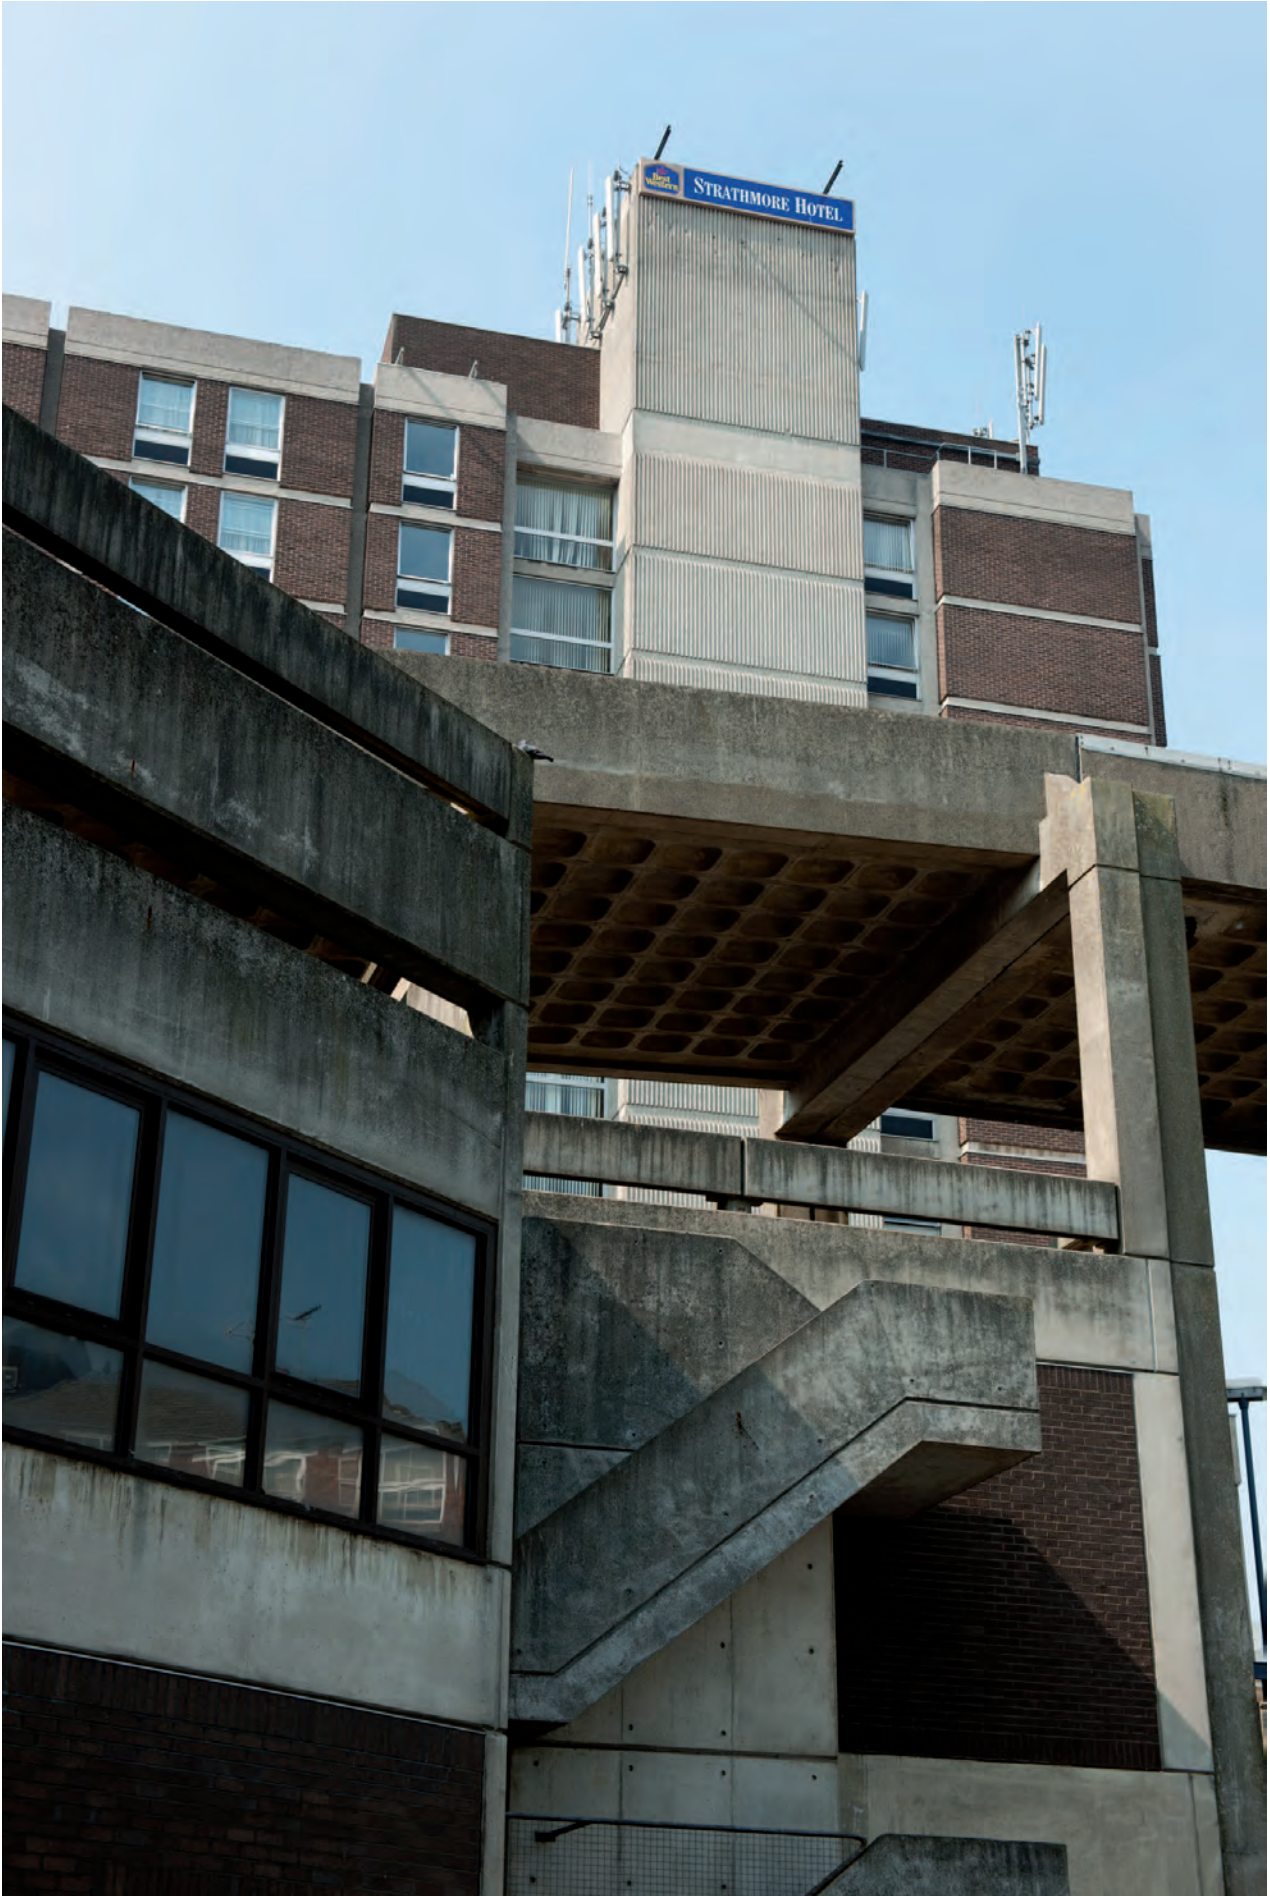
The Armdale covers over 17 acres of Luton city centre at the point where Bute Street, Cheapside, Smith's Lane and Melson Street once met Waller Street. The interior of the mall was specifically related to the previous street pattern. The main mall runs for a quarter of a mile at first-floor level, following the line of Waller Street and is punctuated by four squares: Bute Square, Cheapside/Central Square, Smith's Square and Melson Square, at the points where those roads once met. The mall is accessed from Church Street and Smith's Lane, with secondary entrances at Cheapside, Bute Street and Williamson Street as well as through several of the larger stores along George Street. Directly beneath the mall, at ground-floor level, is a service road which follows the course of Waller Street and is 24 feet wide by 14ft 6 high with access from Melson Street and exit via Library Road.

The overhaul of the Armdale in the mid-1990s had the greatest impact on the structure since its initial construction. The entire roof was replaced - almost doubling the internal ceiling height and admitting natural light for the first time. (Luton Herald, 20th Oct 1994). This was followed by the 75,000 square foot St George's Square extension which opened in 2010 at a cost of £20 million. The Armdale severs the link between the station and George Street, disrupting the historic street plan and dominating the skyline. The northern face of the Armdale is particularly dominant - an almost completely blind wall rising three storeys or more above the conservation area.
