## The Engine House Swindon

### Thermal performance of energy efficiency improvements to timber windows

Research Report Series 002-2017

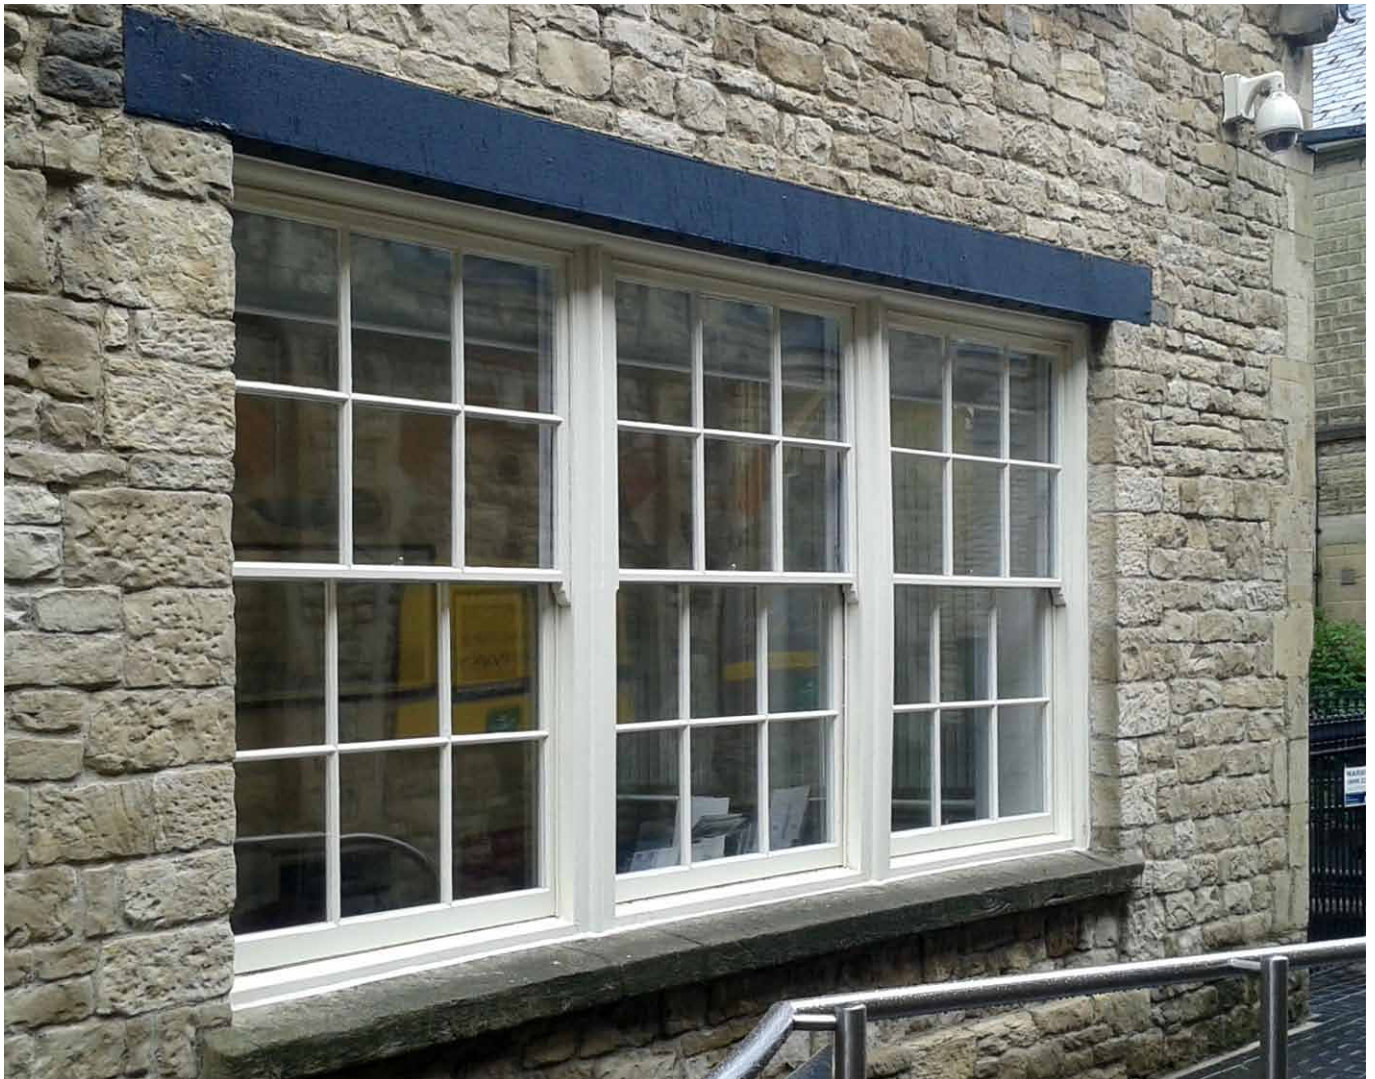
Front cover: Reception Area window after installation of double glazing (at The Engine House, Swindon).

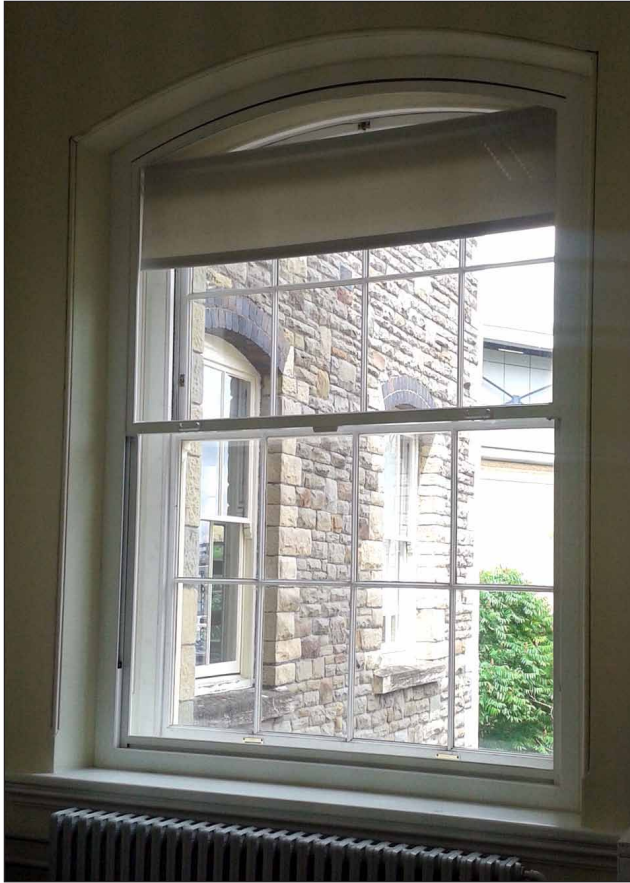
*Figure 3: Typical secondary glazing installation in The Engine House.*

A heavy-duty, aluminium-framed secondary glazing system incorporating pre-tensioned spring-balanced vertical sliding sashes, twin brush draught seals, and low emissivity glass. The frames were polyester powder-coated to match the colour of the existing window frames. Secondary glazed units were fixed to the internal window reveals some 75–100 mm behind the existing windows (Figures 2–4).

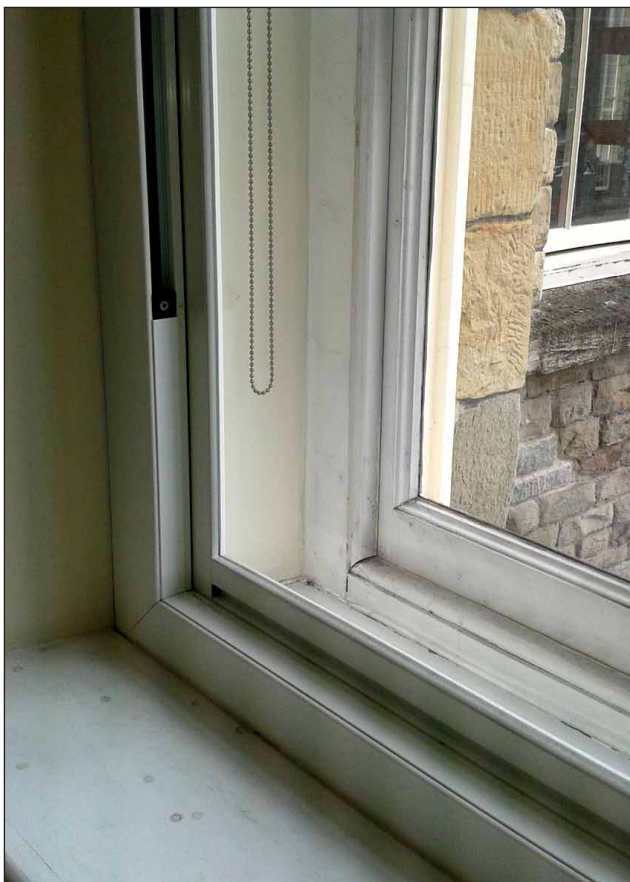
*Figure 4: Typical secondary glazing installation – detail at sill level.*

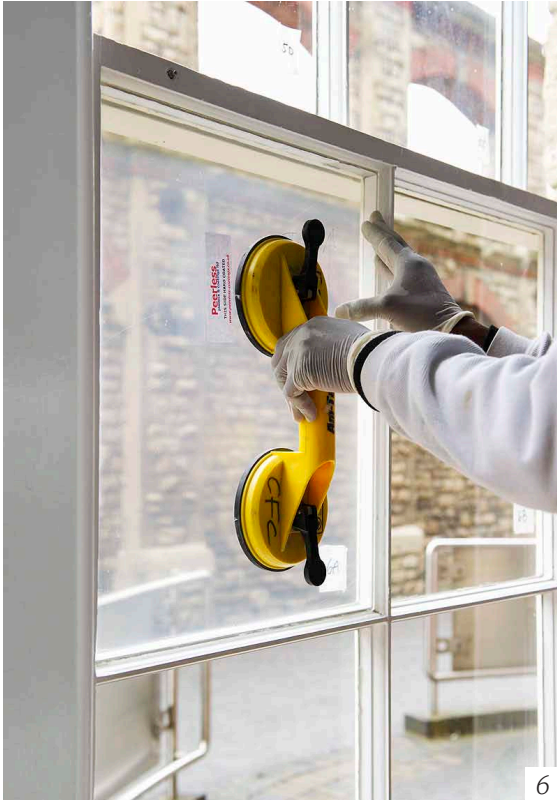
*Figure 6: An acrylic pane being fitted between the glazing bars of the original window.*

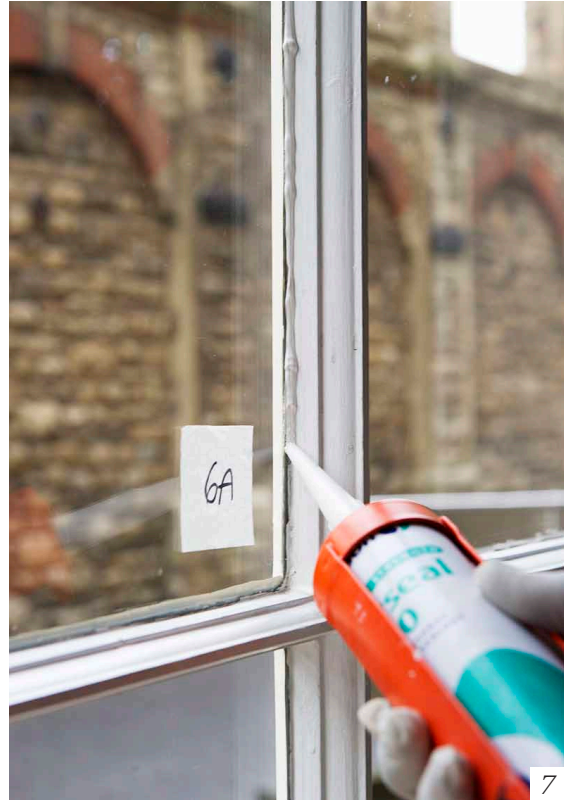
*Figure 7: The application of butyl mastic sealant to the glazing bars prior to the fitting of the acrylic pane.*

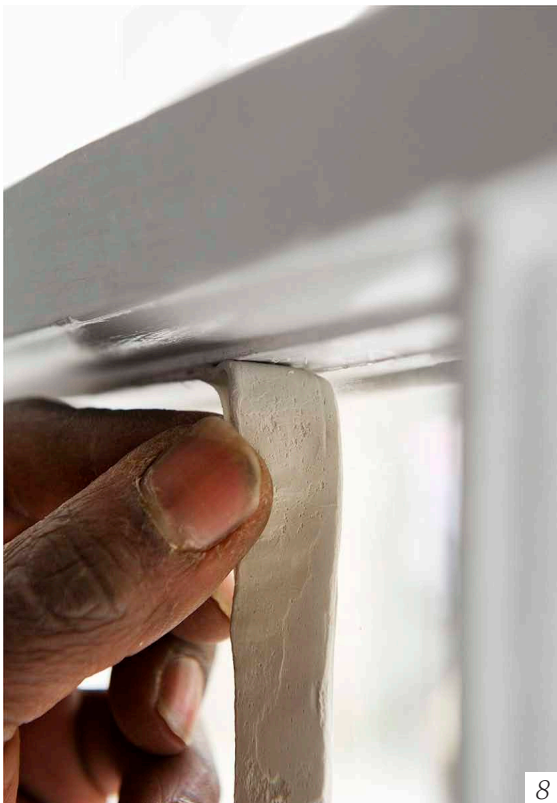
*Figure 8: The application of the desiccant strip between the two panes to aid the control of humidity.*

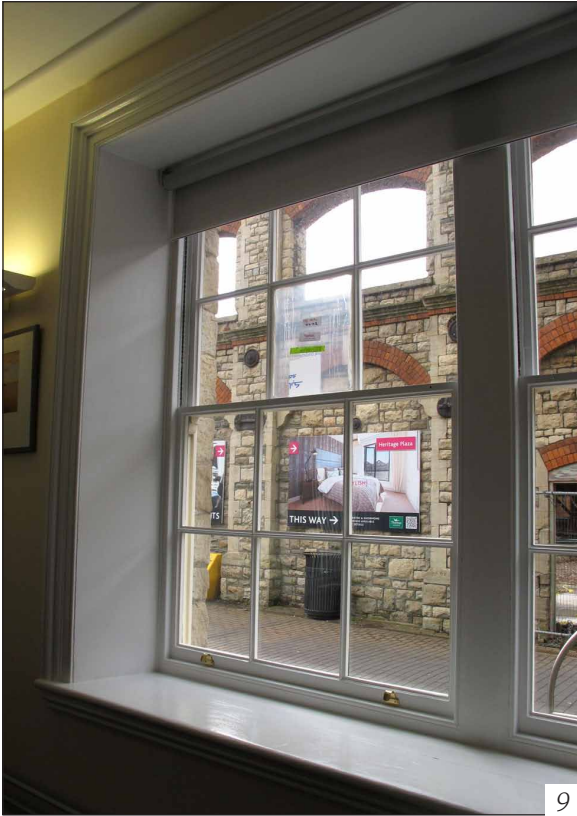
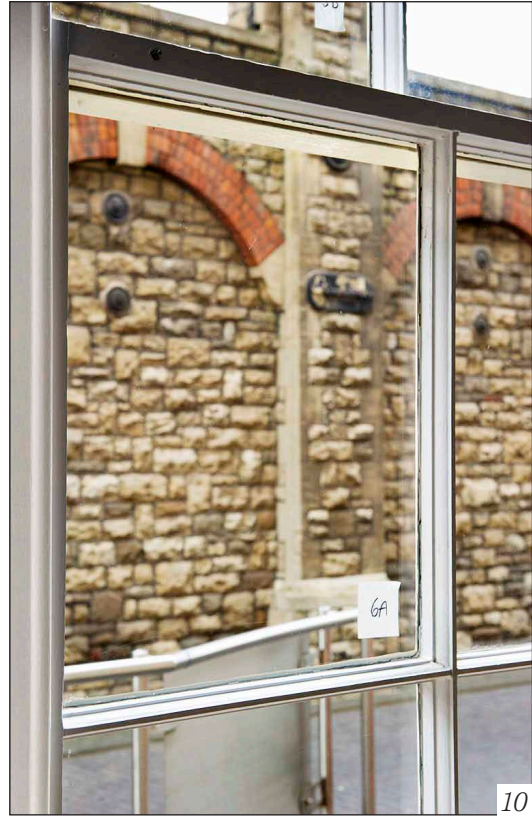
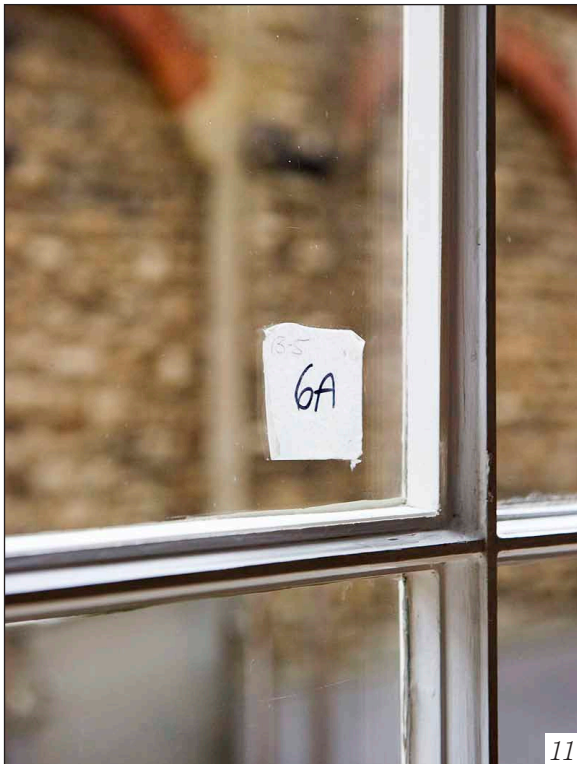
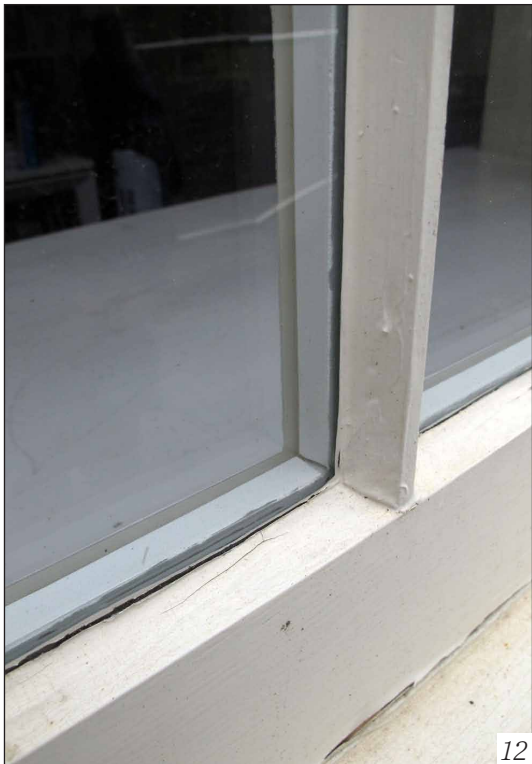
Figure 9: Reception Area windows after installation of double glazing system.  
Figure 10: Typical window pane before installation (interior view).  
Figure 11: Typical window pane after installation (interior view).  
Figure 12: Interior of the Reception Area window after installation.

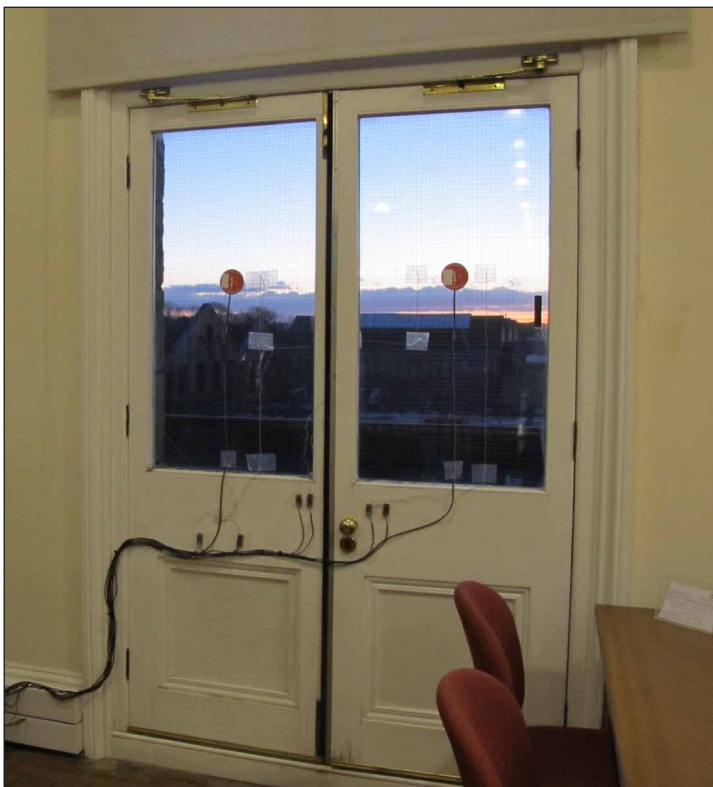
*Figure 15: In-situ U-value measurements of the double doors in the Public Search Room before installation of the 'breather' double glazing system.*

The three monitored locations were: Room 1/24 where a secondary glazing system was installed; the ground floor Reception Area where the 'Conservation Glazing' double glazing system was installed (Figure 14); the Public Search Room where the breather system of 'Conservation Glazing' double glazing was used for the large panes of glass on the double doors (Figure 15).

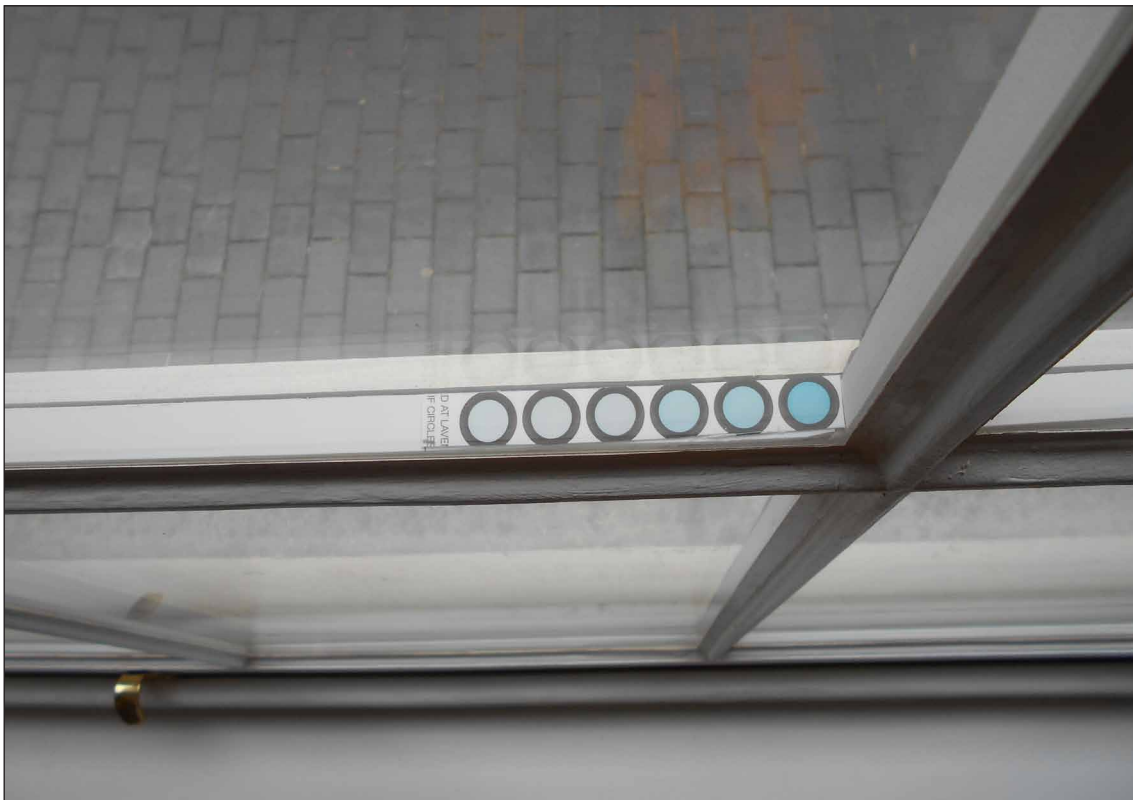
*Figure 16: A humidity card inserted between the original glazing and the acrylic pane of the double glazing system in the ground floor reception area.*

In addition, humidity cards were inserted between the original glazing and acrylic panes of the two 'Conservation Glazing' double glazing systems to assess the performance of the desiccant strips (Figure 16).

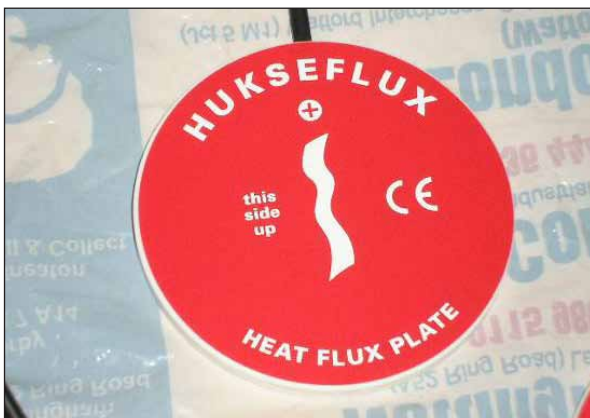
Figures 17 and 18: © Dr Paul Baker, Glasgow Caledonian University.

Hukseflux Type HFP01 heat flux meters were used to measure the heat flow through the selected glazing (see figure 1). They are 5mm thick and 80mm in diameter. Two heat flux sensors were used for each window. They were mounted on the panes of glazing in the interior with double sided tape. In addition, surface temperature measurements were taken with type-T thermocouples of the glazing, one on the exterior pane of the window and the other on the heat flux sensor. A third thermocouple was attached to the interior pane of the window as an additional check. The thermocouples were affixed to the glazing with transparent tape.
