Inspecting historic fibrous plaster ceilings

The risk of collapse of fibrous plaster ceilings is being addressed by a review of current practices throughout the theatre industry.

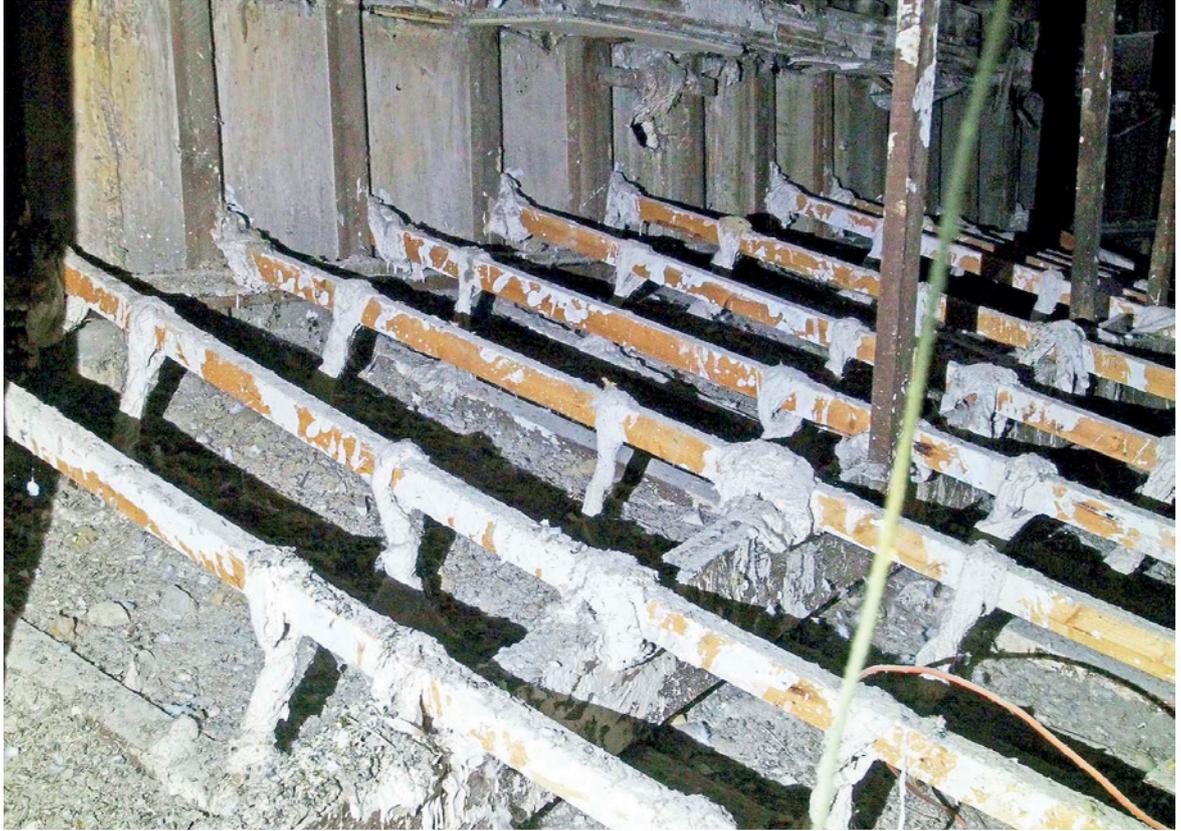
The void over a fibrous plaster ceiling, showing the fibrous plaster panels fixed to the original timber structure (below), with new reinforcement wads attached to new timber (above)
(Photo: Richard Ireland, © Historic England)

Fibrous plaster is composed of gypsum plaster reinforced with sheets of hessian and timber. Its advantages were numerous: relatively light in weight; cheap to produce; fabricated off-site; and quickly installed. Fibrous plaster ceilings were either fixed (nailed directly to the structure or on to an intermediate timber system); or suspended (secured by means of ‘wads’ of hessian and plaster, sometimes reinforced with wire, to a framework of timber battens fastened to the structure).

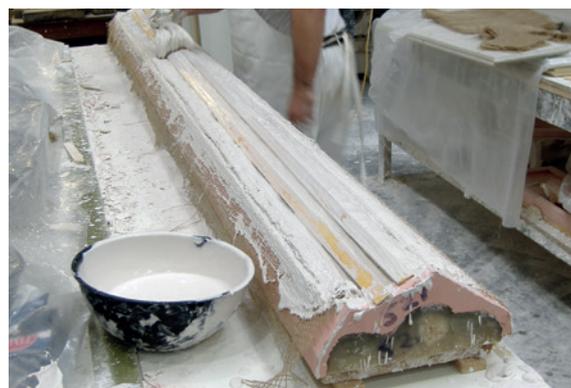
Fabrication of a new fibrous moulding, consisting of layers of plaster and hessian, reinforced with timber battens (Photo: John Stewart, © Historic England)
