Case study for Heritage Counts 2015

Theme demonstrated by case study:	Supply of stone roof slates
Name of project/group:	Reroofing of Apethorpe Palace and other projects
Location:	North Northamptonshire and surrounding area
Duration (if applicable):	2013 onwards

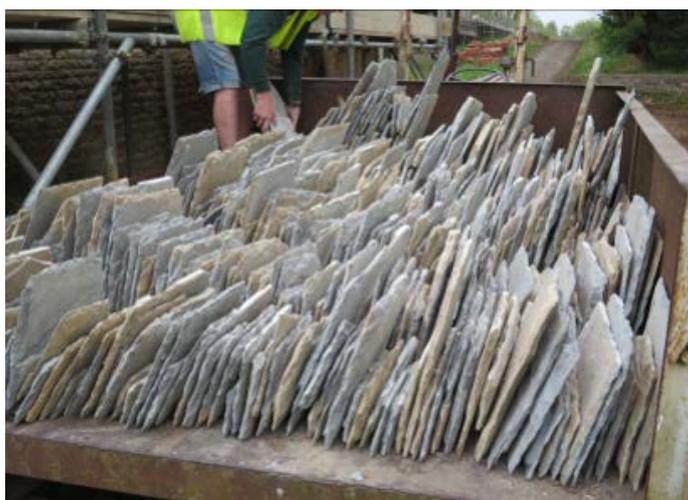
New Collyweston slates awaiting laying at Apethorpe Palace (Nick Hill, Historic England).

As a result, 96 square metres at Apethorpe Palace have been successfully reroofed, and the new slates are performing well.

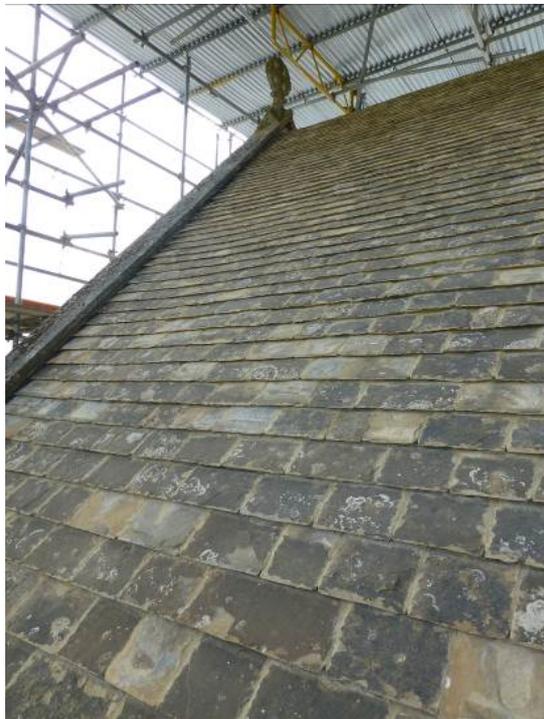
Left - St Andrew's Church, Ufford, near Stamford, during re-roofing.

Apethorpe was not the only site where the new technique has been successfully deployed. The Churches Conservation Trust have re-roofed part of Ufford Church, Cambridgeshire with the new slates. Wycombe District Council turned to Messenger for Collyweston slates for a successful repair scheme to the former Town Hall at High Wycombe, requiring 135 square metres of new slate.

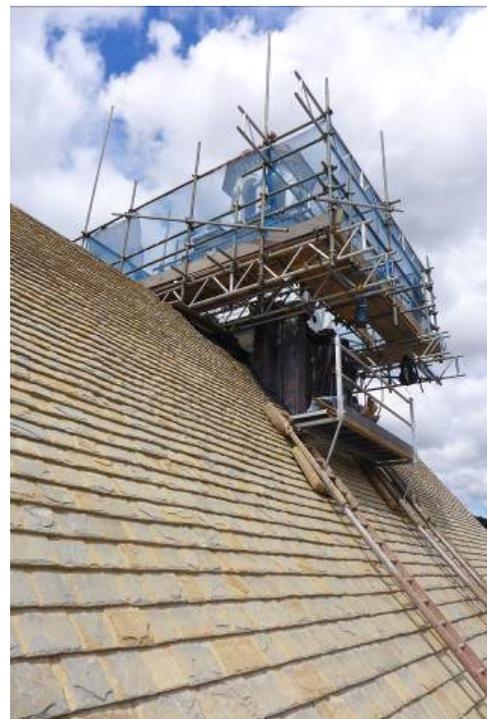
(Photo: Churches' Conservation Trust). Right - Former Town Hall, High Wycombe (Photo: Oxley Conservation).
