# Conserving Historic Water Meadows

# Summary

Historic England 2017 Conserving Historic Water Meadows. Swindon. Historic England.

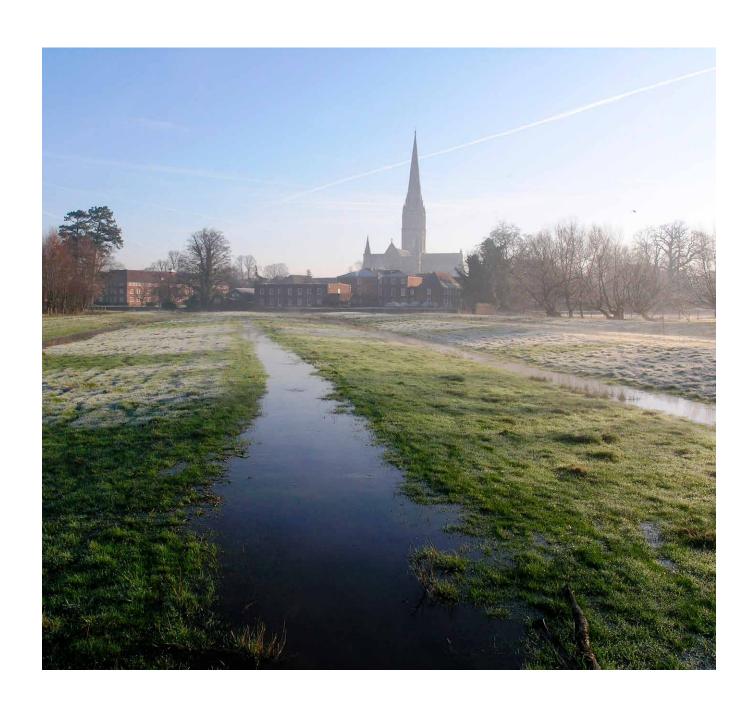
**Front cover:** Drowning of Lower Seven Acres at Harnham water meadows near Salisbury in February 2008. Note the element of protection from frost afforded by irrigation.

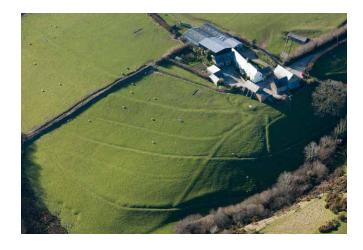
# Figure 1 (top)

Catchwork meadows such as these at Clogg's Farm on Exmoor are evident as parallel channels ('field gutters') on hill slopes. They follow the natural contours roughly, dropping down just slightly to allow water to flow along their courses.

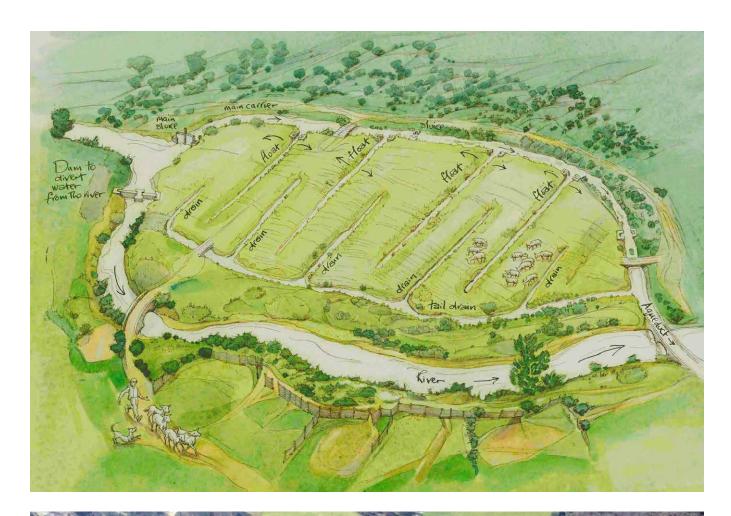
Figure 3 (top)
Artist's reconstruction showing a simple bedwork water meadow.

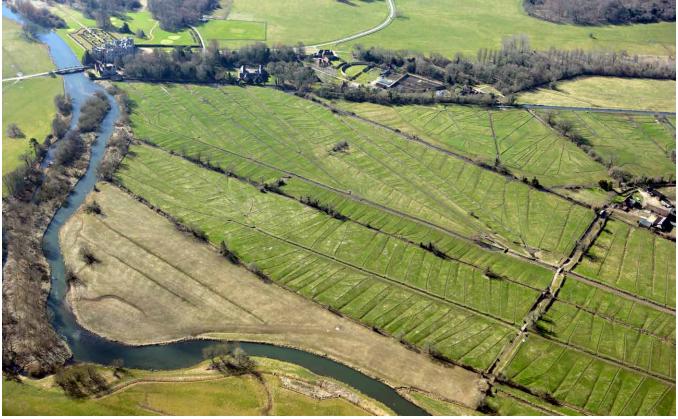
Figure 4 (bottom) Elaborate bedworks by the River Avon, Alderbury near Salisbury.

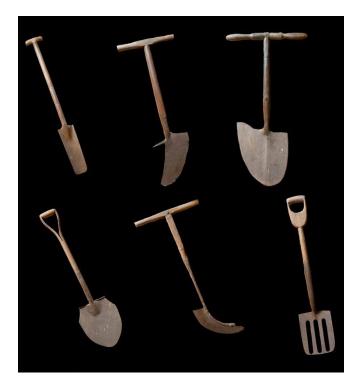
### Figure 5 (top)

Drowners' tools displayed at Breamore Countryside Museum, Hampshire.

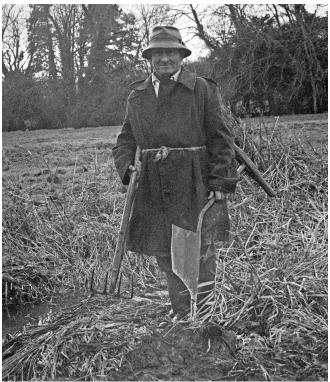
# Figure 6 (bottom)

Maintaining and working water meadows was a skilled art and water meadow drowners enjoyed a high status amongst farm staff. This photograph shows Mr Bill 'Barleymow' West, the drowner at Lower Woodford, Wiltshire, in the early 20th century. He is holding the tools of his trade – a cutting knife for trimming channels and a 'gravel' for removing rushes and reeds once cut.

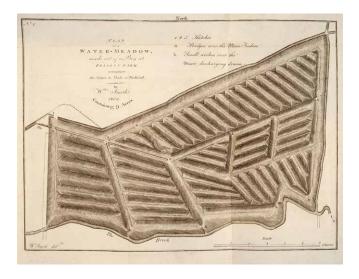
# Figure 9 (bottom)

The Agricultural Revolution saw English wetlands turned into productive fields and pastures. At Prisley Farm, Bedfordshire, William Smith worked for the Duke of Bedford, transforming boggy ground into water meadows.

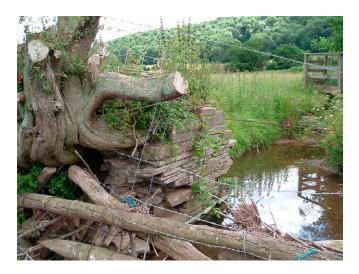
Figure 10 (top)

Removing trees, a first step towards conserving sluices, Turnastone Court Farm, Herefordshire.

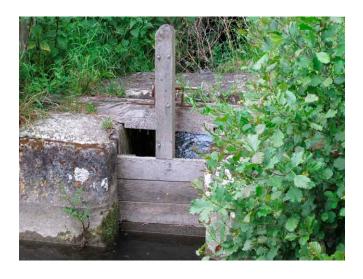
# Figure 12 (bottom)

Simple hatches, like this restored example at Harnham, controlled the flow of water.

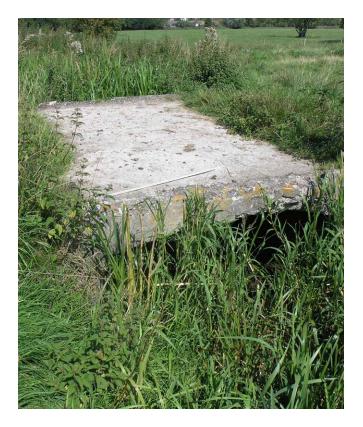
Figure 13 (top)
Victorian concrete bridge providing access for hay-carts at Harnham.

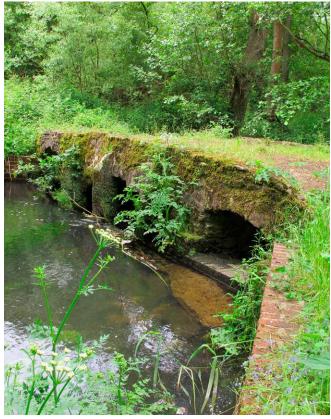
# Figure 14 (bottom) Bridge saved from collapse by the River Wey Trust.

Modern extensions prevent river erosion.

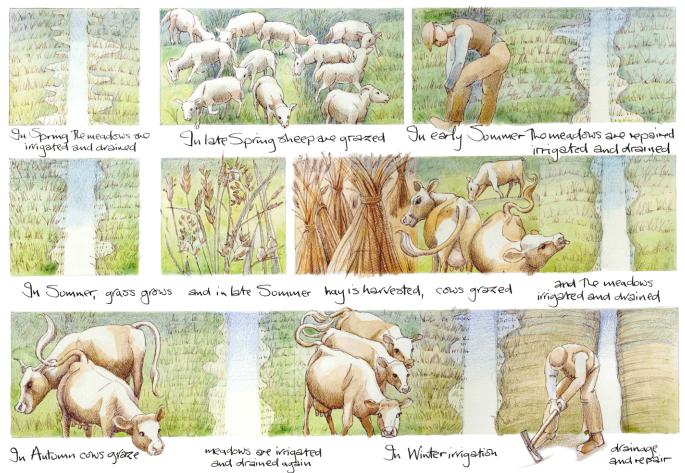
Figure 15

The precise methods of irrigation followed and their timing varied according to local circumstances. The reconstruction drawing shows a typical year in the water meadows, as advocated by William Smith in his 'Observations on the Utility, Form and Management of Water Meadows, and Draining and Irrigating of Peat Bogs',

published in 1806. Winter irrigation produced an 'early bite' for sheep, before grass was available elsewhere. The sheep came off the meadows in May to avoid contracting liver fluke and foot rot. Further irrigation in late spring made two or more hay crops possible, following which cattle grazed on the aftermath.

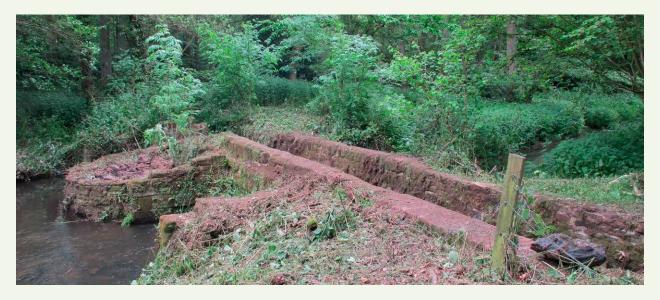
Figure 16
Aqueducts carried water through narrow sections of the Wey Valley, allowing its water meadow systems

to function in difficult topography. This example at Bramshott Court, was one of several connecting water meadows on either side of the Wey.

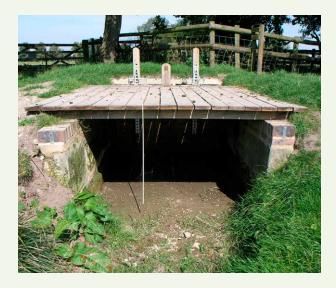
Figure 17
A 'double hatch' water control structure installed at Harnham Water Meadows in 2009 with joint funding from the Environment Agency and Salisbury District Council. It replaces an earlier structure removed during the 1930s.

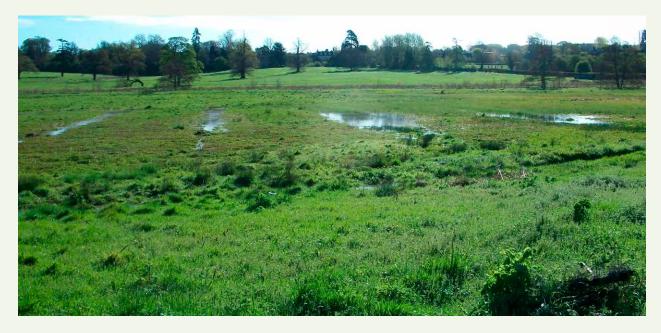
Figure 18
Recently restored water meadows at Wicksteed, form an integral part of the wider historic landscape. Barton Seagrave Hall's landscape park, laid out with advice from Humphrey Repton in

the late 18th and early 19th centuries, lies in the background. The meadow is a key area for wetland biodiversity, forming part of a linear habitat stretching through Kettering.
