Historic England

# Energy Efficiency and Historic Buildings

Open Fires, Chimneys and Flues

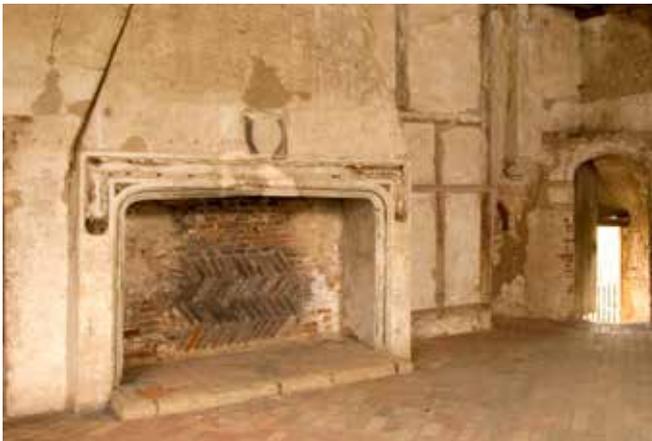
**Figure 1 (above)**  
Fireplace in the first floor bedchamber at Castle Acre Priory.

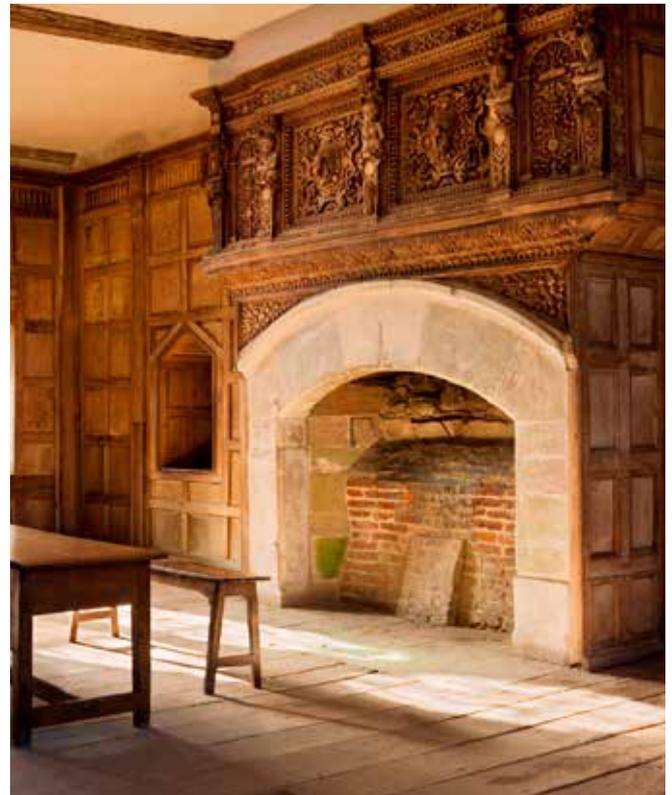
**Figure 2 (right)**  
Fireplace in the solar at Stokesay Castle with 17th century carved overmantel.

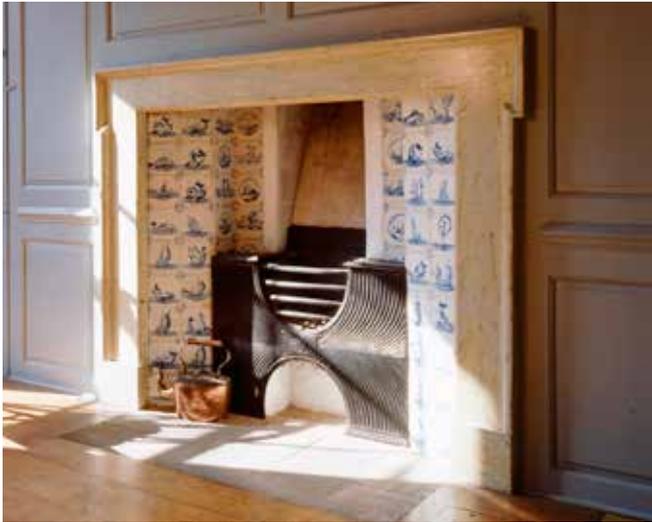
**Figure 3 (above)**  
An 18th century cast iron grate in a fireplace at the Great Yarmouth Row Houses.

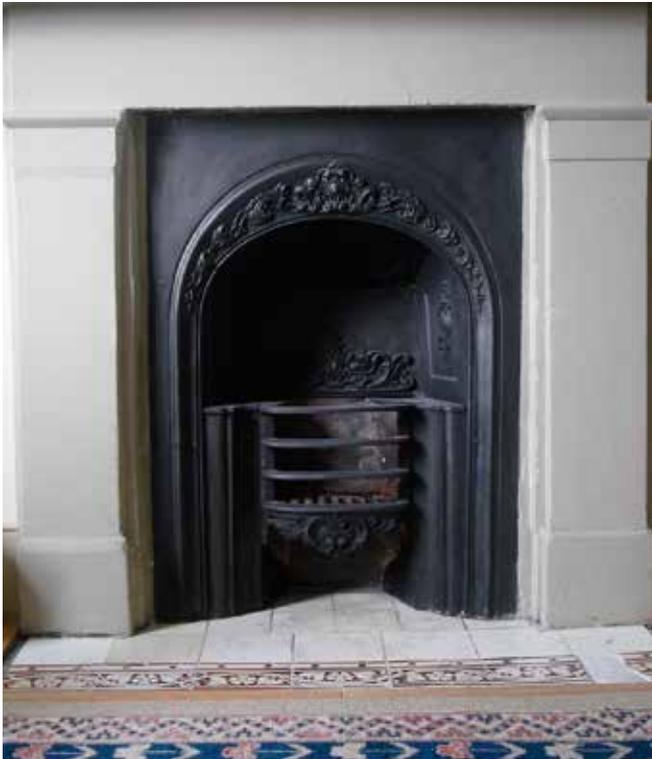
**Figure 7**  
Cast iron fireplaces such as this one often incorporated built in dampers to restrict draughts when the fireplace was not in use.

A chimney for an open fire will be a cause significant draughts when it is not in use. A good remedy for this is to fit a damper, which can be installed either in the throat of the chimney, the flue or at the top of the chimney. The best types are easily opened and closed using a handle that also indicates the position of the damper flap. Dampers should not block all the air entering the chimney as a small permanent flow is necessary to ventilate the flue when it is not in use. If a gas appliance is to be used any damper must be fixed in the permanently open position.

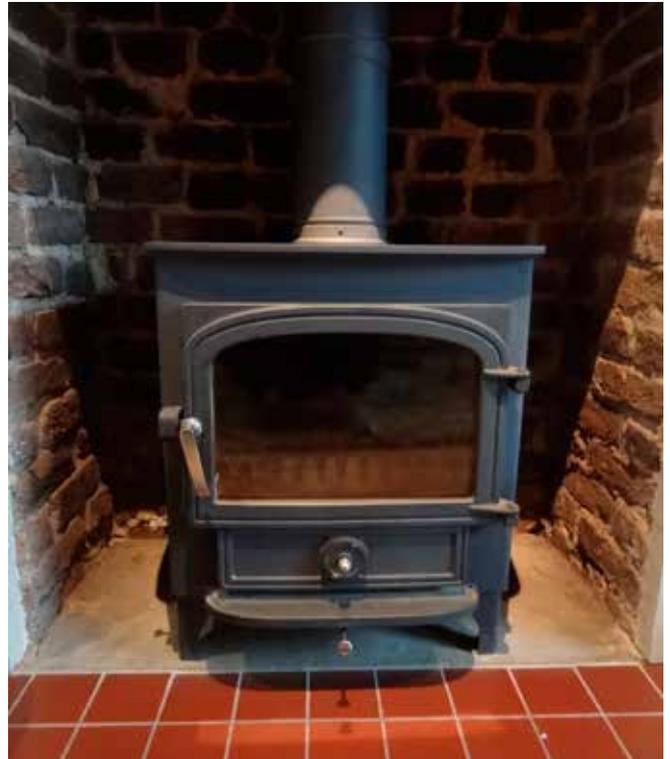
**Figure 8**  
Stoves burn fuel much more efficiently than open fires and cause fewer draughts.

A 'room heater', an enclosed appliance in which fuels are burnt, can be a suitable alternative to an open fire in traditional buildings. A wide range of designs are available. They burn fuel much more efficiently than open fires and cause fewer draughts. Often they can burn wood logs, scraps, chips and pellets, which can help to reduce carbon dioxide emissions. Gas fired versions are also available.

Heat radiates from the casing and through a glass front and by convection from air passing around or through the appliance. Some room heaters are recessed or semi-recessed into a wall, often in an existing fireplace; others are freestanding away from the wall. Some recessed models have back boilers which can supply hot water or central heating. Freestanding stoves are types of room heater. Certain room heaters are certified as being able to burn wood and coal without creating smoke, allowing wood to be burned in smoke control areas.
