ENGLISH HERITAGE

HERITAGE AT
RISK
REGISTER
2013

SOUTH EAST

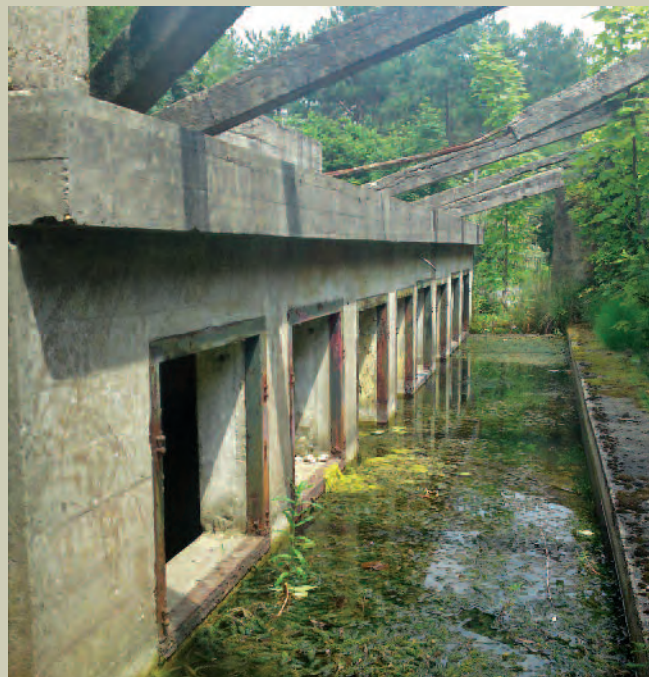
BOULDNOR BATTERY, SHALFLEET, ISLE OF WIGHT

Bouldnor Battery is a military battery situated on the north-west coast of the Isle of Wight, overlooking the western entrance to the Solent. It saw active service in World War II and was fully decommissioned in 1956. The former battery is now in use as a water storage facility and is in a poor state of decay.

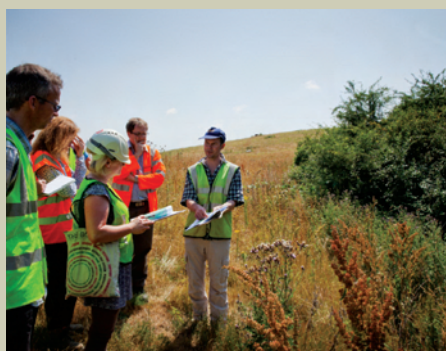
PALAEOLITHIC SITES NEAR BAKER'S HOLE, SWANSCOMBE AND GREENHITHE, KENT

Although now protected from quarrying and other damaging activities, the site has not been managed in any way since at least the early 20th century when it began to be surrounded by chalk quarries. Since then, it has become progressively overgrown by thick scrub and undergrowth, and increasingly subject to animal burrowing and decay due to exposure to the

Deposits known to contain evidence of Palaeolithic occupation and important faunal remains are currently directly exposed to the elements, and being damaged by root growth and animal burrowing. This is affecting key aspects of the site, compromising continuing survival of the evidence that led to its initial protection as a scheduled monument and SSSI.
