# Heritage at **Risk**

Historic England

**Yorkshire Register 2015**

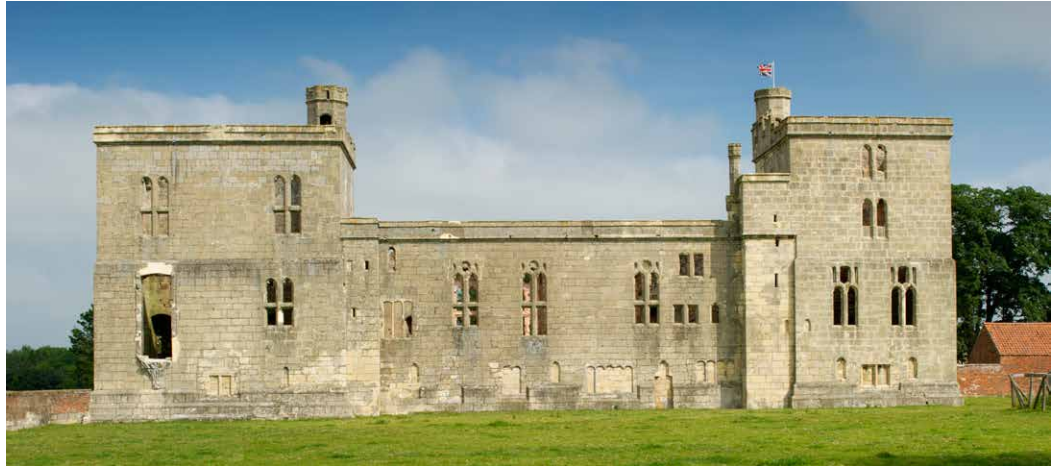
The castle was built for Thomas Percy, Earl of Worcester, around 1380-90. Unfortunately he had little chance to enjoy his new home. His uncle, the Earl of Northumberland, led a revolt against King Henry IV. Sir Thomas was taken prisoner at the Battle of Shrewsbury in 1403 and afterwards beheaded for treason. The majority of the castle was destroyed during the Civil War. However, it continued in use as a manor for nearly 150 years. In 1796 a fire burnt out the remaining part. Sadly the fine plasterwork interiors were lost. Today, about a quarter of the original castle remains above ground.

Wressle Castle has been on the Heritage at Risk Register since 1999. Following close work with the owners and

£500,000 of repairs by Historic England, Natural England and The Country Houses Foundation, the castle was removed from the Register this year.
